# Building and Timber Pest Inspection Report

Inspection Date: Fri, 9 Jan 2026

Property Address: 16 James Cook Pkwy, Shell Cove NSW  
2529, Australia

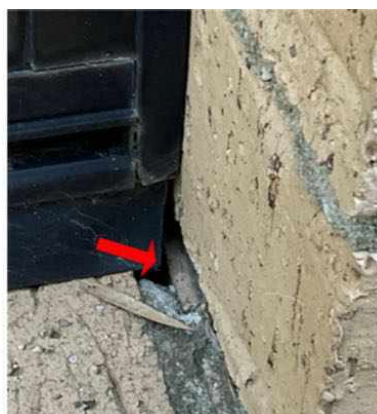
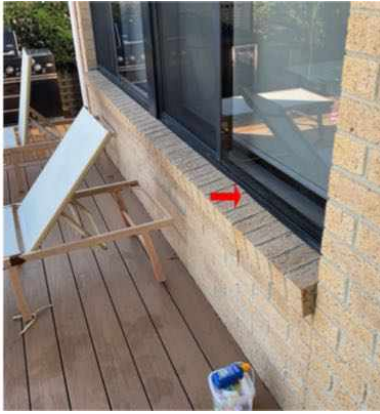
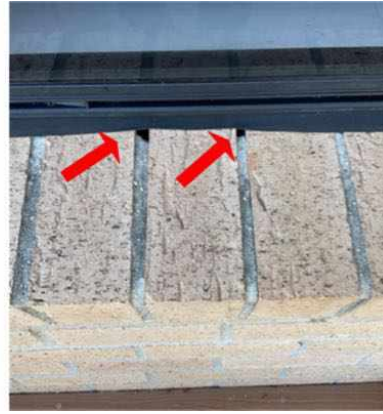
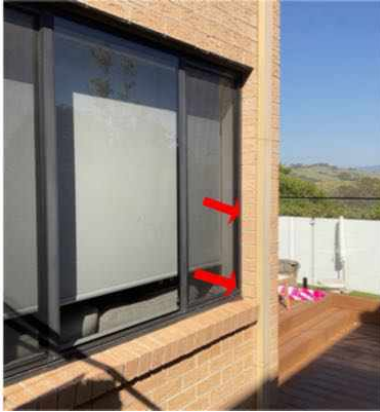
Building: Building 1  
 Location: Exterior walls  
 Finding: Sealant (external) - missing  
 Information: It was noted on inspection that areas of external sealant was missing to areas of the external windows and garage roof. The hole in the garage roof (pictured 1 & 2) is described in this report as a major defect due to the potential damage this hole can cause to the garage. This hole requires urgent flashings. The window photos after this are minor defects.

Flexible sealants should be applied to these affected areas to prevent any subsequent water damage that is likely to occur. All windows on the property should be checked and sealant around the perimeter of any windows with gaps should be applied if required.

A sealant specialist or skilled handy person should be appointed to complete these works as soon as possible

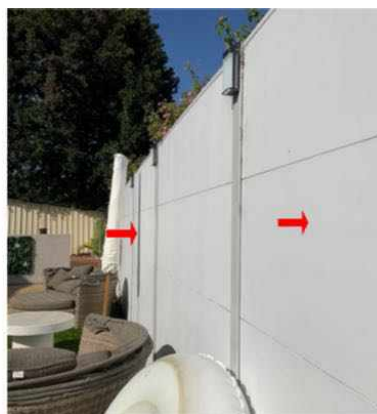
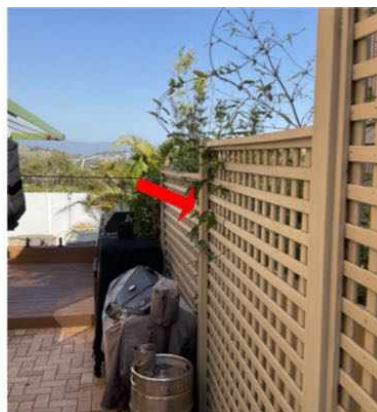
### Finding 3.01

Building:	Building 1
Location:	Pictured rear and rear right fences/lattice
Finding:	Fences damaged - leaning
Information:	Evidence of damage to the pictured fences was identified at the time of the inspection. The likely cause of the rear fence leaning is not enough concrete used in the post footings. If left unmanaged this fence may deteriorate further.

It is suggest a fencing contractor be engaged for rectification when convenient.

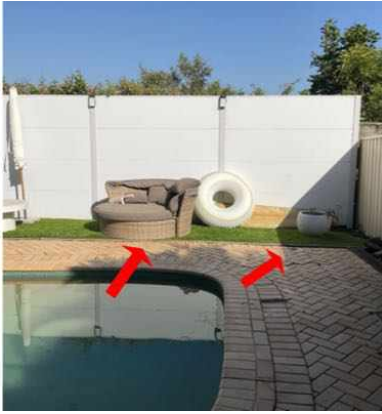
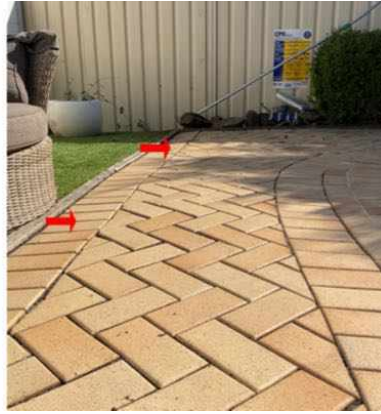
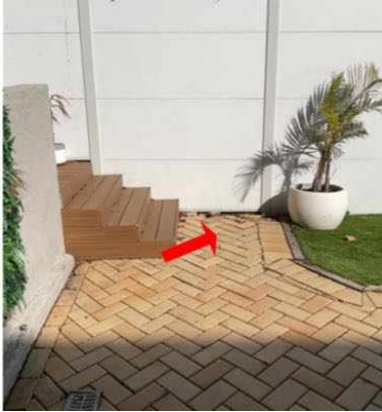
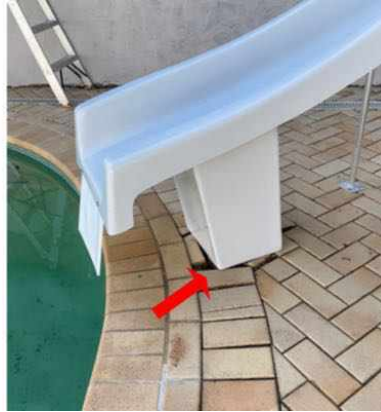
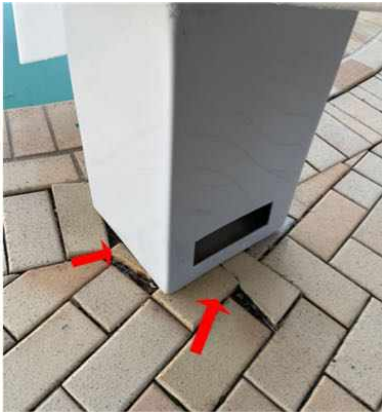
### Finding 3.02

Building:	Building 1
Location:	Pictured areas
Finding:	Subsidence - monitor annually
Information:	It appears that some pool paved areas has been affected by movement, often referred to as sinking or subsidence. General subsidence is usually initiated by changes in soil moisture content. The most critical factor is identifying the specific causes, and identifying if this is a recurring or ongoing problem, or one that has been resolved by previous works in the past.

At this point it is recommended to contain storm water flows, ensure pavements flow away from buildings to lessen any excessive wetting and drying effects and monitor the areas annually.

A landscaping contractor can repair these areas if required.

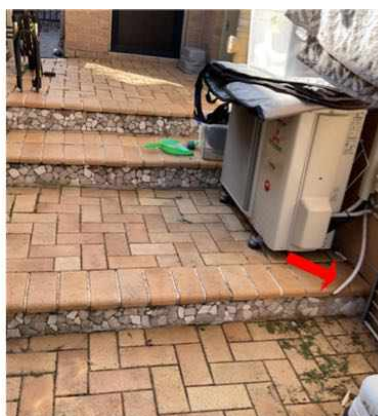
### Finding 3.03

Building:	Building 1
Location:	Walls
Finding:	Site drainage - Inadequate
Information:	The site drainage in this left rear area was found to be inadequate at the time of inspection, creating potential for subsequent water damage to associated building elements.

The air conditioners (on both sides of the house) and hot water system overflows run against the house walls. The left paving adjacent to the left rear house and left rear retaining walls is lower than the surrounding area allowing rainwater to pool.

It is important that water does not lie against the base of walls; surrounding paths and ground levels should be sloped to drain water away from walls. Downpipes should not discharge stormwater onto lower walls or plinths. Stormwater should be carried away by large, regularly cleaned drains. Ground levels may need to be lowered to expose a buried DPC.

Where site drainage is inadequate, installation of an Agricultural (Aggie) Drain may be required. A qualified plumber should be appointed to further inspect the property and perform any remedial works as necessary. Secondary defects are likely to occur if left unmanaged.

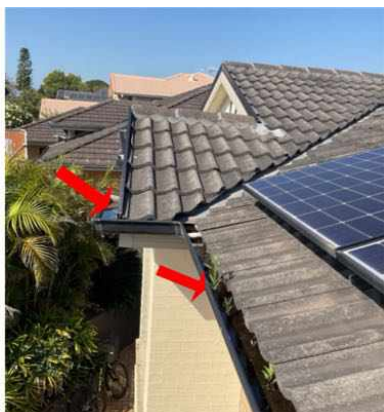
### Finding 3.04

Building:	Building 1
Location:	Roof Exterior
Finding:	Gutter - Insufficient fall
Information:	There is an insufficient fall in the upper front gutters, which means that the angle of this gutter is inadequate for rainwater to drain away. This has resulted in pooling of water in the area, creating the potential for water damage to nearby areas. This is likely to lead to further defects if not repaired. All gutters should be checked as some were inaccessible. Adjustment by a roofing contractor is required as soon as possible to prevent any damage to this area.

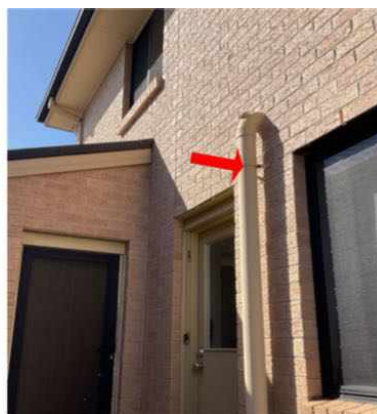
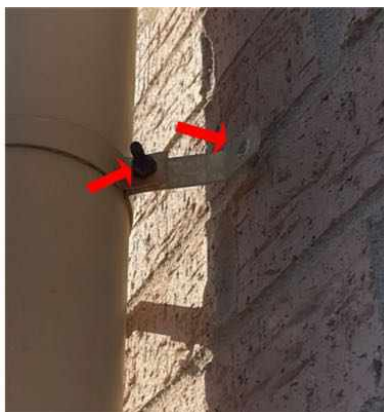
### Finding 3.05

Building:	Building 1
Location:	Pictured areas
Finding:	Additional fixings to pipes
Information:	Evidence of insufficient fixings were evident to these pipes. This downpipe and drain need additional fixings to affix to the adjoining wall ensure its longevity. Some pipe and gutter brackets around the house walls also showed rust.

A carpenter, plumber or skilled handy person should add additional fixings to this area as soon as possible to limit potential damage.

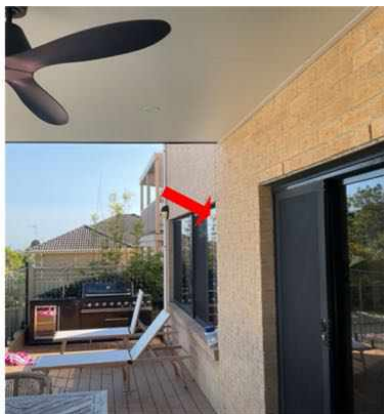
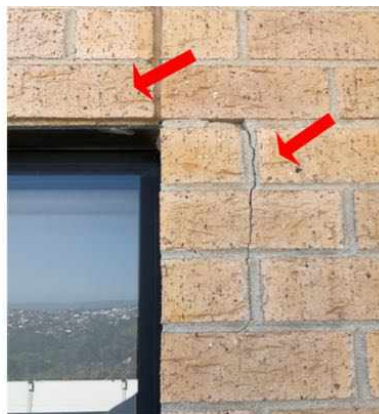
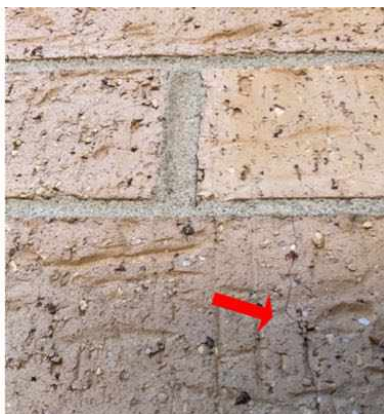
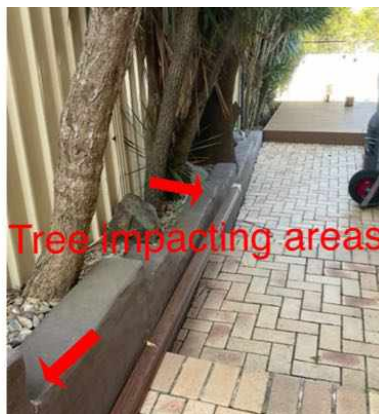
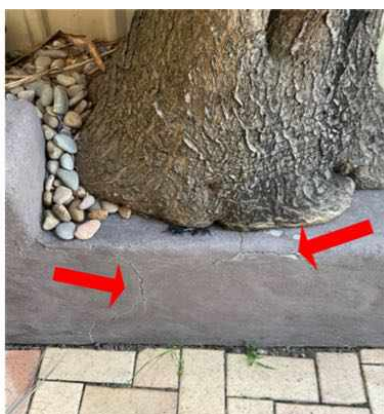
### Finding 3.06

Building:	Building 1
Location:	Exterior rear house and garden walls
Finding:	Step cracking to brickwork (minor)
Information:	Step cracking was identified to the brickwork in this area at the time of inspection. Step cracking, which is similar to other forms of cracking, has a variety of possible causes. However, the most common is the subsidence of adjacent footings.

Where step cracking is extensive or severe, the client is advised to consult a structural engineer. This minor step cracking can be used as a warning sign to address factors causing stress to the wall, which can include the effect of surrounding trees, water leaks, soil erosion, or even the presence of reactive soils in the surrounding area.

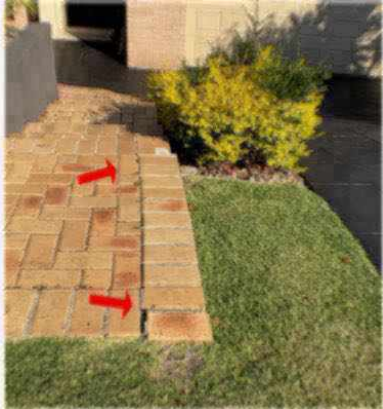
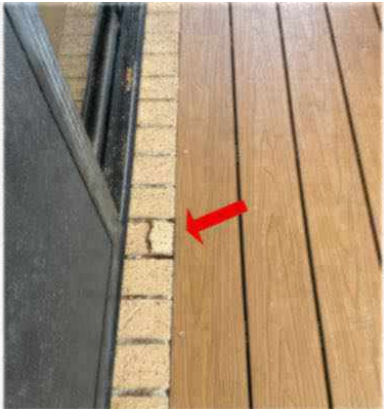
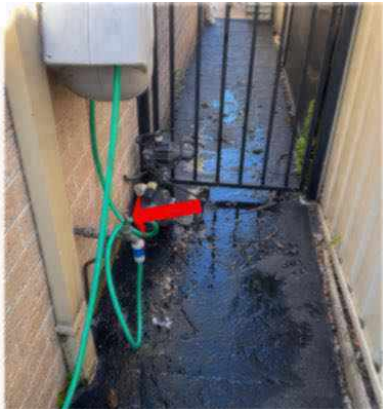
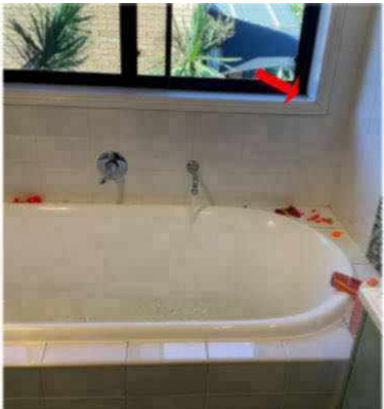
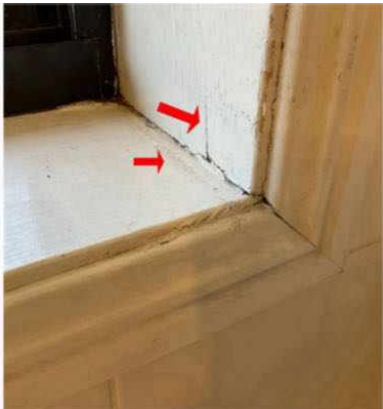
Building: Building 1  
 Location: Pictured external areas  
 Finding: Building elements - Damaged  
 Information: Evidence of minor missing or damaged areas was identified at the time of the inspection. These include -

1. The water meter has minor impact damage not affecting its function.
2. Some path brickwork is loose requiring refixing. One rear entry brick has cracked.
3. The right front tap has a small leak from the handle (water pictured not from this

leak).

5. The bedroom light fitting is loose.

A carpenter and plumber would be the trades responsible for rectification of these areas when convenient.

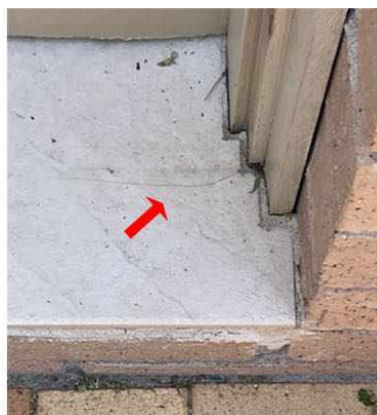
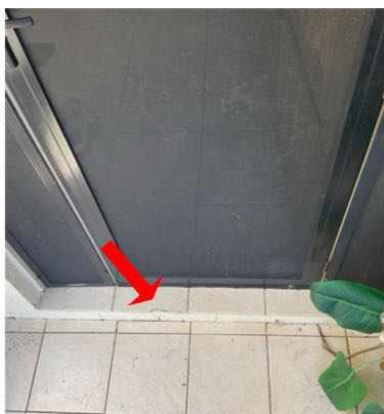
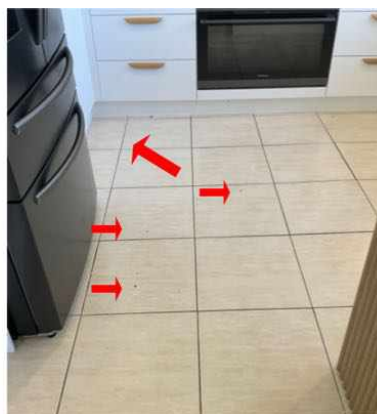
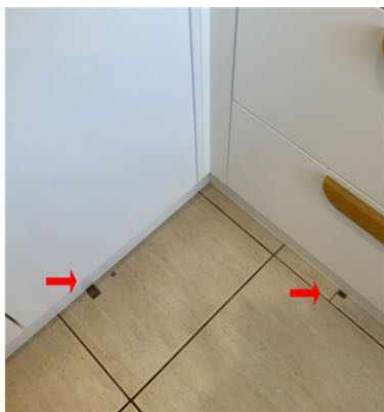
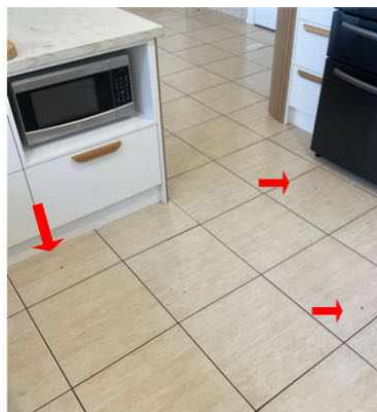
### Finding 3.10

Building:	Building 1
Location:	Entry areas, kitchen
Finding:	Tiles cracked, chipped
Information:	Cracked, chipped and cut (old renovations) tiles were evident in these pictured areas at the time of inspection. It is suspected that this cracking has occurred as a result of minor settlement and impact damage. Cracked tiles throughout the household detract from the overall appearance of the affected areas. In wet areas of kitchens and bathrooms, it can lead to water damage of adjoining walls and floors.

Replacement of cracked tiles is recommended as soon as possible. A tiling contractor may be appointed to perform these works. Where cracks become more numerous, contact a licensed building inspector for further investigation.

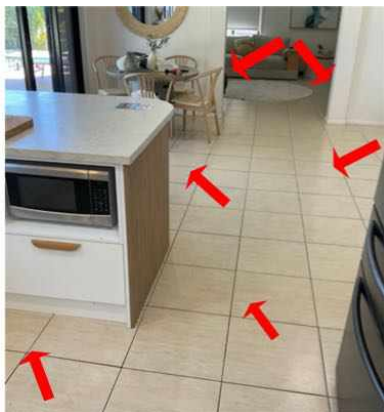
### Finding 3.11

Building:	Building 1
Location:	Pictured lower areas
Finding:	Tiles - Drummy
Information:	Drummy tiled areas were identified at the time of inspection. The term 'drummy' refers to tiles that have become detached from their fixing, despite otherwise being in relatively good condition. Such defects are generally caused by physical or moisture damage to the area. Drummy tiled areas may also be a direct result of poor workmanship during the construction process.

Specialist trades are available for these types of services. A registered builder may be required to undertake works if damage is extensive or if secondary building defects have resulted. Otherwise, it is advised that a tiling contractor be appointed to perform works as necessary.

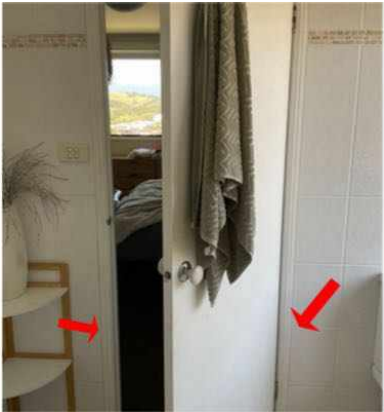
### Finding 3.12

Building:	Building 1
Location:	Bathrooms and other areas
Finding:	Cracking & other damage - Damage Category 1 - Fine (up to 1mm)
Information:	Although fine cracks and impact damage are quite noticeable, they are often only considered to be an appearance defect, and usually do not indicate any structural damage. Generally, the cause of a fine crack is indicative of a separation between building materials and finishes (e.g. paint, plaster, etc.) along joins.

Over a dozen areas of plaster impact damage was found throughout, most were repaired but not repainted.

Cracking of this nature can generally be repaired with minor sanding, filling and/or repainting. Such works should be performed by a qualified painter or a general handyman.

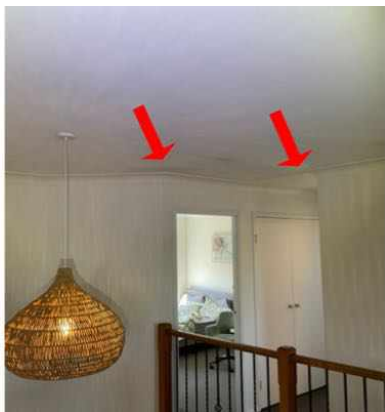
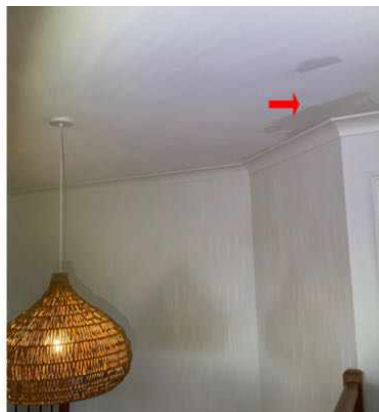
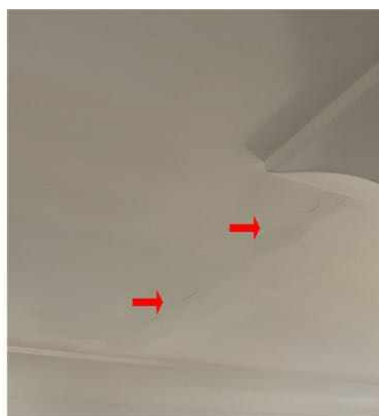
**Finding 3.13**

Building: Building 1  
Location: Pictured areas  
Finding: Plaster - Cracking noticeable  
Information: There were several cracks and or crack repairs evident to the upper stairs and hall plaster ceilings areas.

Noticeable cracks are a common occurrence and are a likely result of age expected building movement, general expansion, and/or contraction of building materials in different weather conditions. This area may have had previous water damage or impact from persons accessing the ceiling void.

It is highly advised that a qualified plasterer be appointed to provide necessary works to repair these areas. Such works should be conducted as soon as possible.

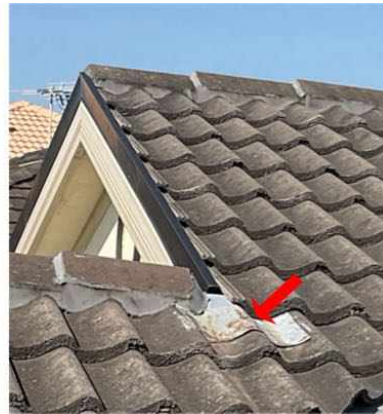
### Finding 3.14

Building:	Building 1
Location:	Garage lintel, roof and internal areas
Finding:	Building elements - Rusted or corroded
Information:	These building element shows evidence of minor rusting and corrosion, which is likely to have developed as a result of excessive exposure to moisture and or inadequate coatings.

Rusting and corrosion should be managed by ideally removing or limiting the affected surface from exposure to moisture. A registered builder may be appointed to replace

any building elements that have been severely affected by rust or water damage.

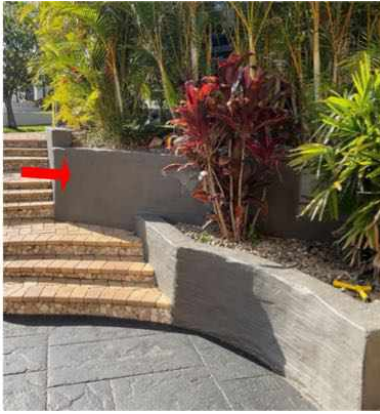
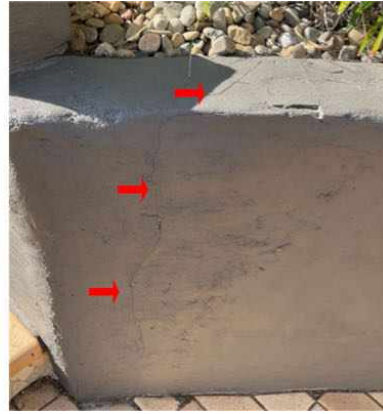
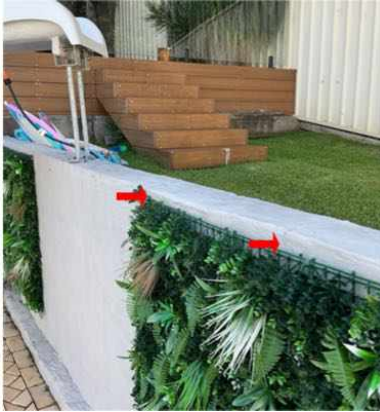
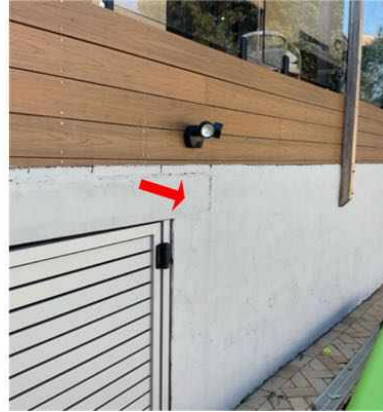
Building:	Building 1
Location:	Pictured external areas
Finding:	Render (external) cracking.
Information:	It has been observed that minor cracking to some external rendered surfaces. The degree of damage is described as "slight" noticeable cracks which are easily filled. Cracking of this size are generally less than 5mm in width.

Always contact your building inspector should cracks widen, lengthen, or become more numerous.

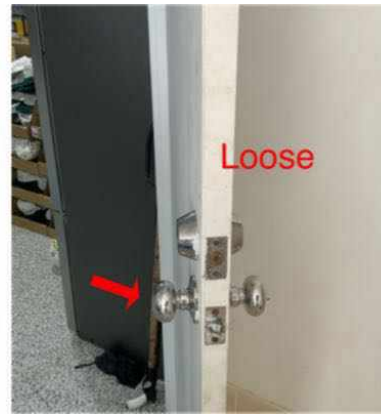
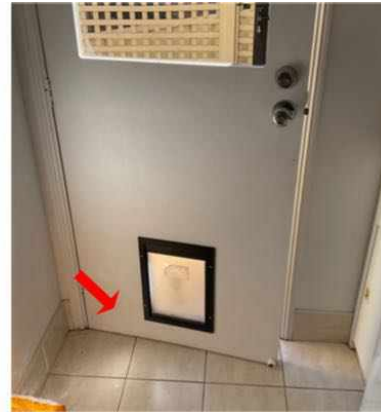
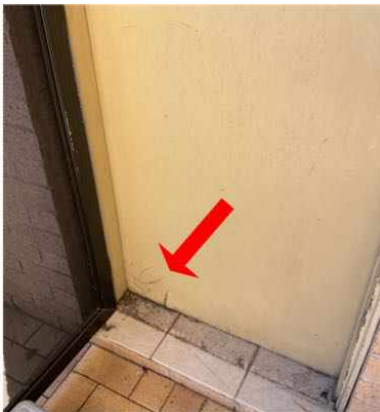
### Finding 3.16

Building:	Building 1
Location:	Pictured areas
Finding:	Doors - Missing handle, loose, binding, delaminating
Information:	One bedroom door has a handle missing, one has a loose handle and the lower toilet door is binding on the frame. The laundry door is delamination and needs repair, the rear garage door has rotted requiring replacement. Although some building elements may seem irrelevant or unnecessary, all building elements play a key role in the operation and function of the overall structure and its performance.

Replacement or repair of these doors is advised . A building maintenance person can perform these works at client discretion.

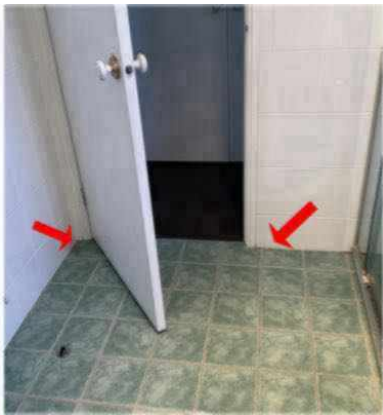
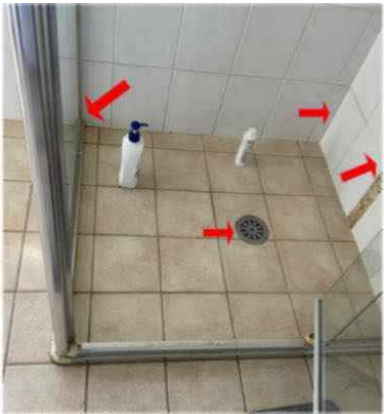
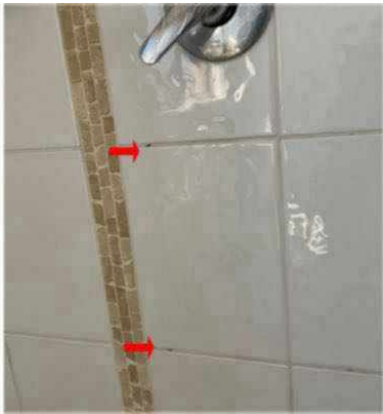
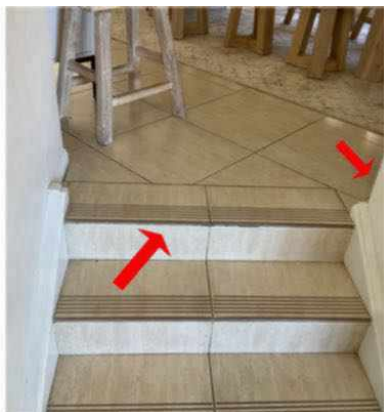
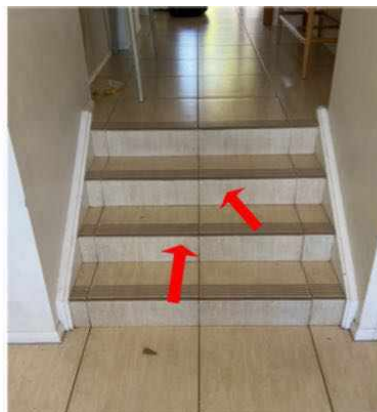
Building:	Building 1
Location:	Bathrooms and laundry
Finding:	Sealant and grouting - Missing or damaged
Information:	It was noted on inspection that sealant or grout is degraded to these pictured areas.

Different materials and floor areas move at different rates, generally causing cracking to grout or sealant at this point. A flexible sealant is required to allow for expected expansion and contraction, while keeping the joint water tight and protective of all associated building materials.

Flexible and mould resistant materials should be applied to affected areas to prevent any subsequent water damage that is likely to occur. Regular maintenance and

replacement of damage or missing or damaged sealant and grout is highly recommended to the wet areas, as this is a regular wear and tear defect. Sealant and grouting in areas that come into regular contact with water should be maintained for the long term care of your property.

A sealant specialist or tiling contractor should be appointed to complete these works as soon as possible

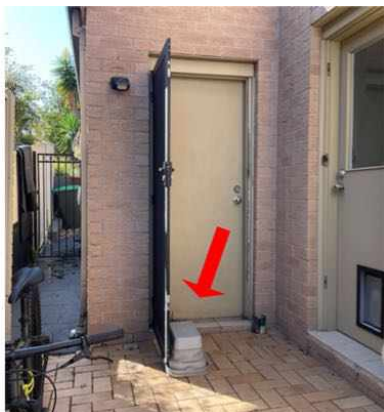
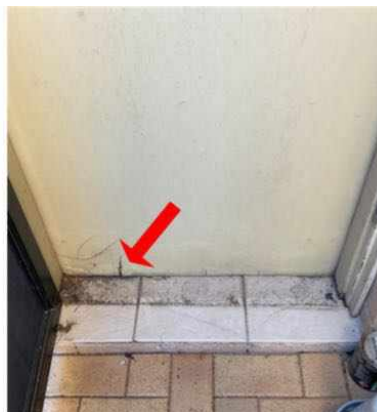
### Finding 3.19

Building:	Building 1
Location:	Garage door
Finding:	Wood rot
Information:	This door shows evidence of wood rot. Wood rot, also known as Fungal Decay, occurs when timbers and other cellulose building materials are exposed to damp conditions on an ongoing basis. This could be the result of exposure to weathering over a prolonged period of time, or the attraction of excessive moisture from other abutting building materials.

Early intervention and regular maintenance, particularly of exterior timbers, will prolong the useful life of these building elements. Prior to any works being performed, the cause of the moisture that has created the visible wood rot should be identified and addressed in a suitable manner. Replacement of affected timbers may then be a necessary step in protecting surrounding building elements from such deterioration.

A qualified carpenter or registered builder may also be required to replace the affected door.

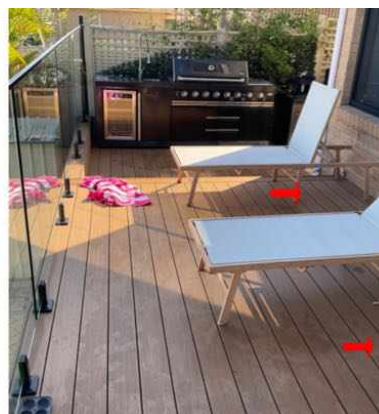
## Finding 6.02

Building:	Building 1
Location:	Yard - front
Finding:	Bridging - decking
Information:	Where decking obstructs inspection of building elements, also known as bridging as it provides a bridging point for the access of termites, full inspection can not be achieved. Consequently moisture or dampness may be present and the areas becomes conducive to termite activity. Decks against or very close to buildings provide cover, shade and can provide an environment that is attractive to termite infestation.
	Leaving a small gap between decking and the building walls will assist greatly in preventing Bridging from occurring.

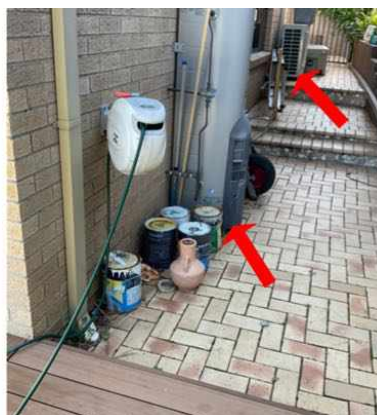
### Finding 6.04

Building:	Building 1
Location:	Pictured external wall areas
Finding:	Overflows - Not plumbed for drainage
Information:	The pictured overflow pipes are not plumbed or connected to suitable drainage. These areas can lead to secondary defects such as rot, rust or corrosion of associated building elements, the formation of fungal decay, or even the creation of potential slip hazards. When coupled with poor site drainage, pooling of water may also attract termite activity to this area. It is highly recommended that a qualified plumber be appointed to install adequate drainage to these areas. These works will ensure that the area remains dry and free of any secondary defects.

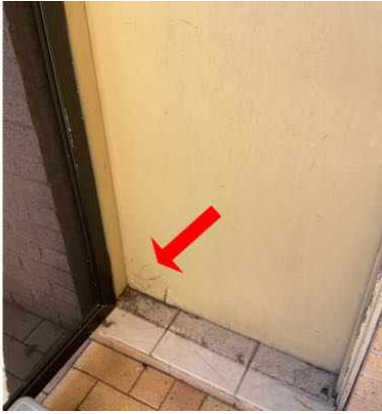
Building:	Building 1
Location:	Rear garage door
Finding:	Fungal decay - present (localised)
Information:	Fungal decay also known as wood decay or wood rot generally refers to the deterioration of timber elements when in contact with excessive levels of moisture for a prolonged period of time.

The development of fungal decay is accelerated by temperatures from 5degreeC to 40degreeC as well as the presence of oxygen. Generally fungal decay develops on timber elements that are in use in an external environment which are exposed to rain penetration.

Note - See ALL wood rot photos in building defects above, all these show fungal decay.

In this case, the affected timber element is in a decaying state and will need replacement by a carpenter or licensed builder.

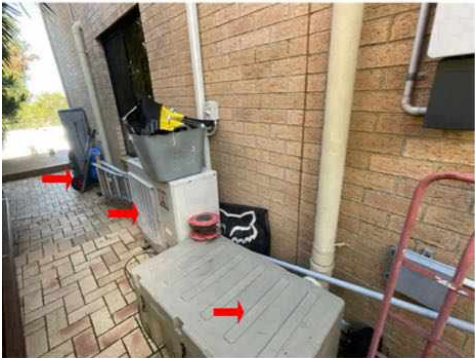
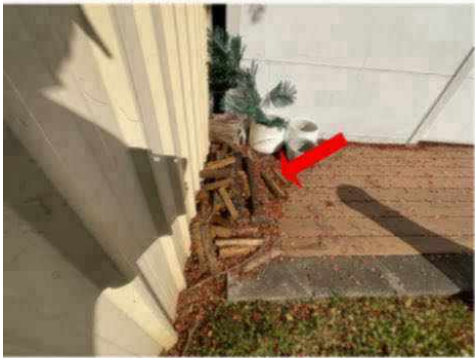
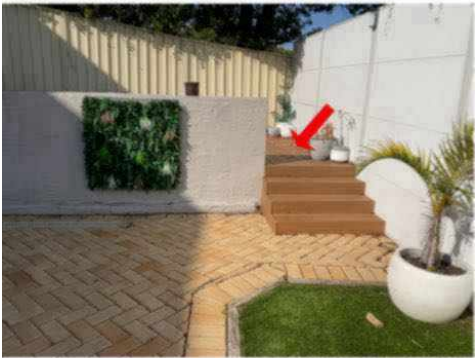
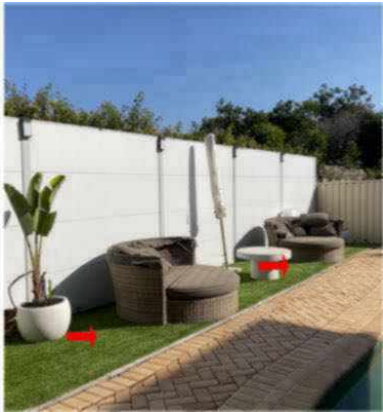
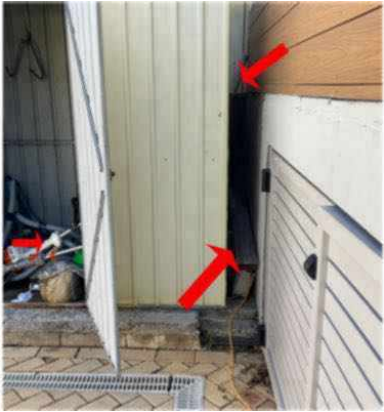
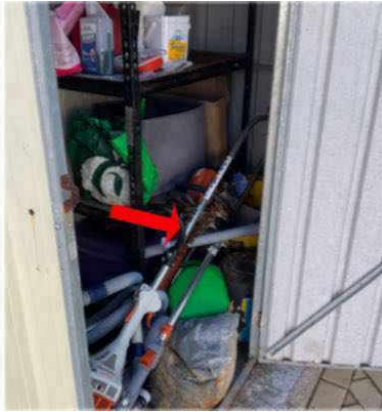
Building: Building 1  
Location: All External Areas  
Finding: Additional Photos - Obstructions and Limitations of EXTERNAL AREAS  
Information: These photographs are an indication of the obstructions and limitations which impeded full inspection of external areas at the time of inspection. These obstructions can hide an array of defects and should be removed to allow full inspection to be carried out. A re-inspection is recommended once the areas are made accessible.

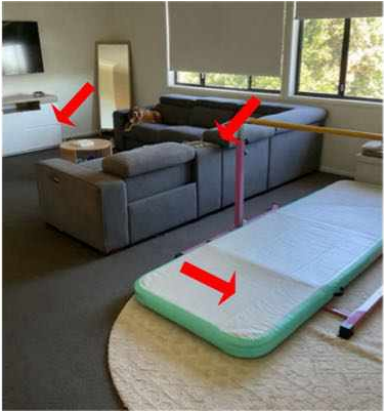
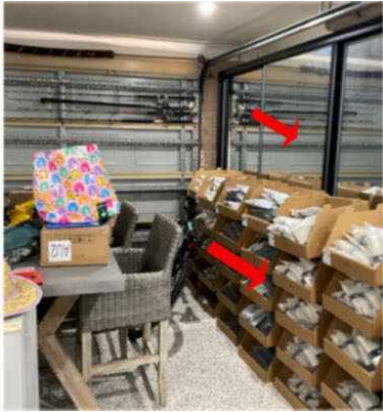
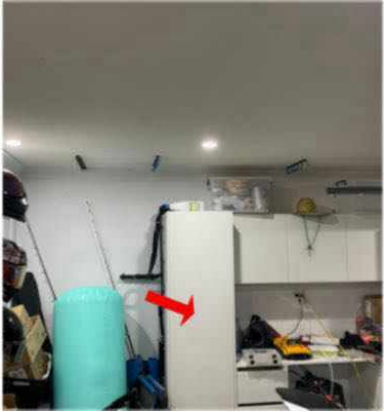
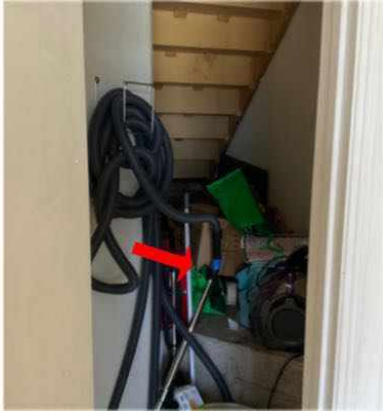
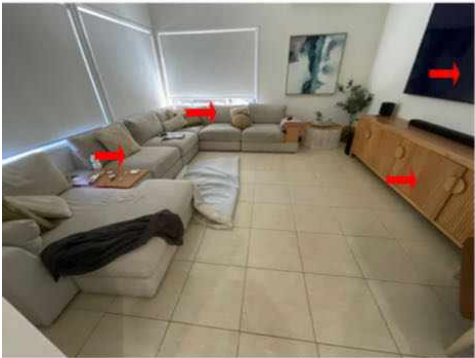
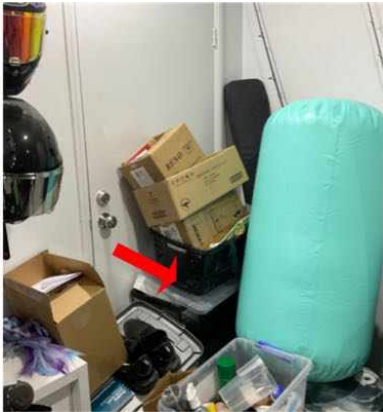
Building: Building 1  
Location: All Internal Areas  
Finding: Additional Photos - Obstructions and Limitations of INTERNAL AREAS  
Information: These photographs are an indication of the obstructions and limitations which impeded full inspection of Internal areas at the time of inspection. These obstructions can hide an array of defects and should be removed to allow full inspection to be carried out. A re-inspection is recommended once the areas are made accessible.

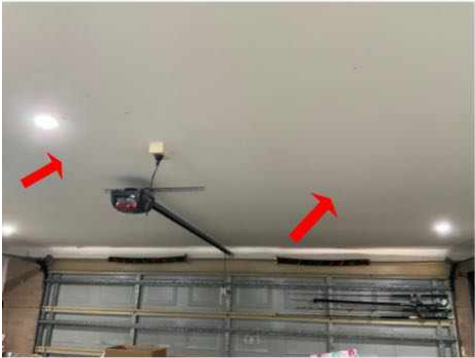
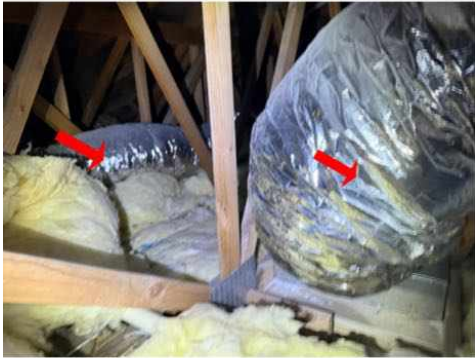
Building: Building 1  
Location: All Roof cavity areas  
Finding: Additional Photos - Obstructions and Limitations of the ROOF CAVITY  
Information: These photographs are an indication of the obstructions and limitations which impeded full inspection of roof cavity areas at the time of inspection. These obstructions can hide an array of defects and should be removed to allow full inspection to be carried out if applicable. A re-inspection is recommended once the areas are made accessible.

The inspection was also limited to areas with an allowable crawl space of 600mm x 600mm, in particular towards the external walls where the roof line diminishes, these areas were not accessible.

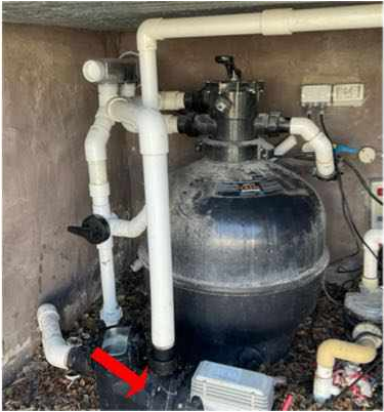
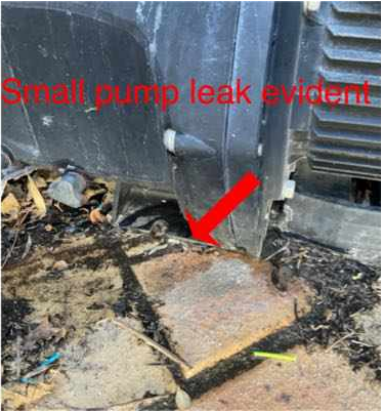
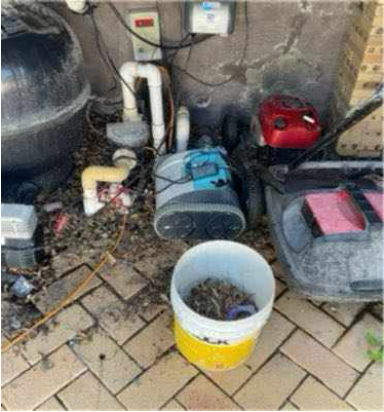
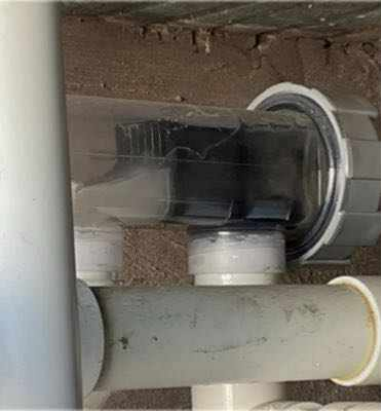
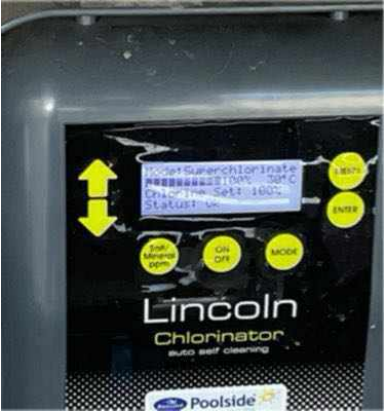
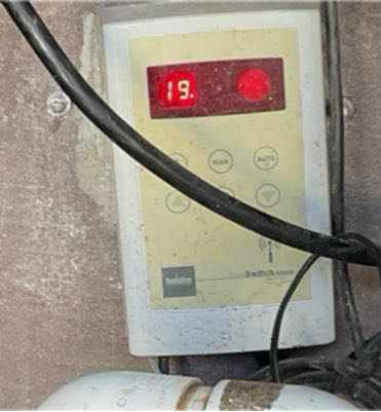
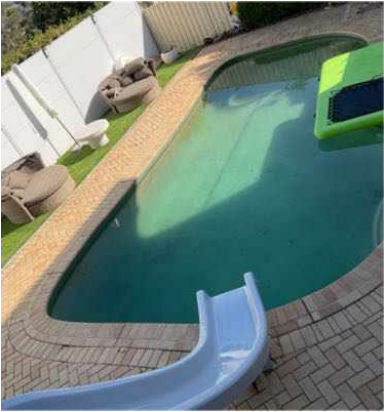
Building: Building 1  
Location: Pool areas  
Finding: Additional Photos and very small pump leak  
Information: A small leak in the pool pump was evident. A pool technician should be consulted for evaluation of this equipment and repair.

Additional photos are provided for your general reference.

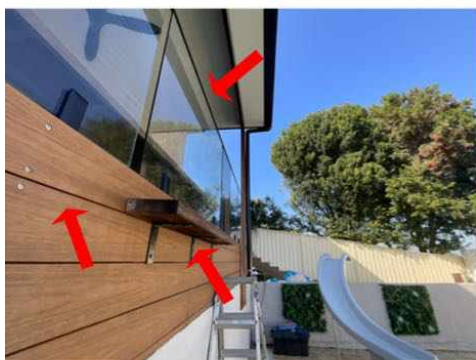
Building:	Building 1
Location:	Rear deck
Finding:	Elevated structure inspections
Information:	Where any elevated Structure (deck, balcony, verandah etc) is present, and this elevated structure is designed to accommodate people, you MUST have this structure checked by an engineer or other suitably qualified person.

Nothing contained in this report should be taken as an indicator that an assessment has been made, on any elevated structure, as suitable for any specific number of people or purpose. This can only be done by a qualified engineer. For the purpose of this report, the Structure includes elevated rear deck and handrails.

You should also arrange annual inspections of the structure by an engineer or other suitably qualified person to ensure any maintenance, that may become necessary, is identified. Care must be taken not to overload the structure.

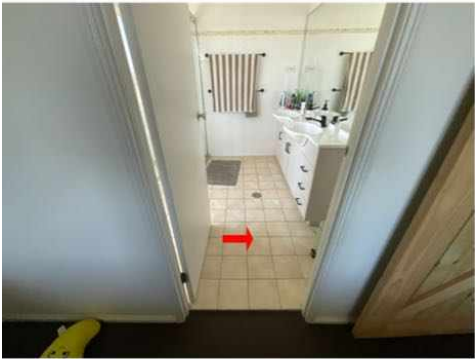
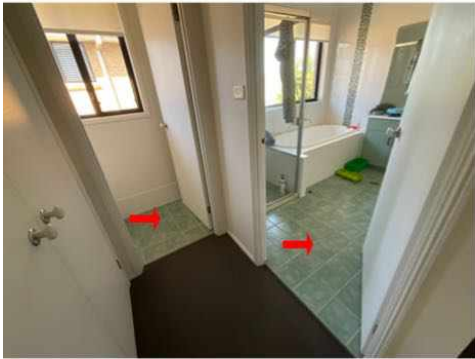
Building:	Building 1
Location:	Bathrooms and laundry
Finding:	Waterproofing membranes - Information Only
Information:	Internal Water Proofing Membranes, are crucial in preventing water ingress into the property is important to know that the Membrane System used is to Australian Standards and has been installed correctly.

With older property's where this information is unavailable all wet areas should be monitored. If any leaks, water staining, peeling or bubbling of the paint become evident to any adjacent walls or ceilings below a licensed builder or waterproofing specialist is recommended to investigate further.
