Building Inspection Report

Inspection Date: Mon, 16 Mar 2026

Property Address: unit125 /151-153 Mudjimba Beach Rd,
Mudjimba QLD 4564, Australia

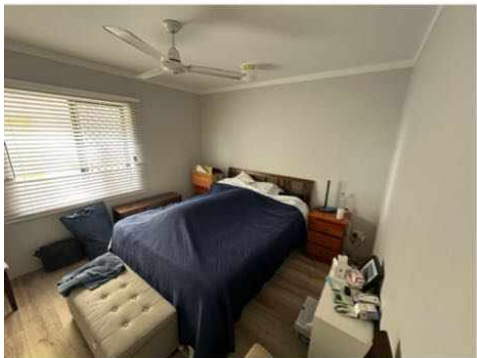
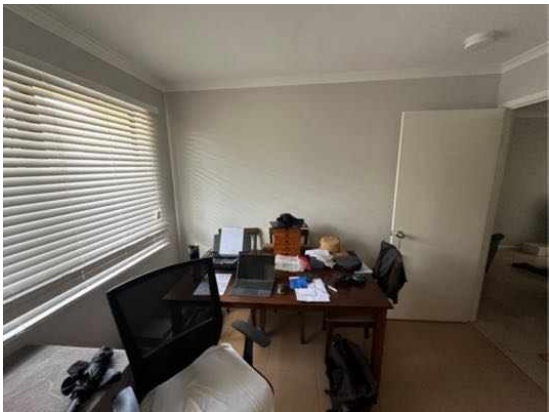
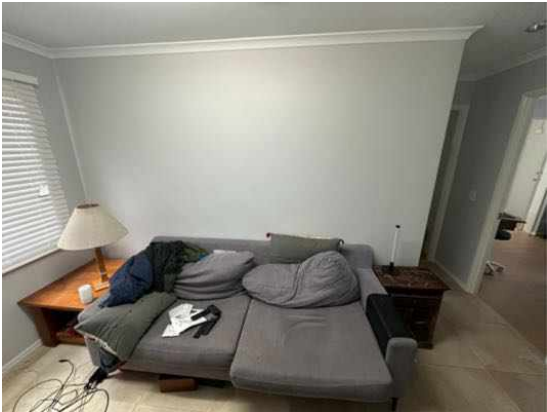
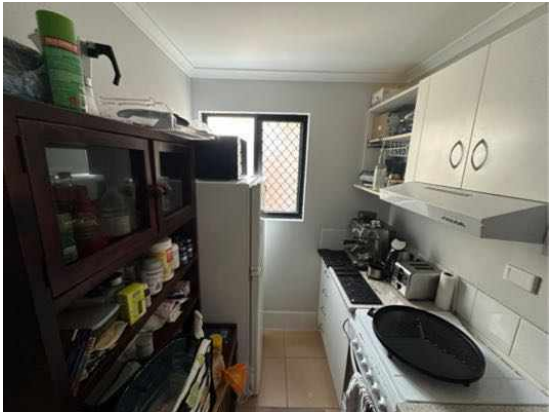
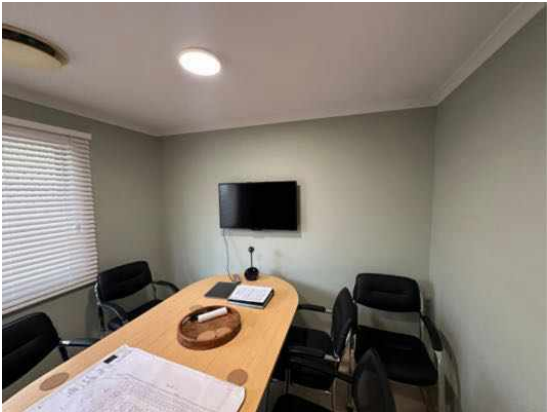
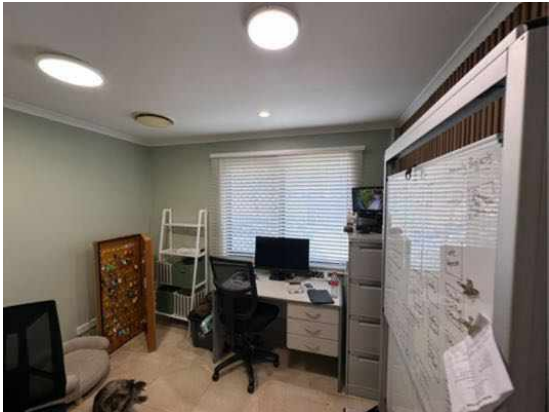
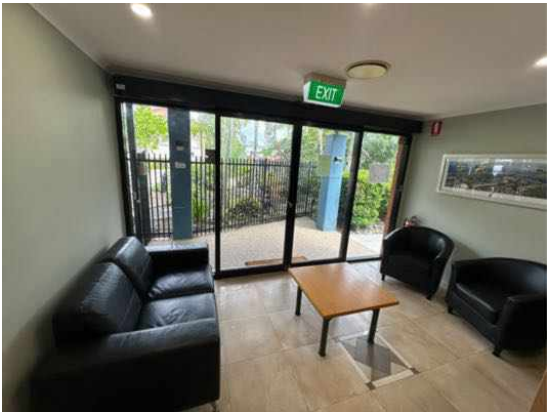
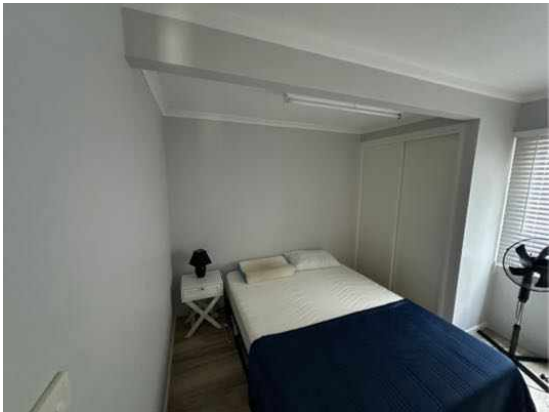
Defects 3.11

Building: Main Building
 Location:
 Finding: Additional Photos - Obstructions and Limitations
 Information: These photographs are an indication of the obstructions and limitations which impeded full inspection of the property at the time of inspection. These obstructions can hide an array of defects and should be removed to allow full inspection to be carried out.

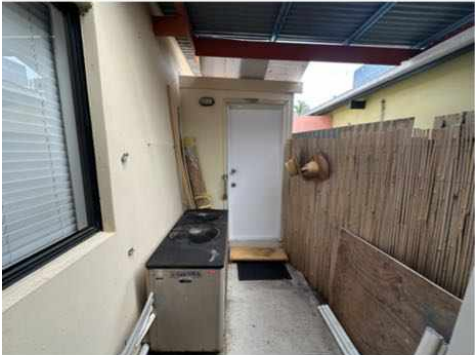
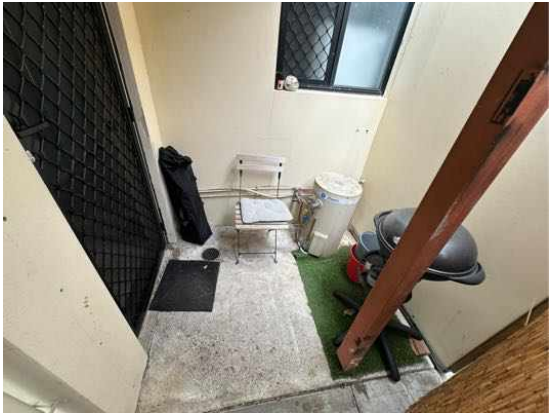
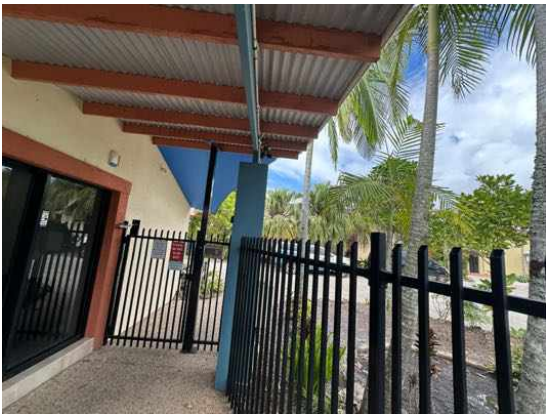
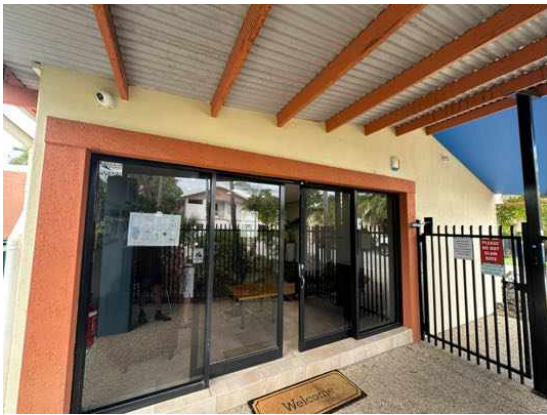
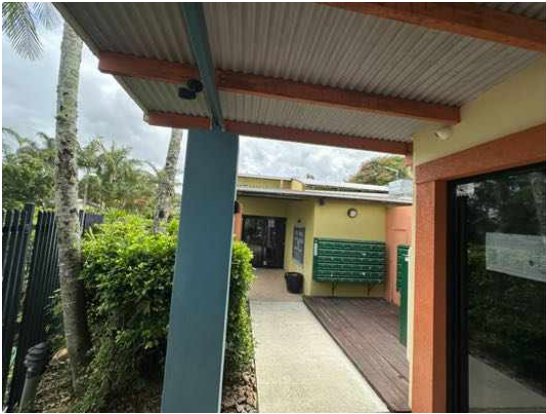
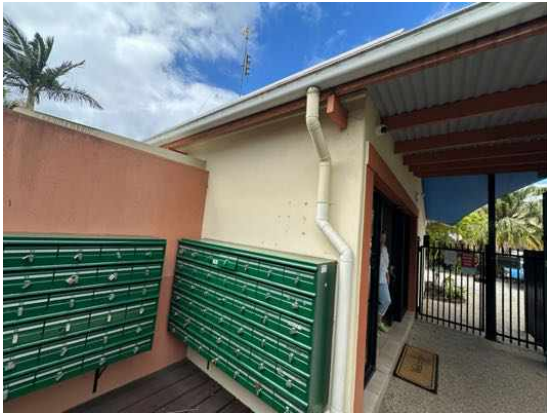
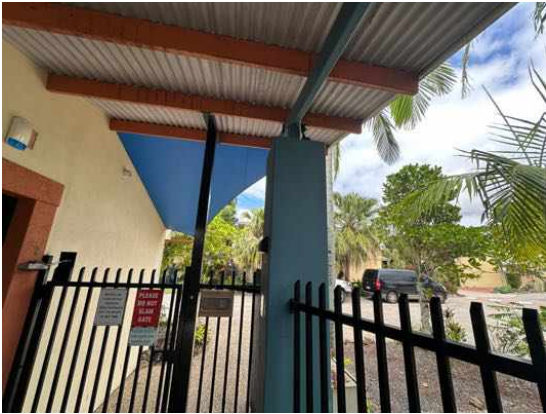
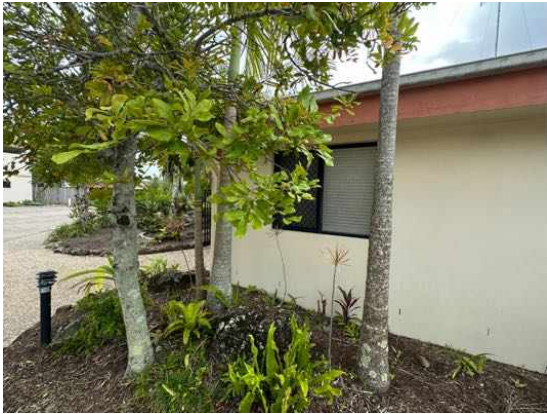
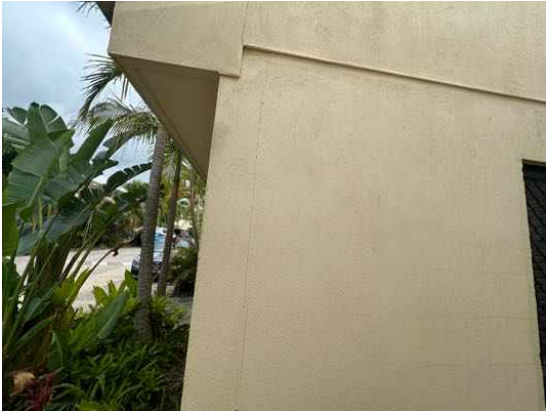
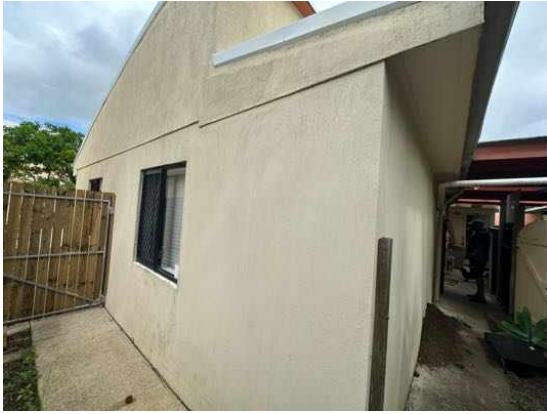
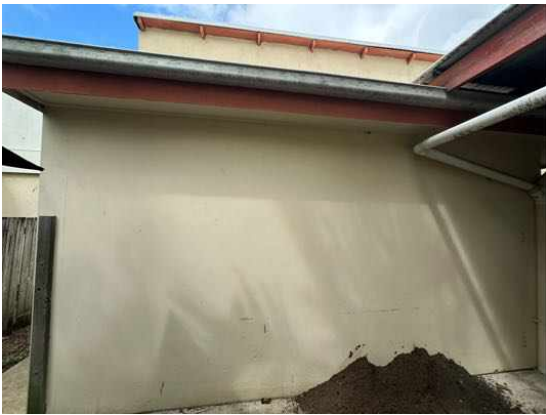
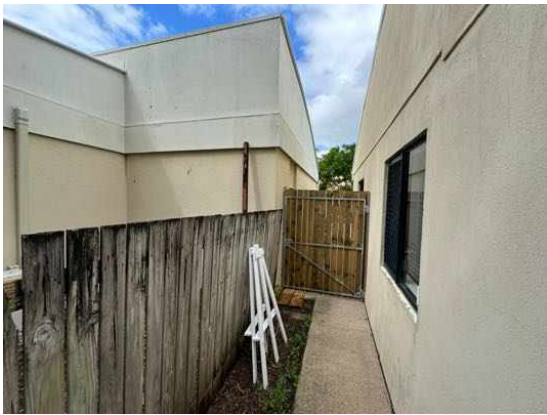
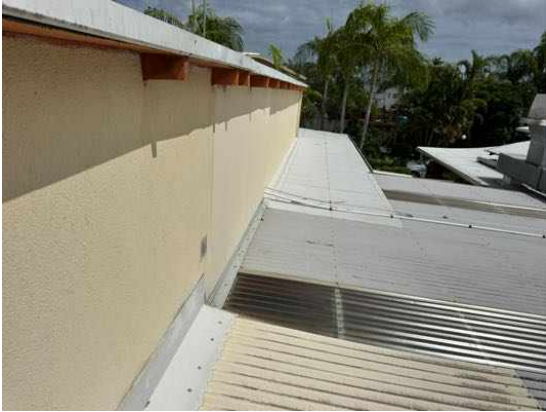
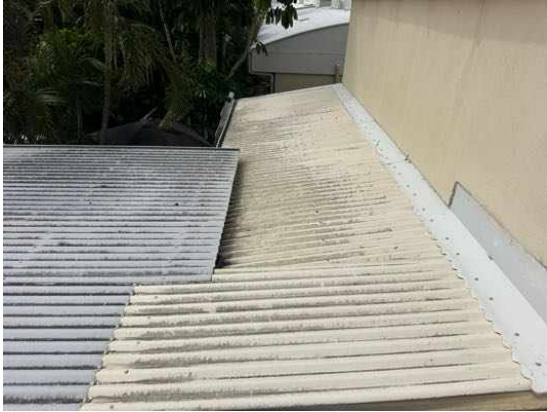
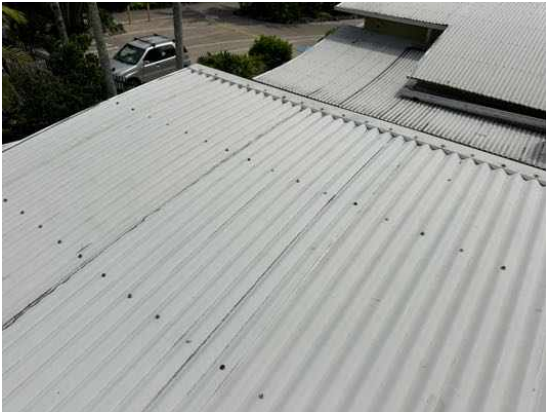
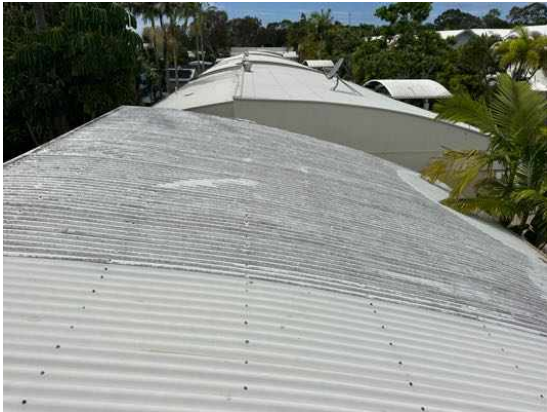
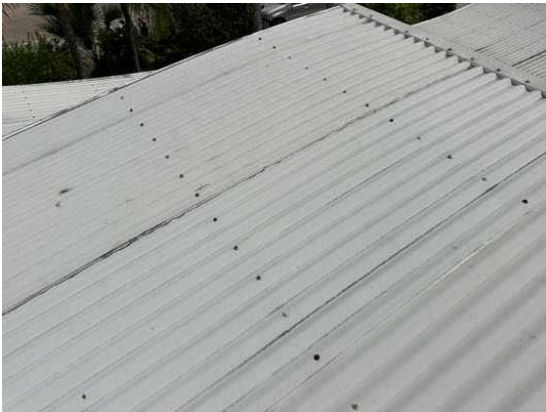
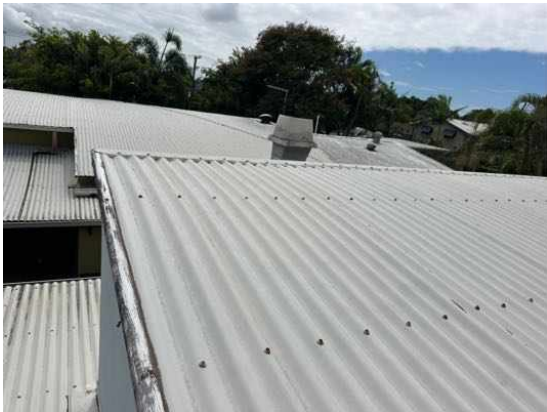
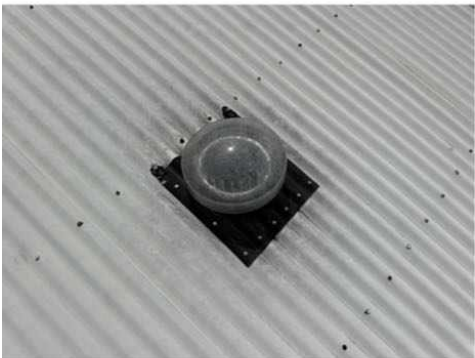
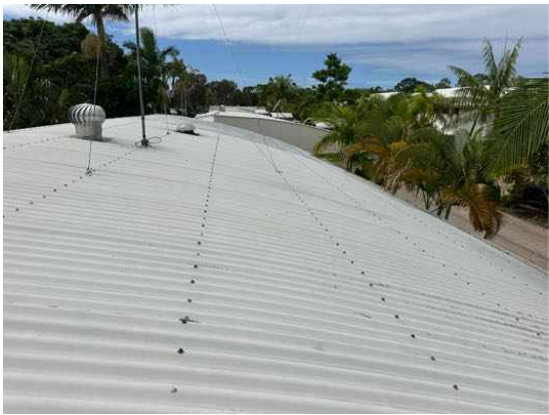
Noted Item

Building: Main Building
Location: External Areas
Finding: Additional Photos
Information: Additional photos are provided for your general reference.

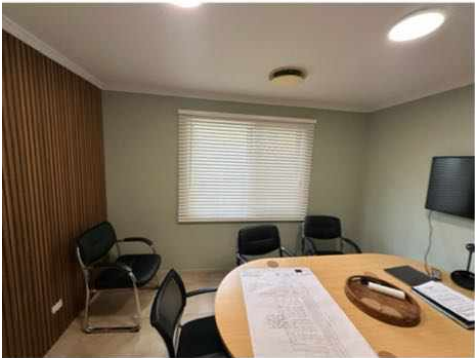
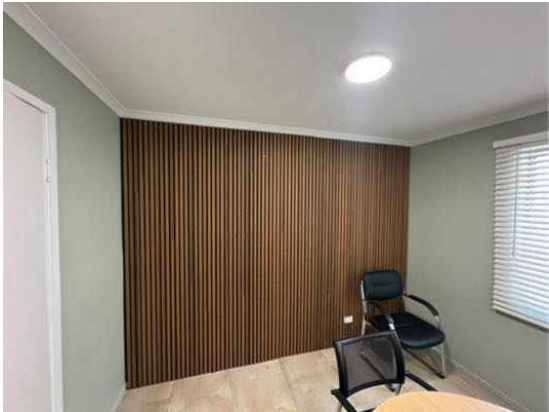
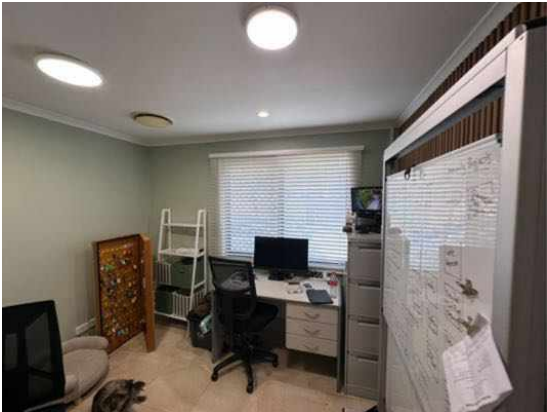
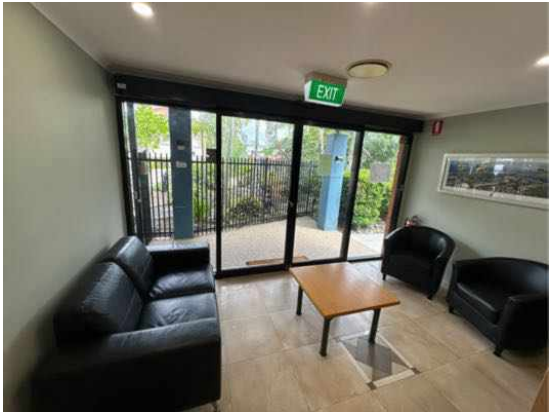
Noted Item

Building: Main Building
Location: Internal Areas
Finding: Additional Photos
Information: Additional photos are provided for your general reference.
