Building Inspection Report

Inspection Date: Tue, 17 Mar 2026

Property Address: 1/223 Elgar Rd, Surrey Hills VIC 3127,
Australia

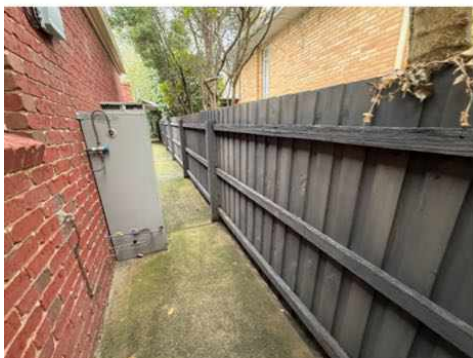
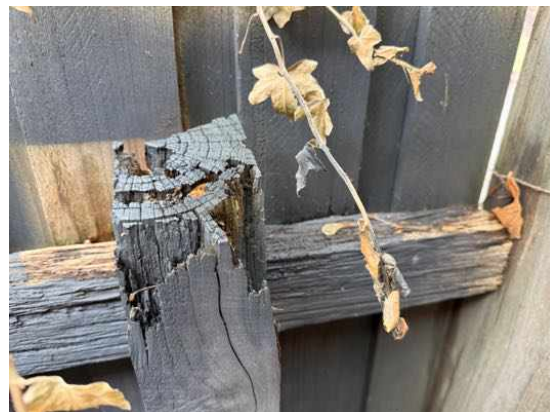
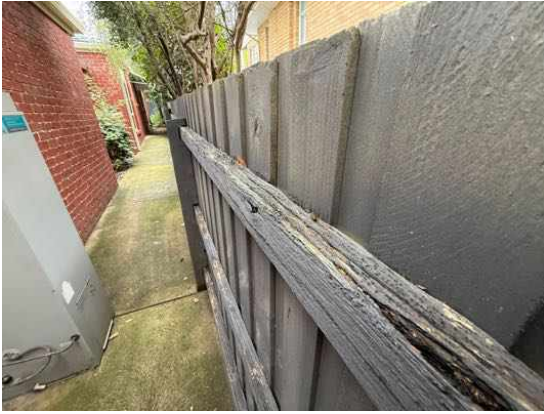
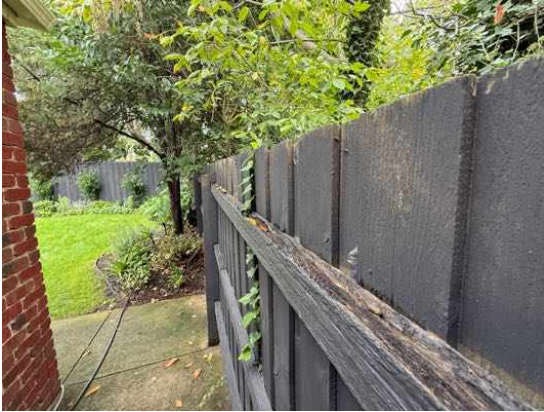
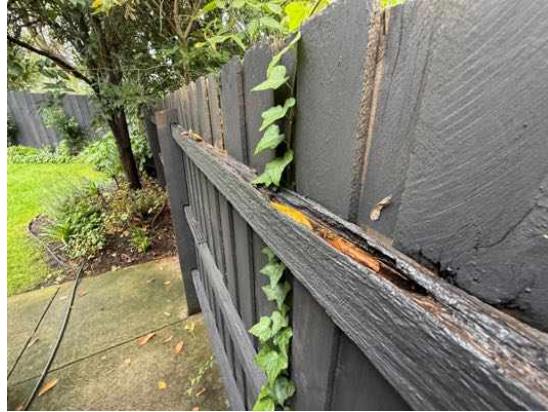
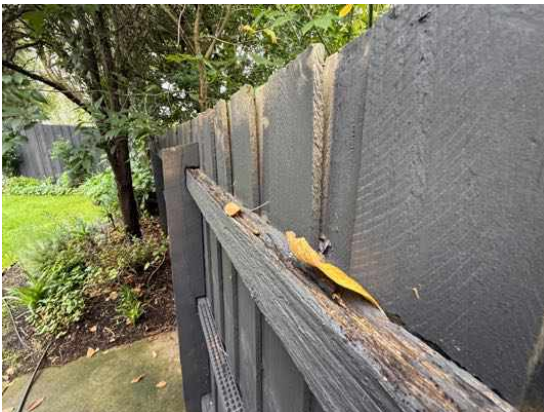
Defects 3.01

Building: Building 1
Location: All Areas > All Areas
Finding: Wood rot affecting the perimeter fencing
Information: Wood rot was observed to be affecting the perimeter post and rail fences at the time of the inspection. This wood rot is suspected to have developed due to timber in contact with the ground and over a prolonged period of time due to frequent weather exposure, which is expected in a property of this age and condition.

Always ensure exterior timbers are not in contact with the ground or soil as this will accelerate damage and deterioration to the timber, if left unmanaged further damage is highly likely to occur. To maintain the condition of the external timber building elements, any affected areas should be substituted as soon as possible with pre-treated replacements. Where weatherboards have rotted due to excessive moisture other than rain penetration, the cause of the moisture should be identified and reduced as deemed necessary. A qualified carpenter should be appointed to repair and replace rotting building elements and materials in the near future.

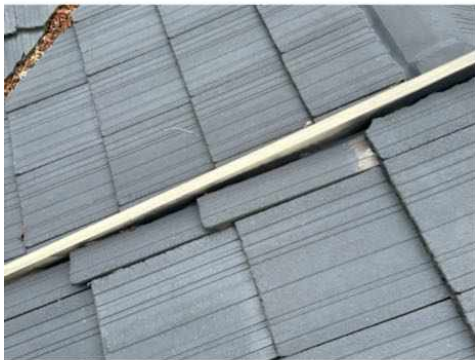
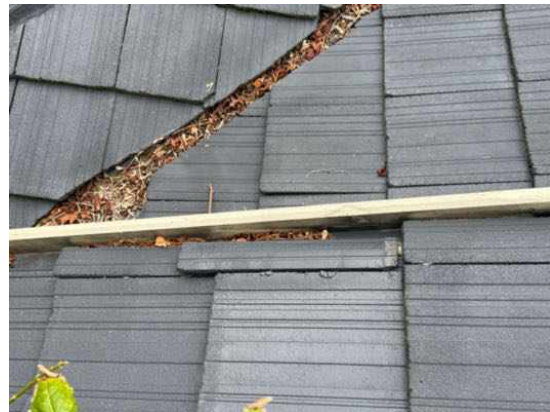
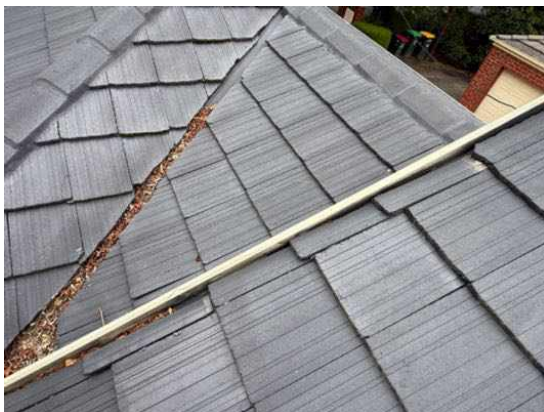
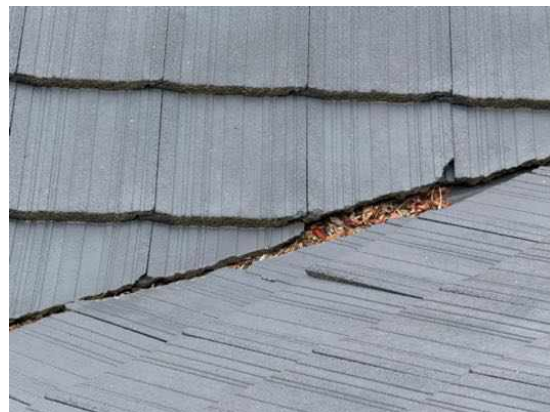
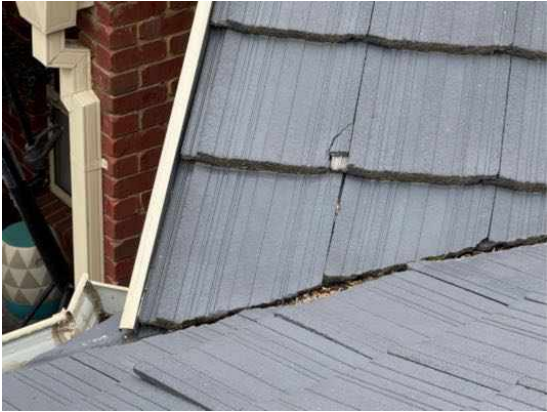
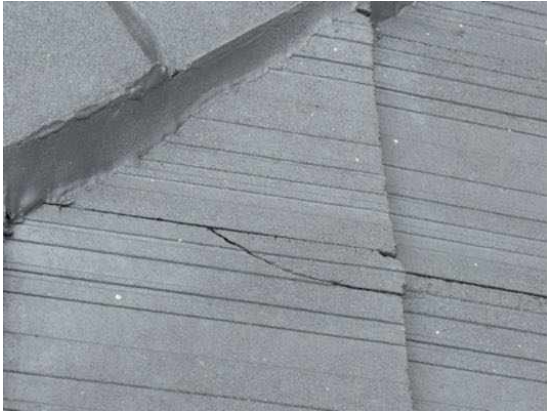
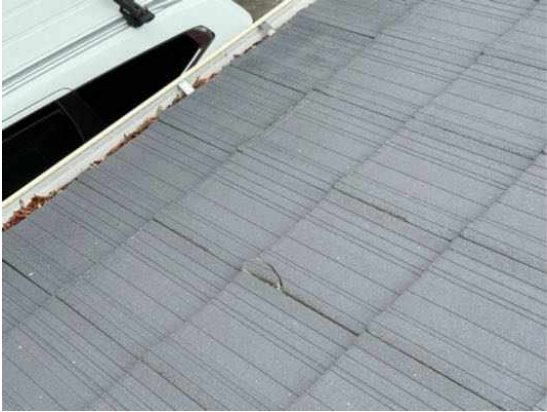
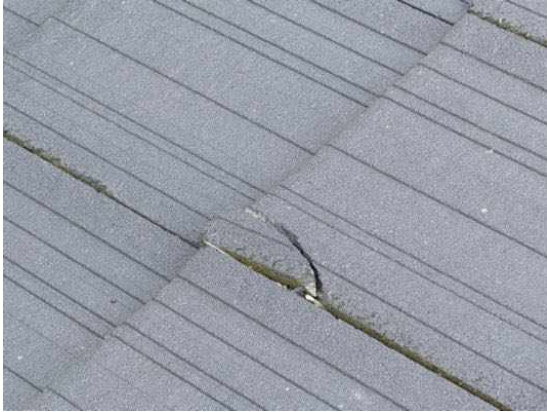
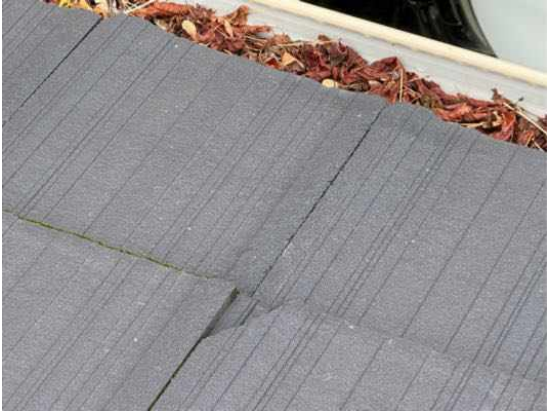
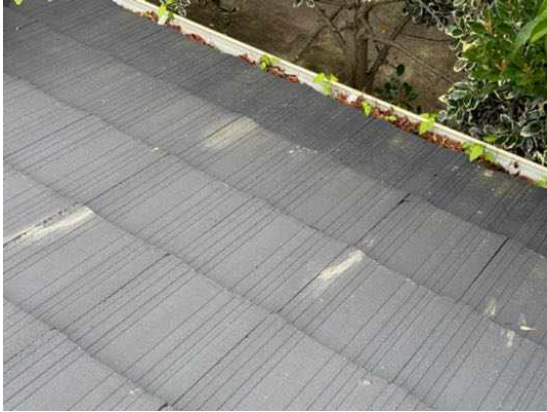
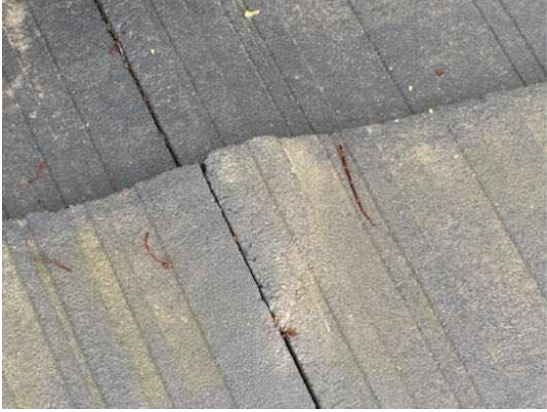
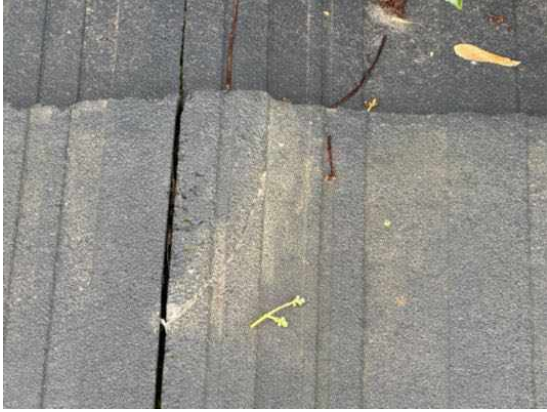
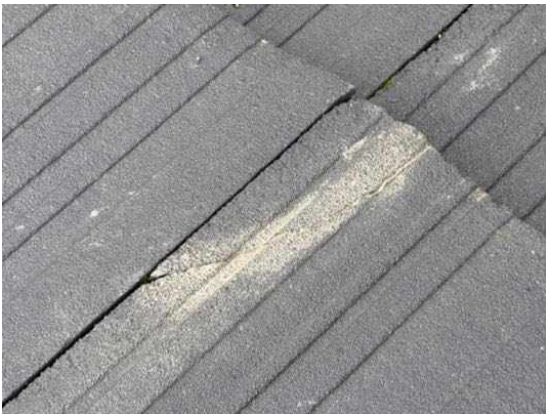
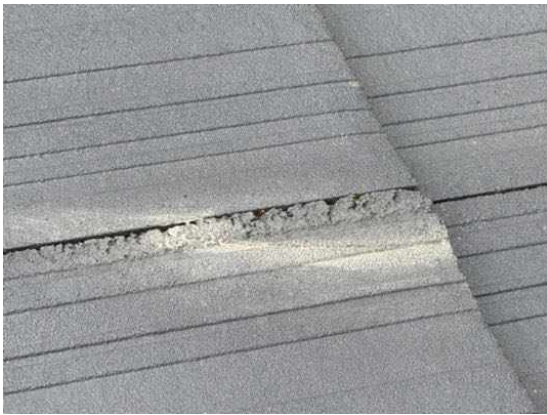
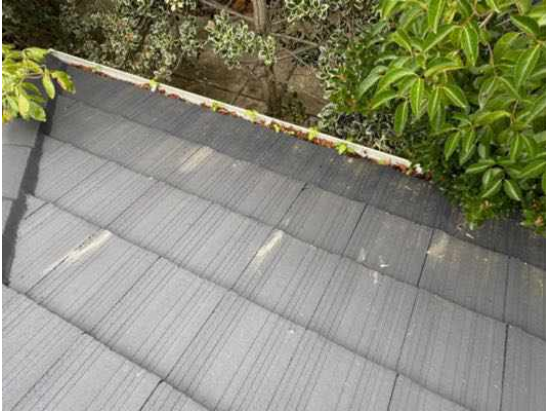
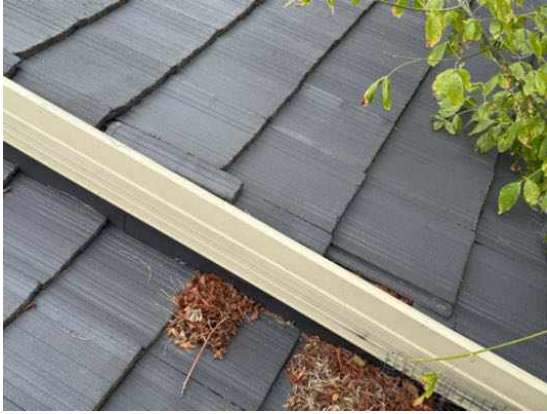
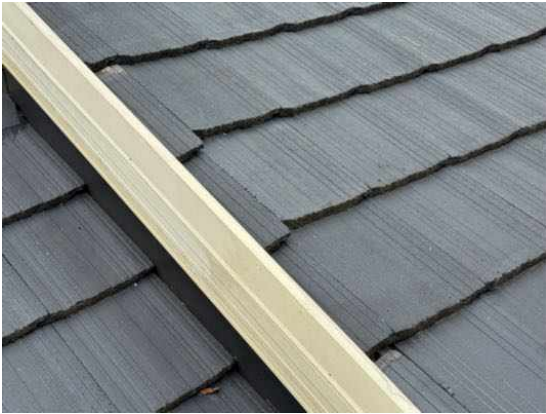
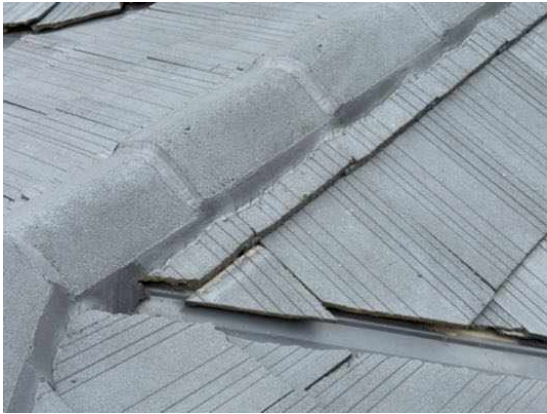
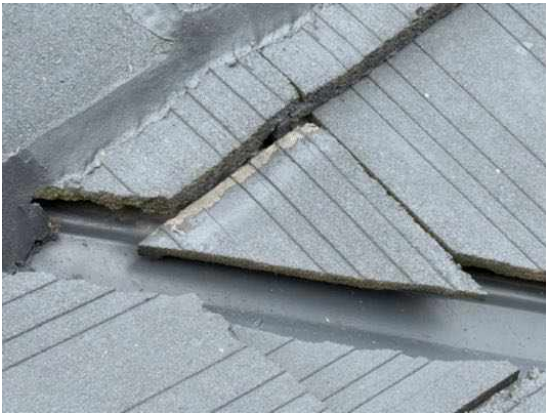
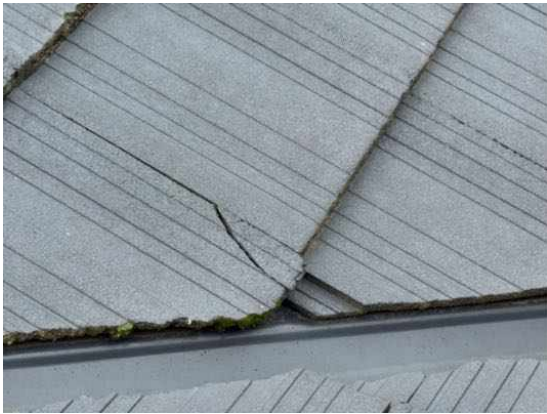
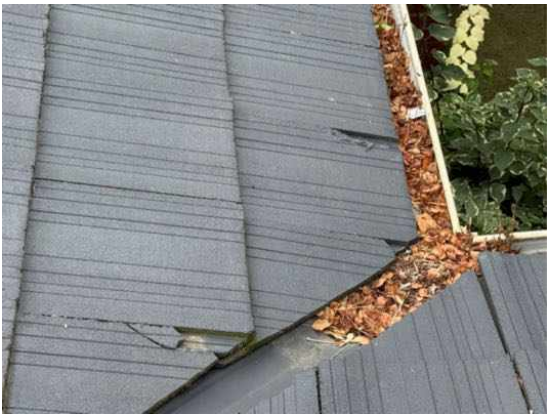
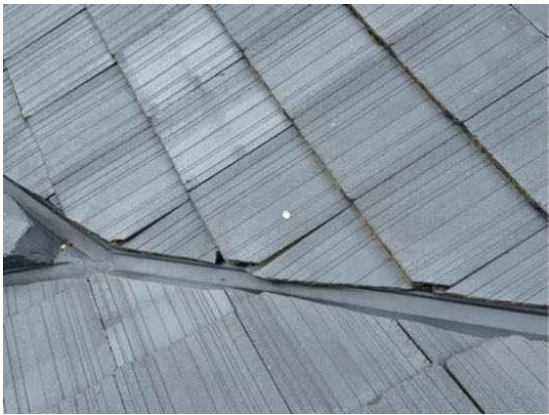
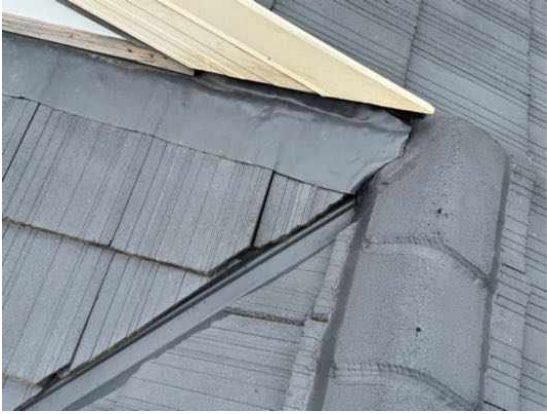
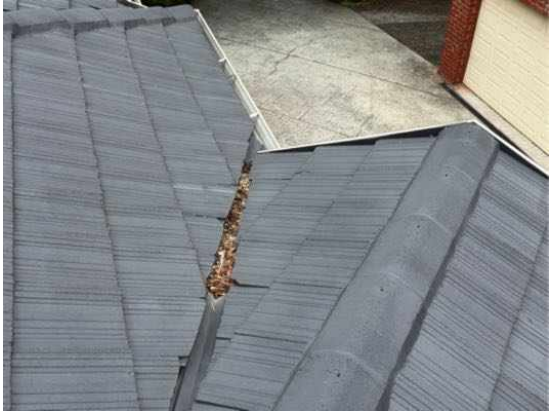
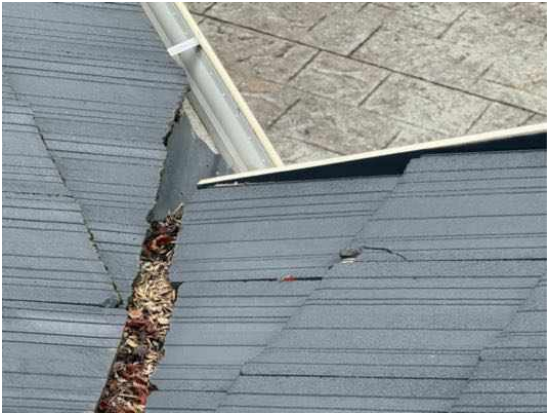
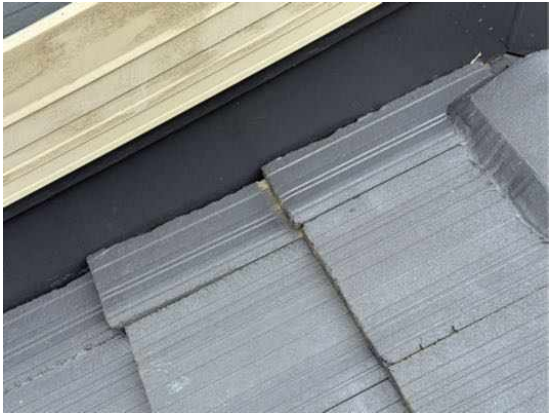
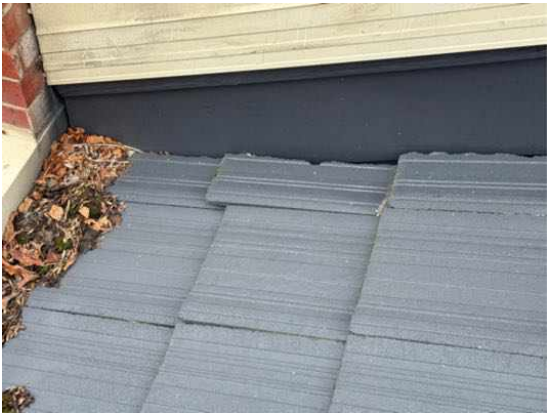
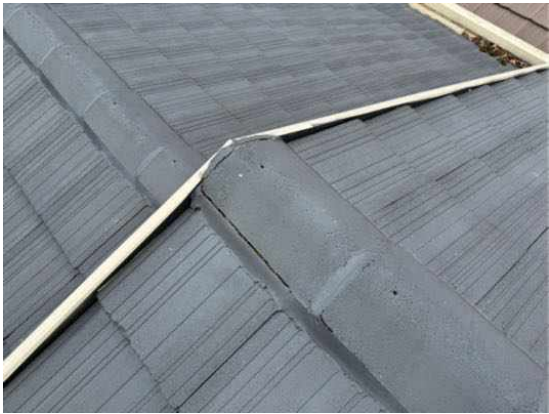
Defects 3.02

Building:	Building 1
Location:	All Areas > All Areas
Finding:	Roof tiles - broken, chipped, roof tiles dislodged and slippage
Information:	Upon inspection of the roof tiles, it was observed that numerous roof tiles (more than normal), have slipped down or have been dislodged from their original positions and have not been repositioned before the roof restoration was completed and shows very poor workmanship and poor trade practices. It is unknown if roof structures or other building elements show any damage or deterioration that may have been as a result of dislodged roof tiles. An invasive inspection is recommended to investigate for any repairs deemed to be required. This type of defect requires immediate attention and

Numerous roof tiles may slip over time due to a number of minor causes, including not placed correctly upon installation, not stuck down on the top of valley irons, flashings, roof tile chips and breakages, failings in the adjoining battens, or fixings that may have failed. In this case I suspect that tiles have just slipped or dislodged from the original positions overtime, these roof tiles when readjusted should receive some form of fixing to fix them down. Either by a good adhesive or a good quality silicon sealant. Roof tiles that have moved from their original position may allow water penetration into the roof void, exposing roofing structures to excessive moisture.

repair, before further damage and deterioration can occur.

This creates an environment that is conducive to water damage and accelerated deterioration of all associated building elements below these areas. Replacement of broken, loose or missing roofing tiles is also highly recommended immediately or in the short term future to prevent the development of any secondary defects overtime if left unmanaged. A roofing plumber or roof tiler should be appointed to complete such works as deemed to be necessary.

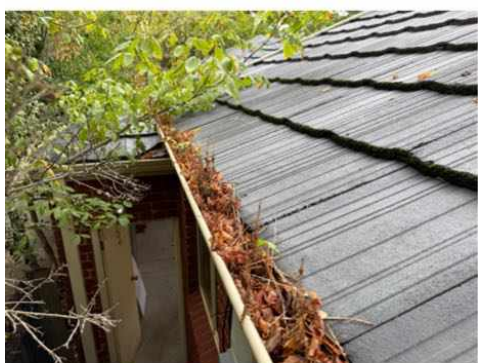
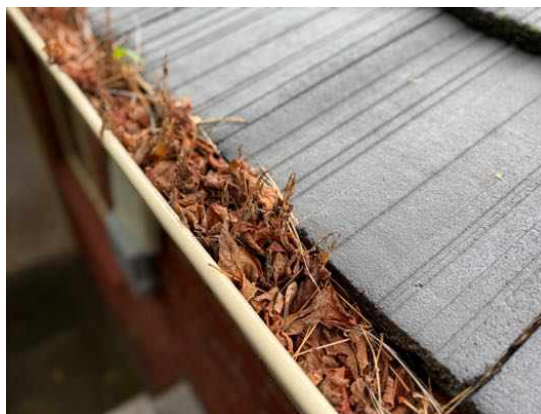
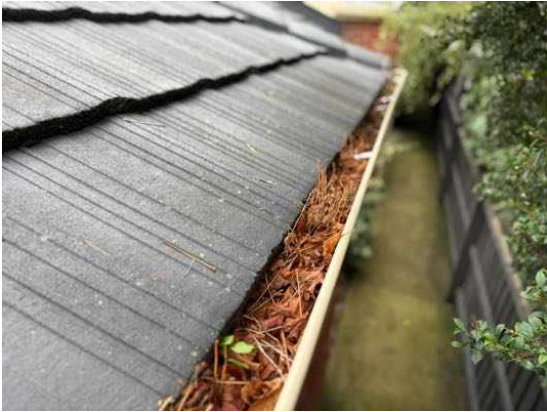
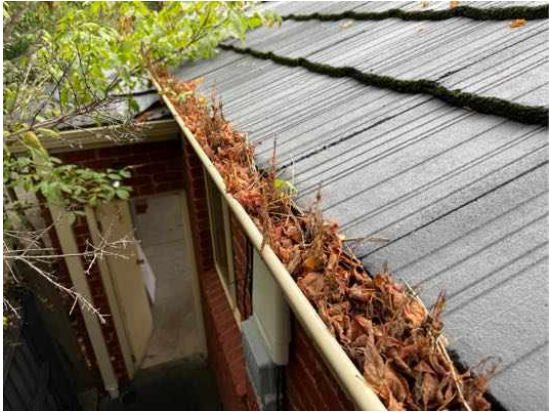
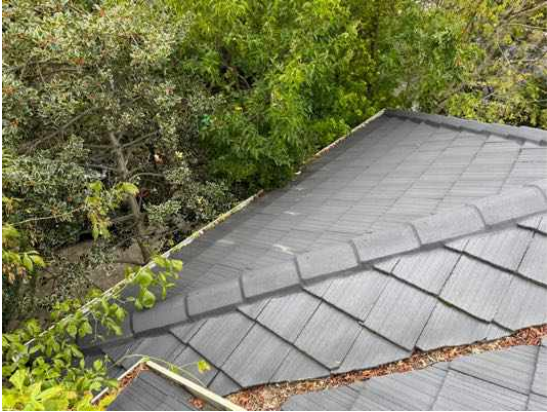
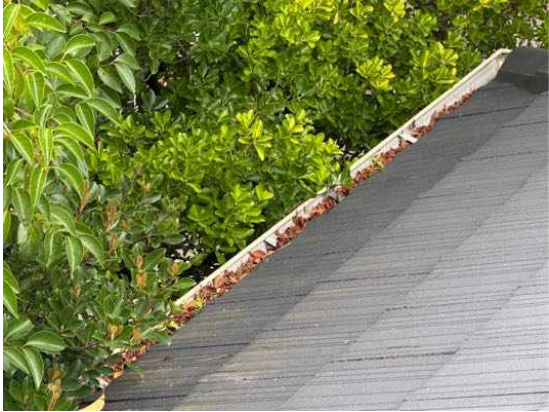
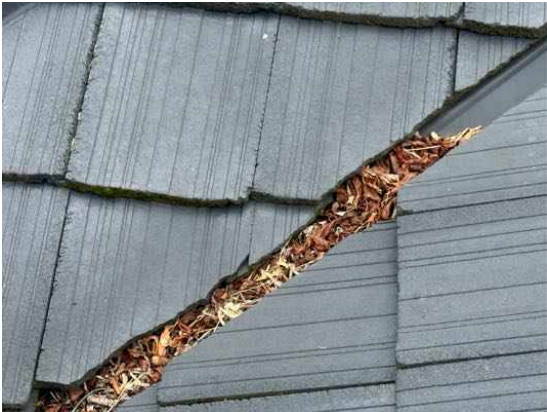
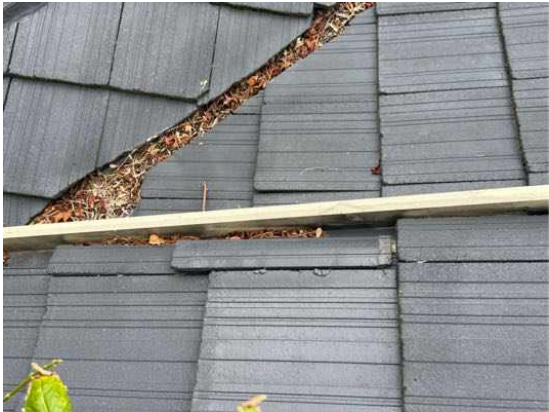
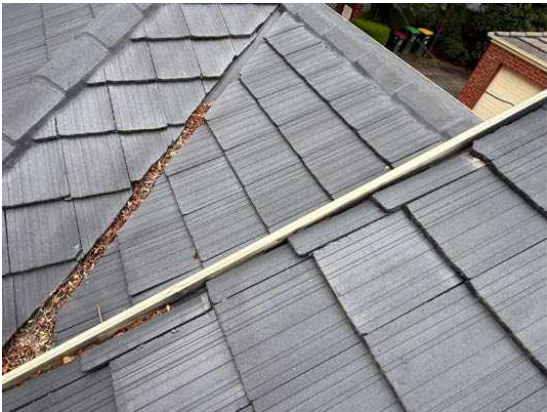
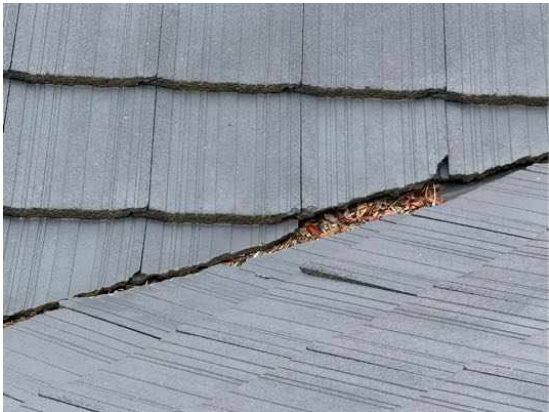
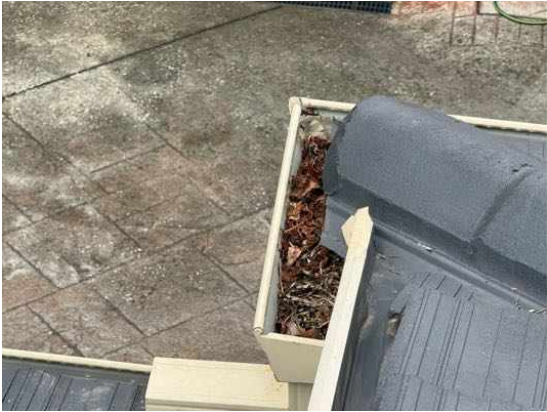
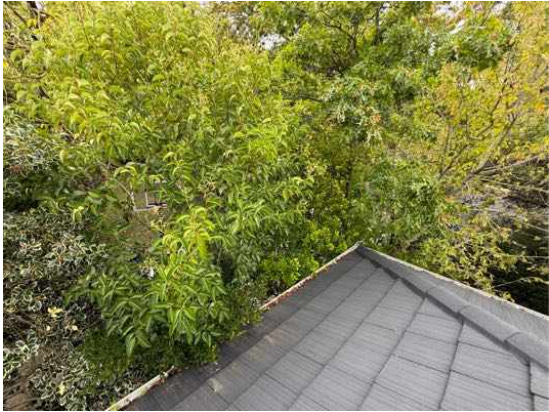
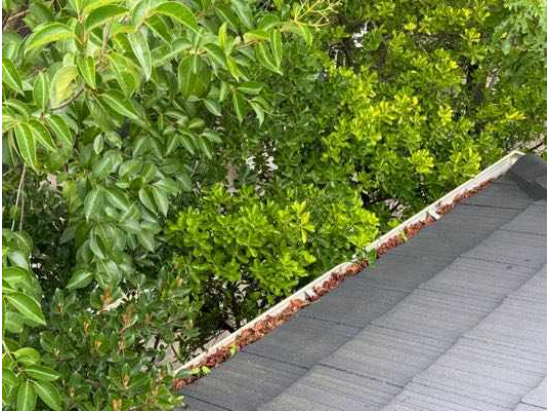
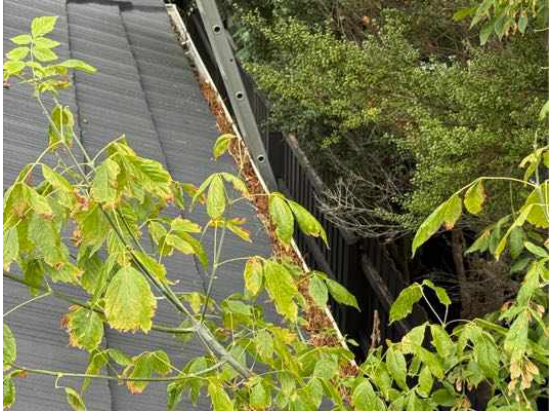
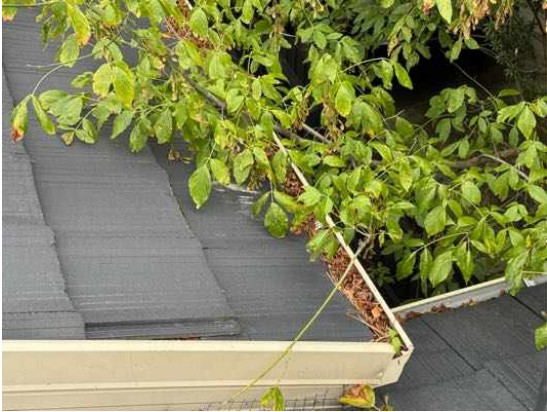
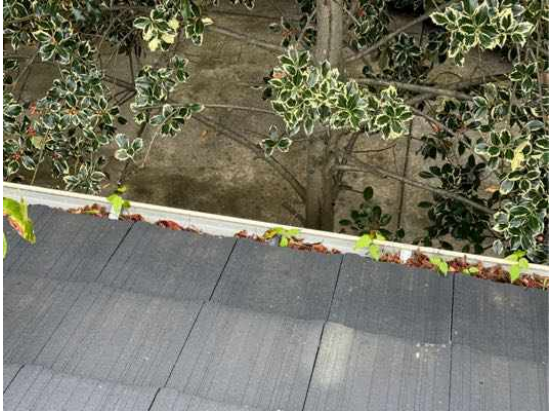
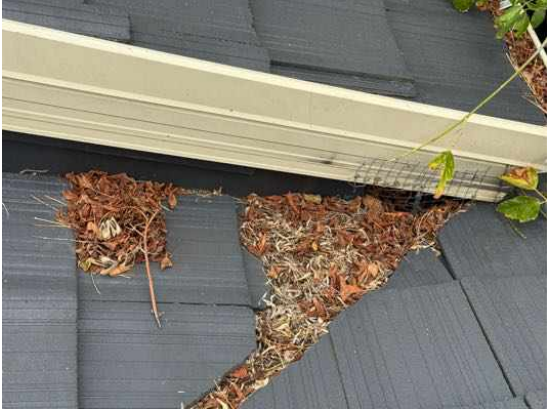
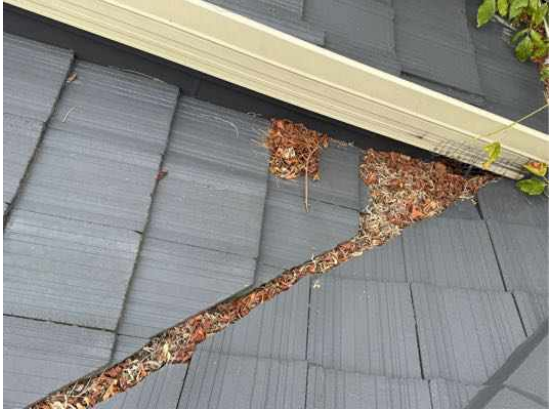
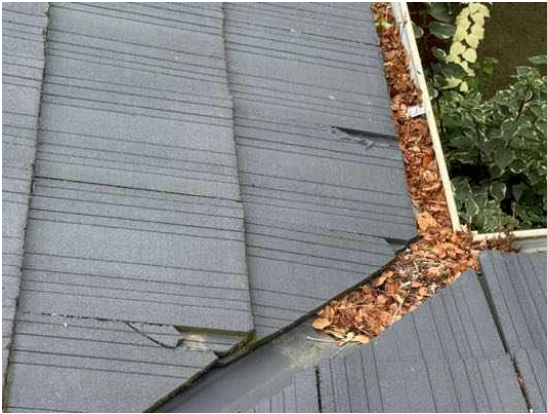
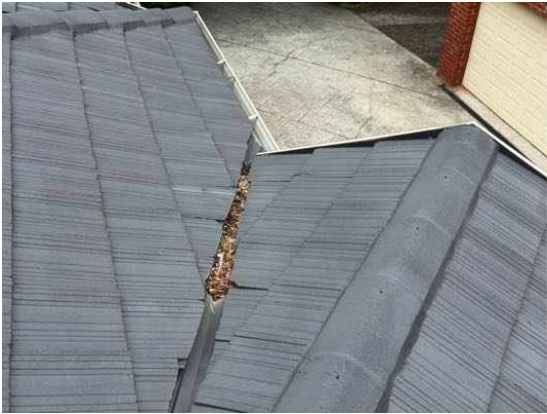
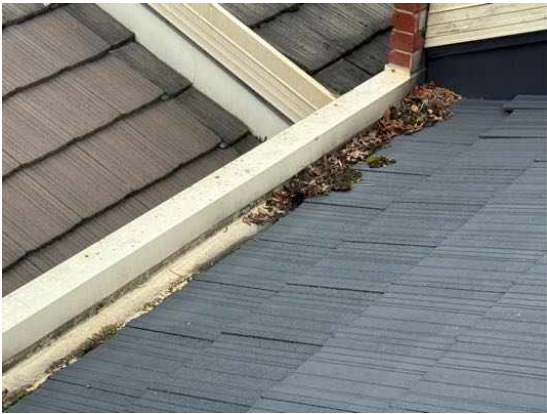
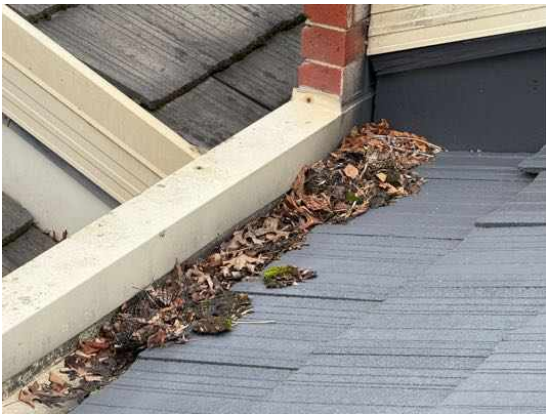
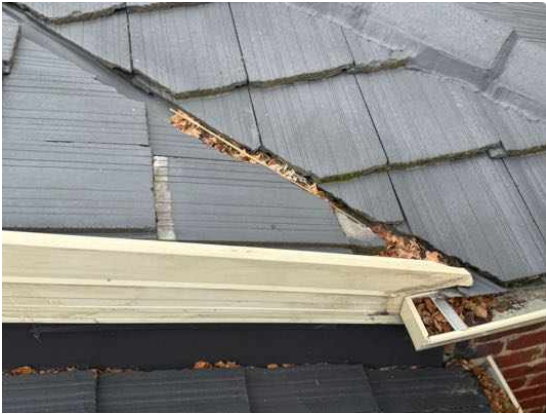
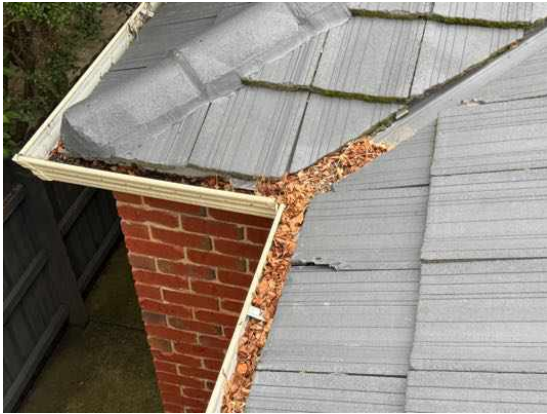
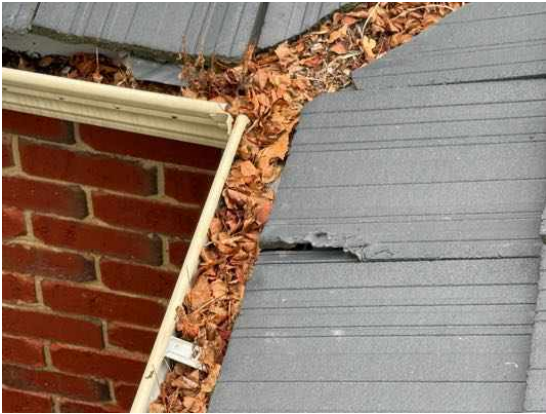
Defects 3.03

Building:	Building 1
Location:	All Areas > All Areas
Finding:	Gutters - Blocked
Information:	Roof plumbing structures, such as guttering and downpipes, should be free of all debris to prevent blockages. Blockages of the guttering and downpipes will lead to pooling and accumulated water overflows, which is likely to subsequently flood eaves and exterior walls. Blocked gutters are likely to lead to high levels of moisture in the affected areas. Such moisture will not only cause rust and decay of the associated building materials, but can also provide conditions that are conducive to termite and timber pest activity. Blockages in gutters should therefore be removed immediately to ensure dry conditions are maintained.

Consult a Licensed Plumber for further specific advice on remedial works that may be required. In the interim, it is highly advised that blocked gutters be removed by a gutter cleaning company or the homeowner or a general handy-person.

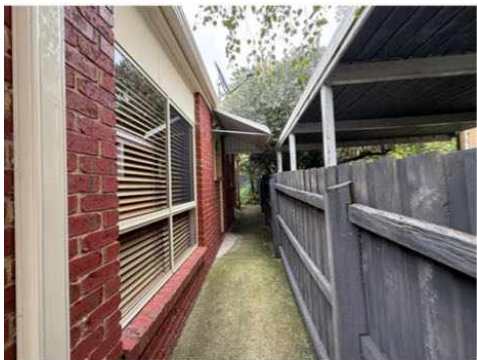
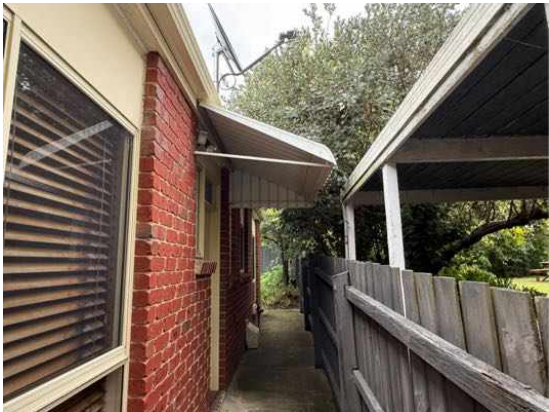
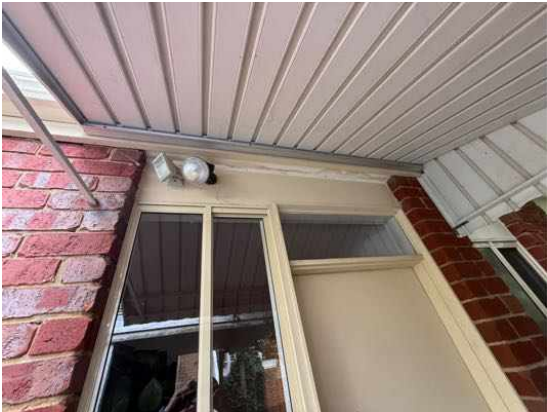
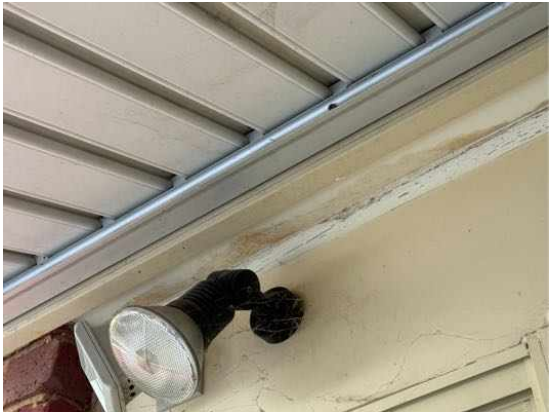
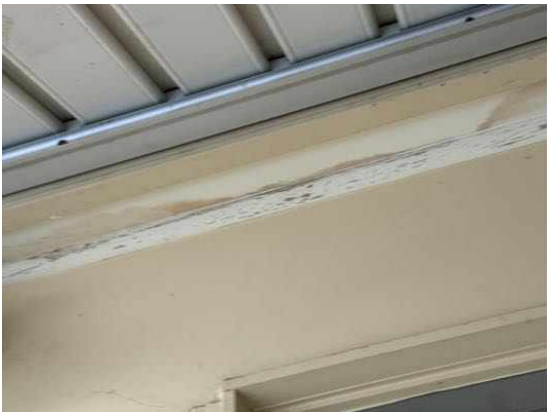
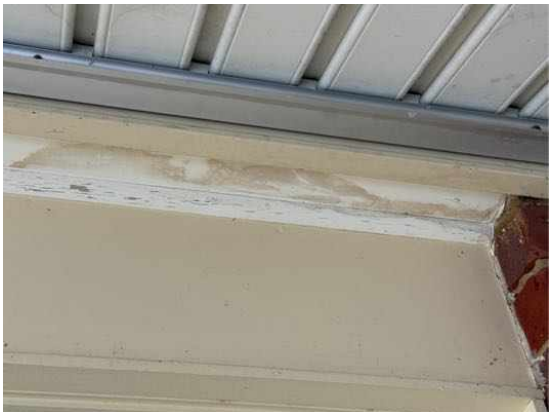
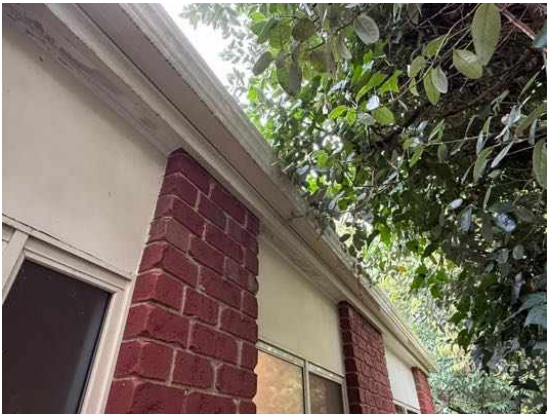
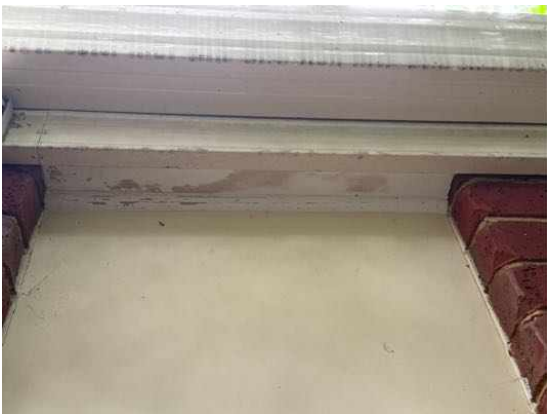
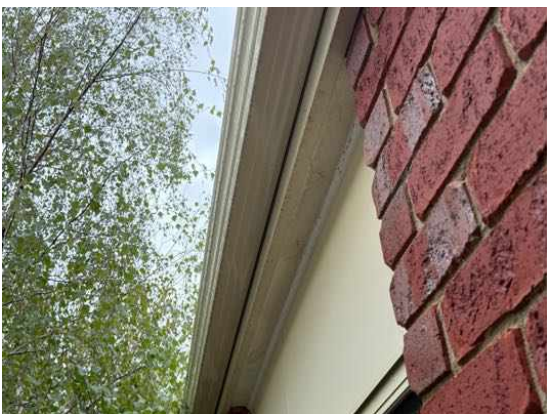
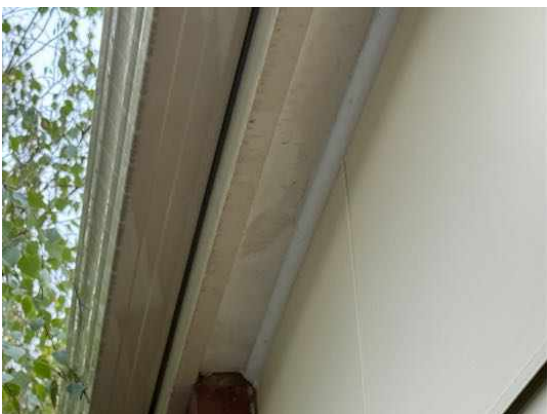
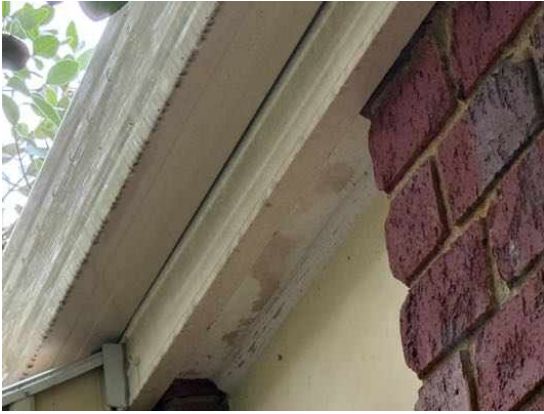
Defects 3.04

Building: Building 1
Location: All Areas > All Areas
Finding: Exterior window eaves soffits appeared to be damaged from suspected previous overwhelmed gutters
Information: The exterior window eaves soffits appeared to be damaged from suspected previous overwhelmed gutters. Window soffits to the right hand side rear areas of the home were observed to showing signs of water and moisture stains. This type of damage is highly suspected to have been as a result of the trees overhanging this area of the roof and filling the guttering with excessive leaf matter and debris causing the gutters and down-pipes to be overwhelmed during heavier rain periods. No definitive answer for

these moisture stains was confirmed on the day of the inspection, further investigation will be required.

Where moisture staining is evident, the primary requirement is to identify and rectify the source of the excessive moisture and or roof leak. The damage to the soffit sheeting in this area detracts from the appearance of the structure, as well as potentially compromising the structural integrity of the adjoining wall and roof areas. Where eaves show moderate to severe damage, remedial works are suspected to be required. Where water damage is suspected as being the underlying cause, appointment of a licensed builder, carpenter is recommended to identify the source of the water leak and repair any areas deemed to be necessary. This should happen in the short term future.

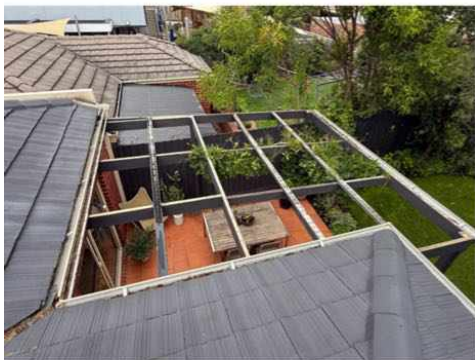
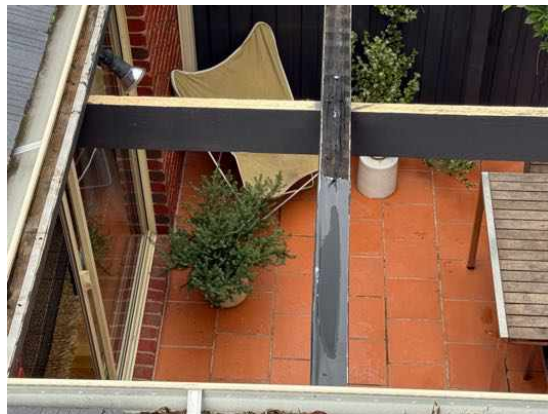
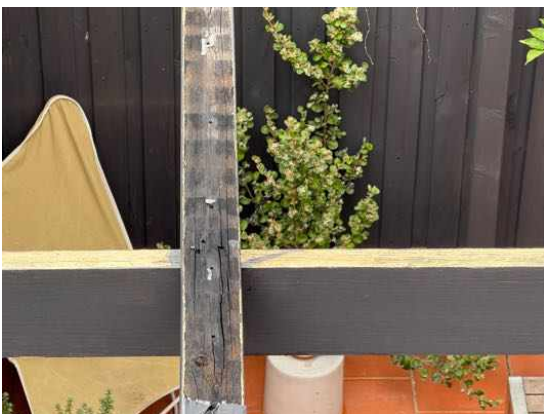
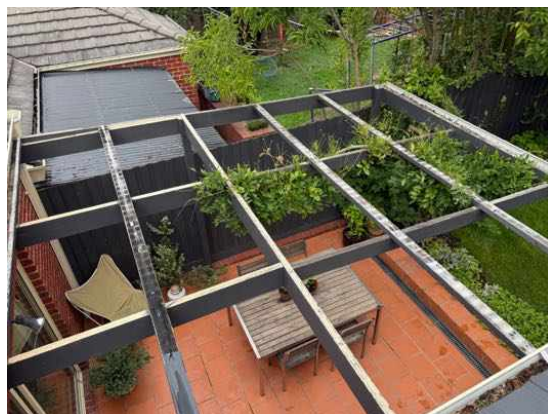
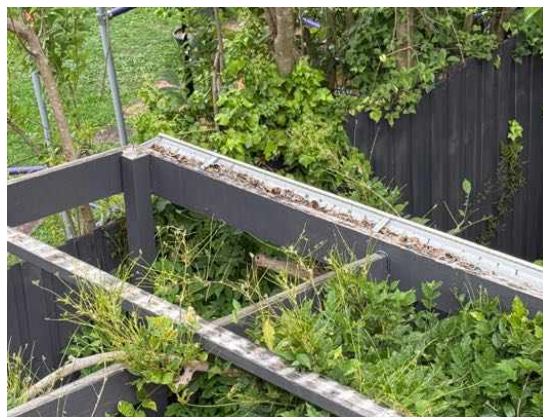
Defects 3.05

Building:	Building 1
Location:	All Areas > All Areas
Finding:	Rear pergola roof was observed to be missing covering and aged and deteriorated
Information:	The rear pergola roof was observed to have been removed and now missing at the time of the inspection. Replacement of this roof covering is recommended to cover vulnerable roof members to wood rot and to promote some protection from the extreme weather conditions to this area. Failure to cover or re-new the roof covering may result in accelerated deterioration of other associated roof members on the pergola and associated building elements. A licensed builder and registered roofing plumber can be appointed to restore the roof covering to this area.

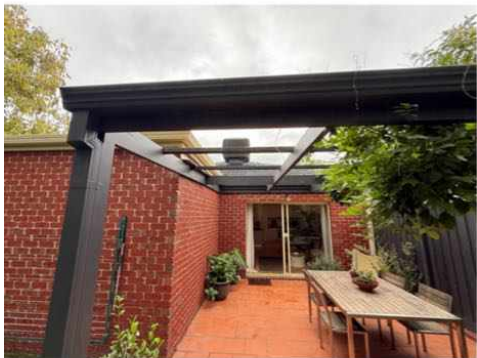
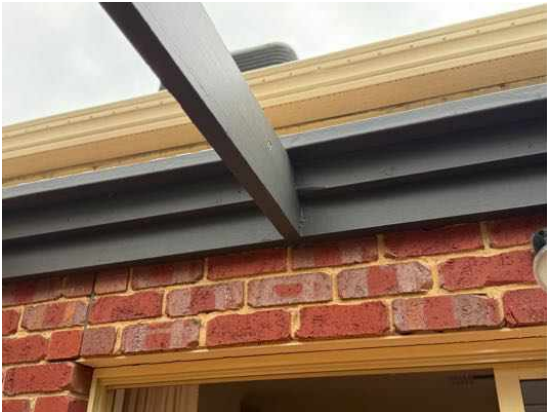
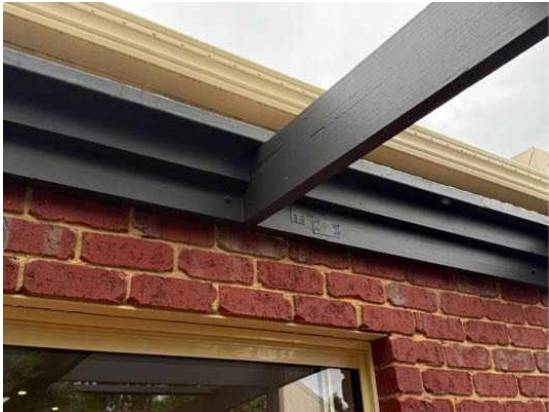
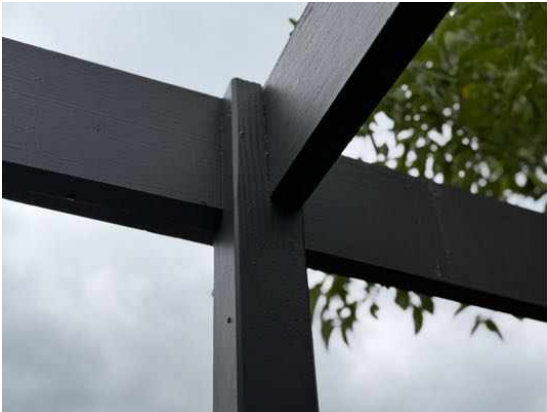
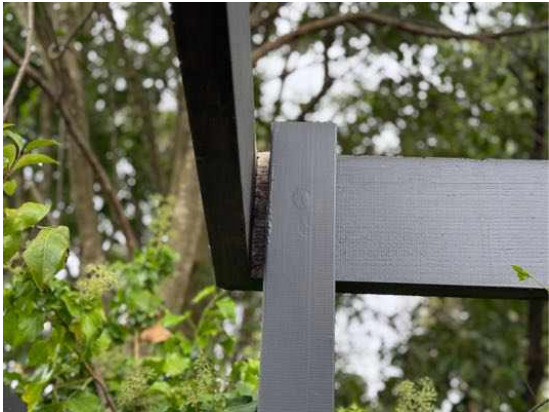
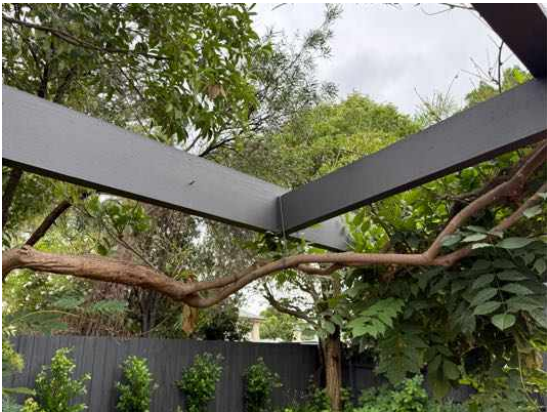
Defects 3.06

Building:	Building 1
Location:	All Areas > All Areas
Finding:	Back pergola roof brackets and bolts to the pergola posts
Information:	Although some building elements may seem irrelevant or unnecessary at the time, all building elements play a key role in the operation and function of the overall structure and its performance as it ages. All the roof brackets and bolts adjoining posts to beams that are missing to this pergola roof structure should be installed, to ensure that when the roof structure ages and begins to deteriorate these roof brackets and bolts will keep these types of structures stable for longer.

Exposure to the exterior weather conditions it is likely to make exterior timber age and deteriorate at an accelerated rate. The appropriate and relevant tradespersons should be appointed, to install, maintain or replace the missing building elements or materials.

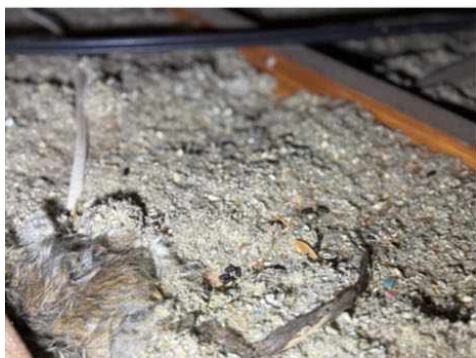
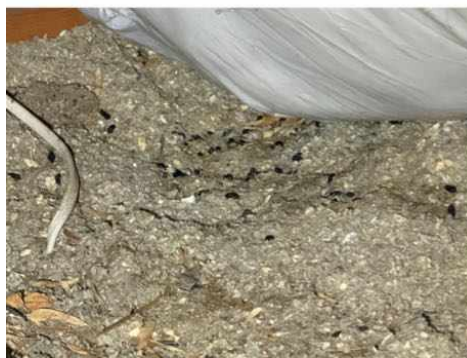
Defects 3.07

Building:	Building 1
Location:	All Areas > All Areas
Finding:	Evidence of Vermin
Information:	Evidence of pests or rodents were present in the roof space at time of inspection. Rodents can cause issues ranging from smells and stains through to physical damage to wiring and other elements in the roof void. A licensed pest controller should be appointed to free the roof void of any pests and to install deterrents or seal access points to ensure that rodents and birds cannot enter the roof space as easily.

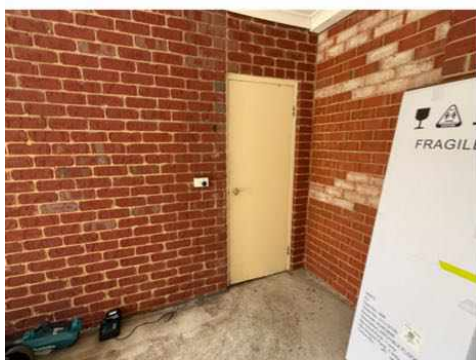
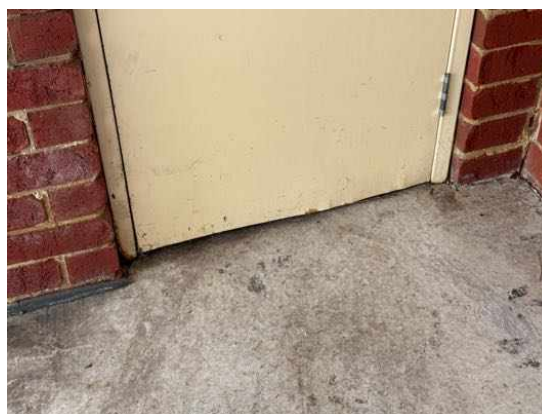
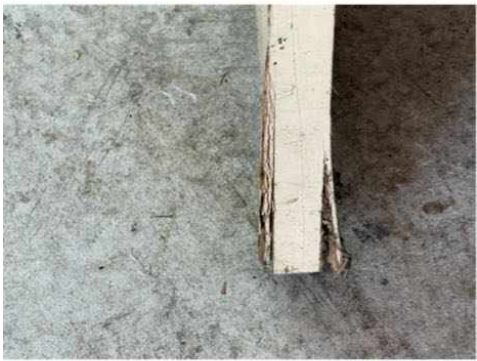
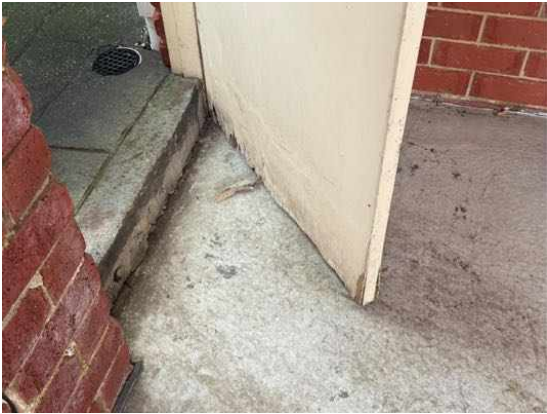
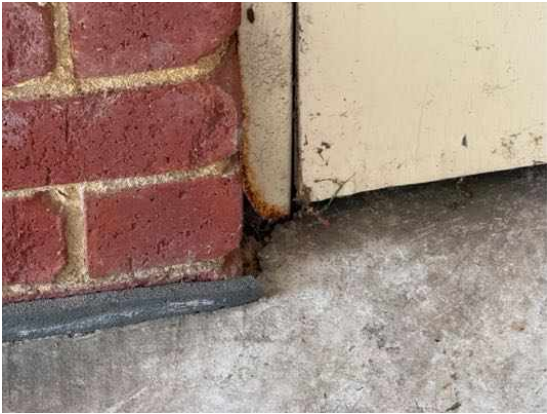
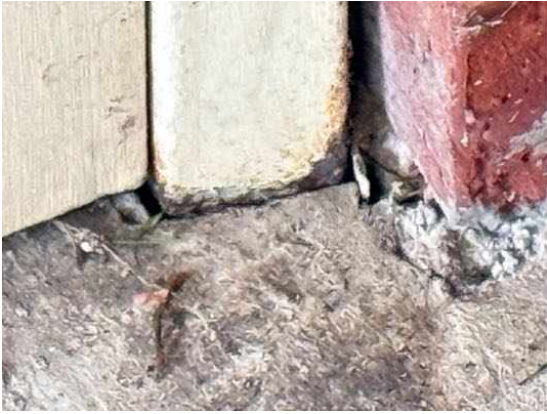
Defects 3.08

Building:	Building 1
Location:	Rear garage door > All Areas
Finding:	Damage to the back and bottom of the garage door
Information:	The back and bottom of the garage door was observed to show excessive moisture damage and appears to be swollen due to this moisture. This type of damage is suspected to be consistent with an un-sealed door. A qualified carpenter should be appointed to replace this door. The door should be then thoroughly sealed on the bottom especially and all other sides to prevent accelerated future moisture damage and deterioration.
