Building Inspection Report

Inspection Date: Tue, 17 Mar 2026

Property Address: 1/223 Elgar Rd, Surrey Hills VIC 3127,
Australia

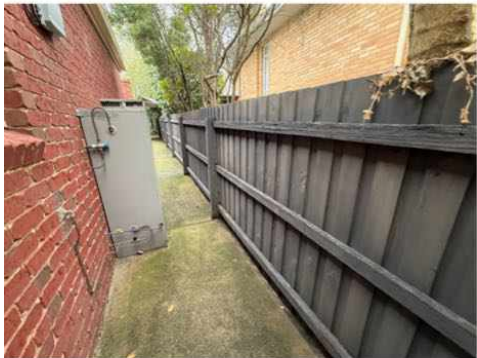
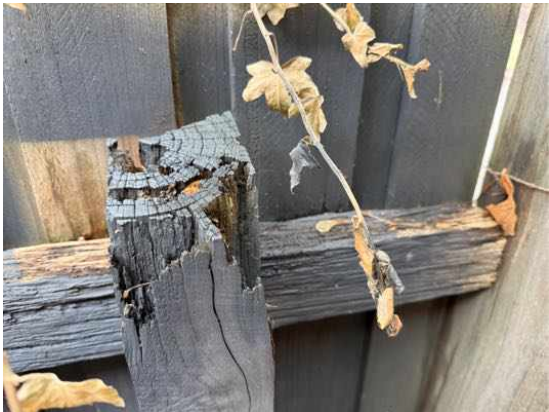
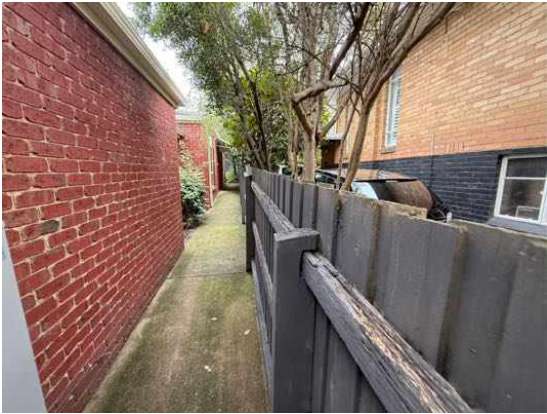
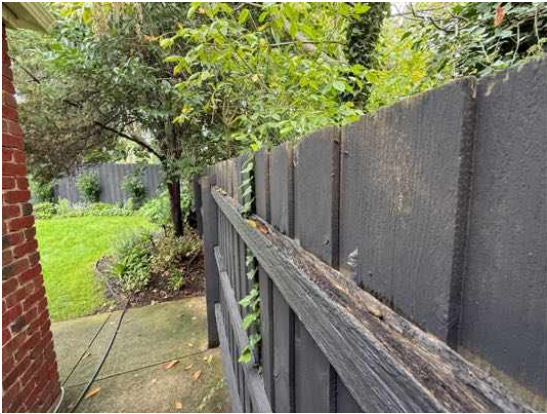
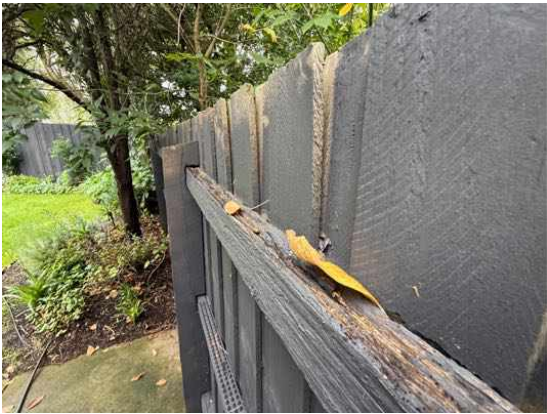
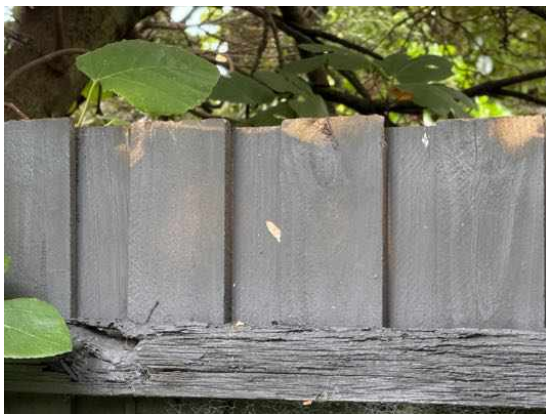
Defects 3.09

Building: Building 1
Location: All Areas > All Areas
Finding: Post and rail fences
Information: Post and rail fences showed damage and deterioration at the time of the inspection. This deterioration is suspected to have developed over a prolonged period of time due to frequent weather exposure, which is expected in a property of this age and condition. Left unmanaged, further deterioration is likely to develop further, necessitating in extensive repair or replacement areas of the timber fences, this will depend on the age and deterioration and or wood rot, further damage is suspected of occur. To maintain the condition of the external timber building elements, any affected areas should be substituted as soon as possible with pre-treated replacements. A qualified fencing contractor should be appointed to repair and replace post and rail fencing where deemed to be necessary.

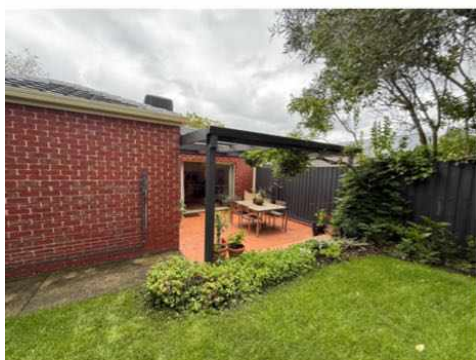
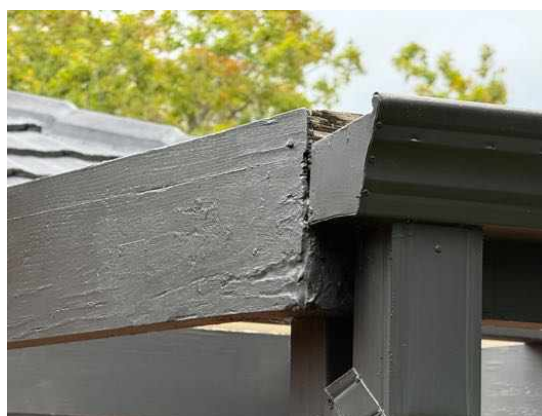
Defects 3.10

Building:	Building 1
Location:	All Areas > All Areas
Finding:	Wood rot
Information:	Wood rot is suspected to be affecting some minor areas on the rear pergola, post and rail fences and other building elements around the exterior areas. Wood rot, also known as Fungal Decay, occurs when timbers and other cellulose building materials are exposed to damp conditions on an ongoing basis. The frequent exposure to rain and extreme weather conditions also make many building elements susceptible to accelerated deterioration.

Early intervention and regular maintenance such as painting will prolong the useful life of these building elements. Prior to any works being performed, the cause of the moisture that has created the visible wood rot should be identified and addressed in a suitable manner. Replacement of affected building elements may then be a necessary step in protecting surrounding areas from such deterioration. A qualified carpenter or registered builder may also be required to replace affected building materials.

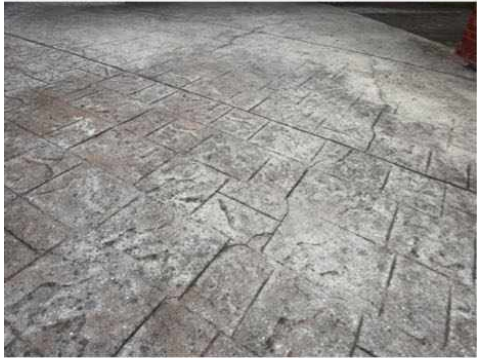
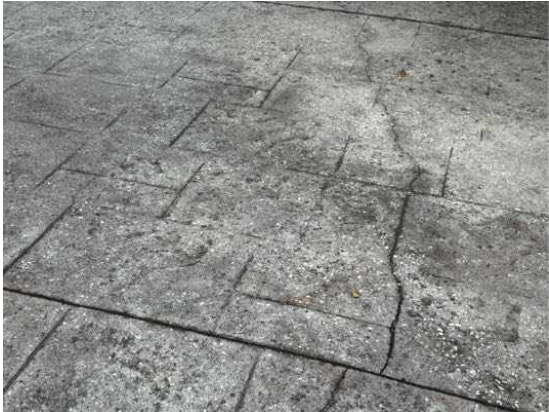
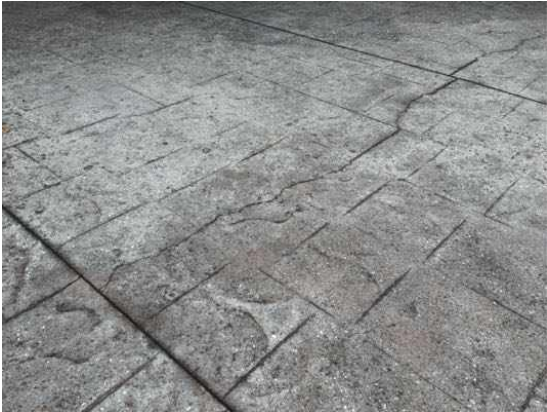
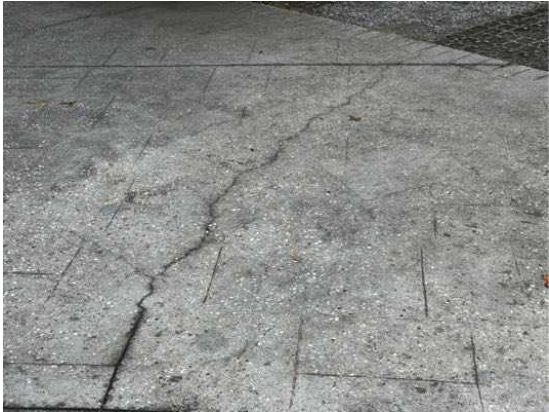
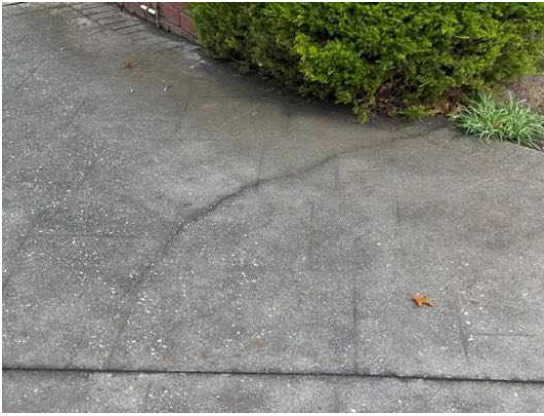
Defects 3.11

Building: Building 1
Location: All Areas > All Areas
Finding: Concrete driveway cracks
Information: Numerous cracks on the driveway were observed at the time of the inspection. Concrete cracks are a common occurrence as a result of many primary defects. Such causes may include age, general wear and tear, expected building movement, general expansion/contraction of building materials in different weather conditions, and/or minor failings in the installation or application of building materials. Monitoring of all cracking should be conducted periodically. Contact a relevant tradespersons should cracks become trip hazards for occupants.

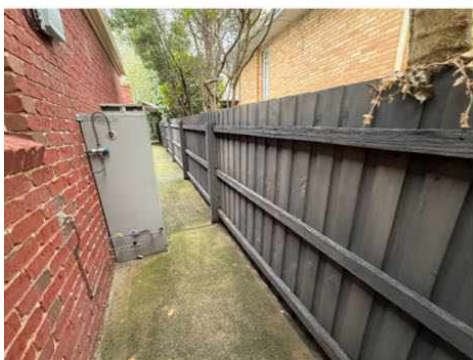
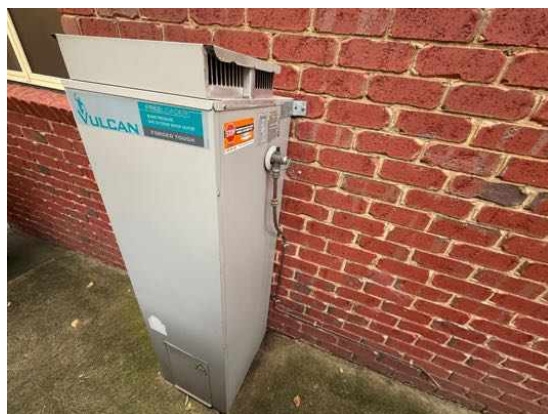
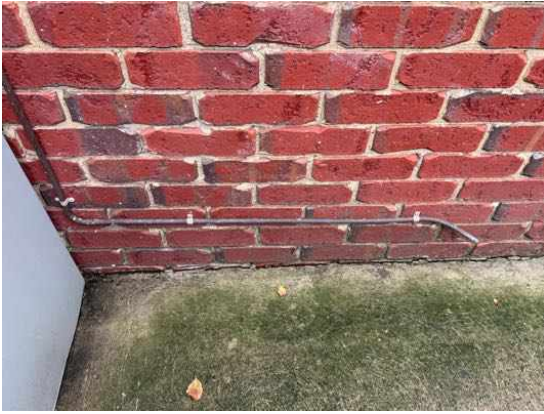
Defects 3.12

Building:	Building 1
Location:	All Areas > All Areas
Finding:	HWS Overflow - Not Connected
Information:	The Hot Water System (HWS) overflow was found to be disconnected from storm water drainage and may be or in the future create excessive moisture in the surrounding area.

These damp conditions can lead to secondary defects such as rot, rust or corrosion of associated building elements, the formation of fungal decay, or even the creation of potential slip hazards. When coupled with poor site drainage, pooling of water may also attract termite activity to this area.

It is highly recommended that a licensed plumber be appointed to connect the HWS overflow in order to prevent such an environment from being created. These minor works should be carried out as soon as possible.

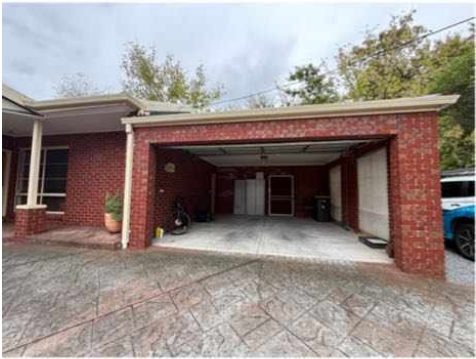
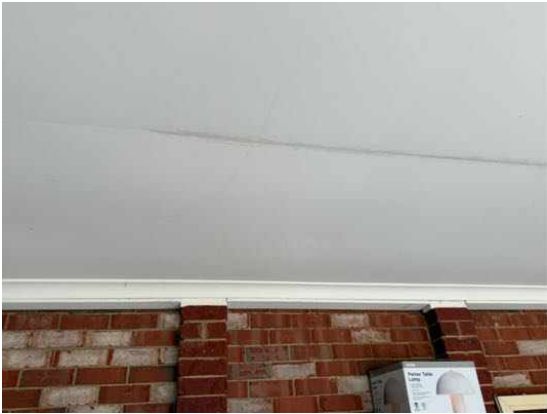
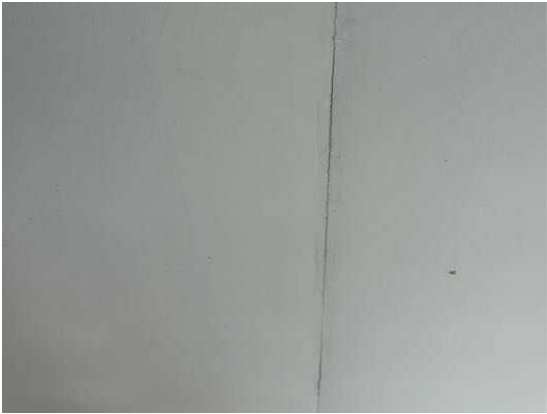
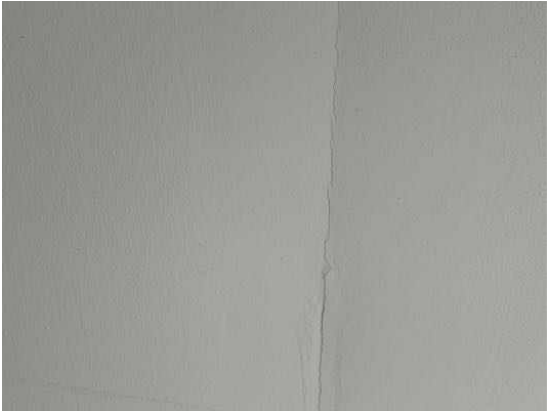
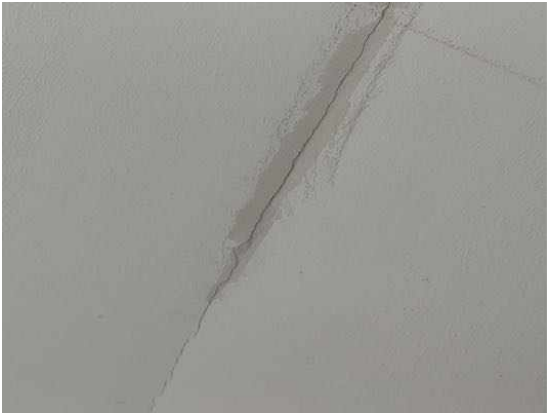
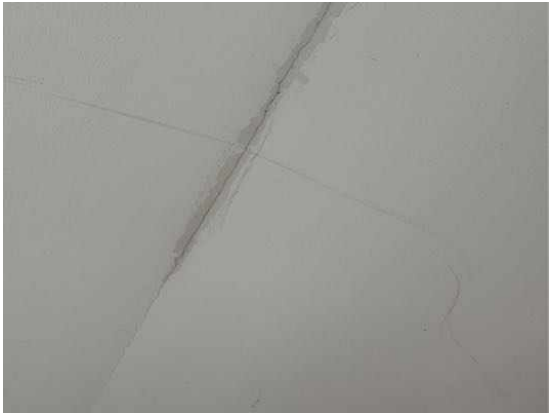
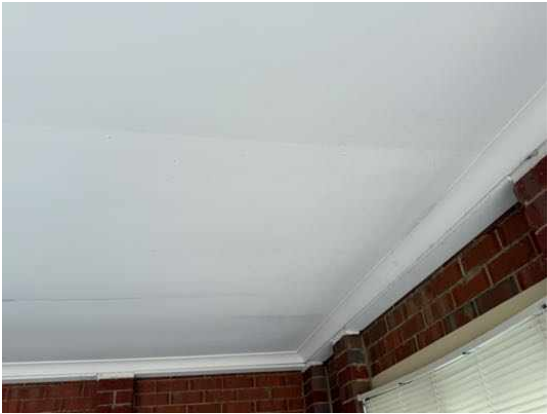
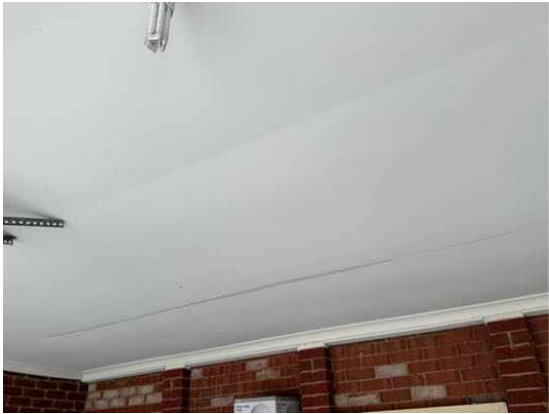
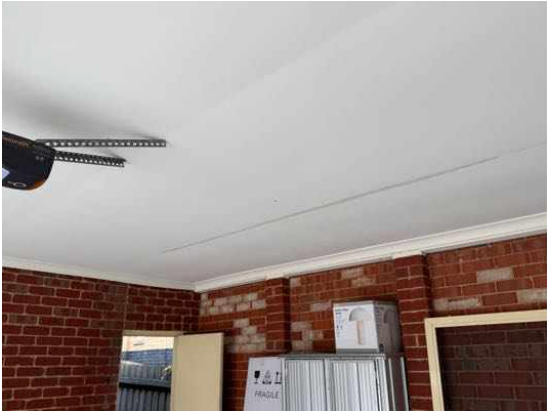
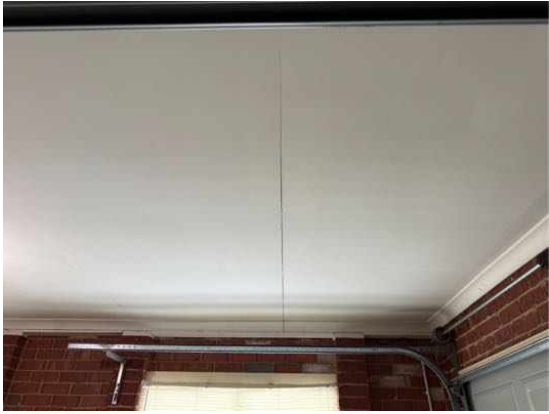
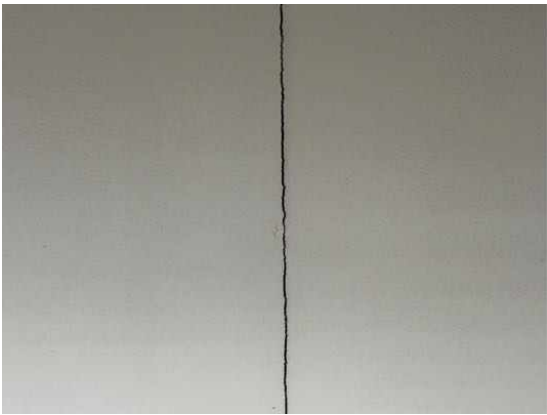
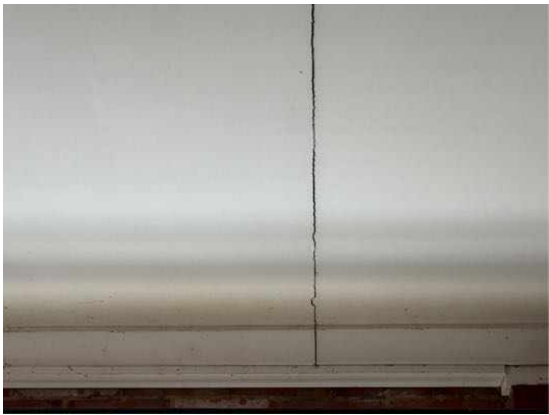
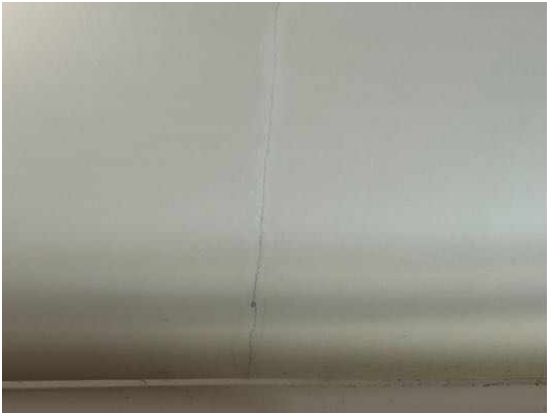
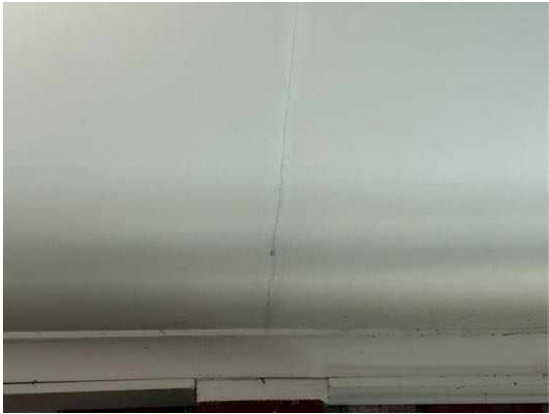
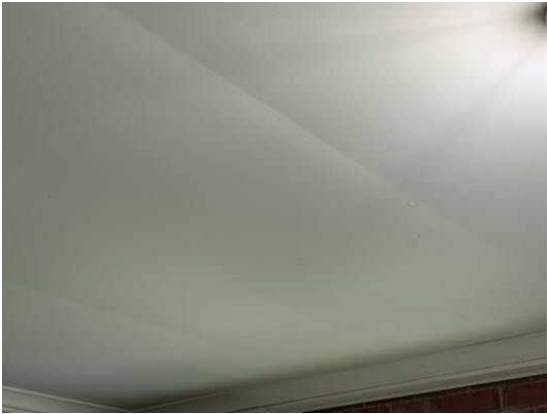
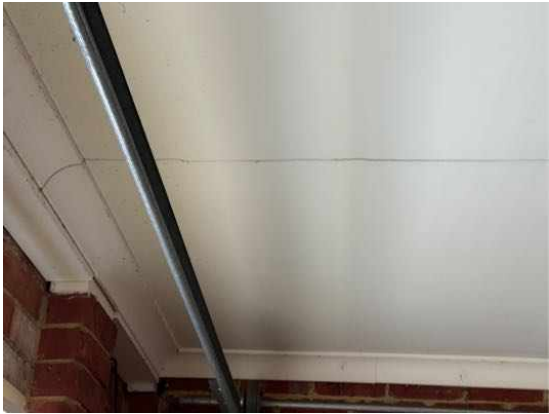
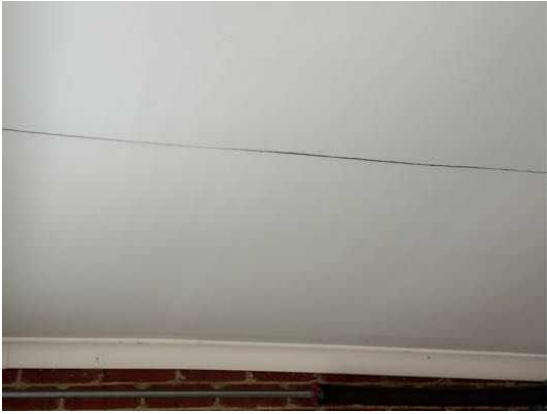
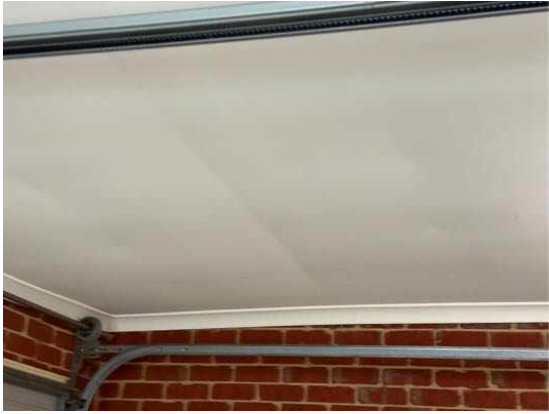
Defects 3.13

Building:	Building 1
Location:	Garage ceiling > All Areas
Finding:	Garage ceiling linings showed suspected previous excessive moisture damage and deterioration
Information:	At the time of the inspection the garage ceiling linings showed suspected previous excessive moisture damage and deterioration from suspected overwhelmed guttering and down-pipes due to trees overhanging filling gutters with excessive amounts of leaf matter and debris. The exterior roof showed the guttering to be reasonably clear of leaf matter and debris however gutters may have been overwhelmed at some time from excessive rain and extreme weather conditions, no other visible conclusive answer to where moisture stains and or leaks may be coming from.

At the time of the inspection the garage ceiling linings showed suspected previous excessive moisture damage and deterioration from suspected overwhelmed guttering and down-pipes due to trees overhanging filling gutters with excessive amounts of leaf matter and debris. The exterior roof showed the guttering to be reasonably clear of leaf matter and debris however gutters may have been overwhelmed at some time from excessive rain and extreme weather conditions, no other visible conclusive answer to where moisture stains and or leaks may be coming from. It is recommended that

It is recommended that the client firstly appoint a qualified arborist to remove as much overhanging trees and limbs away from the roof areas to prevent future overwhelmed gutters and down-pipes. Secondly a qualified gutter cleaning company to periodically clean and remove any leaf matter and debris from the gutters. It is unknown as to the time as to when this damage has occurred. It is very important that this type of defect get rectified in the short term future due to the development of mould and mildew within the plaster linings. The plaster linings will require total removal of any areas of the affected ceiling to ensure mould buildup does not occur. If left unmanaged secondary deterioration is likely to occur. The moisture to these areas may also have affected the roof structure and deteriorate adjoining building elements.

Poorly drained roof areas can and will lead to excessive damp and wet conditions to the adjoining areas which can lead to a range of secondary building defects. A licensed builder and or licensed roof plumber should be appointed to further investigate these areas for damage and deterioration. Where deemed to be necessary these areas will require an invasive inspection which may require removing roof tiles and the affected plaster linings for a more thorough look and assessment.

the client firstly appoint a qualified arborist to remove as much overhanging trees and limbs away from the roof areas to prevent future overwhelmed gutters and down-pipes. Secondly a qualified gutter cleaning company to periodically clean and remove any leaf matter and debris from the gutters. It is unknown as to the time as to when this damage has occurred. It is very important that this type of defect get rectified in the short term future due to the development of mould and mildew within the plaster linings. The plaster linings will require total removal of any areas of the affected ceiling to ensure mould buildup does not occur. If left unmanaged secondary deterioration is likely to occur. The moisture to these areas may also have affected the roof structure and deteriorate adjoining building elements. Poorly drained roof areas can and will lead to excessive damp and wet conditions to the adjoining areas which can lead to a range of secondary building defects. A licensed builder and or licensed roof plumber should be appointed to further investigate these areas for damage and deterioration. Where deemed to be necessary these areas will require an invasive inspection which may require removing roof tiles and the affected plaster linings for a more thorough look and assessment.

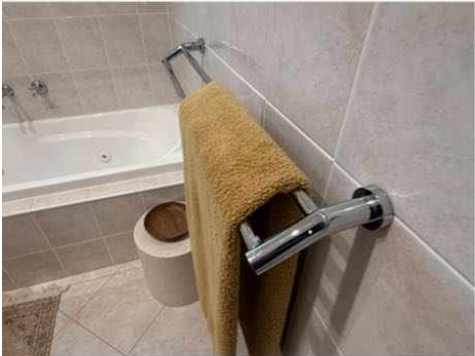
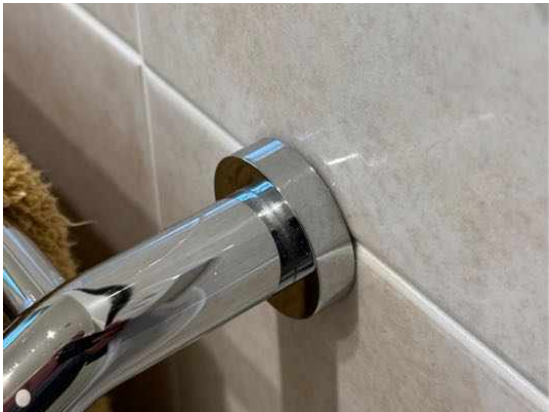
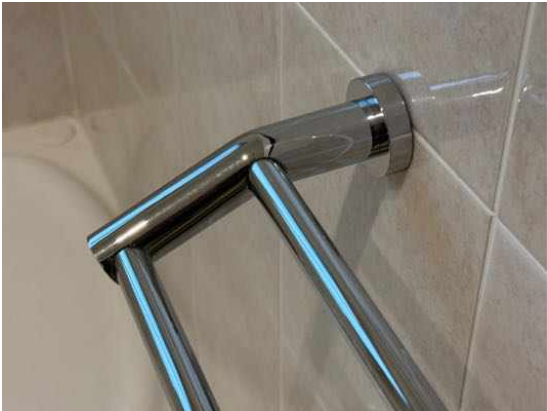
Defects 3.14

Building: Building 1
Location: Bathroom > All Areas
Finding: Bathroom towel rail
Information: Bathroom towel rails were observed to be loose and may require either renewal or maintenance to be good, this type of defects can be caused by substandard fitting and workmanship, poor fixings and sometimes cheaper fittings and fixtures used. A qualified carpenter should be appointed to repair or replace the affected towel rails, at the clients discretion.

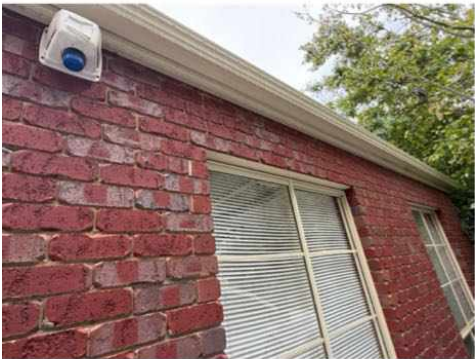
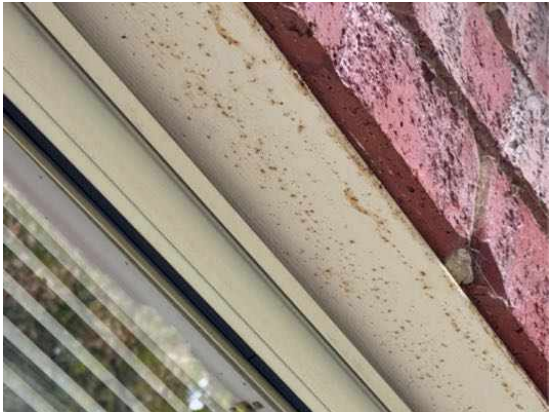
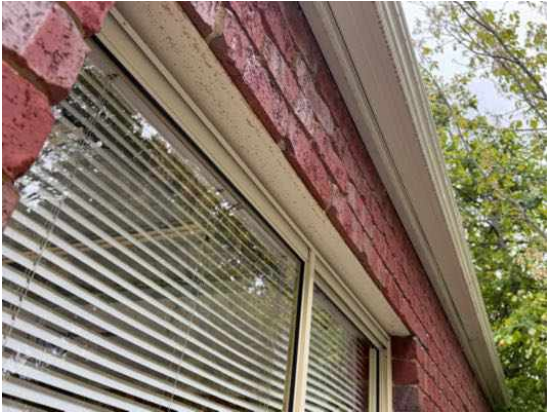
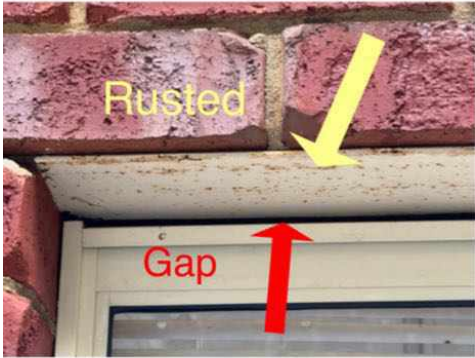
Noted Item

Building: Building 1
Location: All Areas > All Areas
Finding: Additional Photos
Information: Additional photos are provided for either future maintenance items for clients attention and or general reference. Arrows may have been included to highlight areas of importance. Please discuss these photos with your building consultant for clarification.

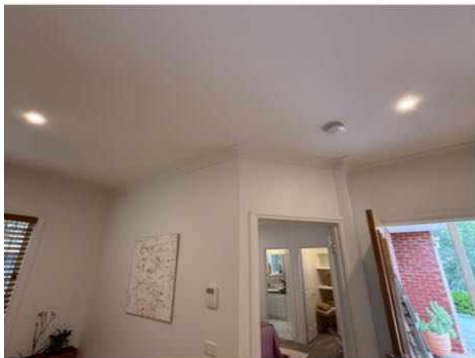
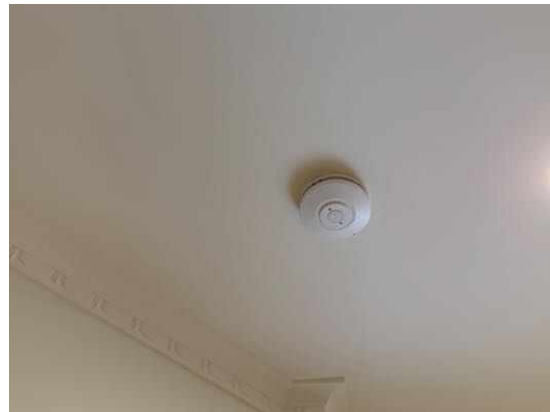
Building: Building 1
 Location: All Areas > All Areas
 Finding: Smoke detectors and alarms
 Information: Reporting on Smoke Detectors or Alarms, including hard wired smoke detection systems and their legislative requirements, is outside the Scope of this Report. Please note that this defect is highlighted as a caution only. We suspect, based on our experience in the building industry, that smoke detectors are sometimes get overlooked, or they may be in a poor condition, so we recommend that they always should be addressed prior to occupation to improve occupant safety.

Always ensure sufficient working and suitable smoke detectors are installed prior and during to occupying any building. Additionally, it is advised that all smoke detectors be tested by the homeowner on a monthly basis.

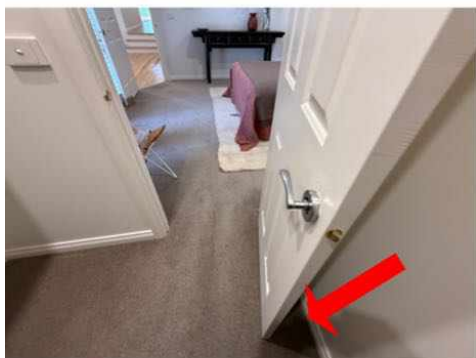
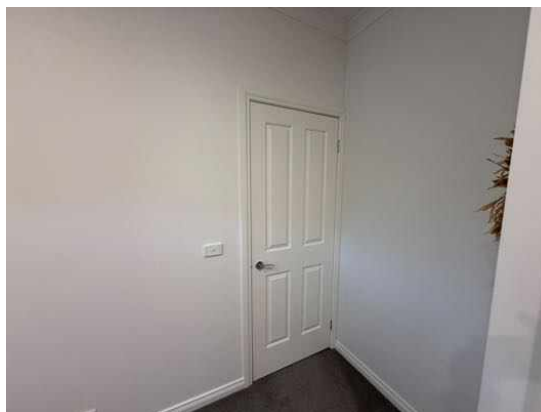
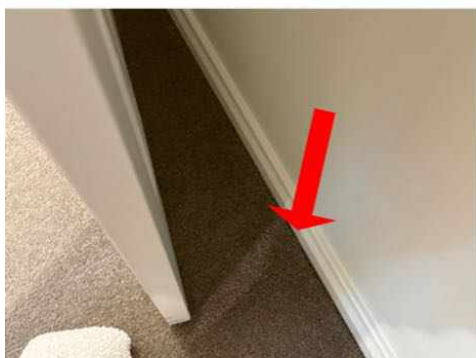
Building: Building 1
 Location: All Areas > All Areas
 Finding: Door stops
 Information: The door stops were mostly observed to be missing at the time of the inspection. When door stops are observed to be broken, missing or inadequate to stop the door

handle from damaging the wall, secondary damage is highly likely to occur. Although some building elements may seem irrelevant or unnecessary, all building elements play a key role in the operation and function of the overall structure and its performance.

The installation of all of the door stops is recommended as soon as possible to prevent any subsequent damage to the wall plaster linings or associated structures. A qualified carpenter may be appointed to perform these works at client discretion.

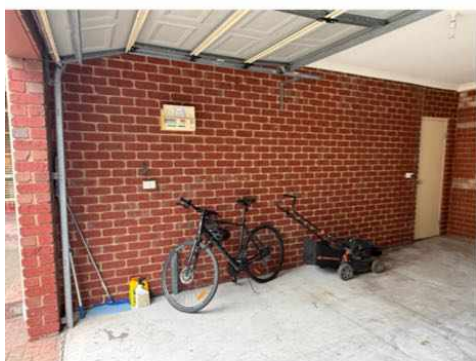
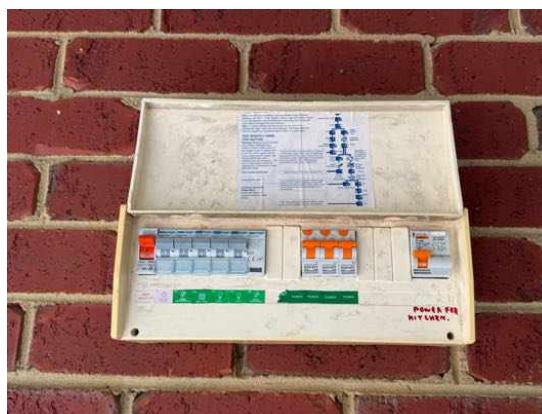
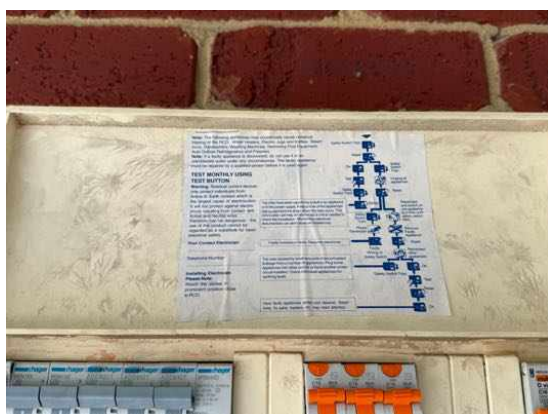
Building: Building 1
 Location: All Areas > All Areas
 Finding: Termite Management System - no evidence of a chemical installation or durable notice
 Information: At the time of the inspection no application of a chemical termite barrier or durable notice was observed. Such barriers are highly effective and highly recommended for all properties in preventing termite attack on any timber building elements throughout the property.

A durable notice should be placed in the switchboard unit or in the another accessible area to indicate current termite barriers. At the time of inspection, no evidence to suggest preventative works taking place. The client may consider gaining further advice from builders or a pest controller and as to the costs and procedures involved with this application. It is recommended that obtaining such advice be a short-term priority.

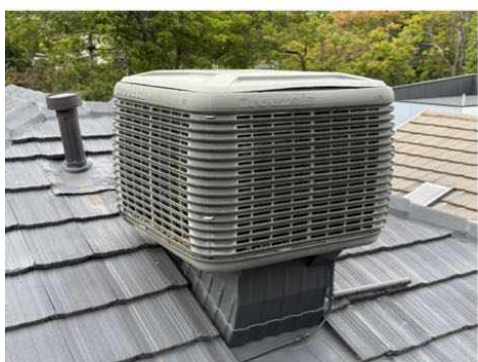
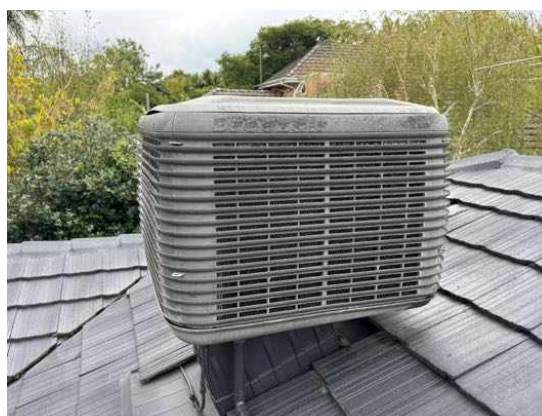
Building: Building 1
 Location: All Areas > All Areas
 Finding: Evaporative air conditioner
 Information: Reporting on the Evaporative air conditioning unit, including as to whether they are working, is outside the Scope of this Report. Please note that this is highlighted as a recommendation only. It is recommended that the Evaporative air conditioning unit to

receive maintenance and servicing. Servicing of this unit will improve occupants well being and ensure good functionality and prolonged serviceability. If left unmaintained, Evaporative air conditioning unit may be or become a health hazard.

We suspect, based on our experience in the building industry, that Evaporative air conditioning unit get over looked and do not get any maintenance for long periods of time. The Evaporative air conditioning unit may therefore be in a, less than perfect condition, so we recommend that they always ensure that these areas be addressed prior to their use, this is to ensure home and occupant health and safety.

A air-conditioner serviceman should be appointed to assess the condition of the unit and to service and clean as deemed necessary, this is at the discretion of the client.

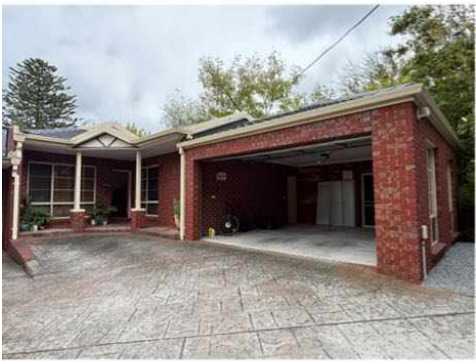
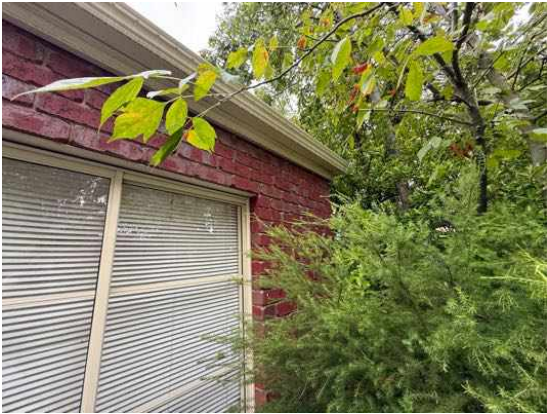
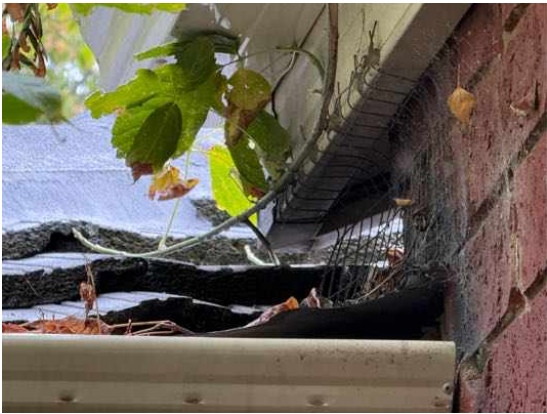
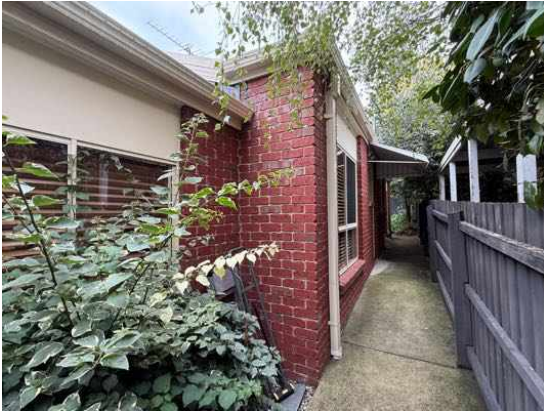
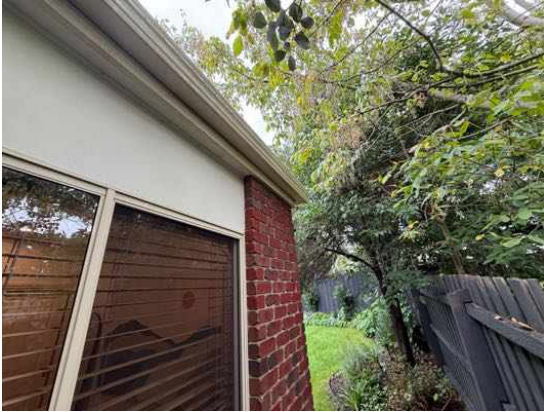
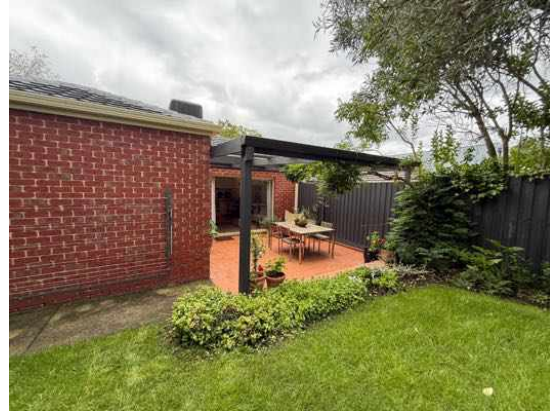
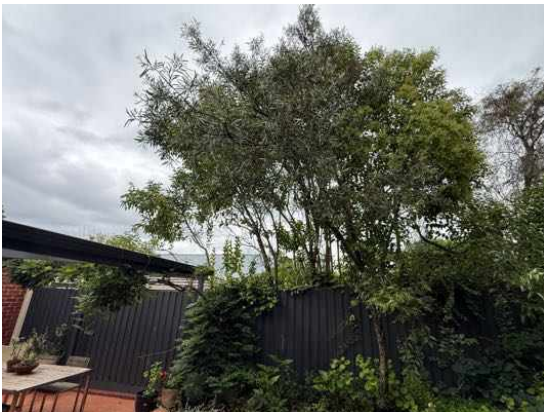
Overhanging trees often result in excessive amounts of leaf debris accumulating in gutters. Gutters are a critical part of the building's management of storm water and rain. It is therefore important that they be kept clear to prevent secondary damage to associated building elements, including exterior and interior walls, ceiling linings and any adjoining building elements. Where gutters get blocked from excessive leaf matter, water pooling is highly likely to occur more frequently, fast-tracking, rust and corrosion of the roof plumbing elements and making these areas even more susceptible to secondary defects. It is highly recommended that if at all possible, all overhanging tree branches be removed to prevent further damage. Such works can be performed by the homeowner; however, appointment of a landscape contractor or an arborist may be required. Consultation with a licensed roof plumber is required where guttering has been damaged.

Building:	Building 1
Location:	All Areas > All Areas
Finding:	Trees - Overhanging and filling gutters
Information:	Overhanging trees often result in excessive amounts of leaf debris accumulating in gutters. Gutters are a critical part of the building's management of storm water and rain. It is therefore important that they be kept clear to prevent secondary damage to associated building elements, including exterior and interior walls, ceiling linings and any adjoining building elements. Where gutters get blocked from excessive leaf matter, water pooling is highly likely to occur more frequently, fast-tracking, rust and corrosion of the roof plumbing elements and making these areas even more susceptible to secondary defects

It is highly recommended that if at all possible, all overhanging tree branches be removed to prevent further damage. Such works can be performed by the homeowner; however, appointment of a landscape contractor or an arborist may be required. Consultation with a licensed roof plumber is required where guttering has been damaged.

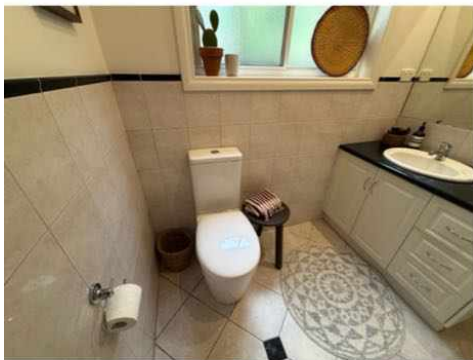
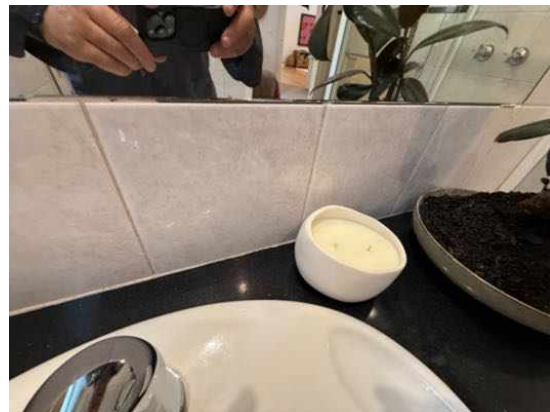
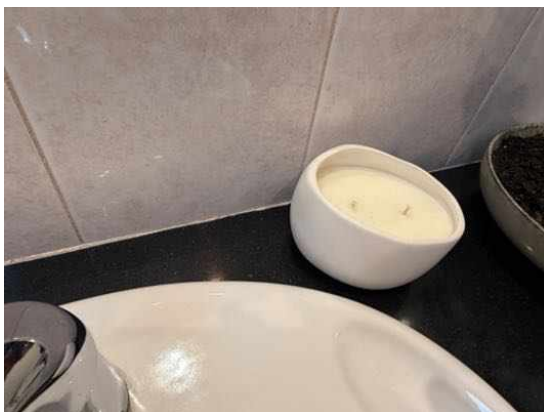
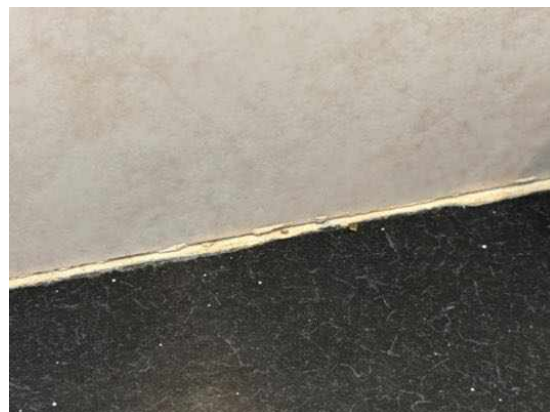
Building:	Building 1
Location:	Bathroom > All Areas
Finding:	Grout and sealant maintenance
Information:	It was observed that grout and sealant had been dislodged from the bottom of the tiled shower alcove in the bathrooms. These types of areas require thorough and frequent maintenance and cleaning to ensure water and moisture does not exit the shower and penetrate and of the tile substrate areas. It is also very important to the laundry and kitchen areas to ensure these areas remain watertight at all times. It is highly recommended that the client appoint a professional wall and floor tiler to provide remedial work to rectify the shower floor grout and sealant before any water

Grout and sealant were observed to have been either deteriorated, dislodged or missing, in these types of wet areas if not rectified and maintained adequately it is highly likely that these areas will have accelerated damage and deterioration to the substrate as well as more serious secondary defects to the adjoining floor and wall structures. Regular maintenance and replacement of grout to any holes or damaged sealant is highly recommended to the wet areas, as this is a regular wear and tear defect. Sealant and grouting in areas that come into regular contact with water should be maintained for the long term care of your property.

Different materials on the walls and floor areas move at different rates, generally causing cracking to grout or sealant at these points. A flexible sealant is required to allow for expected expansion and contraction, while keeping the joint water tight and protective of all associated building structures and materials. Flexible and mould resistant materials should be applied to affected areas to prevent any subsequent water damage that is likely to occur if left unmanaged. A sealant specialist or tiling contractor should be appointed to complete these works immediately or as soon as possible.

damage to the adjoining areas can occur.
