# Building and Timber Pest Inspection Report

Inspection Date: Mon, 19 Jan 2026

Property Address: 3/14-16 Ramona St, Quakers Hill NSW  
2763, Australia

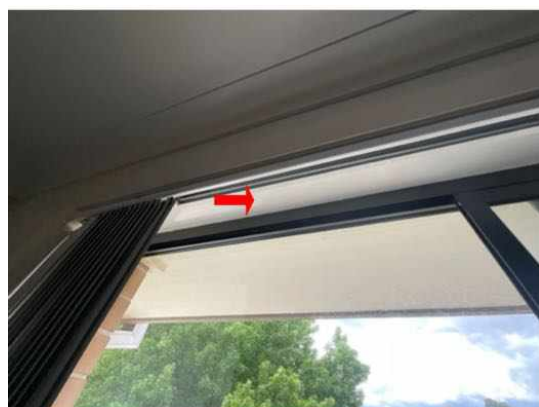
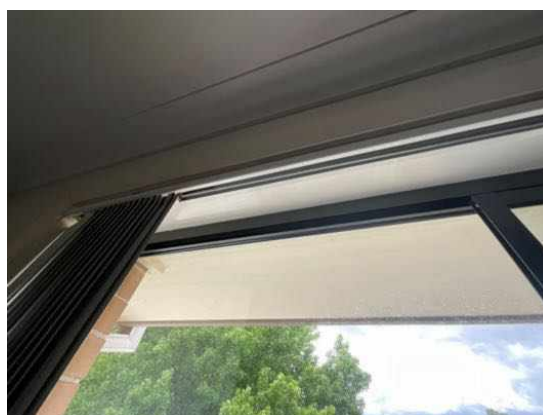
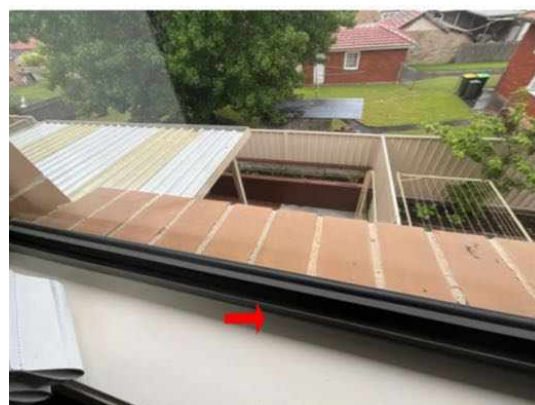
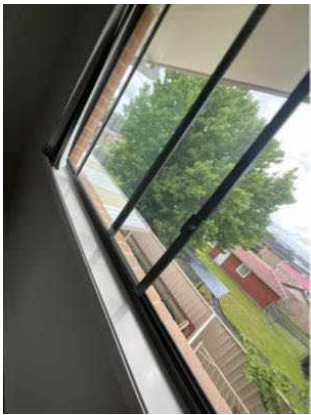
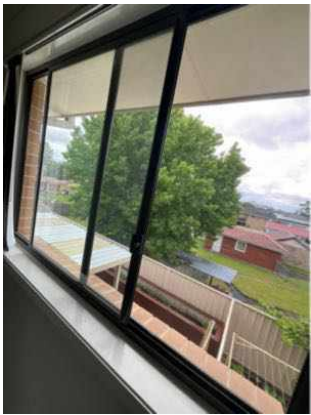
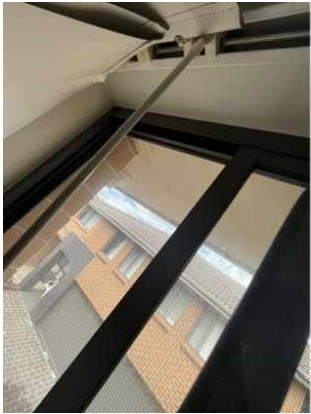
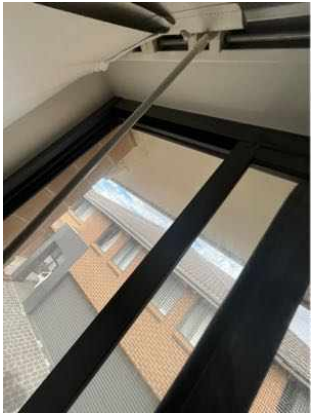
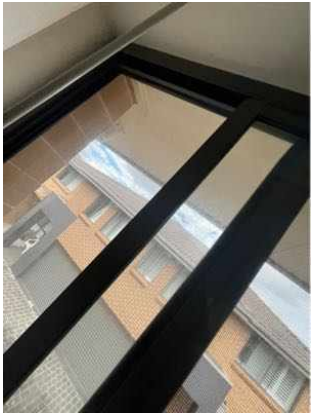
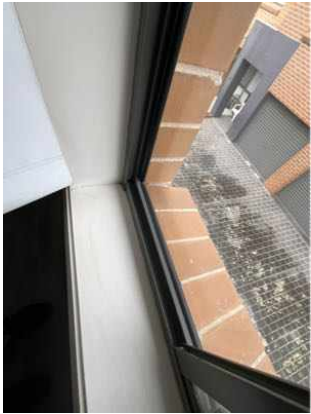
#### Finding 1.01

Building:	Main Building
Location:	All Areas
Finding:	Window child lock missing
Information:	The window in question lacks a child lock mechanism, which poses a potential safety risk to young occupants in the premises. As per Australian Standards windows accessible to children should be equipped with appropriate child safety locks to prevent accidental opening, reducing the risk of falls and ensuring compliance with safety regulations.

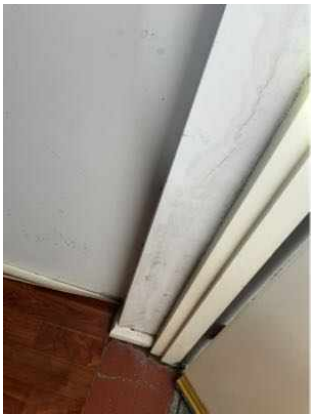
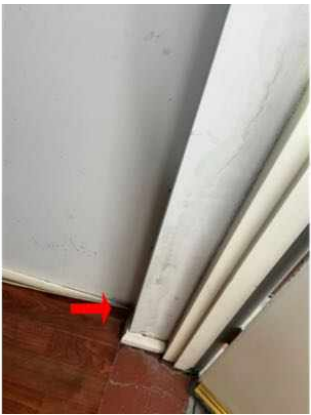
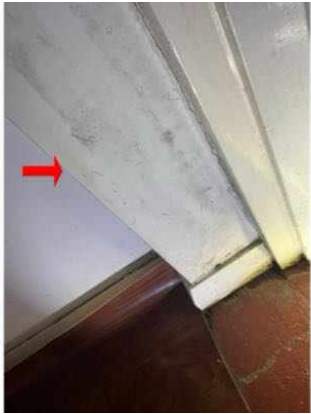
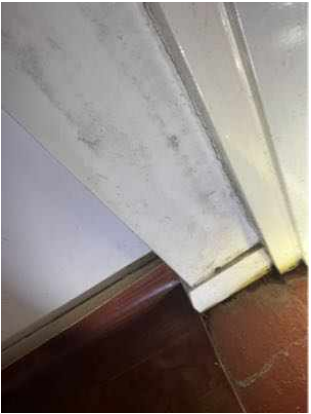
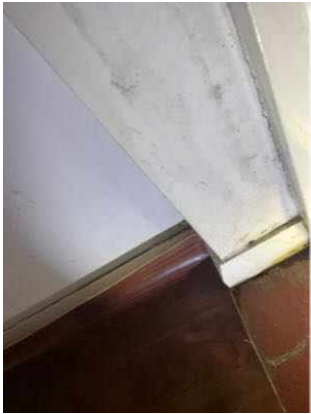
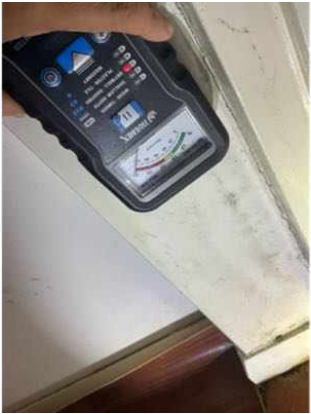
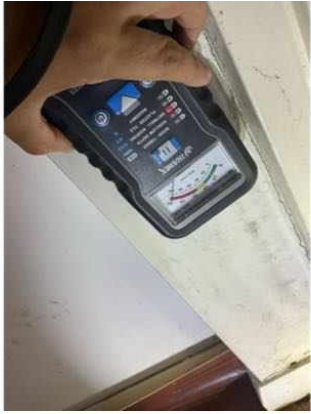
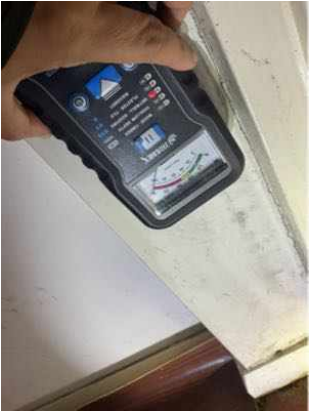
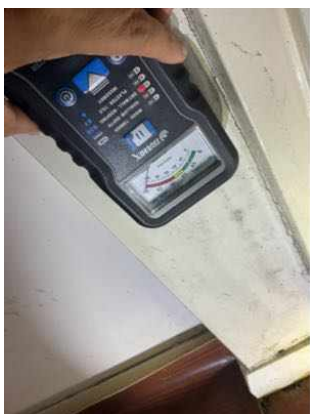
## Finding 2.01

Building: Main Building  
Location: Garage  
Finding: Water damage  
Information: The area has sustained water damage resulting in potential structural issues. This damage compromises both the aesthetic and functional aspects.

1 **Plumber:** If the water damage is due to plumbing issues, a plumber can fix leaks and ensure there are no further water-related problems.

2 **General Contractor:** If the damage is extensive and affects the surrounding area, a general contractor can coordinate the repair work, including any related structural or cosmetic repairs.

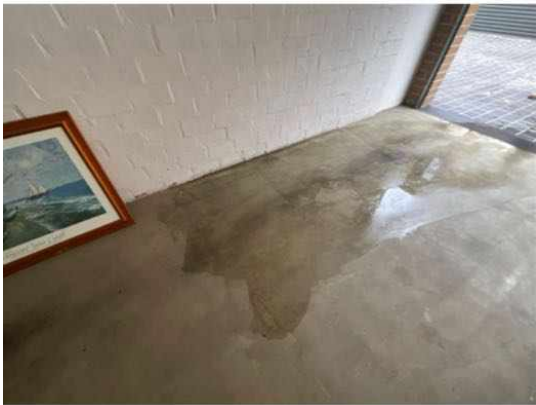
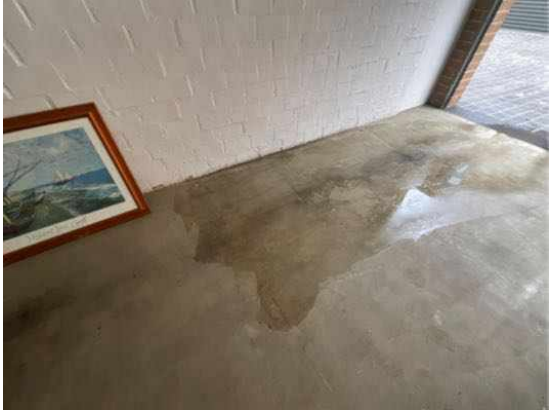
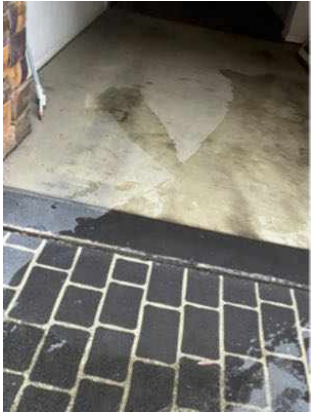
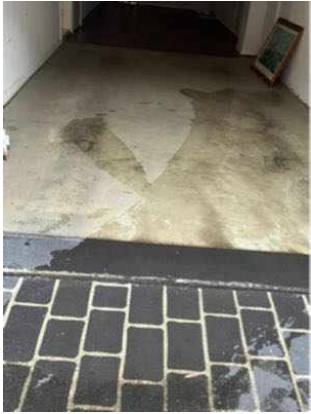
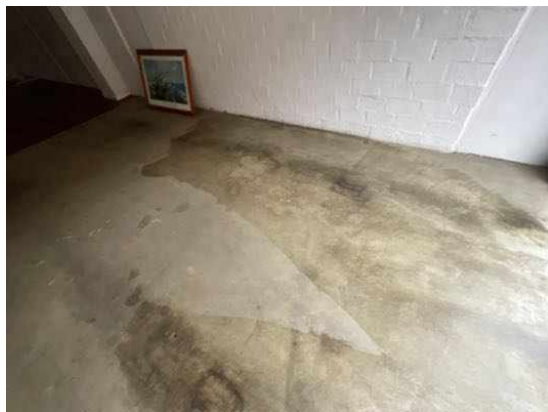
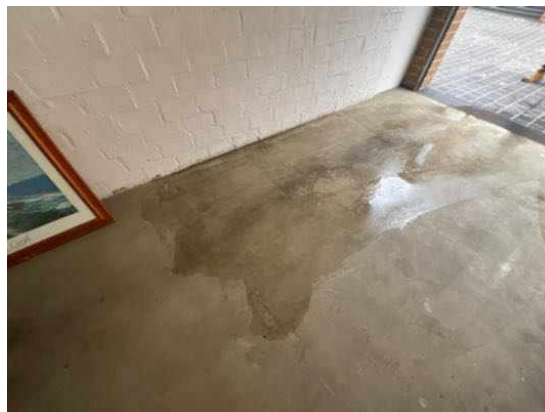
### Finding 3.01

Building:	Main Building
Location:	Garage
Finding:	Garage Floor – Water Ingress / Flooding
Information:	Evidence of water ingress was observed to the garage floor, with visible pooling and damp staining along the slab surface adjacent to the internal wall and near the garage opening. This indicates recent or ongoing water entry into the garage area.

- Inadequate surface drainage or negative fall at the garage entry
- Stormwater runoff entering under the garage door during rainfall
- Blocked or insufficient floor waste / drainage
- Rising damp or moisture migration through the slab edge (where applicable)

- Slip hazard due to wet floor conditions
- Potential deterioration of concrete slab and wall finishes over time
- Increased risk of mould growth and moisture-related damage
- Damage to stored items and garage contents

Further investigation by a licensed plumber or drainage contractor is recommended to identify the source of water ingress. Rectification may include improving surface drainage, installing or upgrading drainage systems, sealing slab joints, and ensuring

appropriate falls away from the garage entry. Ongoing monitoring is advised until rectification is completed.

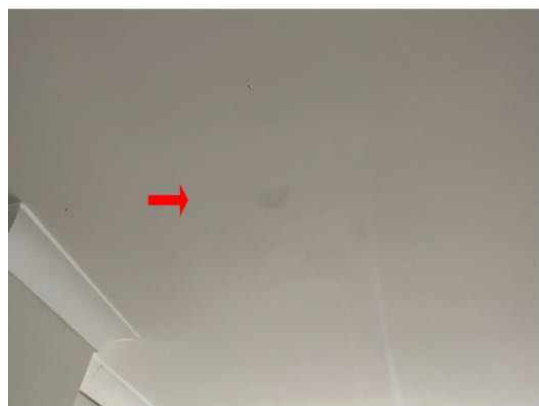
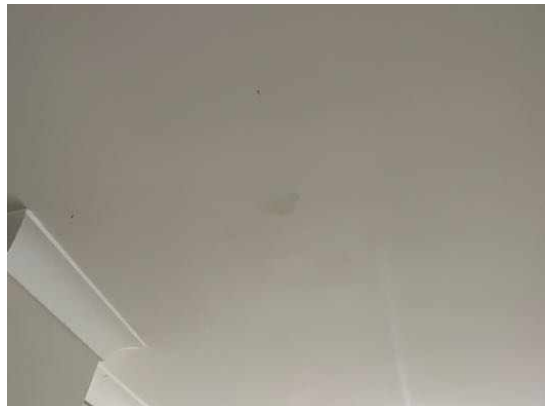
### Finding 3.02

Finding: Water staining

Information: Water staining was evident in this area at the time of inspection. Water staining indicates that surfaces have been exposed to excessive moisture over time. The minerals and other elements in the water lead to staining, which may graduate to corrosion and deterioration if left unmanaged.

While mostly an appearance defect, water staining can be indicative of more serious defects, which may be currently concealed by other building elements.

Where water staining is active, a licensed plumber must be consulted to identify the cause of the staining and to provide advice on any reparation works that may be required. Replacement of any broken or damaged structures is advised.

Conversely, where water staining is old and inactive, affected building materials may be repaired or replaced at client discretion. A qualified carpenter or registered builder may be appointed to perform these works.

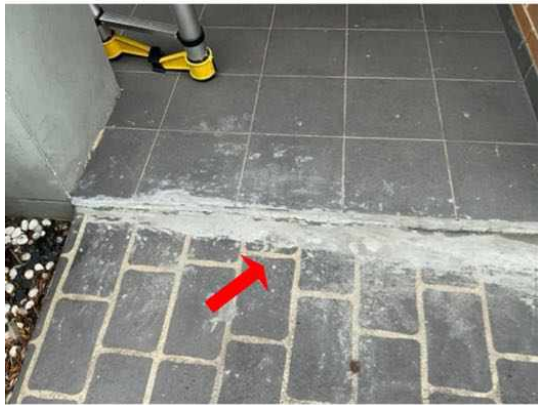
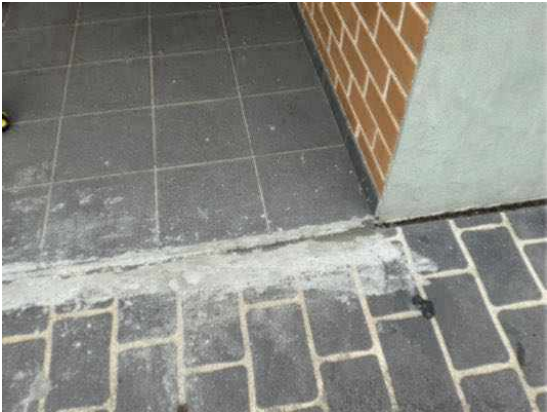
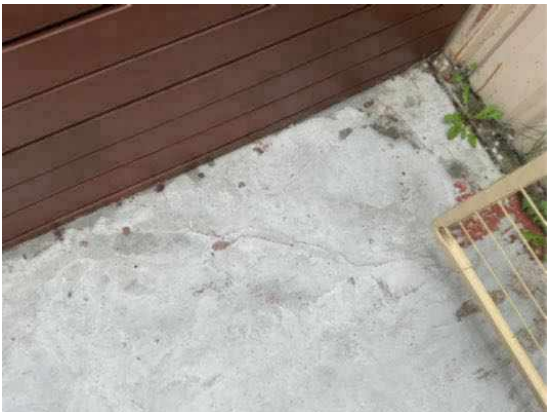
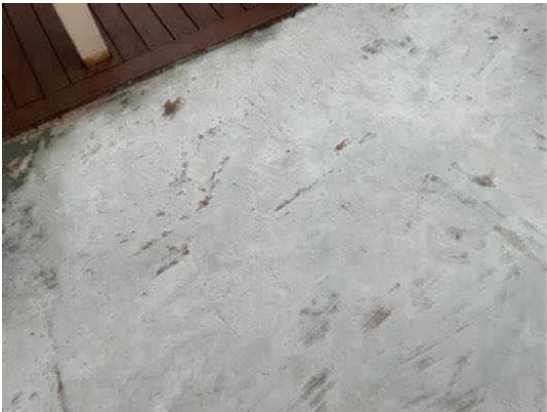
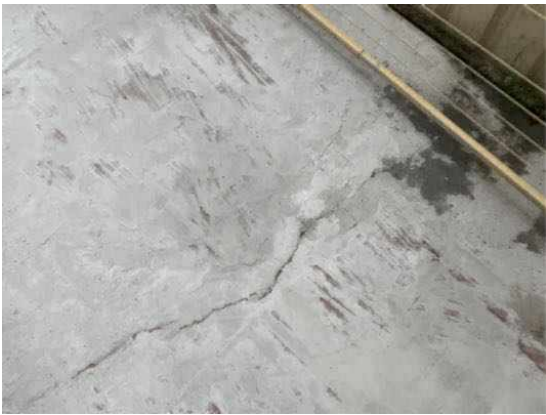
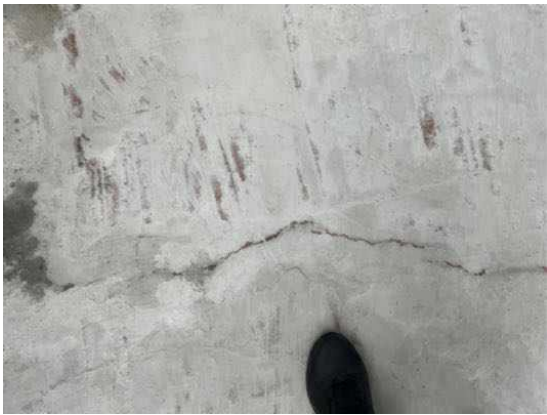
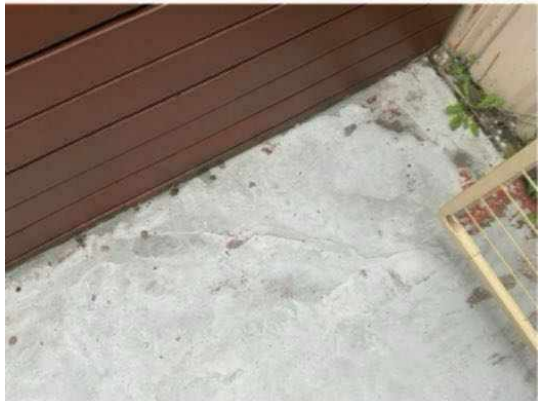
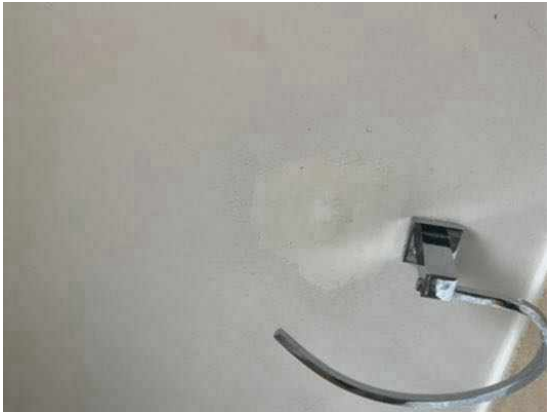
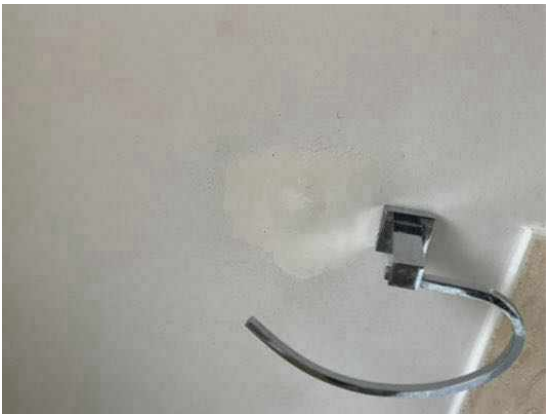
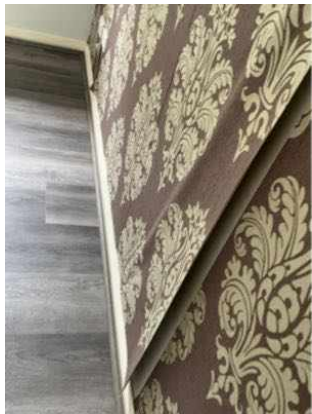
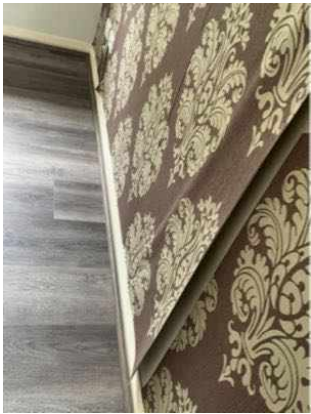
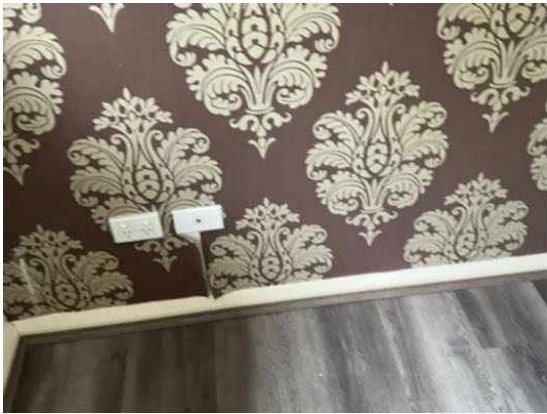
### Finding 3.03

Risk: Poor workmanship poses a range of risks, including compromised structural integrity, potential safety hazards, and a decreased lifespan of the structure. It may also lead to aesthetic and functional issues.

Resolution: A qualified contractor or construction professional should be consulted to assess and address the poor workmanship. They can implement corrective measures to ensure structural soundness, safety, and overall quality of the construction.

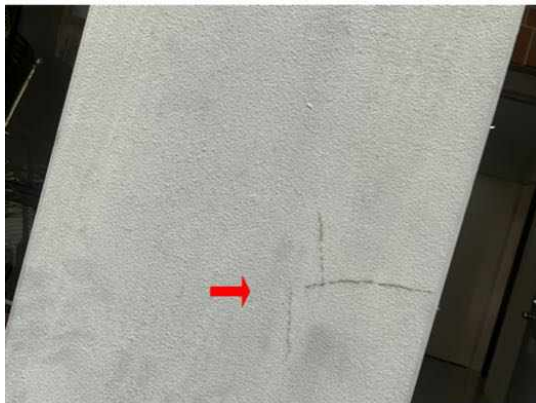
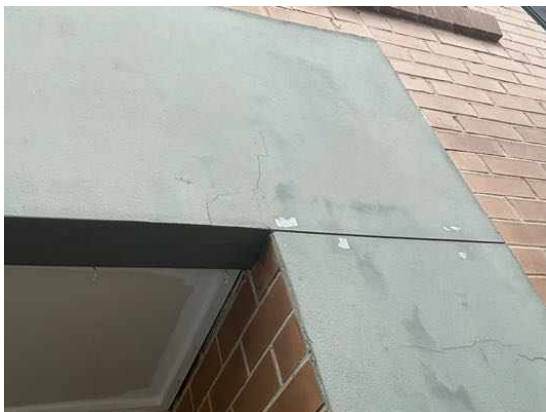
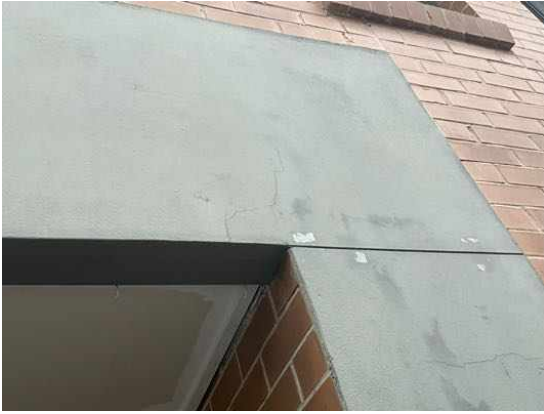
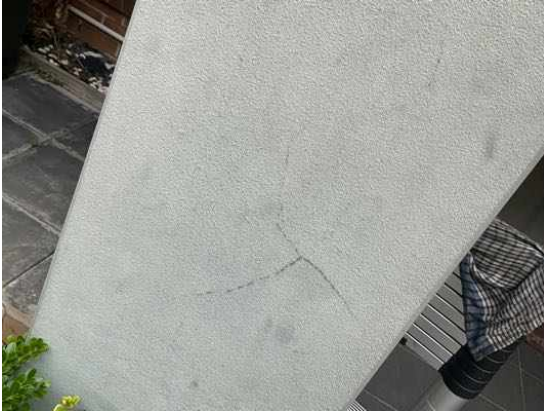
**Finding 3.04**

Building: Main Building  
 Location: Front Elevation  
 Finding: Deteriorated Rendering  
 Information: The rendering on the exterior walls of the building is deteriorating, showing signs of cracking, peeling, and flaking. This can be attributed to weathering, moisture ingress, or poor initial application.

- **\*\*Structural Damage:\*\*** Deteriorated rendering can allow moisture to penetrate the underlying structure, leading to further damage, weakening the integrity of the building,

- **Safety Concerns:** Loose or falling render poses a safety hazard to occupants and passersby.

- **Professional Plasterer or Renderer:** A skilled plasterer or renderer should be engaged to assess the extent of the damage, remove the deteriorated rendering, and apply a new, high-quality render to the affected areas.

- **General Contractor:** For extensive damage, a general contractor may be necessary to coordinate the repair work, ensuring that any underlying structural issues are also addressed.

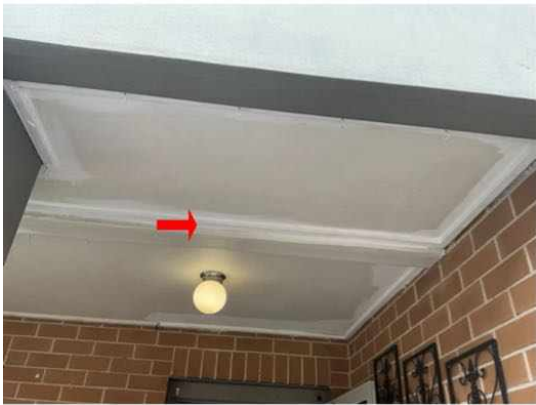
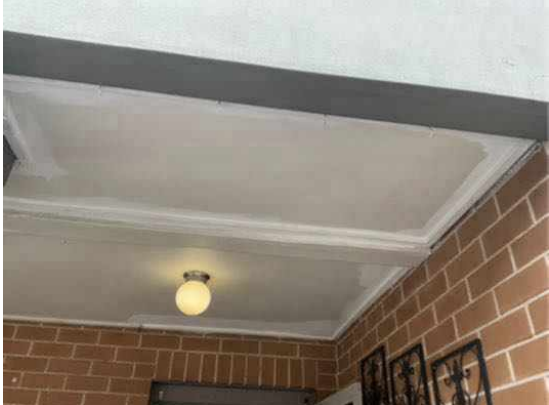
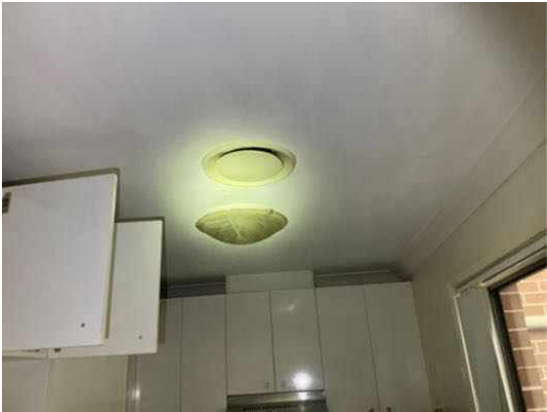
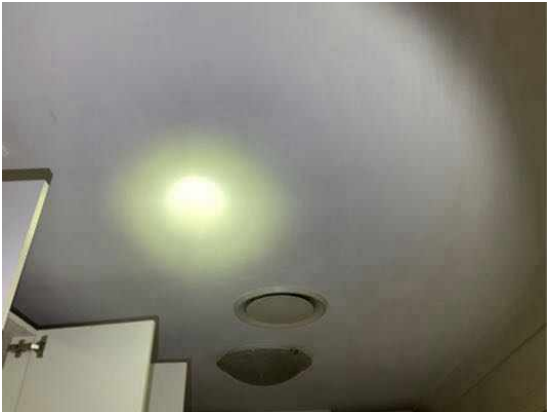
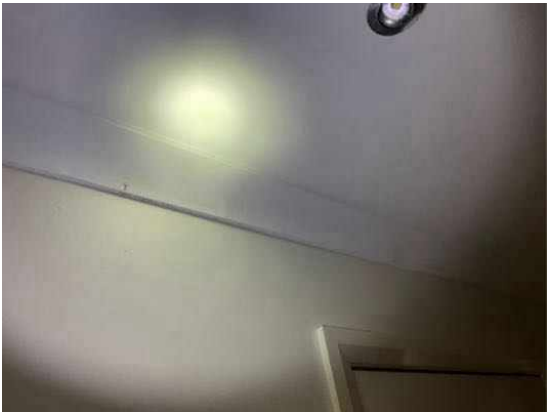
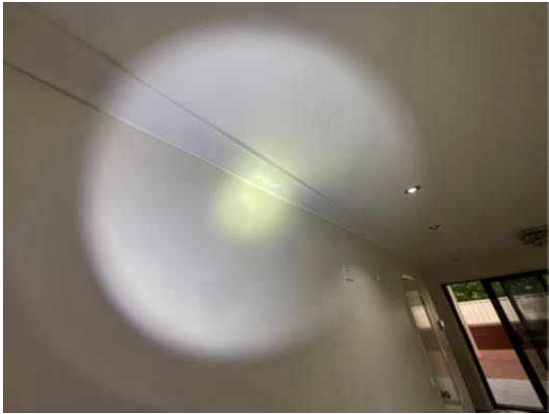
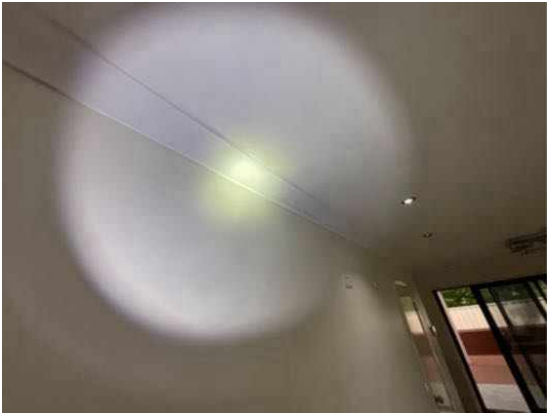
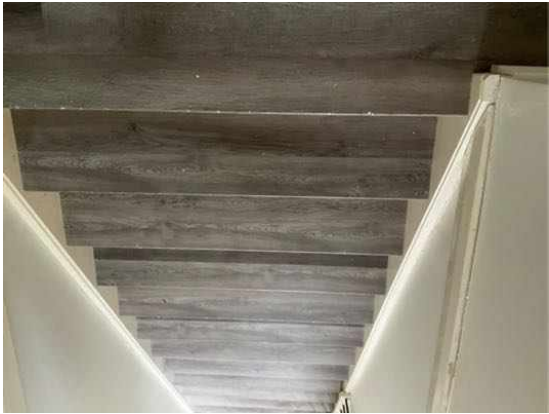
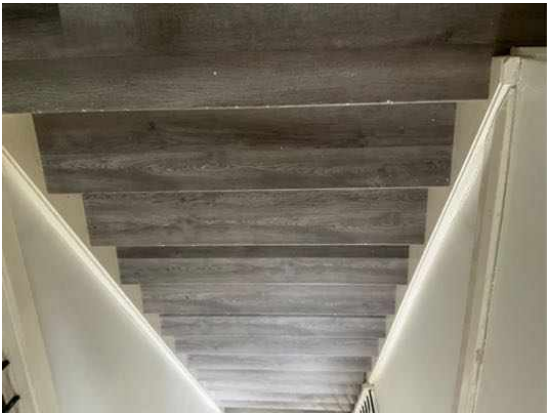
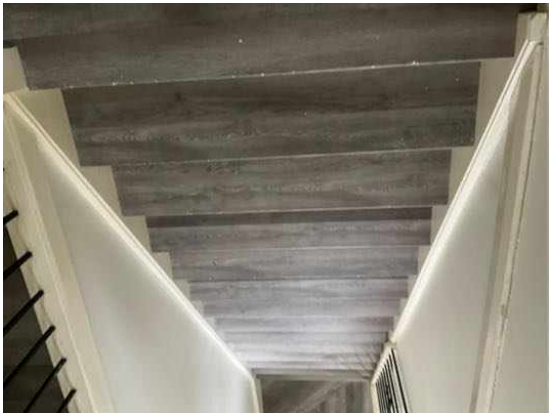
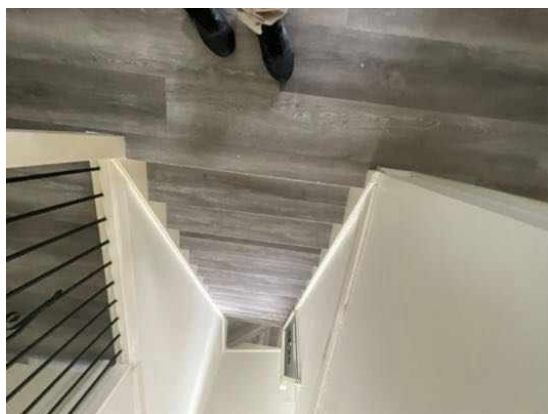
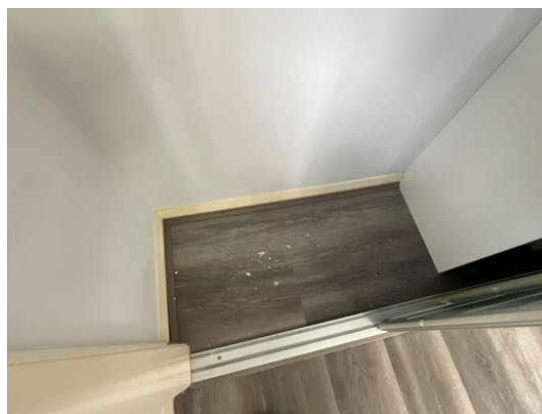
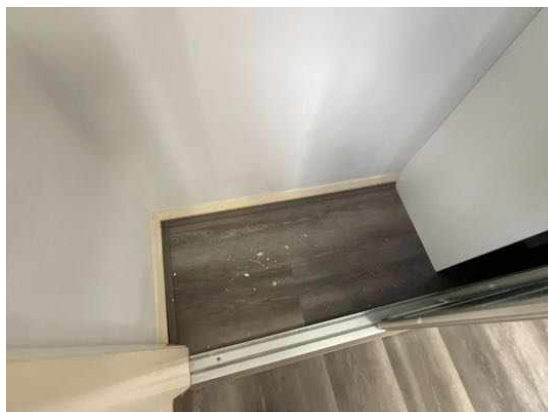
### Finding 3.05

Building:	Main Building
Location:	All Areas
Finding:	Paint - Substandard
Information:	Areas were identified where the surface finish of the painting is substandard and this is considered a defect.

Any irregularity in the surface which is visible from a normal viewing position is considered a defect. Marks may also be a result of fault by other tradespeople throughout the construction process.

Defective surface finish of paintwork is marked with an arrow to the below photos in the following locations.

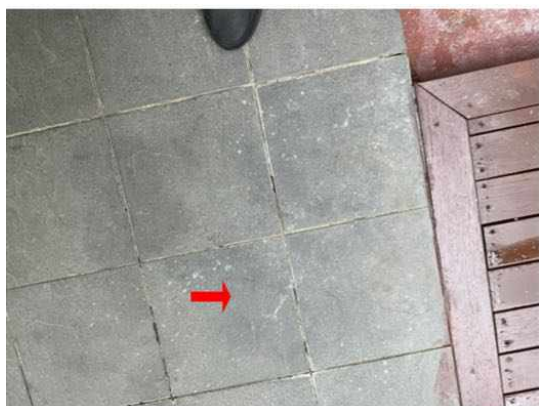
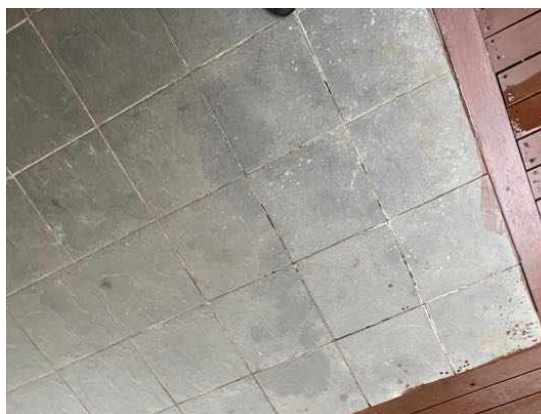
### Finding 3.06

Building:	Main Building
Location:	Yard - Back
Finding:	Grouting - Missing or damaged
Information:	It was noted on inspection that sealant or grout is Missing or damaged. A flexible sealant is required to allow for expected expansion and contraction, while keeping the joint water tight and protective of all associated building materials.

Flexible and mould resistant materials should be applied to affected areas to prevent any subsequent water damage that is likely to occur. Regular maintenance and replacement of damage or missing or damaged sealant and grout is highly recommended , as this is a regular wear and tear defect.

A sealant specialist or tiling contractor should be appointed to complete these works as soon as possible

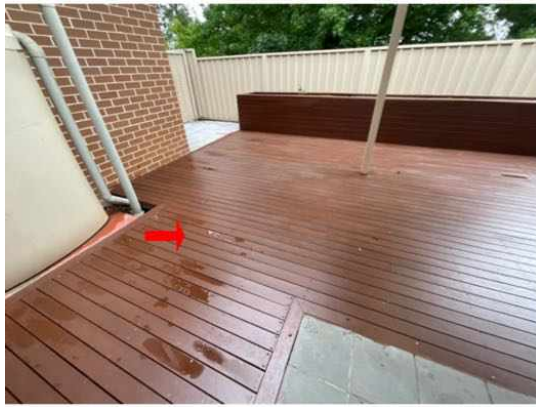
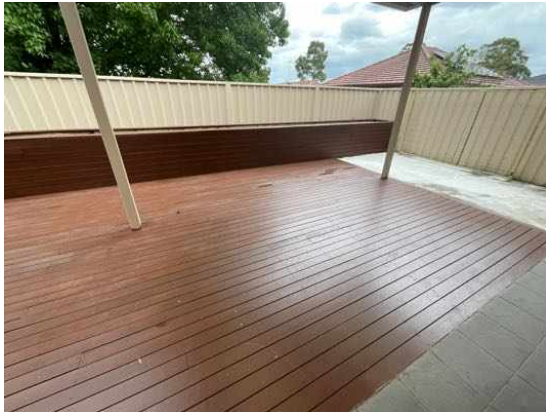
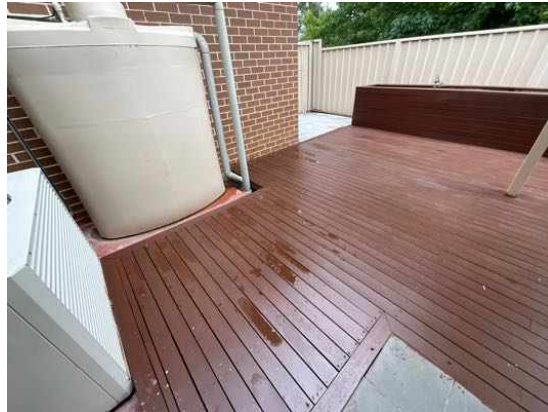
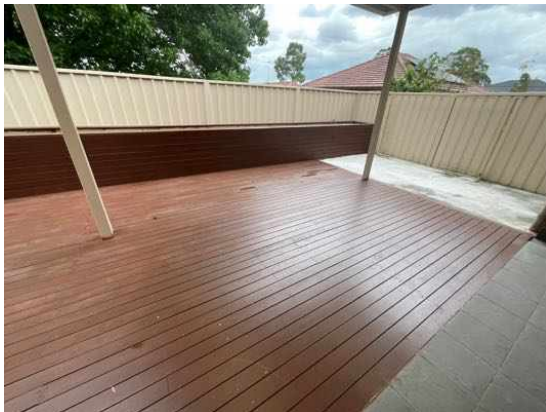
### Finding 3.07

Building:	Main Building
Location:	Deck
Finding:	External timber balcony or deck-structural stability
Information:	The load capacity of the external balcony or deck could not be verified during the inspection.

External timber structures are also constantly exposed to weather deteriorates in an exhilarate manner, ongoing assessments are required.

It is highly recommended that a structural engineer further, assess the external timber balcony or a deck to inform the client of its load capacity.

Regular maintenance inspections by competent practitioners is needed.

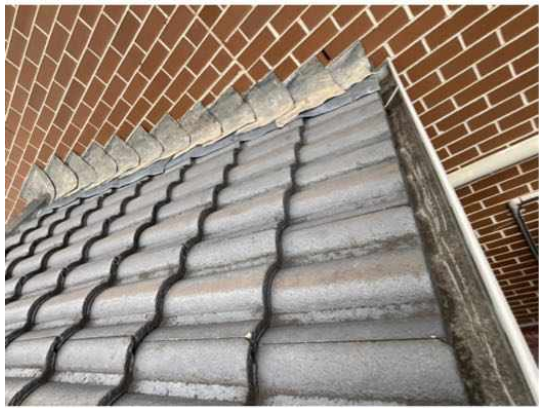
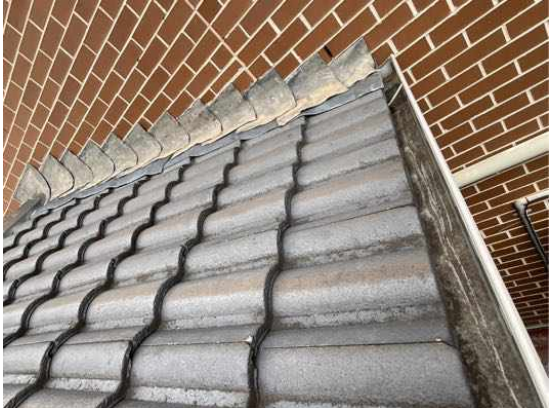
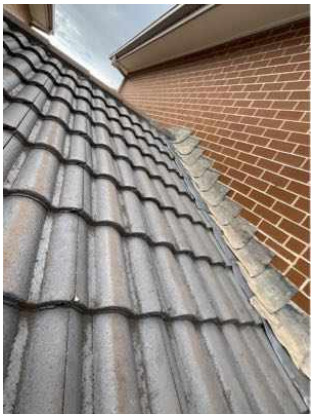
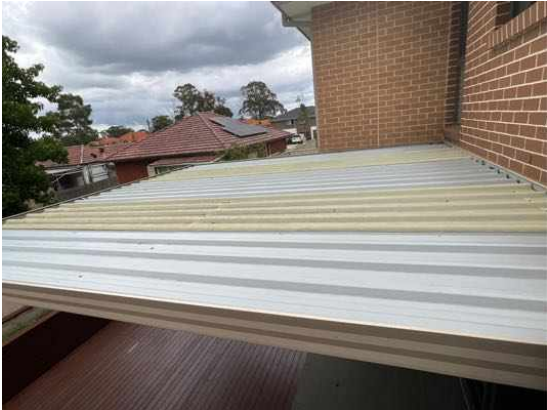
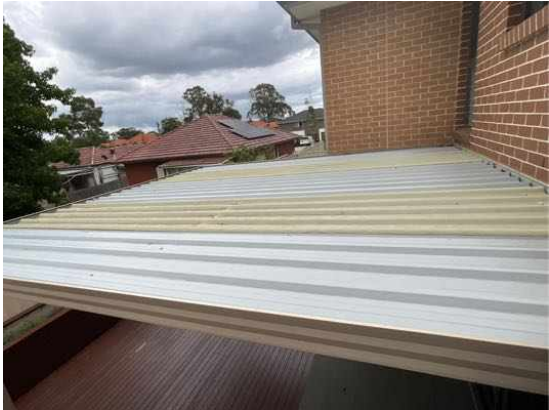
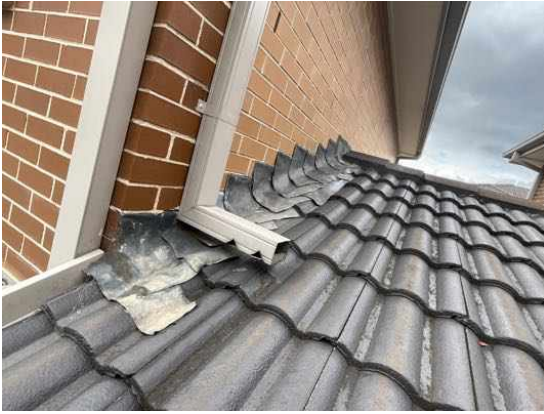
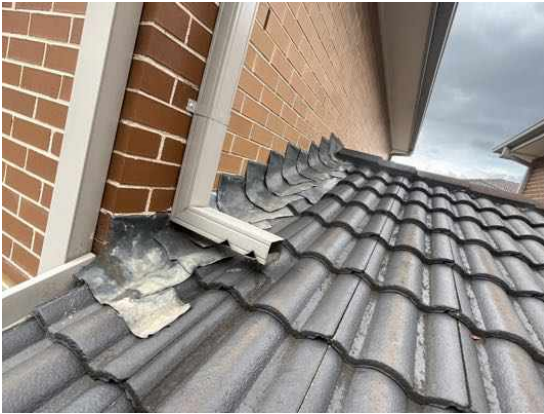
### Finding 3.08

Information: Inspection of the roof revealed widespread weathering to the tiled roof surface. The tiles show loss of surface finish, colour fading, and age-related deterioration typical of older roof coverings. Although no significant cracking was noted, weathering can lead to increased porosity, reduced water-shedding capability, and a higher risk of future cracking or displacement during adverse weather conditions.

A licensed roofer should be engaged to undertake a closer inspection, carry out routine maintenance, and replace any tiles that may be compromised. Ongoing

monitoring is recommended due to the age and condition of the roof covering.

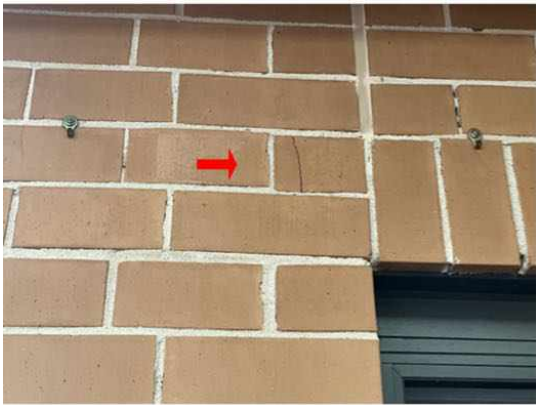
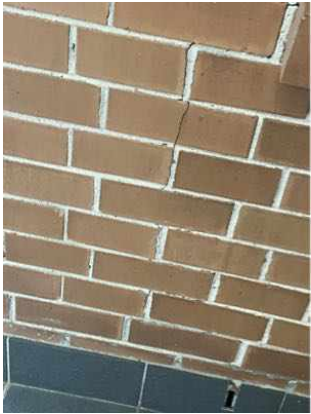
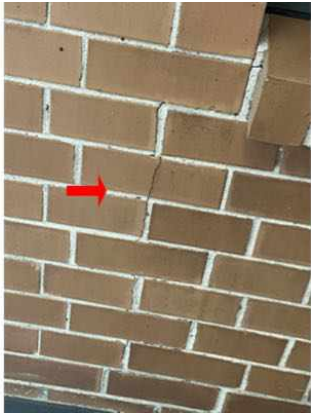
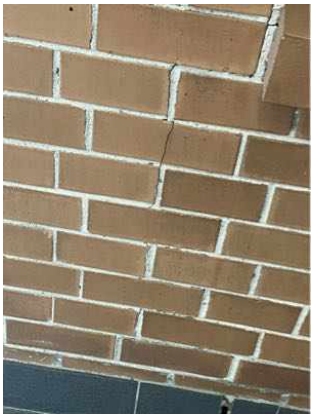
### Finding 3.09

Building:	Main Building
Location:	Exterior walls - rear
Finding:	Brickwork - Cracking [Fine]
Information:	Although fine cracks are quite noticeable, they are often only considered to be an appearance defect and usually do not indicate any structural damage. Generally, the cause of a fine crack is indicative of a separation between brickwork and mortar throughout the structure, but single bricks may also show cracks of this nature.

Cracking of this nature can generally be repaired with minor filling and should be conducted by a qualified bricklayer.

Always contact a building inspector should cracks widen lengthen or become more numerous.

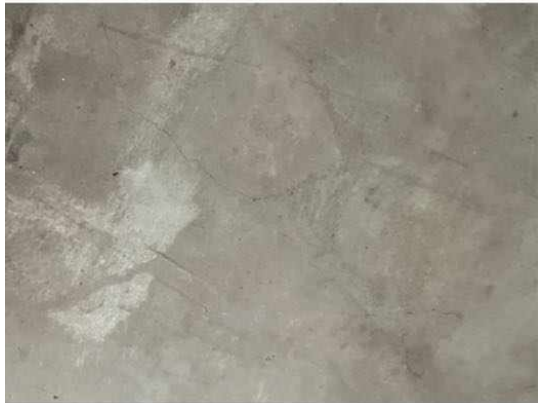
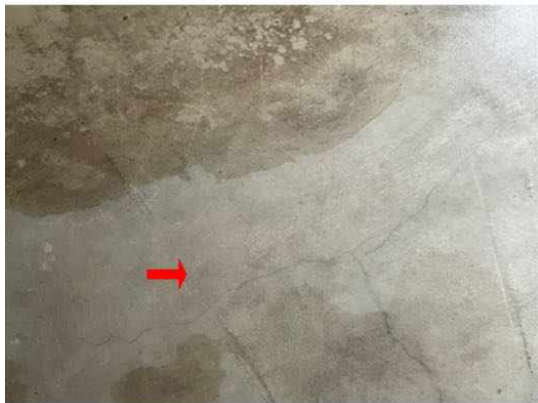
**Finding 3.10**

Building: Main Building  
Location: All Areas  
Finding: Crack in concrete slab - Category 0  
Information: A crack coded as Category 0 was identified in the slab. A Category 0 crack is described as a hairline crack, representing insignificant movement of slab from level.

The approximate width of the crack to be considered Category 0 is 0.3mm, or change in offset of less than 8mm when a 3m straight edge is placed over the defect.

No rectification is required at this time. However, all cracking should be monitored over a 12 month period to identify any further damage in the area.

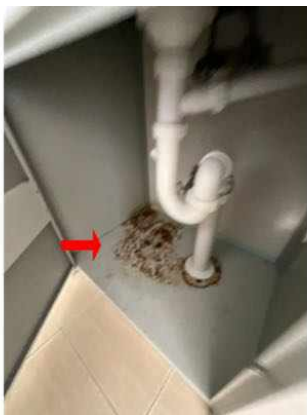
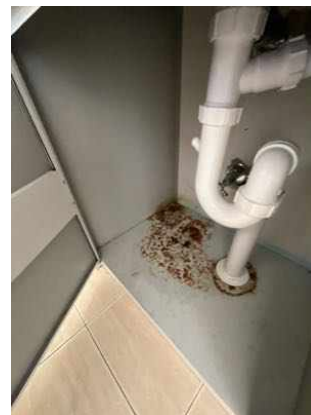
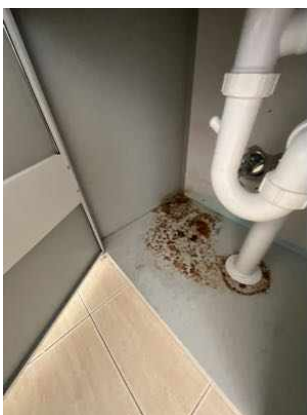
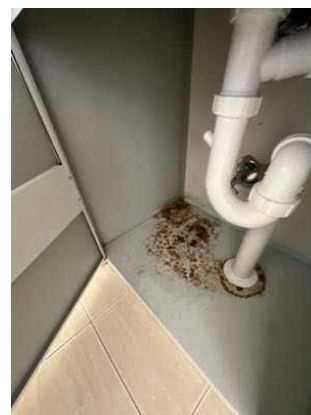
Information: This building element shows evidence of rusting and corrosion, which is likely to have developed as a result of excessive exposure to moisture and or inadequate coatings.

As surface rust provides no protection to the underlying iron, the deteriorating condition is likely to worsen if not addressed in the short-term future.

Where possible, the use of galvanized (treated) metals or aluminium coated metals aid in rust prevention, as does regular general maintenance. Rust formation can be controlled with coatings, such as paint, that isolate the iron from the environment.

Rusting and corrosion should be managed by ideally removing or limiting the affected surface from exposure to moisture. A registered builder may be appointed to replace any building elements that have been severely affected by rust or water damage.

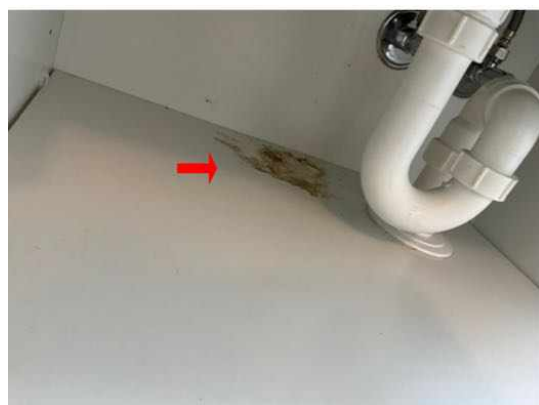
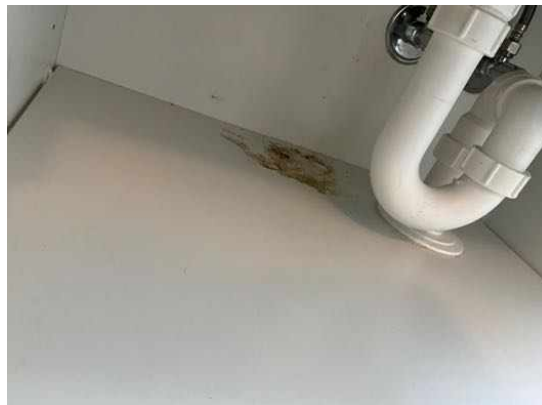
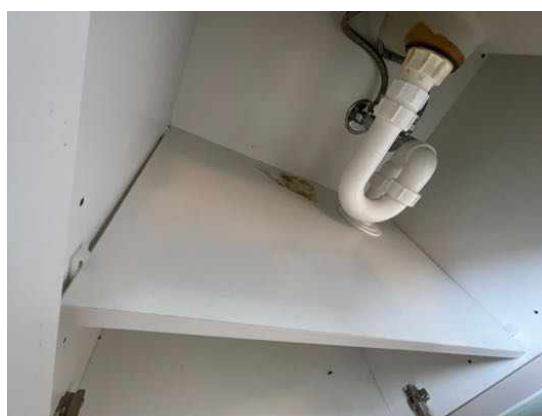
### Finding 3.12

Finding: Water damage / Vanity  
Information: "The vanity in the shower area has sustained water damage, resulting in swelling and discoloration of the wood, as well as potential structural issues. This damage compromises both the aesthetic and functional aspects of the vanity."

1. **Carpenter or Woodworker:** They can assess and repair the damage to the vanity, potentially replacing any irreparable parts.
2. **Plumber:** If the water damage is due to plumbing issues, a plumber can fix leaks and ensure there are no further water-related problems.
3. **General Contractor:** If the damage is extensive and affects the surrounding area, a general contractor can coordinate the repair work, including both the vanity and any related structural or cosmetic repairs.

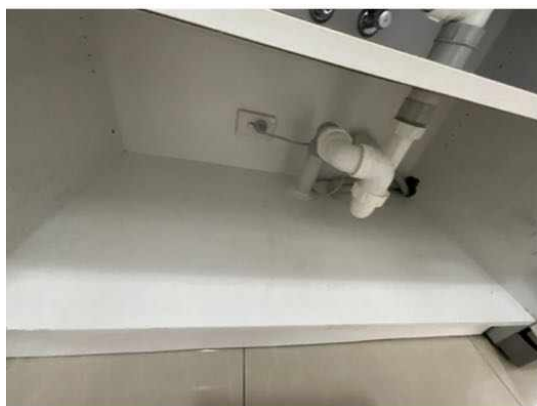
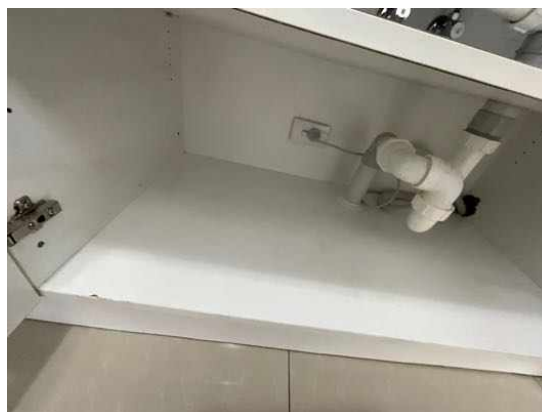
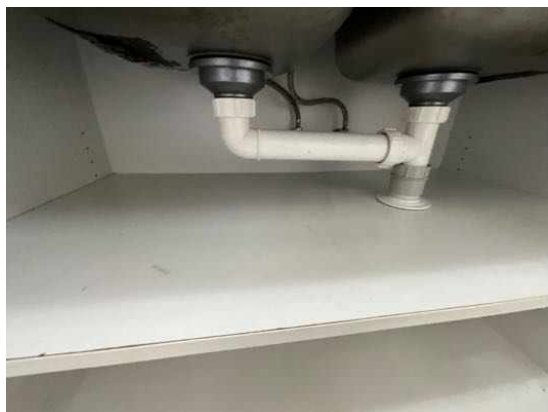
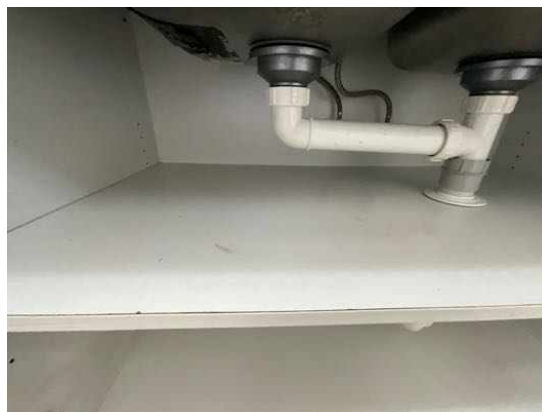
### Finding 3.13

Building: Main Building  
Location: Kitchen

Finding: Stains in Vanity  
Information: Defect: General Stains in the Vanity

Description: The vanity surface exhibits general stains that may be due to water exposure, soap scum, cosmetics, or other substances. These stains are unsightly and may indicate ongoing maintenance issues.

- Clean the vanity using appropriate cleaning agents to remove stains.
- Inspect for any underlying issues, such as leaks or surface damage, and address them accordingly.
- Consider refinishing or replacing the vanity if stains are persistent and cannot be removed.

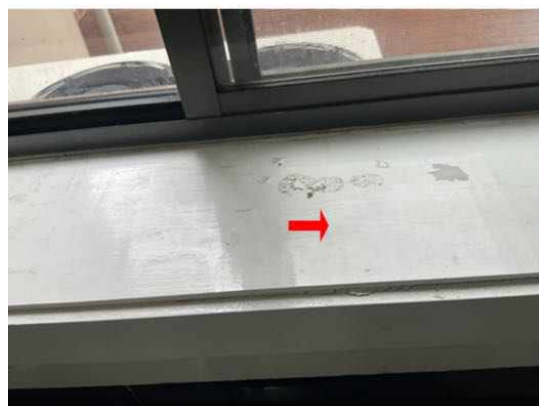
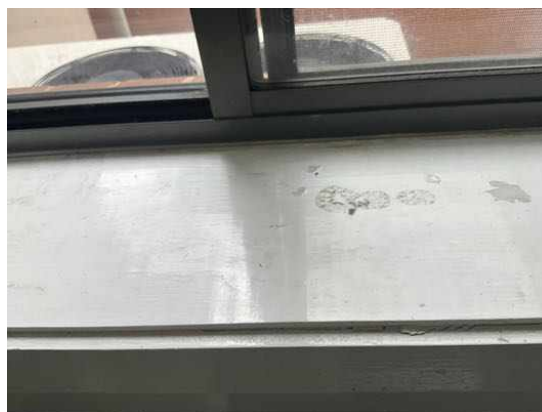
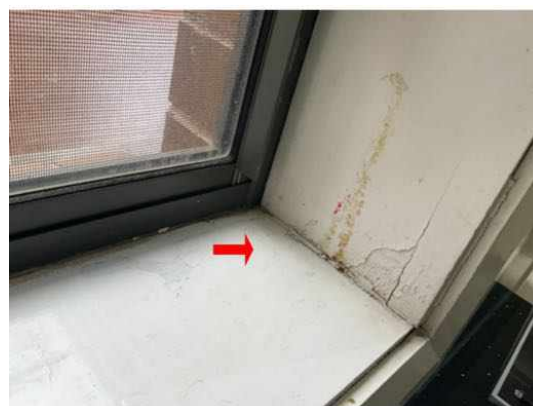
### Finding 3.14

Finding: Water staining

Information: Water staining was evident in this area at the time of inspection. Water staining indicates that surfaces have been exposed to excessive moisture over time. The minerals and other elements in the water lead to staining, which may graduate to corrosion and deterioration if left unmanaged.

While mostly an appearance defect, water staining can be indicative of more serious defects, which may be currently concealed by other building elements.

Where water staining is active, a licensed plumber must be consulted to identify the cause of the staining and to provide advice on any reparation works that may be required. Replacement of any broken or damaged structures is advised.

Conversely, where water staining is old and inactive, affected building materials may be repaired or replaced at client discretion. A qualified carpenter or registered builder may be appointed to perform these works.

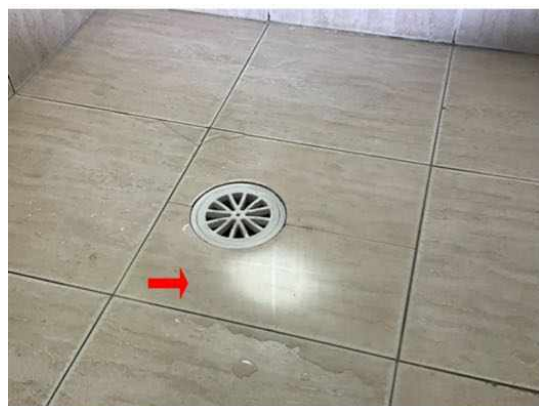
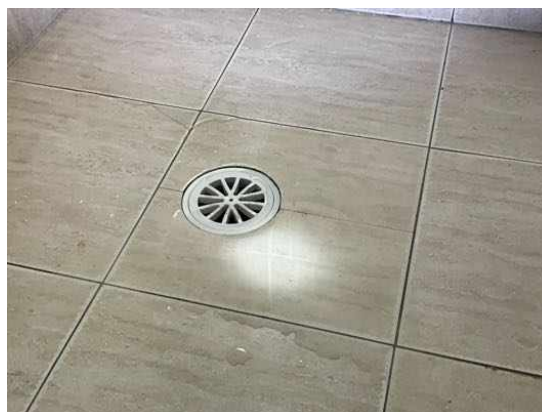
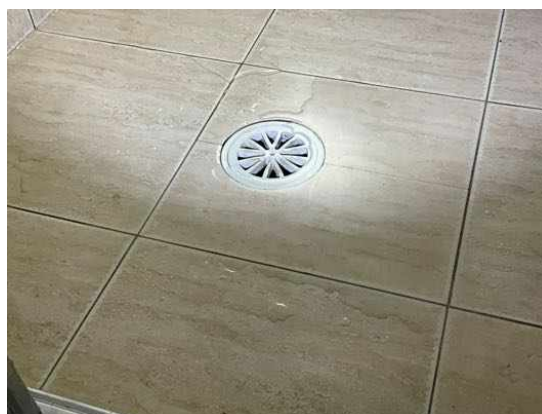
### Finding 3.15

Building:	Main Building
Location:	Ensuite
Finding:	Shower base - Water pooling
Information:	Evidence of water pooling around the floor waste in the shower recess was noticed at the time of inspection. It is suspected that this excessive moisture is attributed to insufficient fall in the shower floor tiles.

This pooling is minor overall but is still considered unsatisfactory, as standard tiling practices would not permit this situation to occur. Pooling water around floor wastes can create a slip hazard in extreme cases and create conditions that are conducive to mould growth over time. Where left unmanaged, the degradation of sealant and grouting is also likely to occur, possibly necessitating further repair works.

Remedial works may involve some sections of tiling and flooring repair and replacement. A tiling contractor or bathroom specialist should be appointed to provide further advice on reparation options and to perform works as necessary.
