# Building and Timber Pest Inspection Report

Inspection Date: Mon, 19 Jan 2026

Property Address: 3/14-16 Ramona St, Quakers Hill NSW  
2763, Australia

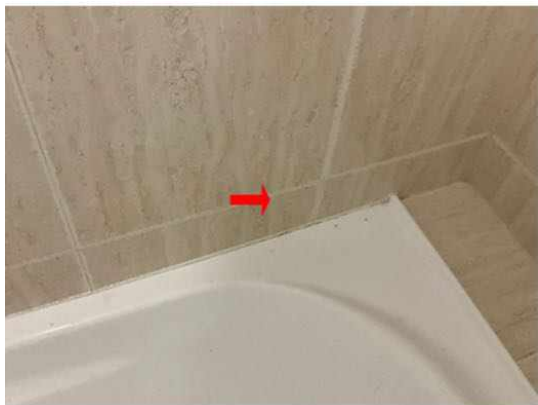
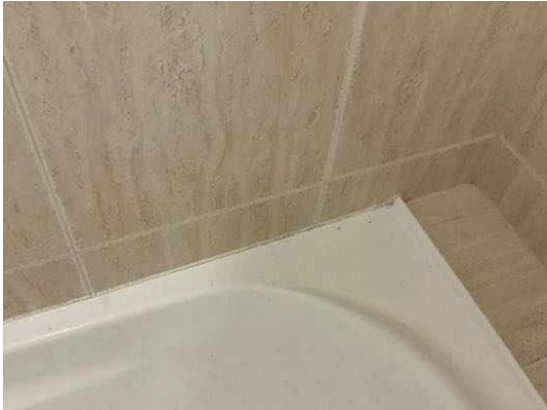
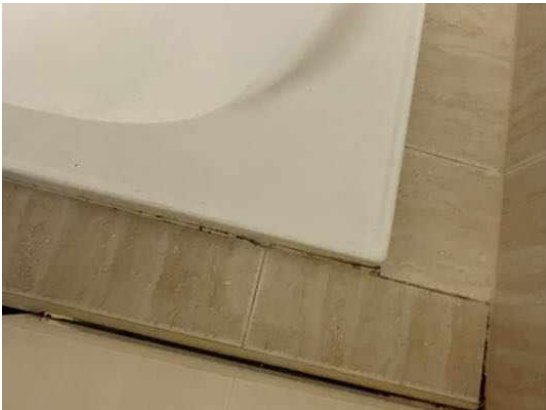
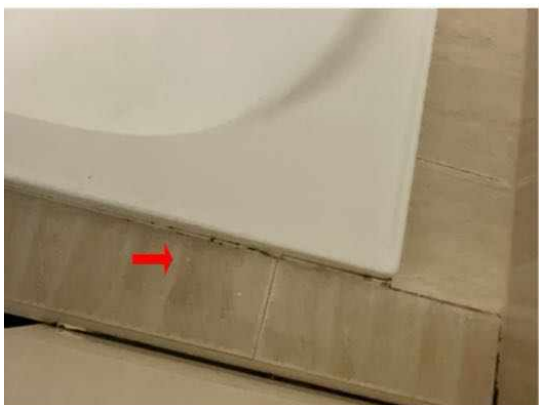
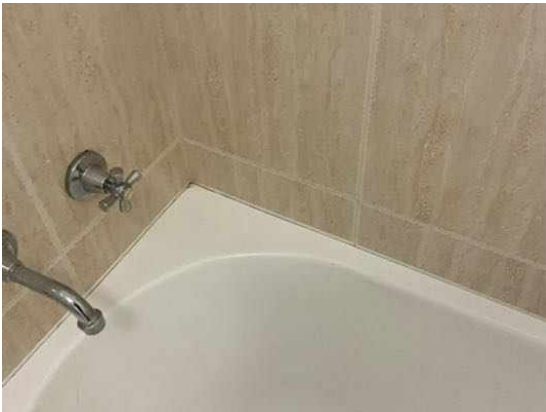
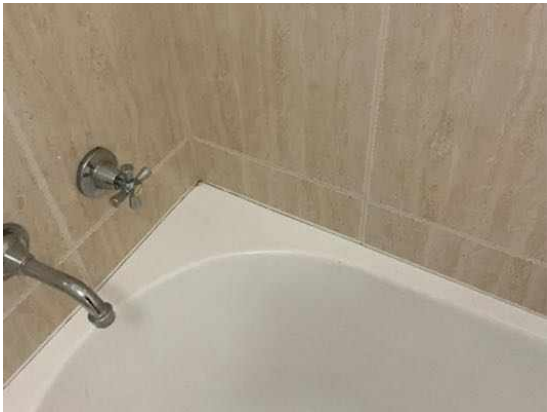
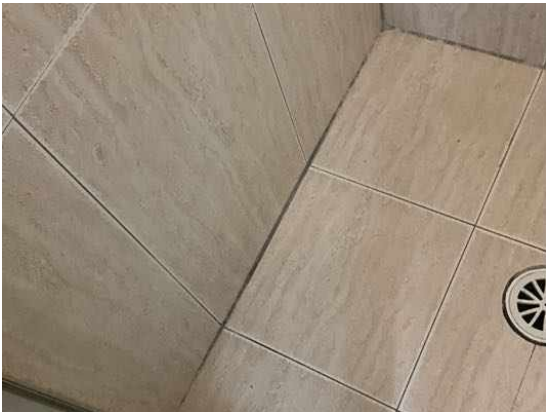
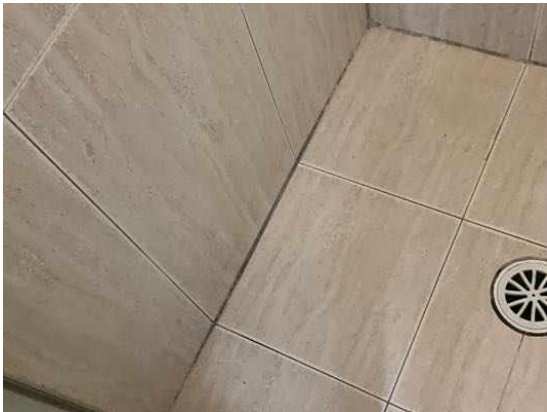
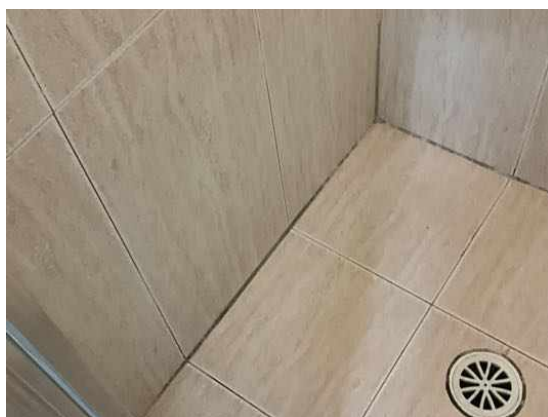
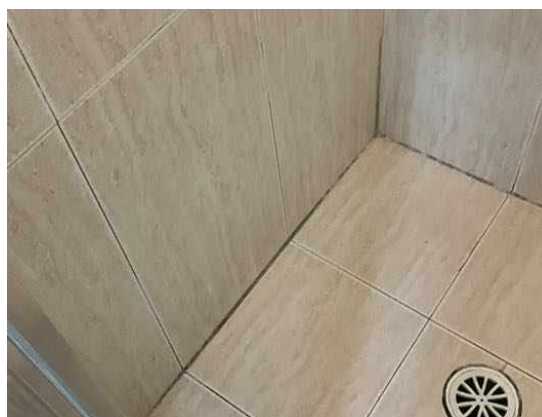
Building:	Main Building
Location:	Bathroom
Finding:	Sealant and grouting - Missing or damaged
Information:	It was noted on inspection that sealant or grout is degraded to the tiled shower alcove and or other areas of the bathroom.

Different materials and floor areas move at different rates, generally causing cracking to grout or sealant at this point. A flexible sealant is required to allow for expected expansion and contraction, while keeping the joint water tight and protective of all associated building materials.

There appears to be excessive mould to the sealant and grout which will likely require scraping out and replacement.

Flexible and mould resistant materials should be applied to affected areas to prevent any subsequent water damage that is likely to occur. Regular maintenance and replacement of damage or missing or damaged sealant and grout is highly recommended to the wet areas, as this is a regular wear and tear defect. Sealant and grouting in areas that come into regular contact with water should be maintained for the long term care of your property.

A sealant specialist or tiling contractor should be appointed to complete these works

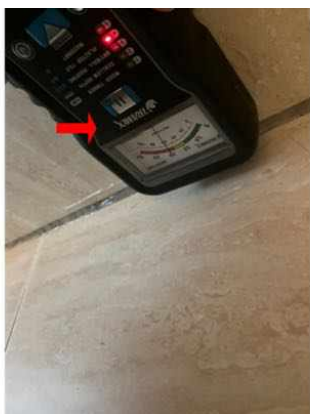
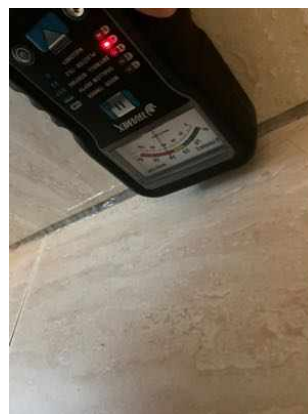
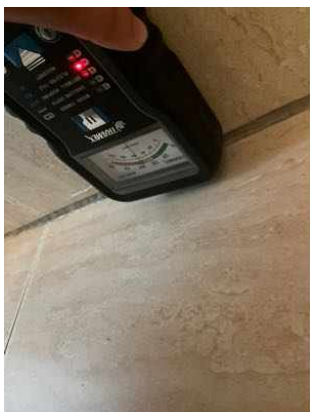
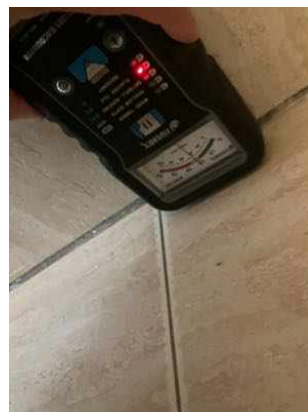
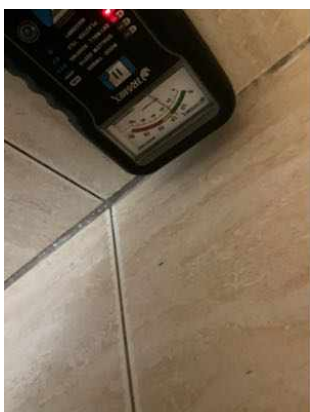
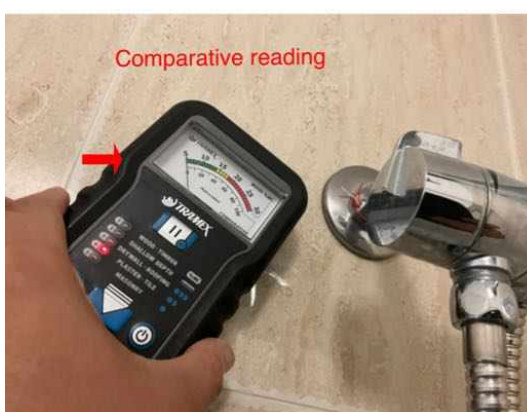
### Finding 3.18

Information: Damp is evident to the lower 300mm of wall to the shower alcove. This defect is quite common, and is suspected to have been caused by moisture permeating through the grouting in this area, which shows evidence of deterioration. Leaking pipes within the adjoining wall is also a possible cause.

Damp (or structural damp) refers to the presence of unwanted moisture in the structure of a building, either as the result of intrusion from outside, or condensation from within the structure. In the shower area, internal water leaks or other sources of excessive moisture are generally the cause of damp.

Unmanaged damp in the shower recess is likely to facilitate the formation and development of mould and fungi growth, decaying associated building materials and compromising their structural integrity. It is important to address damp conditions, as the World Health Organisation notes that excess moisture leads - on almost all indoor materials - to growth of microbes such as moulds, fungi and bacteria, which subsequently emit spores and other matter into the indoor air. Exposure to these contaminants is associated with a wide range of respiratory and other health-related problems.

Consultation with a qualified plumber or bathroom specialist is advised immediately to identify the cause of damp and to perform remedial works as required. Where excessive mould growth is present, further inspection by a specialist environmental health inspector should also be considered.

Always ensure that sealant and grout is in good condition to prevent any moisture issues occurring in the future.

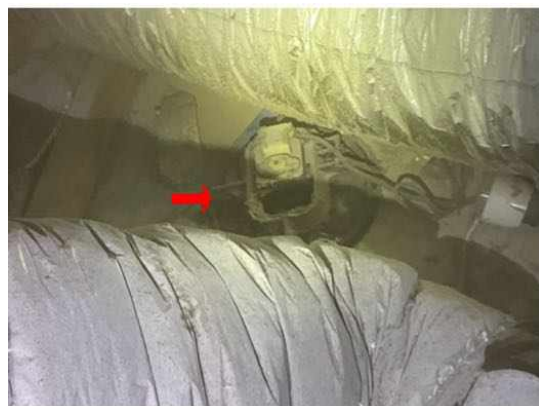
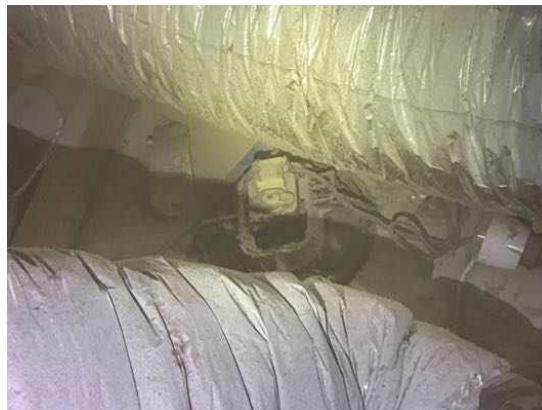
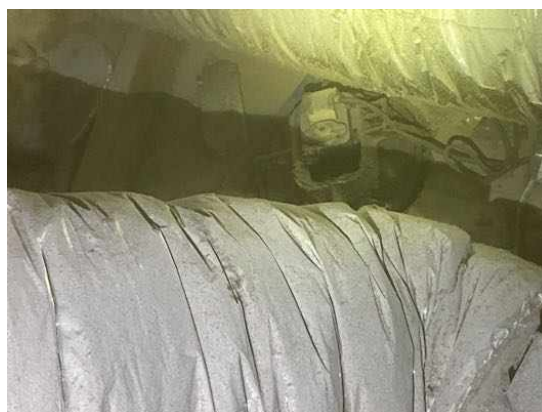
Building: Main Building  
 Location: Roof Void  
 Finding: Exhaust fan not vented out  
 Information: The exhaust fan located within the roof void is not appropriately ducted to the external atmosphere and is currently discharging moist air directly into the roof space. This is considered a defect under AS 4349.1, as it does not meet the minimum standard of residential building performance expected under normal residential building practices.

This condition may lead to excessive condensation within the roof void, increasing the risk of mould growth, deterioration of insulation, timber decay, and overall reduced durability of building elements. It may also result in poor indoor air quality, potentially affecting occupant health.

It is recommended that the exhaust fan be modified by a licensed HVAC contractor or qualified builder, ensuring it is properly ducted to discharge externally in accordance with manufacturer specifications, the National Construction Code (NCC), and applicable Australian Standards.

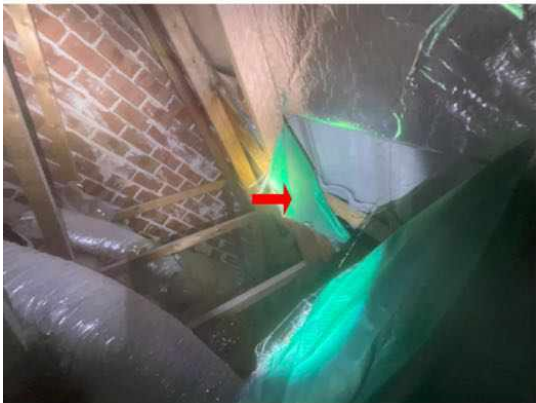
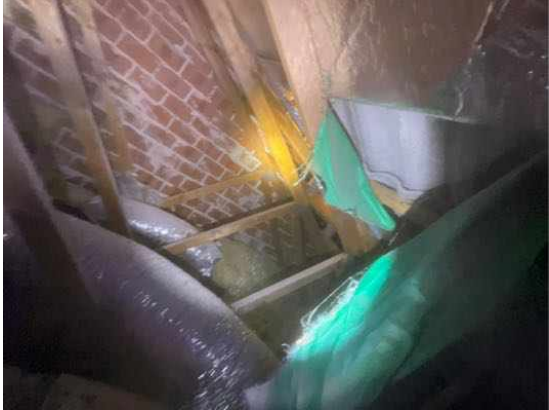
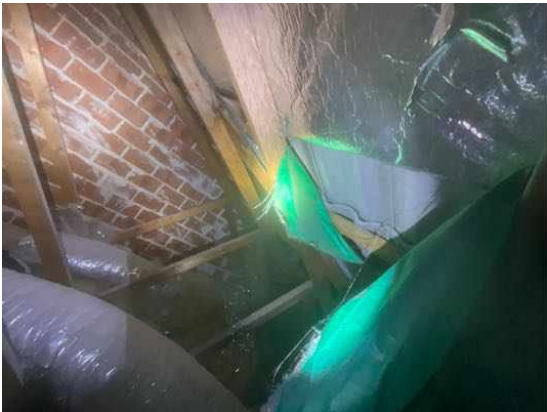
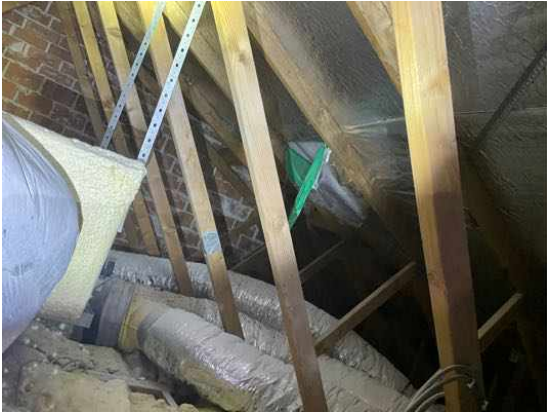
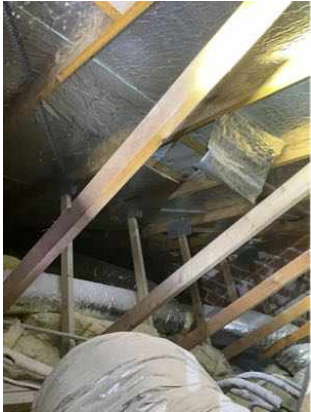
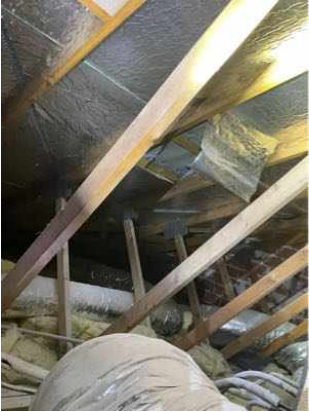
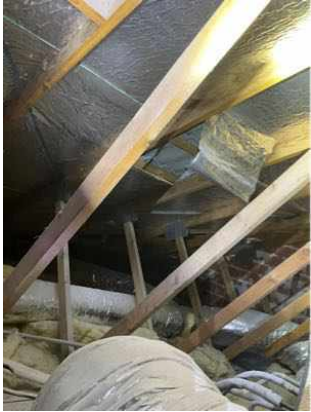
Building:	Main Building
Location:	Roof Void
Finding:	Sarking - Damaged
Information:	Sarking, a laminated aluminium foil applied to the interior of the roof covering, assists in insulating the property and acting as a vapour-barrier to the roof void and, subsequently, to the household.

Where sarking is damaged, both insulation and moisture protection of the property are inhibited. This creates a loss of energy and thus negatively impacts the energy efficiency of the property, allowing potential for moisture ingress from condensation or leaking roof tiles.

It is important to repair any holes or damaged sections of sarking to ensure that the building material is fully functional. A registered builder or qualified carpenter should be consulted to provide further advice on this defect and to perform rectification works at

client discretion.

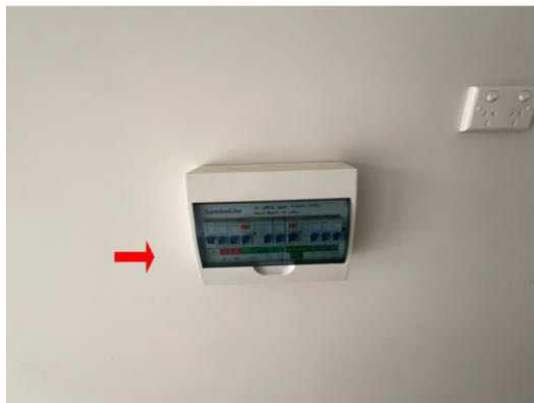
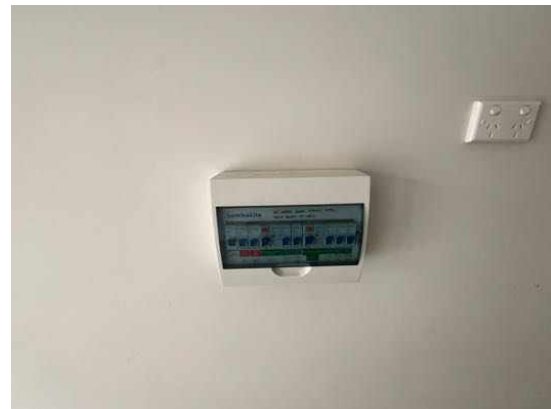
Building: Main Building  
 Location: Garage  
 Finding: No Evidence of Termite Management System - Durable notice / Legible Sticker  
 Information: The application of a pre & post-construction chemical termite barrier is highly recommended for all properties. Such barriers are highly effective in preventing termite attack on any timber building elements throughout the property.

A durable notice was not placed in the switchboard unit to indicate current termite barriers is legible at the time of inspection.

Client must seek further information from the vendor or real estate agent if the conditions of termite management systems were maintained.

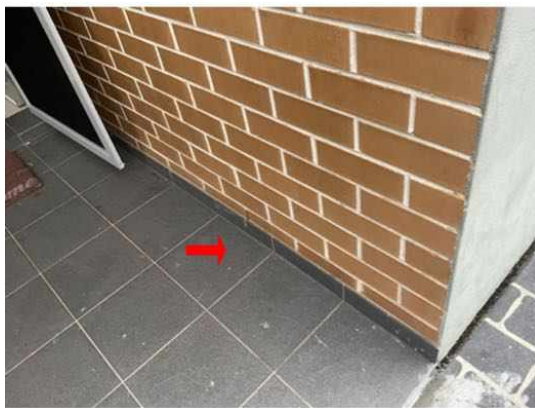
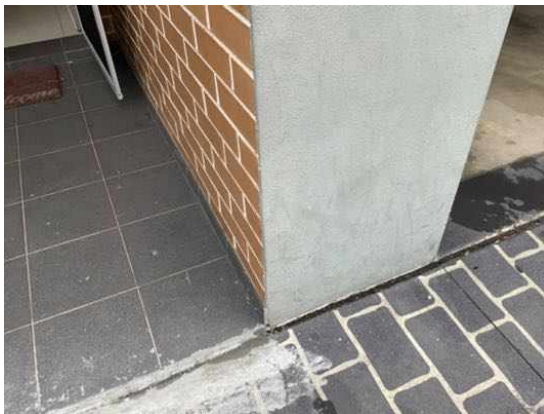
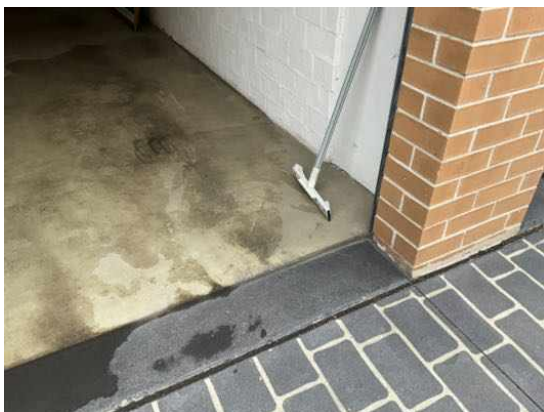
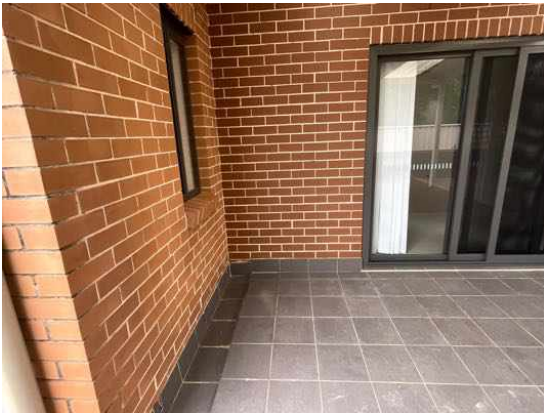
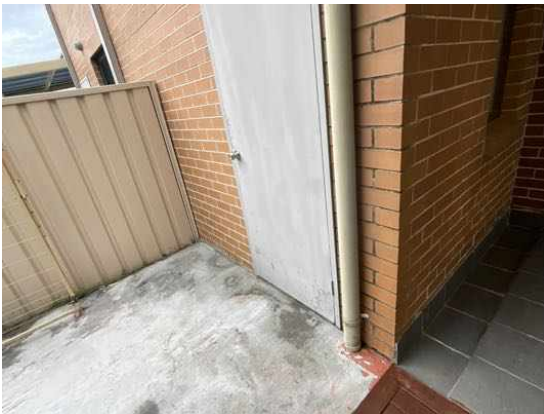
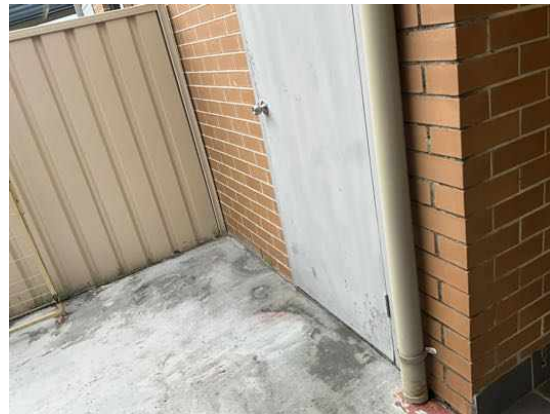
### Finding 6.02

Building: Main Building  
 Location: All Areas  
 Finding: Slab Edge - Exposure  
 Information: An inspection zone of at least 75mm in relation to the exposed slab edge, between the bottom brick and the perimeter pavement, is required. This inspection zone

If the slab edge is not properly exposed there is a high risk of termite attack. Sometimes, in order to determine the type of slab, a suitably qualified person such as an architect or builder may be required to consult the construction plans.

Where the slab edge cannot be properly inspected, it is highly recommended that termite or timber pest inspections be carried out every 6-12 months to aid protection of the property against infestation.

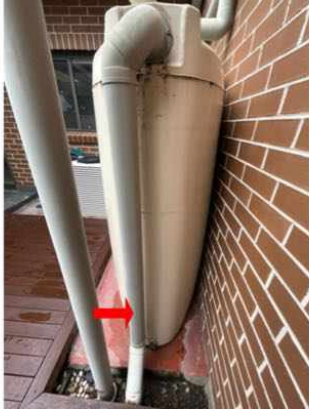
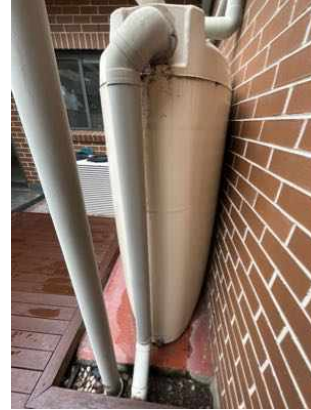
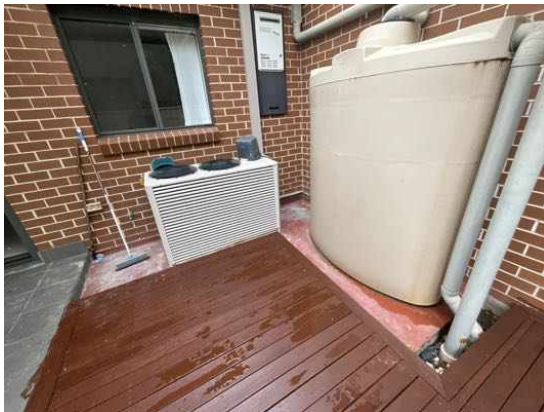
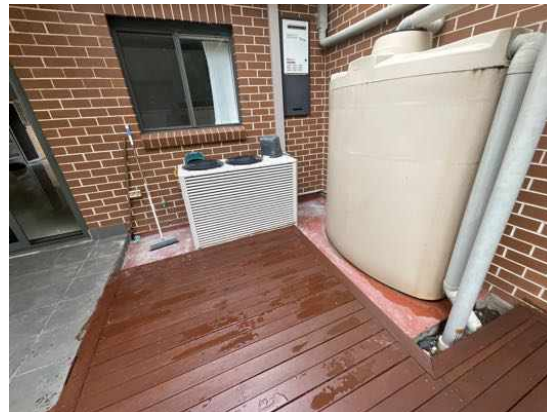
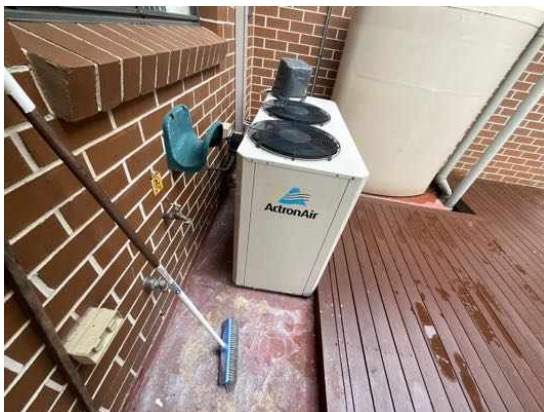
### Finding 6.03

Building: Main Building  
 Location: All Areas  
 Finding: Bridging or Obstruction Conducive environment for Termites  
 Information: Bridging of termite barriers occurs when termites bridge (usually by building a mud tunnel) a termite barrier or inspection zone or where termites have a passage, allowing them to bridge the barrier.

Where bridging has occurred full inspection is prevented and termites may enter a property in a concealed or undetected manner.

Recommended moving obstructions away from the external walls for further and future inspections.

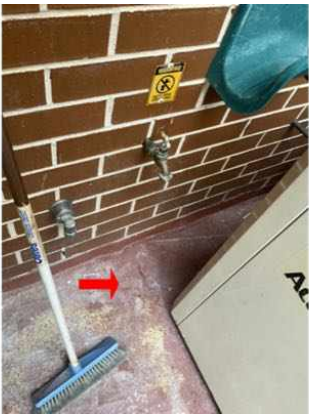
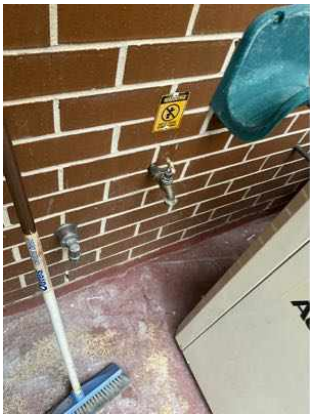
### Finding 6.04

Building: Main Building  
Location: Exterior walls - rear  
Finding: No Drain under tap  
Information: There is no drain installed under the tap, leading to water accumulation and creating

conducive conditions for timber pests. This defect needs immediate attention to prevent potential damage and pest infestation.

1. **Water Accumulation:** Without proper drainage, water can accumulate around the base of the tap, leading to persistent dampness in the surrounding area.
2. **Timber Pest Infestation:** The damp environment created by standing water is highly conducive to timber pests, such as termites and wood borers, which thrive in moist conditions and can cause significant damage to wooden structures.
3. **Structural Damage:** Prolonged exposure to moisture can lead to wood rot and deterioration of structural timber, compromising the integrity of the building.
4. **Health Hazards:** Persistent dampness can also promote mold and mildew growth, posing health risks to occupants.
5. **Aesthetic Damage:** Water stains and damage to finishes and materials around the tap area can detract from the appearance of the building and lead to costly repairs.

A licensed plumber or a qualified building contractor can address this defect by:

1. **Assessment:** Evaluating the area to determine the best approach for installing a proper drainage system under the tap.
2. **Installation:** Installing a drain that effectively channels water away from the base of the tap, preventing water accumulation and dampness.
3. **Repair and Prevention:** Inspecting and repairing any existing water damage and implementing measures to prevent future water accumulation and pest infestations.

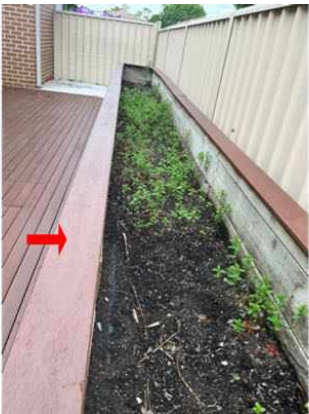
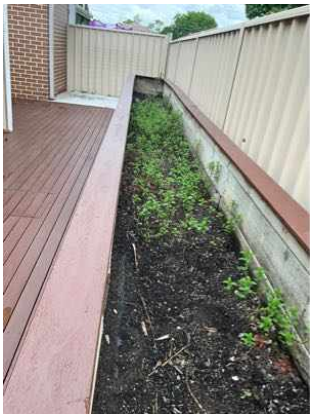
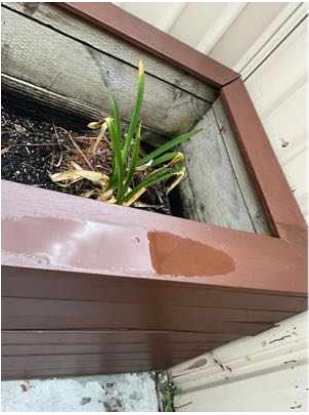
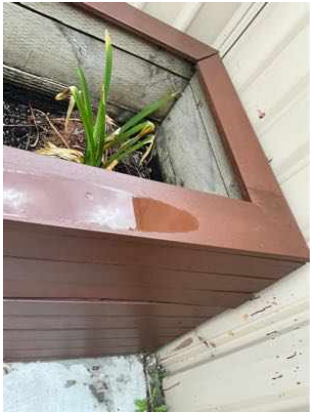
**Finding 6.05**

Building: Main Building  
 Location: All Areas  
 Finding: Timber on ground / conducive conditions to termite damage  
 Information: Timber on the ground is indeed conducive to termite damage. Termites are known to thrive in moist environments, and wood in contact with soil or moisture is more susceptible to infestation.

To prevent this, it's important to keep timber elevated and away from direct ground contact. Regular inspections and proper termite control measures are also essential to protect your wooden structures from termite damage.

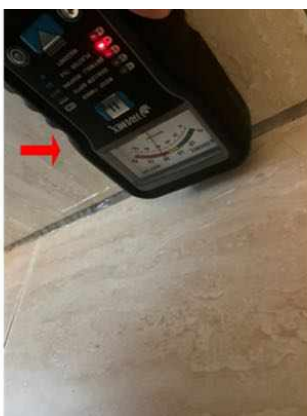
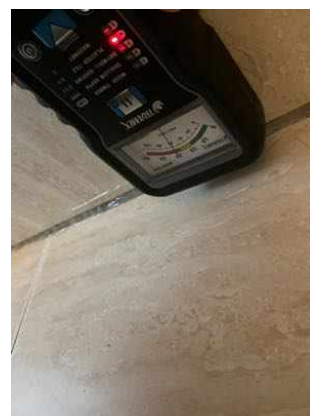
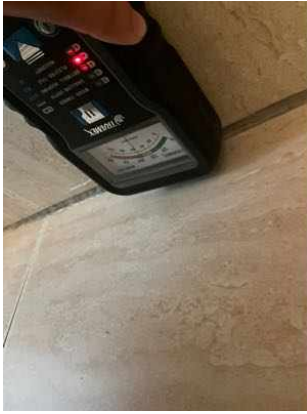
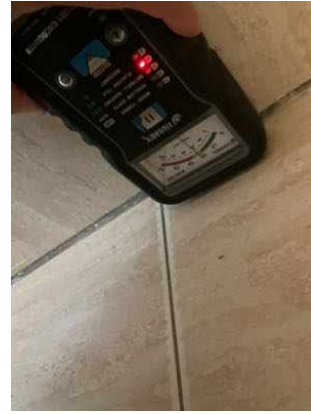
### Finding 6.06

Building:	Main Building
Location:	Bathroom
Finding:	Excessive moisture - Conducive to Timber pest
Information:	Excessive moisture can attract termites and produce conditions that promote fungal growth and wood decay.

Excessive moisture is generally caused by deteriorated inadequate or missing roof drainage leaking plumbing pipes or fixtures poorly plumbed HWS overflows or condenser units and poor site drainage.

Prior to any remedial works being performed a qualified plumber should be appointed to further inspect the property and to identify the cause of the excessive moisture. Works to remove affected building elements may then be necessary and should be performed by an appropriate tradesperson.

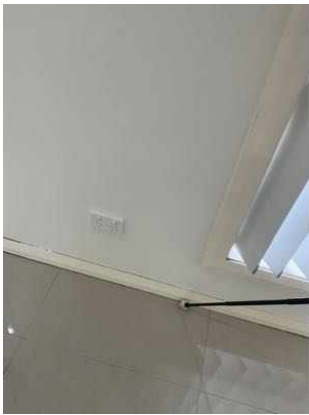
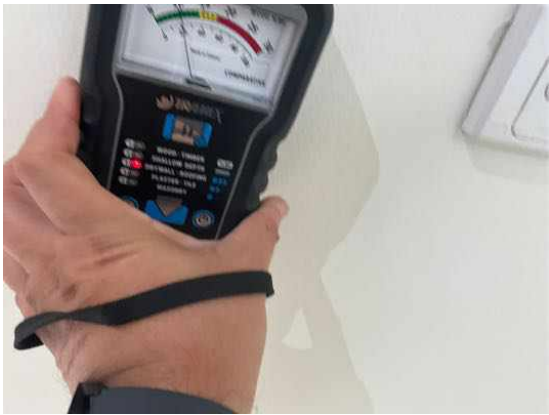
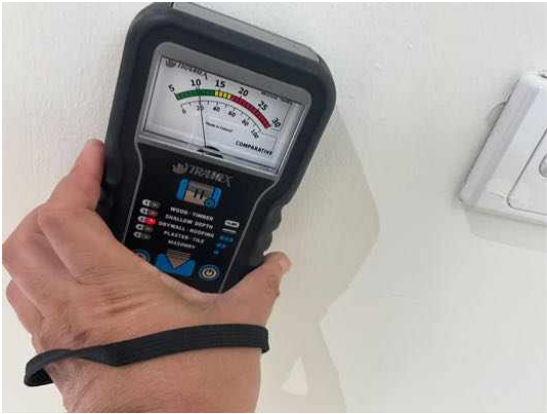
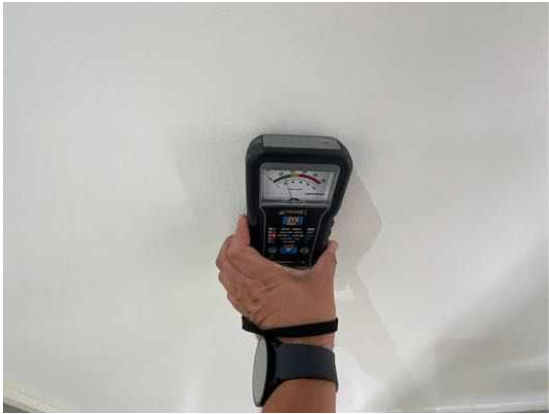
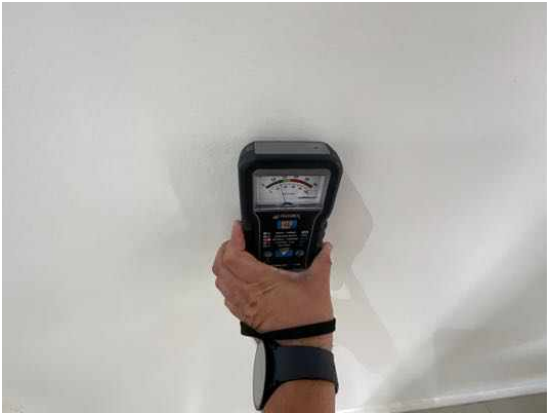
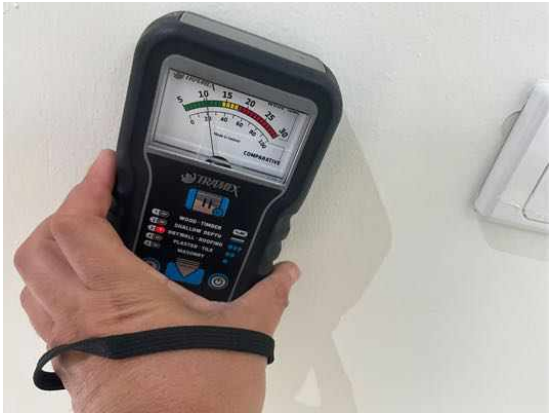
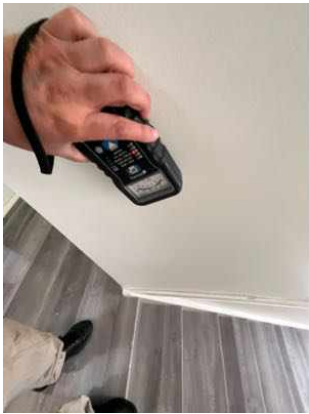
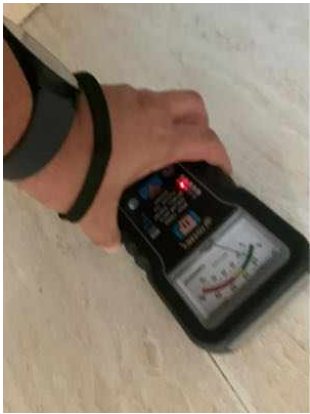
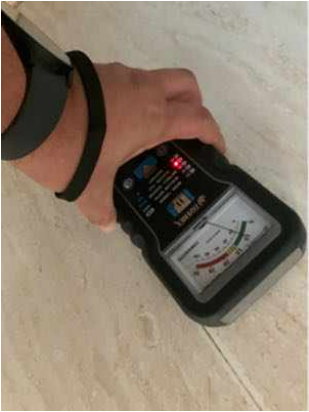
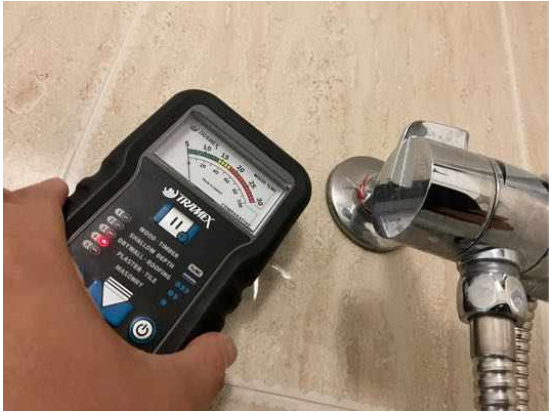
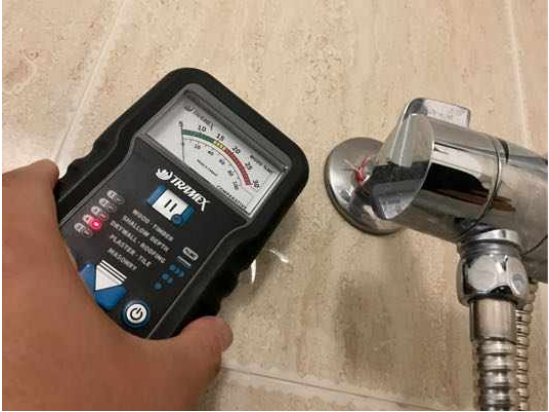
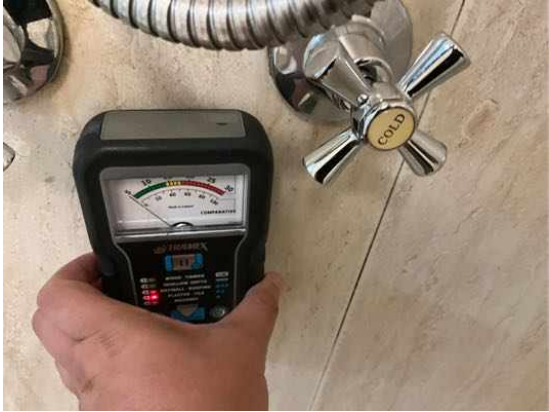
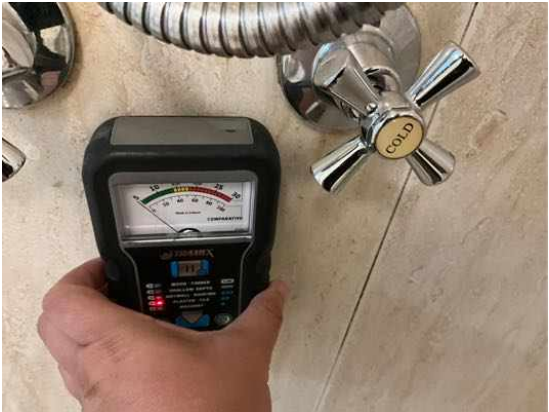
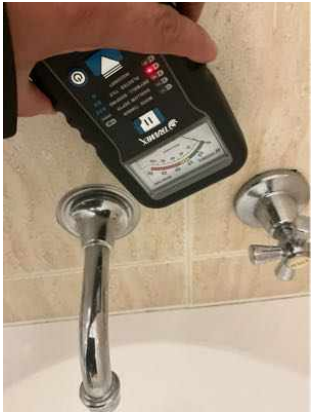
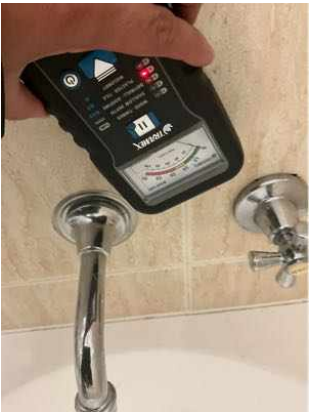
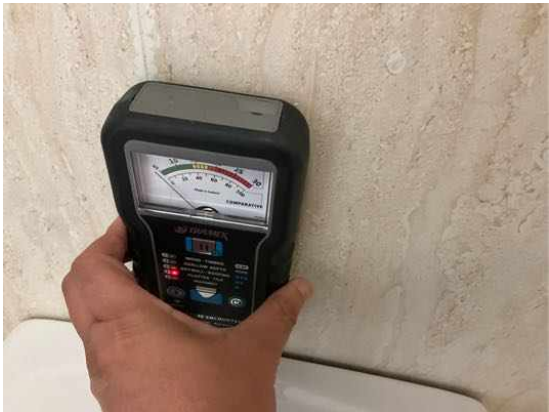
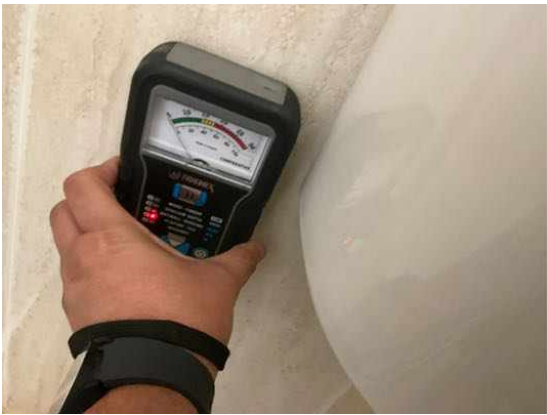
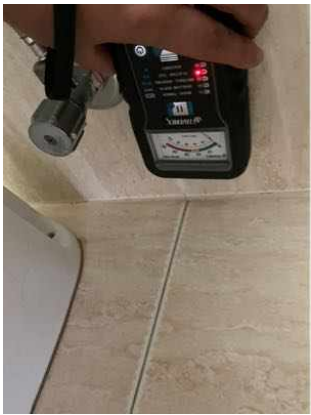
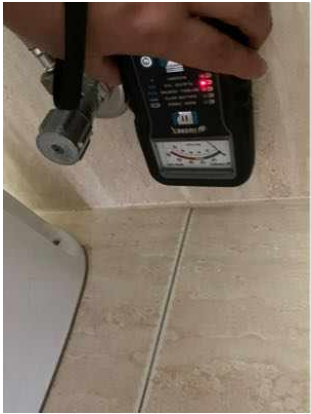
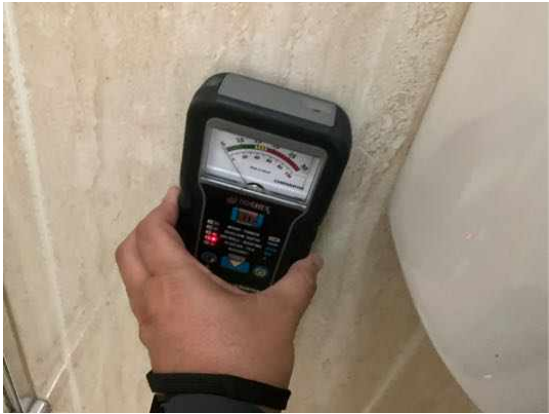
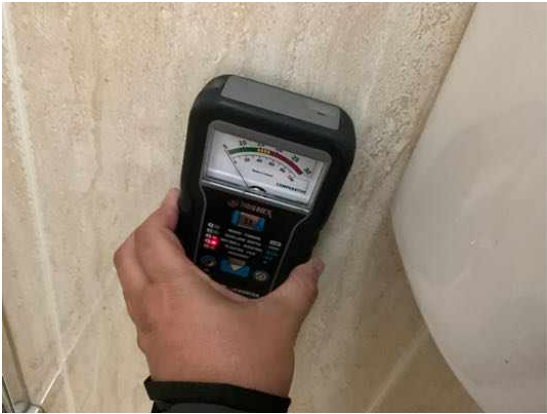
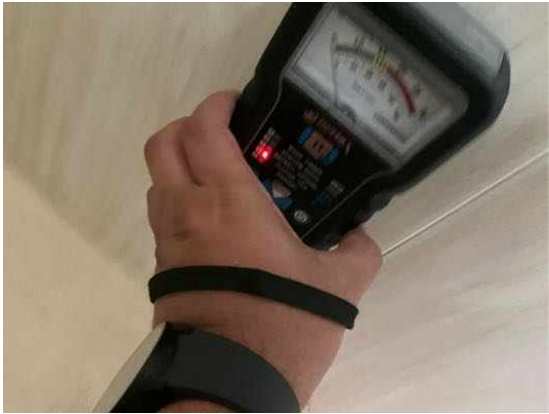
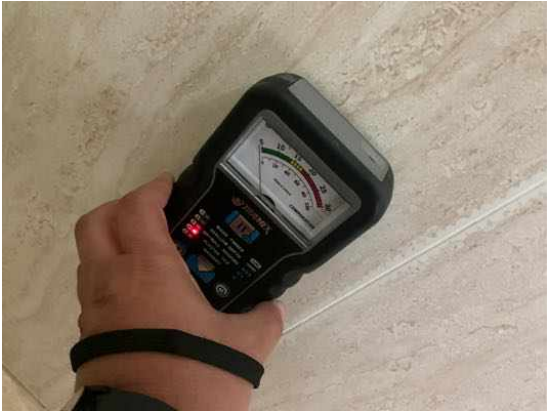
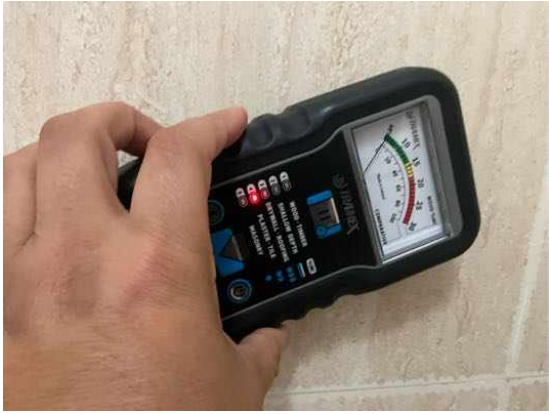
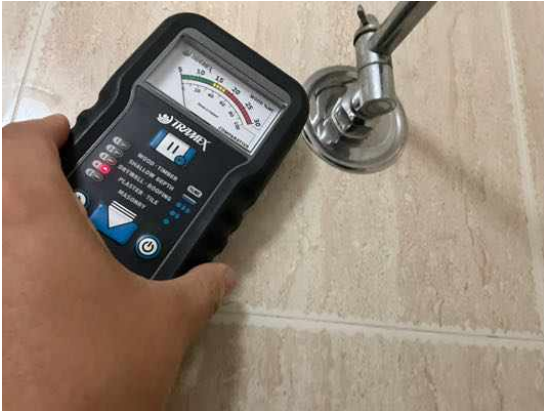
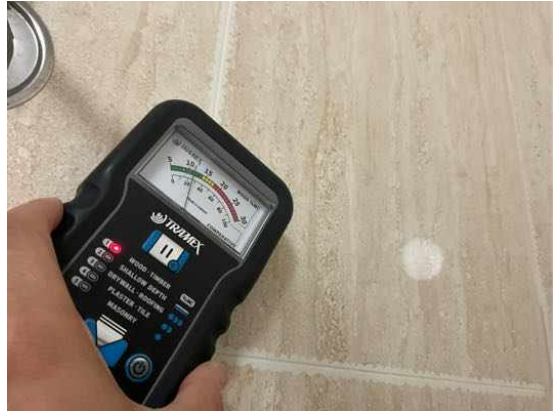
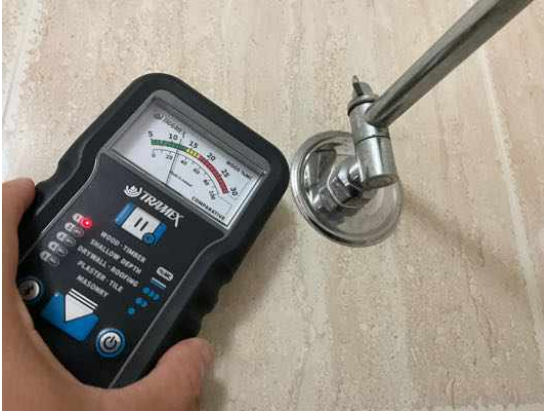
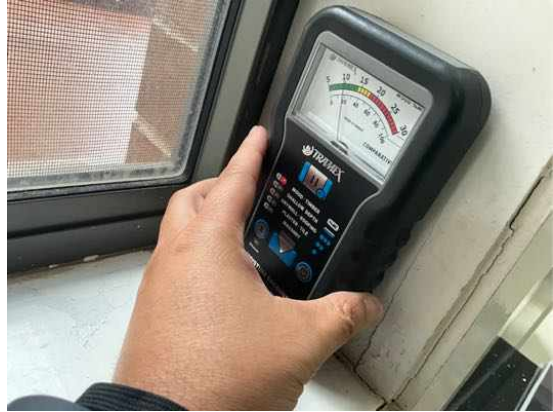
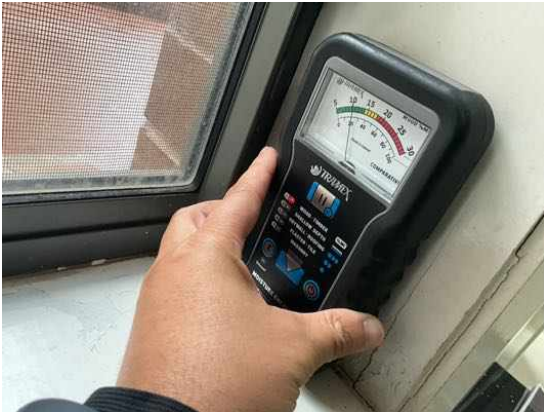
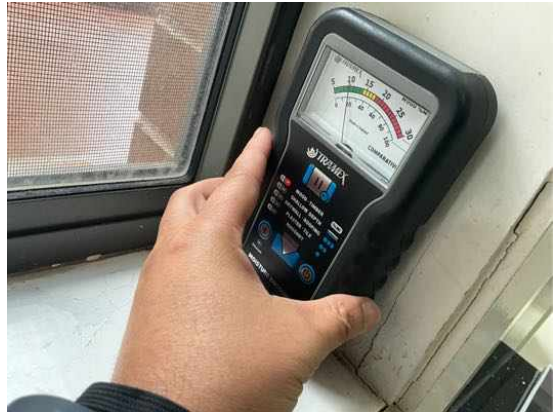
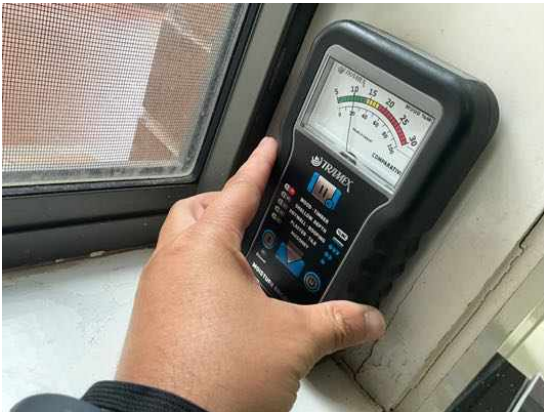
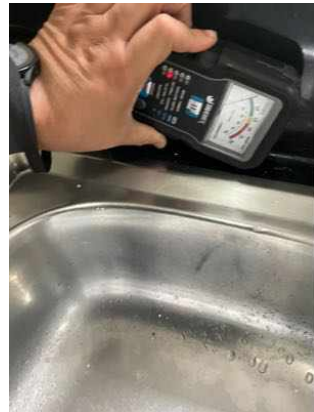
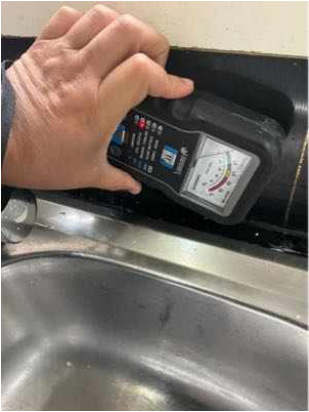
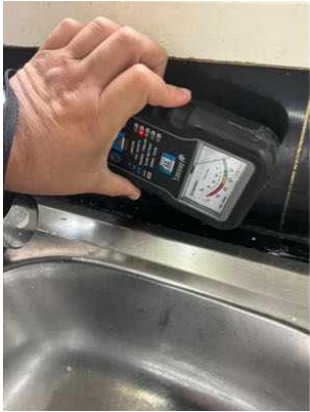
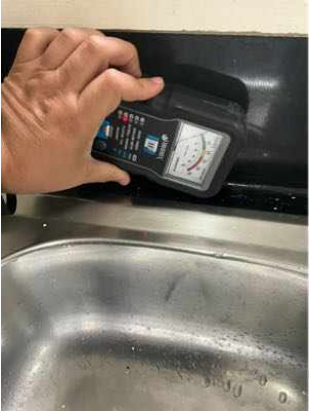
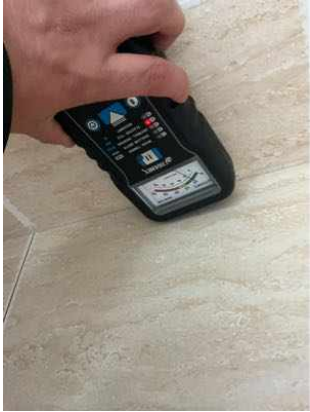
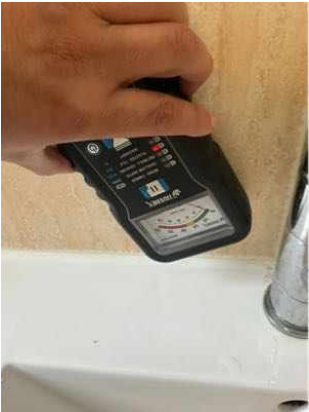
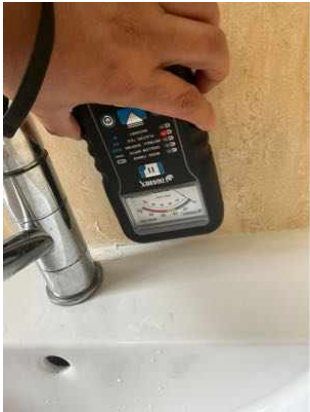
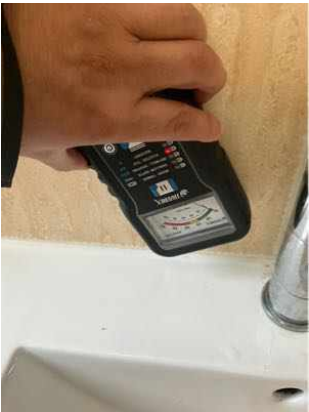
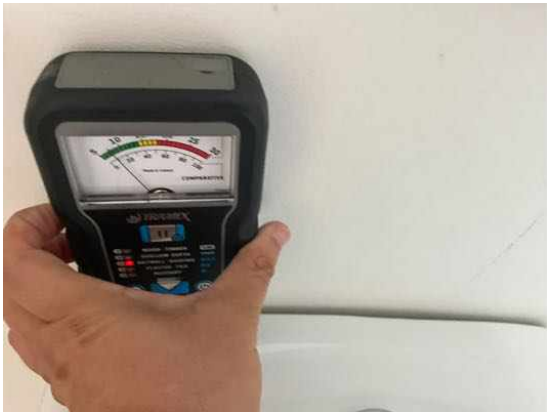
Building: Main Building  
Location: All Areas  
Finding: Additional Photos  
Information: Additional photos are provided for your general reference

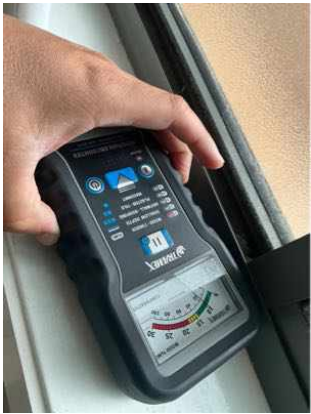
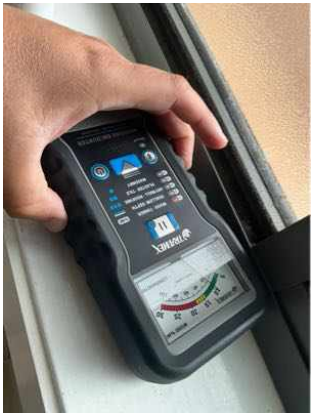
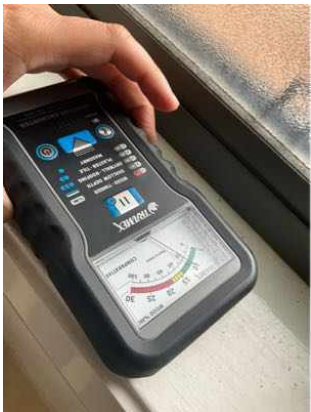
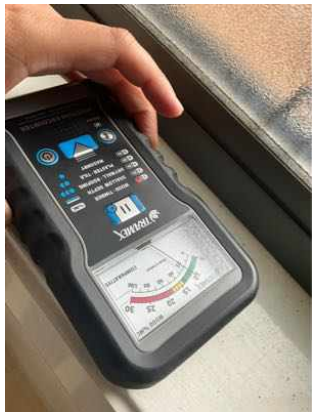
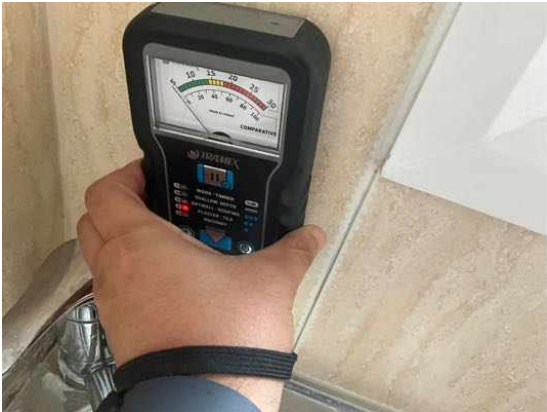
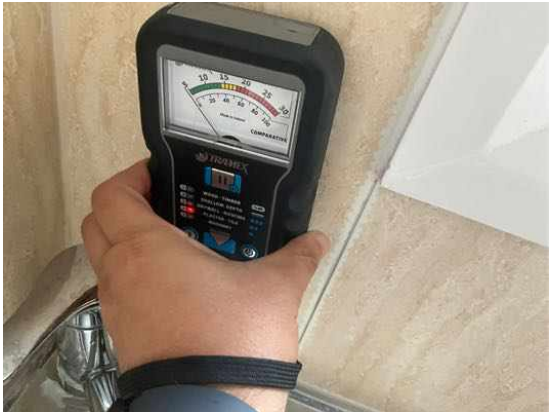
**Noted Item**

Building: Main Building  
Location: All Areas  
Finding: Additional Photos - Obstructions and Limitations  
Information: These photographs are an indication of the obstructions and limitations which impeded full inspection of the property at the time of inspection. These obstructions can hide an array of defects and should be removed to allow full inspection to be carried out. A re-inspection is recommended once the areas are made accessible.
