Building and Timber Pest Inspection Report

Inspection Date: Wed, 28 Jan 2026

Property Address: 2A Hancock Dr, Cherrybrook NSW 2126,
Australia

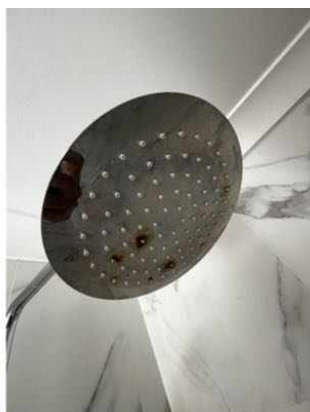
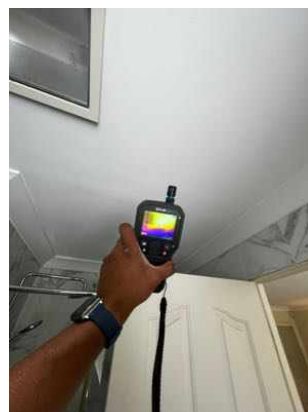
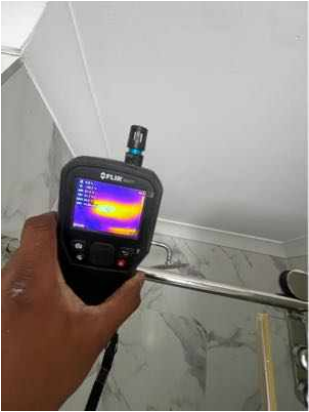
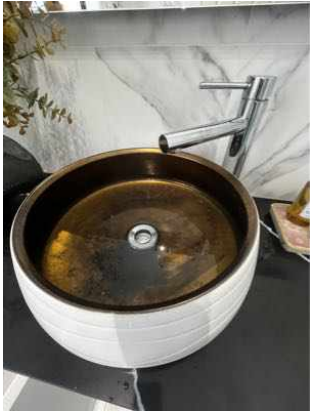
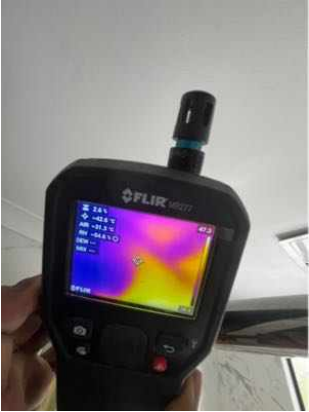
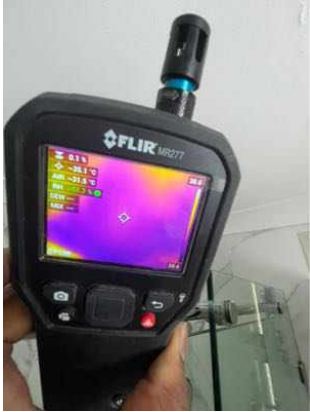
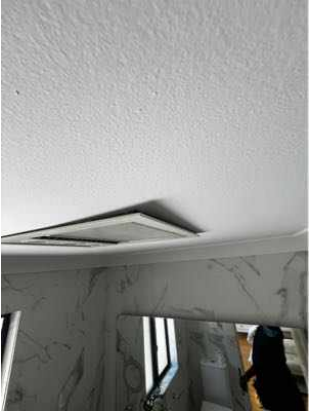
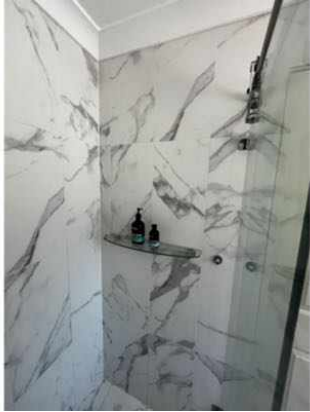
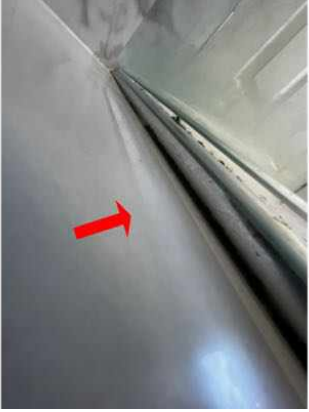
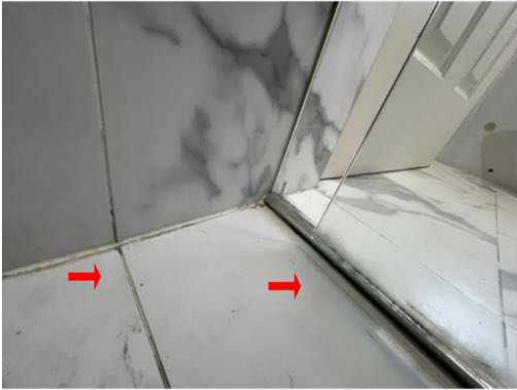
Building: Main Building
Location: Ensuite
Finding: Sealant and grouting - Missing or needs Cleaning
Information: It was noted on inspection that sealant or grout is to be cleaned and attended to before final handover in the tiled shower alcove and or other areas of the bathroom.

Different materials and floor areas move at different rates, generally causing cracking to grout or sealant at this point. A flexible sealant is required to allow for expected expansion and contraction, while keeping the joint water tight and protective of all associated building materials.

Flexible and mould resistant materials should be applied to affected areas to prevent any subsequent water damage that is likely to occur. Regular maintenance and replacement of damage or missing or damaged sealant and grout is highly recommended to the wet areas, as this is a regular wear and tear defect. Sealant and grouting in areas that come into regular contact with water should be maintained for the long term care of your property.

A sealant specialist or tiling contractor should be appointed to complete these works as soon as possible

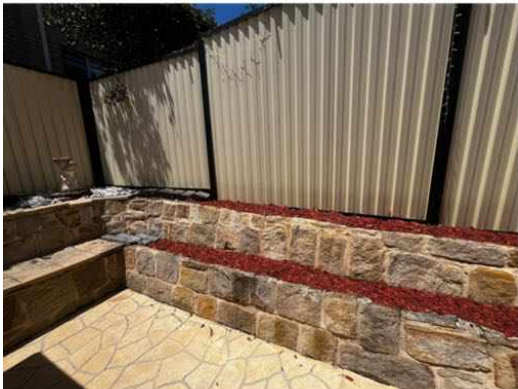
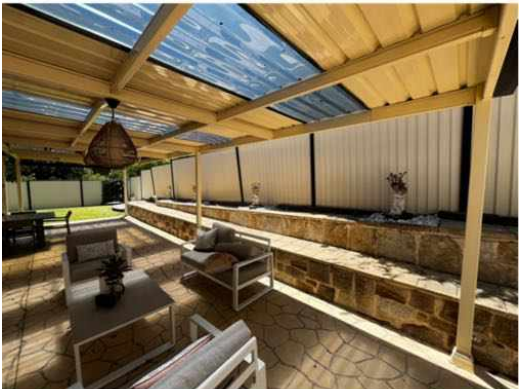
Finding 3.02

Building: Main Building
 Location: Yard
 Finding: Perimeter Fencing -
 Information: For your information photos taken at the time of inspection.

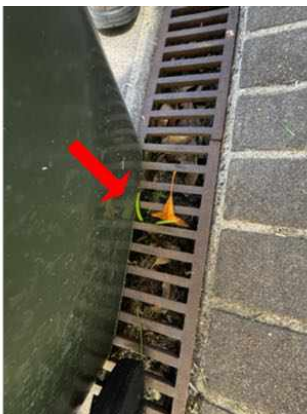
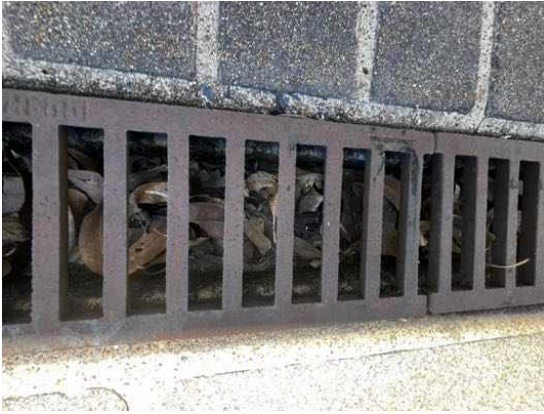
Finding 3.04

Building:	Main Building
Location:	All External Areas
Finding:	Gutters - Blocked
Information:	Plumbing structures, such as guttering and downpipes, should be free of all debris to prevent blockages. Blockages of the guttering and downpipes will lead to pooling and accumulated water overflows, which is likely to subsequently flood eaves and exterior walls.

Blocked gutters are likely to lead to high levels of moisture in the affected areas. Such moisture will not only cause rust and decay of the associated building materials, but can also provide conditions that are conducive to termite and timber pest activity. Blockages in gutters should therefore be removed immediately to ensure dry conditions are maintained.

Consult a Licensed Plumber for further specific advice on remedial works that may be required. In the interim, it is highly advised that blocked gutters be removed by the homeowner or a general handyperson as a matter of urgency.

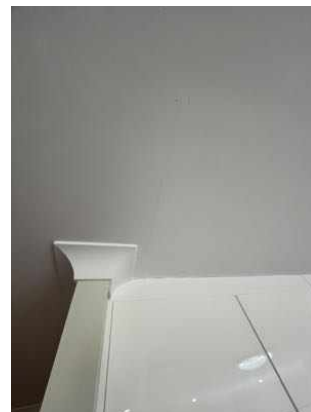
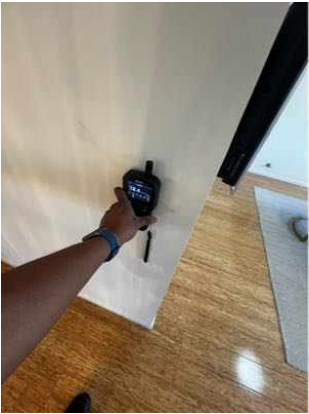
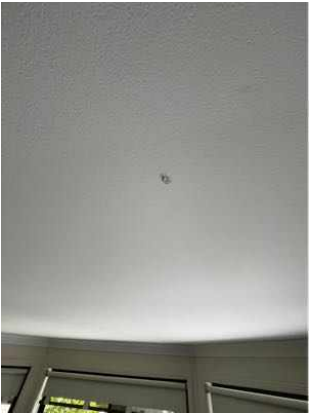
Finding 3.05

Building:	Main Building
Location:	All Internal Areas
Finding:	Paint finish - Incomplete
Information:	The paint finish in this area was identified as being incomplete at the time of inspection.

Whilst incomplete or missing paint finish is generally an appearance defect, it can also lead to the development of secondary building defects over time. Incomplete areas of paint finish expose the area to moisture, potentially accelerating the deterioration of underlying building materials.

Incomplete paint finishes should be sanded back, filled, leveled and painted, as applicable. Where inadequate or missing paint protection has led to the deterioration of the associated building element, repair and/or replacement of this building element may be required.

A painting contractor should be appointed as soon as possible to perform necessary works to aid the appearance of the affected area and to ensure the area is protected against further deterioration. Alternatively, the homeowner following manufacturer instructions may perform these works.

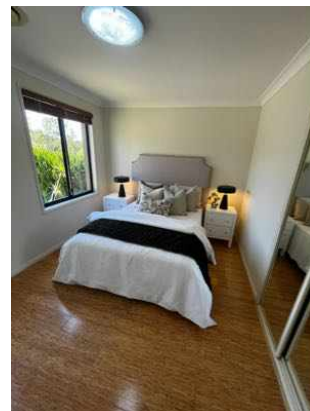
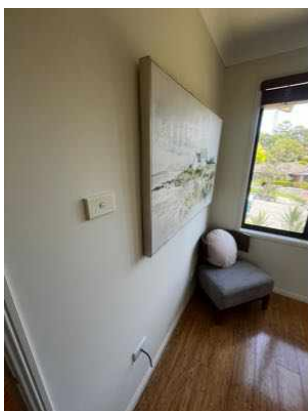
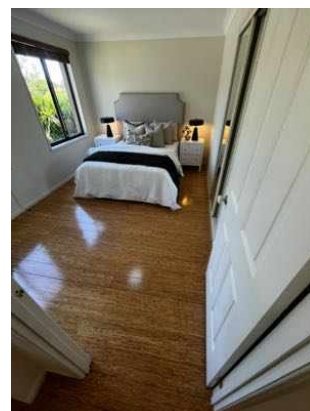
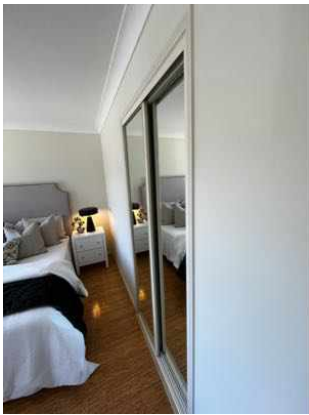
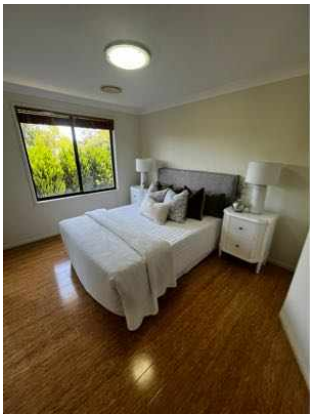
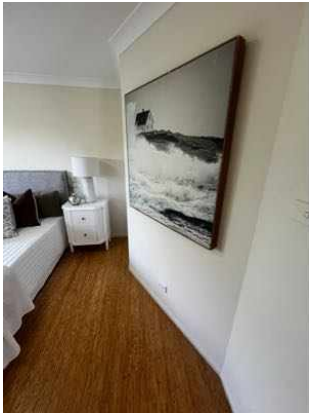
Finding: Additional Photos - Obstructions and Limitations

Information: These photographs are an indication of the obstructions and limitations which impeded full inspection of the property at the time of inspection. These obstructions can hide an array of defects and should be removed to allow full inspection to be carried out. A re-inspection is recommended once the areas are made accessible.

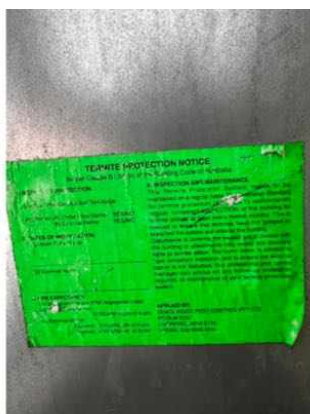
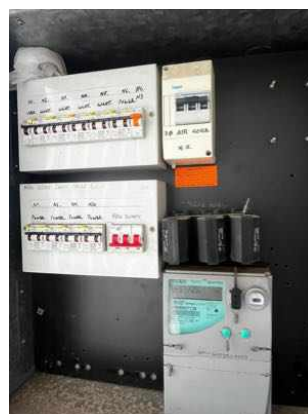
Finding 6.02

Building:	Main Building
Location:	Electrical Switchboard
Finding:	Evidence of a previous termite management system was identified
Information:	Upon Inspection There was a Durable Notice of Termite treatment identified but the date and the information in the notice was not readable/ identifiable - So It is highly recommended to have a termite treatment organised and to follow a termite treatment proposal and keep note of the system every 12 months in duration.

Where a Termite Management System has been identified you should refer to the type of barrier date of installation warranty conditions and any documentation provided by a builder or past owner. Consult the company who installed the barrier to confirm whether the system is still under warranty.

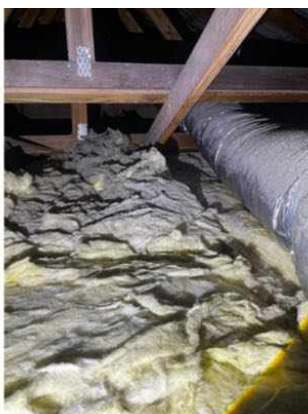
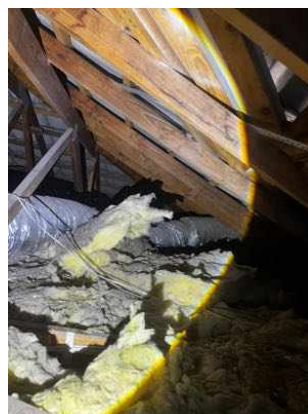
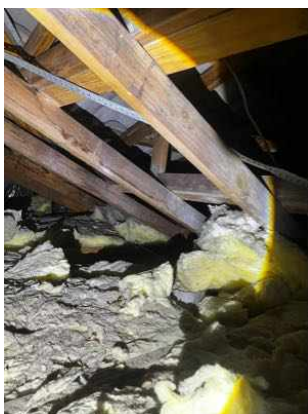
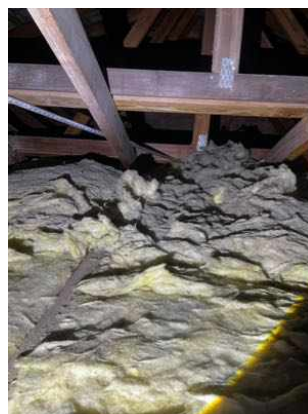
Finding 6.03

Building: Main Building
Location: Roof Void
Finding: Obstructions and Limitations - Roof space
Information: The Roof Void was inspected up to the safe point of access possible -

These obstructions can hide an array of defects and should be removed to allow full inspection to be carried out.

A re-inspection is recommended once the areas are made accessible.

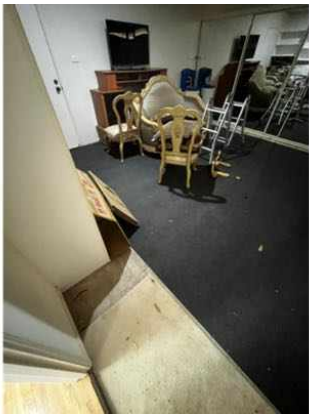
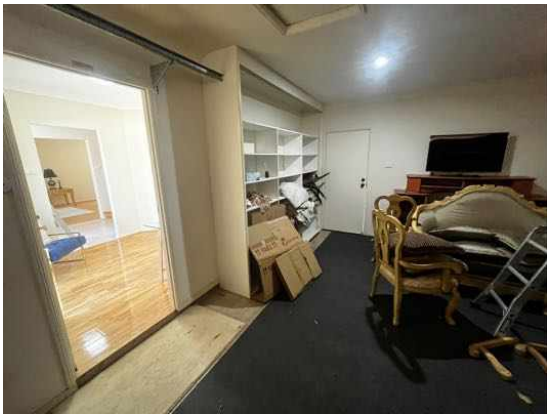
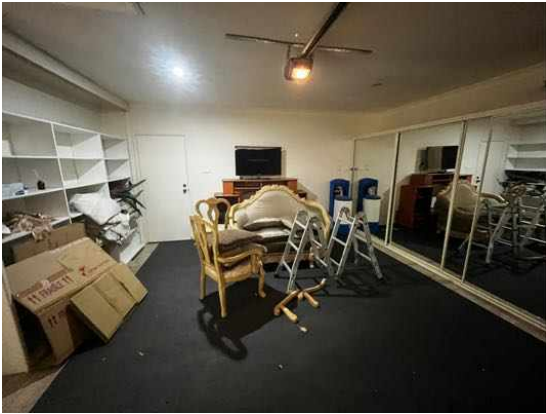
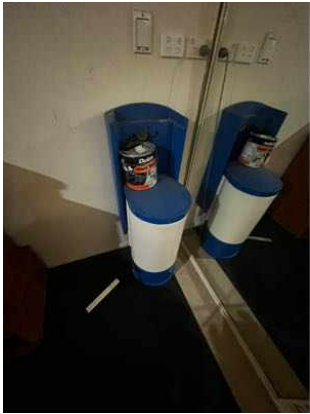
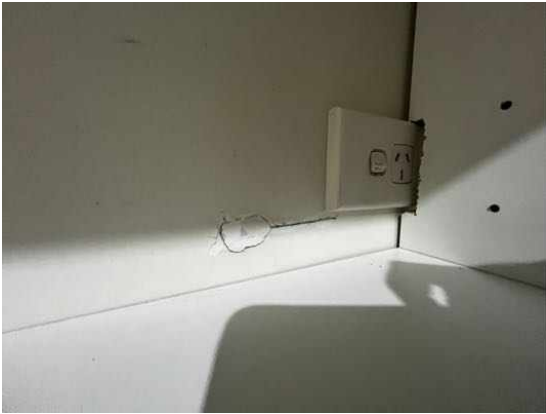
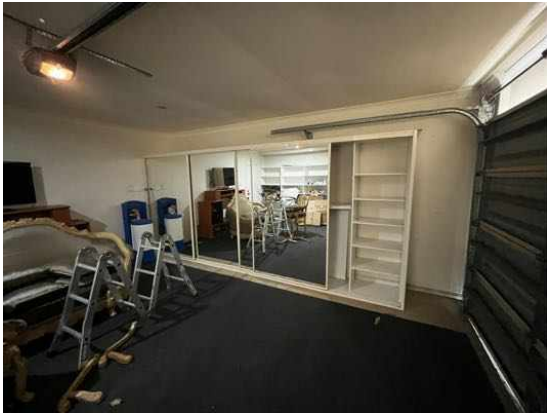
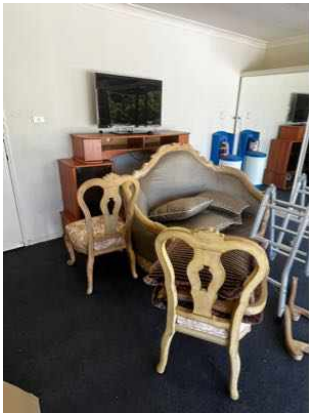
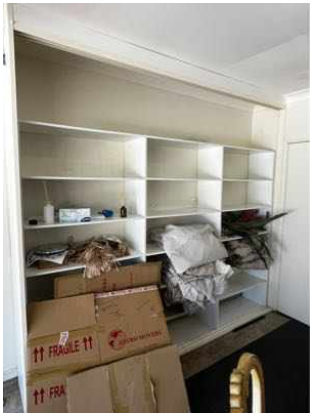
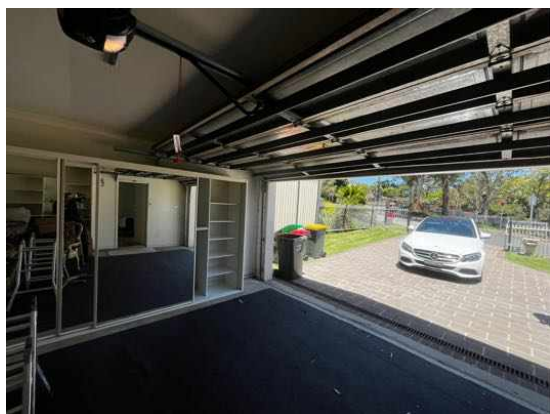
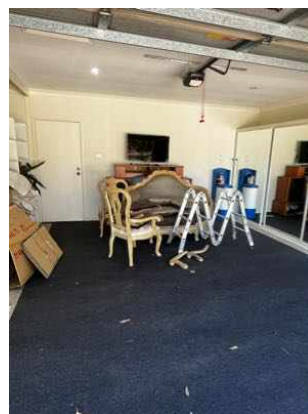
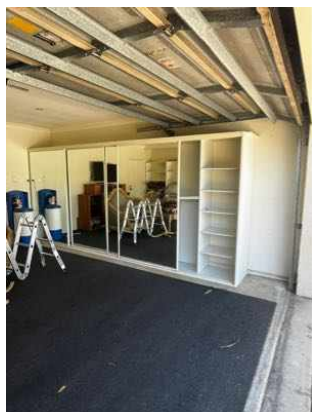
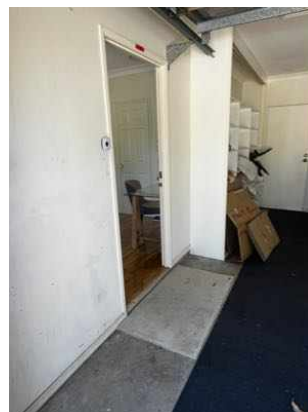
Finding 6.04

Building: Main Building
Location: Garage
Finding: Obstructions and Limitations - Internal Areas
Information: These photographs are an indication of the obstructions and limitations in the Garage which impeded full inspection of the property at the time of inspection.

These obstructions can hide an array of defects and should be removed to allow full inspection to be carried out.

A re-inspection is recommended once the areas are made accessible.

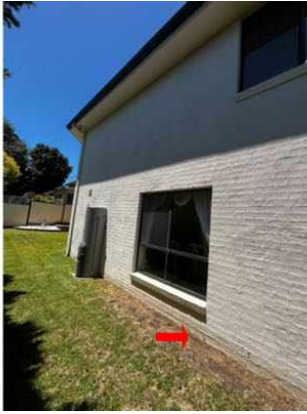
Finding 6.05

Building:	Main Building
Location:	All External Areas
Finding:	Slab Edge - Exposure (No Access)
Information:	An inspection zone of at least 75mm in relation to the exposed slab edge, between the bottom brick and the perimeter pavement, is required. This inspection zone should be maintained in order to force termites into the open where they can be detected more readily during regular inspections. The slab edge should not be concealed by anything that may prevent inspection of the area, including render, landscaping, soil, turf, paving, concrete cladding or other structures.

If the slab edge is not properly exposed there is a high risk of termite attack. Sometimes, in order to determine the type of slab, a suitably qualified person such as an architect or builder may be required to consult the construction plans.

Where the slab edge cannot be properly inspected, it is highly recommended that termite or timber pest inspections be carried out every 6-12 months to aid protection of the property against infestation.

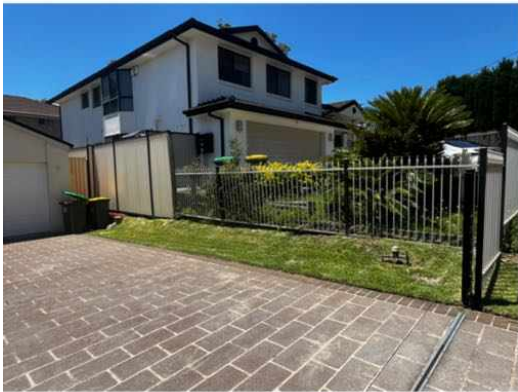
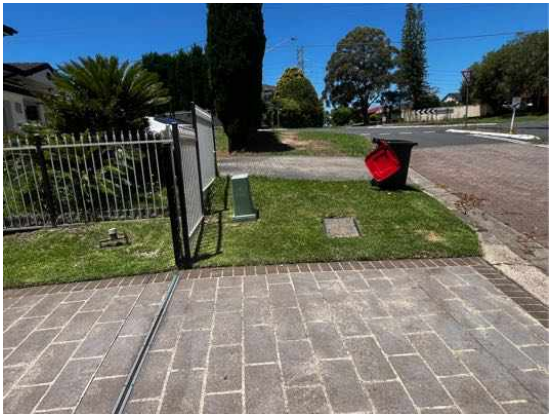
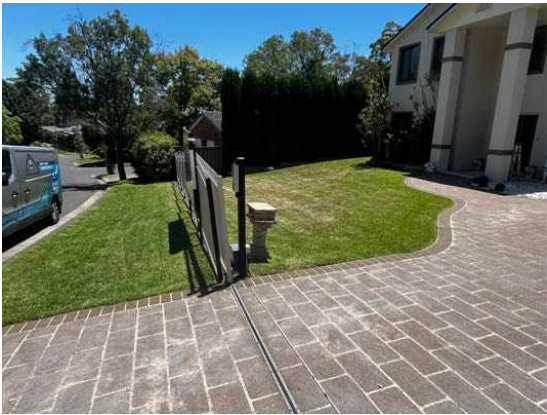
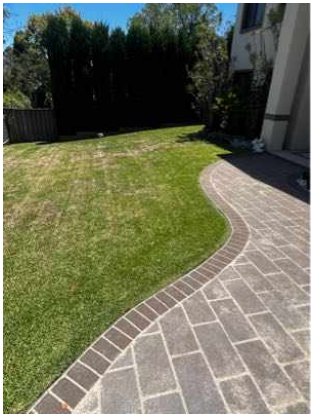
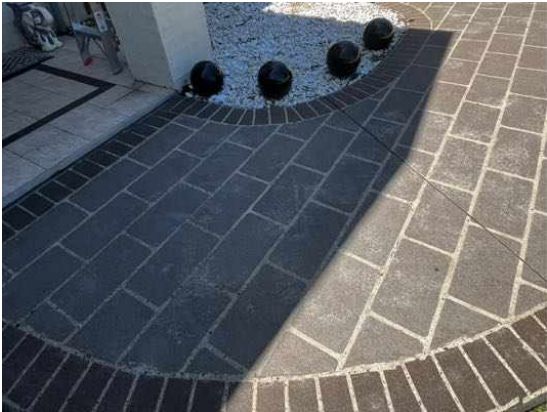
Noted Item

Building: Main Building
Location: Driveway
Finding: For information only
Information: No remedial works are required at the current time.

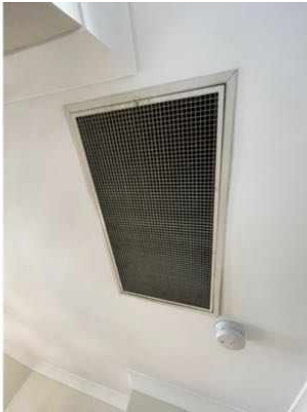
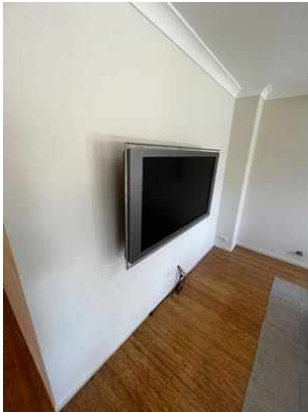
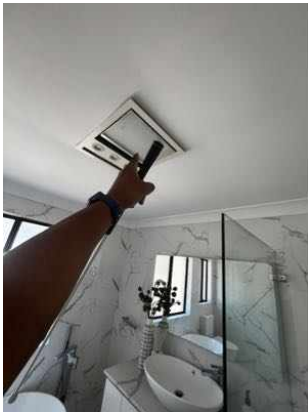
Noted Item

Building: Main Building
Location: All Areas
Finding: Plumbing/electrical/gas/aircon/appliances/pool equipment/fire safety etc
Information: Plumbing and electrical inspections are outside the scope of the building inspection and must be conducted by a Licensed and registered Trades person.

It was noted that the Appliances in the kitchen had to be installed yet during inspection.

It is highly recommended that the client makes immediate arrangements to have the gas appliances checked by a licensed gas plumber to ensure that the appliances are working safely and efficiently.

We recommend all other installations be checked also.

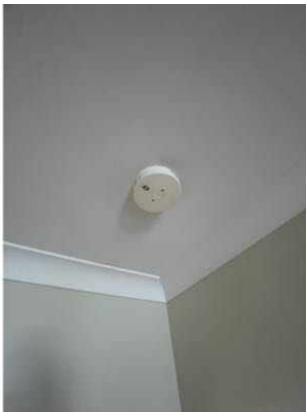
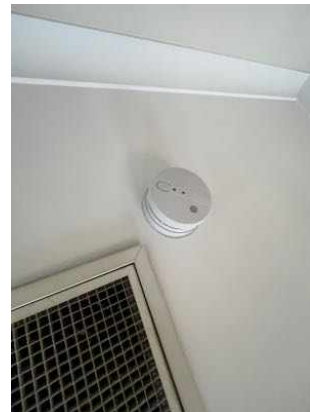
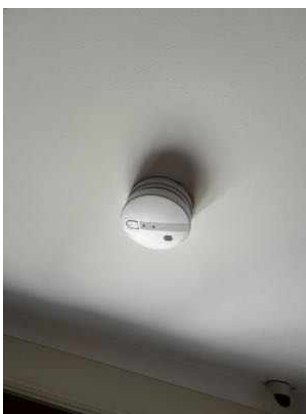
Building: Main Building
 Location: All Internal Areas
 Finding: Smoke Detector and Alarms
 Information: Reporting on Smoke Detectors or Alarms, including hard wired smoke detection systems and their legislative requirements, is outside the Scope of this Report.

Additionally, it is advised that all smoke detectors be tested by the homeowner on a monthly basis.

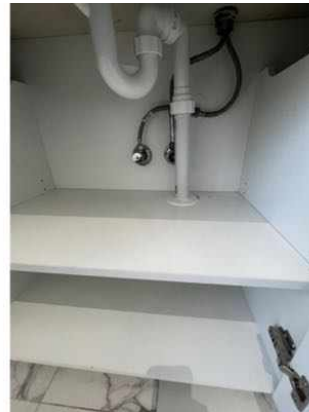
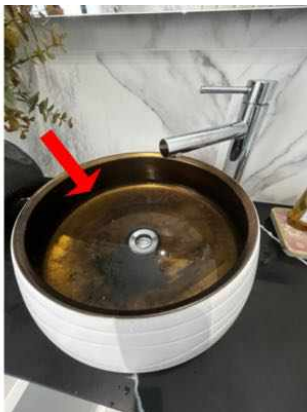
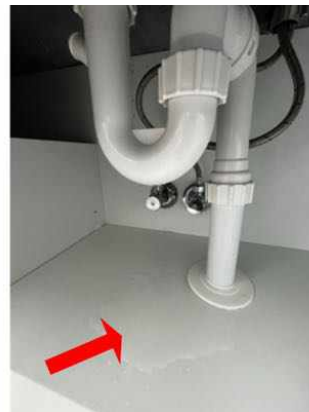
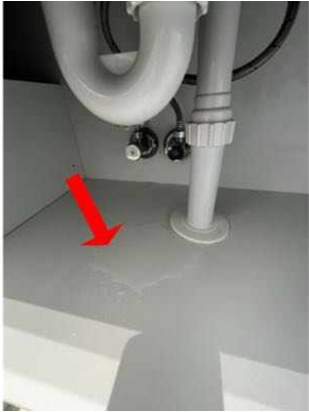
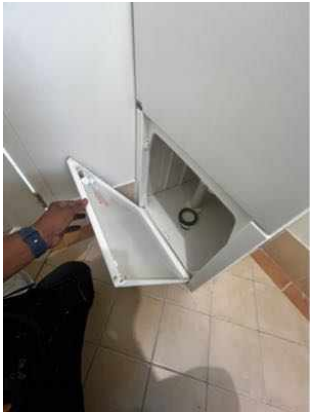
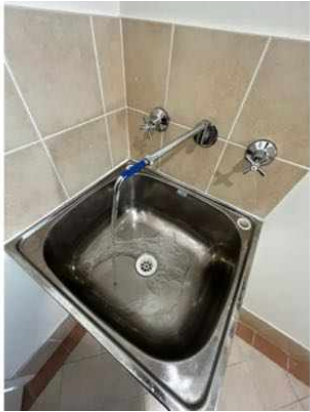
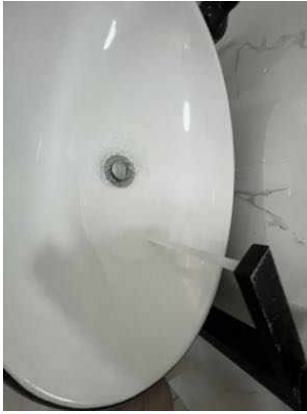
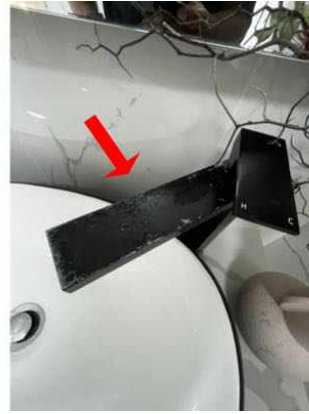
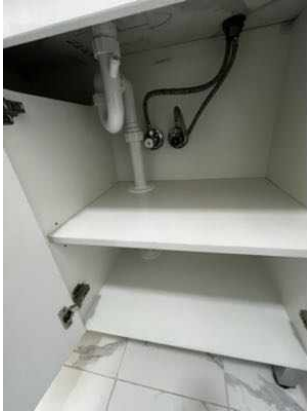
Information: All cupboards where sinks and basins with drainage plumbing were inspected and the ensuite vanity had evidence of leaks were present at the time of inspection.

The Laundry tub door was damaged noted during inspection.

The shower rail and head in the ensuite had signs of rust during inspection.

For your information only no remedial works are required at the time of inspection.

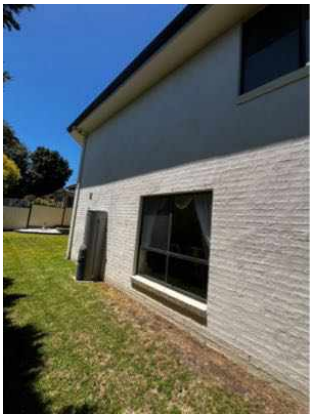
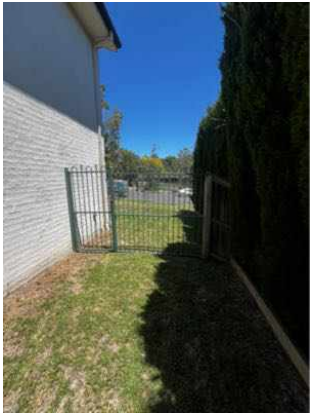
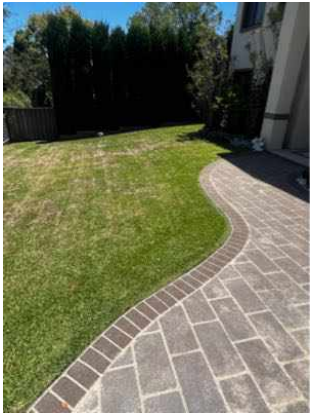
Building: Main Building
 Location: All External Areas
 Finding: Site drainage - For your Information
 Information: Site Drainage appears to be acceptable at the time of inspection, however, the site/ Yard should be monitored during heavy rain to determine whether the existing drains cope. If it appears that they cannot cope, then additional drains may be required.

Any comments made in the section are relevant only in light of the conditions present at the time of inspection. It is recommended that a smoke test be obtained to determine any illegal connections, blocked or broken drains.
