Building and Timber Pest Inspection Report

Inspection Date: Wed, 28 Jan 2026

Property Address: 7/11 Lisson Grove, Hawthorn VIC 3122,
Australia

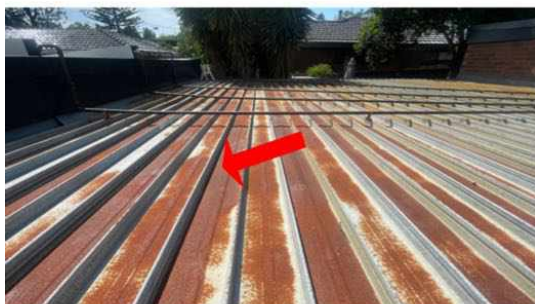
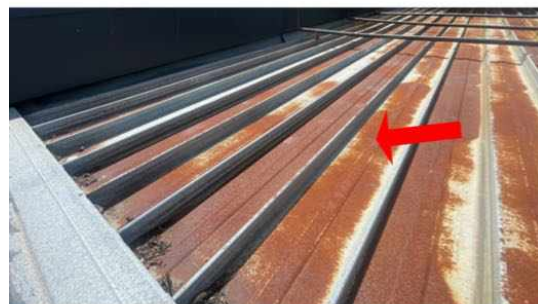
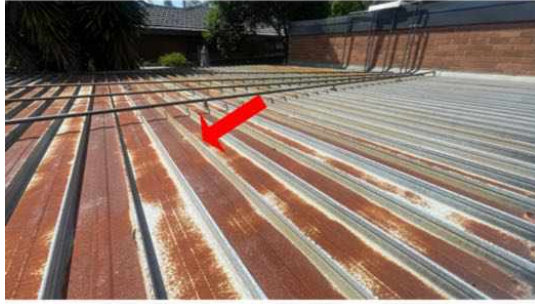
Finding: Metal Roof - Deteriorated and rusting (possible owners corporation issue)

Information: Upon inspection of the exterior roofing of the carport, it was found that the metal roof shows signs of deterioration due to rust, with holes noted within the surface.

Rusted, deteriorated and damaged metal roofing is susceptible to water penetration, exposing the surrounding associated area to internal roof leaks and potential water damage.

A roofing contractor should be appointed immediately to assess the damage to the metal roofing and to perform remedial works as necessary. Works may include replacement of severely affected roofing or minor works such as the application of rust-retardant surface protectors.

Please note: as this is an external item, it may be covered within the owners corporation. Your own enquiry should be made to determine whether this is the case.

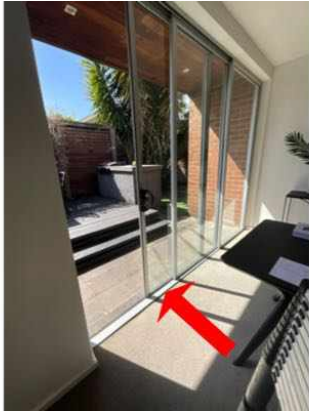
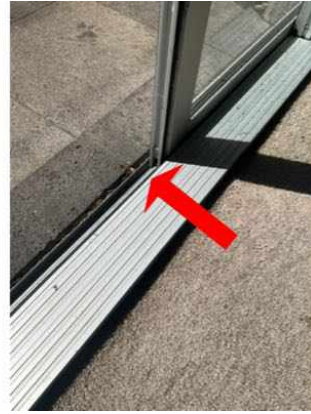
Finding 3.01

Information: The sliding door in this area was stiff and difficult to slide along the associated tracks at the time of the inspection. Restricted function of the affected door may pose as a potential safety hazard if required for emergency egress from the building.

Generally, factors such as general age of the building element and a lack of maintenance are the usual causes for this type of defect.

Cleaning of the tracks may improve the operation of the door. Replacement of door hardware or tracks may be required should the cleaning not be effective.

A door specialist or competent handyman may be engaged to perform this task.

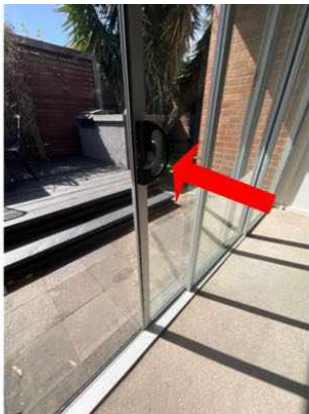
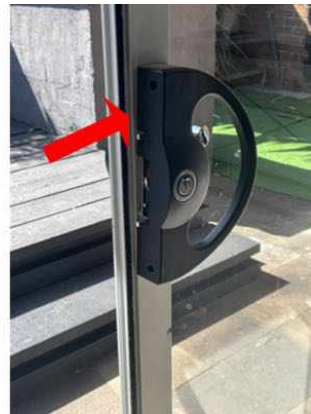
Finding 3.02

Finding: Door - loose handle

Information: The door handle in this area was found to be loose at the time of inspection. This can occur when the building materials have aged, but may be indicative of impact damage (accidental or deliberate).

Repair and/or replacement of the loose door handle is advised to improve the operational state of the associated door.

A door specialist or general handyman may be appointed to perform this task at the client's discretion.

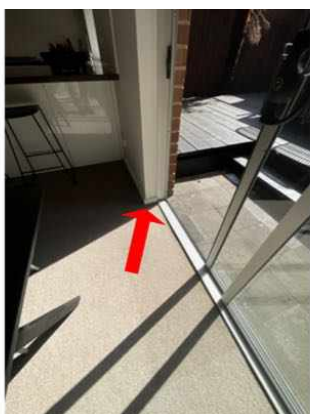
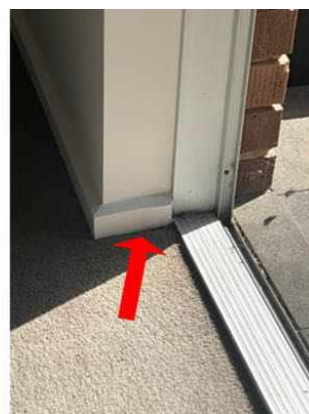
Finding 3.03

Finding: Moisture damage to skirting board and architrave next to sliding door

Information: Evidence of moisture damage was identified to the skirting board and architrave next to the sliding door to the outdoor area.

It is suspected that this has occurred as a result of excess moisture from external

sources. No current moisture was noted to the area when tested with a moisture meter.

A licenced carpenter or competent handyman should be engaged to inspect the moisture damaged areas and repair or replace any items where necessary. The area should be monitored for any future signs of moisture ingress eg further swelling, staining etc. Should this occur, consultation with a licensed plumber should be sought as a matter of urgency.

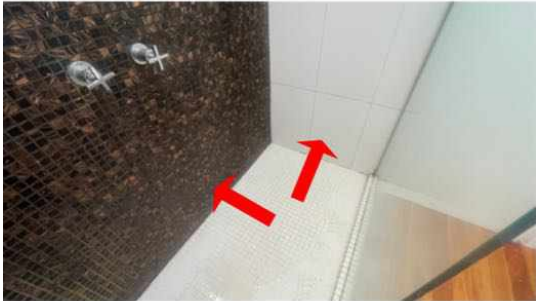
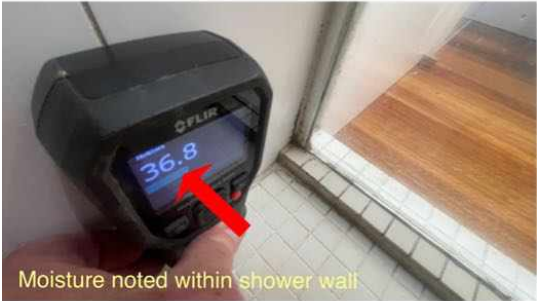
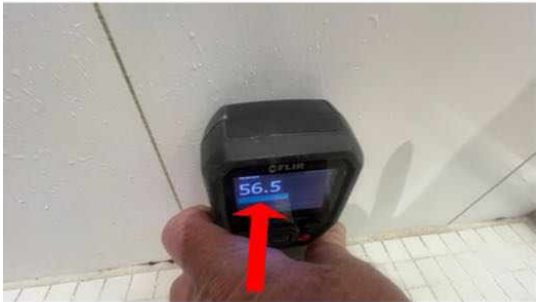
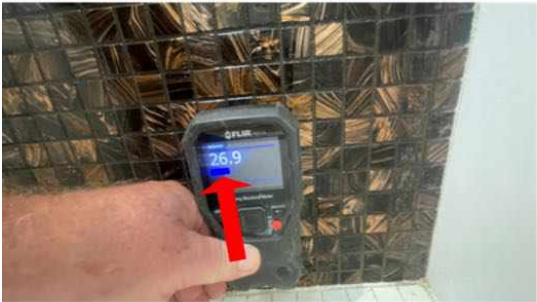
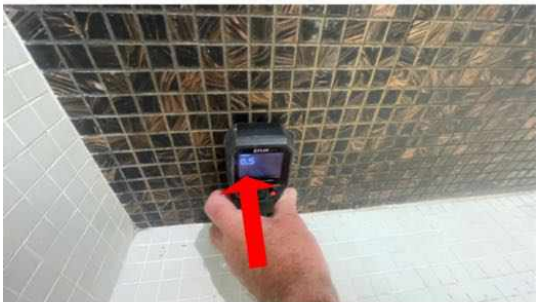
Building:	
Location:	Bathroom
Finding:	Shower - Damp noted within wall of shower
Information:	Damp was evident to the lower part of the tiled walls within the shower alcove when tested with a moisture meter. This defect is quite common, and is suspected to have been caused by moisture permeating through the grouting in this area, which shows evidence of deterioration. Leaking pipes within the adjoining wall is also a possible cause although there was no moisture noted higher up the wall nor to the wall in the bedroom or living area behind the shower.)

Damp (or structural damp) refers to the presence of unwanted moisture in the structure of a building, either as the result of intrusion from outside, or condensation from within the structure. In the shower area, internal water leaks or other sources of excessive moisture are generally the cause of damp.

Unmanaged damp in the shower recess can facilitate the formation and development of mould and fungi growth. It is important to address damp conditions, as the World Health Organisation notes that excess moisture leads - on almost all indoor materials - to growth of microbes such as moulds, fungi and bacteria, which subsequently emit spores and other matter into the indoor air. Exposure to these contaminants is associated with a wide range of respiratory and other health-related problems.

Should the damp continue and/or staining to the walls behind the bathroom occurs, consultation with a qualified plumber or bathroom specialist would be advised

immediately to identify the cause of damp and to perform remedial works as required.

Always ensure that sealant and grout is in good condition to prevent any moisture issues occurring in the future.

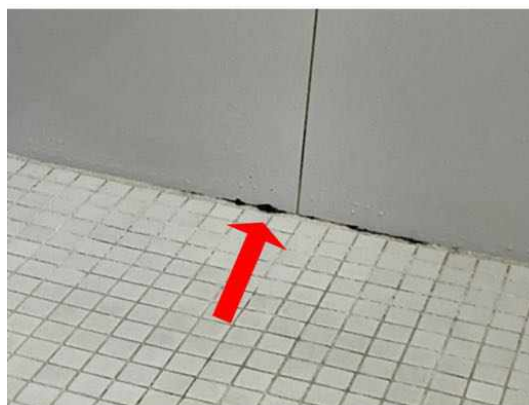
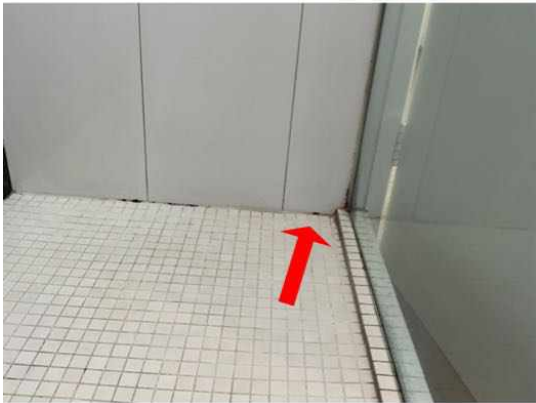
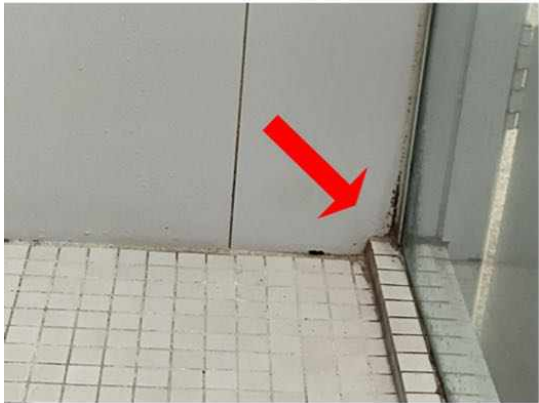
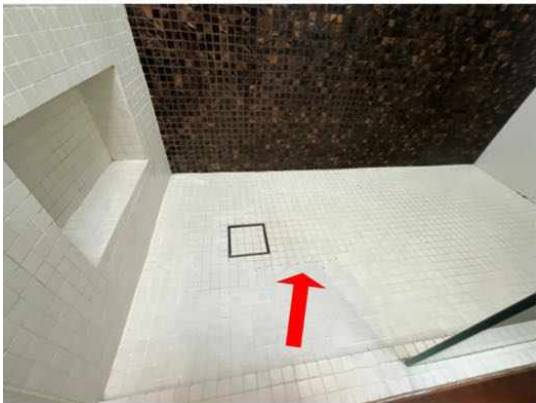
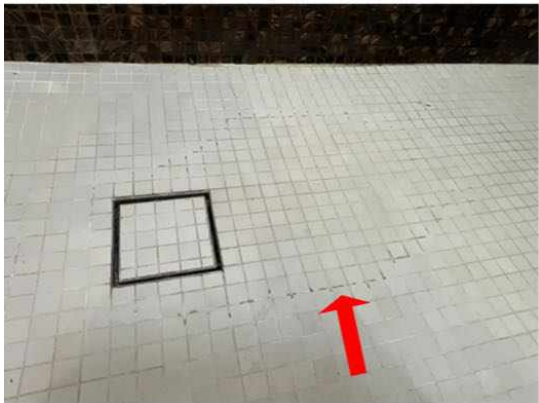
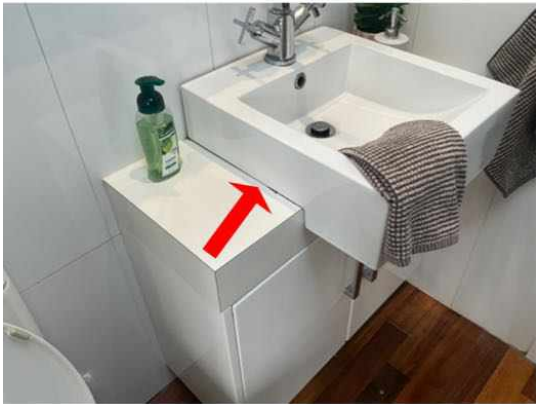
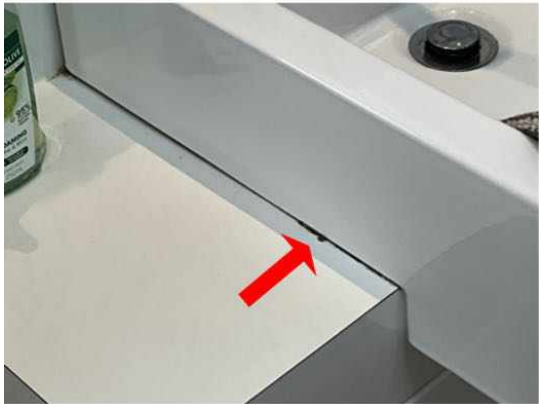
Finding 3.05

Finding: Grout and sealant - Missing or degraded within the bathroom area

Information: It was noted on inspection that grout or sealant is degraded to the shower and other areas within the bathroom.

Different materials move at different rates, generally causing cracking to grout at this point. Build up of moisture in the bathroom can also cause grout and sealants to degrade and become mouldy.

Any damaged or degraded materials should be scraped out and flexible and mould resistant materials should be applied to affected areas to prevent any subsequent water damage that may occur. Regular maintenance and replacement of damaged or missing grout/ sealant is highly recommended to the wet areas, as this is a regular wear and tear defect. Both grout and sealant in areas that come into regular contact with water should be maintained for the long term care of your property.

A bathroom specialist or tiling contractor should be appointed to complete these works as a matter of urgency.

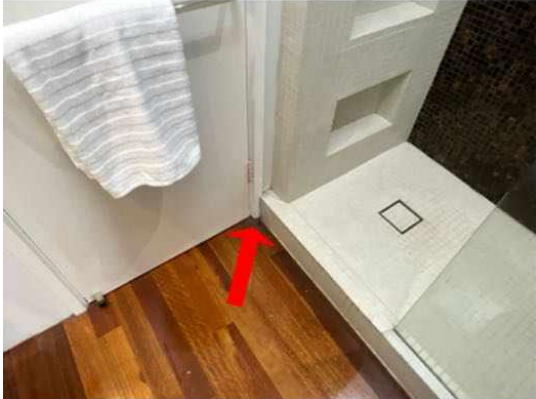
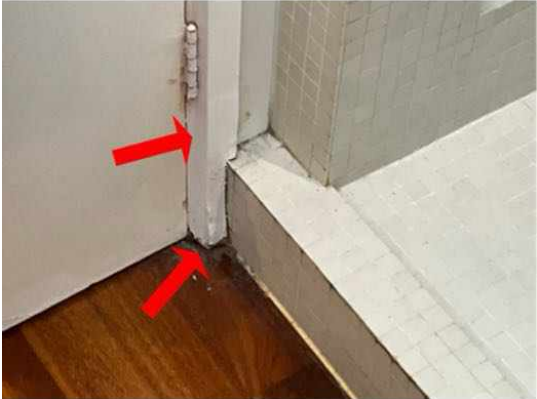
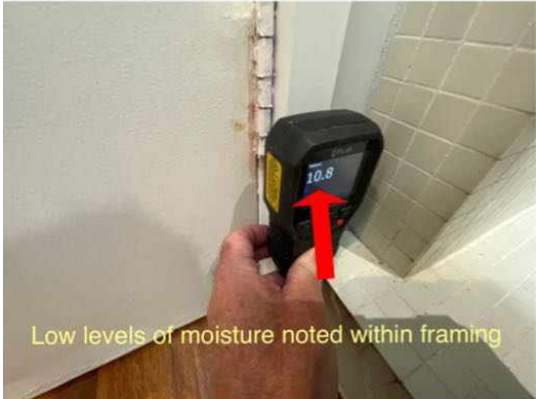
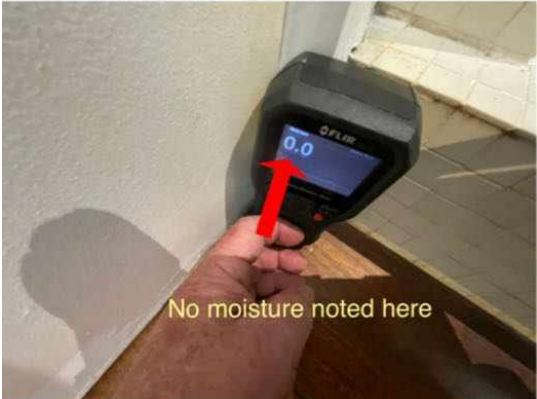
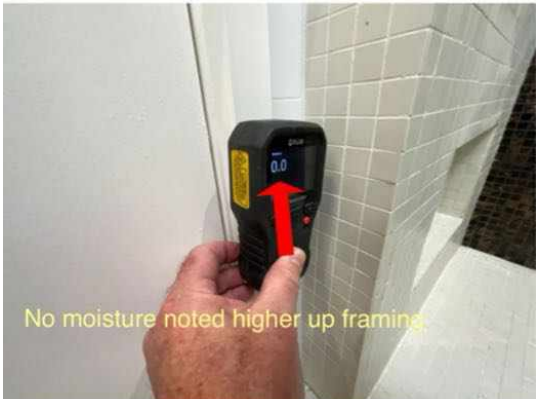
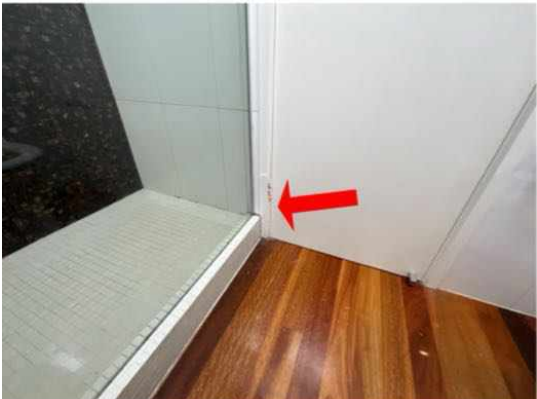
Finding 3.06

Finding: Moisture damage to architrave and door frame with current moisture noted in the area

Information: Evidence of moisture damage was identified to the architrave and door frame in the bathroom. Current Moisture was also noted within the area when tested with a moisture meter.

It is suspected that moisture has escaped the shower and soaked into the timber framing next to the shower.

It is highly recommended that a bathroom specialist be engaged to inspect the area to improve the water tightness of the bathroom and prevent moisture exiting. Where moisture damage is not severe, minor repairs and repainting may be carried out. Where damage becomes excessive, replacement of framing may be required.

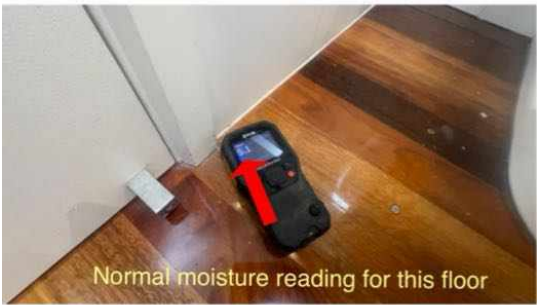
Normal moisture reading for this floor

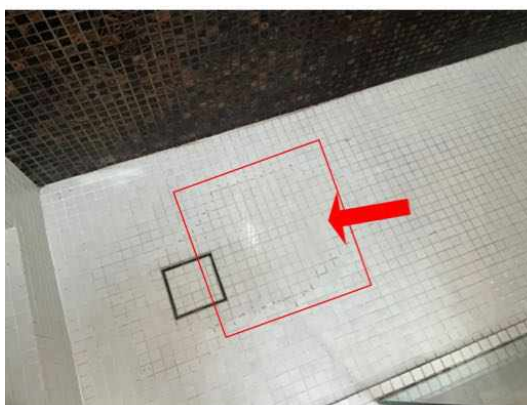
This pooling is minor overall but is still considered unsatisfactory, as correct tiling practices would not permit this situation to occur. Pooling water around floor tiles can create a slip hazard in extreme cases and also create conditions that are conducive to mould growth over time. Where left unmanaged, the degradation of sealant and grouting may also occur, possibly necessitating further repair works.

In severe cases (not noted in this instance) , works may involve repair and replacement of some sections of tiling and flooring . A tiling contractor or bathroom specialist can be appointed to provide further advice on repair options and to perform works as necessary.

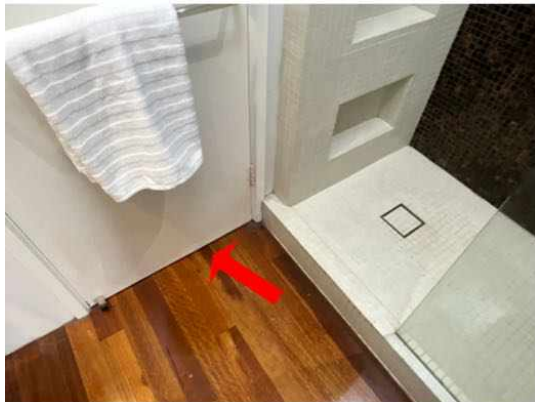
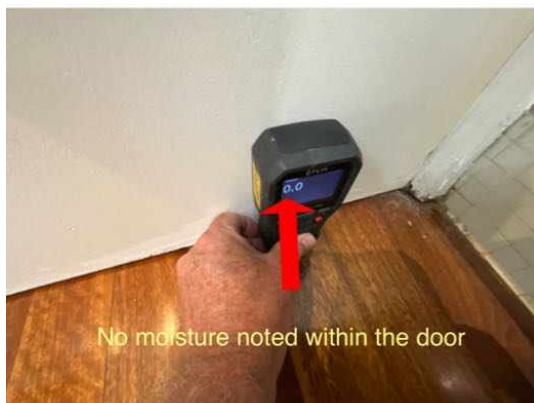
Finding: Door showing signs of damage to the base
 Information: At the time of inspection moisture damage was noted to the base of the door in the bathroom. It is suspected moisture may have entered the base of the door from internal spills.

Doors should be sealed on all faces including top and bottom to prevent moisture seeping into the door structure and potentially causing secondary damage.

A suitably qualified handyman should be engaged to inspect the door. The door should be removed, repaired and repainted to seal all exposed faces.

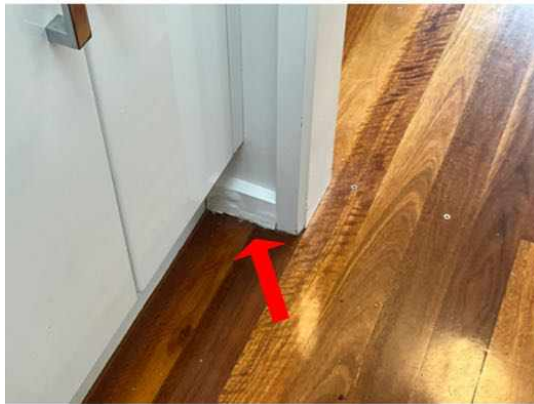
Building: Laundry
 Location: Laundry
 Finding: Moisture damage to architraves and door frame in the laundry area
 Information: Evidence of moisture damage was identified to the architraves and door frame in the laundry area.

It is suspected that this has occurred as a result of excess moisture from internal spills.

At the time of inspection no current moisture was noted when checked with a

moisture meter. As a result , no further damage is likely in this area.

A licenced carpenter or competent handyman should be engaged to inspect the moisture damaged areas and repair or replace any items where necessary.

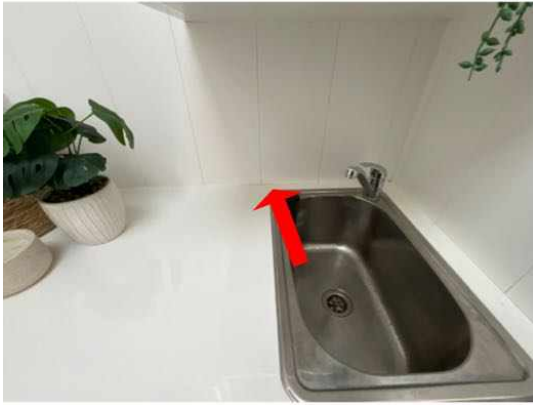
Building:	
Location:	Laundry
Finding:	Sealant - Damaged or Missing
Information:	Sealant is damaged in this area. Sealant is used to protect gaps and crevices in building materials to ensure that they are water-tight and prevent water penetration to the associated structures.

Failure to do so may lead to further deterioration of the sealant which in turn can lead to water damage to the surrounding area.

Where sealant is missing or damaged , a competent handyman may be appointed to scrape out and re-apply any silicone where necessary.

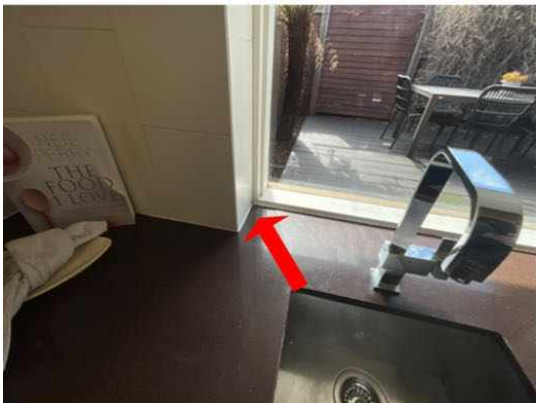
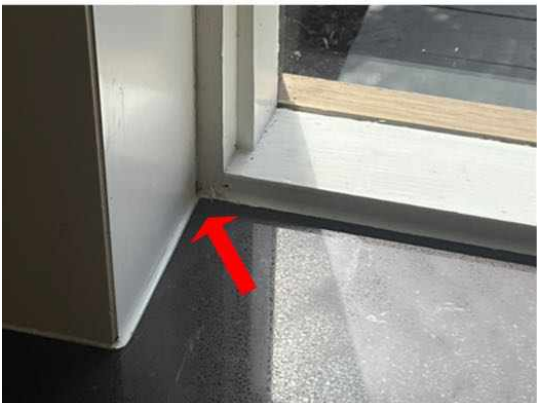
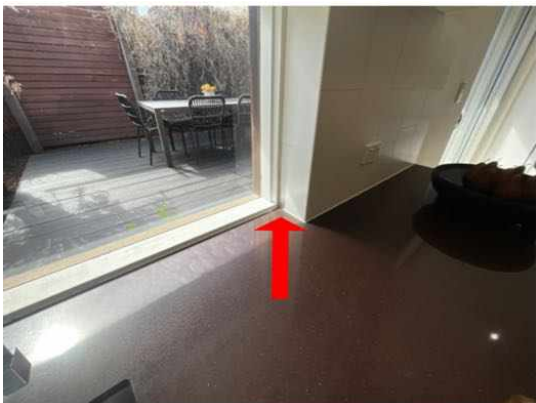
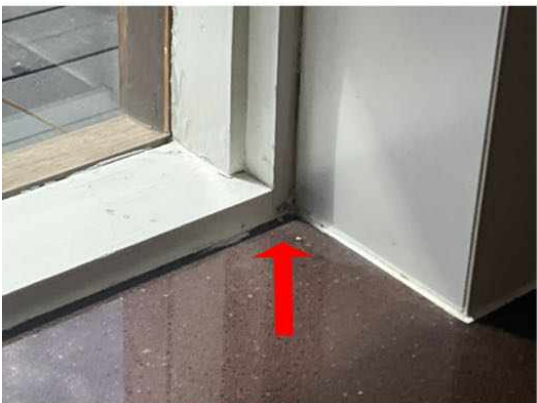
Finding: Grout/ sealant - Missing or degraded

Information: Grout/ sealant is missing or degraded in this area. Grout and sealant is used to protect gaps and crevices in building materials to ensure that they are water-tight and prevent water penetration to the associated structures.

Failure to do so may lead to further deterioration of the grout or sealant which in turn can lead to water damage to the surrounding area.

Where grout or sealant is missing, a tiling contractor should be appointed immediately to apply grout and re-apply any silicone where necessary.

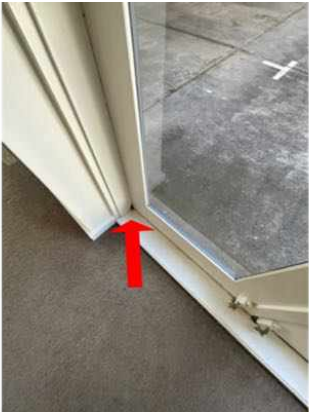
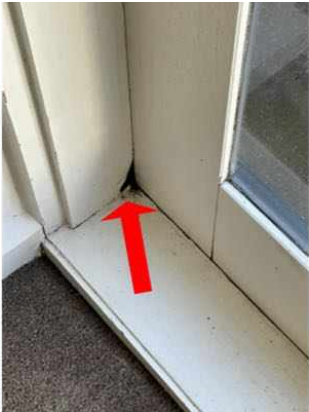
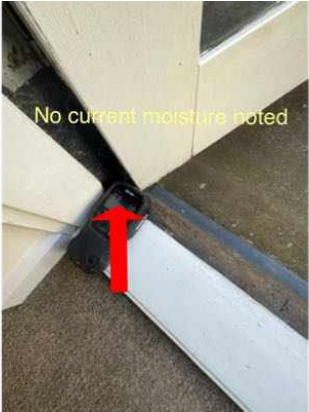
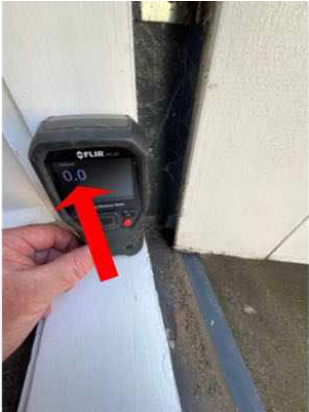
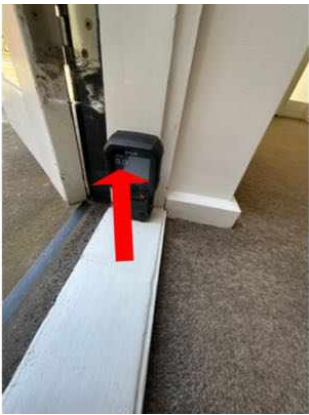
Finding 3.12

Building:
Location: Living Room
Finding: Moisture damage to the door frame of the French doors.
Information: Evidence of moisture damage was identified to the door frame of the French doors in the living area.

It is suspected that this has occurred as a result of excess moisture from external sources. No current moisture was noted in the area when tested with a moisture meter.

A licenced carpenter or competent handyman should be engaged to inspect the moisture damaged areas and repair or replace any items where necessary.

Should further damage occurred to the framing, further works may be required to prevent moisture ingress in this area.

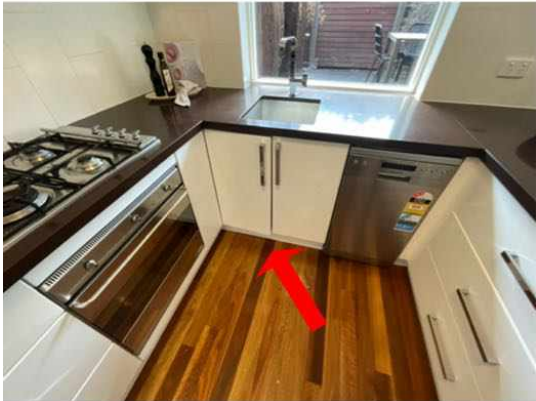
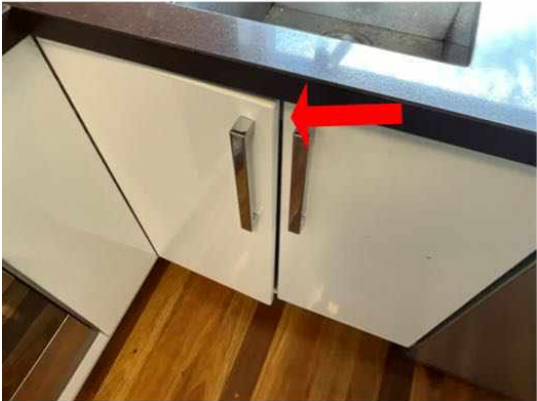
Finding 3.13

Building:
Location: Kitchen
Finding: Cabinet - misaligned doors
Information: The doors to the cabinet in the kitchen appeared to be out of alignment slightly and did not close flush with each other. This could be due to a hinging issue or could be caused by the door slightly warping .

A general handyman may be appointed to inspect the doors and make necessary repairs. Replacement of the doors may also be required where repairs cannot be performed satisfactorily.

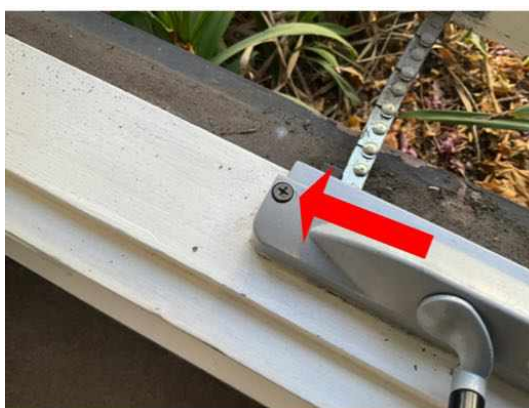
Finding 3.14

Finding: Window winder loose - window still operates

Information: At the time of inspection the window winder to the bedroom window appeared to be loose. It is suspected that this has occurred as a result of deterioration with age.

Even though the winder is loose, the window was still able to be operated.

It is recommended that the winder be tightened.

A competent handyman or window specialist can be engaged to perform this task.

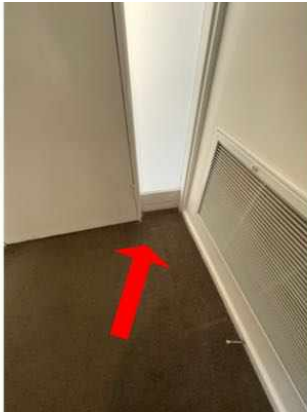
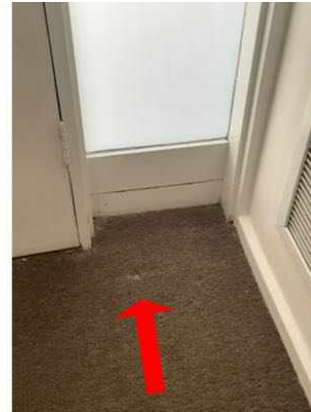
Finding 3.15

Finding: Carpet deteriorated in some areas

Information: At the time of inspection, some areas of the carpet throughout the property showed signs of wear. This is consistent with properties of this age.

The carpet may be replaced at the discretion of the homeowner.

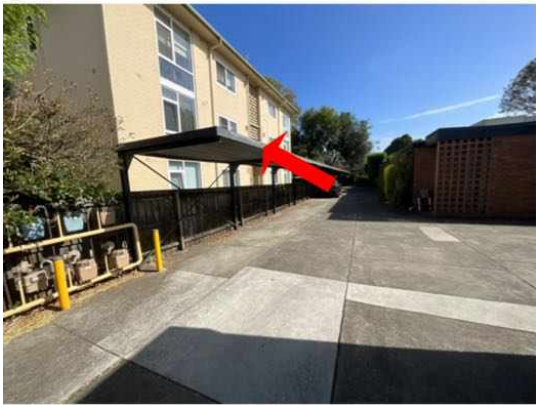
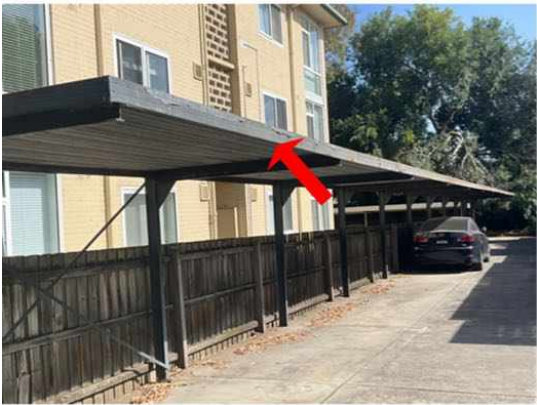
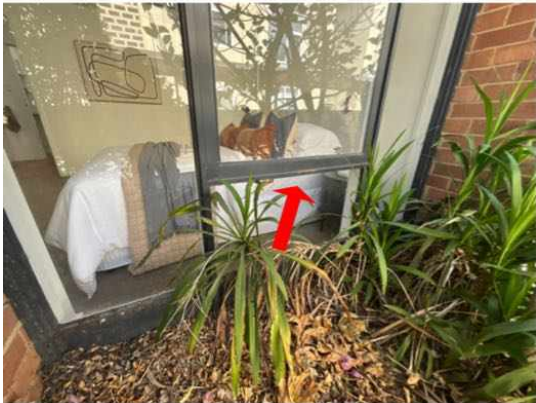
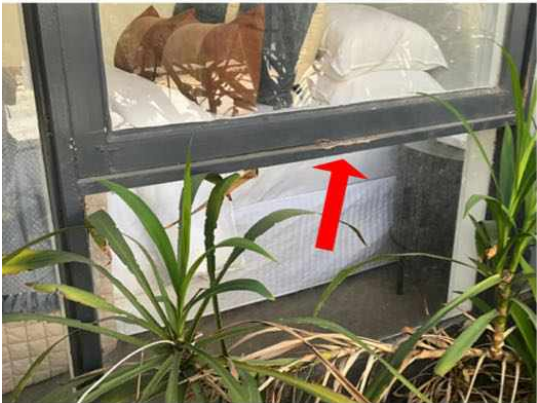
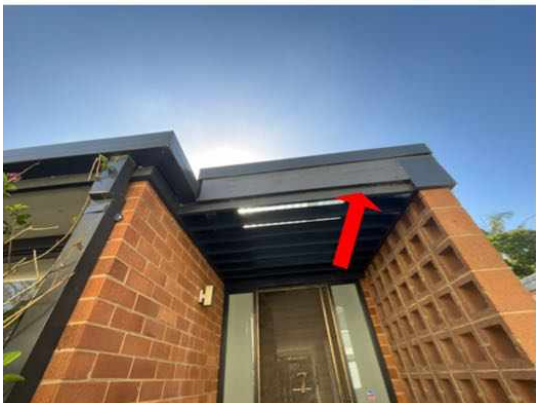
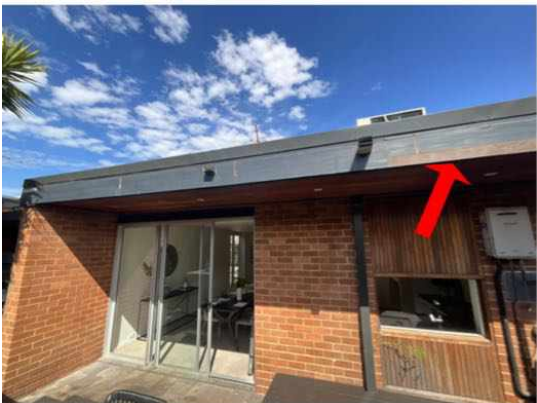
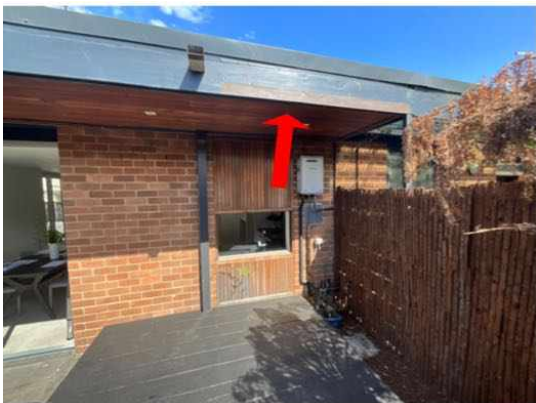
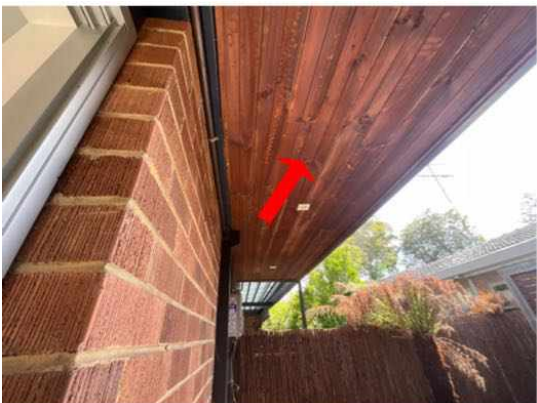
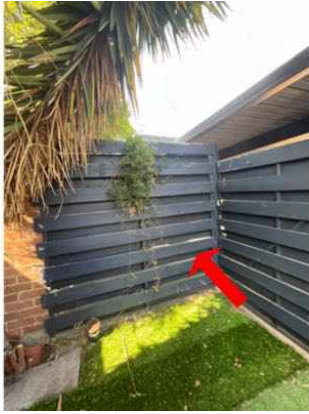
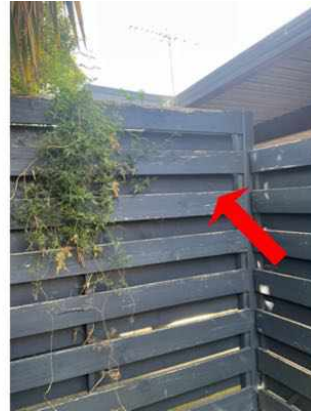
Finding 3.16

Information: External areas that are frequently exposed to harsh weather conditions require adequate protection in order to maintain their condition. Where these areas have not been painted or treated adequately, general deterioration is likely to occur at an accelerated rate.

If left unattended, replacement of some items may likely to be necessary in the short-term future.

Adequate treatment of external areas is required as soon as possible by a painting contractor or general handyman.

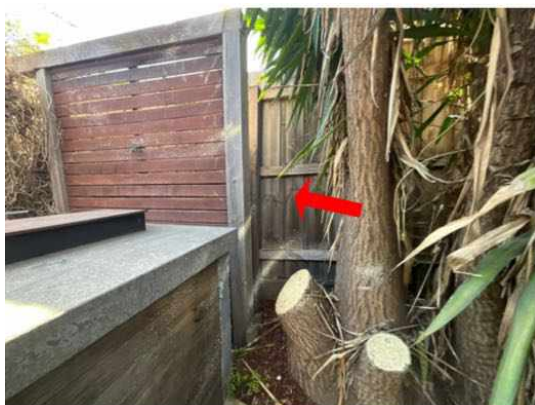
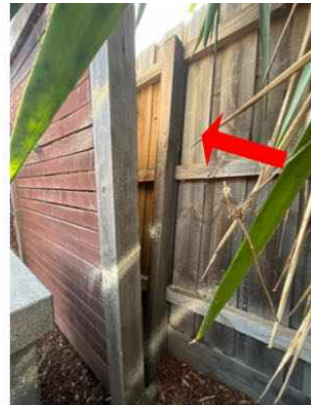
Finding 3.17

Information: It was noted at the time of inspection that a section of the fencing at the rear of the property was leaning slightly.

Typically fencing deteriorates due to age and or wear, rot and or rust which is generally expected for a structure of this age, due to prolonged exposure to weather conditions. Sometimes inadequate installation or maintenance can be to blame. Movement due to trees and their roots can also cause issues with the fencing.

Should further damage occur, repair of several elements of the fencing may be required. Replacement may also be a consideration.

A licensed fencing contractor should be appointed to provide further advice and perform rectification works as necessary.

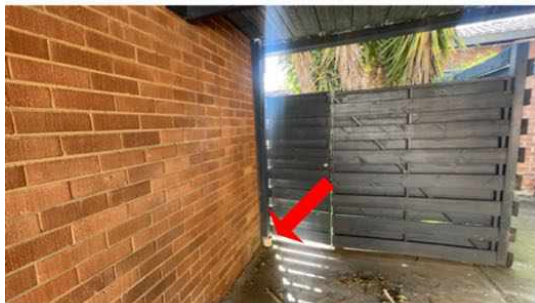
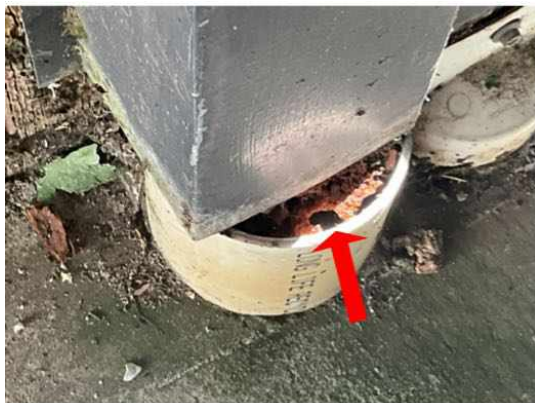
Finding 3.18

Finding: Building element - Rusted or corroded

Information: This building element shows evidence of slight rusting and corrosion, which is likely to have developed as a result of excessive exposure to moisture and or inadequate coatings.

As surface rust provides no protection to the underlying iron, the deteriorating condition is likely to worsen if not addressed in the short-term future.

Where possible, the use of galvanized (treated) metals or aluminium coated metals aid in rust prevention, as does regular general maintenance. Rusting and corrosion should be managed by ideally removing or limiting the affected surface from exposure to moisture. Rust formation can be controlled with coatings, such as paint, that isolate the iron from the environment.

Where sealing with a specialised coating is not effective, a registered builder may be appointed to replace any building elements that have been severely affected by rust or water damage.

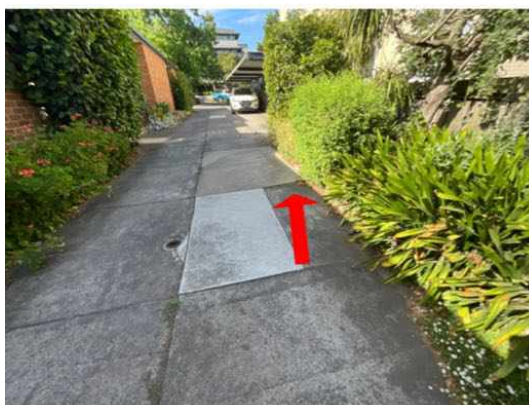
Finding 3.19

Building:
Location: Driveway
Finding: Cracking - Noticeable cracking to driveway paving (probable owners corporation issue)
Information: Noticeable cracks were identified in the concrete paving of the driveway. These noticeable cracks may lead to the development of tripping hazards and secondary defects if they develop further.

General age and expected deterioration of the paved areas is a common cause of this type of cracking. However, expansion and contraction of the driveway may also have occurred due to environmental factors. Such factors include variable moisture and weather conditions, the presence of trees and their roots having a settling or lifting affect on the soil, or the effect of load bearing, e.g. heavy vehicles over a sustained period of time.

Cracking to this degree may also be due to poor original installation of the driveway. Factors such as poor compaction of the sub surface and/or inadequate reinforcing of the slab may create cracking and other secondary defects. Noticeable cracks may also be due to subsidence of soils.

The area should be monitored for any changes that may occur and potentially cause tripping hazards. Should this occur, repair or replacement of the concrete paving may be necessary.

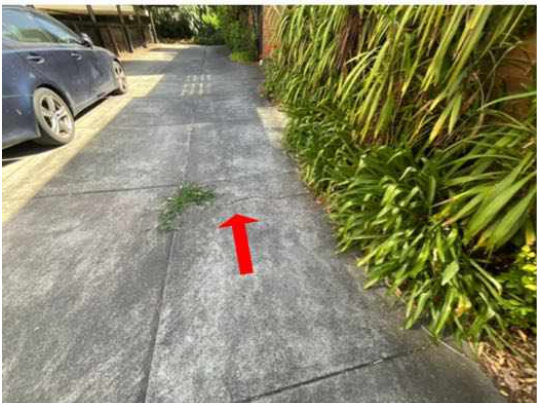
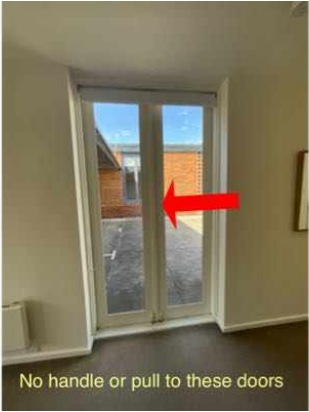
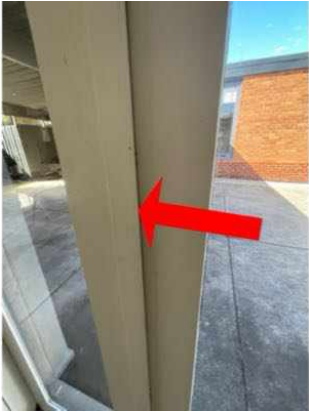
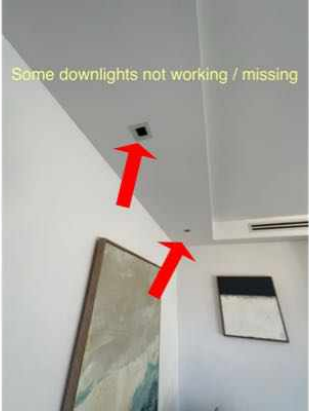
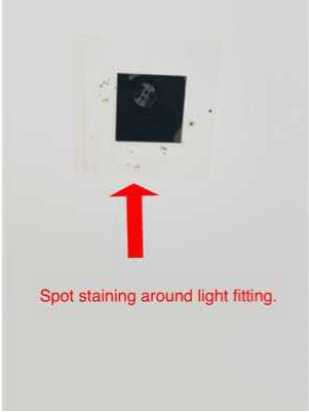
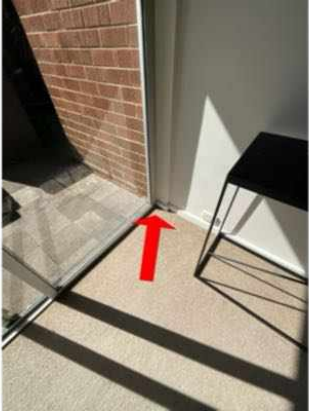
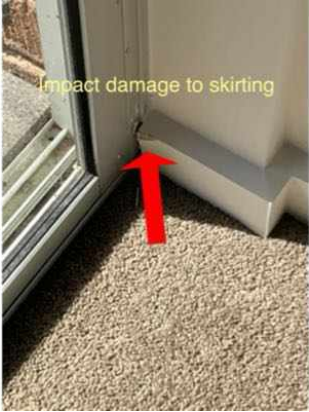
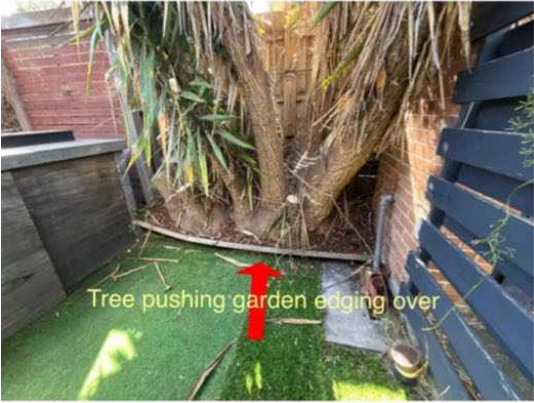
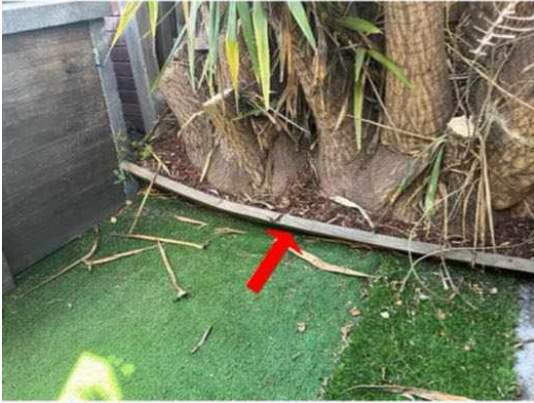
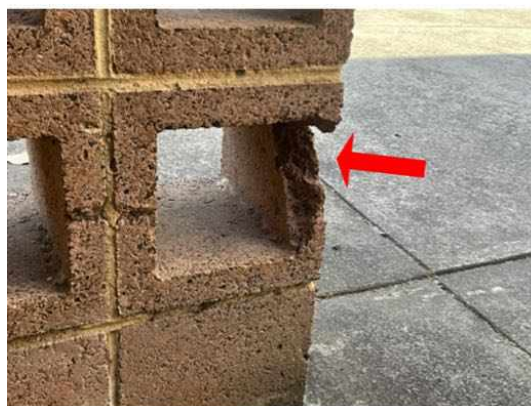
Finding 3.20

Building:
Location: All Areas
Finding: Additional Photos - minor defects
Information: Additional photos are provided for your general reference. Arrows have been included where necessary to highlight areas of importance.

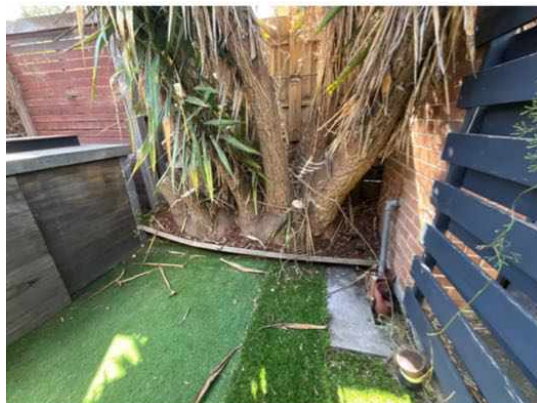
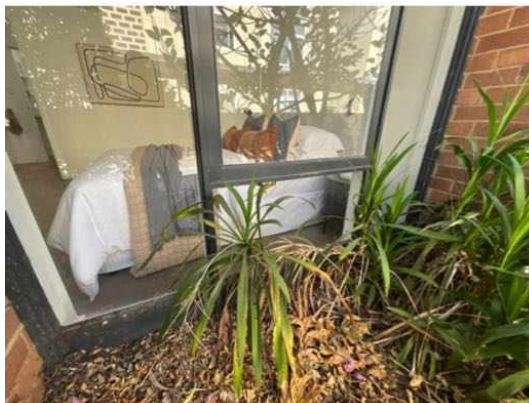
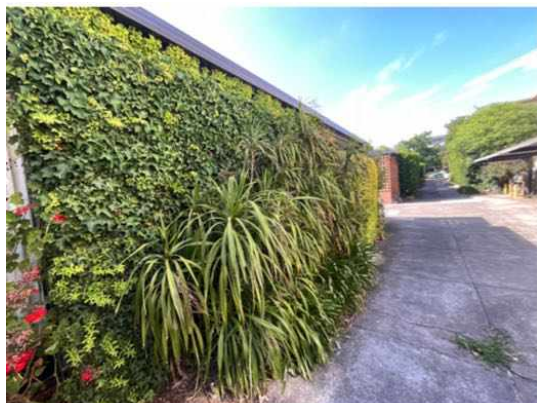
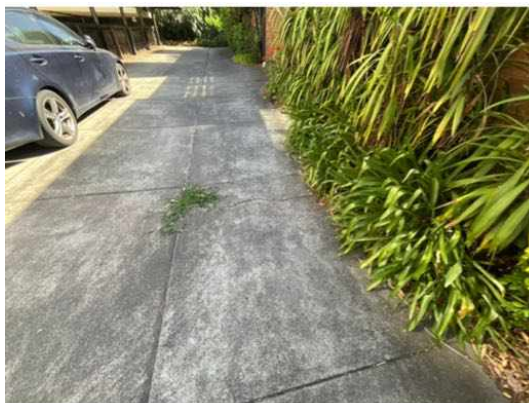
Finding: Trees and Garden Beds - Conditions Conducive to Termites

Information: Trees and Garden beds were found to be evident around and against the property. These areas can include untreated timber, and with a combination of moisture from rainfall and hosing, can make conditions conducive to termite activity and termite ingress.

The removal and replanting of species that do not provide "cover" or cutting back of existing vegetation will assist greatly in preventing this from occurring.

The removal of any such materials that may be conducive to termite activity should be carried out as soon as possible to minimize the risk of potential termite attack.

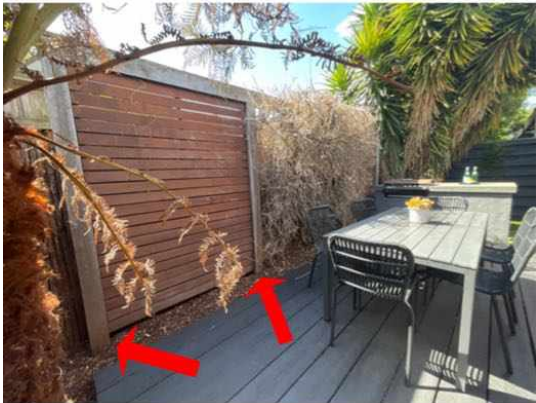
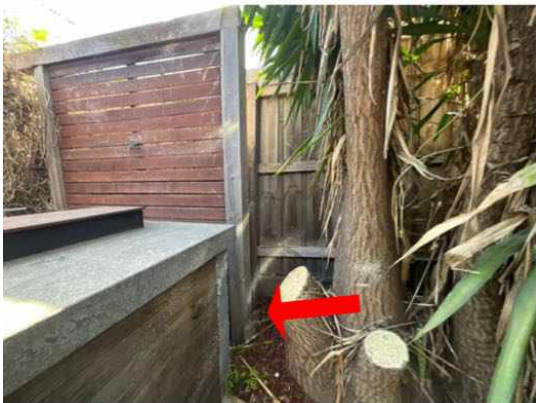
Finding 6.02

Information: Where timber elements are in direct contact with the ground and consequently moisture or dampness, they become conducive to termite activity. Whether timber is used as a building element, part of a fencing structure or stored as an unused item, they can provide an environment that is attractive to termite infestation.

When met with excessive moisture, timber begins to decay and develop wood rot. Any timbers that are in direct contact with external grounds especially if left untreated or non-durable also provide ingress for subterranean termites into that particular element.

Where possible, the removal of any such materials that may be conducive to termite activity should be carried out as soon as possible to minimise the risk of termite attack. Where not possible or practical, regular monitoring of timber elements is recommended. Replacement of any damaged materials should be carried out where necessary.

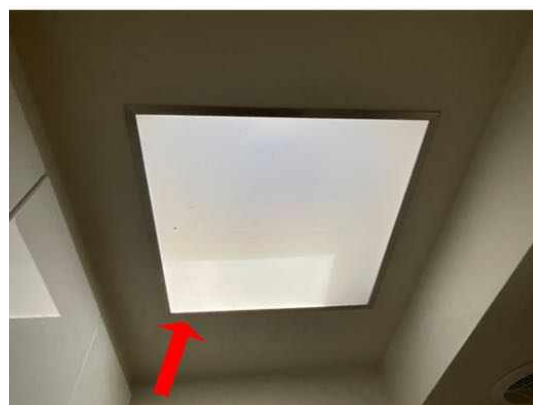
Information: It was noted the property has skylights present.

Whilst no evidence of any moisture leaking was noted during the inspection, skylights are notorious for leaking. The seals and/or flashing around the skylights can deteriorate allowing moisture to enter.

The ceilings around the skylights should be regularly monitored for any evidence of moisture leaking eg staining or bubbling of paint.

Where moisture damage is evident, a plumber should be appointed as soon as possible to identify the leak and perform rectification works as necessary, ensuring the moisture damage is restricted.

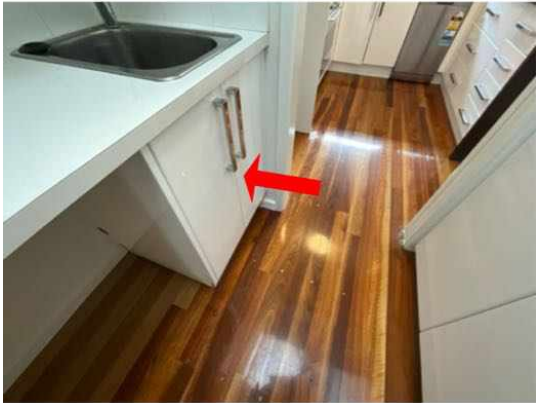
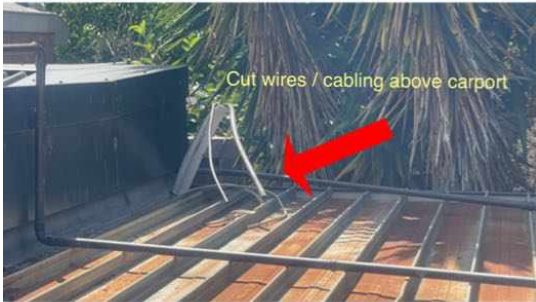
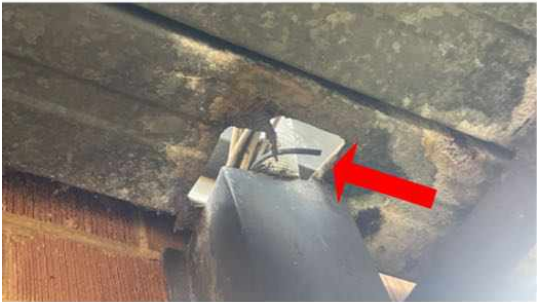
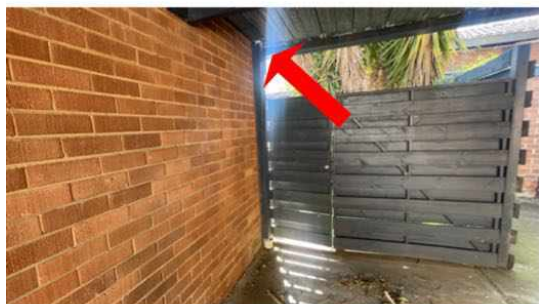
2. Loose cabling was noted on the carport roof . It could be some old electrical

cabling or old AC cabling. It is recommended this be inspected by an electrician to confirm what it is and also its current safety.

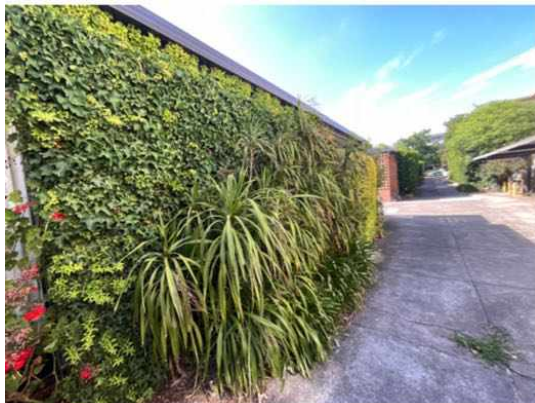
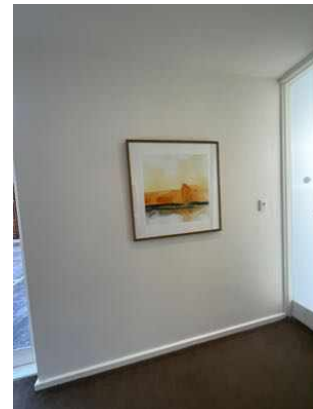
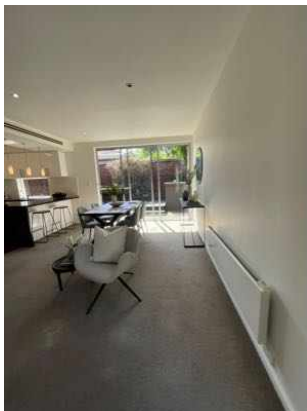
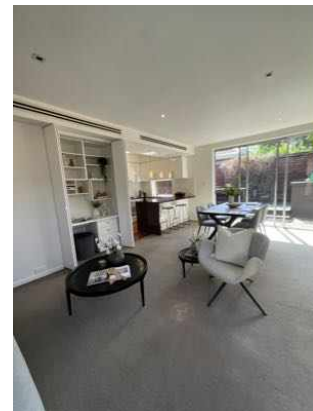
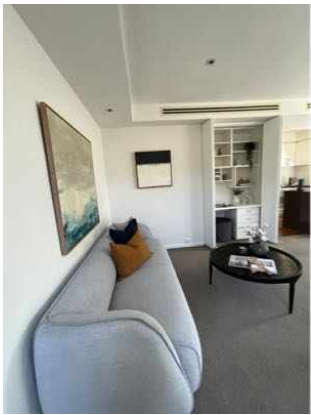
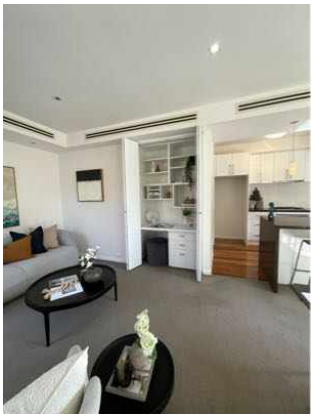
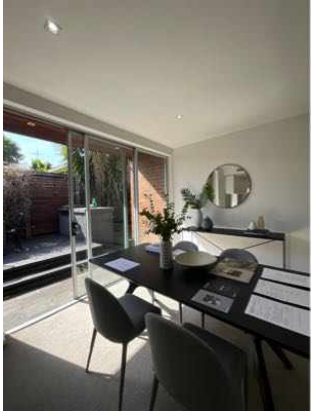
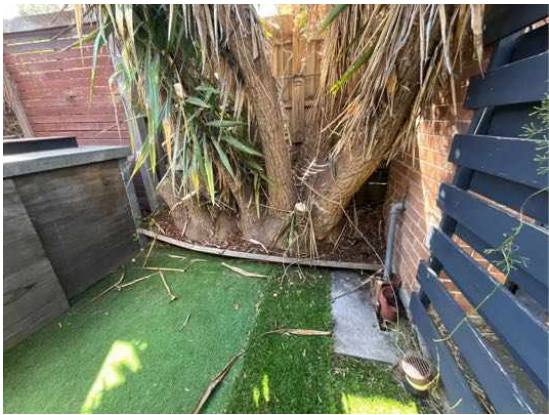
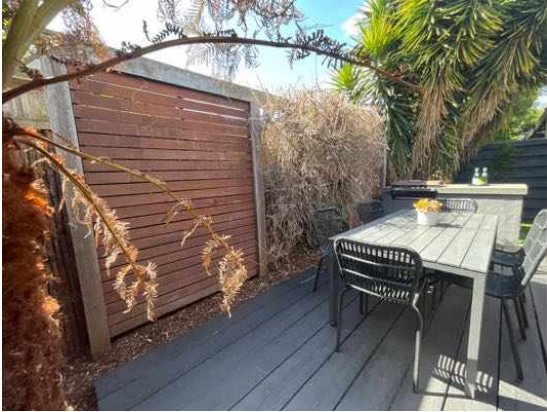
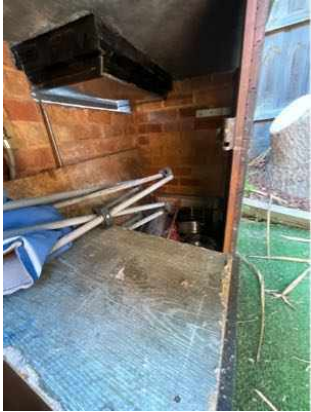
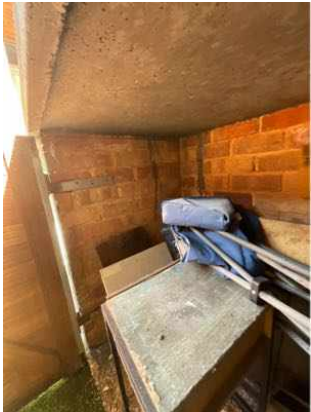
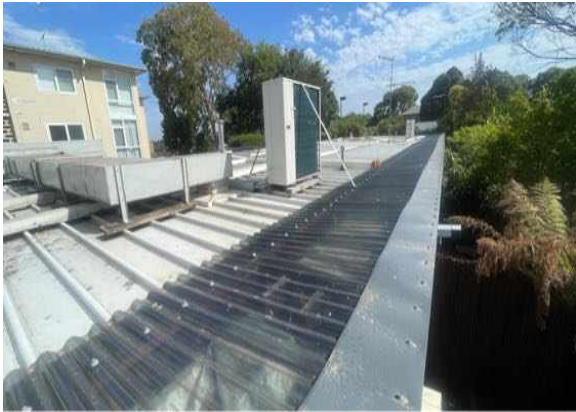
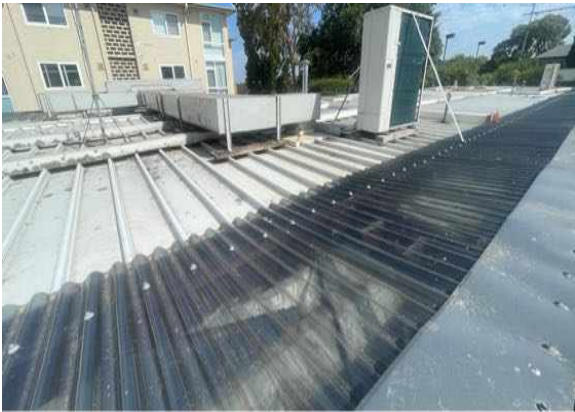
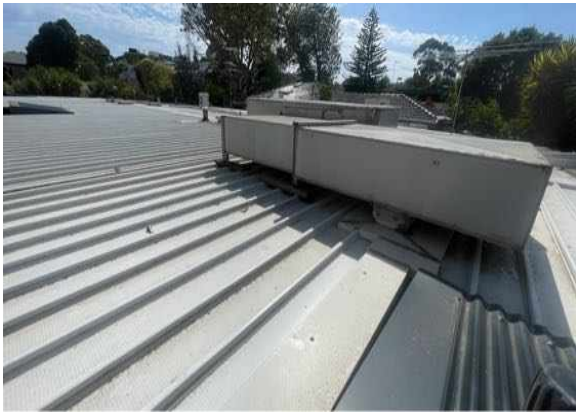
These photographs are an indication of the obstructions and limitations which impeded full inspection of the property at the time of inspection. These obstructions can hide an array of defects and should be removed to allow full inspection to be carried out. A re-inspection is recommended once the areas are made accessible.
