# Building and Timber Pest Inspection Report

Inspection Date: Wed, 21 Jan 2026

Property Address: 1/86 Lincoln Rd, Croydon VIC 3136,  
Australia

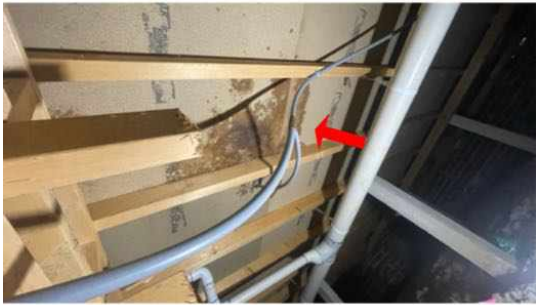
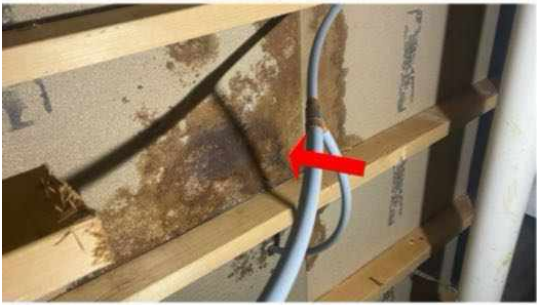
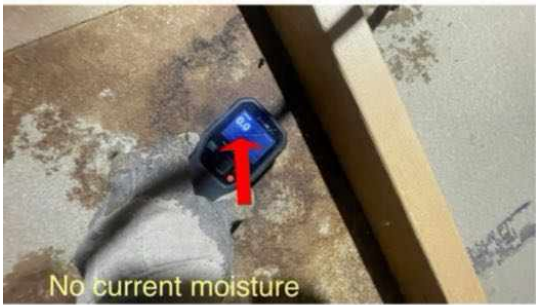
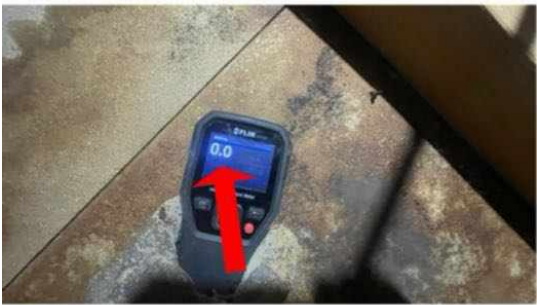
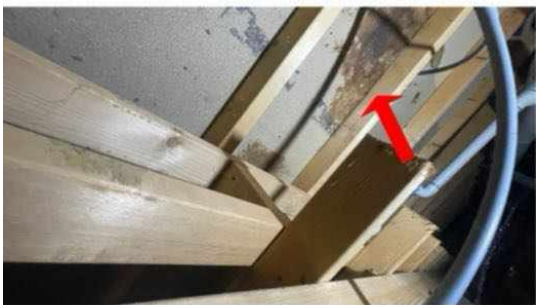
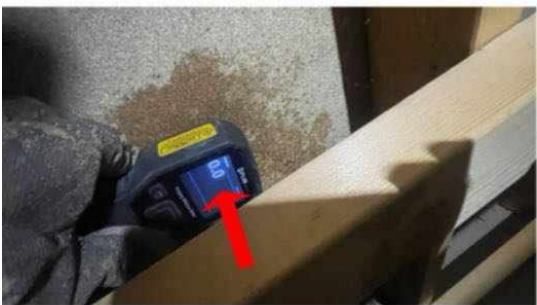
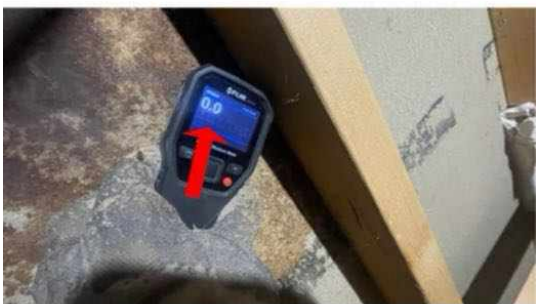
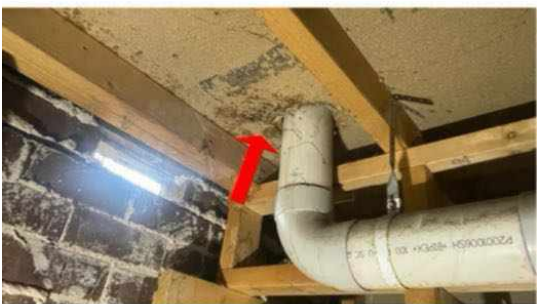
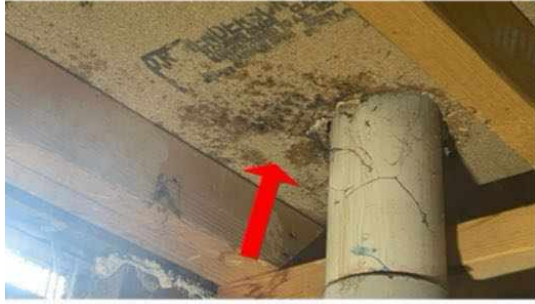
Finding: Moisture staining to flooring underneath ensuite bathroom

Information: At the time of inspection, the flooring underneath the ensuite bathroom area had evidence of moisture staining when viewed from within the subfloor. No current moisture was noted in the area when tested with a moisture meter.

It is suspected that there may have been a moisture leak from the shower or the vanity within the ensuite bathroom previously, causing the staining to occur.

It should be noted that the property is vacant and it may have been some time since the shower has been operated on an ongoing basis. (Note the shower and taps were run for a short while during the inspection with no current leaking evident, however any leaking may not be obvious with a one off use).

As there is no current moisture within the flooring, the defect is classified as a minor defect at this stage.

The purchaser should be aware that there is a risk the bathroom may leak if it is used on a daily basis. This would then become a major defect which may require a significant spend to be carried out to rectify any leaks.

The area should be monitored for any new signs of leaks . Should leaking occur, consultation with a licensed plumber should be carried out immediately.

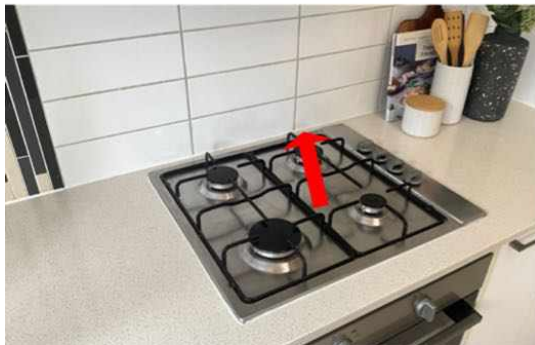
### Finding 3.02

Finding: Sealant - Damaged or Missing

Information: Sealant is damaged in this area. Sealant is used to protect gaps and crevices in building materials to ensure that they are water-tight and prevent water penetration to the associated structures.

Failure to do so may lead to further deterioration of the sealant which in turn can lead to water damage to the surrounding area.

Where sealant is missing or damaged , a competent handyman may be appointed to scrape out and re-apply any silicone where necessary.

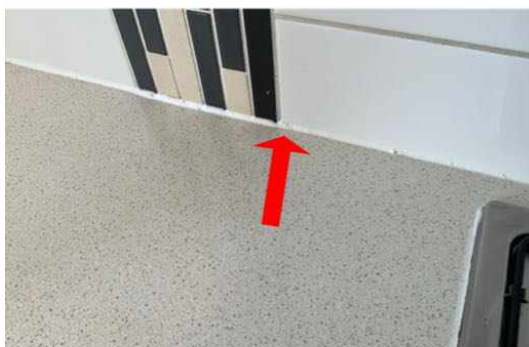
### Finding 3.03

Information: At the time of inspection, the join within the bench top surface was slightly open and not sealed effectively. This has the potential to allow water ingress into the gap and cause secondary damage to the cabinets underneath.

It is highly recommended that the benchtop be sealed to prevent water ingress.

A competent handyman or kitchen benchtop specialist may be engaged to perform this task.

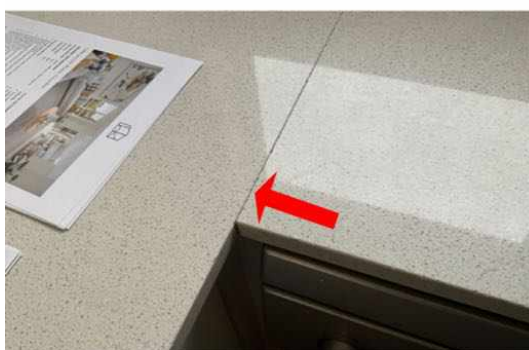
### Finding 3.04

Finding: Cracking - fine

Information: Some fine cracking was noted throughout the property.

Although fine cracks are quite noticeable, they are often only considered to be an appearance defect, and usually do not indicate any structural damage. Generally, the cause of a fine crack is indicative of a separation between building materials and

Cracking of this nature can generally be repaired with minor sanding, filling and/or repainting. Such works should be performed by a qualified painter or a general handyman.

Monitoring of all cracking should be conducted frequently. Always contact a building inspector should cracks widen, lengthen, or become more numerous.

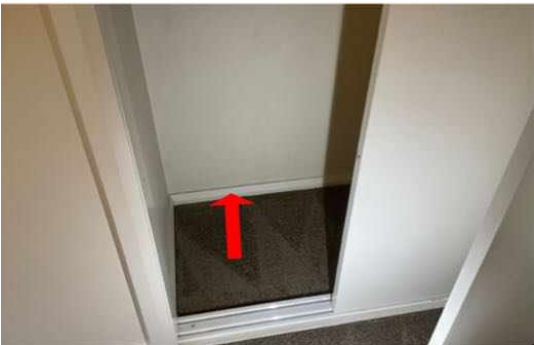
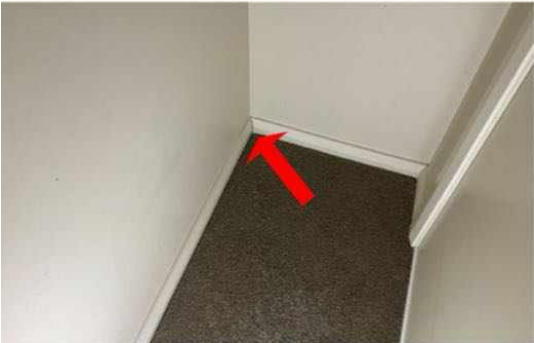
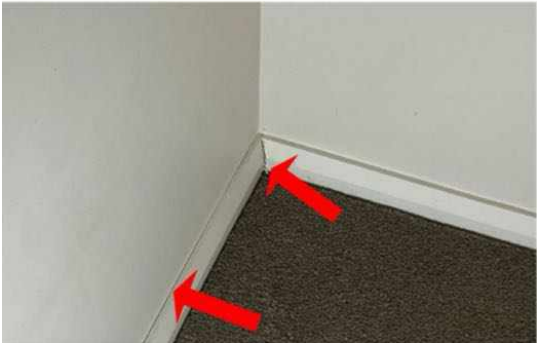
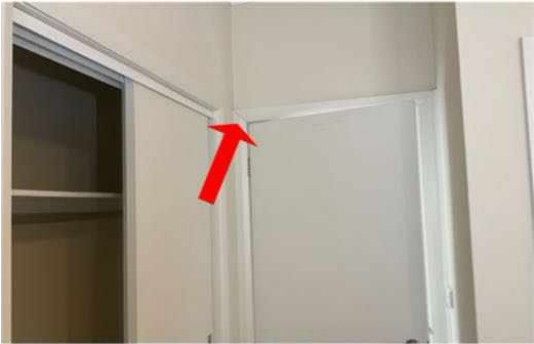
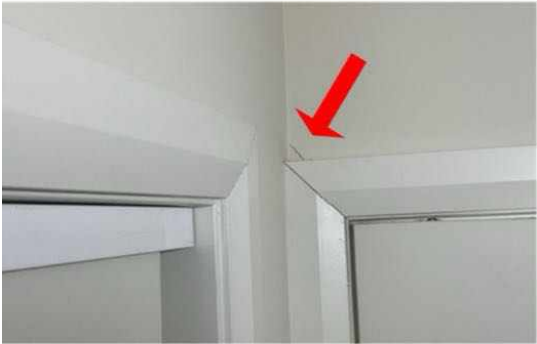
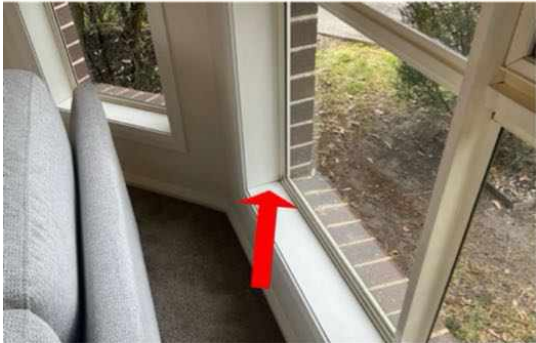
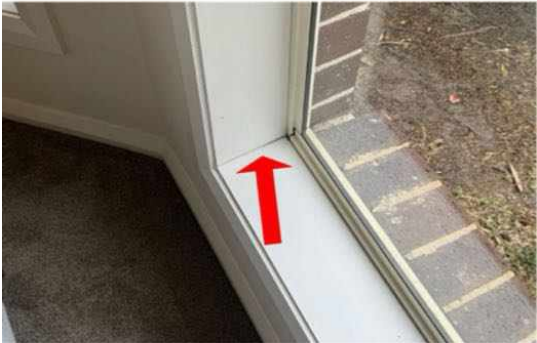
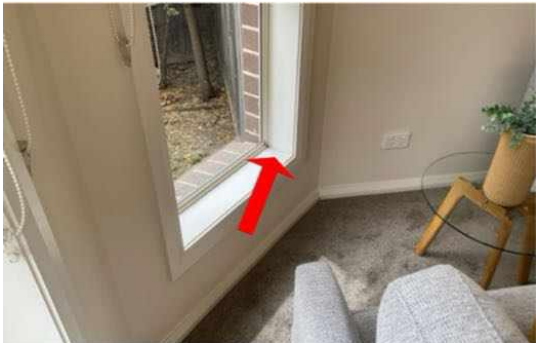
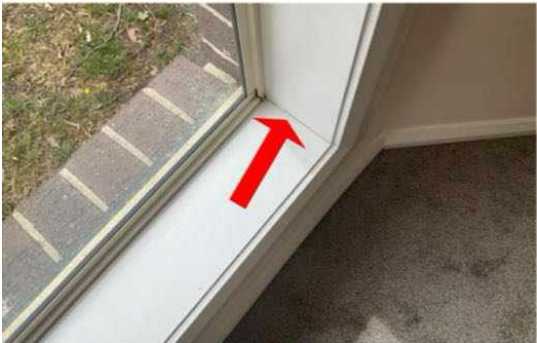
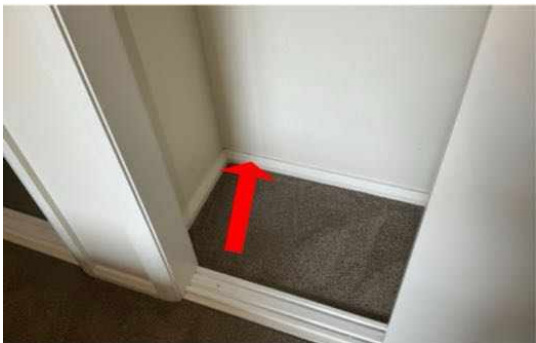
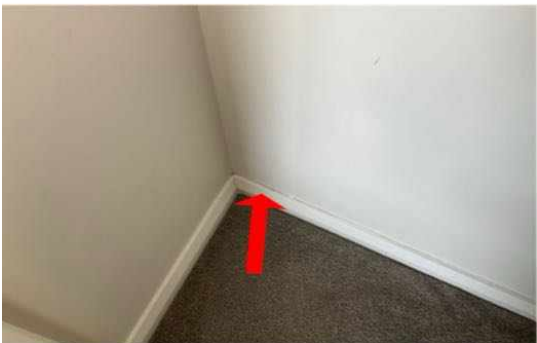
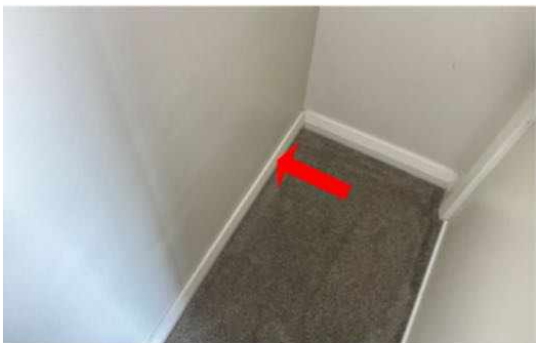
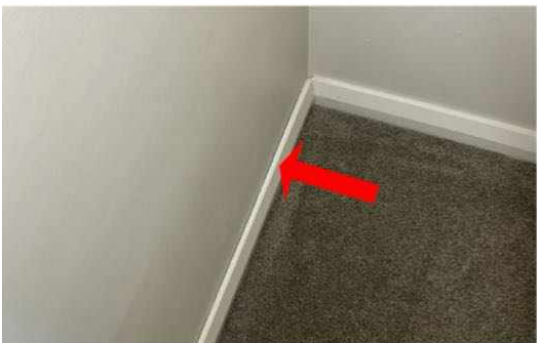
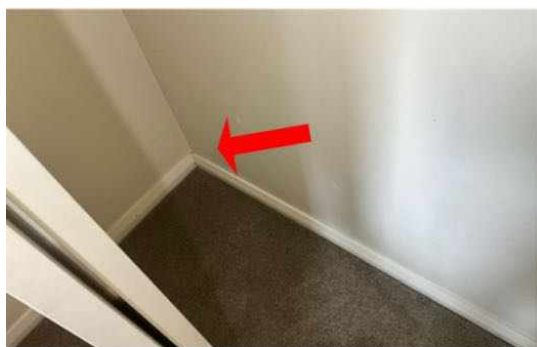
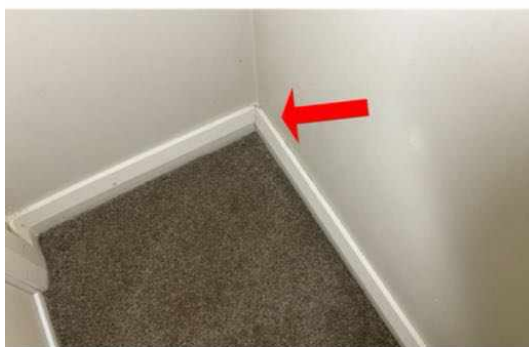
Note: photos included are indicative of fine cracking noted at the the time of inspection. Other fine cracks may be present but not recorded here.

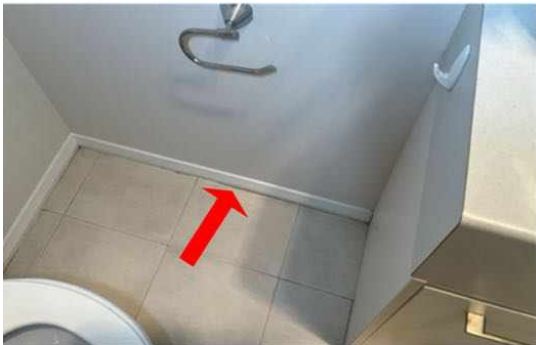
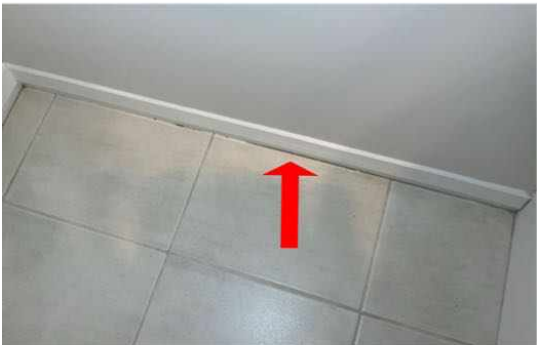
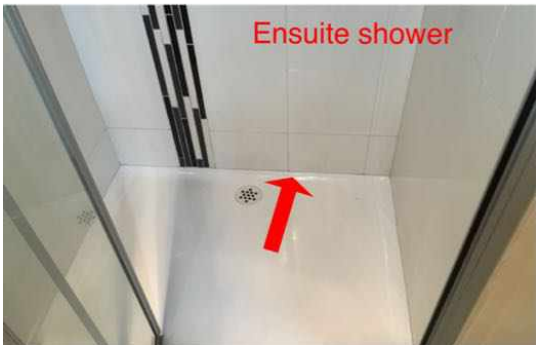
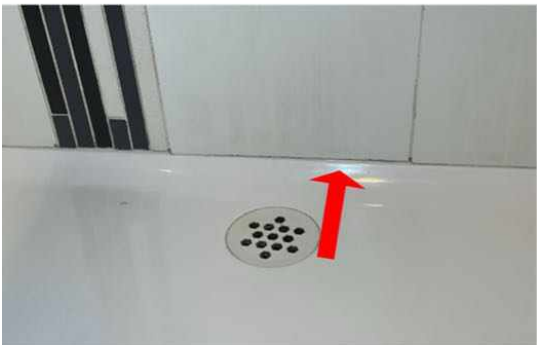
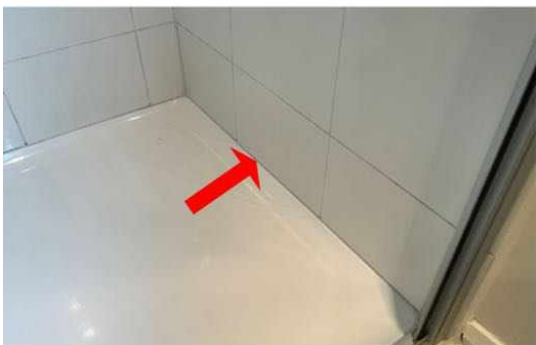
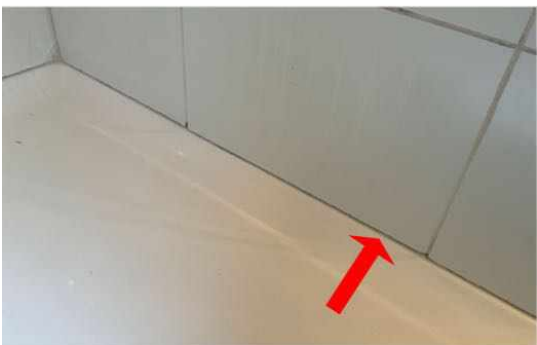
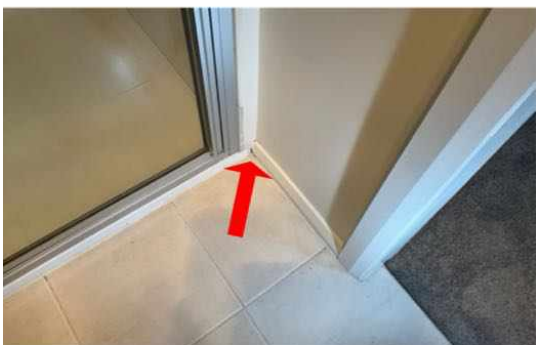
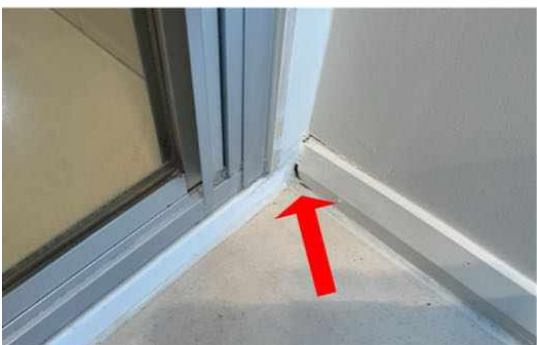
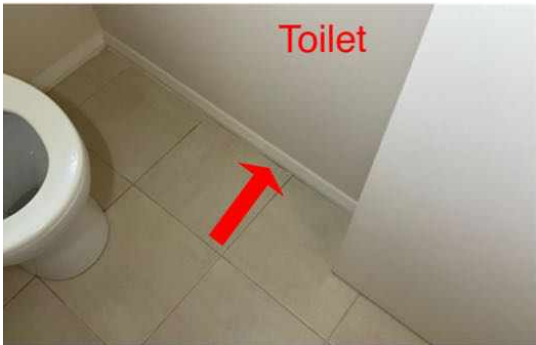
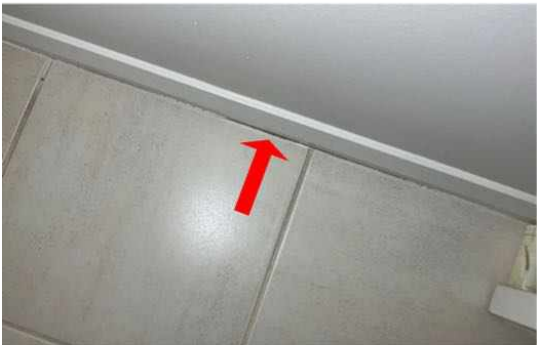
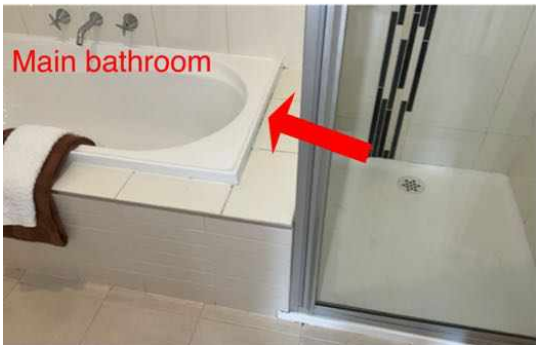
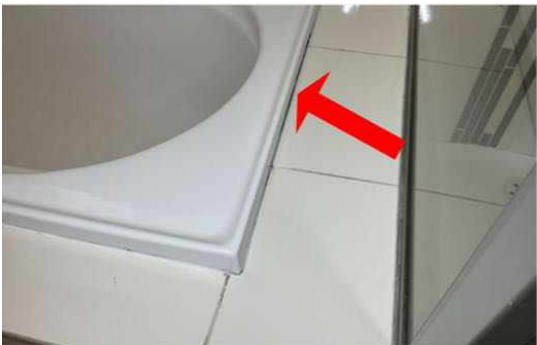
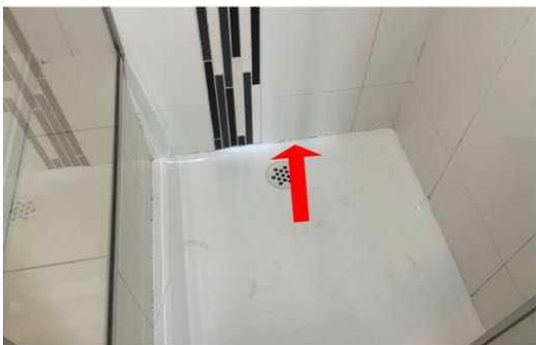
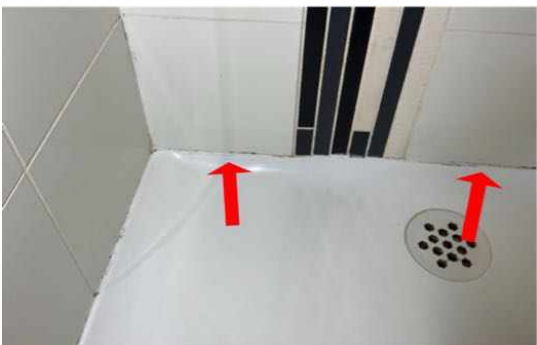
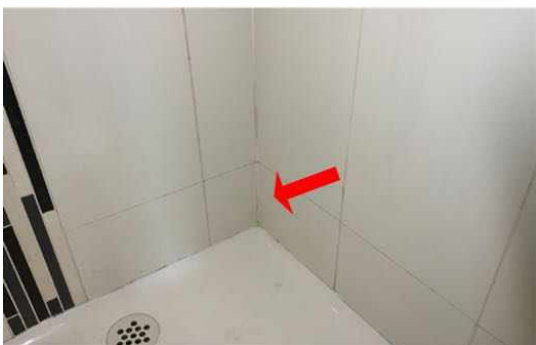
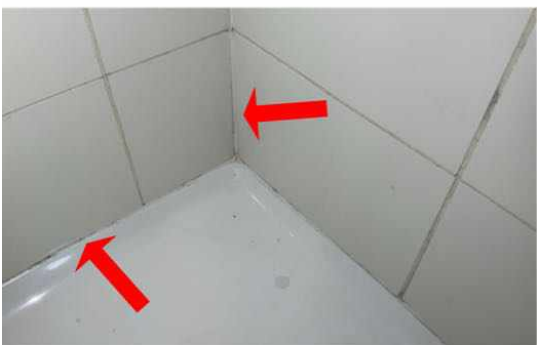
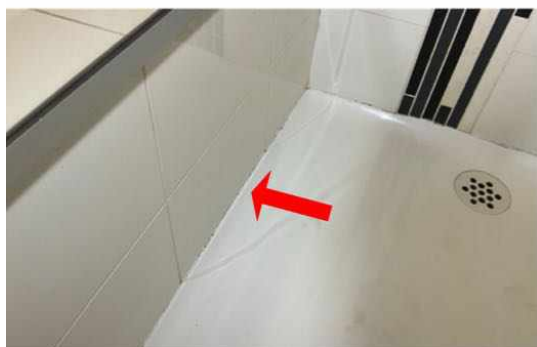
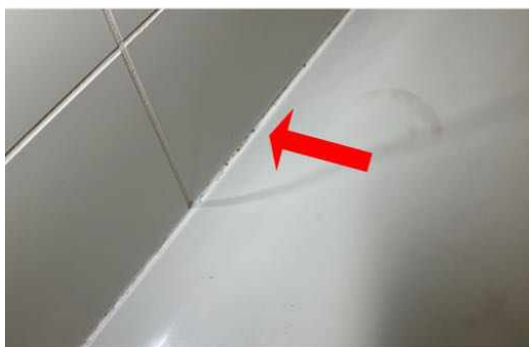
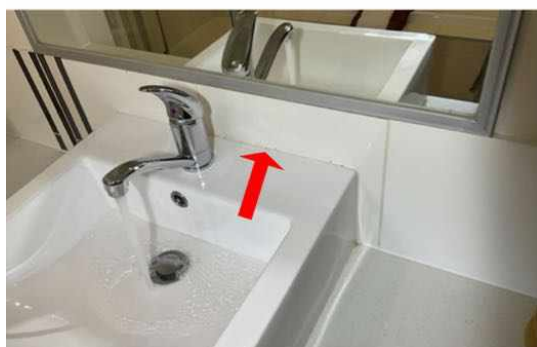
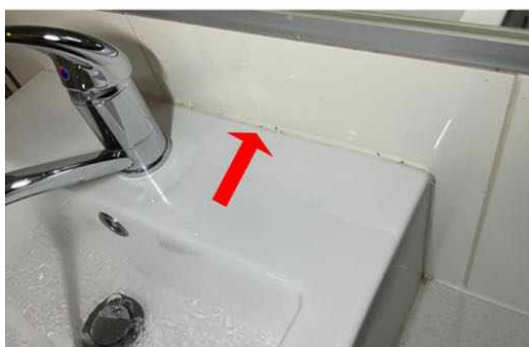
Finding: Grout and sealant - Missing or degraded within the bathroom area

Information: It was noted on inspection that grout or sealant is degraded to areas within the bathroom.

Different materials move at different rates, generally causing cracking to grout at this point. Build up of moisture in the bathroom can also cause grout and sealants to degrade and become mouldy.

Any damaged or degraded materials should be scraped out and flexible and mould resistant materials should be applied to affected areas to prevent any subsequent water damage that may occur. Regular maintenance and replacement of damaged or

missing grout/ sealant is highly recommended to the wet areas, as this is a regular wear and tear defect. Both grout and sealant in areas that come into regular contact with water should be maintained for the long term care of your property.

A bathroom specialist or tiling contractor should be appointed to complete these works as soon as possible.

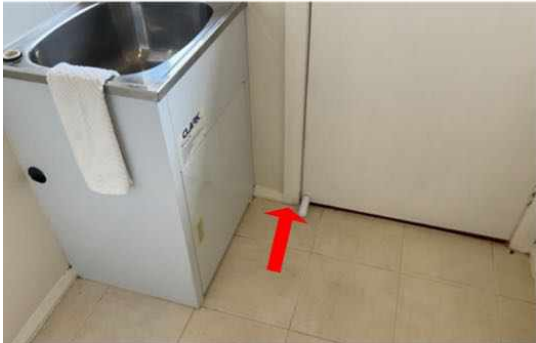
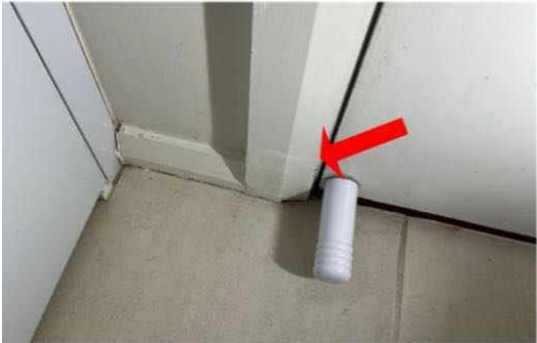
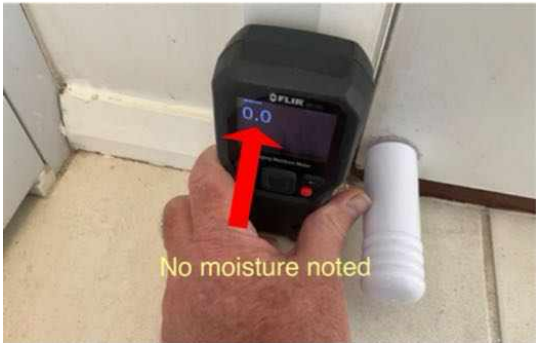
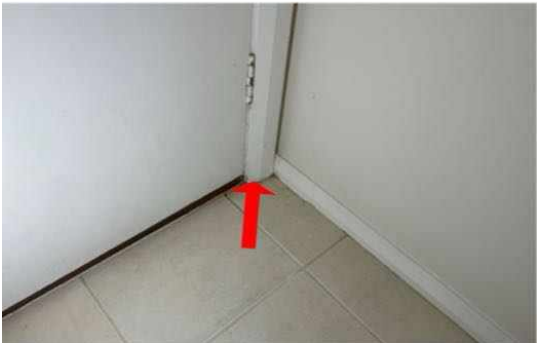
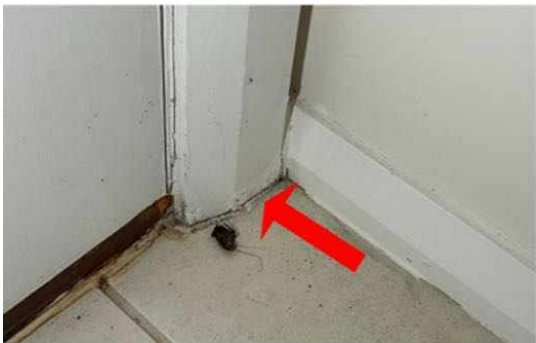
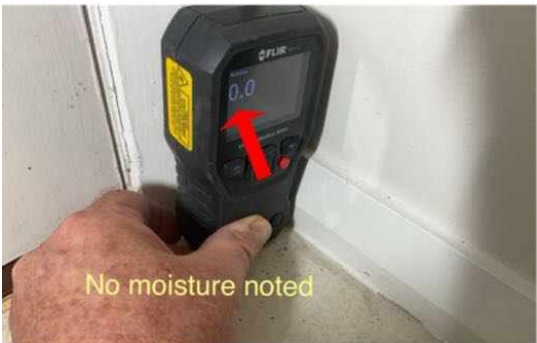
### Finding 3.08

Finding: Moisture damage to architraves and door frame in the laundry area

Information: Evidence of moisture damage was identified to the architraves and door frame in the laundry area.

It is suspected that this has occurred as a result of excess moisture from either external sources or internal spills.

At the time of inspection no current moisture was noted when checked with a moisture meter. As a result , no further damage is likely in this area.

A licenced carpenter or competent handyman should be engaged to inspect the moisture damaged areas and repair or replace any items where necessary.

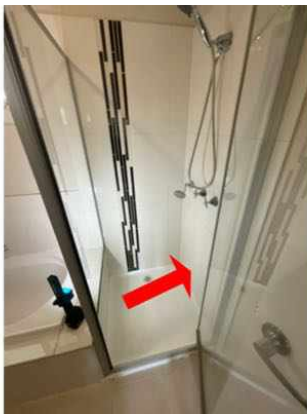
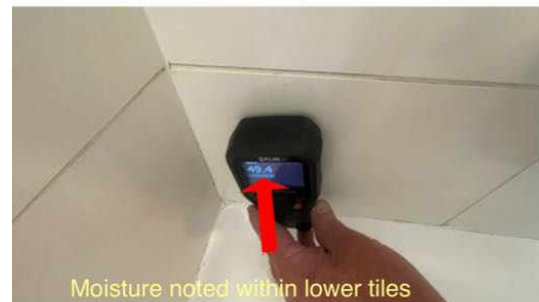
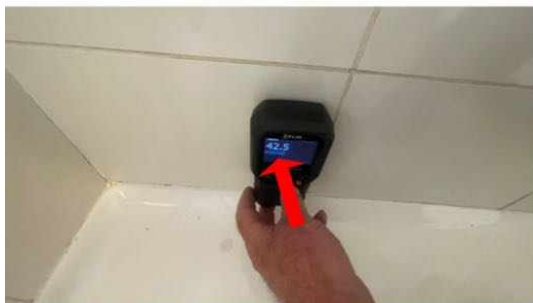
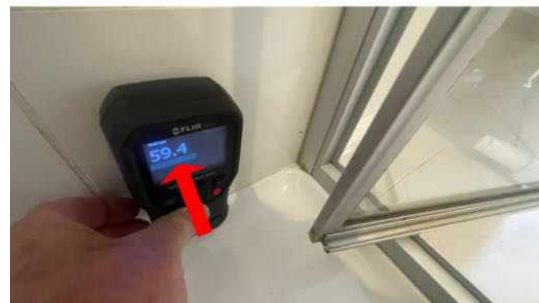
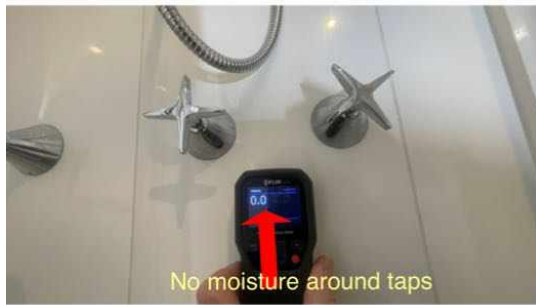
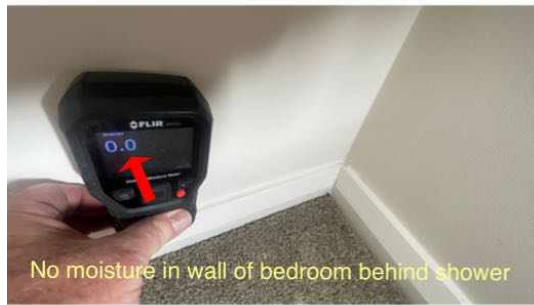
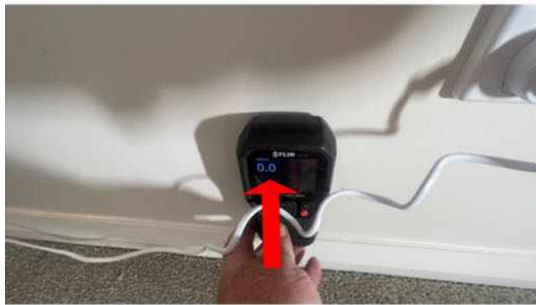
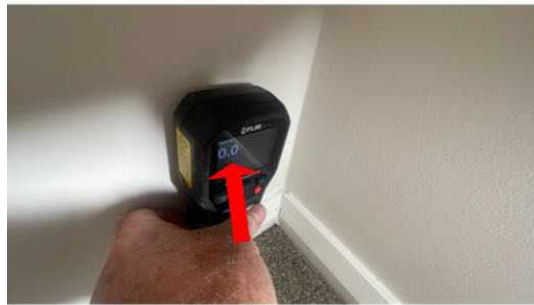
**Finding 3.09**

Building:  
Location: Bathroom  
Finding: Shower damp - Monitor  
Information: Damp is evident to the lower 400mm of wall to the shower alcove. There was no moisture noted higher up the wall nor in the wall of the bedroom directly behind the shower area.

This defect is quite common, and is suspected to have been caused by moisture permeating or leaching through the grouting and perhaps gaps in the sealant.

Monitoring the area is advised and if any visual signs of excessive moisture appear (peeling paint, mould) then consultation with a qualified plumber or bathroom specialist would be advised to identify the cause of damp and to perform remedial works as required.

Always ensure that sealant and grout is in good condition to prevent any moisture issues occurring in the future.

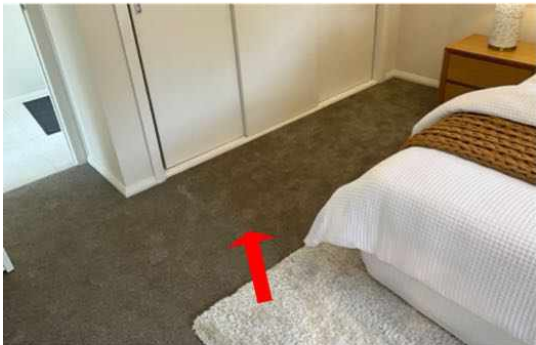
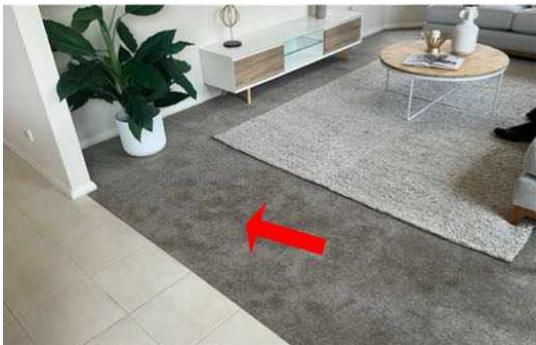
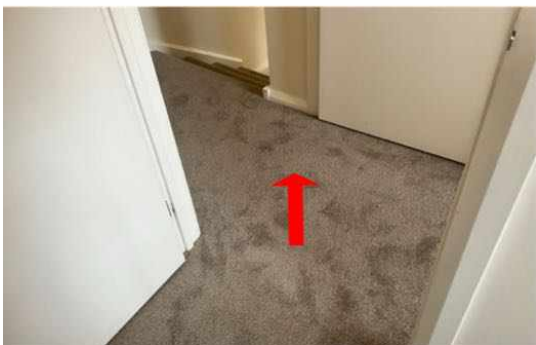
### Finding 3.10

Creaking floors generally indicate that the fixings for the flooring may be coming loose slightly.

The area should be monitored for any changes or unevenness. Should this occur, consultation with a registered builder should be undertaken to determine the cause. The potential resolution may involve regluing and screwing the floor down through to replacement of subfloor support structures.

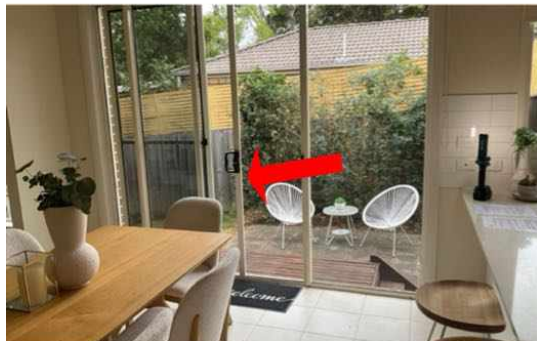
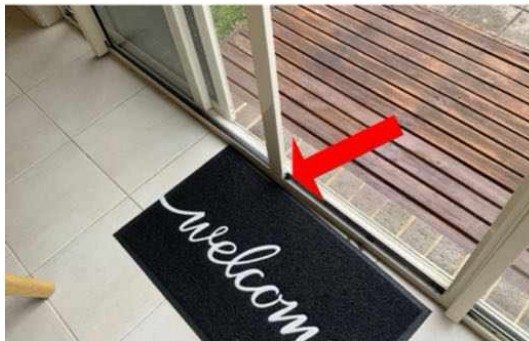
**Finding 3.11**

Building:  
 Location: Dining Room  
 Finding: Door - Stiff to slide  
 Information: The door in this area was stiff and difficult to slide along the associated tracks at the time of the inspection. The door also appeared to be slightly loose within the frame.

Restricted function of the affected door may pose as a potential safety hazard if required for emergency egress from the building.

Generally, factors such as age of the building element and a lack of maintenance are the usual causes for this type of defect.

Cleaning of the tracks may improve the operation of the door. Replacement of door hardware or tracks may be required should the cleaning not be effective.

A door specialist or competent handyman may be engaged to perform this task.

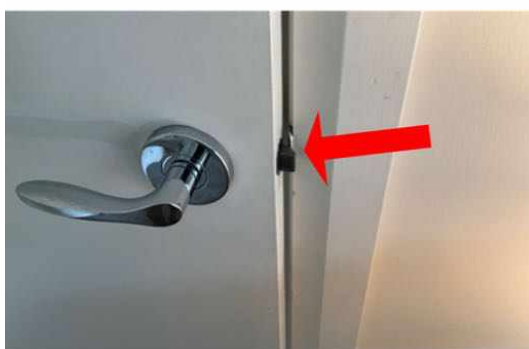
### Finding 3.12

This is a common defect and is expected in a property of this age, whether being due to substandard installation or general deterioration of the door hardware.

Readjustment of the striker plate is recommended at client discretion. Works such as these can be completed by a general handyman or qualified carpenter.

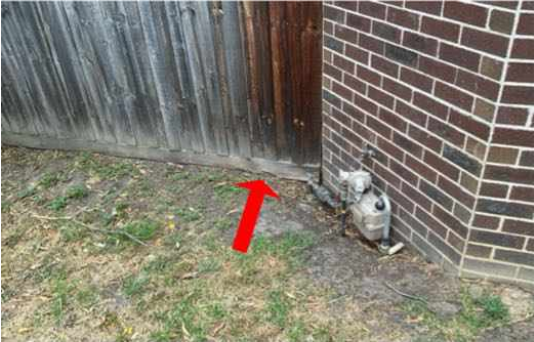
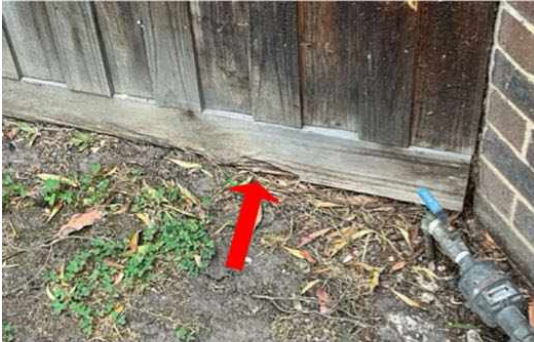
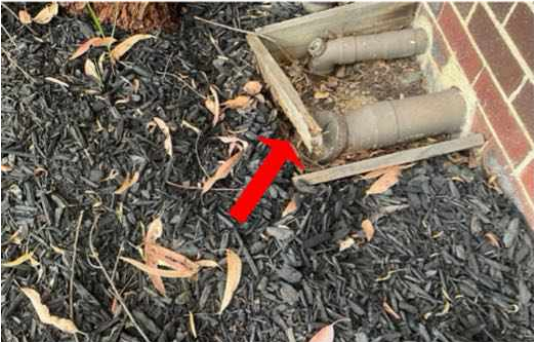
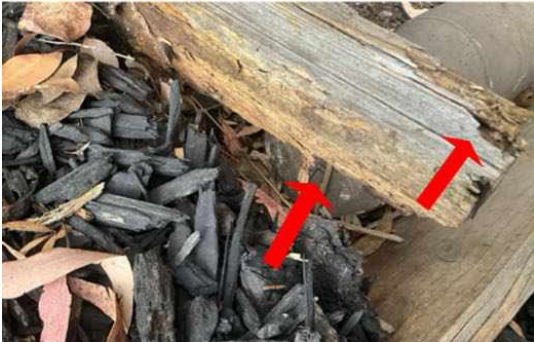
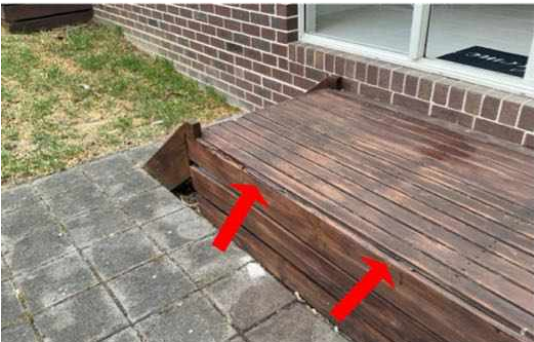
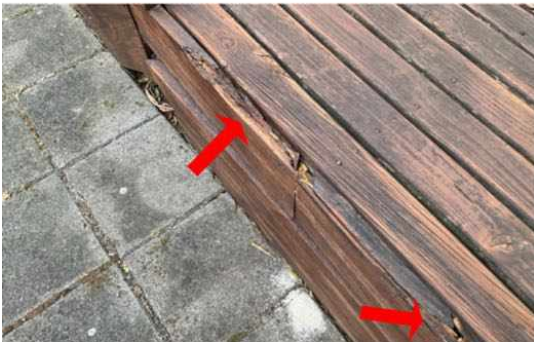
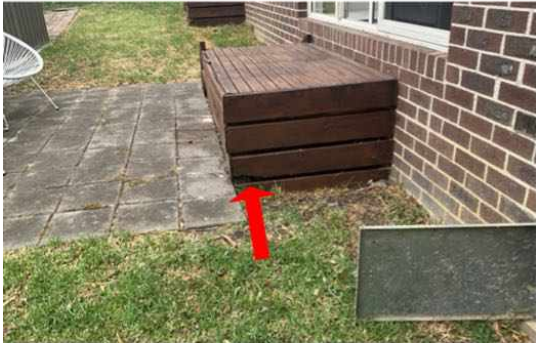
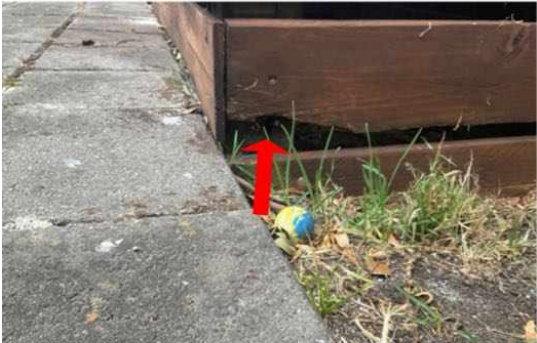
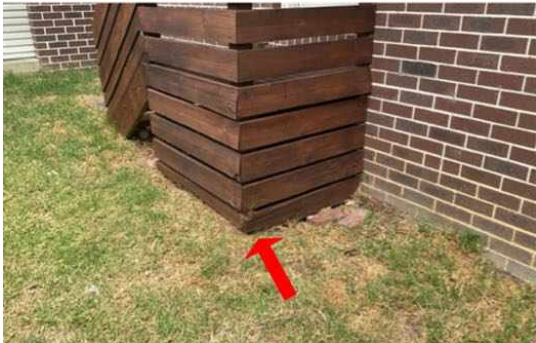
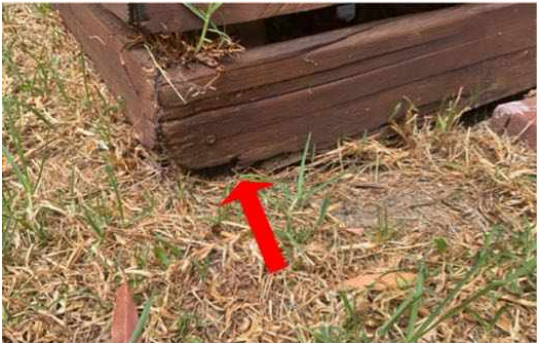
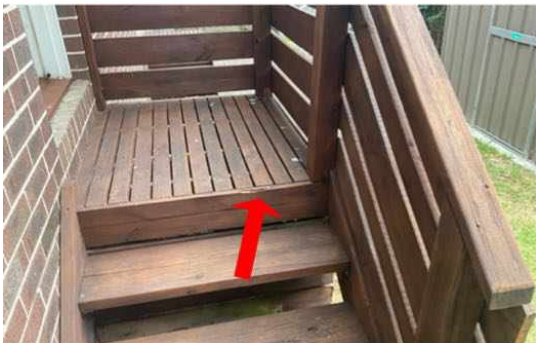
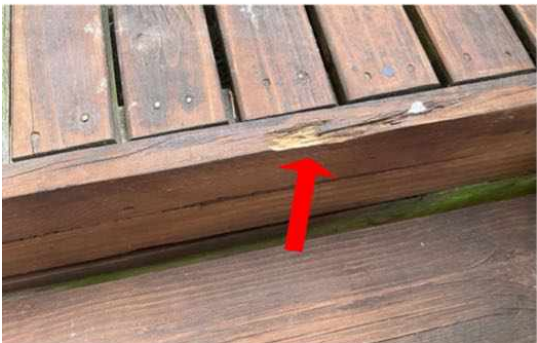
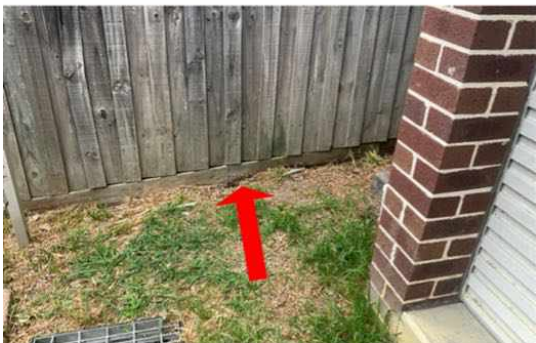
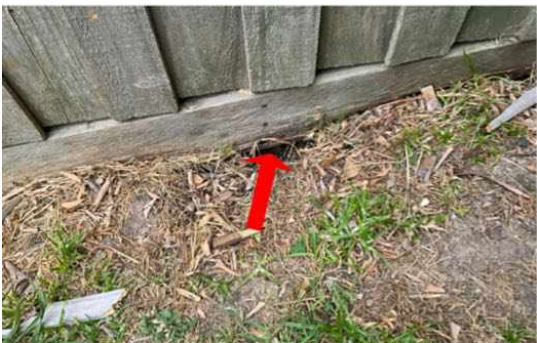
### Finding 3.14

Building:  
 Location: All External Areas  
 Finding: Wood rot - landscaping timbers  
 Information: These building elements show evidence of wood rot. Wood rot, also known as Fungal Decay, occurs when timbers and other cellulose building materials are exposed to damp conditions on an ongoing basis. This could be the result of exposure to weathering over a prolonged period of time, or the attraction of excessive moisture from other abutting building materials.

Wood rot is often associated with general damp problems and if left unmanaged,

these damp conditions can lead to further decay of timbers.

Early intervention and regular maintenance, particularly of exterior timbers, will prolong the useful life of these building elements. Repair or replacement of affected timbers may then be a necessary step in protecting surrounding building elements from such deterioration.

A landscaper may be engaged to replace affected building materials where necessary.

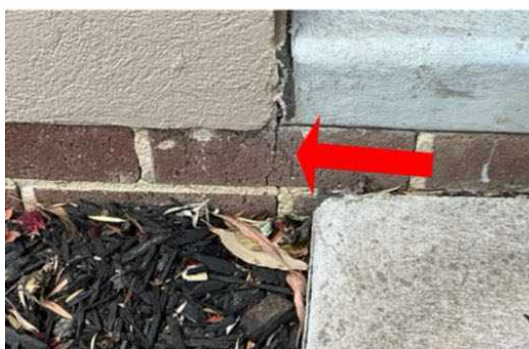
Finding 3.15

Building:  
 Location: All External Areas  
 Finding: Brickwork - Cracking [Fine]  
 Information: Although fine cracks are quite noticeable, they are often only considered to be an appearance defect and usually do not indicate any structural damage. Generally, the cause of a fine crack is indicative of a separation between brickwork and mortar throughout the structure, but single bricks may also show cracks of this nature.

Cracking of this nature can generally be repaired with minor filling and should be conducted by a qualified bricklayer.

Always contact a building inspector should cracks widen lengthen or become more numerous.

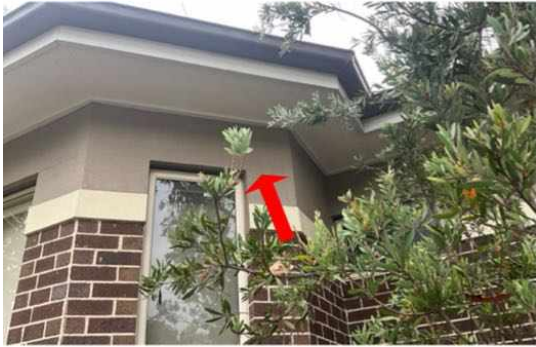
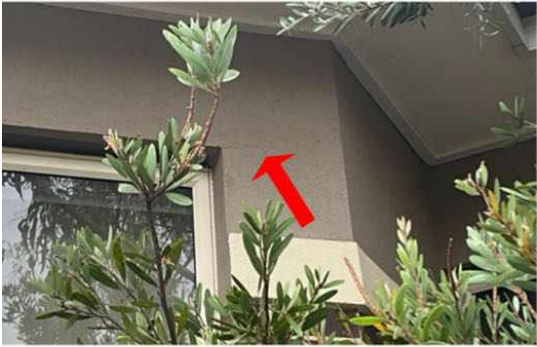
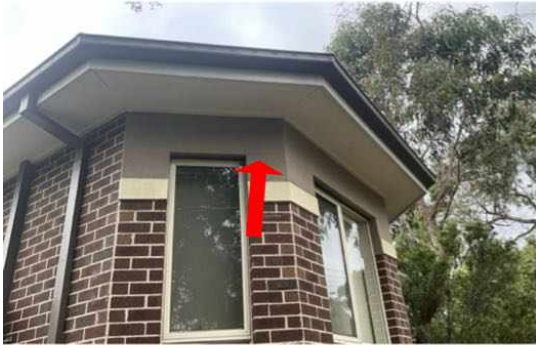
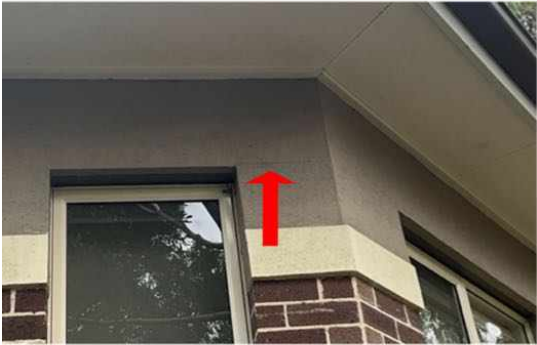
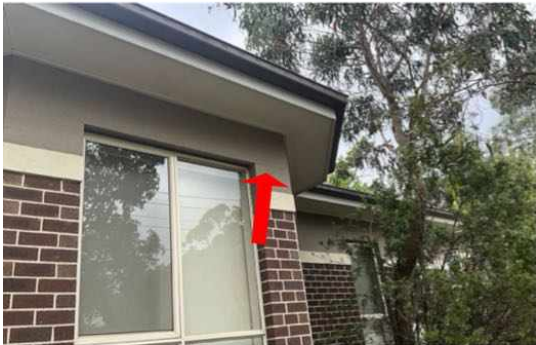
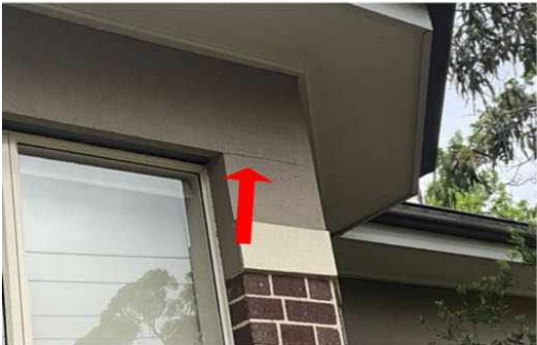
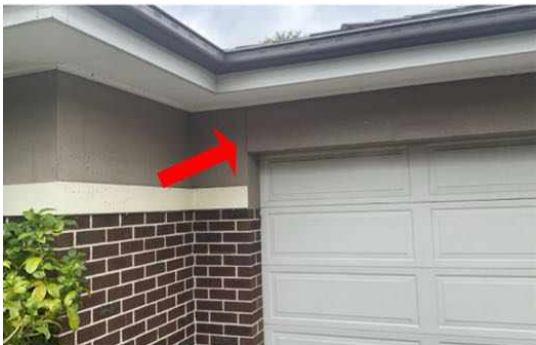
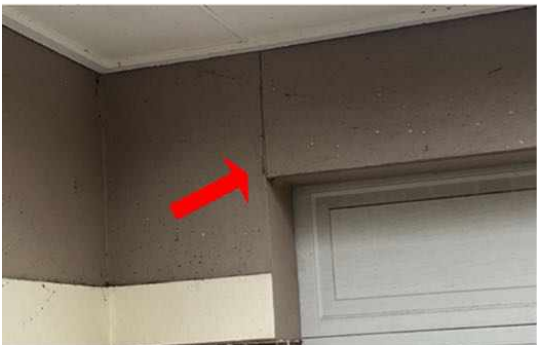
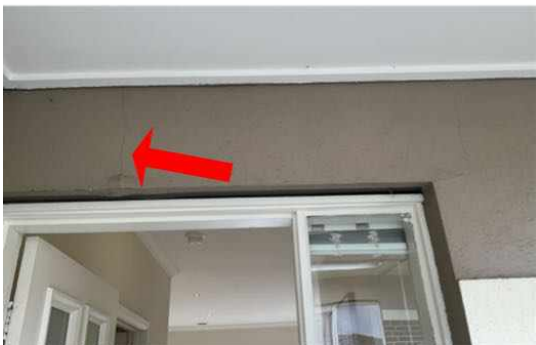
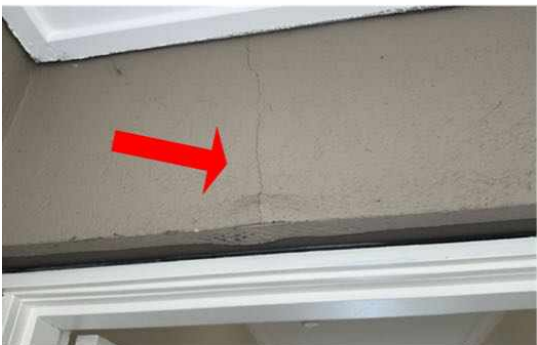
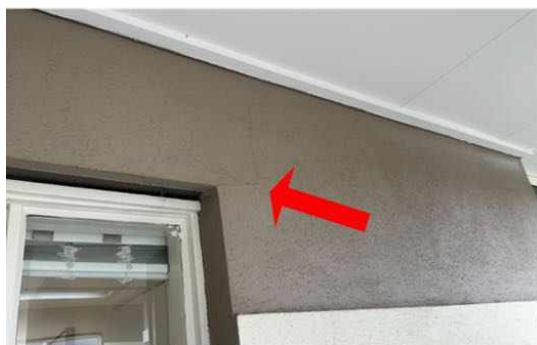
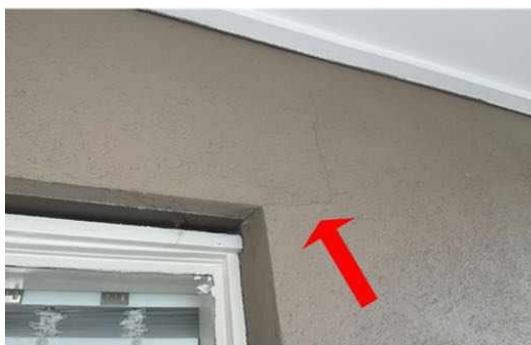
### Finding 3.16

Building:  
 Location: All External Areas  
 Finding: Rendered wall - minor but noticeable cracking  
 Information: Minor but noticeable cracking was noted to the expansion joints within the rendered wall at the time of inspection.

This type of defect is often consistent with general movement of the foundations of the property and is not considered a major structural defect.

Whilst it is more of an appearance issue, repairs may be required as failure to act may allow moisture to enter any cracks and cause secondary damage to other building elements.

Consultation with a suitably qualified renderer should be sought to determine costs involved with any repairs necessary.

The areas should be monitored for any further changes. Should cracks increase in size or number, or the joints become further exposed, speak with your building inspector for further advice.

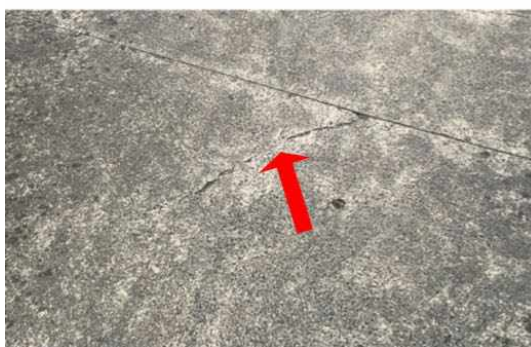
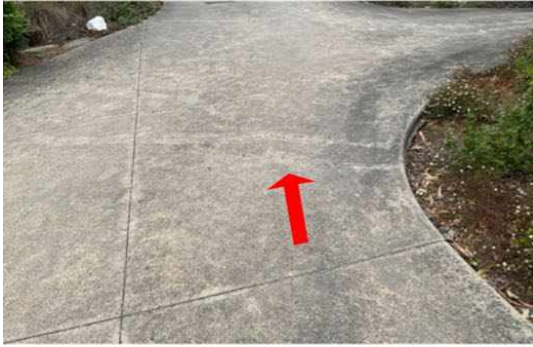
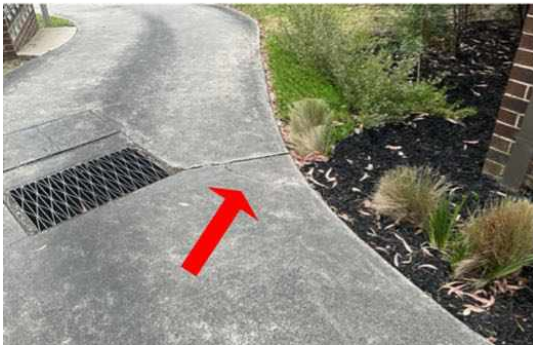
### Finding 3.17

Building:  
Location: Driveway  
Finding: Noticeable Cracking - Concrete driveway ( suspected owners corporation responsibility)  
Information: Noticeable cracks were identified in the concrete driveway.

General age and expected deterioration of the concreted areas is a common cause of this type of cracking. However, expansion and contraction of the driveway may also have occurred due to environmental factors. Such factors include variable moisture and weather conditions, the presence of trees and their roots having a settling or lifting affect on the soil, or the effect of load bearing, e.g. heavy vehicles over a sustained period of time.

Cracking to this degree may also be due to poor original installation of the driveway. Factors such as poor compaction of the sub surface and/or inadequate reinforcing of the slab may create cracking and other secondary defects. Noticeable cracks may also be due to subsidence of soils.

The area should be monitored for any changes that may occur and potentially cause tripping hazards. Should this occur, repair and likely replacement of the concrete section may be necessary.

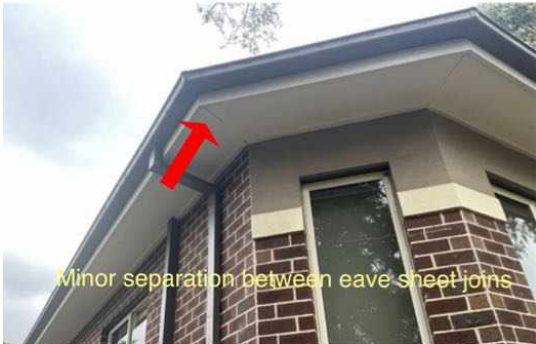
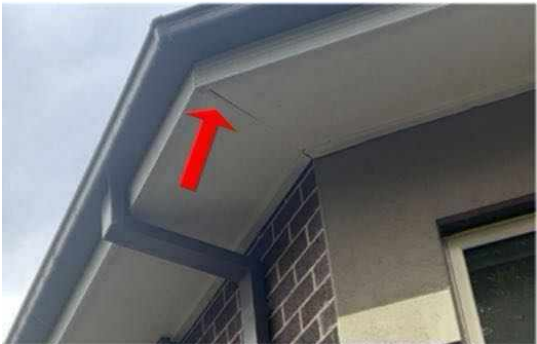
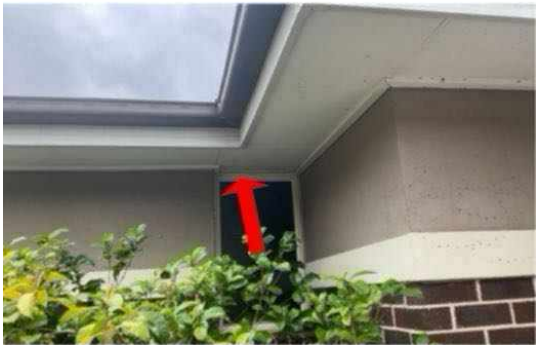
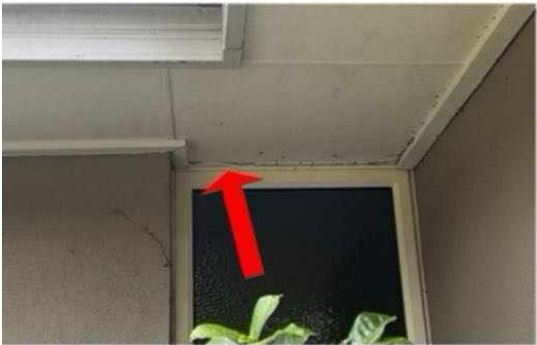
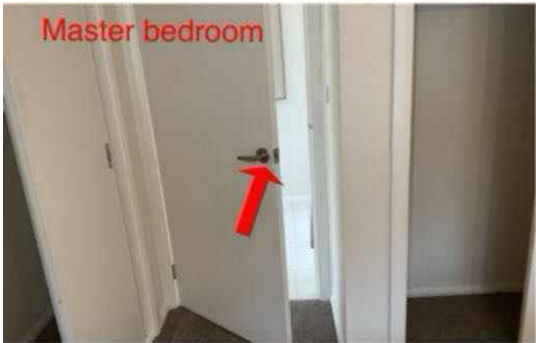
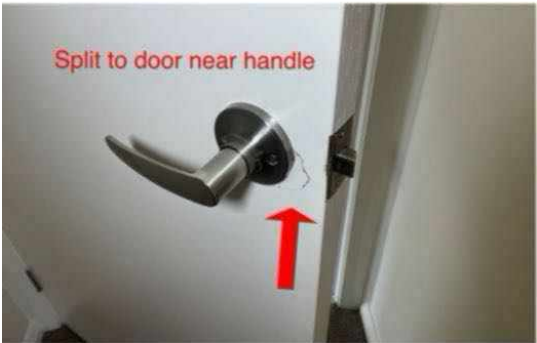
Finding 3.21

Building:  
Location: All Areas  
Finding: Additional Photos - minor defects  
Information: Additional photos are provided for your general reference. Arrows have been included where necessary to highlight areas of importance.

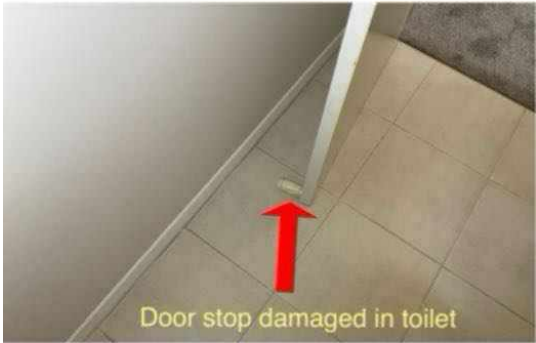
Door stop damaged in toilet

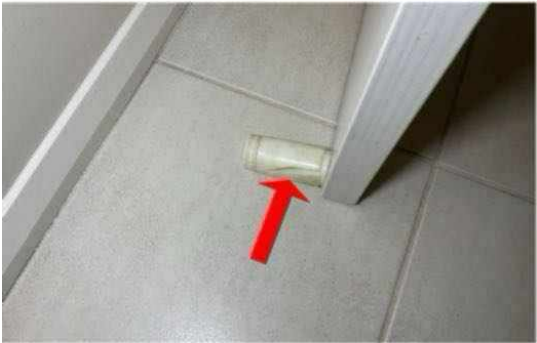
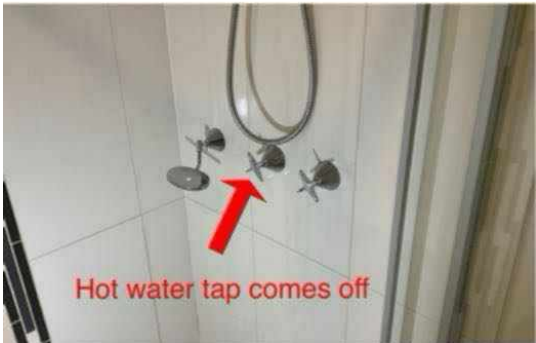
Hot water tap comes off

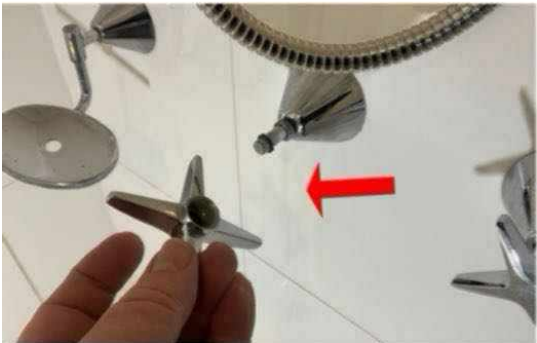
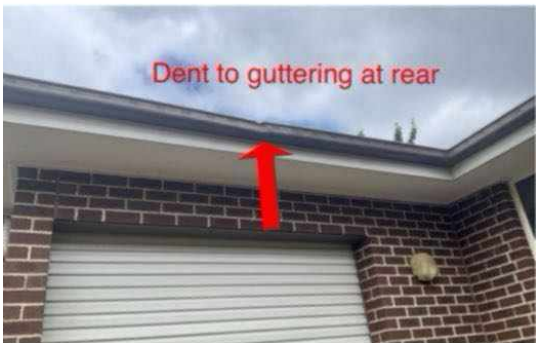
Dent to guttering at rear

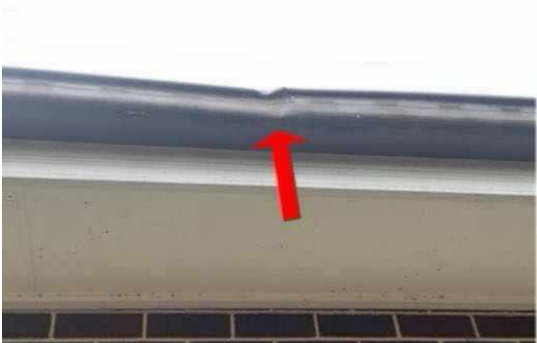
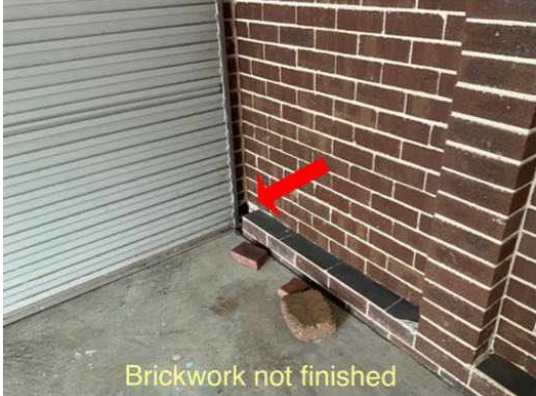
Brickwork not finished
