# Building and Timber Pest Inspection Report

Inspection Date: Wed, 21 Jan 2026

Property Address: 1/86 Lincoln Rd, Croydon VIC 3136,  
Australia

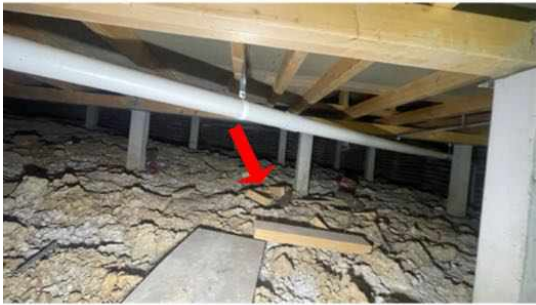
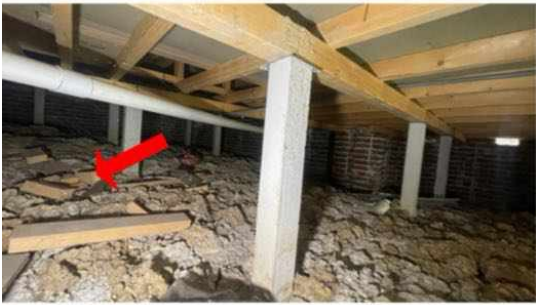
Information: An array of debris was found in the subfloor area at the time of inspection. Debris in this area restricts subfloor ventilation and creates potential for concealed pest entry. Stored timbers and other materials may also make the area susceptible to termite activity and wood rot.

A clear and empty subfloor will be better ventilated and easier to maintain in a dry condition. The removal of any timber debris is vital in minimising the risk of termite or wood borer activity.

Debris in the subfloor should be removed as soon as possible. Depending on the location and amount of debris and stored items, the homeowner may elect to undertake this task. Alternatively there are a large number of rubbish removal subcontractors that could undertake these works.

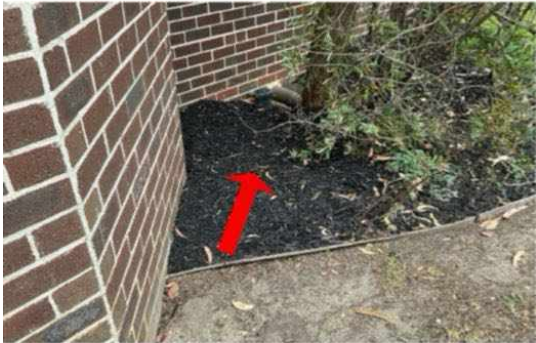
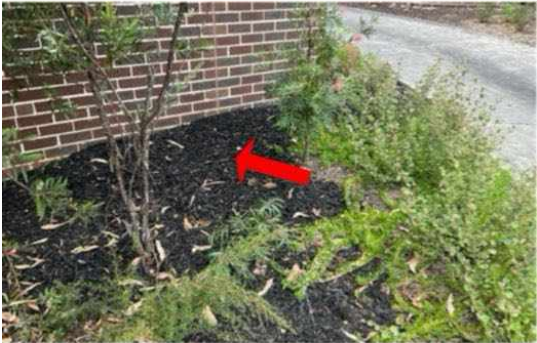
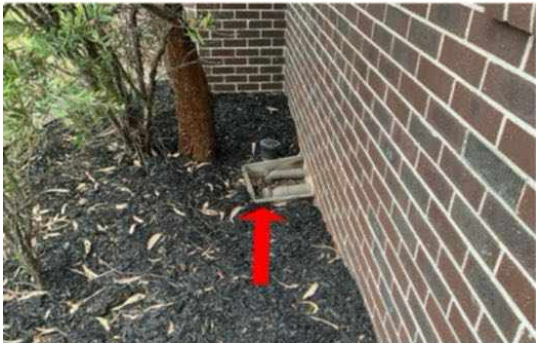
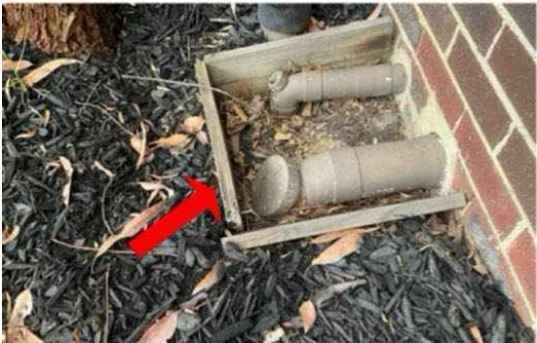
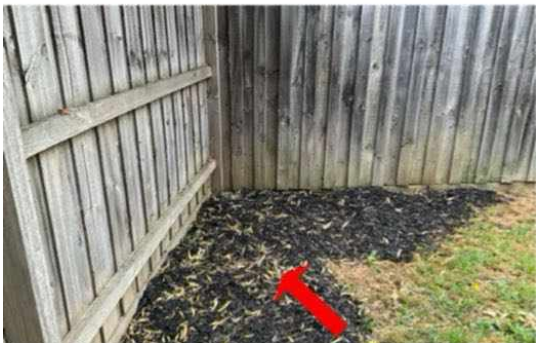
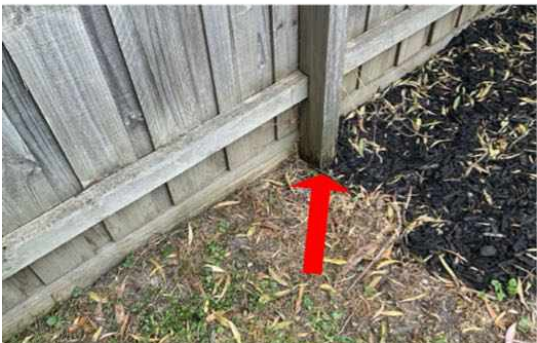
Finding 6.02

Building:	
Location:	All External Areas
Finding:	Building materials in direct ground contact - conducive to termites
Information:	Where timber elements are in direct contact with the ground and consequently moisture or dampness, they become conducive to termite activity. Whether timber is used as a building element, part of a fencing structure or stored as an unused item, they can provide an environment that is attractive to termite infestation.

When met with excessive moisture, timber begins to decay and develop wood rot. Any timbers that are in direct contact with external grounds especially if left untreated or non-durable also provide ingress for subterranean termites into that particular element.

Where possible, the removal of any such materials that may be conducive to termite activity should be carried out as soon as possible to minimise the risk of termite attack. Where not possible or practical, regular monitoring of timber elements is recommended. Replacement of any damaged materials should be carried out where necessary.

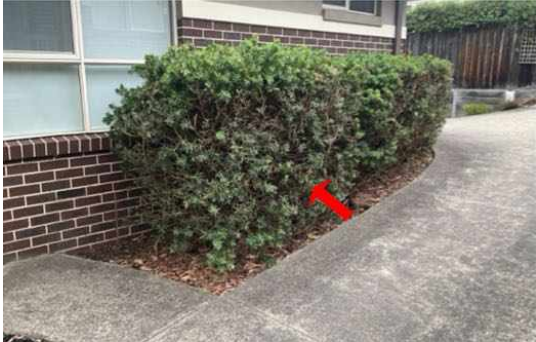
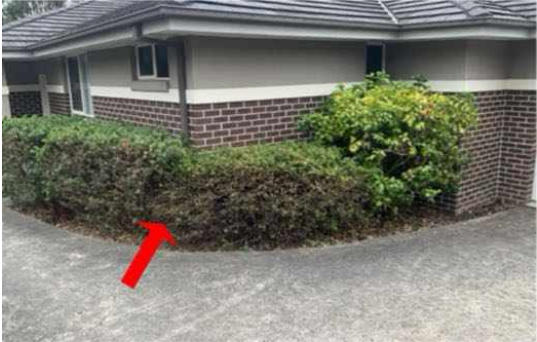
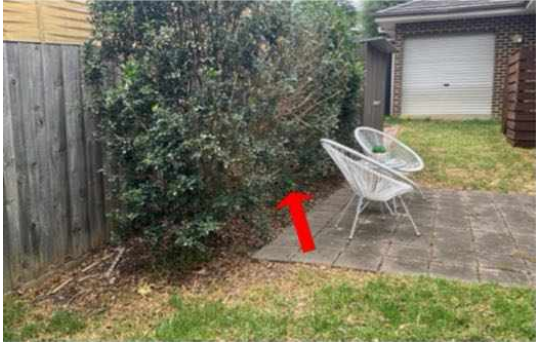
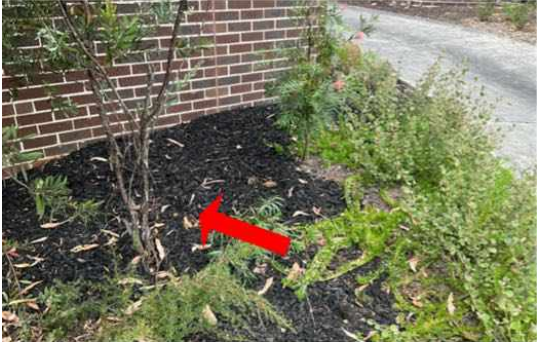
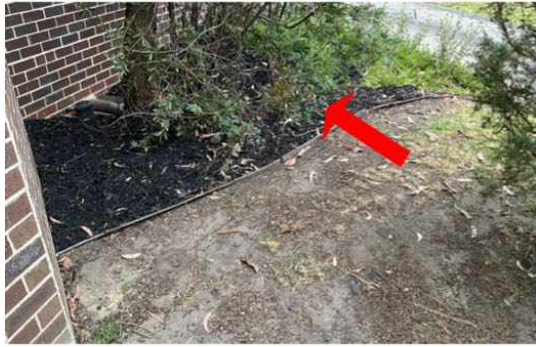
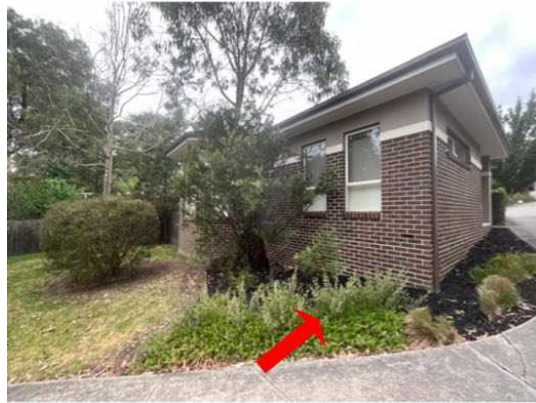
Finding 6.03

Building:  
Location: All External Areas  
Finding: Garden Beds - Conditions Conducive to Termites  
Information: Garden beds were found to be evident around and against the property. These garden beds can include untreated timber, and with a combination of moisture from rainfall and hosing, can make conditions conducive to termite activity and termite ingress.

The removal and replanting of species that do not provide "cover" or cutting back of existing vegetation will assist greatly in preventing this from occurring.

The removal of any such materials that may be conducive to termite activity should be carried out as soon as possible to minimize the risk of potential termite attack.

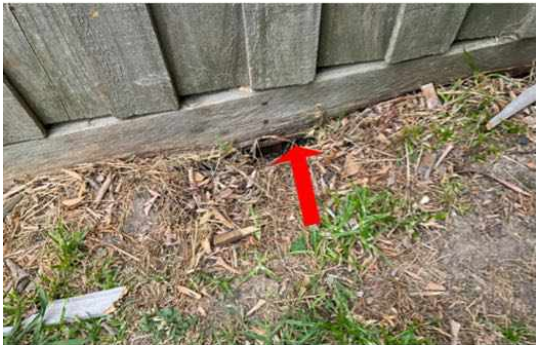
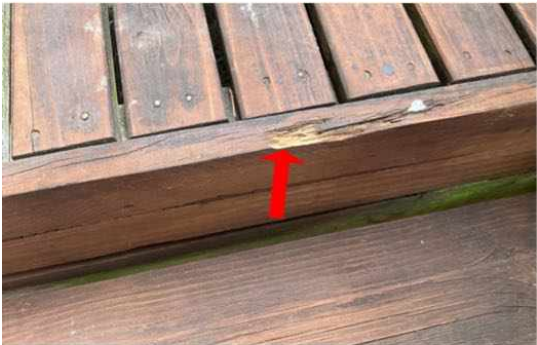
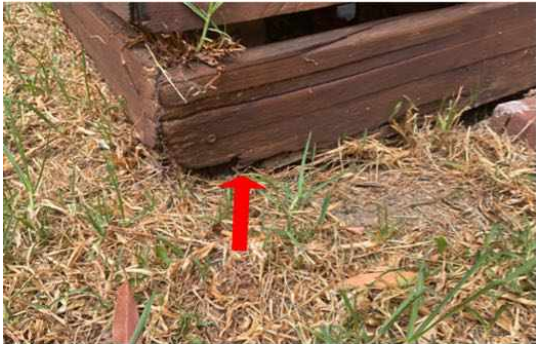
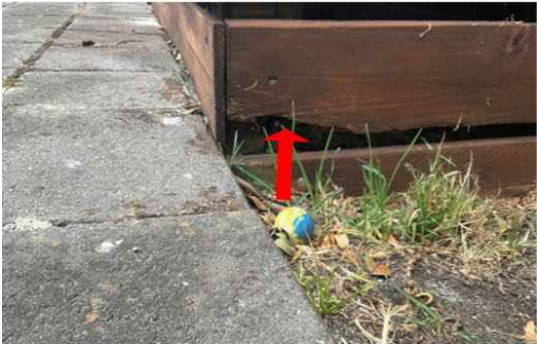
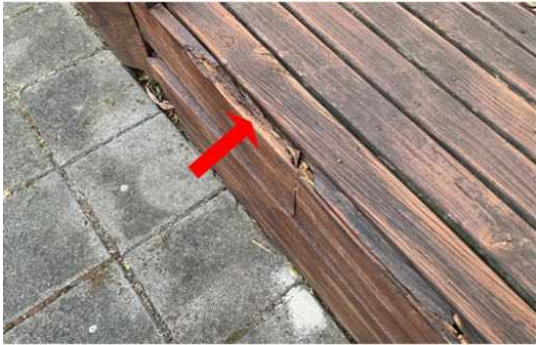
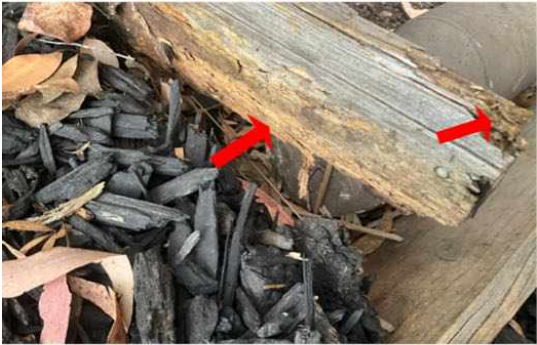
Finding: Fungal decay - conditions conducive to timber pest attack  
Information: Fungal decay also known as wood decay or wood rot generally refers to the deterioration of timber elements when in contact with excessive levels of moisture for a prolonged period of time.

Generally fungal decay develops on timber elements that are in use in an external environment which are exposed to rain penetration.

Decaying timbers can create an environment conducive to timber pest attack. It is recommended that the decaying timbers be repaired / replaced to lessen the risk of timber pests.

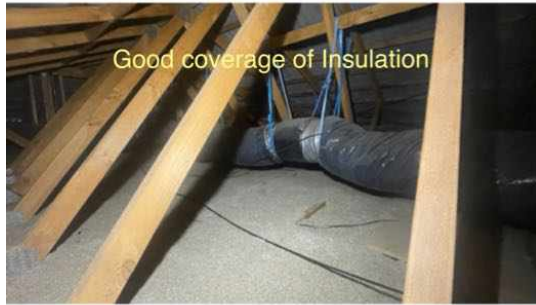
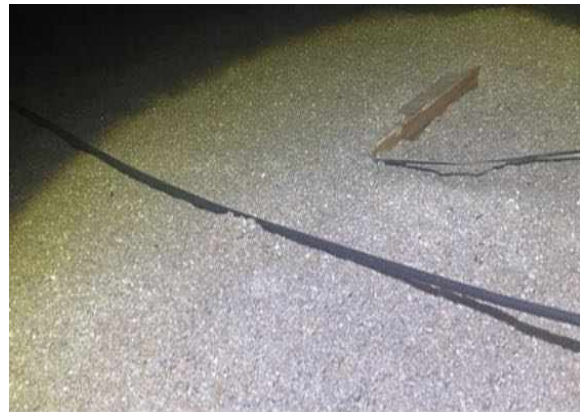
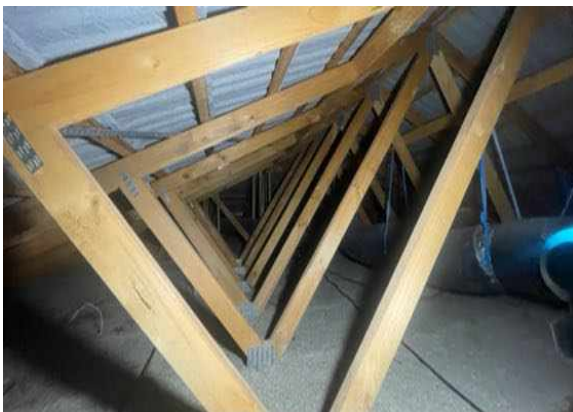
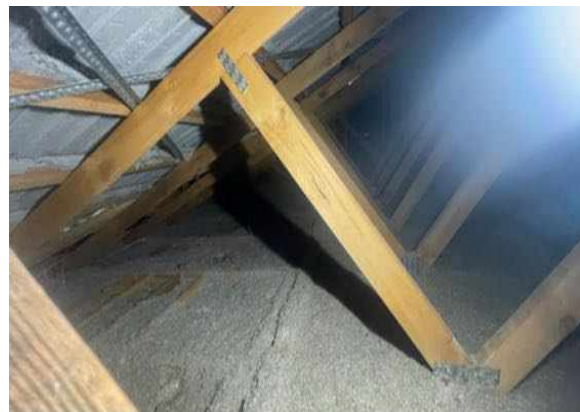
Building:  
 Location: All Areas  
 Finding: Additional Photos - for your information  
 Information: Additional photos are provided for your general reference.

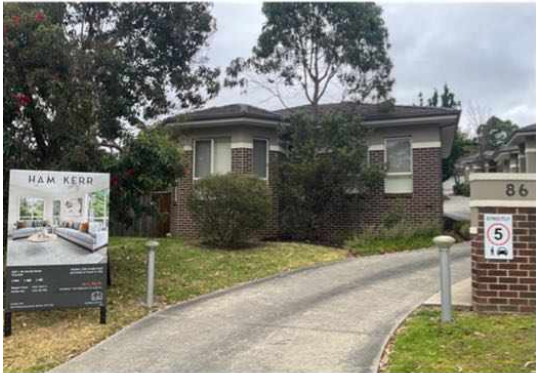
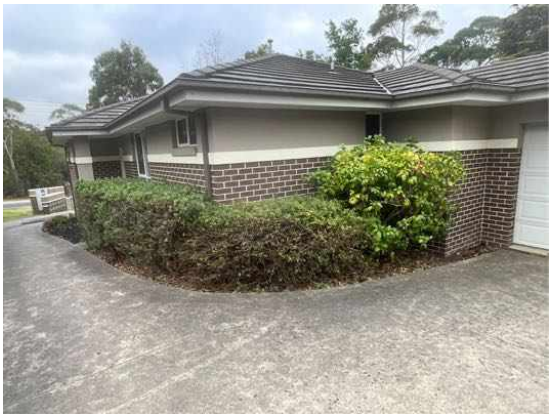
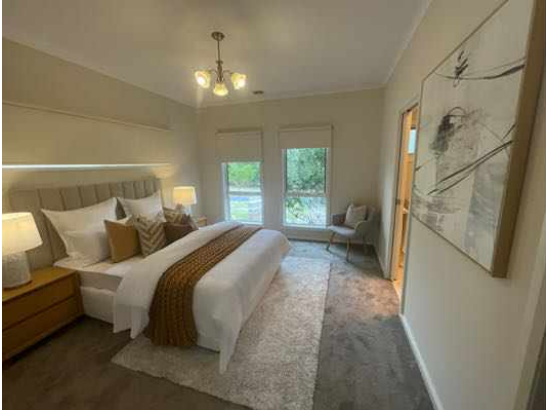
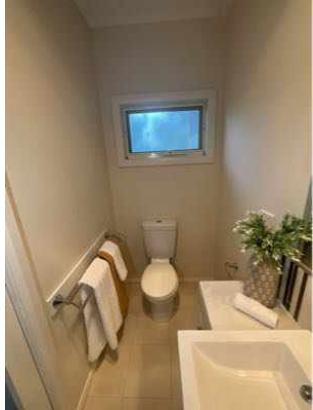
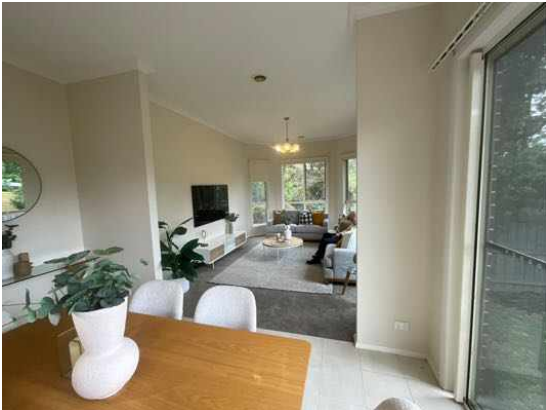
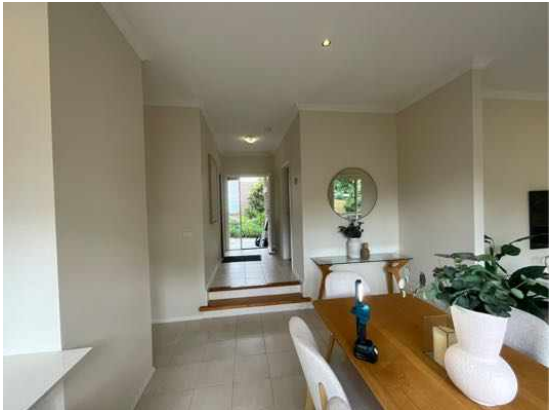
Building:  
 Location: All Areas  
 Finding: Additional Photos - Obstructions and Limitations  
 Information: These photographs are an indication of the obstructions and limitations which impeded full inspection of the property at the time of inspection. These obstructions can hide an array of defects and should be removed to allow full inspection to be carried out. A re-inspection is recommended once the areas are made accessible.
