## Building Inspection Report

Inspection Date: Thu, 26 Feb 2026

Property Address: 18/22 Cohen Ct, Clovelly Park SA 5042,  
Australia

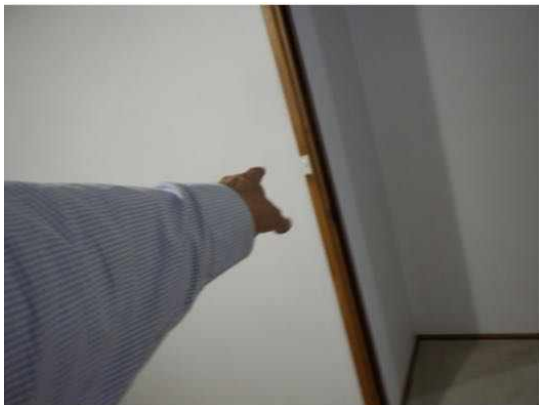
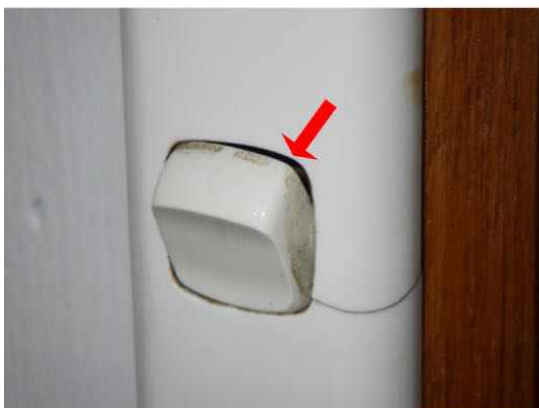
#### Defects 1.01

Building:	Building 1
Location:	All Internal Areas
Finding:	Electrical fitting - Broken
Information:	The electrical fitting in this bedroom -3 area was found to be broken at the time of inspection. Breakage occurs generally when the building materials have aged and decayed, but may also be indicative of impact damage to the building element (accidental or deliberate).

Left unmanaged, the fitting is unlikely to cause further damage to surrounding building elements. However, the broken fitting does expose electrical works, and may create a safety hazard if there is potential contact with persons in the area.

Repair and/or replacement of the broken fitting is advised. A Licensed electrician should be appointed to repair/replace the fitting immediately.

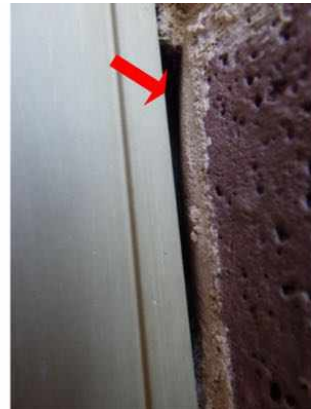
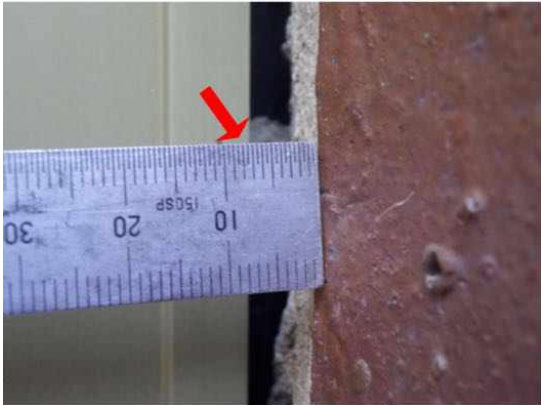
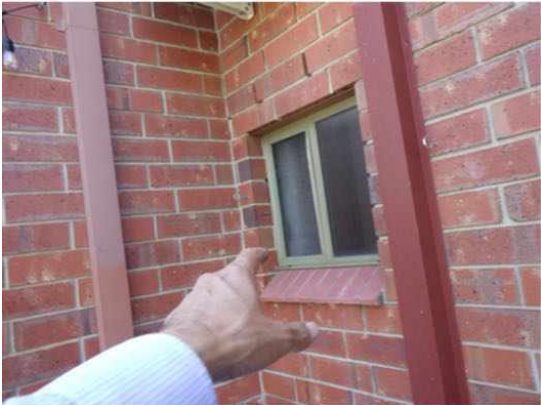
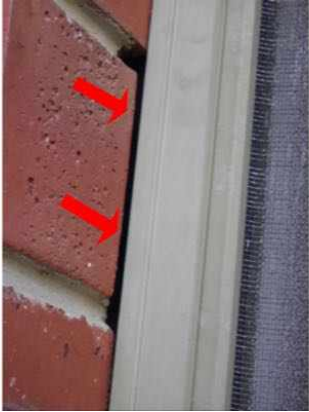
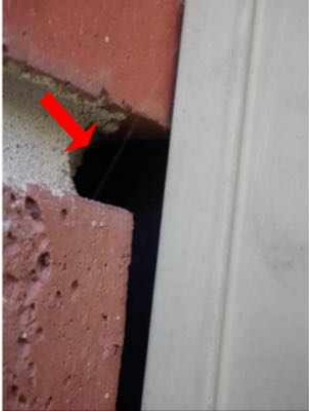
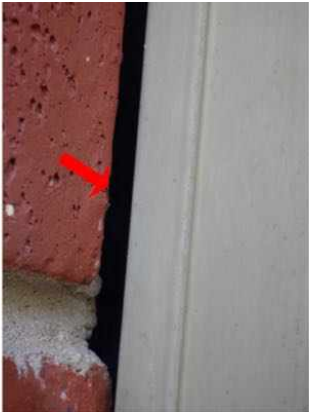
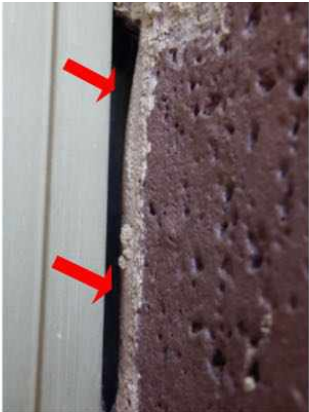
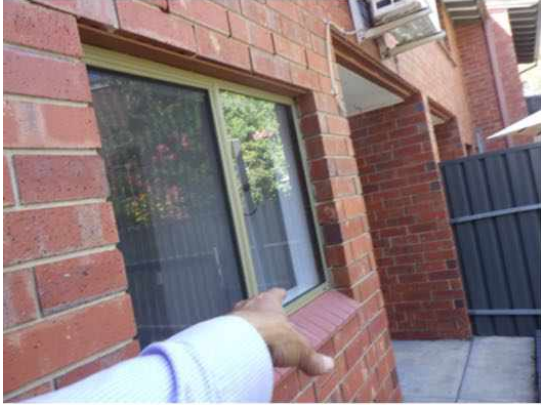
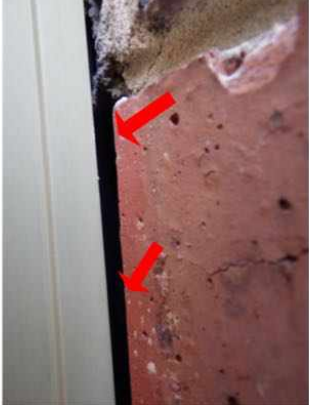
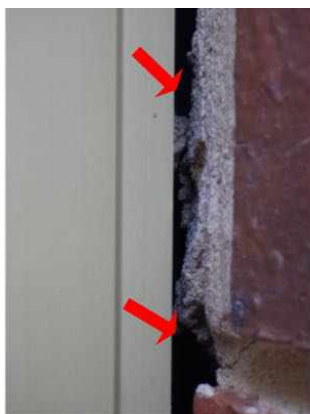
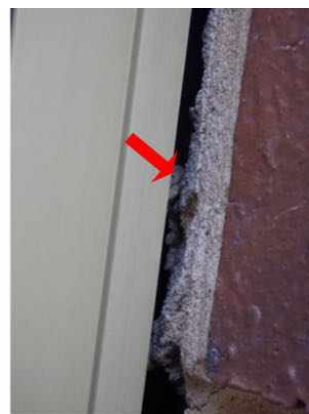
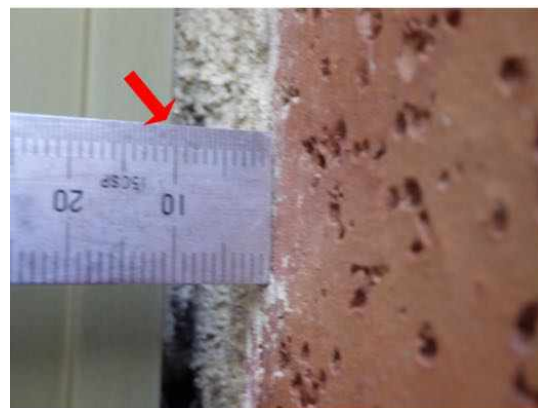
## Defects 2.01

Breakage occurs generally when the building materials have either aged and decayed, or as a result of damage (accidental or deliberate).

Repair and/or replacement of broken elements is advised to ensure that additional secondary defects do not arise as a consequence. Such works are necessary, as all building elements play a key role in the operation and function of the overall structure and its performance.

A relevant tradesperson should be appointed as soon as possible to repair or replace the affected building element prior to any subsequent damage being caused.

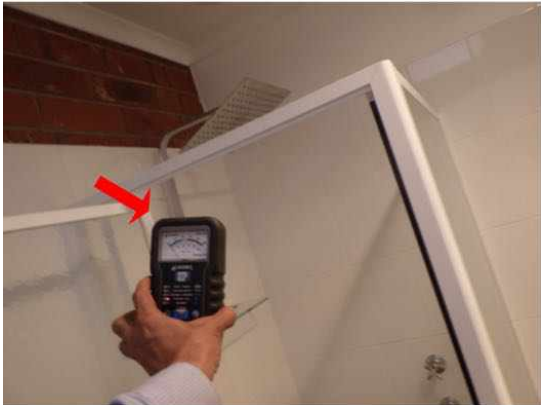
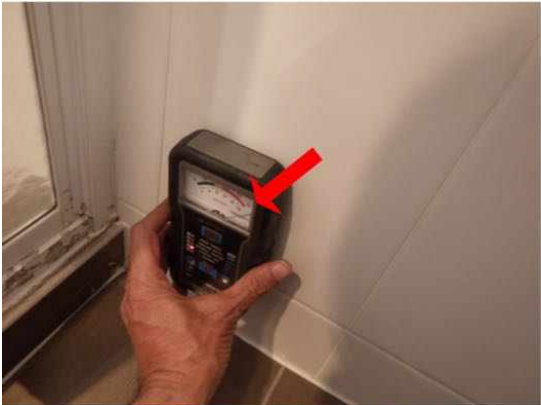
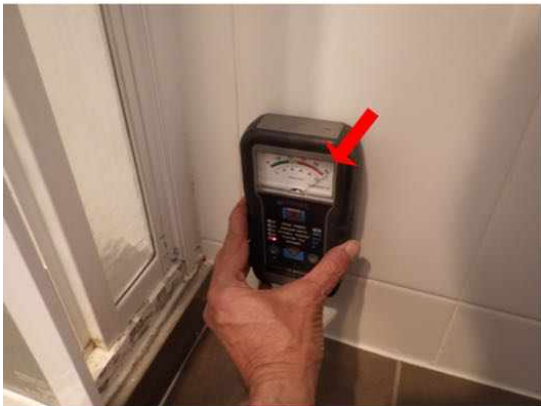
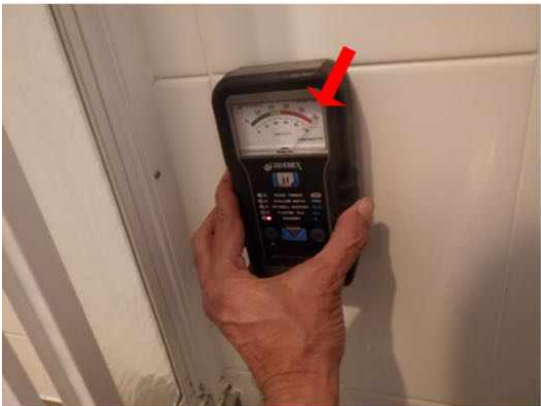
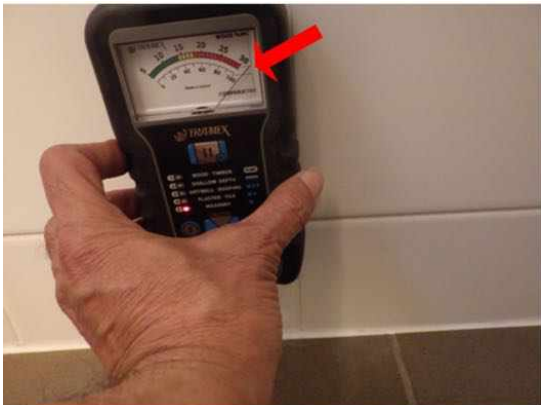
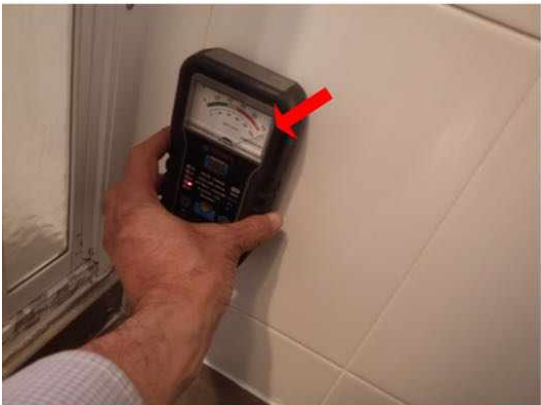
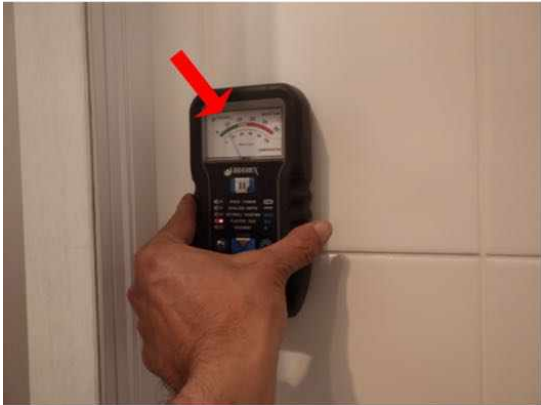
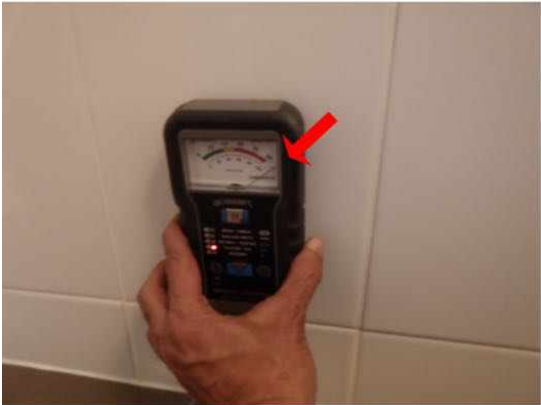
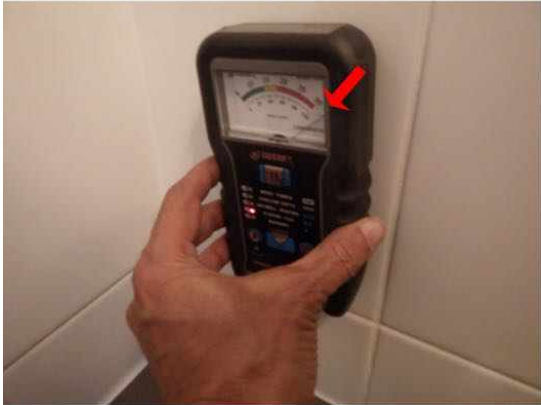
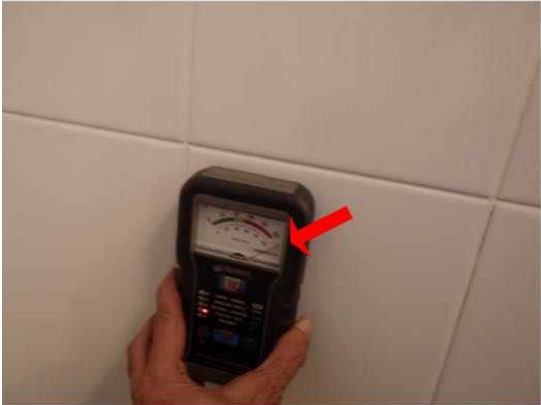
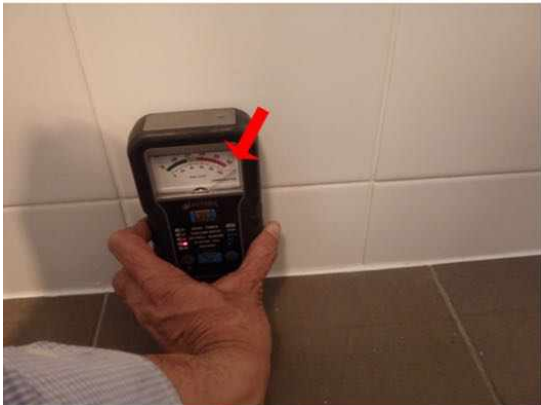
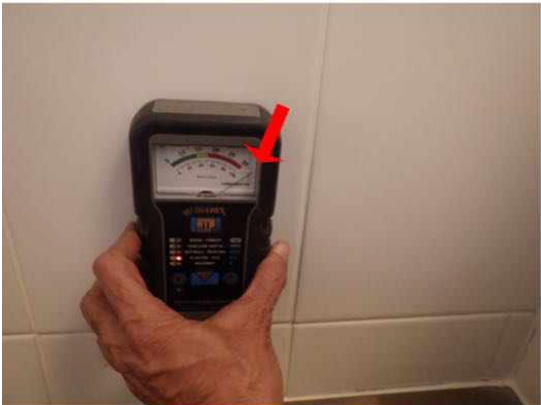
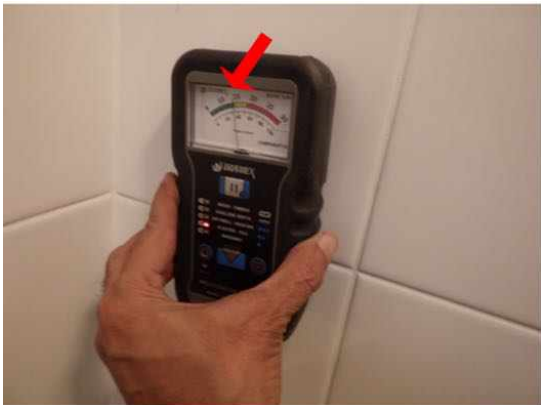
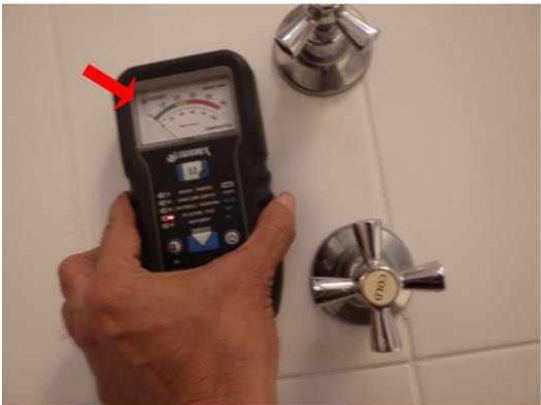
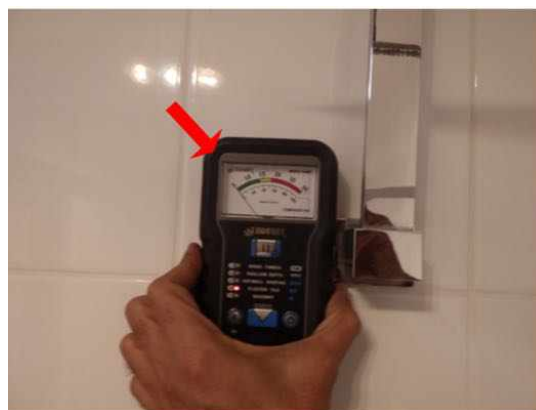
## Defects 2.02

Building:	Building 1
Location:	Bathroom
Finding:	Shower Alcove - Damp
Information:	Damp is evident to the lower 400mm approximately of wall to the shower alcove. This defect is quite common, and is suspected to have been caused by moisture permeating through the grouting in this area, which shows evidence of deterioration. Leaking pipes within the adjoining wall is also a possible cause.

Damp (or structural damp) refers to the presence of unwanted moisture in the structure of a building, either as the result of intrusion from outside, or condensation from within the structure. In the shower area, internal water leaks or other sources of excessive moisture are generally the cause of damp.

Unmanaged damp in the shower recess is likely to facilitate the formation and development of mould and fungi growth, decaying associated building materials and compromising their structural integrity. Exposure to these contaminants is associated with a wide range of respiratory and other health-related problems.

Consultation with a qualified plumber or bathroom specialist is advised immediately to identify the cause of damp and to perform remedial works as required. Where excessive mould growth is present, further inspection by a specialist environmental health inspector should also be considered.

Always ensure that sealant and grout is in good condition to prevent any moisture issues occurring in the future.

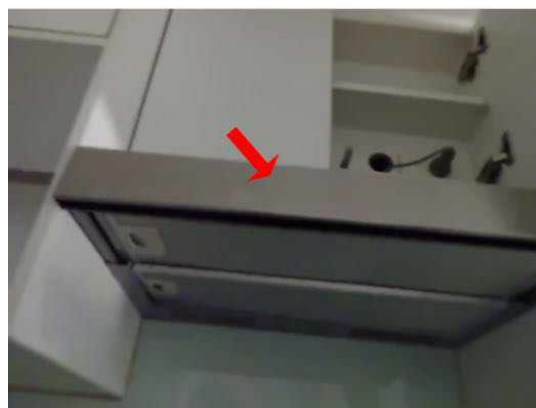
### Defects 2.03

Building:	Building 1
Location:	Kitchen
Finding:	Range hood assembly - Not operating
Information:	At the time of inspection it was noticed that range hood assembly is not operational in this kitchen area.

Non-operational items should be addressed to ensure that the full function of the building structure is available. Where some building elements are not operating as intended, it is possible that secondary building defects could arise due to their non-operation.

Repair and/or replacement of the faulty building element is recommended. It is highly recommended that the relevant tradesperson be engaged to as soon as possible perform any necessary works.

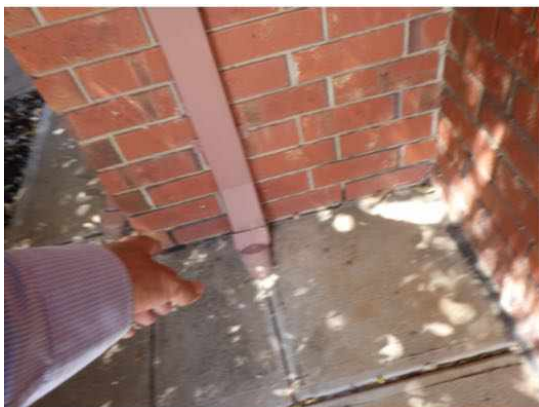
### Defects 3.01

Blocked gutters are likely to lead to high levels of moisture in the affected areas. Such moisture will not only cause rust and decay of the associated building materials, but can also provide conditions that are conducive to termite and timber pest activity. Blockages in gutters should therefore be removed immediately to ensure dry conditions are maintained.

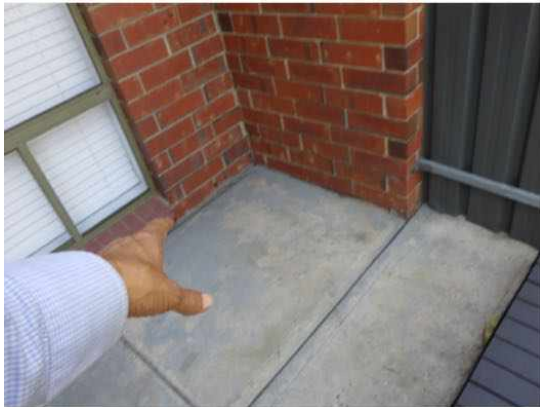
### Defects 3.02

If the slab edge is not properly exposed there is a high risk of termite attack. Sometimes, in order to determine the type of slab, a suitably qualified person such as an architect or builder may be required to consult the construction plans.

Where the slab edge cannot be properly inspected, it is highly recommended that termite or timber pest inspections be carried out every 6-12 months to aid protection of the property against infestation.

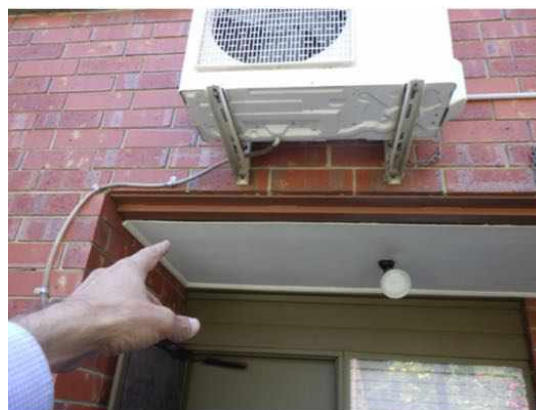
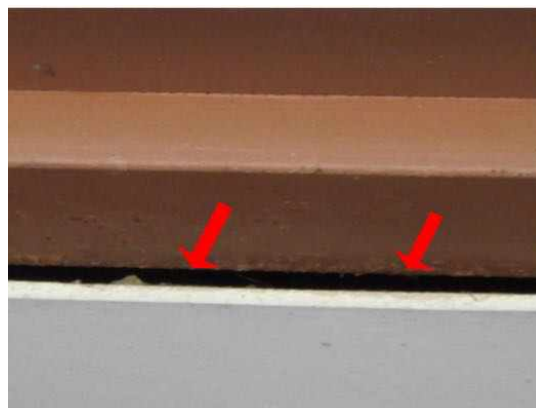
### Defects 3.03

Building:	Building 1
Location:	All External Areas
Finding:	Building element - Damaged/ Loose from its original fixing
Information:	At the time of inspection it was noticed that ceiling in this rear area is loose from its original fixing.

Breakage occurs generally when the building materials have either aged and decayed, or as a result of damage (accidental or deliberate).

Repair and/or replacement of broken elements is advised to ensure that additional secondary defects do not arise as a consequence. Such works are necessary, as all building elements play a key role in the operation and function of the overall structure and its performance.

A relevant tradesperson should be appointed to repair or replace the affected building element prior to any subsequent damage being caused.

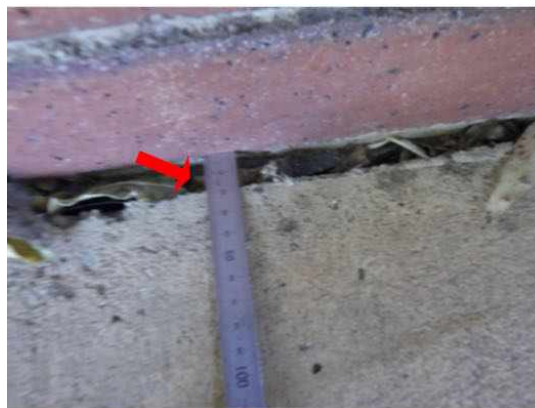
### Defects 3.04

Building:	Building 1
Location:	All External Areas
Finding:	Gaps in perimeter pavement
Information:	Gaps in the external concrete paving were identified at the time of inspection. Gaps in the slab are significant and are likely to lead to the development of secondary defects if left unmanaged, such as the creation of a trip hazard and water entry points.

With reactive clay soils, it is extremely important to ensure that all stormwater flows including roof and ground flows, contained and continually maintained. High moisture also creates an environment that is conducive to termite attack.

A licensed Plumber should be appointed immediately to ensure that the stormwater pipework is intact and adequate, and all gaps to concrete, driveways and paths should be sealed by a licensed builder or a general handy person to keep moisture from entering.

A licensed concretor may be required to replace pavements that are beyond repair.

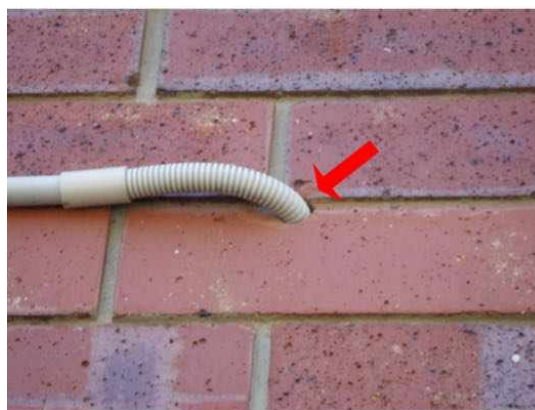
### Defects 3.05

Building:	Building 1
Location:	All External Areas
Finding:	External walls - Holes
Information:	Significant holes were identified around pipe penetrations in this wall section. It is suspected that the installation of this pipework was completed to a substandard level of workmanship or is incomplete.

Gaps and holes around pipework makes the area susceptible to insect and vermin ingress, as well as allowing water penetration to the cavity wall. As such, associated building elements are likely to deteriorate at an accelerated rate, and major implications are expected if holes around the pipework are left unmanaged.

All excessive holes, gaps or cracks should be adequately filled by a suitable sealant or trimmings as soon as possible to prevent any further damage. Such works may be conducted by a general handyperson or licensed plumber.

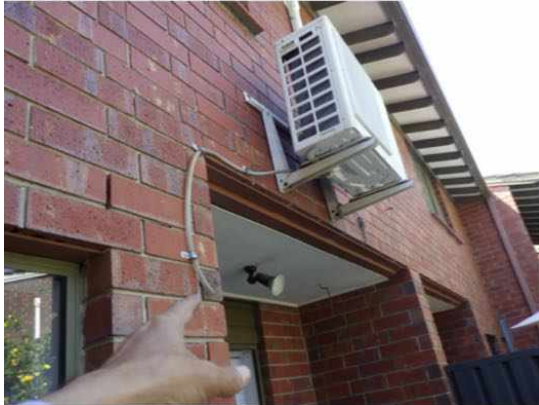
### Defects 3.06

Building:	Building 1
Location:	All External Areas
Finding:	Air conditioner - Disconnected overflow
Information:	The Air Conditioner (A/C) overflow was found to be disconnected from storm water drainage and is creating excessive moisture in the surrounding area.

Such leaking creates an environment which is conducive to an array of defects, including water damage to associated building elements and the attraction of termite or timber pest infestation.

It is highly recommended that a licensed plumber be appointed to connect the A/C overflow in order to prevent such an environment from being created. These minor works should be carried out as soon as possible.

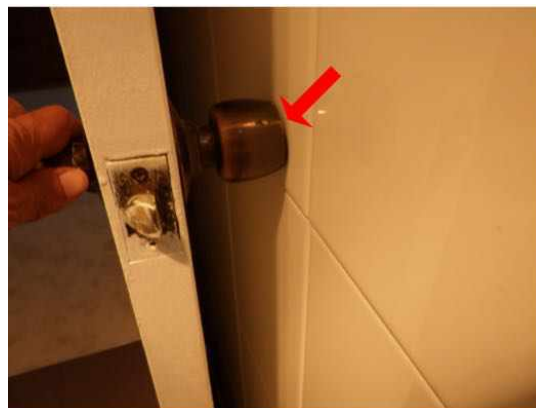
### Defects 3.07

Building:	Building 1
Location:	Bathroom
Finding:	Door stop - Missing
Information:	The door stop is missing or is inadequate to stop the door handle from damaging the wall. Although some building elements may seem irrelevant or unnecessary, all building elements play a key role in the operation and function of the overall structure and its performance.

Re-installation or replacement of the door stop is advised as soon as possible to prevent any subsequent damage to the door or associated structures. A general handyman may be appointed to perform these works at client discretion.

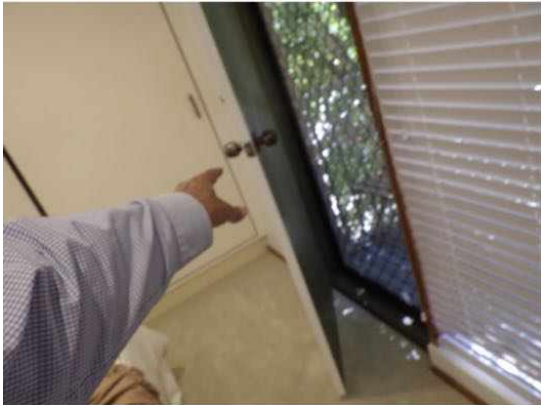
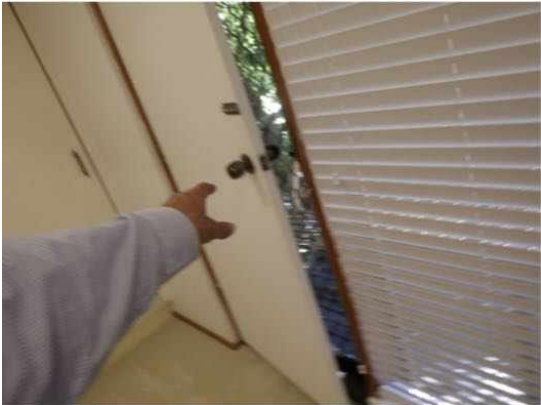
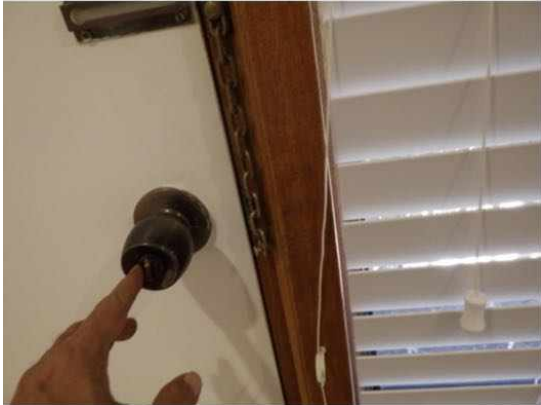
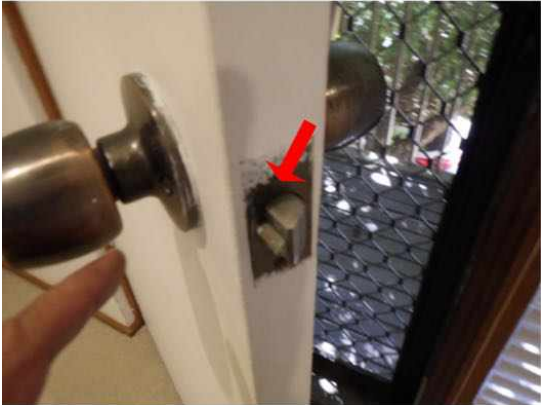
### Defects 3.08

Building:	Building 1
Location:	All Internal Areas
Finding:	Door handle - Not latching
Information:	It was noted that the door in this area was not latching during operation at the time of inspection. Whilst detracting from the functionality of this building element, this minor defect may also be a security risk, and may therefore have serious implications if left unattended.

It is suspected that this defect has occurred due to minor issues with the associated hinges. Such damage is identified as general wear and tear, which is expected for building elements of this age.

A qualified carpenter or general handyperson may be appointed to perform rectification works as necessary, at client discretion. If left unattended, further functional impairment is likely to occur.

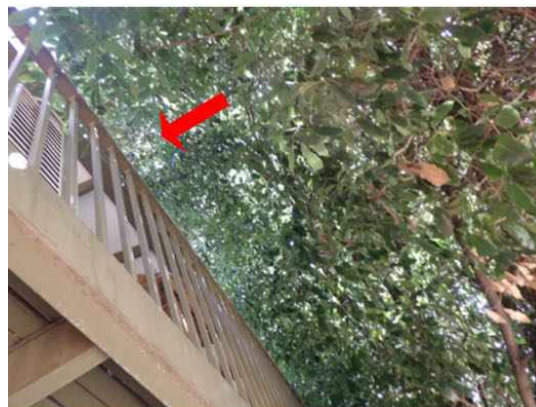
#### Noted Item

Gutters are a critical part of the building's management of storm water and rain. It is therefore important that they be kept clear to prevent secondary damage to associated building elements, including exterior and interior walls, ceiling linings and

any adjoining building elements. Where gutters are blocked, pooling of rainwater is likely to occur, fast-tracking rust and corrosion of the roof plumbing elements.

It is highly advised that all overhanging tree branches be removed as soon as possible to prevent any further damage. Repair and/or replacement of sections of damaged guttering may also be required where the extent of the damage necessitates.

Such works should be performed by the homeowner; however, appointment of a landscape contractor or an arborist may be required. Consultation with a licensed roof plumber is required where guttering has been damaged.

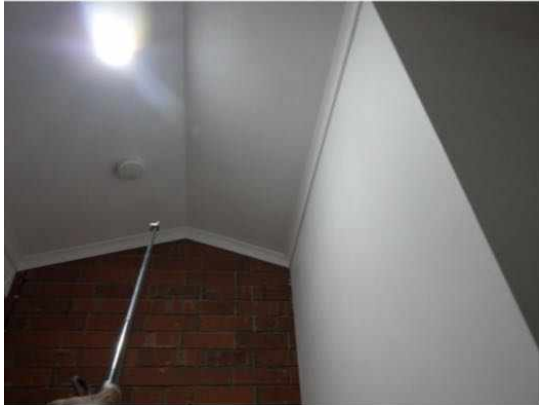
### Noted Item

Building:	Building 1
Location:	All Internal Areas
Finding:	Roof Space – No Access
Information:	At the time of inspection, access to the roof space was not available, and therefore this area could not be inspected. The lack of access appears to be due to the design and construction of the property.

As a result, the condition of the roof structure, insulation, services, and any concealed defects within the roof space could not be assessed.

For further clarification regarding roof space access provisions, approvals, or any associated documentation, it is recommended that you consult your real estate agent or the relevant parties.

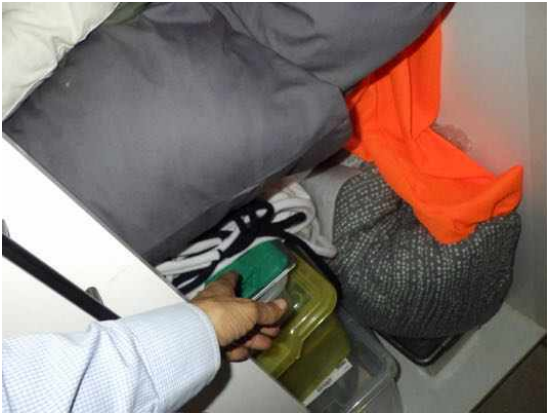
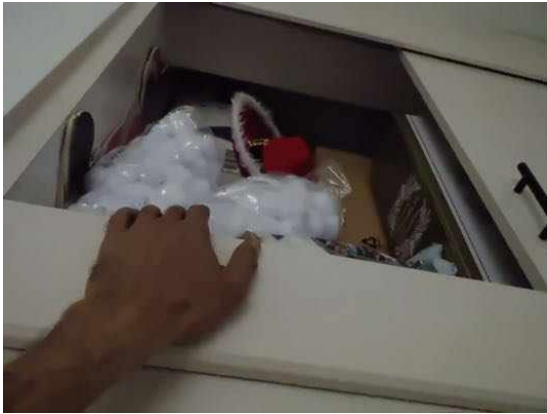
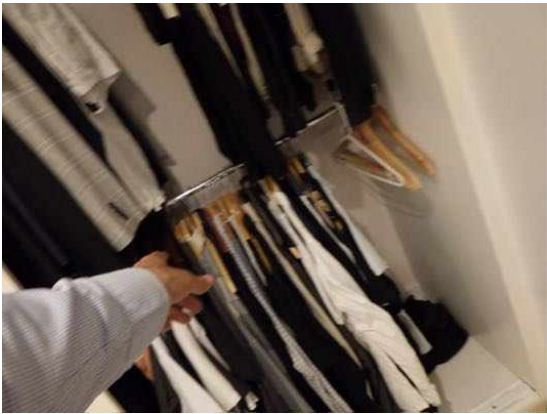
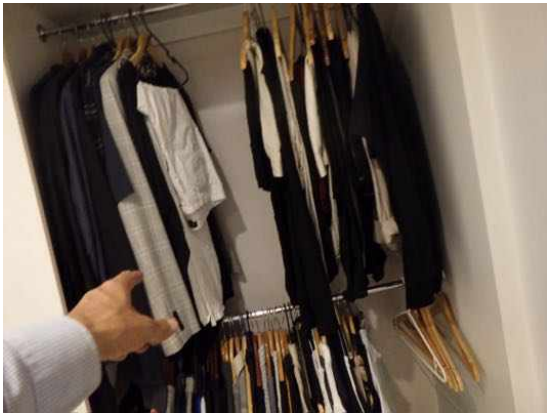
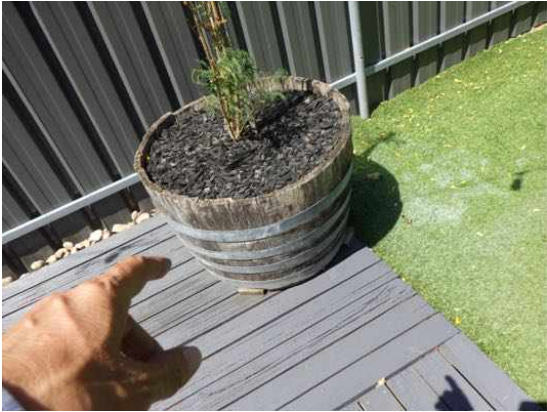
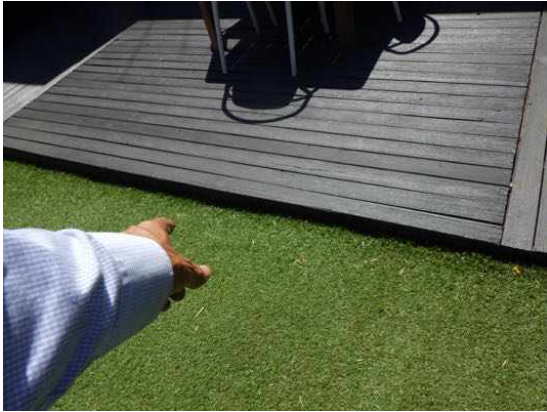
### Noted Item

Building:	Building 1
Location:	All Areas
Finding:	Additional Photos - Obstructions and Limitations
Information:	These photographs are an indication of the obstructions and limitations which impeded full inspection of the property at the time of inspection. These obstructions can hide an array of defects and should be removed to allow full inspection to be carried out. A re-inspection is recommended once the areas are made accessible.

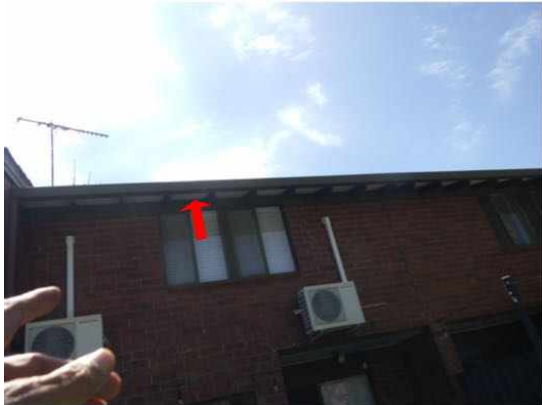
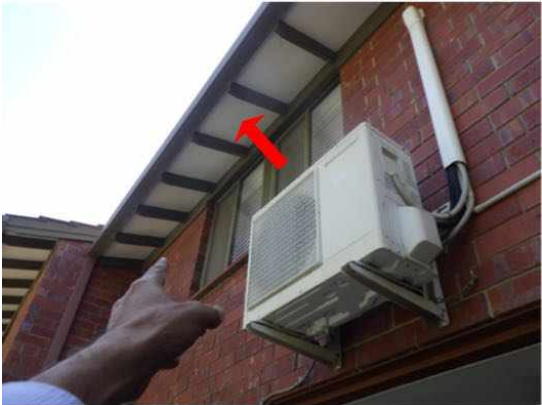
Building: Building 1  
Location: All External Areas  
Finding: Asbestos - Suspected ACM Identified on Site  
Information: Reporting on Asbestos is outside the Scope of this Report. This suspected defect is highlighted as a caution only. We suspect, based on our experience in the building industry, that there is a higher risk of the identified building element containing asbestos.

As Asbestos Reporting is outside the scope of this report, we advise that you consider a separate Asbestos Inspection and Condition Audit, which can include the taking of samples for definitive confirmation of the presence of Asbestos.

In the interim, the client is advised to act with caution, especially when considering any damage to building materials general wear and tear renovations extensions demolition and general maintenance activities due to the suspected presence of Asbestos.
