# Building and Timber Pest Inspection Report

Inspection Date: Thu, 29 Jan 2026

Property Address: U2/68 Flora St, Kirrawee NSW 2232,  
Australia

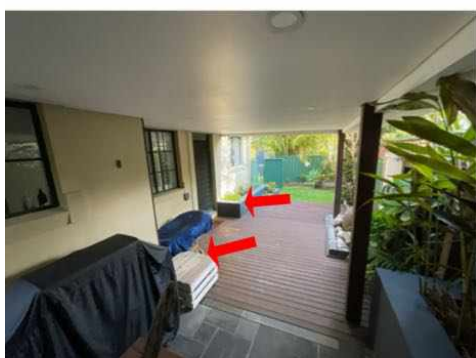
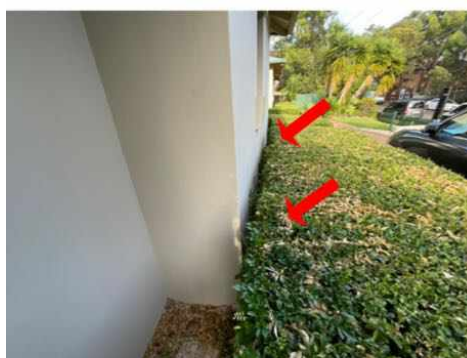
### Finding 6.02

Building: Building 1  
 Location: Yard - front  
 Finding: Bridging - Vegetation and decking  
 Information: Where vegetation and decking obstructs inspection of building elements, also known as bridging as it provides a bridging point for the access of termites, full inspection can not be achieved. Consequently moisture or dampness may be present and the areas becomes conducive to termite activity. Plants and decks against or very close to buildings provide cover, shade and can provide an environment that is attractive to termite infestation.

The removal and replanting of plant species that do not provide "cover" or cutting back of existing vegetation and leaving a small gap between decking and the building walls will assist greatly in preventing Bridging from occurring.

The removal of any such stored building or plant materials that may be conducive to termite activity should be carried out as soon as possible and arrange re inspection to minimize the risk of termite attack.

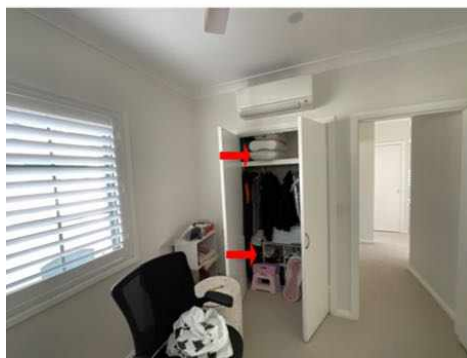
Building: Building 1  
 Location: All Internal Areas  
 Finding: Additional Photos - Obstructions and Limitations of INTERNAL AREAS  
 Information: These photographs are an indication of the obstructions and limitations which impeded full inspection of Internal areas at the time of inspection. These obstructions can hide an array of defects and should be removed to allow full inspection to be

carried out. A re-inspection is recommended once the areas are made accessible.

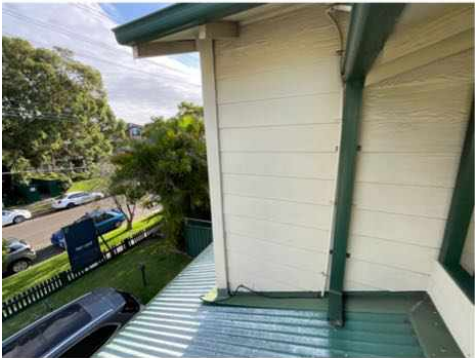
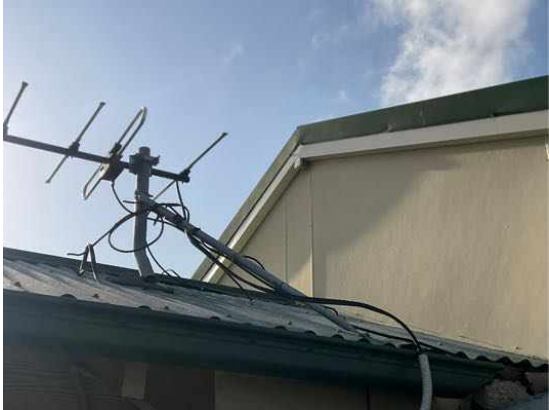
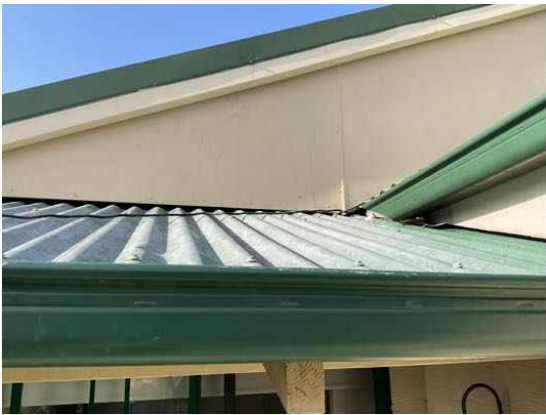
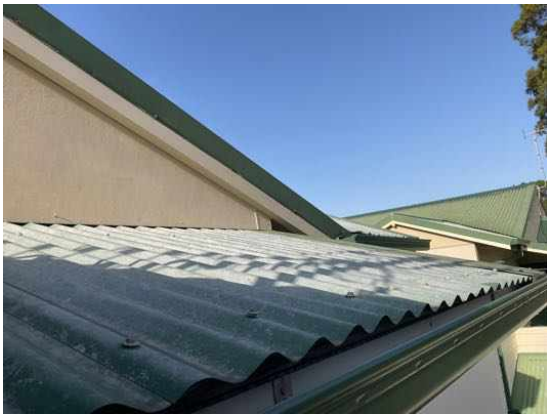
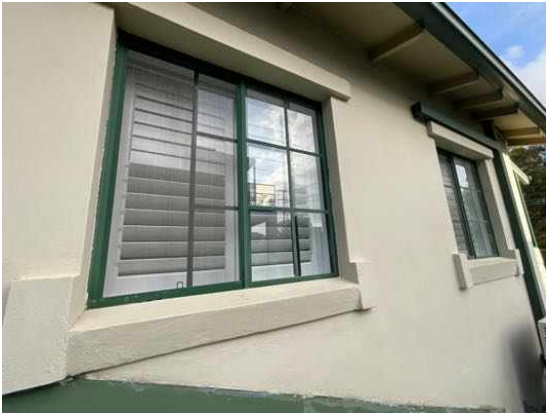
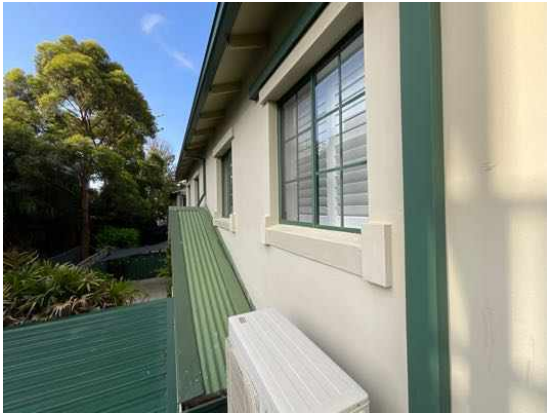
**Noted Item**

Building: Building 1  
Location: Roof Exterior  
Finding: Additional Photos  
Information: Additional photos are provided for your general reference

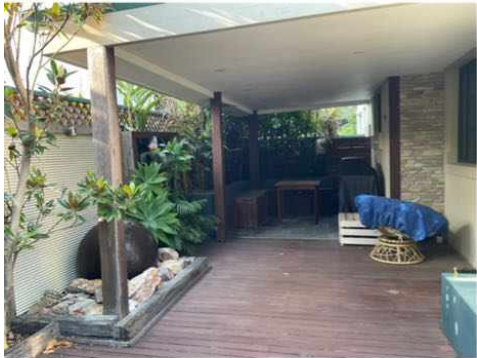
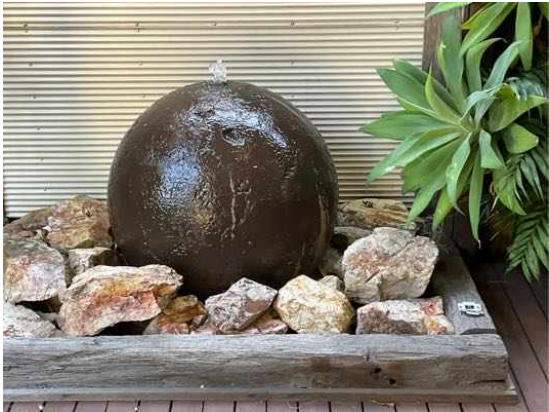
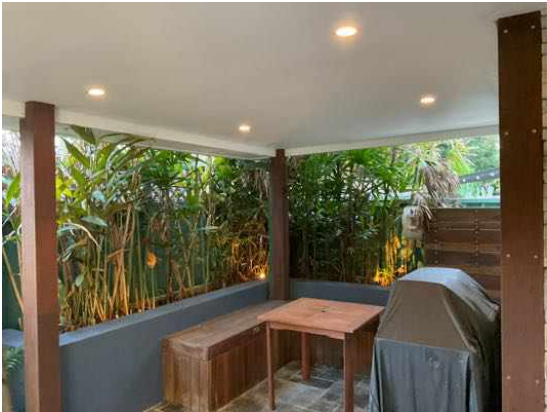
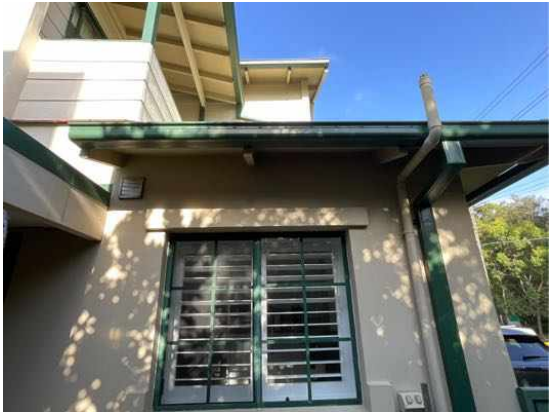
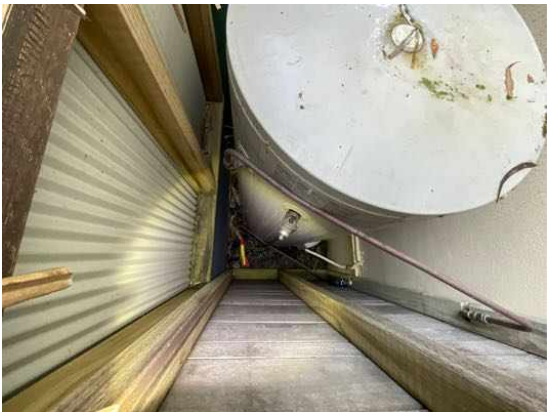
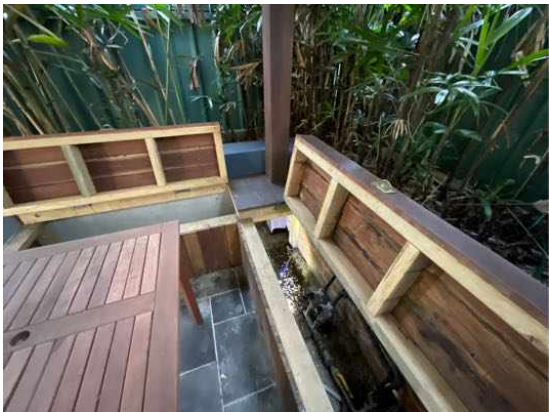
Noted Item

Building: Building 1  
Location: All External Areas  
Finding: Additional Photos  
Information: Additional photos are provided for your general reference

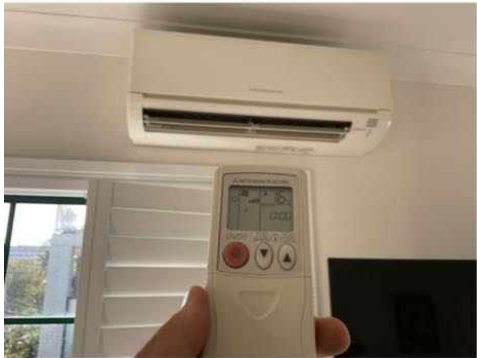
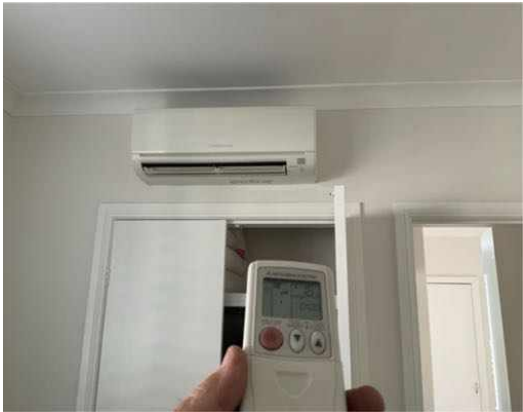
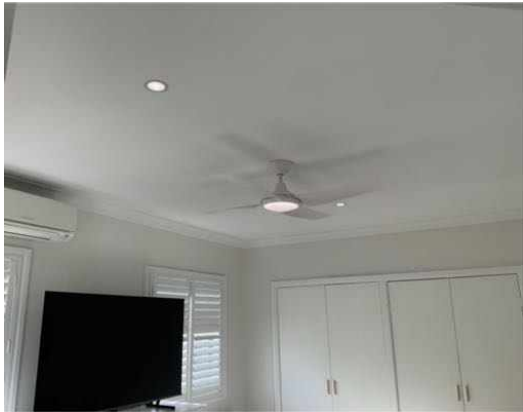
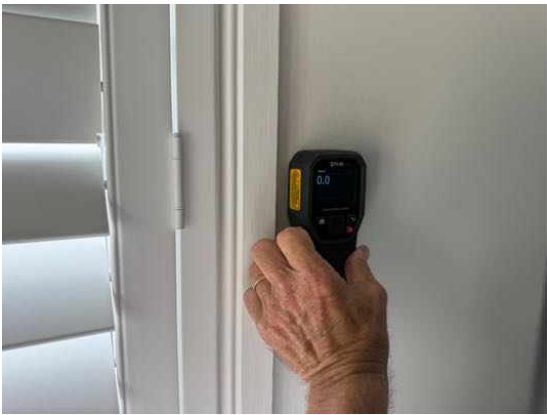
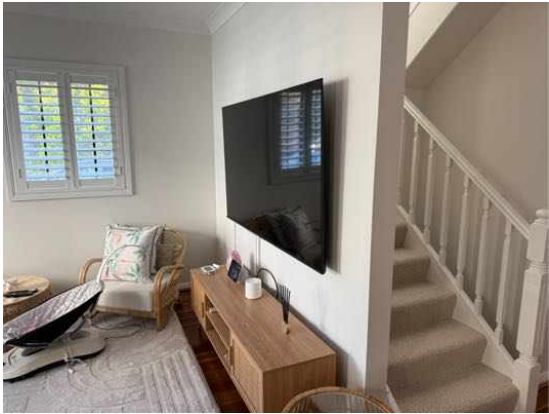
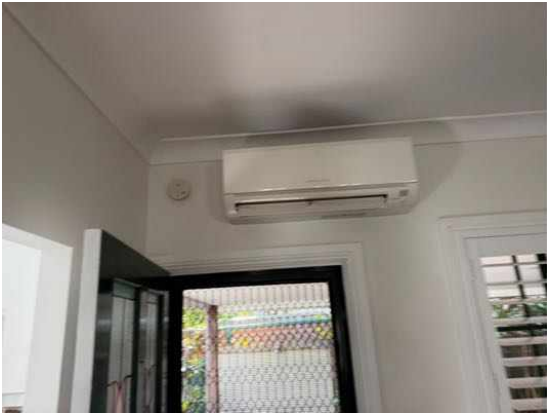
**Noted Item**

Building: Building 1  
Location: All Internal Areas  
Finding: Additional Photos  
Information: Additional photos are provided for your general reference

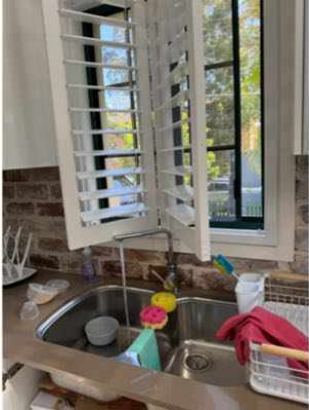
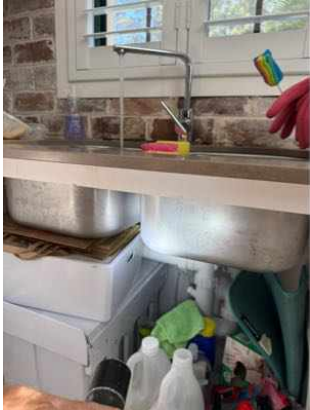
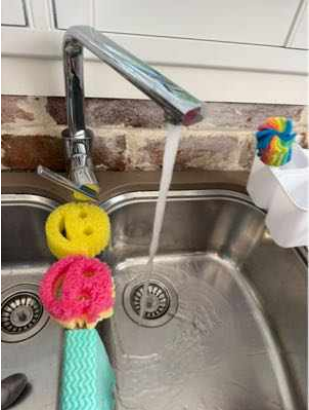
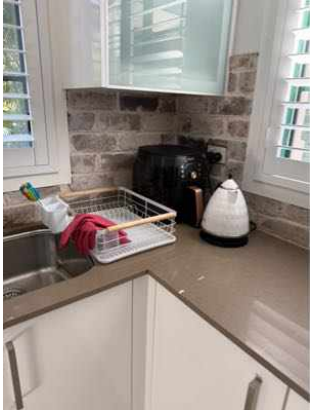
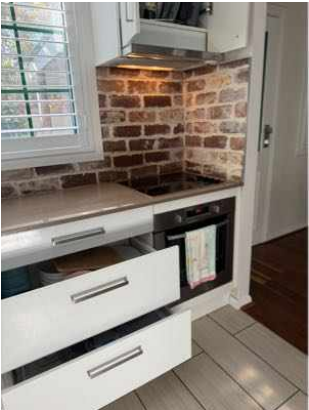
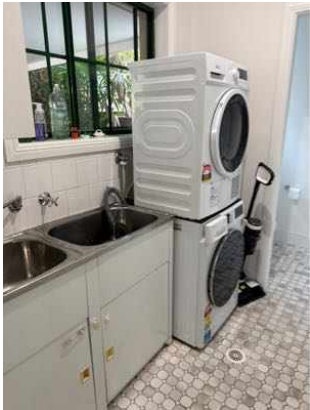
Noted Item

Building: Building 1  
Location: All Internal Areas  
Finding: Additional Photos  
Information: Additional photos are provided for your general reference

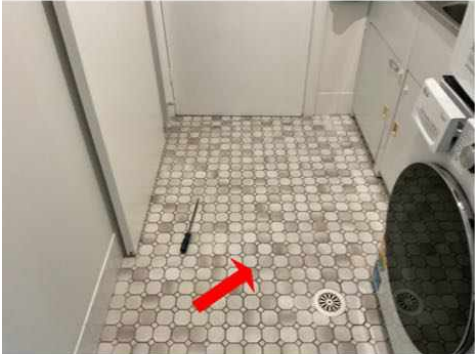
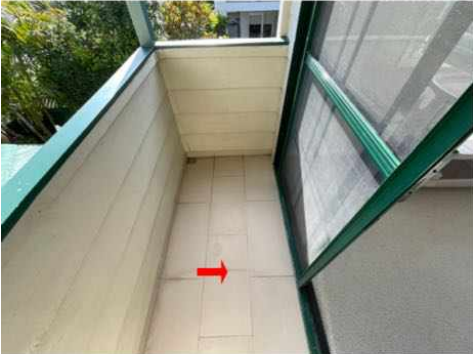
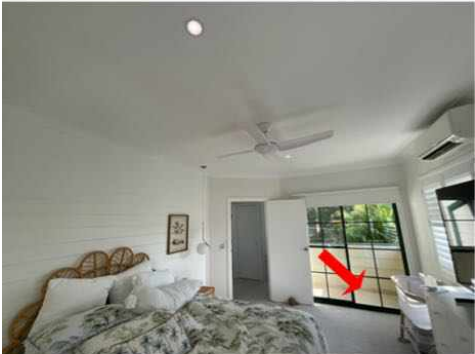
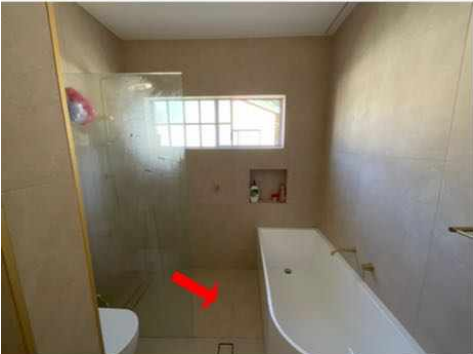
Building: Building 1  
 Location: Bathrooms, laundry, decks  
 Finding: Waterproofing membranes - Information Only  
 Information: Internal Water Proofing Membranes, are crucial in preventing water ingress into the property is important to know that the Membrane System used is to Australian Standards and has been installed correctly.

With older property's where this information is unavailable all wet areas should be monitored. If any leaks, water staining, peeling or bubbling of the paint become evident to any adjacent walls or ceilings below a licensed builder or waterproofing specialist is recommended to investigate further.
