Building and Timber Pest Inspection Report

Inspection Date: Thu, 2 Apr 2026

Property Address: 27A Hollis St, Constitution Hill NSW 2145, Australia

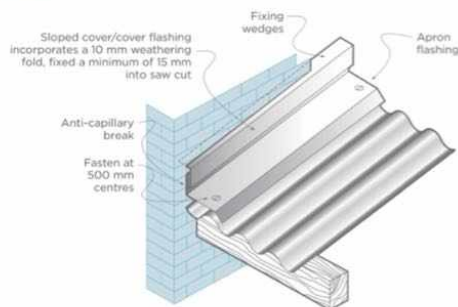
DIAGRAM 8.08 FLASHINGS

Building: Main Building
 Location: Alfresco
 Finding: Flashing - Defective
 Information: Instances where flashings are defective were noted. It is expected the silicon to wear out causing water leaks in this area.

Flashings that are not installed adequately or are missing are likely to result in water penetration to the interior of the property, as well as creating excessively damp conditions against the exterior surfaces and around the base perimeter of the building.

Premature ageing and secondary building defects are imminent where roof plumbing is missing or inadequately installed. Additionally, water pooling also creates an environment that is susceptible to termite and pest infestation.

The client is highly advised to ensure the manufacturer installation guide is followed.

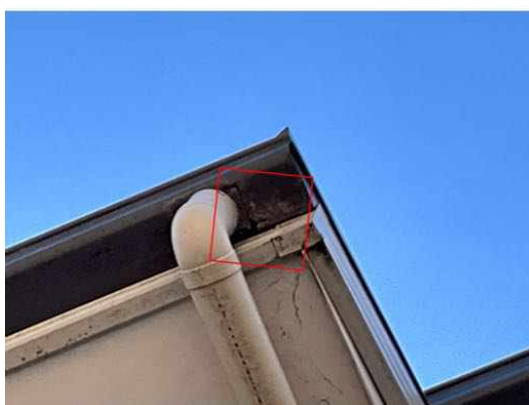
Finding 3.01

Building:	Main Building
Location:	Downpipe LHS
Finding:	Water leak - External
Information:	Water leaks were found to be present to exterior plumbing work. Leaks are generally caused by deterioration of the plumbing elements over time, due to exposure to weather conditions, but may have also been caused by minor impact damage.

Such leaking creates damp conditions in the affected area, causing potential for water pooling and subsequent water damage if left unattended. These conditions may also attract termite attack, particularly if the area is subject to minimal levels of sun throughout daylight hours.

It is highly advised that a licensed plumber be appointed to rectify any water leaks that may be present. Areas of repair and replacement of plumbing fittings and fixtures may be required and, as such, a quotation should be sought.

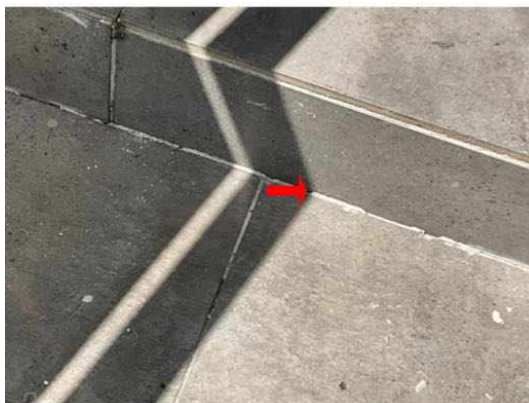
Finding 3.02

Building:	Main Building
-----------	---------------

Location: Entry
 Finding: Grout — Missing/deteriorated
 Information: Grout is missing or deteriorated in this area. Grout is used to protect gaps and crevices in building materials to ensure that they are water-tight and prevent water penetration to the associated structures.

Where grout is missing, a licensed tiling contractor should be appointed immediately to apply grout and re-apply any silicone where necessary. Failure to do so is likely to lead to water damage to the surrounding area.

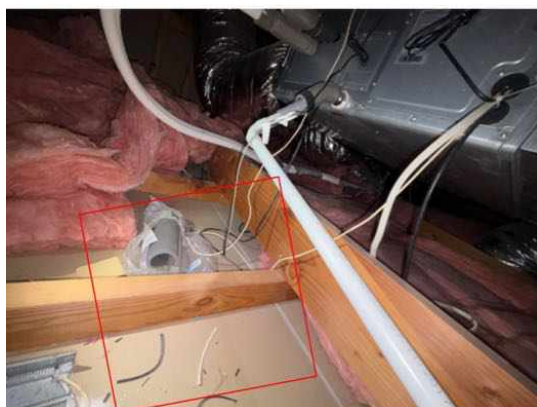
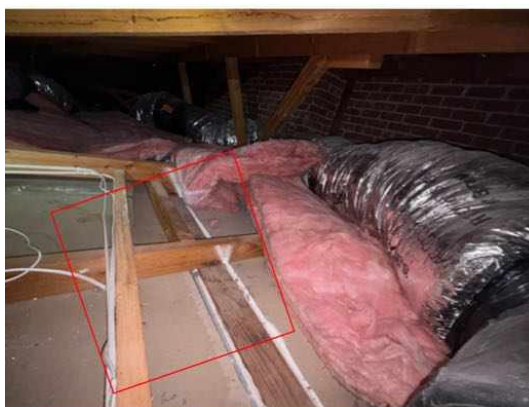
Finding 3.03

Building: Main Building
 Location: Roof Void
 Finding: Internal air conditioning unit - Missing condensation tray
 Information: The internal air conditioning unit in the roof was found to be missing the condensation tray at the time of inspection.

An internal air conditioning unit inside the roof must have a secondary drip tray with a separate drain line to ensure any condensation is dealt with accordingly to avoid water leaks.

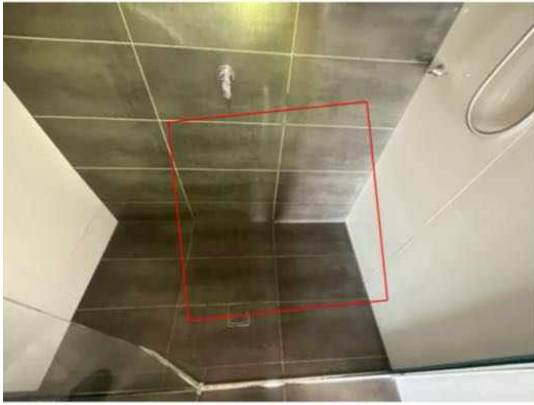
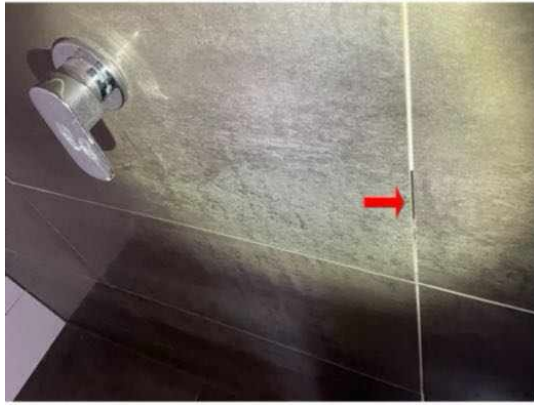
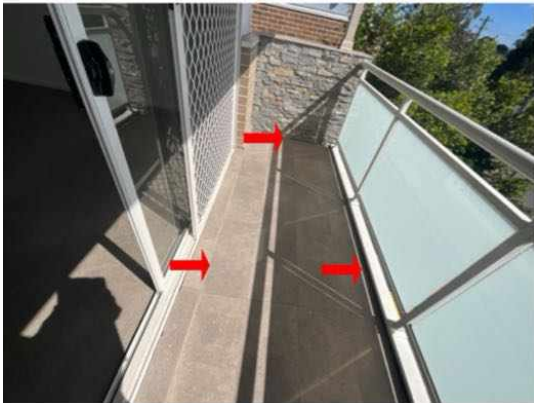
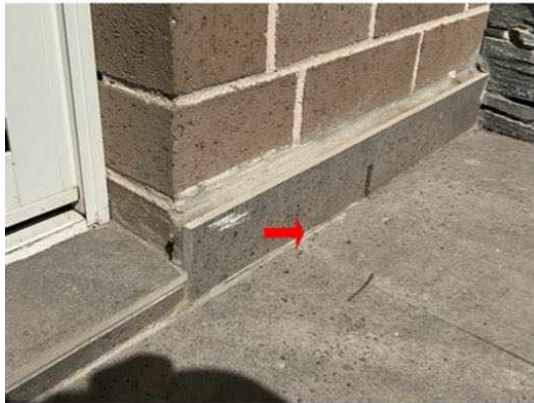
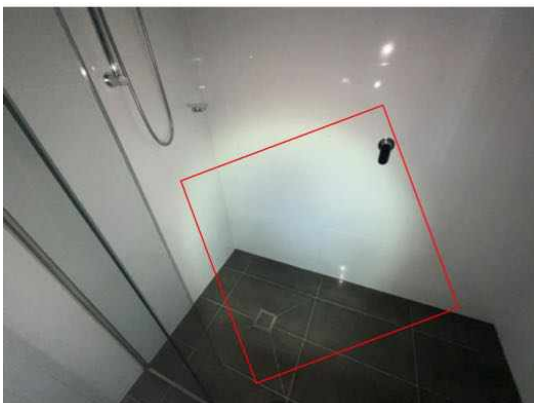
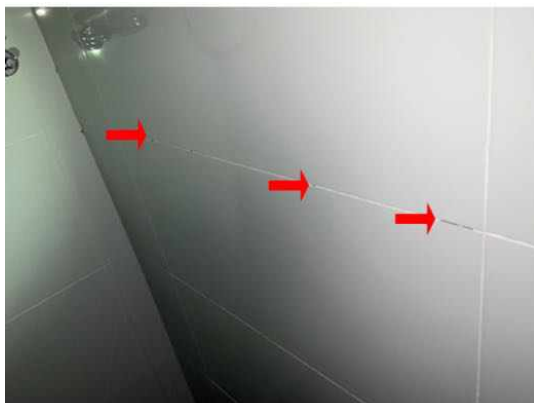
Finding 3.05

Building: Main Building
 Location: All Wet Areas
 Finding: Sealant and grouting - Missing or damaged
 Information:

It was noted on inspection that sealant or grout is degraded to this area.

Different materials and floor areas move at different rates, generally causing cracking to grout or sealant at this point. A flexible sealant is required to allow for expected expansion and contraction, while keeping the joint water tight and protective of all associated building materials.

Flexible and mould resistant materials should be applied to affected areas to prevent any subsequent water damage that is likely to occur. Regular maintenance and replacement of damage or missing or damaged sealant and grout is highly recommended to the wet areas, as this is a regular wear and tear defect. Sealant and grouting in areas that come into regular contact with water should be maintained for the long term care of your property.

A sealant specialist should be appointed to complete these works as soon as possible.

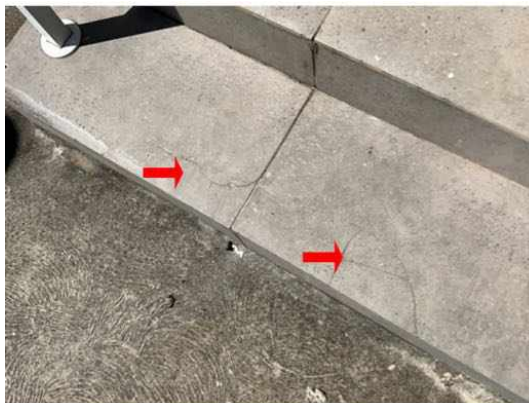
Finding 3.06

Building: Main Building
 Location: Porch
 Finding: Cracked floor tiles
 Information:

Cracking in the floor tiles was evident in this area at the time of inspection. It is suspected that this cracking has occurred as a result of minor settlement or shrinkage.

Cracked tiles throughout the household detract from the overall appearance of the affected areas however it is unlikely to create or lead to any secondary defects.

While not considered a matter of urgency, replacement of cracked floor tiles is recommended at the clients discretion. A licensed tiling contractor may be appointed to perform these works. Where cracks become more numerous, contact a licensed building inspector for further investigation.

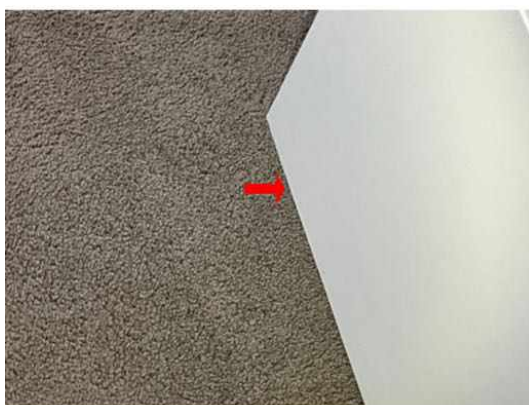
Finding 3.07

Building: Main Building
 Location: Bedroom 4
 Finding: Door - Binding/jamming
 Information:

Binding and/or jamming of this door is evident during standard operation. This defect inhibits the functionality of the affected door as well as creating potential for secondary defects to associated building elements, such as damage to the floor covering or adjacent frame.

A door that binds to flooring or to the associated door frame may have several causes, ranging from minor defects, such as poor installation of the door or deteriorated hinges.

A licensed carpenter should be appointed to perform minor rectification works at client discretion.

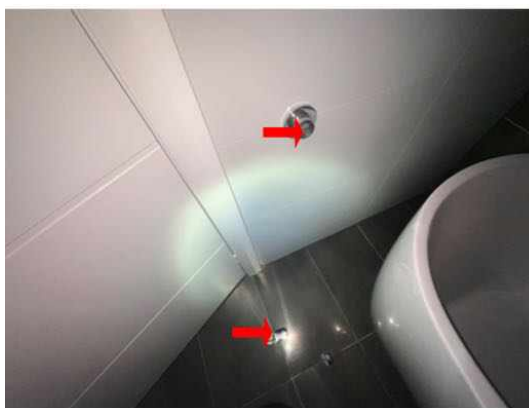
Finding 3.08

Building: Main Building
Location: Laundry, bathroom
Finding: Plumbing fitting or fixture - Loose
Information:

The fitting in this area is loose and requires adjustment to tighten.

If left unmanaged, the fitting may further deteriorate, causing potential for the development of other minor secondary defects.

A licensed plumber should be appointed to perform these rectification works at discretion of the client.

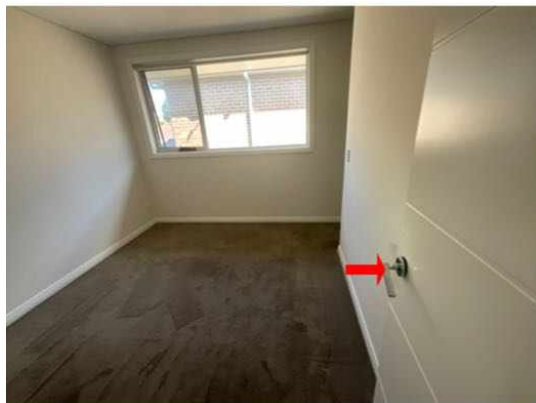
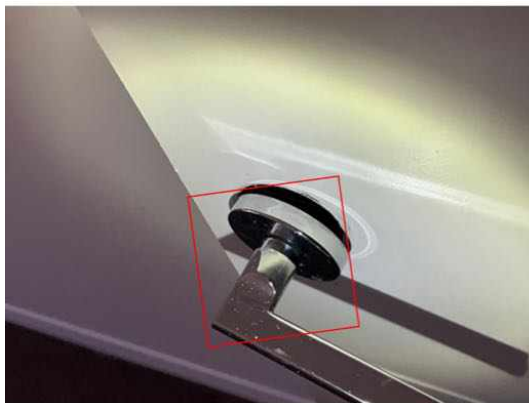
Finding 3.09

Building: Main Building
Location: Bedroom 3
Finding: Fitting or fixture - Loose
Information: The fitting in this area is loose and requires adjustment to tighten.

If left unmanaged, the fitting may further deteriorate, causing potential for the development of other minor secondary defects.

A relevant tradesperson should be appointed to perform these rectification works at discretion of the client.

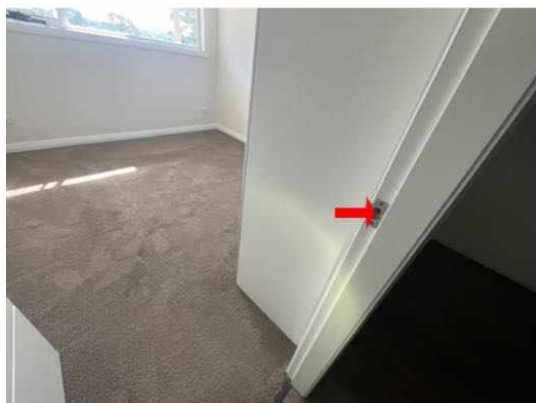
Finding 3.10

Building:	Main Building
Location:	Bedroom 2
Finding:	Door - Striker plate misaligned
Information:	The striker plate to this door appears to have become misaligned and has consequently resulted in the door's operation being compromised.

This is a common defect and is expected in a property of this age, whether being due to substandard installation or general deterioration of the door hardware.

Readjustment of the striker plate is recommended at client discretion. Works such as these can be completed by a general handyman or qualified carpenter.

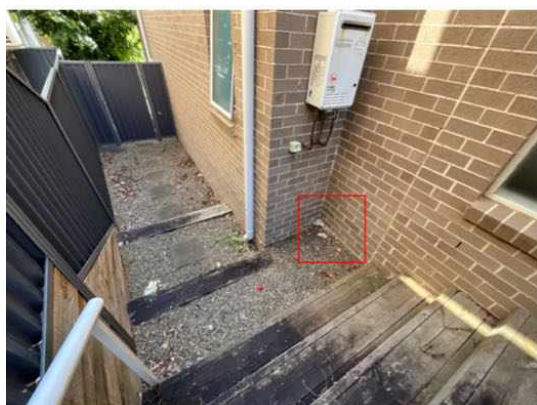
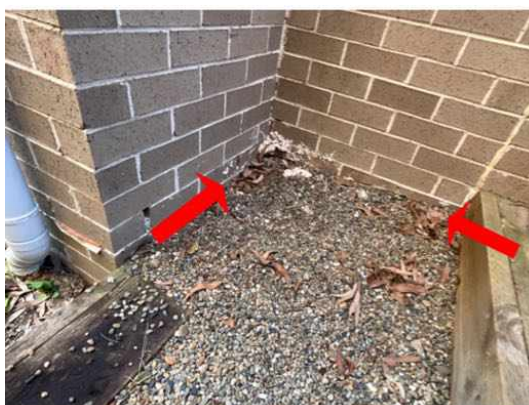
Generally this takes the form of finished ground levels external paving or concrete being retrospectively installed above the damp course level the adjacent internal floor level or weep and ventilation holes.

Where bridging has occurred full inspection is prevented and termites may enter a property in a concealed or undetectable manner. A landscaper must be appointed immediately to lower the ground level in this area.

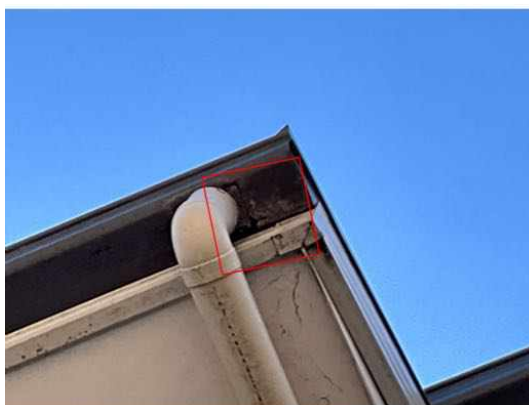
Building:	Main Building
Location:	Downpipe LHS
Finding:	Water leak - External
Information:	Water leaks were found to be present to exterior plumbing work. Leaks are generally

caused by deterioration of the plumbing elements over time, due to exposure to weather conditions, but may have also been caused by minor impact damage.

Such leaking creates damp conditions in the affected area, causing potential for water pooling and subsequent water damage if left unattended. These conditions may also attract termite attack, particularly if the area is subject to minimal levels of sun throughout daylight hours.

It is highly advised that a licensed plumber be appointed to rectify any water leaks that may be present. Areas of repair and replacement of plumbing fittings and fixtures may be required and, as such, a quotation should be sought.

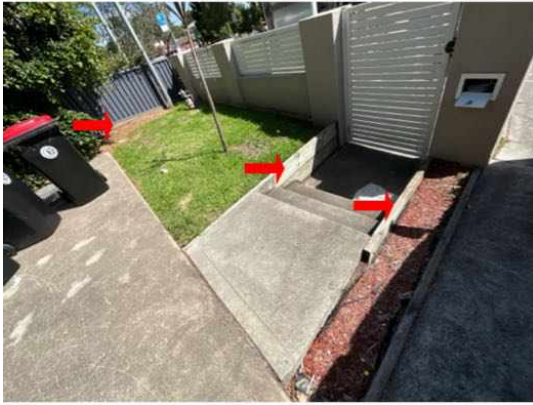
Finding 6.04

Building:	Main Building
Location:	Fencing & Landscaping
Finding:	Building materials in direct ground contact - conducive to termites
Information:	Where timber elements are in direct contact with the ground and consequently moisture or dampness they become conducive to termite activity. Whether timber is used as a building element part of a fencing structure or stored as an unused item they can provide an environment that is attractive to termite infestation.

When met with excessive moisture timber begins to decay and develop wood rot. Any timbers that are in direct contact with external grounds especially if left untreated or non-durable also provide ingress for subterranean termites into that particular element.

The removal of any such materials that may be conducive to termite activity should be removed as soon as possible to minimise the risk of termite attack.

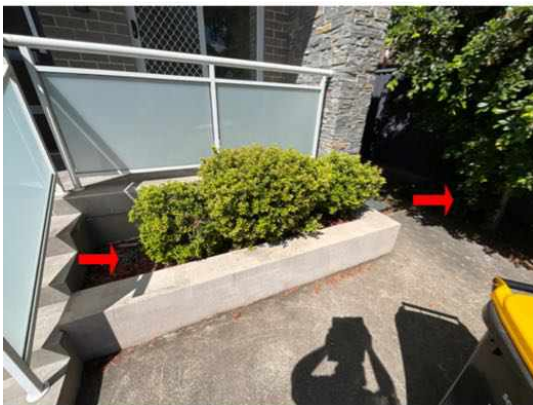
Finding 6.05

Building:	Main Building
Location:	Garden beds
Finding:	Garden Beds
Information:	Garden beds were found to be evident in the garden area. These garden beds can include untreated timber, and with a combination of moisture from watering or hosing can make conditions conducive to termite activity and termite ingress.

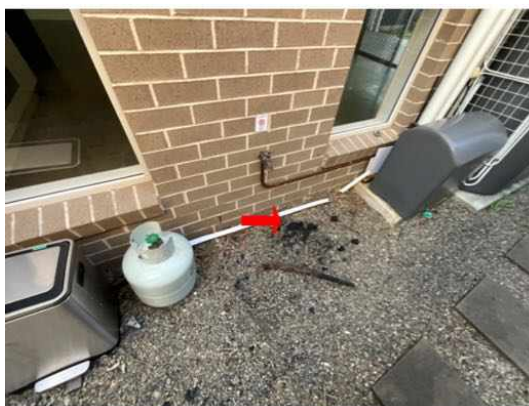
Finding 6.06

Building:	Main Building
Location:	External tap
Finding:	Tap - No drain
Information:	The external tap in this area was noted to have no drain at the time of inspection. This keeps the surrounding surfaces damp while using the tap, which becomes conducive to termite activity. A licensed plumber must be appointed to ensure an appropriate drain is installed.

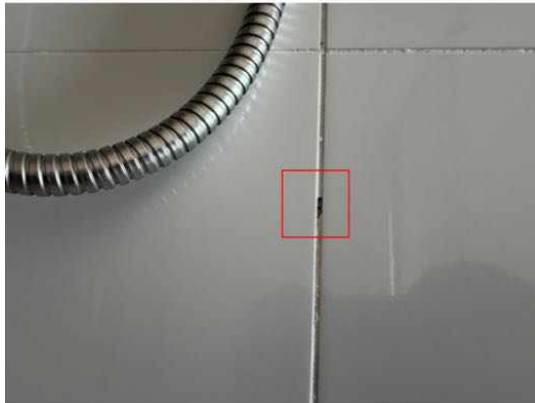
Finding 6.07

Building:	Main Building
Location:	Bathroom
Finding:	Shower damp - Sealant and grout
Information:	Damp is evident to the lower 400mm of wall to the shower alcove. This defect is quite common, and is suspected to have been caused by moisture permeating or leaching through the grouting and sealant in this area, which shows evidence of deterioration. Leaking pipes within the wall is also a possible cause however this seems unlikely in this instance as there is no moisture build up around the taps or transferring to the other side of the wall. There appears to be no sealant around the tap spindles which may be a small contributing factor.

Unmanaged damp in the shower recess is likely to facilitate the formation and development of mould and fungi growth, decaying associated building materials and compromising their structural integrity of associated elements. It is important to address damp conditions, as the World Health Organisation notes that excess moisture leads - on almost all indoor materials - to growth of microbes such as moulds, fungi and bacteria, which subsequently emit spores and other matter into the indoor air. Exposure to these contaminants is associated with a wide range of respiratory and other health-related problems. Damp conditions also create a conducive environment for termite infestation.

Consultation with a bathroom sealant specialist is advised immediately to identify the cause of damp and to perform remedial works as required.

Always ensure that sealant and grout is in good condition to prevent any moisture issues occurring in the future.

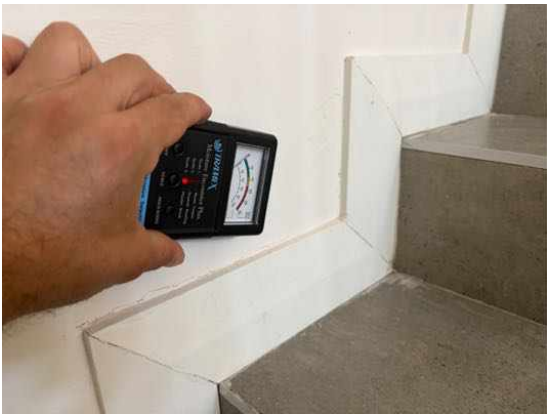
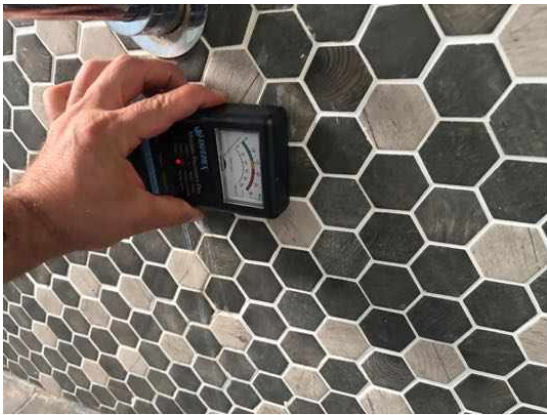
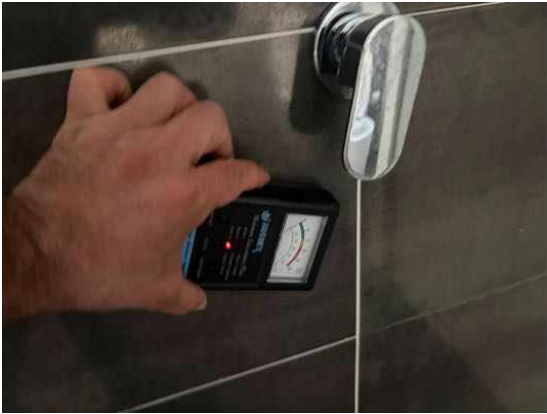
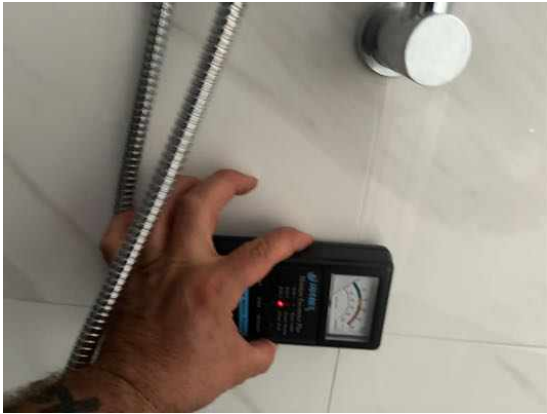
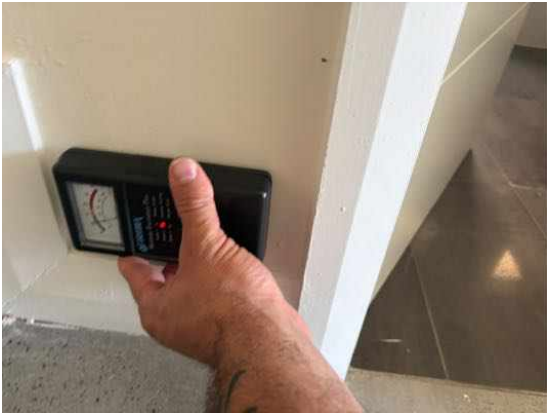
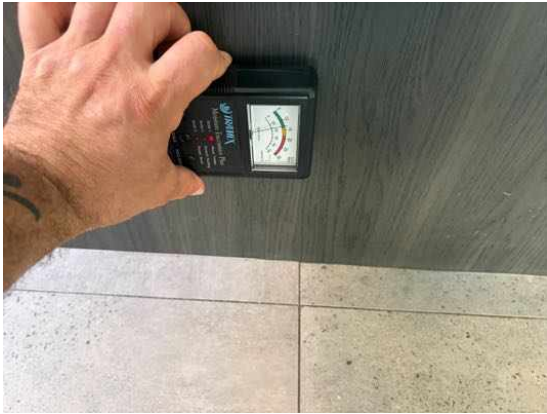
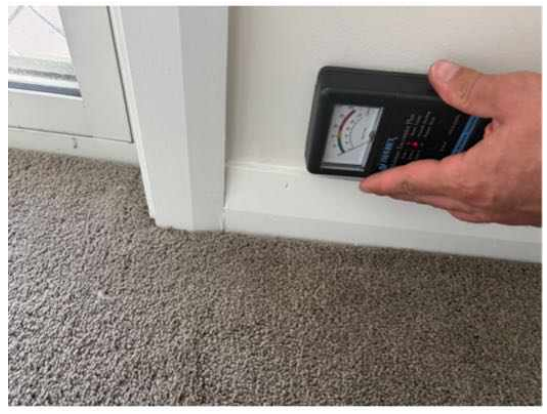
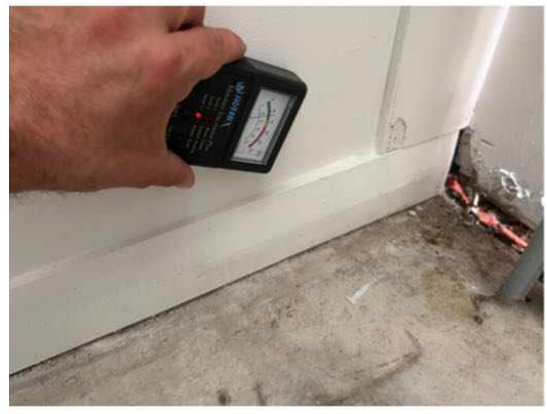
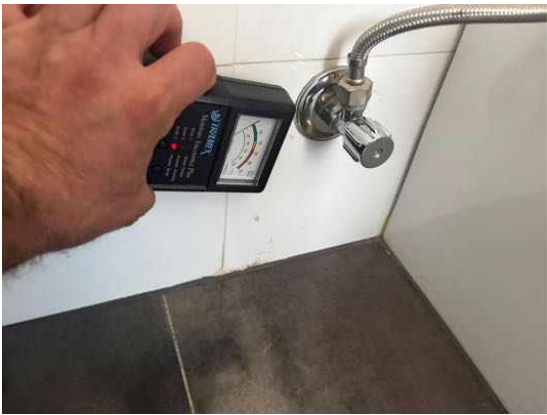
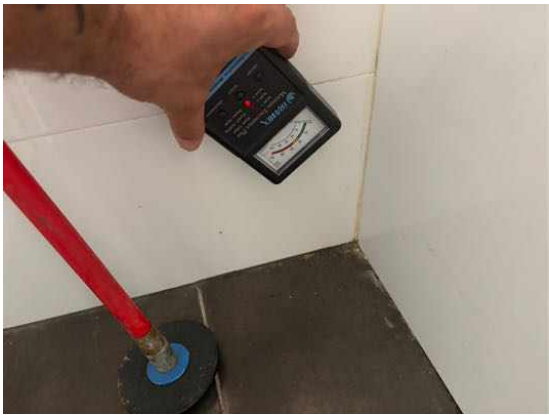
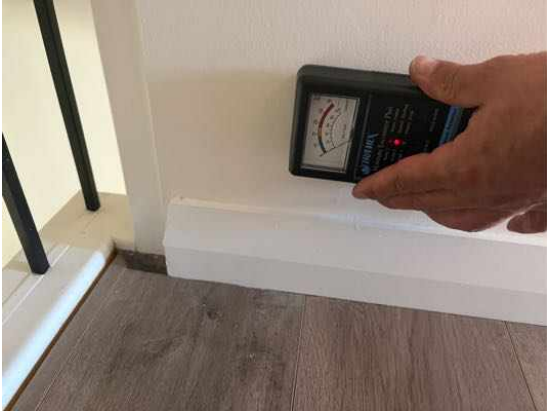
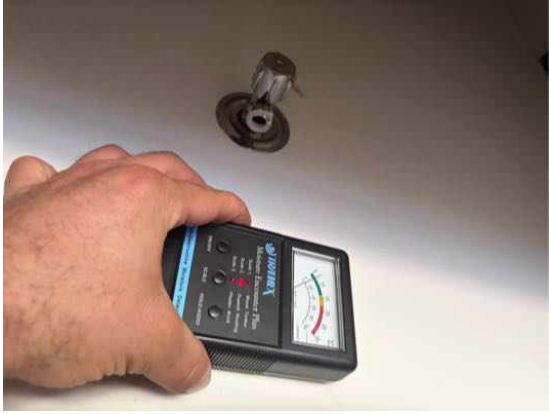
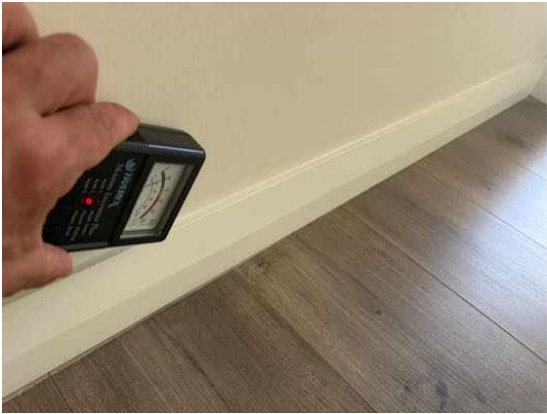
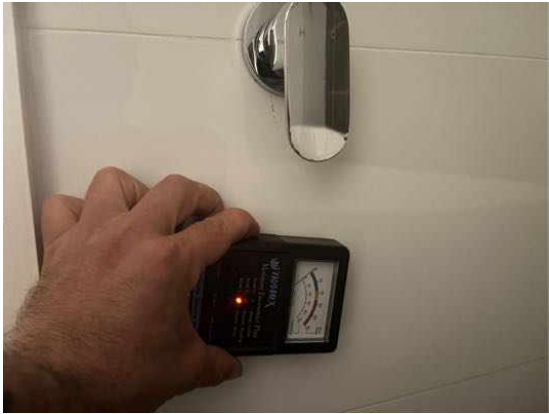
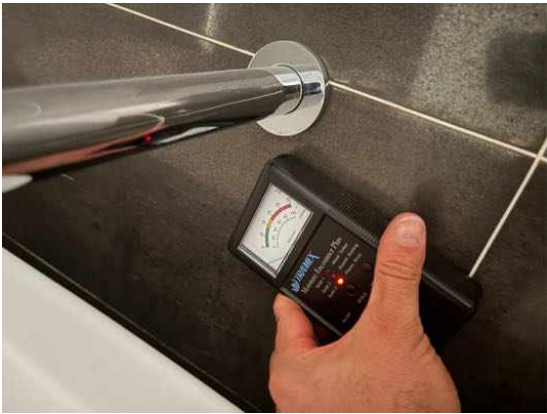
Building: Main Building
Location: All Areas
Finding: Moisture metre
Information: During the inspection the property was checked for moisture using a moisture metre.

This is for information only.

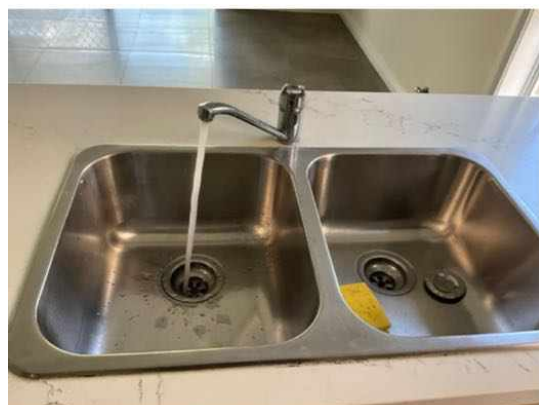
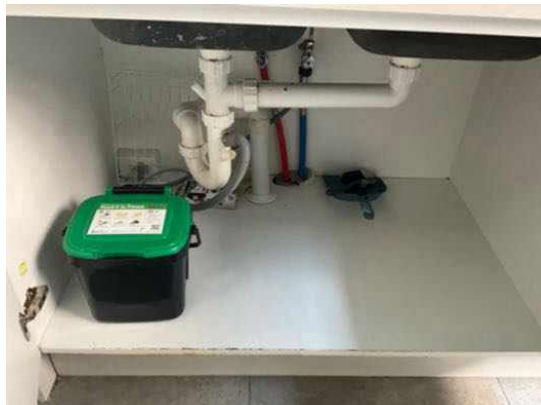
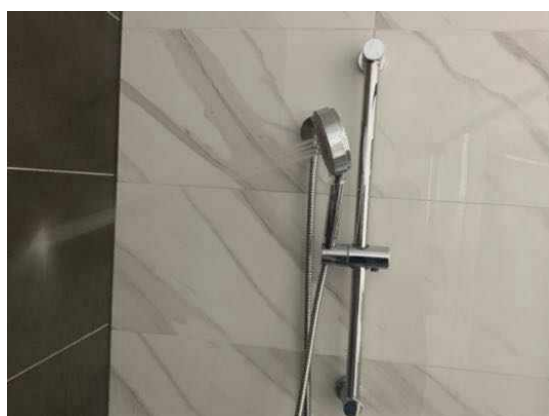
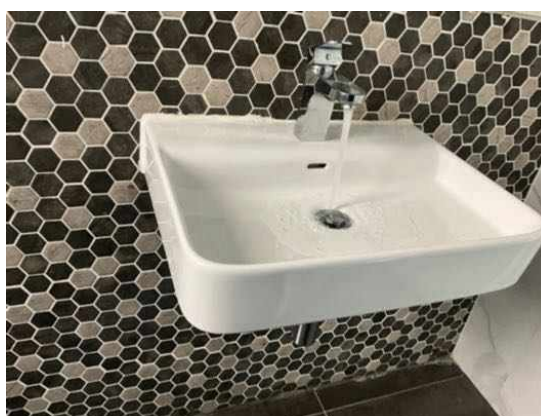
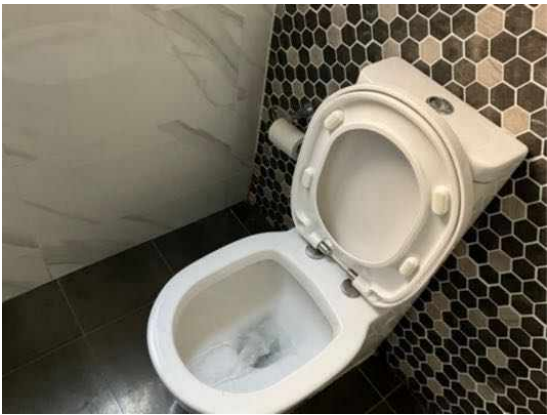
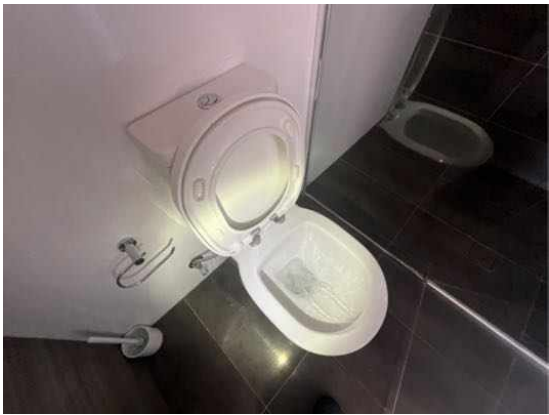
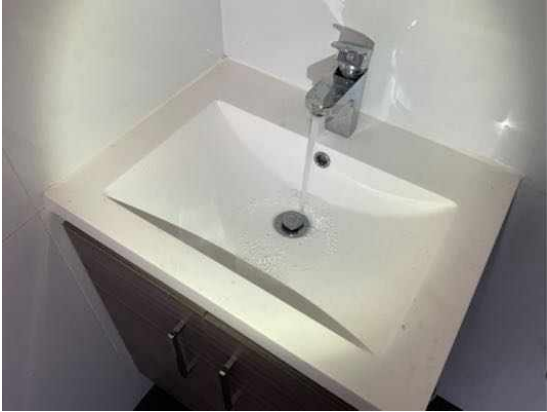
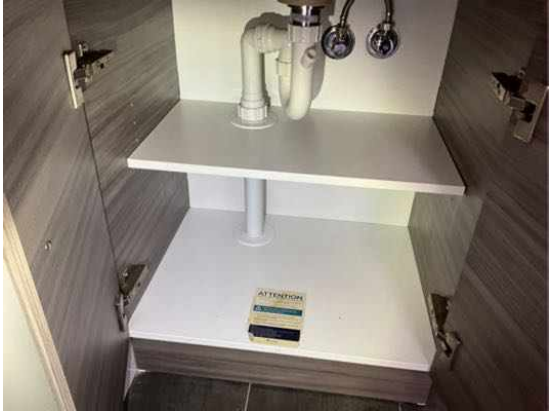
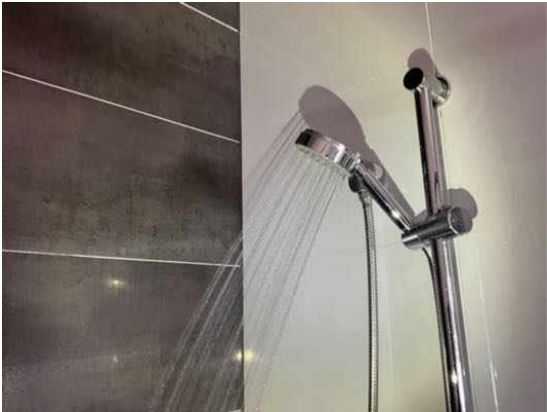
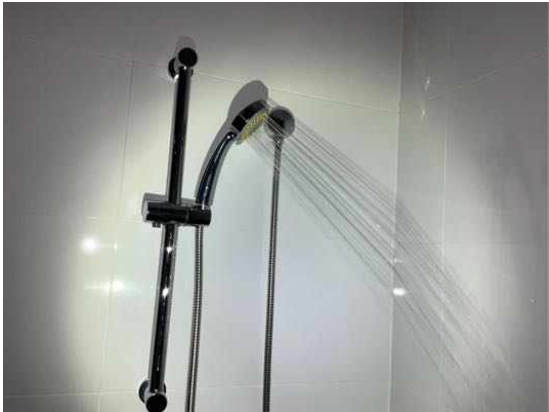
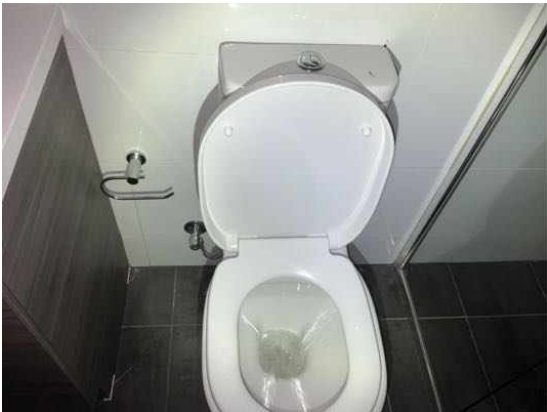
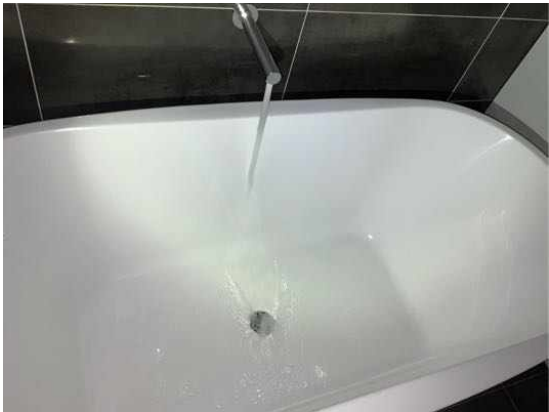
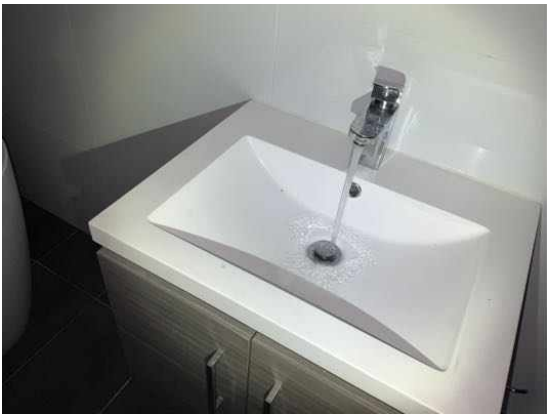
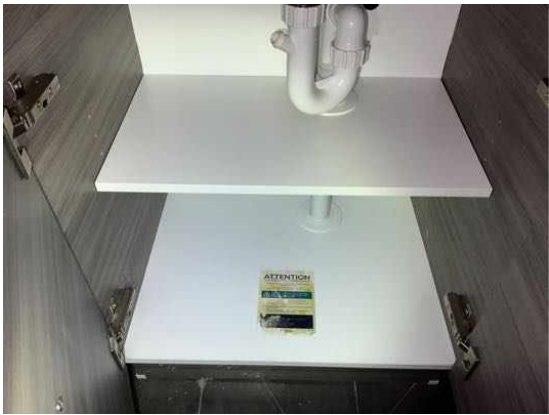
Building: Main Building
Location: All Wet Areas
Finding: Waterproofing
Information:

All taps, mixers and toilets were tested for operation, except for those obstructed. The waterproofing to the shower recess was assessed by checking the walls in and around the shower recess for varying moisture content. There were no significant variations across the tested areas. No sign of recent water damage was evident upon a visual inspection of the surrounding walls, where the visual nature of the inspection was possible.

Consequently, there is no conclusive evidence of any current shower recess leakage other than those which may have already been mentioned earlier in this report. It is reasonable to assume the shower waterproofing is sound. Note that if the shower is not used, or has not been used for some time, moisture readings would not vary significantly and this can lead to erroneous results. It is not possible under the visual inspection criteria (under which a prepurchase inspection is carried out) to categorically determine if there are leaks. If a more accurate assessment is required, a special purpose inspection should be requested. Alternatively, the assumption should be made that the shower may leak.

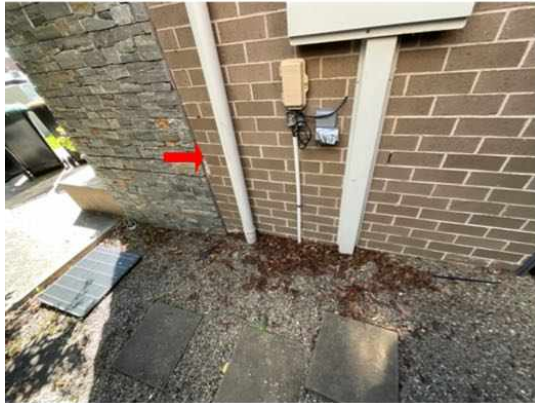
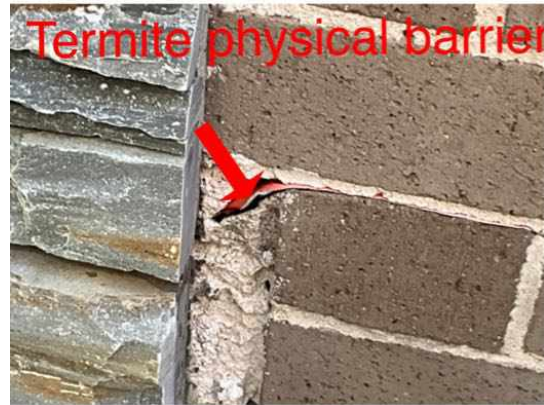
The following items were noted as - Evidence of a previous termite management program

Noted Item

Where a Termite Management System has been identified you should refer to the type of barrier date of installation warranty conditions and any documentation provided by a builder or past owner. Consult the company who installed the barrier to confirm whether the system is still under warranty.

Most chemical termite management systems expire and require replenishment and all physical systems are primarily designed to prevent concealed entry.
