Building and Timber Pest Inspection Report

Inspection Date: Fri, 13 Mar 2026

Property Address: 22 Withers St, West Wallsend NSW 2286,
Australia

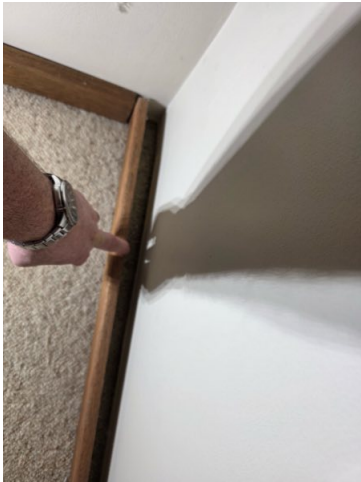
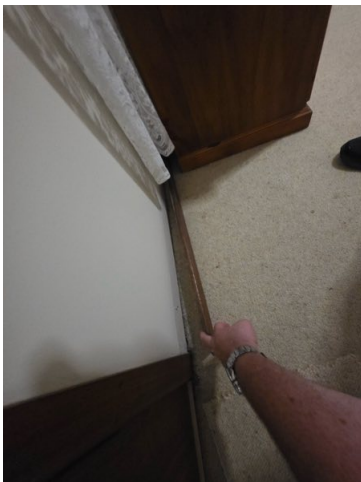
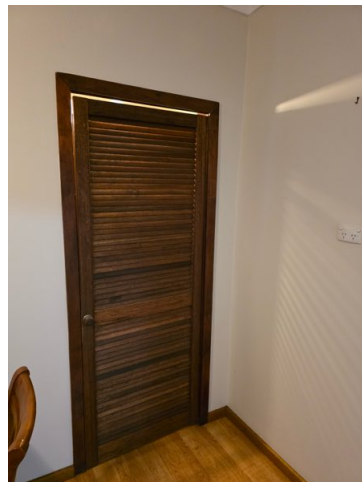
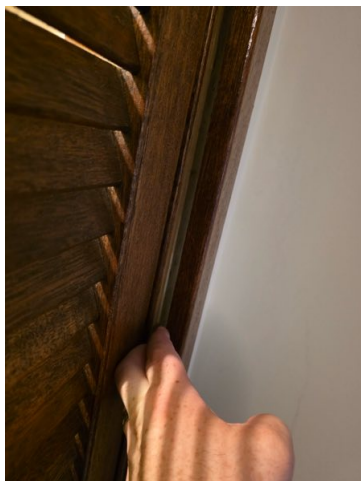
Building:	Main Building
Location:	All Internal Areas
Finding:	Loose and Incomplete Skirting and Architrave Installation (Multiple Rooms)
Information:	<p>Skirting and architrave boards were observed loose in multiple rooms throughout the property. The boards appear to have been cut and positioned against the wall but not fixed in place, and corner joints do not appear to have been mitred or scribed. Unsecured skirting boards can become dislodged with normal use and may leave wall-floor junctions exposed to impact damage, gaps and debris accumulation.</p> <p>A licensed carpenter should be engaged to assess and rectify as required. This should be done at the owner's discretion. Photos are indicative of defect throughout.</p>

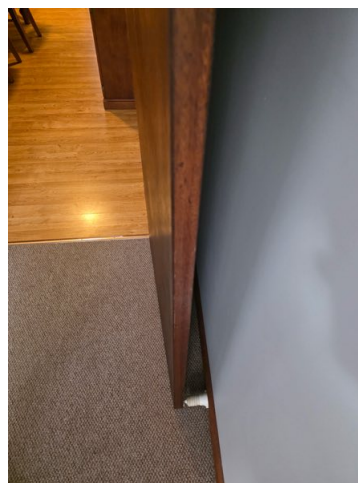
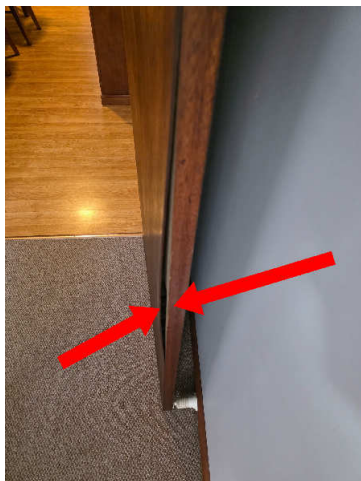
Finding 3.02

Finding: Delaminated and Damaged Door (Bedroom 2)

Information: The door to Bedroom 2 was observed to be delaminated and damaged. The door surface layers have separated and the door panel appears broken, resulting in a loss of rigidity. Where delamination progresses, the door may continue to weaken, affecting normal operation and its ability to function as intended.

A licensed carpenter should be engaged to assess and rectify as required. This should be done as soon as practicable.

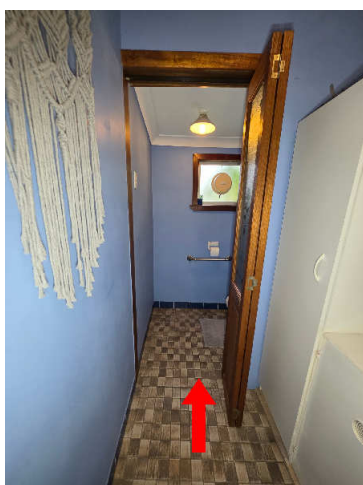
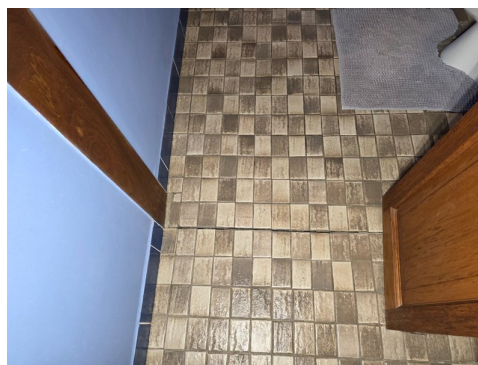
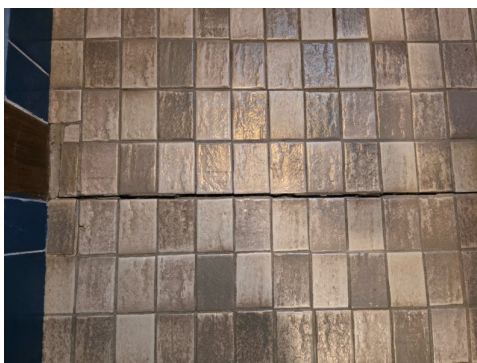
Finding 3.03

Finding: Crack to Floor Tile Grout at Laundry/WC Doorway

Information: A crack was observed within the floor tile grout joint at the doorway between the laundry and WC. The gap appears slightly wider than typical shrinkage cracking and may indicate minor localised movement or tile separation. The cause and extent of this cracking cannot be confirmed during a visual, non-invasive inspection.

A licensed builder should be engaged to carry out further investigation and rectify as required.

This should be done at the owner's discretion.

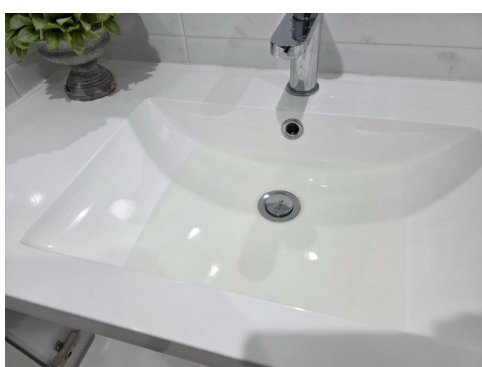
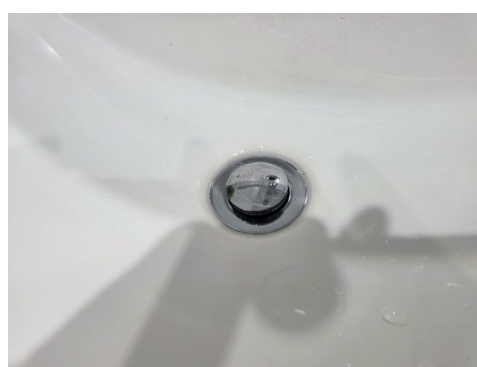
Finding 3.04

Information: The basin waste plug to the main bathroom vanity was not operating as intended. The push-down/push-up mechanism did not function and the plug required manual unscrewing to allow sealing or drainage. This may affect normal basin use and water retention.

A qualified plumber should be engaged to assess and rectify as required. This should be done at the owner's discretion.

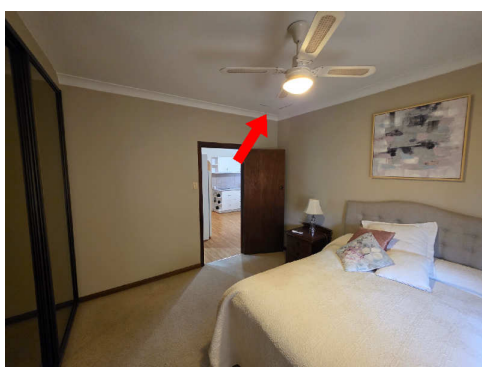
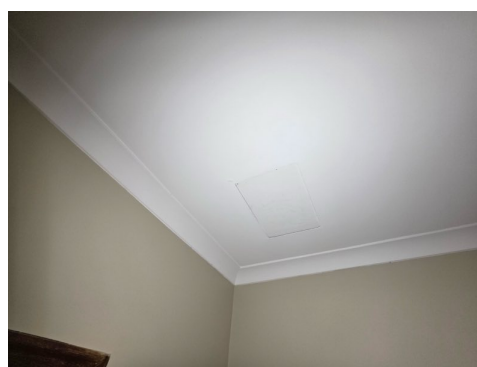
Finding 3.05

Information: The roof void access hatch opening is undersized and did not permit safe entry into the roof void during the inspection. Limited visual viewing was possible only by partially accessing the opening and taking photographs. Where full entry is not possible, elements within the roof void cannot be comprehensively inspected.

A licensed carpenter should be engaged to resize the personal access hatch to allow access for future pest inspections.
This should be done as soon as practicable.

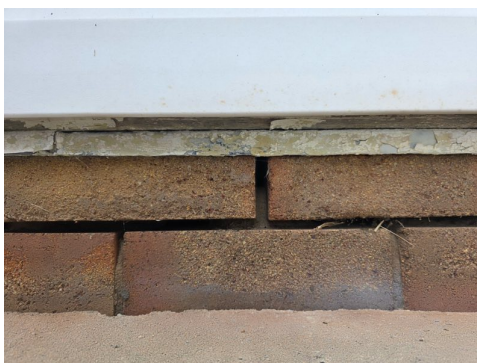
Finding 3.06

Information: Erosion and weathering of mortar joints were observed in sections of the external brickwork wall along the side of the house. This condition is commonly seen in properties of this age due to long-term exposure to weather and natural deterioration of the mortar. Loss of mortar can allow moisture to penetrate the wall assembly and may progressively reduce the bond between bricks if deterioration continues.

A licensed builder should be engaged to assess the condition of the affected brickwork and carry out repointing or repairs as required. This should be done at the owner's discretion.

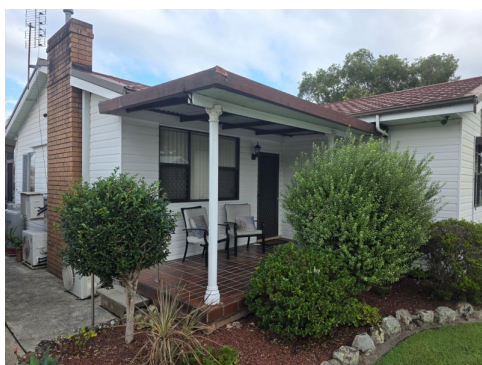
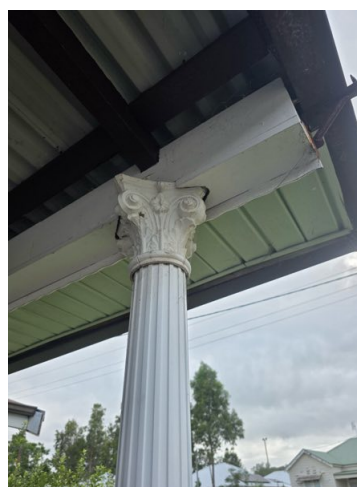
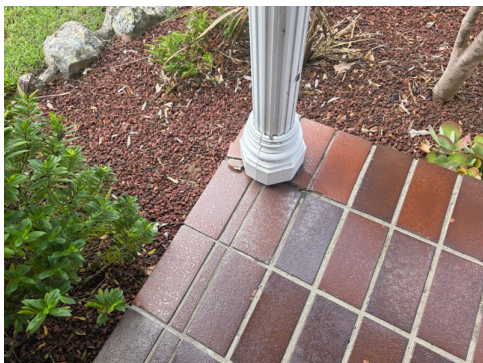
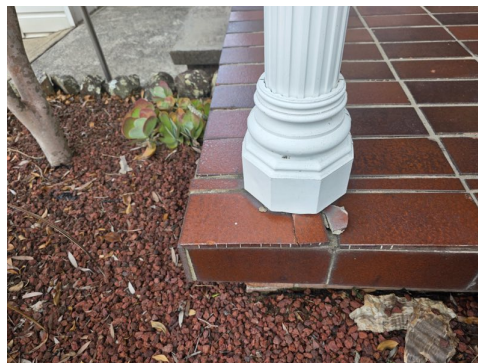
Finding 3.07

Information: Noticeable movement was observed to one of the decorative posts supporting the front veranda roof. The post appears to be a decorative outer covering and it is suspected that a structural support element may exist internally; however this could not be confirmed during a visual, non-invasive inspection. Cracked tiles were also observed at the base of the post. Excessive movement in a supporting element may lead to further damage to surrounding finishes or compromise the stability of the supported structure if deterioration progresses.

A licensed builder should be engaged to carry out further investigation and rectify as required.

This should be done as soon as practicable.

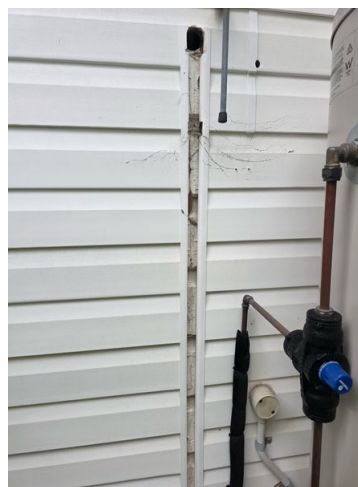
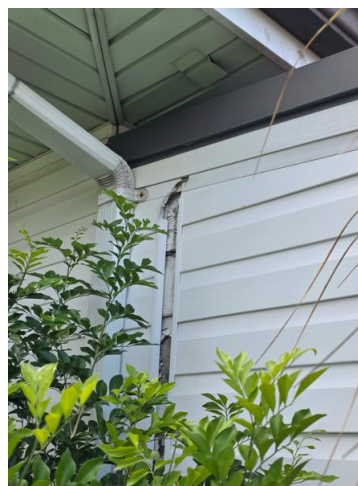
Information: The external walls have been clad with PVC weatherboard strips installed over the original timber weatherboards. In two locations along the side of the house, gaps were observed in the PVC cladding where the original timber weatherboards behind are exposed. These openings appear consistent with cladding being installed around a previous fixture that has since been removed, leaving unfinished openings. Exposed gaps may allow water entry behind the cladding and expose concealed materials to moisture.

A licensed builder should be engaged to assess and rectify as required. This should be done as soon as practicable.

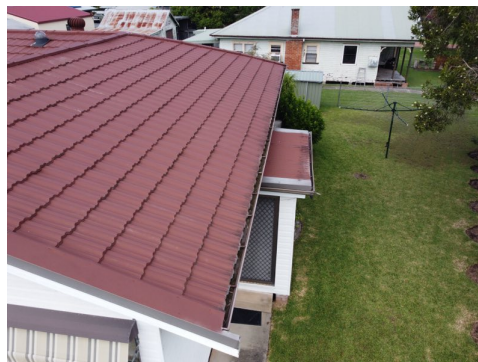
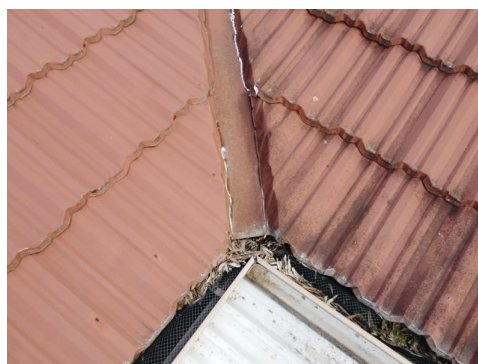
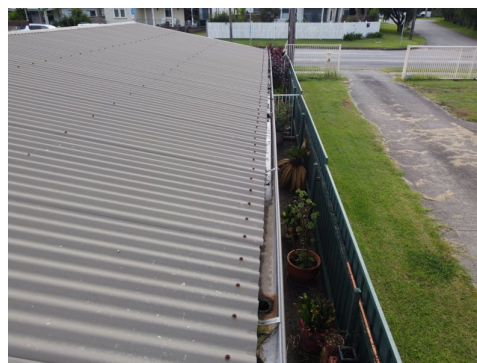
Finding 3.11

Leaf litter was observed within sections of the gutters and minor standing water was present in one gutter to the garage roof. Accumulated debris can obstruct water flow and may lead to overflow or increased moisture exposure to roof edge components if not maintained.

A licensed builder should be engaged to assess and rectify as required. This should be done at the owner's discretion.

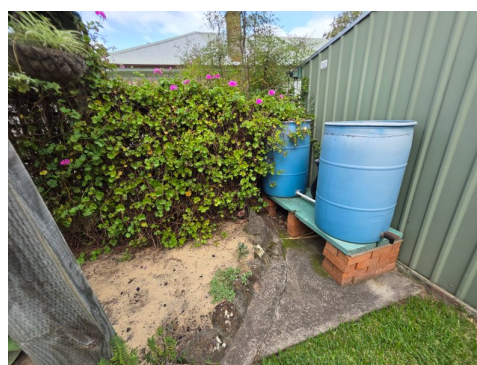
Finding: Garden Beds - Conditions Conducive to Termites

Information: Garden beds, particularly those constructed from untreated timber, were noted adjacent to the dwelling. These create a highly conducive environment for termite activity due to the combination of retained soil moisture from watering, direct soil contact, and the organic material in the soil and timber edging. Such conditions increase the risk of concealed termite ingress into the property, as termites can travel through the garden beds and enter the structure undetected.

To minimize the risk of termite attack, it is recommended to remove any materials that could foster termite activity. If removal is impractical or undesirable, it is strongly advised that termite or timber pest inspections be conducted every 6 to 12 months to protect the property from potential infestation.

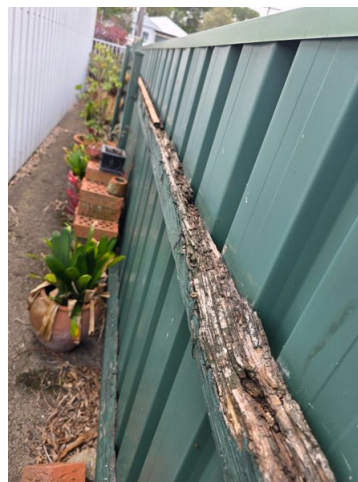
Finding 7.01

Finding: Fungal Decay to Boundary Fence

Fungal decay was observed to sections of the boundary fence shared with the neighbouring property. Timber affected by decay progressively loses strength and durability and may deteriorate further when exposed to ongoing moisture.

A licensed carpenter should be engaged to assess and rectify as required. This should be done at the owner's discretion.

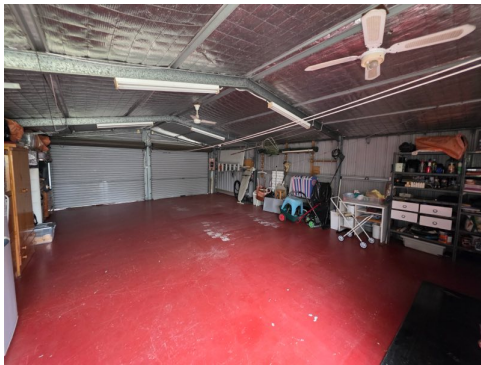
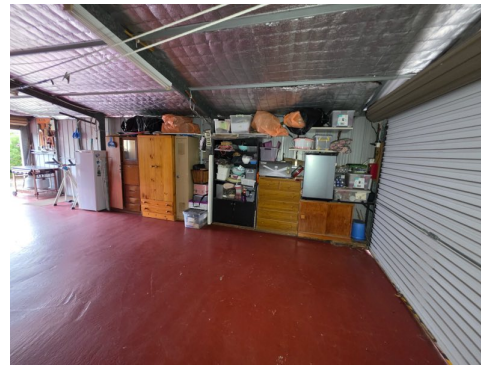
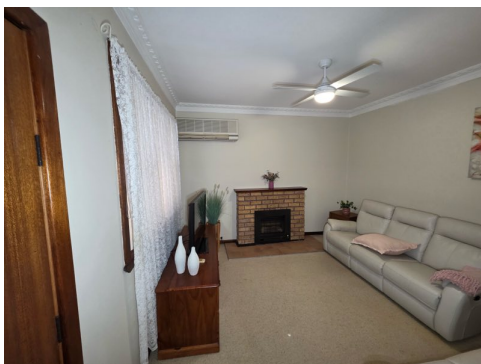
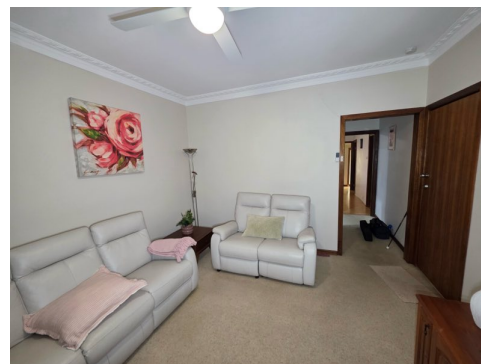
Finding: Additional Photos - Obstructions and Limitations

Information: These photographs are an indication of the obstructions and limitations which impeded full inspection of the property at the time of inspection. These obstructions can hide an array of defects and should be removed to allow full inspection to be carried out. A re-inspection is recommended once the areas are made accessible.

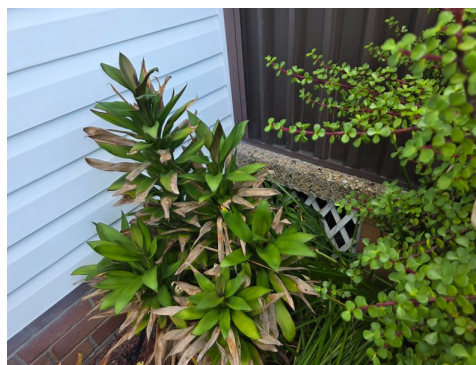
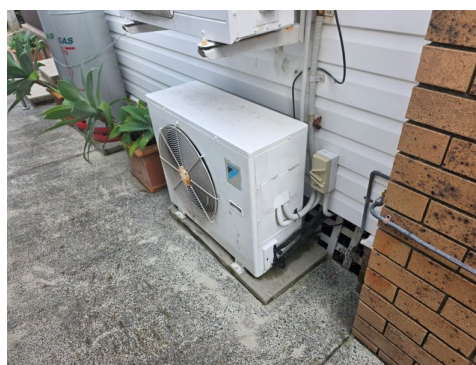
Information: The subfloor area could not be accessed or inspected due to restricted access at the time of inspection. Where areas cannot be entered, elements within the subfloor space cannot be fully assessed and concealed defects, moisture issues or timber pest activity may remain undetected.

Improving access to the subfloor area is recommended to allow proper inspection during future assessments.

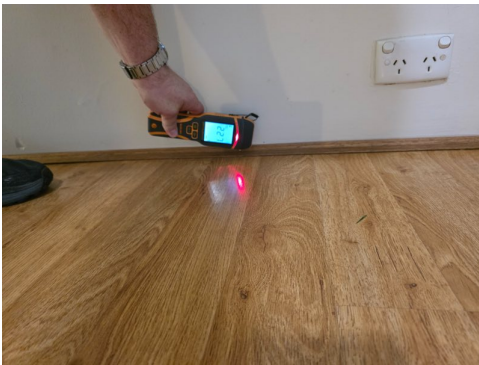
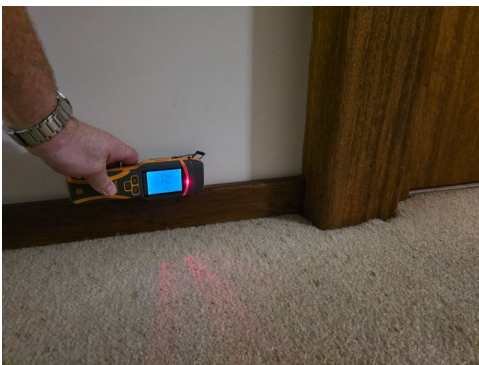
Finding: Low-Level Elevated Moisture

Information: Low-level elevated moisture readings were recorded to some internal walls throughout the property. No visible mould, deterioration or discolouration was observed at the time of inspection. The readings may not necessarily indicate active moisture ingress and could be influenced by environmental conditions; however, the source cannot be confirmed during a visual, non-invasive inspection. The area should be monitored, and if deterioration, discolouration or mould growth develops, further investigation may be required.

A licensed builder should be engaged to assess and provide further investigation if required. This should be done at the owner's discretion.

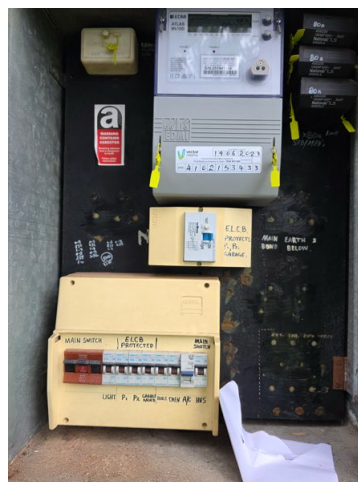
Information: Reporting on asbestos is outside the scope of this inspection. Suspected asbestos-containing material (ACM) was observed in the meter box. Based on our experience in the building industry, there is a higher risk that the identified building elements contain asbestos, particularly given that any home constructed prior to 1990 may contain asbestos in various forms.

No sample testing has been undertaken to confirm the presence of asbestos. We strongly recommend a separate Asbestos Inspection and Condition Audit be carried out by a licensed assessor, which may include laboratory testing for definitive confirmation.

In the meantime, the client is advised to act with caution, especially when considering any disturbance of the material through wear and tear, renovations, extensions, demolition, or maintenance activities.

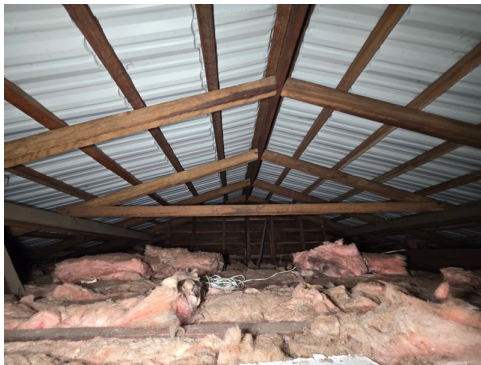
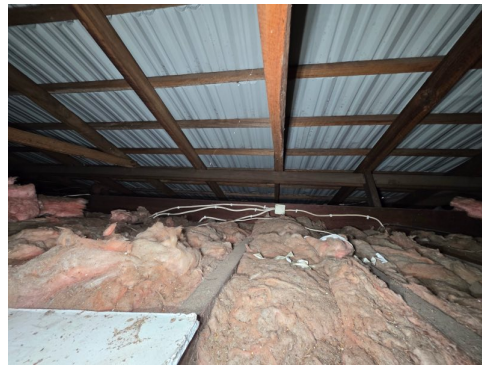
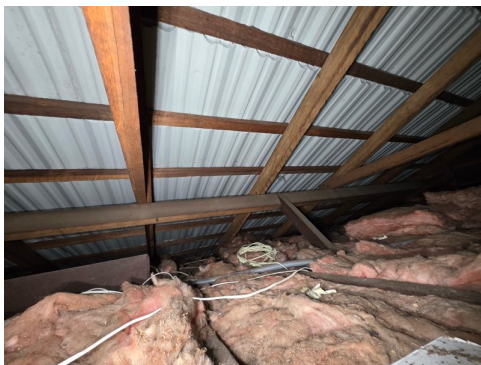
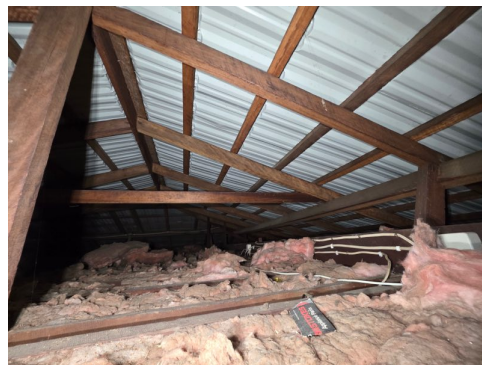
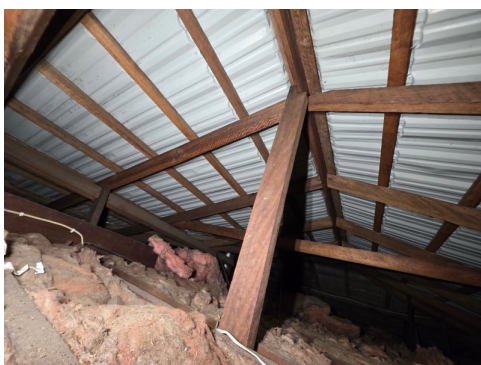
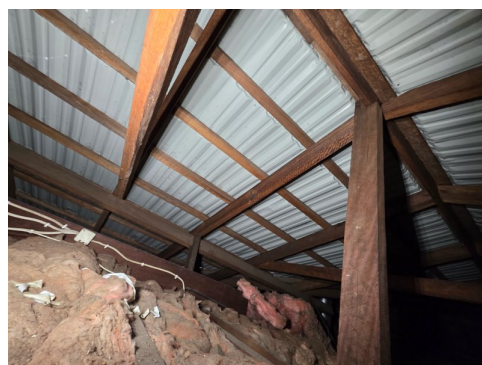
Finding: Additional Photos - Roof void

Information: Additional photos are provided for your general reference. Pictures were taken from the access hatch only. The roof void was not entered at the time of the inspection.

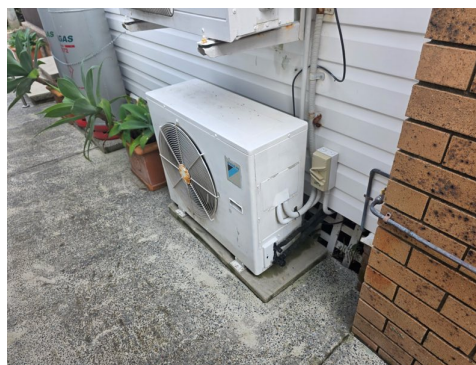
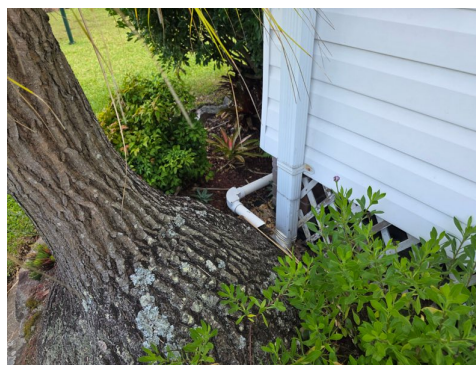
Information: The subfloor area could not be accessed at the time of inspection due to restricted access. Where areas cannot be entered or viewed, their condition cannot be confirmed and defects may be present but not visible during a visual, non-invasive inspection.

Access should be improved to allow inspection during future building and timber pest inspections.

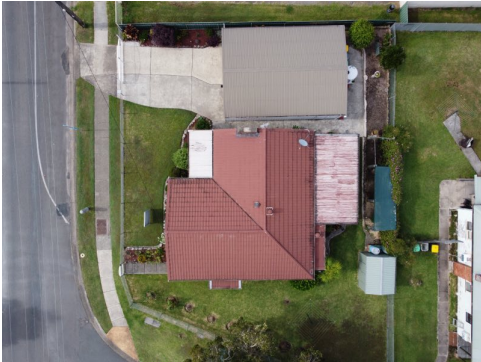
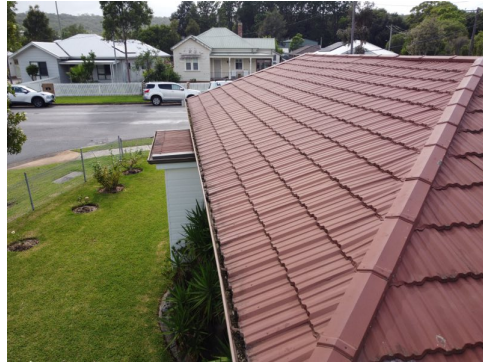
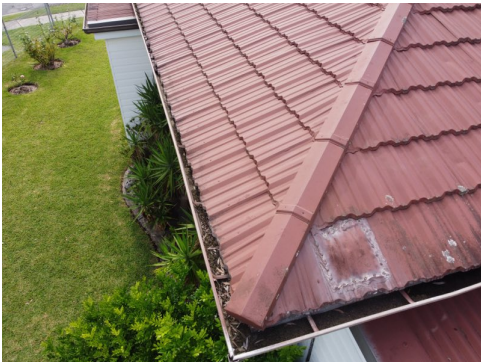
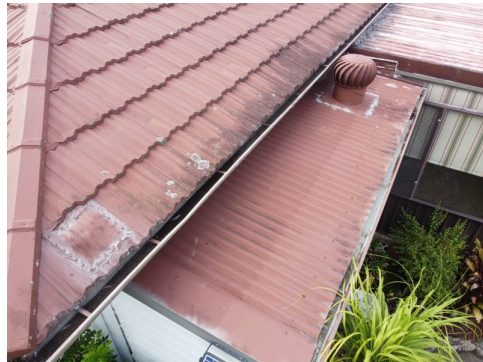
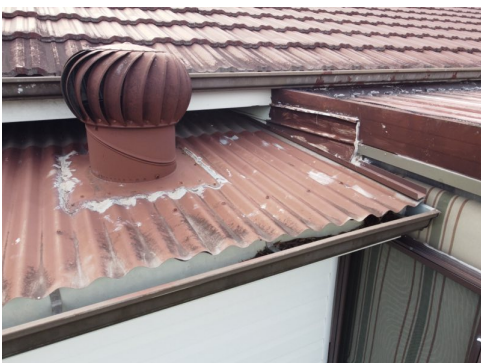
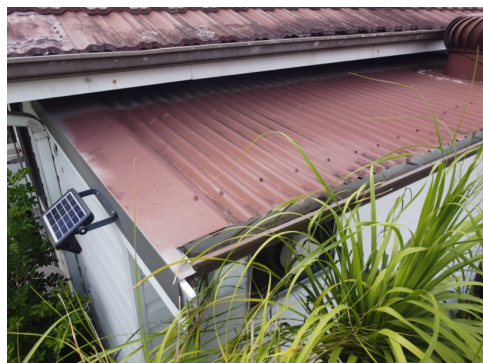
Finding: Additional Photos - Roof Exterior

Information: Additional photos of the roof exterior are provided for your general reference

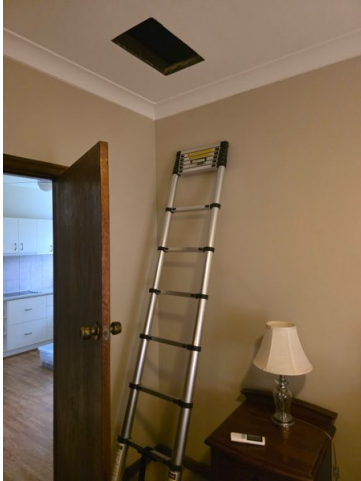
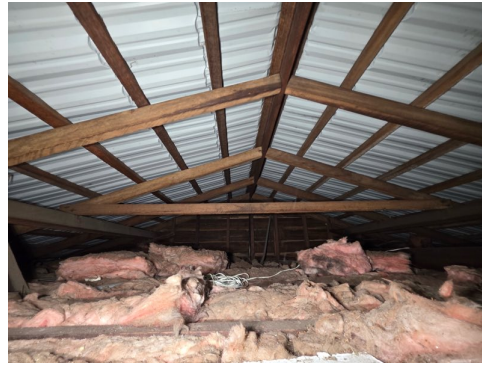
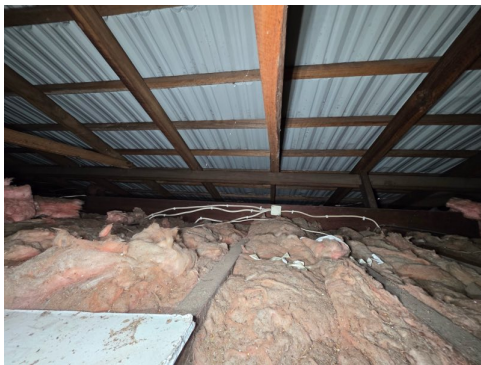
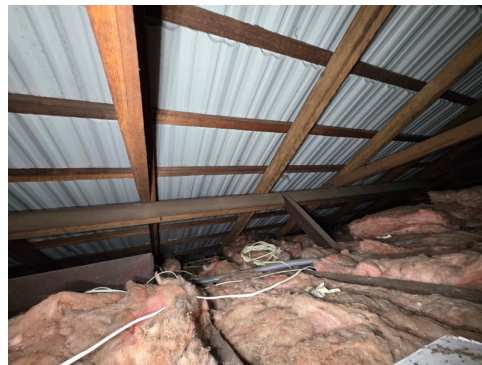
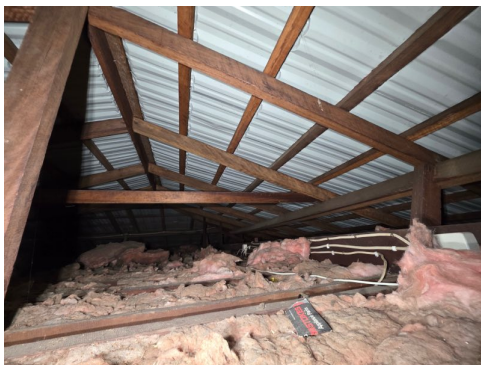
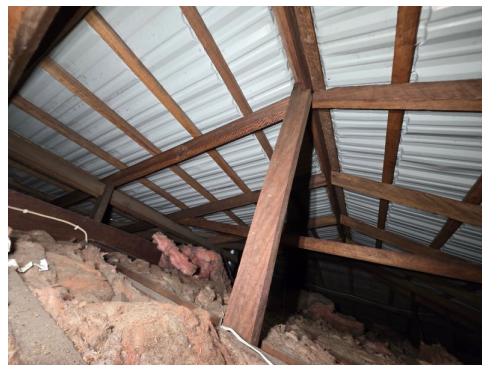
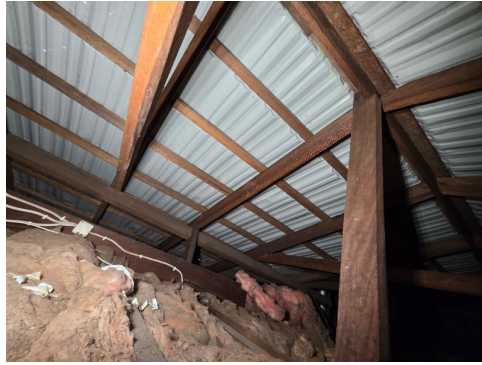
Finding: Additional Photos - Roof Void

Information: Additional photos of the roof void are provided for your general reference
