Building Inspection Report

Inspection Date: Fri, 6 Mar 2026

Property Address: 25 Highfielde Ave, Berwick VIC 3806,
Australia

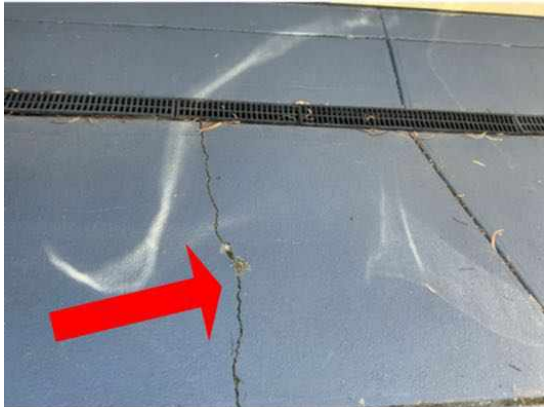
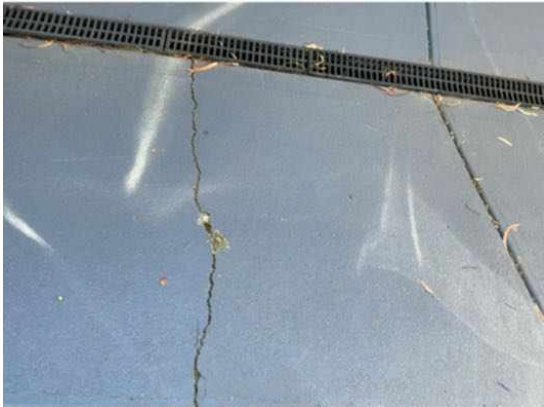
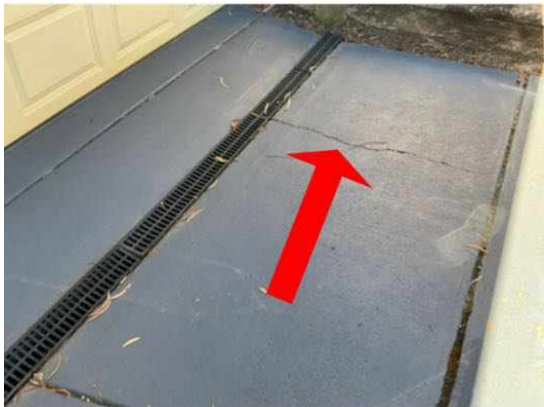
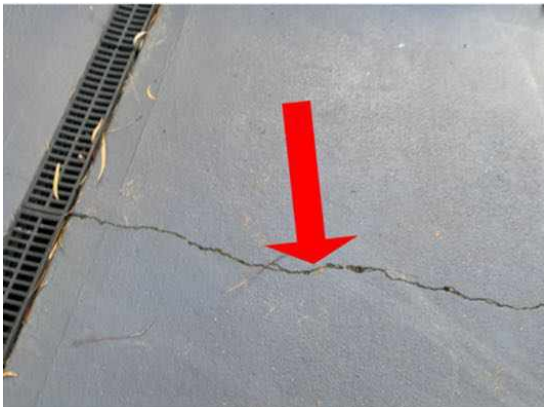
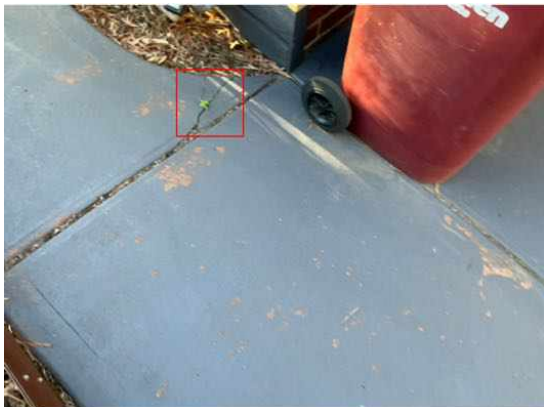
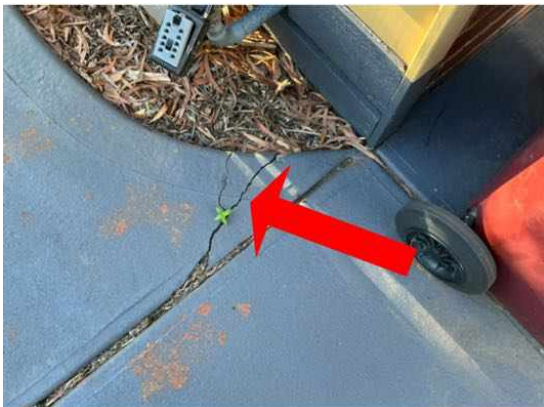
Defects 3.01

Building:	Main Building
Location:	All External Areas
Finding:	Cracking - External Concrete Paving and Driveway Damage Category 2 - Distinct (less than 3mm)
Information:	Distinct cracks were identified in external concrete paving and driveway. Distinct cracks are generally found in older concrete paving, and may also present as a trip hazard as consequence of an uneven or curved surface.

General age and expected deterioration of the paved areas is a common cause of this type of cracking. However, expansion and contraction of the slab may also have occurred due to environmental factors. Such factors include variable moisture and weather conditions, the presence of trees and their roots having a settling or lifting affect on the soil, or the effect of load bearing, e.g. heavy vehicles over a sustained period of time.

Cracking to this degree may also be due to poor original installation of the concrete. Factors such as poor compaction of the sub surface and/or inadequate reinforcing of the slab may create cracking and other secondary defects.

Repairs are likely to be required to prevent further cracking and to reduce hazards associated with cracking, such as tripping. Monitoring of all cracking should be conducted frequently. Always contact a building inspector should cracks widen, lengthen, or become more numerous.

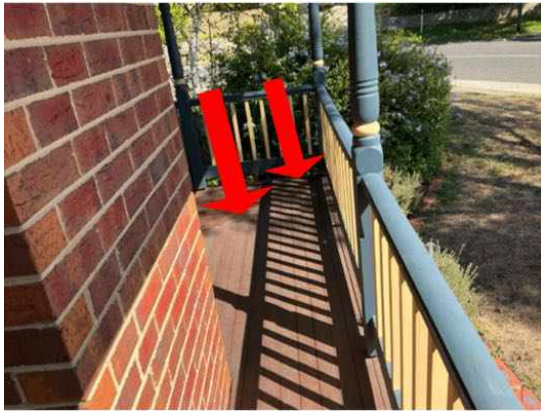
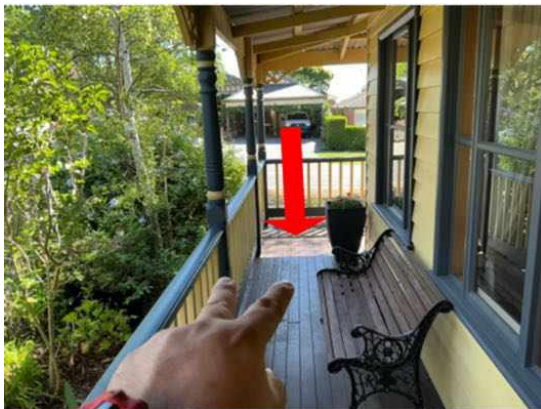
Defects 3.03

During the inspection, several sections of the timber decking at the front veranda were observed to exhibit noticeable movement or bounce underfoot when walked upon.

Movement of this nature may indicate that the decking boards or the supporting structural members beneath, such as joists or bearers, may be inadequately supported, loose, or potentially deteriorated. In some cases, this condition may also be associated with timber decay or failure of the supporting elements beneath the decking.

It is recommended that a licensed carpenter be engaged to further investigate the affected areas. This may involve lifting selected decking boards to inspect the underlying structural members and confirm whether adequate support is present. Any deteriorated timber, loose fixings, or insufficient structural support should be repaired, reinforced, or replaced as required to restore the stability of the veranda decking.

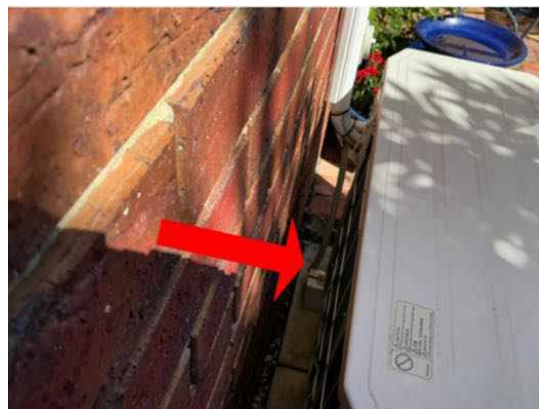
Defects 3.04

Information: Upon inspection, it was found that the AC overflow is not plumbed or connected to

suitable drainage. This could lead to the surrounding area becoming excessively damp, which in turn may cause secondary defects such as rot, rust, corrosion of associated building elements, and the formation of fungal decay. In addition, prolonged damp conditions could create potential slip hazards. Poor site drainage may exacerbate the issue, potentially attracting termite activity to the area.

We recommend that a licensed plumber be appointed to properly plumb the AC overflow and connect it to suitable drainage. This will help ensure that the area remains dry and free from secondary defects.

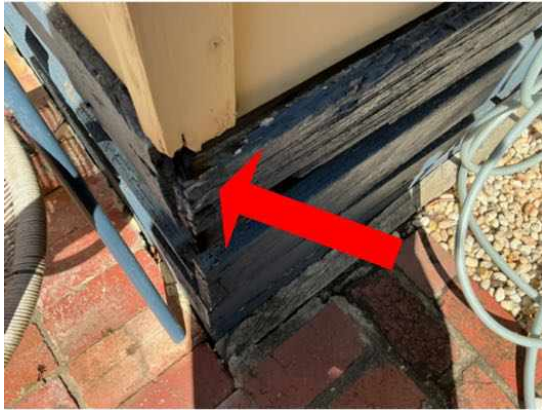
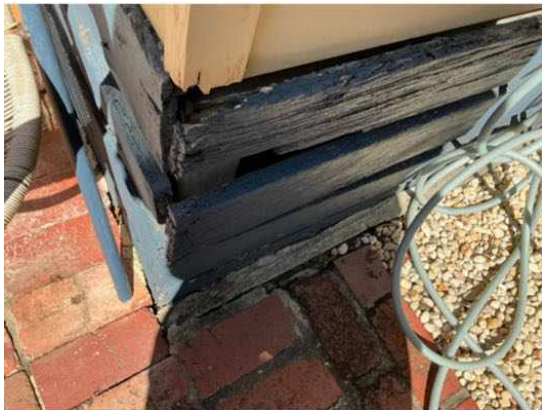
Defects 3.05

Building: Main Building
 Location: All External Areas
 Finding: Timber Rot to Plinth Boards Around the Dwelling
 Information:

Sections of the timber plinth boards around the perimeter of the dwelling were observed to be showing signs of timber rot and deterioration at the time of inspection.

Timber rot typically occurs when timber elements are exposed to prolonged moisture or weathering, which can lead to loss of structural integrity and progressive deterioration if left untreated. Decayed plinth boards may also create conducive conditions for timber pest activity.

It is recommended that a licensed carpenter be engaged to assess the condition of the affected plinth boards and replace any deteriorated sections as necessary. Any new timber installed should be appropriately treated and protected to minimise future moisture exposure and deterioration.

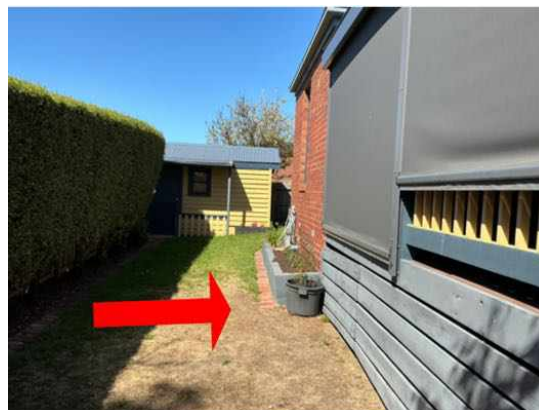
Defects 3.06

Building:	Main Building
Location:	All External Areas
Finding:	Site drainage - Inadequate
Information:	The site drainage in the yards was found to be inadequate at the time of inspection, creating potential for subsequent water damage to associated building elements.

It is important that water does not lie against the base of walls; surrounding paths and ground levels should be sloped to drain water away from walls. Downpipes should not discharge stormwater onto lower walls or plinths. Stormwater should be carried away by large, regularly cleaned drains. Ground levels may need to be lowered to expose a buried DPC.

Where site drainage is inadequate, installation of an Agricultural (Aggie) Drain may be required. A qualified plumber should be appointed to further inspect the property and perform any remedial works as necessary. Water damage and secondary defects are likely to occur if left unmanaged.

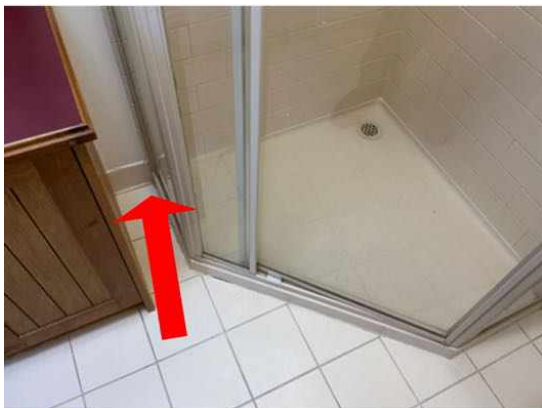
Defects 3.08

Building:	Main Building
Location:	Ensuite - Master
Finding:	Shower screen - Leaking
Information:	Leaking was evident to the ensuite's shower screen at the time of inspection. It is suspected that the leaking has occurred as a result of deteriorated or missing caulking to the shower or general ageing of the building elements.

Leaking from the shower where left unattended, is likely to lead to water damage to adjoining flooring and walls. Such damage can lead to water damage and necessitate extensive remedial works being required. Active water leaks may also create an environment that is susceptible to the formation and development of mould.

Appointment of a caulking contractor is required to repair or replace the caulking to the shower area. Such works should be performed as soon as possible to ensure that no further damage occurs.

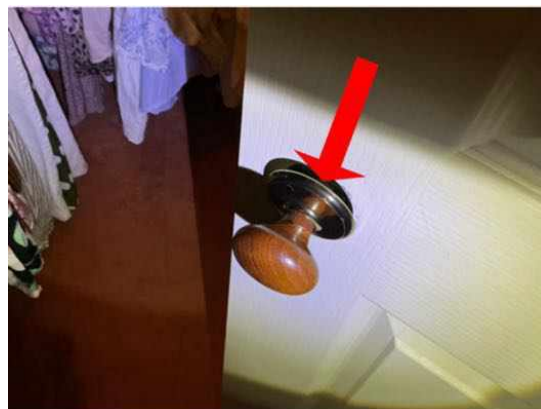
Defects 3.09

Building:	Main Building
Location:	Walk-In Robe - Master
Finding:	Loose Door Handle

Information: Upon visual inspection, we found that the WIR door handle was slightly loose and exhibited some movement when operated from both the interior and exterior sides. This condition may worsen over time with continued use, potentially leading to difficulty in operating the door or further mechanical failure. We recommend that a licensed carpenter or handyman be engaged to tighten or adjust the door handle to ensure secure and reliable operation.

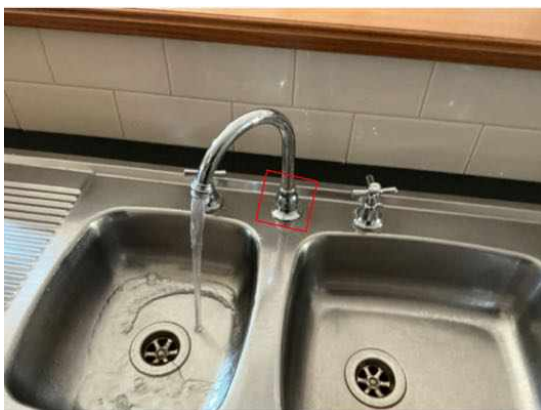
Defects 3.11

Information: The kitchen tap shows evidence of water hammer being present. Water hammer, a pressure surge resulting when a fluid is forced to suddenly change direction, is a common defect in plumbing fittings, particularly those that are aged and not frequently maintained. Water hammer is generally caused by factors that create high water pressure in the affected plumbing fixture, usually evidenced by a faint banging noise during operation of the affected tap.

Although water hammer is generally considered to be a minor defect, subsequent damage such as erosion of tap hardware and/or water damage to associated building elements is likely to occur if left unmanaged.

A licensed plumber should be appointed as soon as possible to replace any affected tap hardware and perform any remedial works as necessary. Please be advised that the appointment of a cabinet maker or qualified carpenter may be necessary if water damage to associated building elements has occurred.

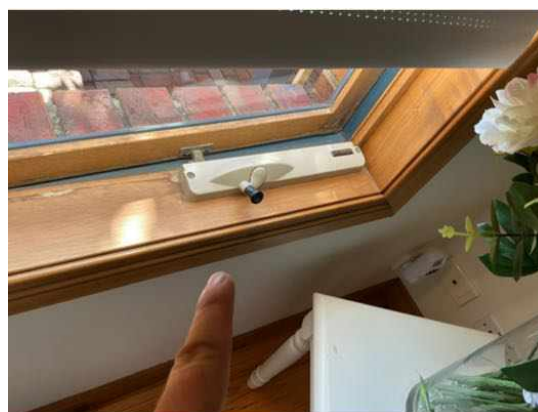
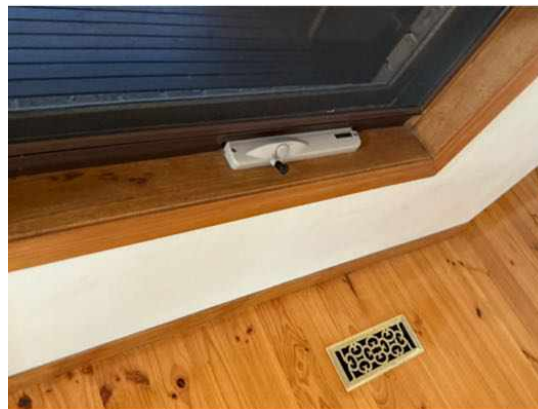
Defects 3.12

Location: All Internal Areas
 Finding: Windows - Stiff to slide
 Information: Several windows throughout the property were jammed and difficult to operate at the time of the inspection. Windows provide ventilation to the adjoining area and should be at a fully operational level to ensure user comfort. Restricted function of the window may also pose as a potential safety hazard if required for emergency egress from the building.

Generally, factors such as general age of the building element and a lack of maintenance are the usual causes for this type of defect.

Replacement of window hardware or frame may be required, as well as minor repairs and cleaning. A registered builder or general handy person will be required to repair the affected windows.

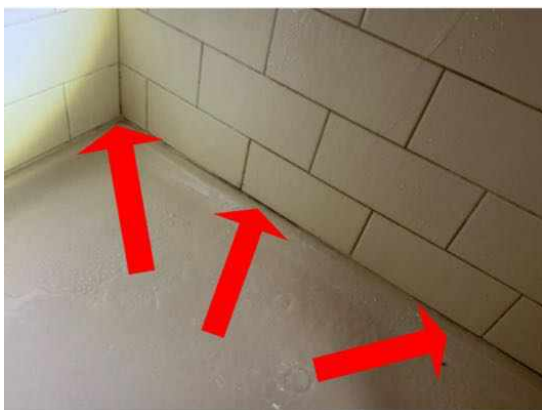
Defects 3.13

Building: Main Building
 Location: Bathroom 2
 Finding: Sealant and grouting - Deteriorated
 Information: It was noted on inspection that sealant or grout is degraded to the tiled shower alcove and or other areas of the bathroom.

Different materials and floor areas move at different rates, generally causing cracking to grout or sealant at this point. A flexible sealant is required to allow for expected expansion and contraction, while keeping the joint water tight and protective of all associated building materials.

Flexible and mould resistant materials should be applied to affected areas to prevent any subsequent water damage that is likely to occur. Regular maintenance and replacement of damage or missing or damaged sealant and grout is highly recommended to the wet areas, as this is a regular wear and tear defect. Sealant and grouting in areas that come into regular contact with water should be maintained for the long term care of your property.

A sealant specialist or tiling contractor should be appointed to complete these works as soon as possible

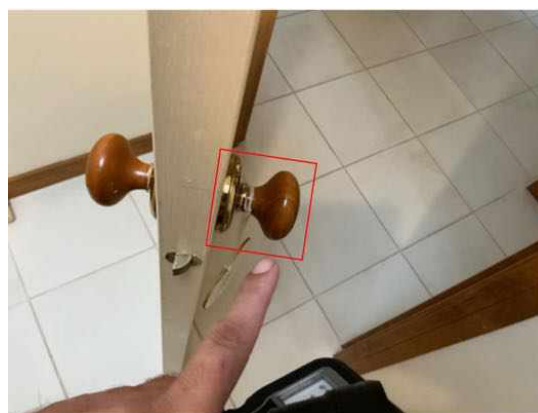
Defects 3.14

Building:	Main Building
Location:	Bathroom 2
Finding:	Loose Door Handle
Information:	Upon visual inspection, we found that the 2nd bathroom's door handle was slightly loose and exhibited some movement when operated from both the interior and exterior sides. This condition may worsen over time with continued use, potentially leading to difficulty in operating the door or further mechanical failure. We recommend that a licensed carpenter or handyman be engaged to tighten or adjust the door handle to ensure secure and reliable operation.

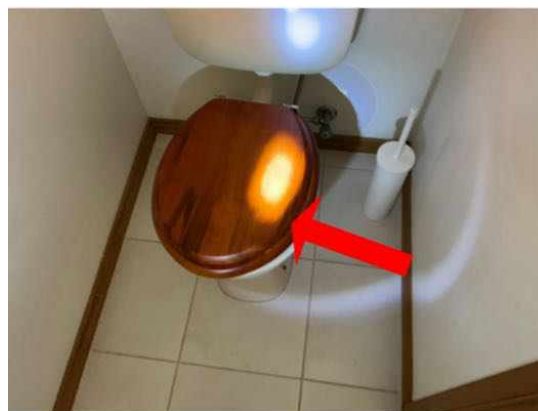
Defects 3.15

Building:	Main Building
Location:	Toilet (WC)
Finding:	Toilet seat - loose
Information:	The toilet seat was found to be loose and shifting during use at the time of inspection. This defect likely developed due to wear and tear of the seat's fixing hardware. However, it may also be the result of improper installation or accidental impact.

If left unaddressed, the loose toilet seat could worsen, leading to potential damage to the mounting points or discomfort for users. In some cases, further instability may lead

to minor injuries or increased wear on the toilet bowl.

It is recommended that the toilet seat be properly refastened or replaced by a licensed plumber to ensure safe and stable use.

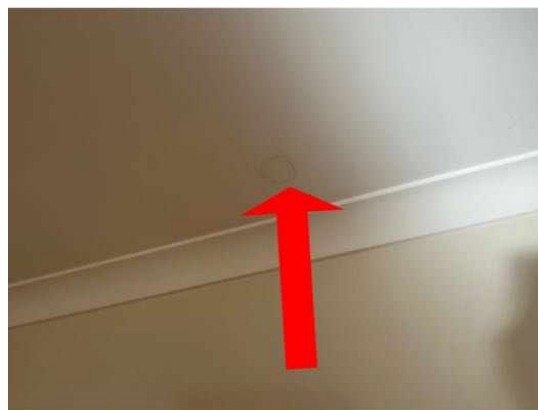
Defects 3.16

Building:	Main Building
Location:	Family Room
Finding:	Ceiling - Water stained
Information:	Water staining to ceiling linings in the family room was evident at the time of inspection. Water staining indicates that surfaces have been exposed to excessive moisture over time. The minerals and other elements in the water lead to staining, which may graduate to corrosion and deterioration if left unmanaged.

While mostly an appearance defect, water staining can be indicative of more serious defects, which may be currently concealed by interior ceilings.

Where water staining is active, a licensed plumber must be consulted to identify the cause of the staining and to provide advice on any reparation works that may be required. Replacement of any damaged structures is advised.

Conversely, where water staining is old and inactive, affected building materials may be repaired or replaced at client discretion.

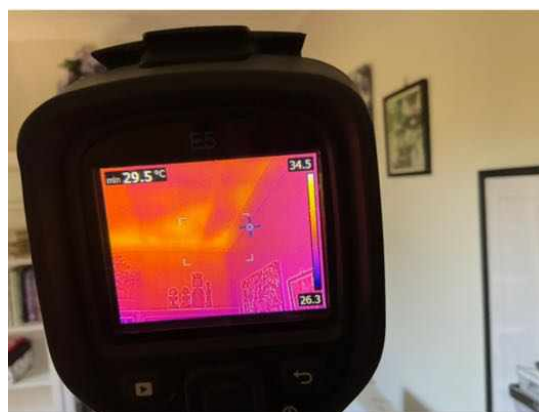
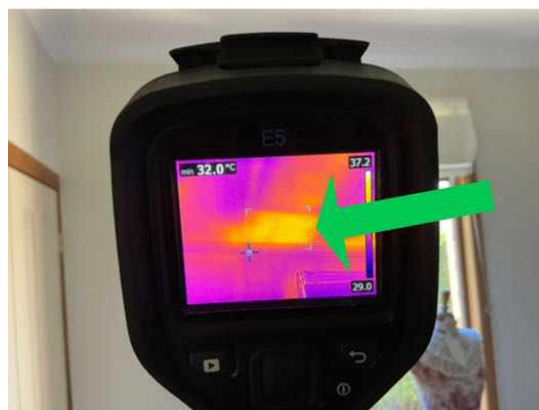
Defects 3.19

Building:	Main Building
Location:	All Internal Areas
Finding:	Inconsistent Thermal Performance to Ceiling Areas – Suspected Insulation Deficiencies
Information:	Thermal imaging conducted to internal ceiling areas at the time of inspection identified inconsistent heat patterns, which are indicative of variations in thermal performance across the roof space. These patterns are commonly associated with areas of missing, displaced, or insufficient insulation above the ceiling linings.

Inadequate or uneven insulation coverage can reduce the energy efficiency of the dwelling, contribute to heat loss in cooler periods and heat gain in warmer conditions, and may result in reduced occupant comfort and increased heating and cooling costs. Due to the non-invasive nature of the inspection, the exact extent and condition of insulation could not be confirmed visually in all affected areas.

It is recommended that a qualified insulation contractor inspect the roof space, assess insulation coverage and condition, and top up or reinstate insulation where required to achieve consistent thermal performance throughout the property.

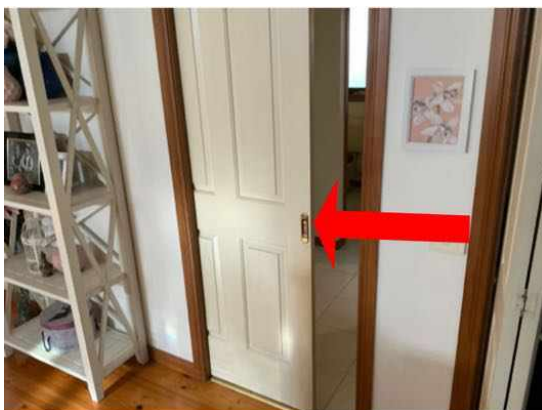
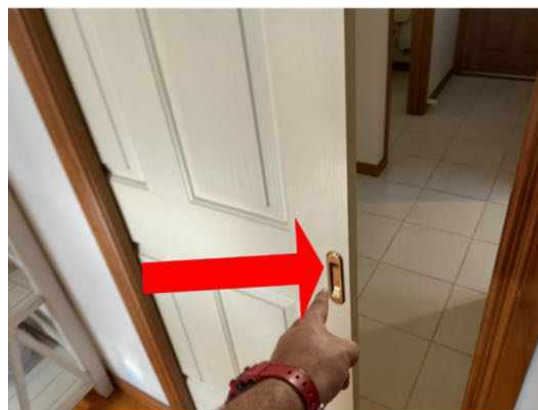
Defects 3.20

Building:	Main Building
Location:	Hallway 2
Finding:	Door - stiff to slide
Information:	The sliding door to rear bathroom hallway was difficult to operate at the time of inspection. This is likely due to damaged wheels which help the door to operate in a smooth fashion.

Doors provide ventilation and exits to the adjoining area and should be at a fully operational level to ensure user comfort and safety. Restricted function of the door may also pose as a potential safety hazard if required for emergency egress from the building.

Generally, factors such as general age of the building element and a lack of maintenance are the usual causes for this type of defect.

Replacement of door running hardware may be required, as well as minor repairs and cleaning. A registered builder or general handy person will be required to repair the sliding door.

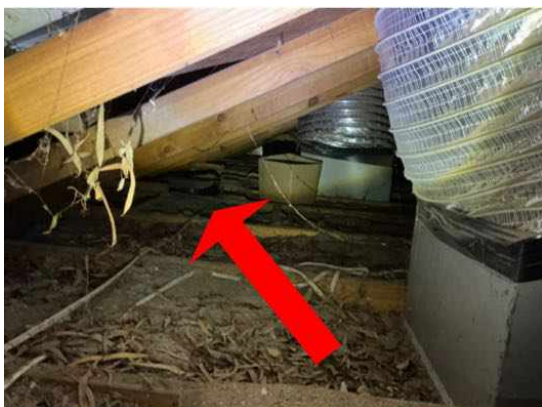
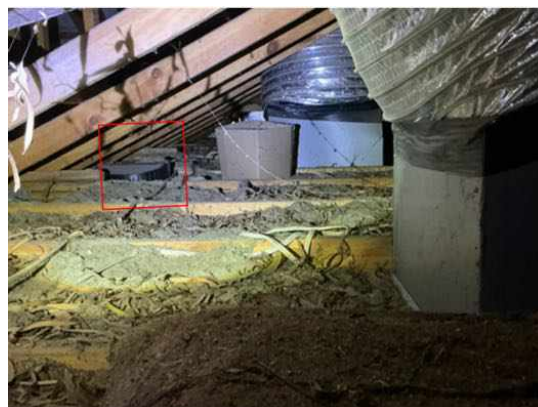
Defects 3.21

Building:	Main Building
Location:	Roof Void
Finding:	Bathroom Exhaust Fans Not Ducted to External Atmosphere
Information:	The exhaust fans installed in the bathrooms were observed to be discharging directly into the roof cavity rather than being ducted to the external atmosphere. This configuration does not comply with best practice ventilation standards, as it allows moist air to accumulate within the roof space.

Prolonged moisture build-up in the roof cavity can lead to elevated humidity levels, which may contribute to mould growth, timber decay, and potential damage to insulation or other roof components over time.

It is recommended that a licensed ventilation specialist or electrician be engaged to install compliant ducting that vents the exhaust air to the outside of the building, in accordance with current building regulations and ventilation standards.

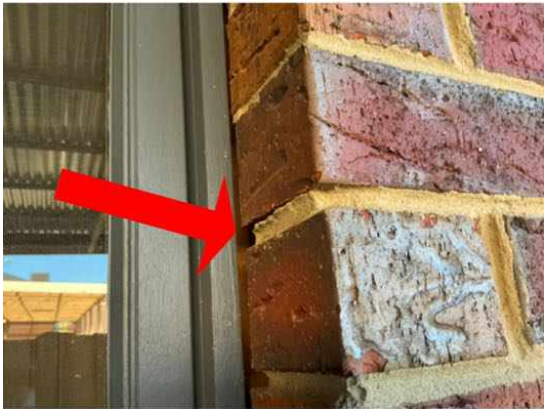
Defects 3.22

Building: Main Building
Location: All External Areas
Finding: Window seals - deteriorated
Information: The window seals have deteriorated and are in a generally poor condition. Due to frequent exposure to weather conditions and subsequent moisture, deterioration of window seals is expected in a property of this condition and age.

Where window seals have deteriorated, the window is no longer weather-tight; rain penetration and subsequent water damage is therefore likely to ensue. Insulation of the area against external weather conditions will also be compromised.

It is recommended that all deteriorated window seals be replaced by a general handyman or sealant expert to prevent any further damage and to restore the window to a fully functional level.

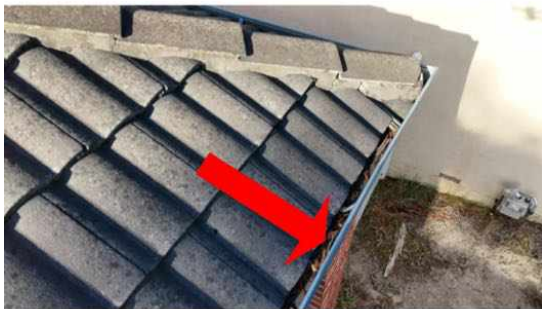
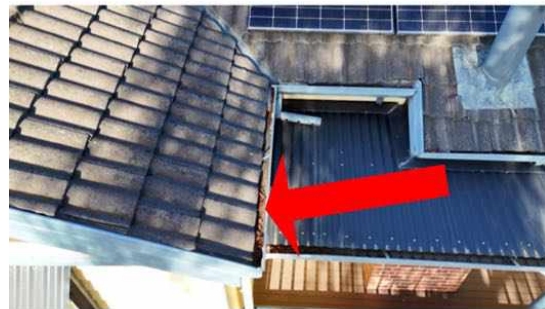
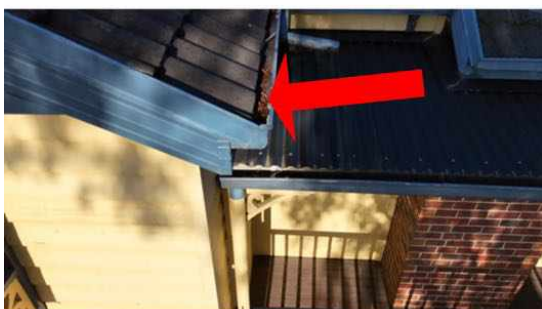
Blocked gutters are likely to lead to high levels of moisture in the affected areas. Such moisture will not only cause rust and decay of the associated building materials, but can also provide conditions that are conducive to termite and timber pest activity. Blockages in gutters should therefore be removed immediately to ensure dry conditions are maintained.

Consult a Licensed Plumber for further specific advice on remedial works that may be required. In the interim, it is highly advised that blocked gutters be removed by the homeowner or a general handyperson as a matter of urgency.

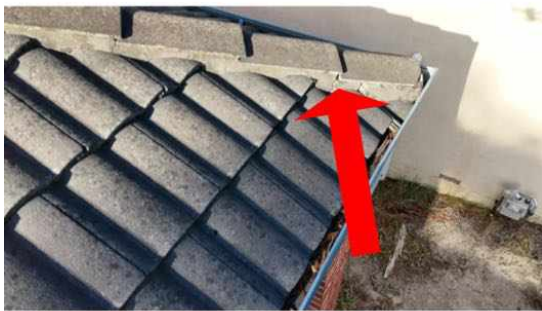
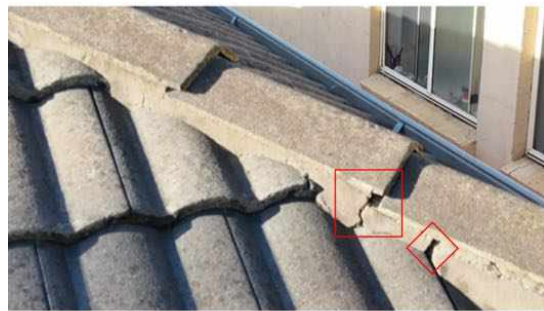
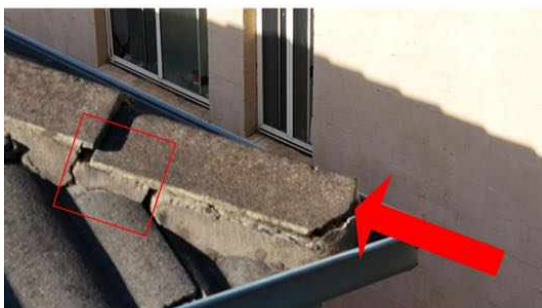
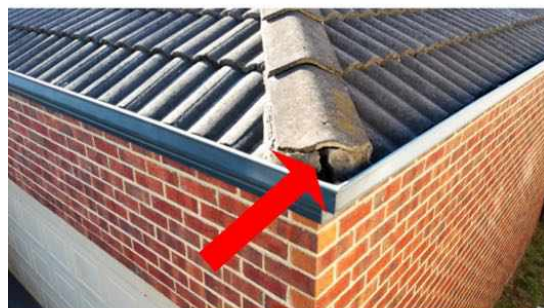
Defects 3.26

Where left unmanaged, deteriorating roof tiles are likely to lead to a number of secondary defects, including minor water leaks and weather exposure to internal roofing structures.

Consultation with a roofing contractor is highly advised to gain advice on cost of remedial works that may be required in the short to medium term. Remedial works are likely to increase the longevity of the exterior roofing structure.

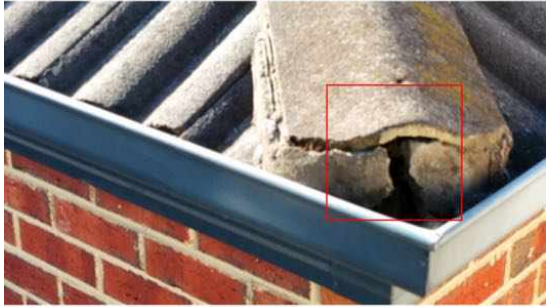
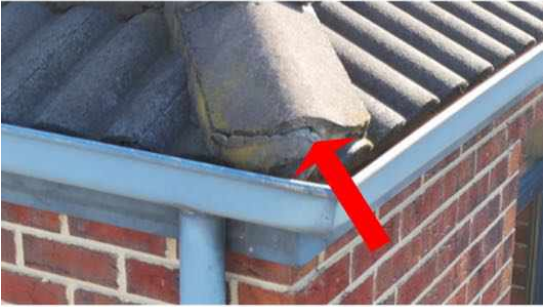
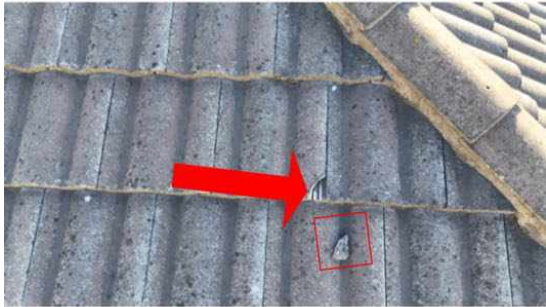
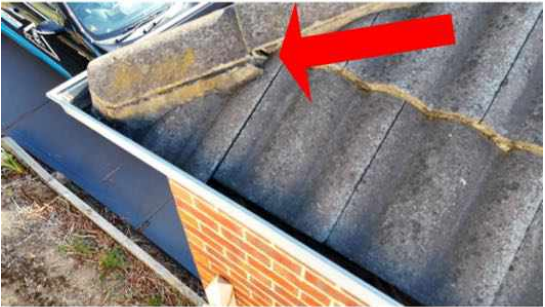
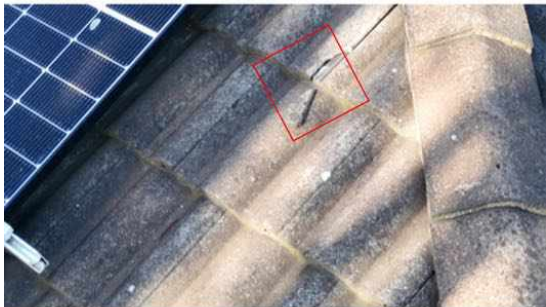
Information: Upon inspection of the exterior roofing, the majority of roof tiles were considered to be in a fair condition. While weathering of the tiles is consistent with the age of the property, maintenance works are required.

Isolated areas of mortar have come loose in the valleys and minor cracking is also present. Re-pointing and re-sealing the may be considered as an interim solution by the client to help preserve and extend the life span of the tiles.

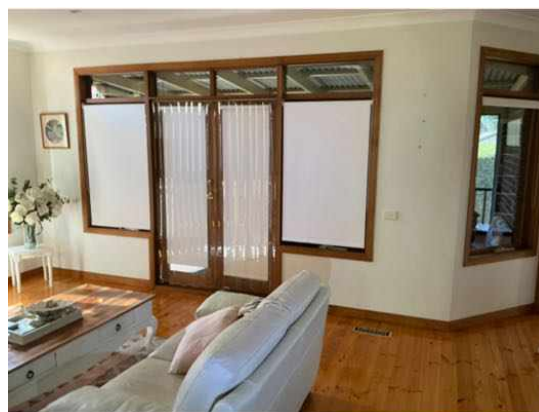
Building: Main Building
Location: All Internal Areas
Finding: Obstructions and Limitations - Interior
Information: These photographs are an indication of the obstructions and limitations which impeded the inspection of the internal areas of the property at the time of inspection. These obstructions can hide an array of defects and should be removed to allow full inspection to be carried out. A re-inspection is recommended once the areas are made accessible.

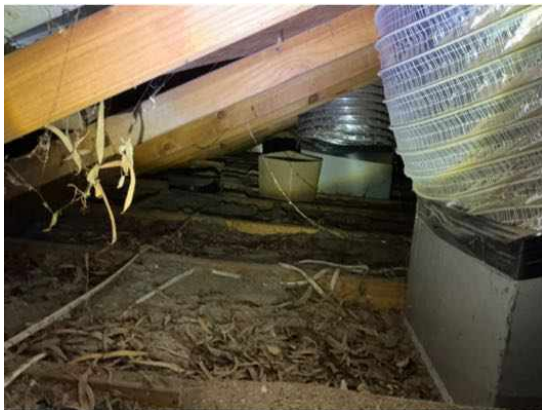
Finding: Obstructions and Limitations - roof cavity

Information: These photographs are an indication of the obstructions and limitations which impeded the inspection of the roof cavity area of the property at the time of inspection. These obstructions can hide an array of defects and should be removed to allow full inspection to be carried out. A re-inspection is recommended once the areas are made accessible.

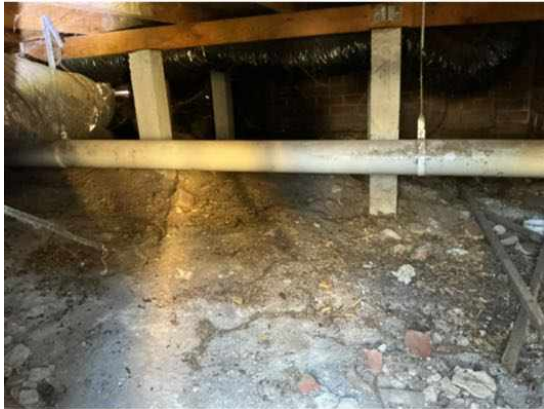
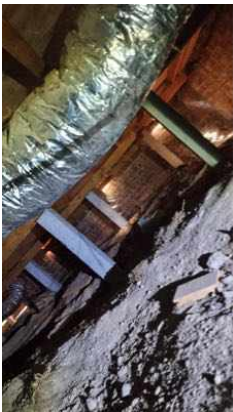
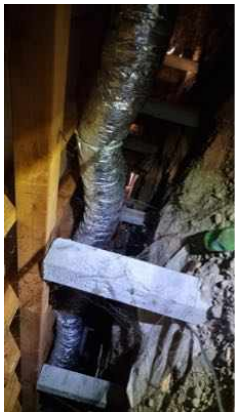
Building: Main Building
Location: Subfloor
Finding: Obstructions and Limitations - subfloor
Information: These photographs are an indication of the obstructions and limitations which impeded the inspection of the subfloor area of the property at the time of inspection. These obstructions can hide an array of defects and should be removed to allow full inspection to be carried out. A re-inspection is recommended once the areas are made accessible.
