Building and Timber Pest Inspection Report

Inspection Date: Wed, 11 Mar 2026

Property Address: 15 Melville Ct, Mount Coolum QLD 4573,
Australia

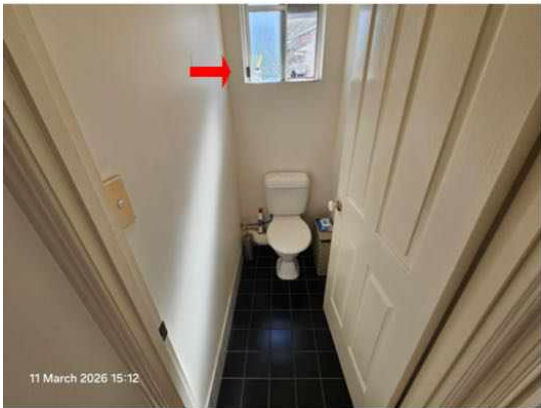
Finding 3.02

Building: Main Building
Location: As shown
Finding: Window sill / reveal damage

Information: During the inspection moisture damage was noted in the plastered reveals of the windows shown.

It is not uncommon for this type of finish to be affected in building close to the coast. It was also noticeable that the moisture is affecting the metal external plaster angle.

This should be monitored and there is no change in the reveal appearance, a licensed plasterer or painter should be engaged to carry out the necessary repairs.

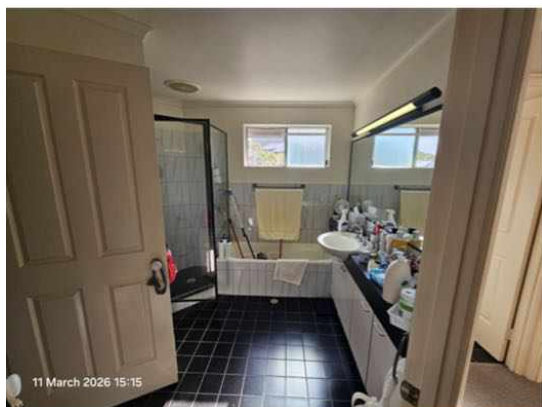
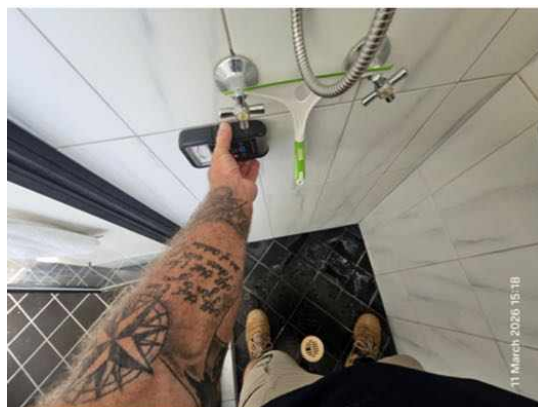
Finding 3.03

Building: Main Building
Location: Bathroom
Finding: Elevated moisture present at the time of inspection - bathroom
Information: Elevated moisture was noted in the lower tiled wall surfaces of the bathroom shower.

The levels varied at differing points throughout the recess. This could possibly be due to deteriorated grout and silicone sealants. These can break down over time and become porous, allowing moisture to enter the wall sheet surface behind the tiles. Some deterioration of the grout and sealant was noted. The opposite side of the showers wall could not be measured on the day due to obstructions.

Elevated moisture can attract timber pests and vermin, and produce conditions that promote timber pest attack, fungal growth and wood decay.

It is recommended that the moisture levels in these areas be monitored over time and the grout and silicone could be renewed to possibly eliminate any further moisture penetration.

A licensed tiler and / or sealant specialist could be engaged to renew these elements.

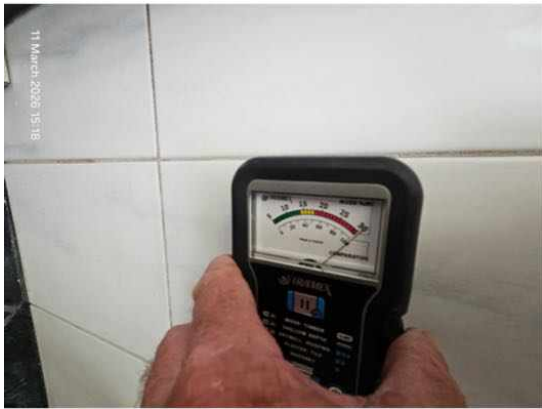
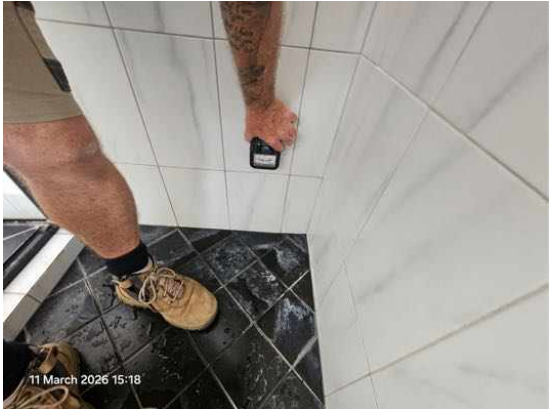
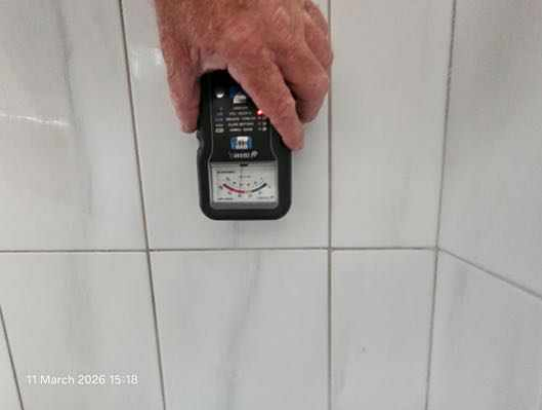
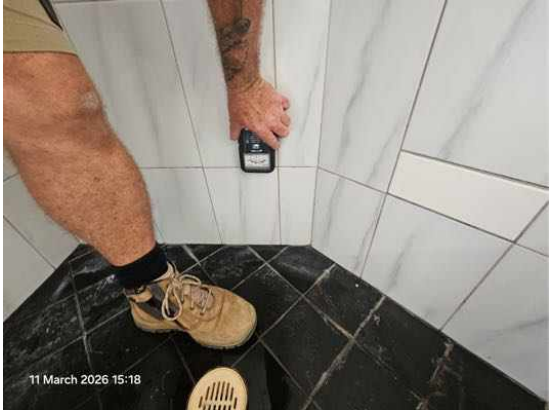
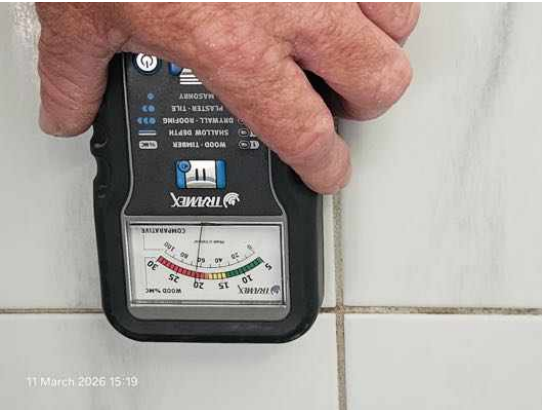
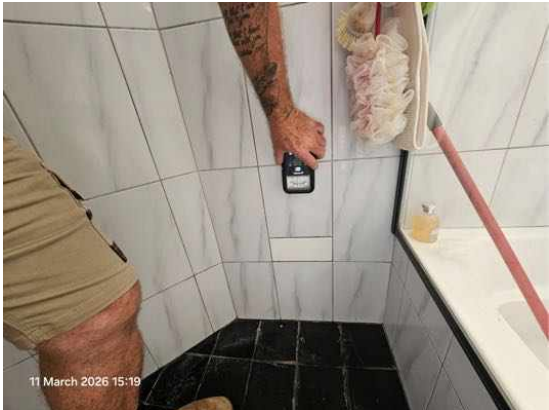
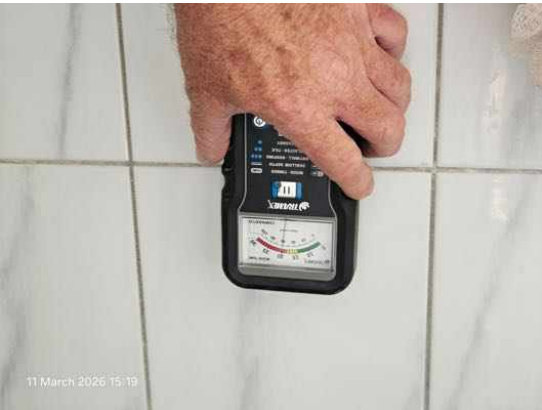
Finding 3.04

Building:	Main Building
Location:	As shown
Finding:	Tiles - Drummy
Information:	Drummy tiled areas were identified at the time of inspection. Please see the attached photos for locations.

The term 'drummy' refers to tiles that have become detached from their fixing, despite otherwise being in relatively good condition. Such defects are generally caused by physical or moisture damage to the area. Drummy tiled areas may also be a direct result of poor workmanship during the construction process.

Tiled areas may swell and shrink with changes in air humidity if the area has sustained moisture damage. Any exposure to moisture is capable of causing tiled areas to become drummy and/or cracked over a prolonged period of time. Drummy tiled areas generally require removal and replacement of affected tiles.

Specialist trades are available for these types of services. A licensed builder may be required to undertake works if damage is extensive or if secondary building defects have resulted. Otherwise, it is advised that a tiling contractor or a tile aggressive injection service may be appointed to perform works as necessary.

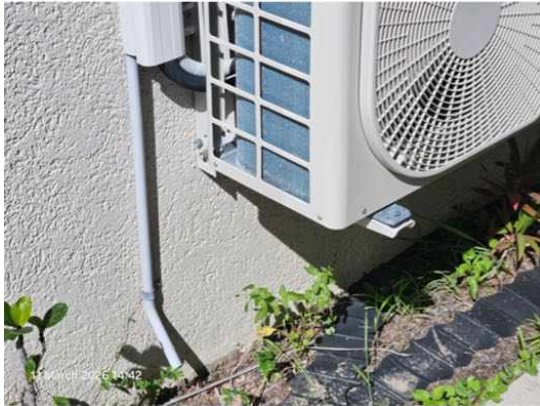
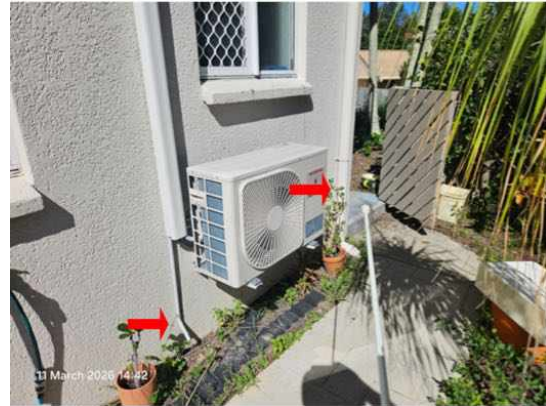
Building: Main Building
 Location: As shown
 Finding: Air conditioner - Disconnected drain
 Information: The Air Conditioner (A/C) overflow was found to be disconnected from storm water drainage and could create excessive moisture in the surrounding area.

Such leaking creates an environment which is conducive to an array of defects, including water damage to associated building elements and the attraction of termite or timber pest infestation.

It is recommended that a licensed plumber be appointed to connect the A/C overflow to a drainage source in order to prevent such an environment from being created. An alternative is to extend the overflow further into the garden away from the building

perimeter.

These minor works should be carried out in the short term.

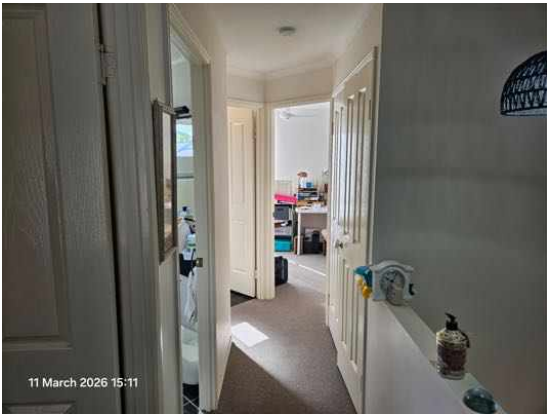
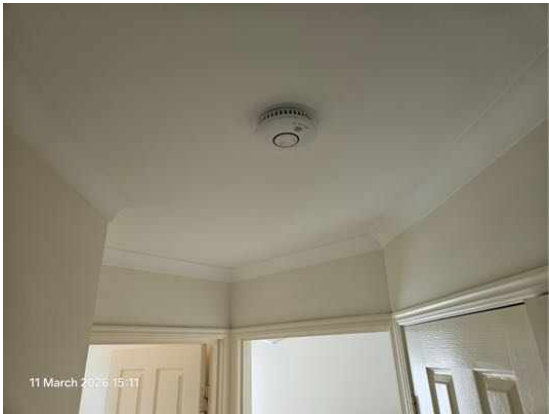
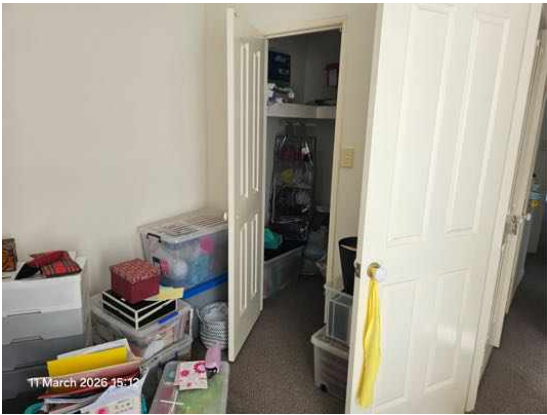
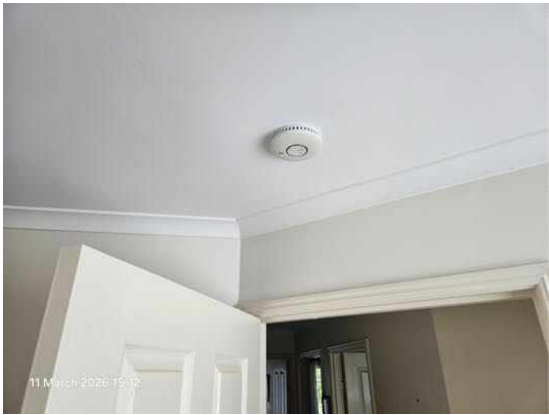
Noted Item

Building: Main Building
Location: All Areas
Finding: Additional Photos - Obstructions and Limitations
Information: These photographs are an indication of the obstructions and limitations which impeded full inspection of the property at the time of inspection. These obstructions can hide an array of defects and should be removed to allow full inspection to be carried out. A re-inspection is recommended once the areas are made accessible.

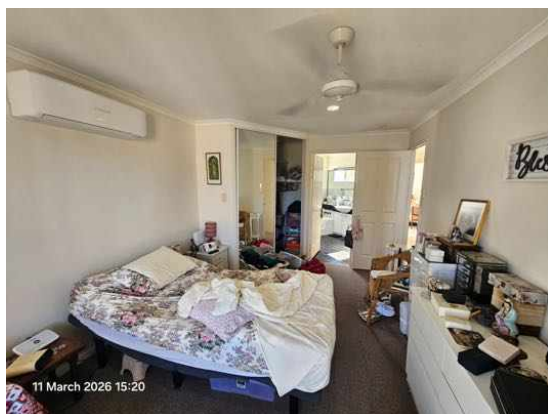
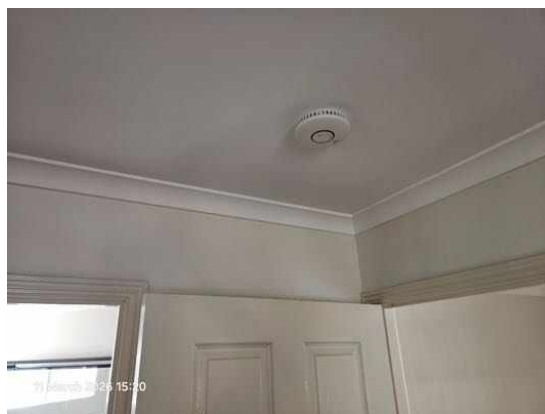
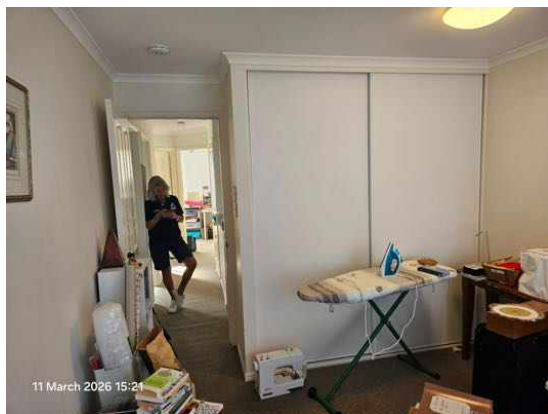
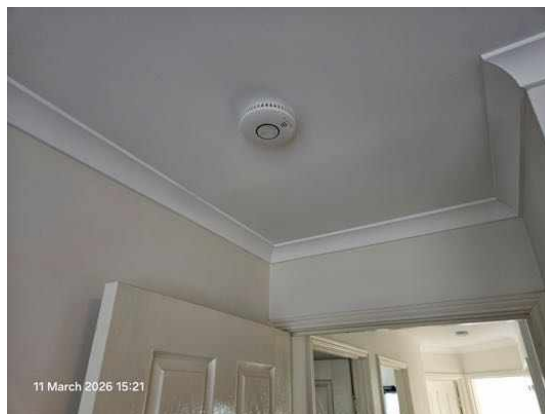
Avoid installing smoke alarms in dead air space. This is an area in which trapped hot air will prevent smoke from reaching the alarm. The space generally occurs at the apex of cathedral ceilings, the corner junction of walls and ceiling, and between exposed floor joists.
