Building and Timber Pest Inspection Report

Inspection Date: Wed, 25 Feb 2026

Property Address: 119A Cottenham Ave, Kingsford NSW
2032, Australia

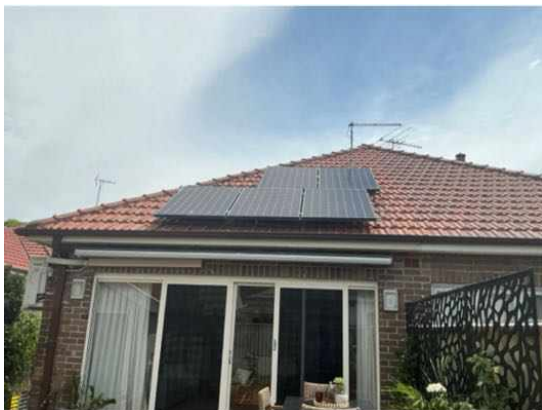
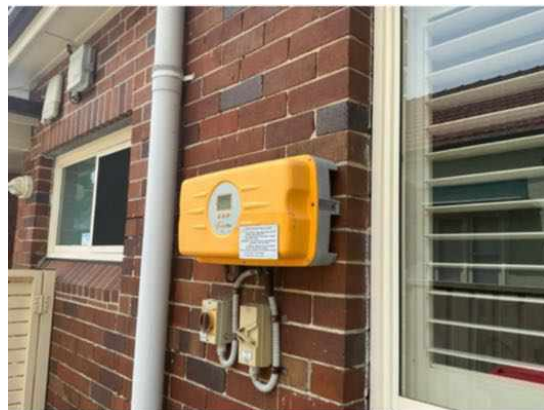
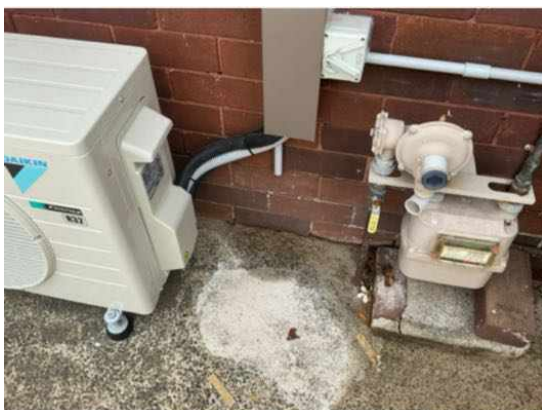
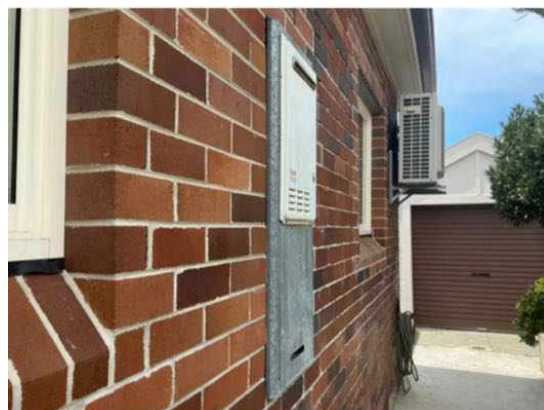
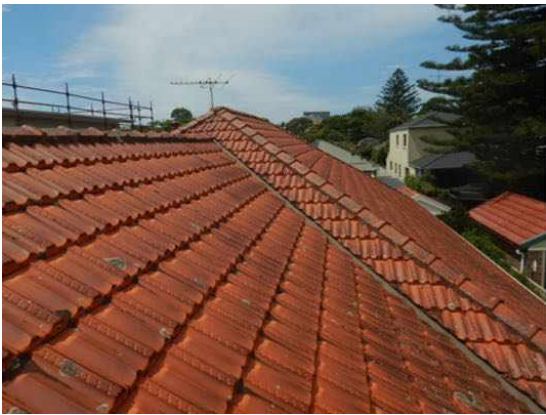
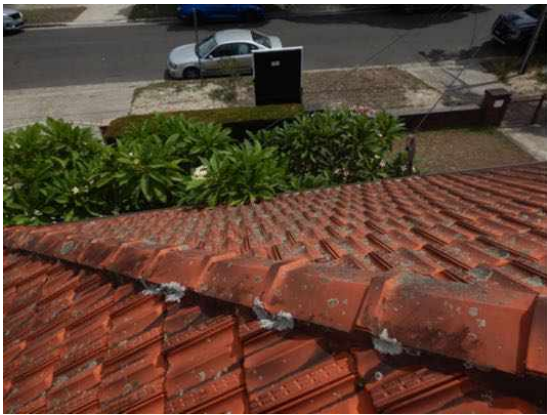
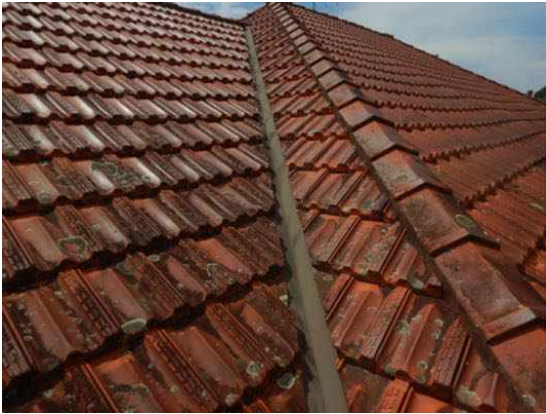
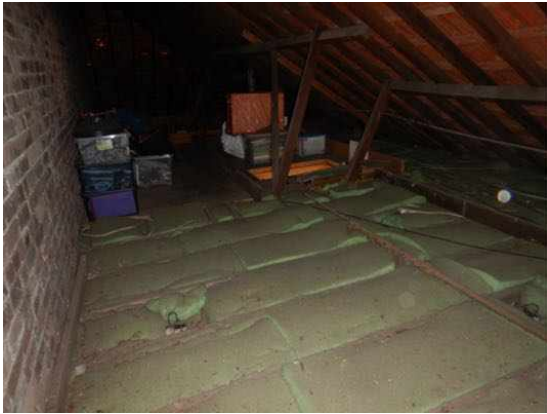
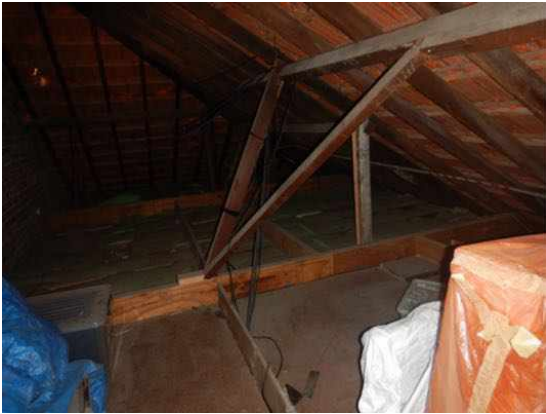
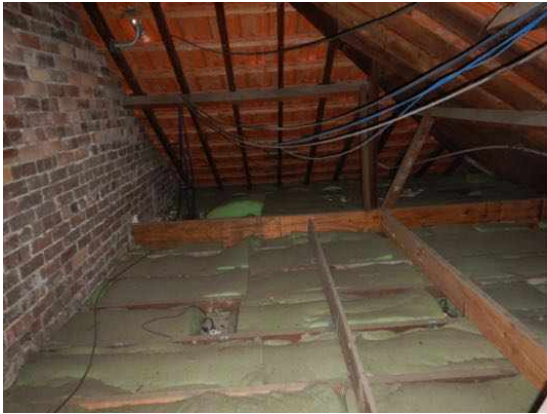
Some photos may also show obstructions and limitations which impeded full inspection of the property at the time of inspection. Additional photos also show other elements such as hot water systems, solar power systems, air conditioning units and RCD switches (electrical safety switches) on power boxes.

This property has insulation in the roof void as shown in the additional photos.
