# Building and Timber Pest Inspection Report

Inspection Date: Fri, 27 Mar 2026

Property Address: 43/59-61 Good St, Westmead NSW 2145,  
Australia

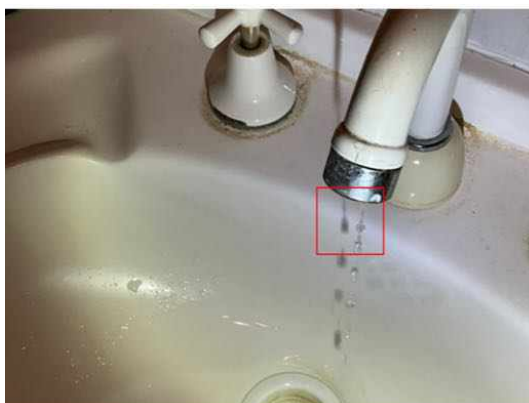
| Finding: | Washers - Degraded |
| Information: | The washers on the taps in this area appear to have degraded as a result of general ageing. Degraded washers generally result in slow, persistent leakage from taps and plumbing hardware. |

Replacement of washers will ensure that water wastage does not occur and that the persistent water leak does not result in secondary damage to surrounding structures. Such damage may range from rust and corrosion to damage of surfaces, e.g. bench tops, etc.

A qualified plumber should be appointed to replace degraded washers and to further inspect associated plumbing fixtures and fittings. Where water damage has occurred, a carpenter or cabinet maker may be appointed to replace affected building elements.

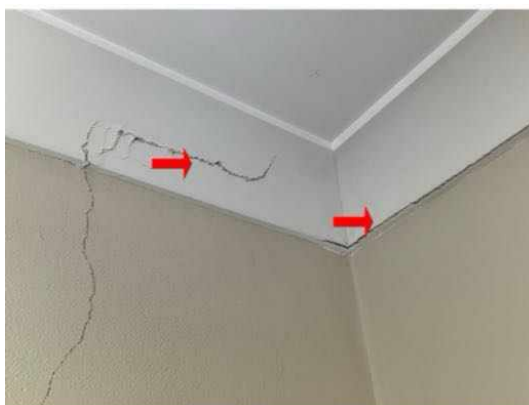
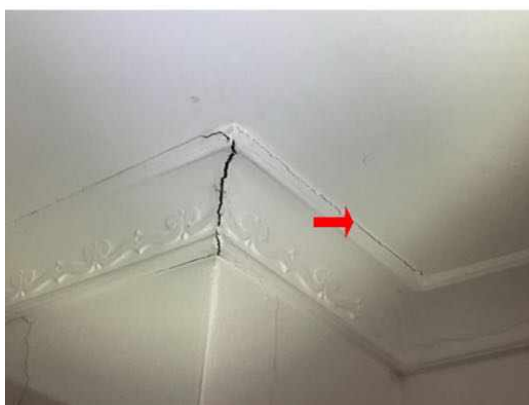
Cracking of this nature can generally be repaired with minor sanding, filling and/or repainting. Such works should be performed by a qualified painter or a general handyman.

Monitoring of all cracking should be conducted frequently. Always contact a building inspector should cracks widen, lengthen, or become more numerous.

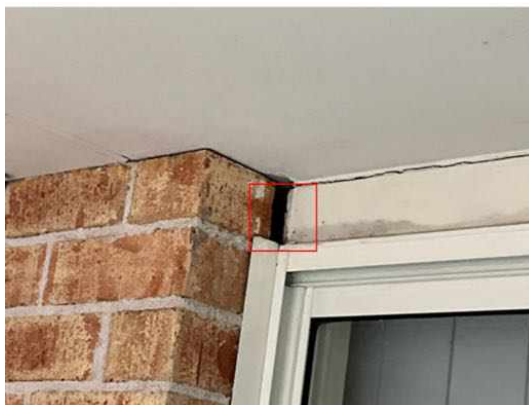
Beading is important in weatherproofing the surrounding building elements and preventing pest ingress. Furthermore, beading works to protect the joins of building materials, which are more susceptible to deterioration and decay.

Replacement of the beading is advised to ensure the protection and longevity of any associated building elements. Such works may be performed by a general handyperson or qualified carpenter.
