Building and Timber Pest Inspection Report

Inspection Date: Thu, 26 Feb 2026

Property Address: 231 A Sydney St, Grantham Farm NSW 2765, Australia

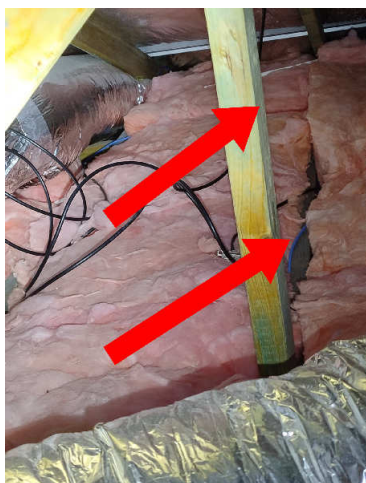
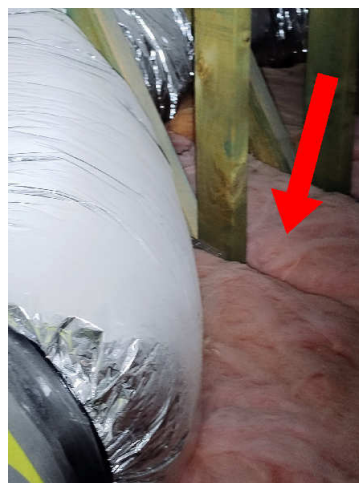
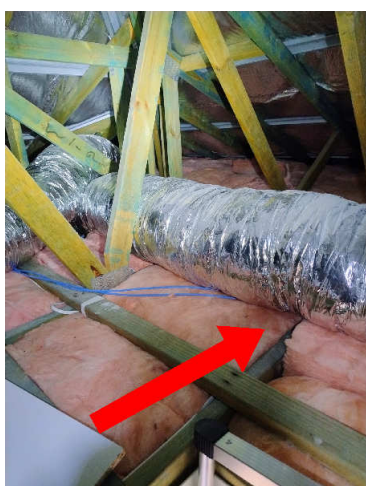
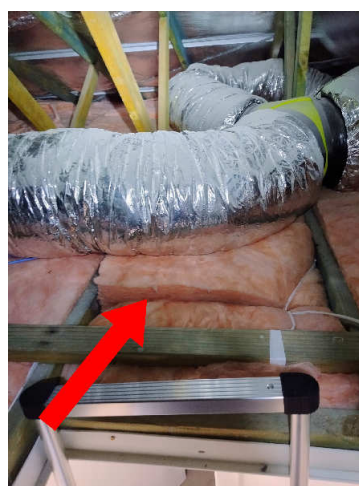
Information: Sections of insulation in the roof void have been poorly installed or moved from their original position and are covering down light fittings at the time of inspection. While the down lights have been fitted with appropriate protective covers, the presence of this insulation creates a potential fire hazard.

Any insulation within the vicinity of down light fixtures should be moved and re-applied to more appropriate sections of the roof void, thus ensuring the area is fire-safe. An insulation contractor should be appointed as soon as possible to perform any necessary works as required.

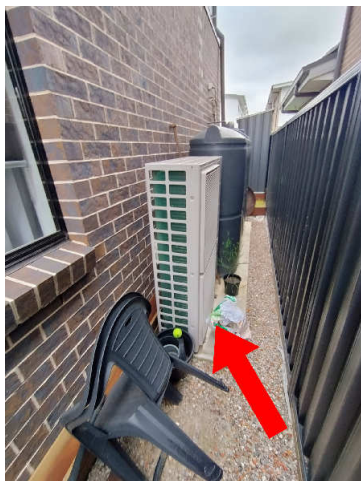
Finding 3.02

Finding: Air conditioner unit - Not connected overflow

Information: The Air Conditioner (A/C) overflow was found to be not connected to storm water drainage and is creating excessive moisture in the surrounding area.

Such leaking creates an environment which is conducive to an array of defects, including water damage to associated building elements and the attraction of termite or timber pest infestation.

It is highly recommended that a licensed plumber be appointed to connect the A/C overflow in order to prevent such an environment from being created. These minor works should be carried out as soon as possible.

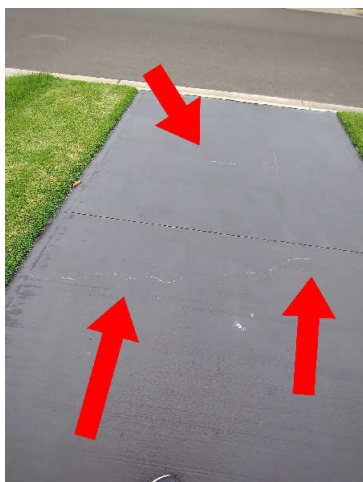
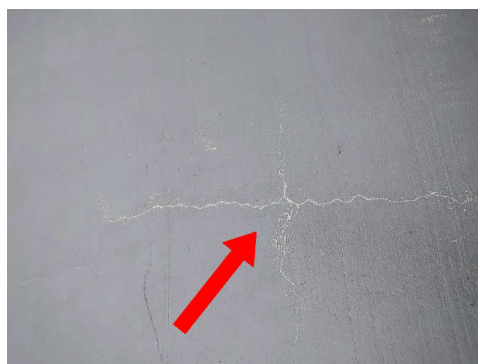
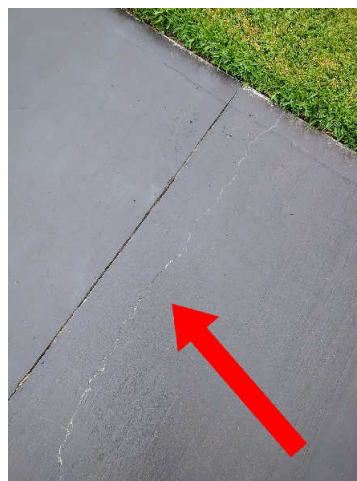
Finding 3.03

Finding: Cracks in concrete slab - Category 2

Information: A crack coded as Category 2 was identified in the driveway slab at the time of inspection. A Category 2 crack is described as a distinct crack, with the slab being noticeably curved or changed in level.

To be considered Category 2, the approximate width of the crack is less than 2.0mm, or a change in offset of less than 15mm when a 3m straight edge is placed over the defect.

Category 2 cracks to slabs should be monitored for a period of 12 months. At the end of the monitoring period, cracks rated greater than Category 2 are considered defects that require rectification.

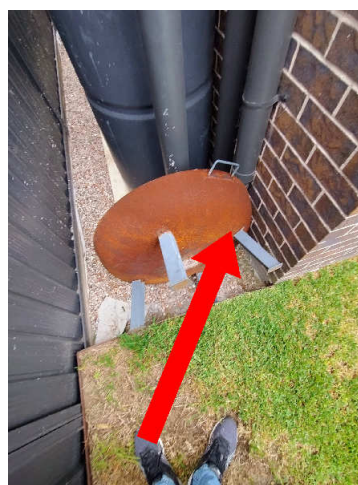
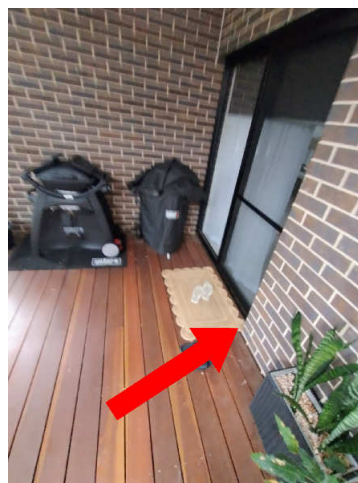
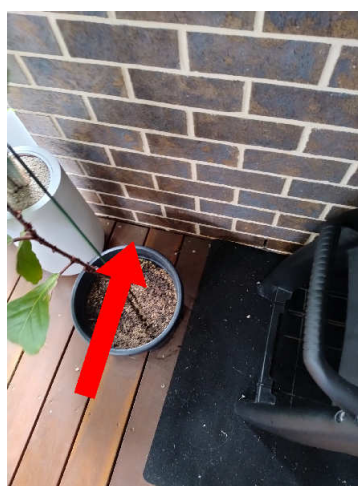
Information: Weep holes were observed to be covered in some location at the time of inspection.

Weep holes in the exterior brickwork of the property are designed to allow condensation that may build up between the brickwork and subsequent timber framework to drain from within the wall hence preventing any deterioration of the timber building elements.

Additionally build-up of moisture is likely to occur if weep holes are covered further attracting termite activity to these areas.

It is highly recommended that weep holes are left exposed in all areas throughout the external property. Therefore if any termite activity leading into weep holes becomes easily detectable during frequent pest inspections.

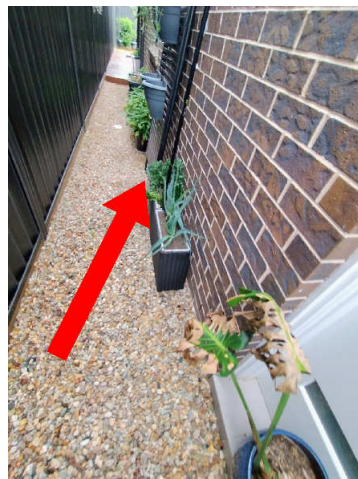
Finding 3.06

Finding: Plumbing work - appears defective

Information: An instance of potentially defective plumbing work was identified in left side yard. Whilst we are not licensed plumbers it appears that work which is not compliant with the relevant plumbing regulations and or the contract documents has occurred. The area of suspected non-compliance or poor workmanship should be referred to the builder and or the Building Surveyor or Certifier. The builder is required to provide a Certificate of Compliance when required by the relevant regulations.

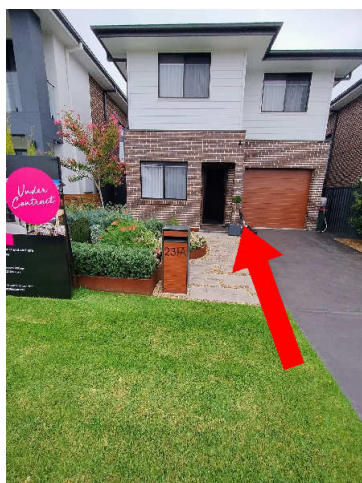
Information: At the time of inspection breaching of termite barriers was observed.

Damp proof course (DPC) is a barrier of impervious material built into a wall or pier to prevent moisture from moving to any part of the building. Where external ground levels are built up over this barrier ingress is provided for moisture from the exterior grounds into the base brickwork or other building material and allowed to rise.

Such conditions attract termites into these damp areas which is likely to lead to infestation if left untreated.

While retrospective fitting of DPC is considered to be impractical works are required in order to prevent the extraction of moisture from the external environment into exterior brickwork or wall materials. Landscaping or re-paving of external grounds may be considered by the client. Regular annual inspections are strongly advised.

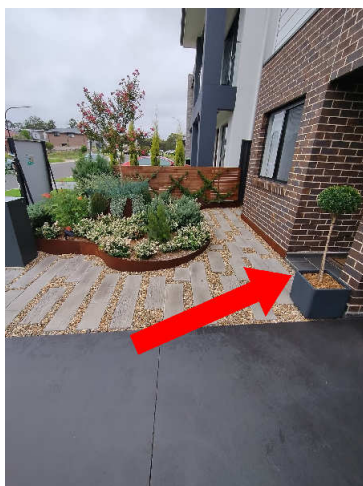
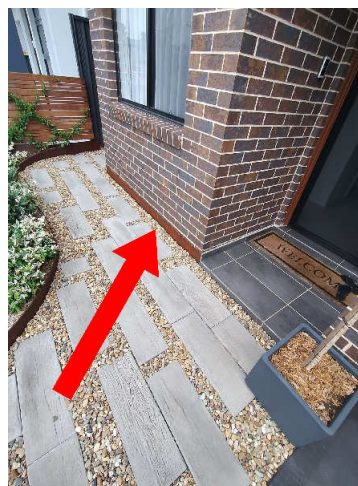
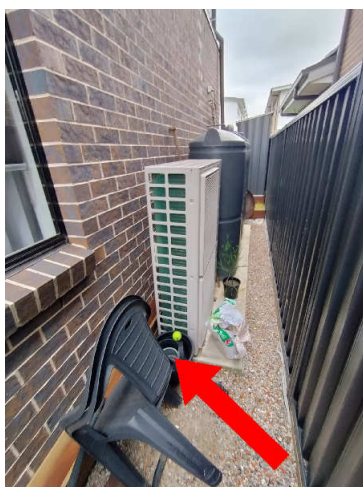
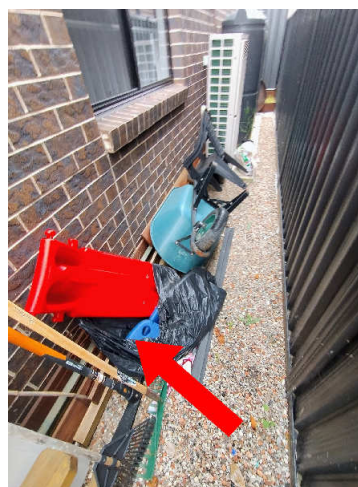
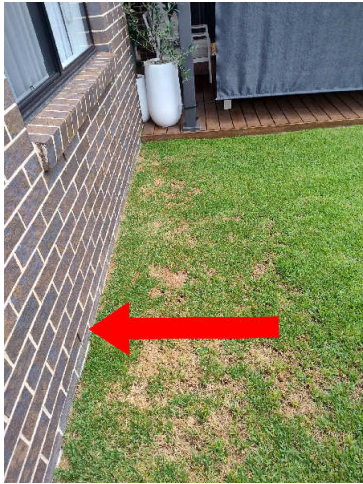
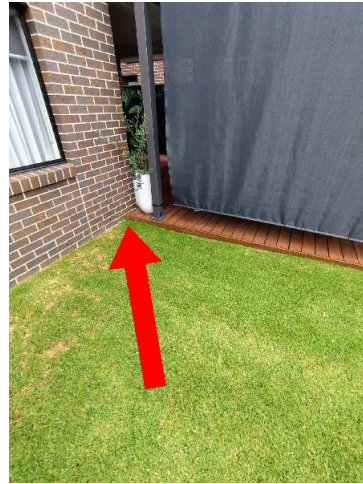
Finding 6.02

Building: Main Building
Location: All External Areas
Finding: Slab Edge - Exposure not fully available

If the slab edge is not properly exposed there is a high risk of termite attack. Sometimes, in order to determine the type of slab, a suitably qualified person such as an architect or builder may be required to consult the construction plans.

Where the slab edge cannot be properly inspected, it is highly recommended that termite or timber pest inspections be carried out every 6-12 months to aid protection of the property against infestation.

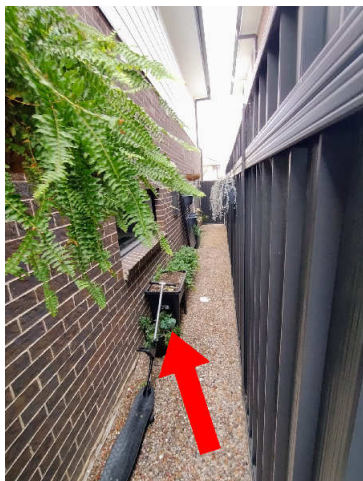
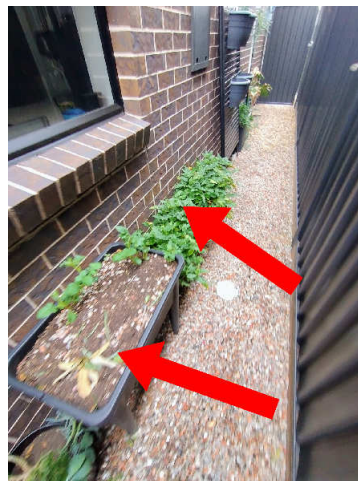
Finding 6.03

Information: The storing of timbers and other material around the external property increases the risk of termite activity being present at the time of inspection. As they are likely to come into contact with weather conditions or excessive moisture wood rot is likely to develop on timbers that are not treated.

It is highly recommended that any stored timbers be immediately removed from areas in which they may attract any termite / timber pest attack. Minimisation of risk / prevention of termite attack is far more adequate than dealing with the presence of termite activity.

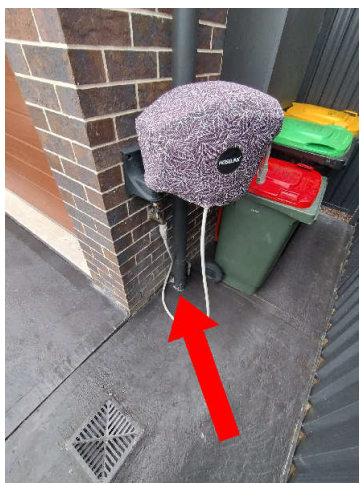
Finding 6.07

This keeps the surrounding surfaces damp while using the tap, which becomes conducive to termite activity.

A licensed plumber must be appointed to ensure an appropriate drain is installed.

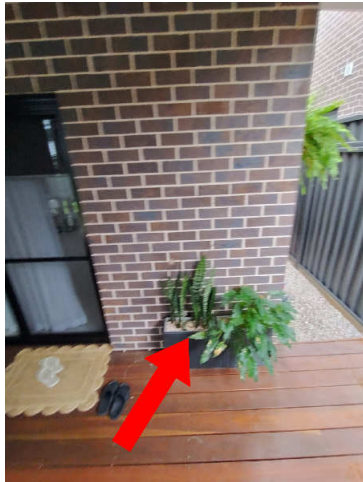
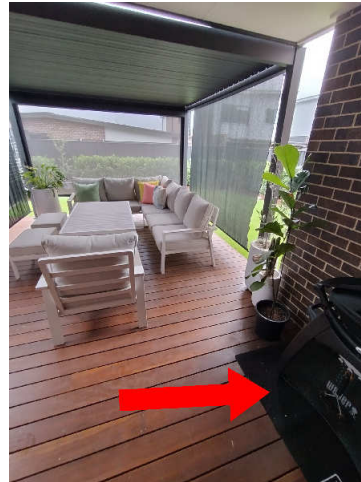
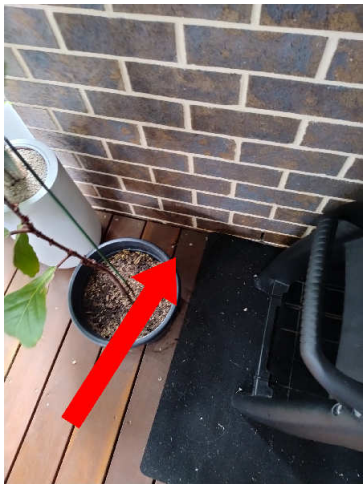
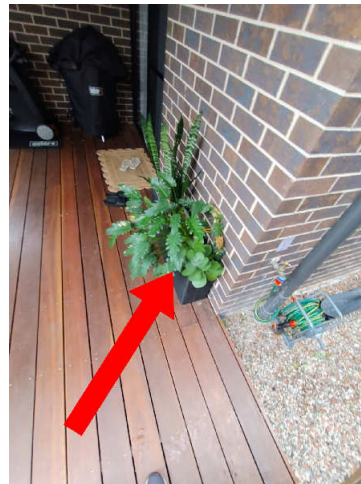
Finding 6.09

Building: Main Building
Location: Rear Elevation
Finding: Building materials in direct ground contact - conducive to termites

Timber was found in direct contact with ground in rear area of building at the time of inspection. Where timber elements are in direct contact with the ground and consequently moisture or dampness they become conducive to termite activity. Whether timber is used as a building element part of a fencing structure or stored as an unused item they can provide an environment that is attractive to termite infestation.

When met with excessive moisture timber begins to decay and develop wood rot. Any timbers that are in direct contact with external grounds especially if left untreated or non-durable also provide ingress for subterranean termites into that particular element.

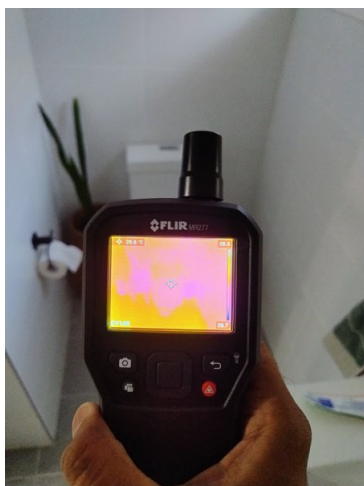
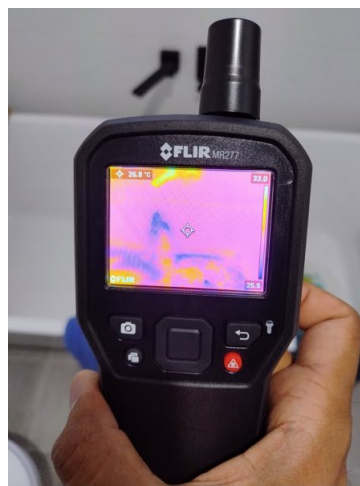
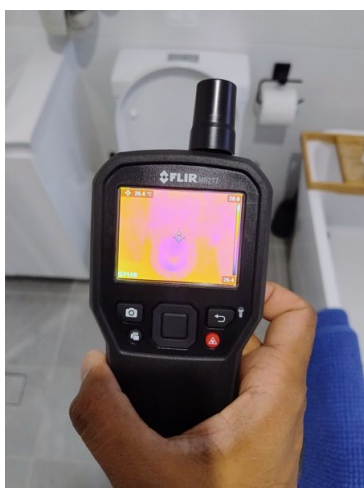
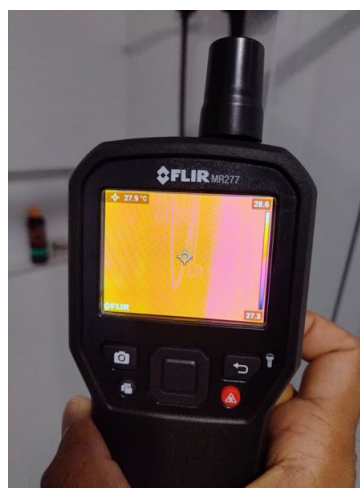
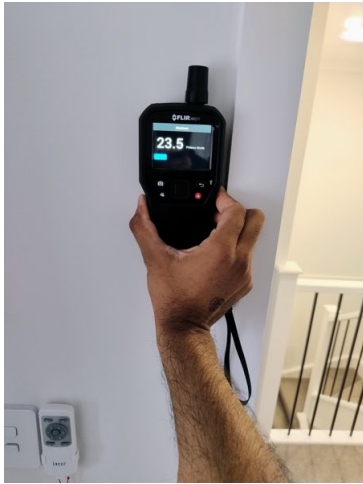
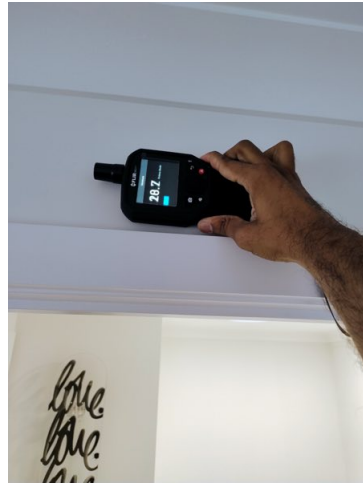
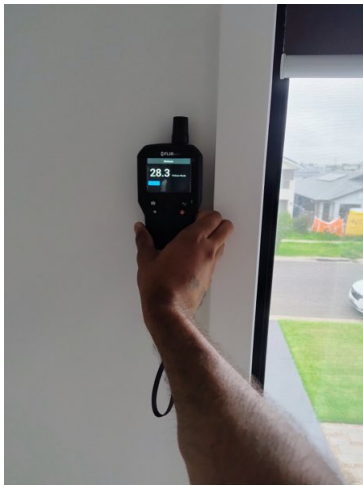
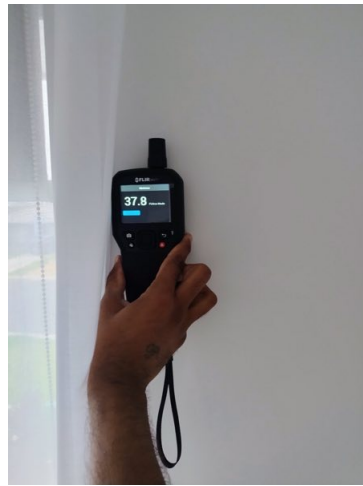
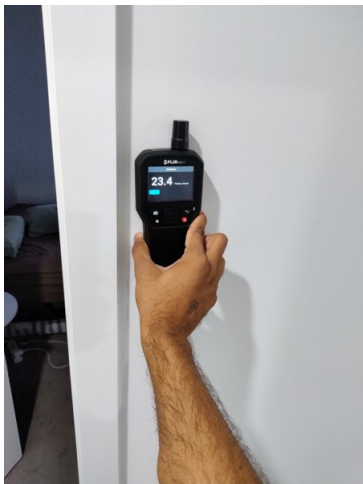
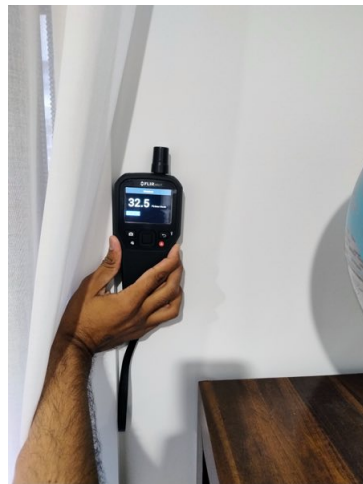
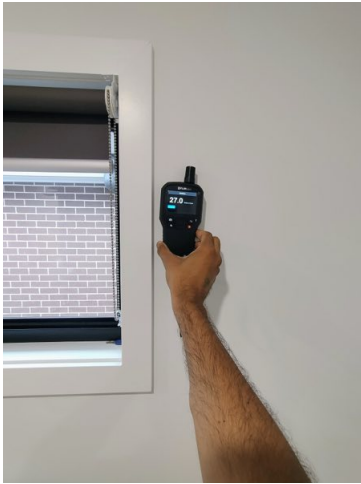
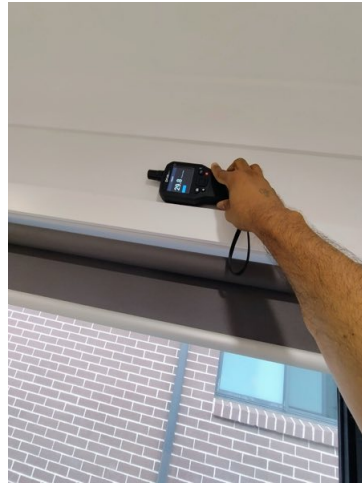
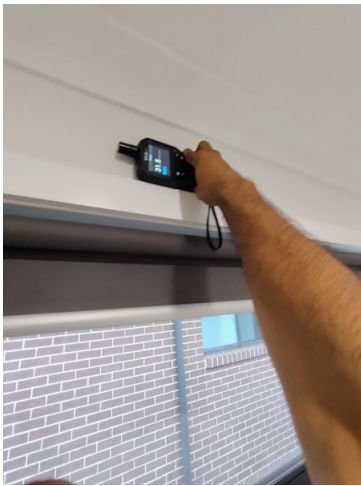
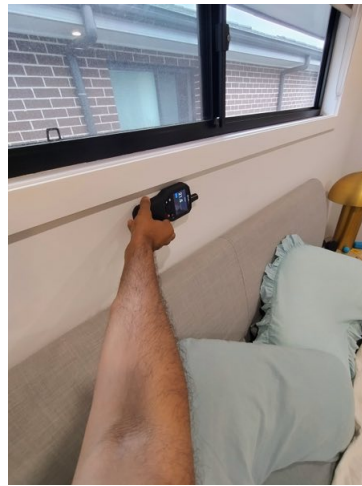
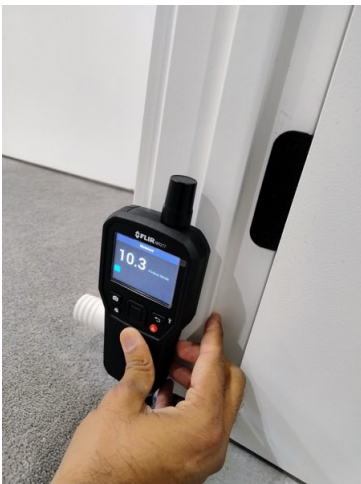
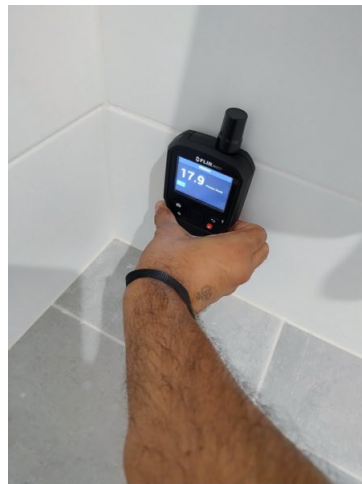
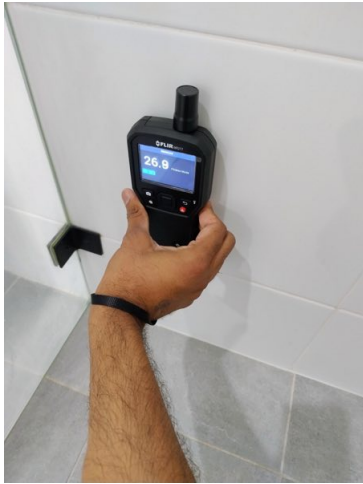
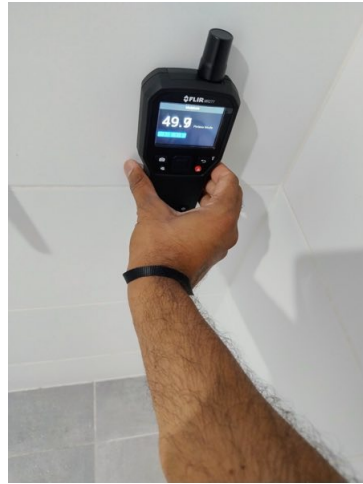
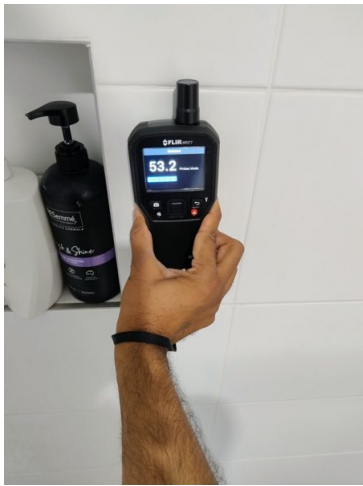
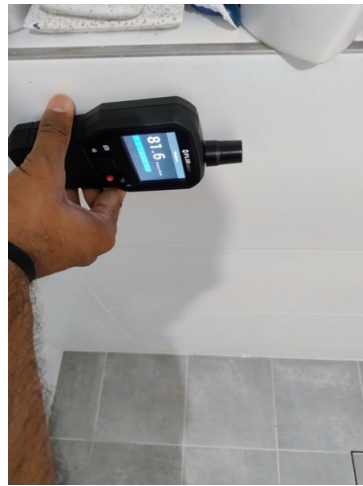
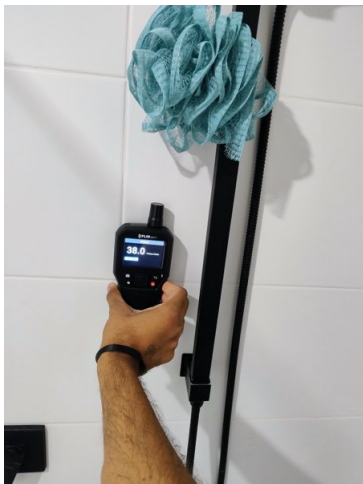
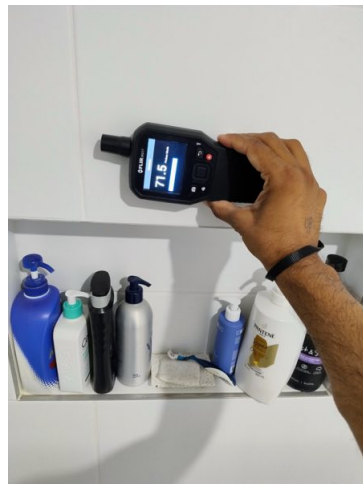
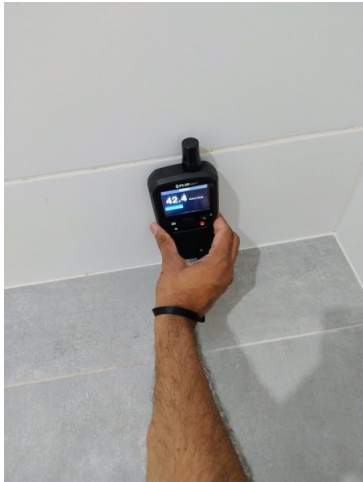
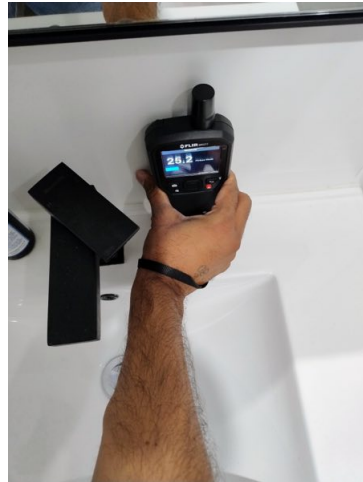
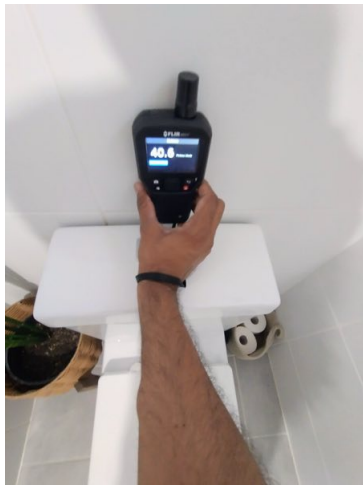
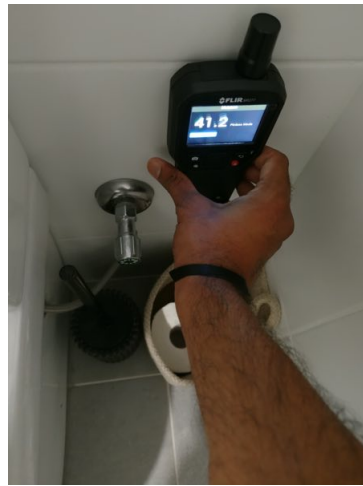
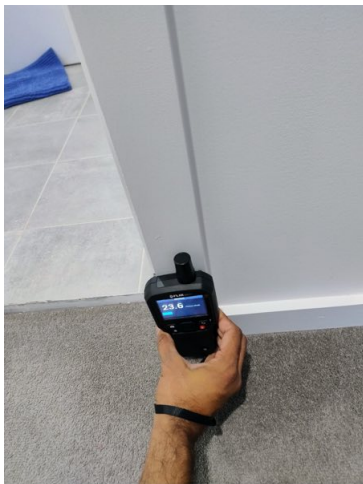
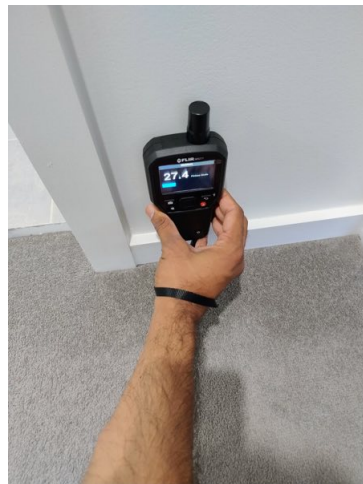
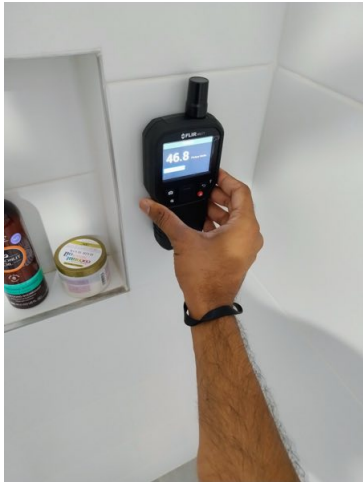
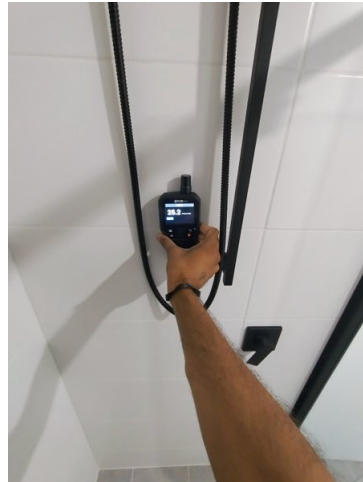
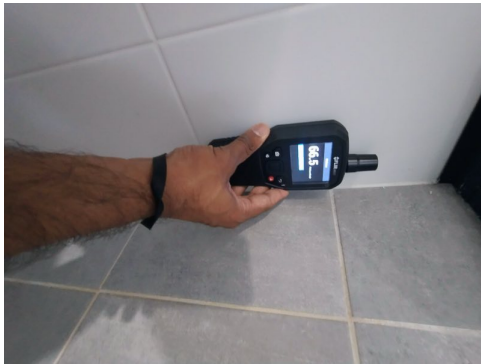
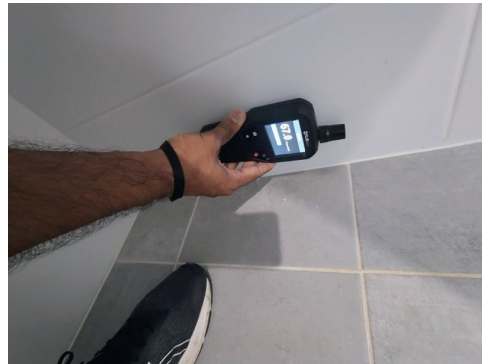
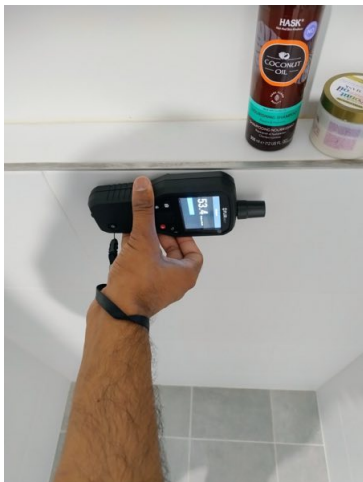
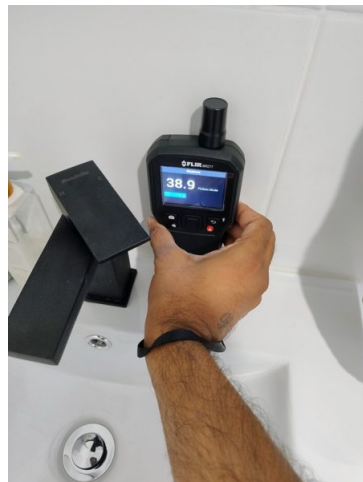
Noted Item

Building: Main Building
Location: All Areas
Finding: Moisture reading taken at different locations
Information: All area moisture reading for reference.

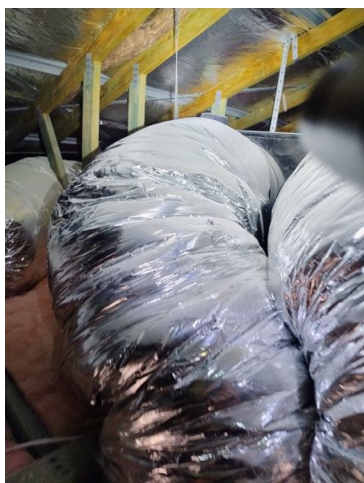
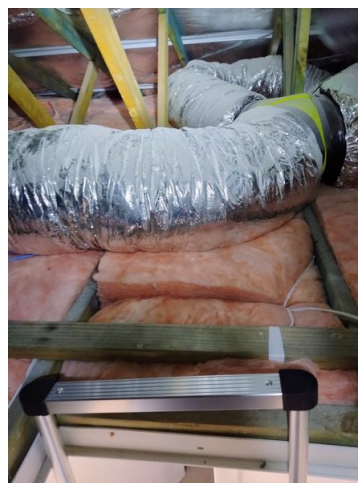
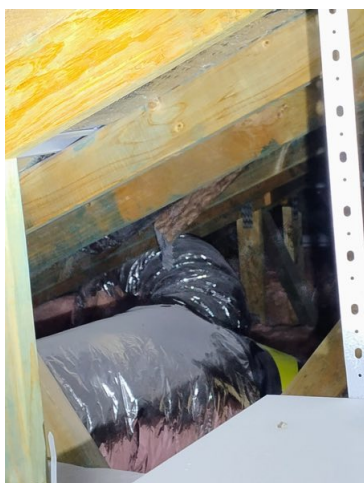
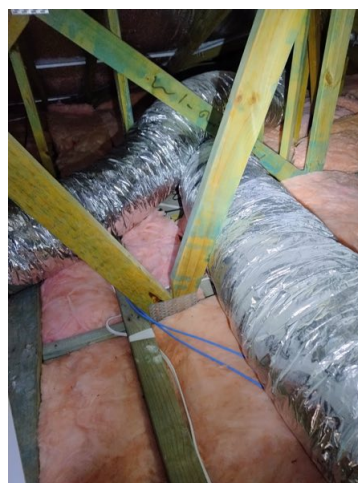
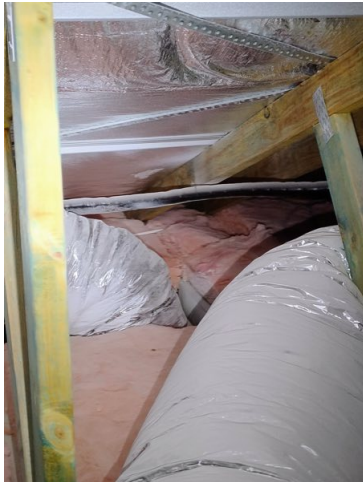
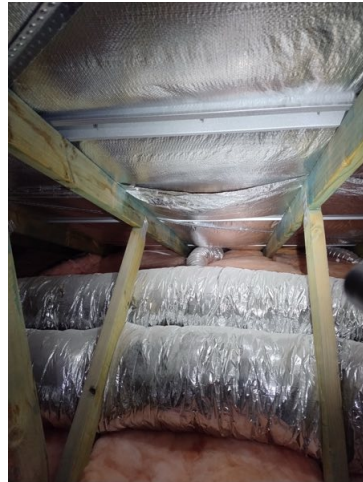
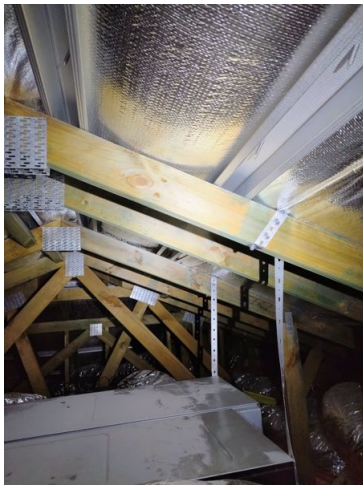
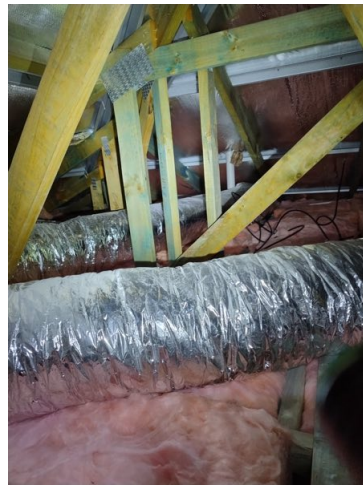
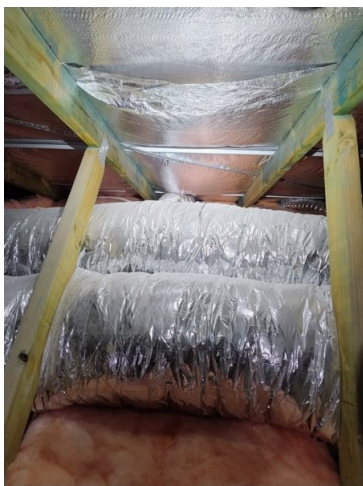
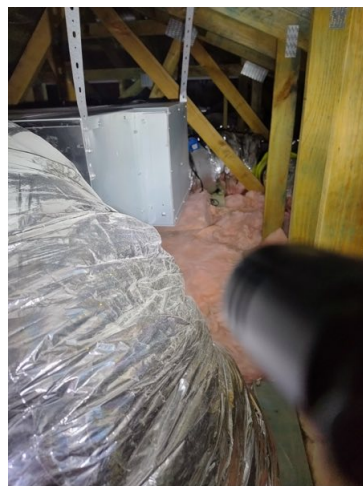
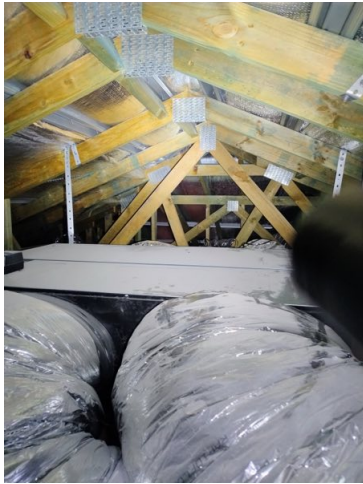
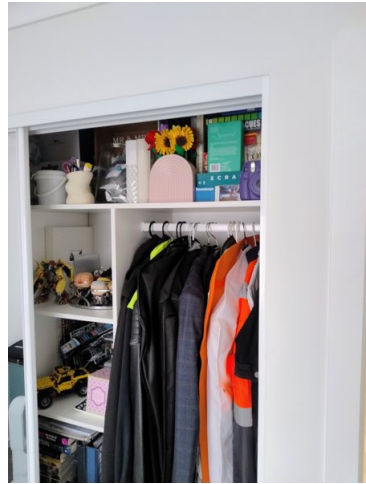
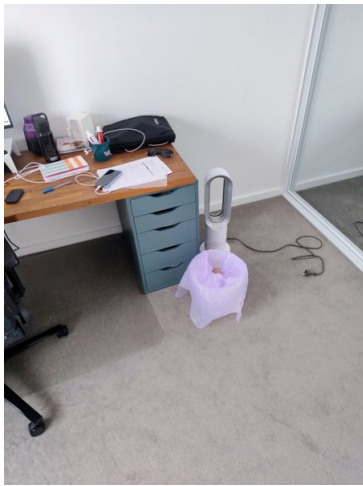
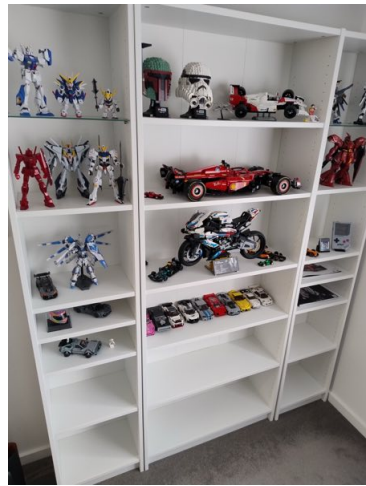
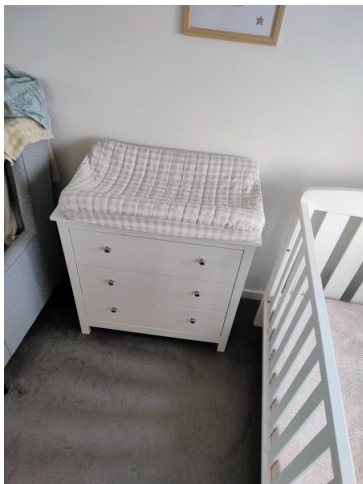
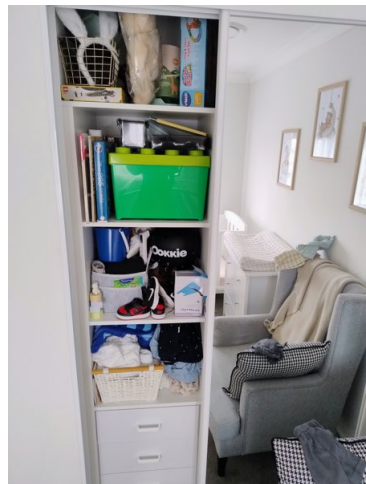
Building: Main Building
Location: All Areas
Finding: Additional Photos - Obstructions and Limitations

The insulation covered nearly all the ceiling joists, which are major structural elements of ceiling. The inspection was also limited to areas with an allowable crawl space of 600mm x 600mm, in particular towards the external walls where the roof line diminishes, it was not accessible. These obstructions and limitations can hide an array of defects and should be removed to allow a full inspection to be carried out

Without full access behind these obstructions, defect, activity and damage may be concealed.

These obstructions can hide an array of defects and should be removed to allow full inspection to be carried out. A re-inspection is recommended once the areas are made accessible.

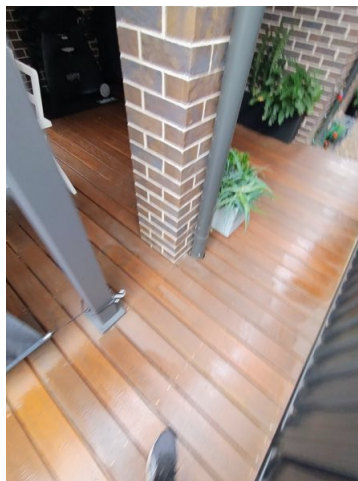
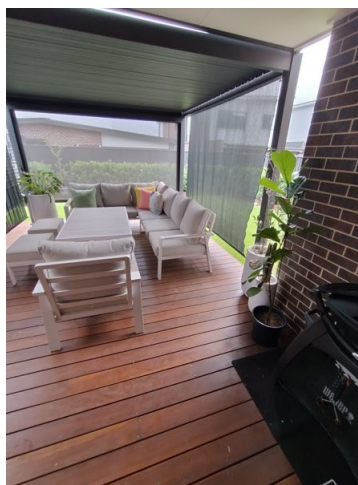
Information: The additional wooden decking structure that has been affixed to rear area of the dwelling does not appear to comply with contemporary building practices and current Australian Standards. While the structure does not currently appear to be unsafe, compliance with such standards ensures the structural integrity of the main dwelling and abutting addition.

As building standards have not been followed, this area provides a heightened risk of the development of building defects. The structural integrity of the area may have been compromised, which creates potential for the development or presence of major safety issues.

It is highly recommended that any planned repair, remodeling or demolition works be carried out by registered builders.

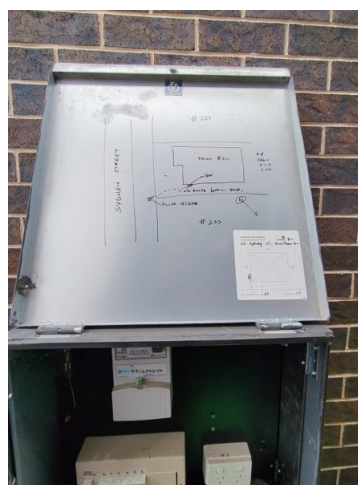
Building:	Main Building
Location:	Meter Box
Finding:	Termite Management System - no evidence of a Termite Management system or Durable notice
Information:	At the time of inspection, it was noted that there is no visible durable notice indicating the installation of a termite management treatment system, as required by current building regulations.

The absence of such a notice may compromise the effectiveness of termite control measures and could lead to potential risks related to termite infestations and damage. It is noted that without further information from the current owner or real estate agent regarding the installation of a termite management treatment system, it is then assumed that there is no termite treatment system installed to the property.

A durable notice, usually in the form of a sticker, found in the main switchboard, should be provided by a licensed pest control contractor upon the installation of a termite management system to inform future occupants or owners of the treatment.

It is strongly recommended that a licensed pest control contractor be engaged to assess the property and to install an appropriate termite management system as a matter of urgency.
