# Building and Timber Pest Inspection Report

Inspection Date: Wed, 1 Apr 2026

Property Address: 10 Lockwood St, Asquith NSW 2077,  
Australia

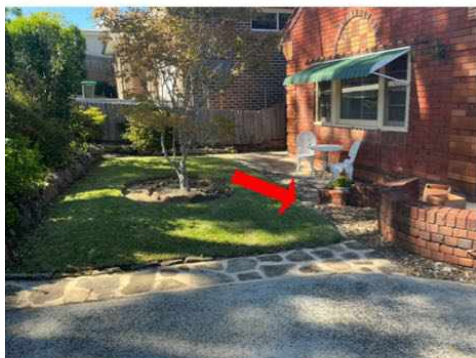
Building:	Main Building
Location:	Yard - Front
Finding:	Inadequate Site Drainage - Exterior Areas
Information:	At the time of inspection, inadequate site drainage was observed around the perimeter of the building, which can lead to water pooling and insufficient runoff management.

This condition may result in moisture being absorbed by the foundation or lower walls, potentially leading to rising damp, cracks in brickwork, erosion of the soil around the building, or structural issues over time. Water pooling can also create ideal conditions for mould growth, contribute to the deterioration of exterior materials, and act as conducive conditions for termite activity, as termites are attracted to areas with elevated and persistent moisture levels.

It is recommended that proper site drainage be installed, such as redirecting water flow away from the building or incorporating drainage systems, to prevent further damage and ensure the long-term stability of the structure.

To address the inadequate site drainage, a qualified landscaper or drainage specialist should be engaged to design and install appropriate drainage solutions, such as grading the ground away from the building or installing French drains, surface drains, or downspout extensions. If more complex issues are present, such as damage to the foundation or moisture entering the walls, a structural engineer may need to assess the situation, and a builder may be required for repairs.

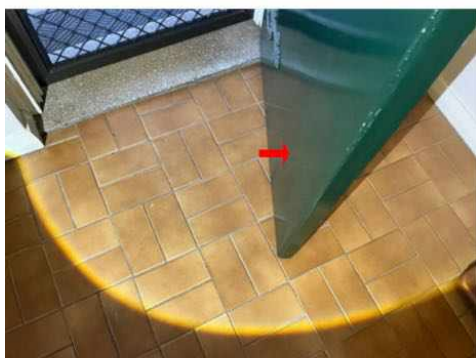
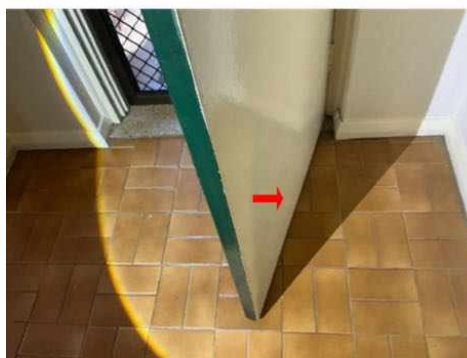
### Finding 3.02

Building:	Main Building
Location:	Entry
Finding:	Door Weatherstrip - Missing
Information:	It was noted at the time of inspection, the door weatherstrip was missing.

The absence of a door weatherstrip could be due to wear and tear, improper installation, or deliberate removal. The implications include increased energy loss, reduced insulation, potential water leaks during rain, and a compromised seal, allowing drafts and noise to enter the space. Replacing the missing weatherstrip is advisable to maintain energy efficiency, weather protection, and overall comfort within the enclosed area.

A general handy man should be appointed to install the weatherstrip at owners discretion.

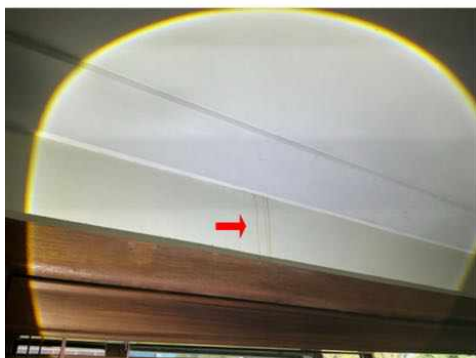
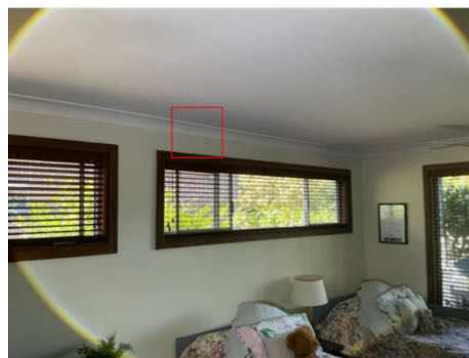
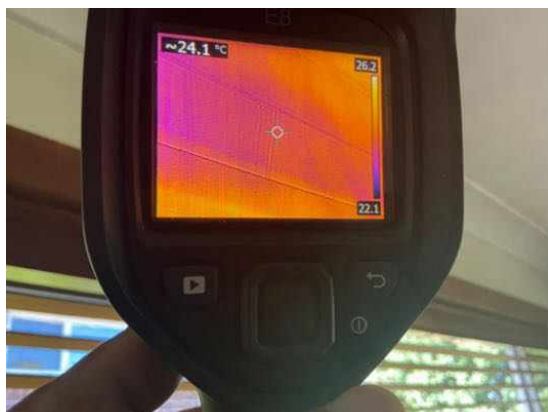
### Finding 3.03

Building:	Main Building
Location:	Rear Bedroom
Finding:	Stains (Dry) - Wall
Information:	At the time of inspection, stains were noted on the internal wall surfaces; however, the

areas were dry and no active moisture ingress was detected. These stains are likely the result of a previous moisture event, such as an historic roof leak or past water penetration during heavy rain, which may have since been repaired. The affected areas appear cosmetic at this stage, but the client is advised to monitor the walls over time, particularly after periods of heavy rainfall, and if staining worsens or moisture reappears, a roofing or waterproofing specialist should be consulted to further investigate. Repainting may be considered once it is confirmed that the issue is no longer active.

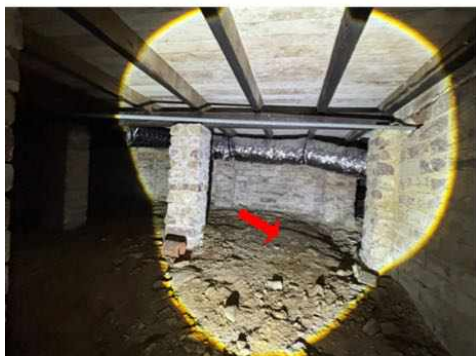
### Finding 3.04

Building:	Main Building
Location:	Subfloor
Finding:	Subfloor Site Drainage - Inadequate
Information:	At the time of inspection, inadequate site drainage was observed under the subfloor, allowing water to accumulate and fail to drain effectively, creating a hazardous condition. This is a common defect in houses constructed on brick stumps, where poor site grading and limited subfloor ventilation can contribute to ongoing moisture retention. The resulting water pooling may lead to structural deterioration from prolonged dampness, mould and mildew growth, and create conditions conducive to termite activity. These issues can also impact indoor air quality and pose safety risks to occupants.

The client is advised to engage a licensed plumber or builder experienced in drainage and foundation work to assess and implement suitable solutions, such as improving site grading, installing appropriate drainage systems, and enhancing moisture barriers.

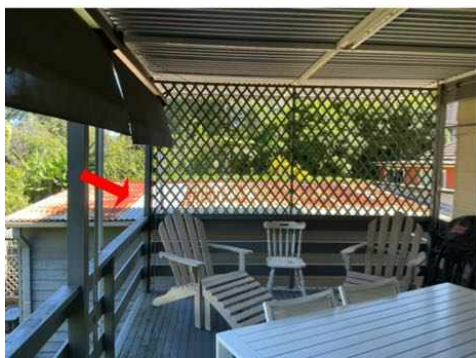
### Finding 3.05

Building:	Main Building
Location:	Garage
Finding:	Roof sheets - Rusted
Information:	Metal roofs generally comprise numerous individual sheets, which join and overlap. These intersections are particularly prone to lift at the edge and consequently rust at these points.

Upon inspection of the exterior roofing structure, evidence of rust to these sections was identified. If left unmanaged, these degrading joins can allow water ingress to the internal roofing structures, potentially leading to secondary damage of building elements. Accelerated deterioration of the roofing sheets and any associated building elements is also likely to occur.

A roofing contractor should be appointed immediately to assess the damage to the roofing sheets and to perform remedial works as necessary. Works may include replacement of severely affected roofing sheets or minor works such as the application of rust-retardant surface protectors.

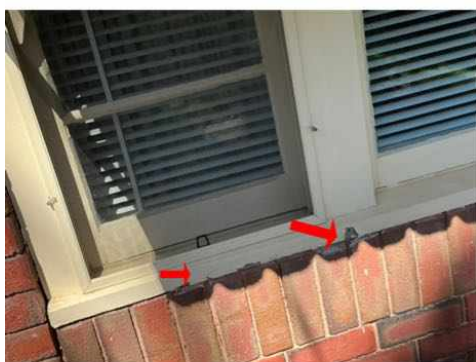
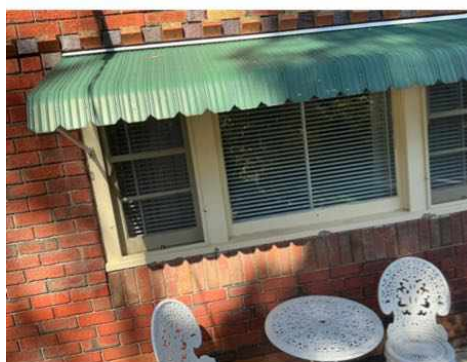
### Finding 3.06

Building:	Main Building
Location:	All Areas
Finding:	Minor Deterioration – Timber Window Frames
Information:	At the time of inspection, minor deterioration was noted to the external timber window frames, including areas of peeling paint and early signs of timber rot. This type of deterioration is commonly associated with prolonged exposure to weather conditions and general wear and tear over time.

If left unaddressed, the affected areas may continue to deteriorate, potentially allowing moisture ingress and further damage to the timber components.

It is recommended that a qualified painter be engaged to prepare, treat, and repaint the affected areas, including addressing any minor timber decay, to prevent further deterioration and maintain the longevity of the window frames.

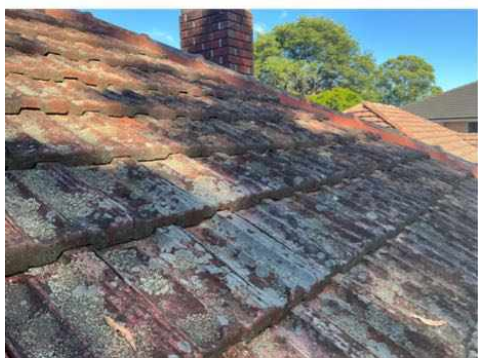
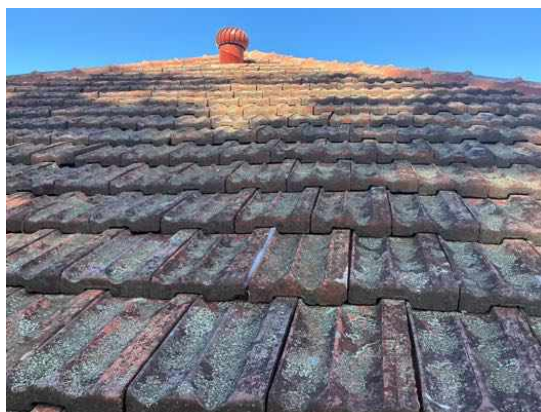
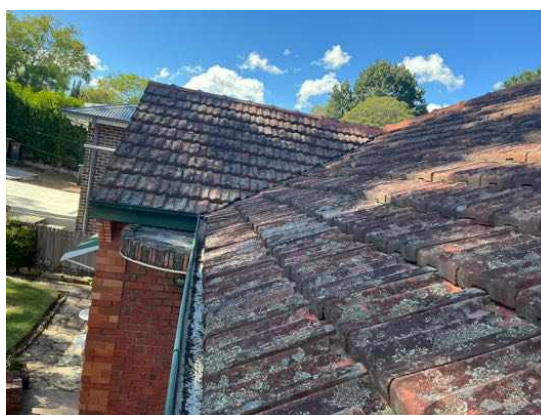
### Finding 3.07

Building:	Main Building
Location:	All Areas
Finding:	Roof Tiles Weathered - Lichen Build Up
Information:	Upon inspection of the exterior roofing, the majority of roof tiles were considered to be in a fair condition with mortar deterioration. While weathering of the tiles is consistent with the age of the property, maintenance works are required.

Concrete roof tiles are typically cleaned to have the visible moss and lichen removed. Concrete tiles are made from a product which is a naturally moist material. Moss and lichen is attracted to the roof tiles surface, and if left will continue to grow and most likely restrict the flow of rain water over the tiles surface, into the roofs gutters. An application of an environmentally friendly anti-fungal solution should be applied to all moss and lichen, prior to undertaking the roof cleaning process.

A roof restoration company can be contacted for further advice at the clients

discretion.

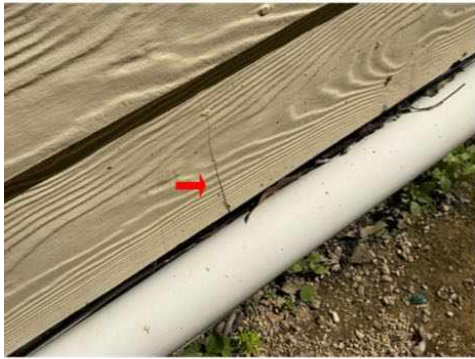
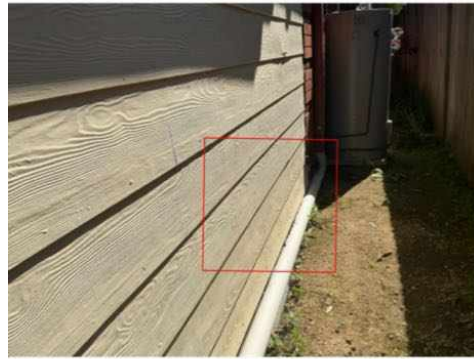
### Finding 3.08

Building:	Main Building
Location:	Exterior walls - left side
Finding:	Cladding - Damaged
Information:	At the time of inspection, the cladding was observed to be damaged, compromising the building's exterior protection against weather exposure and potential water ingress. If left unaddressed, this could lead to structural deterioration, mould growth, and reduced thermal efficiency. It is recommended to engage a qualified cladding specialist to assess the extent of the damage and carry out necessary repairs or replacements to maintain the integrity of the building envelope.

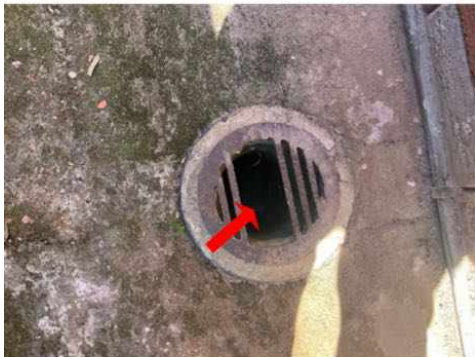
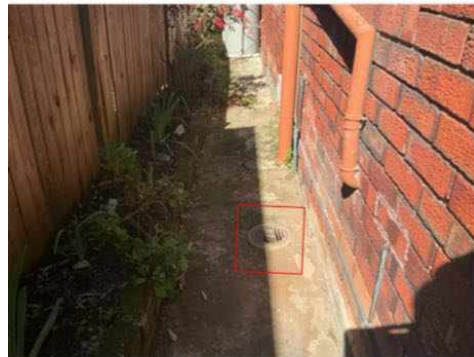
### Finding 3.09

Finding: Drain Cover - Damaged

Information: At the time of inspection, the drain cover was noted to be damaged. The opening may allow larger debris to enter the drainage system, which may lead to blockages or reduced drainage performance over time.

It is recommended that the damaged drain cover be replaced by a licensed plumber or suitably qualified tradesperson.

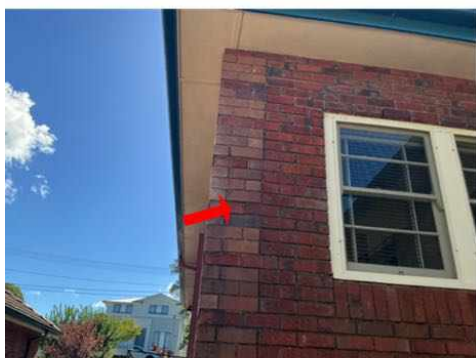
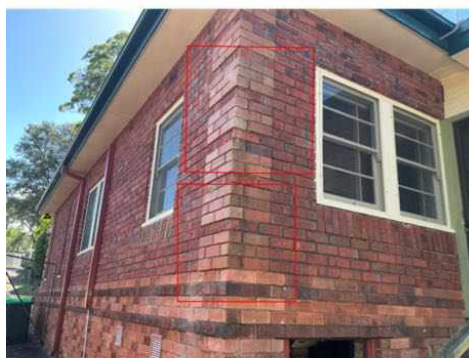
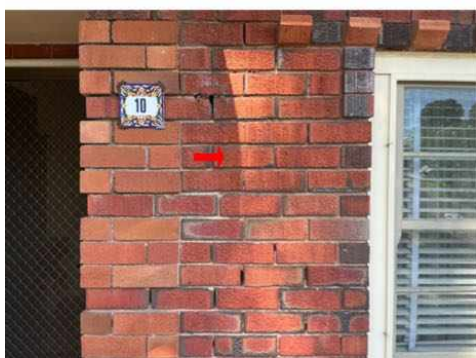
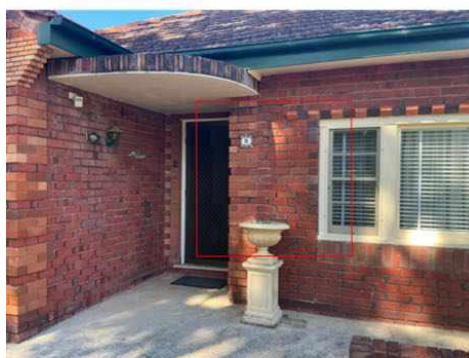
### Finding 3.10

Finding: Brickwork - Deteriorated mortar

Information: Mortar, or 'bedding', is the material which fills joins and intersections between bricks in masonry walls and structures. Sections of mortar in this brickwork were identified as having deteriorated, which is generally expected for a property of this age and condition.

Mortar may deteriorate as a result of age of building materials, minor movement of

bricks, or frequent exposure to weathering. Mortar should be replaced to ensure that bricks remain in their intended location and to prevent gaps, which would allow water or moisture ingress and secondary damage as a result.

Mortar deterioration can be addressed by a bricklayer where areas of deterioration are localised and easily accessible. Alternatively, appointment of a registered builder is advised, to repoint large areas of decaying mortar. Where secondary structural defects have become evident, consultation with a structural engineer may be required.

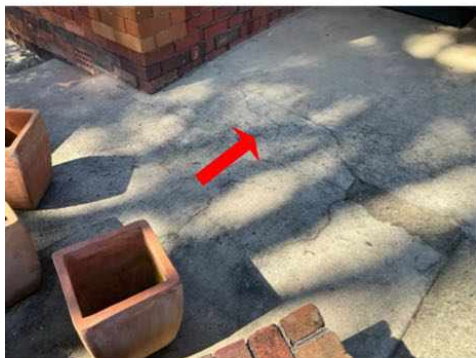
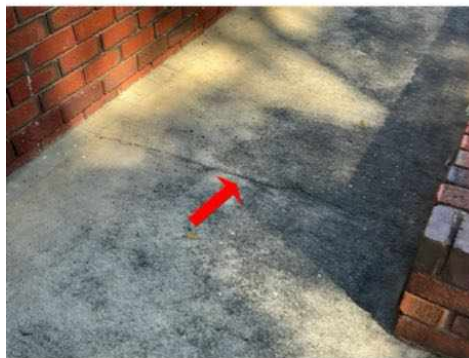
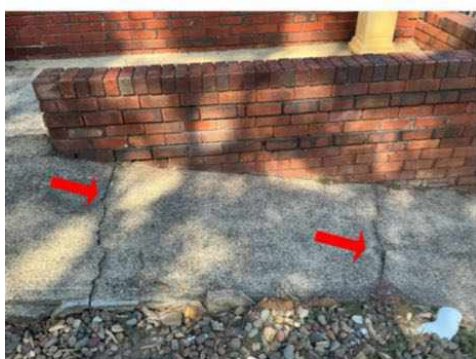
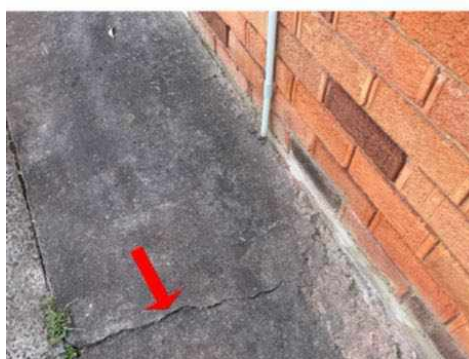
### Finding 3.11

Building:	Main Building
Location:	All Areas
Finding:	Crack in concrete slab - Category 3
Information:	A crack coded as Category 3 was identified in the slab. A Category 3 crack is described as a wide crack with obvious curvature or change in level, affecting the slab.

The approximate width of the crack to be considered Category 3 is greater than 2.0mm, or a change in offset of 15-25mm when a 3m straight edge is placed over the defect.

Category 3 cracks to slabs exceed allowable Standards and Tolerances, and are considered defects requiring rectification.

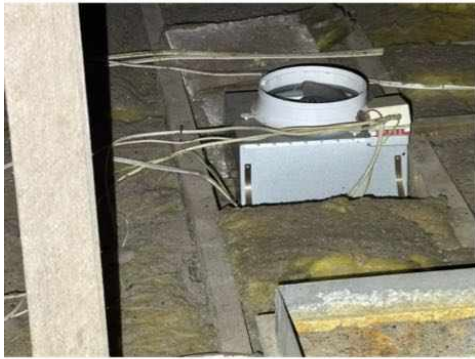
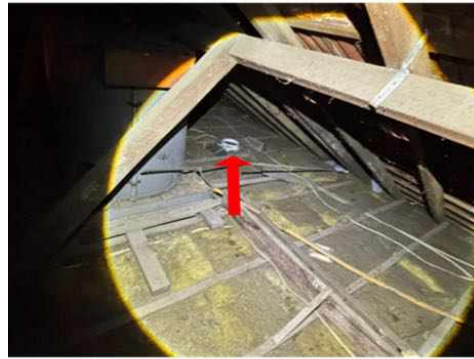
### Finding 3.12

Building:	Main Building
Location:	Roof Void
Finding:	Vent - Extracted into Roof Space
Information:	During the inspection, it was noted that the exhaust vent has been improperly terminated into the roof space instead of being ducted to the exterior of the property.

This configuration is a defect as it allows moist air to accumulate within the roof cavity, increasing the risk of condensation, mould growth, and deterioration of insulation or timber framing. Proper ventilation is essential to maintain a healthy indoor environment and protect the structural integrity of the building. It is recommended that the vent be appropriately re-routed to discharge externally in compliance with relevant building standards.

A licensed mechanical ventilation contractor/electrician should be appointed as soon as possible to provide further consultation on the scope of these works and to provide quotations for any necessary works.

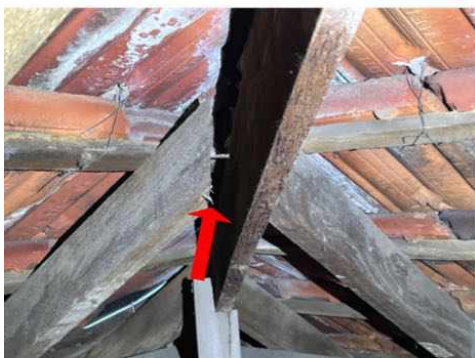
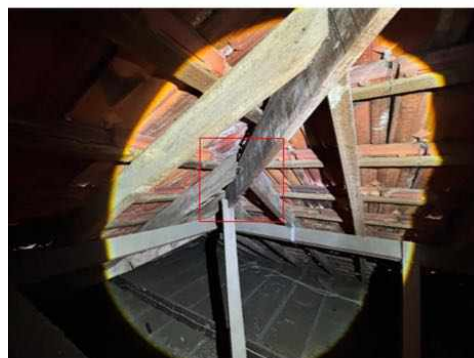
### Finding 3.13

Information: At the time of inspection, a rafter was observed not to be properly connected or secured to the hip rafter within the roof space. This indicates a defect in the roof framing connection, where the structural members are not adequately tied together as intended.

This condition may affect the structural integrity and load distribution of the roof framing system, particularly under wind loads or over time, and may lead to further movement or deterioration if left unaddressed.

It is recommended that a qualified builder or framing specialist be engaged to assess the connection and carry out appropriate rectification works, which may include securing and reinforcing the affected rafter to ensure the structural stability of the roof framework.

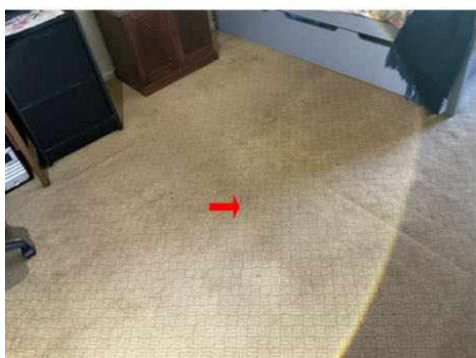
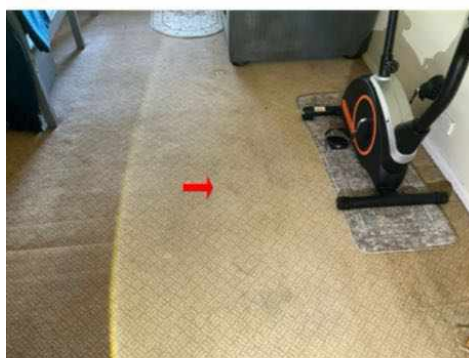
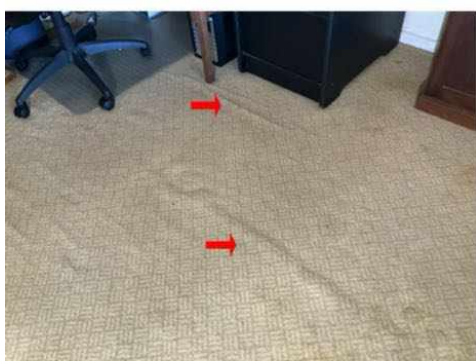
### Finding 3.14

Finding: Carpet - Buckling & Stained

Information: At the time of inspection, the carpet was noted as stained in several areas and also showing signs of buckling, creating uneven surfaces. These conditions detract from the overall appearance of the flooring and may present a trip hazard if left unaddressed.

It is recommended that a professional carpet cleaner be engaged to treat and clean the stained areas. In addition, a qualified carpet specialist should be engaged to re-stretch or otherwise repair the carpet to eliminate the buckling and restore a safe, even surface.

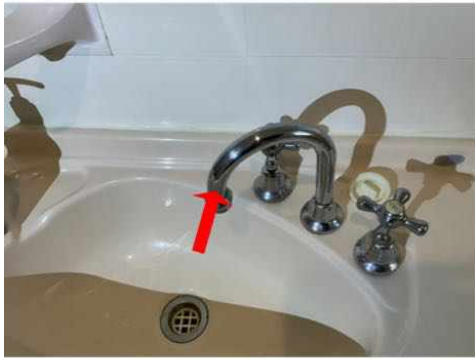
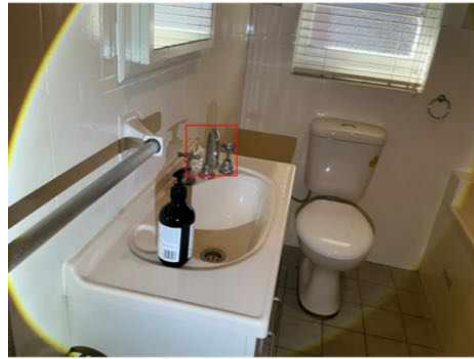
### Finding 3.15

Finding: Tap - Loose

Information: It was noted during inspection, the tap in this area is loose. This tap being loose creates potential for water leaks and subsequent water damage to the surrounding area.

Where taps are loose, a qualified plumber should be appointed to re-fix the plumbing fitting.

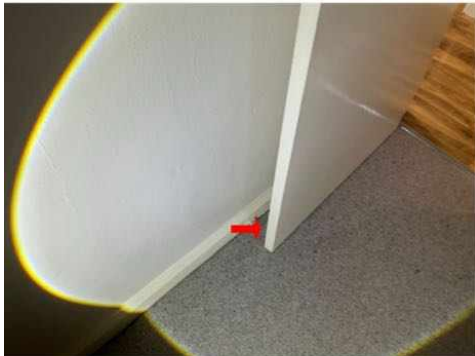
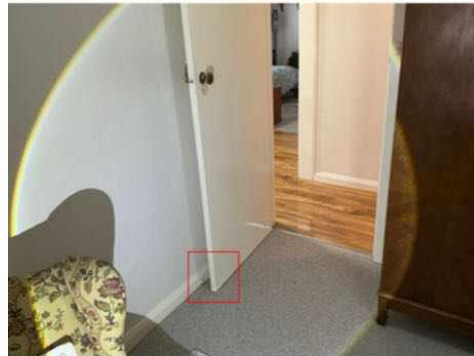
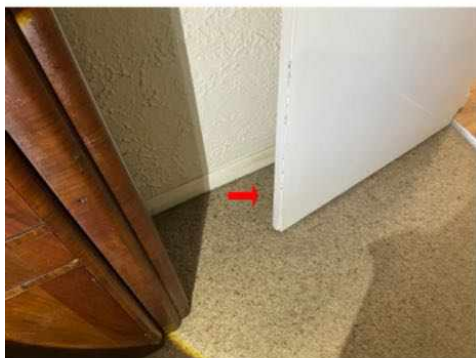
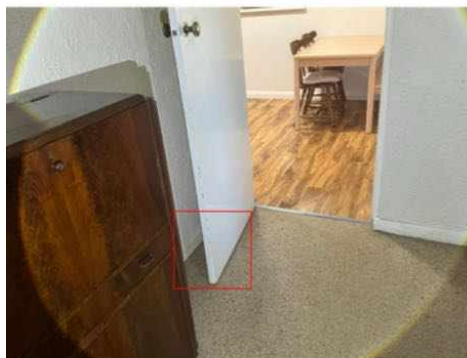
### Finding 3.16

Building: Main Building  
 Location: All Areas  
 Finding: Door Stopper(s) - Missing  
 Information: At the time of inspection, it was noted that a door stopper was missing in this area.

The absence of a door stopper can lead to potential damage to the door, wall, or surrounding finishes, as the door may swing open too far and impact the wall or adjacent objects. Over time, this can cause dents, scuffs, or even structural damage to the wall or door. It is recommended that a door stopper be installed to prevent further damage and ensure the protection of both the door and the surrounding area.

The client is advised to engage services of a handyman to install the door stopper.

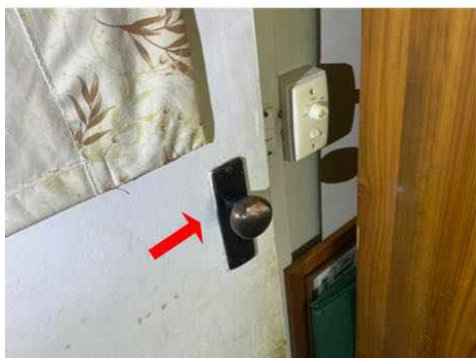
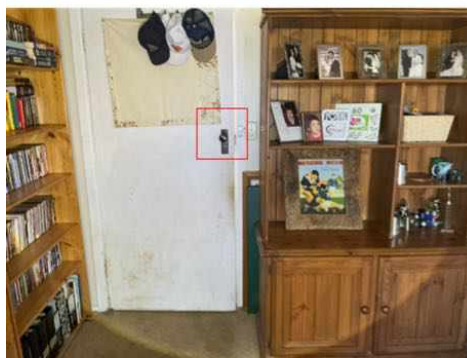
Building:	Main Building
Location:	Rear Bedroom
Finding:	Door Knob - Loose
Information:	It was noted at the time of inspection that the door knob was loose at this area.

A loose door knob can be caused by worn-out screws, loose connections, or general wear and tear over time. Tightening the screws or adjusting the connections often resolves the issue.

Consider hiring a qualified handyman to address the issue at owners discretion.

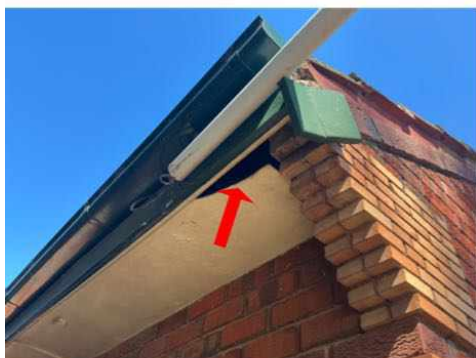
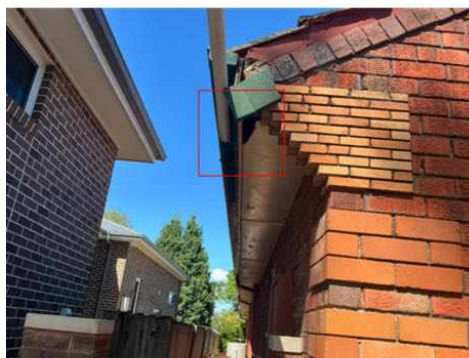
### Finding 3.18

Building:	Main Building
Location:	Eaves
Finding:	Eaves - Damaged
Information:	The eaves were observed to be damaged at the time of inspection, with sections missing and exposing the internal roof structure.

If left unrepaired, this defect can lead to further deterioration due to exposure to weather elements, including rainwater ingress, which may cause rot, mould growth, and structural weakening of the roof timbers. Additionally, the opening provides an

entry point for birds, rodents, and other pests, which can nest within the roof cavity, leading to further damage and potential health risks.

It is recommended that a qualified tradesperson like roofer to be engaged to repair the damaged eaves to prevent further structural and environmental issues.

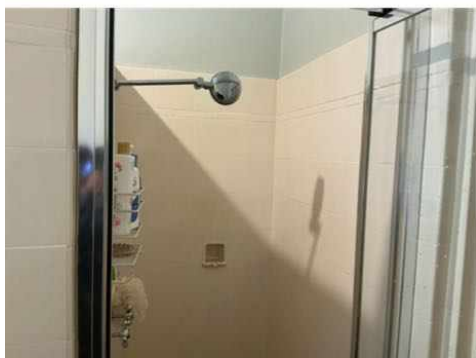
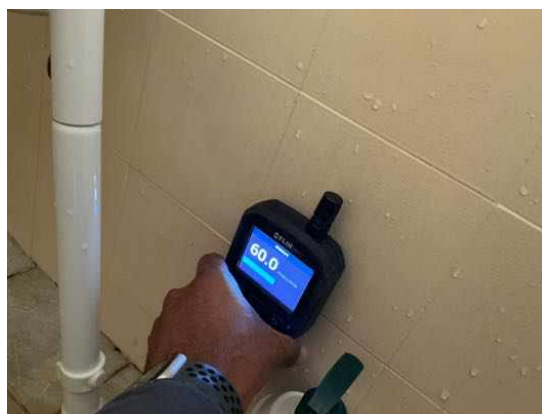
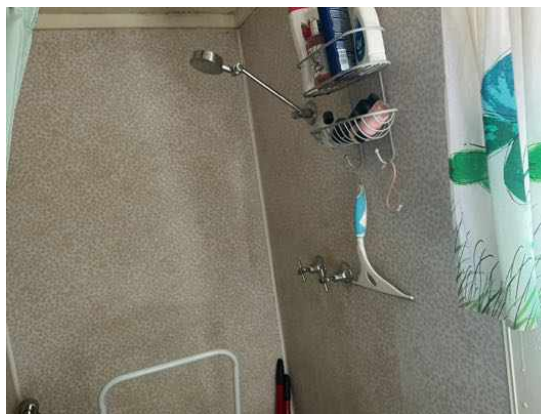
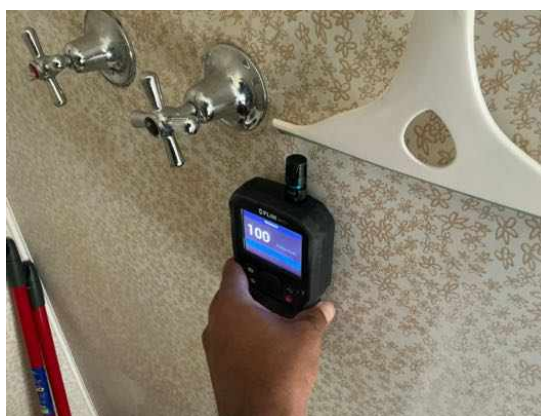
### Finding 3.19

Building:	Main Building
Location:	Both Bathrooms
Finding:	Excessive Moisture - Shower Damp
Information:	At the time of inspection, excessive moisture was noted within the shower area, which is a common issue in wet areas due to the continual exposure to water. This condition is typically caused by moisture seeping through grout lines and settling behind tiles, resulting in localised high-moisture zones. Provided there is no evidence of water staining or elevated moisture readings on the opposite side of the wall, this is considered a minor defect.

However, persistently damp conditions may act as conducive conditions for termite activity, as termites are strongly attracted to moisture-rich environments. It is recommended that the client ensures regular use of the exhaust fan and maintains adequate ventilation after shower use to promote drying and reduce long-term moisture build-up, thereby also reducing the risk of attracting termites.

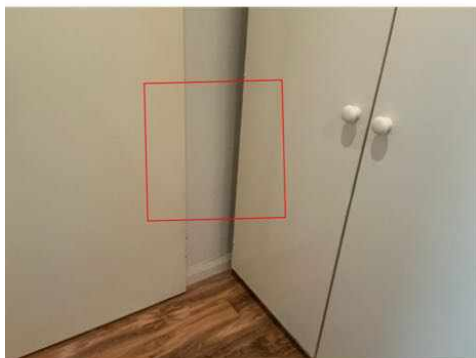
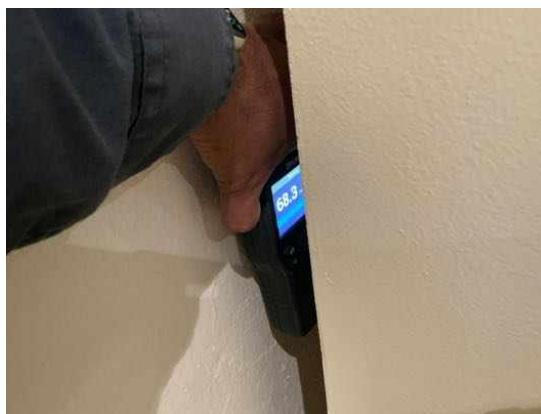
### Finding 3.20

Building:	Main Building
Location:	Front Bathroom
Finding:	Excessive Moisture - Adjacent Bathroom Wall (Monitoring)
Information:	At the time of inspection, elevated moisture levels were detected on the wall opposite the bathroom, as confirmed by the moisture meter readings. The affected area did not show visible signs of active leakage, deterioration, or bubbling at the time of inspection.

While no immediate rectification work is required, the area should be monitored over the next 12 months for any signs of change such as bubbling paint, staining, or deterioration at the bottom of the wall, which could indicate intermittent or recurring moisture ingress.

The client is advised to check with the current owner whether any rectification works or waterproofing repairs were previously undertaken in this area and to obtain details regarding the original cause of moisture ingress and the scope of remedial work completed. This information will assist in determining whether the issue is fully resolved or may require future attention.

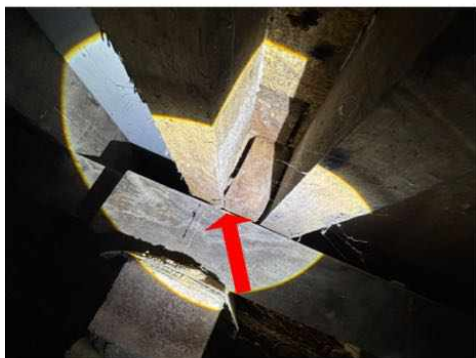
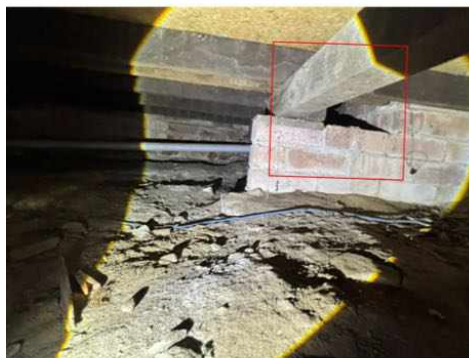
Building:	Main Building
Location:	Subfloor
Finding:	Termite - Damage Identified
Information:	At the time of inspection, evidence of termite damage was identified within the subfloor area. No live termite activity was observed at the time of inspection, indicating that the damage appears to be historical.

It is noted that a current termite management/treatment system is in place and appears to be active. While this is a positive control measure, termite activity can reoccur if ongoing management is not maintained.

The client is advised to continue with regular termite treatments and routine inspections through a licensed pest control provider to ensure the effectiveness of the system and to minimise the risk of future infestation. Ongoing monitoring is essential to protect the structural integrity of the property.

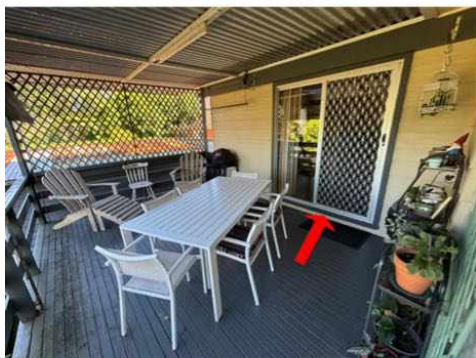
### Finding 6.01

It is important for internal flooring to be raised above adjacent external ground levels. Where external ground levels are above or same level as internal flooring, water pooling and subsequent internal flooding is likely to occur which may attract termite activity to the internal area.

It is highly advised that a landscaper or relevant tradesperson be appointed to lower external grounds that are raised above or same as adjacent internal flooring. Alternatively if external grounds and internal flooring is level installation of a raised door sill may be appropriate in preventing any water pooling in the area. If the client wishes not to make any changes, then a qualified pest controller is recommended for termite treatment around the perimeter of the house and subfloor (if any) as soon as possible.

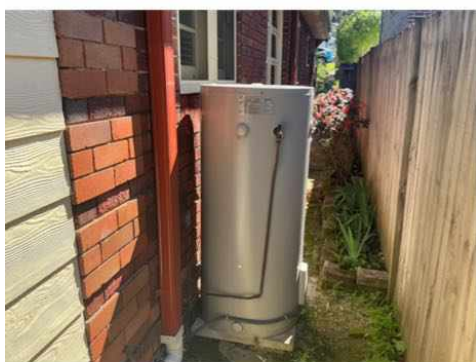
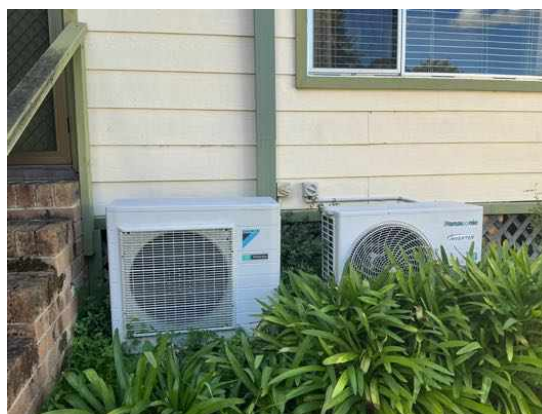
### Finding 6.02

Building:	Main Building
Location:	All Areas
Finding:	Bridging Appliances - Attachment to Buildings
Information:	Bridging occurs when items against a building provide a concealed entry point for termites into the building or by passing around a termite management system.

Where any part of an attachment to a building is not isolated and is not provided with a clear gap of not less than 25mm from the building, bridging occurs. Attachments to buildings such as hot water services, downpipes, verandahs, decks, steps, fences, service conduits and the like provide the opportunity for concealed entry.

Building attachments of this nature need to be frequently inspected for termite activity by a qualified inspector.

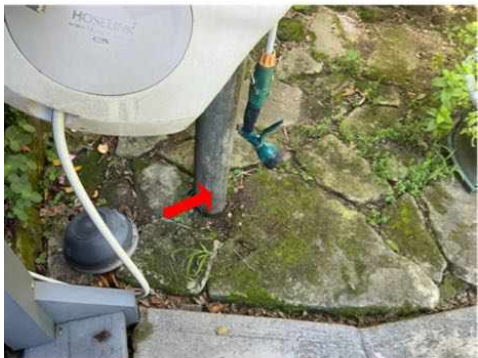
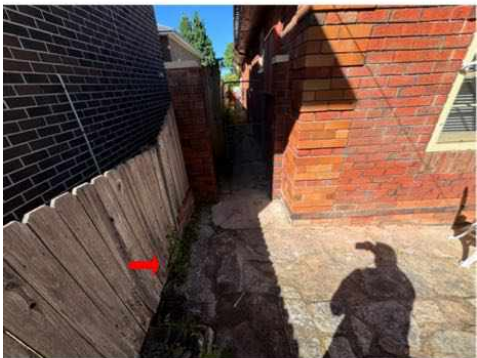
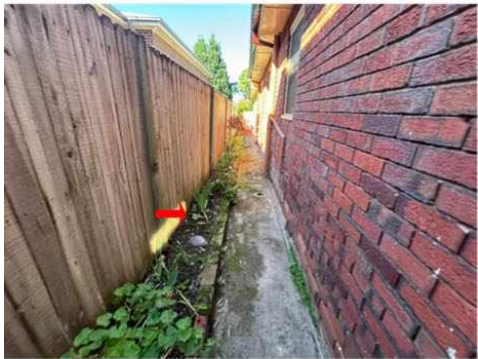
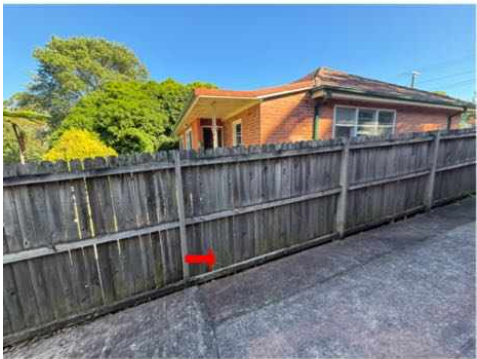
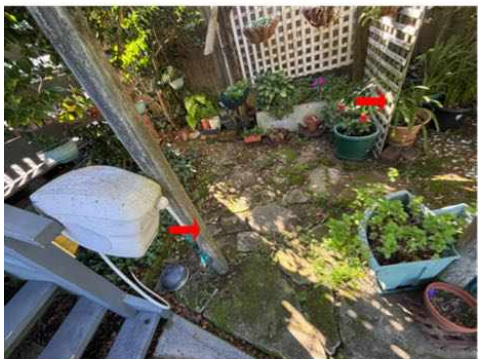
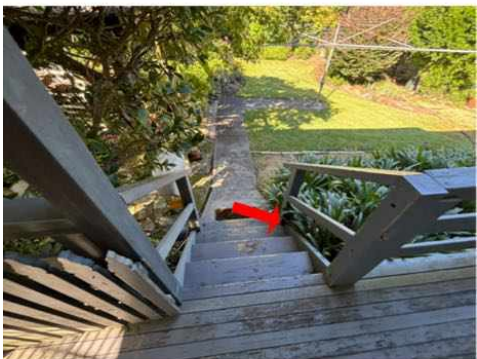
### Finding 6.03

Building:	Yard
Location:	All Areas
Finding:	Building Materials in Direct Ground Contact - Conducive to Termites
Information:	Timber elements that are in direct contact with the ground and exposed to moisture or damp conditions are highly conducive to termite activity. This susceptibility arises

because timber, when in contact with soil and dampness, creates an environment that is particularly attractive to termites, encouraging infestation and potential structural compromise. Whether the timber is used as a part of the building's construction or incorporated into fencing, its presence near or on the ground can become a pathway for termites to access and damage the property.

When exposed to excessive moisture, timber begins to deteriorate, developing conditions such as wood decay and rot. These compromised areas of timber are even more appealing to termites, as they are easier to infest and consume. This is especially true for untreated or non-durable timber, which lacks the protective treatments that can deter or withstand termite attacks. Termites can use these weakened, moisture-laden elements as a bridge into other parts of the structure, creating an entry point for potential infestations that can spread and cause extensive damage if left unchecked.

For any timber in direct contact with the external ground, special attention is required. The combination of moisture, untreated wood, and direct ground contact not only accelerates the decay process but also provides subterranean termites with a straightforward means of ingress into the structure. This entry can lead to termites moving undetected into other vulnerable areas, resulting in potentially significant structural issues and costly repairs.

To mitigate the risk of termite activity, it is imperative that any such materials or timber elements be appropriately treated or removed as soon as possible. Timbers that are necessary for use should be made durable through appropriate treatments and maintained to ensure they do not create conditions conducive to termites. Additionally, the client is advised to schedule regular termite treatments to maintain an effective barrier against infestations and ensure ongoing protection.

The client is strongly advised to assess the property for any timber elements that may be in direct contact with the ground and ensure prompt action is taken to remove or treat them effectively. Regular inspections, proactive maintenance, and consistent termite treatment are essential steps in minimising the risk of termite attack and protecting the structural integrity of the property. Taking these preventive measures is crucial for maintaining a termite-free environment and avoiding potentially costly damage and future repairs.

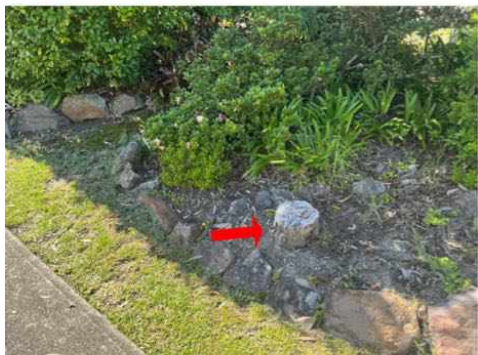
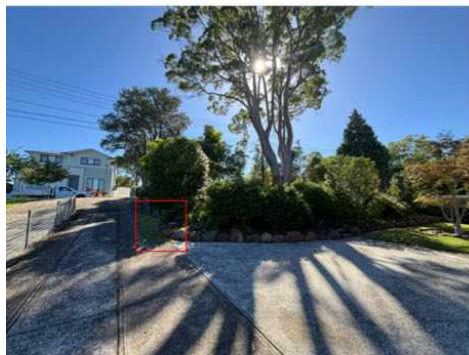
**Finding 6.04**

Building: Yard  
 Location: Yard - Front  
 Finding: Tree Stumps - Remove  
 Information: Old tree stumps were found around the property.

Any tree stumps in ground contact provide opportunity for concealed termite infestation and are likely to be subject to decay as the soil retains moisture or damp conditions against the tree stump.

Timber pest management plan should be implemented and 6-12 monthly Timber Pest inspections carried out in accordance with AS4349.3 or AS 3660.2.

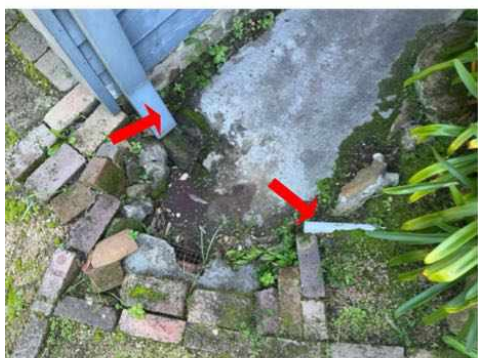
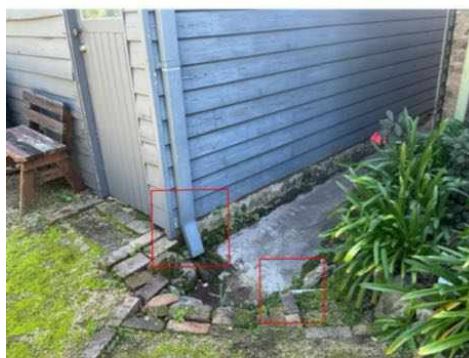
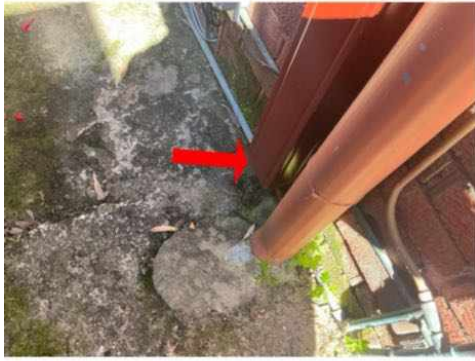
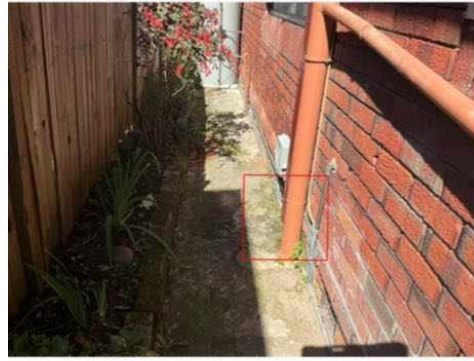
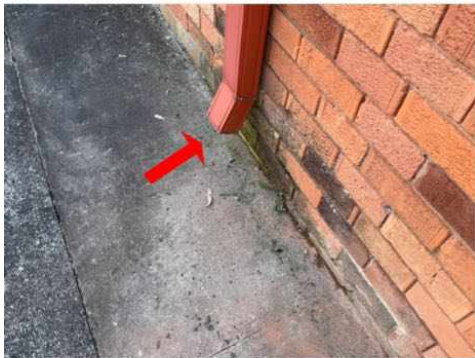
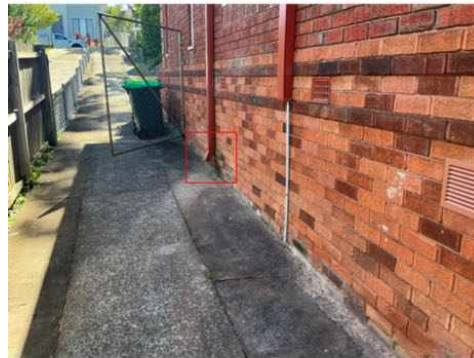
### Finding 6.05

Information: The inspection revealed that the roof plumbing system is not adequately connected to the site's stormwater drainage, reducing its functional efficiency. This disconnection can lead to water pooling around the base of the property, increasing the risk of rust and corrosion to building elements, structural damage, and attracting termites due to the persistent dampness.

Improper drainage can also contribute to mould and mildew growth, affecting indoor air quality and health, and may lead to ground movement, causing cracks in walls and other structural issues.

It is strongly recommended that a licensed roof plumber be engaged to assess the system and ensure appropriate connections to stormwater outlets are installed to effectively redirect water away from the structure.

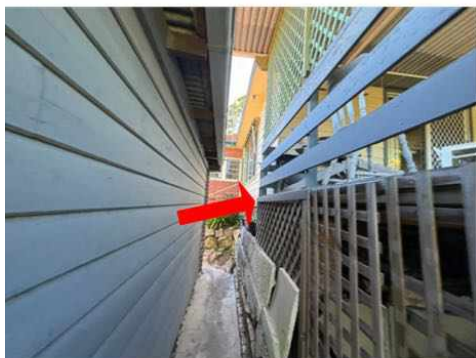
### Finding 6.06

Building:	Main Building
Location:	Deck
Finding:	Timber Directly Attached to Building
Information:	At the time of inspection, timber materials were noted to be directly attached to the external wall of the dwelling. This practice is considered a conducive condition for termite activity, as it provides both a potential food source and concealed entry point for termites into the structure.

It is recommended that the timber be removed, isolated, or appropriately treated to reduce the risk of termite infestation. A licensed pest management specialist should be consulted for further assessment and advice in line with AS 3660.2 (Termite Management).

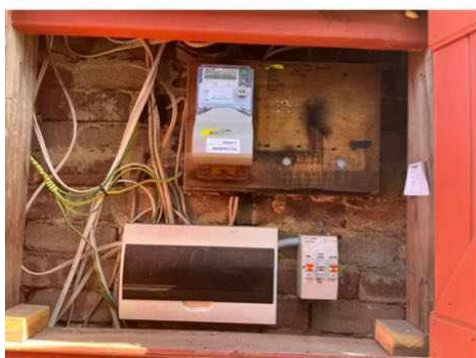
### Finding 6.07

Building:	Main Building
Location:	Meter Box
Finding:	Termite Management System - No Evidence of Installation
Information:	The application of a post-construction chemical termite barrier is strongly recommended for all properties, especially if there has been any history of live termite activity on-site. These barriers are highly effective in protecting timber building elements throughout the property by preventing termite attacks. It is also advisable to install a durable notice within the switchboard unit, indicating the presence of any termite barriers for future reference.

During the inspection, there was no indication that a termite management system had been installed, nor was there any evidence to suggest that preventative measures had previously been undertaken. The client is encouraged to seek further advice from a licensed pest controller regarding the costs and procedures involved in the application of a termite barrier. Prioritizing this step in the short term is strongly advised to ensure long-term protection.

Additionally, the client may want to consult with the vendor to determine whether regular Timber Pest inspections, as per AS4349.3 or AS 3660.2, have been conducted in the past. This will provide further insights into any past termite management practices and help inform the appropriate course of action.

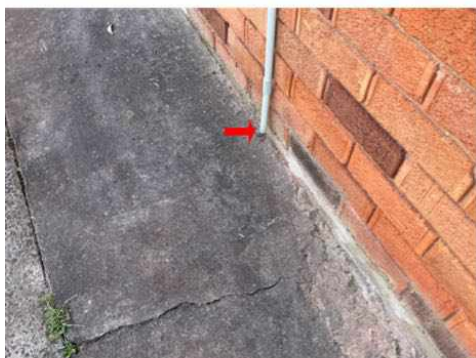
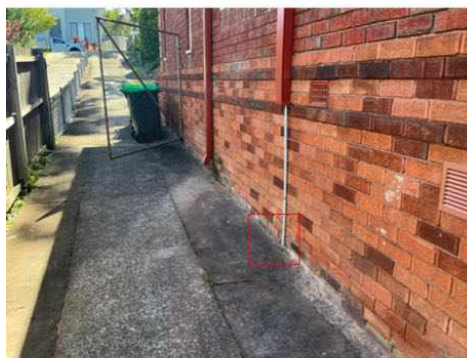
## Finding 6.08

Building:	Main Building
Location:	Exterior walls - right side
Finding:	Overflow Disconnected - Air Conditioning/Hot Water/Gas Services
Information:	The overflow from the air conditioning/hot water/gas systems was observed to be improperly connected, with no connection to the stormwater drainage system.

This lack of proper drainage can result in water pooling around the building, leading to potential issues such as moisture damage, erosion, or rising damp. Prolonged exposure to these conditions could compromise the integrity of the surrounding structures and surfaces, contributing to further deterioration over time.

It is recommended that a qualified plumber be engaged to connect the overflow to the stormwater drainage system to prevent ongoing damage and ensure proper water management.

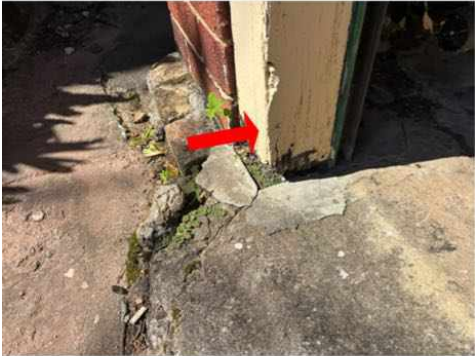
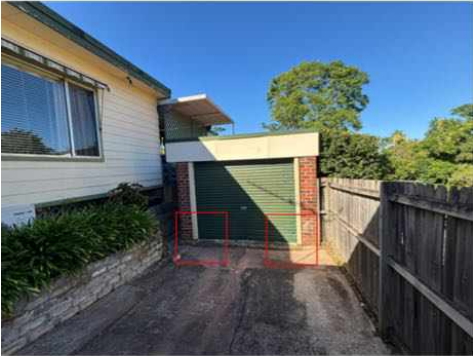
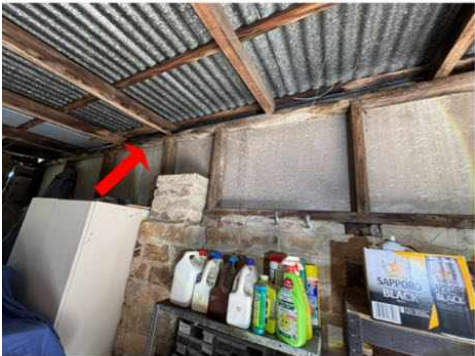
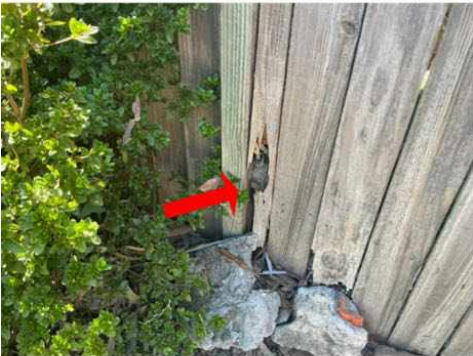
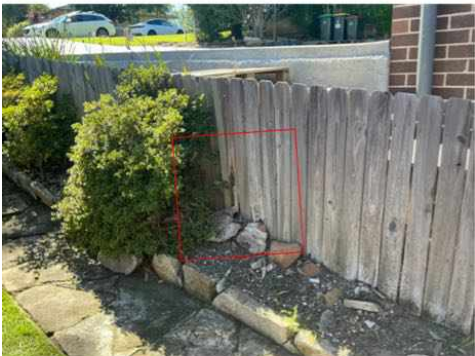
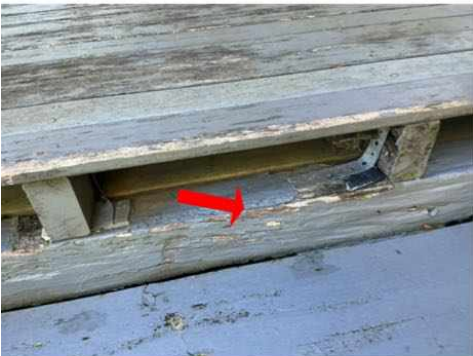
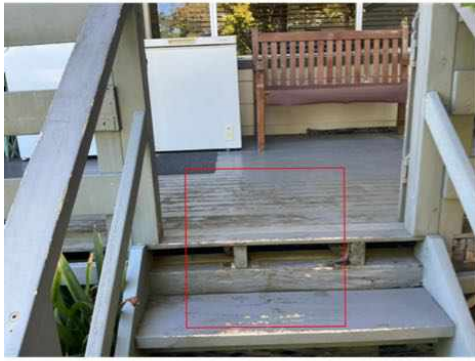
### Finding 7.01

Building:	Main Building
Location:	Garage, Deck, Fencing
Finding:	Fungal Decay - Present (Localised)
Information:	Fungal decay, also referred to as wood decay or wood rot, typically occurs when timber elements are exposed to excessive moisture for extended periods. This deterioration process is accelerated by temperatures ranging between 5°C and 40°C, as well as the presence of oxygen. Fungal decay is commonly found in timber components used in external environments, particularly when they are exposed to rain or moisture penetration.

In this instance, although the timber element shows signs of decay, the visible damage appears to be localized to a specific area and has not yet spread to adjoining

structures or other parts of the building element. As a result, the fungal decay is likely to be relatively superficial, with minimal impact on the structural integrity or tensile strength of the timber. However, it is advisable to monitor the affected area to prevent further deterioration and address the underlying moisture issue to mitigate future risk.
