# Building and Timber Pest Inspection Report

Inspection Date: Wed, 1 Apr 2026

Property Address: 10 Lockwood St, Asquith NSW 2077,  
Australia

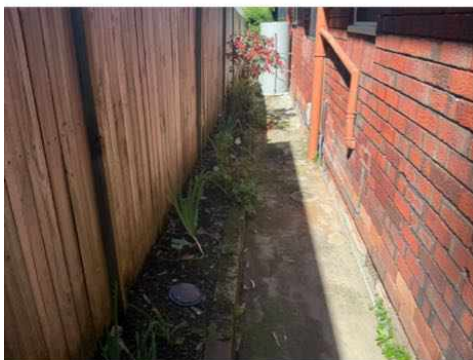
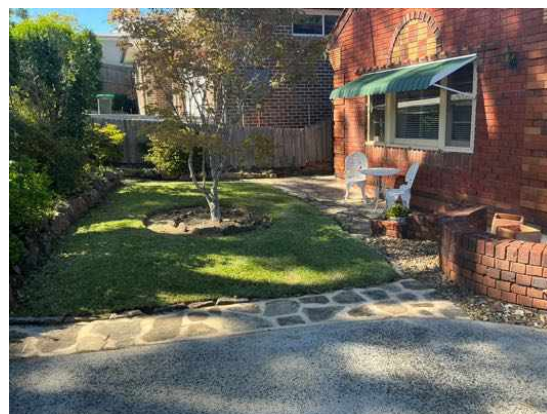
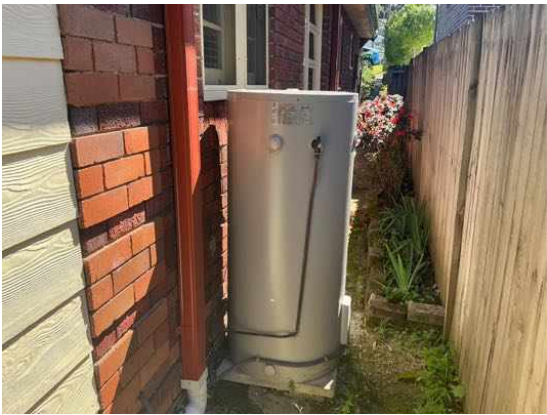
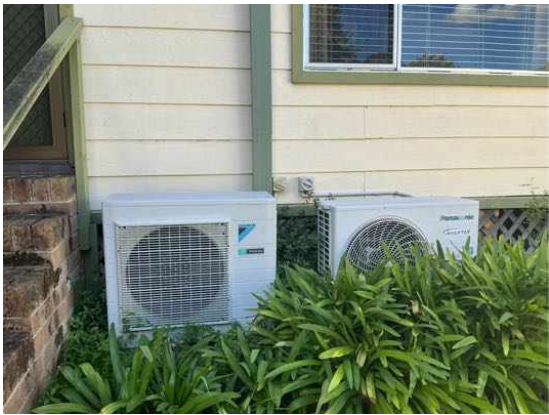
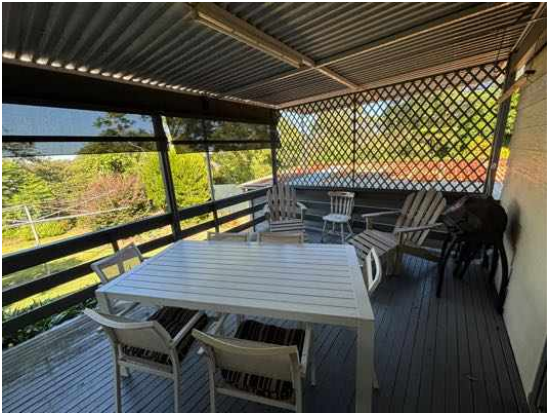
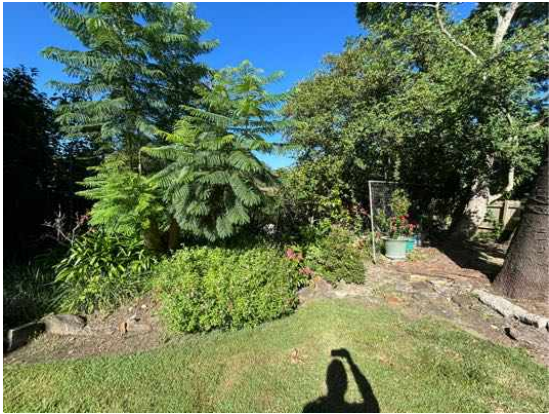
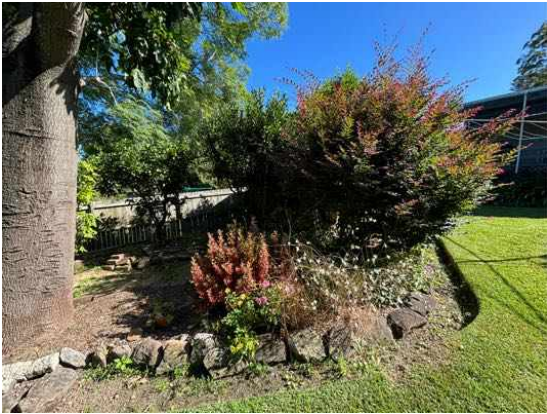
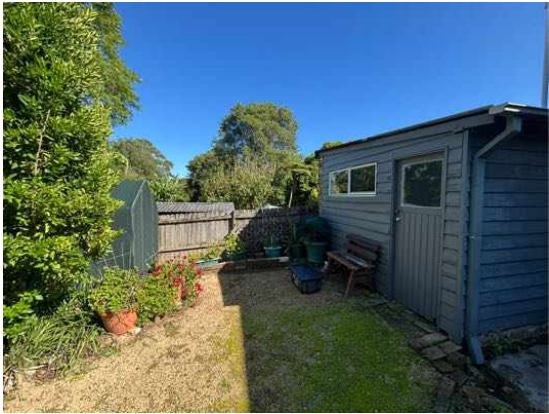
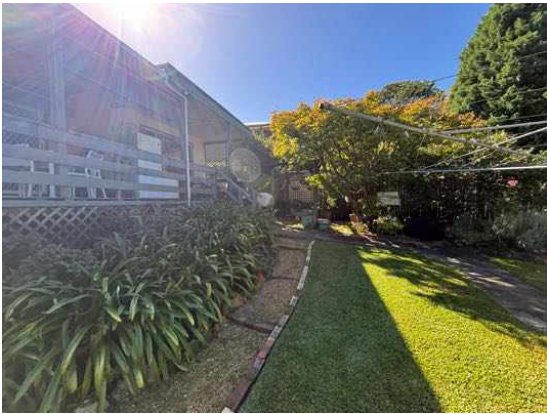
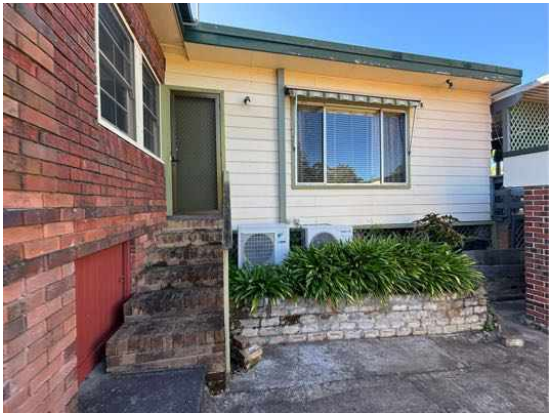
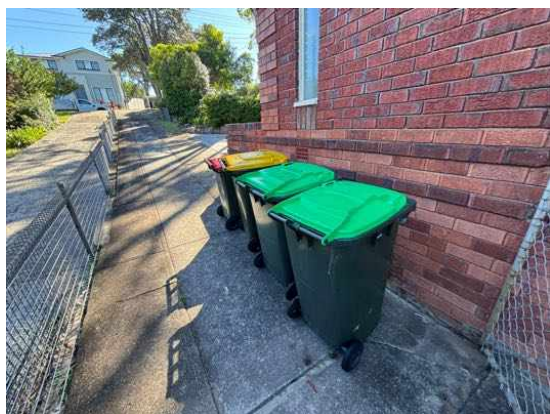
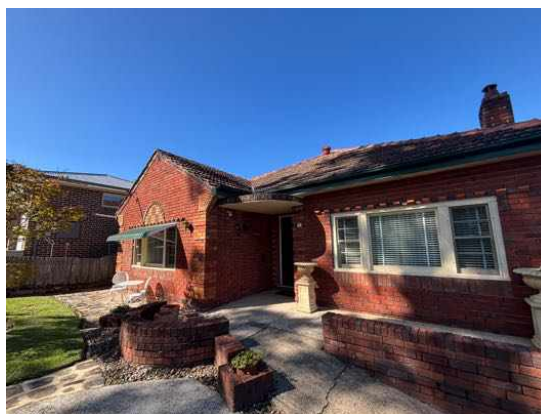
Building: Main Building  
Location: All External Areas  
Finding: Obstructions and Limitations - External Areas  
Information: The attached photographs provide a visual representation of the obstructions and limitations that impeded a full inspection of the external areas of the property at the time of assessment. These obstructions, which may include vegetation, stored items, debris, or other physical barriers, can obscure potential defects and prevent a thorough evaluation of the property's condition. Obstructions of this nature can conceal a wide range of issues, such as structural damage, water ingress, pest infestations, or deteriorating building materials, which may not be visible during the initial inspection.

It is essential that these obstructions be cleared to allow for a comprehensive inspection of the external areas. Removing these barriers will enable a more accurate assessment of the property's condition and allow any hidden defects to be identified and addressed promptly. Failure to do so could result in undetected issues worsening over time, potentially leading to more costly repairs in the future.

Therefore, it is strongly recommended that the obstructions be removed and a re-inspection be scheduled once the affected areas are made fully accessible. This will ensure a complete evaluation of the property's exterior and provide the client with a clear understanding of any potential issues that may have been concealed during the initial inspection.

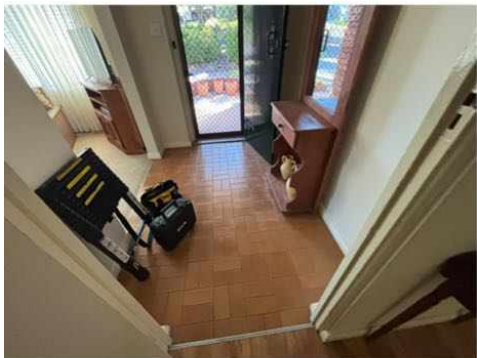
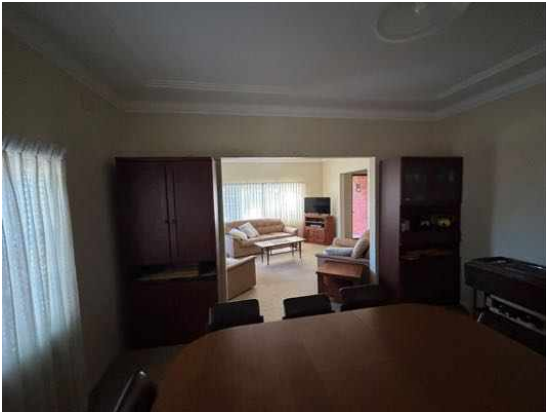
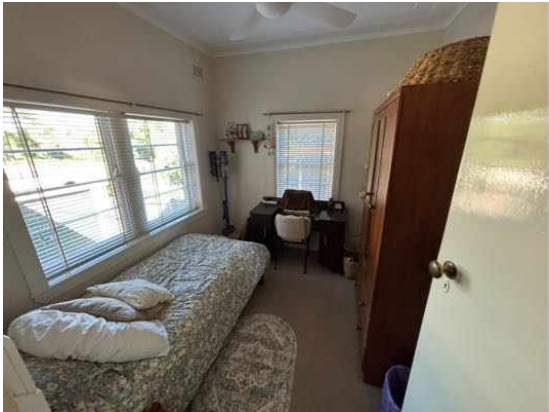
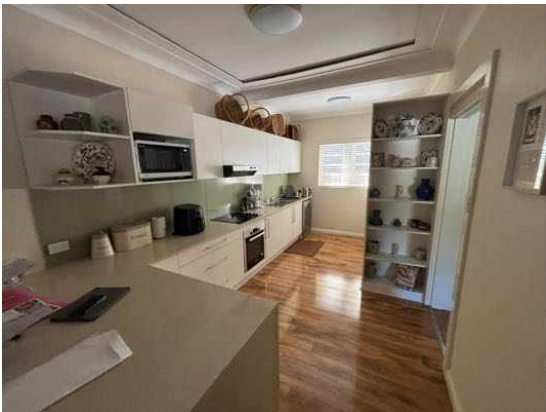
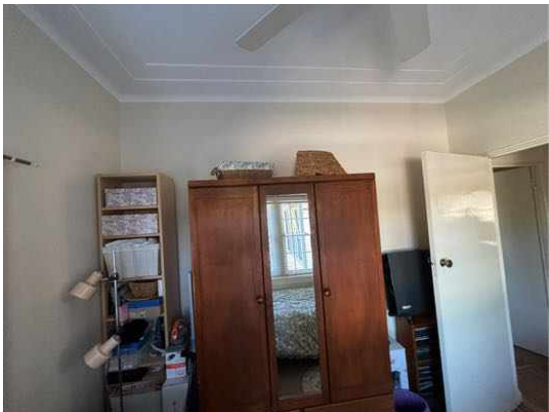
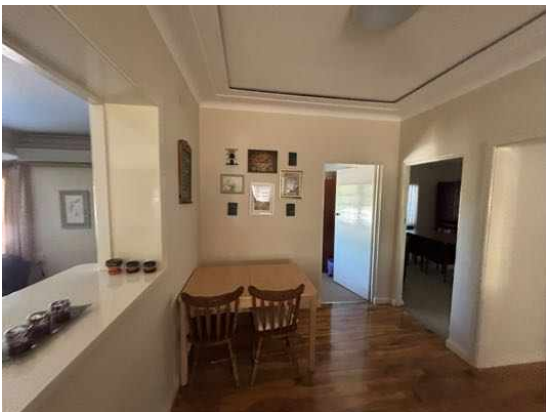
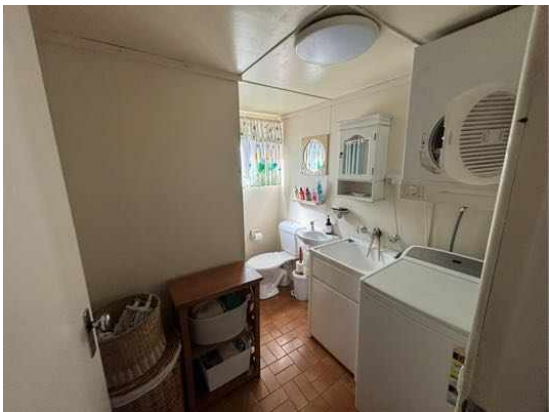
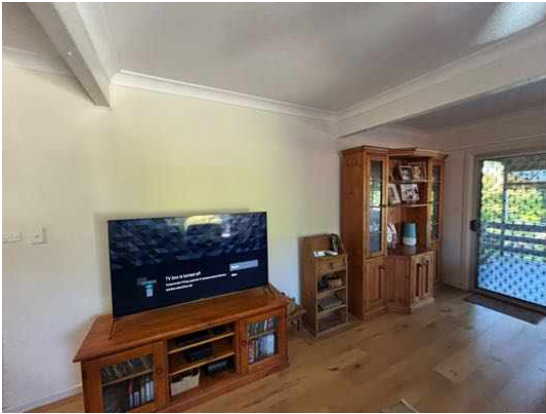
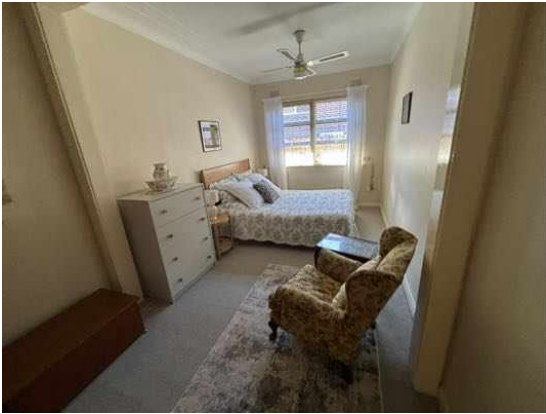
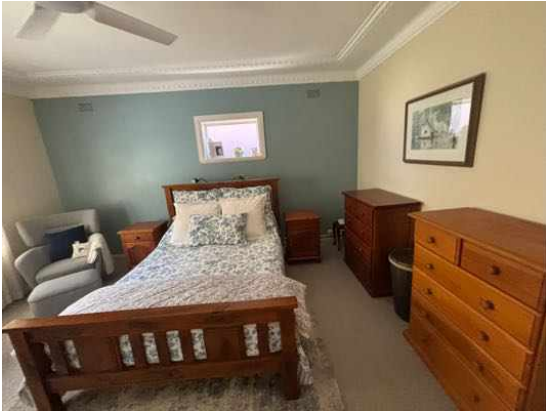
Information: The accompanying photographs provide clear evidence of the obstructions and limitations that restricted a comprehensive inspection of the internal areas of the property at the time of assessment. These obstructions, which may include furniture, personal belongings, stored items, or structural elements such as wall coverings and built-ins, significantly hindered the ability to thoroughly evaluate these areas. It is important to note that such obstructions can potentially conceal a wide array of defects, ranging from hidden structural damage, water leaks, pest infestations, or electrical issues, to deteriorating materials that may not be visible during the initial inspection.

The presence of these impediments means that critical areas of the property were not accessible, and therefore, any underlying defects that may affect the integrity and safety of the property could remain undetected. These hidden defects, if left unaddressed, could worsen over time and may result in costly repairs or pose potential safety hazards to the occupants.

It is highly recommended that all obstructions be cleared to facilitate a complete and thorough inspection of the internal areas. Once the obstructions have been removed and full access is available, a re-inspection should be carried out to ensure that any previously concealed issues can be properly identified and rectified. This follow-up inspection will provide a more accurate assessment of the property's internal condition and help the client make informed decisions about any necessary repairs or maintenance.

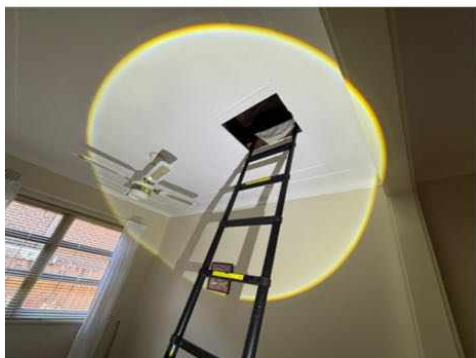
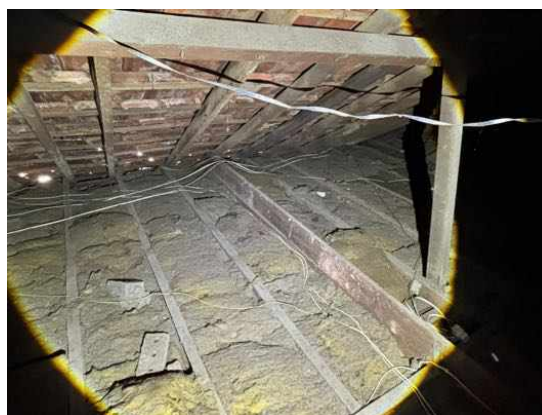
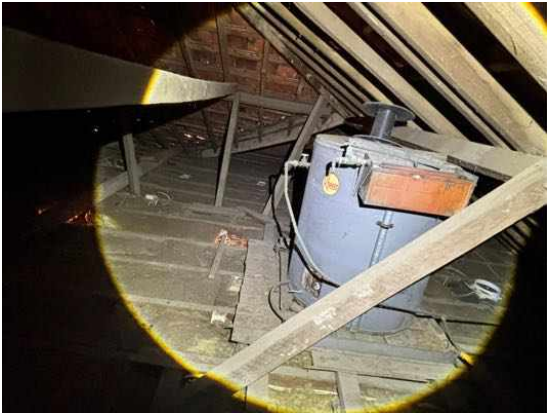
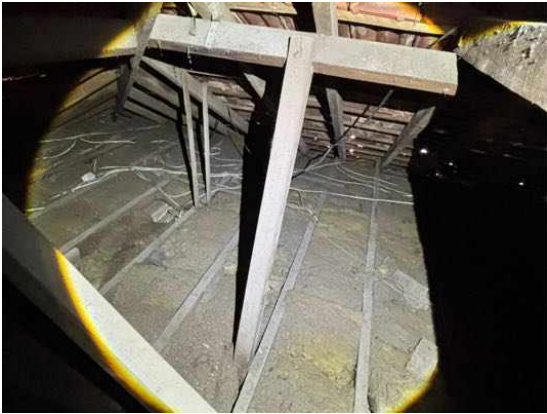
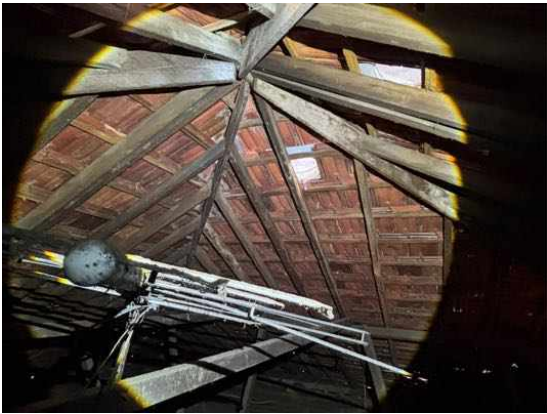
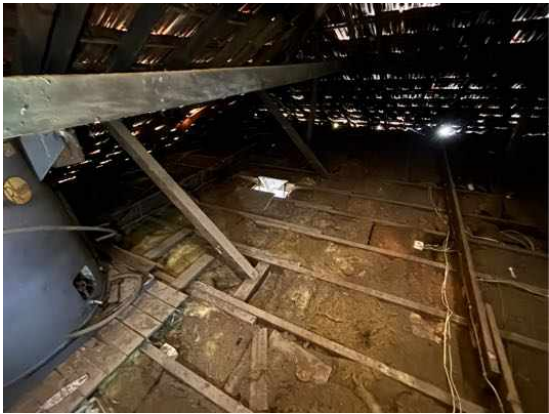
Building: Main Building  
Location: Roof Void  
Finding: Obstructions, Limitations, and General Roof Space Condition  
Information: The photographs provided document both the general condition and the obstructions and limitations that were present in the roof cavity of the main building at the time of inspection. These obstructions—such as insulation materials, stored items, structural elements, or electrical wiring—restricted safe and adequate access to key areas within the roof space. As a result, a comprehensive inspection of all components could not be completed.

Obstructions of this nature may conceal a variety of potential defects, including damaged framing, compromised insulation, evidence of moisture ingress, pest activity, or electrical hazards. While no major issues were observed in the visible areas, the presence of these limitations means that some defects may remain undetected.

It is recommended that these barriers be removed or repositioned to facilitate full and safe access to the roof space. Once clear, a follow-up inspection should be conducted to allow for a thorough assessment of all concealed areas. This will help ensure that the condition of the roof cavity is accurately evaluated and any hidden issues are appropriately identified and addressed.

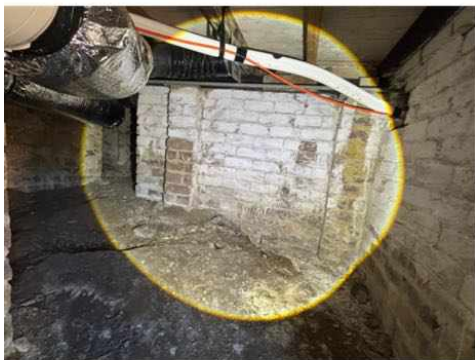
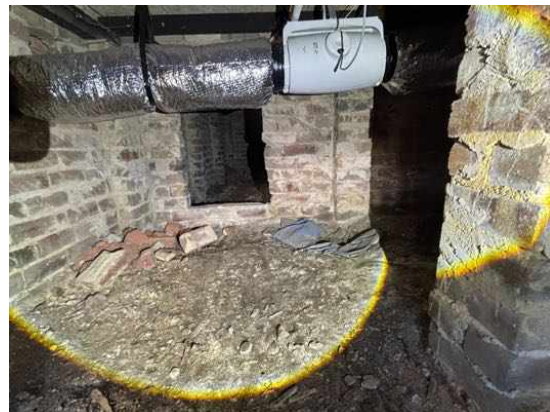
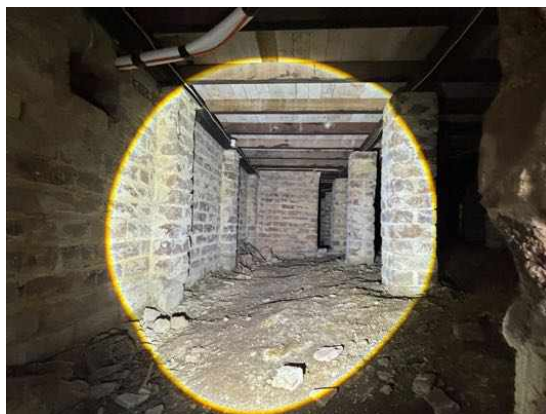
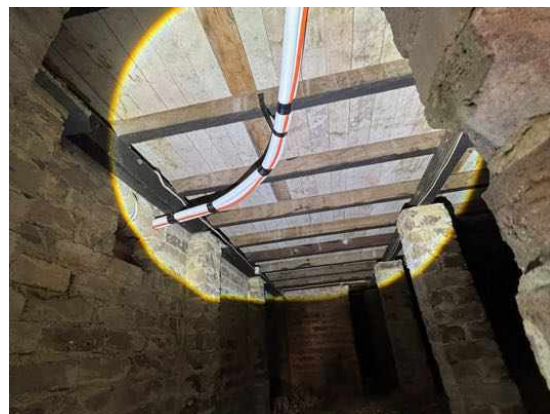
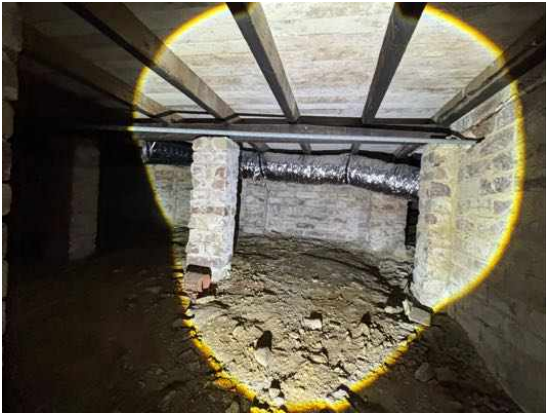
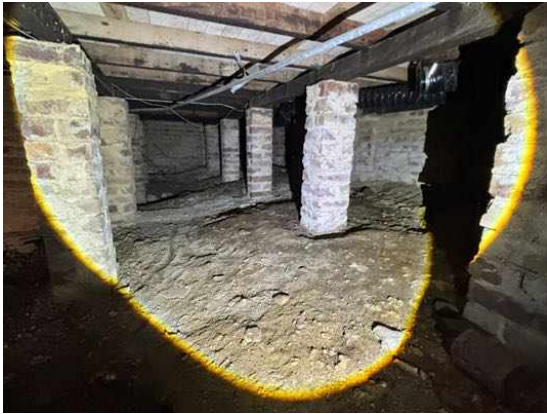
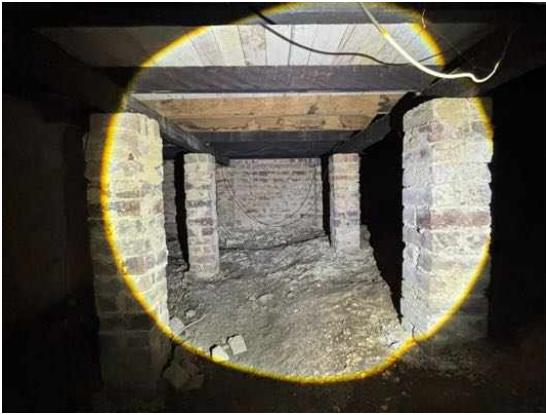
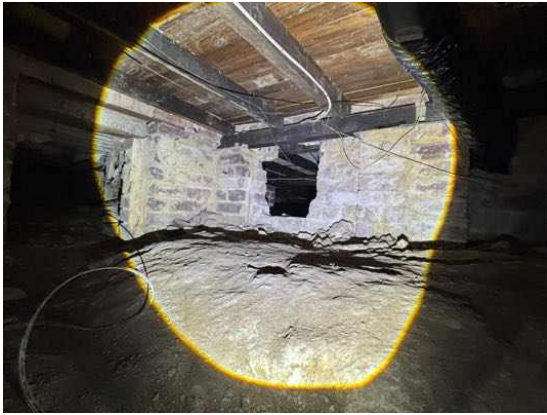
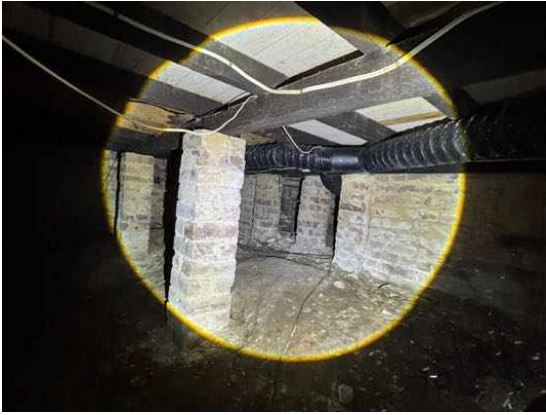
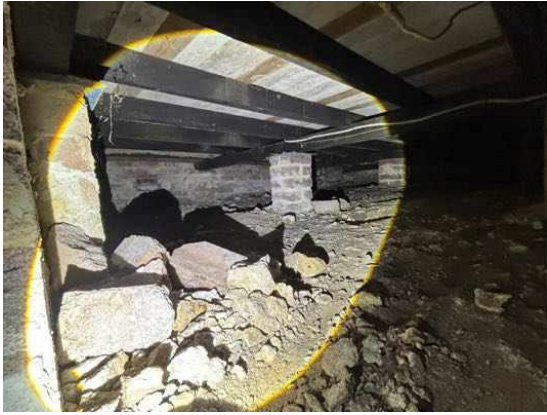
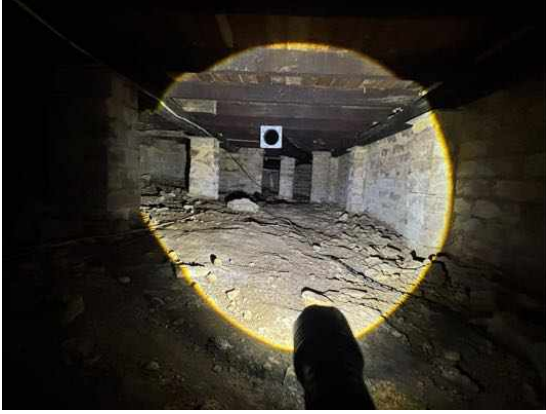
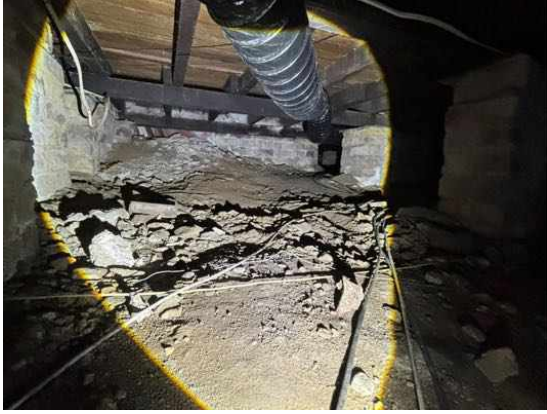
Building: Main Building  
Location: Subfloor  
Finding: Obstructions, Limitations, and General Subfloor Condition  
Information: The attached photographs illustrate the obstructions and access limitations that restricted a full inspection of the subfloor area of the main property at the time of assessment. Items such as stored materials, construction debris, low-hanging services, and insulation impeded movement and visibility within key sections of the subfloor. In addition, the limited crawl height further restricted safe access to inspect critical structural components.

Restricted access and confined spaces can significantly hinder the ability to evaluate important elements such as floor joists, bearers, stumps, drainage, subfloor ventilation, and signs of moisture or pest activity. These obstructions may also conceal defects such as timber decay, water ingress, termite damage, inadequate support, or ventilation issues that are not immediately visible during a limited inspection.

While no major concerns were identified in the accessible areas, a full and unobstructed inspection is necessary to properly assess the overall condition of the subfloor. It is recommended that obstructions be removed and access improved where possible. Once adequate clearance is provided, a re-inspection should be arranged to ensure that any concealed defects can be identified and addressed accordingly. This will assist in providing a more comprehensive understanding of the subfloor's condition and reduce the risk of unforeseen issues.

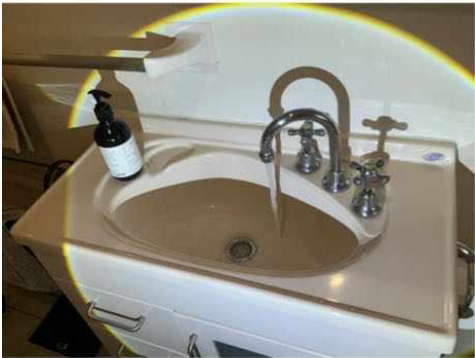
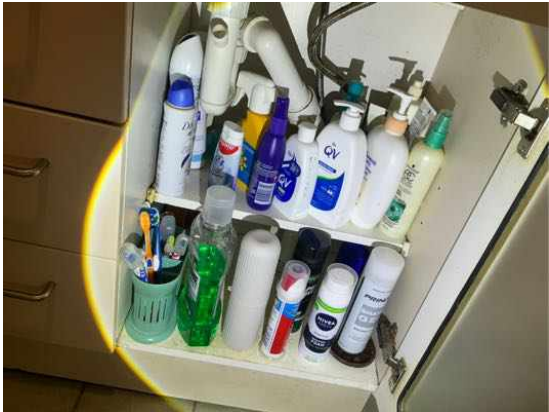
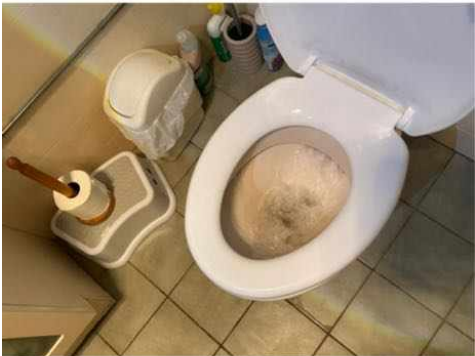
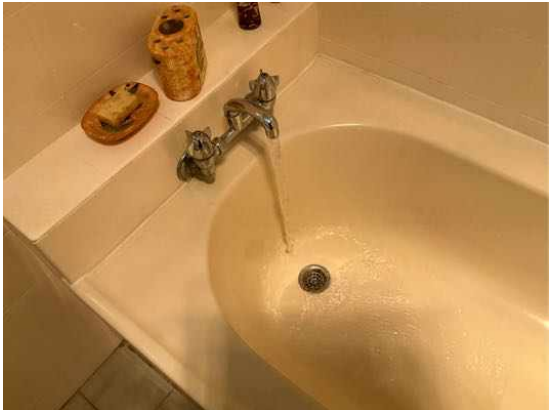
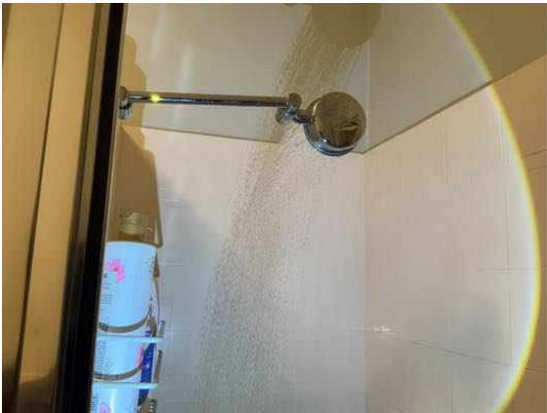
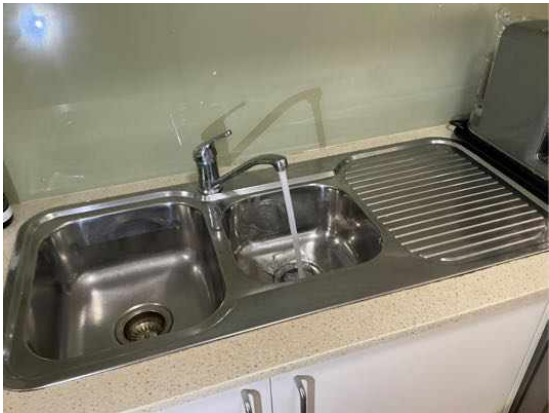
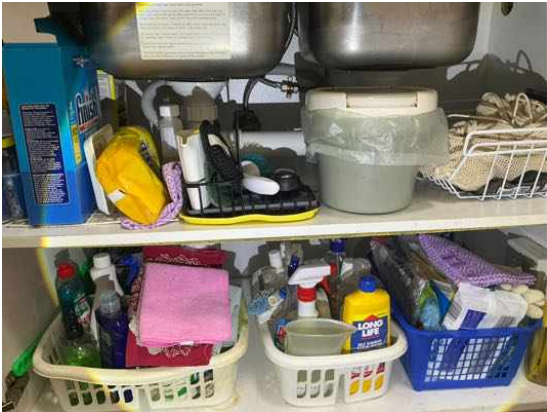
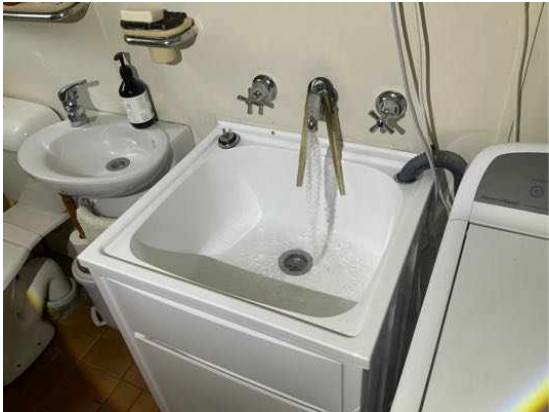
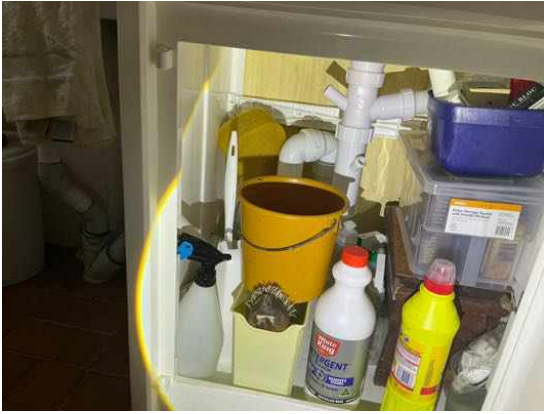
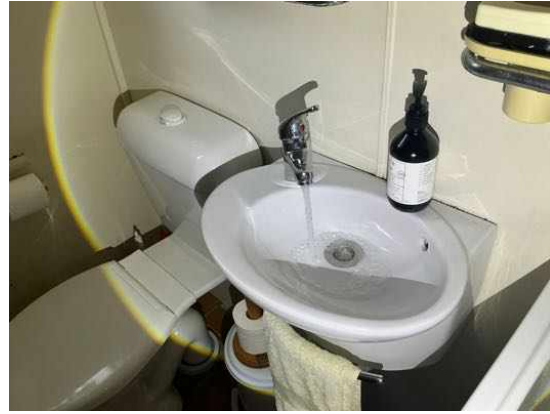
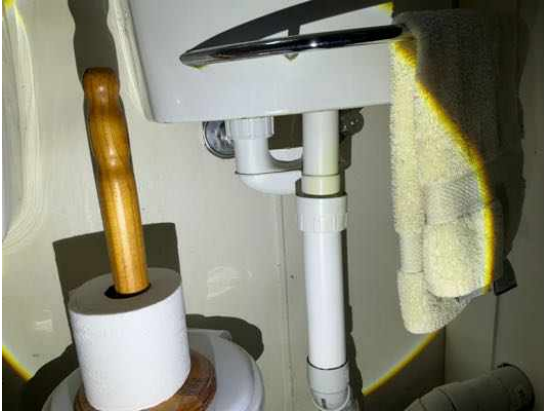
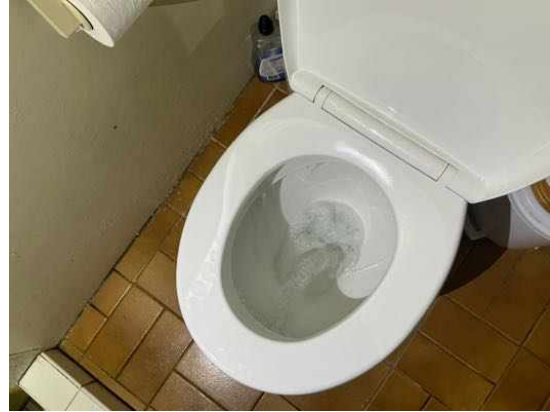
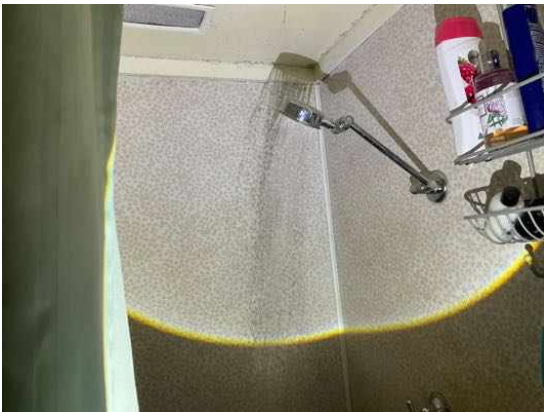
Building:	Main Building
Location:	All Areas
Finding:	FYI - Taps, Drainage & Toilets Tested and Cabinetry Obstructions
Information:	During the inspection, all accessible taps, drainage systems, and toilets were tested for water flow and drainage efficiency, and checked for any visible signs of leakage. At the time of the inspection, no issues were noted in these areas. Unless highlighted in a separate defect statement, no immediate remedial work appears necessary. Supporting images may be found in the additional photos section for reference.

It is important to note that while a visual inspection of cupboards and cabinetry beneath sinks and vanities was undertaken, stored personal items and fixtures presented obstructions that limited full visibility of the internal areas. As per standard inspection practices, inspectors are not permitted to move or disturb personal belongings during the inspection process. Therefore, only visible and accessible sections were inspected, and concealed water damage or plumbing defects may not have been detected.

Given this, a re-inspection is recommended after all obstructions have been cleared to allow for a comprehensive assessment of these areas. Regular maintenance and monitoring of plumbing and drainage systems is also advised to ensure ongoing functionality and early detection of potential issues.

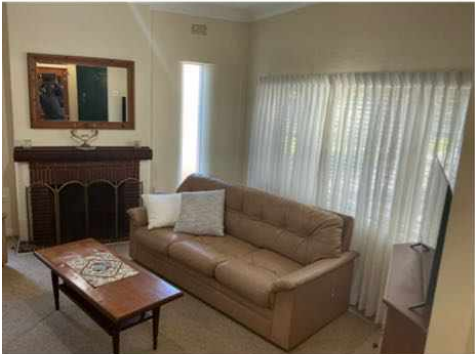
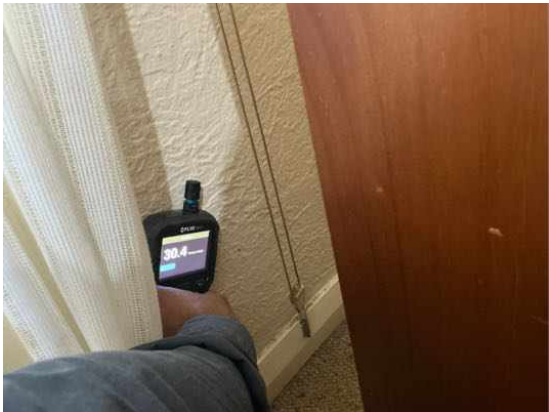
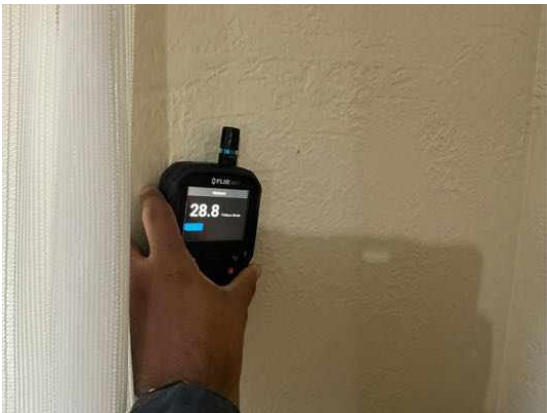
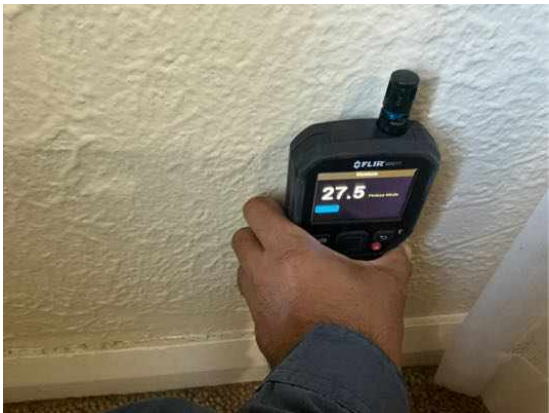
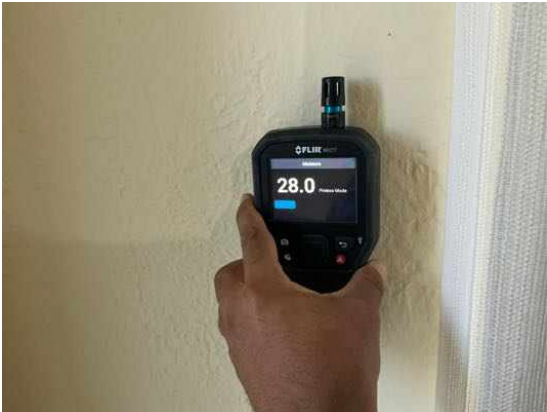
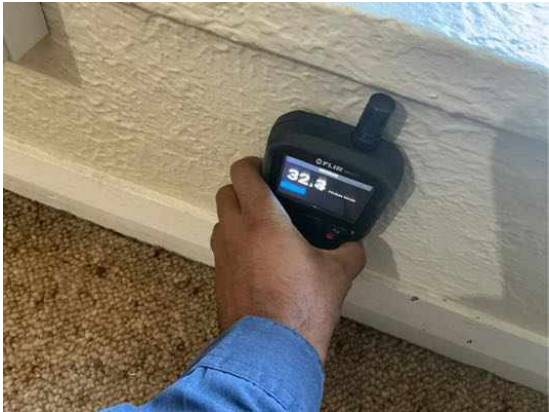
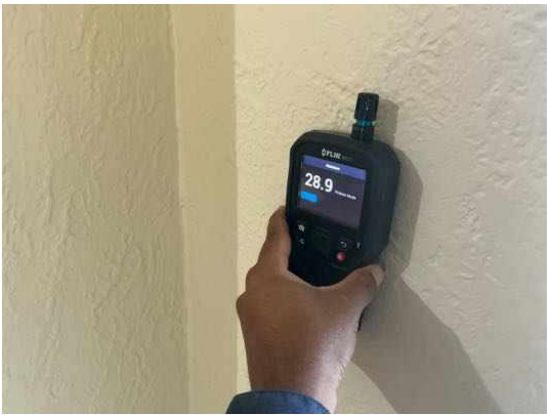
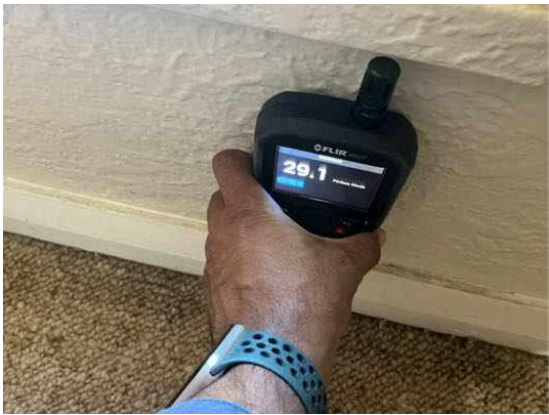
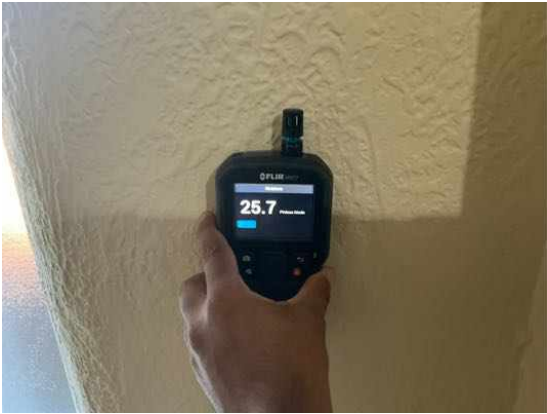
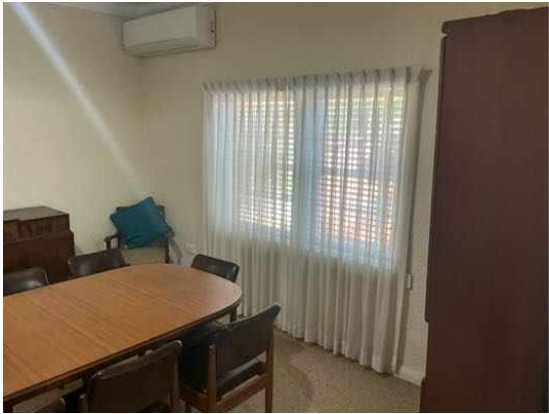
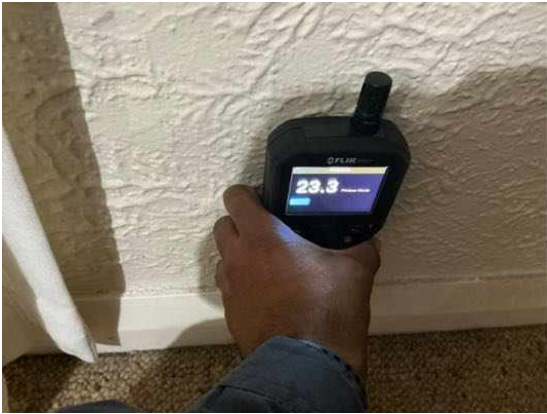
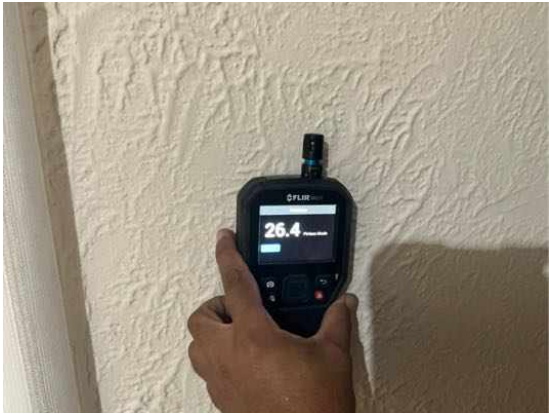
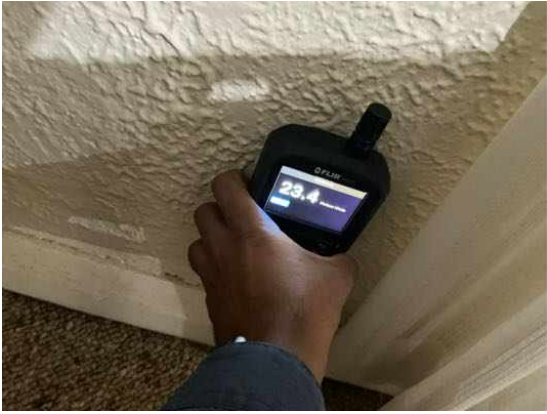
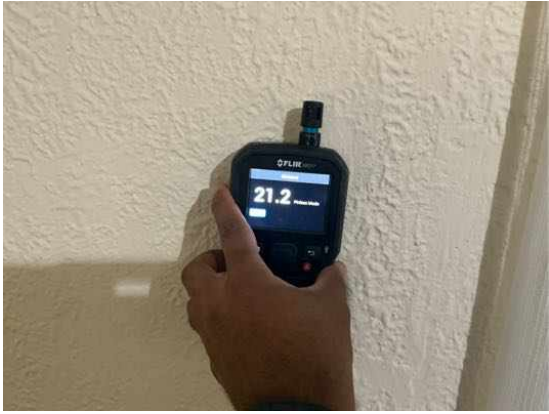
Finding: Additional Photos - Moisture Meter Readings

Information: Additional moisture meter reading photos have been provided for the property to offer further clarity on areas tested during the inspection. These photos are intended to give a visual reference for the specific locations where moisture levels were measured. These readings were taken at the time of the inspection to assess any potential moisture-related issues within the property. Any defects related to moisture that were identified during the inspection have been separately mentioned in the defect statements within the report.

It is important for the client to understand that moisture levels can fluctuate over time due to various factors, including changes in weather, humidity, and environmental conditions. While the readings reflect the property's moisture levels during the inspection, they may not represent future conditions, and increased moisture could lead to issues such as dampness, mould growth, or deterioration of building materials if left unmonitored.

For further clarification or additional information regarding the moisture readings, the client is encouraged to contact the building inspector directly. Regular monitoring of moisture-prone areas is recommended to ensure any emerging concerns are addressed promptly, particularly during wetter seasons or in high-humidity conditions.
