# Building and Timber Pest Inspection Report

Inspection Date: Wed, 1 Apr 2026

Property Address: 10 Lockwood St, Asquith NSW 2077,  
Australia

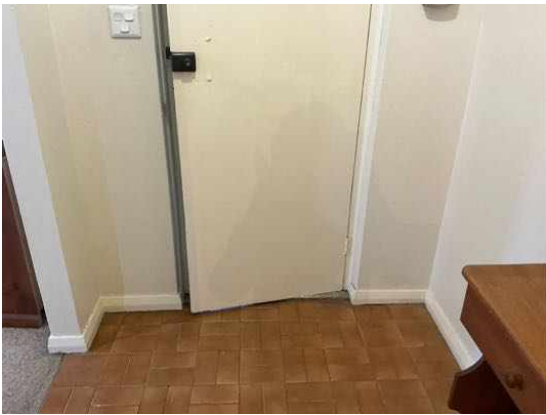
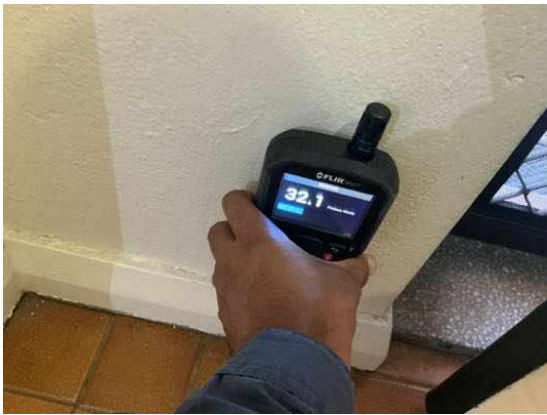
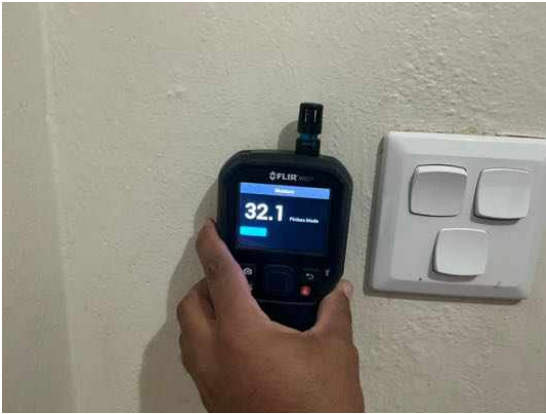
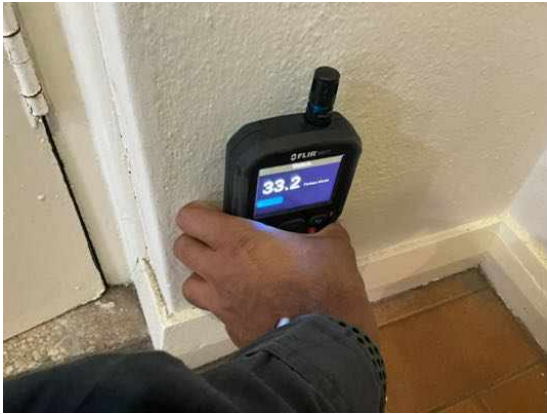
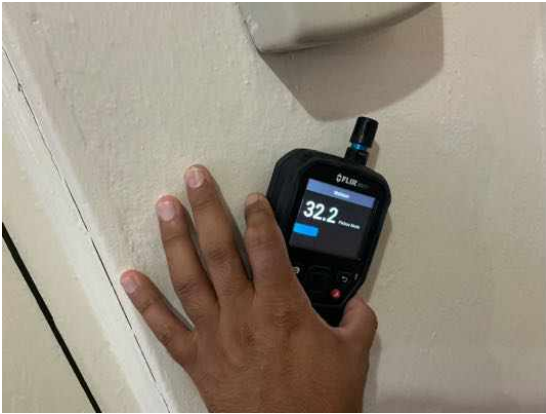
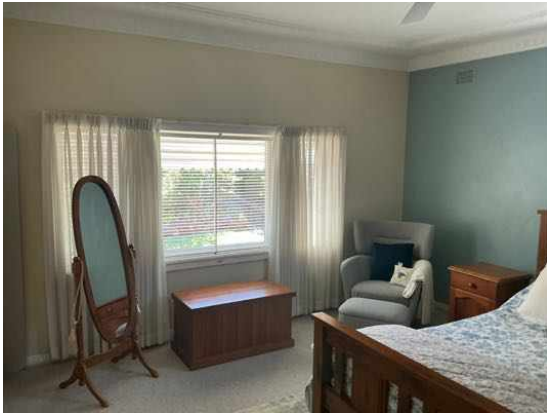
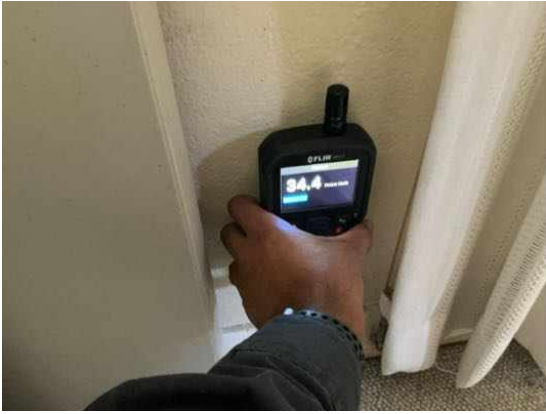
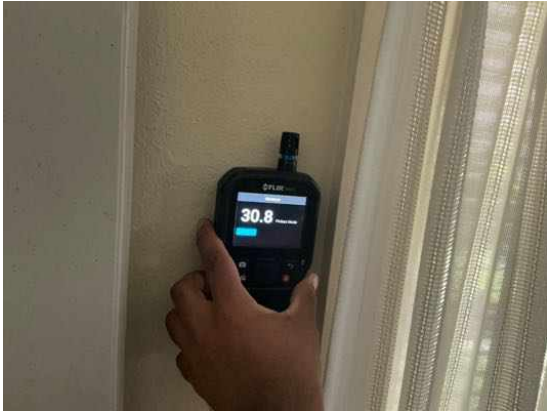
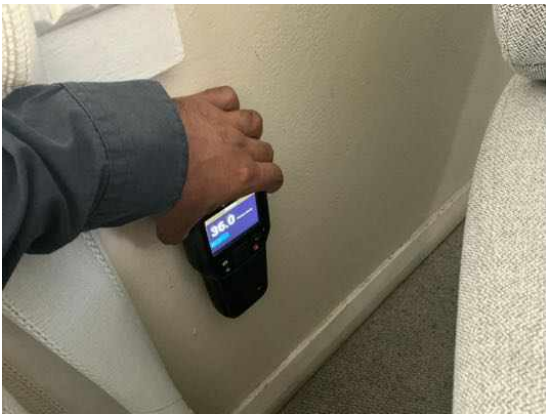
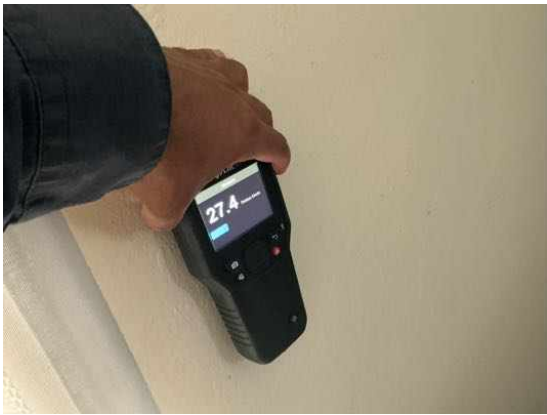
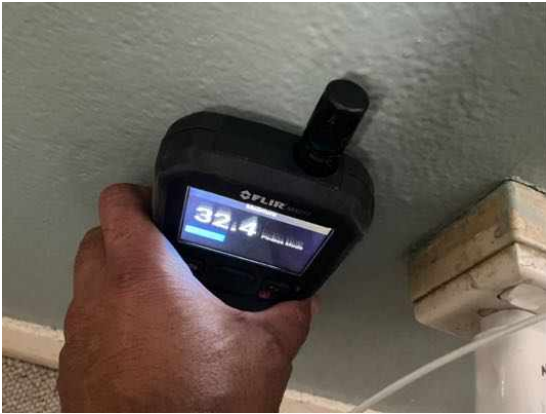
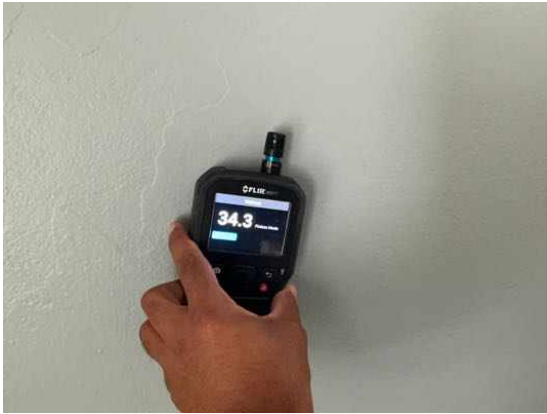
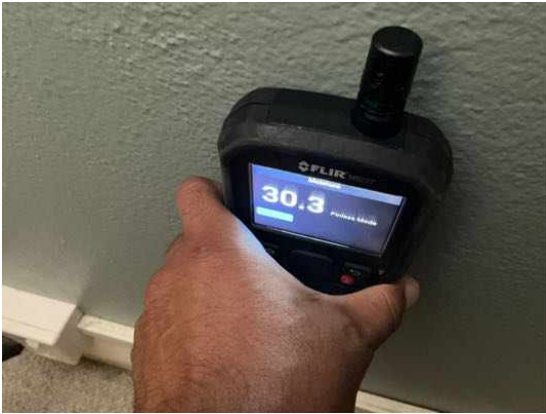
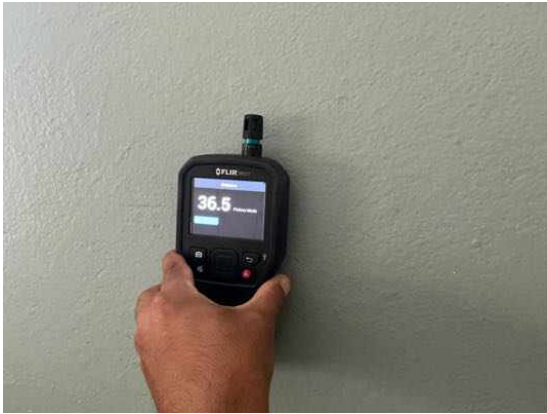
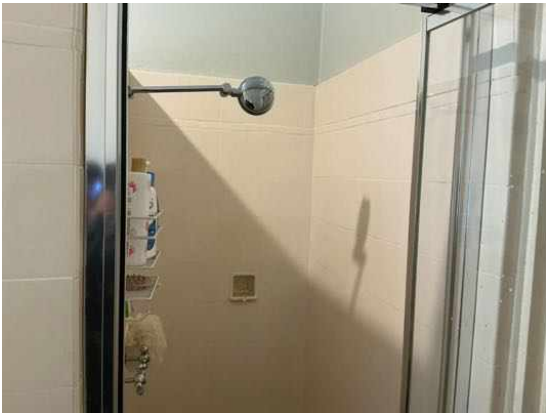
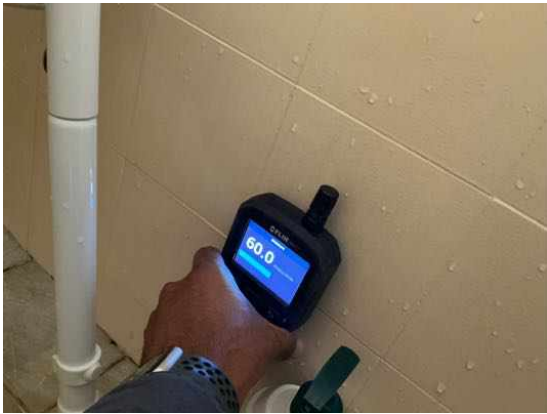
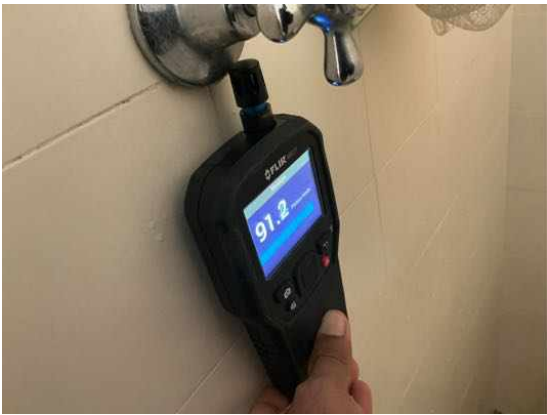
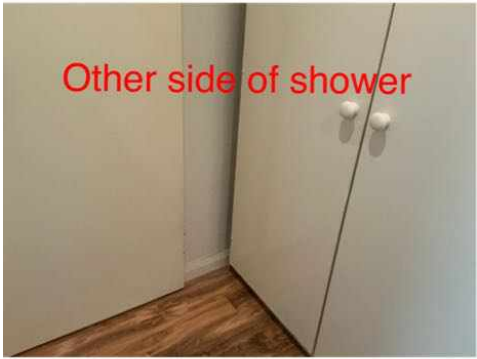
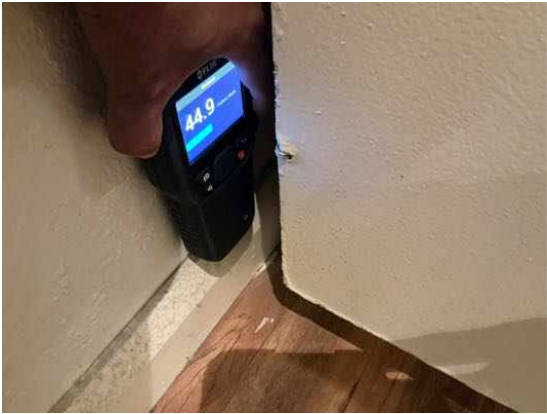
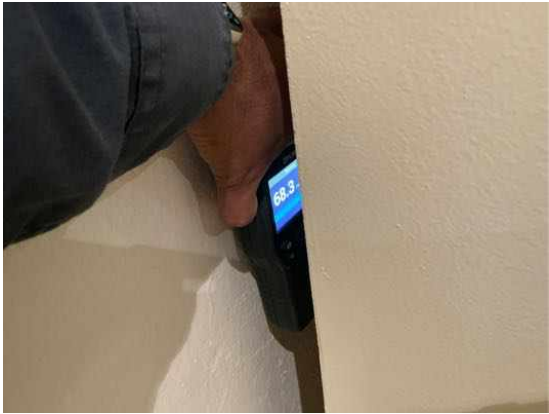
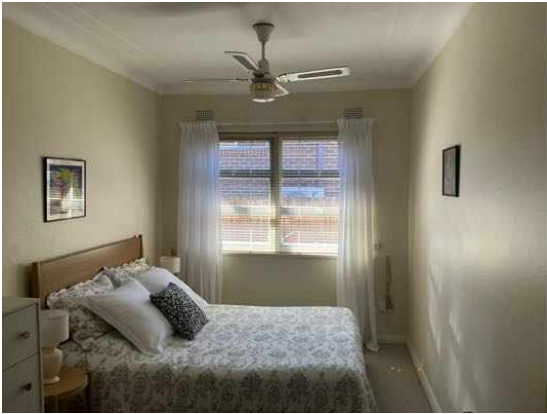
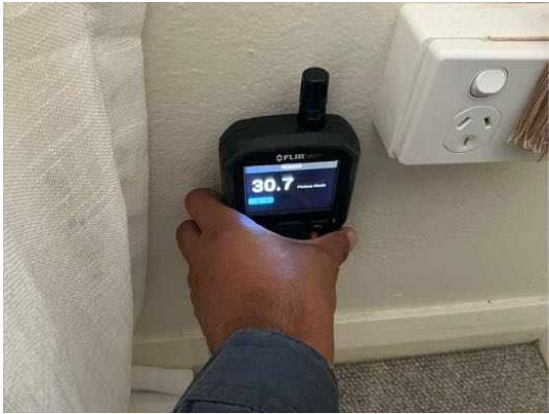
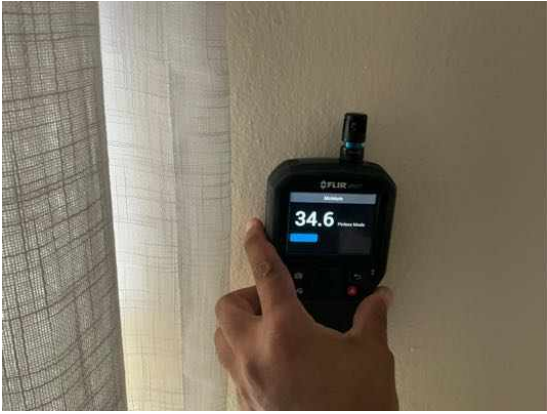
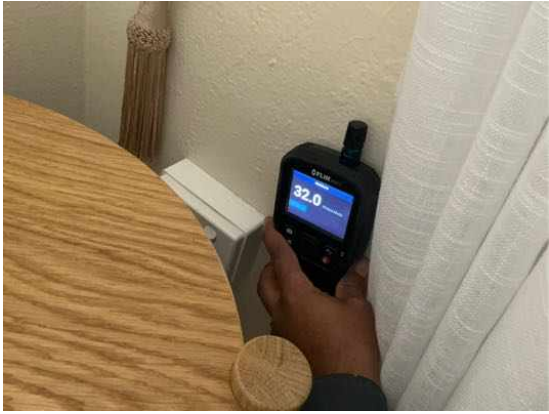
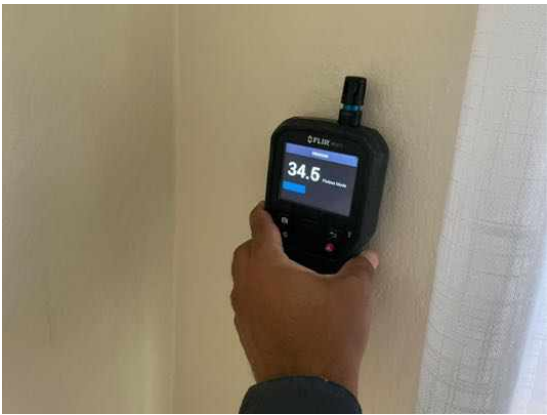
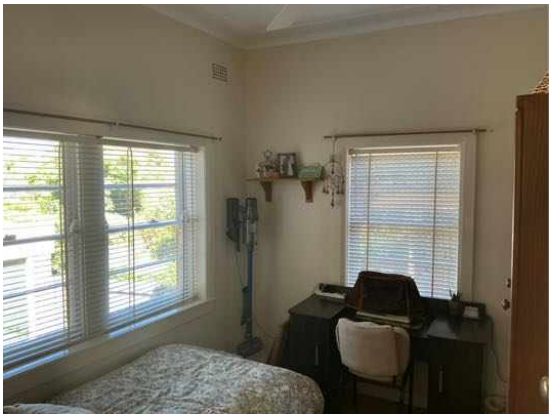
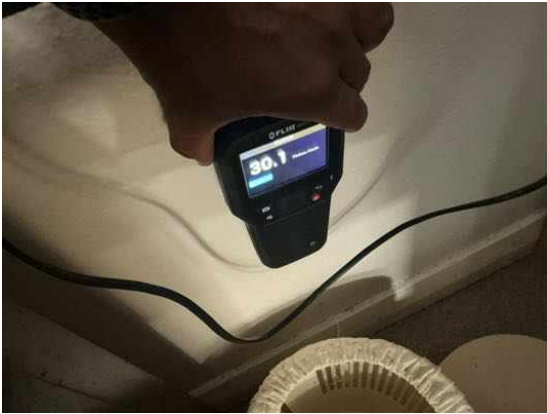
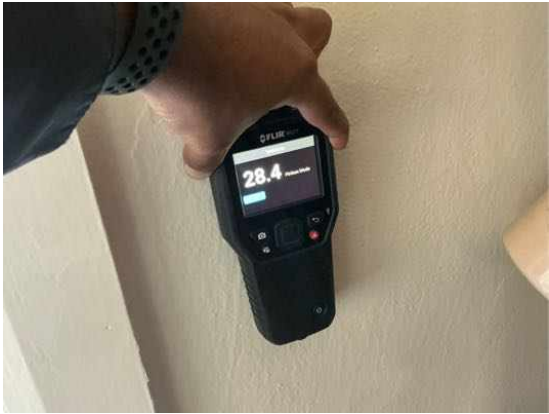
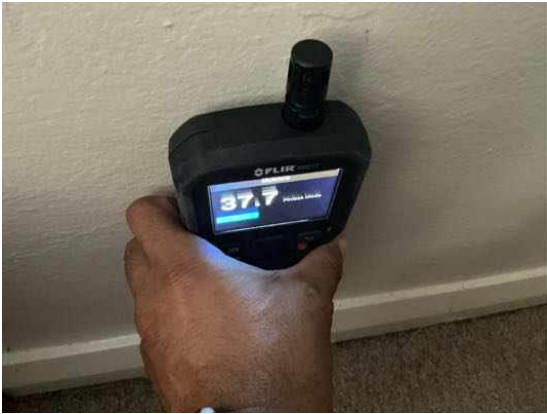
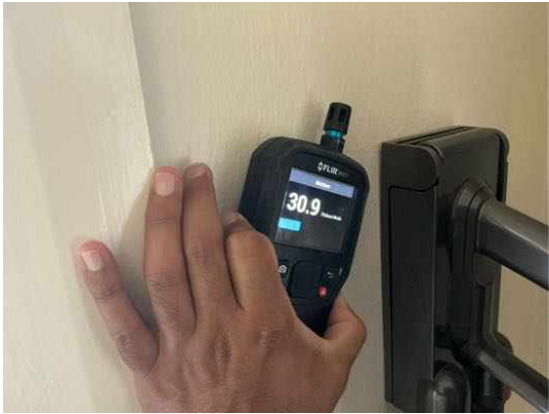
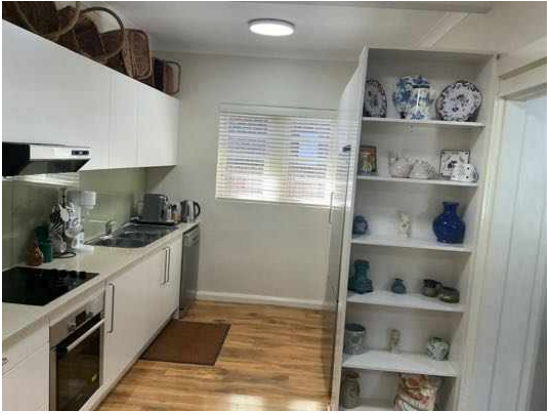
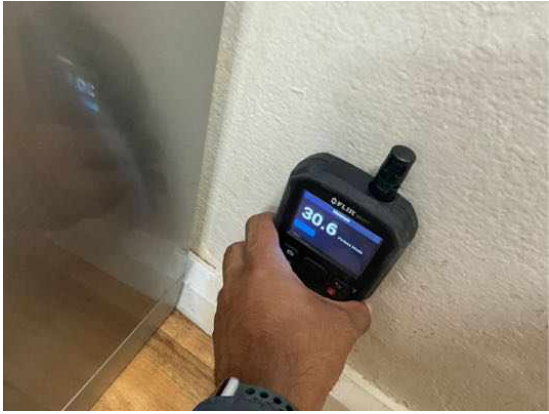
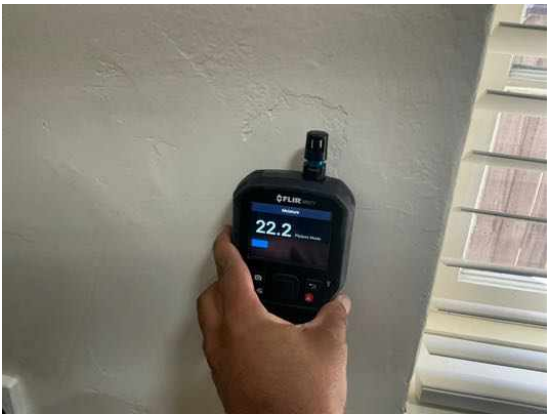
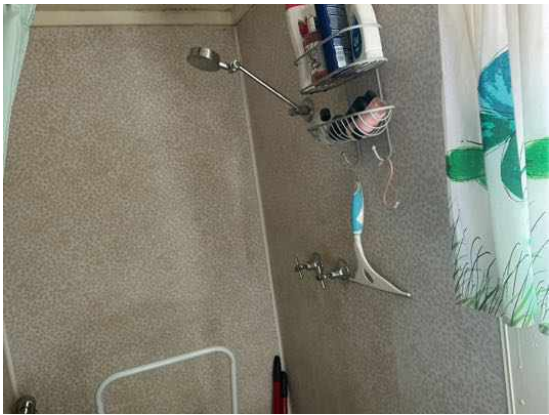
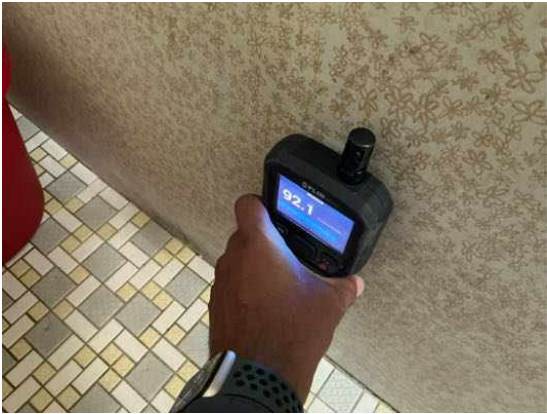
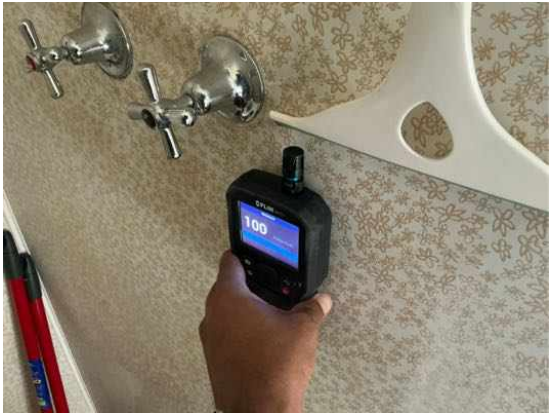
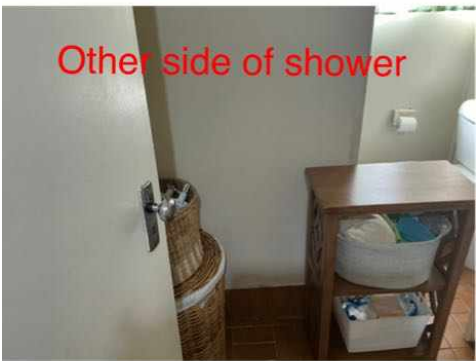
Finding: Additional Photos - Moisture Meter Readings

Information: Additional moisture meter reading photos have been provided for the property to offer further clarity on areas tested during the inspection. These photos are intended to give a visual reference for the specific locations where moisture levels were measured. These readings were taken at the time of the inspection to assess any potential moisture-related issues within the property. Any defects related to moisture that were identified during the inspection have been separately mentioned in the defect statements within the report.

For further clarification or additional information regarding the moisture readings, the client is encouraged to contact the building inspector directly. Regular monitoring of moisture-prone areas is recommended to ensure any emerging concerns are addressed promptly, particularly during wetter seasons or in high-humidity conditions.

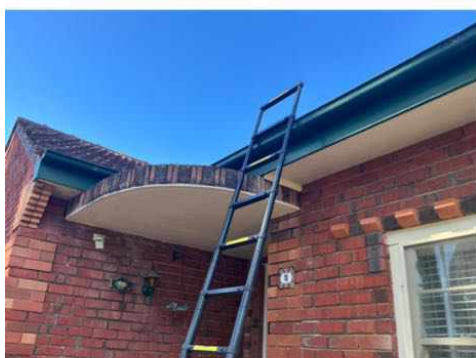
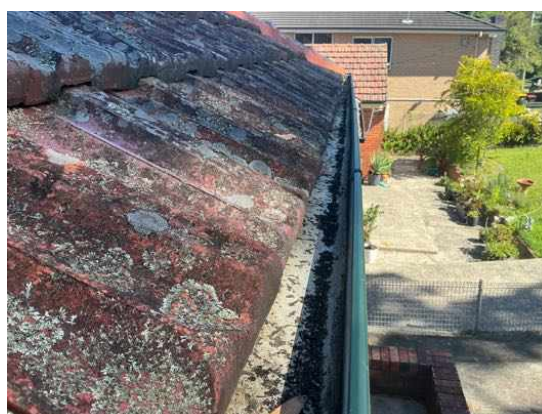
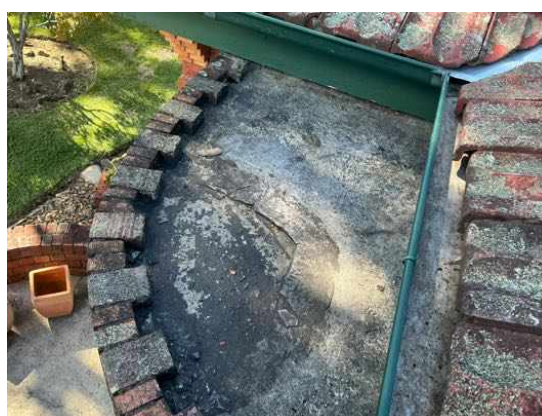
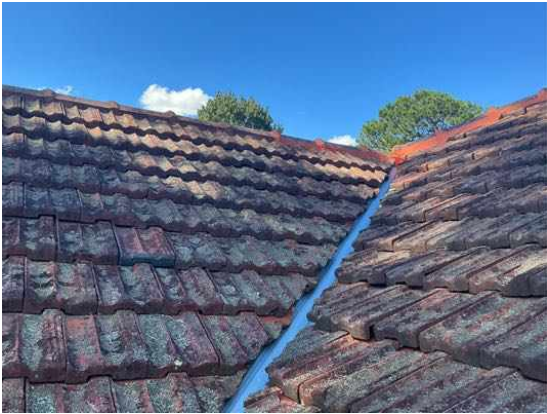
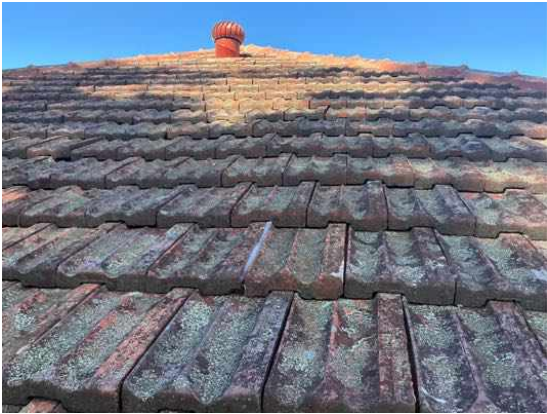
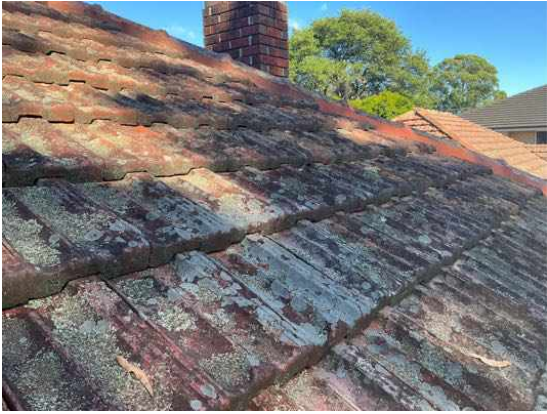
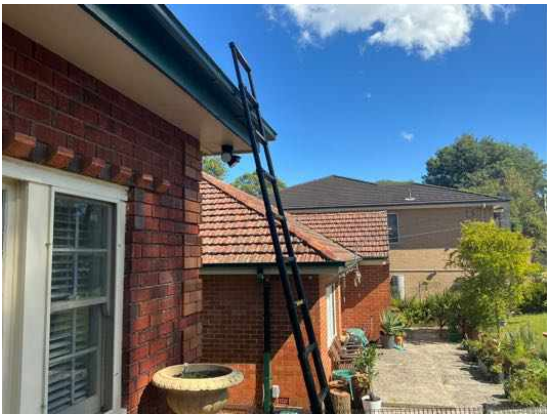
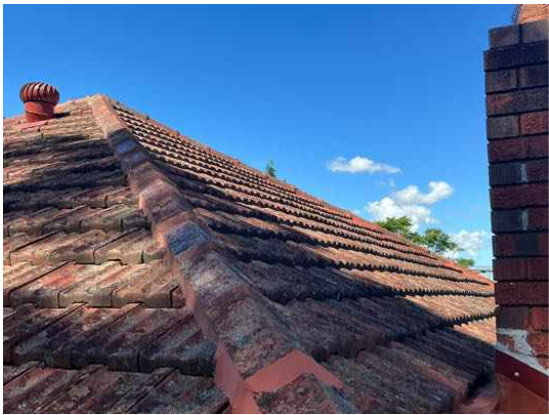
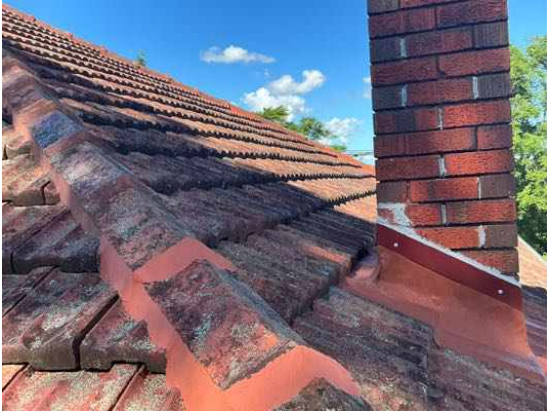
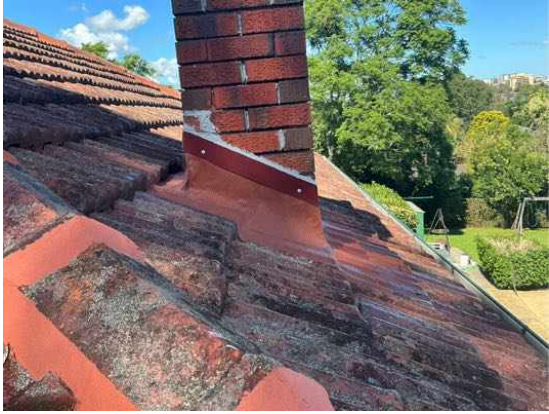
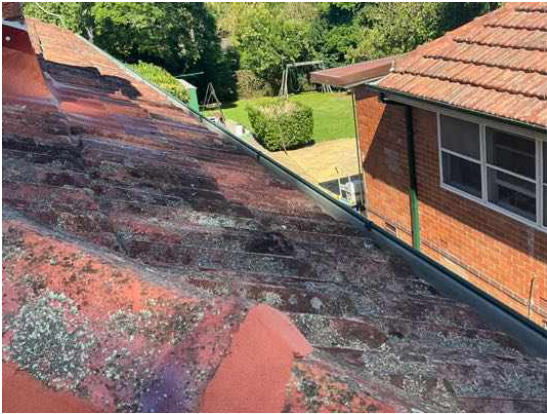
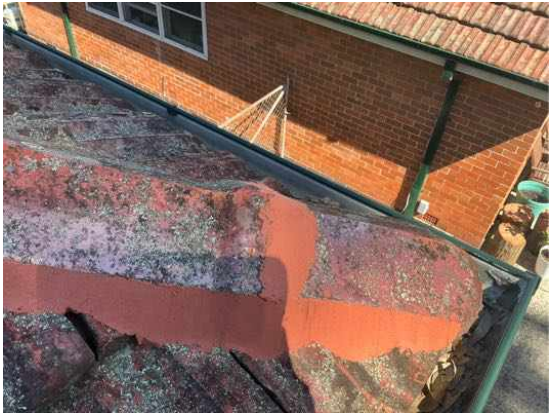
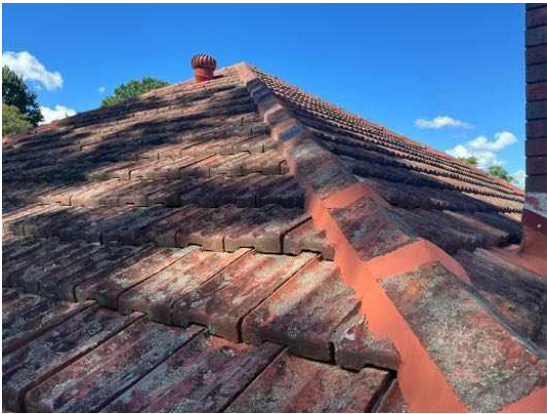
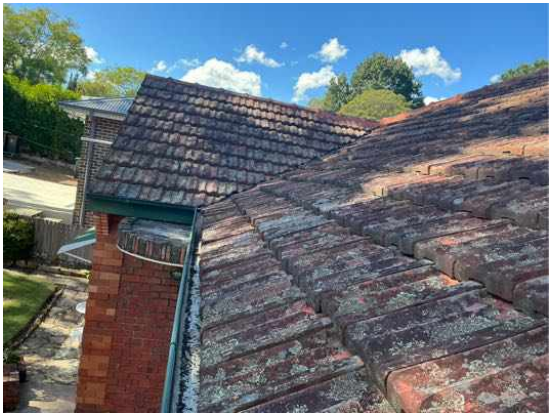
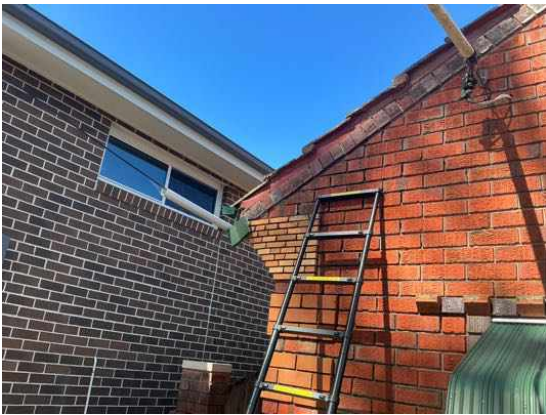
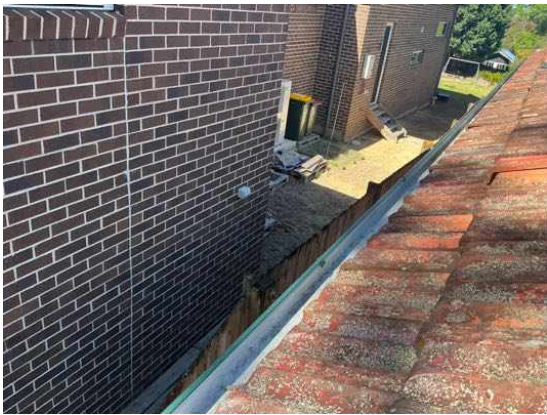
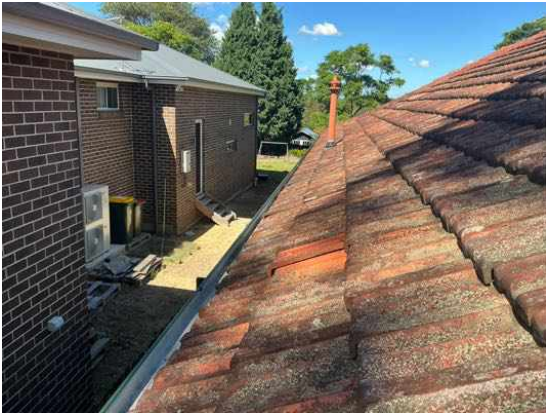
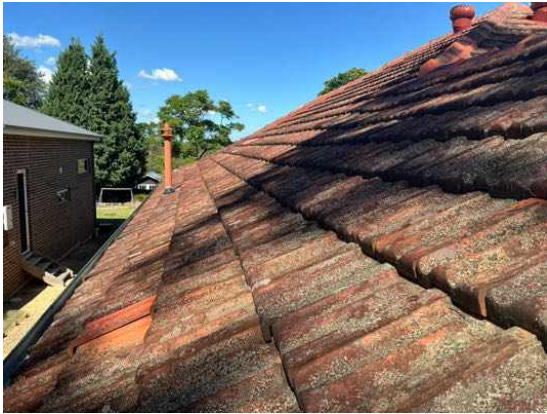
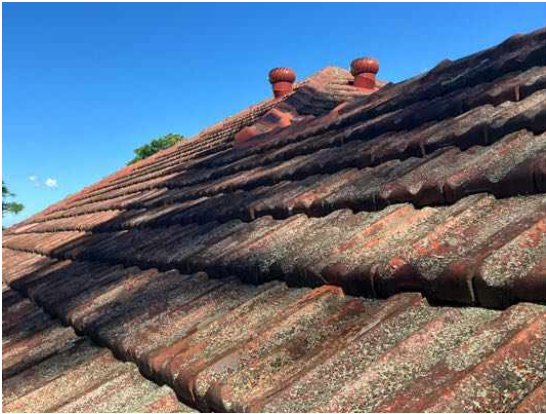
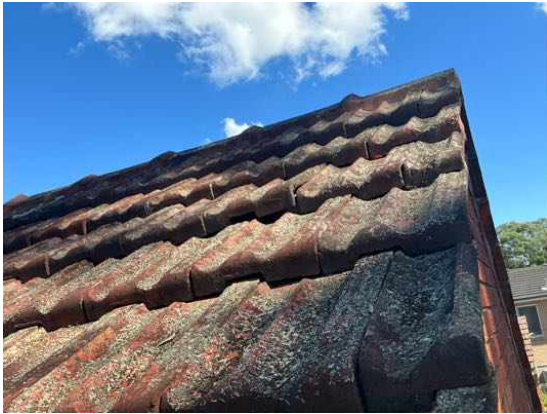
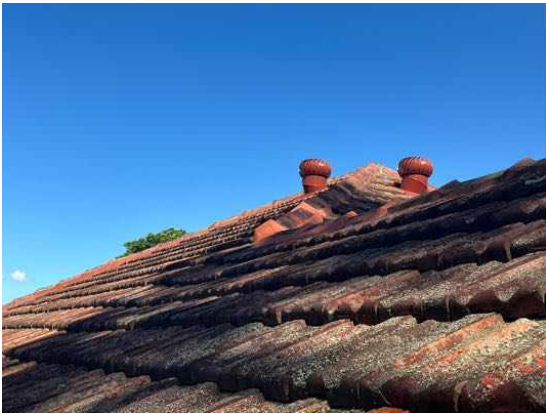
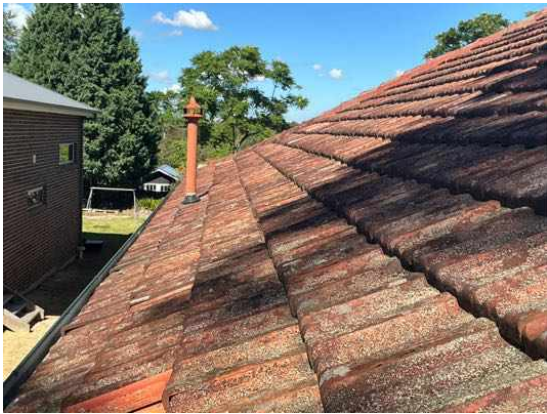
Building: Main Building  
Location: Roof Exterior  
Finding: Additional Roof Photos  
Information:

As part of the information provided, please note that the attached roof photos represent the condition of the roof at the time of inspection. These photos are for visual reference only and do not constitute a detailed roofing assessment. Any defects or issues identified with the roof are mentioned separately in the defect statements. It is strongly recommended that the client engage a qualified roofer to conduct a thorough inspection of the roof, ensuring that any potential issues, such as leaks, structural integrity, or wear and tear, are properly identified and addressed.

Additionally, the condition of the roof may change over time due to weather, natural wear, or other unforeseen factors. Regular maintenance and inspections by a licensed professional are advised to ensure the roof remains in good condition and to avoid costly repairs in the future. The information provided in these photos should be considered a snapshot of the roof's condition during the time of inspection and not a guarantee of its future performance.

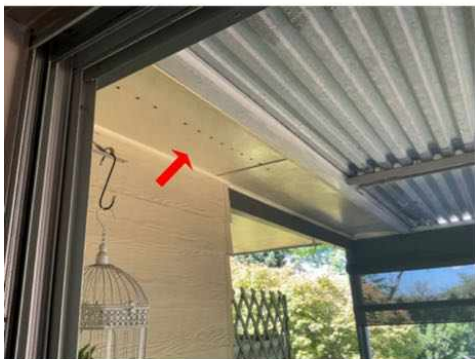
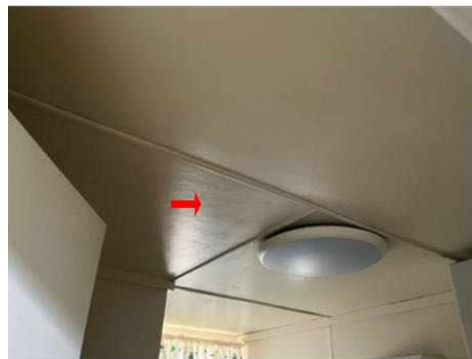
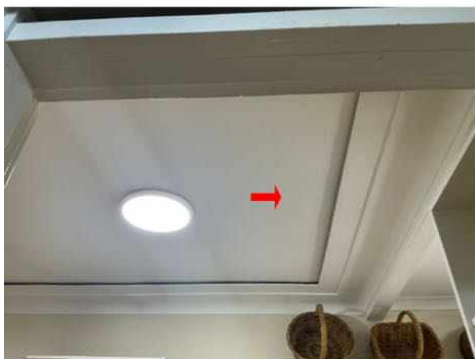
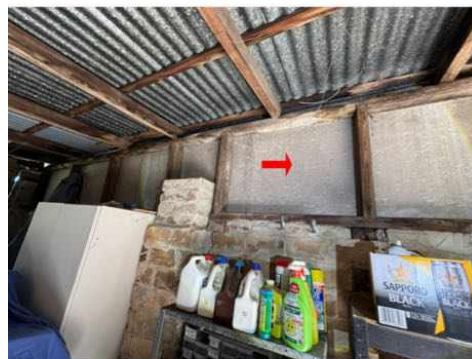
Building: Main Building  
 Location: Old part of the house, Garage, Eaves  
 Finding: Asbestos - Suspected ACM Identified on Site  
 Information: Reporting on Asbestos is outside the Scope of this Report. This suspected defect is highlighted as a caution only. We suspect, based on our experience in the building industry, that there is a higher risk of the identified building element containing asbestos.

As Asbestos Reporting is outside the scope of this report, we advise that you consider a separate Asbestos Inspection and Condition Audit, which can include the taking of samples for definitive confirmation of the presence of Asbestos.

In the interim, the client is advised to act with caution, especially when considering any damage to building materials general wear and tear renovations extensions demolition and general maintenance activities due to the suspected presence of Asbestos.

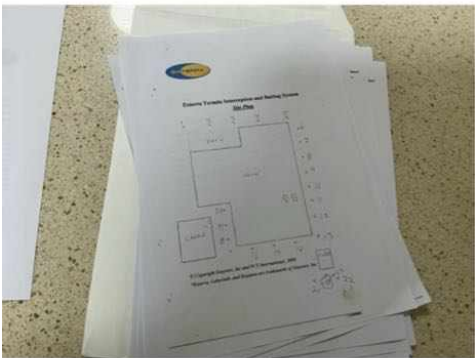
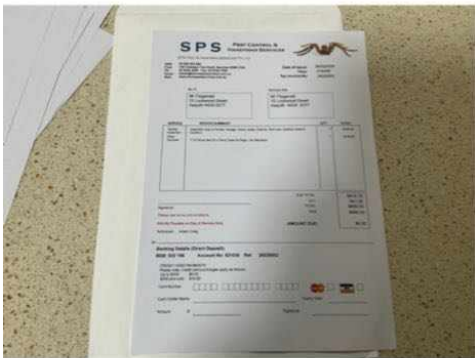
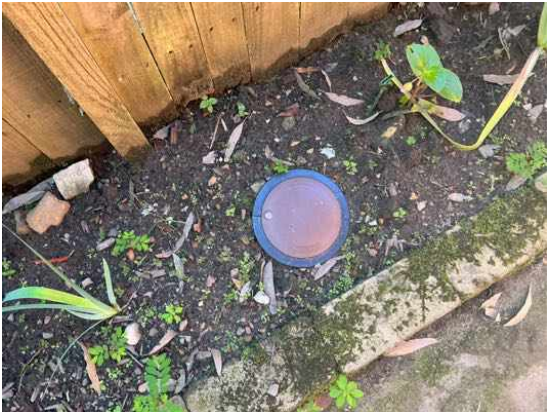
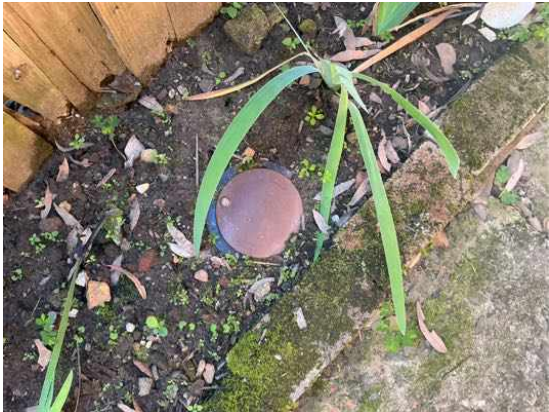
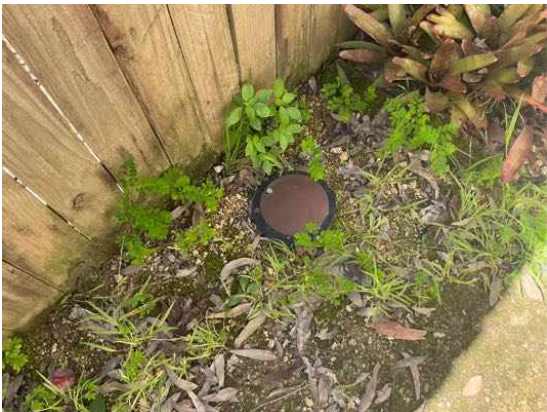
The current owner has advised that regular termite treatments have been carried out over approximately the past 15 years. Baiting systems were observed installed around the perimeter of the property, and relevant documentation supporting these treatments was available at the time of inspection. It is recommended that the client continue engaging the same pest control company for ongoing inspections and treatments, and obtain copies of all records for future reference.

It is noted that the baiting system appears to have been installed due to previous termite activity, with minor termite damage identified in the subfloor area beneath the laundry. At the time of inspection, no live termite activity was observed in this area. Ongoing monitoring and routine maintenance of the termite management system are strongly recommended to minimise the risk of future infestation.

It should be noted that most chemical termite management systems have a limited effective lifespan and require periodic replenishment, while physical barrier systems are primarily designed to prevent concealed entry and may not stop termites entirely. Regular inspections remain essential to ensure the continued effectiveness of the system.
