Building and Timber Pest Inspection Report

Inspection Date: Tue, 3 Feb 2026

Property Address: 15 Kurama Cres, Whalan NSW 2770,
Australia

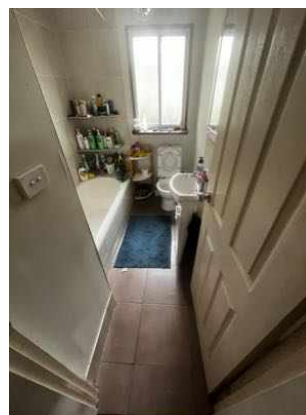
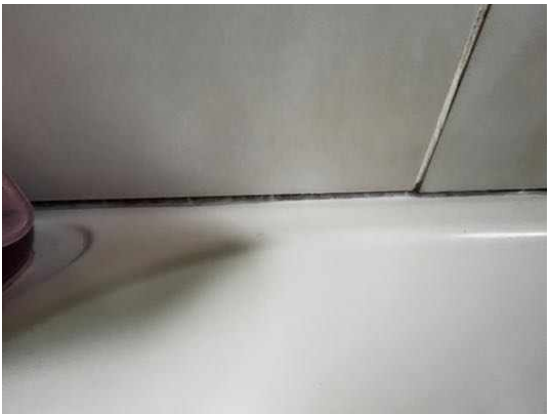
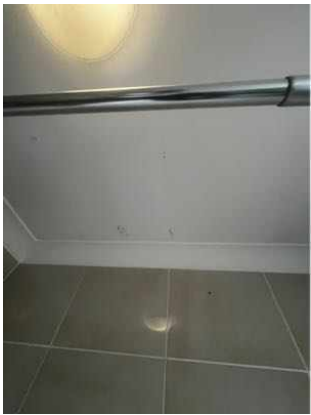
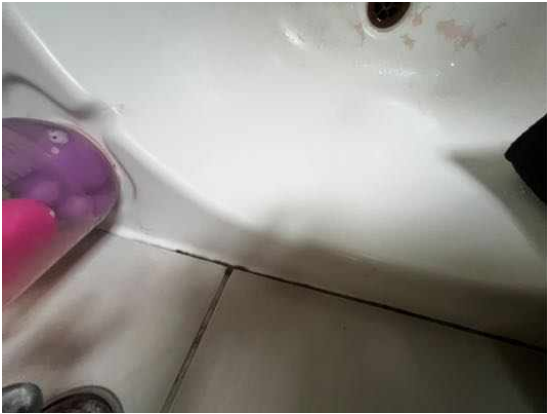
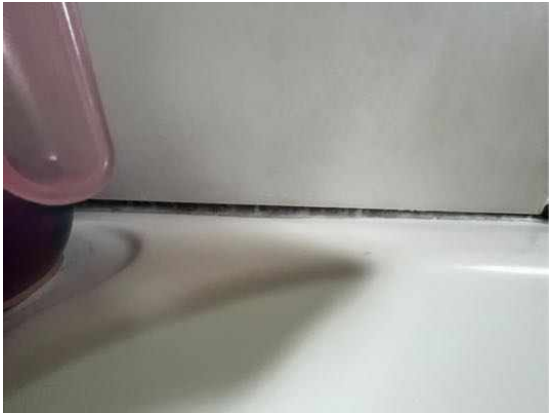
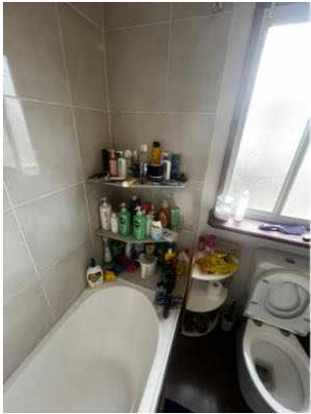
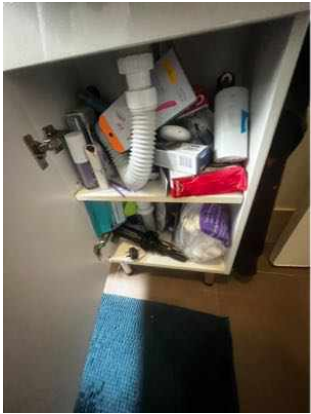
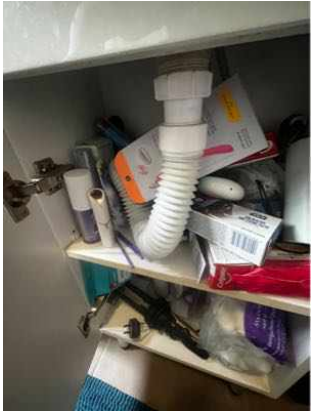
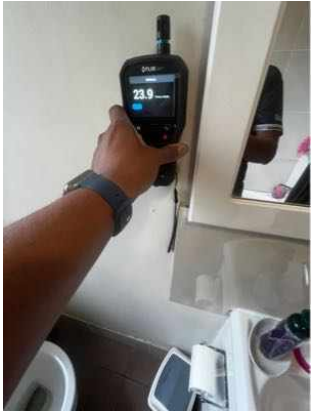
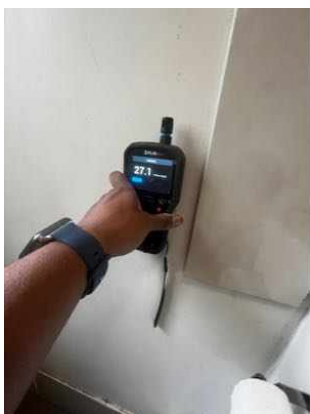
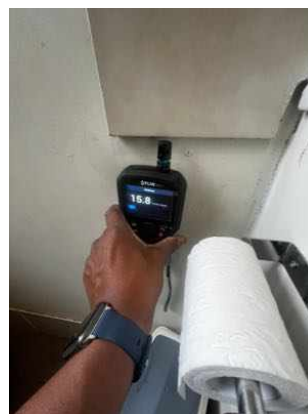
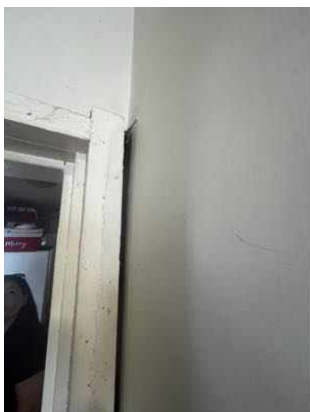
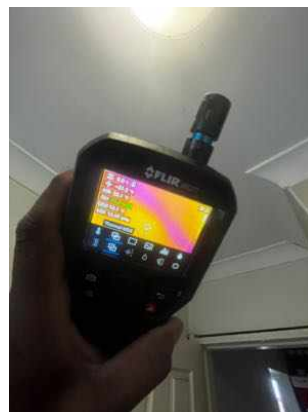
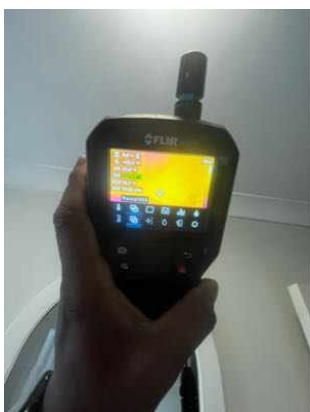
Building: Main Building
Location: Main Bathroom >
Finding: Sealant and grouting - Missing or damaged -
Information: It was noted on inspection that sealant or grout is degraded to the tiled shower alcove and or other areas of the bathroom.

Different materials and floor areas move at different rates, generally causing cracking to grout or sealant at this point. A flexible sealant is required to allow for expected expansion and contraction, while keeping the joint water tight and protective of all associated building materials.

There appears to be excessive mould to the sealant and grout which will likely require scraping out and replacement.

Flexible and mould resistant materials should be applied to affected areas to prevent any subsequent water damage that is likely to occur. Regular maintenance and replacement of damage or missing or damaged sealant and grout is highly recommended to the wet areas, as this is a regular wear and tear defect. Sealant and grouting in areas that come into regular contact with water should be maintained for the long term care of your property.

A sealant specialist or tiling contractor should be appointed to complete these works as soon as possible to prevent water ingress

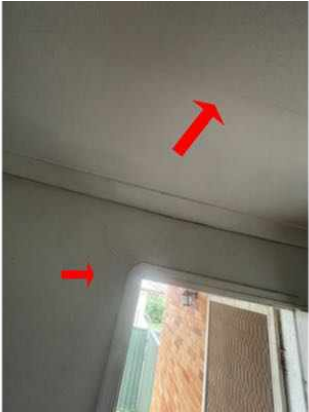
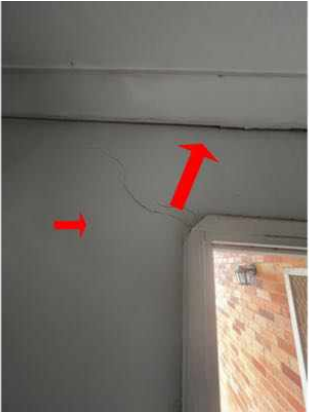
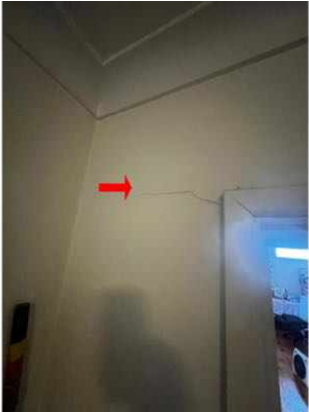
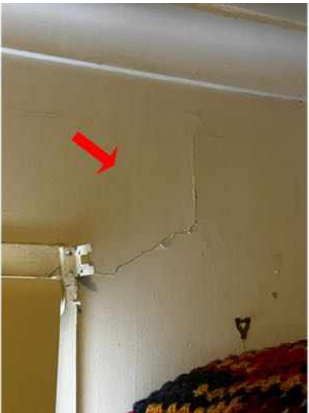
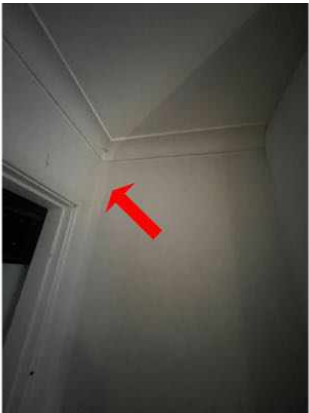
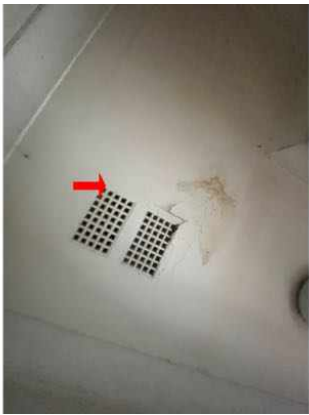
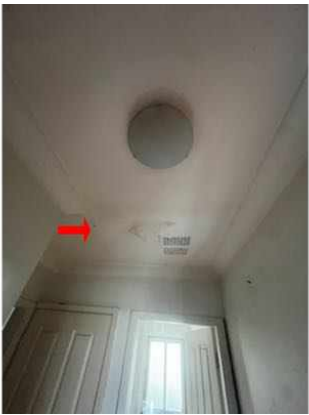
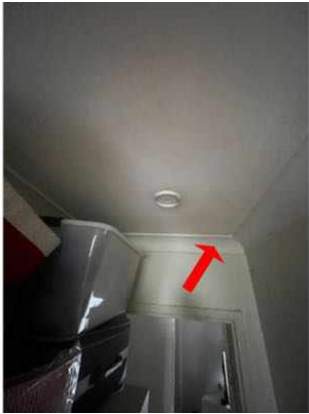
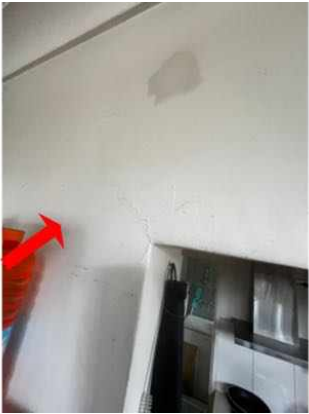
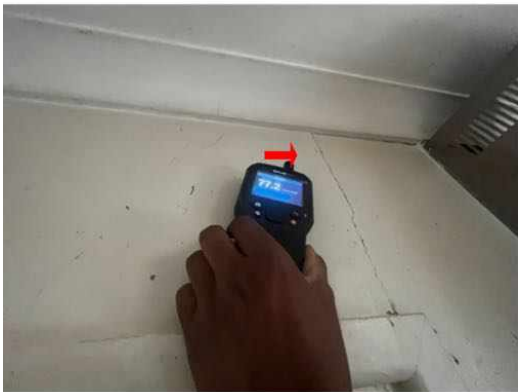
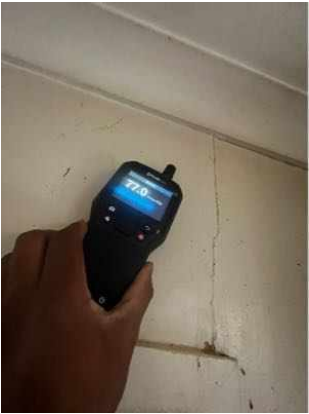
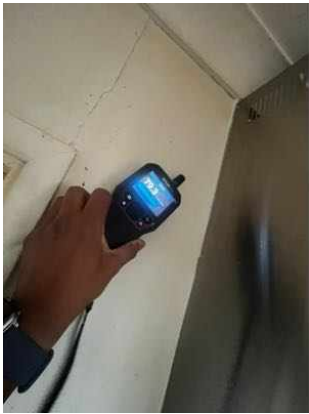
Finding 2.02

Building: Main Building

Finding: Cracking - Damage Category 2 - Noticeable (up to 5mm)

Information: Noticeable cracks are a common occurrence as a result of many primary defects. Such causes may include age, general wear and tear, expected building movement, general expansion/contraction of building materials in different weather conditions, and/or minor failings in the installation or application of building materials.

Noticeable cracks may result in minor sticking or jamming of associated doors and windows, which require easement. However, noticeable cracks are easily filled and repaired. A plasterer can be consulted to install an expansion joint at this point to allow

for this movement during different weather conditions.

Monitoring of all cracking should be conducted frequently. Always contact a building inspector should cracks widen, lengthen, or become more numerous. Additionally, your building inspector should also be contacted if associated building elements such as doors and windows become more difficult to operate over time.

Relevant tradespeople, such as carpenters, painters and plasterers, should be appointed to perform remedial works, as deemed necessary.

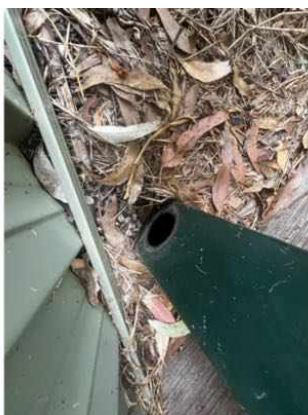
Finding 2.03

Building:	Main Building
Location:	All External Areas
Finding:	Down Pipes not Connected
Information:	The Roof plumbing is not adequately connected to stormwater drainage on the site.

Where roof plumbing doesn't drain adequately, the area at the base perimeter can become excessively damp, potentially creating an environment that is susceptible to rust and corrosion of surrounding building elements, as well as attracting termites and other pests.

It is highly recommended that a plumber be appointed to further inspect the area and to install adequate drainage equipment where necessary.

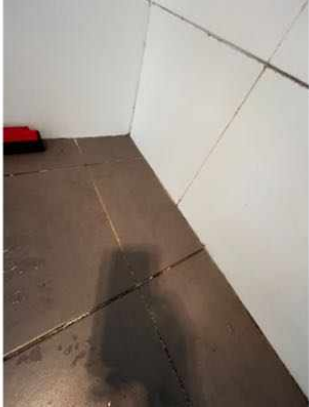
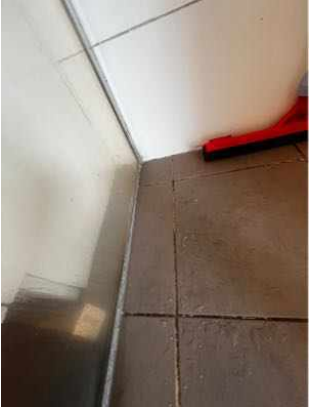
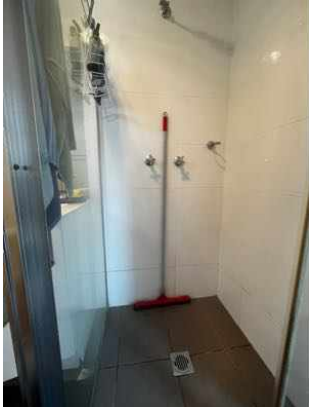
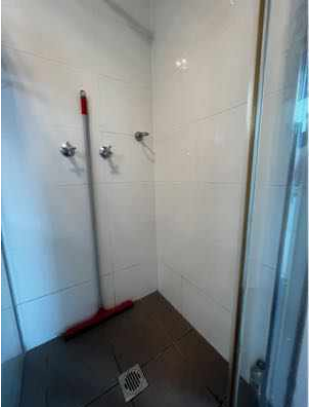
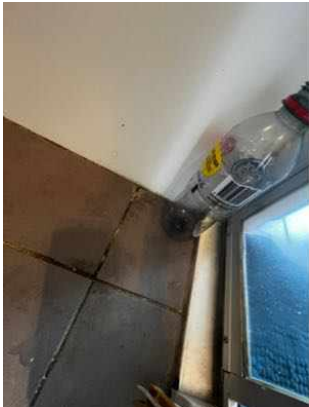
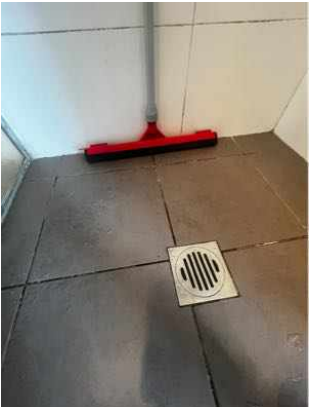
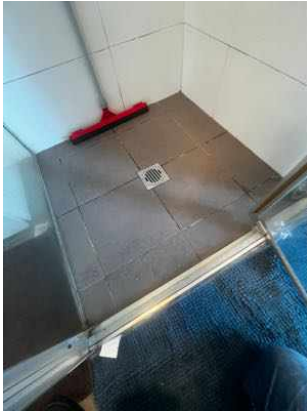
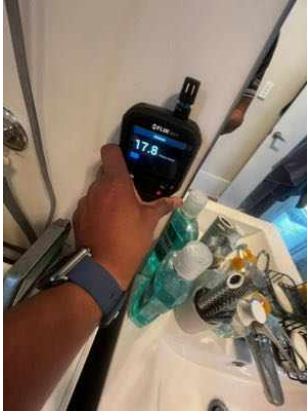
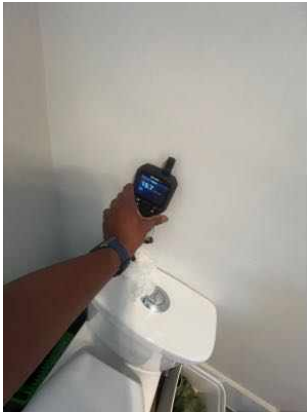
Finding 2.04

Building:	Main Building
Location:	All Internal Areas
Finding:	Sealant and grouting - Missing or damaged
Information:	It was noted on inspection that sealant or grout is degraded to the tiled shower alcove and or other areas of the bathroom.

There appears to be excessive mould to the sealant and grout which will likely require scraping out and replacement.

grouting in areas that come into regular contact with water should be maintained for the long term care of your property.

A sealant specialist or tiling contractor should be appointed to complete these works as soon as possible

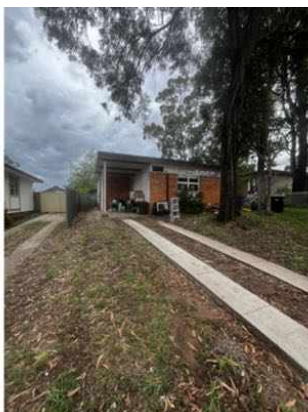
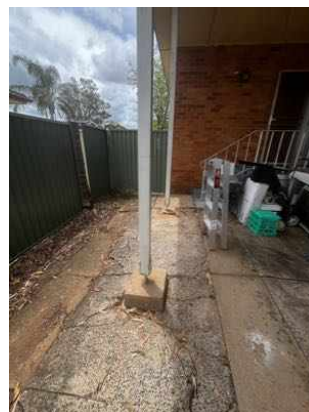
Finding 3.01

To be considered Category 2, the approximate width of the crack is less than 2.0mm, or a change in offset of less than 15mm when a 3m straight edge is placed over the defect.

Category 2 cracks to slabs should be monitored for a period of 12 months. At the end of the monitoring period, cracks rated greater than Category 2 are considered defects that require rectification.

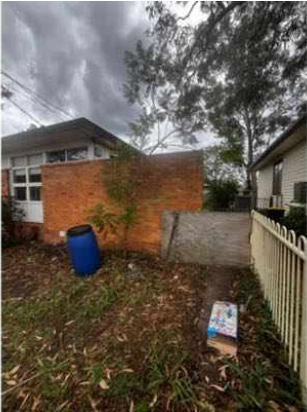
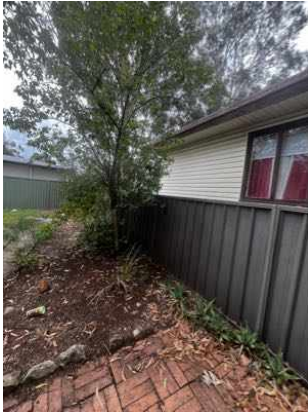
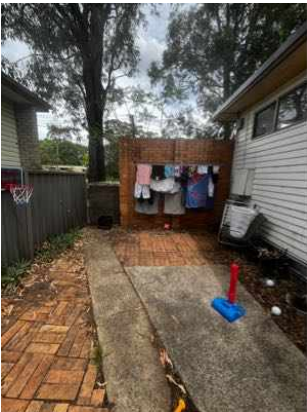
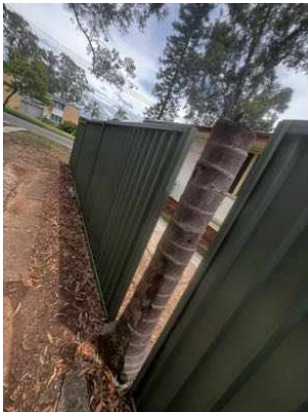
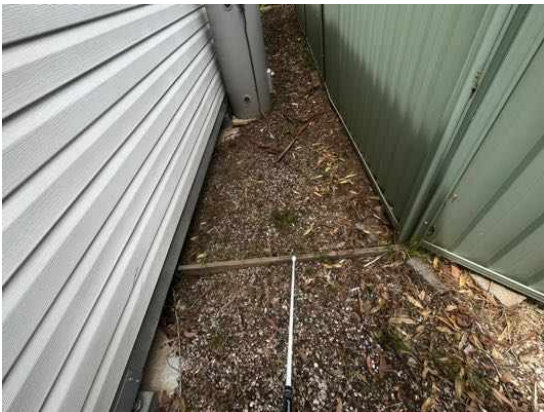
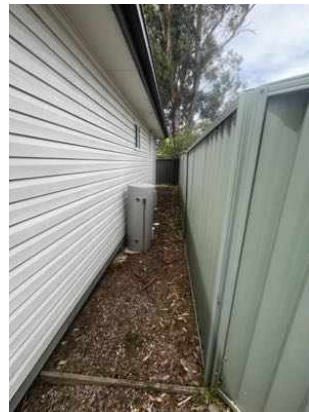
Finding: Fencing - Deteriorated

If left unattended, it is likely that further damage will occur. It is suspected that repair of several elements of the fencing may be required however replacement may be a consideration of the client also.

A licensed fencing contractor should be appointed to provide further advice and perform rectification works as necessary.

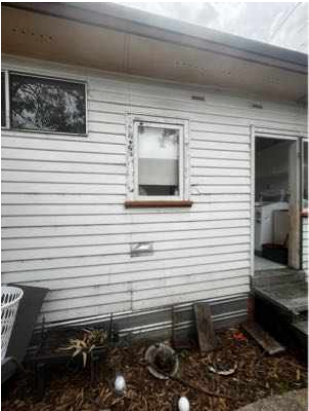
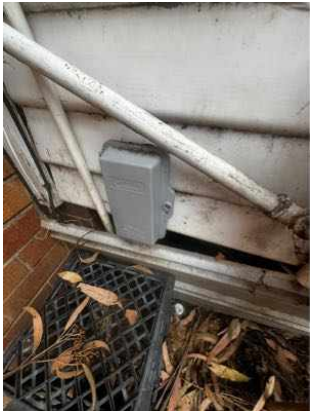
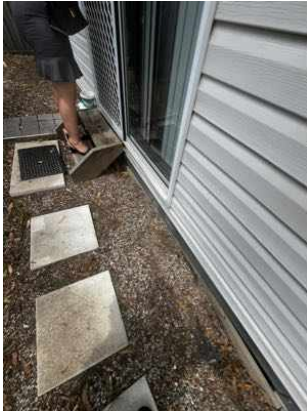
Finding 3.03

Building:	Main Building
Location:	Main House
Finding:	Weatherboards - Rotting
Information:	The external weatherboards show signs of fungal decay (wood rot) in several sections. This wood rot is suspected to have developed over a prolonged period of time due to frequent weather exposure, which is expected in a property of this age and condition

Weatherboards are sealed and protected by paint and other sealants. When these sealants deteriorate over time, they allow water penetration to the weatherboards, causing wood rot. If left unmanaged, the wood rot is likely to develop further, possibly necessitating major repair or replacement works in the long-term future.

To maintain the condition of the external wall cladding, any severely affected weatherboards should be substituted as soon as possible with pre-treated replacements. Where weatherboards have rotted due to excessive moisture other than rain penetration, the cause of the moisture should be identified immediately by a licensed plumber. A qualified carpenter should be appointed to repair and replace rotting weatherboards.

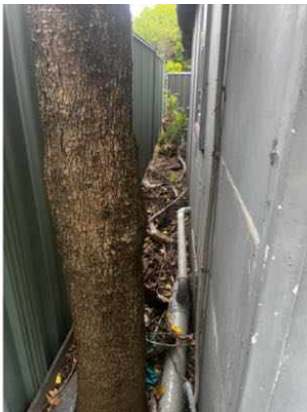
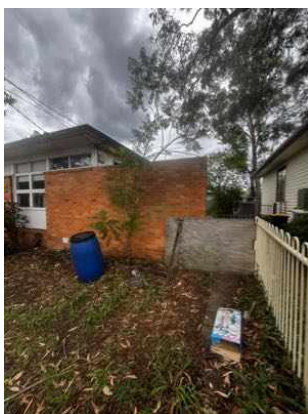
Finding 3.04

Building:	Main Building
Location:	Roof Exterior
Finding:	Trees - Overhanging and filling gutters
Information:	Upon Inspection The gutters in the property were filled with leaves and rubbish, Overhanging trees often result in excessive amounts of leaf debris accumulating in gutters.

Gutters are a critical part of the building's management of storm water and rain. It is therefore important that they be kept clear to prevent secondary damage to associated building elements, including exterior and interior walls, ceiling linings and any adjoining building elements. Where gutters are blocked, pooling of rainwater is likely to occur, fast-tracking rust and corrosion of the roof plumbing elements.

It is highly advised that all overhanging tree branches be removed as soon as possible to prevent any further damage. Repair and/or replacement of sections of damaged guttering may also be required where the extent of the damage necessitates.

Such works should be performed by the homeowner; however, appointment of a landscape contractor or an arborist may be required. Consultation with a licensed roof plumber is required where guttering has been damaged.

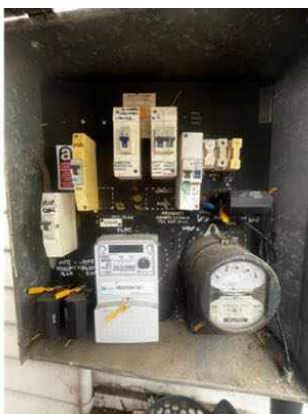
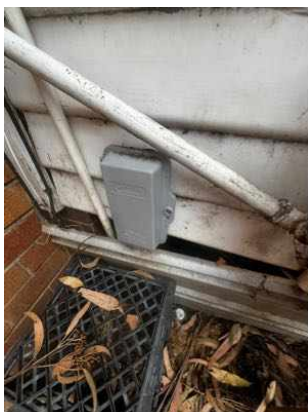
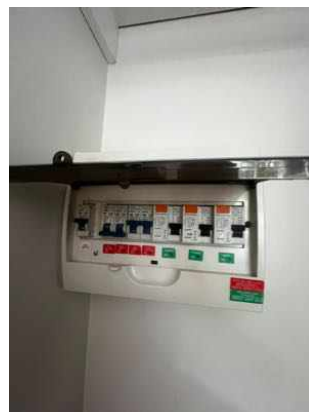
Building:	Main Building
Location:	Electrical Switchboard
Finding:	Termite Management System - no evidence of a chemical installation no Durable Notice
Information:	The application of a post-construction chemical termite barrier is highly recommended for all properties, particularly if live termite activity has been found on the site previously. Such barriers are highly effective in preventing termite attack on any timber building elements throughout the property.

A durable notice should be placed in the switchboard unit to indicate current termite barriers. At the time of inspection, it appeared as though no termite management system has been installed, with no evidence to suggest preventative works taking place.

The client may consider gaining further advice from a pest controller as to the costs and procedures involved with this application. It is recommended that obtaining such advice be a short-term priority.

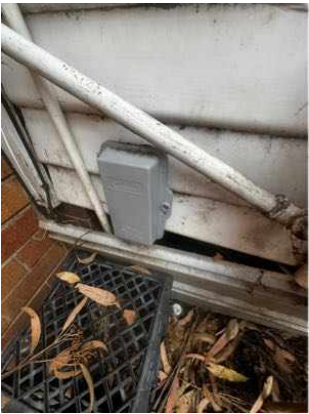
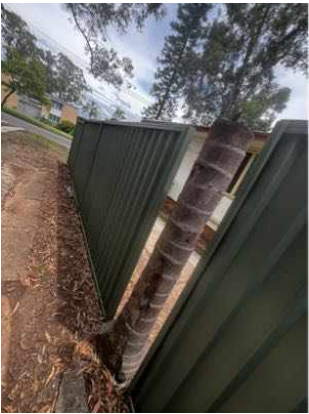
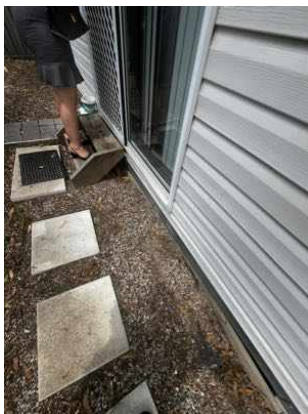
Finding 6.02

Information: Any timbers in direct ground contact provide opportunity for concealed termite entry and are likely to be subject to premature rot and decay as the soil retains moisture or damp conditions against the timbers.

Remove untreated timber that is in direct contact with external grounds. Consider replacement with more durable materials i.e. treated timber or non timber elements. Frequent pest inspections are advised to readily identify any termite activity in these areas.

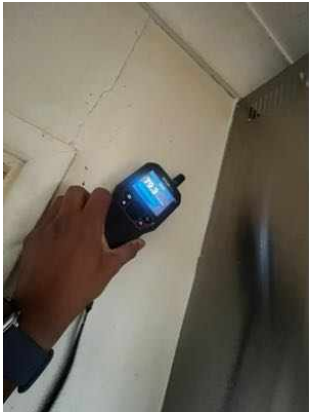
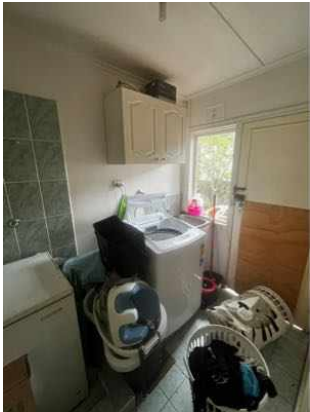
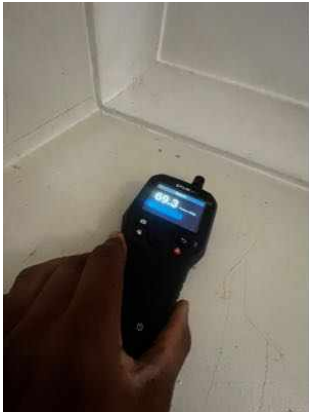
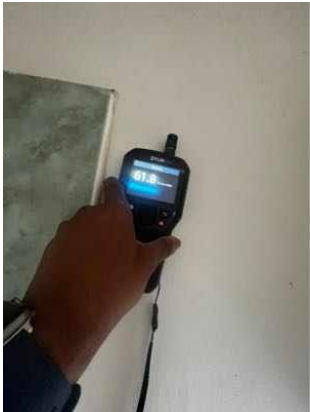
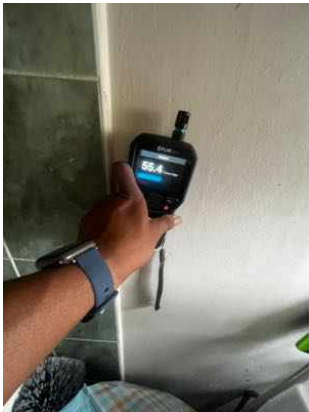
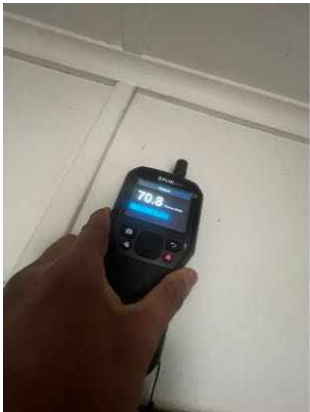
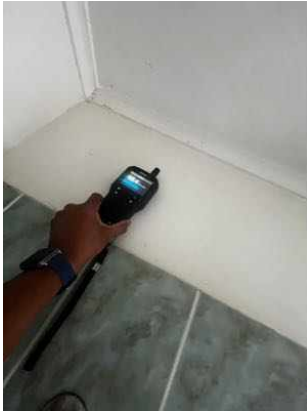
Finding 6.03

Building:	Main Building
Location:	Laundry
Finding:	High Moisture Readings
Information:	All areas of dwellings are checked with particular attention paid to wet areas which were closely assessed to check for moisture levels of moisture and temperature anomalies.

Some readings for moisture were found in the walls adjacent the showers at the time of inspection.

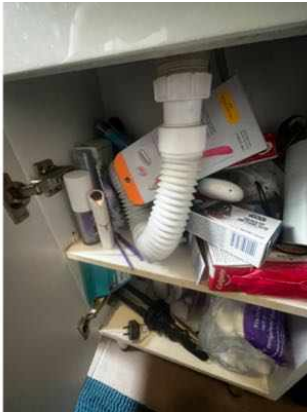
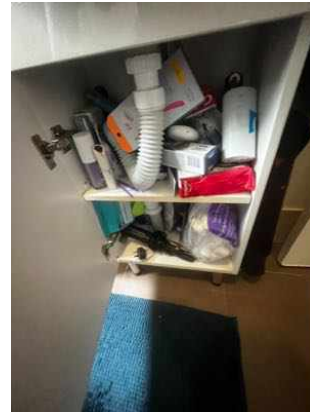
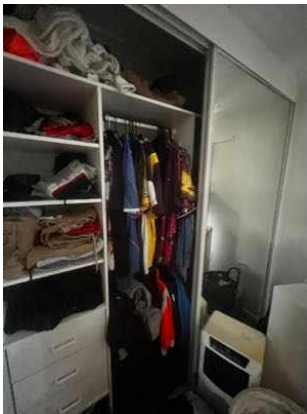
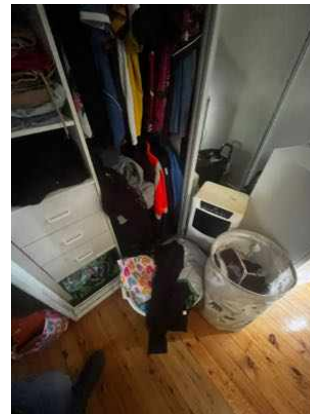
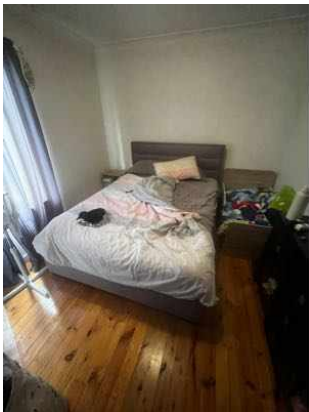
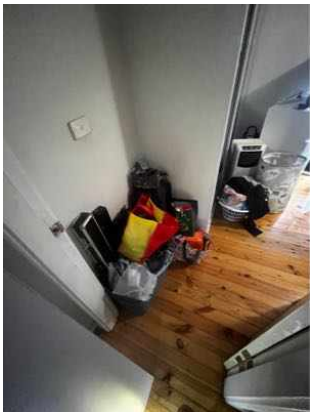
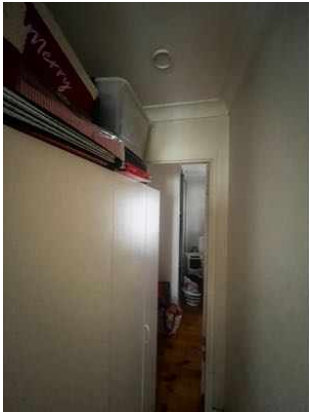
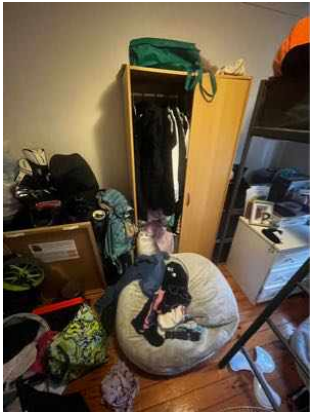
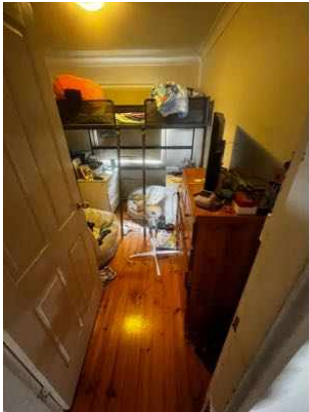
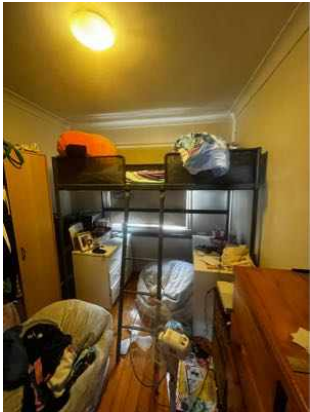
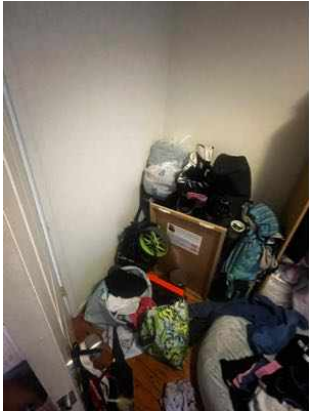
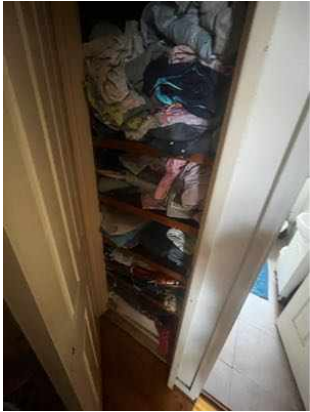
Noted Item

Building: Main Building
Location: All Internal Areas
Finding: Additional Photos - Obstructions and Limitations
Information: These photographs are an indication of the obstructions and limitations which impeded full inspection of the property at the time of inspection. These obstructions can hide an array of defects and should be removed to allow full inspection to be carried out. A re-inspection is recommended once the areas are made accessible.

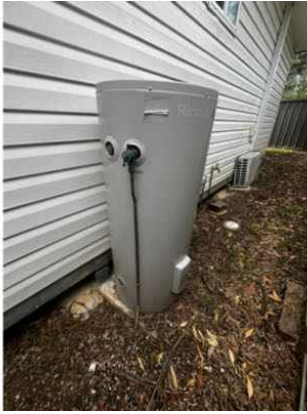
Building: Main Building
Location: Yard - Back
Finding: Hot Water Unit
Information: The HWS appeared to be in good condition at the time of inspection.

Water pressure appears to be normal, however, this is not an opinion of a licensed plumber. No water hammer was noted when taps are turned off fast.

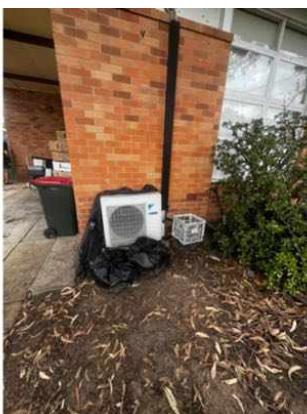
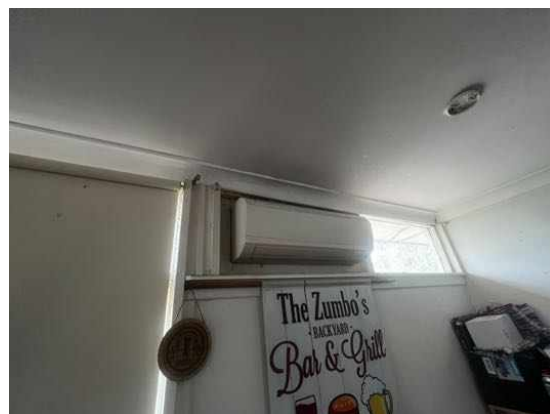
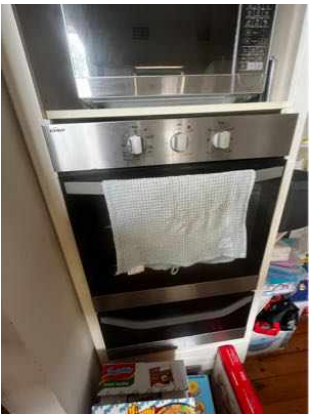
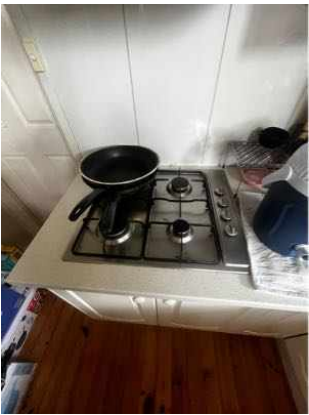
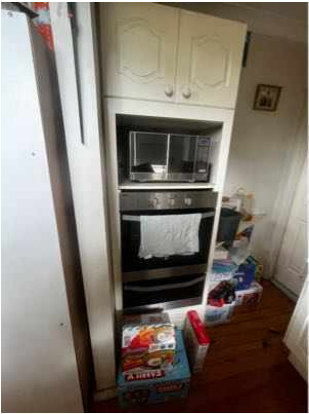
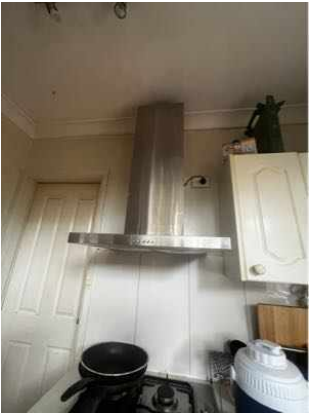
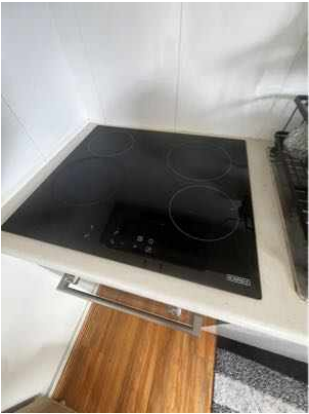
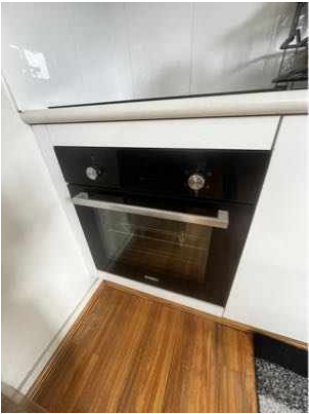
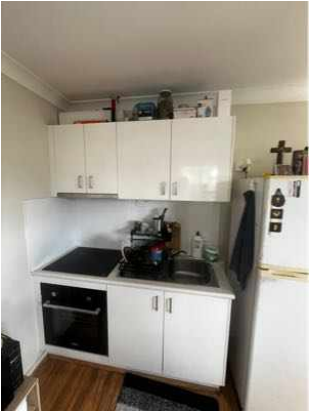
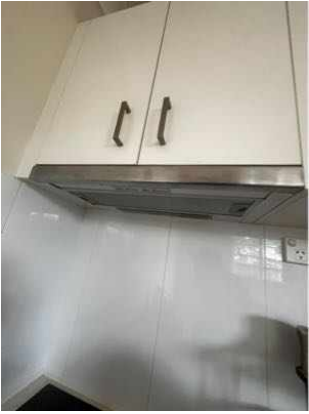
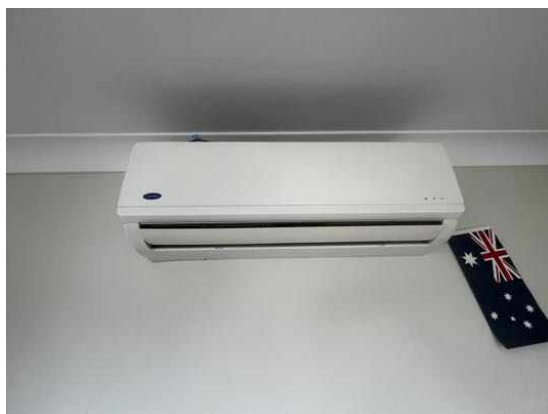
Building:	Main Building
Location:	All Areas
Finding:	Plumbing/electrical/gas/aircon/appliances/pool equipment/fire safety etc
Information:	Plumbing and electrical inspections are outside the scope of the building inspection and must be conducted by a Licensed and registered Trades person.

It is highly recommended that the client makes immediate arrangements to have the gas appliances checked by a licensed gas plumber to ensure that the appliances are working safely and efficiently.

We recommend all other installations be checked also.

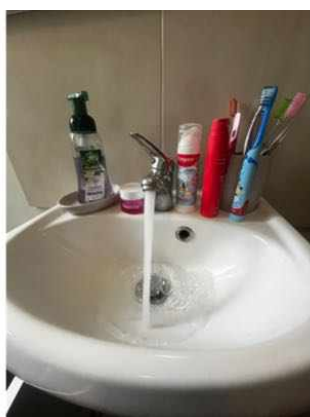
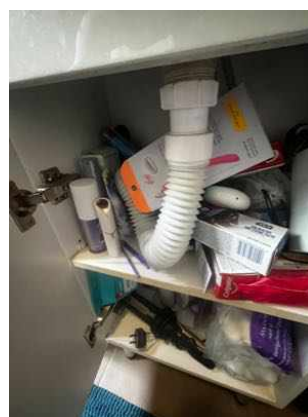
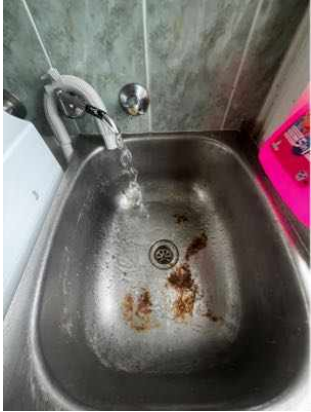
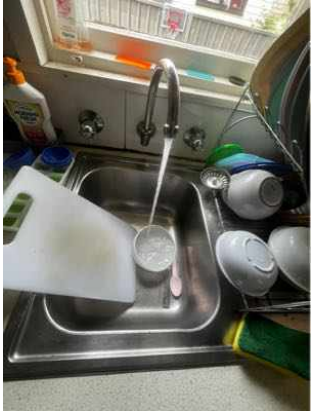
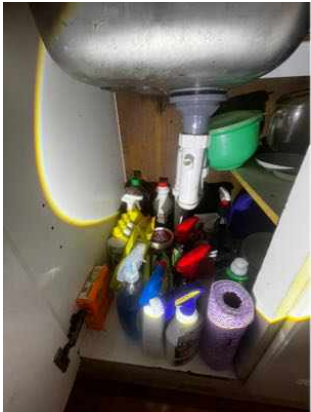
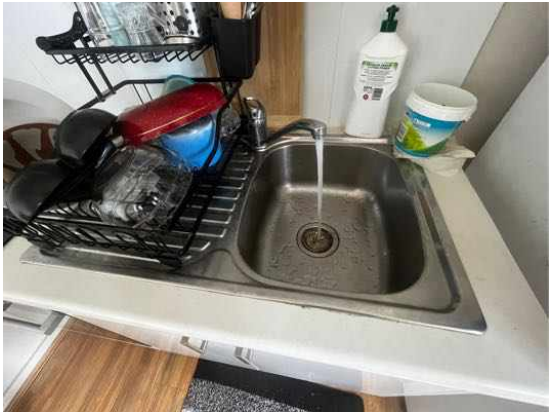
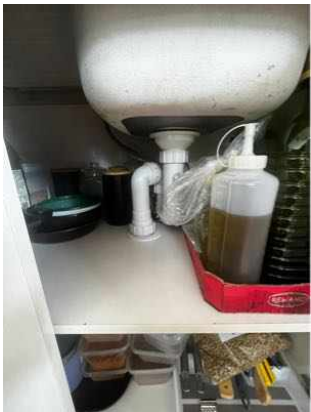
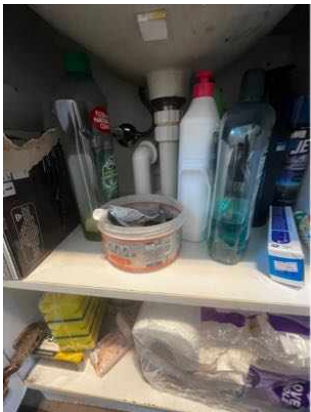
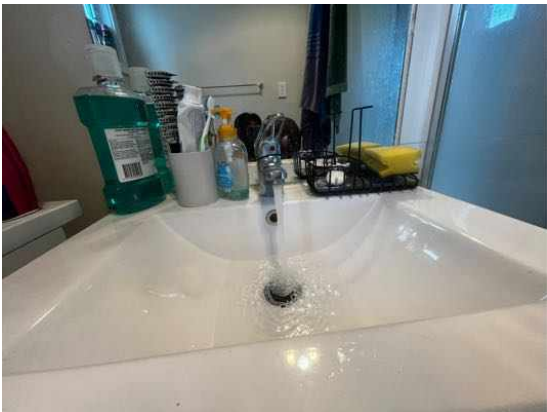
Building: Main Building
 Location: Kitchen/ Bathroom
 Finding: Cabinetry Plumbing - Kitchen/ Bathroom
 Information: All cupboards where sinks and basins with drainage plumbing were inspected and no evidence of leaks were present at the time of inspection.

If damp or wet conditions do occur there are many consequences including the development of fungal decay and/or wood rot, swelling or water damage to building materials.

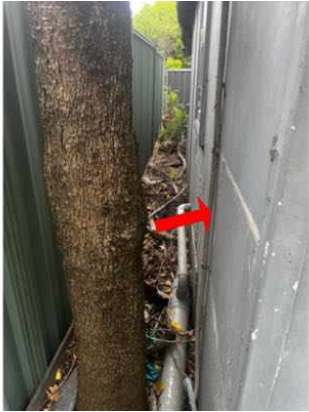
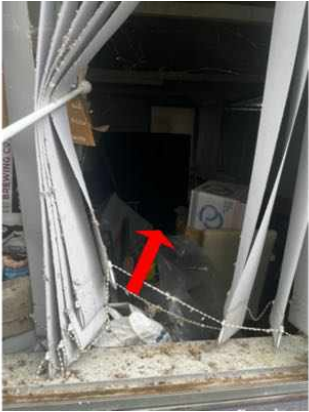
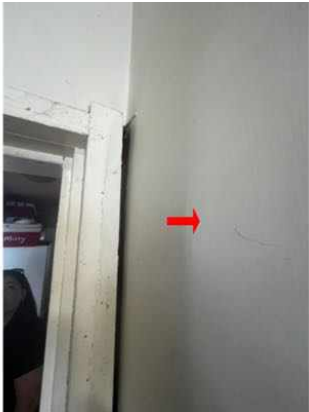
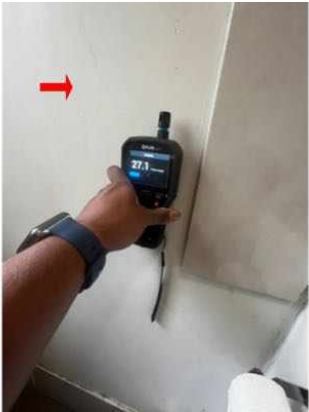
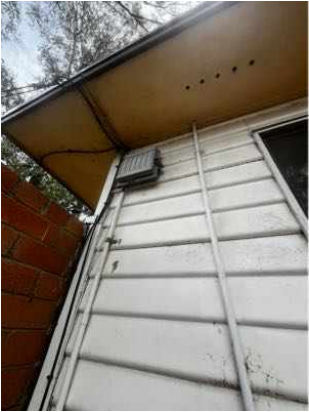
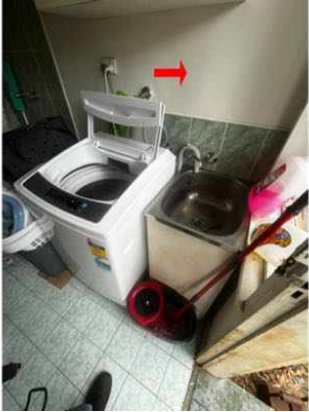
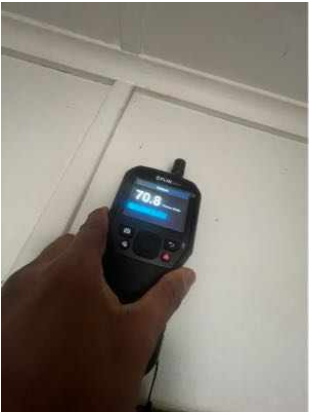
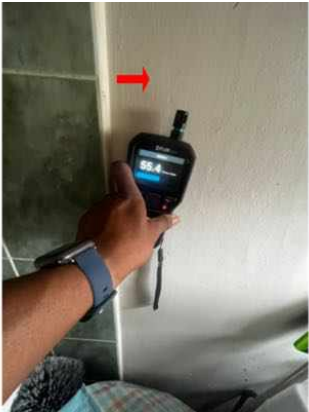
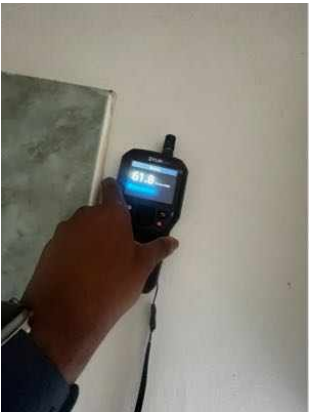
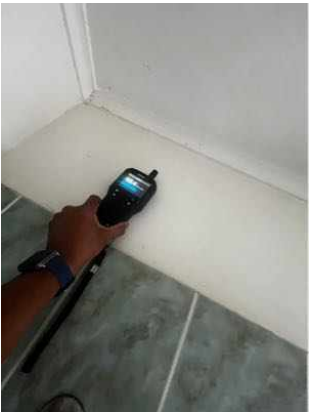
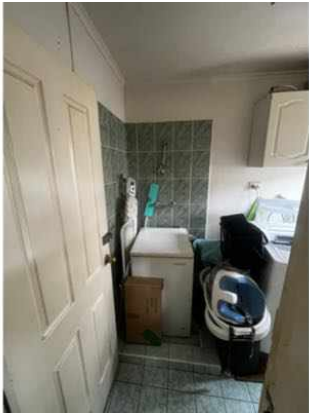
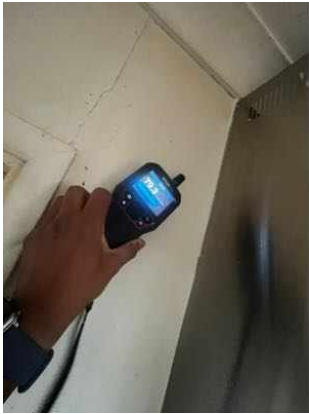
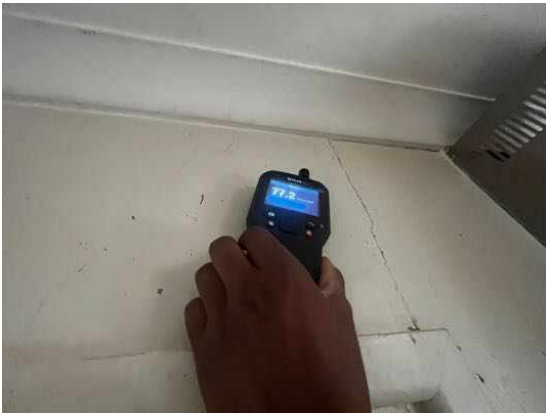
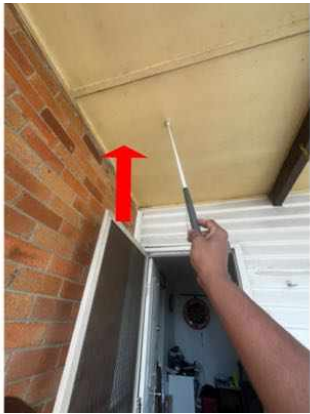
Building: Main Building
Location: All Areas
Finding: Asbestos - Suspected ACM Identified on Site
Information: Reporting on Asbestos is outside the Scope of this Report. This suspected defect is highlighted as a caution only. We suspect, based on our experience in the building industry, that there is a higher risk of the identified building element containing asbestos.

As Asbestos Reporting is outside the scope of this report, we advise that you consider a separate Asbestos Inspection and Condition Audit, which can include the taking of samples for definitive confirmation of the presence of Asbestos.

In the interim, the client is advised to act with caution, especially when considering any damage to building materials general wear and tear renovations extensions demolition and general maintenance activities due to the suspected presence of Asbestos.

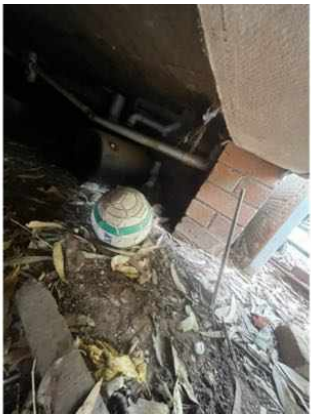
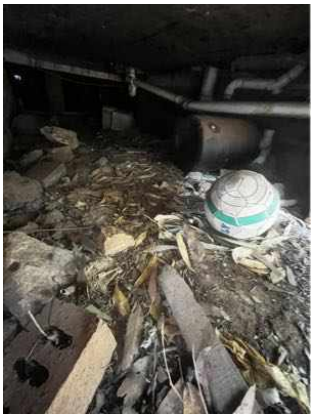
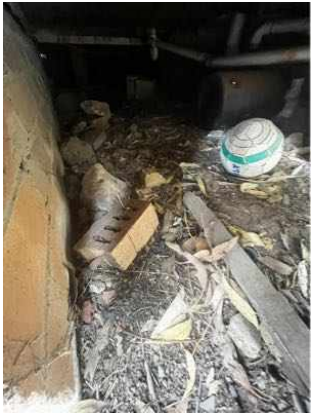
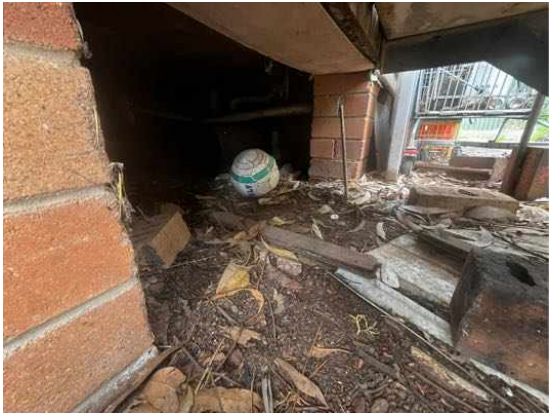
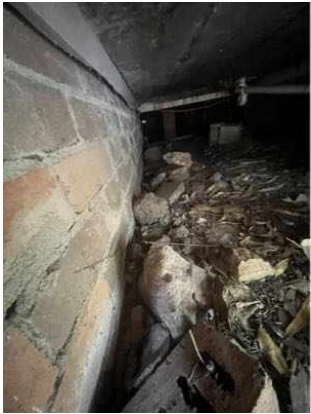
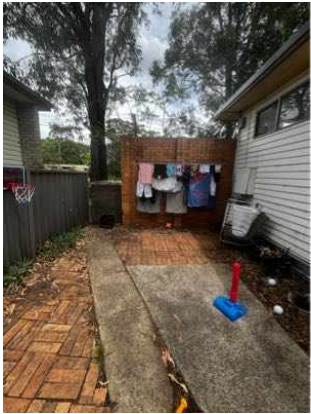
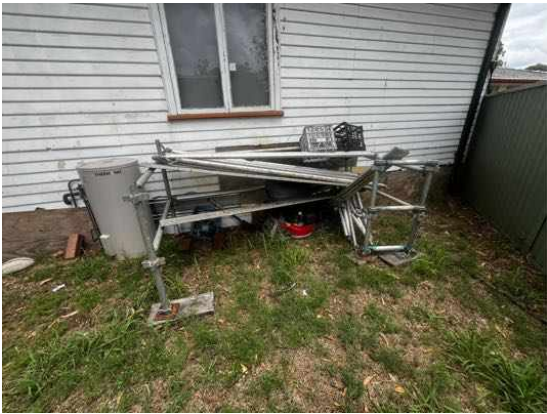
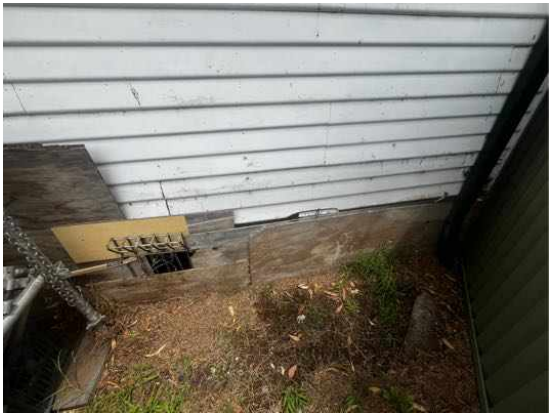
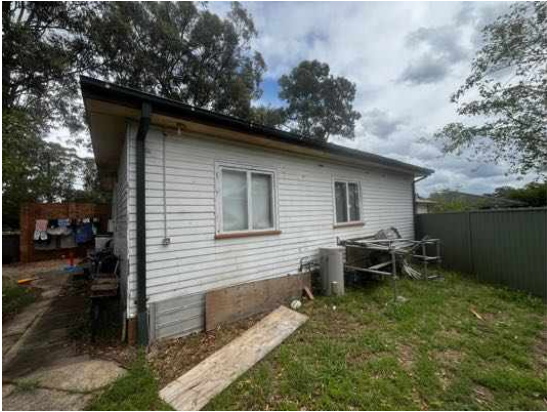
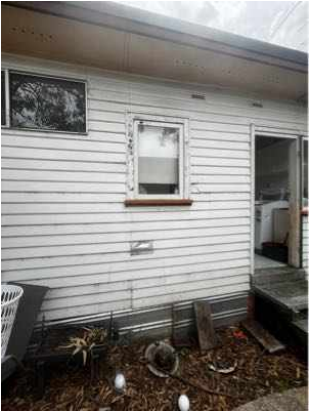
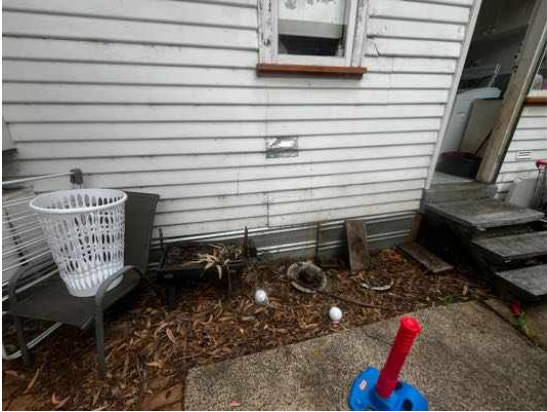
Building: Main Building

These obstructions can hide an array of defects and should be removed to allow full inspection to be carried out.

A re-inspection is recommended once the areas are made accessible.
