Building and Timber Pest Inspection Report

Inspection Date: Fri, 6 Mar 2026

Property Address: 306 Sutherland St, Lavington NSW 2641,
Australia

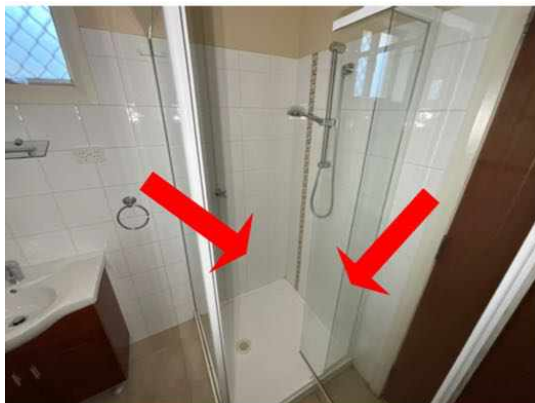
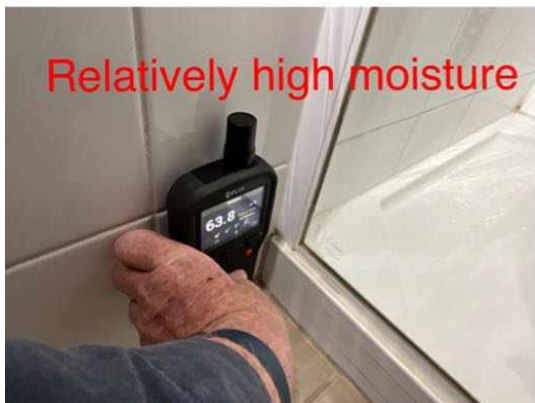
Building:	Building 1
Location:	Bathroom 2
Finding:	Shower Damp- Major
Information:	Damp is evident to the lower 300mm of wall to the Shower Alcove. This is suspected to have been caused by moisture permeating through the grouting in this area, which shows evidence of deterioration.

High levels of moisture were observed on the outside of the shower walls in the opposite wall.

Consultation with a qualified Plumber or Bathroom Specialist is advised immediately to identify the cause of damp and to perform remedial works as required.

Always ensure that sealant and grout is in good condition to prevent any moisture issues occurring in the future.

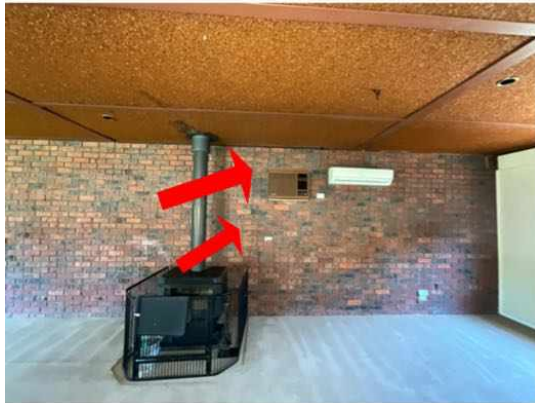
Finding 3.01

Building: Building 1
Location: Family Room
Finding: Brickwork - Cracking noticeable
Information: There were several cracks and or crack repairs evident to external brickwork.

Noticeable cracks are a common occurrence in external brickwork and are a likely result of age expected building movement, general expansion, and/or contraction of

building materials in different weather conditions. Noticeable cracks in brickwork may develop if left unattended, with potential for necessitating major remedial works or replacement of the brickwork.

It is highly advised that a qualified bricklayer be appointed to provide necessary works to cracked brickwork to prevent any further damage. Such works should be conducted as soon as possible.

Always monitor these cracks and contact a building inspector should cracks widen, lengthen, or become more numerous.

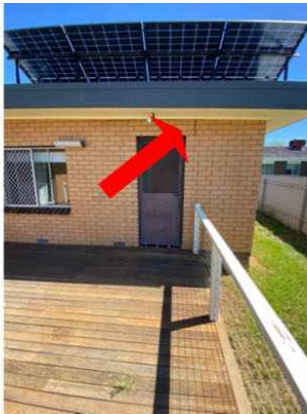
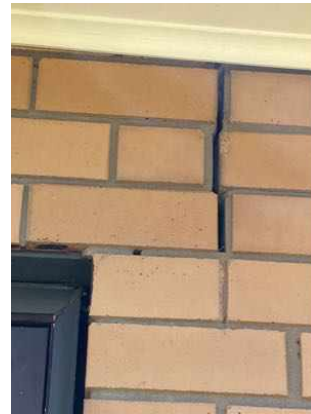
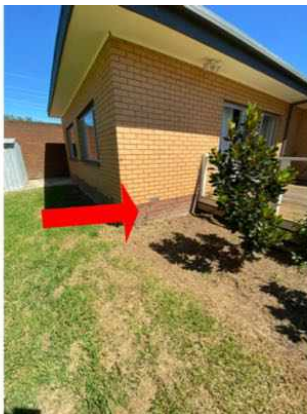
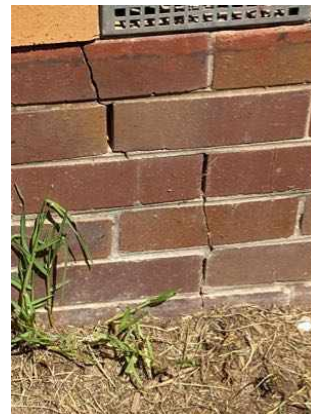
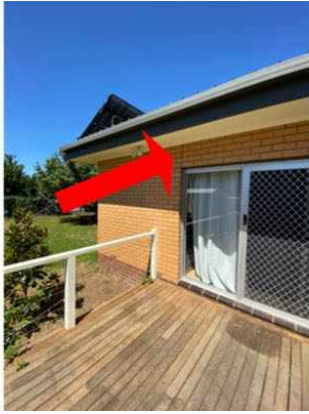
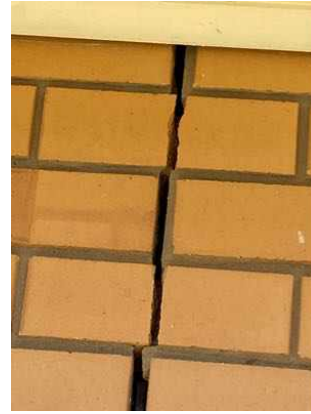
Finding 3.02

Building: Building 1
Location: External brickwork
Finding: Brickwork - Cracking noticeable
Information: There were several cracks and or crack repairs evident to external brickwork.

Noticeable cracks are a common occurrence in external brickwork and are a likely result of age expected building movement, general expansion, and/or contraction of building materials in different weather conditions. Noticeable cracks in brickwork may develop if left unattended, with potential for necessitating major remedial works or replacement of the brickwork.

It is highly advised that a qualified bricklayer be appointed to provide necessary works to cracked brickwork to prevent any further damage. Such works should be conducted as soon as possible.

Always monitor these cracks and contact a building inspector should cracks widen, lengthen, or become more numerous.

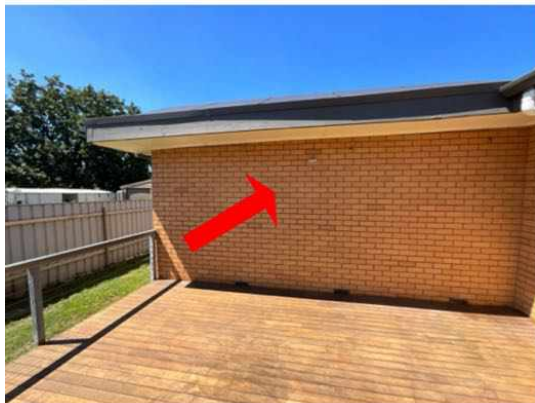
Finding 3.03

Building:	Building 1
Location:	Yard - Side
Finding:	Brickwork - Cracking [Fine]
Information:	Although fine cracks are quite noticeable, they are often only considered to be an appearance defect and usually do not indicate any structural damage. Generally, the cause of a fine crack is indicative of a separation between brickwork and mortar throughout the structure, but single bricks may also show cracks of this nature.

Cracking of this nature can generally be repaired with minor filling and should be conducted by a qualified bricklayer.

Always contact a building inspector should cracks widen lengthen or become more numerous.

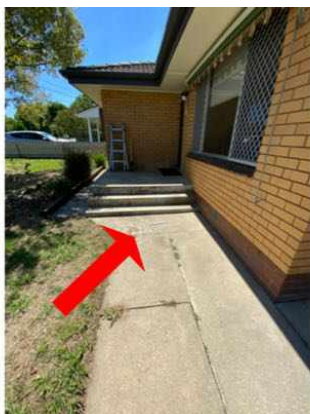
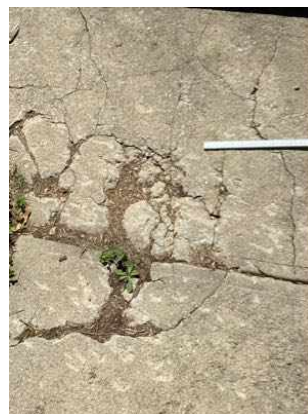
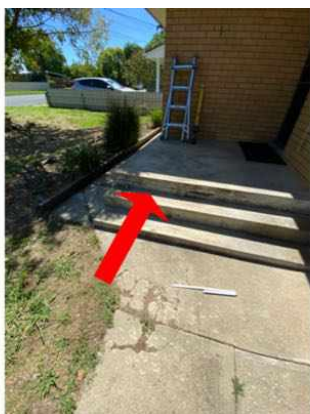
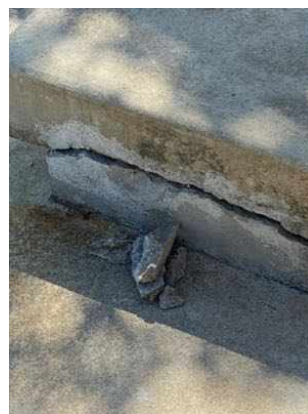
Building:	Building 1
Location:	Entry area
Finding:	Cracking - External Concrete Paving Damage Category 4 - Gaps in Slab (4mm - 10mm +)
Information:	Gaps in the slab were identified in external concrete paving. Gaps in the slab are significant and are likely to lead to the development of safety hazards and secondary defects if left unmanaged, such as the creation of a trip hazard.

General age and expected deterioration of the paved areas is a common cause of this type of cracking. However, expansion and contraction of the slab may also have occurred due to environmental factors. Such factors include variable moisture and weather conditions, the presence of trees and their roots having a settling or lifting affect on the soil, or the effect of load bearing, e.g. heavy vehicles over a sustained period of time.

Cracking to this degree may also be due to poor original installation of the concrete. Factors such as poor compaction of the sub surface and/or inadequate reinforcing of the slab may create cracking and other secondary defects. Gaps in the concrete paving may also have a more significant structural cause, such as subsidence of soils.

Where gaps in the concrete paving are adjacent to structural elements of the building, the advice of a Structural Engineer is advisable before undertaking repairs. Significant repair and likely replacement of the concrete paving is probable.

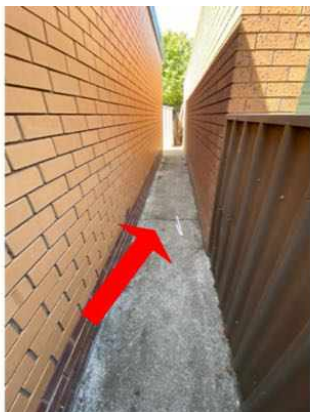
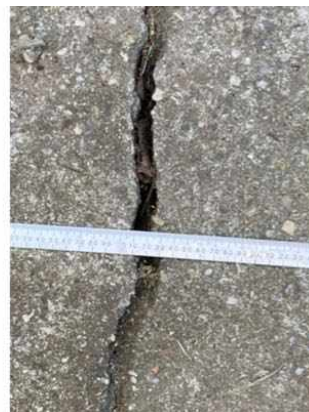
Finding 3.11

Building:	Building 1
Location:	Yard - Side
Finding:	Cracking - External Concrete Paving Damage Category 4 - Gaps in Slab (4mm - 10mm +)
Information:	Gaps in the slab were identified in external concrete paving. Gaps in the slab are significant and are likely to lead to the development of safety hazards and secondary defects if left unmanaged, such as the creation of a trip hazard.

General age and expected deterioration of the paved areas is a common cause of this type of cracking. However, expansion and contraction of the slab may also have occurred due to environmental factors. Such factors include variable moisture and weather conditions, the presence of trees and their roots having a settling or lifting affect on the soil, or the effect of load bearing, e.g. heavy vehicles over a sustained period of time.

Cracking to this degree may also be due to poor original installation of the concrete. Factors such as poor compaction of the sub surface and/or inadequate reinforcing of the slab may create cracking and other secondary defects. Gaps in the concrete paving may also have a more significant structural cause, such as subsidence of soils.

Where gaps in the concrete paving are adjacent to structural elements of the building, the advice of a Structural Engineer is advisable before undertaking repairs. Significant repair and likely replacement of the concrete paving is probable.

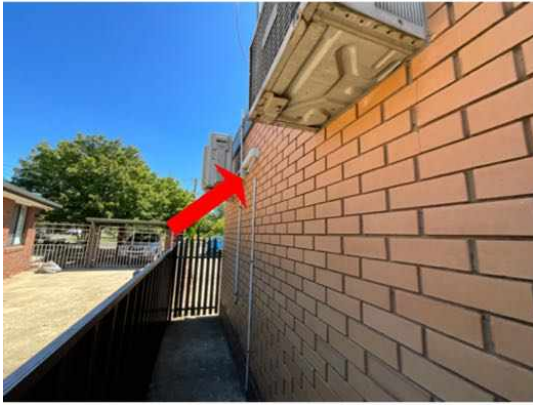
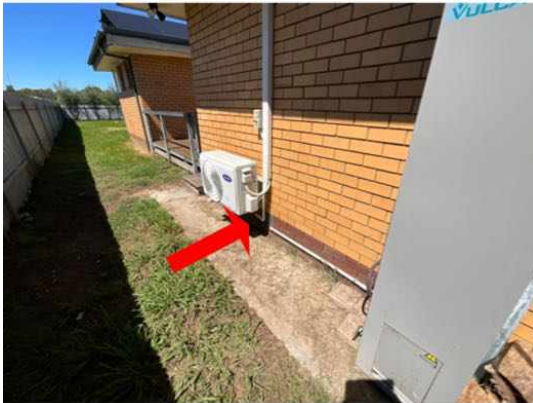
Building:	Building 1
Location:	Yard - Back,side
Finding:	Air conditioner - Disconnected overflow
Information:	The Air Conditioner (A/C) overflow was found to be disconnected from storm water drainage and is creating excessive moisture in the surrounding area.

Such leaking creates an environment which is conducive to an array of defects, including water damage to associated building elements and the attraction of termite or timber pest infestation.

It is highly recommended that a licensed plumber be appointed to connect the A/C overflow in order to prevent such an environment from being created. These minor works should be carried out as soon as possible.

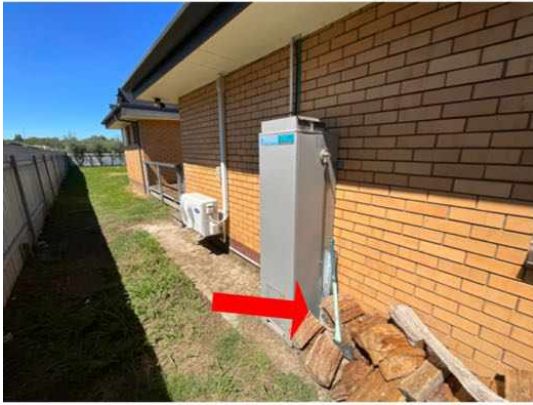
Finding 6.02

Building:	Building 1
Location:	Yard - Side
Finding:	HWS Overflow - Not Connected
Information:	The Hot Water System (HWS) overflow was found to be disconnected from storm water drainage and is creating excessive moisture in the surrounding area.

These damp conditions can lead to secondary defects such as rot, rust or corrosion of associated building elements, the formation of fungal decay, or even the creation of potential slip hazards. When coupled with poor site drainage, pooling of water may also attract termite activity to this area.

It is highly recommended that a licensed plumber be appointed to connect the HWS overflow in order to prevent such an environment from being created. These minor works should be carried out as soon as possible.

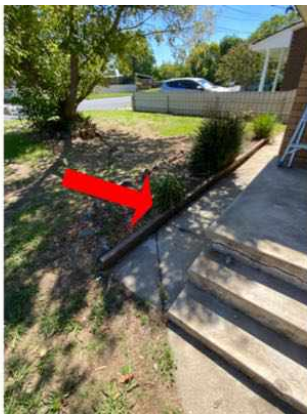
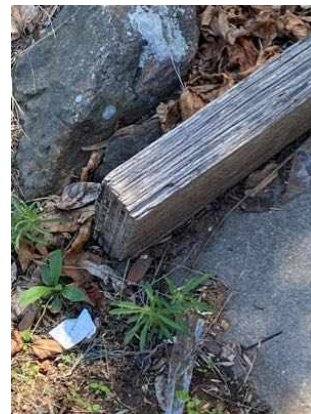
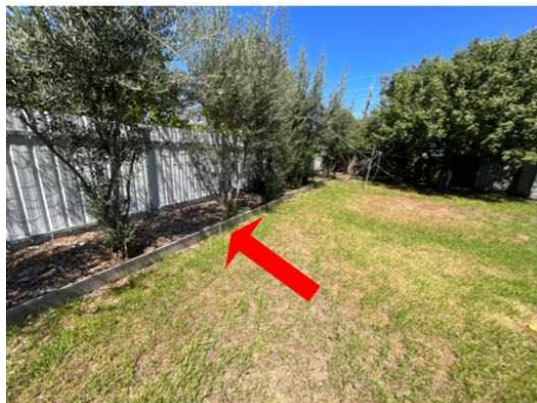
Untreated timbers in direct contact with the ground are likely to develop severe wood rot and/or fungal decay if left unattended creating attraction for subterranean termites to infest the timbers from surrounding areas.

If untreated or non-durable timbers are found to be in a hazardous environment it is highly advised that replacement of these building elements be performed as soon as possible to aid the protection of the property against termite / timber pest attack.

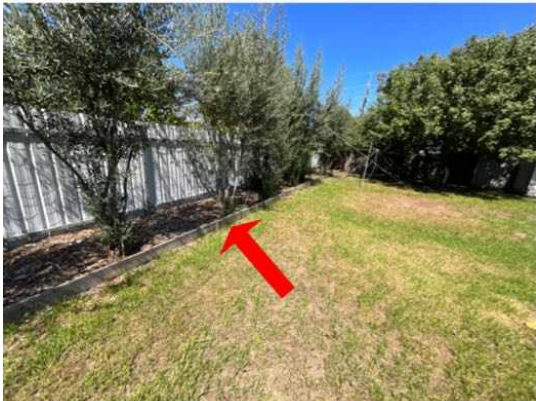
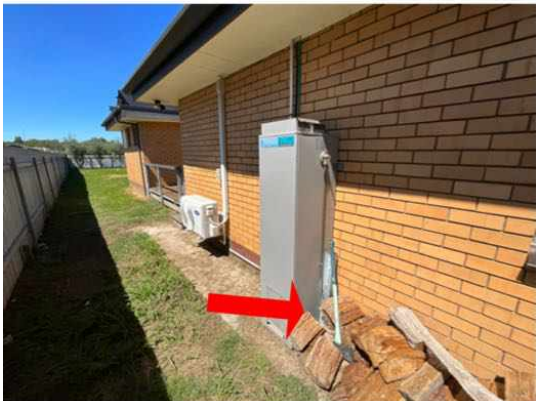
Building: Building 1
 Location: All External Areas
 Finding: Termite Management System - no evidence of a chemical installation
 Information: The application of a post-construction chemical termite barrier is highly recommended for all properties, particularly if live termite activity has been found on the site previously. Such barriers are highly effective in preventing termite attack on any timber building elements throughout the property.

A durable notice should be placed in the switchboard unit to indicate current termite barriers. At the time of inspection, it appeared as though no termite management system has been installed, with no evidence to suggest preventative works taking place.

The client may consider gaining further advice from a pest controller as to the costs and procedures involved with this application. It is recommended that obtaining such advice be a short-term priority.

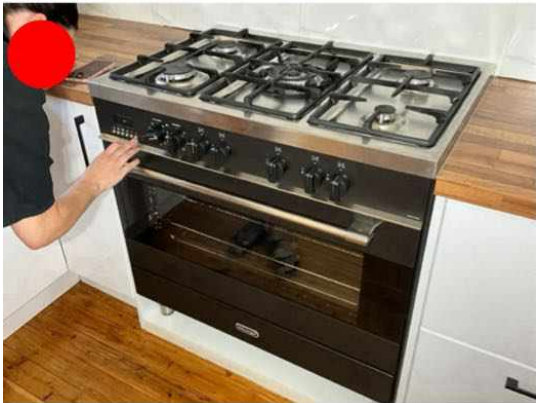
Building: Building 1
 Location: All Areas
 Finding: Additional Photos - Obstructions and Limitations
 Information: These photographs are an indication of the obstructions and limitations which impeded full inspection of the property at the time of inspection. These obstructions can hide an array of defects and should be removed to allow full inspection to be carried out. A re-inspection is recommended once the areas are made accessible.
