Building and Timber Pest Inspection Report

Inspection Date: Wed, 18 Feb 2026

Property Address: 34 Mann St, Wodonga VIC 3690, Australia

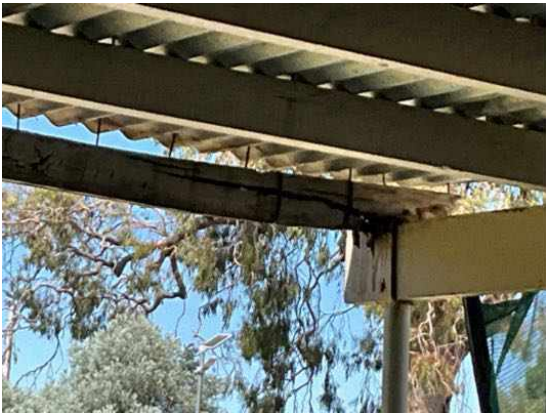
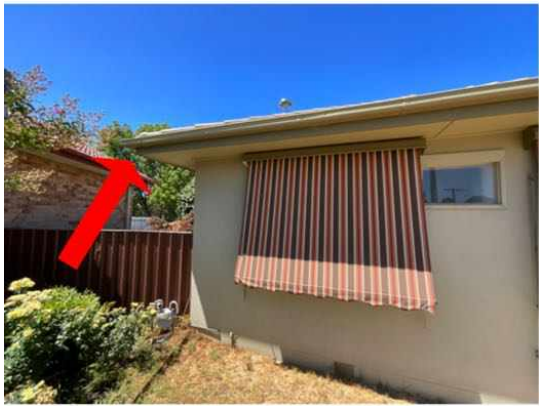
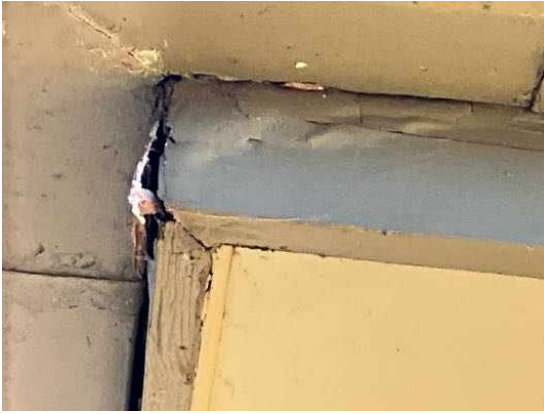
The development of fungal decay is accelerated by temperatures in the range of 5degreeC to 40degreeC as well as the presence of oxygen. Generally fungal decay develops on timber elements that are in use in an external environment which are exposed to rain penetration.

In this case although the affected timber element is in a decaying state the extent of any visible damage appears to be localised to a specific area and is yet to spread to other parts of the building element or affect adjoining structures. The fungal decay is therefore likely to be of a relatively superficial nature with minimal impact on the structural integrity or tensile strength of the timber element.
