Building and Timber Pest Inspection Report

Inspection Date: Mon, 16 Feb 2026

Property Address: 12 Disraeli St, Kew VIC 3101, Australia

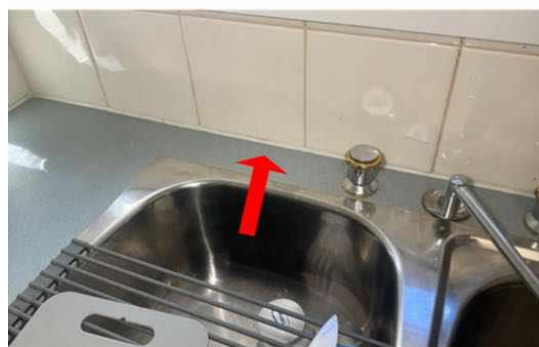
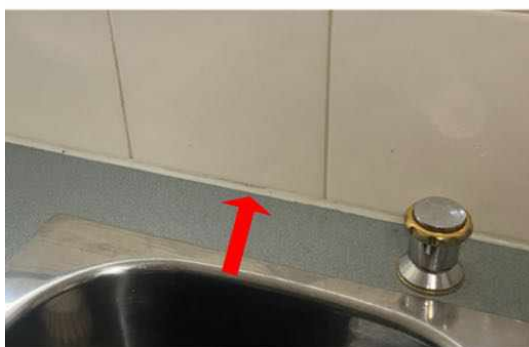
Finding: Sealant - Missing or degraded

Information: Sealant is missing or degraded in this area. Sealant is used to protect gaps and crevices in building materials to ensure that they are water-tight and prevent water penetration to the associated structures.

Where sealant is missing or degraded , a tiling contractor should be appointed immediately to re-apply any silicone where necessary. Failure to do so may lead to water damage to the surrounding area.

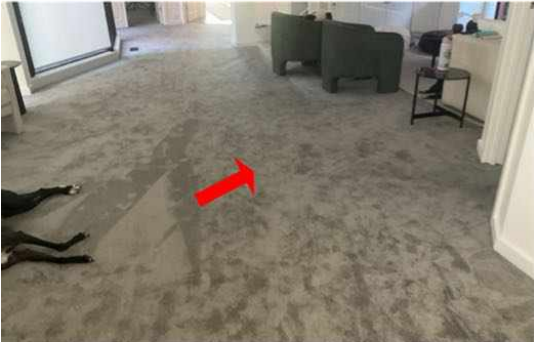
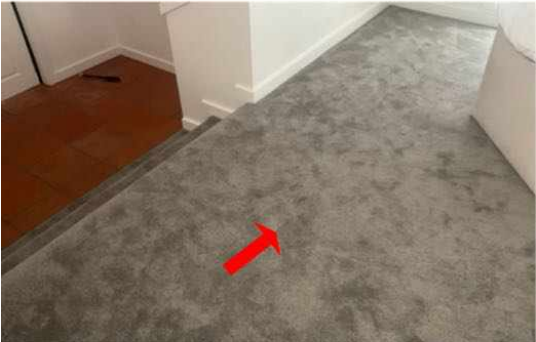
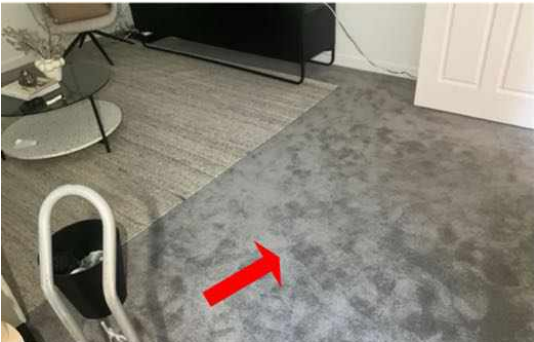
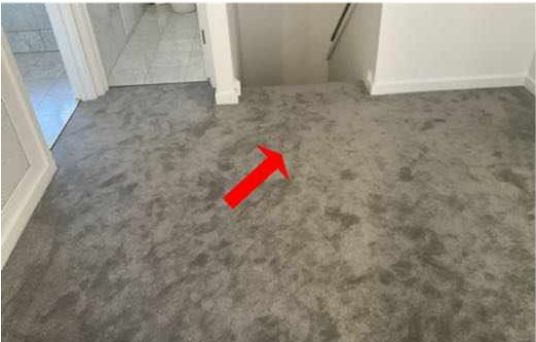
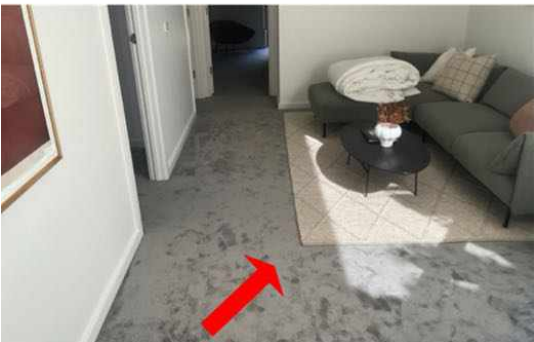
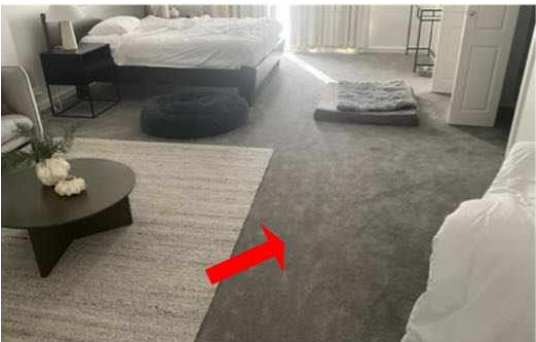
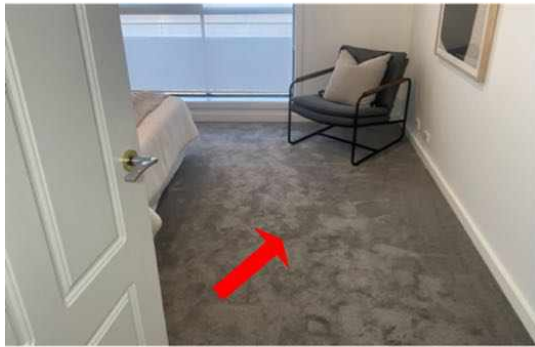
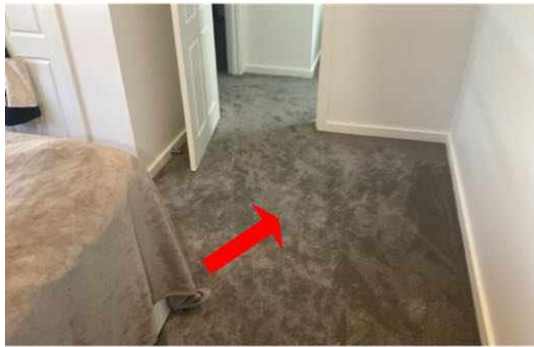
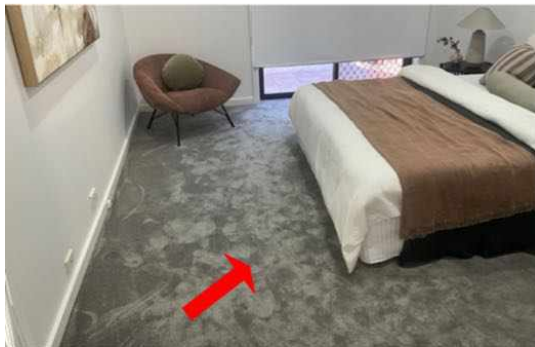
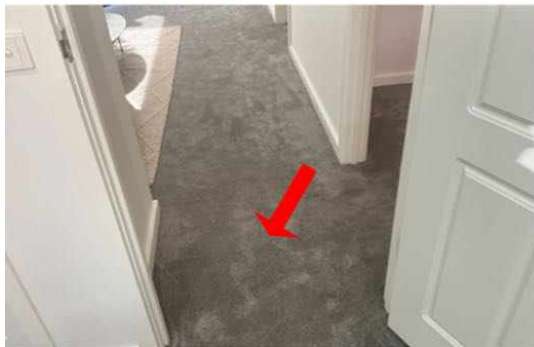
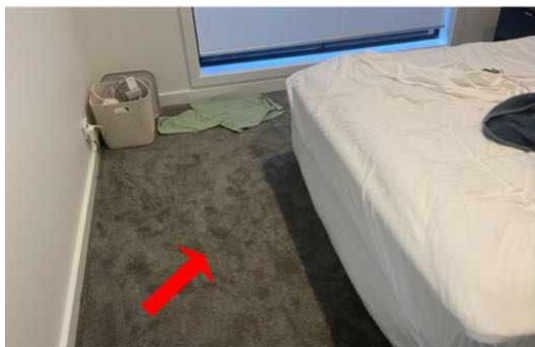
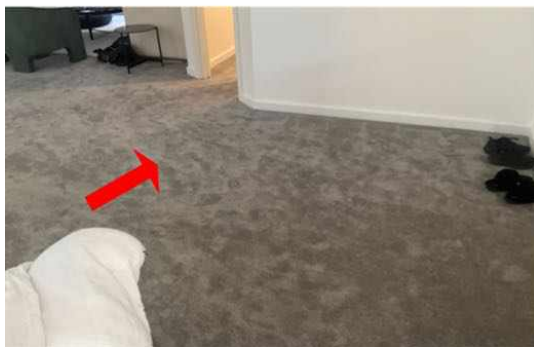
Finding 3.02

coming loose from the supporting structure that they are installed on.

The areas should be monitored for any changes or unevenness. Should this occur, consultation with a registered builder should be undertaken to determine the cause . The potential resolution may involve regluing and screwing the floor down through to replacement of subfloor support structures.

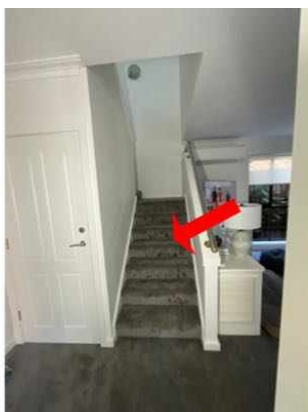
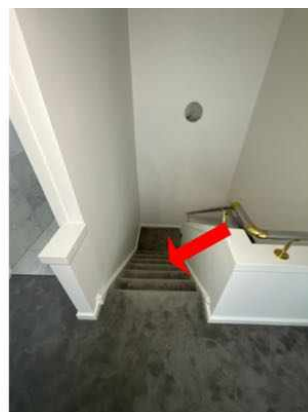
Finding 3.03

Building: Stairs - Internal
 Location: Stairs - Internal
 Finding: Stairs - creaking when walked upon
 Information: Some parts of the stairs were creaking when walked upon at the time of inspection.

Creaking flooring generally indicate that the treads are coming loose slightly from the supporting structures that they are installed on as opposed to any structural issues.

Should the client wish to address this, they should seek quotations for required repairs from a qualified carpenter or Registered Builder .

The potential resolution may involve regluing and screwing the floor down through to replacement of flooring.

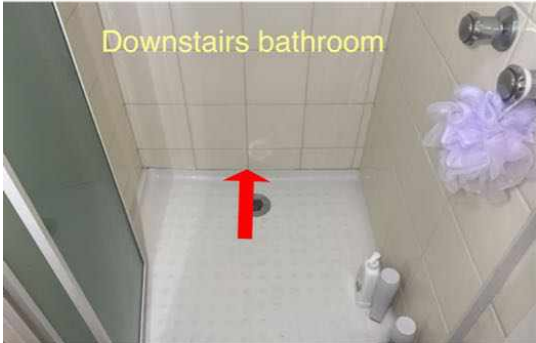
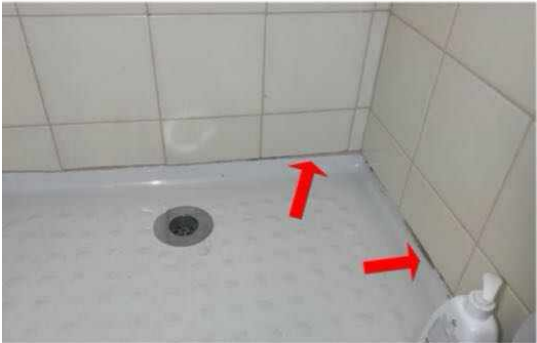
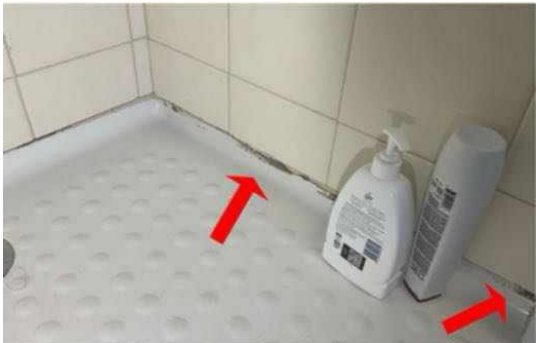
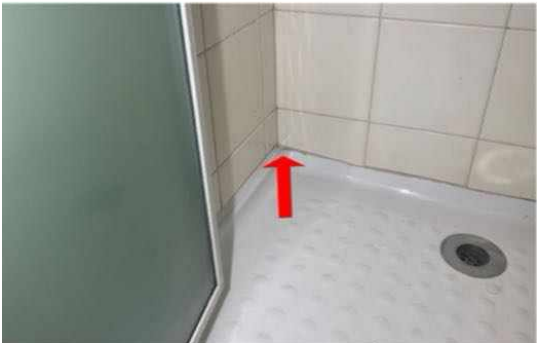
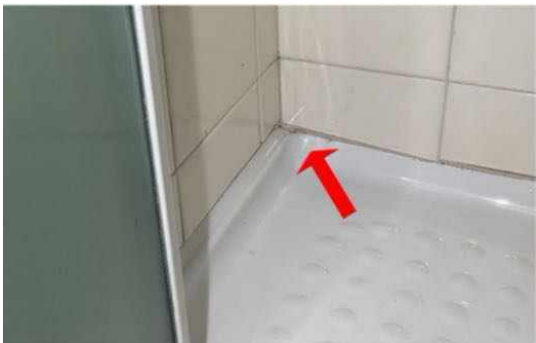
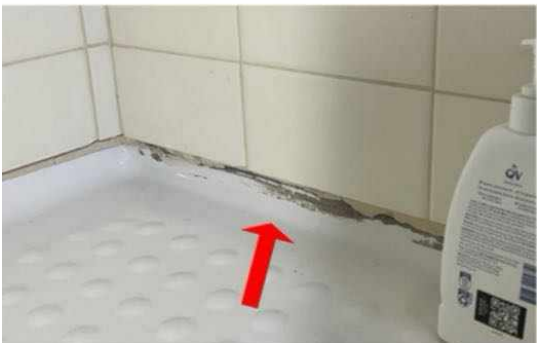
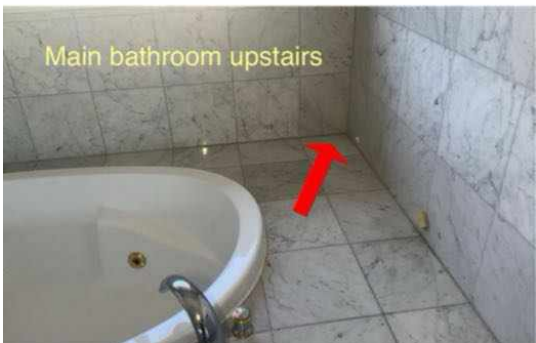
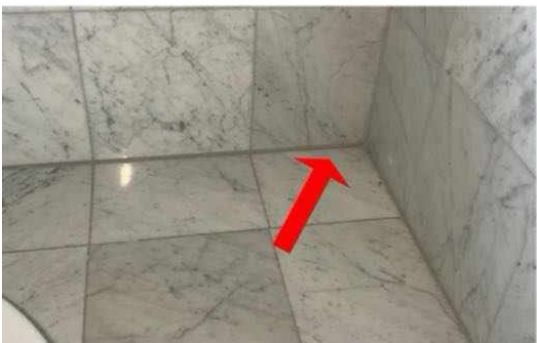
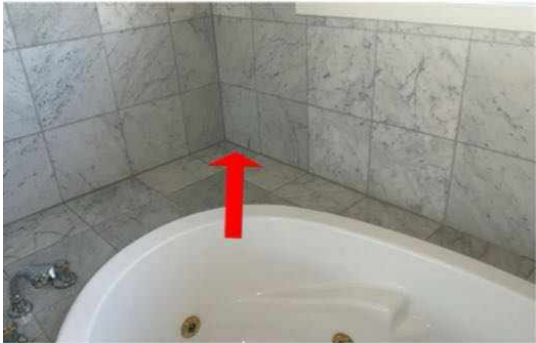
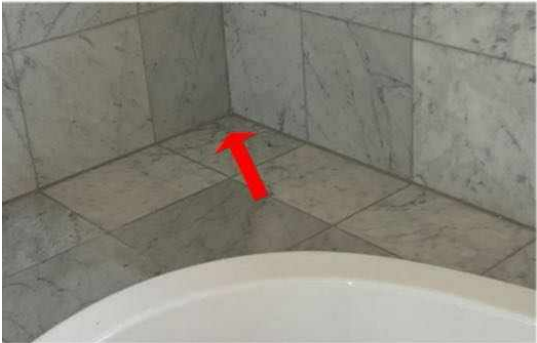
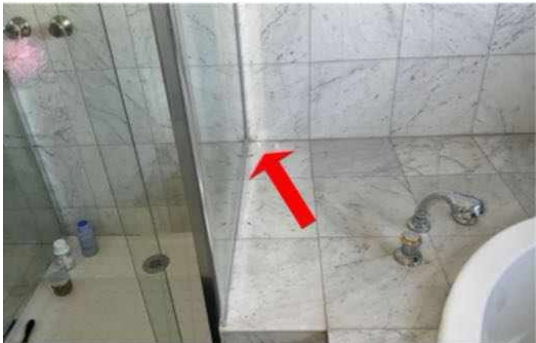
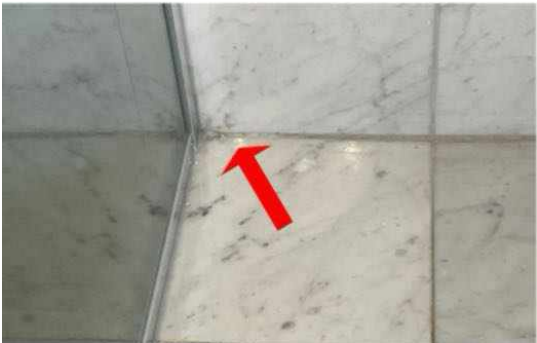
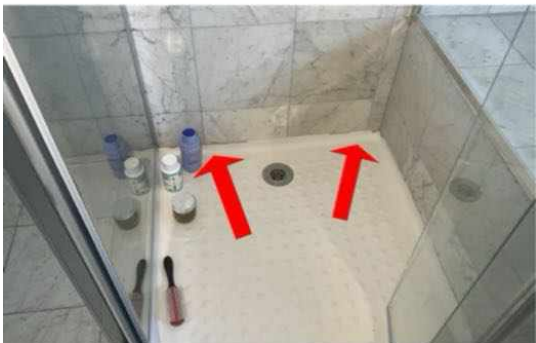
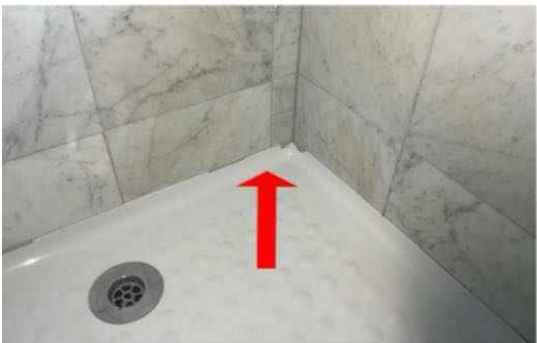
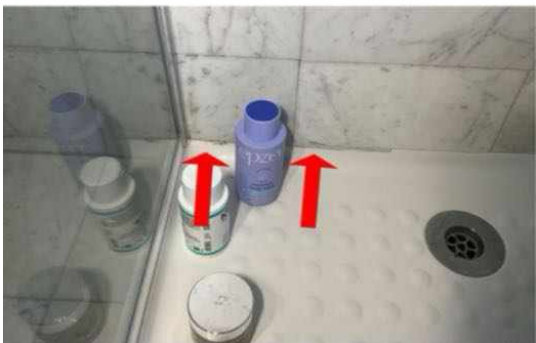
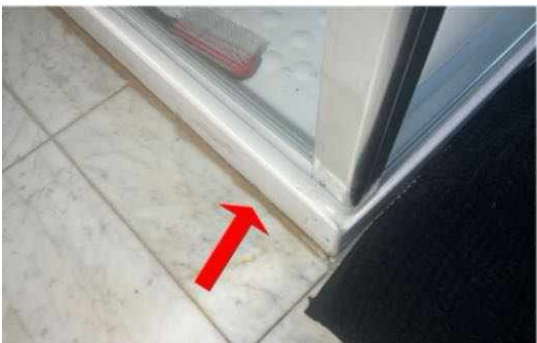
Finding 3.04

Finding: Grout and sealant - Missing or degraded within the bathroom area

Information: It was noted on inspection that grout or sealant is degraded to areas within the bathroom.

Different materials move at different rates, generally causing cracking to grout at this point. Build up of moisture in the bathroom can also cause grout and sealants to degrade and become mouldy.

Any damaged or degraded materials should be scraped out and flexible and mould resistant materials should be applied to affected areas to prevent any subsequent water damage that may occur. Regular maintenance and replacement of damaged or missing grout/ sealant is highly recommended to the wet areas, as this is a regular wear and tear defect. Both grout and sealant in areas that come into regular contact with water should be maintained for the long term care of your property.

A bathroom specialist or tiling contractor should be appointed to complete these works as soon as possible.

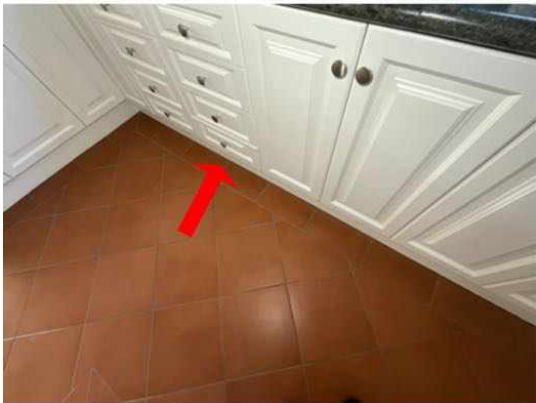
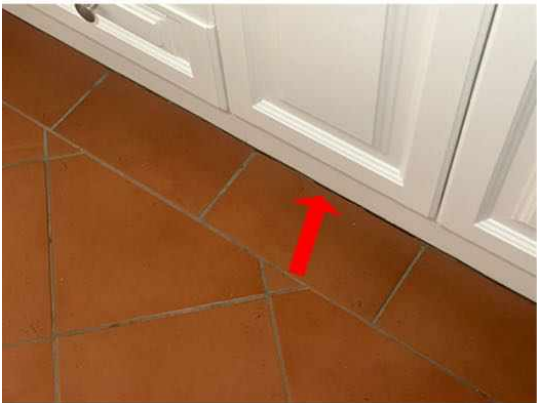
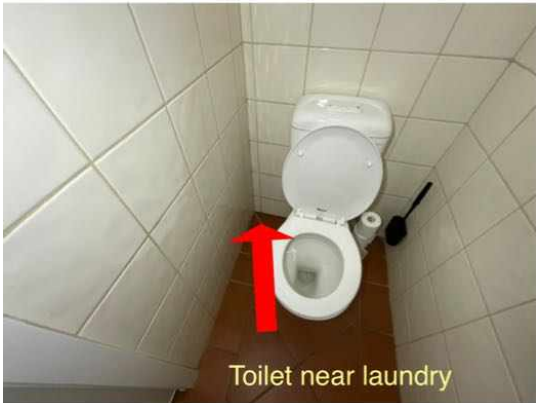
Toilet near laundry

Building:
Location: All Areas
Finding: Grouting - Missing or damaged within floor tiles
Information: It was noted on inspection that grout is degraded around various areas of the floor tiles.

This can be the result of floor tiles moving at different rates generally causing cracking to grout at this point, or poor installation of the grout. A flexible sealant should be used around edges where movement is anticipated, to lessen the chance of cracking.

The deteriorated grout should be scraped out and new grouting or flexible sealant applied where necessary.

A competent handyman may be appointed to complete these works.

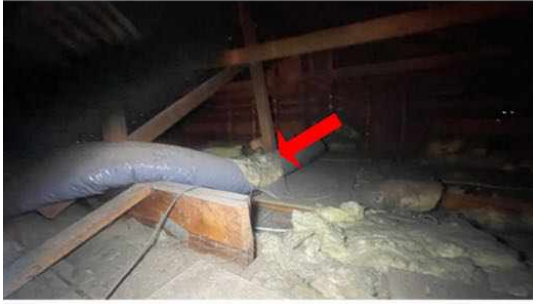
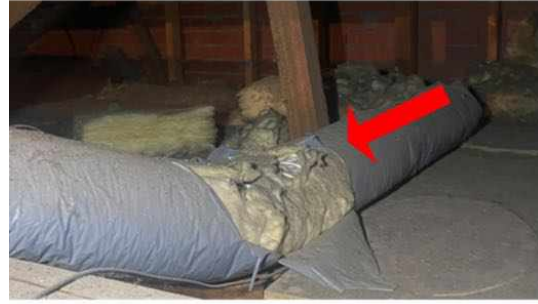
Finding: Heating / Cooling Ducts - damaged within the roof space

Please note: the vendor mentioned they don't use this heating/cooling as they use the reverse cycle split systems in the various rooms. It is unclear whether the ducted heating/cooling actually works. Your own enquiry should be made to determine whether it does in fact work.

A heating/cooling specialist should be appointed to provide further advice on remedial work options and to perform any works deemed necessary.

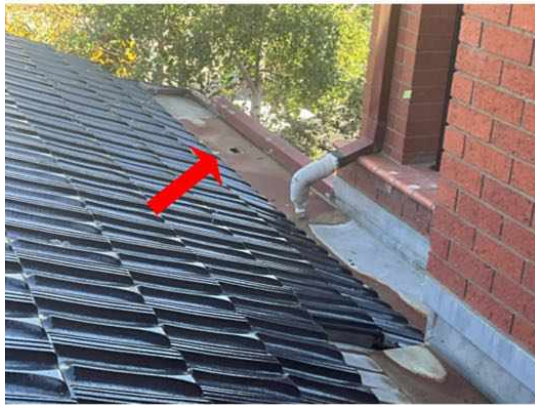
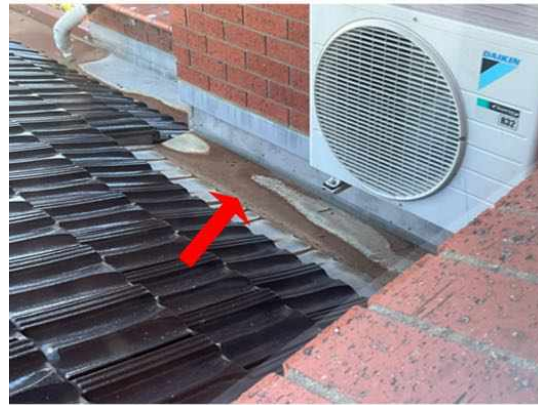
Finding 3.14

Finding: Guttering - Deterioration and rusting

Information: Upon inspection of the exterior roofing, it was found that the guttering above the garage shows signs of deterioration, with surface rust noted.

Rusted, deteriorated and damaged guttering is susceptible to water penetration, exposing the surrounding associated area to potential roof leaks and water damage.

A roofing contractor should be appointed immediately to assess the damage to the guttering and to perform remedial works as necessary. Works may include replacement of severely affected roofing or minor works such as the application of rust-retardant surface protectors.

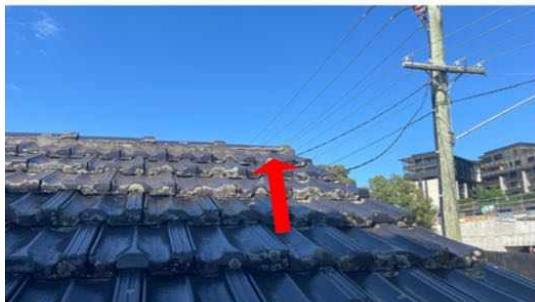
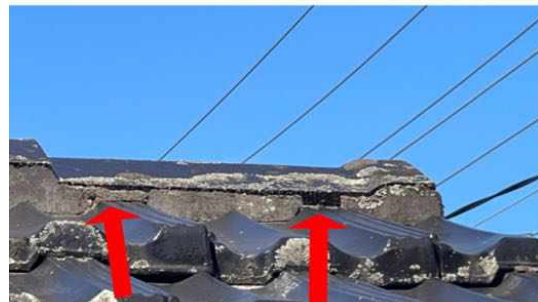
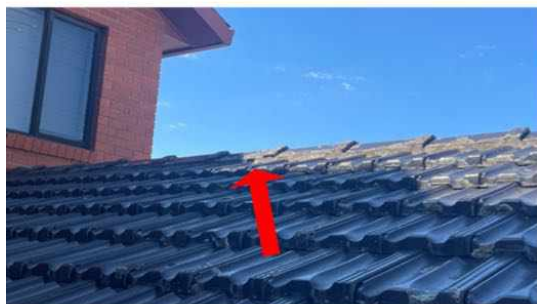
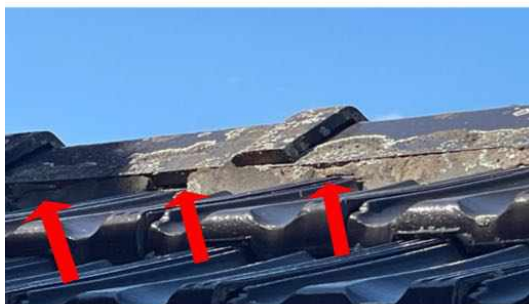
Finding 3.15

Finding: Roof tiles - generally good condition but with some maintenance required

Information: Upon inspection of the exterior roofing, the majority of roof tiles were considered to be in a good condition. While weathering of the tiles is consistent with the age of the property, some minor maintenance works are required.

Areas of cracking within the mortar around the ridge capping was also noted.

Repairs to cracked mortar is required.

Consultation with a roofing contractor is advised to gain advice on remedial works that will be required. Where left unmanaged, damage may lead to a number of secondary defects, including water leaks and weather exposure to internal roofing structures.

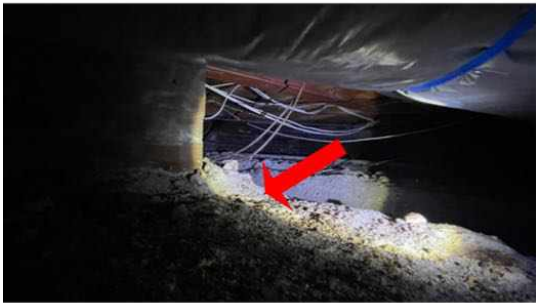
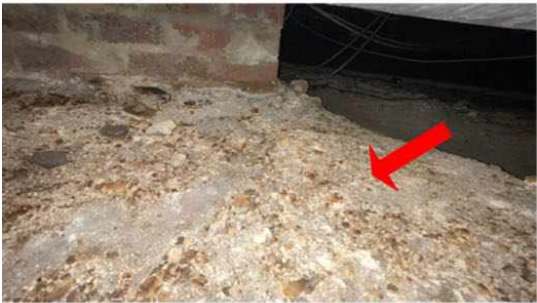
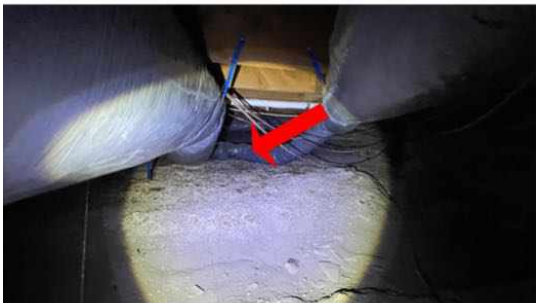
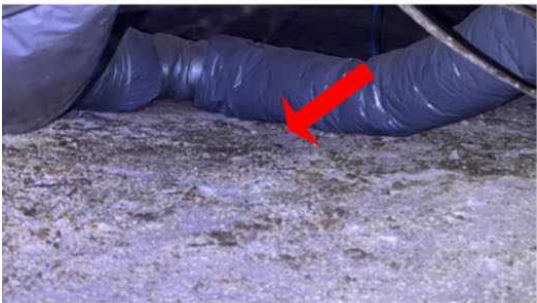
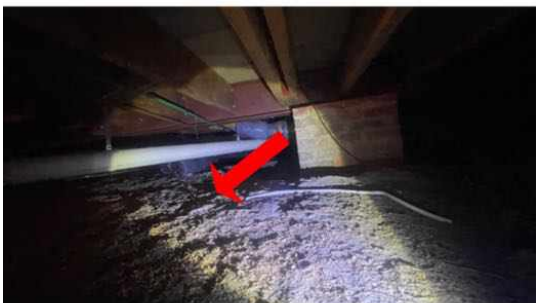
Finding 3.16

Finding: Surface mould found within the subfloor

Information: Upon inspection of the subfloor area, some surface mould was noted on the ground . It is suspected that the subfloor ventilation may be insufficient in these areas allowing the ground to remain slightly damp after rainfall. As a result, mould then forms on the surface. This is very common for properties such as this where ducting may prevent full cross flow ventilation .

Please note: no evidence of mould was noted to the underside of the flooring nor to any areas within the property.

Subfloor ventilation can be improved in some cases by addressing the causes such as exposing subfloor vents, installing additional new vents, installing mechanical (forced airflow) ventilation or removing debris from the subfloor.

A registered builder may be appointed to inspect the subfloor area and make any recommendations as necessary.

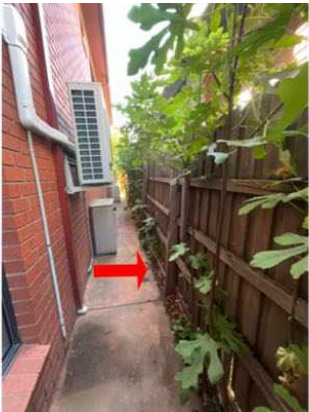
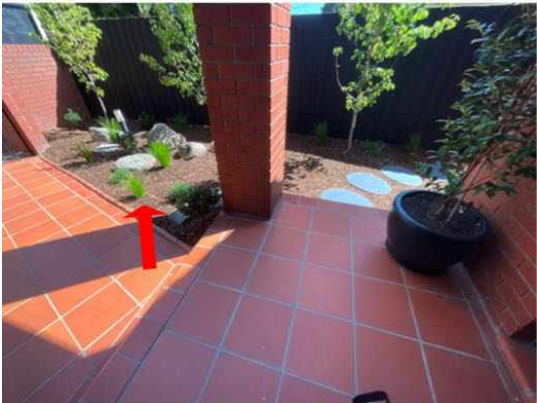
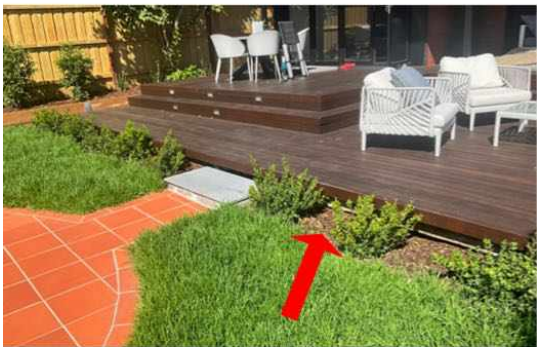
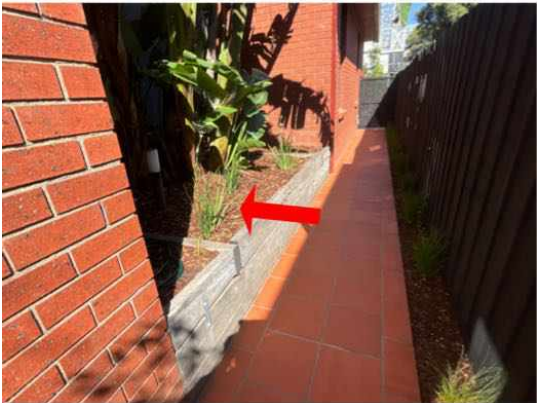
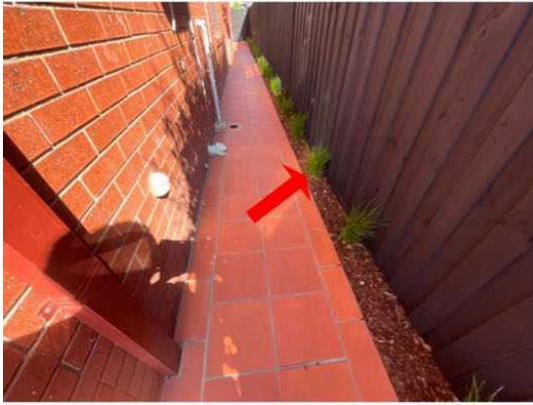
Building:
Location: All External Areas
Finding: Garden Beds - Conditions Conducive to Termites
Information: Garden beds were found to be evident around and against the property. These garden beds can include untreated timber, and with a combination of moisture from rainfall and hosing, can make conditions conducive to termite activity and termite ingress.

The removal and replanting of species that do not provide "cover" or cutting back of existing vegetation will assist greatly in preventing this from occurring.

Where removal of any such materials that may be conducive to termite activity is not possible or practical regular monitoring of the areas should be carried out to minimize the risk of potential termite attack.

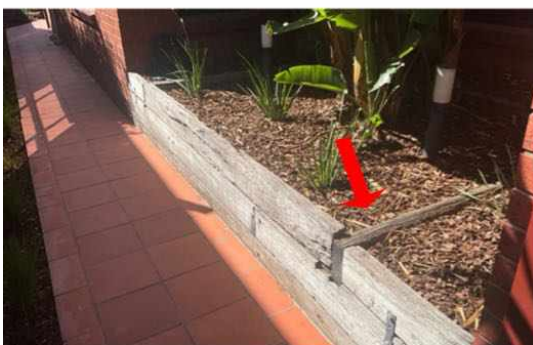
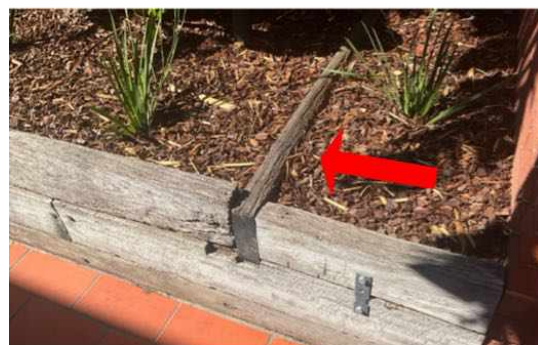
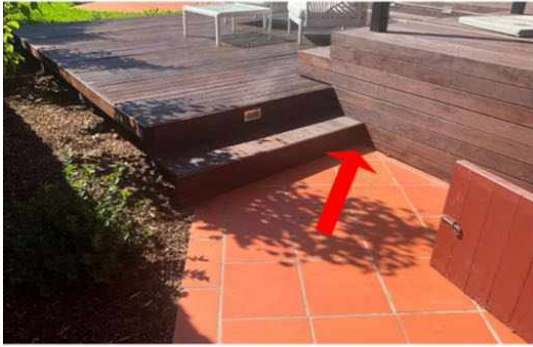
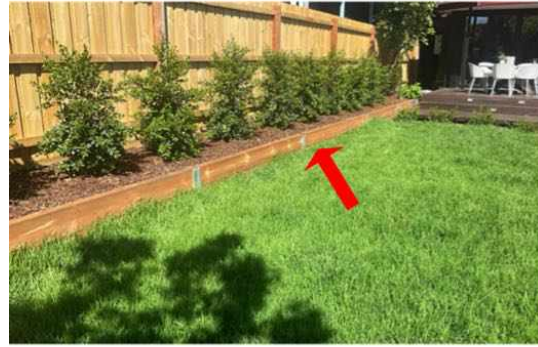
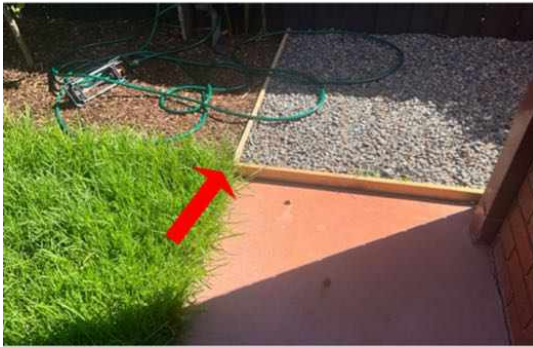
Finding 6.02

Information: Where timber elements are in direct contact with the ground and consequently moisture or dampness, they become conducive to termite activity. Whether timber is used as a building element, part of a fencing structure or stored as an unused item, they can provide an environment that is attractive to termite infestation.

When met with excessive moisture, timber begins to decay and develop wood rot. Any timbers that are in direct contact with external grounds especially if left untreated or non-durable also provide ingress for subterranean termites into that particular element.

Where possible, the removal of any such materials that may be conducive to termite activity should be carried out as soon as possible to minimise the risk of termite attack. Where not possible or practical, regular monitoring of timber elements is recommended. Replacement of any damaged materials should be carried out where necessary.

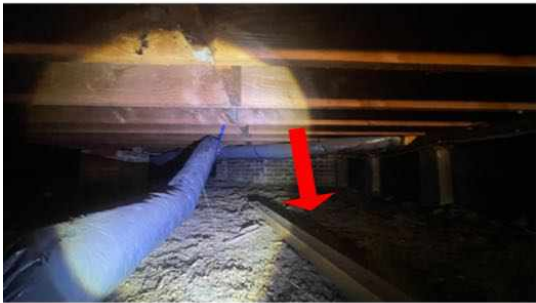
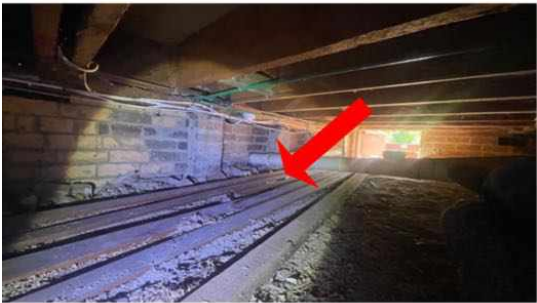
Finding 6.03

Information: An array of stored items, debris and timber were found in the subfloor area at the time of inspection. Stored items and debris in this area restricts subfloor ventilation and creates potential for concealed pest entry. Stored timbers and other materials may also make the area susceptible to termite activity and wood rot.

A clear and empty subfloor will be better ventilated and easier to maintain in a dry condition. The removal of any timber debris is vital in minimising the risk of termite or wood borer activity.

Please note: stored items and debris prevented full access to the subfloor area to inspect for any pest activity or defects.

Any stored items and debris in the subfloor should be removed as soon as possible.

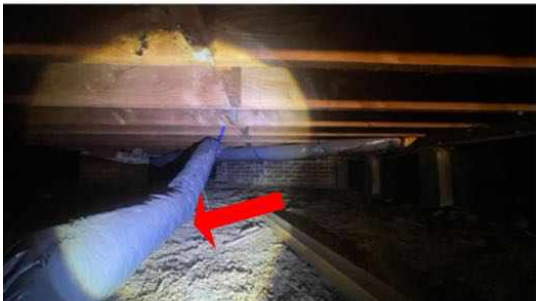
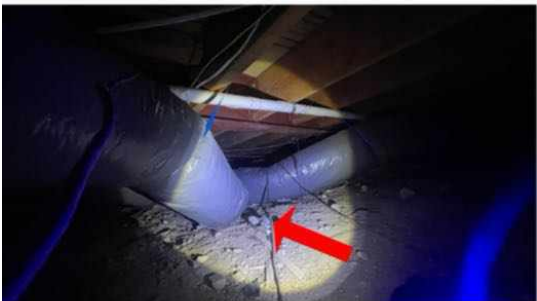
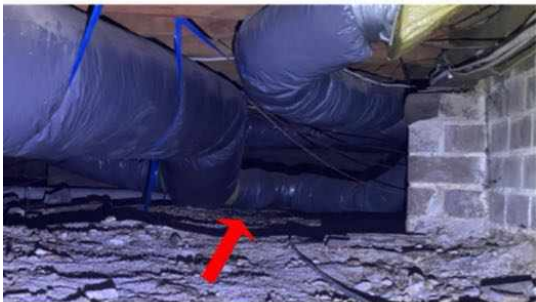
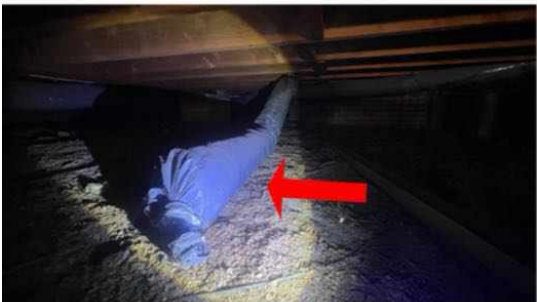
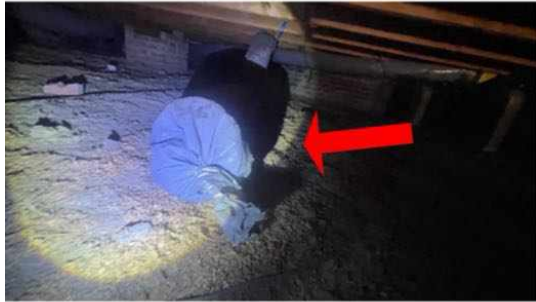
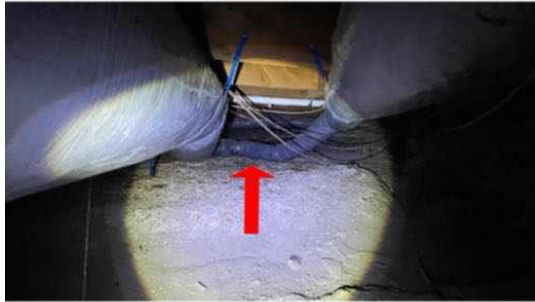
Finding 6.04

Building:
Location: Subfloor
Finding: Heating/Cooling Ducts - resting on the ground within the subfloor
Information: The heating/cooling ducts were found to be resting the ground in some areas.

As the ducting is resting on the ground, the airflow within the property is likely to be restricted as well as increased chance of damage to the ducting .

A heating/cooling specialist should be appointed to provide further advice on remedial work options and to perform any works deemed necessary.

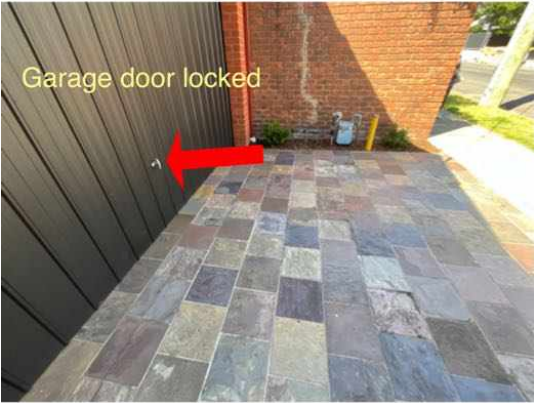
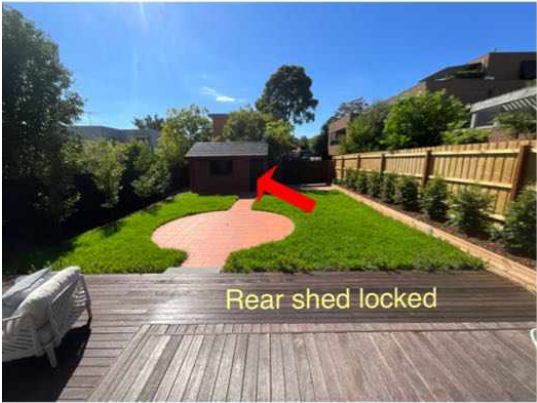
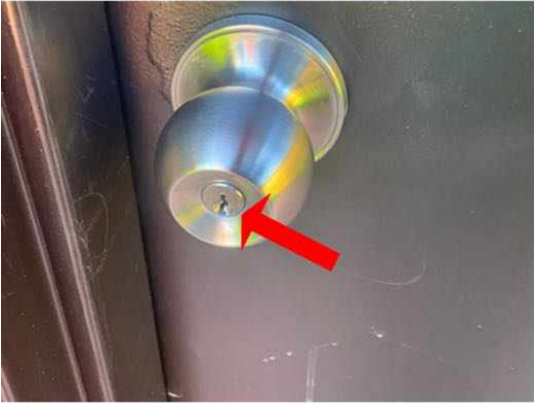
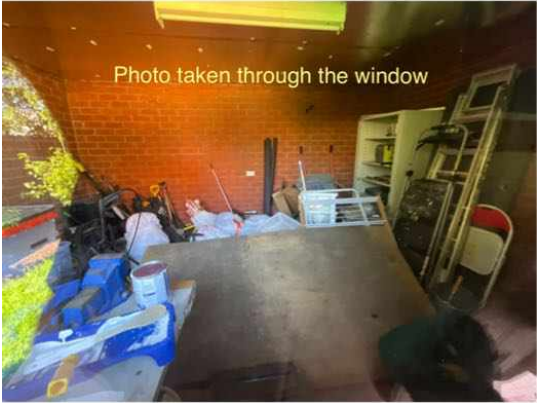
Please note: the shed at the rear of the property and the garage were not able to be inspected due to the doors being locked. It is highly recommended that you conduct a further inspection of these areas during an open for inspection to ensure no damage is present.

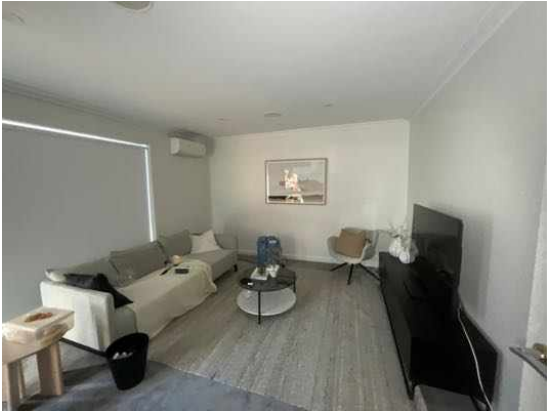
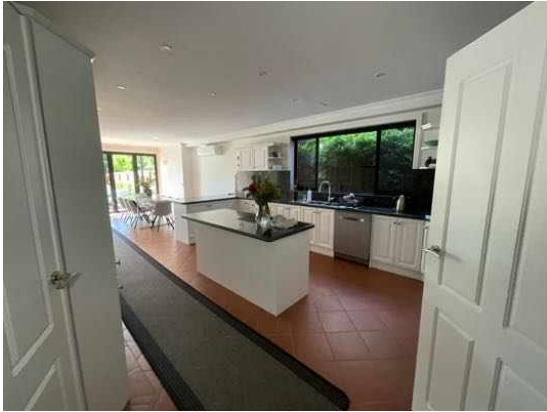
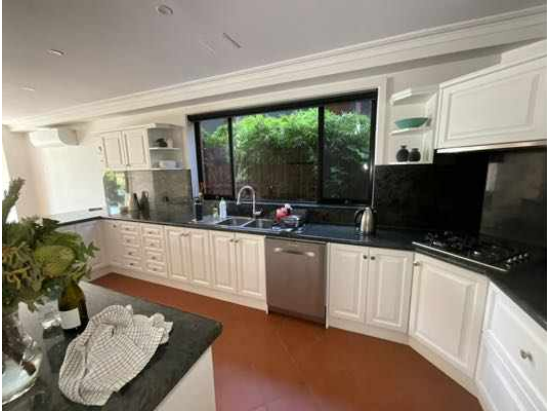
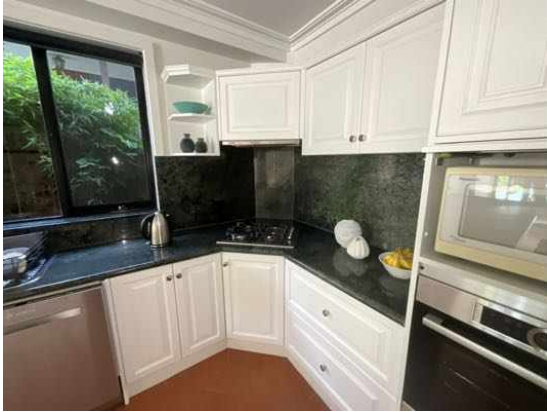
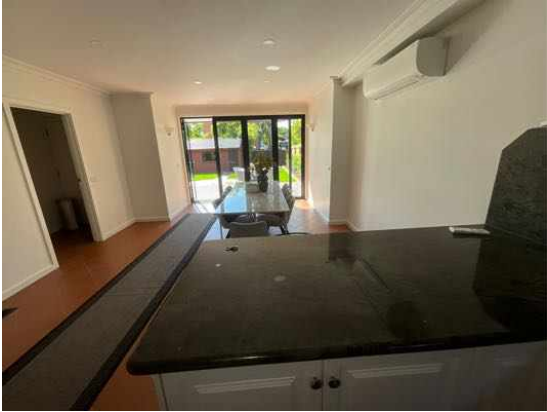
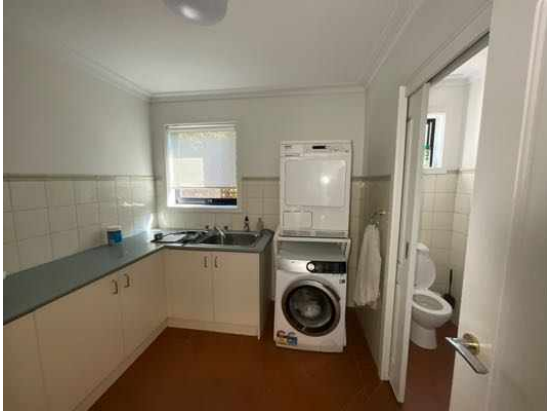
Building:
 Location: All Areas
 Finding: Additional Photos - Obstructions and Limitations
 Information: These photographs are an indication of the obstructions and limitations which impeded full inspection of the property at the time of inspection. These obstructions can hide an array of defects and should be removed to allow full inspection to be carried out. A re-inspection is recommended once the areas are made accessible.
