## Building Inspection Report

Inspection Date: Thu, 12 Mar 2026

Property Address: 5 Dunoon Ct, Brighton East VIC 3187,  
Australia

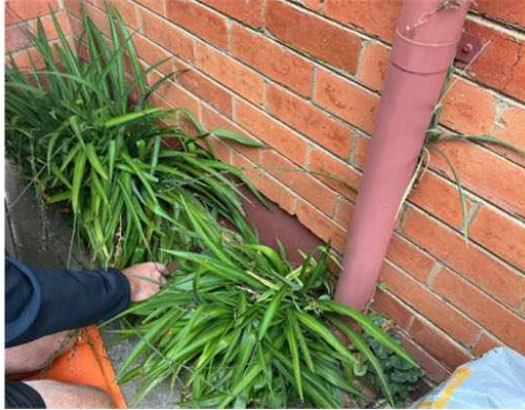
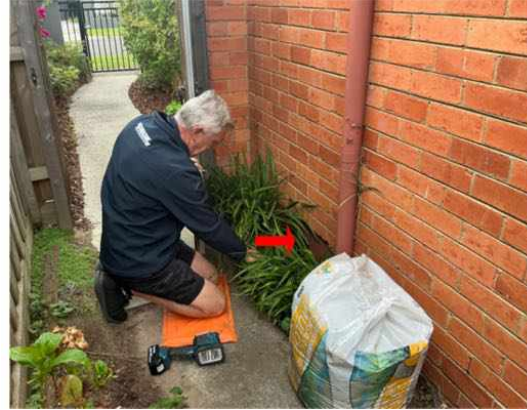
#### Defects 1.02

Building:	Main Building
Location:	Subfloor
Finding:	Asbestos - Suspected ACM Identified on Site
Information:	Reporting on Asbestos is outside the Scope of this Report. This suspected defect is highlighted as a caution only. We suspect, based on our experience in the building industry, that there is a higher risk of the identified building element containing asbestos.

As Asbestos Reporting is outside the scope of this report, we advise that you consider a separate Asbestos Inspection and Condition Audit, which can include the taking of

samples for definitive confirmation of the presence of Asbestos.

In the interim, the client is advised to act with caution, especially when considering any damage to building materials general wear and tear renovations extensions demolition and general maintenance activities due to the suspected presence of Asbestos.

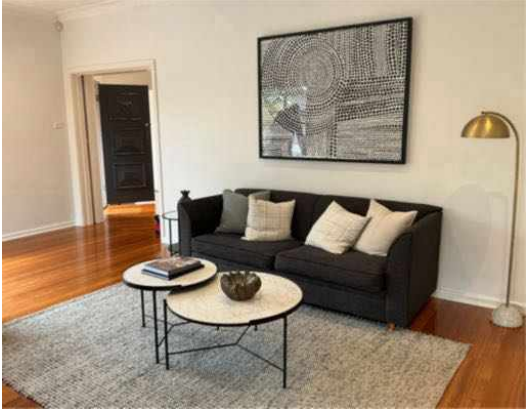
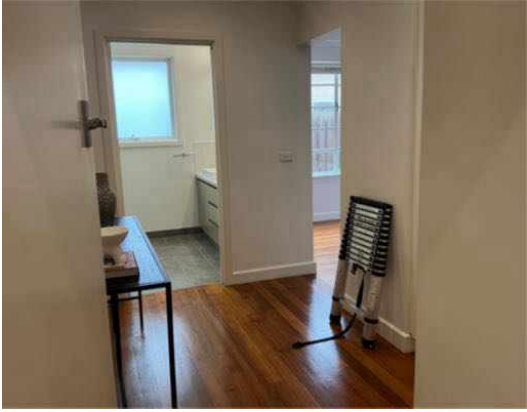
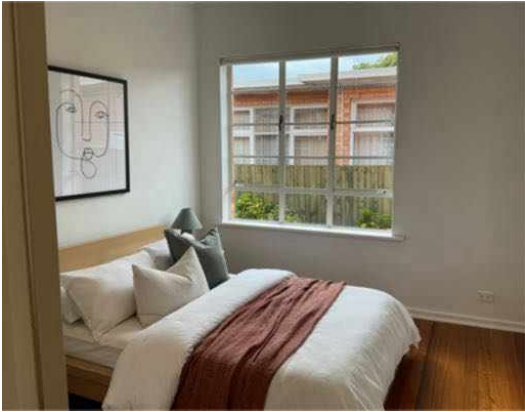
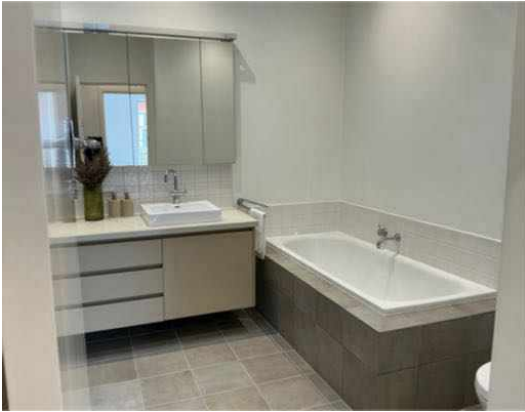
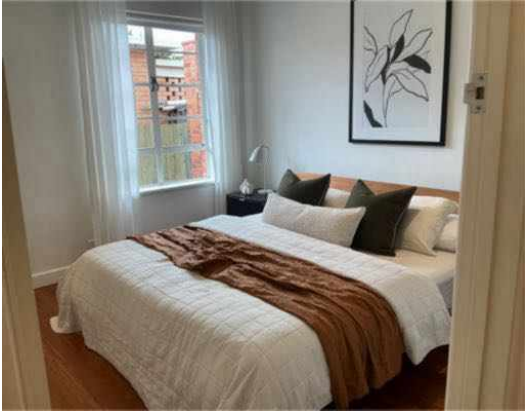
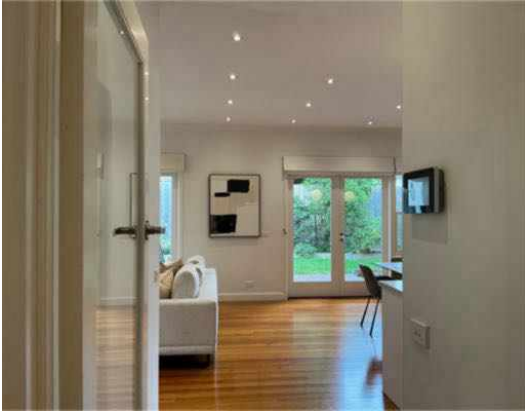
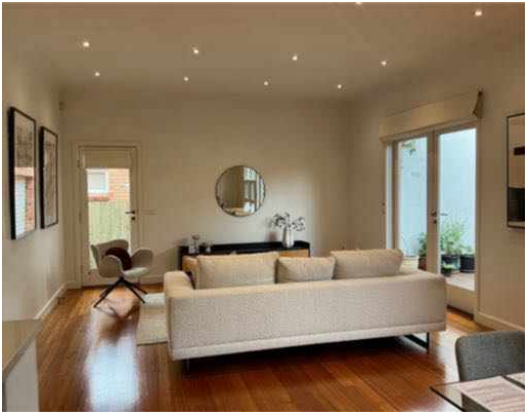
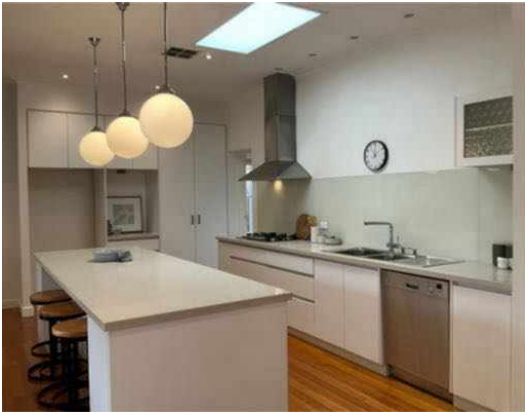
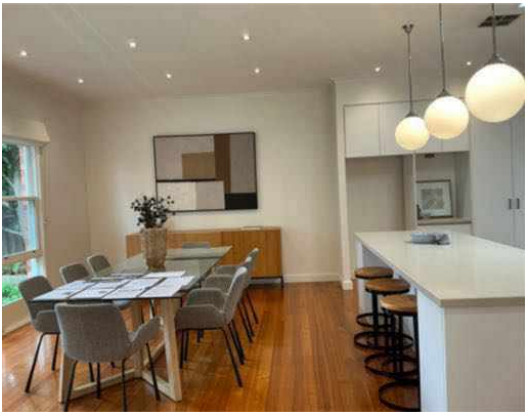
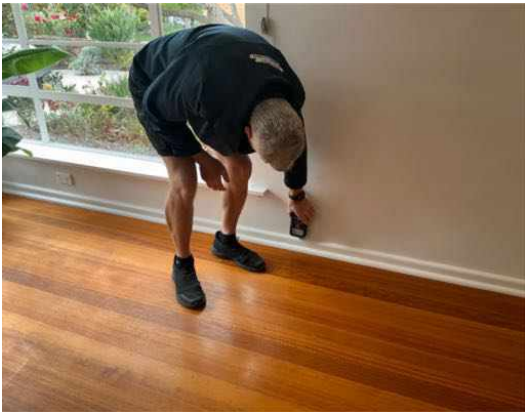
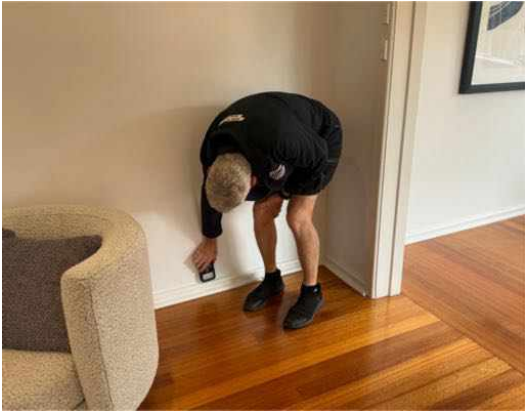
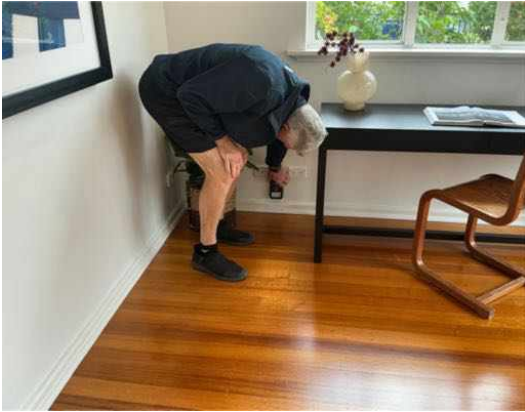
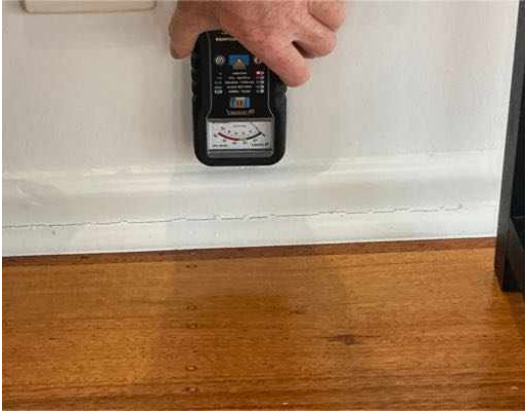
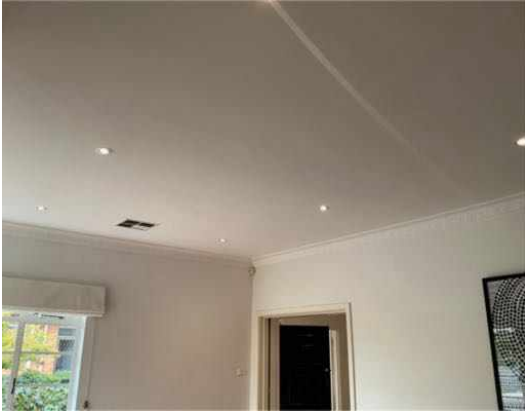
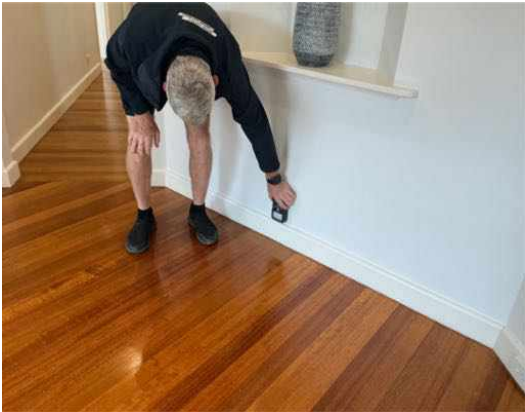
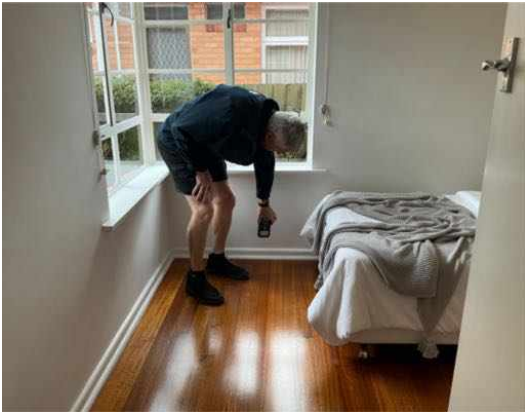
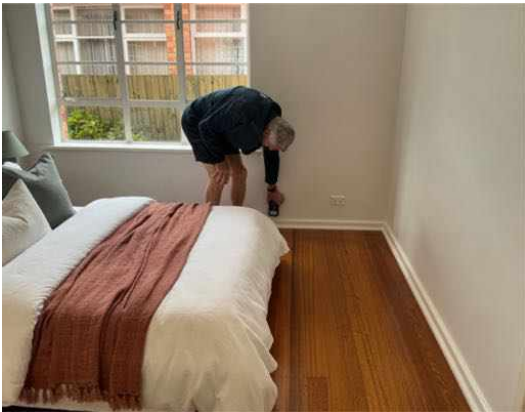
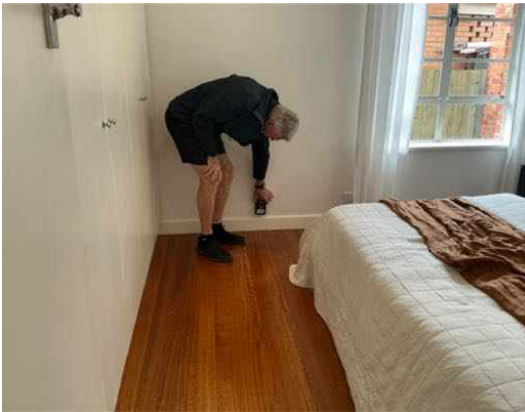
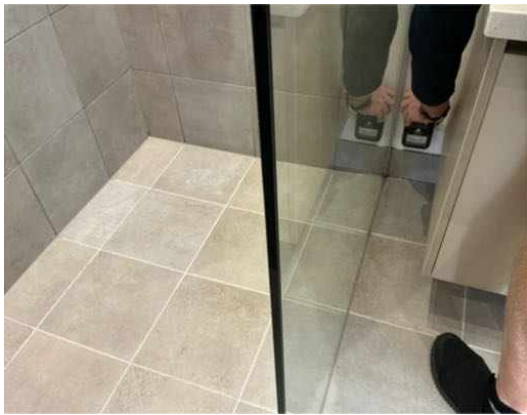
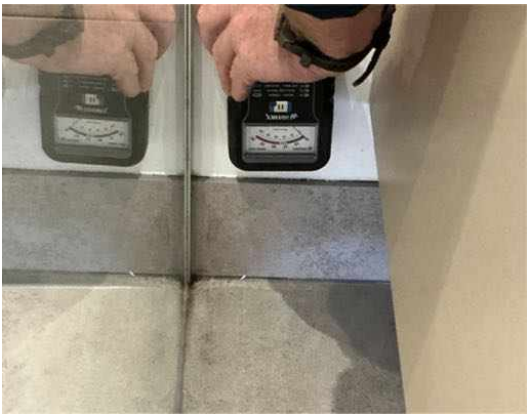
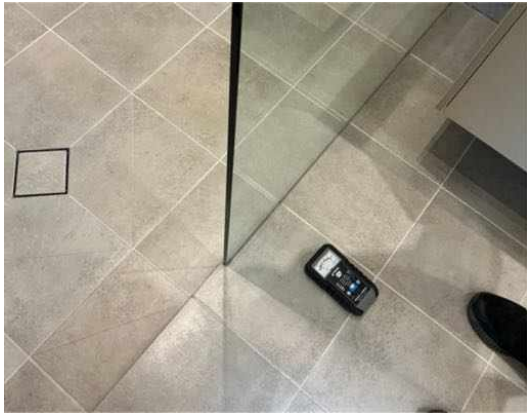
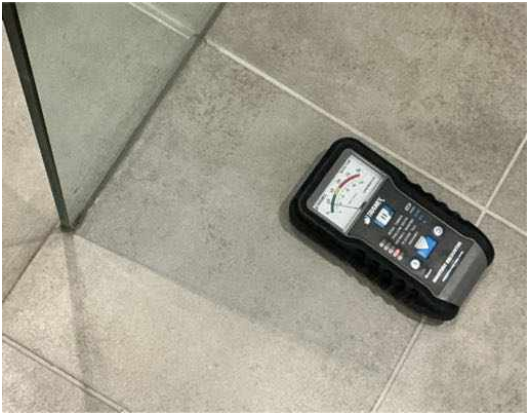
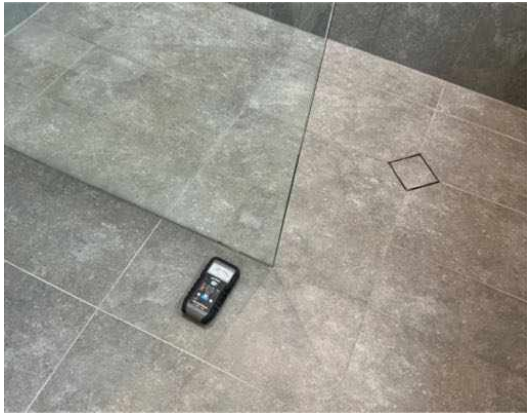
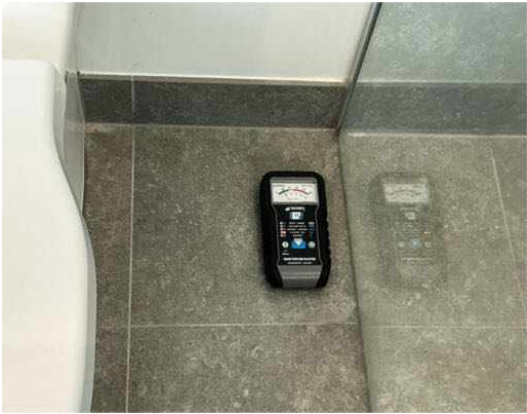
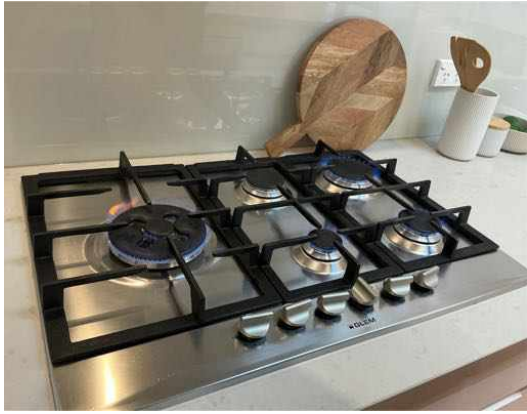
## Defects 3.01

Building:	Main Building
Location:	All Areas
Finding:	Additional Photos - Obstructions and Limitations
Information:	These photographs are an indication of the obstructions and limitations which impeded full inspection of the property at the time of inspection. These obstructions can hide an array of defects and should be removed to allow full inspection to be carried out. A re-inspection is recommended once the areas are made accessible.

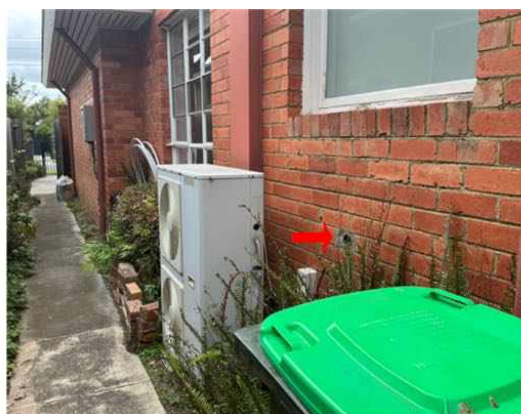
### Defects 3.03

Gaps and holes around pipework makes the area susceptible to insect and vermin ingress, as well as allowing water penetration to the cavity wall. As such, associated building elements are likely to deteriorate at an accelerated rate, and major implications are expected if holes around the pipework are left unmanaged.

All excessive holes, gaps or cracks should be adequately filled by a suitable sealant or trimmings as soon as possible to prevent any further damage. Such works may be conducted by a general handyman or licensed plumber.

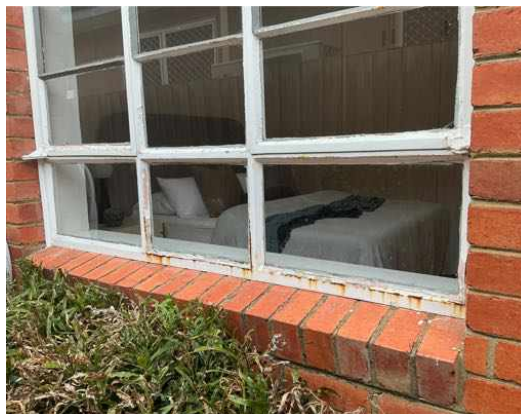
### Defects 3.04

Building:	Main Building
Location:	Side Metal Windows
Finding:	Building element - Rusted or corroded
Information:	This building element shows evidence of rusting and corrosion, which is likely to have developed as a result of excessive exposure to moisture and or inadequate coatings.

As surface rust provides no protection to the underlying iron, the deteriorating condition is likely to worsen if not addressed in the short-term future.

Where possible, the use of galvanized (treated) metals or aluminium coated metals aid in rust prevention, as does regular general maintenance. Rust formation can be controlled with coatings, such as paint, that isolate the iron from the environment.

Rusting and corrosion should be managed by ideally removing or limiting the affected

surface from exposure to moisture. A registered builder may be appointed to replace any building elements that have been severely affected by rust or water damage.

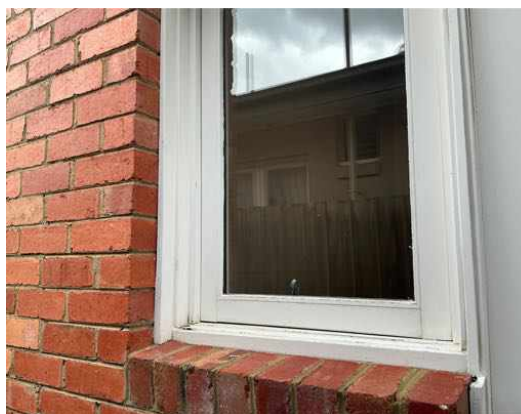
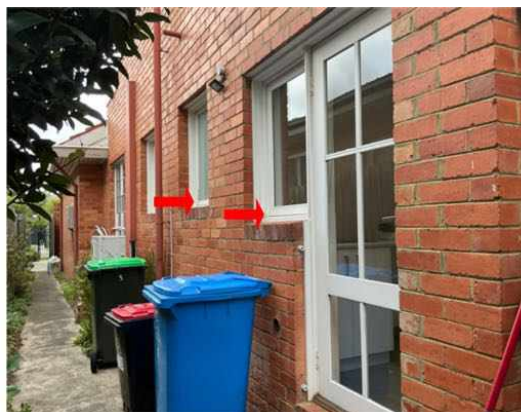
### Defects 3.05

Building:	Main Building
Location:	Timber Windows
Finding:	Windows - Wood rot
Information:	Wood rot was found to be affecting external windows. Wood rot, also known as Fungal Decay, occurs when timbers and other cellulose building materials are exposed to damp conditions on an ongoing basis.

It is likely that this wood rot has developed as a result of frequent exposure to rain and other weather conditions. It is suspected that failure to maintain the window frames over a prolonged period has resulted in them deteriorating at an accelerated rate, increasing their susceptibility to the development of wood rot. Leaks in roof plumbing or associated pipework may have also contributed to the formation of the wood rot in this area.

Early intervention and regular maintenance will prolong the useful life of these building elements. Prior to any works being performed, any associated pipework or roof plumbing should be inspected by a licensed plumber for faults or leaks.

Repair and/or replacement of affected window frames may be a necessary step in protecting surrounding building elements from such deterioration. Remedial works should be performed by a qualified carpenter or registered builder as soon as possible to prevent any further damage.

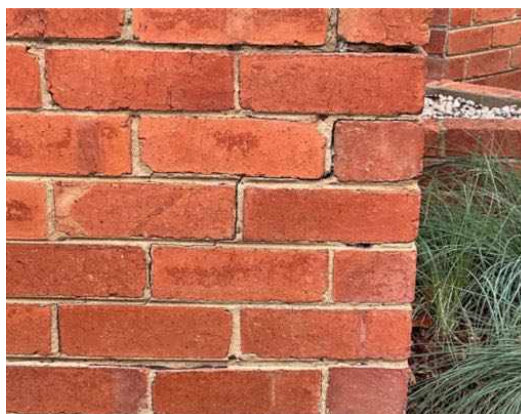
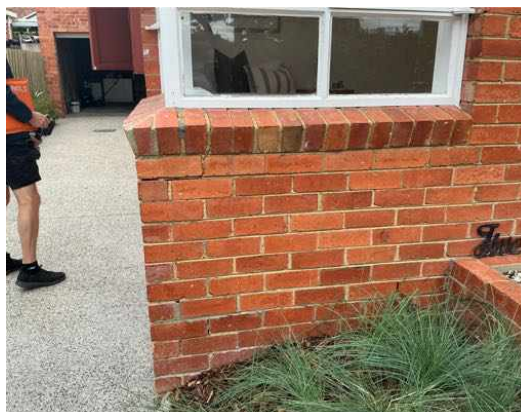
### Defects 3.06

Building:	Main Building
Location:	Exterior walls - front
Finding:	Brickwork - Step cracking
Information:	Step cracking was identified to the brickwork in this area at the time of inspection. Step cracking, which is similar to other forms of cracking, has a variety of possible causes. However, the most common is the subsidence of adjacent footings.

Step cracking is a relatively common defect, and is most likely to occur adjacent to windows, doors and other openings. Mortar failure in the gaps between affected bricks indicates the stresses and tensions affecting the wall.

Where step cracking is extensive or severe, the client is advised to consult a structural engineer. Minor step cracking can be used as a warning sign to address factors causing stress to the wall, which can include the effect of surrounding trees, water leaks, soil erosion, or even the presence of reactive soils in the surrounding area.

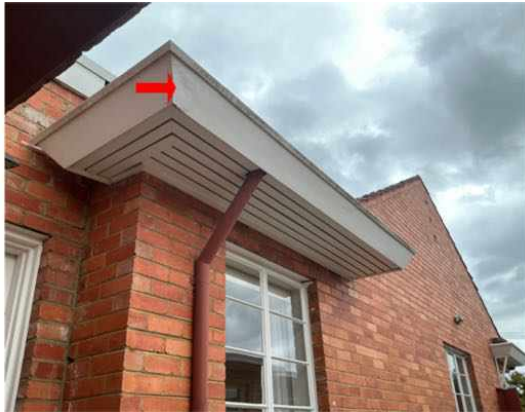
### Defects 3.07

Building:	Main Building
Location:	Fascias
Finding:	Fascias - Wood rot
Information:	Wood rot was found to be affecting fascias and barges in this area, evidenced by the presence of mould on the surface in some areas. Wood rot, also known as Fungal Decay, occurs when timbers and other cellulose building materials are exposed to damp conditions on an ongoing basis.

It is likely that this wood rot has developed as a result of faults in the roof plumbing, creating excessive moisture in this areas. Frequent exposure to rain and other weather conditions also make fascias and barges susceptible to accelerated deterioration.

Early intervention and regular maintenance will prolong the useful life of these building elements. Prior to any works being performed, the cause of the moisture that has created the visible wood rot should be identified and addressed in a suitable manner.

It is advised that a roof plumber be appointed to inspect all roof plumbing and subsequently identify the cause of the wood rot. Replacement of affected fascias and barges may then be a necessary step in protecting surrounding building elements from such deterioration.

A qualified plumber may be appointed to assess the cause of excessive moisture and

to provide advice on any remedial works as required. A qualified carpenter or registered builder may also be required to replace affected building materials.

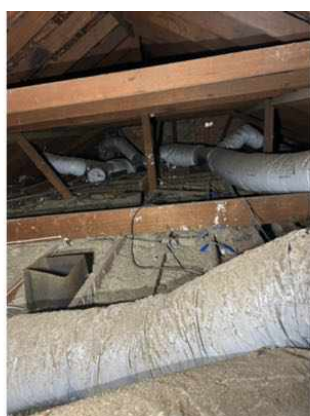
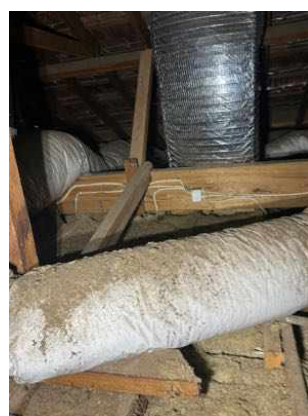
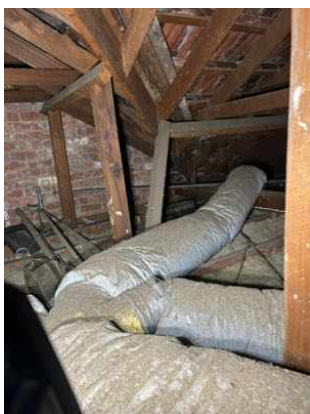
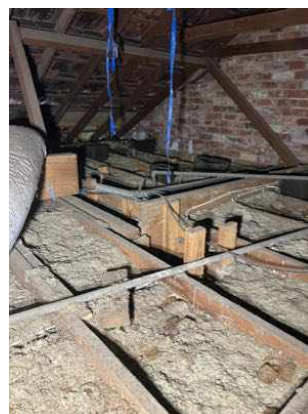
This type of insulation is susceptible to settling and reducing in volume, detracting from its effectiveness and resulting in an overall loss of energy within the household. Additionally, the reduction in volume has led to an uneven distribution of insulation within the ceiling void, further detracting from its effectiveness.

It is highly advised that this insulation be removed and replaced with a more appropriate material. This will ensure that the property is adequately insulated and will promote an increase in energy efficiency within the property. An insulation contractor should be appointed to provide further advice on replacement options and to perform works as necessary.

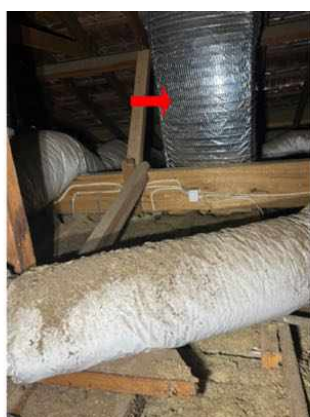
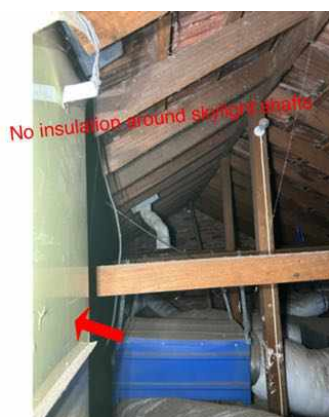
### Defects 3.15

Building: Main Building  
Location: Skylights  
Finding: Insulation - Inadequate  
Information: Upon inspection of the roof void it was noted that there is a lack of adequate insulation.

The level of insulation in the property does not meet current Australian Standards. Installation of adequate insulation is required and should be conducted as soon as possible.

Caution should be exercised when accessing the roof void. Do not attempt to stand on the framework to the underside of the trusses and be aware there is a potential for electric shock if contact is made with exposed or faulty electrical wiring.

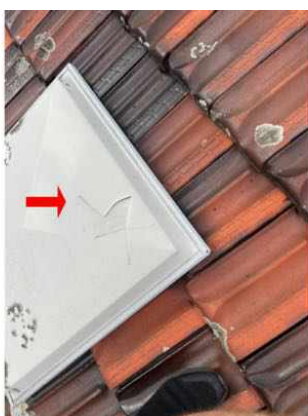
## Defects 3.16

Building:	Main Building
Location:	All Areas
Finding:	Building element - Damaged ( Skylight dome)
Information:	Breakage occurs generally when the building materials have either aged and decayed, or as a result of damage (accidental or deliberate).

Repair and/or replacement of broken elements is advised to ensure that additional secondary defects do not arise as a consequence. Such works are necessary, as all building elements play a key role in the operation and function of the overall structure and its performance.

A relevant tradesperson should be appointed to repair or replace the affected building element prior to any subsequent damage being caused.

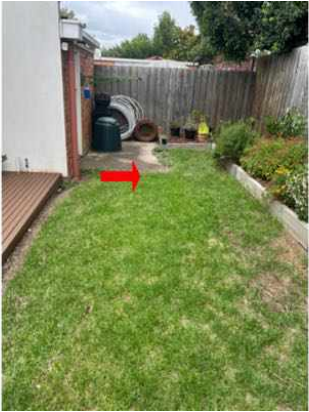
## Defects 3.17

Building:	Main Building
Location:	Yard - Back
Finding:	Perimeter Paving - Insufficient Fall
Information:	The perimeter paving or ground levels were found to have an inadequate slope away from the adjoining building structure, creating potential for water pooling in this area.

Perimeter paving is required to fall from the building by a minimum of 25mm in the first metre and bare ground should fall away from the house by 50mm in the first meter. This standard ensures that excessive moisture does not pool around the base of building structures, which creates potential for water and structural damage, as well as making the area susceptible to termite and timber pest activity.

Where paving or ground levels do not have adequate fall, a licensed paving contractor should be appointed to install or remove and re-level pavement.

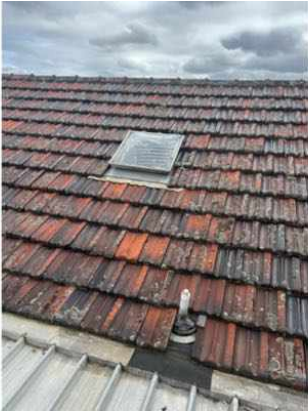
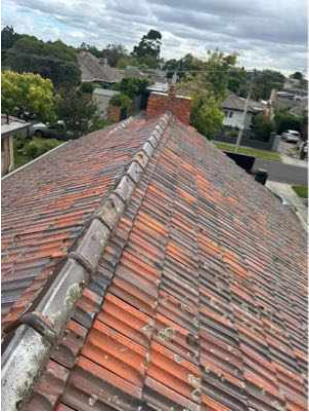
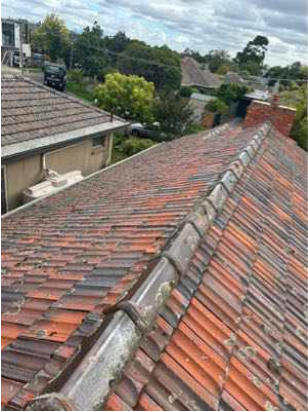
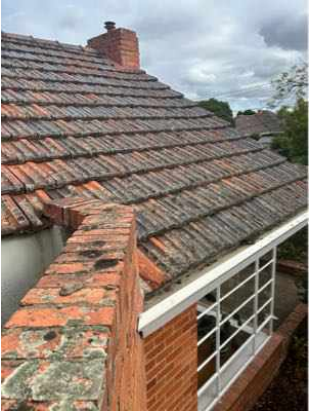
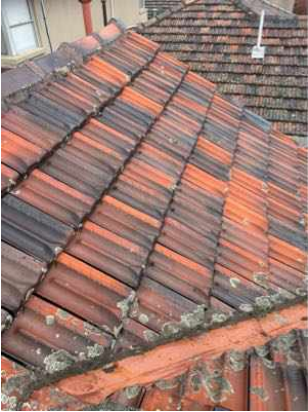
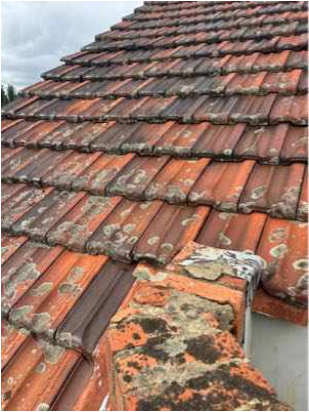
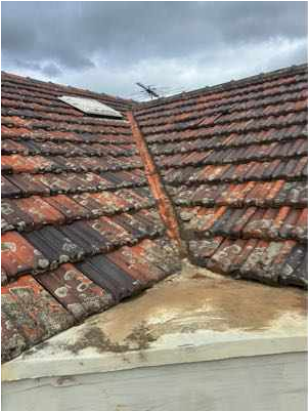
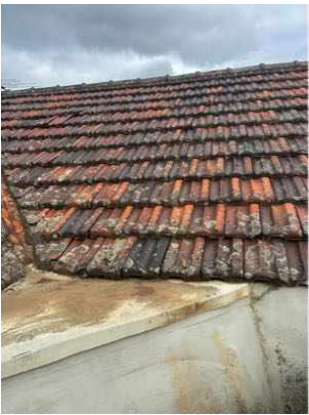
Building: Main Building  
Location: Roof  
Finding: Roof tiles - Weathered  
Information: Upon inspection of the exterior roofing, the majority of roof tiles were considered to be in a fair condition. While weathering of the tiles is consistent with the age of the property, maintenance works are required.

Isolated areas of mortar have come loose in the valleys and minor cracking is also present. Re-pointing and re-sealing the may be considered as an interim solution by the client to help preserve and extend the life span of the tiles.

Where left unmanaged, deteriorating roof tiles are likely to lead to a number of secondary defects, including minor water leaks and weather exposure to internal roofing structures.

Consultation with a roofing contractor is highly advised to gain advice on cost of remedial works that may be required in the short to medium term. Remedial works are likely to increase the longevity of the exterior roofing structure.

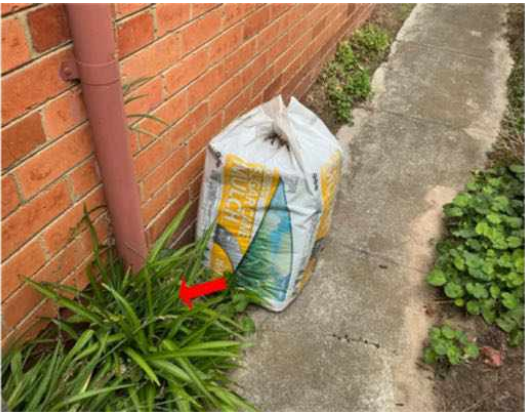
brittle nature of clay or terracotta pipes problems can begin to occur over time. Even if they're functioning fine now, clay pipes will need replacing eventually.

The average lifespan of a clay pipe sewer system is 60 years — which means an upgrade is decades overdue for many homes. For your peace of mind you may wish to have your sewer pipes inspected and replaced before a major problem occurs

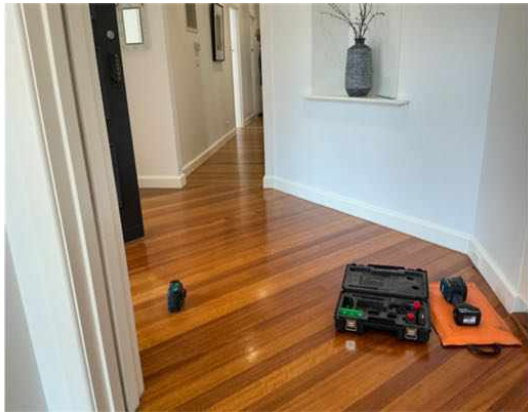
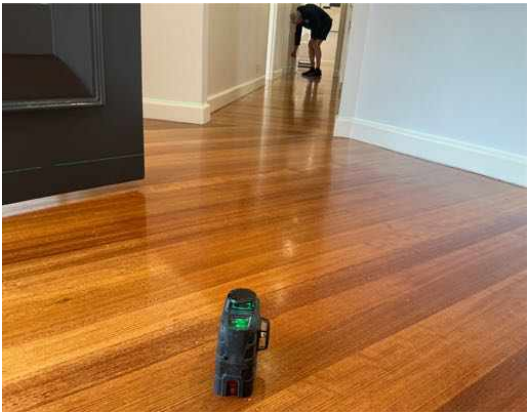
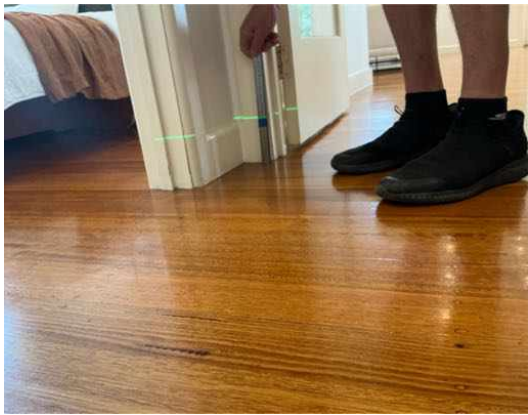
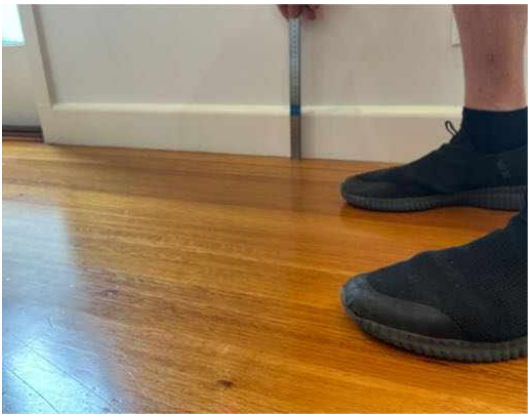
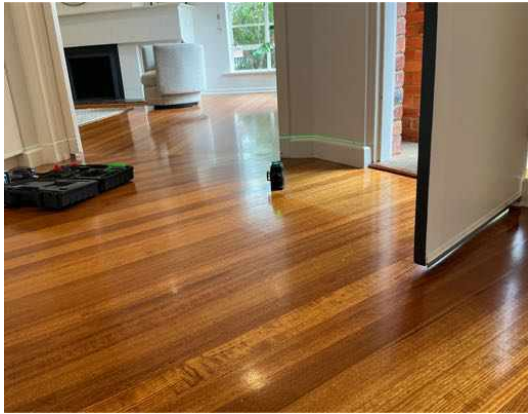
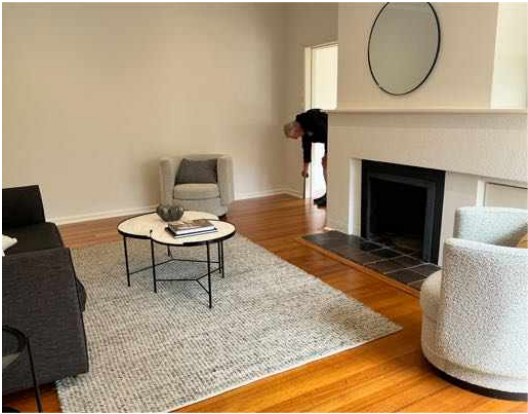
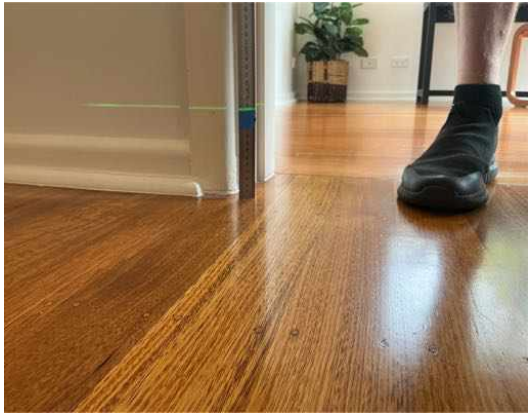
Building: Main Building  
Location: All Areas  
Finding: Additional Photos  
Information: A laser level was used to check floor levels and they were found to be within tolerance.

Additional photos are provided for your general reference

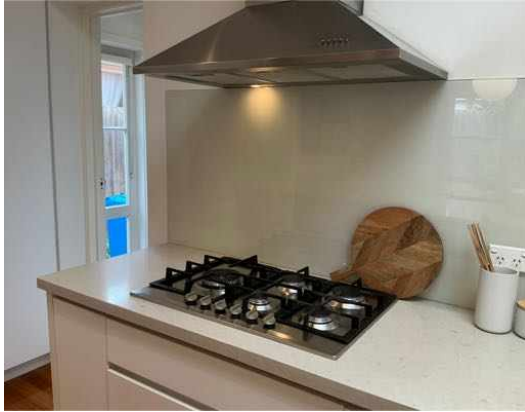
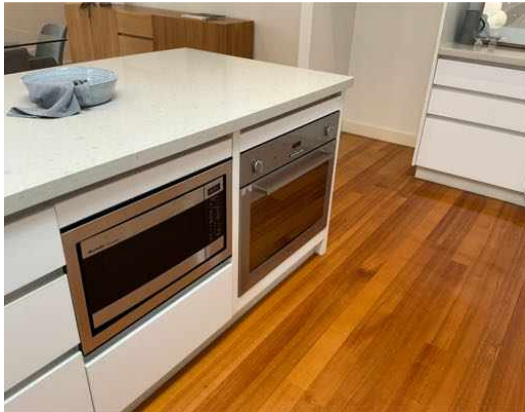
Building: Main Building  
 Location: Appliances  
 Finding: Warranty - Expired  
 Information: Where appliances are beyond their warranty period, the owner should be prepared to meet the cost of replacement or repair of the item at any time. The operation of the appliance can not be guaranteed and further inspection by an appropriately qualified tradesperson may be required.

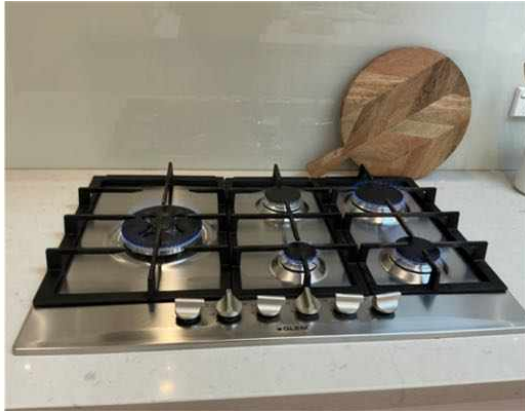
Building: Main Building  
 Location: Kitchen  
 Finding: Building element - Not operating igniter to stove top  
 Information: Non-operational items should be addressed to ensure that the full function of the building structure is available. Where some building elements are not operating as intended, it is possible that secondary building defects could arise due to their non-operation.

Repair and/or replacement of the faulty building element is recommended. It is highly recommended that the relevant tradesperson be engaged to perform any necessary works.

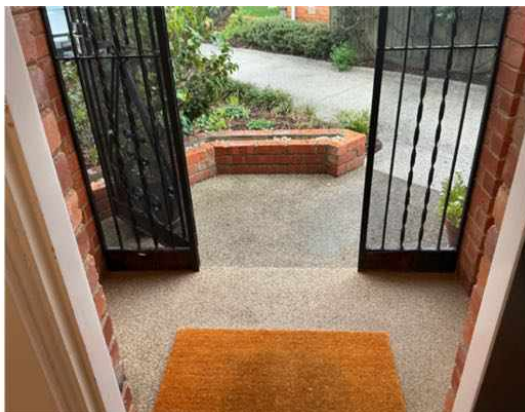
Building:	Main Building
Location:	Entry
Finding:	Building element - Rusted or corroded
Information:	This building element shows evidence of rusting and corrosion, which is likely to have developed as a result of excessive exposure to moisture and or inadequate coatings.

As surface rust provides no protection to the underlying iron, the deteriorating condition is likely to worsen if not addressed in the short-term future.

Where possible, the use of galvanized (treated) metals or aluminium coated metals aid in rust prevention, as does regular general maintenance. Rust formation can be controlled with coatings, such as paint, that isolate the iron from the environment.

Rusting and corrosion should be managed by ideally removing or limiting the affected surface from exposure to moisture. A registered builder may be appointed to replace any building elements that have been severely affected by rust or water damage.

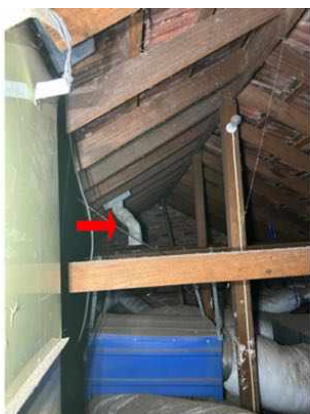
Building:	Main Building
Location:	Roof Void
Finding:	Asbestos - Suspected ACM Identified on Site
Information:	Reporting on Asbestos is outside the Scope of this Report. This suspected defect is highlighted as a caution only. We suspect, based on our experience in the building industry, that there is a higher risk of the identified building element containing asbestos.

As Asbestos Reporting is outside the scope of this report, we advise that you consider a separate Asbestos Inspection and Condition Audit, which can include the taking of samples for definitive confirmation of the presence of Asbestos.

In the interim, the client is advised to act with caution, especially when considering any damage to building materials general wear and tear renovations extensions demolition and general maintenance activities due to the suspected presence of Asbestos.

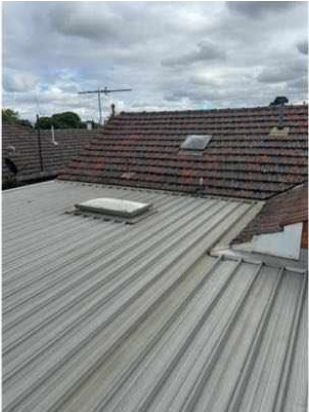
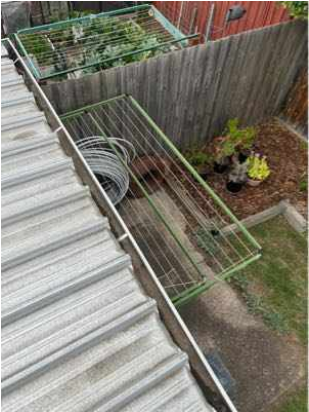
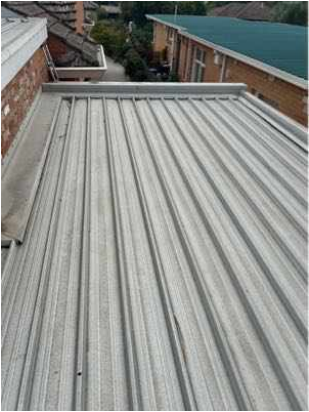
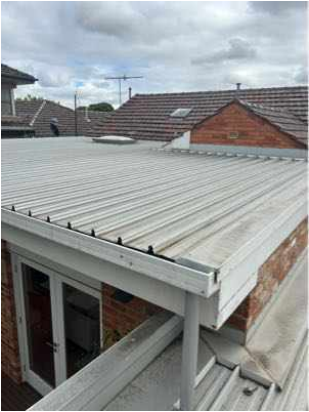
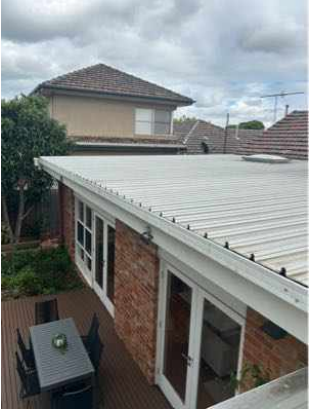
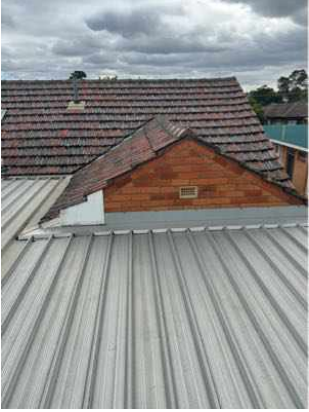
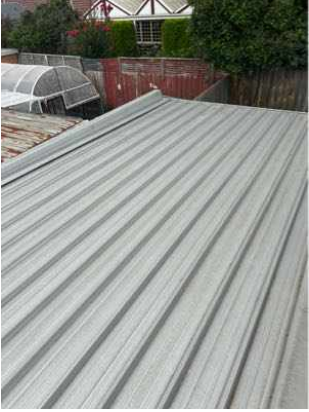
Building:	Main Building
Location:	Roof
Finding:	Additional Photos

Information: Additional photos are provided for your general reference
