Building and Timber Pest Inspection Report

Inspection Date: Wed, 25 Mar 2026

Property Address: 27 Ferndale St, Newtown NSW 2042,
Australia

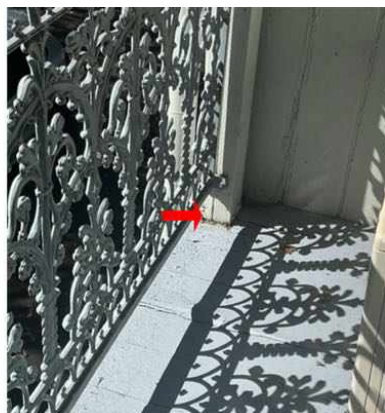
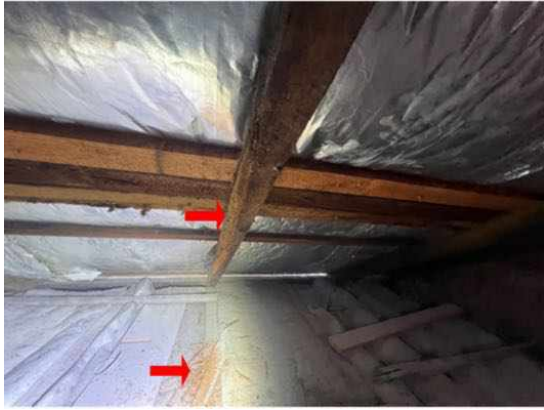
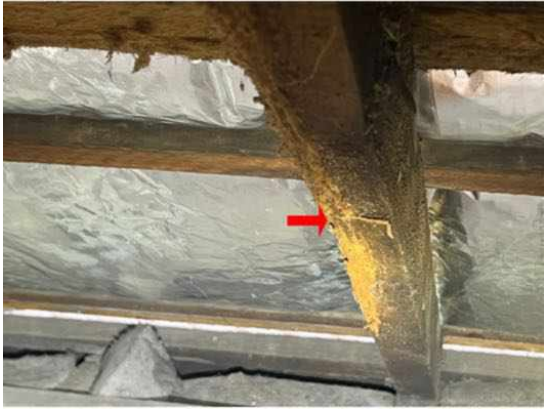
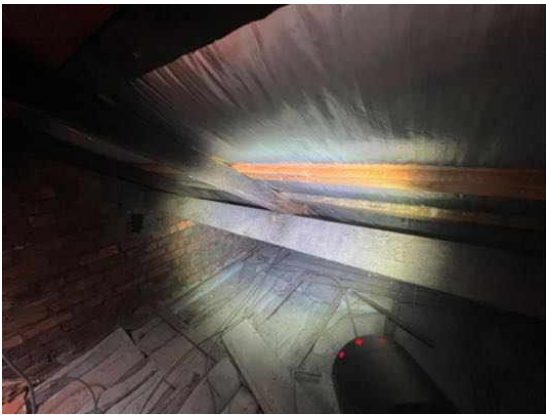
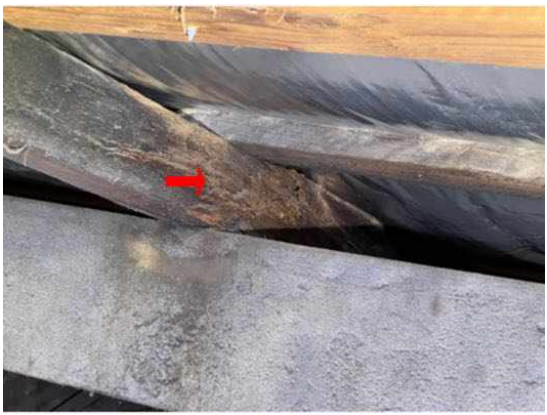
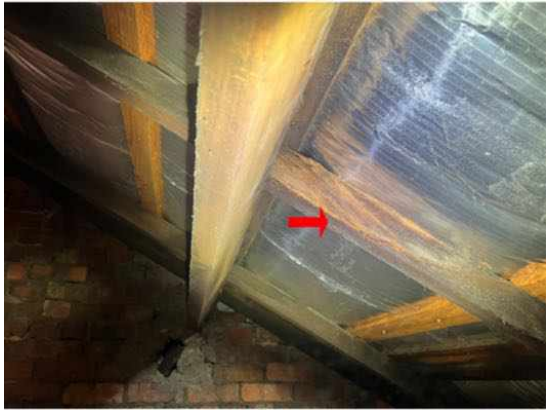
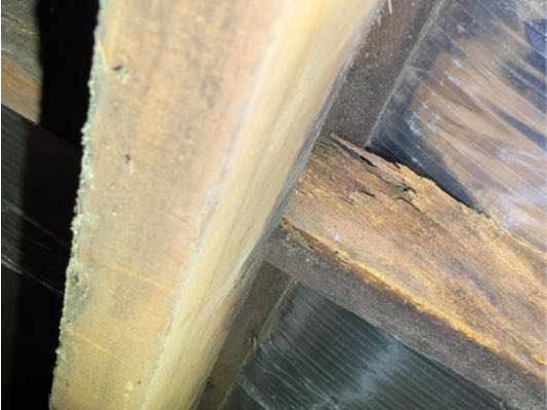
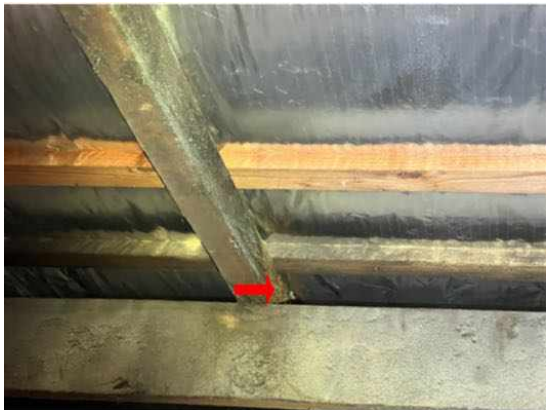
Finding 2.01

Building:	Main Building
Location:	Roof Void
Finding:	Chemical delignification identified to timber elements
Information:	Chemical delignification also known as wood defibration refers to the chemical breakdown of timber building elements. This breakdown of the Lignin deteriorates the wood impacting on the structural integrity and tensile strength of the affected building element.

Chemical delignification is most common near marine environments due to the high levels of salt in the air however this deterioration may also occur in other areas where timber elements are frequently exposed to damaging gases chemicals etc.

charring was observed on roof framing members adjoining the internal brick chimney wall, likely due to historic heat exposure, a further inspection by a licensed roofing carpenter is also recommended.

Where timber building elements have deteriorated repair and / or replacement is required immediately to ensure the safety of the associated structures. The likely cause of the defibration should also be investigated and dealt with accordingly.

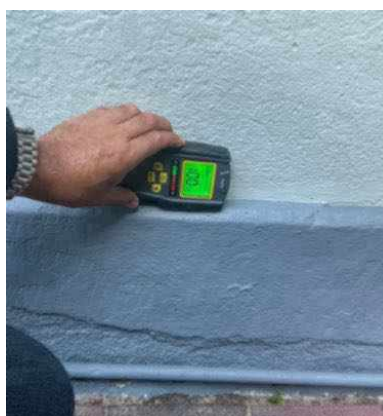
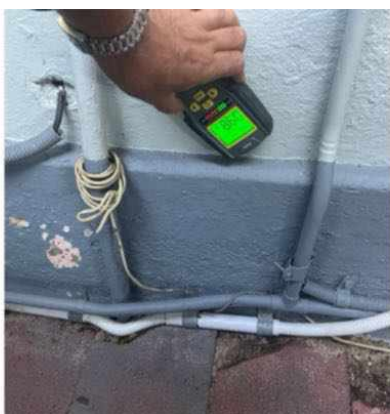
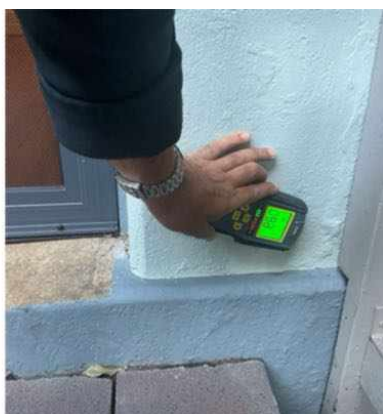
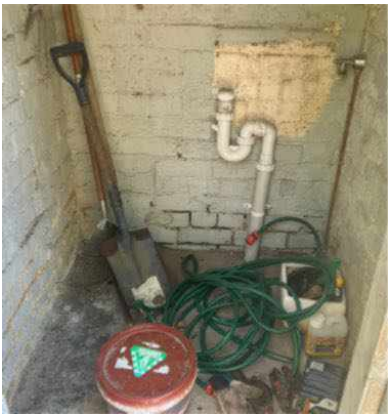
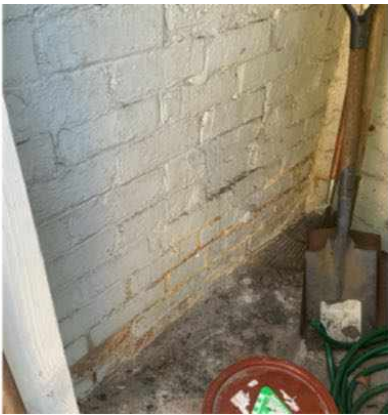
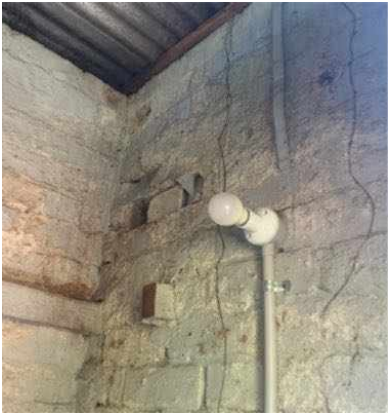
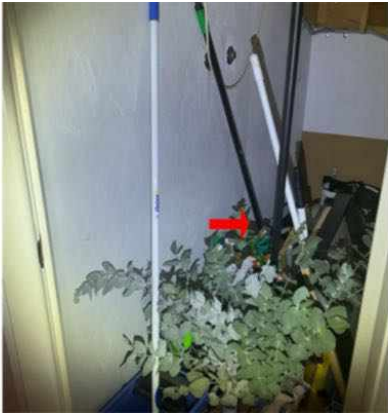
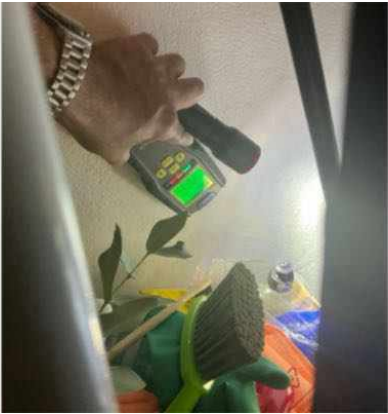
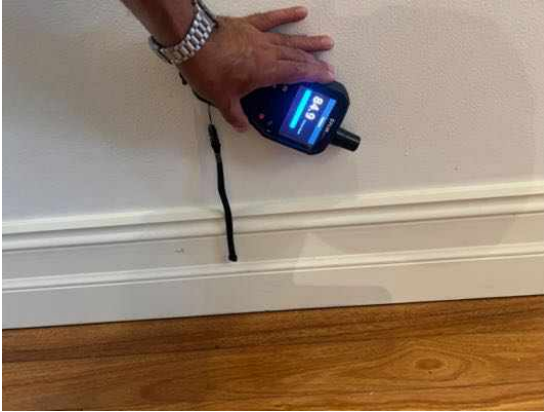
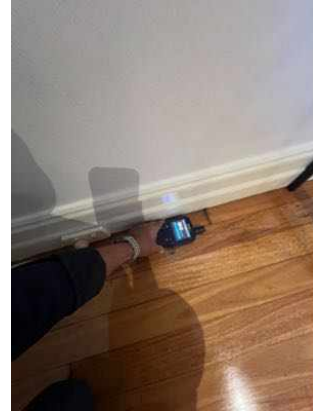
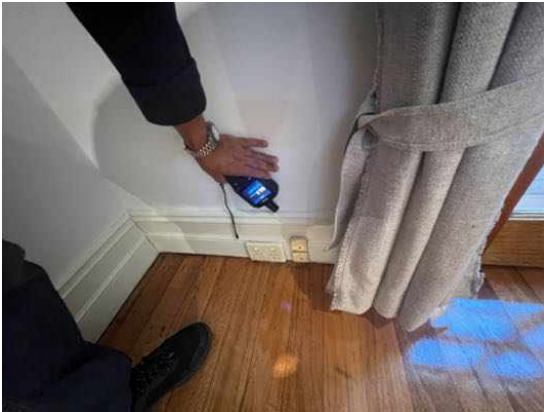
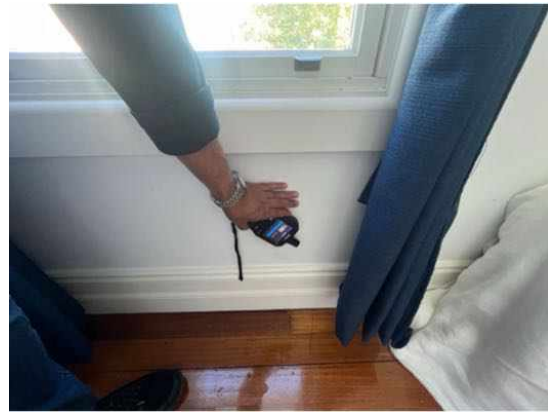
Finding 3.01

The first step in addressing damp is to diagnose the cause. The identified cause should be addressed first prior to repairing the appearance and other defects which have resulted from the rising damp. If the original cause is not resolved, further cases of damp are likely to ensue, resulting in secondary defects.

Consultation with a qualified plumber is advised immediately to identify the cause of damp and perform remedial works as required. Where excessive mould growth is present, further inspection by a specialist environmental health inspector should also be considered.

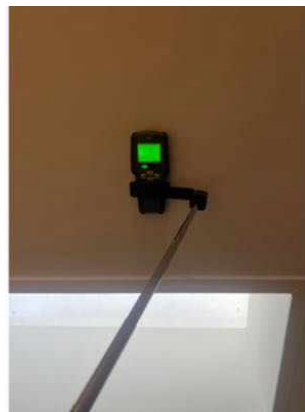
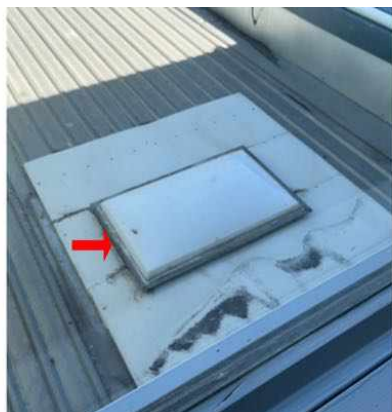
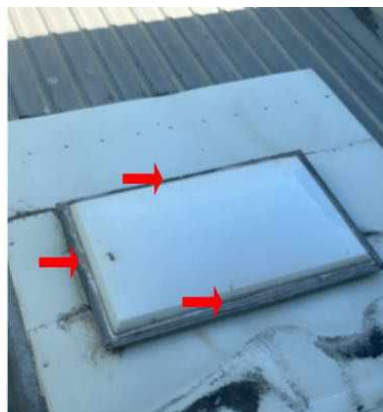
Finding 3.02

Building:	Main Building
Location:	All Internal Areas - Skylight
Finding:	Elevated Moisture – Further Investigation Recommended
Information:	Elevated moisture was recorded around skylight, although no significant structural damage was evident at the time of inspection, dampness can contribute to deterioration if left unaddressed. Skylight also required closer inspection as excessive use of sealant was evident. A further investigation by a licensed plumber or skylight specialist is recommended to confirm the source and ensure no concealed issues are developing.

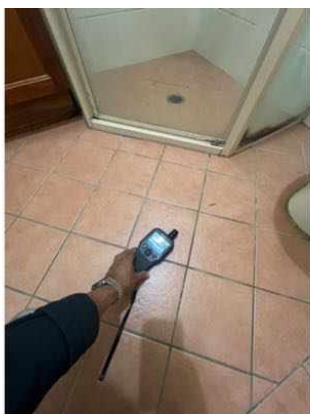
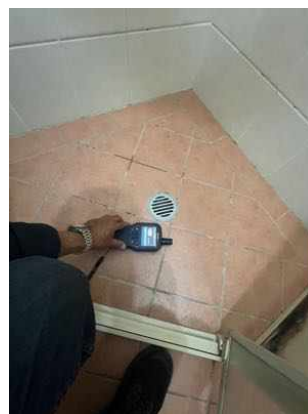
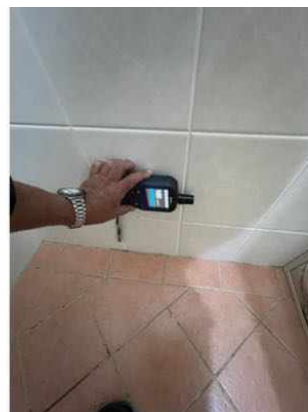
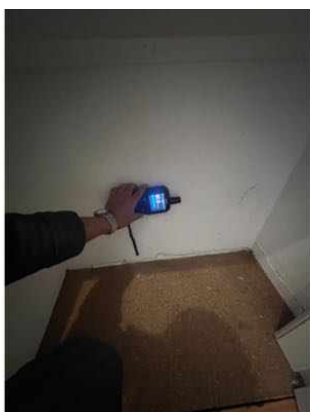
Finding 3.03

Building:	Main Building
Location:	Bathroom
Finding:	Elevated Moisture Bathroom
Information:	Elevated moisture levels were detected to tiled surfaces in bathroom/shower areas. Persistent moisture ingress can lead to concealed damage, including timber rot and mould growth.

A wall adjacent to the bathroom also showed elevated moisture above typical thresholds.

Monitor the area over time for signs of drumming, efflorescence, tile movement, or grout deterioration. Further inspection by a licensed waterproofing is recommended (e.g., pressure testing, membrane assessment).

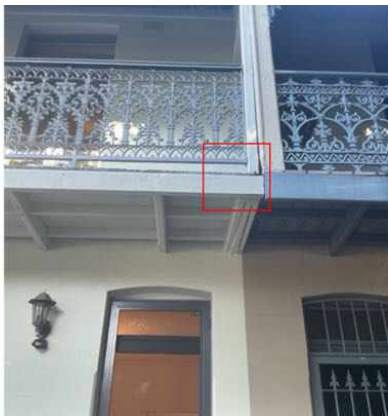
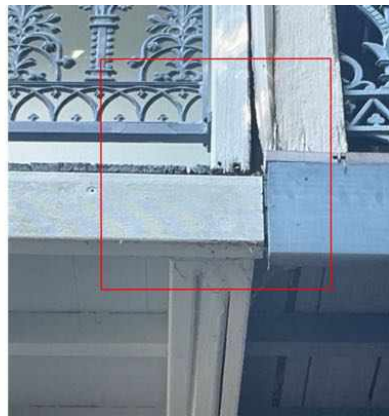
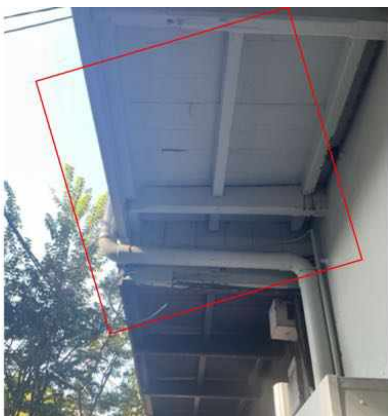
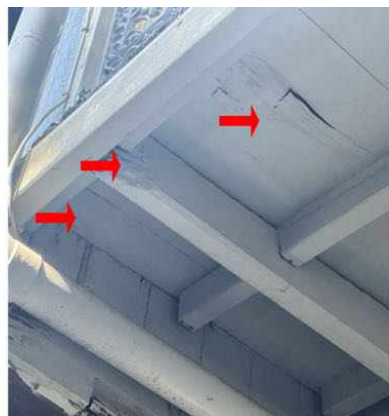
Finding 3.04

Building:	Main Building
Location:	All External Areas
Finding:	Wood rot to some areas
Information:	This building element shows evidence of wood rot. Wood rot, also known as Fungal Decay, occurs when timbers and other cellulose building materials are exposed to damp conditions on an ongoing basis. This could be the result of exposure to weathering over a prolonged period of time, or the attraction of excessive moisture from other abutting building materials. Contributing factors also include poor air ventilation in the area.

Wood rot is often associated with general damp problems and is evidenced by a

A qualified plumber may be appointed to assess the cause of excessive moisture and to provide advice on any remedial works as required. A qualified carpenter or registered builder may also be required to replace affected building materials.

Even though Liverpool termite activity was not visible. A further invasive inspection by a licensed termite technician its also highly recommended to eliminate possibility of potential termite activity.

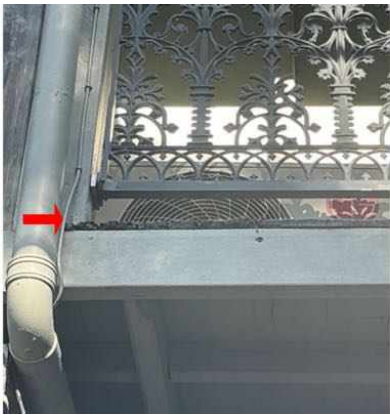
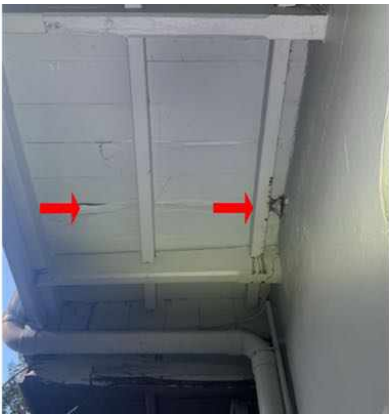
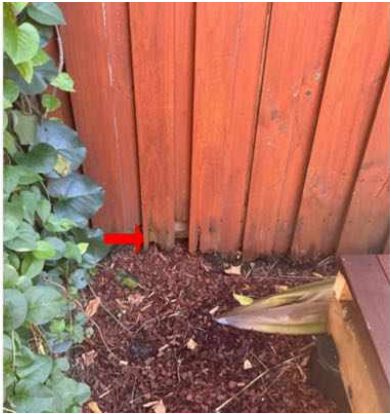
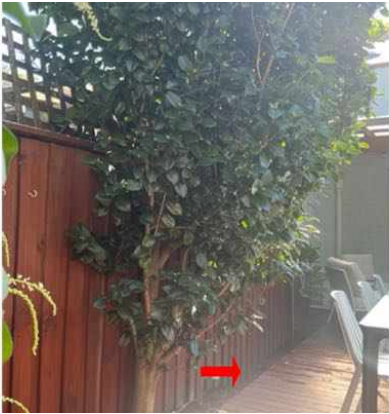
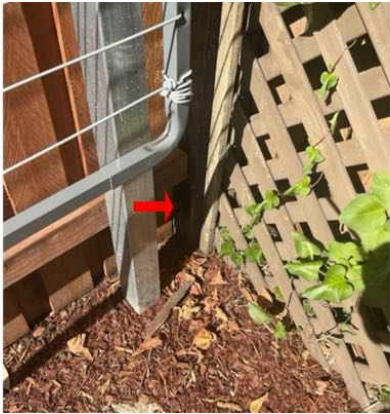
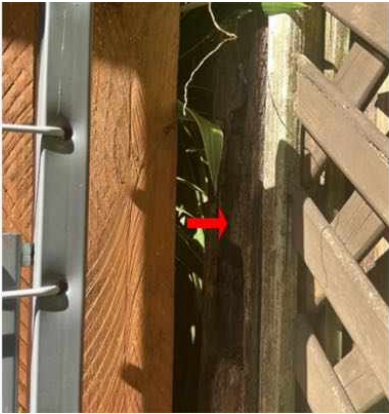
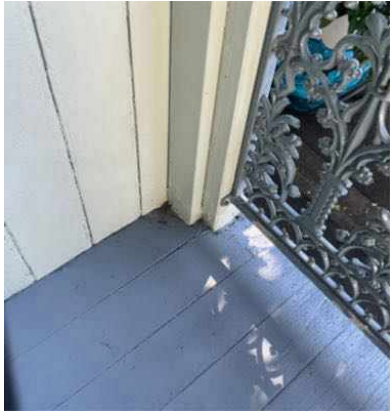
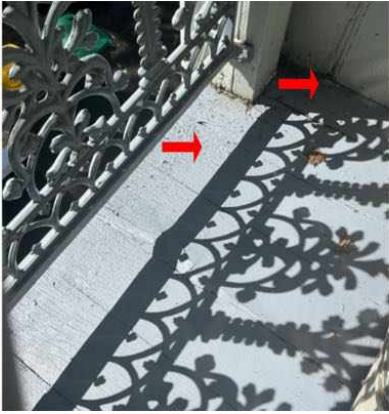
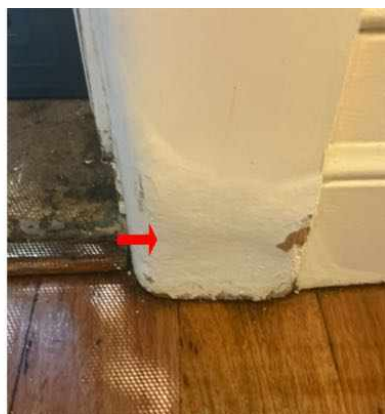
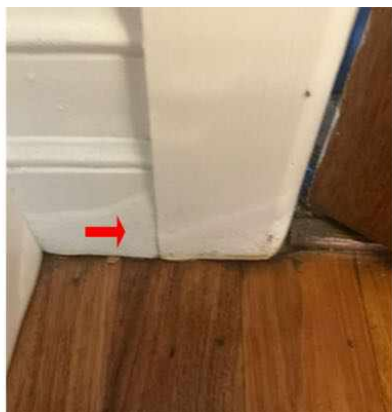
'musty' smell or mould and mildew occurring on surfaces. If left unmanaged, damp conditions can lead to further health problems and the decay of timbers will continue.

Early intervention and regular maintenance, particularly of exterior timbers, will prolong the useful life of these building elements. Prior to any works being performed, the cause of the moisture that has created the visible wood rot should be identified and addressed in a suitable manner. Replacement of affected timbers may then be a necessary step in protecting surrounding building elements from such deterioration.

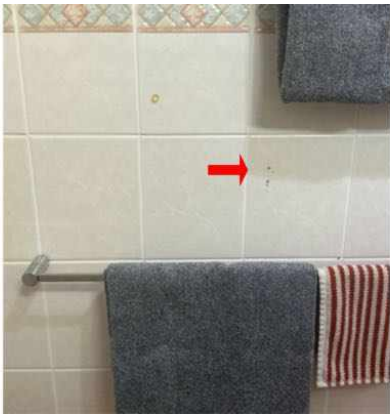
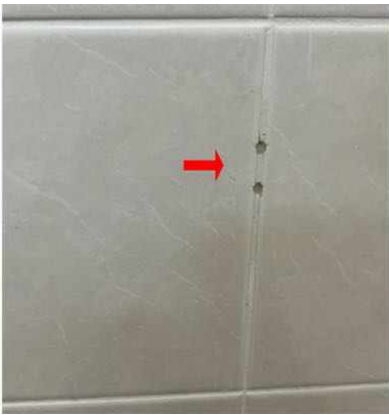
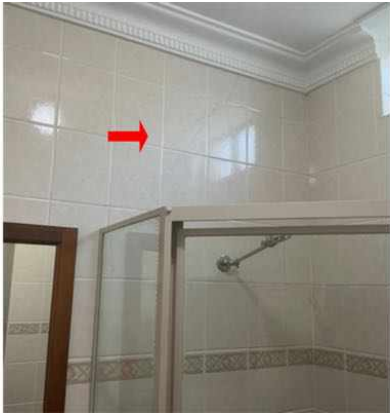
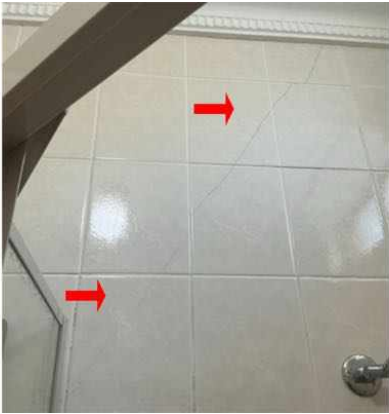
Finding 3.05

Building:	Main Building
Location:	Bathroom
Finding:	Tiles - Cracked or damaged
Information:	Cracking was evident to the tiling in this area at the time of inspection. While the cracking appears to be minor, this area is frequently exposed to water, allowing potential for water penetration into adjoining sections of walls or flooring.

If left unmanaged, water penetration to these areas may lead to subsequent water damage, which is likely necessitate repair work to affected building elements.

A tiling contractor should be appointed to ensure that no further water damage occurs. The re-application of silicone and grouting throughout remaining tile work is also advised, to further protect the area against water penetration.

Where water penetration has led to water damage, appointment of a relevant tradesperson may be required to repair damaged building elements.

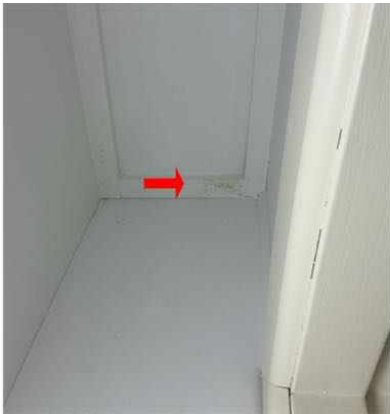
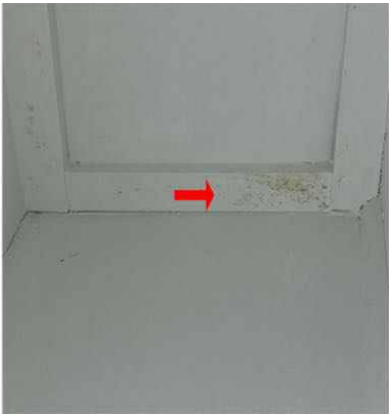
Finding 3.06

Building: Main Building
Location: All Internal Areas - Hallway cupboard
Finding: Moisture staining and mould
Information: Moisture staining and mould are visible indicating humid conditions or moisture ingress. Further assessment by a licensed plumber is recommended to identify the cause.

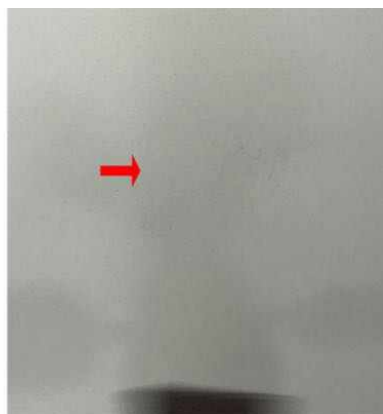
Finding 3.07

Location: Bedroom - Front
 Finding: Water staining
 Information: Water staining was evident in this area at the time of inspection. Water staining indicates that surfaces have been exposed to excessive moisture over time. The minerals and other elements in the water lead to staining, which may graduate to corrosion and deterioration if left unmanaged.

While mostly an appearance defect, water staining can be indicative of more serious defects, which may be currently concealed by other building elements.

Where water staining is active, a licensed plumber must be consulted to identify the cause of the staining and to provide advice on any reparation works that may be required. Replacement of any broken or damaged structures is advised.

Conversely, where water staining is old and inactive, affected building materials may be repaired or replaced at client discretion. A qualified carpenter or registered builder may be appointed to perform these works.

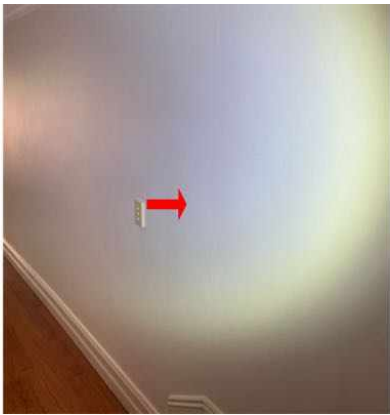
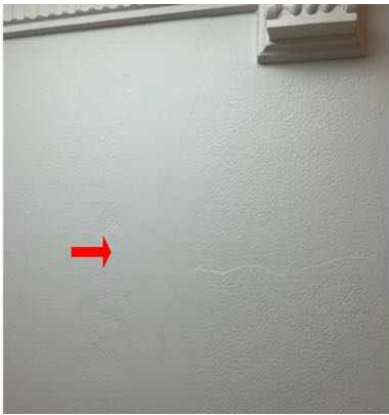
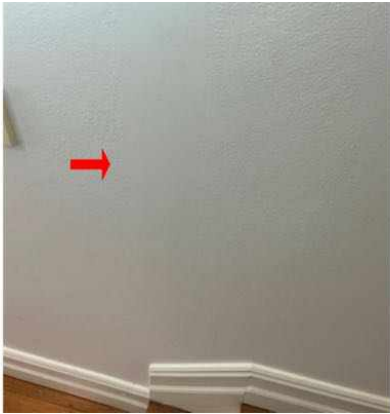
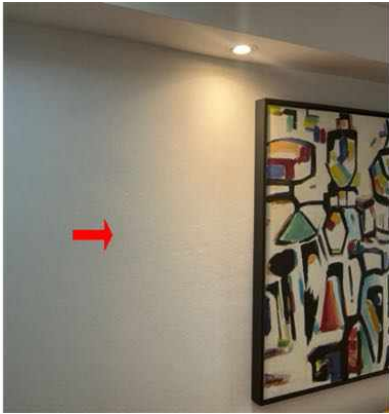
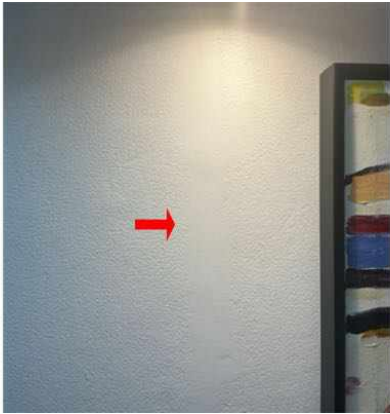
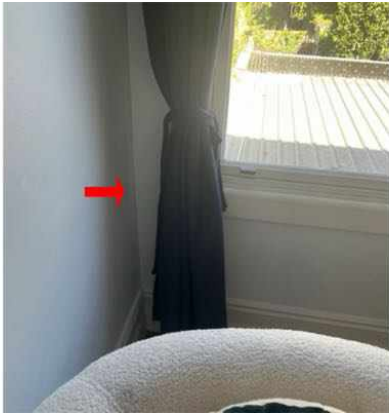
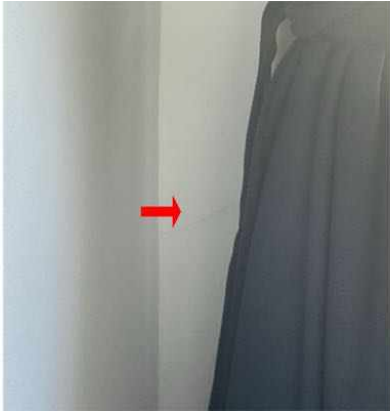
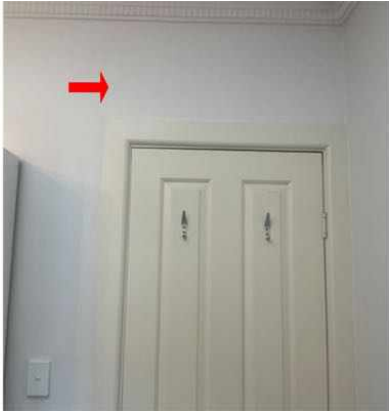
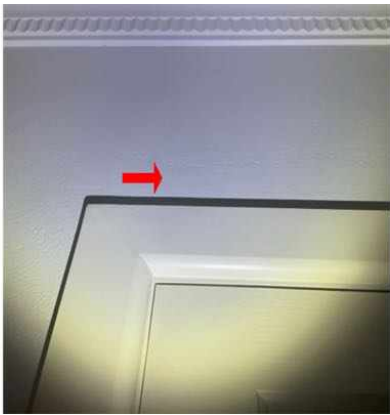
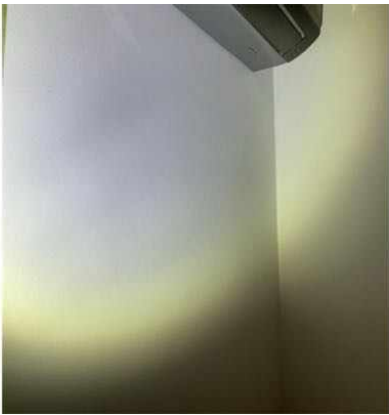
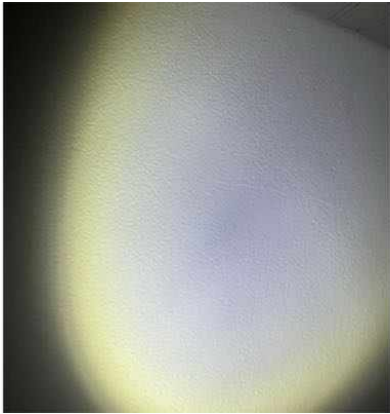
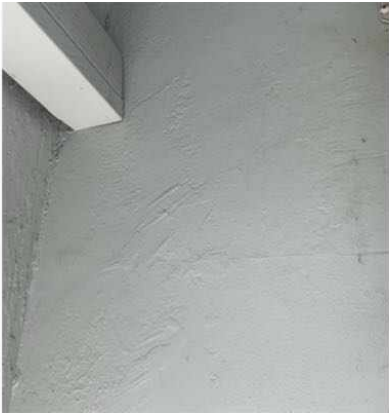
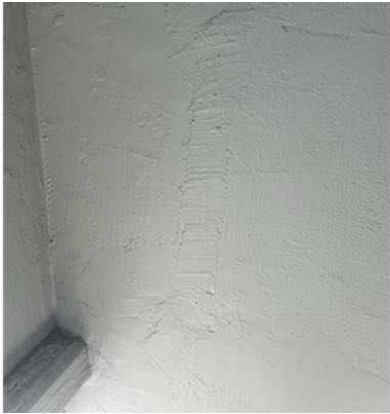
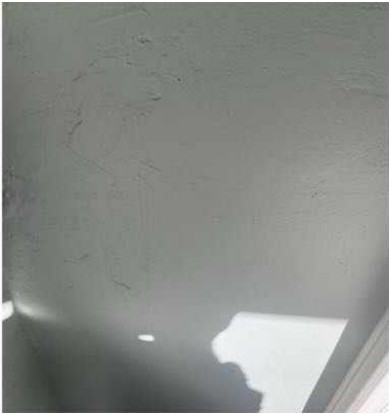
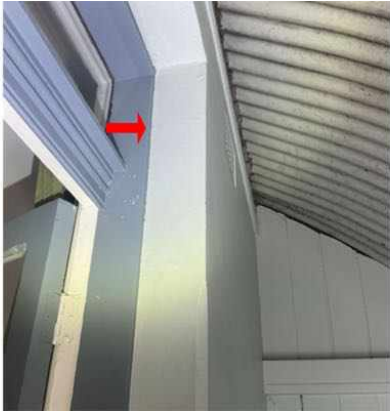
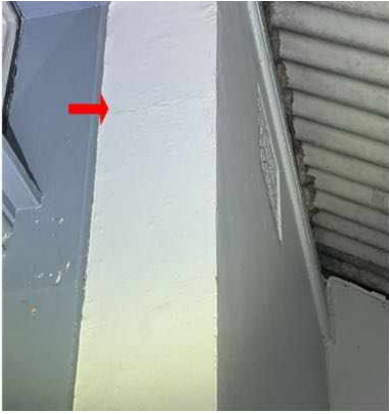
Finding 3.08

Building: Main Building
 Location: All Internal Areas
 Finding: Cracks to internal render & Past Repairs
 Information: It has been observed that cracking to internal rendered surfaces has occurred. The extent of cracking cannot be determined during a visual inspection.

Buyers should check with the owners upon extent and scope of repairs or request documentation if any.

Always contact your building inspector should cracks widen, lengthen, or become more numerous.

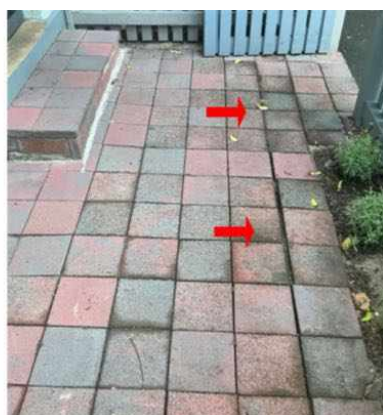
Finding 3.09

Building:	Main Building
Location:	All External Areas
Finding:	Paving - Uneven
Information:	Sections of the external paved area are uneven, creating a potential trip hazard. It appears as though the area has been subject to rough installation, or that paving sections have lifted due to movements in the foundation of the property.

Where paving creates a trip hazard, personal injury may ensue if due caution is not taken by all persons within this area.

Re-paving of the area is required as soon as possible to remedy this situation. Further consultation with a specialist concreter is advised.

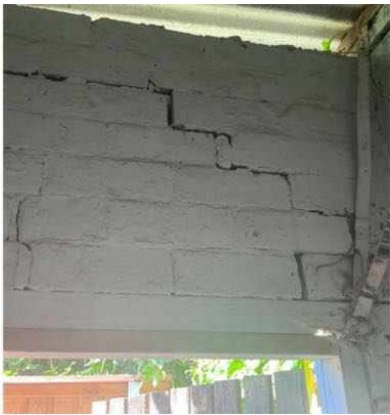
Finding 3.10

Building:	Main Building
Location:	All External Areas - Rear shed
Finding:	Brickwork - Step cracking
Information:	Step cracking was identified to the brickwork in this area at the time of inspection. Step cracking, which is similar to other forms of cracking, has a variety of possible causes. However, the most common is the subsidence of adjacent footings.

Step cracking is a relatively common defect, and is most likely to occur adjacent to windows, doors and other openings. Mortar failure in the gaps between affected bricks indicates the stresses and tensions affecting the wall.

Where step cracking is extensive or severe, the client is advised to consult a structural engineer. Minor step cracking can be used as a warning sign to address factors causing stress to the wall, which can include the effect of surrounding trees, water leaks, soil erosion, or even the presence of reactive soils in the surrounding area.

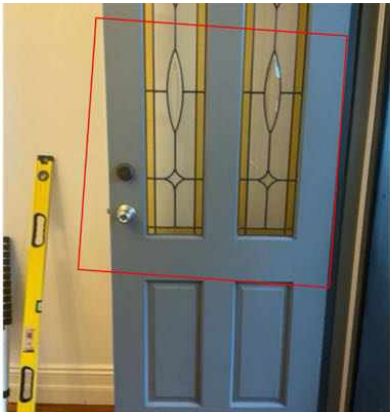
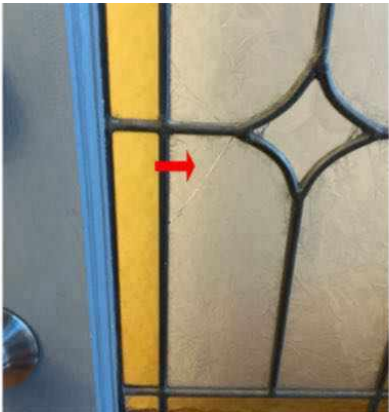
Finding 3.11

Building: Main Building
Location: All External Areas - Front door
Finding: Building element - Damaged - Glass cracked , rear shed damage
Information: Breakage occurs generally when the building materials have either aged and decayed, or as a result of damage (accidental or deliberate).

Repair and/or replacement of broken elements is advised to ensure that additional secondary defects do not arise as a consequence. Such works are necessary, as all building elements play a key role in the operation and function of the overall structure and its performance.

A relevant tradesperson should be appointed to repair or replace the affected building element prior to any subsequent damage being caused.

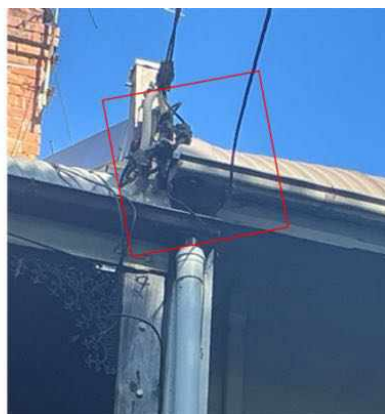
Finding 3.13

Finding: Water staining

Information: Water staining was evident in this area at the time of inspection. Water staining indicates that surfaces have been exposed to excessive moisture over time. The minerals and other elements in the water lead to staining, which may graduate to corrosion and deterioration if left unmanaged.

While mostly an appearance defect, water staining can be indicative of more serious defects, which may be currently concealed by other building elements.

Where water staining is active, a licensed plumber must be consulted to identify the cause of the staining and to provide advice on any reparation works that may be required. Replacement of any broken or damaged structures is advised.

Conversely, where water staining is old and inactive, affected building materials may be repaired or replaced at client discretion. A qualified carpenter or registered builder may be appointed to perform these works.

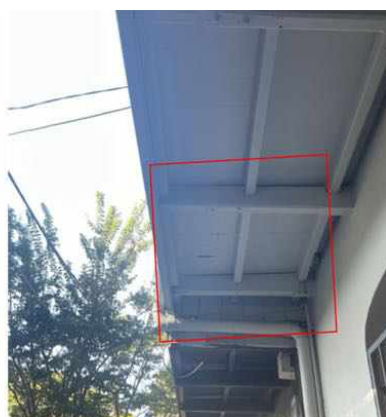
Finding 3.14

Location:	All External Areas
Finding:	External Timber Balcony or Deck - Structural Stability (Wood rot also present at the time of inspection)
Information:	The load capacity of the external balcony or deck could not be verified during the inspection.

External timber structures are also constantly exposed to weather elements and can deteriorate in an accelerated manner, ongoing assessments are required.

It is highly recommended that a Structural Engineer further assess the external timber balcony or deck to inform the client of its load capacity. Regular maintenance inspections by competent practitioners is needed.

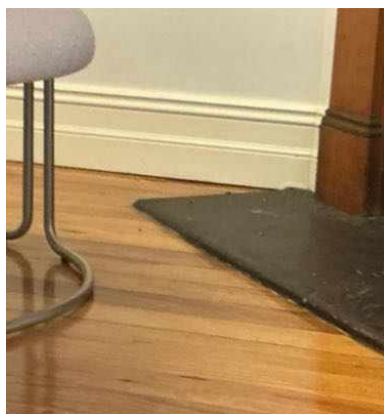
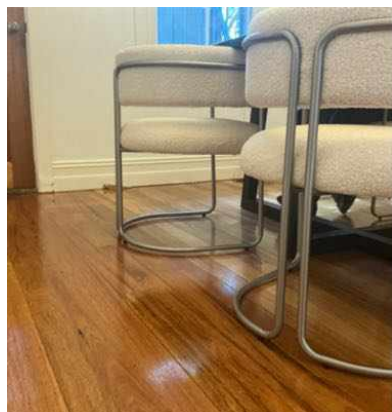
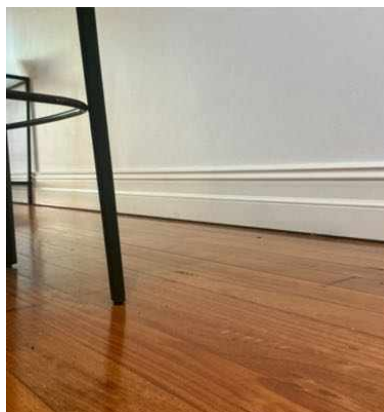
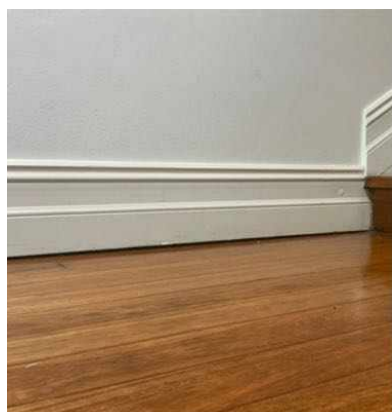
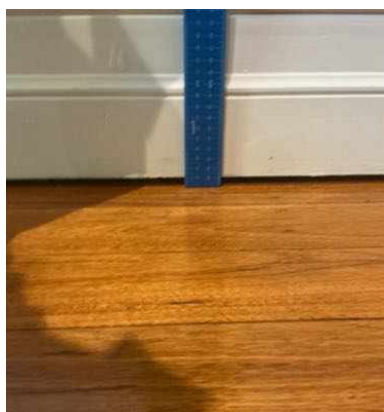
Finding 3.15

Building:	Main Building
Location:	All Internal Areas
Finding:	Gap between skirting and Floor
Information:	gap is visible between the skirting board and timber floor finish, indicating minor floor level variation or movement of the floating floor system. This condition is most consistent with minor slab/floor unevenness, floor finish movement or shrinkage. While primarily cosmetic/serviceability in nature, monitoring is recommended and further assessment may be warranted by a licensed builder if additional signs of structural movement become apparent.

Subfloor could not be inspection due to access limitations

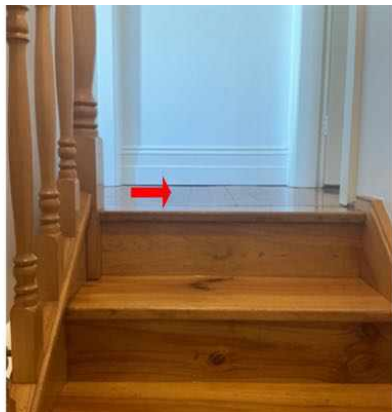
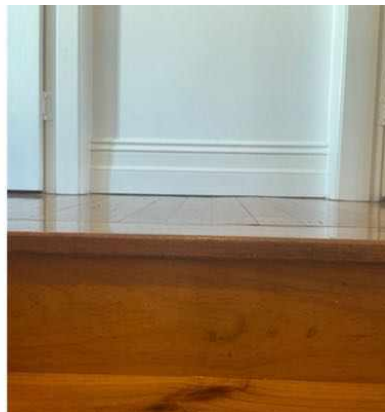
Finding 3.16

Building:	Main Building
Location:	All Internal Areas
Finding:	Flooring - Uneven to some areas
Information:	The internal flooring in this area is out of level and uneven. Uneven flooring is likely to indicate minor defects such as expected movement of the foundations of the property, but may also indicate subsidence of the associated subfloor stumps.

It is advised that the flooring be closely monitored to identify any further movement. Where flooring remains relatively unchanged for an extended period of time (i.e. several months), it is likely that this defect has been caused by expected movement of the foundations of the property.

However, where flooring is uneven further, potentially invasive inspection of the subfloor structures and stumps in this area is required. In this case, works to repair are likely to be required, and would be carried out by a registered builder specialising in re-stumping.

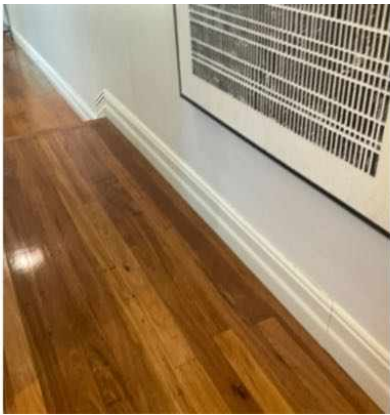
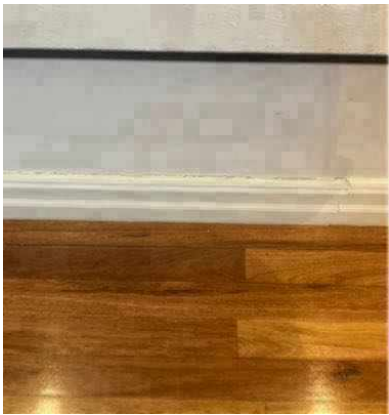
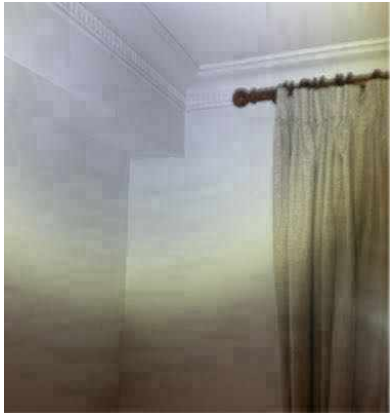
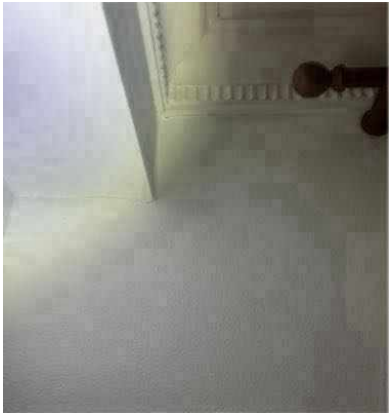
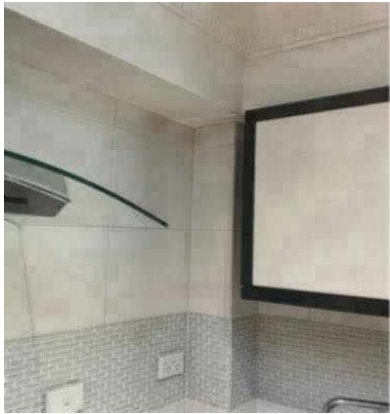
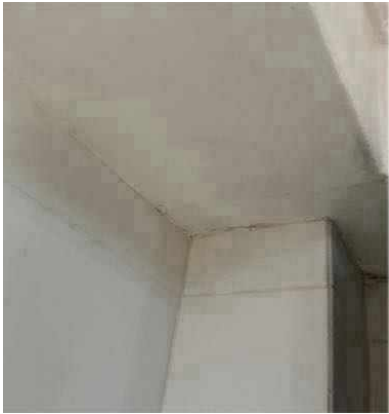
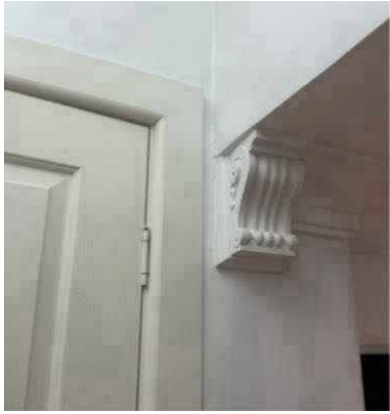
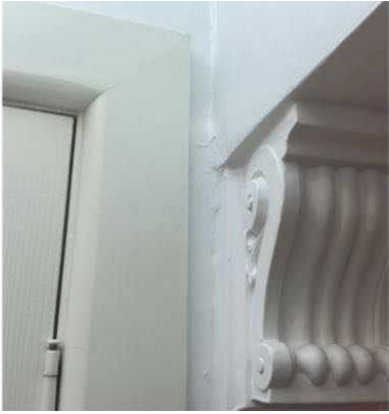
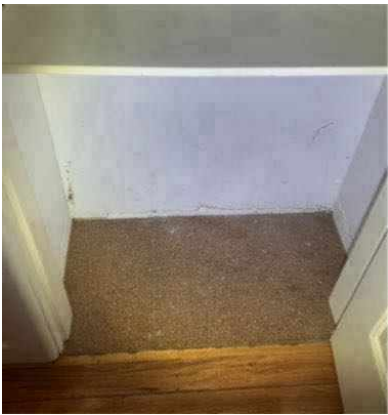
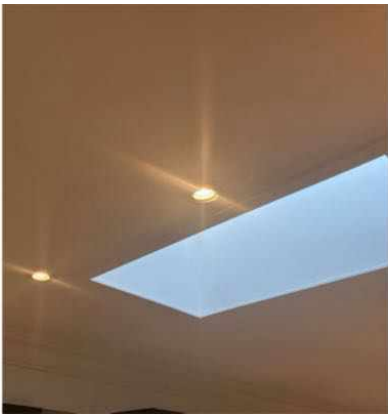
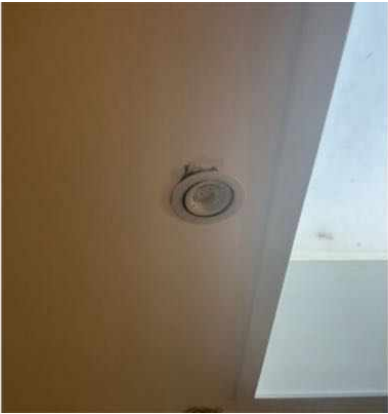
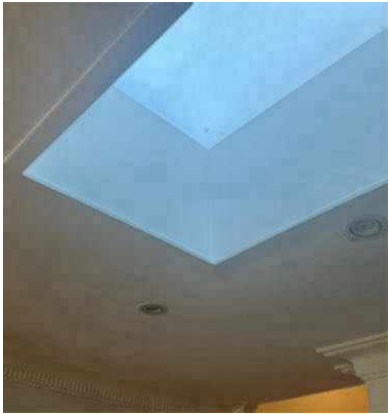
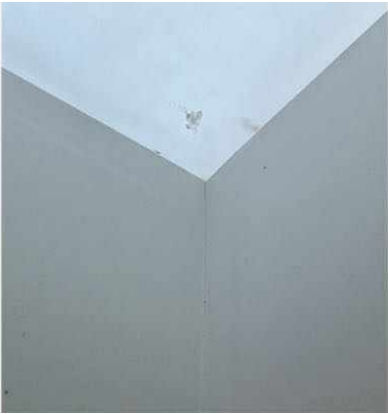
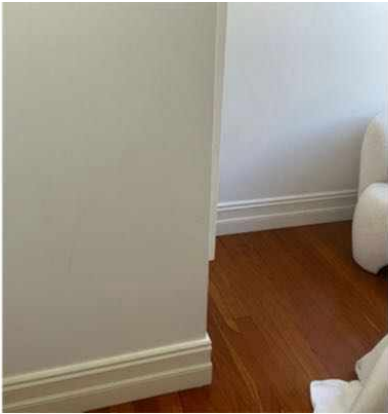
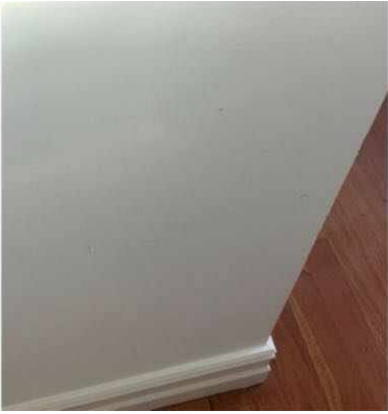
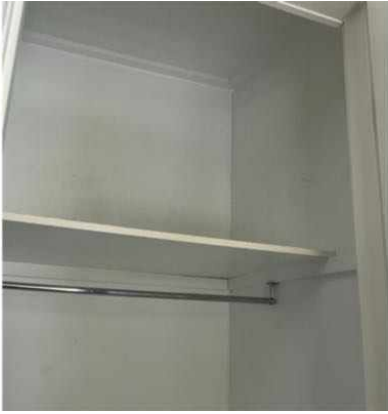
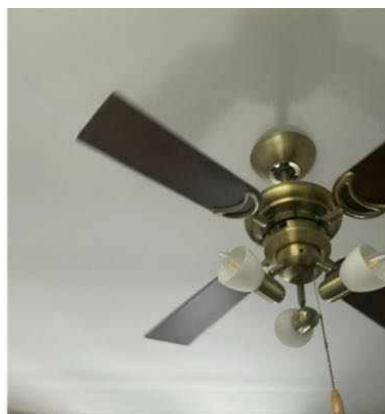
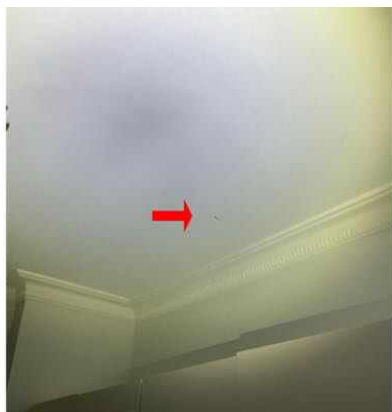
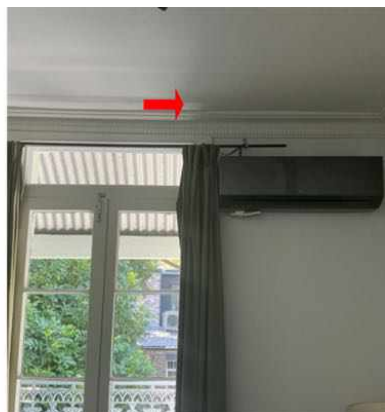
Finding 3.17

Building:	Main Building
Location:	All Internal Areas
Finding:	Paint Finish & Hairline Cracking - To some areas
Information:	The paint finish in this area was identified as being incomplete at the time of inspection including some hairline minor cracking.

Whilst incomplete or missing paint and minor cracking and imperfections in finish is generally an appearance defect, it can also lead to the development of secondary building defects over time. Incomplete areas of paint finish expose the area to moisture, potentially accelerating the deterioration of underlying building materials.

Incomplete paint finishes should be sanded back, filled, leveled and painted, as applicable. Where inadequate or missing paint protection has led to the deterioration of the associated building element, repair and/or replacement of this building element may be required.

A painting contractor should be appointed as soon as possible to perform necessary works to aid the appearance of the affected area and to ensure the area is protected against further deterioration. Alternatively, the homeowner following manufacturer instructions may perform these works.

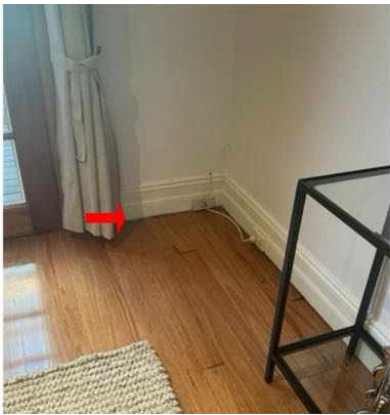
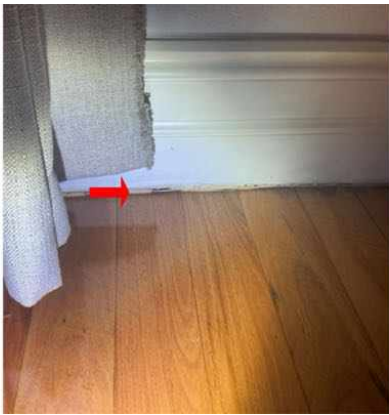
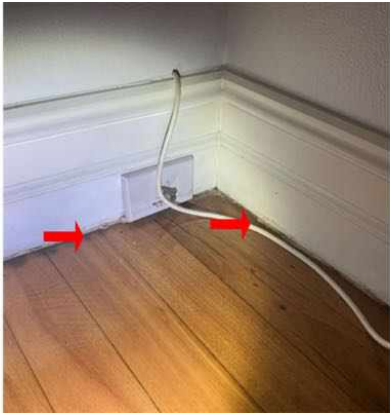
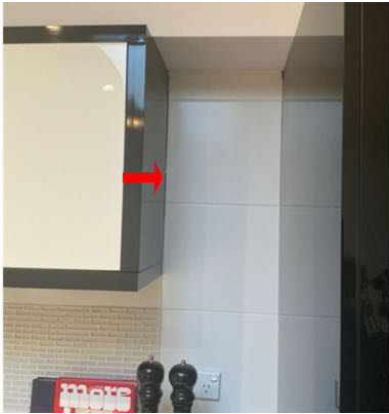
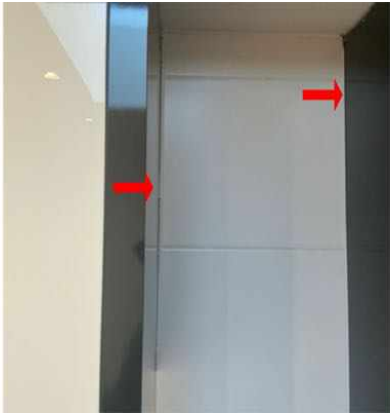
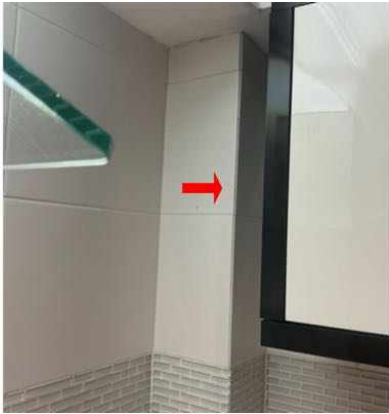
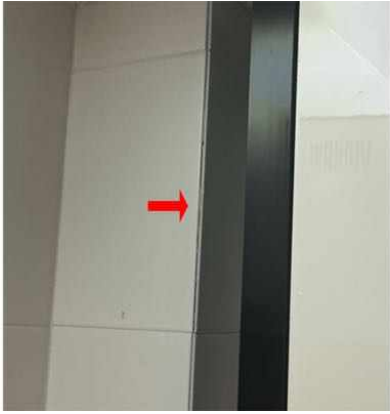
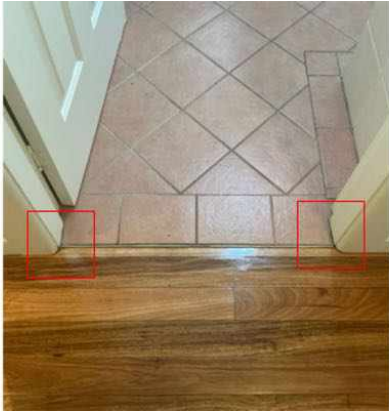
Finding 3.18

Building:	Main Building
Location:	All Internal Areas
Finding:	Sealant and grouting - Missing or degraded to some areas
Information:	It was noted on inspection that sealant or grout is degraded.

Different materials and floor areas move at different rates, generally causing cracking to grout or sealant at this point. A flexible sealant is required to allow for expected expansion and contraction, while keeping the joint water tight and protective of all associated building materials.

Excessive mould to the sealant and grout may require scraping out and replacement.

Flexible and mould resistant materials should be applied to affected areas to prevent any subsequent water damage that is likely to occur. Regular maintenance and replacement of damage or missing or damaged sealant and grout is highly recommended to the wet areas, as this is a regular wear and tear defect. Sealant and grouting in areas that come into regular contact with water should be maintained for the long term care of your property.

A sealant specialist or tiling contractor should be appointed to complete these works as soon as possible
