Building and Timber Pest Inspection Report

Inspection Date: Wed, 25 Mar 2026

Property Address: 27 Ferndale St, Newtown NSW 2042,
Australia

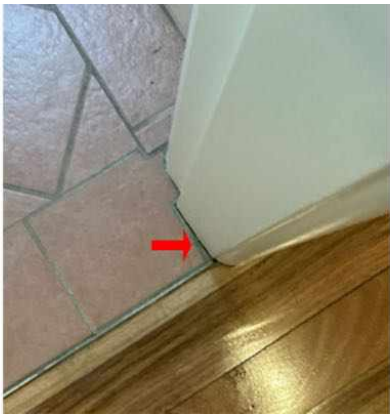
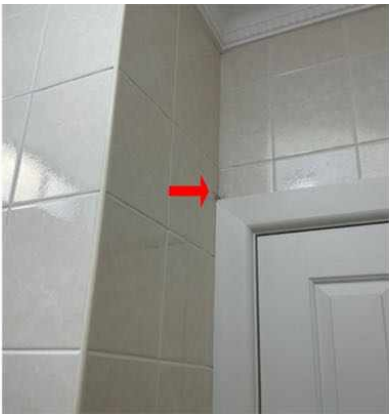
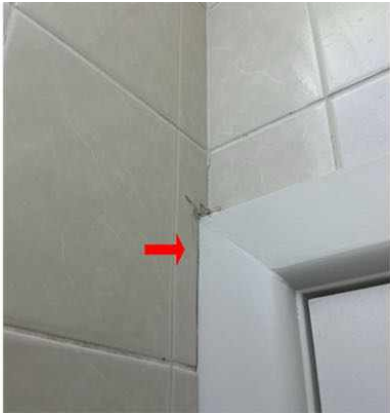
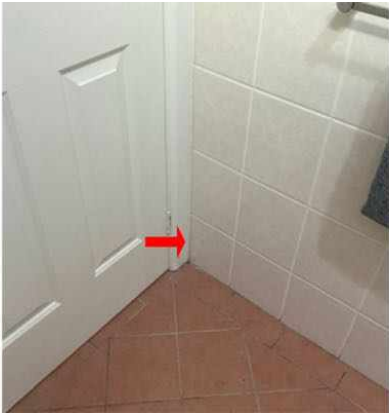
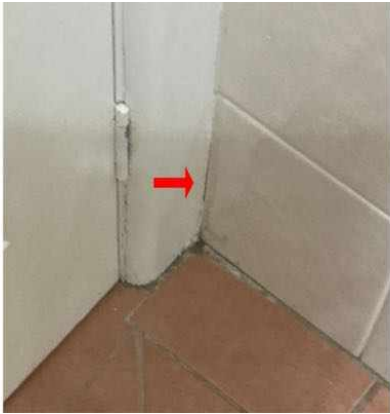
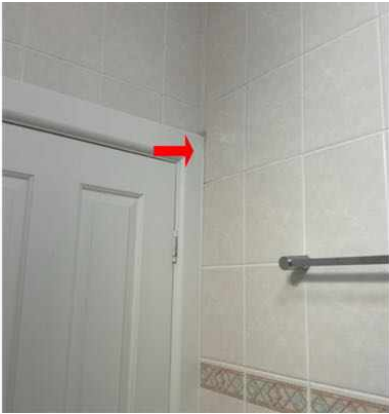
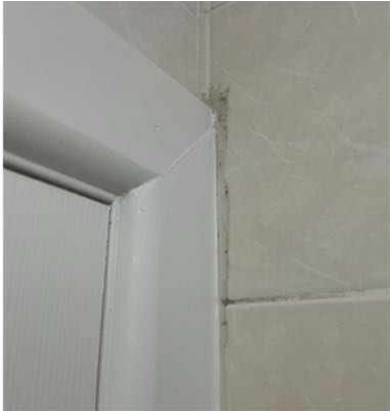
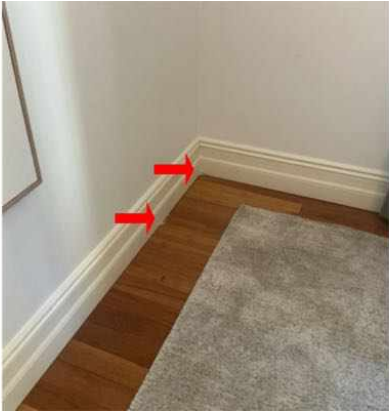
Building:	Main Building
Location:	All Internal Areas
Finding:	Sealant and grouting - Missing or degraded to some areas
Information:	It was noted on inspection that sealant or grout is degraded.

Different materials and floor areas move at different rates, generally causing cracking to grout or sealant at this point. A flexible sealant is required to allow for expected expansion and contraction, while keeping the joint water tight and protective of all associated building materials.

Excessive mould to the sealant and grout may require scraping out and replacement.

Flexible and mould resistant materials should be applied to affected areas to prevent any subsequent water damage that is likely to occur. Regular maintenance and replacement of damage or missing or damaged sealant and grout is highly recommended to the wet areas, as this is a regular wear and tear defect. Sealant and grouting in areas that come into regular contact with water should be maintained for the long term care of your property.

A sealant specialist or tiling contractor should be appointed to complete these works as soon as possible

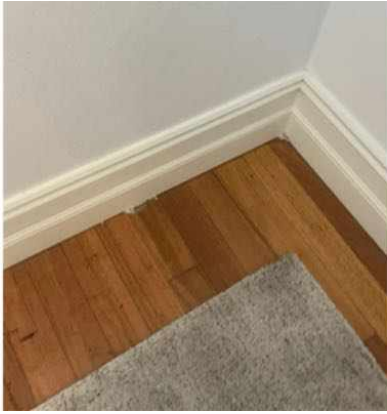
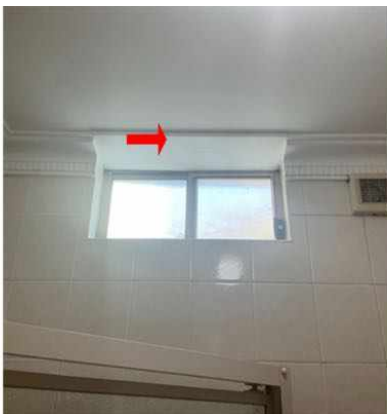
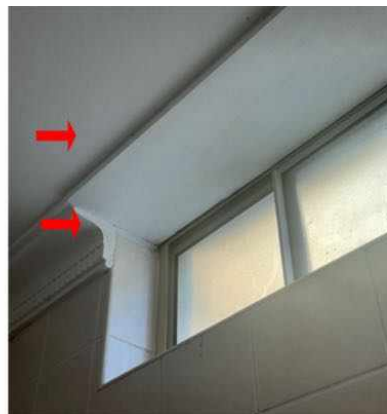
Finding 3.19

Finding: Water Staining - Humidity or Ventilation

Information: The ceiling surface shows faint darkened spotting or shadowing, commonly consistent with surface mould or humidity-related staining, often found in bathroom or wet area ceilings with insufficient ventilation. While there is no visible sagging or major water damage, the pattern suggests prolonged moisture exposure, possibly due to steam accumulation or minor condensation issues. According to AS 4349.1–2007 (Appendix C), this would be classified as a minor defect unless further deterioration or active leaks are found. Recommend improving mechanical or natural ventilation, cleaning the surface with mould treatment, and monitoring for recurrence.

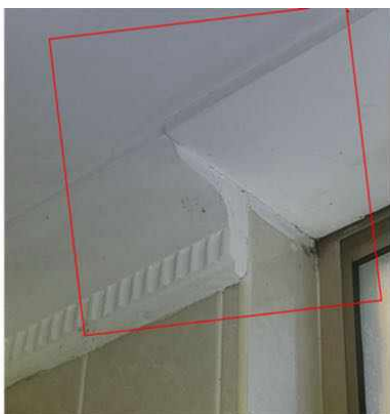
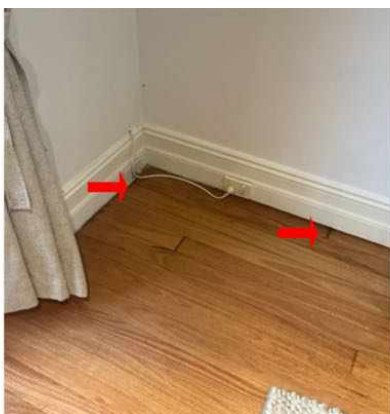
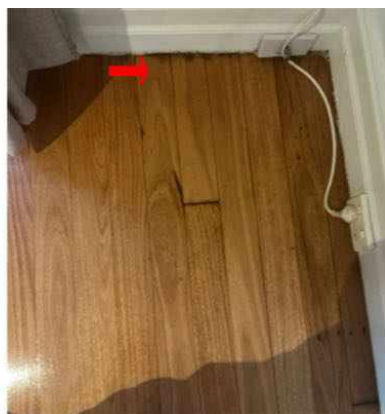
Finding 3.20

Building:	Main Building
Location:	All Internal Areas
Finding:	Water staining to timber floorboards
Information:	Water staining was evident in this area at the time of inspection. Water staining indicates that surfaces have been exposed to excessive moisture over time. The minerals and other elements in the water lead to staining, which may graduate to corrosion and deterioration if left unmanaged.

While mostly an appearance defect, water staining can be indicative of more serious defects, which may be currently concealed by other building elements.

Where water staining is active, a licensed plumber must be consulted to identify the cause of the staining and to provide advice on any reparation works that may be required. Replacement of any broken or damaged structures is advised.

Conversely, where water staining is old and inactive, affected building materials may be repaired or replaced at client discretion. A qualified carpenter or registered builder may be appointed to perform these works.

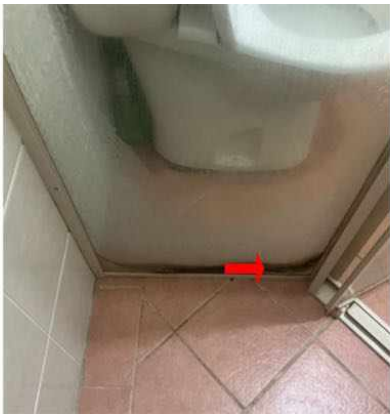
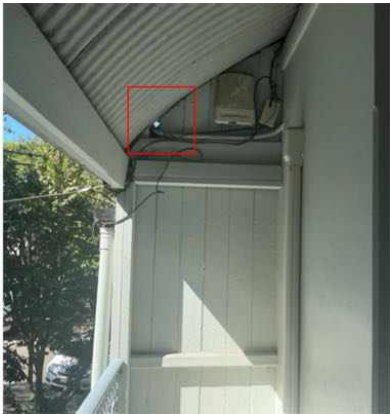
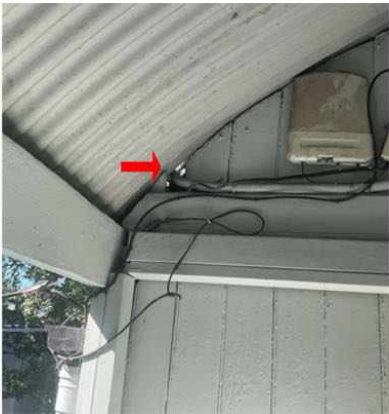
Finding 3.22

Building: Main Building
Location: Balcony
Finding: Installation - substandard or incomplete - Hole not sealed moisture ingress possible
Information: The installation of this building element appears to have been completed to a substandard level of workmanship or is incomplete. Generally substandard repairs or installation are related to poor workmanship, the use of inappropriate materials, or a failure to complete installation to a suitable standard.

Where installation is substandard and/or incomplete, the client should contact the responsible trade to undertake rectification. Unfinished and substandard building works are likely to degrade more quickly and may create potential for secondary defects to associated building elements.

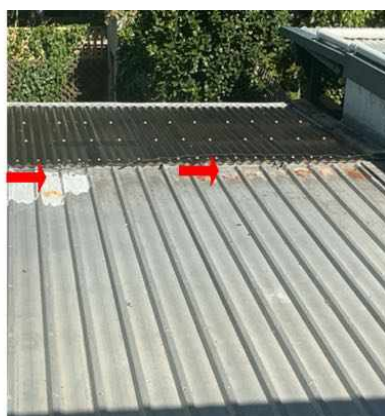
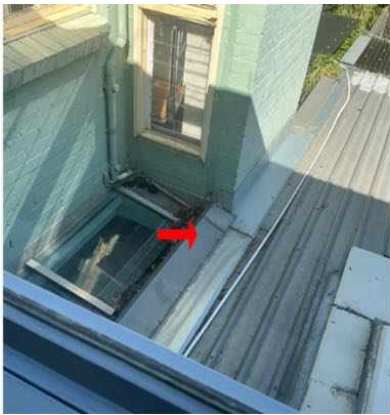
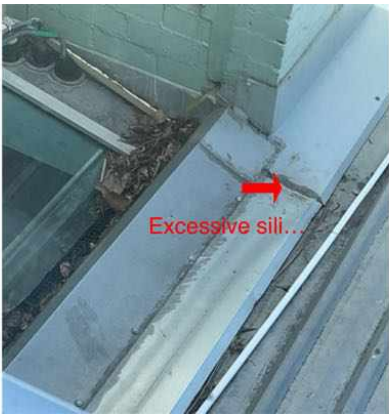
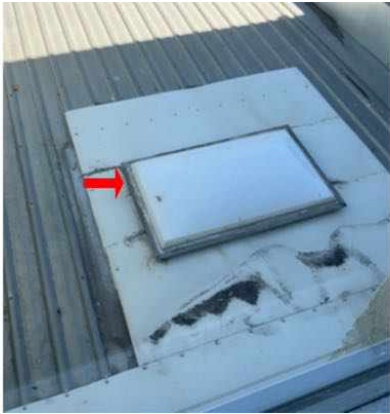
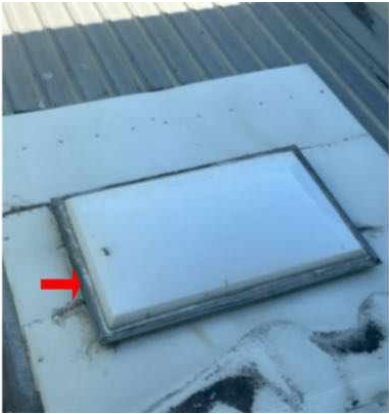
Finding 3.26

Building:	Main Building
Location:	Roof Exterior
Finding:	Flashing defective -poor installation
Information:	The metal flashing at the wall junction appears inadequately installed, with visible gaps and lifting and reliance on surface sealant rather than a properly chased and continuous detail. The junction does not appear fully weather-tight, increasing the risk of moisture ingress into the wall cavity or roof structure over time. Defective flashing installation can lead to concealed deterioration if not addressed. Recommend assessment and rectification by a qualified roofing contractor to ensure compliant and effective weatherproofing.

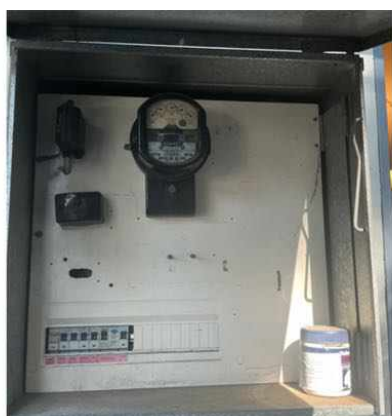
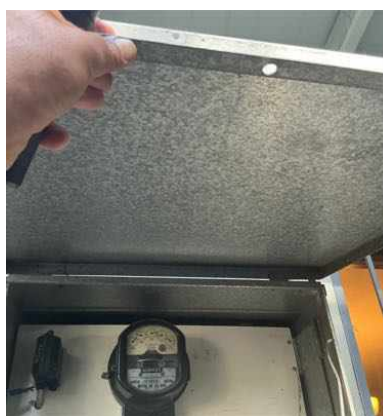
A durable notice should be placed in the switchboard unit to indicate current termite barriers. At the time of inspection, it appeared as though no termite management system has been installed, with no evidence to suggest preventative works taking place.

The client may consider gaining further advice from a pest controller as to the costs and procedures involved with this application. It is recommended that obtaining such advice be a short-term priority.

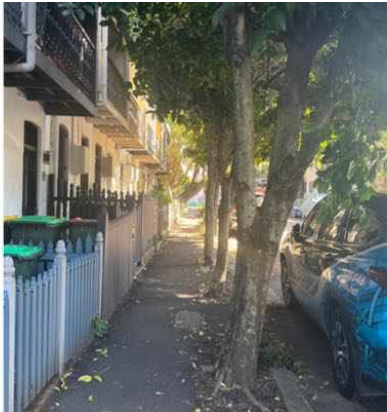
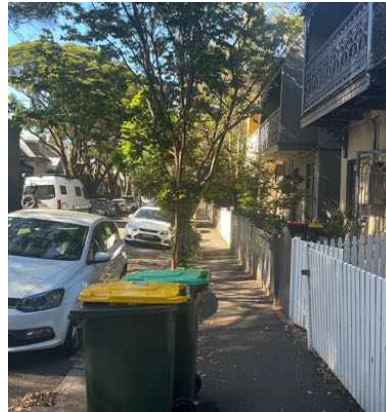
Finding 6.02

Building: Main Building
 Location: All External Areas
 Finding: Trees within 50m

Information: Trees within 50m of the property can be conducive to termite activity. It is recommended an invasive inspection of all trees with 50m to the property be carried out by a qualified pest control expert.

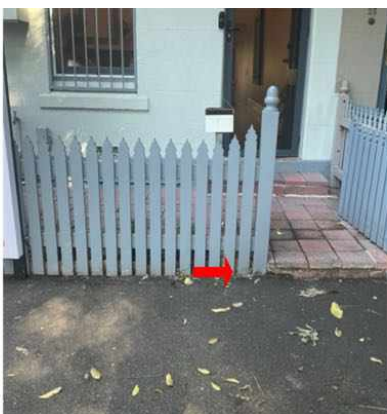
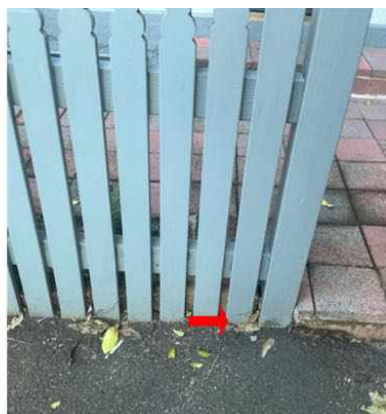
Finding 6.03

Information: Any timbers in direct ground contact provide opportunity for concealed termite entry and are likely to be subject to premature rot and decay as the soil retains moisture or damp conditions against the timbers.

Remove untreated timber that is in direct contact with external grounds. Consider replacement with more durable materials i.e. treated timber or non timber elements. Frequent pest inspections are advised to readily identify any termite activity in these areas.

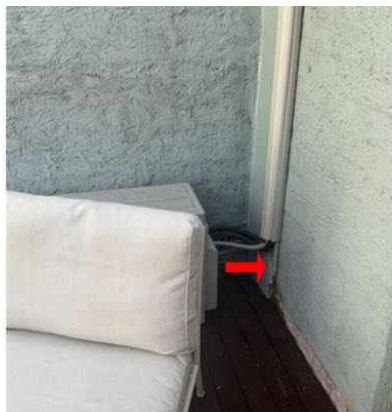
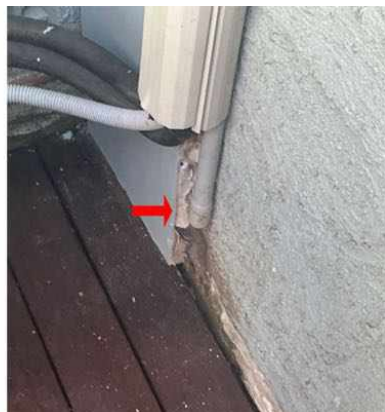
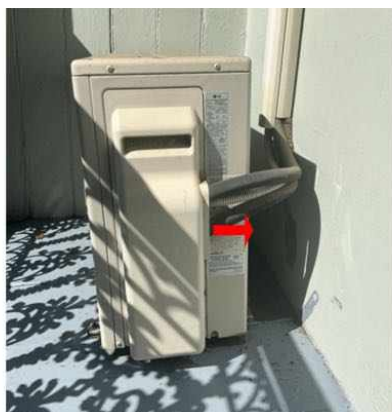
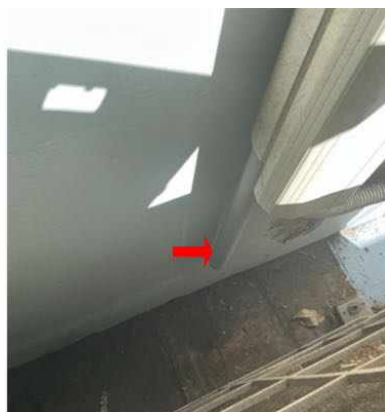
Finding 6.04

Finding: Air conditioner - Disconnected overflow

Information: The Air Conditioner (A/C) overflow was found to be disconnected from storm water drainage and is creating excessive moisture in the surrounding area.

Such leaking creates an environment which is conducive to an array of defects, including water damage to associated building elements and the attraction of termite or timber pest infestation.

It is highly recommended that a licensed plumber be appointed to connect the A/C overflow in order to prevent such an environment from being created. These minor works should be carried out as soon as possible.

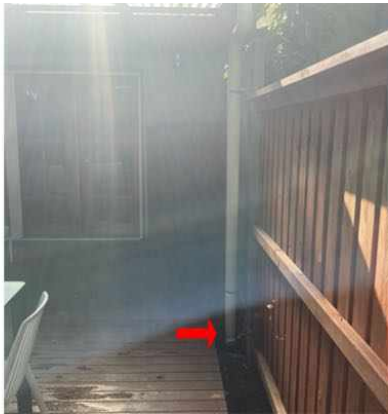
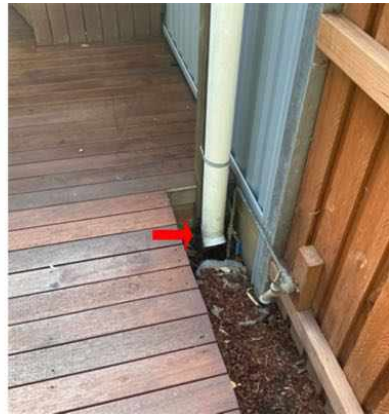
Finding 6.05

Information: The overflow is not plumbed or connected to suitable drainage, which has resulted in the surrounding area becoming excessively damp. These damp conditions can lead to secondary defects such as rot, rust or corrosion of associated building elements, the formation of fungal decay, or even the creation of potential slip hazards. When coupled with poor site drainage, pooling of water may also attract termite activity to this area. It is highly recommended that a qualified plumber be appointed to install adequate drainage to the overflow. These works will ensure that the area remains dry and free of

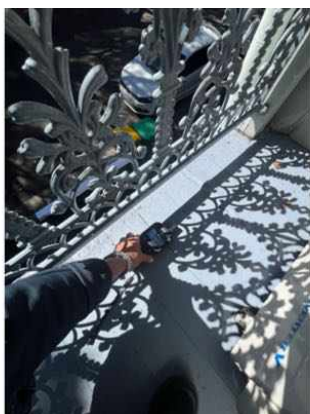
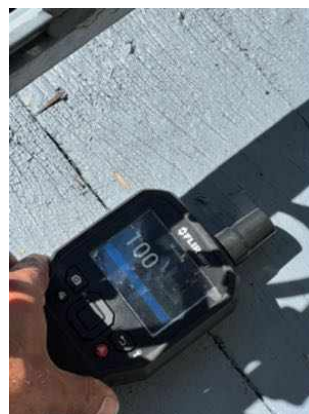
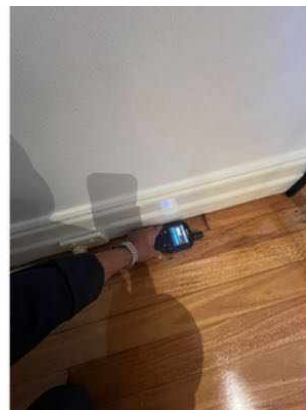
Building:	Main Building
Location:	All Internal Areas - Floorboards , Balcony Timbers
Finding:	Elevated moisture - identified
Information:	Elevated moisture can attract termites and produce conditions that promote fungal growth and wood decay.

Elevated moisture is generally caused by deteriorated, inadequate or missing roof drainage, leaking plumbing pipes or fixtures, poorly plumbed HWS overflows or condenser units and poor site drainage.

Prior to any remedial works being performed a qualified plumber should be appointed to further inspect the property and to identify the cause of the excessive moisture. Works to remove affected building elements may then be necessary and should be performed by an appropriate tradesperson.

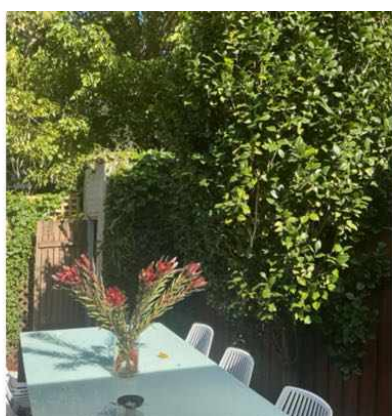
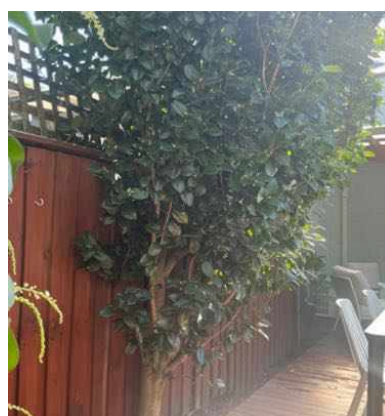
Finding 6.08

Building:	Main Building
Location:	All External Areas
Finding:	Bridging - Vegetation
Information:	Where vegetation obstructs inspection of building elements, also known as bridging as it provides a bridging point for the access of termites, full inspection can not be achieved. Consequently moisture or dampness may be present and the areas becomes conducive to termite activity. Plants against or very close to buildings provide cover, shade and can provide an environment that is attractive to termite infestation.

The removal and replanting of species that do not provide "cover" or cutting back of existing vegetation will assist greatly in preventing Bridging from occurring.

The removal of any such materials that may be conducive to termite activity should be carried out as soon as possible and arrange re inspection to minimize the risk of termite attack.

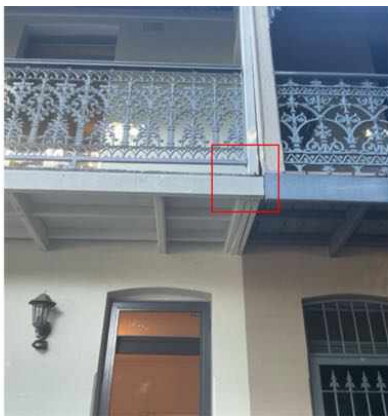
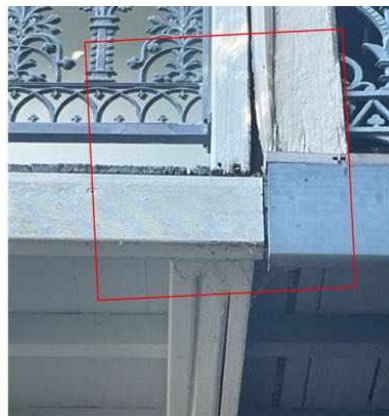
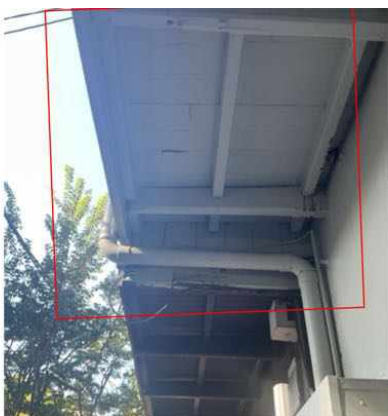
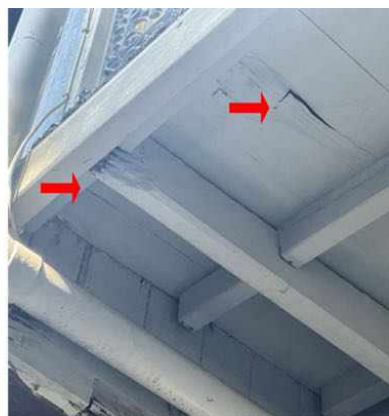
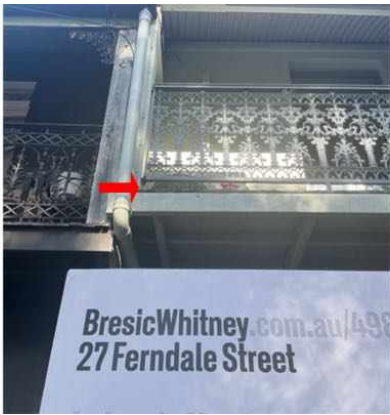
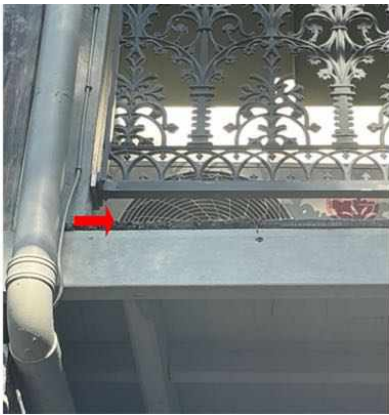
Finding: Fungal decay - present to some areas

Information: Fungal decay also known as wood decay or wood rot generally refers to the deterioration of timber elements when in contact with excessive levels of moisture for a prolonged period of time.

The development of fungal decay is accelerated by temperatures in the range of 5degreeC to 40degreeC as well as the presence of oxygen. Generally fungal decay develops on timber elements that are in use in an external environment which are exposed to rain penetration.

In this case although the affected timber element is in a decaying state the extent of any visible damage appears to be localised to a specific area and is yet to spread to other parts of the building element or affect adjoining structures. The fungal decay is therefore likely to be of a relatively superficial nature with minimal impact on the structural integrity or tensile strength of the timber element.

A further invasive inspection by a licensed timber pest technician is highly recommended to check for concealed activity.

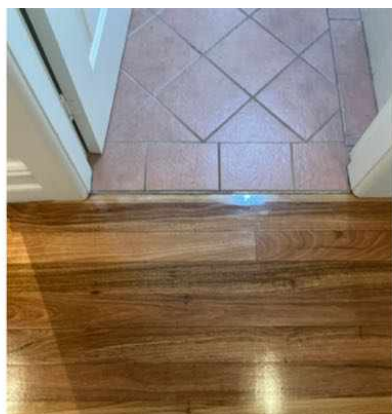
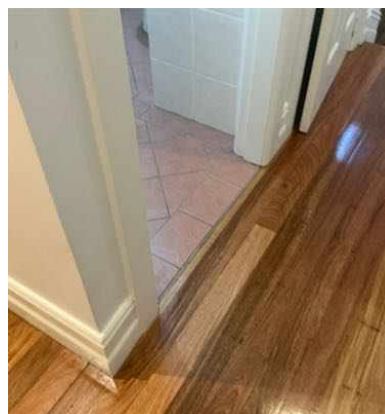
Building: Main Building
 Location: All Internal Areas
 Finding: Bathroom & external floor threshold
 Information: The bathroom floor is at the same level as the adjoining timber flooring. This configuration is typical in modern apartments and is permitted where compliant waterproofing and floor falls are provided. No evidence of moisture damage was observed at the time of inspection; however, waterproofing performance cannot be confirmed without invasive inspection.

Care should be taken to avoid excessive water migration beyond the bathroom during use.

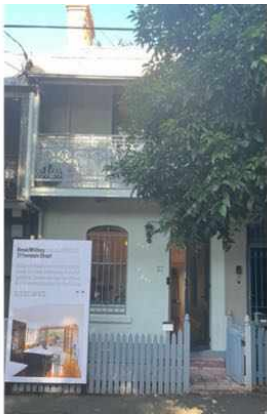
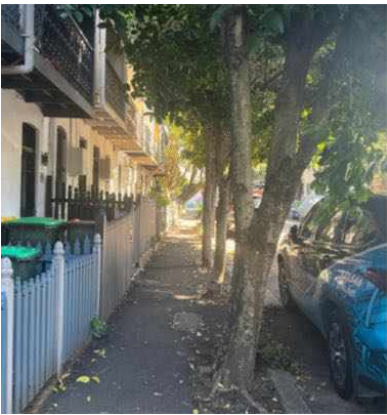
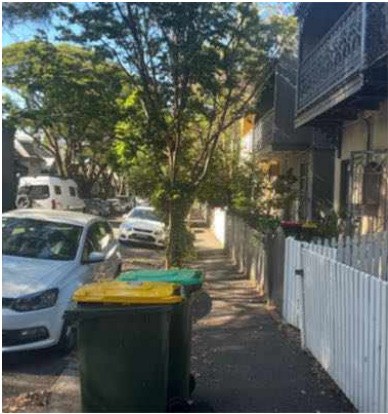
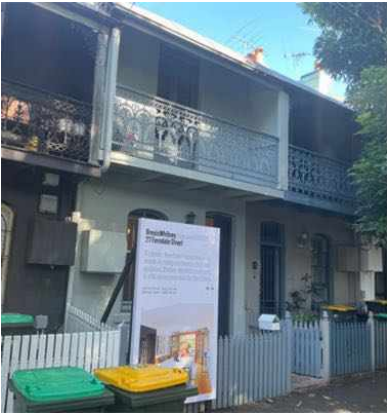
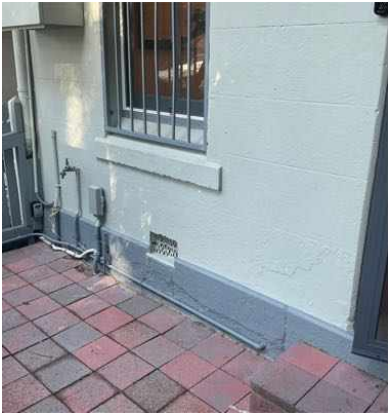
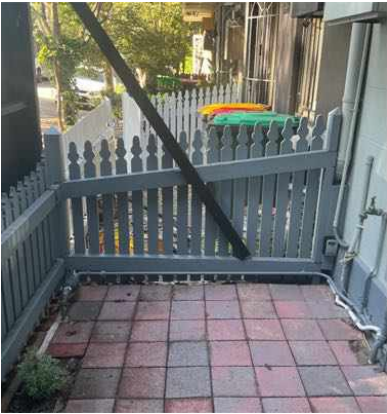
Building: Main Building
 Location: All External Areas
 Finding: Additional Photos - Obstructions and Limitations
 Information: These photographs are an indication of the obstructions and limitations which impeded full inspection of the property at the time of inspection. These obstructions can hide an array of defects and should be removed to allow full inspection to be carried out. A re-inspection is recommended once the areas are made accessible.

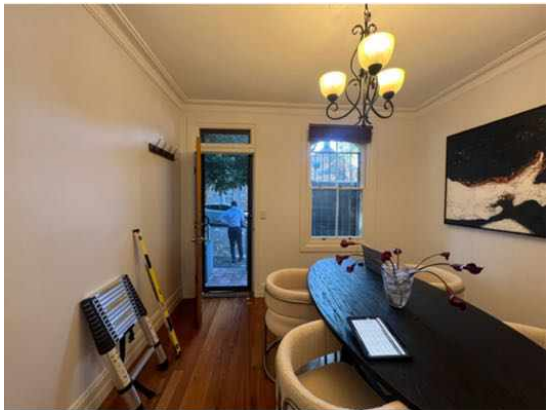
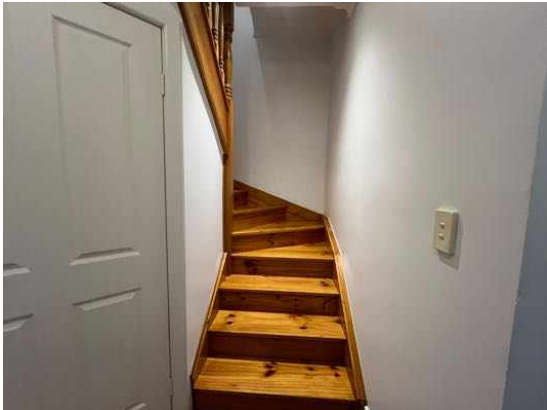
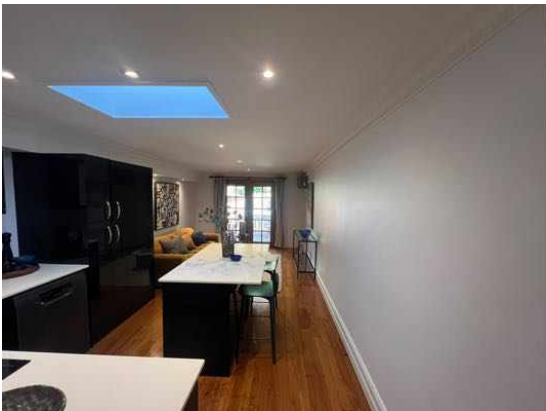
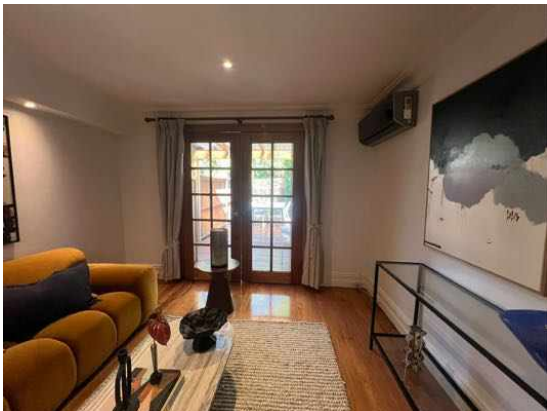
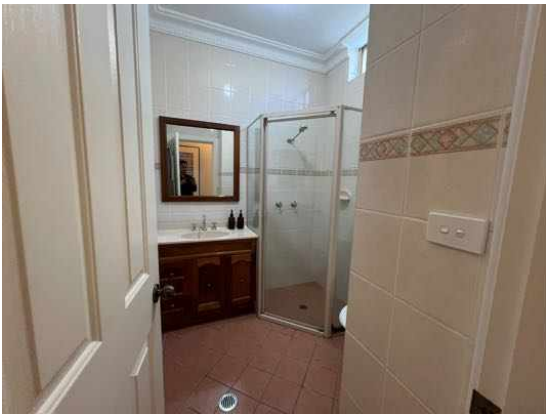
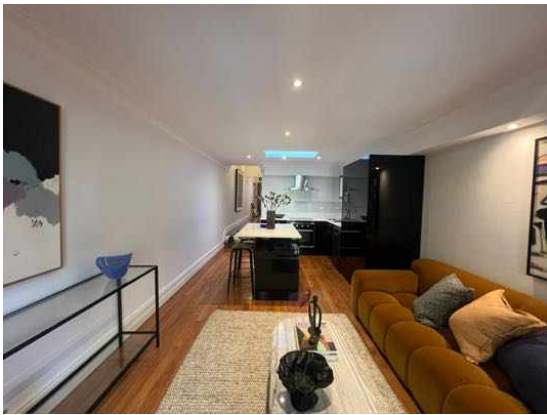
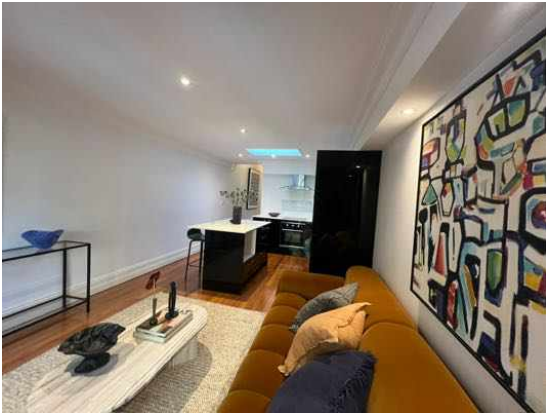
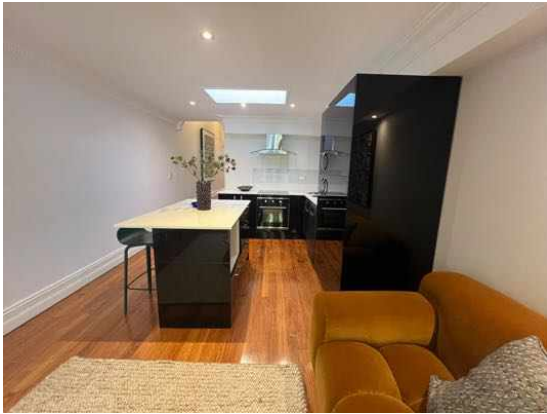
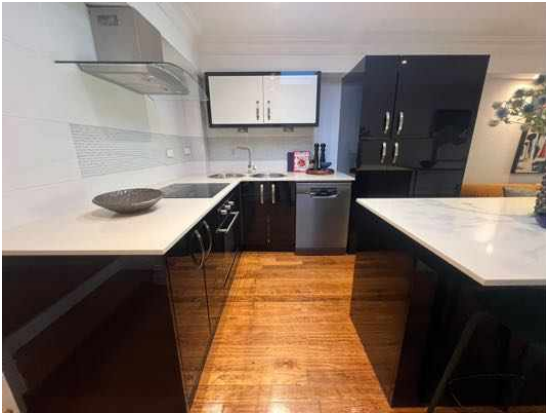
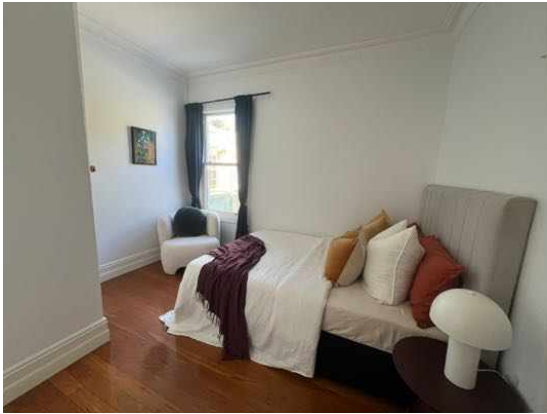
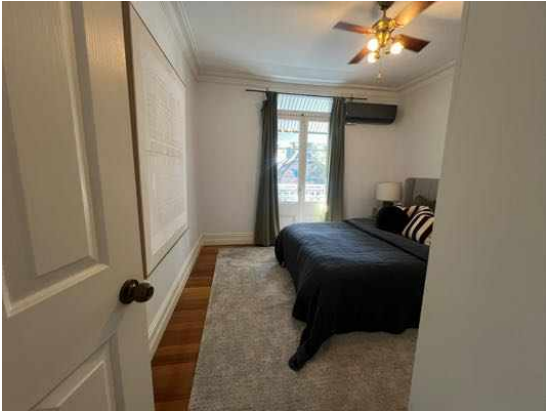
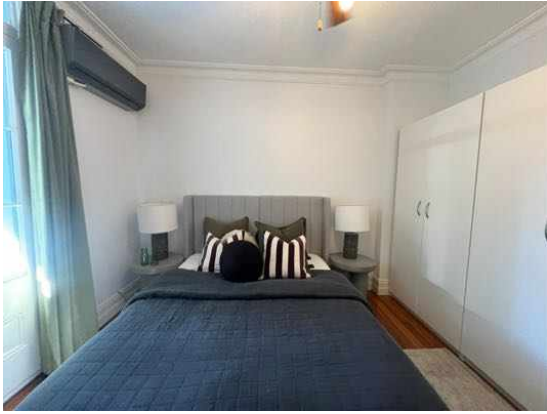
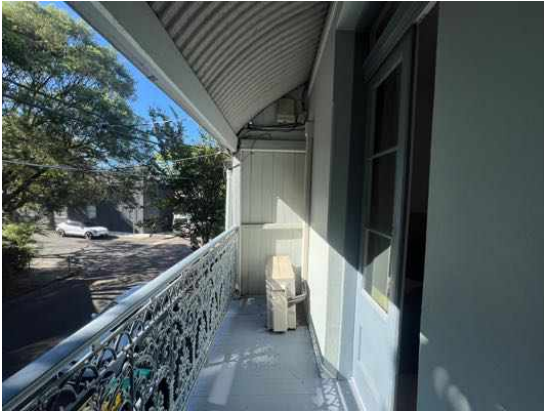
Building: Main Building
Location: All Internal Areas
Finding: Additional Photos - Obstructions and Limitations
Information: These photographs are an indication of the obstructions and limitations which impeded full inspection of the property at the time of inspection. These obstructions can hide an array of defects and should be removed to allow full inspection to be carried out. A re-inspection is recommended once the areas are made accessible.

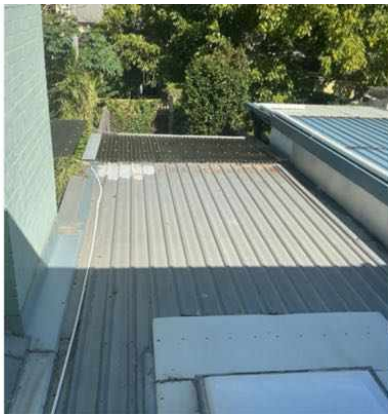
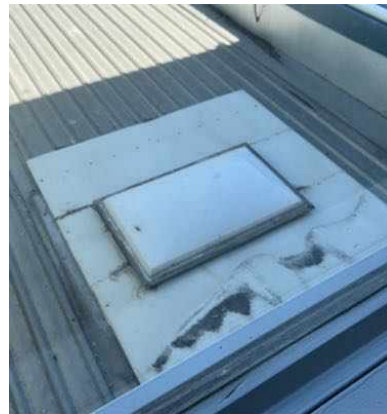
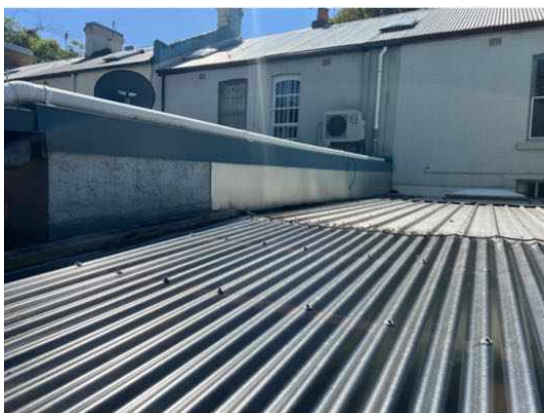
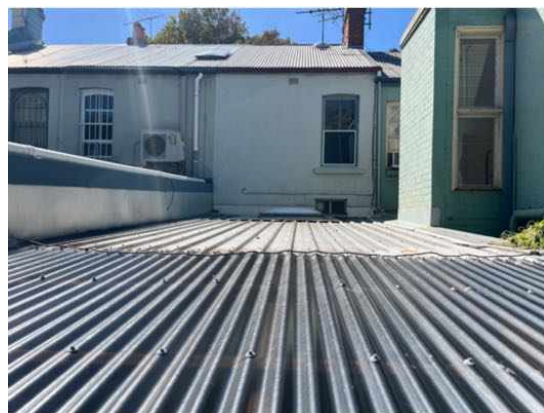
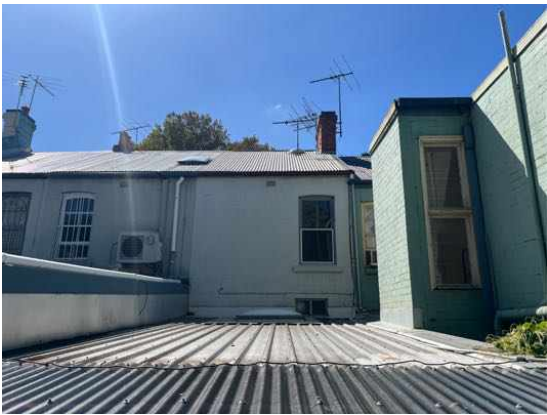
Finding: Additional Photos - Obstructions and Limitations

Information: These photographs are an indication of the obstructions and limitations which impeded full inspection of the property at the time of inspection. These obstructions can hide an array of defects and should be removed to allow full inspection to be carried out. A re-inspection is recommended once the areas are made accessible.

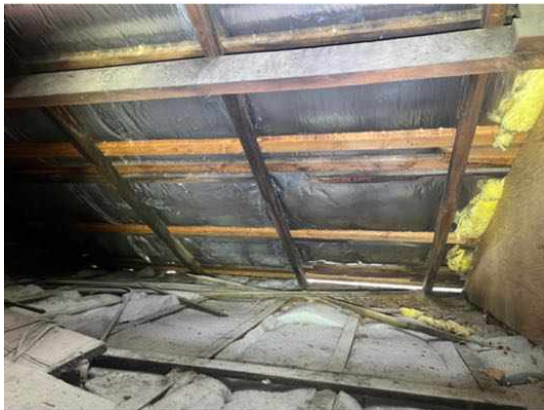
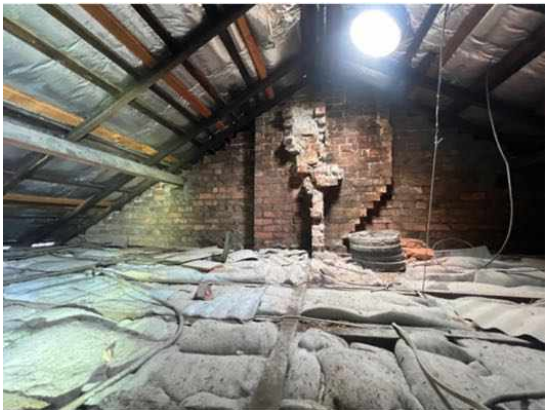
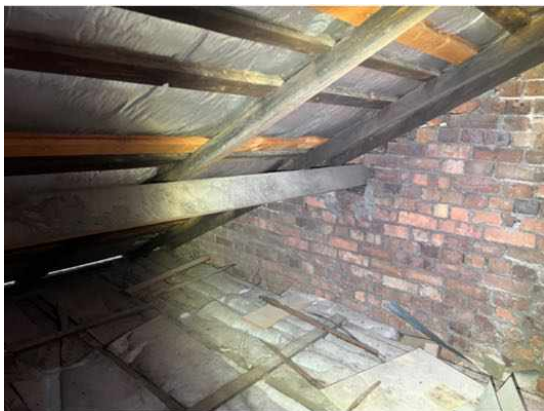
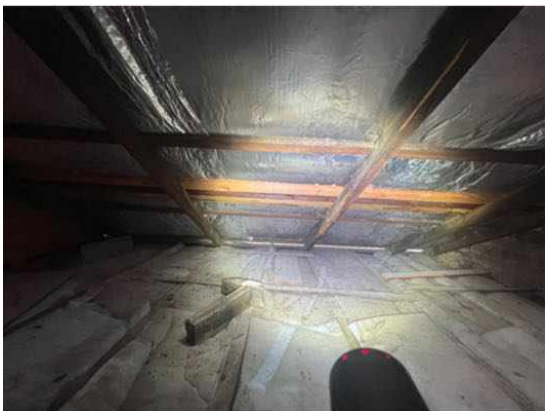
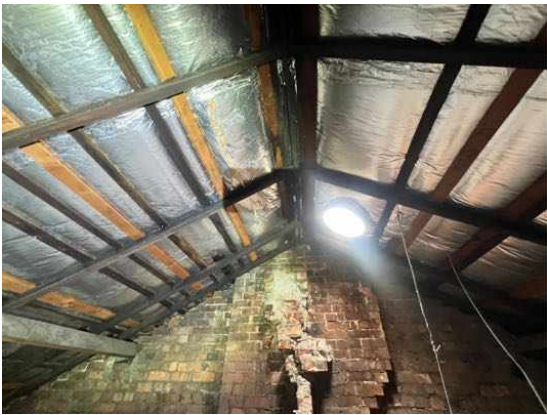
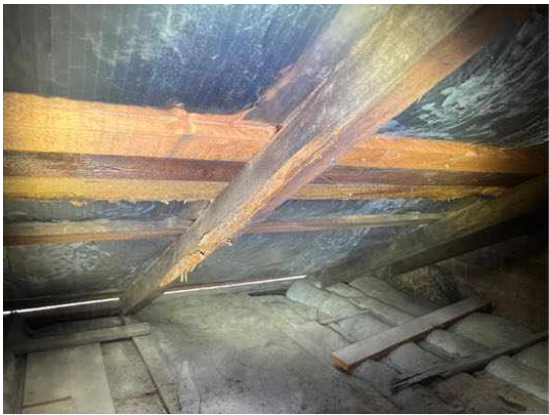
Building: Main Building
Location: Roof Void
Finding: Additional Photos - Obstructions and Limitations
Information: These photographs are an indication of the obstructions and limitations which impeded full inspection of the property at the time of inspection. These obstructions can hide an array of defects and should be removed to allow full inspection to be carried out. A re-inspection is recommended once the areas are made accessible.
