## Building and Timber Pest Inspection Report

Inspection Date: Mon, 23 Mar 2026

Property Address: 11 Hermies Ave, Milperra NSW 2214,  
Australia Updated to include asbestos lab  
test

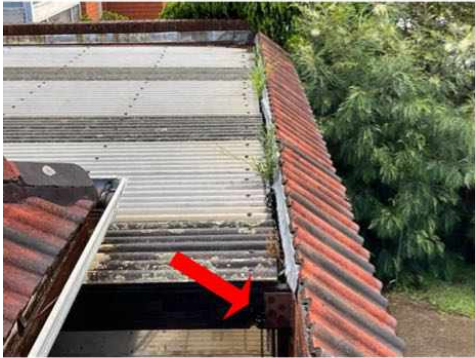
Building: Building 1  
Location: Front Pergola  
Finding: Wood rot  
Information: The front pergola shows evidence of wood rot to the front timbers on either side due to a full and leaking gutter and downpipes. Wood rot, also known as Fungal Decay, occurs when timbers and other cellulose building materials are exposed to damp conditions on an ongoing basis. Cleaning and repair of the front gutters is required regularly.

A qualified carpenter or registered builder is immediately required to replace the affected rotted pergola timbers and a plumber should repair the gutter/dpwnpipe.

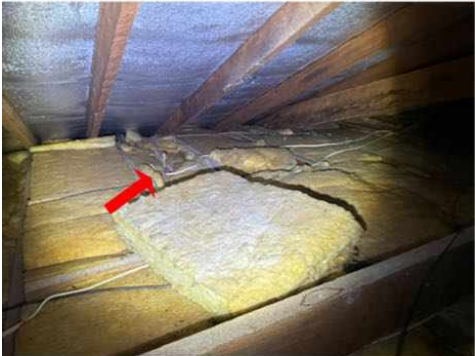
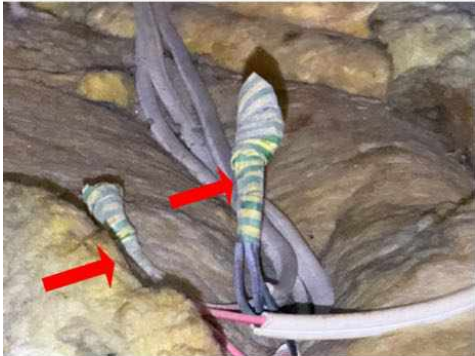
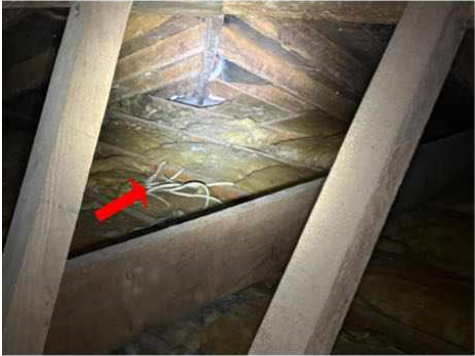
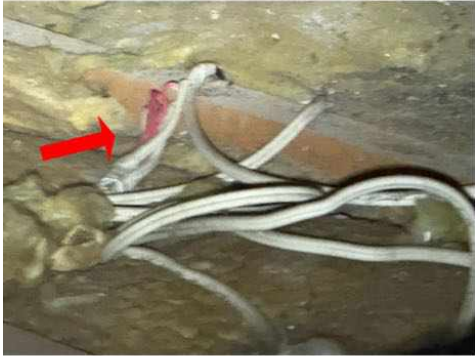
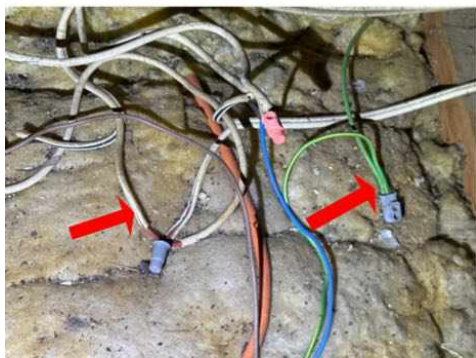
**Finding 1.02**

Building: Building 1  
Location: Roof Cavity - front and rear middle areas  
Finding: Electrical cables missing a junction box  
Information: The electrical fittings in these roof areas were found to be missing a junction boxes at the time of inspection.

This missing fittings and loose cables does expose electrical works, and may create a safety hazard if there is potential contact with persons in the area.

A Licensed electrician should be appointed to rectify these areas immediately.

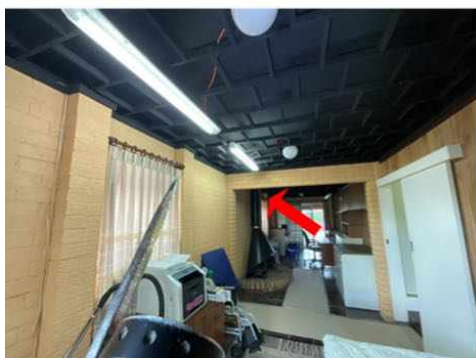
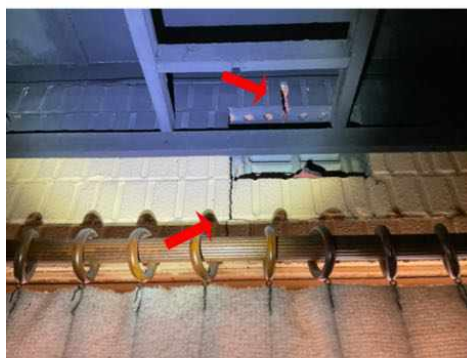
Building:	Building 1
Location:	Exterior front and side walls
Finding:	Step cracking to brickwork (minor under 5mm)
Information:	Step cracking of up to 4mm was identified to the brickwork in these areas at the time of inspection. Step cracking, which is similar to other forms of cracking, has a variety of possible causes. However, the most common is the subsidence of adjacent footings.

If any of this step cracking continues (ie, if this cracking reached 5mm or greater), the client is advised to consult a structural engineer.

Adding external drainage may slow or stop the cracking in these areas. This minor step cracking can be used as a warning sign to address factors causing stress to the wall, which can include the effect of surrounding trees, water leaks, soil erosion, or even the presence of reactive soils in the surrounding area.

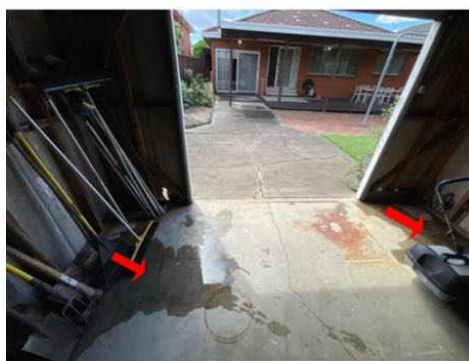
Building:	Building 1
Location:	Wall areas, gutters, garage, yard rear left
Finding:	Site drainage - Inadequate
Information:	The site drainage in these areas was found to be inadequate on the left at the time of inspection, creating potential for subsequent water damage to associated building elements. Photos 1-4 show where water is pooling in rear areas due to poor drainage.

The air conditioner and wet area overflows run against the side house walls. The rear left downpipe and nearby drainage also empty on the left rear yard area. This ground in this area is really boggy as water has nowhere to go and can pool here. The garage downpipes and gutters have rusted out requiring replacement.

It is important that water does not lie against the base of walls; surrounding paths and ground levels should be sloped to drain water away from walls. Downpipes should not discharge stormwater onto lower walls or plinths. Stormwater should be carried away by large, regularly cleaned drains. Ground levels may need to be lowered to expose a buried DPC.

Where site drainage is inadequate, installation of an Agricultural (Aggie) Drain may be required. A qualified plumber should be appointed to further inspect the property and perform any remedial works as necessary. Secondary defects are likely to occur if left unmanaged.

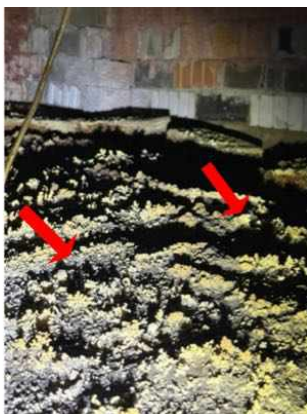
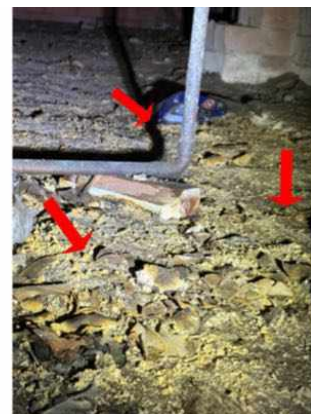
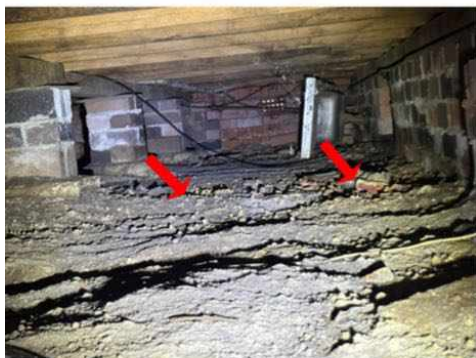
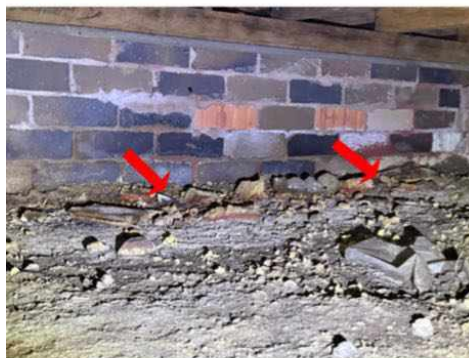
### Finding 3.04

Building:	Building 1
Location:	Subfloor
Finding:	Severe mould - Present in subfloor
Information:	Where evidence of severe mould growth was noted in the middle and left subfloor areas, there may be environmental, biological or health issues associated with the report. A specialist inspection by a suitably qualified environmental health inspector is warranted, where mould is extensive or where any queries regarding air quality spores or other related issues apply.

Subfloor mould is generally caused by moisture ingress, lack of external drainage, lack of adequate ventilation and subfloor debris present. These issues need rectification

to stop mould development. Any mould found during the inspection should be cleaned immediately by a cleaning contractor.

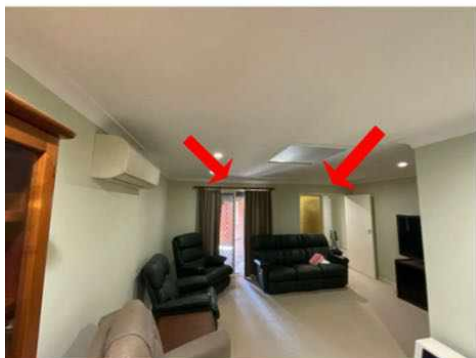
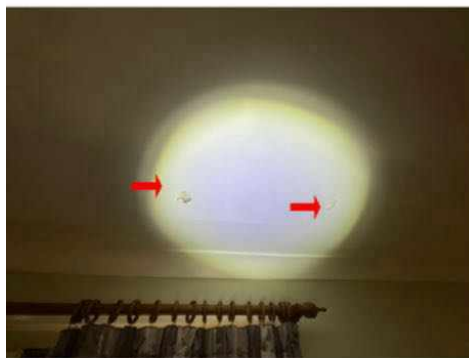
### Finding 3.05

Building:	Building 1
Location:	Lounge Room - front
Finding:	Ceiling - Sagging/deflection evident
Information:	The ceiling and cornice area in the front loungeroom was found to be sagging at the time of inspection. Sagging to the fixed ceiling structure generally indicates that the building materials have swollen, due to contact with water, or that fixings (e.g. nails or glue) have become loose and require reattachment.

Where minor sagging is evident here, comparatively minor works, such as re-gluing of ceiling sheets, may be required. Such works may be performed by relevant tradespeople, such as plasterers and painters. Where excessive moisture has caused the roofing structure to swell and sag, the source of the water leak should primarily be identified prior to any remedial works being performed. As no moisture was found and a new roof valley was evident above this area on the exterior roof, it is suspected this leak has been repaired. This area should be monitored annually for further roof leaks.

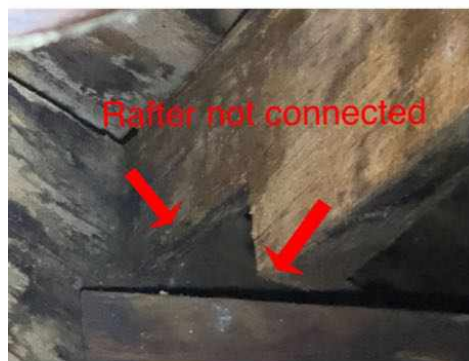
**Finding 3.06**

Building: Building 1  
 Location: Roof Cavity  
 Finding: Rafters - wood rot and rafter unsupported  
 Information: Minor timber staining and a disconnected (floating) rafter was found in the roof void above the front entry area.

It is likely that this staining has developed as a result of faults in the roof plumbing, however, it is again suspected the new roof valley repair that appears to have occurred has stopped the moisture creating the timber staining.

This external roof area should be monitored annually and a roofing contractor

engaged if any internal staining occurs.

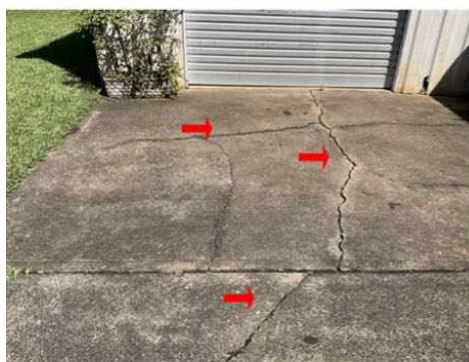
### Finding 3.07

Building: Building 1  
 Location: Yard - front & rear  
 Finding: Crack in concrete slab - Category 3  
 Information: A crack coded as Category 3 was identified in the slab. A Category 3 crack is described as a wide crack with obvious curvature or change in level, affecting the slab.

The approximate width of the crack to be considered Category 3 is greater than 2.0mm, or a change in offset of 15-25mm when a 3m straight edge is placed over the defect.

Category 3 cracks to slabs exceed allowable Standards and Tolerances, and are considered defects requiring rectification.

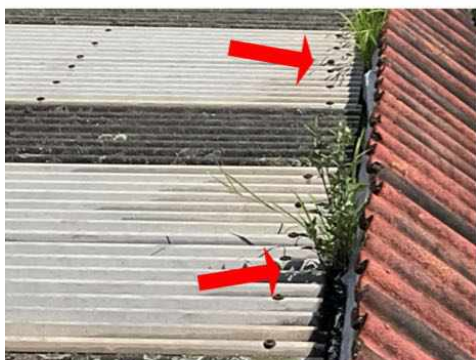
Building:	Building 1
Location:	Pergola roof exterior (front)
Finding:	Gutters - Full and blocked
Information:	The guttering on around the roof was found to be blocked at the time of the inspection. Roof plumbing structures, such as guttering and downpipes, should be free of all debris to prevent blockages. Blockages of the guttering and downpipes will lead to pooling and accumulated water overflows, which is likely to subsequently flood eaves and exterior walls.

Blocked gutters are likely to lead to high levels of moisture in the affected areas which can cause rust and decay of the gutters and downpipes and wood rot to adjoining timber areas. Blockages in gutters should therefore be removed immediately to ensure dry conditions are maintained.

It is highly advised that gutters be cleaned by the homeowner or a general handyperson as a matter of urgency.

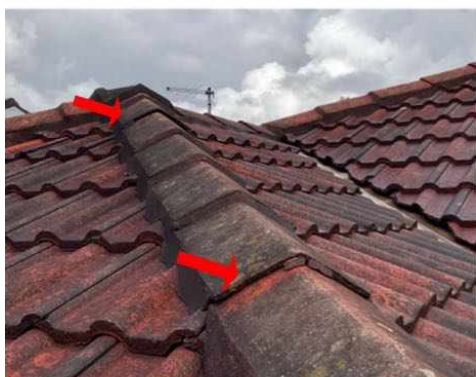
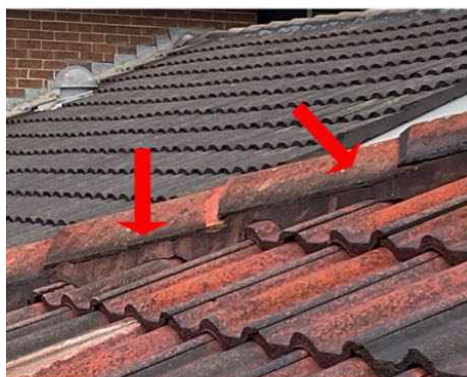
### Finding 3.10

Building:	Building 1
Location:	Roof Exterior
Finding:	Roofing areas - Weathered requiring repair
Information:	Upon inspection of the exterior roofing, the majority of the roof areas were considered to be in a good condition. While weathering of these pictured areas is consistent with the age of the property, maintenance works are immediately required.

Re-sealing and replacing small areas of gaps, damage or rust the may be considered as an interim solution by the client to help preserve and extend the life span of these roofing areas. Where left unmanaged, deteriorating roofing materials are likely to lead to a number of secondary defects, including minor water leaks and weather exposure to internal roofing structures.

Consultation with a roofing contractor is highly advised to gain advice on cost of remedial works that may be required in the short to medium term.

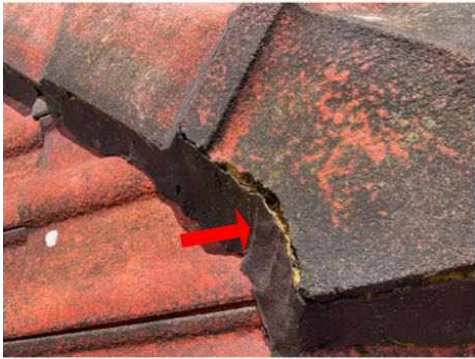
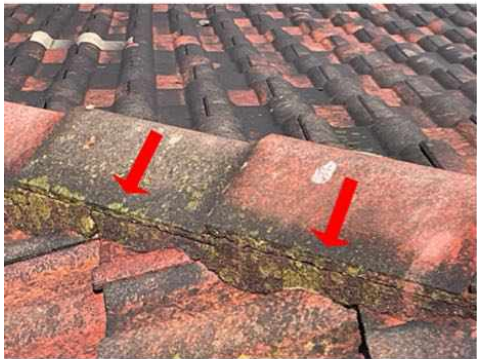
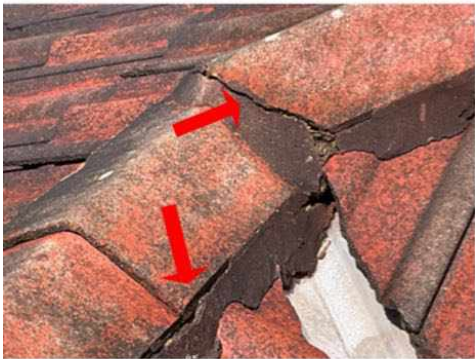
**Finding 3.11**

Building: Building 1  
Location: Pergola Roof Exterior  
Finding: Roof tiles - Slippage  
Information: Upon inspection of the exterior front pergola roof, it was noted that numerous tiles have slipped from their original fixing. Tiles may slip over time due to a number of minor causes, including breakage of tiles or fixings that may have failed.

Replacement of loose roofing tiles is recommended immediately to prevent the development of any secondary defects. A roofing restoration specialist should be appointed to complete such works as necessary.

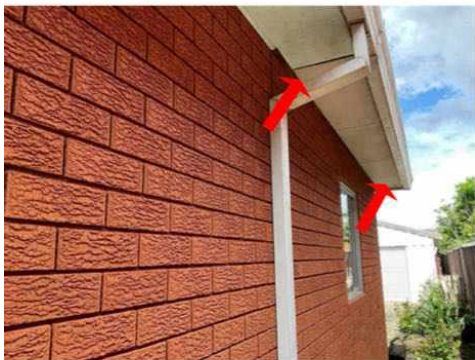
1. The eave joiners and paint are incomplete to some eave areas.
2. The plumbing protrudes from the ground allowing it to be easily damaged.
3. The laundry walls are unfinished.

A Registered Builder and plumber should be appointed immediately to complete this construction process.

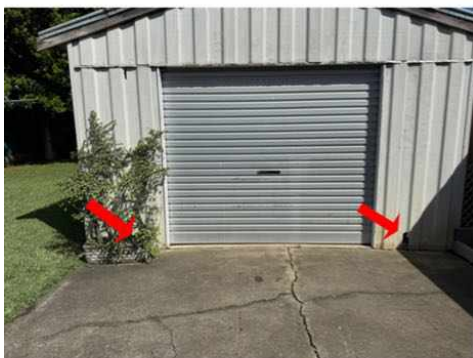
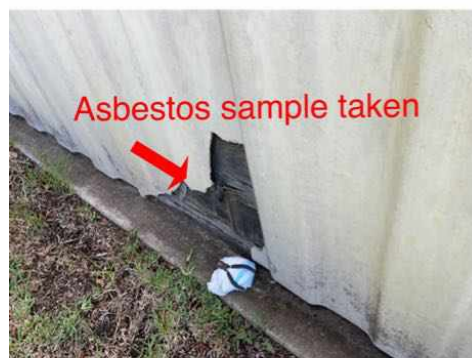
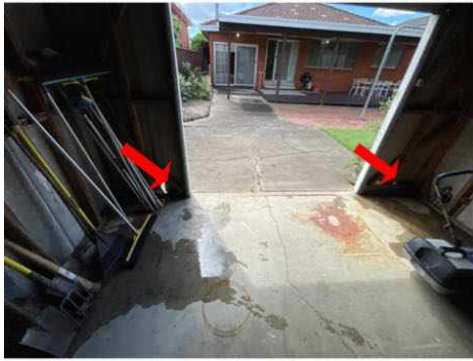
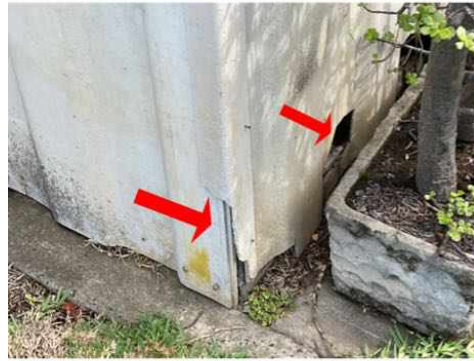
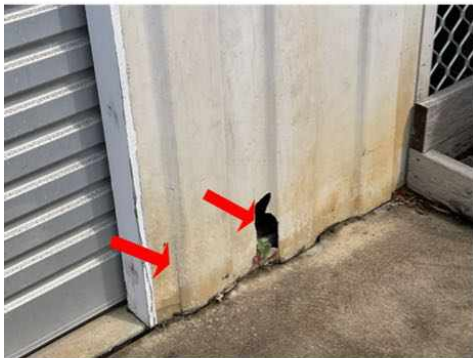
### Finding 3.17

Building: Building 2  
 Location: Exterior walls - garage  
 Finding: Cladding damaged  
 Information: Evidence of damage was identified to the left side wall where the cladding has minor damage. A carpenter would be the trade responsible for rectification of this wall area.

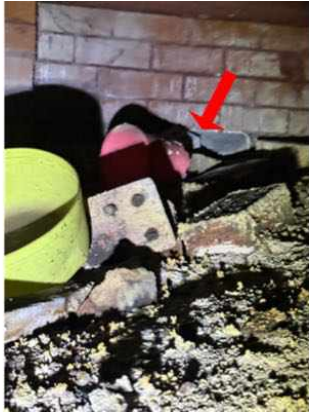
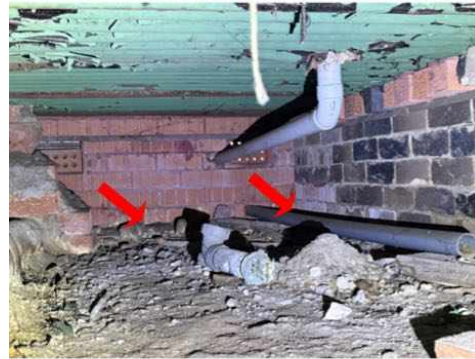
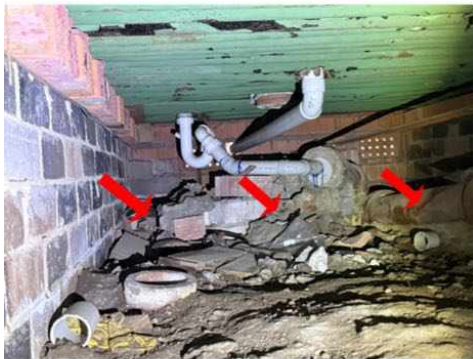
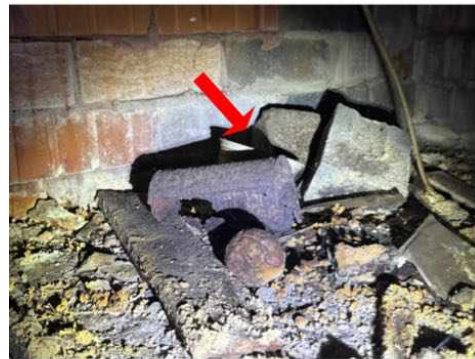
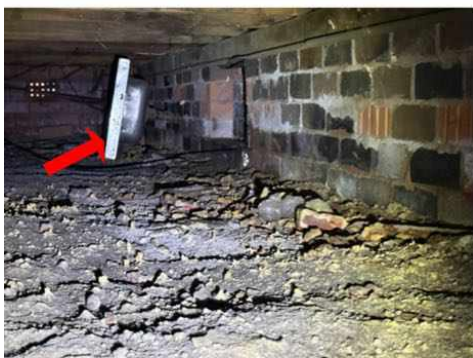
A clear and empty subfloor will be better ventilated and easier to maintain in a dry condition. The removal of any timber debris is vital in minimising the risk of termite or wood borer activity.

Debris in the subfloor should be removed as soon as possible. Depending on the location and amount of debris and stored items, the homeowner may elect to undertake this task. Alternatively there are a large number of rubbish removal subcontractors that could undertake these works.

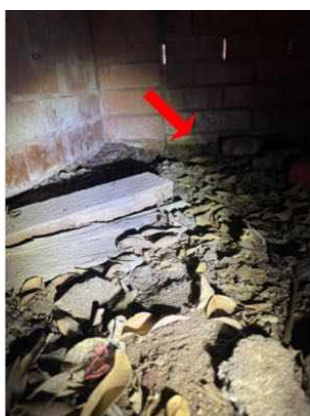
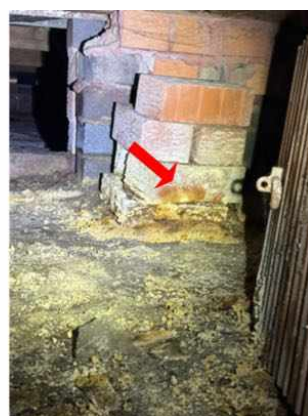
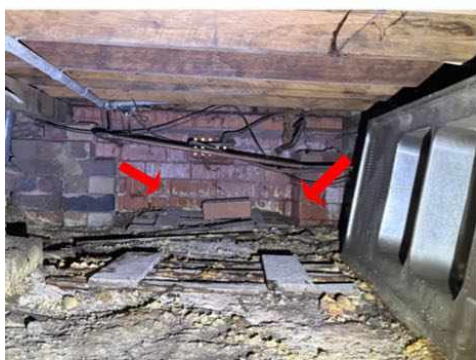
### Finding 6.05

Building:	Building 1
Location:	Subfloor
Finding:	Damp - Rising
Information:	Rising damp describes the upward movement of water in low sections of building elements (e.g. walls) by capillary action - the movement of water through porous

Rising damp is generally managed by the installation of a damp proof course during construction. A Damp Proof Course (DPC) is an impermeable barrier at the base of the wall above ground level. However, many 19th Century buildings have no damp course installed, or the materials have failed. The DPC may have been omitted as a consequence of poor workmanship, or it may have been bridged where materials built up against the side of the house allow moisture ingress above the DPC level.

The first step in addressing rising damp is to diagnose the cause. The identified cause should be addressed first before addressing the appearance and other defects which have resulted from the rising damp. If the original cause is not resolved, further cases of damp are likely to ensue, resulting in secondary defects.

Consultation with a qualified plumber is advised immediately to identify the cause of the damp and perform remedial works as required.

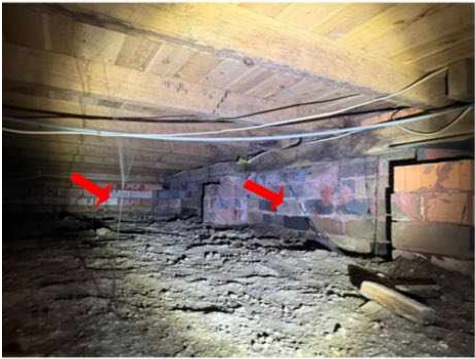
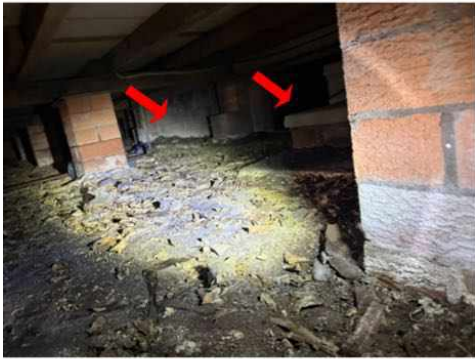
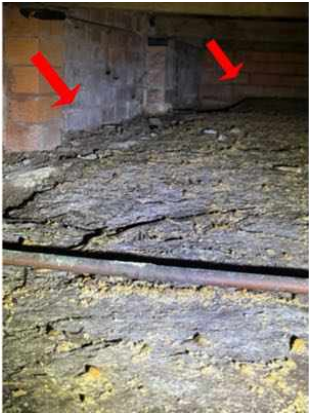
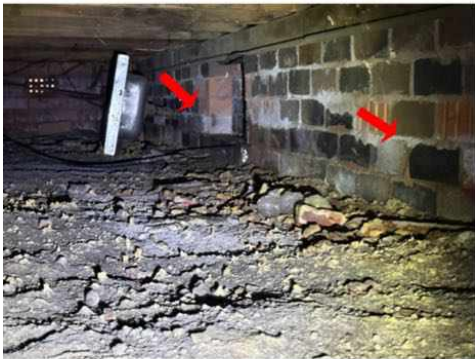
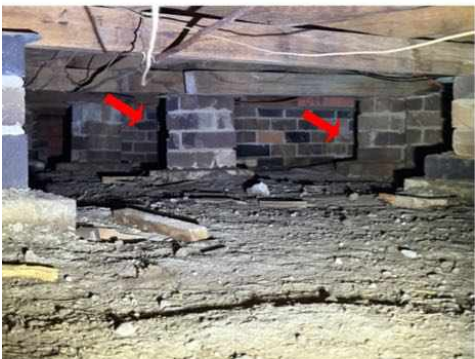
Building: Building 1  
 Location: Subfloor  
 Finding: Subfloor ventilation - Inadequate  
 Information: Adequate subfloor ventilation aids in preventing excessive moisture wood rot and termite activity by ensuring a dry subfloor environment.

Where ventilation is substandard or blocked, it is usually caused by factors such as failure to install adequate vents during construction or earth and vegetation covering vents. Low subfloor clearance and stored items or debris in the subfloor also restricting airflow.

Subfloor ventilation can be improved in most cases by addressing the causes such as exposing subfloor vents, installing additional vents, installing mechanical ventilation and removing debris from the subfloor.

A registered builder should be appointed as soon as possible to perform these works as necessary.

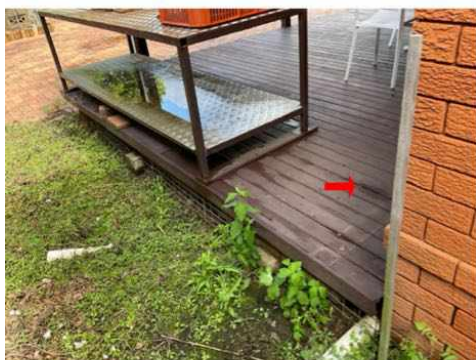
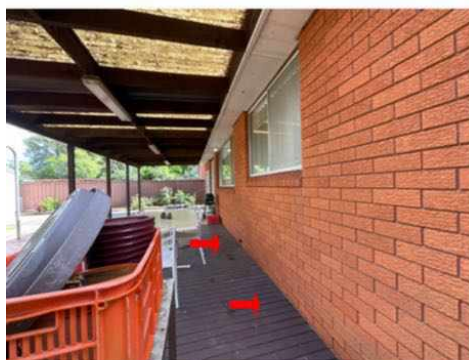
Building:	Building 1
Location:	Exterior walls - rear
Finding:	Bridging - decking
Information:	Where decking obstructs inspection of building elements, also known as bridging as it provides a bridging point for the access of termites, full inspection can not be achieved. Consequently moisture or dampness may be present and the areas becomes conducive to termite activity. Decks against or very close to buildings provide cover, shade and can provide an environment that is attractive to termite infestation.

Leaving a small gap between decking and the building walls will assist greatly in preventing Bridging from occurring.

The removal of any such stored building materials that may be conducive to termite activity should be carried out as soon as possible and arrange re inspection to minimize the risk of termite attack.

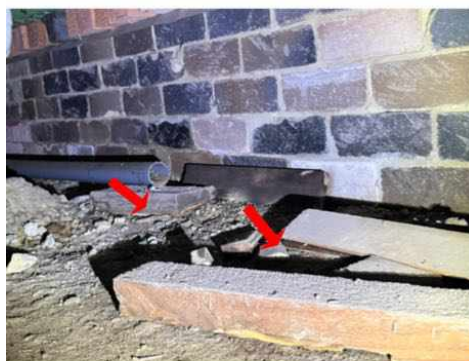
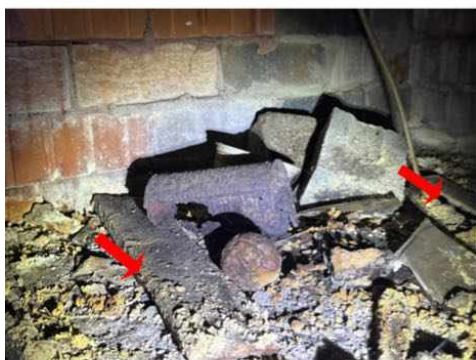
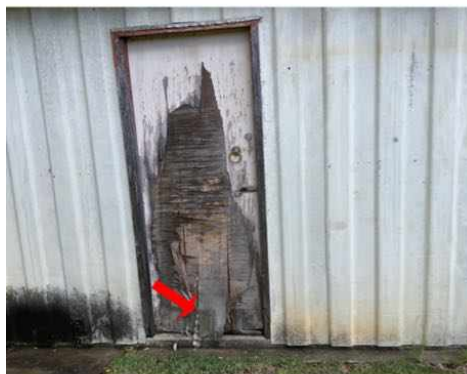
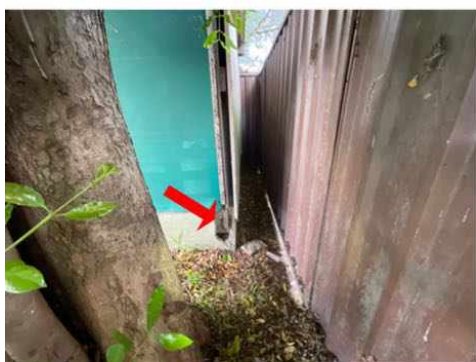
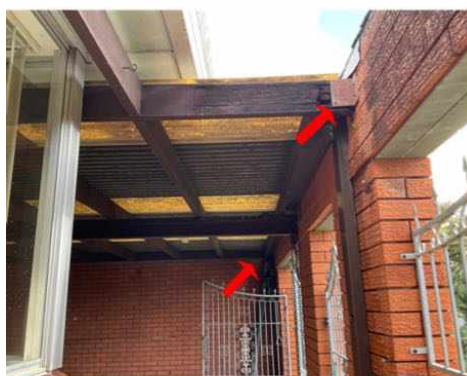
### Finding 7.01

Building:	Building 1
Location:	Front pergola, rear buildings & subfloor
Finding:	Fungal decay - present (localised)
Information:	Fungal decay also known as wood decay or wood rot generally refers to the deterioration of timber elements when in contact with excessive levels of moisture for a prolonged period of time.

The development of fungal decay is accelerated by temperatures from 5degreeC to 40degreeC as well as the presence of oxygen. Generally fungal decay develops on timber elements that are in use in an external environment which are exposed to rain penetration.

Note - See ALL wood rot photos, all these show fungal decay.

In this case, the affected timber element is in a decaying state and will need replacement by a carpenter or licensed builder.

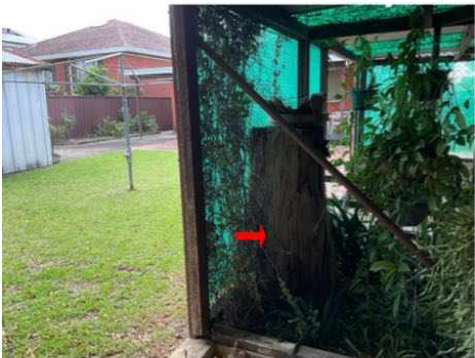
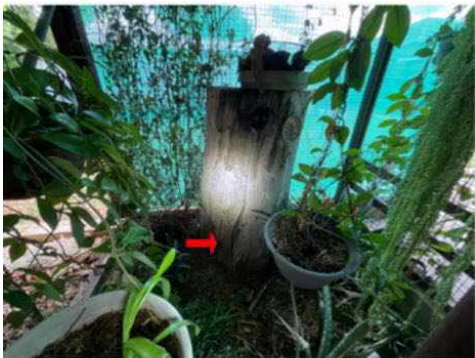
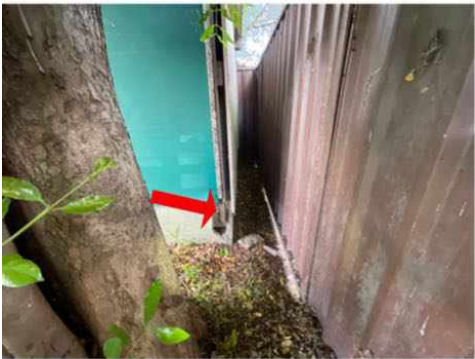
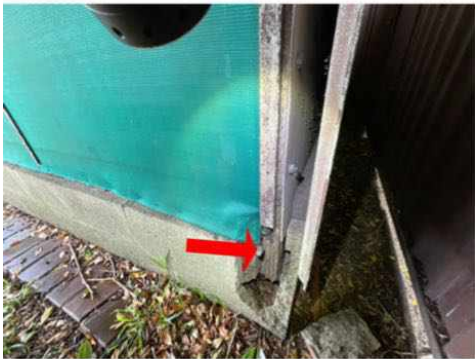
### Finding 8.01

Building:	Building 3
Location:	Stumps and greenhouse
Finding:	Evidence of wood borer activity identified
Information:	Wood borers small beetles that colonise in exposed timber elements are a common timber pest that are regularly mistaken for termites. Although wood borer activity is generally not detrimental to the affected timber they may lead to serious damage and necessitate replacement of certain building elements if left unattended.

The other commonly known borer the Anobium borer is more likely to attack floorboards and may cause severe structural damage to flooring areas.

As no live wood borer activity was identified treatment is not required at this time.

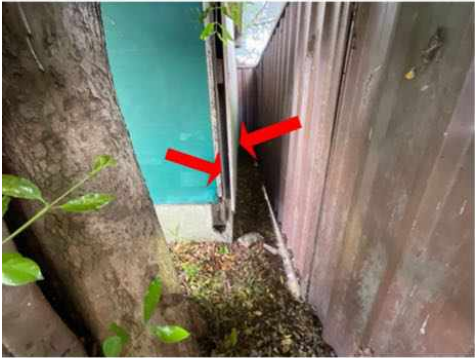
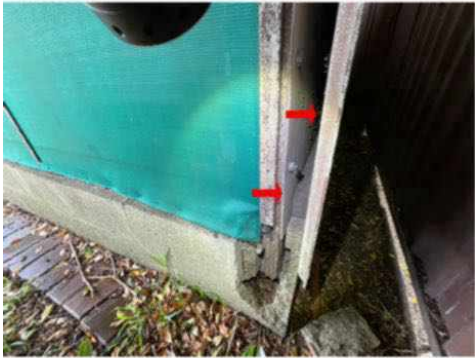
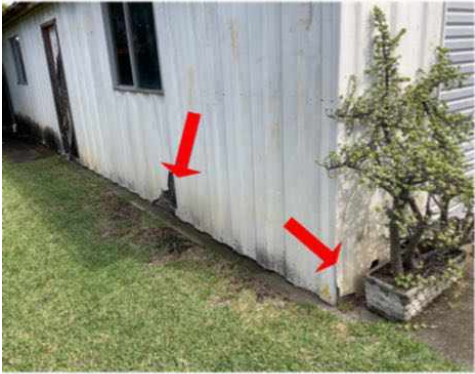
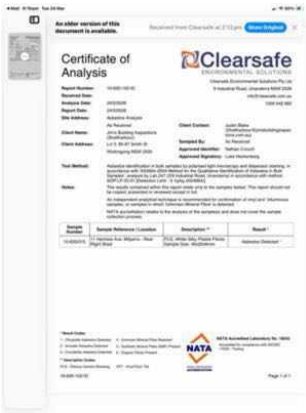
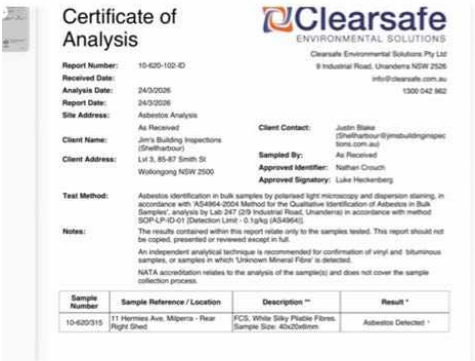
The client is advised to act with caution, especially when considering any damage to building materials, general wear and tear, renovations, extensions, demolition and general maintenance activities due to the presence of Asbestos. The damage to this cladding presents an increased risk of injury. An asbestos removal company should

give quotes for removal of these damaged walls. Contact this inspector for recommendations.

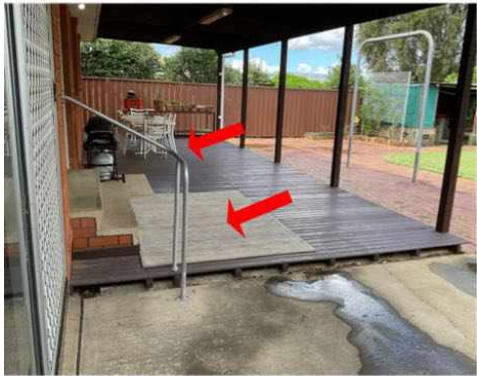
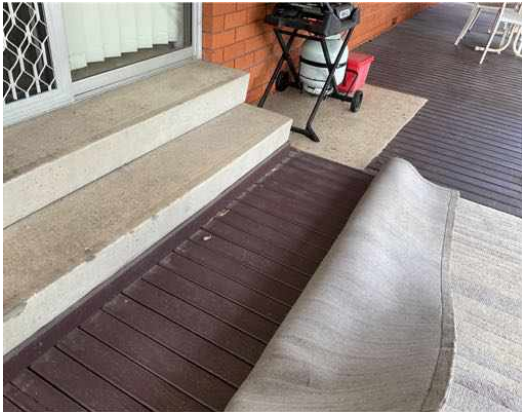
- Building: Building 1
- Location: All External Areas
- Finding: Additional Photos - Obstructions and Limitations of EXTERNAL AREAS
- Information: These photographs are an indication of the obstructions and limitations which impeded full inspection of external areas at the time of inspection. These obstructions can hide an array of defects and should be removed to allow full inspection to be carried out. A re-inspection is recommended once the areas are made accessible.

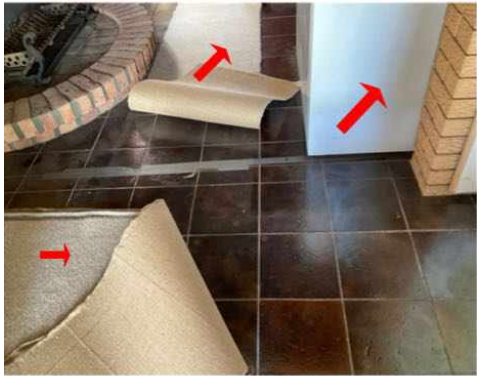
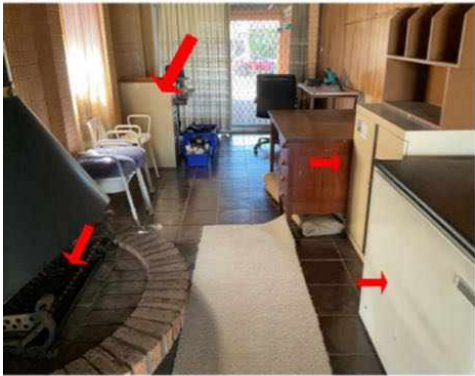
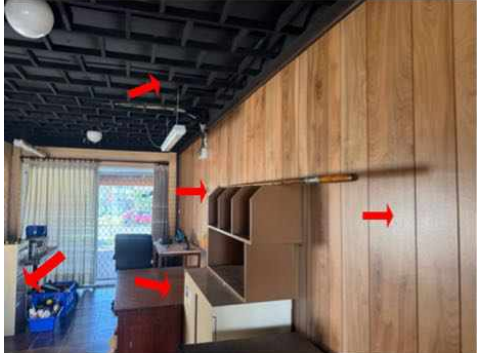
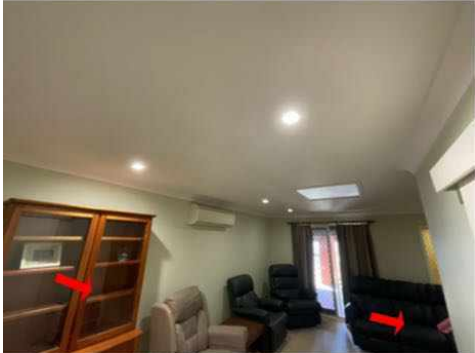
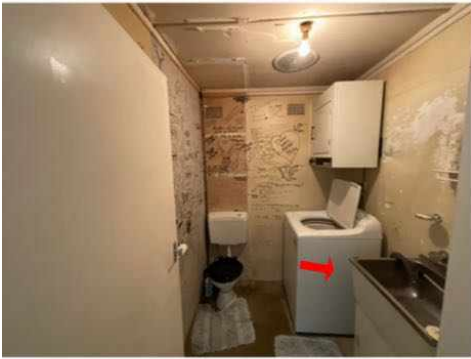
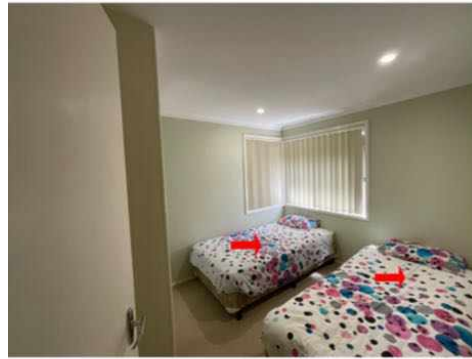
Building: Building 1  
Location: All Internal Areas  
Finding: Additional Photos - Obstructions and Limitations of INTERNAL AREAS  
Information: These photographs are an indication of the obstructions and limitations which impeded full inspection of Internal areas at the time of inspection. These obstructions can hide an array of defects and should be removed to allow full inspection to be carried out. A re-inspection is recommended once the areas are made accessible.

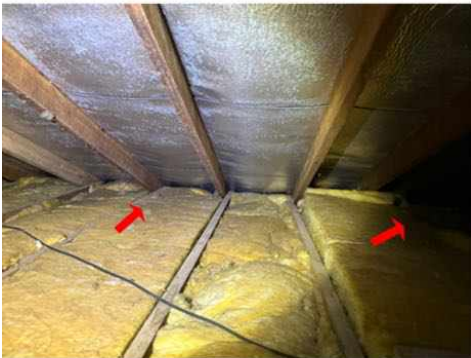
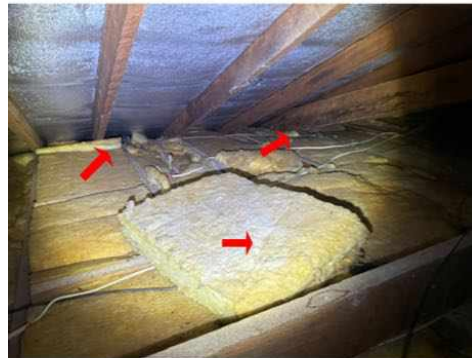
Building: Building 1  
 Location: Some Roof cavity areas  
 Finding: Additional Photos - Obstructions and Limitations of the ROOF CAVITY  
 Information: These photographs are an indication of the obstructions and limitations which impeded full inspection of roof cavity areas at the time of inspection. These obstructions can hide an array of defects and should be removed to allow full inspection to be carried out if applicable. A re-inspection is recommended once the areas are made accessible.

The inspection was also limited to areas with an allowable crawl space of 600mm x 600mm, in particular towards the external walls where the roof line diminishes, these areas were not accessible.

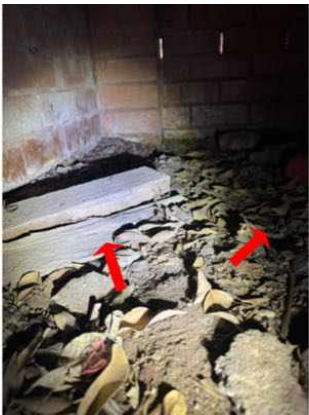
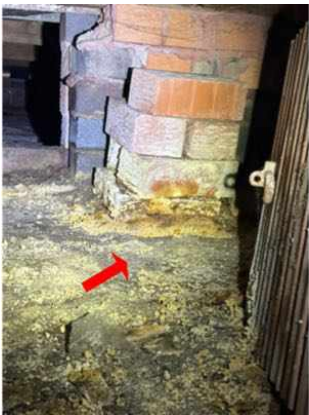
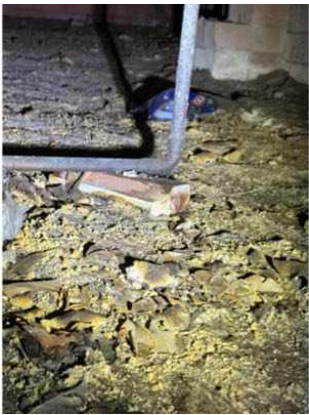
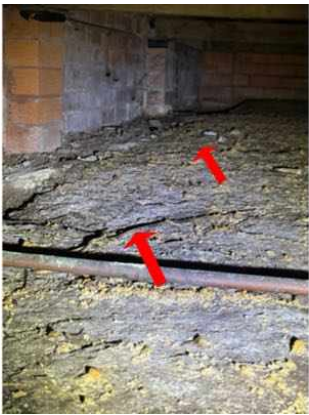
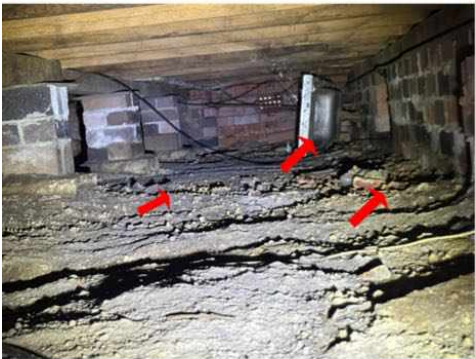
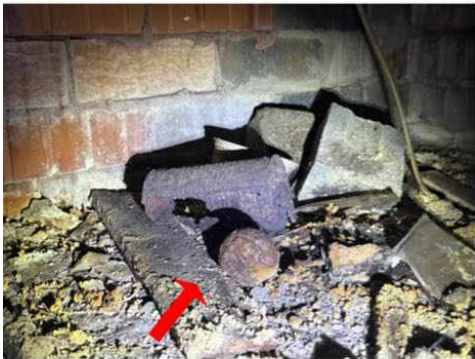
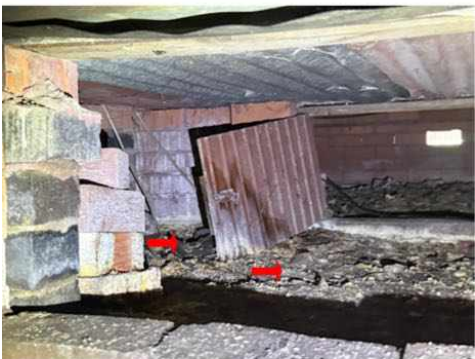
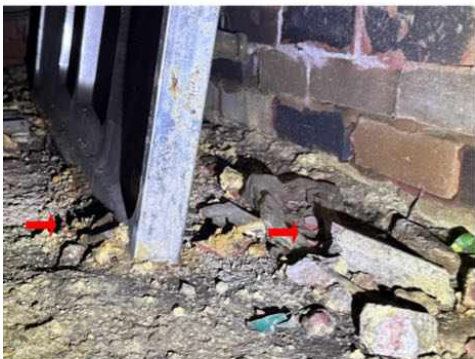
Building: Building 1  
Location: Some Subfloor Areas  
Finding: Additional Photos - Obstructions and Limitations of SUBFLOOR AREAS  
Information: These photographs are an indication of the obstructions and limitations which impeded full inspection of subfloor areas at the time of inspection. These obstructions can hide an array of defects and should be removed to allow full inspection to be carried out. A re-inspection is recommended once the areas are made accessible.

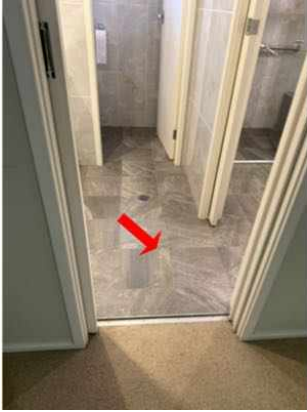
Building: Building 1  
 Location: Bathroom and laundry  
 Finding: Waterproofing membranes - Information Only  
 Information: Internal Water Proofing Membranes, are crucial in preventing water ingress into the property is important to know that the Membrane System used is to Australian Standards and has been installed correctly.

With older property's where this information is unavailable all wet areas should be monitored. If any leaks, water staining, peeling or bubbling of the paint become evident to any adjacent walls or ceilings below a licensed builder or waterproofing specialist is recommended to investigate further.
