Building and Timber Pest Inspection Report

Inspection Date: Tue, 24 Mar 2026

Property Address: 18 Bounty Ave, Castle Hill NSW 2154,
Australia

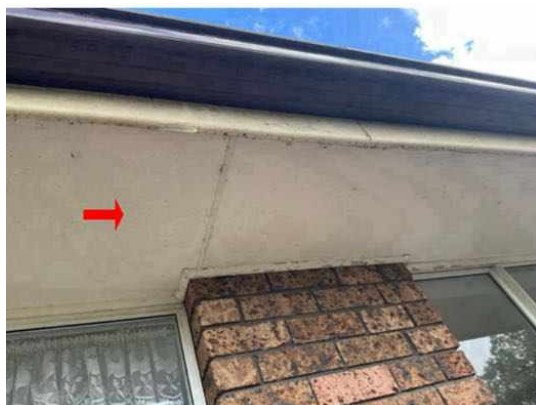
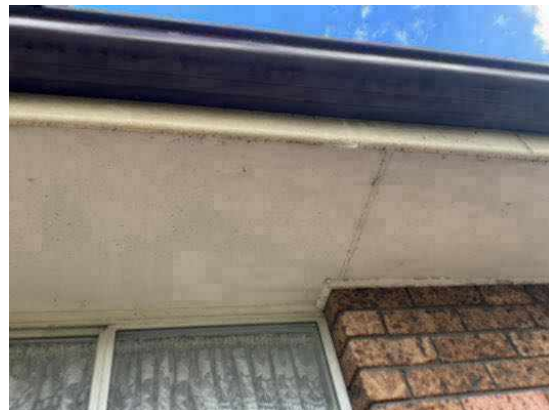
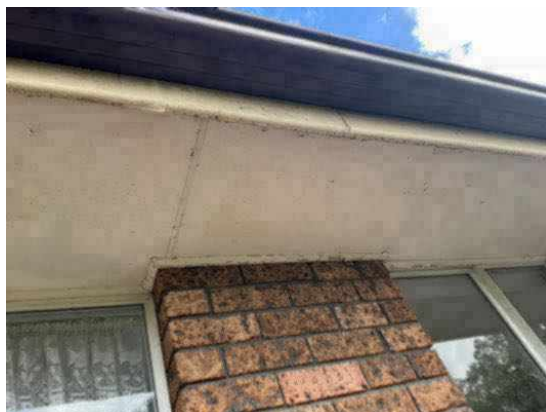
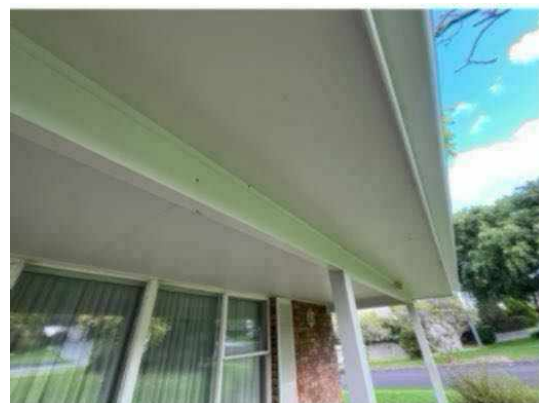
Building:	Main Building
Location:	All Areas
Finding:	Asbestos - Suspected ACM Identified on Site
Information:	Reporting on Asbestos is outside the Scope of this Report. This suspected defect is highlighted as a caution only. We suspect, based on our experience in the building industry, that there is a higher risk of the identified building element containing asbestos.

As Asbestos Reporting is outside the scope of this report, we advise that you consider a separate Asbestos Inspection and Condition Audit, which can include the taking of samples for definitive confirmation of the presence of Asbestos.

In the interim, the client is advised to act with caution, especially when considering any damage to building materials general wear and tear renovations extensions demolition and general maintenance activities due to the suspected presence of Asbestos.

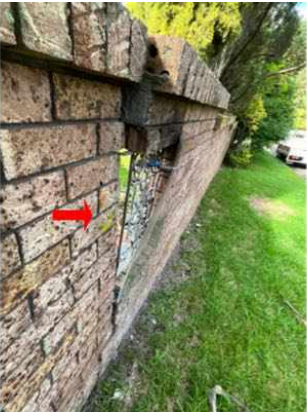
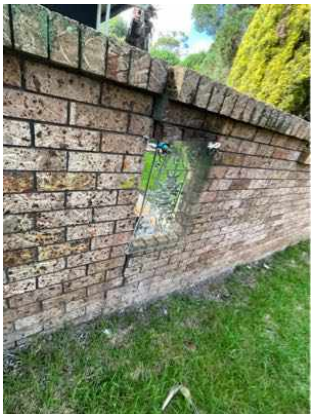
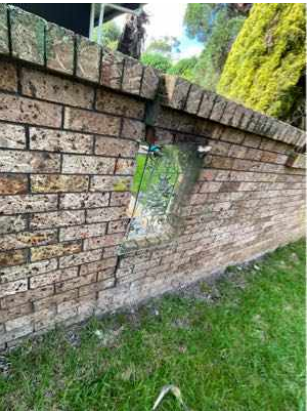
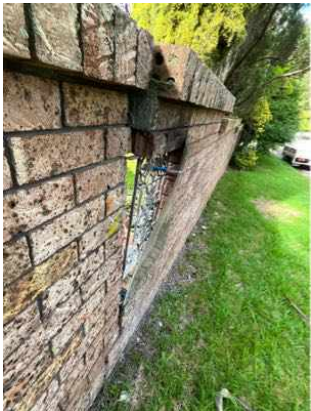
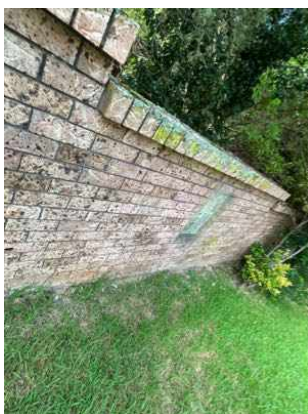
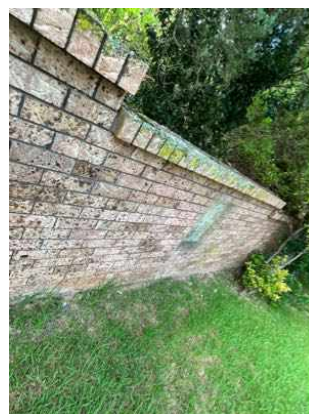
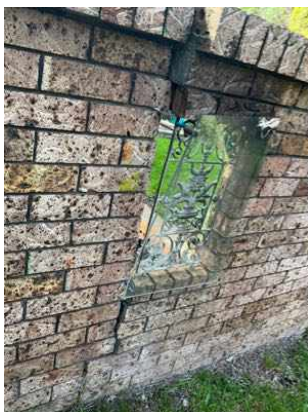
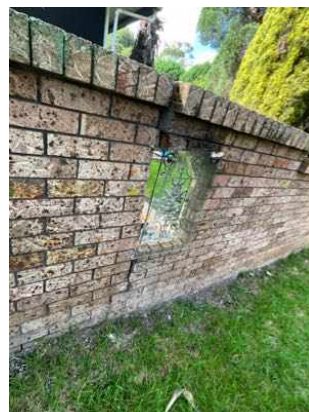
Finding 2.02

Information: A section of the masonry fence wall in boundary is leaning. The movement appears to originate from the base, suggesting inadequate footing, ground movement, or poor structural tie-back to adjoining walls or posts.

This is considered a defect under AS 4349.1-2007, as it poses a safety risk if movement continues or if the wall collapses. It may also indicate subsoil instability or

A qualified structural engineer or licensed bricklayer should assess the extent of displacement and recommend appropriate remedial action. This may involve partial demolition and reconstruction with reinforced footing or bracing to ensure long-term stability.

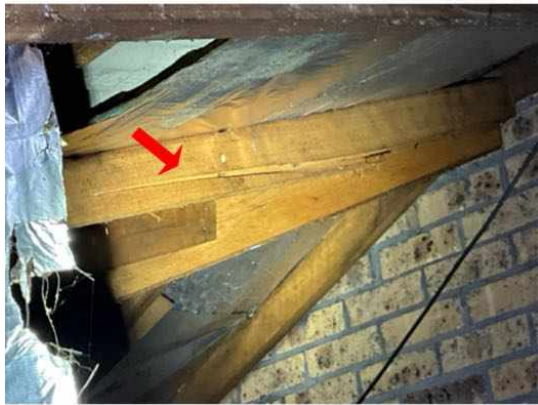
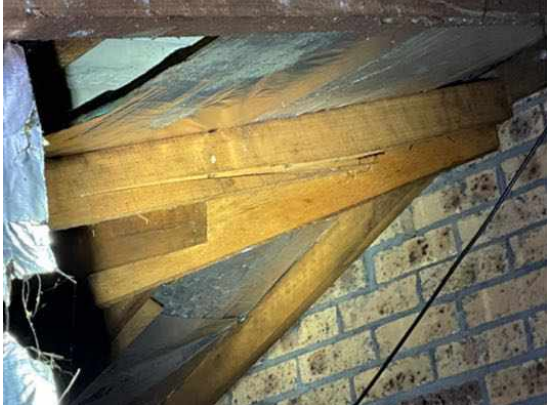
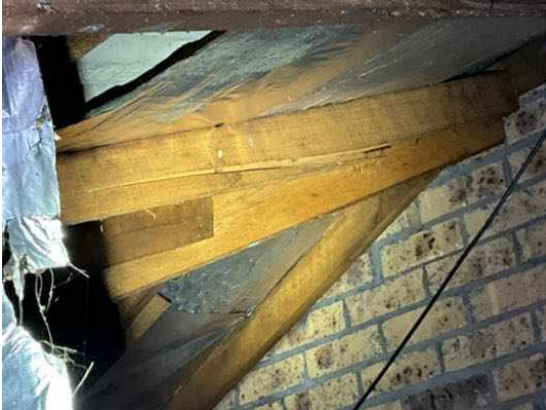
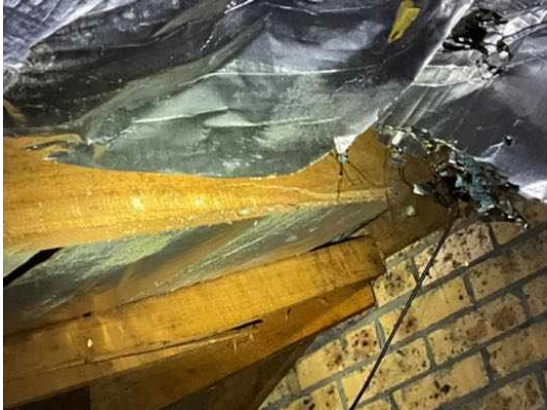
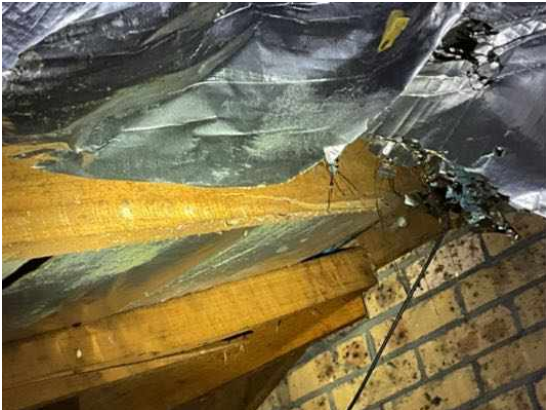
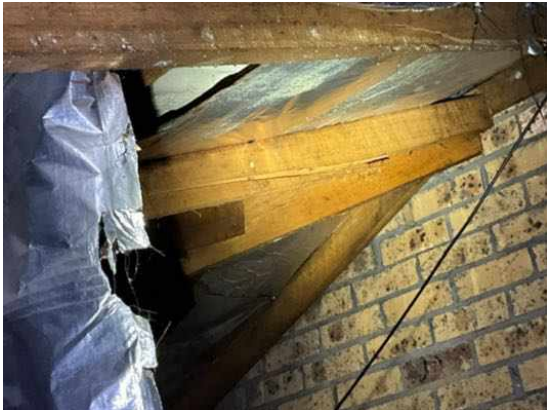
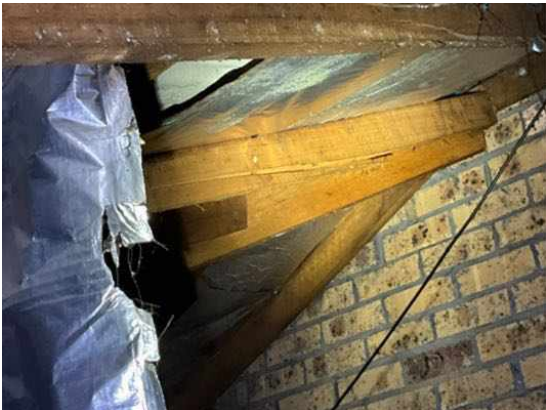
Finding 2.03

Building:	Main Building
Location:	Garage void
Finding:	Roof Cavity - crack in one of the trusses
Information:	There is a crack in one of the trusses in the roof cavity.

The crack in the truss compromises the structural integrity of the roof, potentially leading to partial or complete collapse. This poses a significant safety hazard to occupants and can cause extensive damage to the property, especially during adverse weather conditions like heavy rainfall or strong winds.

A licensed structural engineer or a qualified contractor experienced in roof truss repair should be contacted immediately. They can assess the extent of the damage, recommend appropriate repairs or replacements, and carry out the necessary work to restore the structural integrity and safety of the roof.

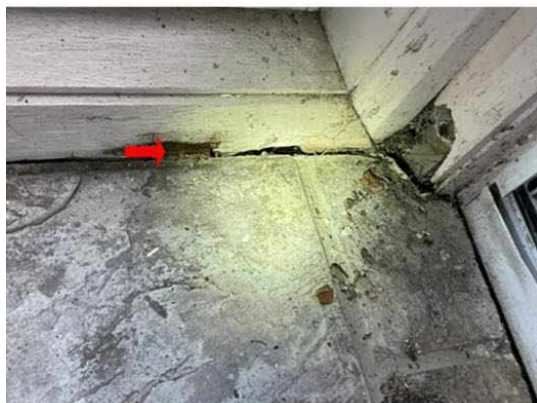
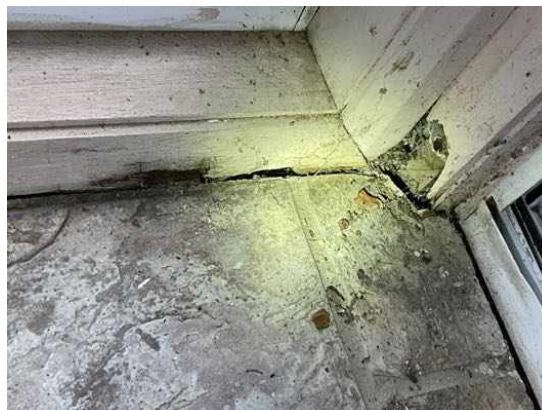
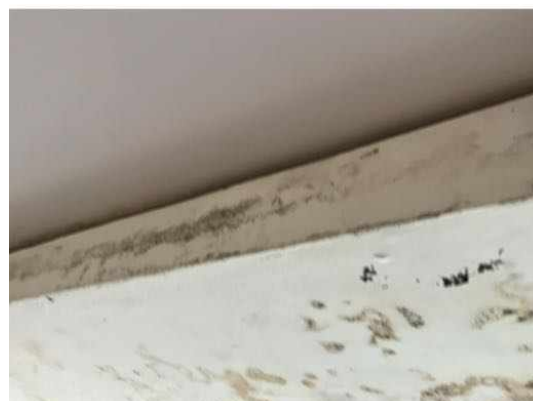
Finding 2.04

Building: Main Building
Location: Spa
Finding: Water damage
Information: The area has sustained water damage resulting in potential structural issues. This damage compromises both the aesthetic and functional aspects.

1 **Plumber:** If the water damage is due to plumbing issues, a plumber can fix leaks and ensure there are no further water-related problems.

2 **General Contractor:** If the damage is extensive and affects the surrounding area, a general contractor can coordinate the repair work, including any related structural or cosmetic repairs.

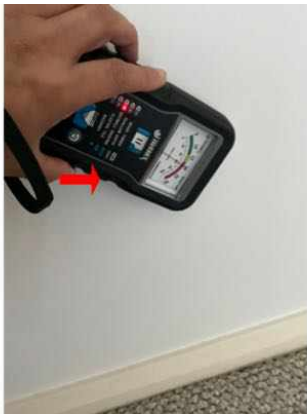
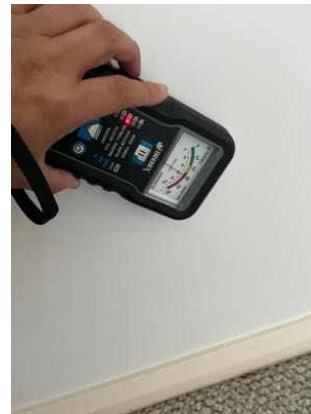
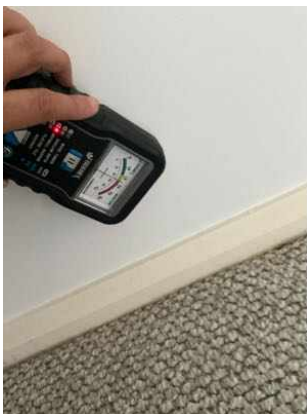
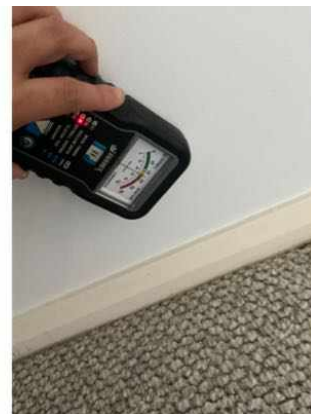
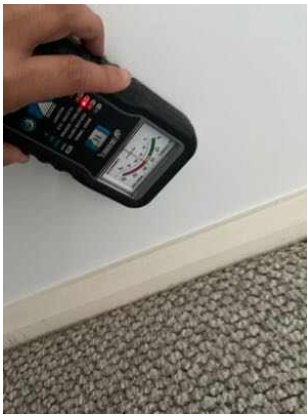
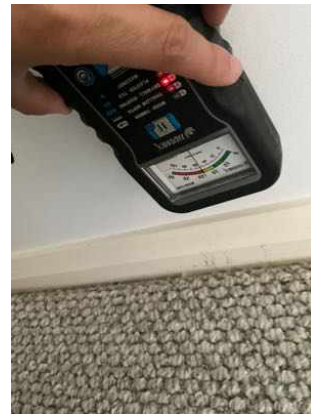
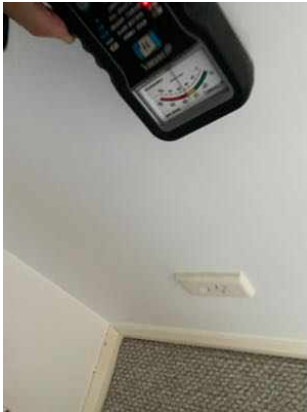
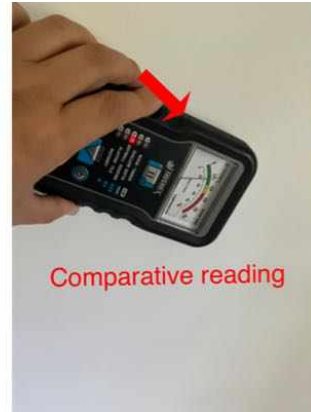
Finding 2.05

Building:	Main Building
Location:	Entrance Living Room
Finding:	Damp - Rising
Information:	Rising damp describes the upward movement of water in low sections of building elements (e.g. walls) by capillary action - the movement of water through porous materials such as bricks, sandstone or mortar.

Rising damp is generally managed by the installation of a damp proof course during construction. A Damp Proof Course (DPC) is an impermeable barrier at the base of the wall above ground level. However, many 19th Century buildings have no damp course installed, or the materials have failed. The DPC may have been omitted as a

consequence of poor workmanship, or it may have been bridged where materials built up against the side of the house allow moisture ingress above the DPC level.

The first step in addressing rising damp is to diagnose the cause. The identified cause should be addressed first before addressing the appearance and other defects which have resulted from the rising damp. If the original cause is not resolved, further cases of damp are likely to ensue, resulting in secondary defects.

Consultation with a qualified plumber is advised immediately to identify the cause of the damp and perform remedial works as required.

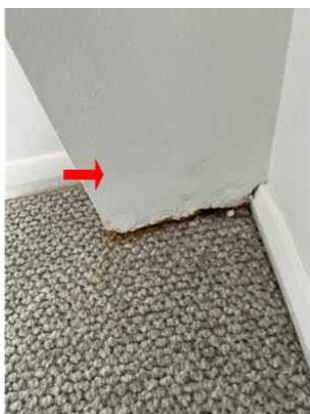
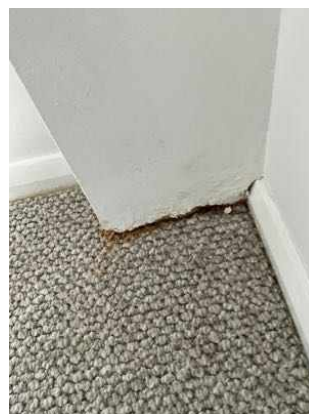
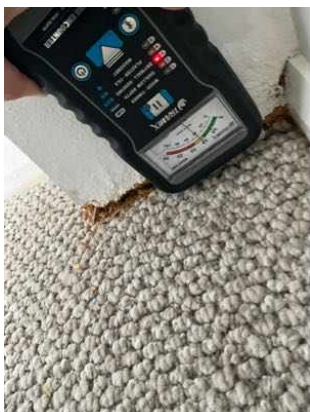
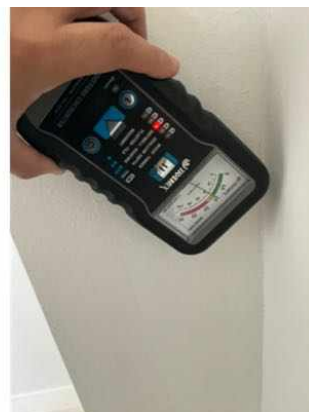
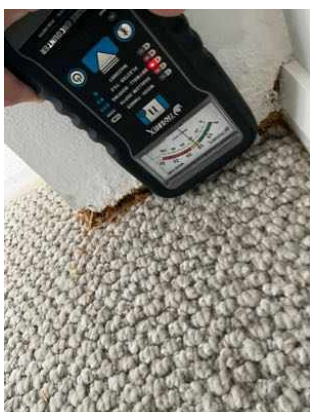
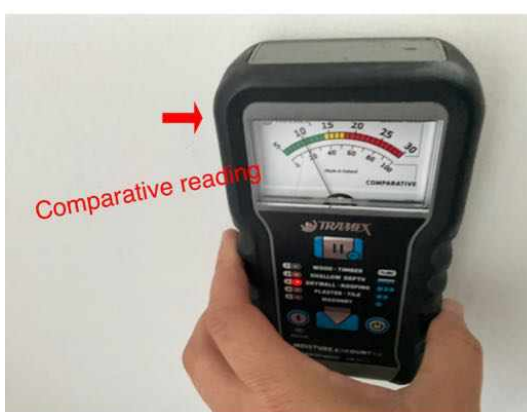
Finding 2.06

Building:	Main Building
Location:	Bedroom 3
Finding:	Water damage
Information:	The area has sustained water damage resulting in potential structural issues. This damage compromises both the aesthetic and functional aspects.

1 **Plumber:** If the water damage is due to plumbing issues, a plumber can fix leaks and ensure there are no further water-related problems.

2 **General Contractor:** If the damage is extensive and affects the surrounding area, a general contractor can coordinate the repair work, including any related structural or cosmetic repairs.

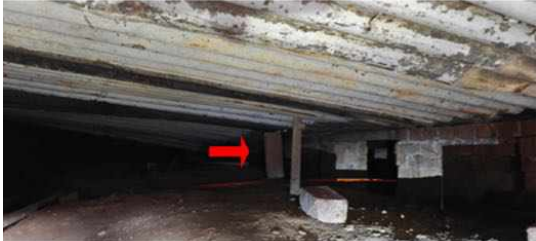
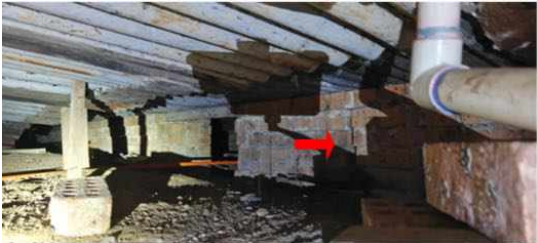
Finding 2.07

Building:	Main Building
Location:	Subfloor
Finding:	Subfloor Piers - Unstable or deteriorated
Information:	Piers to the subfloor structure are unstable, indicating that their structural integrity has been affected. The cause of this instability is likely to be movement by which piers deteriorate at a rapid rate.

The piers are suspected to be failing in their structural purpose, which is likely to lead to a range of major and minor defects. Further (potentially major) damage to the piers and structure may be imminent if left unattended.

Appointment of a Registered Builder specialising in re-stumping is required immediately to assess the condition of the stumps and provide advice on remedial works. This defect should not be left unmanaged.

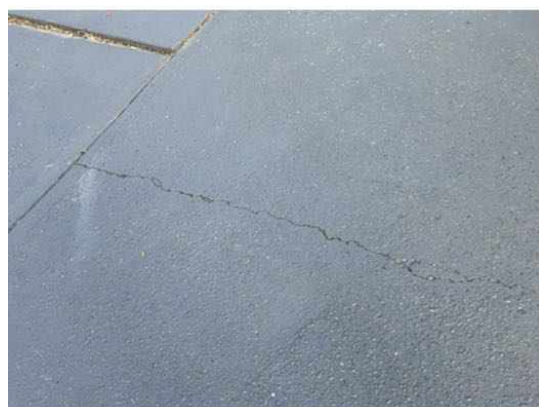
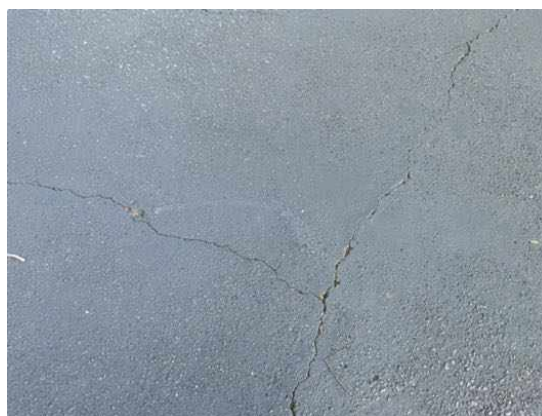
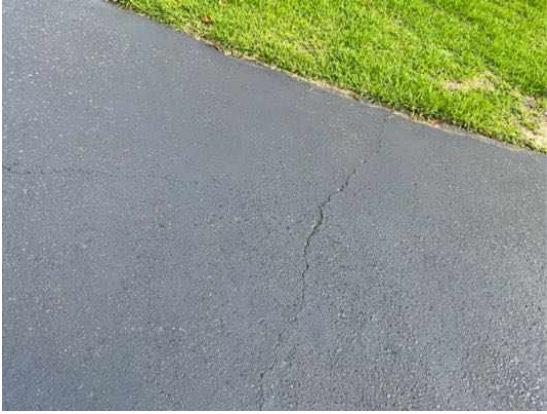
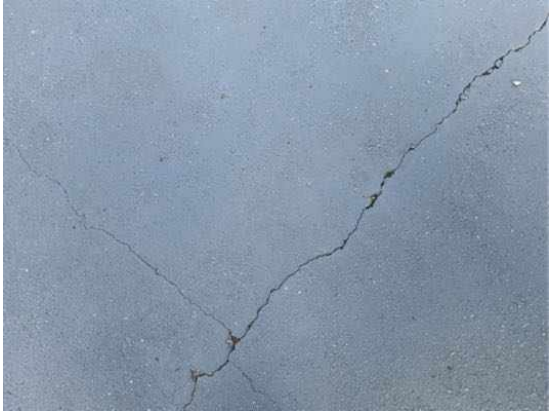
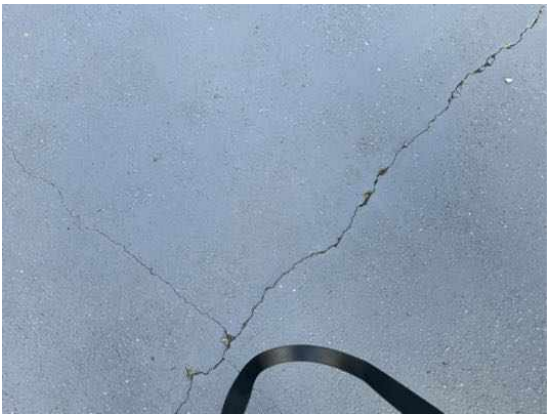
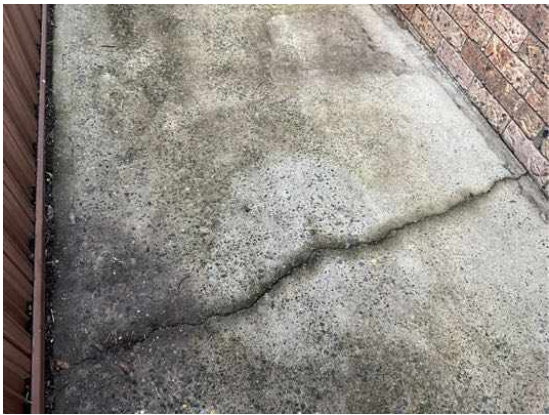
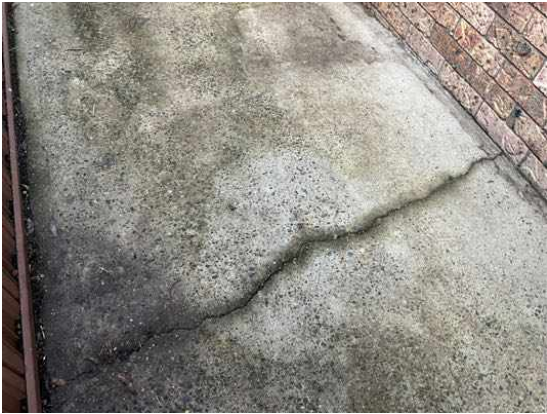
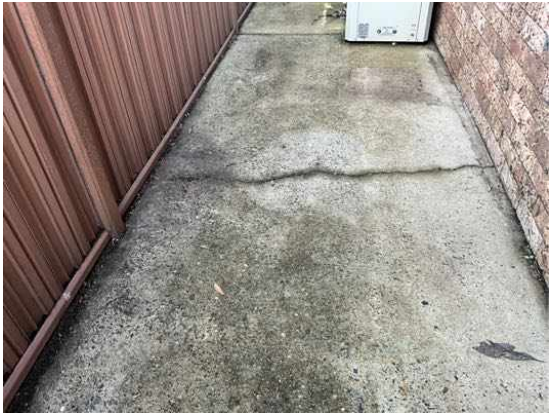
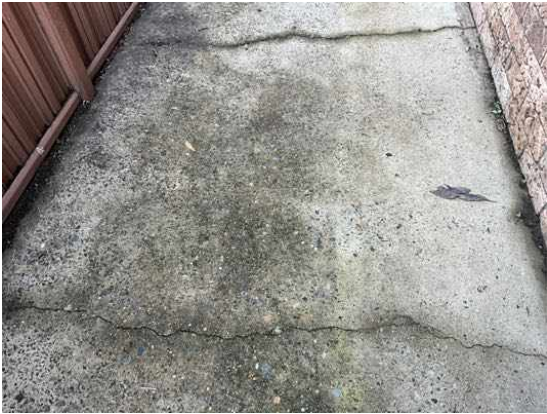
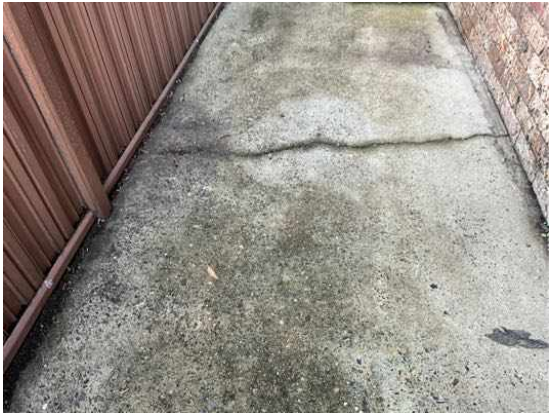
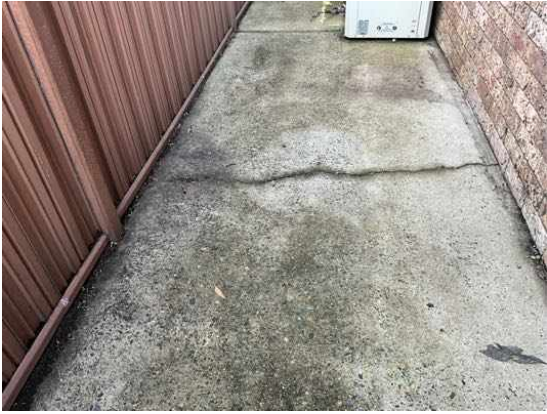
Finding 3.01

Building: Main Building
Location: All Areas
Finding: Noticeable Cracking in Concrete Slab

Information: Noticeable cracking has been observed in the concrete slab, failing to meet the required construction and quality standards.

- Cracks are visible on the surface and may extend through the depth of the slab.
- Evidence of improper curing or inadequate reinforcement leading to cracking.

- Compromised structural integrity of the slab, potentially leading to failure under load.
- Water ingress through cracks, causing corrosion of reinforcement and further weakening the structure.
- Potential trip hazards and aesthetic issues, reducing the overall value and safety of the property.
- Increased maintenance and repair costs due to ongoing deterioration.

- A structural engineer should be engaged to assess the extent of the cracking and recommend appropriate repair methods.
- A licensed contractor or concrete repair specialist should carry out the recommended repairs under the guidance of the structural engineer.

A detailed inspection should be conducted post-repair to confirm compliance with the required standards and to ensure that the structural integrity of the concrete slab has been restored.

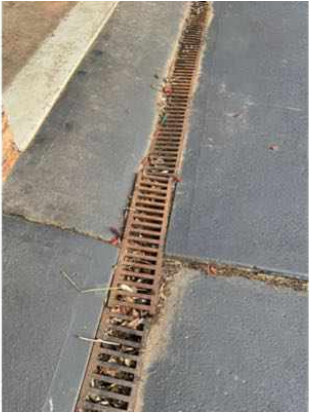
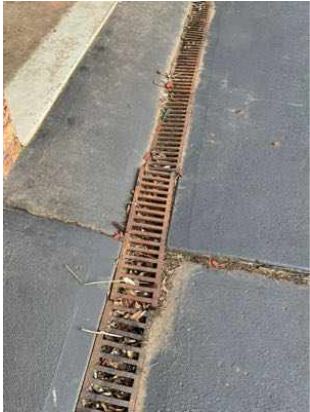
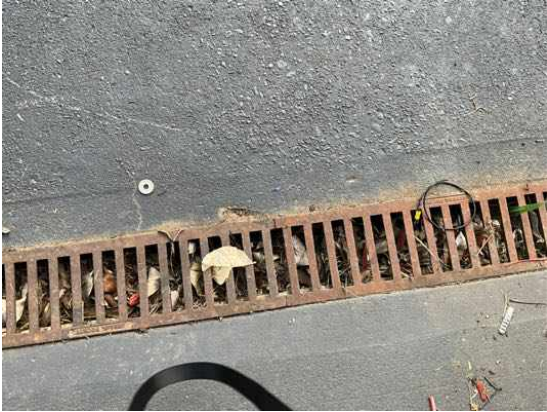
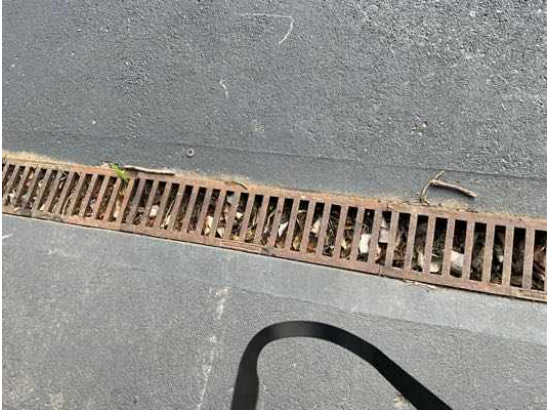
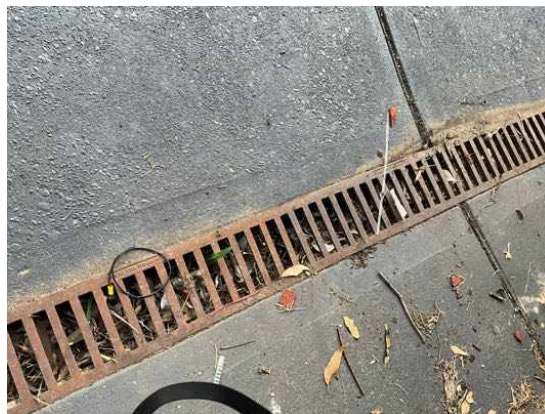
Finding 3.02

Building: Main Building
Location: Driveway
Finding: Blocked channel Drain
Information: Blocked channel Drain , observed vegetation grown in the gutter , advised channels to be cleaned.

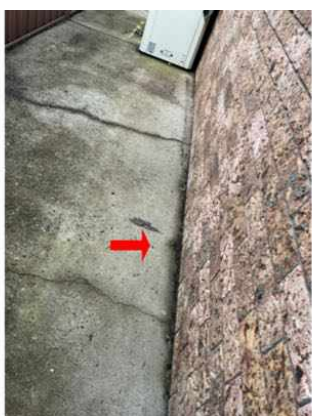
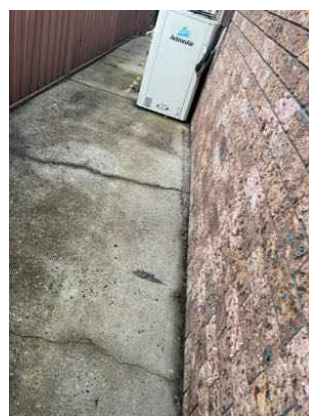
Finding 3.03

Information: The perimeter paving or ground levels were found to have an inadequate slope away from the adjoining building structure, creating potential for water pooling in this area.

Perimeter paving is required to fall from the building by a minimum of 25mm in the first metre and bare ground should fall away from the house by 50mm in the first meter. This standard ensures that excessive moisture does not pool around the base of building structures, which creates potential for water and structural damage, as well as making the area susceptible to termite and timber pest activity.

Where paving or ground levels do not have adequate fall, a licensed paving contractor should be appointed to install or remove and re-level pavement.

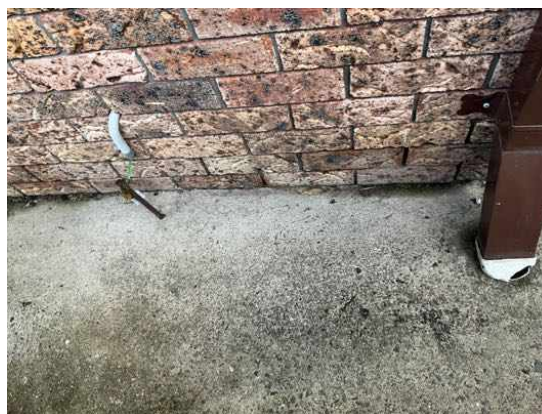
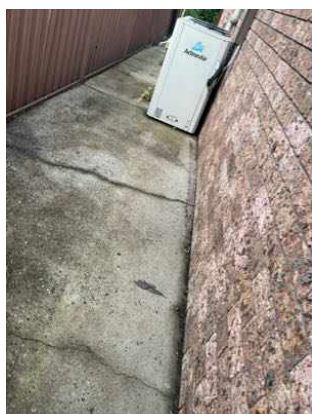
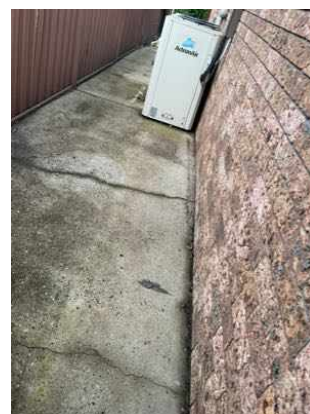
Finding 3.04

Building:	Main Building
Location:	Exterior walls - left side
Finding:	Downpipe cracked and damaged
Information:	The downpipe is visibly cracked and damaged, compromising its ability to effectively discharge rainwater.

- Water leakage at the break point may lead to pooling near the building foundation, increasing the risk of moisture ingress and structural damage.
- Soil erosion and deterioration of landscaping around the area.
- Potential blockage due to debris entering through the cracked section.

- A licensed plumber or roof plumber should be engaged to replace or repair the damaged section of the downpipe and ensure proper reconnection to the stormwater system.

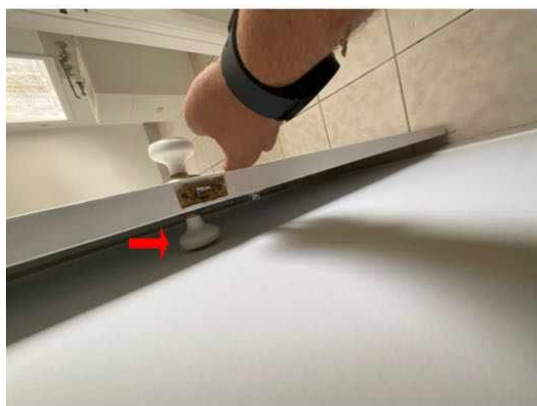
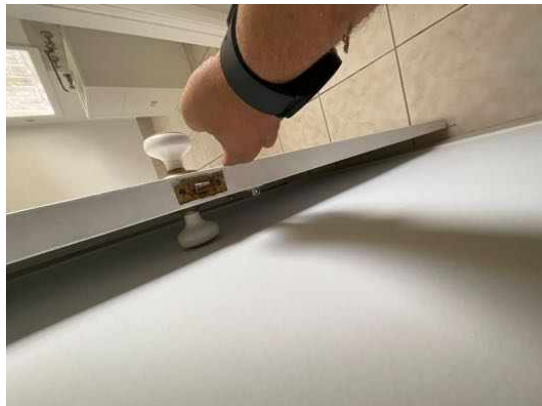
Finding 3.12

Building: Main Building
 Location: Toilet (WC)
 Finding: Missing Door Stopper
 Information: The door lacks a stopper, which is essential to prevent the door from swinging too far and potentially damaging the wall or the door handle. The absence of a door stopper increases the likelihood of impact damage to both the door and surrounding surfaces over time.

- **Damage Risk:** Moderate risk of damage to the door handle, wall, or door itself from repeated impacts when the door is opened forcefully or by a gust of wind.
- **Wear and Tear Risk:** Increased wear on door hardware and hinges due to the potential for abrupt stops without a dedicated stopper.

This issue is a minor defect but should be addressed to prevent potential damage and maintain the integrity of the door and surrounding areas.

- **Engage a Handyperson or Carpenter:** A handyperson or carpenter should install a suitable door stopper to prevent excessive door movement. This could be a floor-mounted or wall-mounted stopper depending on the space and door design.

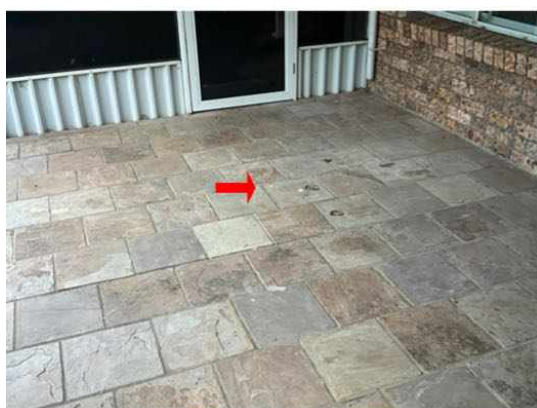
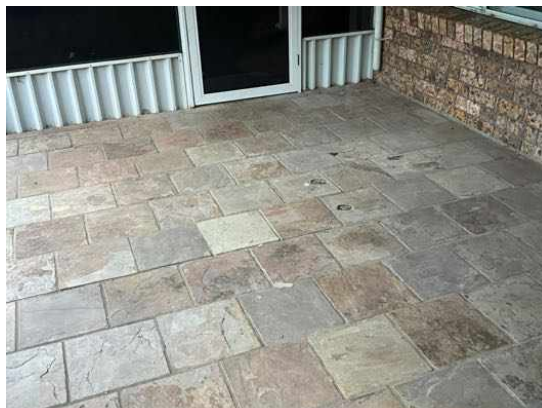
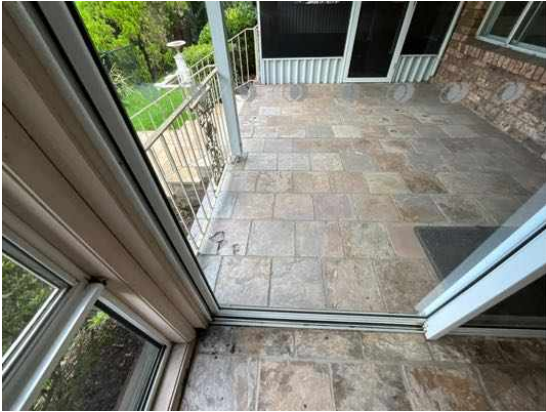
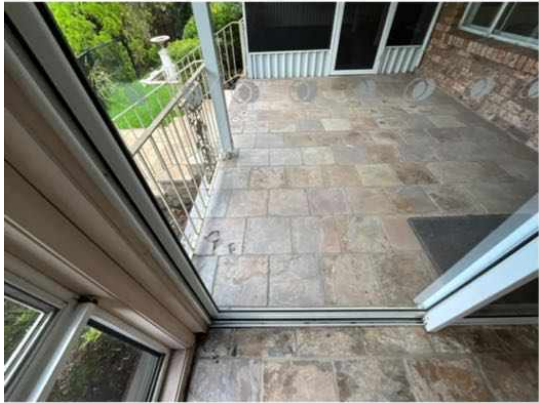
Finding 3.13

Building: Main Building
 Location: Spa
 Finding: Tile - Floor Tile Damaged
 Information: A floor tile is visibly damaged, showing a chipped/broken section on the surface.

The damaged tile presents a trip hazard, may lead to cuts if stepped on barefoot, and can allow moisture ingress into the substrate, which may cause further deterioration or loosening of adjacent tiles. It also affects the overall appearance of the floor.

A licensed tiler should be engaged to remove the damaged tile and install a matching replacement. If spare tiles are unavailable, additional remedial work may be required to blend the repair with surrounding finishes.

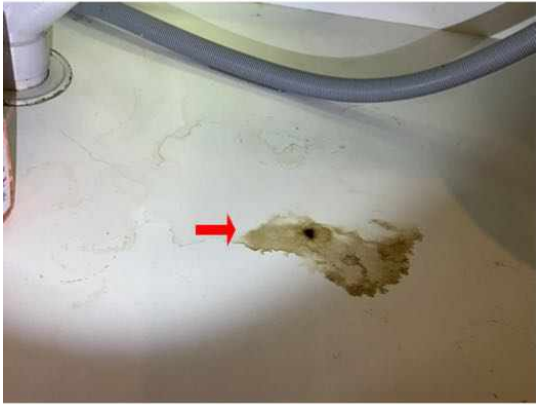
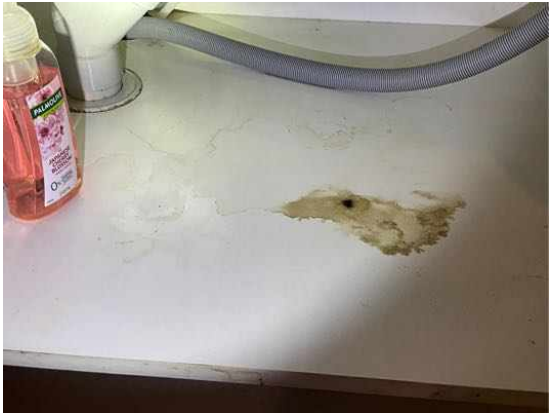
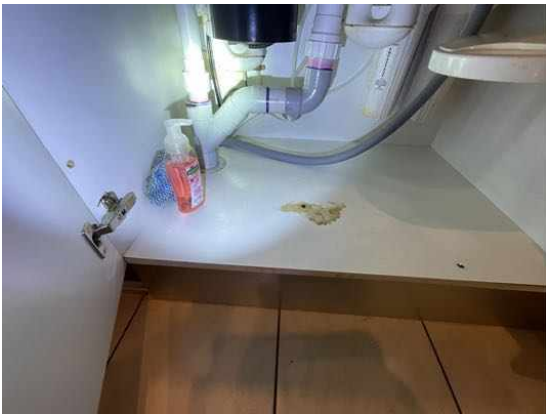
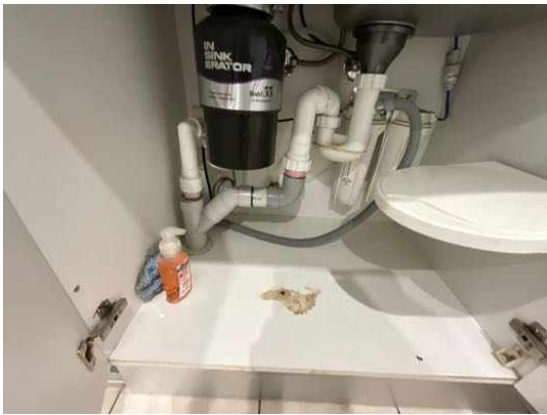
Finding 3.14

Building: Main Building
Location: Kitchen
Finding: Water Stains in Vanity
Information: "Water stains observed in the vanity area, compromising its appearance and potentially causing damage."

Continued water exposure may lead to material damage, mold growth, and diminished aesthetic appeal.

A licensed plumber or maintenance professional should assess and fix any leaks contributing to the water stains, while a cleaning or restoration service may be needed to address the visible stains and prevent further damage.

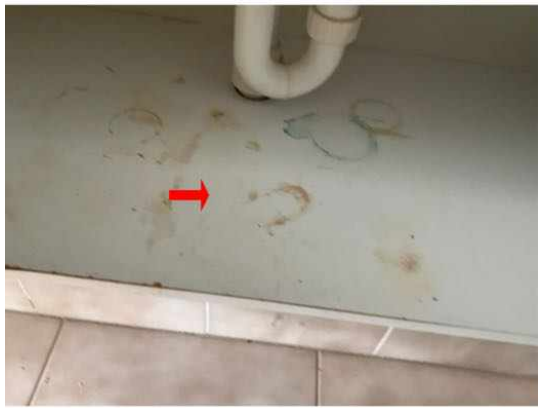
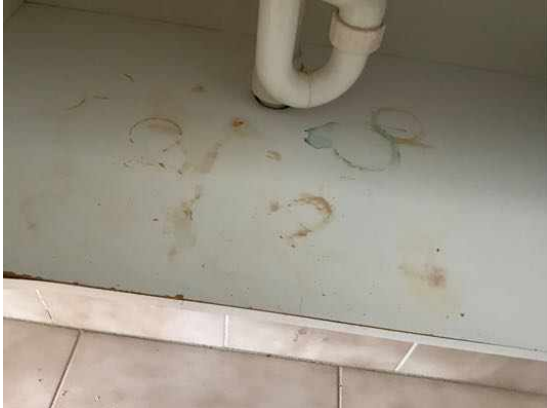
Finding 3.15

Building: Main Building
Location: Ensuite
Finding: Water Stains in Vanity
Information: "Water stains observed in the vanity area, compromising its appearance and potentially causing damage."

Continued water exposure may lead to material damage, mold growth, and diminished aesthetic appeal.

A licensed plumber or maintenance professional should assess and fix any leaks contributing to the water stains, while a cleaning or restoration service may be needed to address the visible stains and prevent further damage.

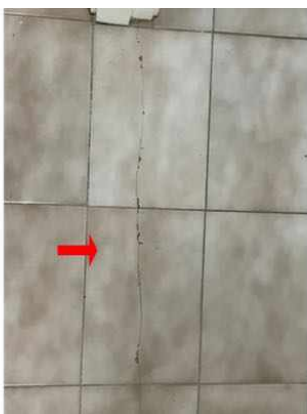
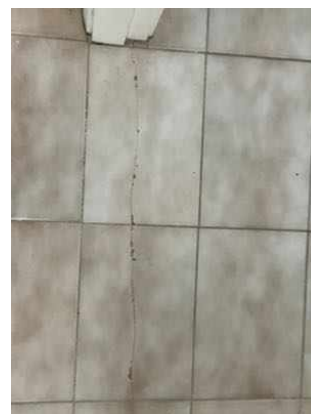
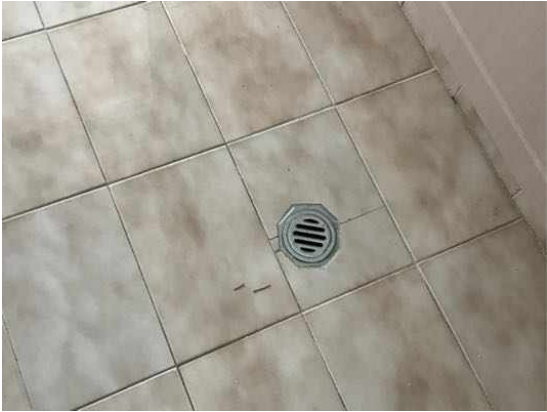
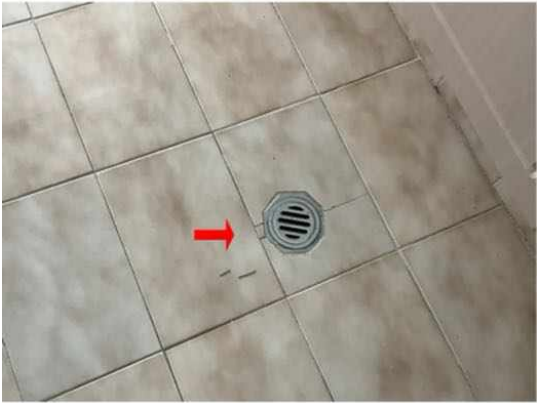
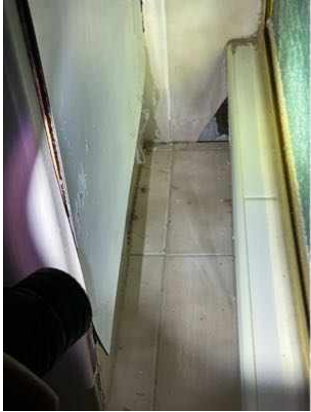
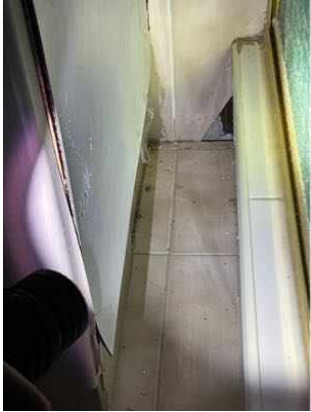
Finding 3.16

Finding: Tiles - Cracked or damaged

Information: Cracking was evident to the tiling in this area at the time of inspection. While the cracking appears to be minor, this area is frequently exposed to water, allowing potential for water penetration into adjoining sections of walls or flooring.

If left unmanaged, water penetration to these areas may lead to subsequent water damage, which is likely necessitate repair work to affected building elements.

A tiling contractor should be appointed to ensure that no further water damage occurs. The re-application of silicone and grouting throughout remaining tile work is also advised, to further protect the area against water penetration.

Where water penetration has led to water damage, appointment of a relevant tradesperson may be required to repair damaged building elements.

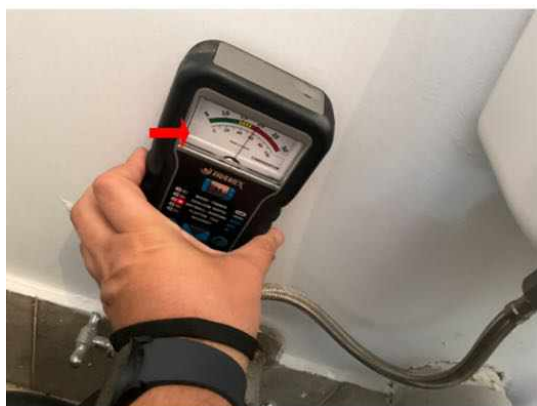
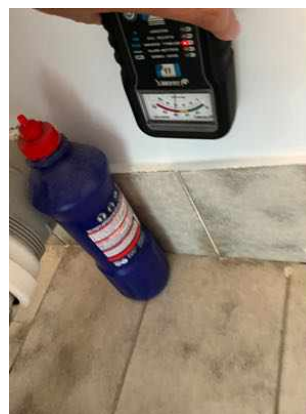
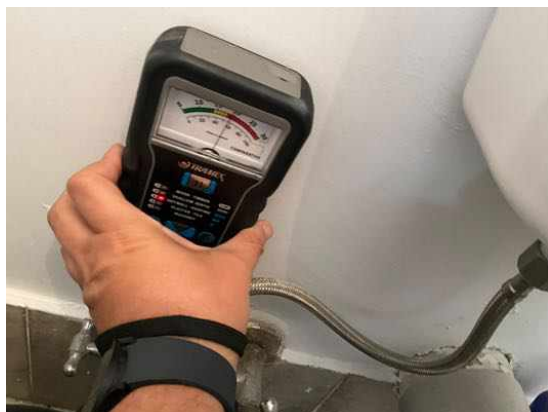
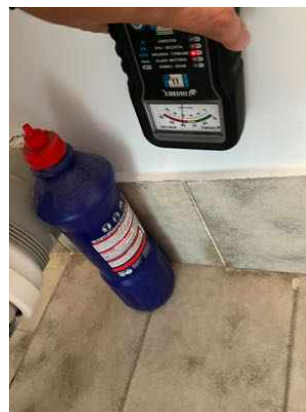
Finding 3.17

Building: Main Building
Location: Toilet (WC)
Finding: Evidence of excessive moisture - Drywall
Information: Excessive moisture is present at the time of , indicating a potential water leakage issue within the wall.

The prolonged presence of moisture can lead to mold growth, deteriorate the structure, and create an environment conducive to health hazards. Additionally, it may compromise the adhesive holding the tiles, leading to their detachment.

A licensed plumber or a qualified contractor specializing in water damage remediation should investigate the source of the moisture, fix any leaks, and address the damage. Additionally, replacing affected tiles and ensuring proper waterproofing are crucial to preventing future issues.

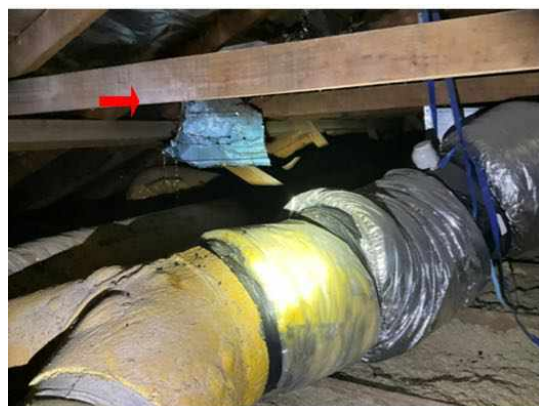
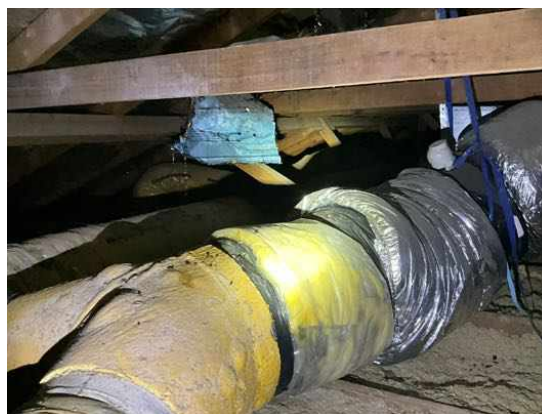
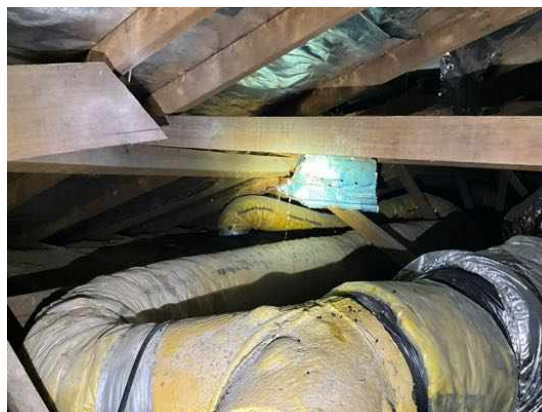
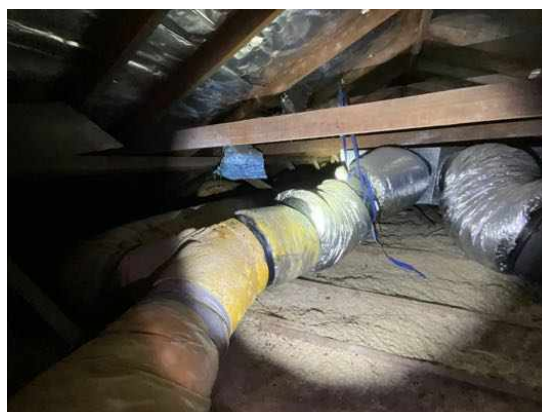
Finding 3.18

Building:	Main Building
Location:	Roof Void
Finding:	Sarking - Damaged
Information:	Sarking, a laminated aluminium foil applied to the interior of the roof covering, assists in insulating the property and acting as a vapour-barrier to the roof void and, subsequently, to the household.

Where sarking is damaged, both insulation and moisture protection of the property are inhibited. This creates a loss of energy and thus negatively impacts the energy efficiency of the property, allowing potential for moisture ingress from condensation or leaking roof tiles.

It is important to repair any holes or damaged sections of sarking to ensure that the building material is fully functional. A registered builder or qualified carpenter should be consulted to provide further advice on this defect and to perform rectification works at client discretion.

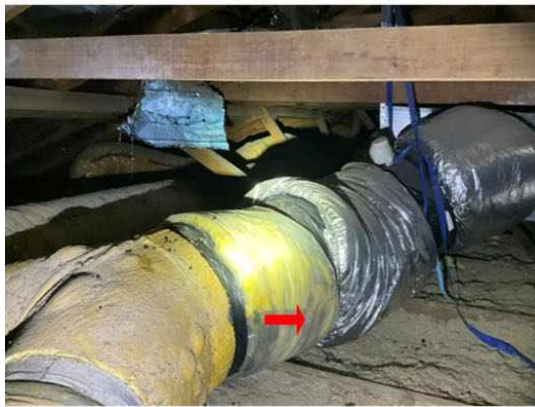
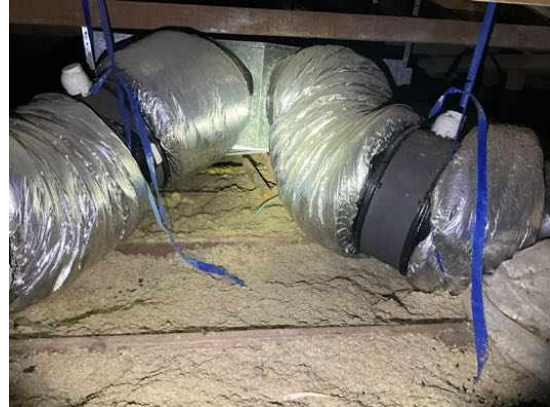
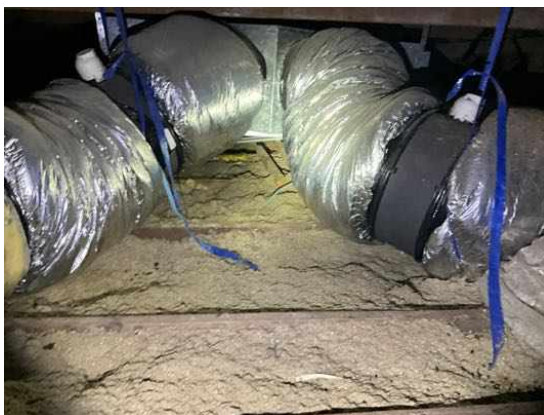
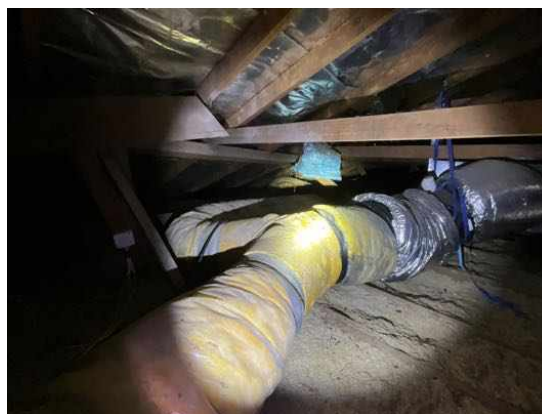
Finding 3.19

Building:	Main Building
Location:	Roof Void
Finding:	Air Conditioning Ducting (Unsupported / Lying on Insulation)
Information:	The air conditioning flexible ducting within the roof void is observed to be laid directly over the ceiling insulation and not adequately supported or suspended. This installation is not in accordance with good building practice and may not comply with relevant requirements of AS 4254 – Ductwork for Air-Handling Systems, which requires ductwork to be properly supported to prevent sagging, kinking, or restriction of airflow.
	Risk

- Restricted airflow due to kinks/sagging, reducing system efficiency and performance
- Increased wear on the HVAC system, potentially shortening its lifespan
- Compression of insulation, reducing its thermal effectiveness
- Potential for condensation build-up and moisture-related issues
- Risk of long-term duct damage or disconnection

It is recommended that a licensed HVAC technician (air conditioning contractor) be engaged to properly support and suspend the ducting using appropriate hangers/straps. The system should be reinstalled or adjusted to ensure compliance with relevant Australian Standards and optimal performance.

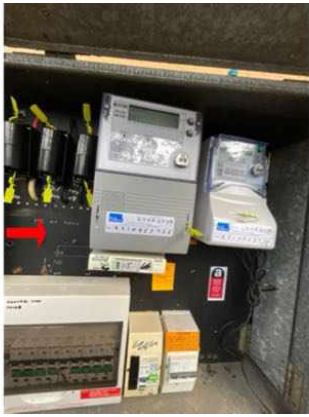
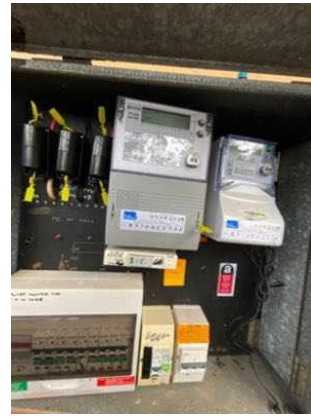
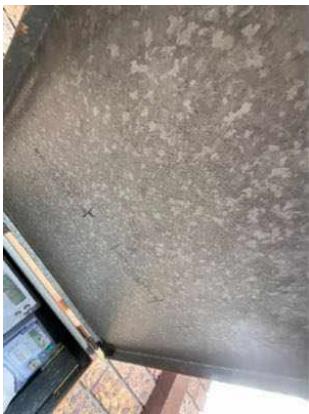
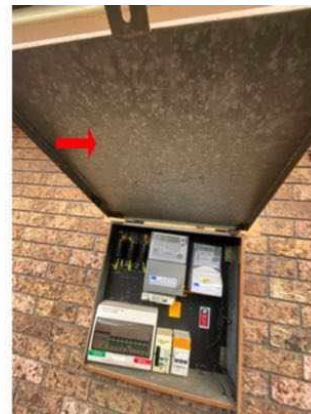
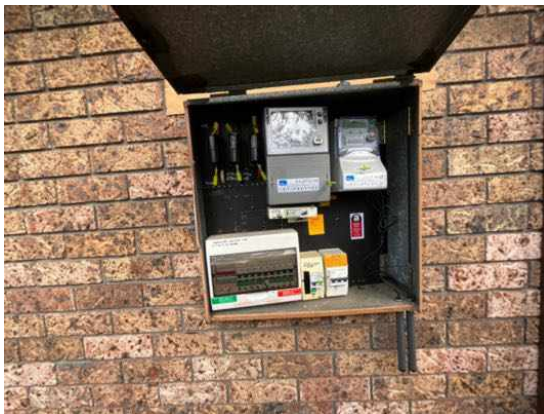
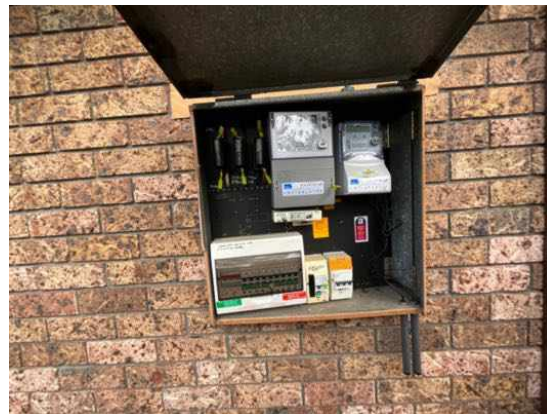
Building: Main Building
 Location: Exterior walls - left side
 Finding: No Evidence of Termite Management System - Durable notice / Legible Sticker
 Information: The application of a pre & post-construction chemical termite barrier is highly recommended for all properties. Such barriers are highly effective in preventing termite attack on any timber building elements throughout the property.

Client must seek further information from the vendor or real estate agent if the

conditions of termite management systems were maintained.
