Building and Timber Pest Inspection Report

Inspection Date: Tue, 24 Mar 2026

Property Address: 18 Bounty Ave, Castle Hill NSW 2154,
Australia

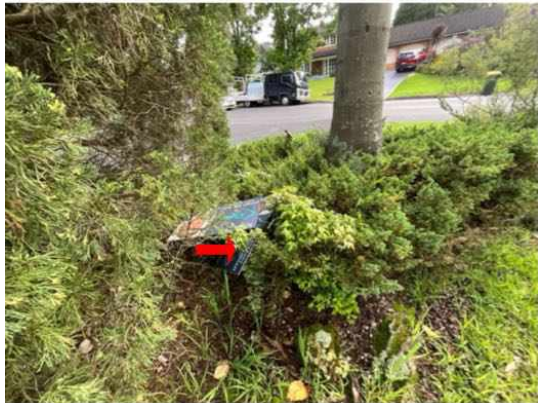
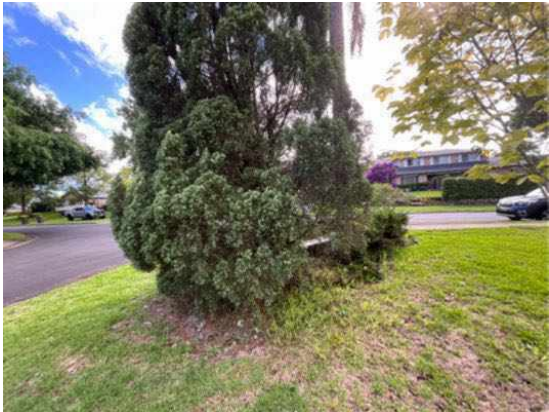
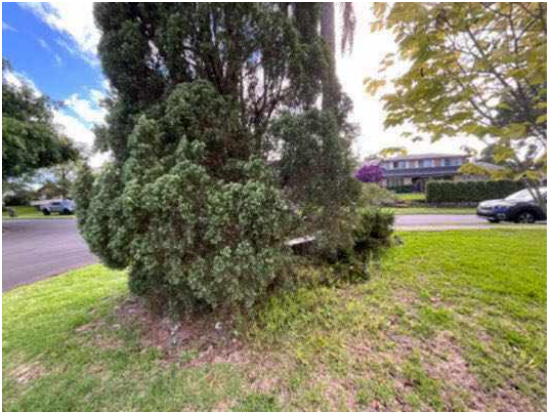
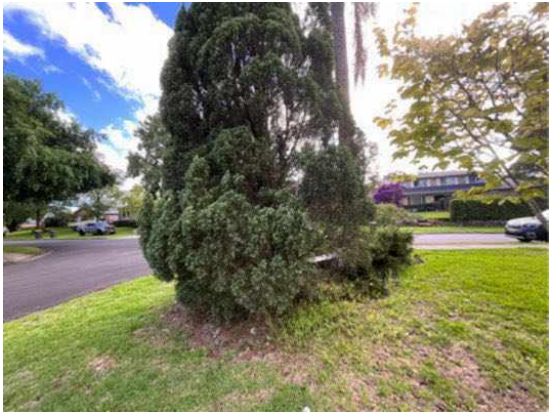
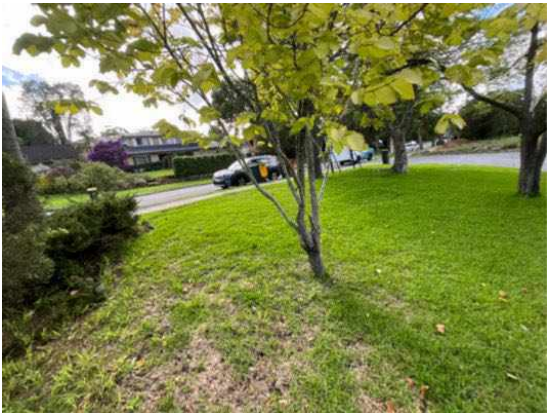
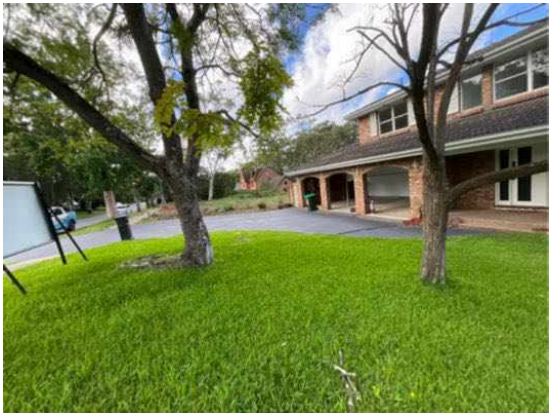
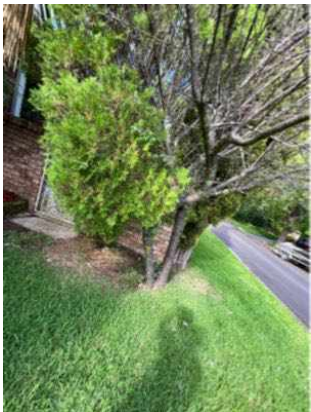
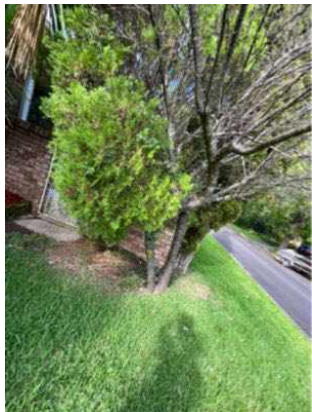
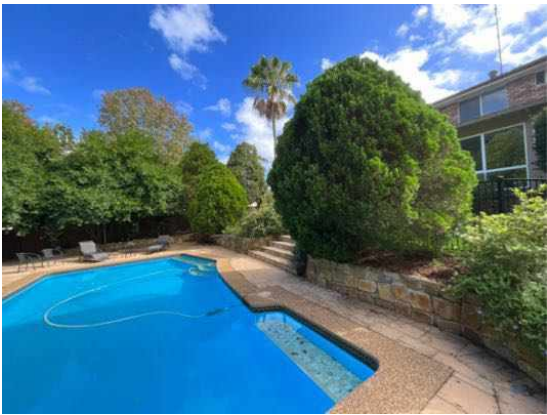
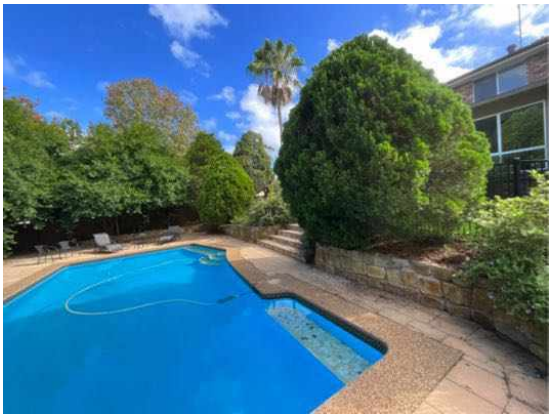
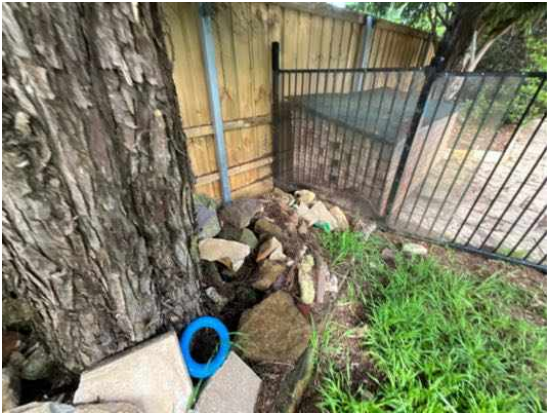
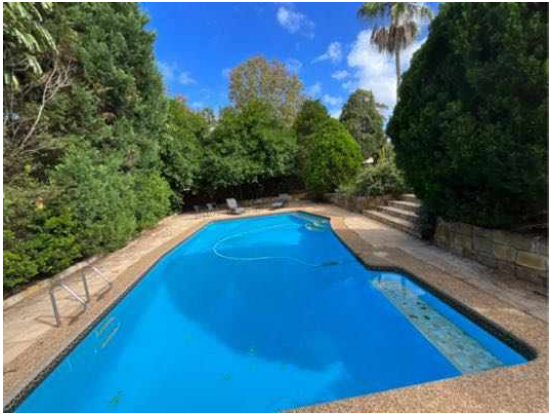
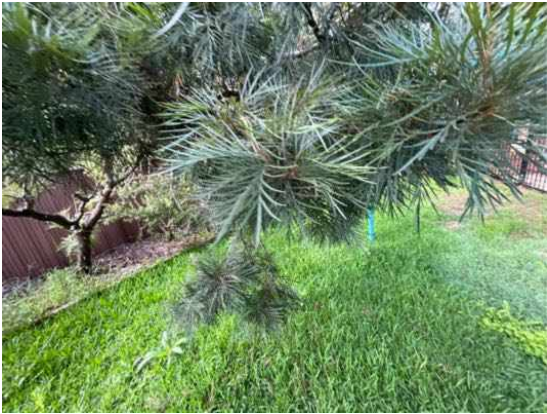
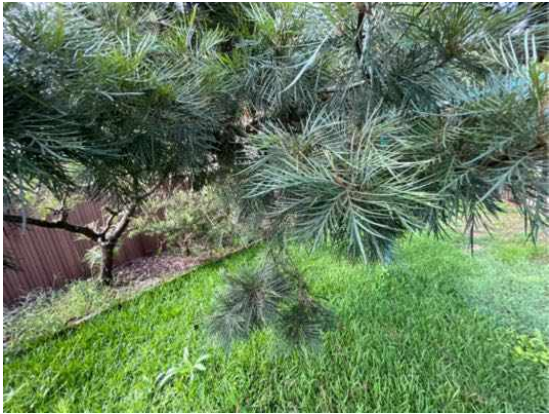
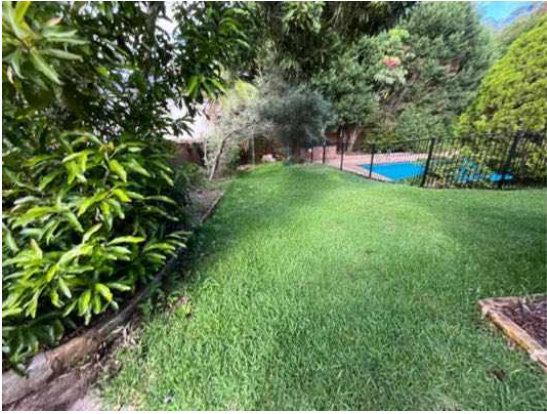
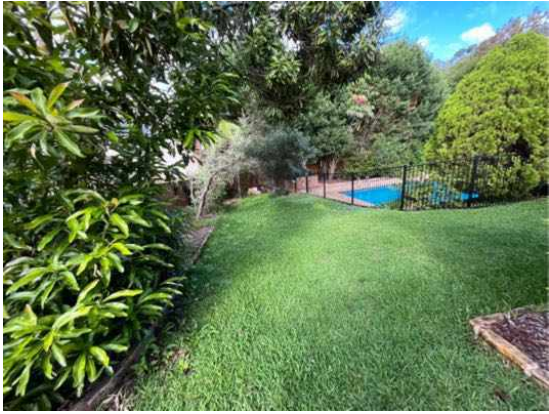
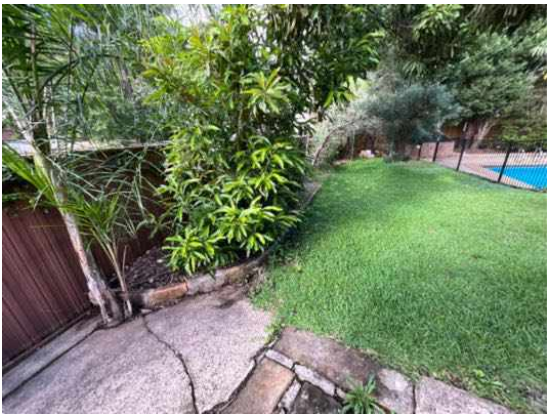
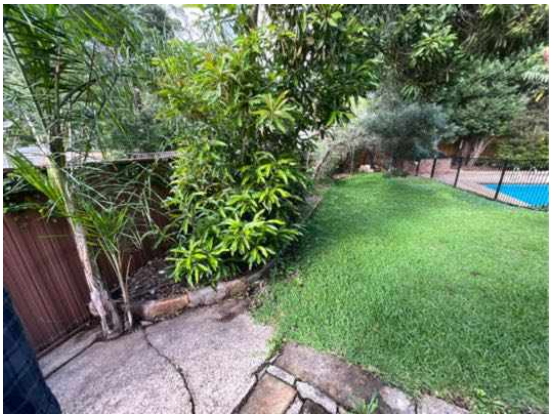
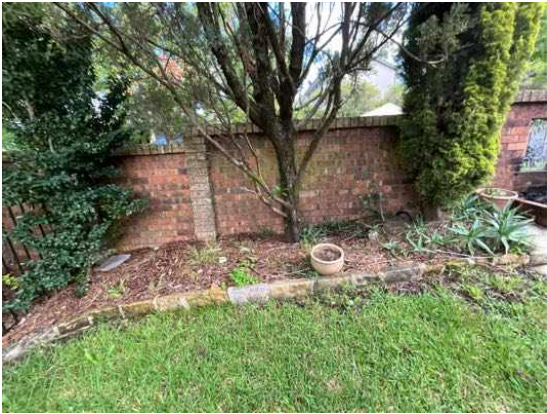
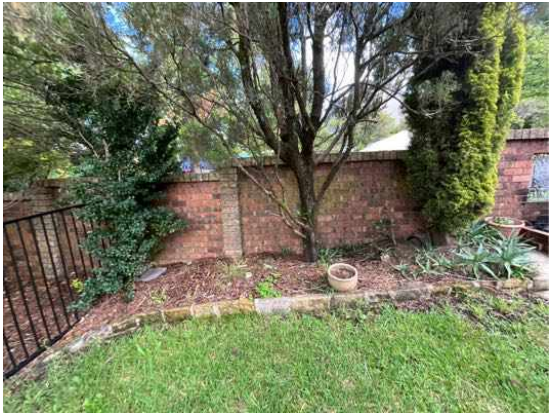
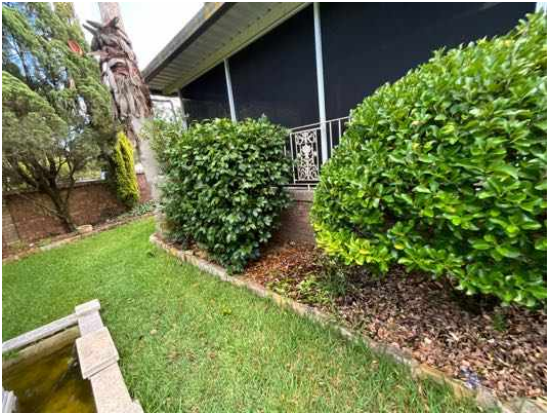
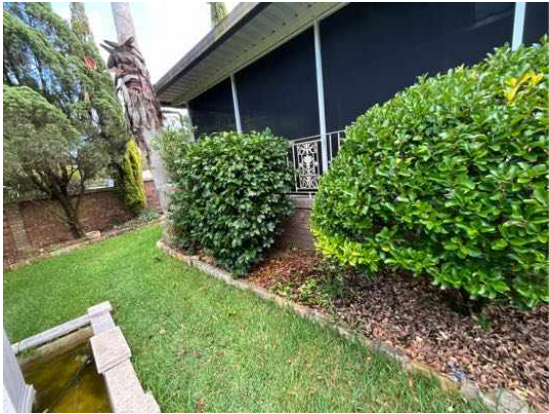
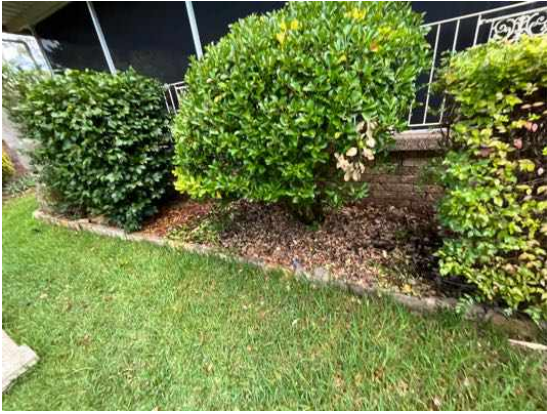
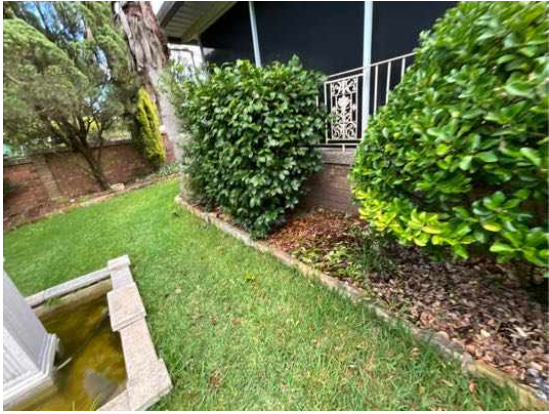
Finding 6.02

Building:	Main Building
Location:	All Areas
Finding:	Dense vegetation around a property can increase the risk of termite infestation
Information:	The presence of dense vegetation around a property can increase the risk of termite infestation, as it provides a conducive environment for them. To address this, consider maintaining a clear space between the vegetation and your home. If you suspect a termite issue, it's advisable to consult with a licensed pest control professional for inspection and treatment.

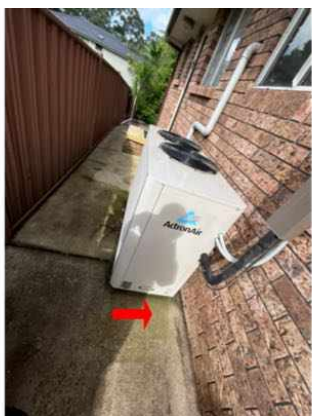
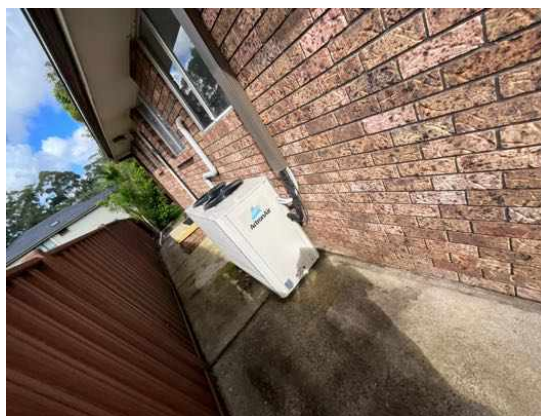
Finding 6.03

Building:	Main Building
Location:	All Areas
Finding:	Bridging or Obstruction Conducive environment for Termites
Information:	Bridging of termite barriers occurs when termites bridge (usually by building a mud tunnel) a termite barrier or inspection inspection zone or where termites have a passage, allowing them to bridge the barrier.

Where bridging has occurred full inspection is prevented and termites may enter a property in a concealed or undetected manner.

Recommended moving obstructions away from the external walls for further and future inspections.

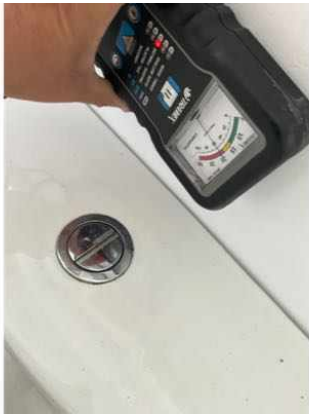
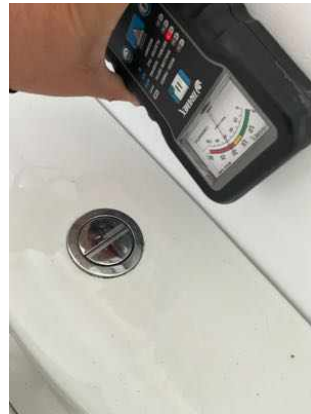
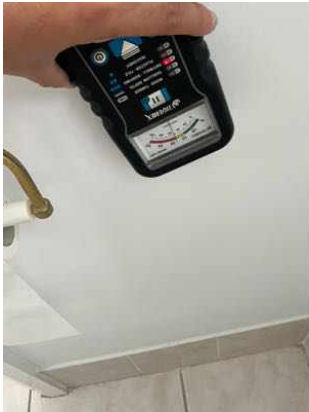
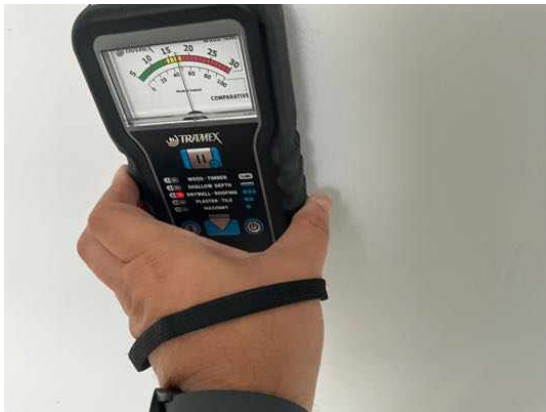
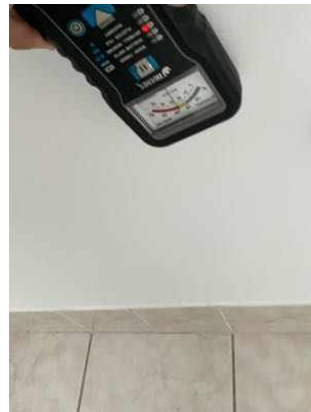
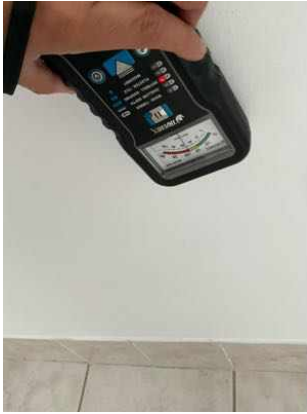
Finding 6.04

Building:	Main Building
Location:	Laundry & Toilet
Finding:	Excessive moisture - Conducive to Timber pest
Information:	Excessive moisture can attract termites and produce conditions that promote fungal growth and wood decay.

Excessive moisture is generally caused by deteriorated inadequate or missing roof drainage leaking plumbing pipes or fixtures poorly plumbed HWS overflows or condenser units and poor site drainage.

Prior to any remedial works being performed a qualified plumber should be appointed to further inspect the property and to identify the cause of the excessive moisture. Works to remove affected building elements may then be necessary and should be performed by an appropriate tradesperson.

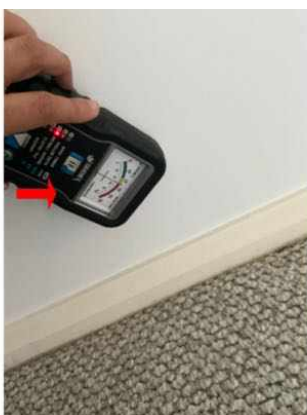
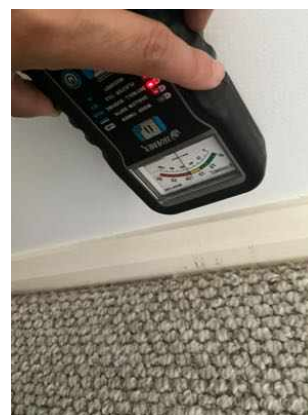
Finding 6.05

Building:	Main Building
Location:	Entrance Living Room
Finding:	Excessive moisture - Conducive to Timber pest
Information:	Excessive moisture can attract termites and produce conditions that promote fungal growth and wood decay.

Excessive moisture is generally caused by deteriorated inadequate or missing roof drainage leaking plumbing pipes or fixtures poorly plumbed HWS overflows or condenser units and poor site drainage.

Prior to any remedial works being performed a qualified plumber should be appointed to further inspect the property and to identify the cause of the excessive moisture. Works to remove affected building elements may then be necessary and should be performed by an appropriate tradesperson.

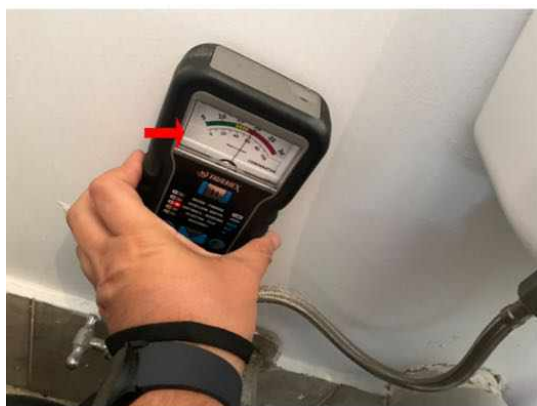
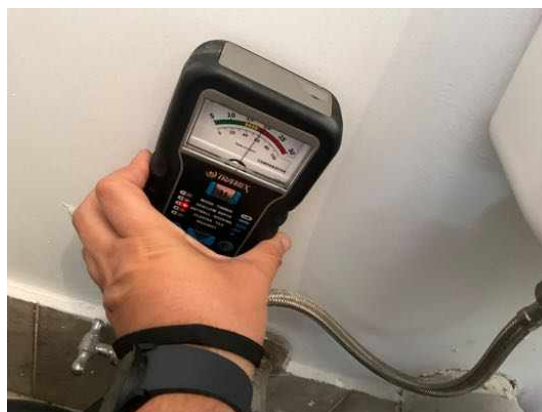
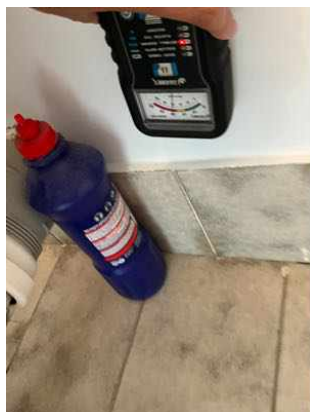
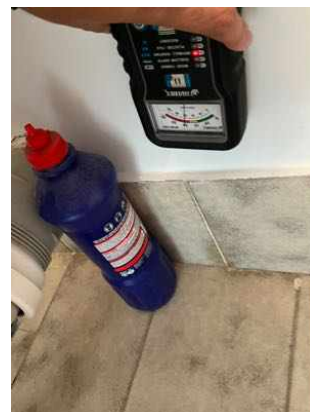
Finding 6.06

Building:	Main Building
Location:	Toilet (WC)
Finding:	Excessive moisture - Conducive to Timber pest
Information:	Excessive moisture can attract termites and produce conditions that promote fungal growth and wood decay.

Excessive moisture is generally caused by deteriorated inadequate or missing roof drainage leaking plumbing pipes or fixtures poorly plumbed HWS overflows or condenser units and poor site drainage.

Prior to any remedial works being performed a qualified plumber should be appointed to further inspect the property and to identify the cause of the excessive moisture. Works to remove affected building elements may then be necessary and should be performed by an appropriate tradesperson.

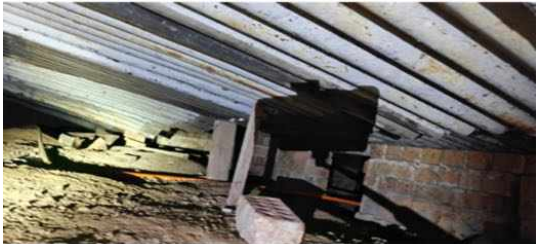
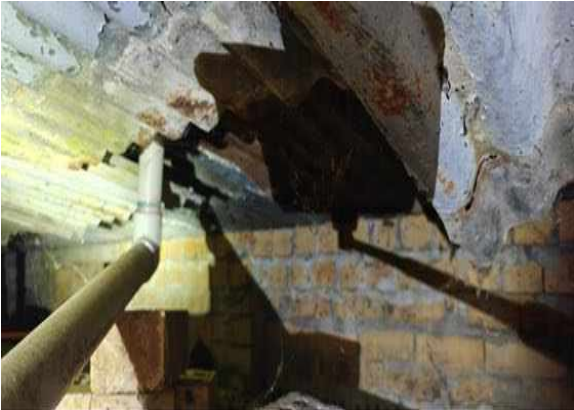
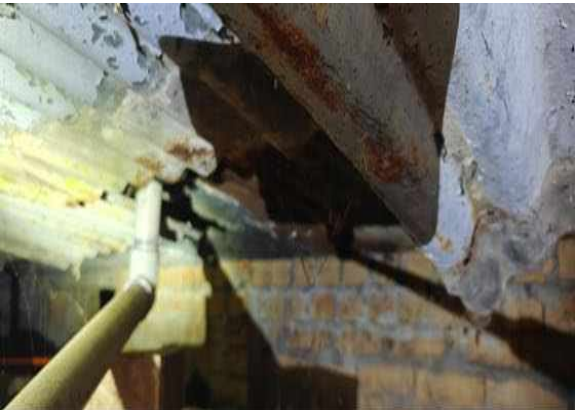
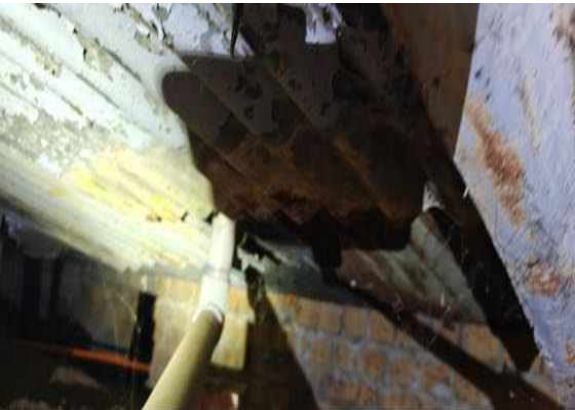
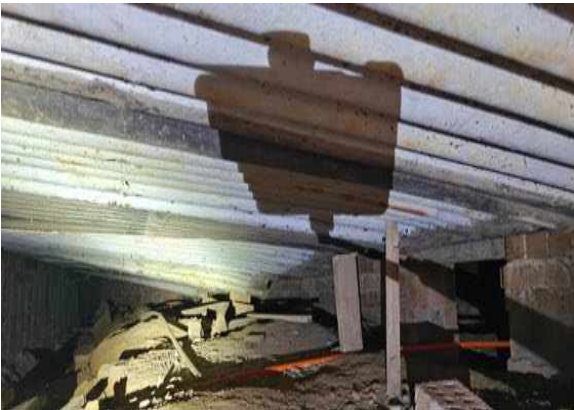
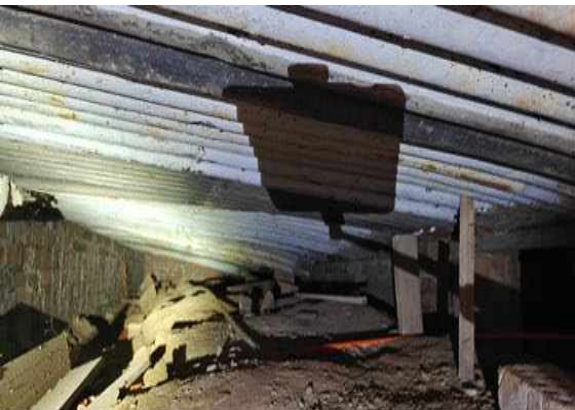
Finding 6.07

Building:	Main Building
Location:	Subfloor
Finding:	Subfloor - poor ventilation, inadequate site drainage, water stains
Information:	The subfloor lacks adequate ventilation, suffers from inadequate site drainage, exhibits water stains, creating conducive conditions for timber pests such as termites.

Risk: The combination of poor ventilation, inadequate drainage, water stains significantly increases the risk of timber pest infestations. Termites are attracted to moist environments and can thrive in subfloors with high humidity levels and water damage. The lack of proper ventilation and drainage exacerbates moisture retention, providing an ideal habitat for timber pests to establish colonies and cause extensive damage to the subfloor structure. Additionally, water stains indicate previous or ongoing moisture issues, which further attract timber pests and contribute to the deterioration of timber materials.

A licensed pest control professional specializing in timber pest management should be consulted to assess the extent of the infestation and develop a comprehensive treatment plan. They can implement strategies to eliminate existing timber pests, such as termites and prevent future infestations by addressing underlying moisture issues. Additionally, a qualified plumber or builder may be needed to improve subfloor ventilation, enhance site drainage, repair water-damaged areas. Regular inspections and maintenance are essential to ensure ongoing protection against timber pests and

maintain the structural integrity of the subfloor.

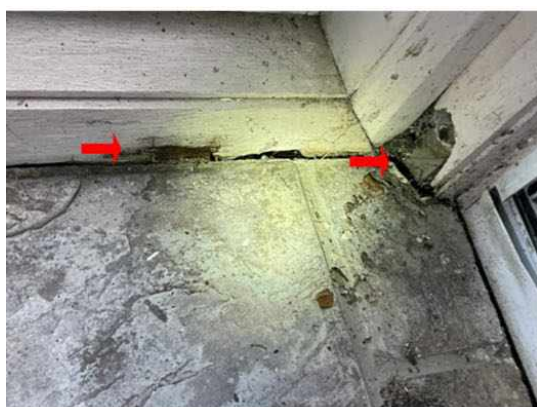
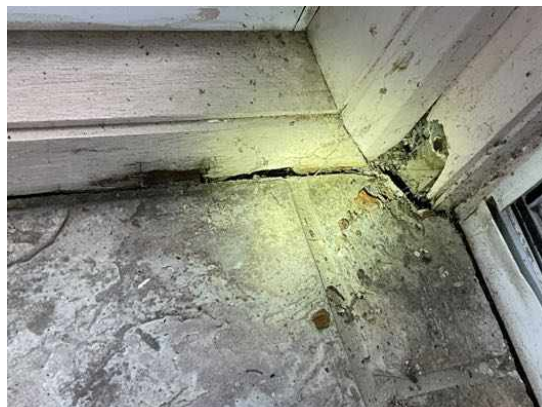
Finding 7.01

Building:	Main Building
Location:	Spa
Finding:	Wood rot
Information:	This building element shows evidence of wood rot. Wood rot, also known as Fungal Decay, occurs when timbers and other cellulose building materials are exposed to damp conditions on an ongoing basis. This could be the result of exposure to weathering over a prolonged period of time, or the attraction of excessive moisture from other abutting building materials. Contributing factors also include poor air ventilation in the area.

Wood rot is often associated with general damp problems and is evidenced by a 'musty' smell or mould and mildew occurring on surfaces. If left unmanaged, damp conditions can lead to further health problems and the decay of timbers will continue.

Early intervention and regular maintenance, particularly of exterior timbers, will prolong the useful life of these building elements. Prior to any works being performed, the cause of the moisture that has created the visible wood rot should be identified and addressed in a suitable manner. Replacement of affected timbers may then be a necessary step in protecting surrounding building elements from such deterioration.

A qualified plumber may be appointed to assess the cause of excessive moisture and to provide advice on any remedial works as required. A qualified carpenter or registered builder may also be required to replace affected building materials.
