Building and Timber Pest Inspection Report

Inspection Date: Mon, 30 Mar 2026

Property Address: 12 Kotuku St, Coffs Harbour NSW 2450, Australia

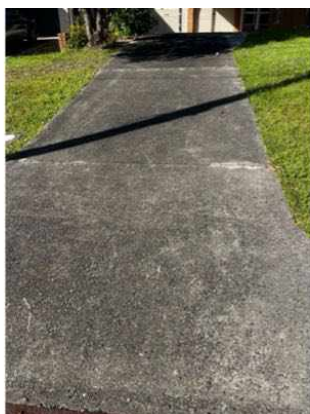
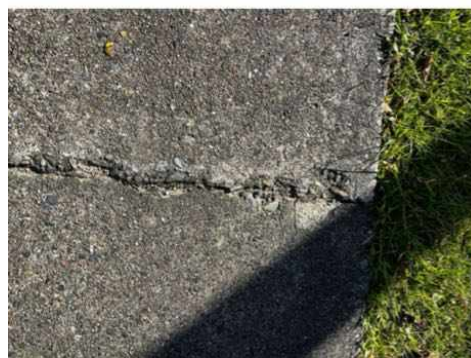
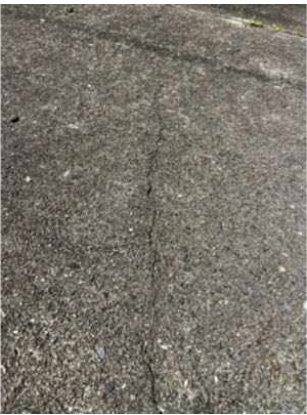
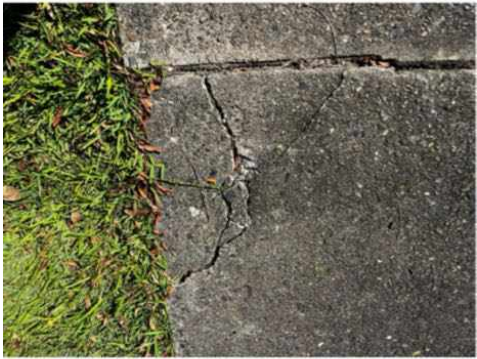
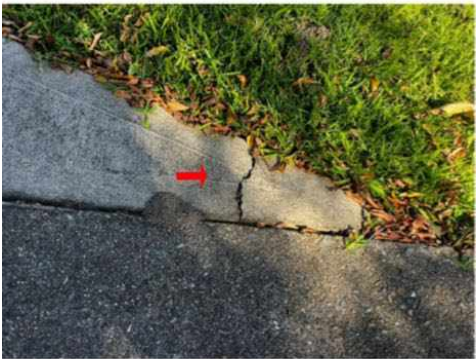
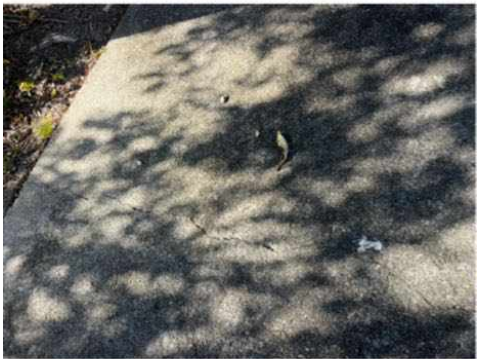
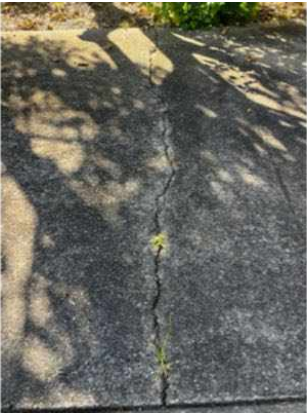
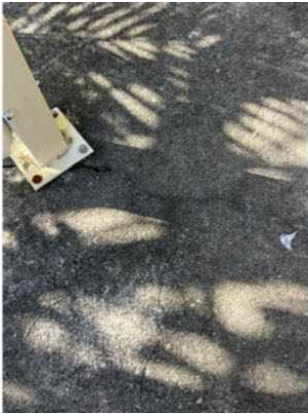
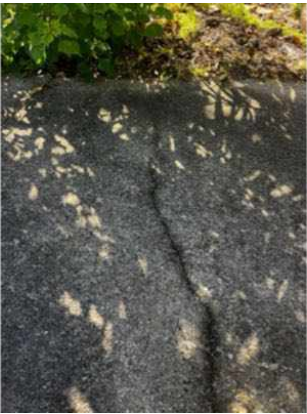
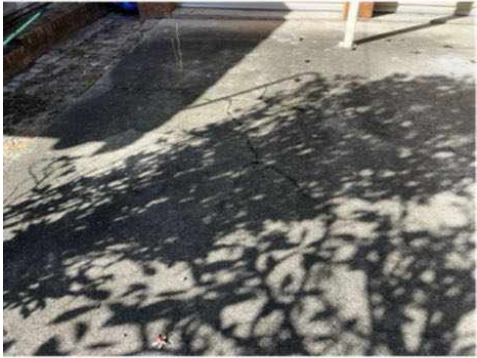
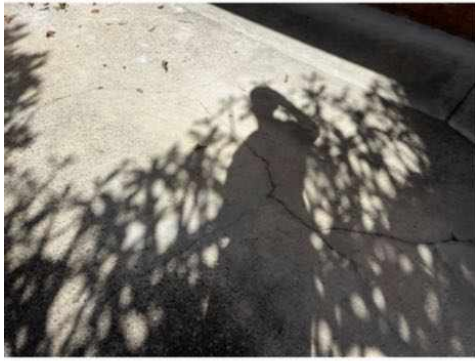
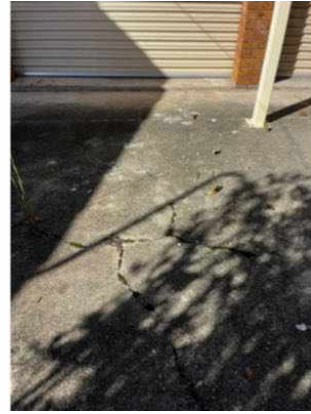
Building: Main Building
Location: Driveway
Finding: Crack in concrete slab - Category 4
Information: At the time of this inspection a number of significant cracks and areas of damage were evident in the concrete driveway.

A crack coded as Category 4 was identified in the slab.

A Category 4 crack is described as a crack that appears as a gap in the slab, with disturbing curvature or change in level affecting the slab.

The approximate width of the crack or gap is 4mm-10mm or a change in offset of greater than 25mm when a 3m straight edge is placed over the defect.

Category 4 cracking to slabs exceeds allowable Standards and Tolerances, and are therefore considered as major defects that require rectification.

It was also observed that there were areas of damage to the concrete driveway, it is recommended that a concreter repair these areas.

The driveway should also be pressure cleansed to remove any mould growth.

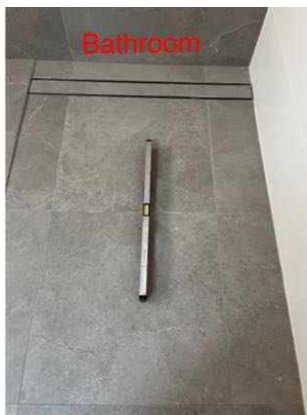
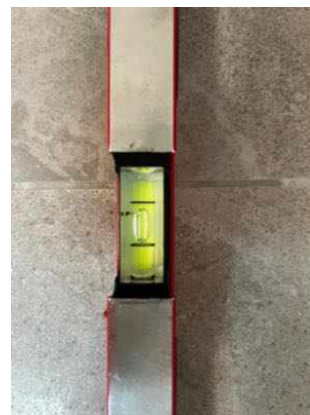
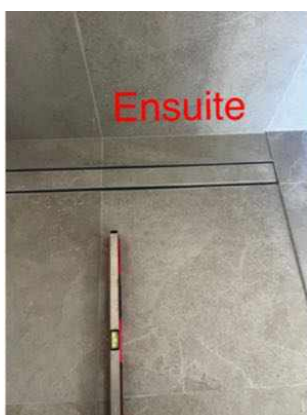
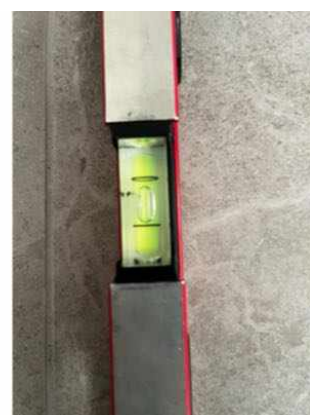
Finding 2.02

Finding: Shower tiled floors - defects

Information: It was observed at the time of this inspection, that the bathroom and ensuite tiled shower floor appeared to be non compliant with the Australian Standard. Both floors had minimal fall to the floor waste. It is recommended that both floors be re installed with the appropriate falls.

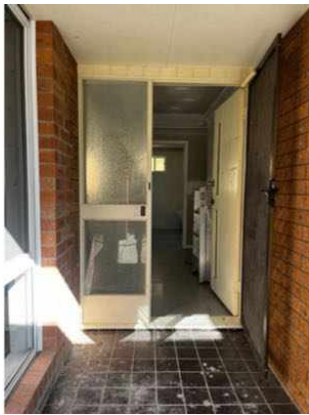
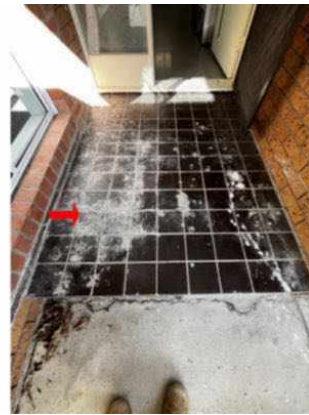
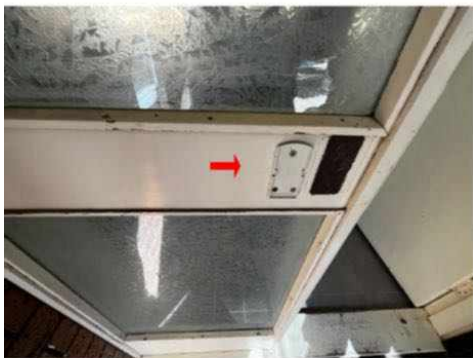
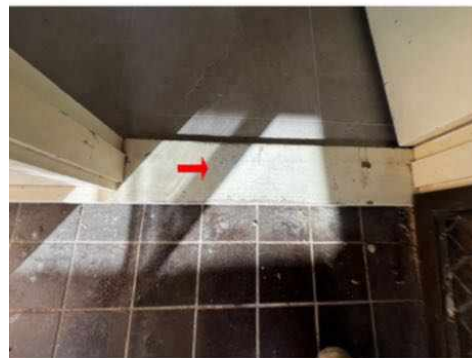
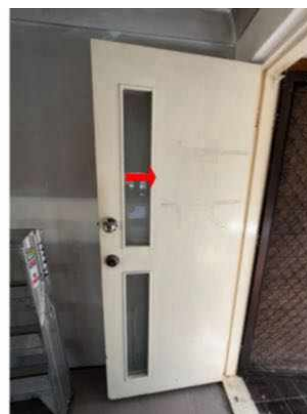
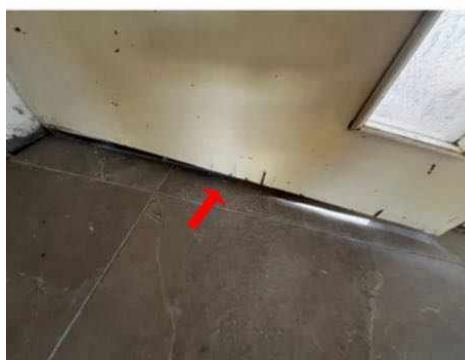
Finding 3.01

Finding: Entry - minor defects

Information: At the time of this inspection it was observed that there were a number of minor defects in the front entry area,

1 - The entry tiled floor was covered in cement, glue, paint etc, the tiled floor should be cleaned or a new tiled floor added.

2 - It was observed that the timber entry door jamb, side light, door sill and entry door had minor damage and deterioration evident. It is recommended that a painter patch, sand and repaint all timber elements of the entry door unit. The locks should also be replaced.

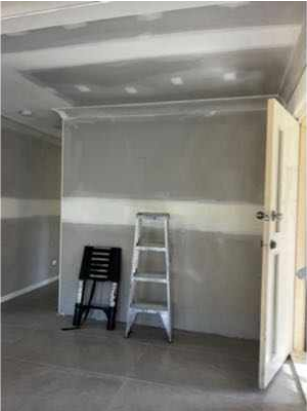
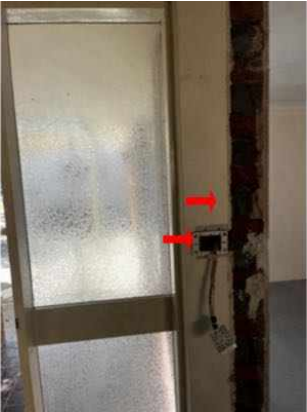
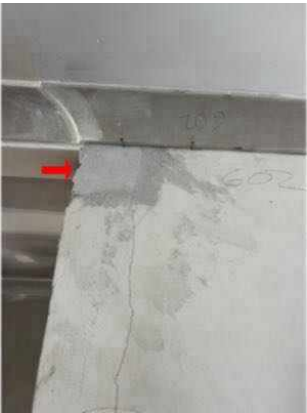
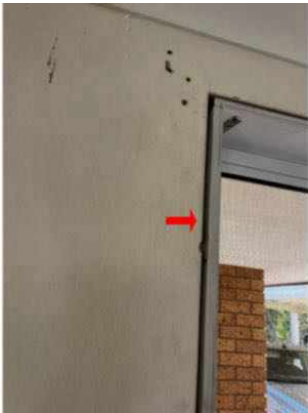
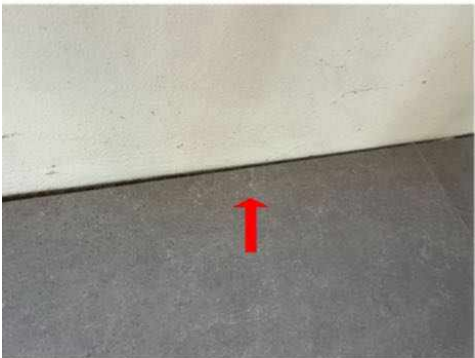
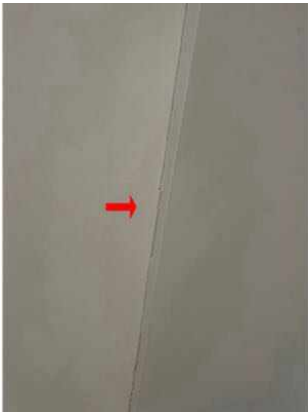
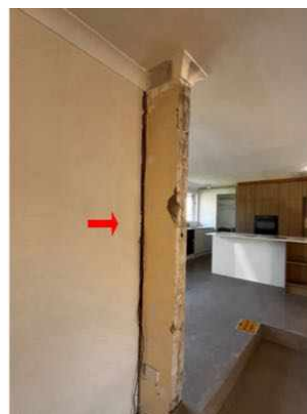
Finding 3.02

Building: Main Building
 Location: Entry/lounge Room
 Finding: Entry/lounge room - defects
 Information: At the time of this inspection it was observed that there were a number of defects and unfinished works to the entry/lounge room areas,

1 - There were several cracks to the masonry internal wall skin, the cracks should be patched.

2 - It was observed that there was a masonry nib wall and a gap in the masonry wall where a wall has been removed that required rendering and finishing, a renderer should complete this work.

4 - It was observed that there was a gap to the underside of the cornice/wall junction and a vertical crack to one internal wall junction, a painter should fill this gap.

5 - All internal wall, ceiling and window trims require painting.

6 - It was observed that the electrical works were not finished (switches fitting) in this room, an electrician should complete this work.

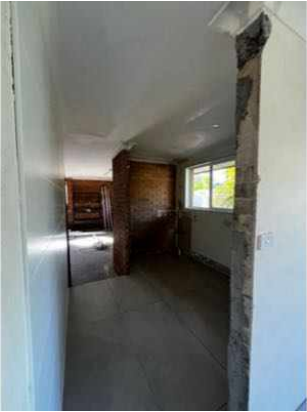
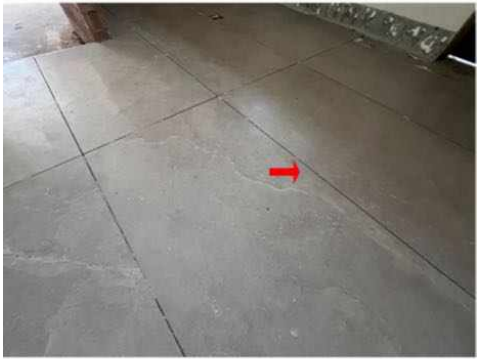
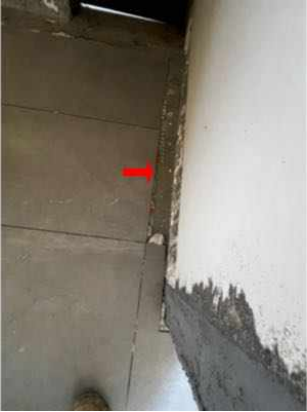
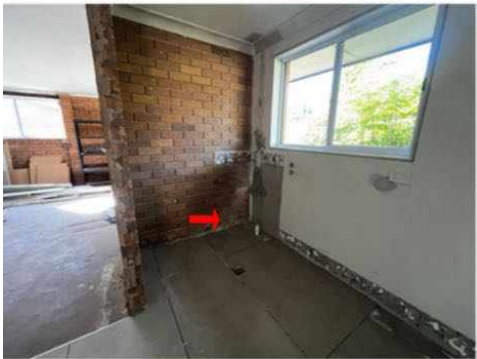
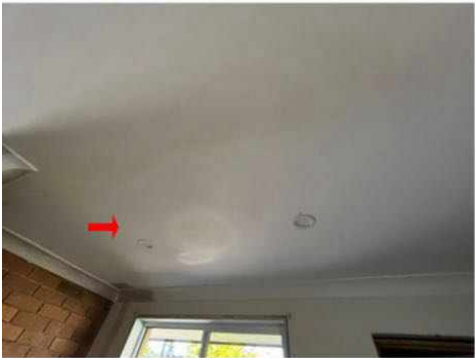
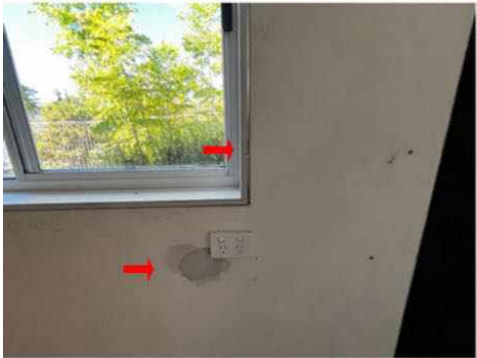
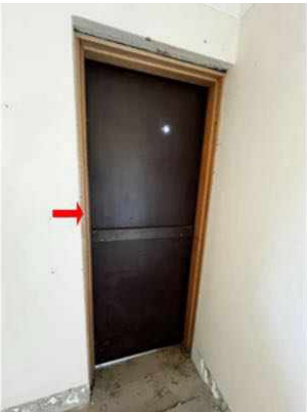
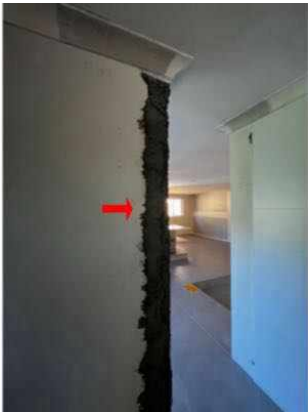
Finding 3.03

Finding: Laundry - defects

Information: At the time of this inspection it was noted that there were a number of minor defects and unfinished works in the laundry.

1 - A section of tile was missing and the floor tiles required grouting.

7 - A dummy tile was observed at the garage step.

8 - All area should be painted.

9 - All electrical fixtures and fittings should be supplied and fitted.

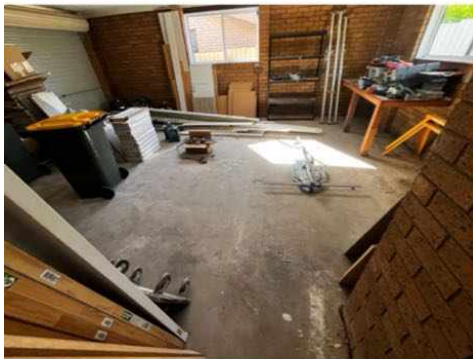
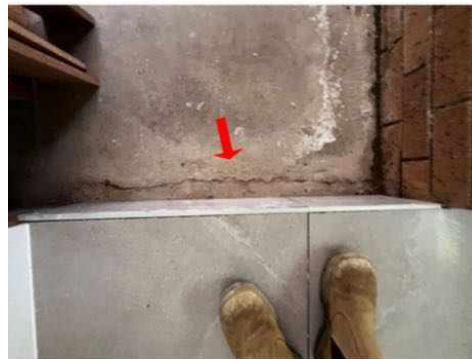
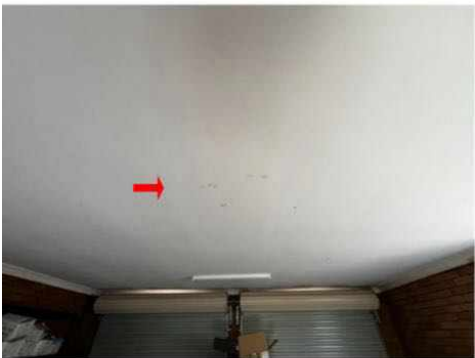
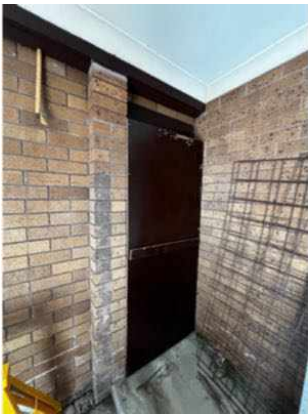
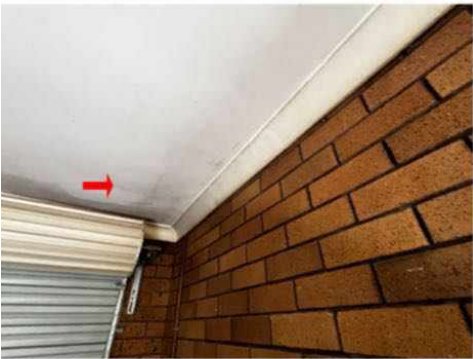
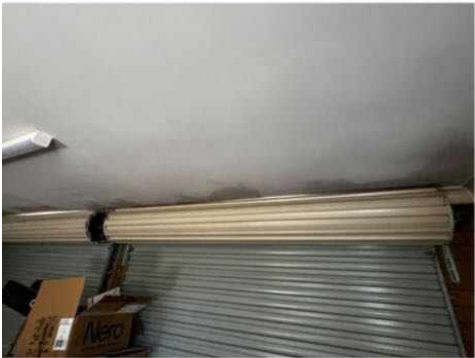
Finding 3.04

Finding: Garage - internal defects

Information: At the time of this inspection there were a number of defects and unfinished items in the garage,

- 1 - The external door and internal door and door jamb should be supplied and fitted.
- 2 - The window architrave should be fitted.
- 3 - The garage should have all items of materials removed and cleaned.
- 4 - All areas of the ceiling, cornice and trims should be painted.

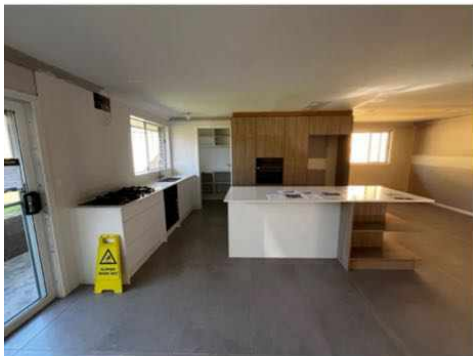
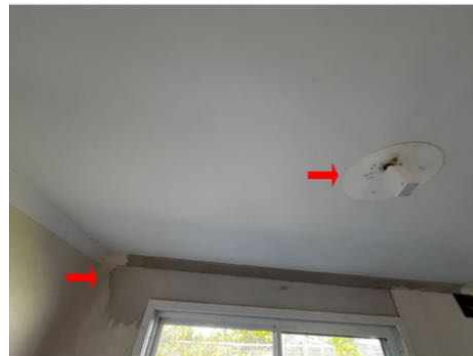
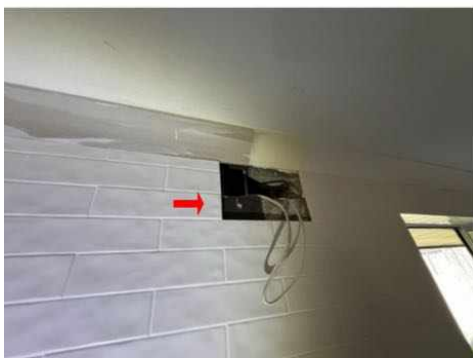
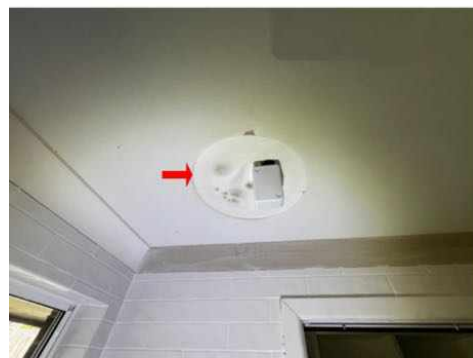
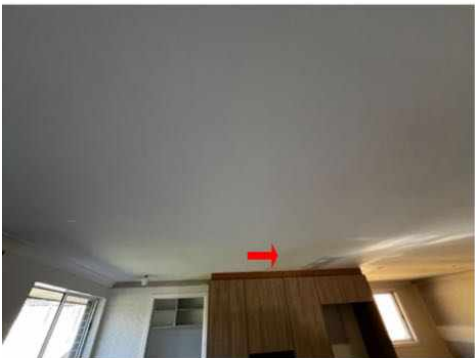
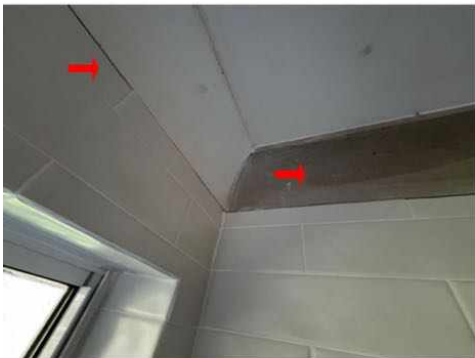
Finding 3.05

Building: Main Building
Location: Kitchen
Finding: Kitchen - minor defects
Information: At the time of this inspection it was noted that there were several minor defects and unfinished works in the kitchen area,

1 - Sections of floor tiles were missing and also areas requiring grout to the floor tiles, a tiler should complete this work.

3 - It was observed that the garbage bin drawer was hitting on the pantry door architrave, a carpenter or joiner should adjust the materials to prevent this happening.

5 - All electrical fixtures and fittings should be supplied and fitted.

6 - All wall/ceiling, walls trim junctions should be sealed by a tiler.

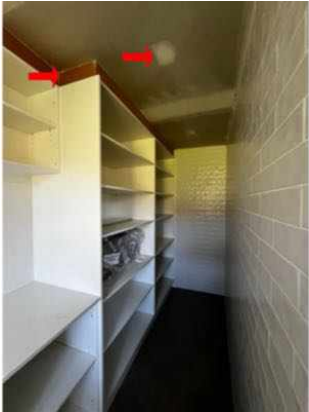
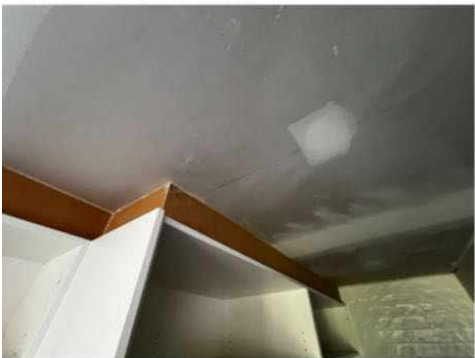
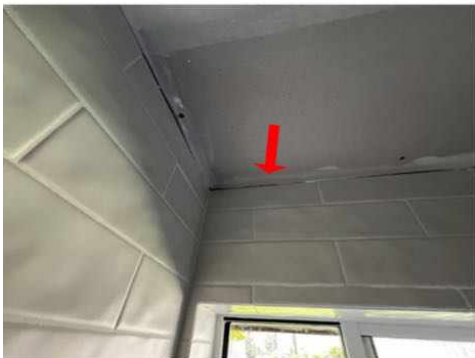
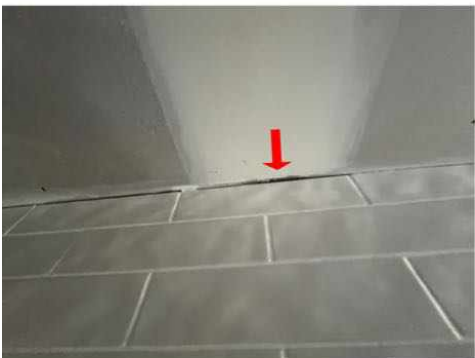
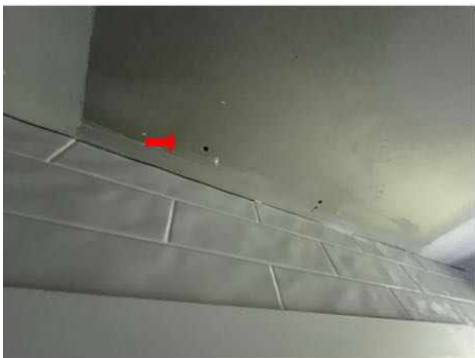
Finding 3.06

Building: Main Building
Location: Pantry - Walk In
Finding: Pantry defects
Information: At the time of this inspection it was observed that there were a number of defects and unfinished works in the walk in pantry,

- 1 - The cavity sliding door and trims should be fitted.
- 2 - The plasterboard ceiling has areas that require patching.
- 3 - All ceiling and joinery bulkheads and walls require painting.
- 4 - All wall/ceiling, walls trim junctions should be sealed by a tiler.
- 5 - All electrical fixtures and fittings should be supplied and fitted.

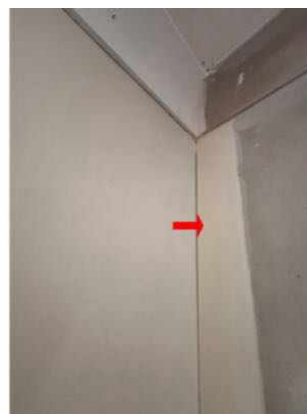
Finding 3.07

Building: Main Building
Location: Dining Room
Finding: Dining room - defects
Information: It was observed that there were a number of unfinished items in the dining room,

- 1 - There floor tiles require grouting in one area.
- 2 - All areas of the walls and ceiling require painting.

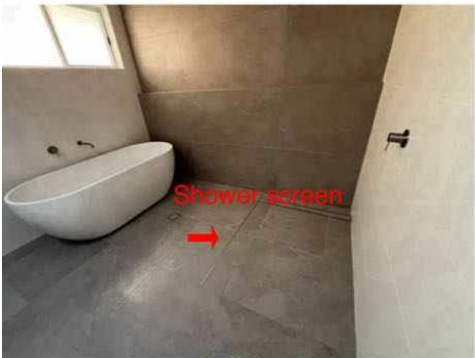
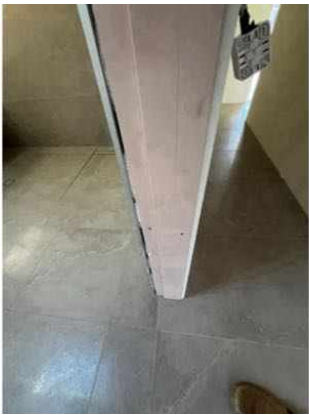
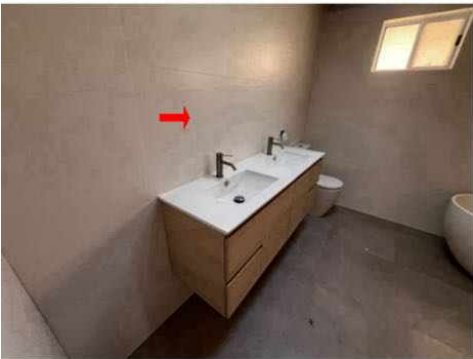
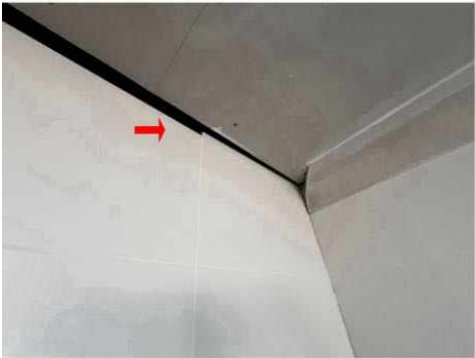
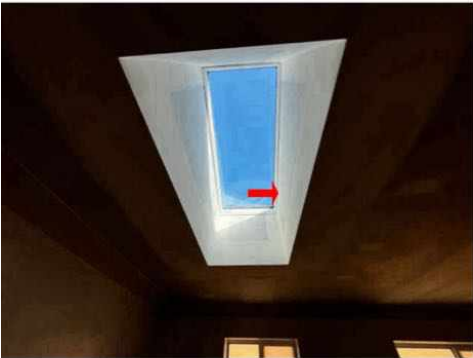
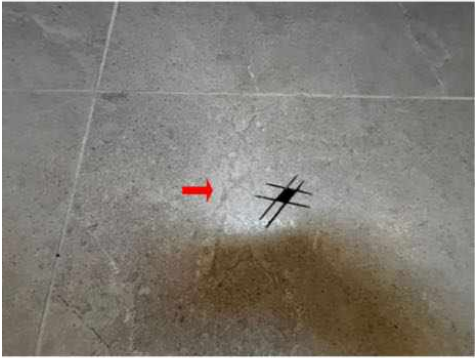
Finding 3.08

Building: Main Building
 Location: Bathroom
 Finding: Bathroom - defects
 Information: At the time of this inspection it was observed that there were a number of unfinished works in the bathroom area,

- 1 - The shower screen should be supplied and fitted.
- 2 - The shower rose/head should be supplied and fitted.
- 3 - The mirror should be supplied and fitted.
- 4 - The floor waste should be cut in and fitted.
- 5 - The plasterboard cornice should be completed.
- 6 - All painting to the ceiling and skylight should be completed.
- 7 - The electrical fixtures and fittings should be supplied and fitted.
- 8 - The cornice/wall tile junction should be sealed by a tiler.

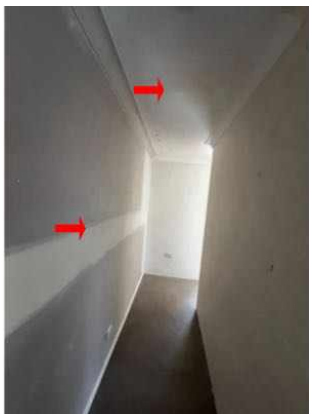
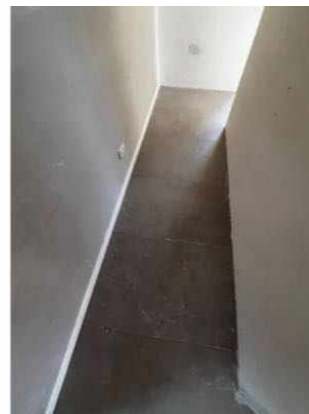
Finding 3.09

Finding: Hallway - defects

Information: At the time of this inspection it was observed that there was a number of minor defects and unfinished works present in hallway.

2 - Several wall cracks should be patched by a painter.

4 - All electrical fixtures and fittings should be supplied and fitted.

It is recommended that the renovation builder be asked to provide a waterproofing certificate for the bathroom.

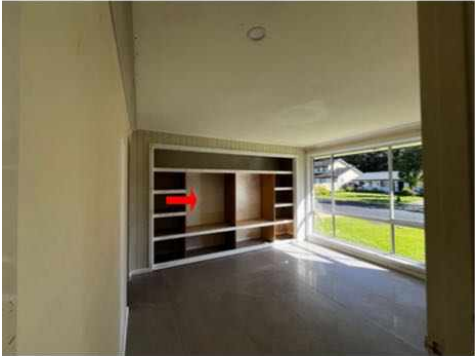
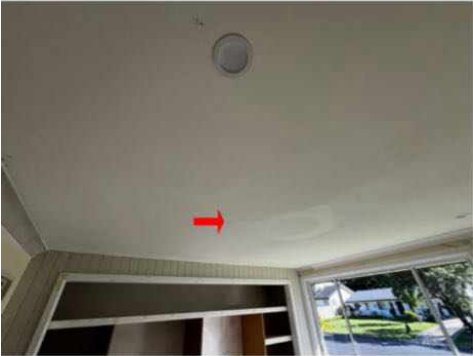
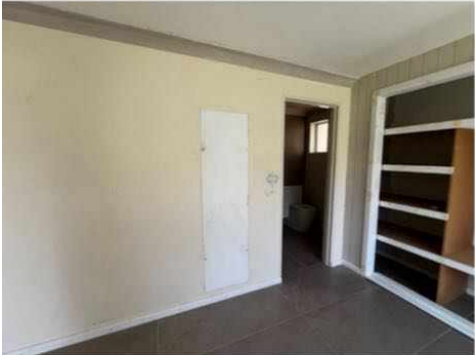
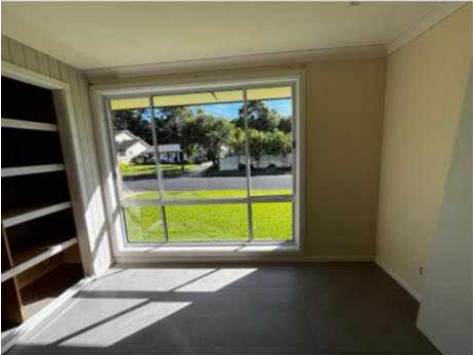
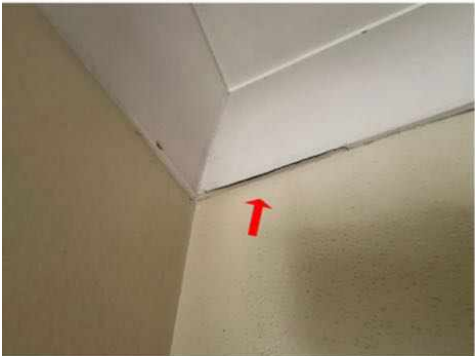
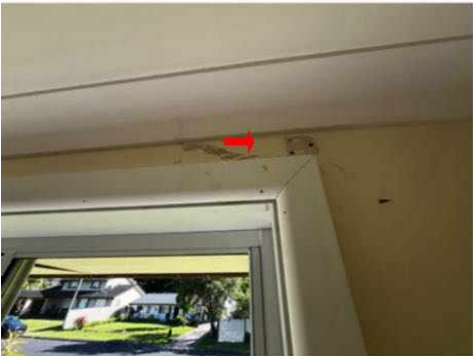
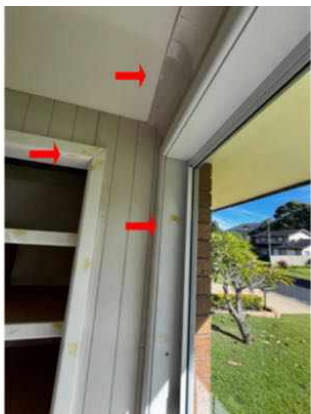
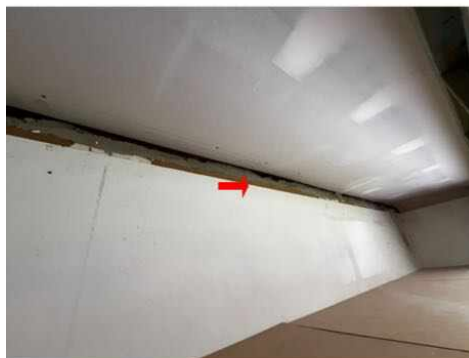
Finding 3.10

Building: Main Building
 Location: Bedroom - Master
 Finding: Bedroom 1 - defects
 Information: At the time of this inspection several defects and unfinished works were observed in the main bedroom,

- 1 - The wardrobe sliding door unit should be supplied and fitted and shelving painted.
- 2 - All walls and ceilings should be patched and painted.
- 3 - All electrical fixtures and fittings should be supplied and installed.

4 - Fit cornice to back of wardrobe

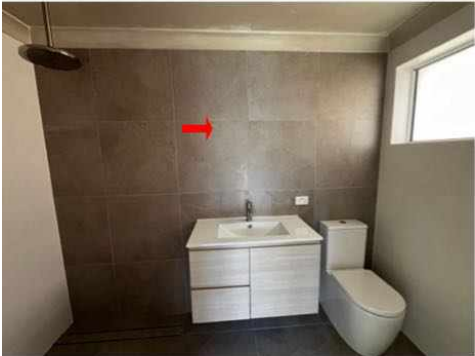
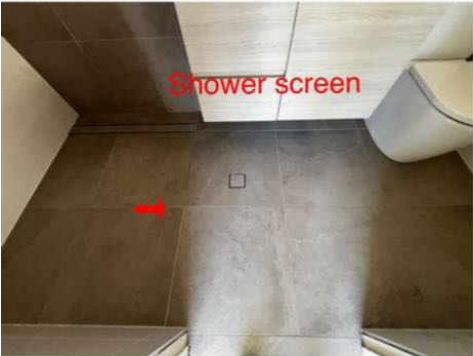
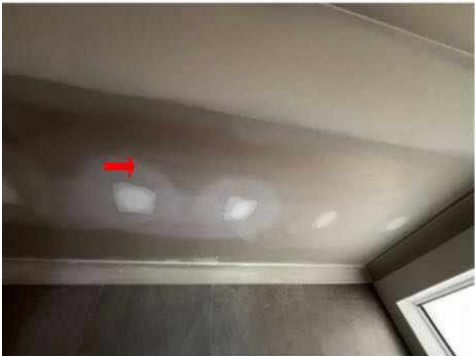
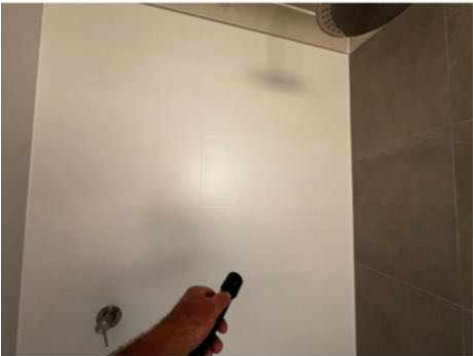
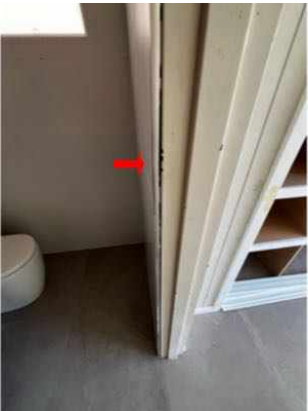
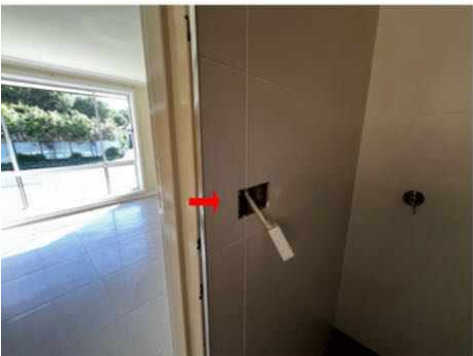
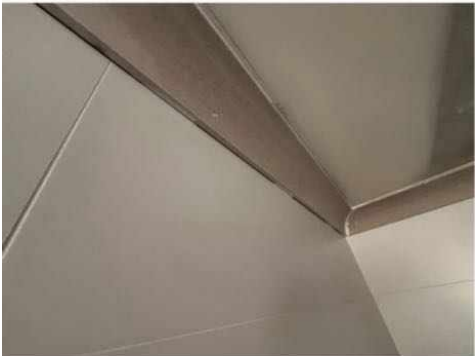
Finding 3.11

Building: Main Building
 Location: Ensuite - Master
 Finding: Ensuite - defects
 Information: At the time of this inspection it was observed that there were a number of unfinished works to the ensuite.

- 1 - The shower screen should be supplied and fitted.
- 2 - The mirror should be supplied and fitted.
- 3 - The floor waste should be cut in and fitted.
- 4 - The plasterboard cornice should be completed.
- 5 - All painting to the ceiling should be completed.
- 6 - The electrical fixtures and fittings should be supplied and fitted.
- 7 - The cornice/wall tile junction should be sealed by a tiler.

It is recommended that the renovation builder be asked to provide a waterproofing certificate for the ensuite.

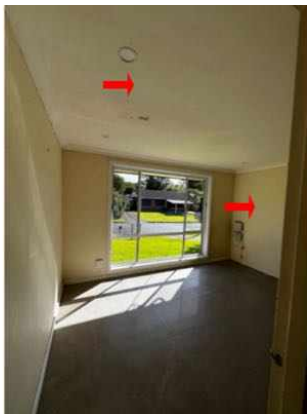
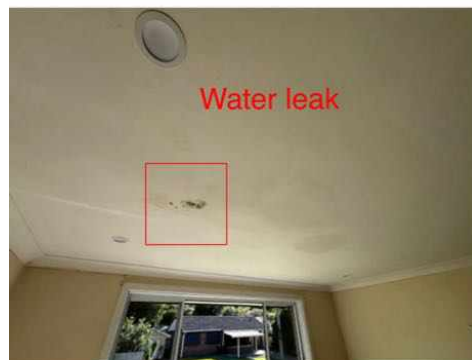
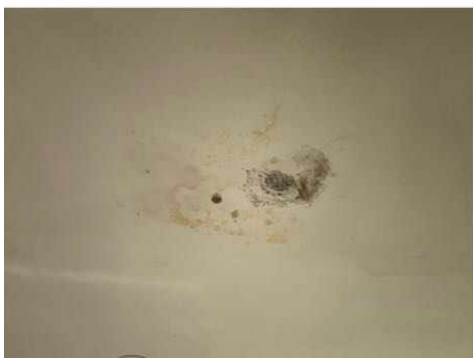
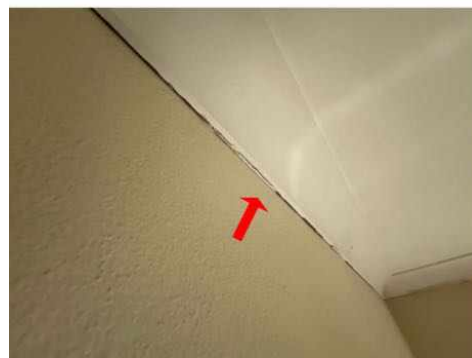
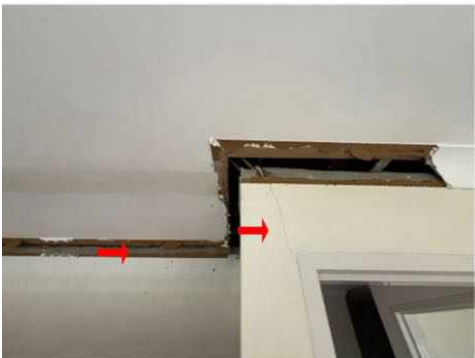
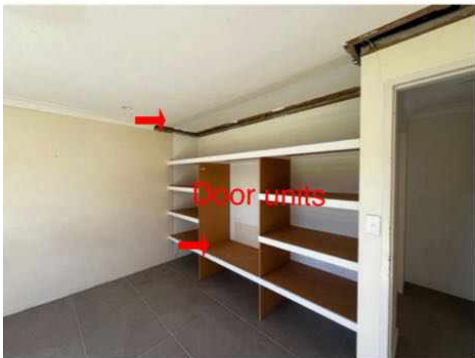
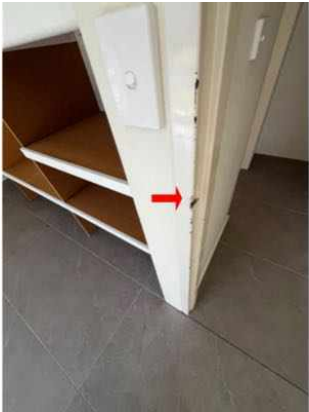
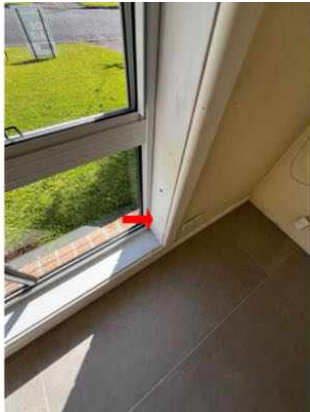
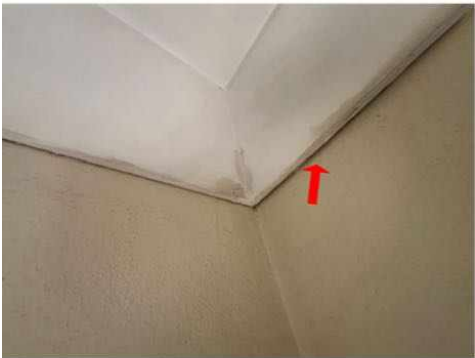
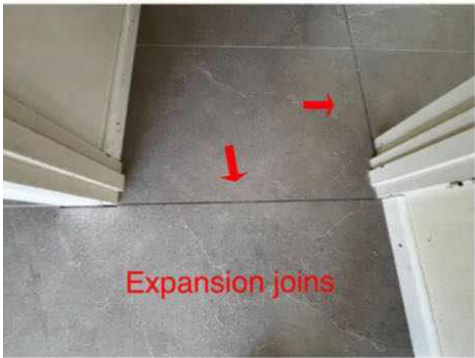
Finding 3.12

Building: Main Building
Location: Bedroom 2
Finding: Bedroom 2 - defects
Information: At the time of this inspection several defects and unfinished works were observed in bedroom 2,

- 1 - The wardrobe sliding door unit should be supplied and fitted.
- 2 - All walls and ceilings should be patched and painted.
- 3 - Fit missing cornice, fill gap at wall/cornice junction.
- 4 - Check roof tiles and flashings for leak where ceiling has water damage.
- 5 - Fit cornice to back of wardrobe and fill gap under cornice (wall/cornice junction).
- 6 - Paint wardrobe shelving.
- 7 - Tiler fit flexible sealant to floor tile expansion joints.
- 8 - All electrical fixtures and fittings should be supplied and installed.

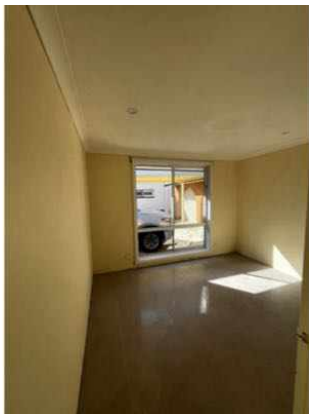
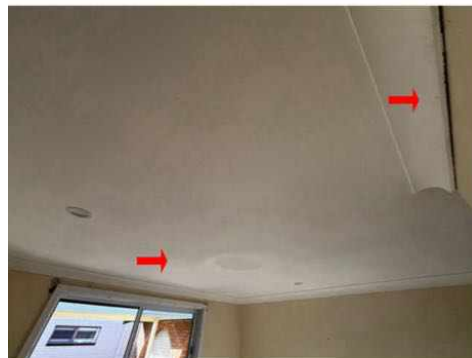
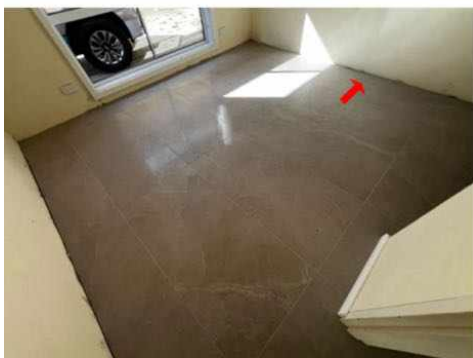
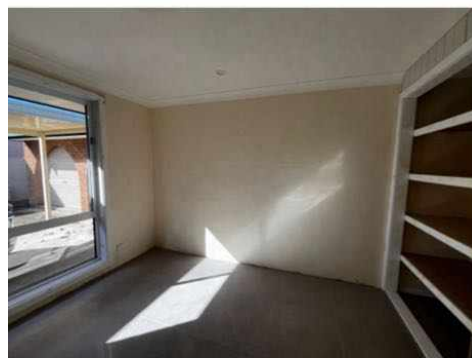
Finding 3.13

Finding: Bedroom 3 - defects

Information: At the time of this inspection several defects and unfinished works were observed in bedroom 3,

4 - Fit missing cornice to room.

6- Supply and install wardrobe doors.

7 - Supply and install all electrical fixtures and fittings.

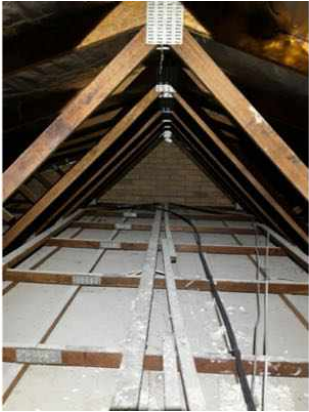
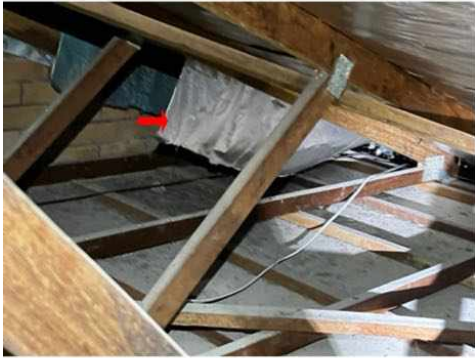
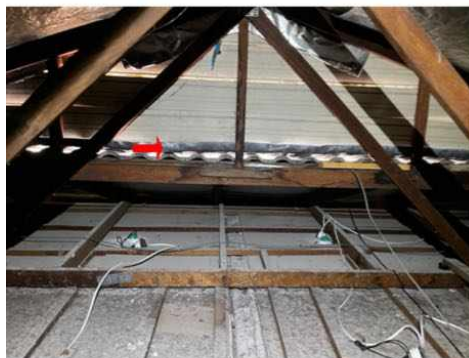
Finding 3.14

Building: Main Building
Location: Roof Void
Finding: Roof void
Information: The roof void appeared to be in fair condition, no insulation was present to the ceiling.

It was observed that there were several areas of damaged sarking to the roof tiles. It is recommended that a roofer repair the joins and any damage.

It was observed that there were big gaps between the roof tiles and roof flashing at the northern gable end, it is recommended that the gable end flashing be “dressed” down onto the roof tile surface.

It is recommended that the ceiling be insulated for thermal efficiency.

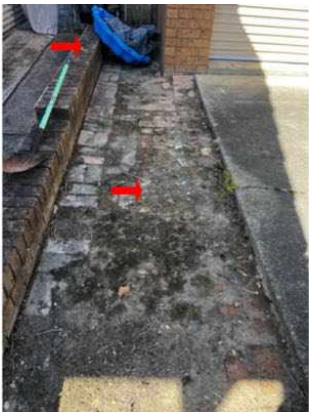
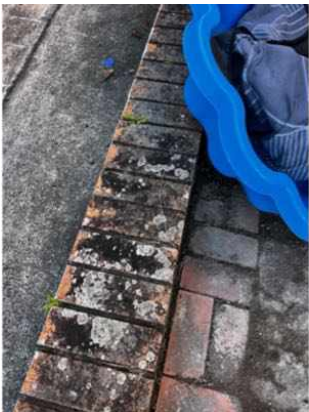
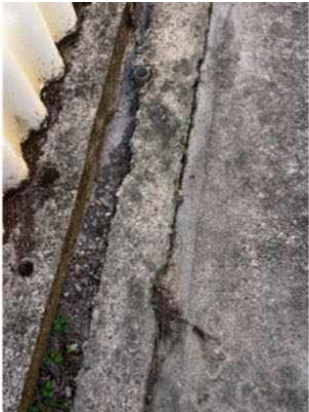
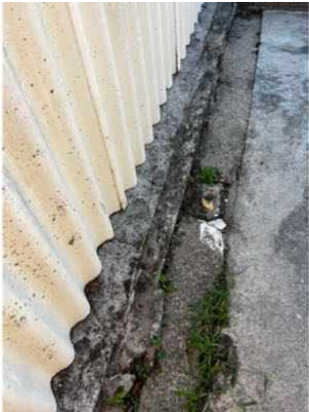
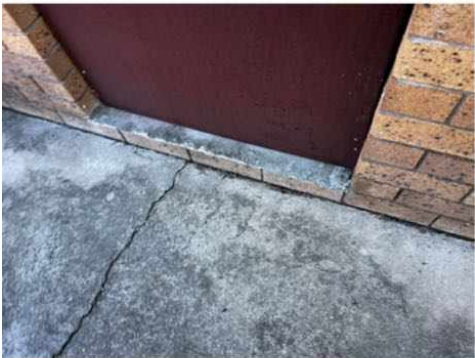
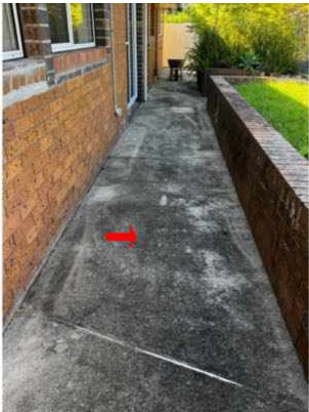
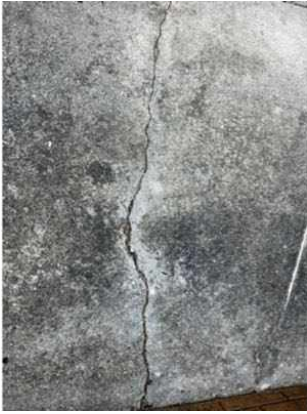
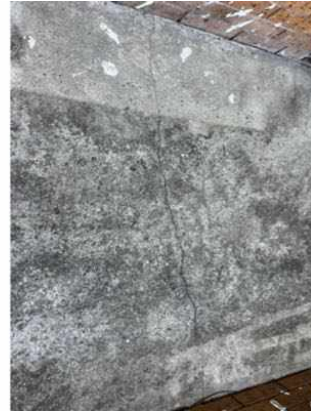
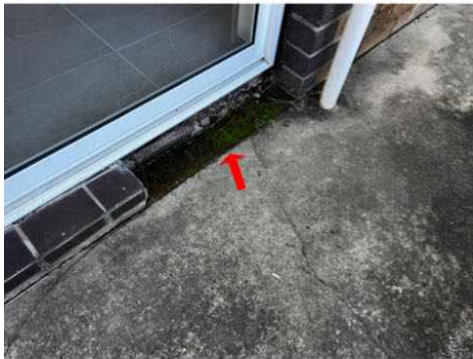
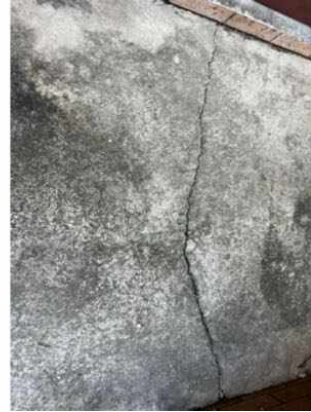
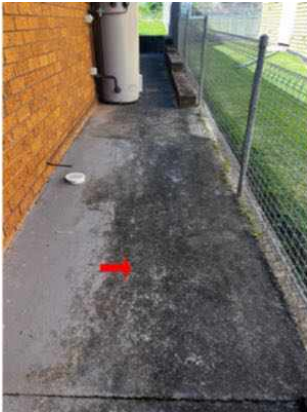
Finding 3.15

Building:	Main Building
Location:	External paths and paved areas
Finding:	External paths - defects
Information:	<p>It was observed at the time of this inspection that the concrete and paved paths to the exterior of the house were in poor condition,</p> <ol style="list-style-type: none"> 1 - There were numerous cracks to the concrete paths, a concreter should repair the paths where applicable. 2 - The paved section of path was in very poor condition, it is recommended that a landscaper replace the paving. 3 - The concrete paths had mould growth evident, the paths and front brick retaining wall should be pressure cleaned. 4 - It was also observed that a section of tile sill has missing from the rear sliding door, a tiler should replace the tiled sill.

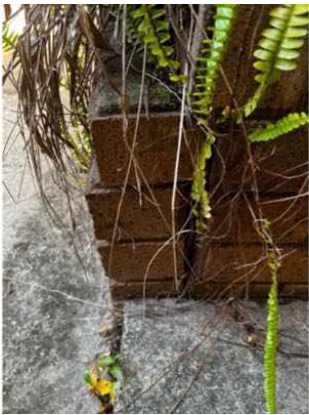
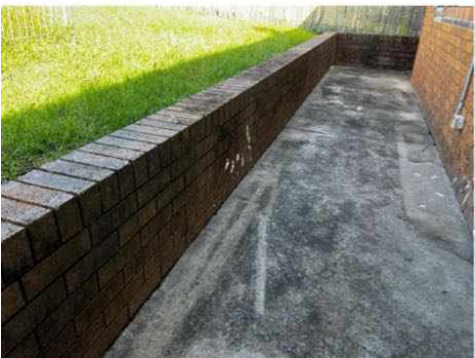
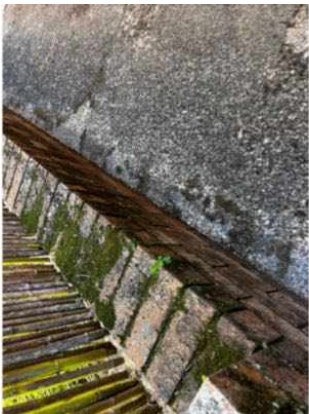
Finding 3.16

Building:	Main Building
Location:	Masonry retaining walls
Finding:	Retaining walls
Information:	At the time of this inspection, it was observed that the masonry retaining wall at the rear of the house had minor cracking due to the vegetation growth. The vegetation should be removed and a bricklayer repair the damage.

The retaining wall should be pressure cleaned to remove the moss and mould growth.

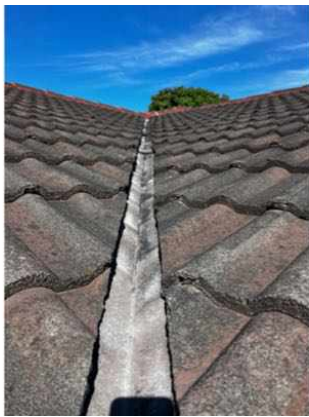
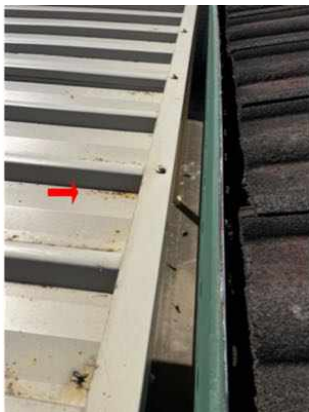
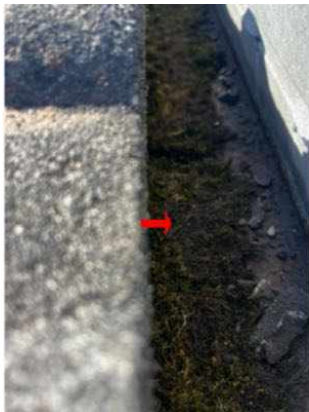
Finding 3.17

Building: Main Building
Location: Roof exterior
Finding: Roof exterior and guttering
Information: At the time of this inspection, the roof appeared to be in a weathered but fair condition with minor damage evident.

The roof sheeting to the carport had minor rusting to the sheeting evident in areas.

The guttering was in a damaged and poor condition and should be replaced.

It is recommended that a roofer thoroughly inspect the roof sheets, roof flashings and guttering.

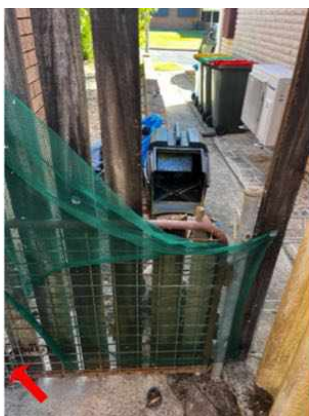
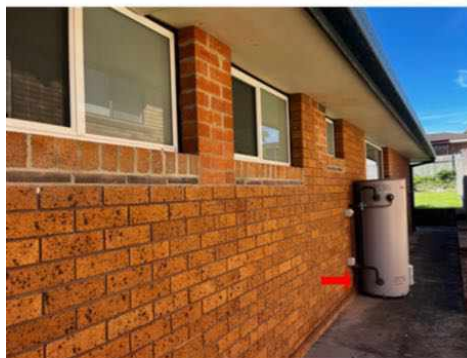
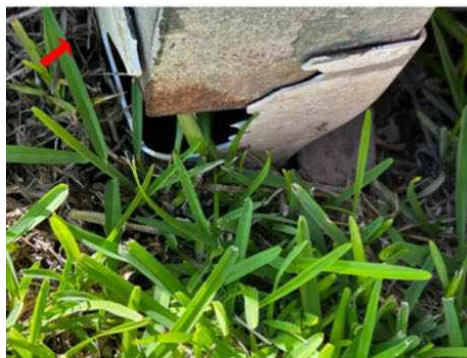
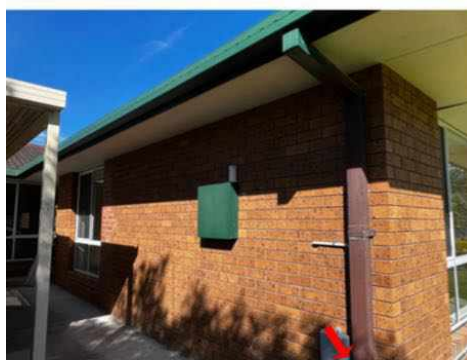
Building:	Main Building
Location:	All External Areas
Finding:	Possible concealed termite entry areas - conducive to termite attack
Information:	At the time of this inspection, numerous areas of possible concealed termite entry points were observed around the exterior of the building.

These areas are points on the exterior of the building where it is not possible to view the external cladding or slab/foundation edge because of close proximity of external members/features.

It was also observed that numerous areas around the perimeter of the building and deck had Timbers in contact with the ground. This has the potential to attract termites to the building and should be removed as soon as possible.

These areas should be cleared if possible and monitored regularly for termite infestation by a timber pest expert.

It is recommended that a timber pest expert provide and implement a Timber Pest Management Plan as soon as possible.

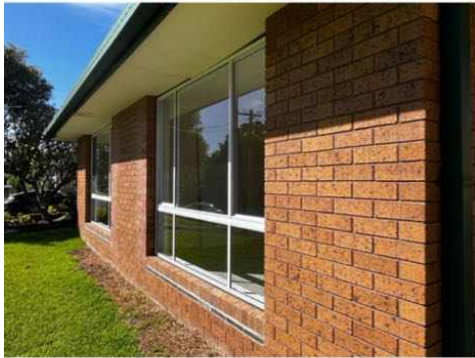
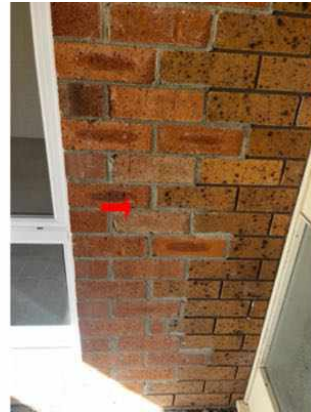
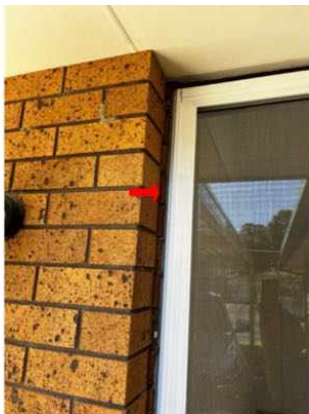
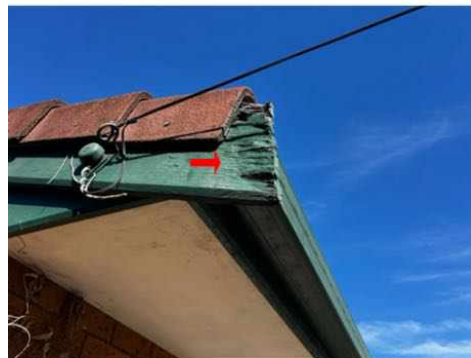
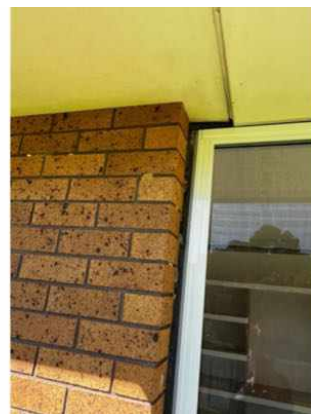
Finding 7.01

Building: Main Building
 Location: Exterior walls - front
 Finding: Exterior area front - defects
 Information: It was observed at the time of this inspection that there were a number of defects and unfinished works at the front of the house,

1 - It was noted that there new brickwork has been added to the external walls where the windows have been altered/replaced. It is recommended that all external brick walls be rendered and painted.

3 - It was observed that the timber barge board in this area had significant fungal decay (woof rot) present, it is recommended that a carpenter repair or replace the affected timber.

4 - It was observed that there was water staining and mould growth to the eaves

sheets in one area, also noted was that the eaves sheets were damaged and not fitted correctly, it is recommended that a roof tiler check the roof for leaks. It is further recommended that a carpenter repair the eaves sheets and all sheets be repainted.

5 - It was observed that's the guttering had minor rust and damage evident, the guttering and down pipes should be replaced by a plumber.

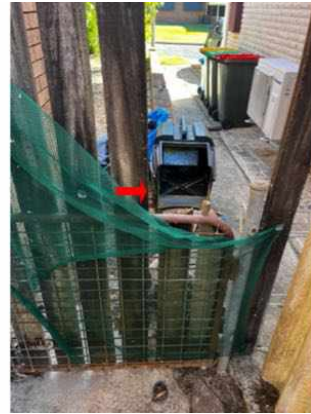
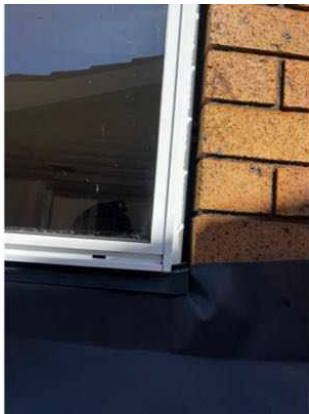
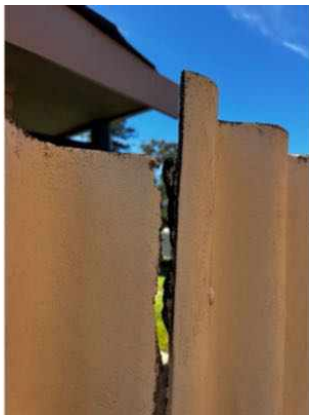
Finding 7.02

Building: Main Building
 Location: Exterior walls - left side
 Finding: Exterior area - left side
 Information: At the time of this inspection it was observed that there were a number of minor defects to the external walls on the left side of the house.

1 - It was observed that the timber fence panel to the side gate was damaged and should be replaced by a carpenter.

3 - It was observed that the timber barge board in this area had significant fungal decay (woof rot) present, it is recommended that a carpenter repair or replace the affected timber.

NOTE: It was observed that the left side fence was made from "Super six: sheeting, there was minor damage to the fence in areas. The fence contains asbestos and consideration should be given for removing the fence. No work should be carried out to the fence until the fence material has been sampled, tested and reported for asbestos.
