Building and Timber Pest Inspection Report

Inspection Date: Mon, 30 Mar 2026

Property Address: 12 Kotuku St, Coffs Harbour NSW 2450, Australia

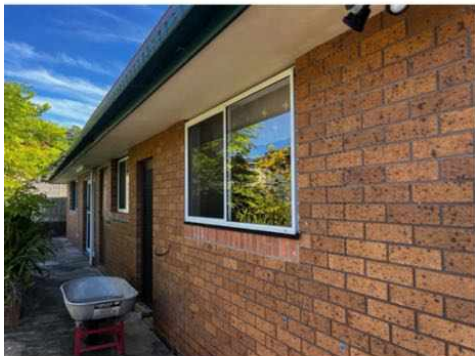
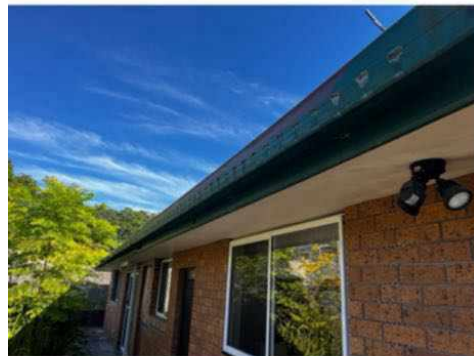
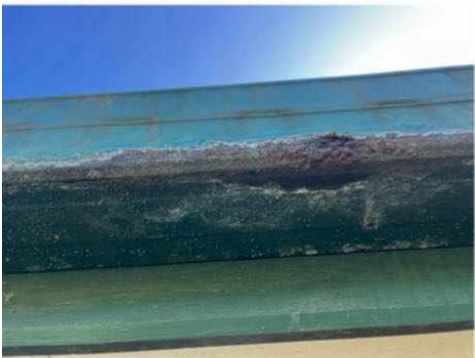
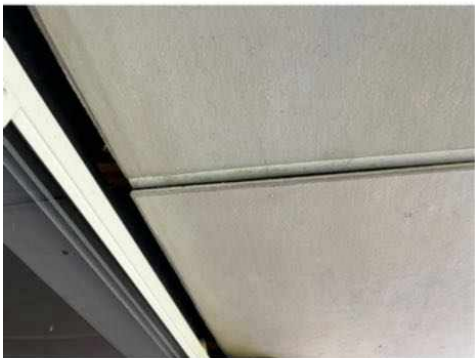
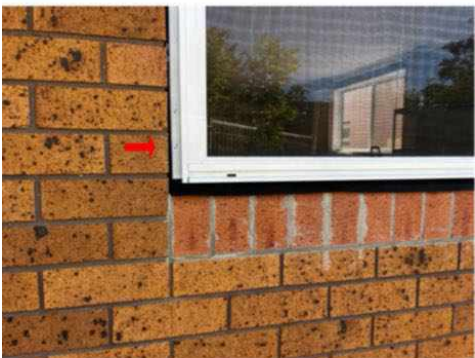
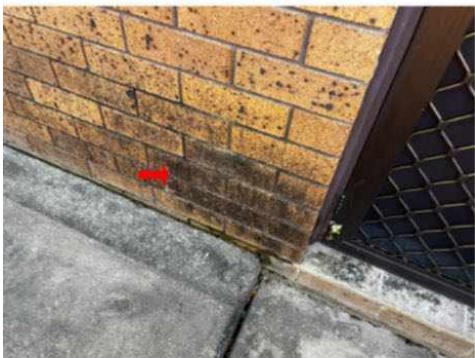
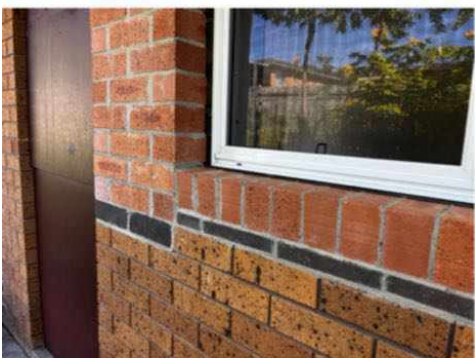
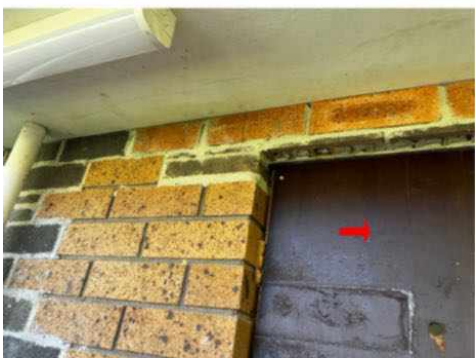
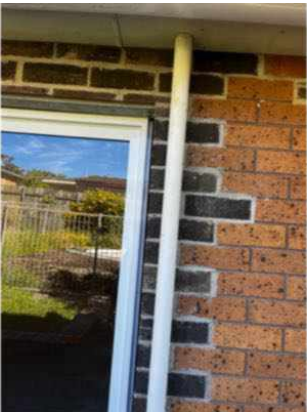
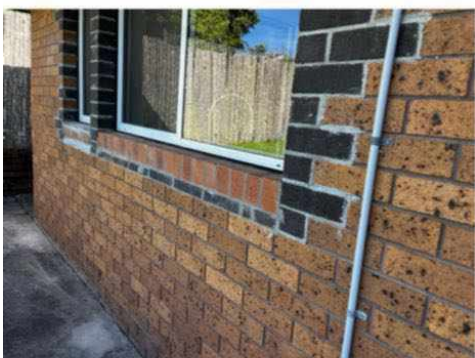
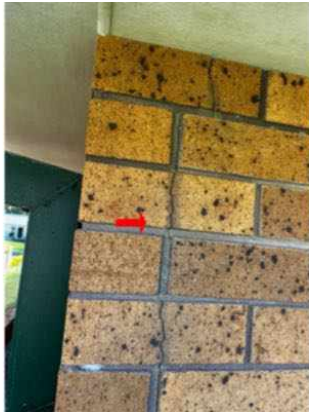
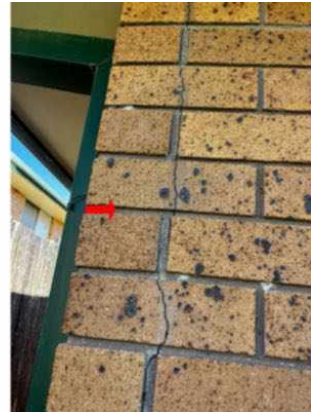
Finding 7.03

Building: Main Building
 Location: Exterior walls - rear
 Finding: Exterior rear - defects
 Information: It was observed at the time of this inspection that there were a number of minor defects and unfinished works to the rear of the house,

1 - It was noted that there new brickwork has been added to the external walls where the windows have been altered/replaced. It is recommended that all external brick walls be rendered and painted. Some cracking was observed to the west end of the

rear wall, it is assumed that minor movement in the foundation has caused the cracking over time. It is recommended that the crack be sealed with flexible sealant and rendered. If you are concerned by the cracking, a structural engineer should be consulted.

3 - It was observed that the timber fascia in this area had significant fungal decay (woof rot) present, it is recommended that a carpenter repair or replace the affected timber.

4 - It was observed that there was water staining and mould growth to the eaves sheets in one area, also noted was that the eaves sheets were damaged and not fitted correctly, it is recommended that a roof tiler check the roof for leaks. It is further recommended that a carpenter repair the eaves sheets and all sheets be repainted.

5 - It was observed that's the guttering had significant rust and damage evident, the guttering and down pipes should be replaced by a plumber.

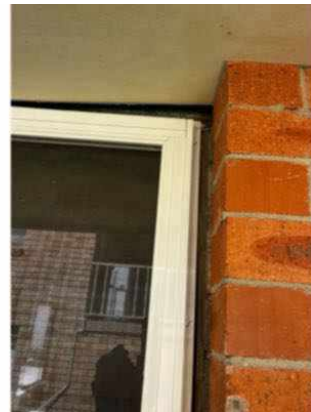
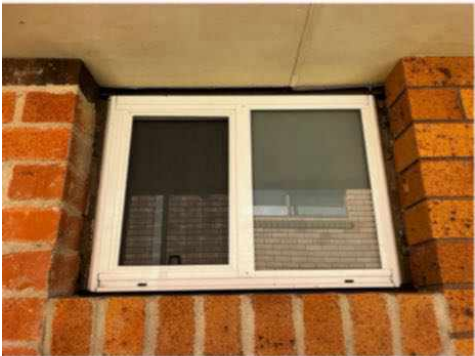
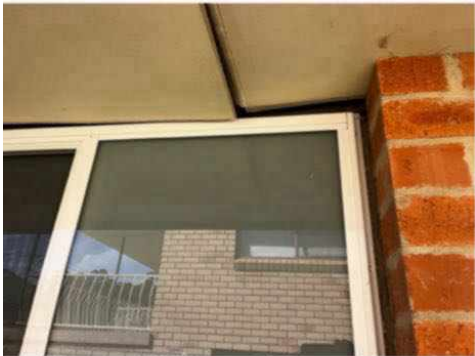
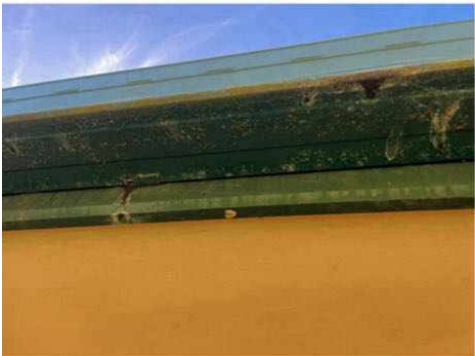
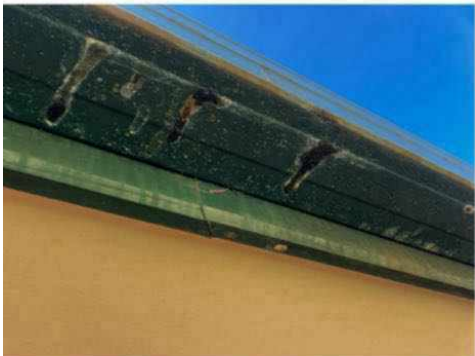
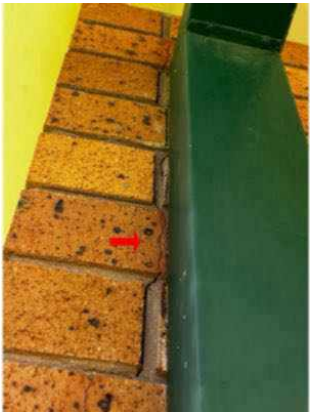
Finding 7.04

Building: Main Building
 Location: Exterior walls - right side
 Finding: Exterior area - right side
 Information: It was observed at the time of this inspection that there were a number of defects and unfinished works at the right side of the house,

1 - It was noted that there new brickwork has been added to the external walls where the windows have been altered/replaced. It is recommended that all external brick walls be rendered and painted.

3 - It was observed that the timber fascia in this area had minor fungal decay (woof rot) present, it is recommended that a carpenter repair or replace the affected timber.

4 - It was observed that there was water staining and mould growth to the eaves sheets in one area, also noted was that the eaves sheets were damaged and not fitted correctly, it is recommended that a roof tiler check the roof for leaks. It is further recommended that a carpenter repair the eaves sheets and all sheets be repainted.

5 - It was observed that's the guttering and down pipe had rust and damage evident, the guttering and down pipes should be replaced by a plumber.

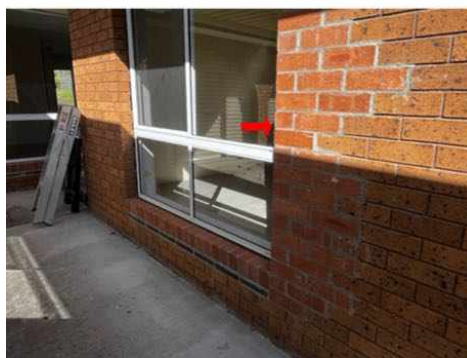
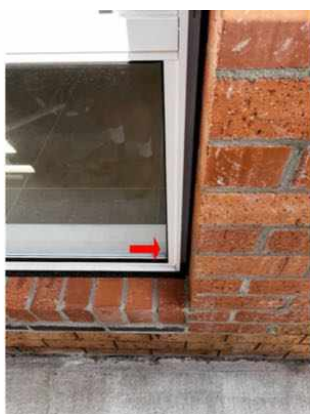
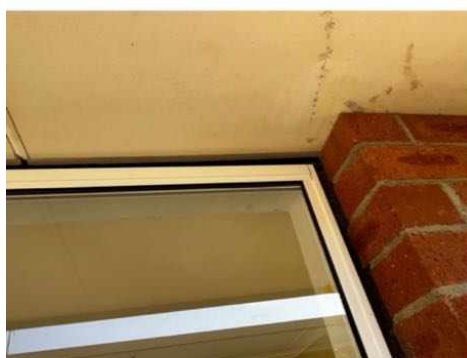
Finding 7.05

Building: Main Building
Location: Entry/carport wall
Finding: Entry carport wall - defects
Information: It was observed at the time of this inspection that there were a number of defects and unfinished works at the entry carport wall area,

1 - It was noted that there new brickwork has been added to the external walls where the windows have been altered/replaced. It is recommended that all external brick walls be rendered and painted.

3 - It was observed that the eaves sheets were damaged and not fitted correctly, it is recommended that a roof tiler check the roof for leaks. It is further recommended that a carpenter repair the eaves sheets and all sheets be repainted.

5 - It was observed that the guttering and metal fascia had minor rust and damage evident, the guttering and down pipes should be replaced by a plumber.

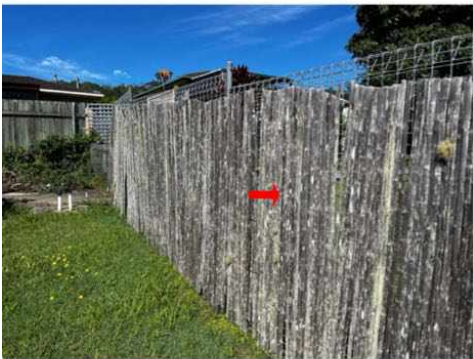
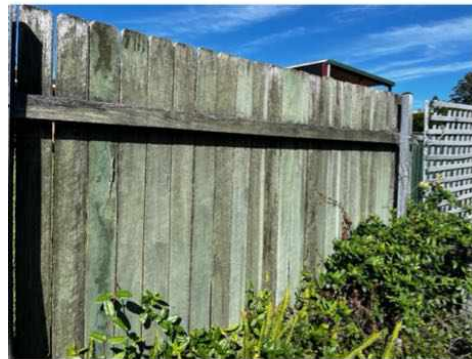
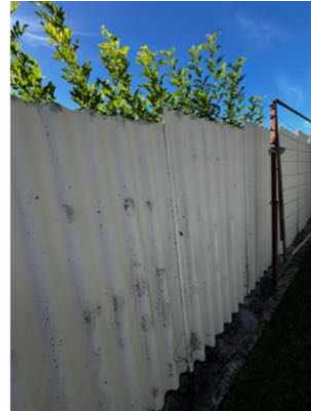
Finding 7.06

Building:	Main Building
Location:	Boundary fences
Finding:	Timber fence - fungal decay front boundary fence
Information:	At the time of this inspection it was observed that the timber fences appeared to have an older section and newer section.

The older section of timber fence was in a deteriorated state with mould and fungus growth evident and minor fungal decay (wood rot) observed.

A fencer should be engaged to repair or replace any affected sections and provide maintenance to all fences as required.

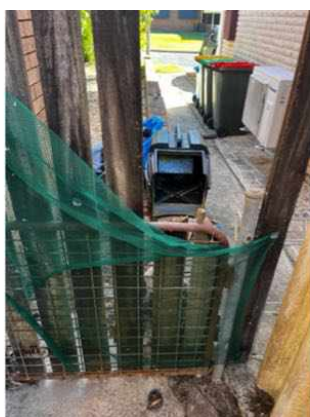
Building: Main Building
 Location: All External Areas
 Finding: Obstructions and Limitations External Areas
 Information: These photographs are an indication of the obstructions and limitations which impeded full inspection of external areas of the property at the time of inspection. These obstructions can hide an array of defects and should be removed to allow full inspection to be carried out. A re-inspection is recommended once the areas are made accessible.

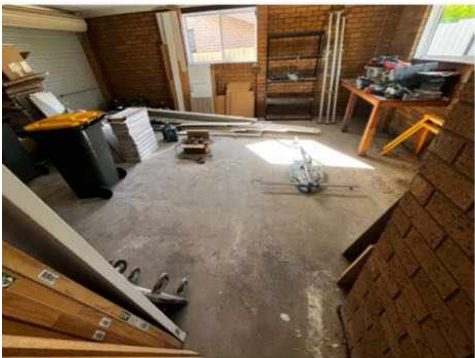
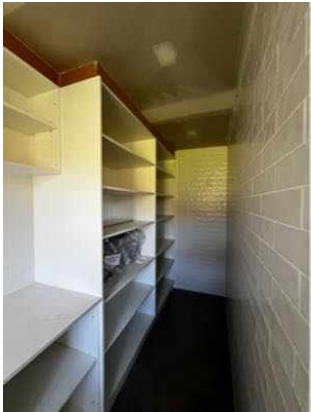
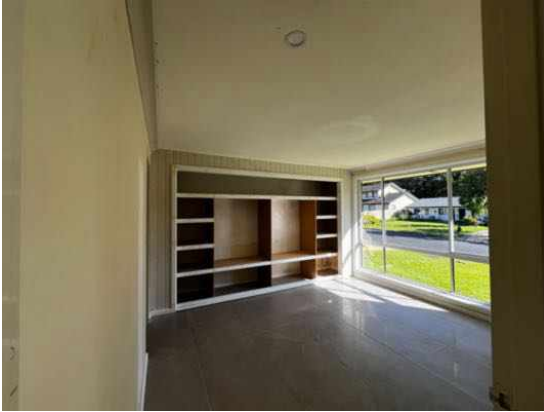
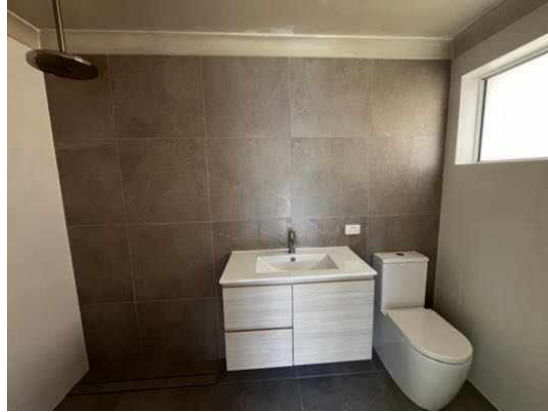
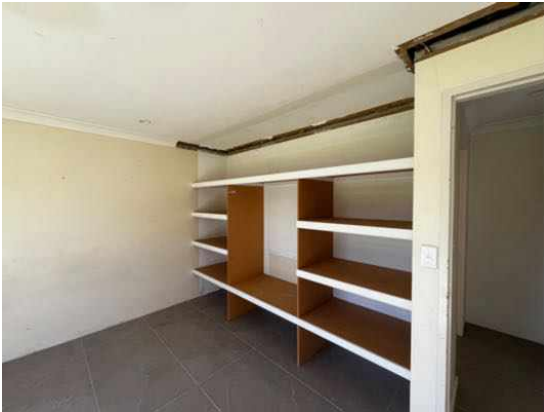
Building: Main Building
 Location: All Internal Areas
 Finding: Obstructions and Limitations Internal Areas
 Information: These photographs are an indication of the obstructions and limitations which impeded full inspection of internal areas of the property at the time of inspection.

These obstructions can hide an array of defects and should be removed to allow full inspection to be carried out. A re-inspection is recommended once the areas are made accessible.
