Building Inspection Report

Inspection Date: Mon, 09 Feb 2026

Property Address: 1 Heber Cl, Cobbitty NSW 2570, Australia

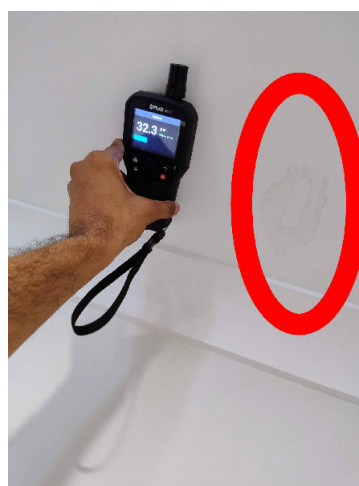
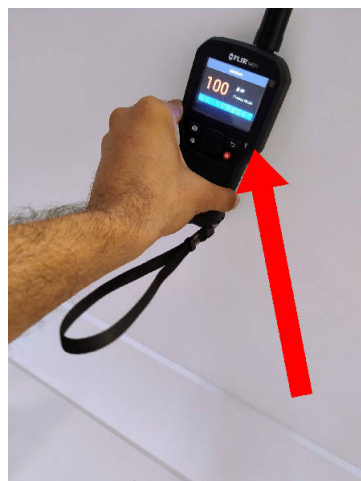
Defects 2.01

Finding: Air-conditioning unit - Leak - Roof Void

Information: Air condition unit leak was observed at the time of inspection. Leaking from an air-conditioning unit may be a result of several causes, including poor installation, blockages in internal drains, or a blockage to the drain hole.

Heavy leaking from the air-conditioning unit is likely to produce damp conditions in the surrounding area conditions which can affect the structural integrity of the roof structure. If left unattended, such leaking can develop into water pooling below the unit, creating potential for subsequent water damage to roof structure.

A refrigeration mechanic or licensed plumber should be appointed to assess the condition of the unit and to perform any remedial works on urgent basis.

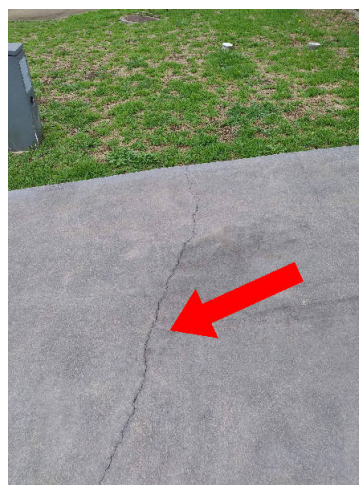
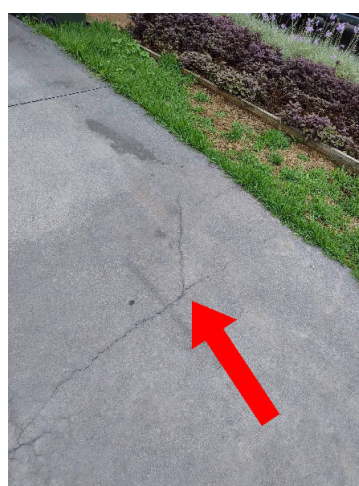
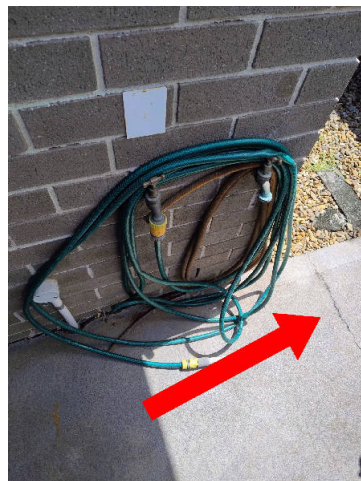
Defects 3.01

Finding: Crack in concrete slab - Category 2

Information: Cracks in driveway in Category 2 was identified in the slab at the time of inspection . A Category 2 crack is described as a distinct crack, with the slab being noticeably curved or changed in level.

To be considered Category 2, the approximate width of the crack is less than 2.0mm, or a change in offset of less than 15mm when a 3m straight edge is placed over the defect.

Category 2 cracks to slabs should be monitored for a period of 12 months. At the end of the monitoring period, cracks rated greater than Category 2 are considered defects that require rectification.

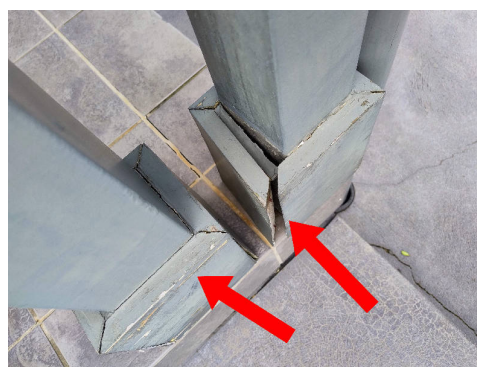
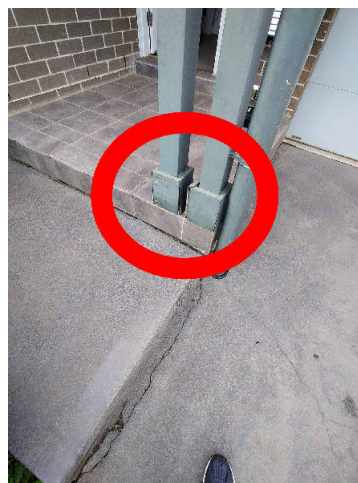
Defects 3.02

Information: During the inspection, it was observed that timber support members at the entrance, which provides structural support to the exterior roof, is in a degraded condition.

If left unmanaged can cause further deterioration to building elements.

Qualified trade person must be appointed for rectification on priority.

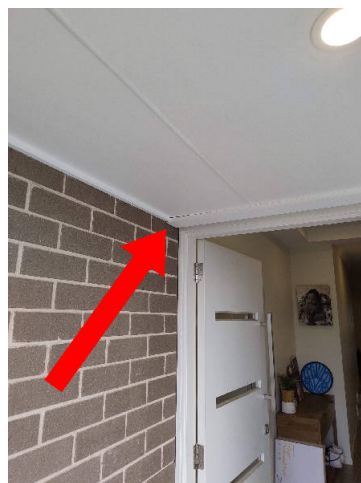
Defects 3.03

Finding: Cracking - Damage Category 2 - Noticeable (up to 5mm)

Information: Cracks been observed in ceiling and at the bottom near front door framing area.

Noticeable cracks are a common occurrence as a result of many primary defects. Such causes may include age, general wear and tear, expected building movement, general expansion/contraction of building materials in different weather conditions, and/or minor failings in the installation or application of building materials.

Noticeable cracks may result in minor sticking or jamming of associated doors and windows, which require easement. However, noticeable cracks are easily filled and repaired. A plasterer can be consulted to install an expansion joint at this point to allow for this movement during different weather conditions.

Relevant tradespeople, such as carpenters, painters and plasterers, should be appointed to perform remedial works, as deemed necessary.

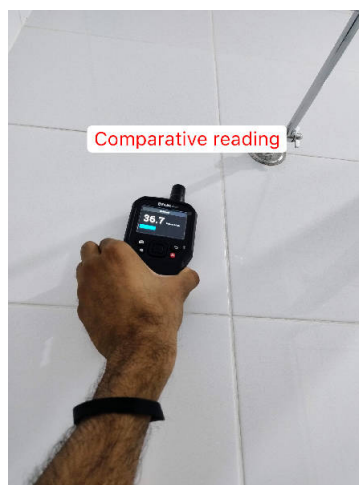
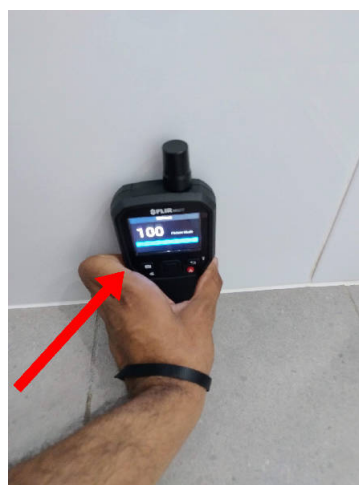
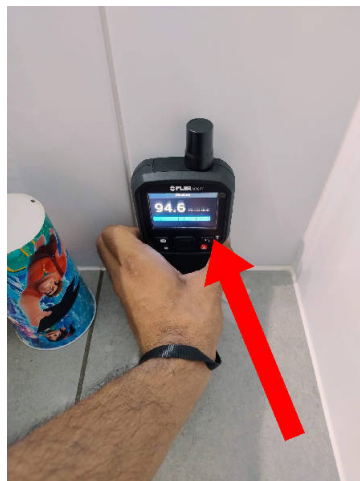
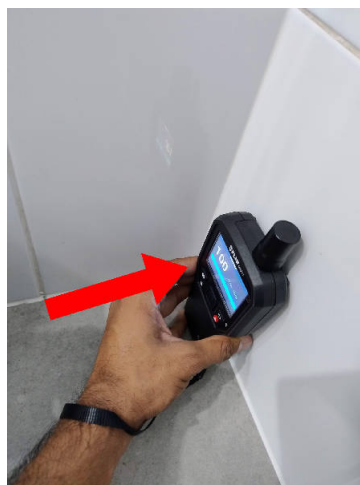
**Defects 3.06**

Finding: Evidence of Excessive moisture - identified

Information: Evidence of excessive moisture recorded by moisture meter in the bottom area of shower of common bathroom.

Excessive moisture can attract termites and produce conditions that promote fungal growth and wood decay.

Excessive moisture is generally caused by deteriorated, inadequate or missing roof drainage, leaking plumbing pipes or fixtures, poorly plumbed HWS overflows or condenser units and poor site drainage.

Prior to any remedial works being performed a qualified plumber should be appointed to further inspect the property and to identify the cause of the excessive moisture. Works to remove affected building elements may then be necessary and should be performed by an appropriate tradesperson.

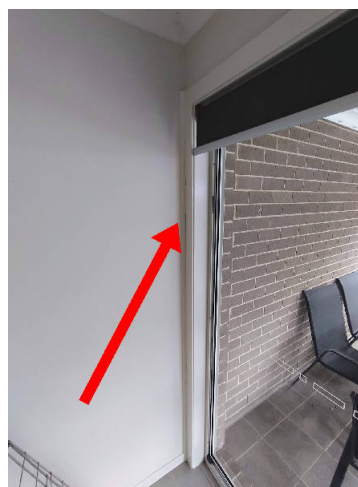
Defects 3.07

Finding: Cracking - Damage Category 2 - Noticeable (up to 5mm)

Information: Cracks have been observed at the time of inspection between sliding door frame and wall.

Noticeable cracks are a common occurrence as a result of many primary defects. Such causes may include age, general wear and tear, expected building movement, general expansion/contraction of building materials in different weather conditions, and/or minor failings in the installation or application of building materials.

Noticeable cracks may result in minor sticking or jamming of associated doors and windows, which require easement. However, noticeable cracks are easily filled and repaired. A plasterer can be consulted to install an expansion joint at this point to allow for this movement during different weather conditions.

Relevant tradespeople, such as carpenters, painters and plasterers, should be appointed to perform remedial works, as deemed necessary.

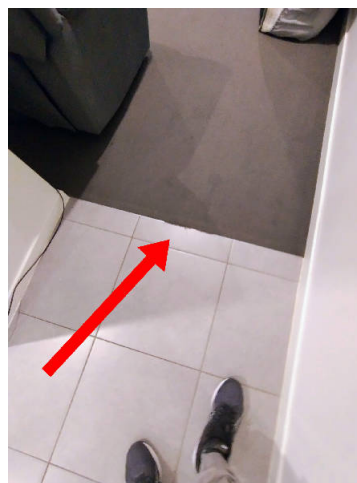
Defects 3.08

Finding: Carpet - Deteriorated

Information: Entrance area of the carpet floor covering in Media room appeared to be deteriorated. Deteriorated carpet pose health hazards by trapping allergens like dust mites and pet dander, which can trigger asthma and allergies. They can also hold bacteria, mould and fungi, especially if damp, leading to respiratory problems and infections,

Replacement of the carpet is suggested as a matter to ensure the safety of the area at client discretion. Where required, remedial works should be undertaken to any associated walls and flooring showing evidence of mould.

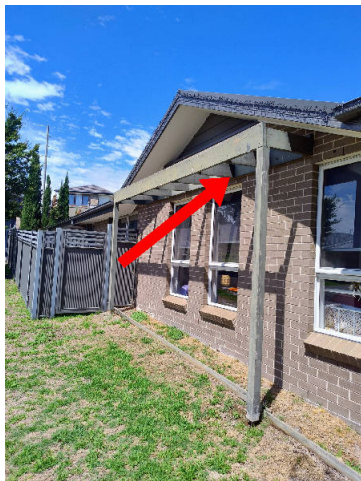
Information: It was observed that external timber pergola structure was not stable at the time of inspection.
It may primarily happened due to poor workmanship or differential movement within the pergola structure.

It is recommended that a suitably qualified and licensed builder to be engaged to further assess the cause and provide the appropriate rectification details as per client discretion.

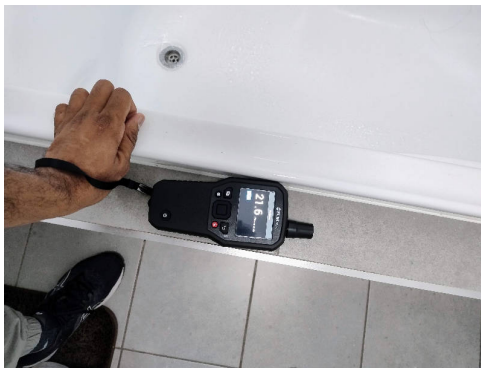
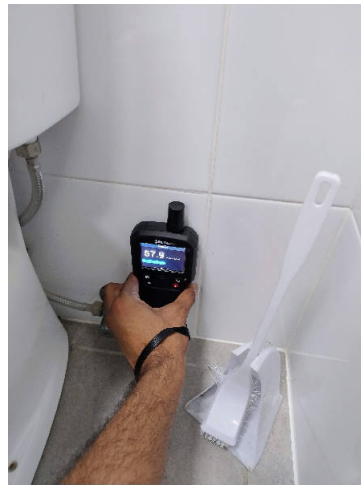
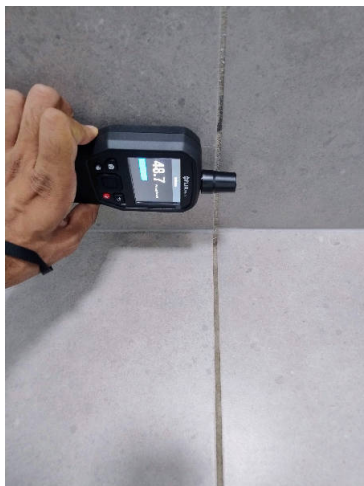
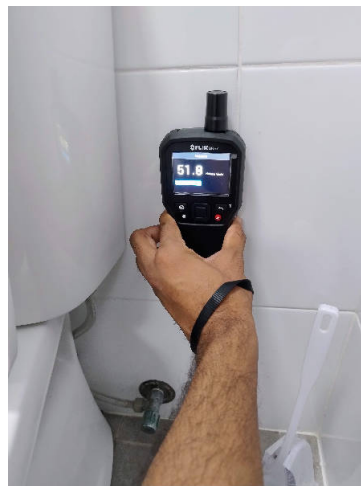
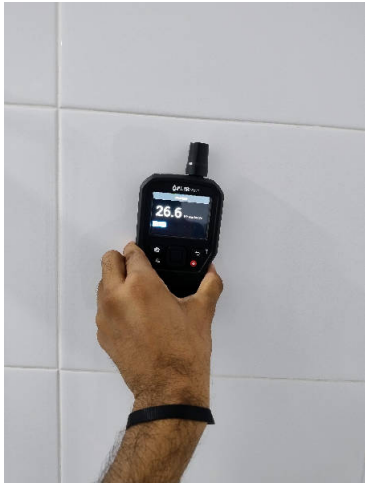
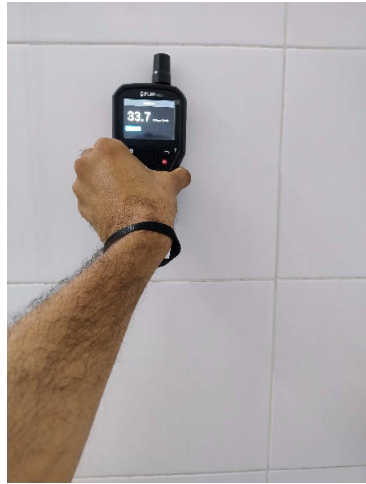
Building: Main Building
Location: All Areas
Finding: Moisture reading taken at different locations
Information:
