# Building and Timber Pest Inspection Report

Inspection Date: Mon, 9 Mar 2026

Property Address: U2/20 Dido St, Kiama NSW 2533, Australia

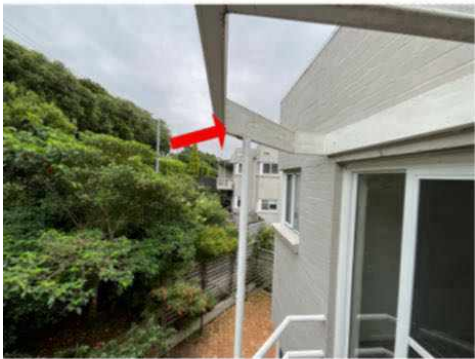
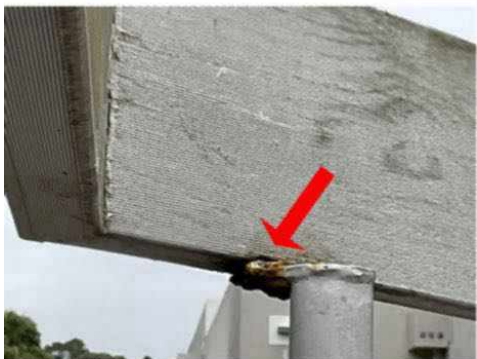
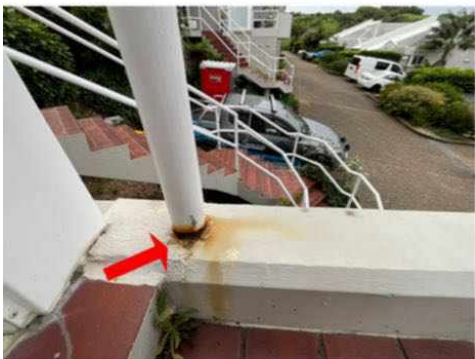
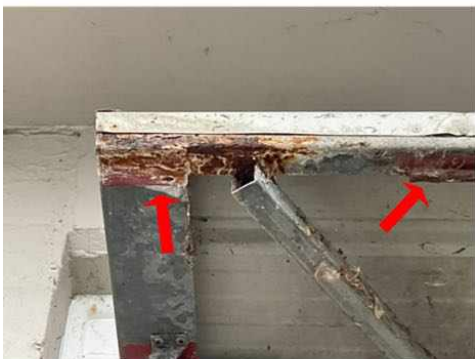
Building:	Main Building
Location:	Stairs and pergola areas
Finding:	Balcony & stair railings - rusted or corroded
Information:	These railings shows evidence of rusting and corrosion, which is likely to have developed as a result of excessive exposure to moisture and or inadequate coatings.

As surface rust provides no protection to the underlying iron, the deteriorating condition is likely to worsen if not addressed in the short-term future.

The garage door area also shows minor rust.

Rusting and corrosion should be managed by ideally removing or limiting the affected surface from exposure to moisture. A registered builder must be appointed to replace these railings that have been severely affected by rust or water damage.

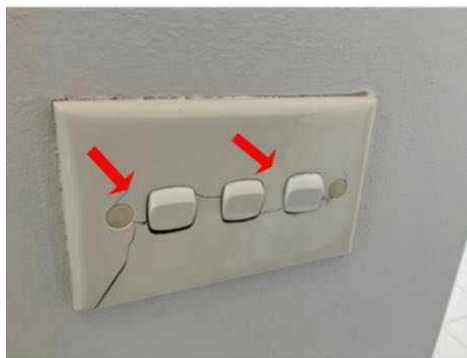
Building: Main Building  
 Location: Bathroom, hall, lounge room  
 Finding: Switches - Damaged  
 Information: The switches in this area was found to be damaged at the time of inspection. This occurs generally when the building materials have either aged and decayed or as a result of impact damage (accidental or deliberate). This damage may also have

Repair and/or replacement of the switches is advised to ensure the fixture and its associated structures are safe and fully operational. A licensed electrician should be appointed to repair/replace the light switch as soon as possible.

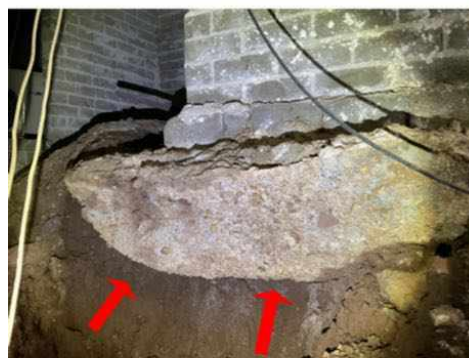
### Finding 2.01

Building:	Main Building
Location:	Subfloor
Finding:	Subsidence
Information:	It appears that the subfloor structure has been affected by movement of the ground foundations, often referred to as subsidence.

General subsidence is usually initiated by changes in soil moisture content. The most critical factor is identifying the specific causes, and identifying if this is a recurring or ongoing problem, or one that has been resolved by previous works in the past.

Subsidence can have complex and varying causes, which will influence the required remedial works. It is advised to begin by consulting a structural engineer to determine the required scope of works. A small area past this further in the subfloor also shows a crack opened up in the ground.

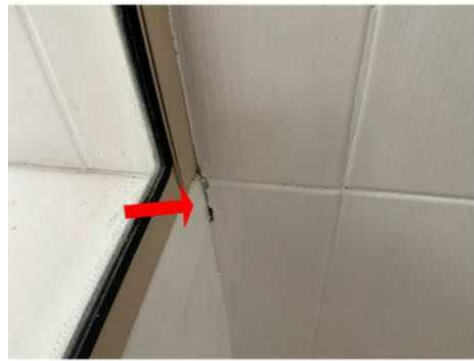
Building: Main Building  
 Location: Laundry, kitchen and bathroom areas  
 Finding: Sealant and grouting - Missing  
 Information: It was noted on inspection that sealant or grout is missing to these pictured areas of the building.

Flexible and mould resistant materials should be applied to affected areas to prevent any subsequent water damage that is likely to occur.

A sealant expert is required to replace all damaged areas of sealing in the near future.

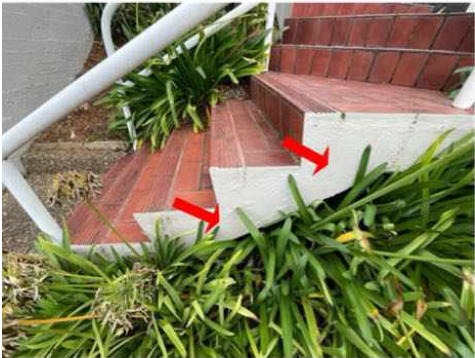
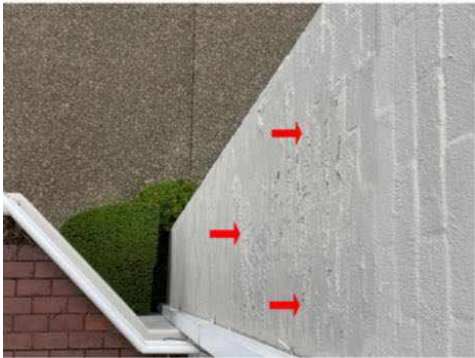
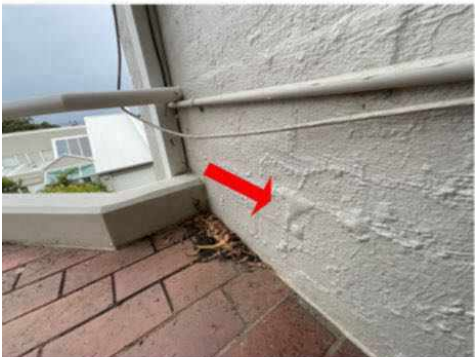
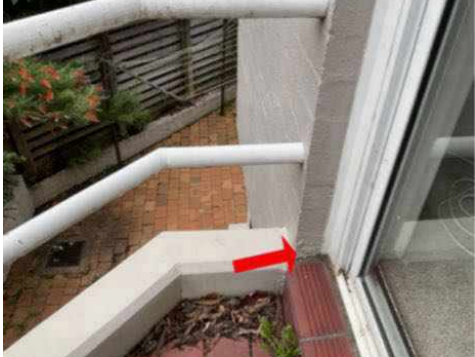
**Finding 3.05**

Building: Building 1  
Location: Stairs, walls and laundry areas  
Finding: Excessive moisture and damaged wall elements  
Information: The pictured external walls shows signs of excessive moisture damaging the wall paint. Excessive moisture can compromise the structural integrity of the wall over time as well as lead to the formation of mould. Works to remove and replace any damaged paint is necessary.

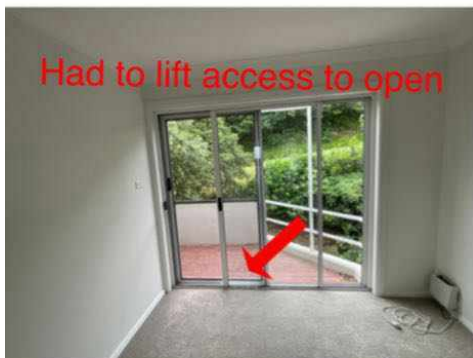
**Finding 3.06**

Building: Main Building  
Location: 3 sliding and other doors  
Finding: Doors - Stiff to slide/ binding/ broken  
Information: These doors were jammed and difficult to slide along the associated tracks at the time of the inspection. The upper rear door will not slide and has a broken handle and lock all requiring replacement.

Generally, factors such as general age of the building element and a lack of maintenance are the usual causes for this type of defect.

Replacement of door hardware or tracks may be required, as well as minor repairs and cleaning. A registered builder or general handy person will be required to repair the affected doors.

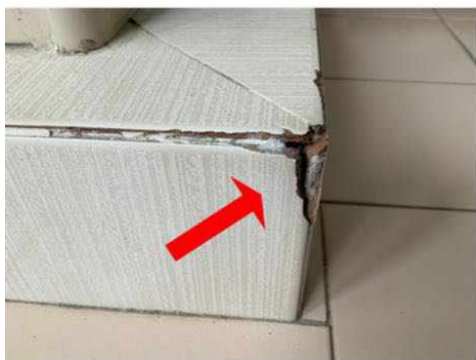
**Finding 3.07**

Building: Main Building  
Location: Stairs and bathroom areas  
Finding: Cracked and loose floor tiles  
Information: Cracking in the floor tiles was evident in this area at the time of inspection. It is suspected that this cracking has occurred as a result of water ingress.

Cracked tiles throughout the household detract from the overall appearance of the affected areas however it is unlikely to create or lead to any secondary defects.

While not considered a matter of urgency, replacement of cracked floor tiles is recommended at the clients discretion. A tiling contractor may be appointed to perform these works. Where cracks become more numerous, contact a licensed building inspector for further investigation.

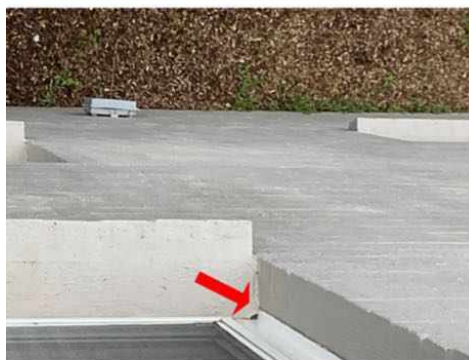
### Finding 3.08

Building:	Main Building
Location:	Exterior walls
Finding:	Sealant (external) - Missing.
Information:	It was noted on inspection that areas of external sealant was missing to small areas of the external walls.

Flexible sealants should be applied to these affected areas to prevent any subsequent water damage that is likely to occur.

A sealant specialist or skilled handy person should be appointed to complete these works as soon as possible

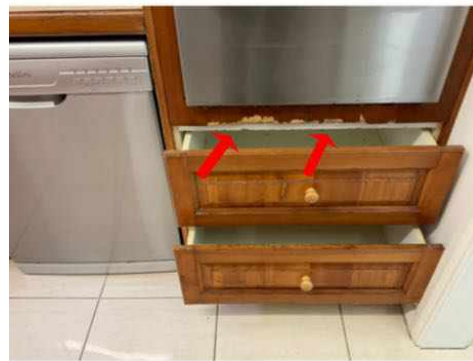
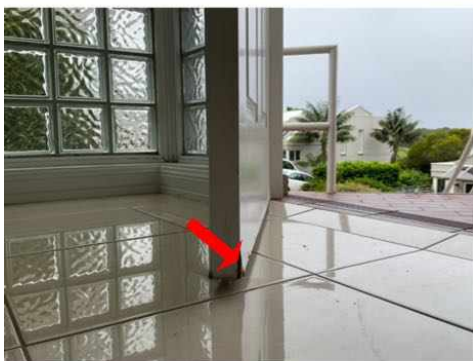
**Finding 3.09**

Building: Main Building  
 Location: Bathrooms , wardrobe,  
 Finding: Doors and cupboard areas - Swollen or damaged  
 Information: Swollen building elements (doors, cupboards) generally indicate that the building materials have been affected by excessive moisture over a prolonged period of time, and have swollen as a result.

Repair and/or replacement of swollen building elements should be conducted as a matter of urgency by a registered builder or qualified carpenter.

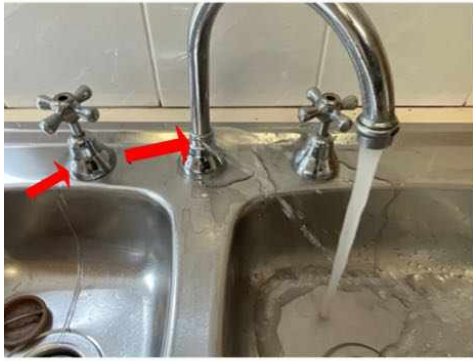
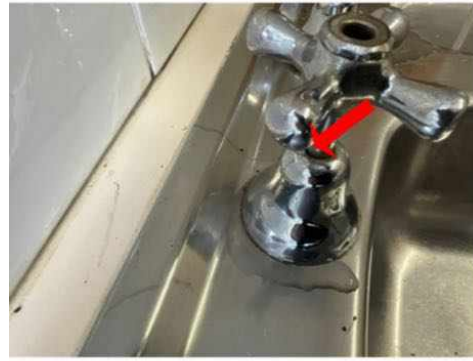
Information: The tap in this area was found to be leaking, spraying water in different directions at the time of inspection. This is a common defect that is consistent with general ageing of the building element. While this defect only seems minor, if left unmanaged, it is likely to result in the development of rust, water damage and/or extensive water usage.

It is advised that a handyman or licensed plumber be appointed to perform remedial works on the affected tap. Such works should be performed prior to the development of secondary defects to ensure adequate functionality of all associated building elements.

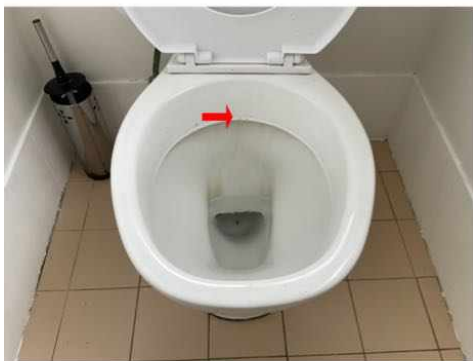
### Finding 3.17

Building: Main Building  
Location: Toilets  
Finding: Toilets - continually running.  
Information: Both toilet flushes needs to be adjusted by a plumber as it is currently continually running and not cutting out 10 minutes after flushing.

Non-operational building elements such as this are vital to the function of the household and must be fixed.

A qualified plumber should be appointed immediately to repair the toilet and return it to an operational state.

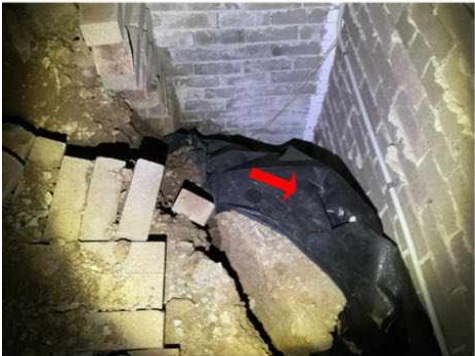
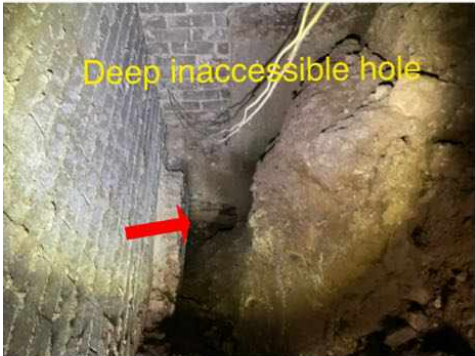
Building:	Main Building
Location:	Subfloor
Finding:	Additional Photos - Obstructions and Limitations of SUBFLOOR AREAS
Information:	These photographs are an indication of the obstructions and limitations which impeded full inspection of subfloor areas at the time of inspection. These obstructions can hide an array of defects and should be removed to allow full inspection to be carried out. A re-inspection is recommended once the areas are made accessible.
