Building and Timber Pest Inspection Report

Inspection Date: Wed, 8 Apr 2026

Property Address: 10/99 Heeb St, Ashmore QLD 4214,
Australia

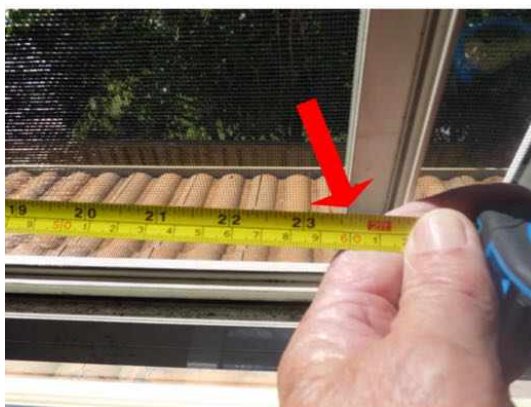
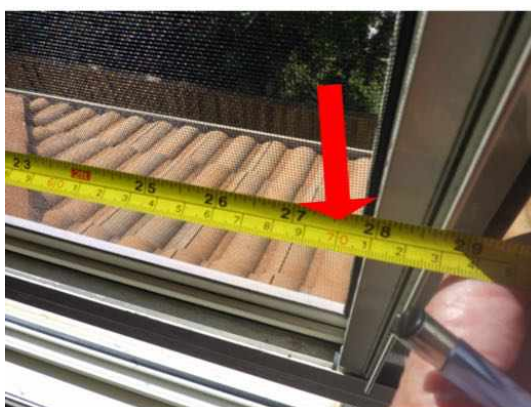
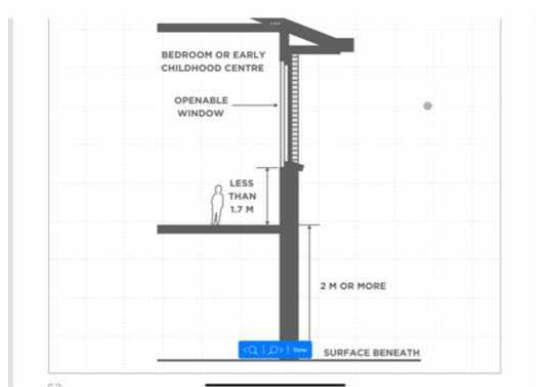
Building: Main Building
Location: Bedrooms > Existing
Finding: Window safety
Information: It was noted that the windows of the upper level bedrooms are less than 1.7m from the floor and have a fall greater than 2m on the exterior from the sill and as such are required to only open upto 125mm or have security grills fitted.

This is noted as a safety concern and this regulation may not have been in place at the time of construction.

Windows are defective if they do not comply with provision 3.9.2.5 of Volume 2 of the BCA that requires that a window opening must have protection if the floor below the window in a bedroom is 2 m or more above the ground surface beneath.

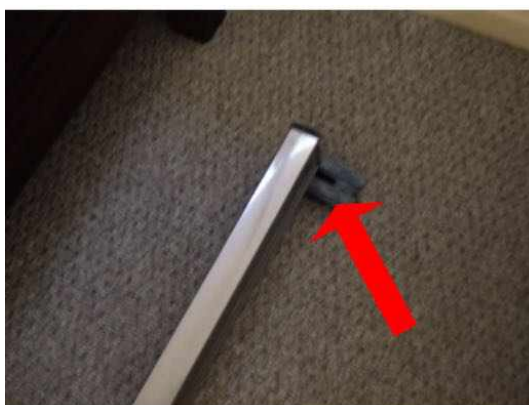
Finding 2.04

Building:	Main Building
Location:	Bedroom 3 > Rear Right
Finding:	Levelness of floors
Information:	At the time of inspection, although there was no obvious damage or cracking to wall

and ceiling linings, the bedroom 3 area floor deviated in levelness by more than the recommended QBCC standard and tolerances. In this instance the bedroom 3 floor was found to be off level by 26mm over a 2.0m length.

Floor areas are defective if they differ in level by more than 10mm in any room or area, or more than a 12mm deviation over a three metre length under the QBCC Standards and Tolerances Guide.

A licensed builder or structural engineer could be engaged for further investigation and/or advice.

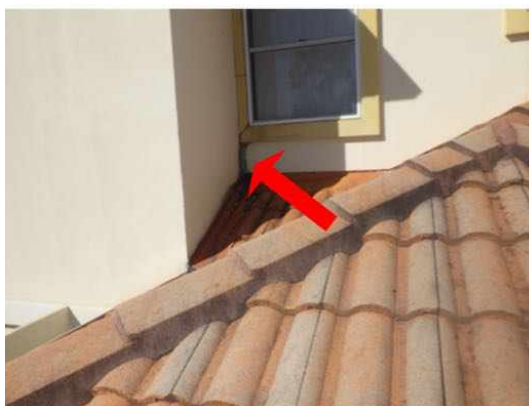
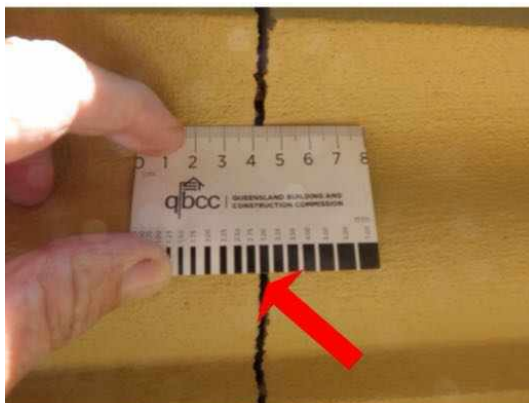
Finding 3.03

Building:	Main Building
Location:	Exterior walls > Existing
Finding:	Cracks to internal rendered surfaces - Category 1 - 2
Information:	It has been observed that cracking to external rendered surfaces has occurred (as per example photos).

The degree of damage falls within Category 1 - 2, described as noticeable cracks which are easily filled. Such cracking may cause doors and/or windows to stick slightly, and are generally less than 5mm in width.

Damage of this category is required to be monitored for a period of 12 months, after which time a crack rated at Category 2 or above is considered a defect that requires rectification. Always contact your building inspector should cracks widen, lengthen, or become more numerous.

A licensed builder or solid plasterer should be consulted for further advice on rectification procedure's.

NOTE - External wall area repairs and/or maintenance may be the responsibility of the building complex's body corporate managers.

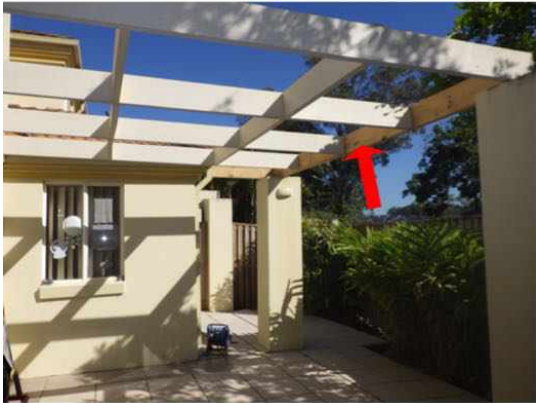
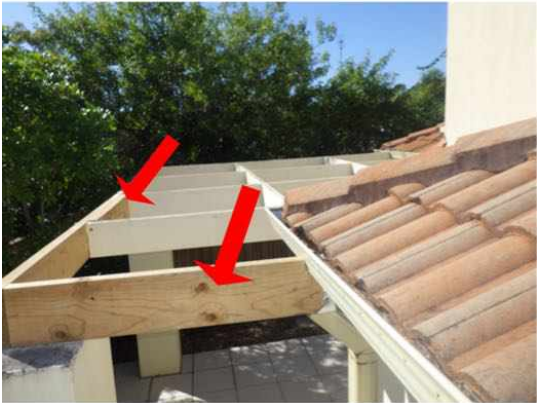
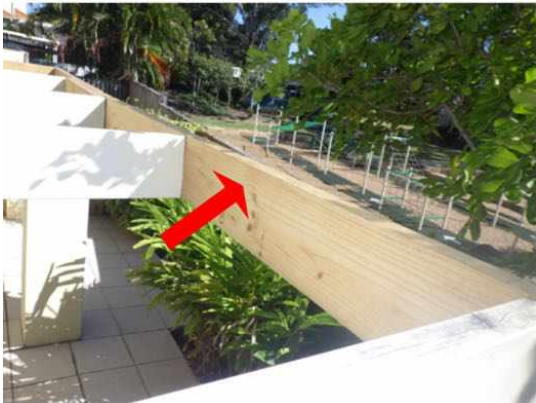
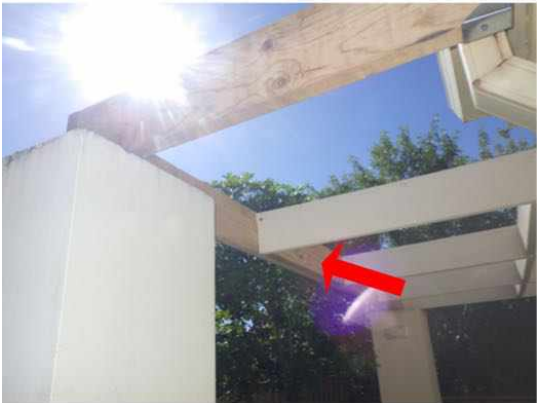
Finding 3.06

Building: Main Building
Location: Pergola > Rear
Finding: Incomplete works.
Information: At the time of inspection it appeared there were areas of incomplete repair work to the alfresco area timber pergola.

A qualified painter or general handyman could be engaged to complete the work, at the clients discretion.

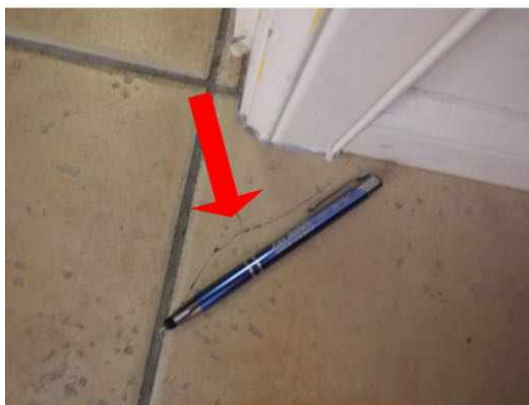
Finding 3.07

Building: Main Building
 Location: Entry > Centre Right
 Finding: Tile - Cracked
 Information: Cracked tiles to the entry floor area was identified at the time of inspection. Such defects are generally caused by impact. Cracked or broken tiled areas may also be a direct result of poor workmanship during the construction process.

A tiling contractor could be appointed to perform repair works at the clients discretion.

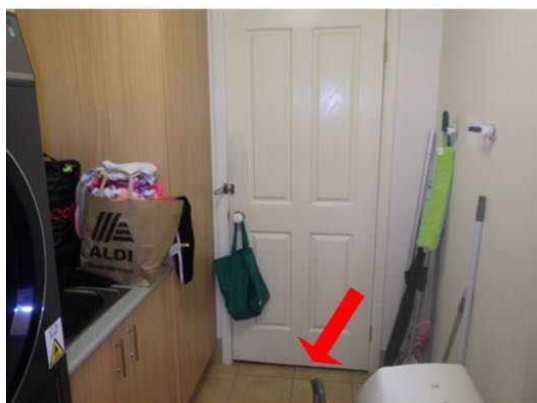
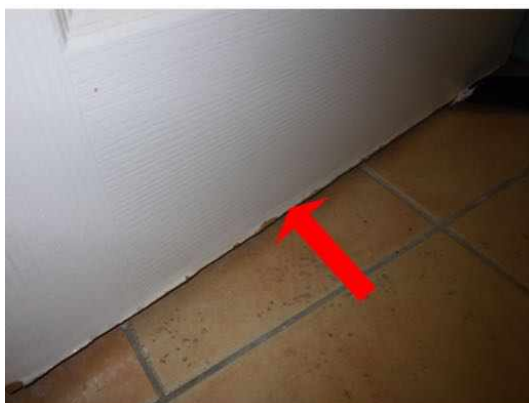
Finding 3.08

Building: Main Building
 Location: Laundry > Rear
 Finding: Damaged Door
 Information: The laundry area door leading into the garage has suffered damage to the bottom edge.

Damage occurs generally when the building materials have aged and decayed, but in this instance the damage appears to be the result of exposure to moisture, possibly from the bottom and/or top edges of the door not being sealed with a suitable paint or sealant at the time of construction.

A qualified carpenter or general handyman could be appointed to repair/replace the door at the clients discretion.

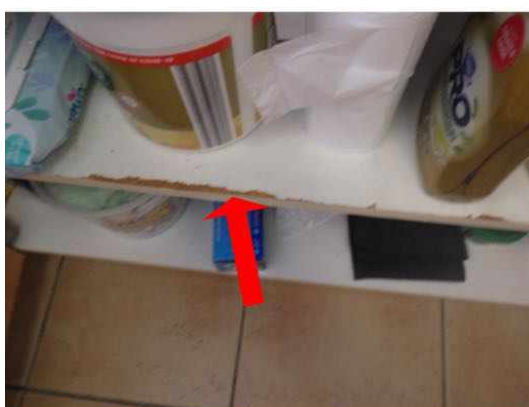
Finding 3.09

Building: Main Building
 Location: Kitchen > Centre Left
 Finding: Cabinetry - Deterioration
 Information: At the time of inspection the kitchen cabinetry showed signs of minor deterioration. The level of damage appears consistent with exposure to moisture or general wear and tear.

A qualified cabinet maker or general handyman could be engaged to undertake repair works at the clients discretion.

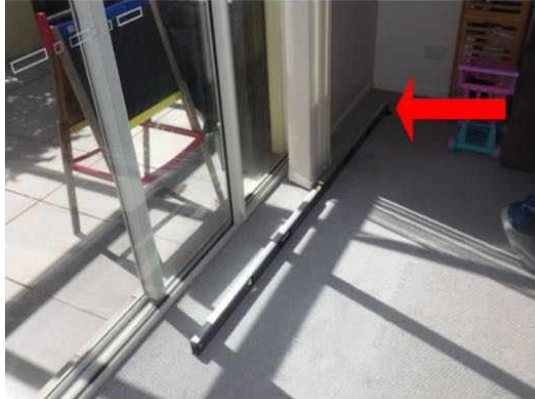
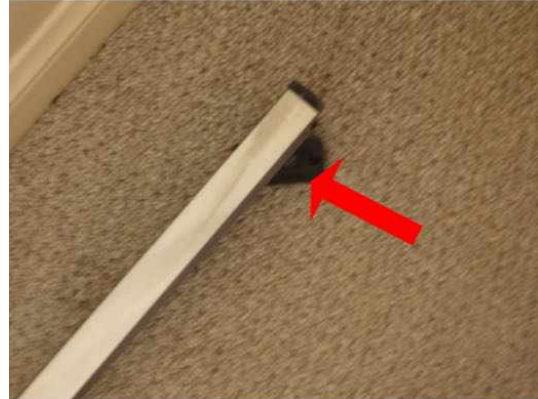
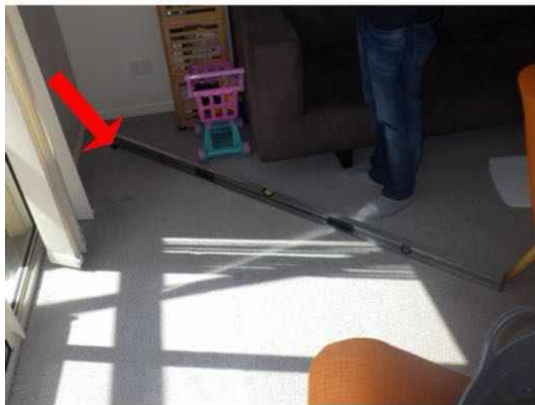
Finding 3.10

Building: Main Building
 Location: Living Room > Rear Right
 Finding: Levelness of floors
 Information: At the time of inspection, although there was no obvious damage or cracking to wall and ceiling linings, the living room area concrete floor deviated in levelness by more than the recommended QBCC standard and tolerances. In this instance the living room floor was found to be off level by 10mm over a 2.0m length.

Floor areas are defective if they differ in level by more than 10mm in any room or area,

or more than a 12mm deviation over a three metre length under the QBCC Standards and Tolerances Guide.

A licensed builder or structural engineer could be engaged for further investigation and/or advice.

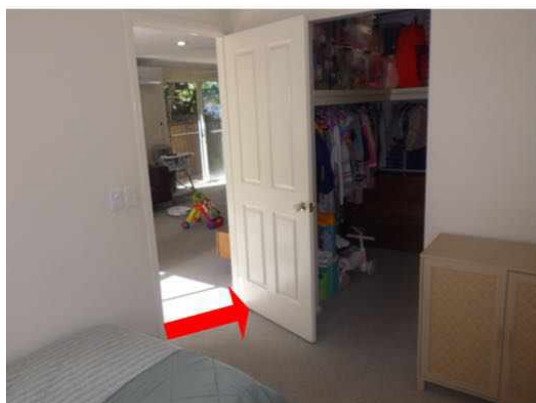
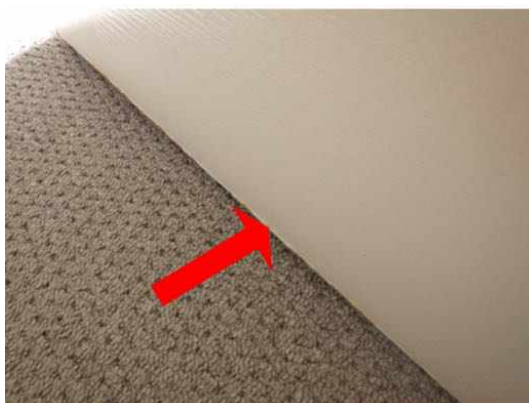
Finding 3.11

Building:	Main Building
Location:	Bedroom - Master > Front
Finding:	Damaged Door
Information:	The door leading into the main bedroom has suffered damage to the bottom edge.

Damage occurs generally when the building materials have aged and decayed, but in this instance the damage appears to be the result of exposure to moisture, possibly from the bottom and/or top edges of the door not being sealed with a suitable paint or sealant at the time of construction.

A qualified carpenter or general handyman could be appointed to repair/replace the door at the clients discretion.

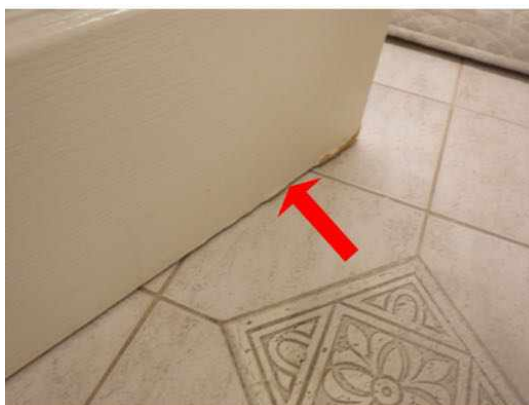
Finding 3.12

Building:	Main Building
Location:	Ensuite > Front
Finding:	Damaged Door
Information:	The door leading into the ensuite has suffered damage to the bottom edge.

Damage occurs generally when the building materials have aged and decayed, but in this instance the damage appears to be the result of exposure to moisture, possibly from the bottom and/or top edges of the door not being sealed with a suitable paint or sealant at the time of construction.

A qualified carpenter or general handyman could be appointed to repair/replace the door at the clients discretion.

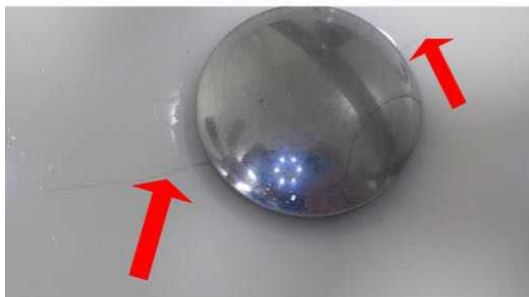
Finding 3.13

Building:	Main Building
Location:	Ensuite > Centre Right
Finding:	Basin - cracking
Information:	Fine cracking was evident to the ensuite basin at the time of inspection. While the cracking appears to be minor, any further impact damage sustained by the basin may lead to additional cracking.

The fine cracking may provide potential ingress for water and/or secondary water damage may occur to associated cabinetry if left unmanaged.

Consultation with a plumber regarding basin repair or replacement may be required.

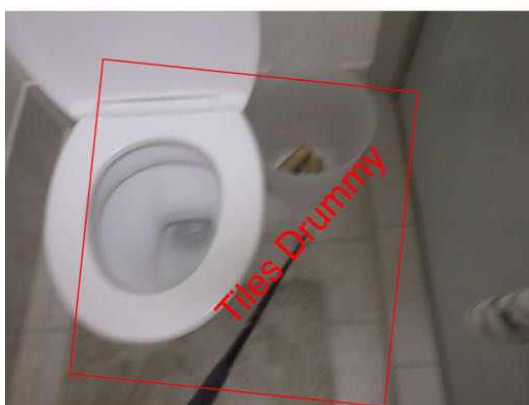
Finding 3.14

Building: Main Building
 Location: Ensuite > Front Left
 Finding: Tiles - Drummy
 Information: Drummy tiles were identified in the ensuite area floor at the time of inspection. The term 'drummy' refers to tiles that despite being in relatively good condition have a hollow sound when tapped on and may be inclined to crack from heavy impact whether accidental or deliberate. Drummy tiled areas may be a direct result of poor workmanship during the construction process.

A tiling contractor could be appointed to perform works if necessary.

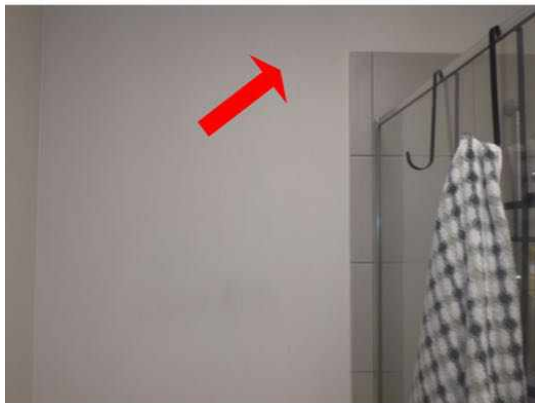
Finding 3.15

Building: Main Building
 Location: Ensuite > Centre Left
 Finding: Cracking - Wall

Information: There is cracking to an area of the wall lining in the ensuite area.

The cracking appears minor in nature and is generally only ever an appearance defect. While such cracking may be noticeable in some cases, it is quite common and does not indicate any structural damage.

Cracking of this nature can generally be repaired with minor sanding, filling and/or repainting. Such works should be performed by a qualified painter or a general handyman.

Monitoring of all cracking should be conducted frequently. Always contact a building inspector should cracks widen, lengthen, or become more numerous.

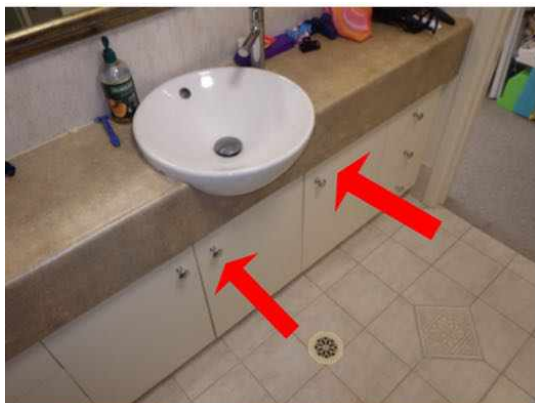
Finding 3.16

Finding: Cabinetry - Deterioration

Information: At the time of inspection the ensuite cabinetry showed signs of deterioration. The level of damage appears consistent with exposure to moisture or general wear and tear.

A qualified cabinet maker or general handyman could be engaged to undertake repair works at the clients discretion.

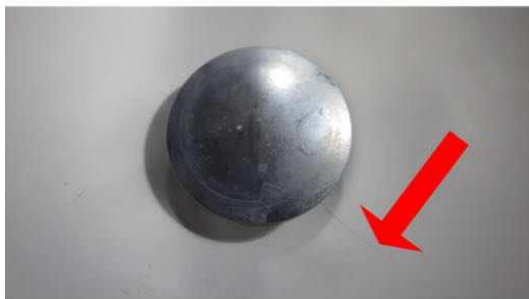
Finding 3.19

Building: Main Building
 Location: Bathroom > Centre, Rear
 Finding: Basin - Pop up waste stiff.
 Information: The bathroom basin pop up waste was stiff to operate at the time of inspection. It is advised that maintenance is carried out on the waste so as it functions as intended.

A handyman could be appointed to perform any remedial works where required.

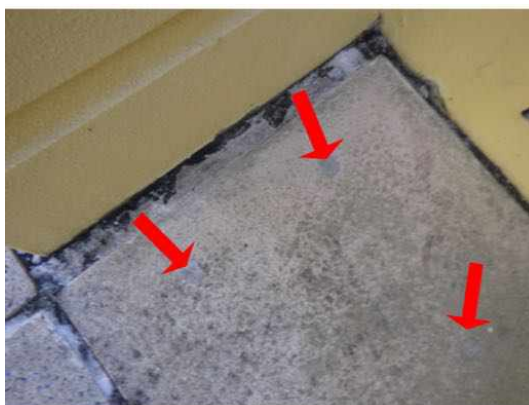
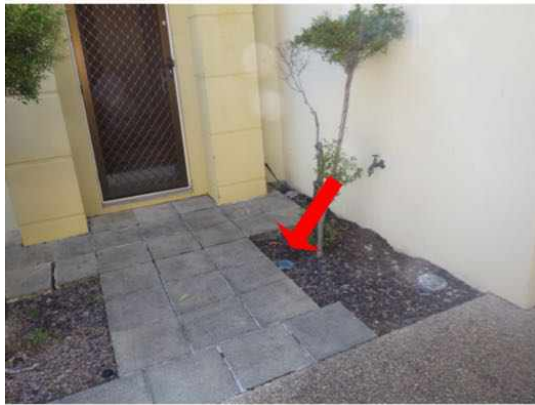
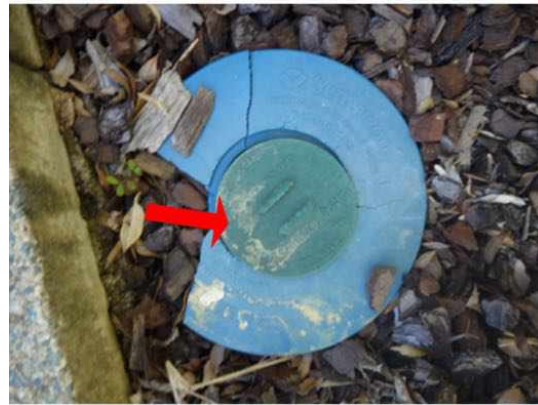
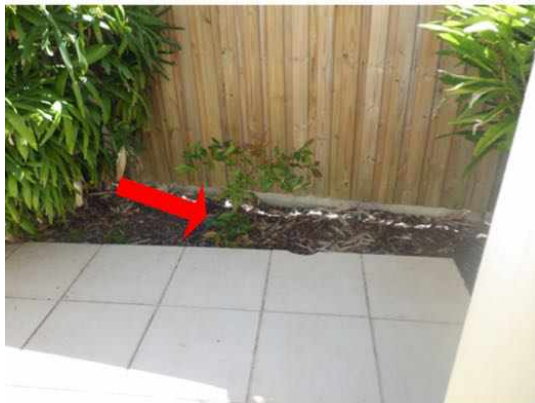
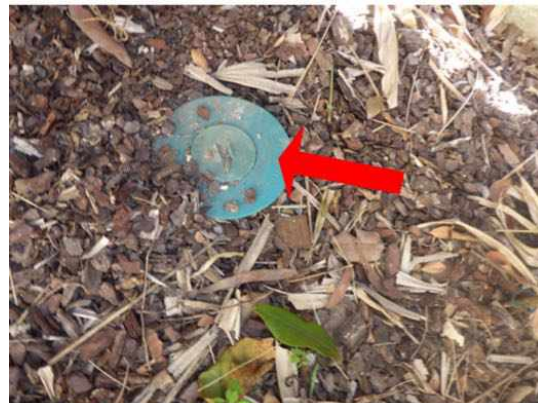
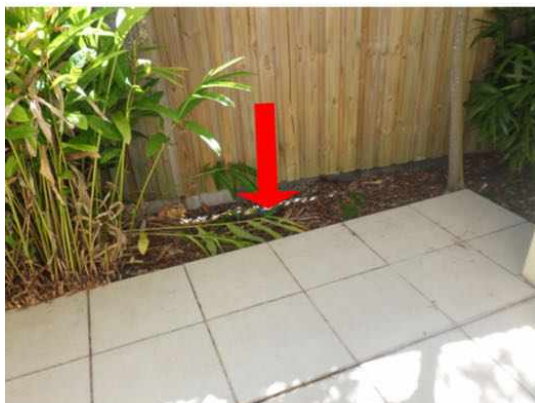
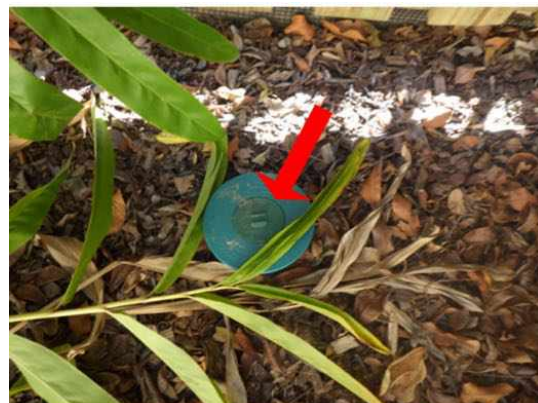
Building: Main Building
Location: Exterior walls > Existing
Finding: Termite Management System - no evidence of a chemical installation
Information: At the time of inspection, it appeared as though no current or active termite management system is installed on the property, with no evidence to suggest preventative works or regular inspections taking place. It was observed there has been previous in ground baiting stations and chemical treatment work undertaken but these systems appeared non-operational and/or expired.

The application of a post-construction chemical termite barrier is highly recommended for all properties, particularly if live termite activity has been found on the site previously. Such barriers are highly effective in preventing termite attack on any timber building elements throughout the property.

A durable notice should be placed in the switchboard unit or the under sink cabinetry to indicate current termite barriers.

The client should consider gaining further advice from a licensed timber termite pest technician as to the costs and procedures involved with this application. It is highly recommended that obtaining such advice be a short-term priority.

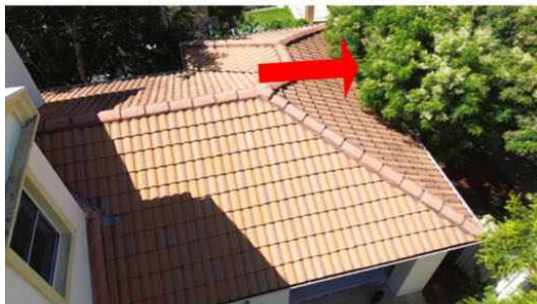
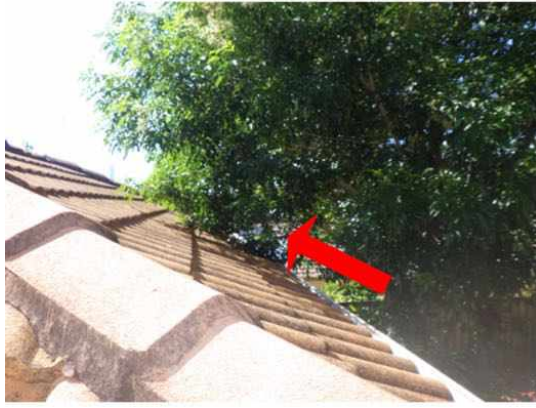
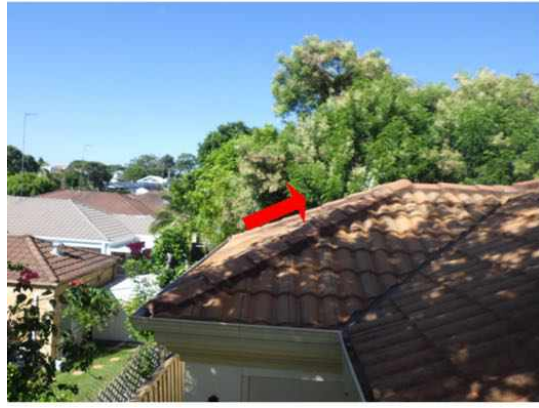
At the time of inspection there was vegetation growing over external roof areas. Consequently moisture or dampness may be present and the areas become conducive to termite activity. Plants against or very close to buildings provide cover, shade and can provide an environment that is attractive to termite infestation.

The vegetation over growing roof and/or wall areas should be trimmed back clear of the external surfaces.

The grass and other vegetation heights should be maintained around the perimeter of the building to allow for an inspection zone around the building exterior.

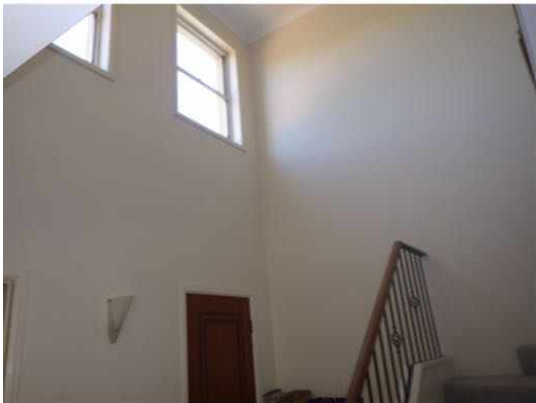
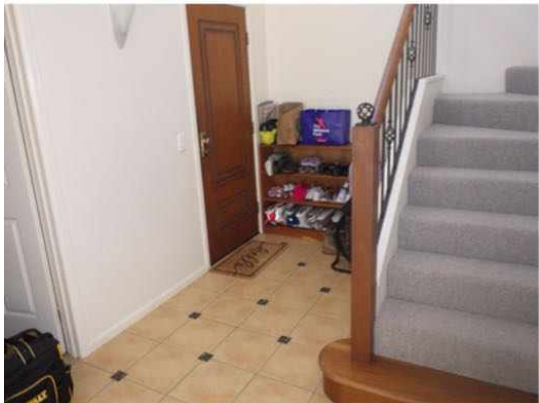
Building: Main Building
Location: Entry > Existing
Finding: Additional Photos
Information: Additional photos are provided for your general reference

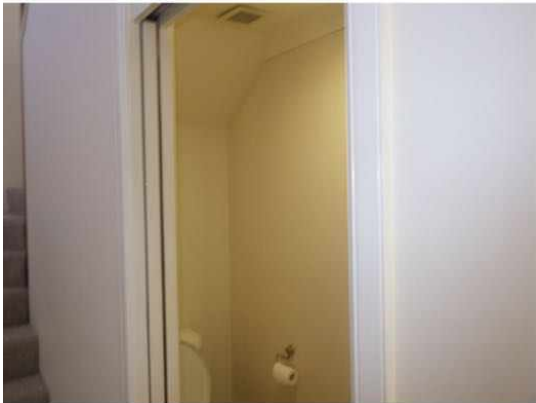
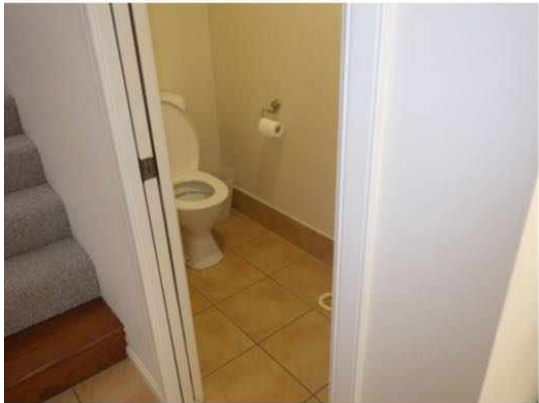
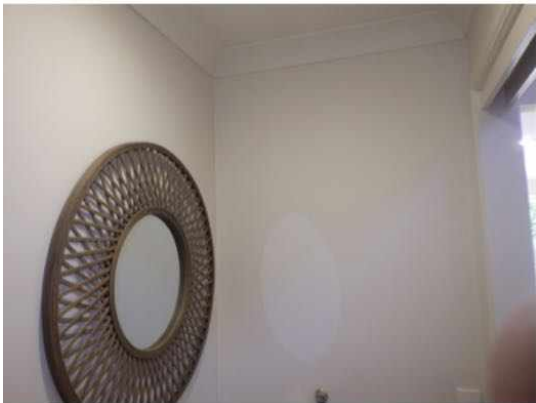
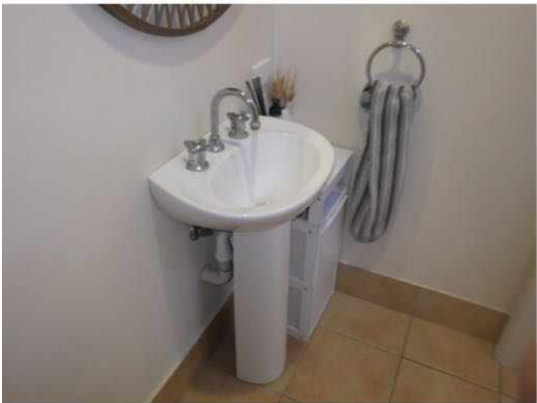
Building: Main Building
Location: Powder Room > Existing
Finding: No obvious defect
Information: No obvious defects found at the time of inspection.

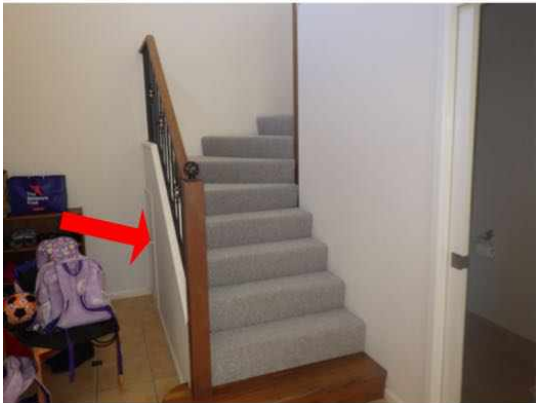
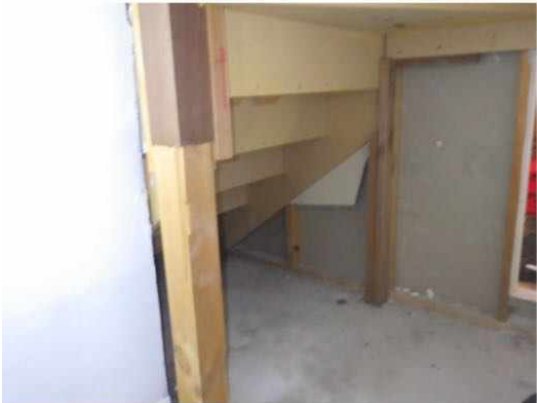
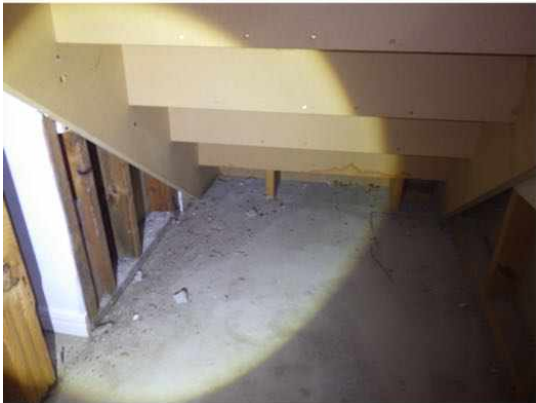
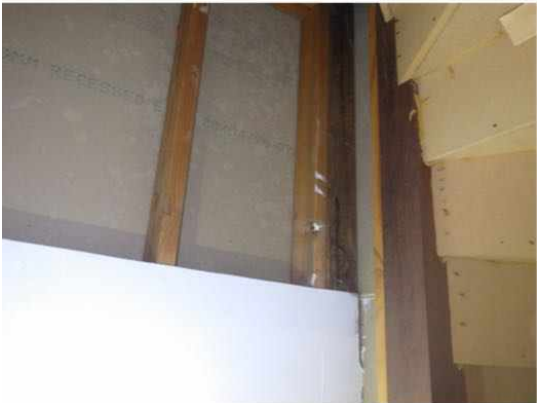
Building: Main Building
 Location: Under Stair Void or Storeroom > Existing
 Finding: No obvious defect
 Information: No obvious defects found at the time of inspection.

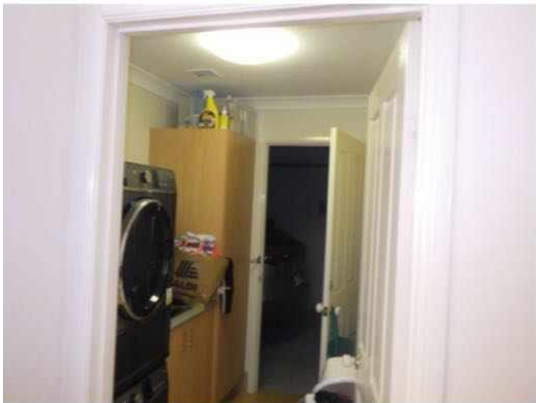
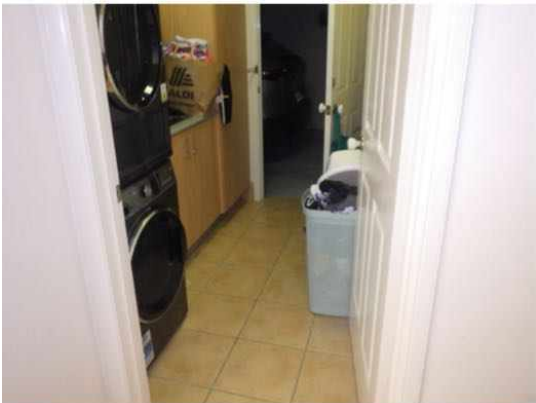
Building: Main Building
 Location: Laundry > Existing
 Finding: Additional Photos

Information: Additional photos are provided for your general reference

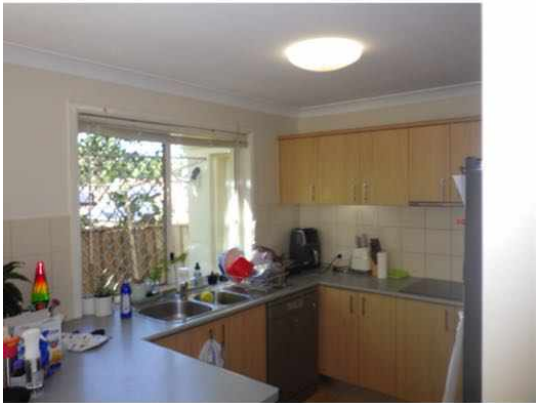
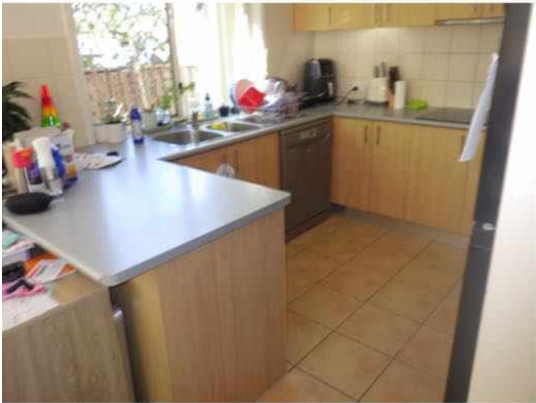
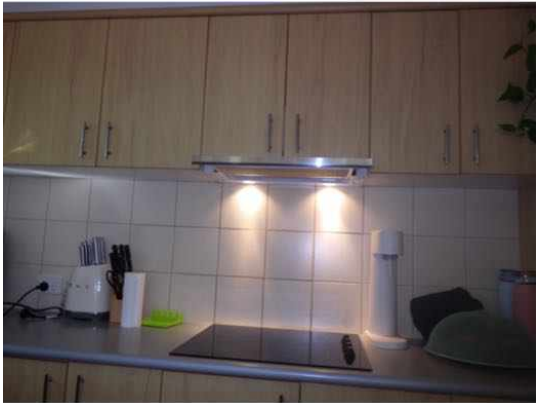
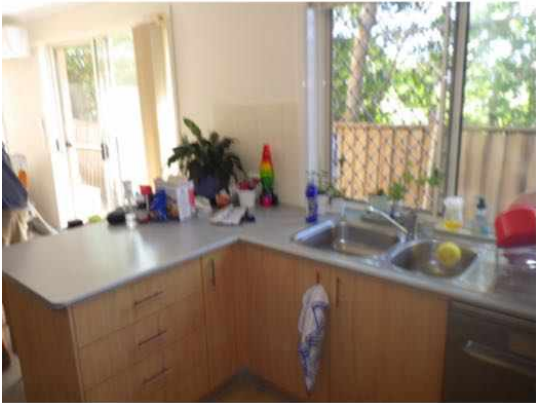
Building: Main Building
Location: Kitchen > Existing
Finding: Additional Photos
Information: Additional photos are provided for your general reference

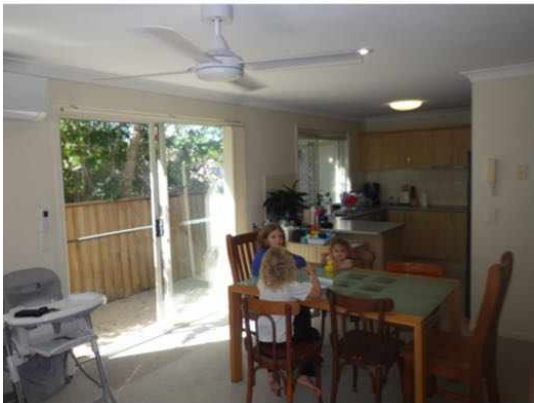
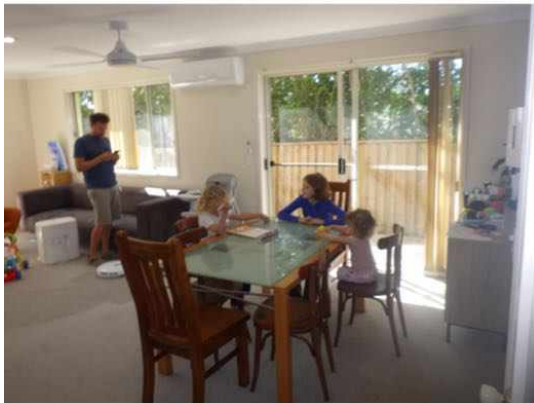
Building: Main Building

Location: Dining Room > Existing
Finding: No obvious defect
Information: No obvious defects found at the time of inspection.

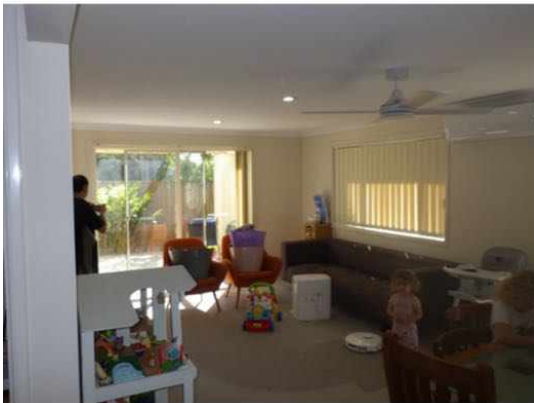
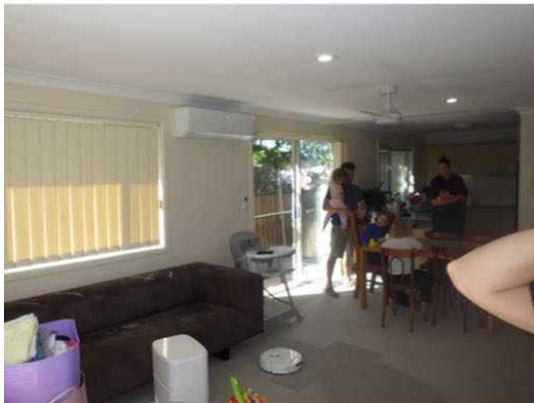
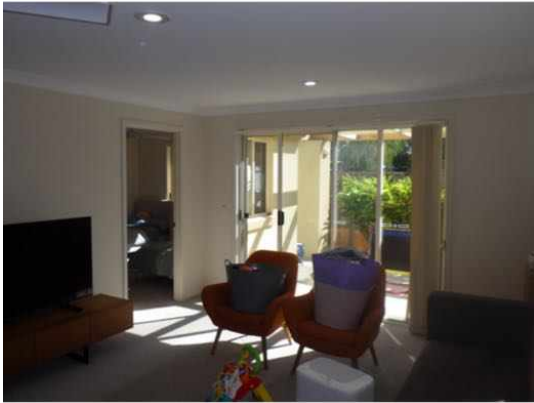
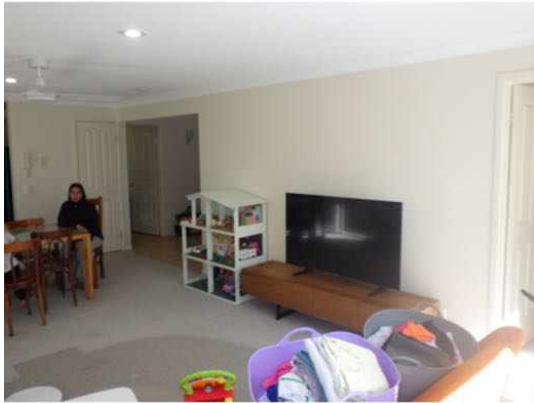
Building: Main Building
Location: Living Room > Existing
Finding: Additional Photos
Information: Additional photos are provided for your general reference

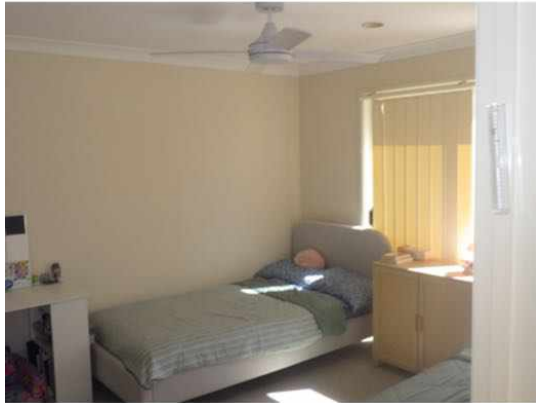
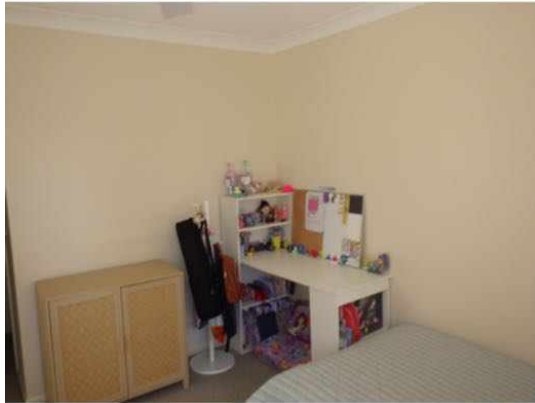
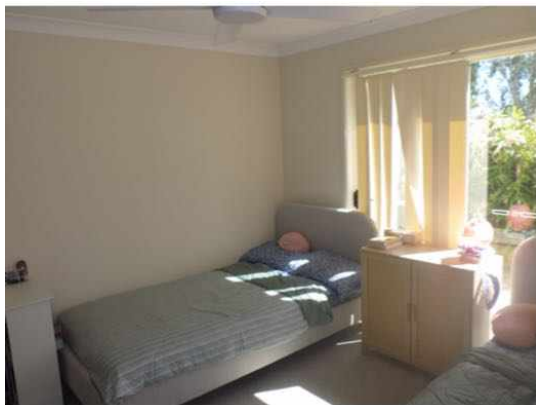
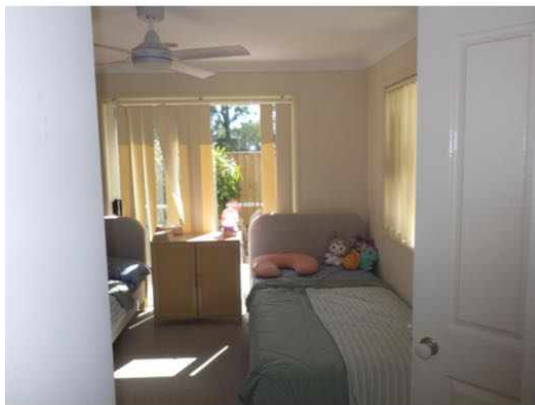
Building: Main Building
Location: Bedroom - Master > Existing
Finding: Additional Photos
Information: Additional photos are provided for your general reference

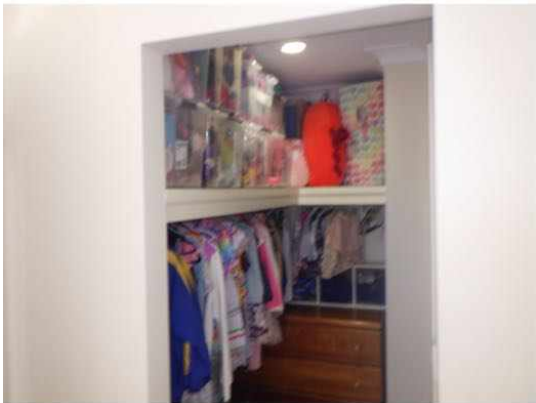
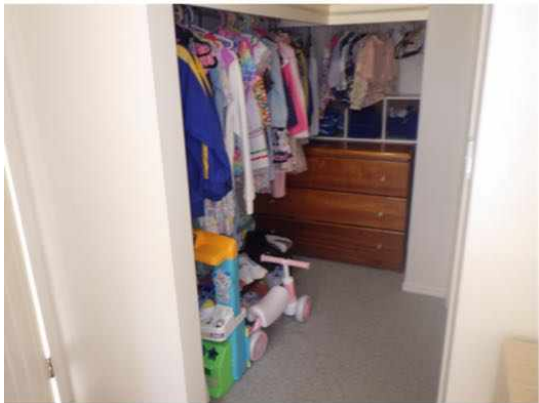
Building: Main Building
Location: Walk In Robe > Existing
Finding: No obvious defect
Information: No obvious defects found at the time of inspection.

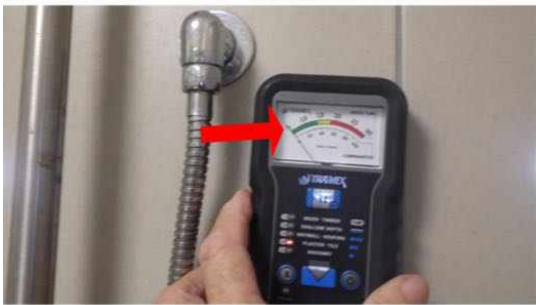
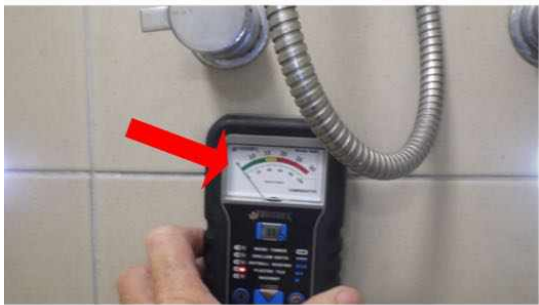
Building: Main Building
Location: Ensuite > Rear Left
Finding: Moisture Level Readings
Information: At the time of inspection the ensuite shower cubicle areas checked with the Tramex Moisture Meter returned low - normal moisture level readings.

The shower area grout and sealant presented in a fair - good condition.

Monitoring the area is advised and if any visual signs of excessive moisture appear (peeling paint, mould) then consultation with a bathroom specialist would be advised.

Always ensure that sealant and grout is in good condition to prevent any moisture issues occurring in the future.

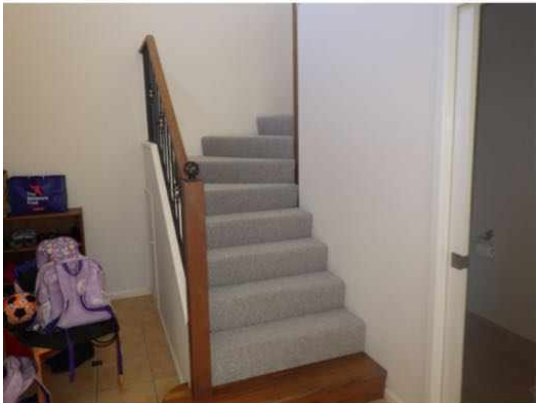
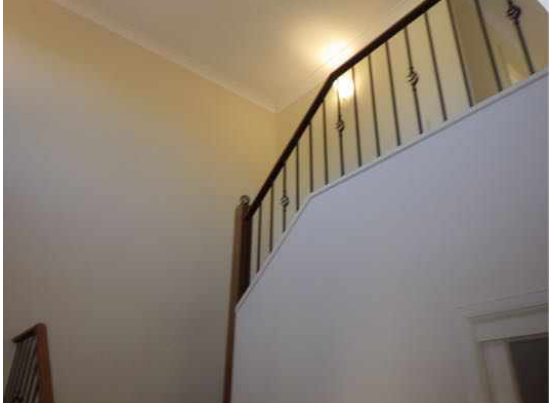
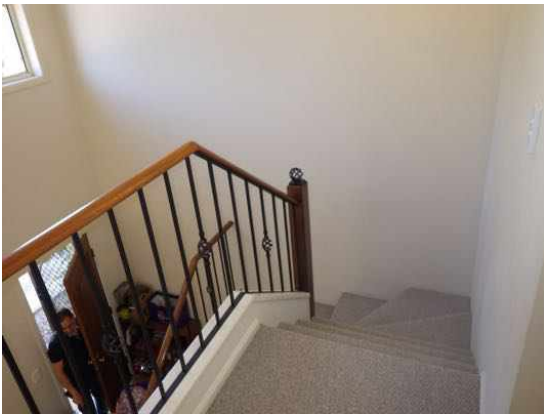
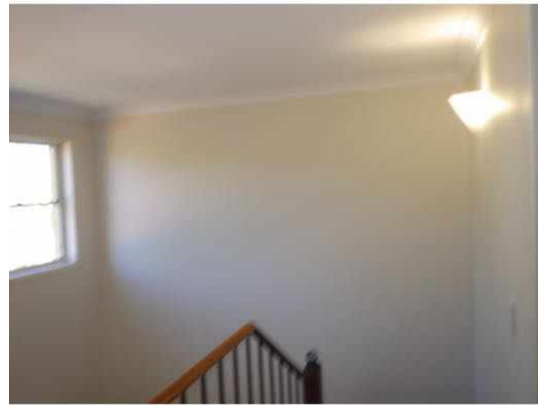
Building: Main Building
Location: Stairs - Internal > Existing
Finding: No obvious defect
Information: No obvious defects found at the time of inspection.

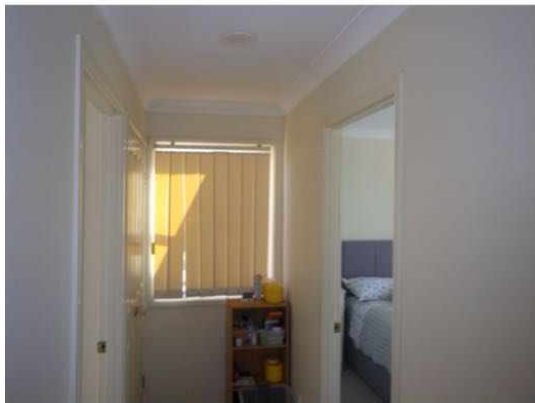
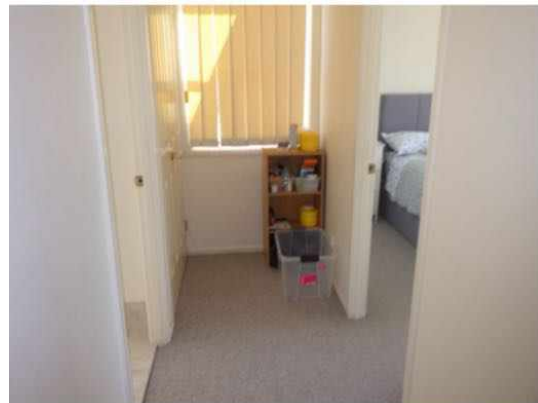
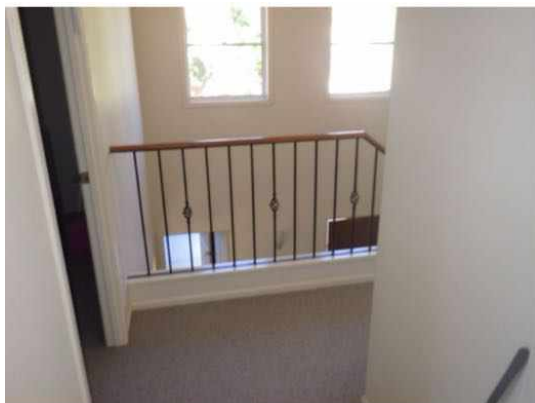
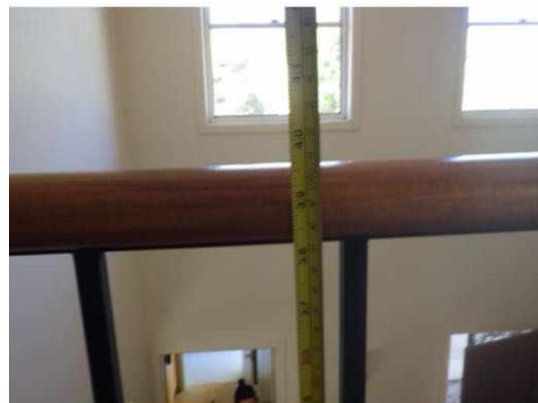
Building: Main Building
Location: Stair Landing/Hallway > Existing
Finding: No obvious defect
Information: No obvious defects found at the time of inspection.

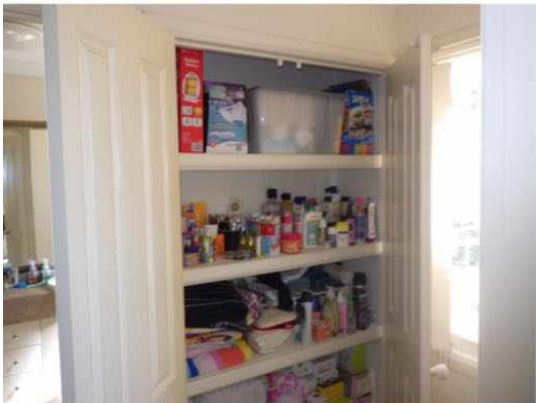
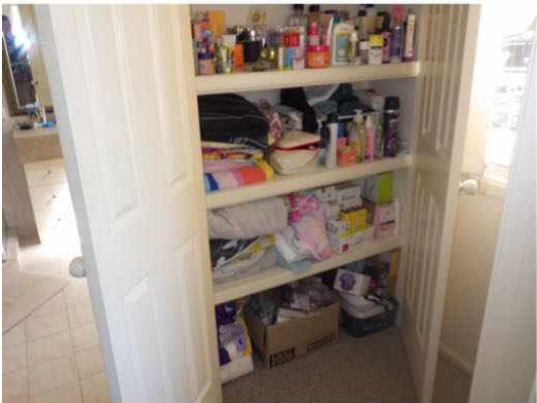
Building: Main Building
Location: Linen Cupboard > Existing
Finding: No obvious defect

Information: No obvious defects found at the time of inspection.

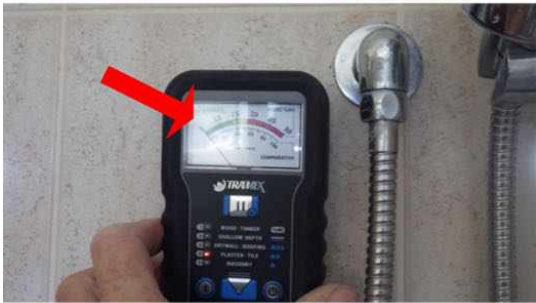
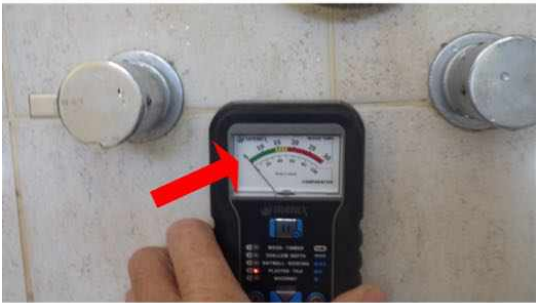
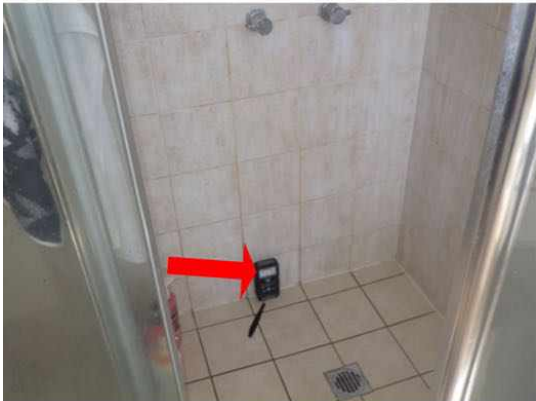
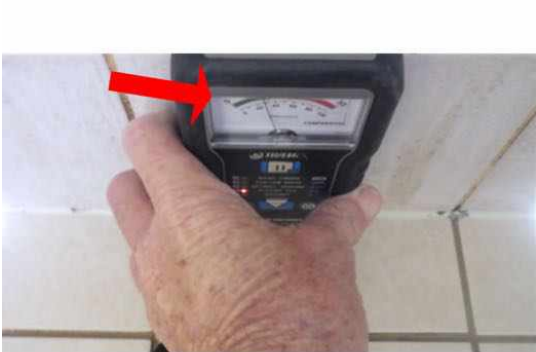
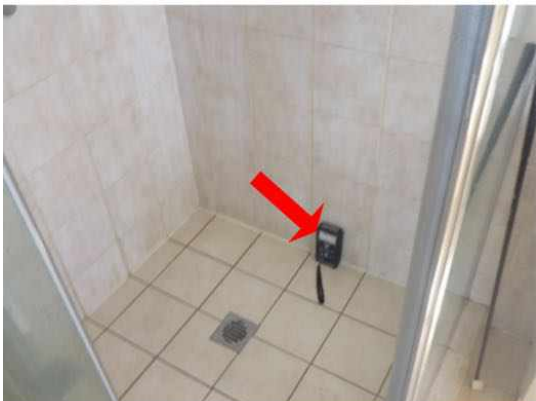
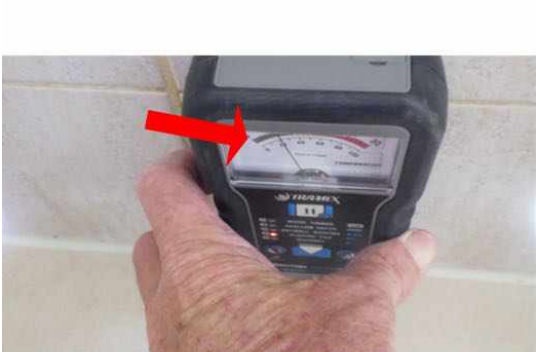
Building: Main Building
 Location: Bathroom > Rear Left
 Finding: Moisture Level Readings
 Information: At the time of inspection the bathroom shower cubicle areas checked with the Tramex Moisture Meter returned low - normal moisture level readings.

The shower area grout and sealant presented in a fair - good condition.

Monitoring the area is advised and if any visual signs of excessive moisture appear (peeling paint, mould) then consultation with a bathroom specialist would be advised.

Always ensure that sealant and grout is in good condition to prevent any moisture issues occurring in the future.
