Building and Timber Pest Inspection Report

Inspection Date: Wed, 8 Apr 2026

Property Address: 10/99 Heeb St, Ashmore QLD 4214,
Australia

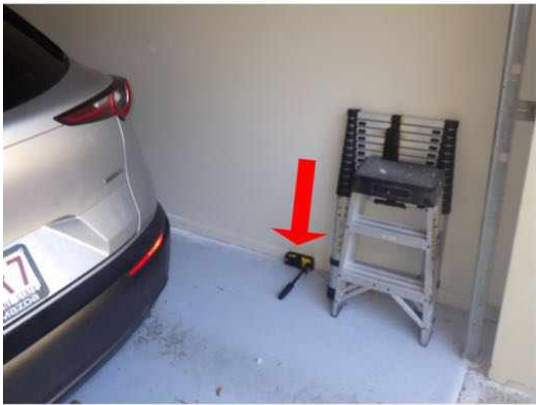
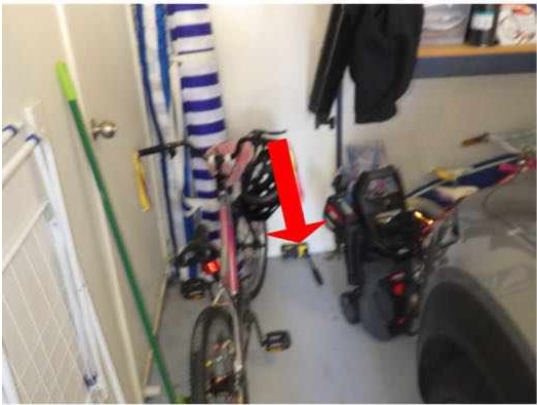
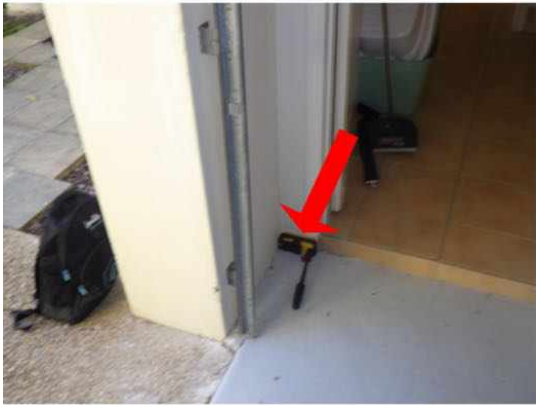
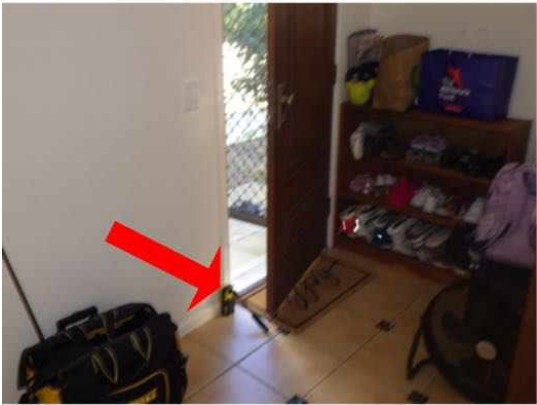
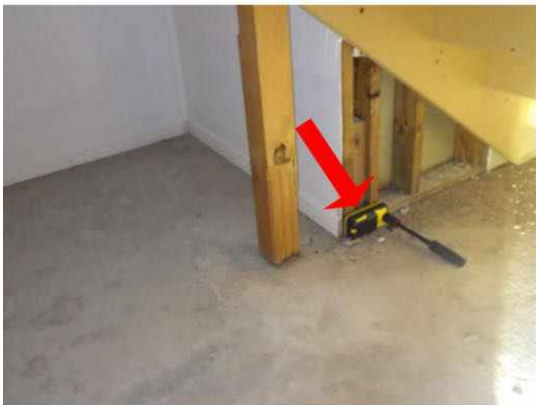
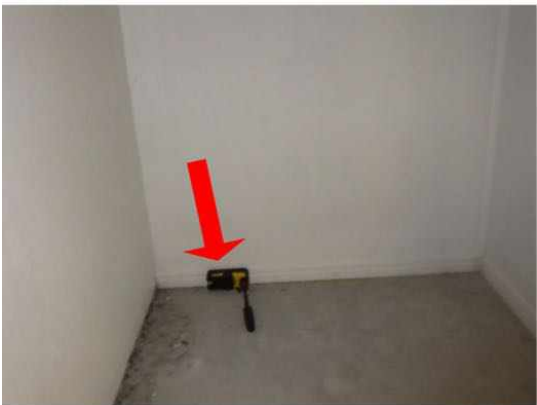
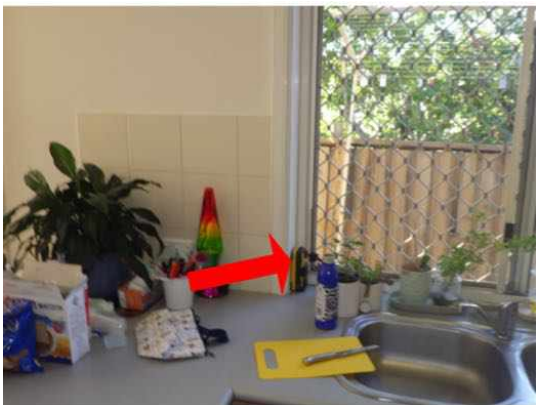
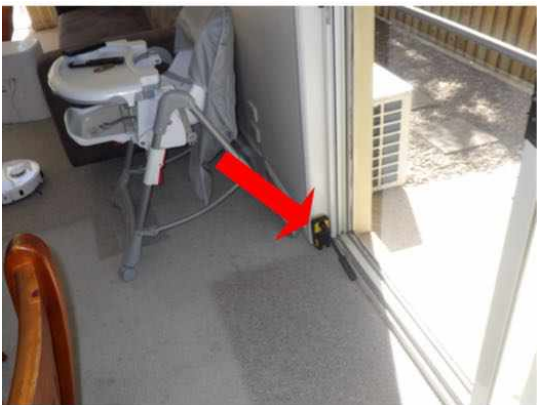
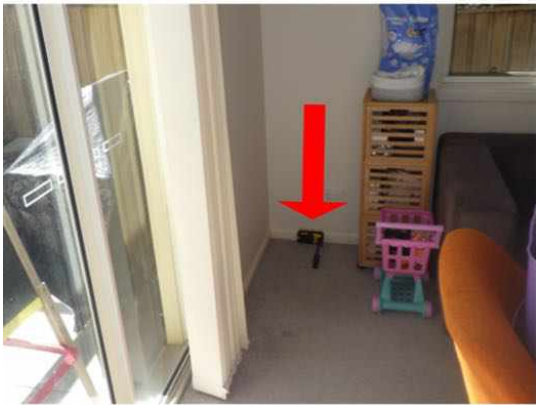
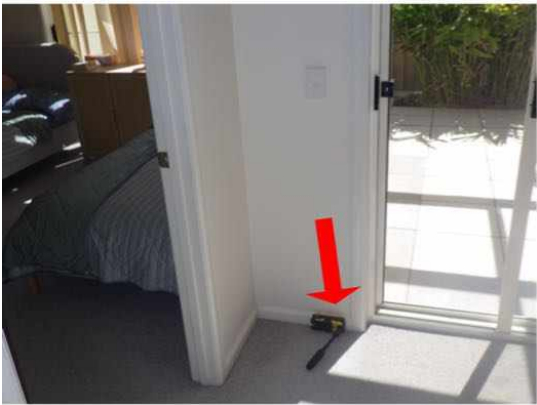
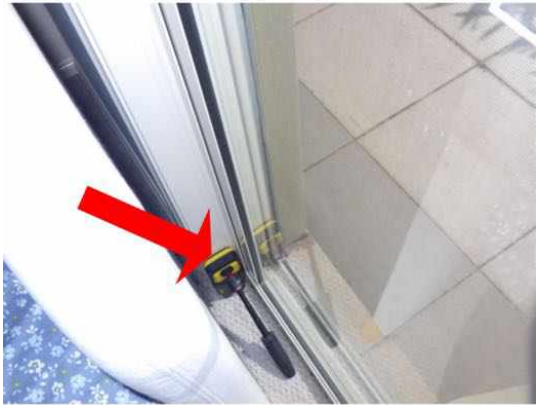
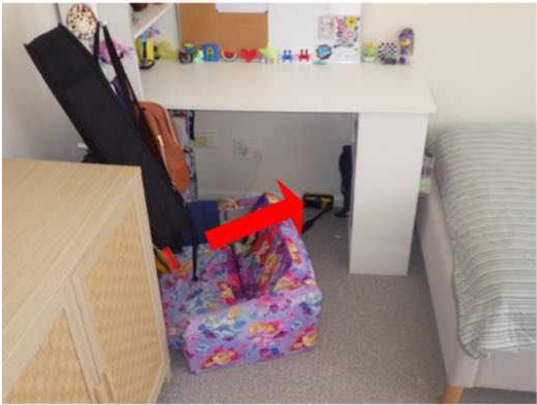
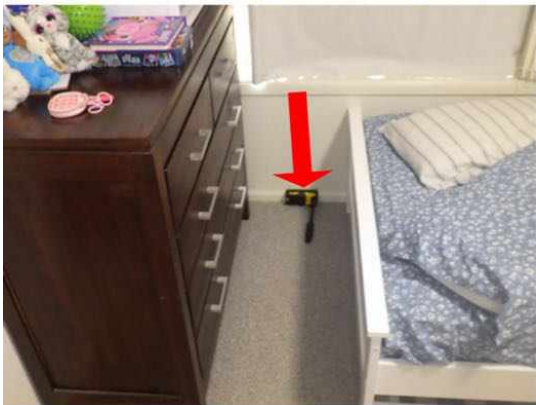
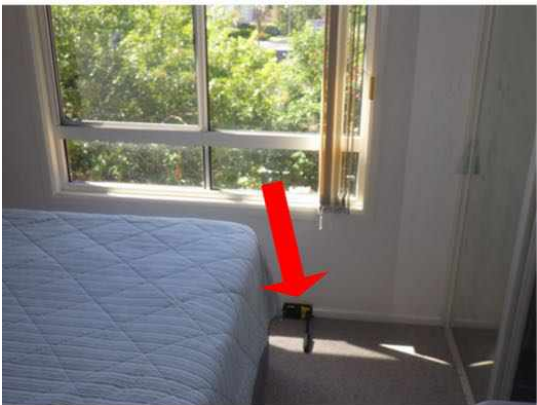
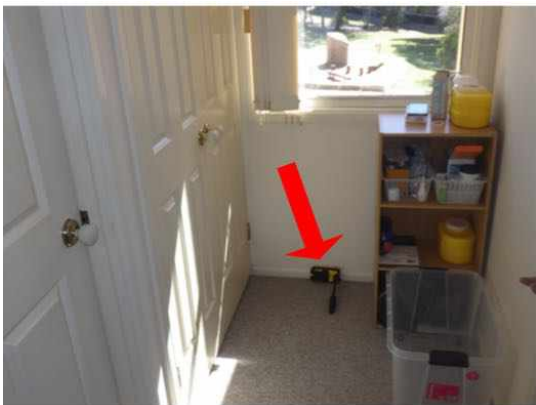
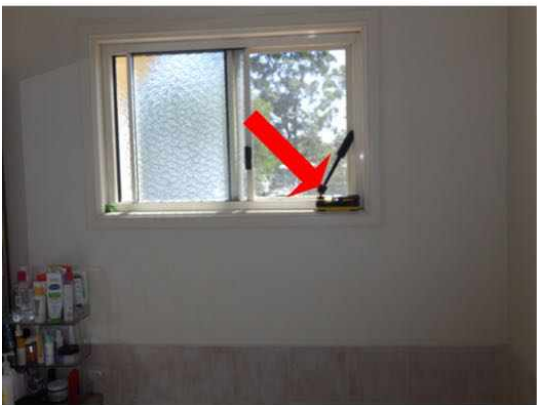
Building: Main Building
 Location: Internal Areas > Existing
 Finding: Termitracker
 Information: The termitracker itracker was positioned randomly to internal wall, timber skirting and window frame areas checking for signs of termite activity.

No activity was recorded at the time of inspection.

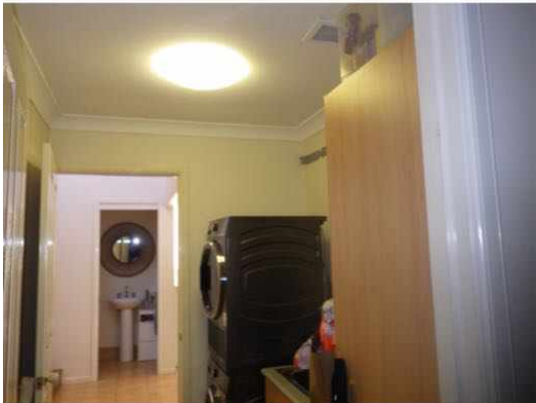
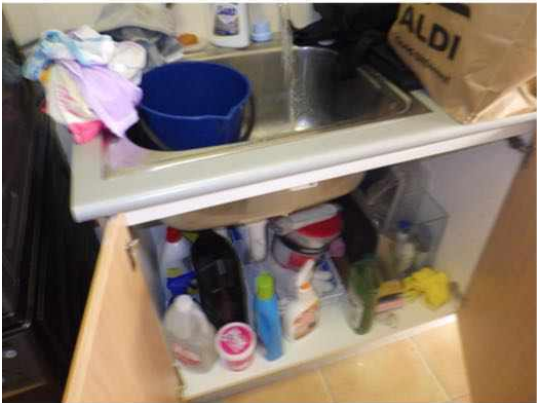
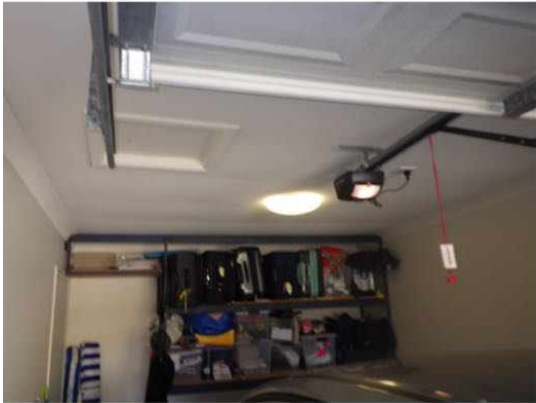
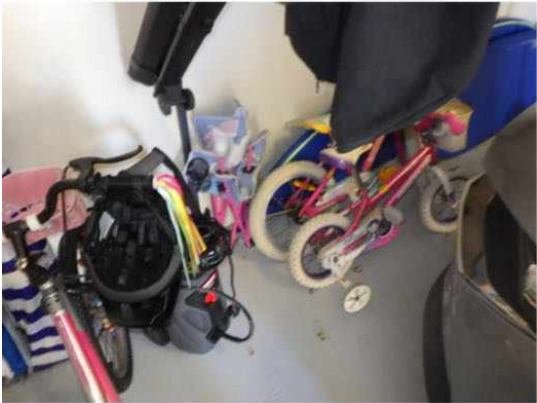
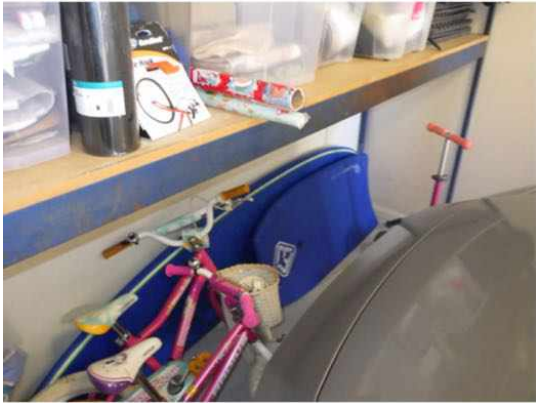
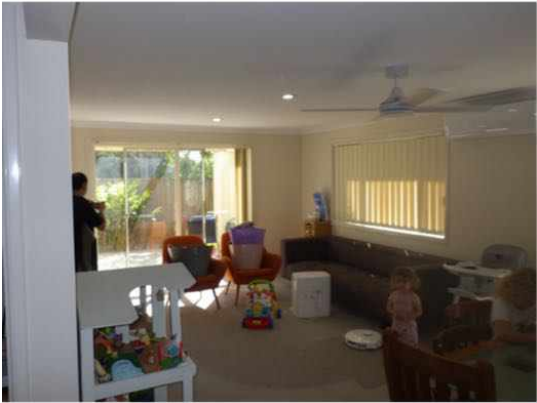
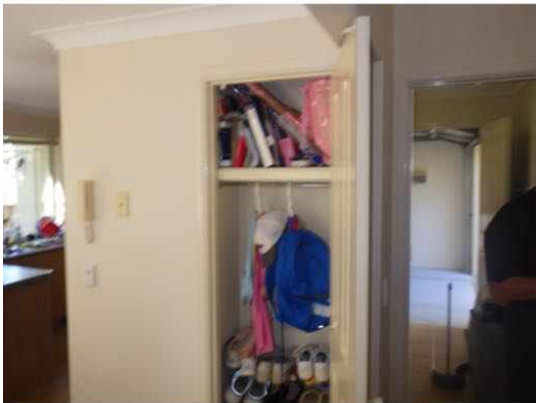
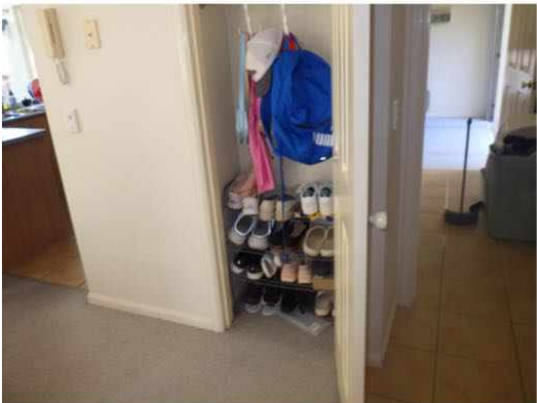
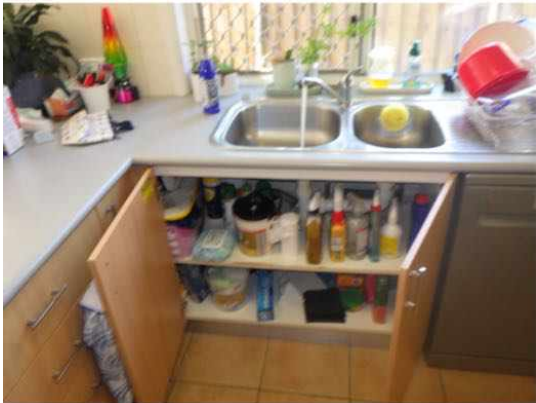
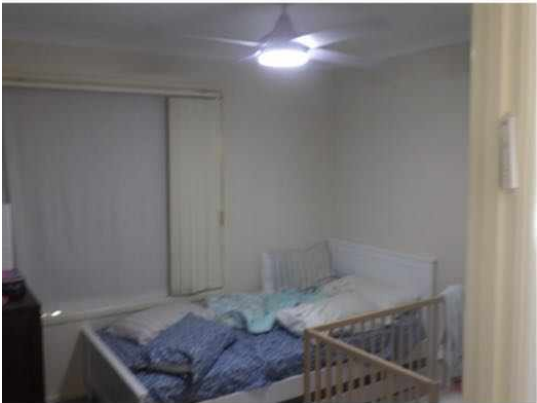
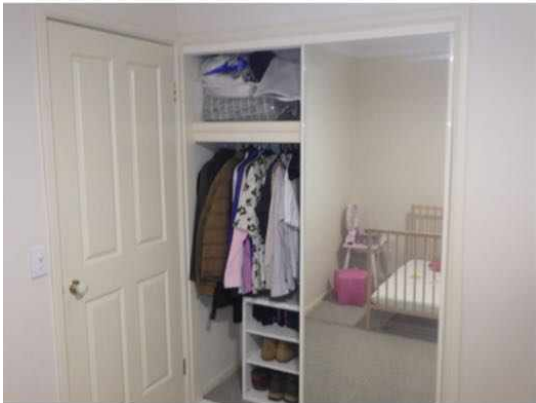
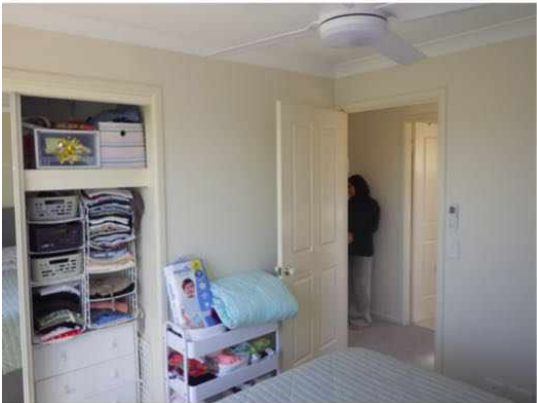
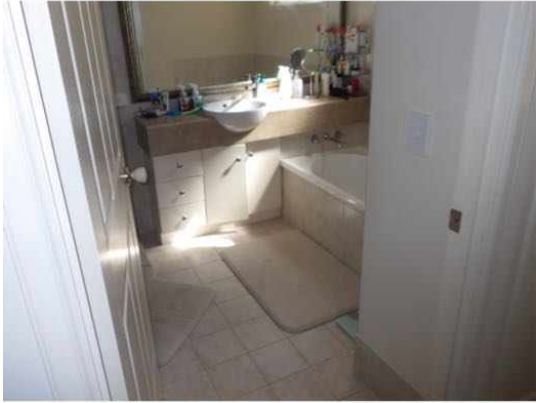
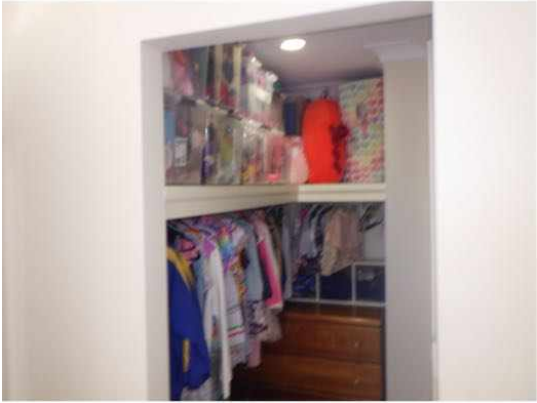
Building: Main Building
Location: Internal Areas > Existing
Finding: Additional Photos - Obstructions and Limitations
Information: These photographs are an indication of the obstructions and limitations which impeded full inspection of the property at the time of inspection. These obstructions can hide an array of defects and should be removed to allow full inspection to be carried out. A re-inspection is recommended once the areas are made accessible.
