# Building and Timber Pest Inspection Report

Inspection Date: Fri, 13 Mar 2026

Property Address: 18 Narellan Cres, Bonnyrigg Heights NSW  
2177, Australia

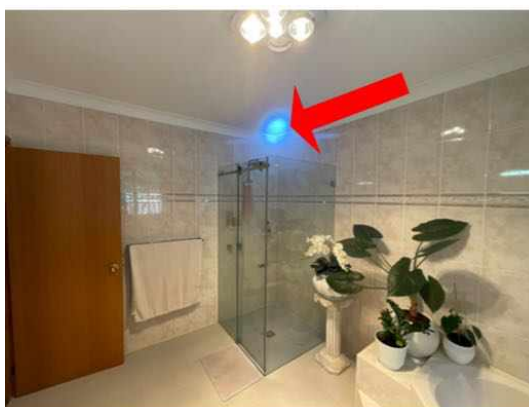
Building: Main Building  
 Location: Bathroom  
 Finding: Ceiling - Water damaged  
 Information: Water damage to the ceiling lining is generally an indication of excessive moisture being present in the roof void, usually via a leak to the roof covering.

Where water damage is evident to the ceiling, the primary requirement is to identify and rectify the source of the leak. A roofing plumber should be appointed as soon as possible to identify the leak and perform rectification works as necessary, ensuring the water damage is restricted.

Once the leak is repaired, consultation with relevant tradespeople, including plasterers and painters, is advised. Rectification works may include replacement of ceiling lining or minor repainting, depending on the extent of the damage.

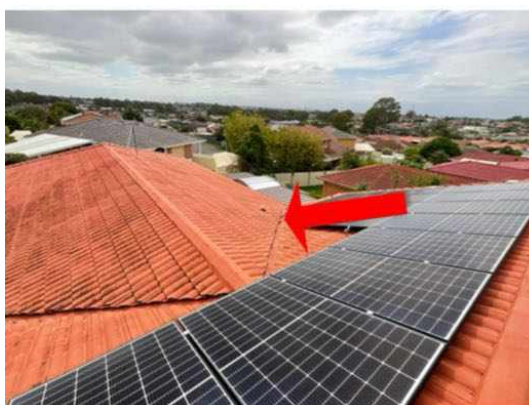
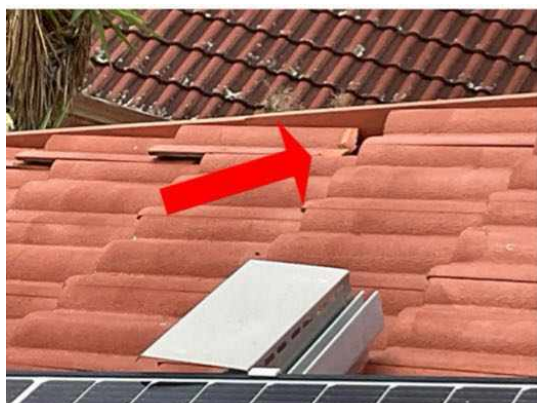
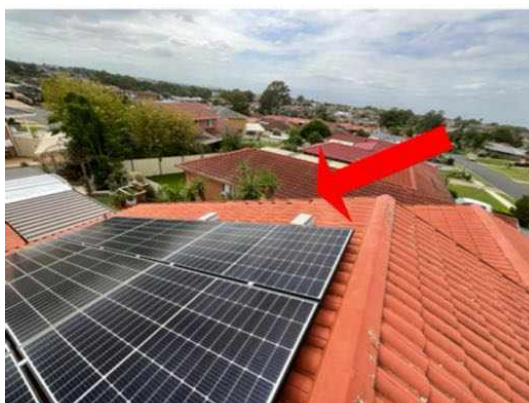
#### Finding 2.02

Building: Main Building  
 Location: Roof Exterior  
 Finding: Roof tiles - Slippage  
 Information: Upon inspection of the exterior roof covering, it was noted that numerous tiles have slipped from their original fixing. Tiles may slip over time due to a number of minor causes, including breakage of tiles, failings in the adjoining battens, or fixings that may have failed.

Roof tiles that have moved from their original position are very likely to allow water penetration into the roof void, exposing roofing structures to excessive moisture. This creates an environment that is conducive to water damage and accelerated deterioration of all associated building elements.

Replacement of loose or missing roofing tiles is recommended immediately to prevent the development of any secondary defects. A roofing restoration specialist should be appointed to complete such works as necessary.

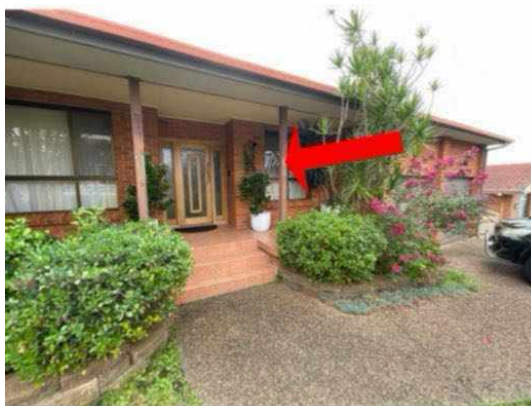
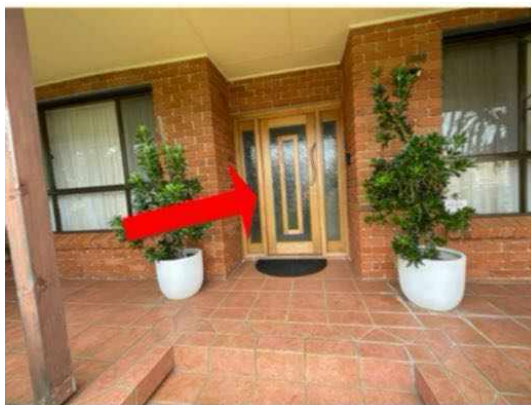
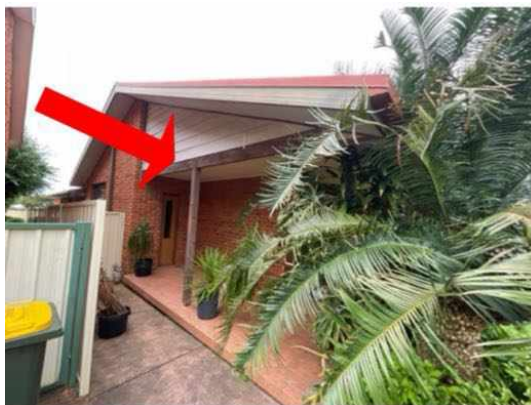
### Finding 3.01

Building:	Main Building
Location:	All External Areas
Finding:	External painting deteriorated
Information:	Much of the external paintwork including but not limited to windows, fascias, guttering, veranda and other external fitments have been neglected and require attention to prepare and re-paint.

Whilst incomplete or missing paint finish is generally an appearance defect, it can also lead to the development of secondary building defects over time. Incomplete areas of

paint finish expose the area to moisture, potentially accelerating the deterioration of underlying building materials.

Degraded paint finishes should be sanded back, filled, leveled and painted, as applicable. Where inadequate or missing paint protection has led to the deterioration of the associated building element, repair and/or replacement of this building element may be required.

A painting contractor should be appointed as soon as possible to perform necessary works to aid the appearance of the affected area and to ensure the area is protected against further deterioration. Alternatively, the homeowner following manufacturer instructions may perform these works.

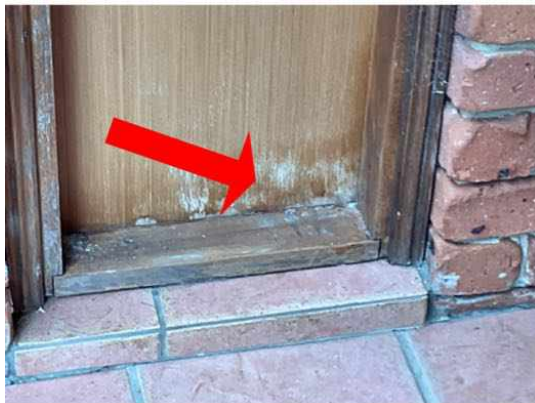
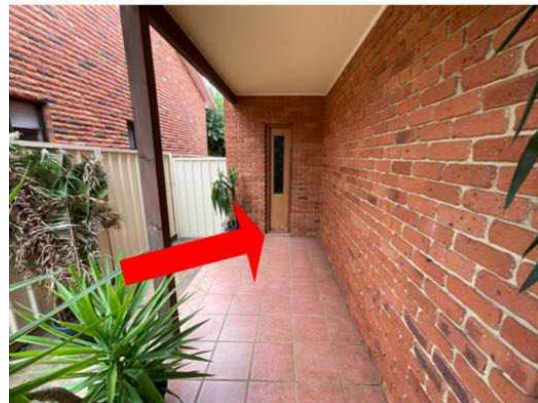
### Finding 3.02

Building:	Main Building
Location:	Porch
Finding:	External Timber - Weather damaged
Information:	Damaged external timber were found during the inspection. External timber structures are constantly exposed to weather elements and can deteriorate in an accelerated manner, ongoing assessments are required.

It is highly recommended that a Structural engineer further assess the external timber balcony/deck to inform the client of its load capacity. Regular maintenance inspections by competent practitioners is needed.

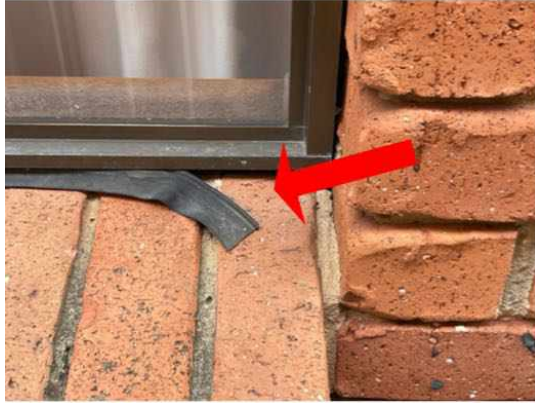
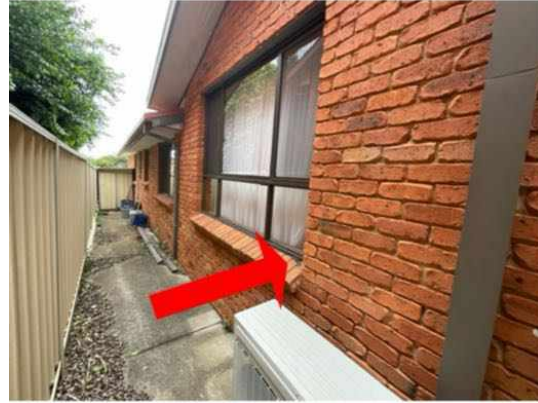
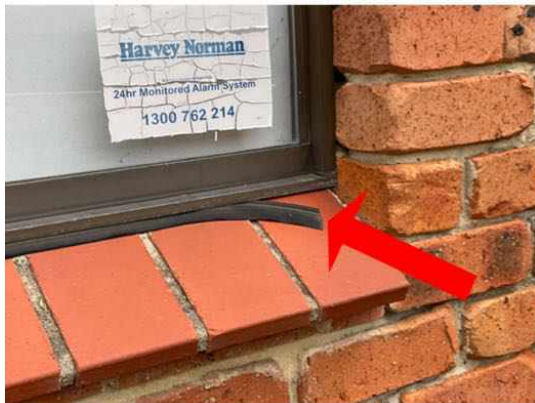
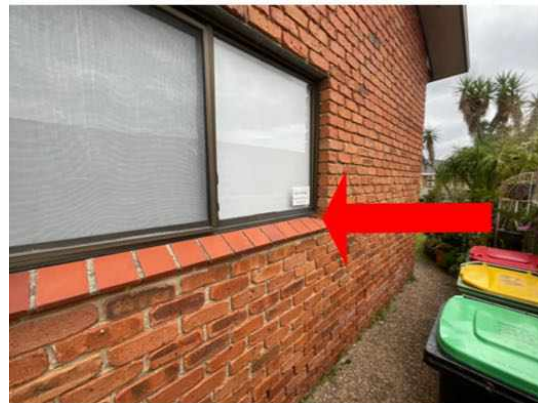
### Finding 3.03

Building:	Main Building
Location:	All External Areas
Finding:	Window rubbers - Inadequate
Information:	There are a number of window rubbers that been installed inadequately or have fallen back behind the brickwork. The window rubbers need to be installed in a manner that restricts water ingress, ensuring the longevity of the window and associated building elements. It is highly recommended that the relevant trades be appointed to repair the substandard works and ensure the longevity of all associated building elements.

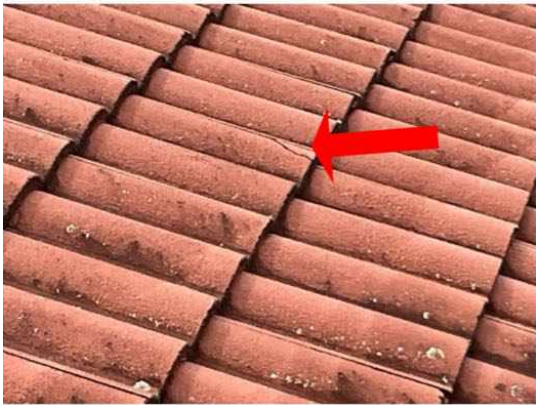
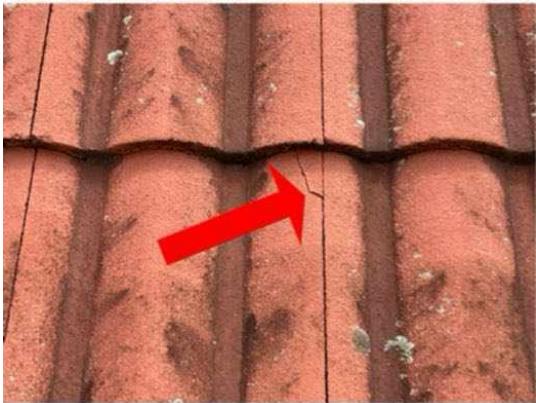
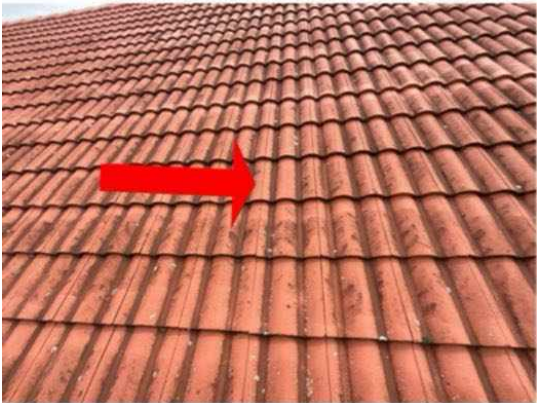
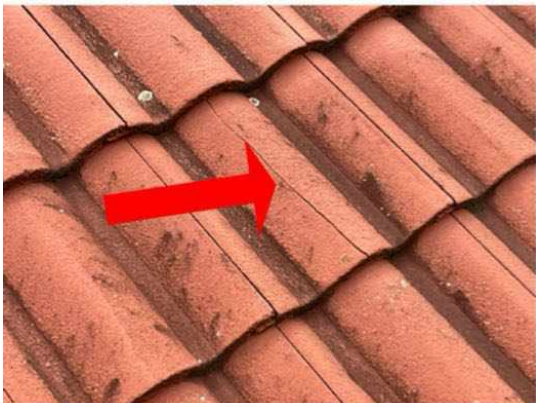
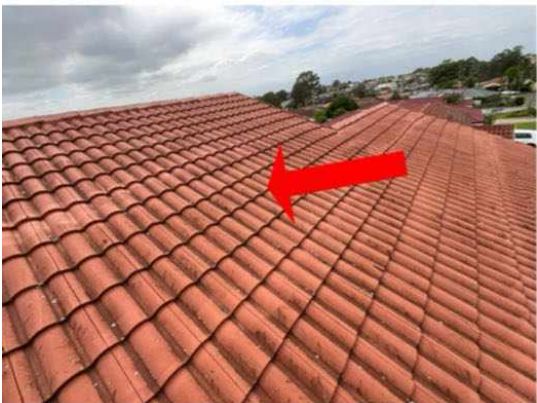
### Finding 3.04

Building:	Main Building
Location:	Roof Exterior
Finding:	Roof tiles - Broken / Missing
Information:	Upon inspection of the exterior roof covering, broken / missing roofing tiles were identified. Broken and friable roof tiles are generally the result of ageing and weathering of what is essentially a porous material.

If left to further deteriorate, broken / missing and brittle roof tiles are likely to lead to water penetration via the roof into the ceiling space, causing secondary damage to ceiling linings, insulation and roof structures. Broken roof tiles are also likely to detract from the effectiveness of the roof drainage system, creating potential for secondary damage to the exterior roof covering and roof plumbing.

Replacement of broken tiles is required and should be performed by a roofing contractor as soon as possible.

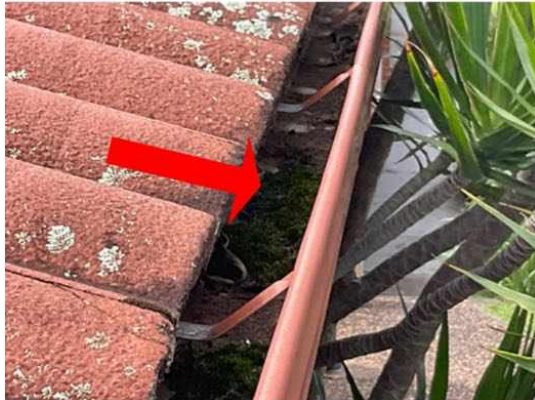
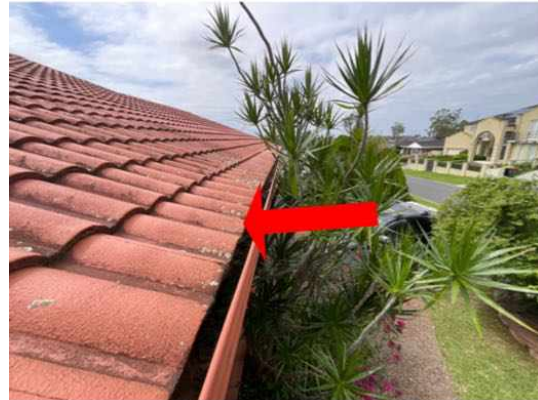
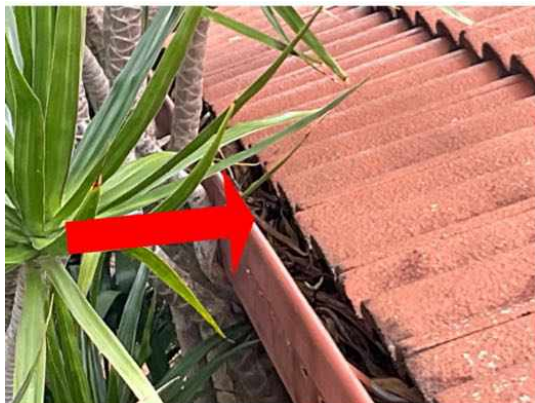
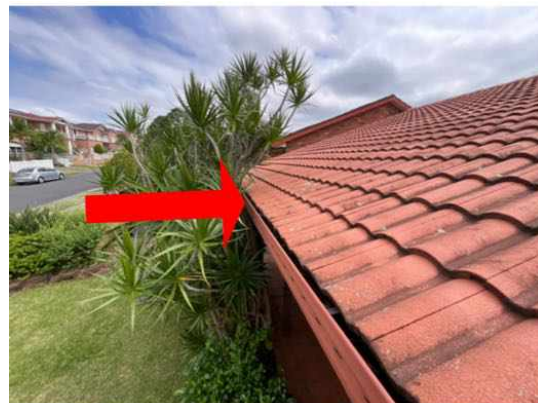
**Finding 3.05**

Building: Main Building  
Location: Roof Exterior  
Finding: Gutters - Blocked  
Information: Roof plumbing structures, such as guttering and downpipes, should be free of all debris to prevent blockages. Blockages of the guttering and downpipes will lead to pooling and accumulated water overflows, which is likely to subsequently flood eaves and exterior walls.

Blocked gutters are likely to lead to high levels of moisture in the affected areas. Such moisture will not only cause rust and decay of the associated building materials, but can also provide conditions that are conducive to termite and timber pest activity. Blockages in gutters should therefore be removed immediately to ensure dry conditions are maintained.

Consult a Licensed Plumber for further specific advice on remedial works that may be required. In the interim, it is highly advised that blocked gutters be removed by the homeowner or a general handyperson as a matter of urgency.

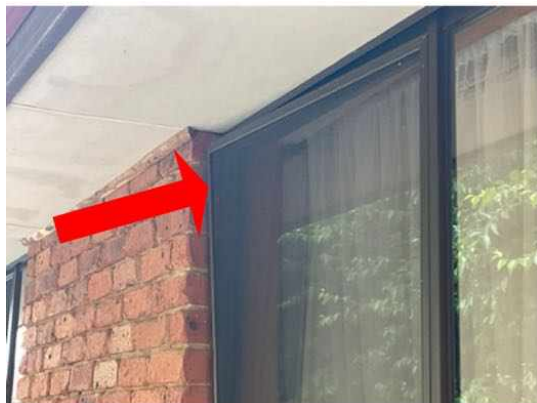
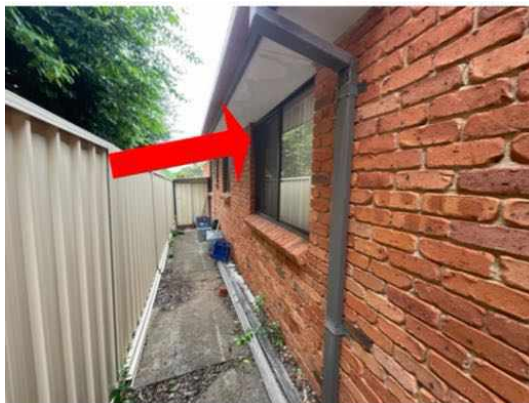
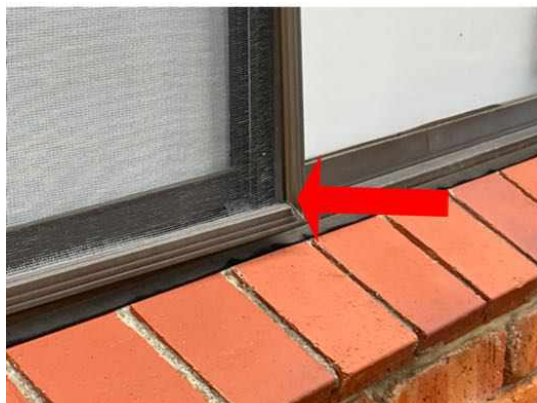
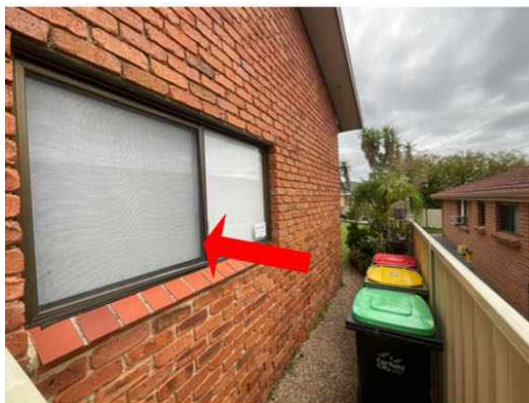
### Finding 3.06

Building:	Main Building
Location:	All External Areas
Finding:	Flyscreens - Damaged
Information:	Flyscreens were found to be damaged to the windows in this area at the time of inspection. This damaged building element detracts from the operational state of the window. Where not replaced, damaged flyscreens allow pest and insect ingress into the adjoining room/s. It is advised that all damaged building elements be replaced in order to ensure the full function of all building structures. A general handyperson may be appointed to replace flyscreens at the discretion of the client.

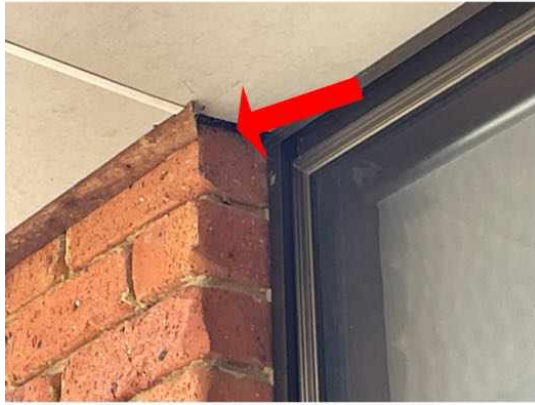
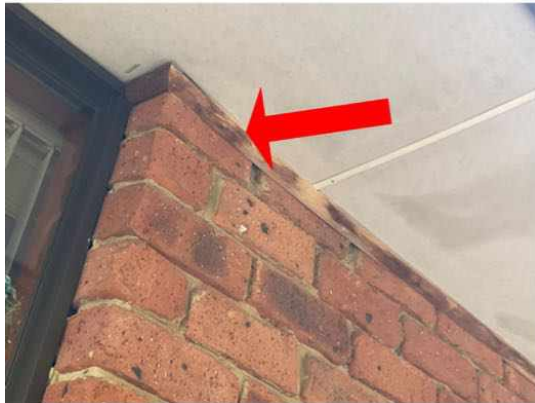
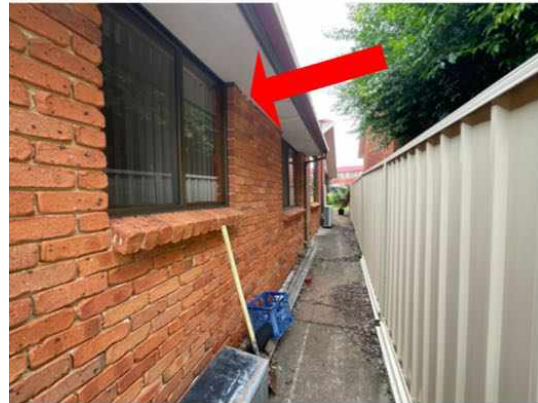
### Finding 3.07

Building:	Main Building
Location:	All External Areas
Finding:	Beads - damage
Information:	Where beading (also known as 'quad') are damaged from the eaves It was noted at the time of inspection that beading in this area has deteriorated. Beading is important in weatherproofing the surrounding building elements and preventing termite or pest ingress. Furthermore, beading works to protect the joints of building materials, which are more susceptible to deterioration and decay. Repair or replacement of the beading is advised to ensure the protection and longevity of any associated building elements. Such works may be performed by a general handyperson or qualified carpenter.

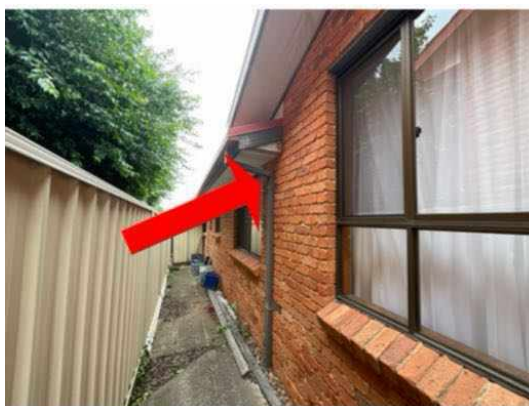
### Finding 3.08

Building:	Main Building
Location:	Roof Exterior
Finding:	Water Leak - Gutters
Information:	Water leaks were found to be present to exterior plumbing work. Leaks are generally caused by deterioration of the plumbing elements over time, due to exposure to weather conditions, but may have also been caused by minor impact damage.

Such leaking creates damp conditions in the affected area, causing potential for water pooling and subsequent water damage if left unattended. These conditions may also attract termite attack, particularly if the area is subject to minimal levels of sun throughout daylight hours.

It is highly advised that a licensed plumber be appointed to rectify any water leaks that may be present. Areas of repair and replacement of plumbing fittings and fixtures may be required and, as such, a quotation should be sought.

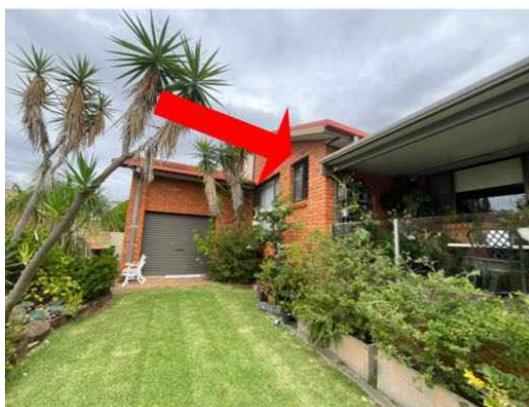
### Finding 3.09

Information: A significant gap was identified between the brick and window frame in this area. Where large gaps to the head appear, it may be indicative of a variety of defects, ranging from uneven framework, sagging hinges or uneven flooring.

A gap to the head of the window may also indicate movement of the foundation of the property, which is a common occurrence and does not indicate structural damage.

A qualified tradesman should be appointed to perform remedial works to restore the window to a fully operational level.

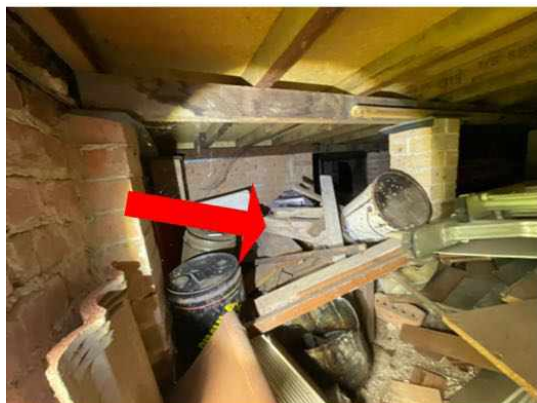
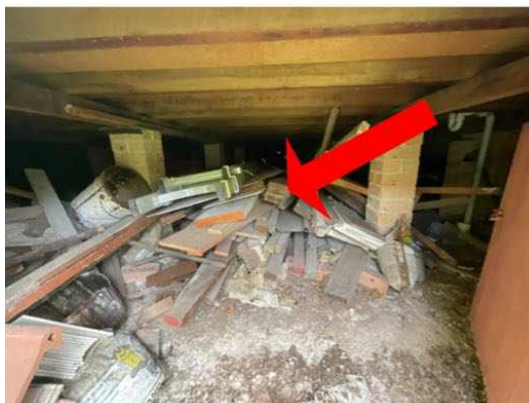
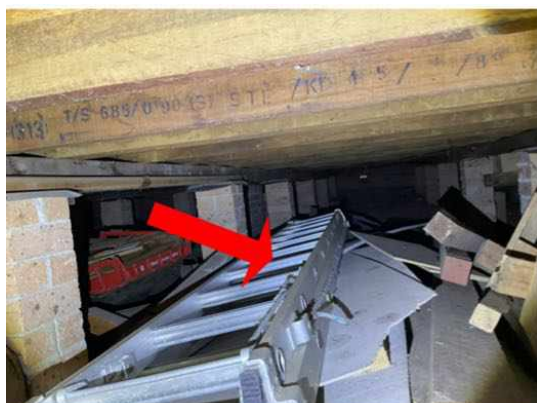
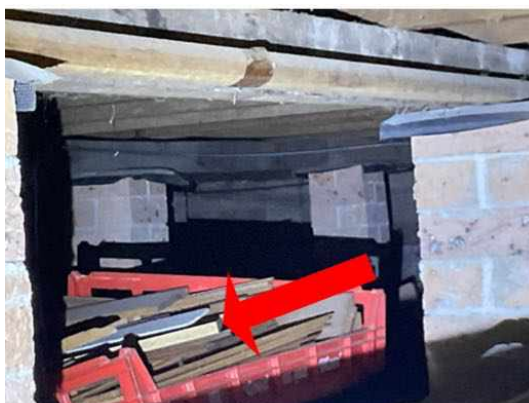
### Finding 3.10

Information: An array of debris was found in the subfloor area at the time of inspection. Debris in this area restricts subfloor ventilation and creates potential for concealed pest entry. Stored timbers and other materials may also make the area susceptible to termite.

activity and wood rot.

A clear and empty subfloor will be better ventilated and easier to maintain in a dry condition. The removal of any timber debris is vital in minimising the risk of termite or wood borer activity.

Debris in the subfloor should be removed as soon as possible. Depending on the location and amount of debris and stored items, the homeowner may elect to undertake this task. Alternatively there are a large number of rubbish removal subcontractors that could undertake these works.

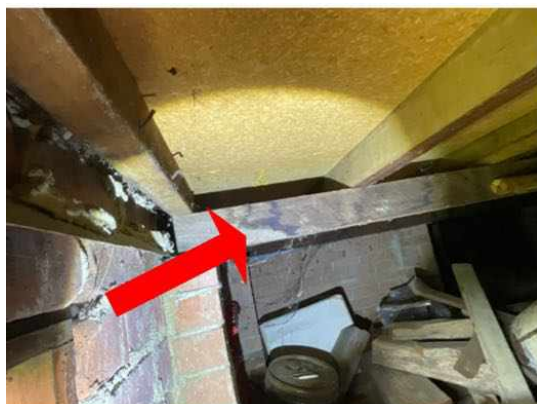
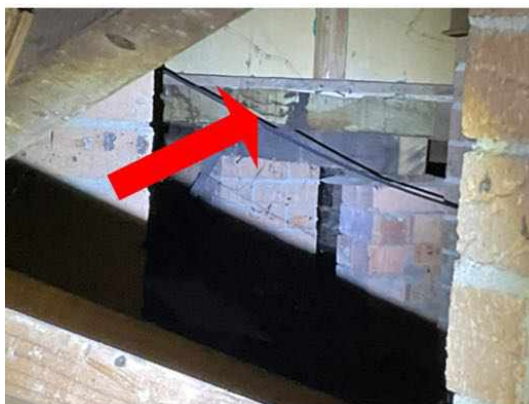
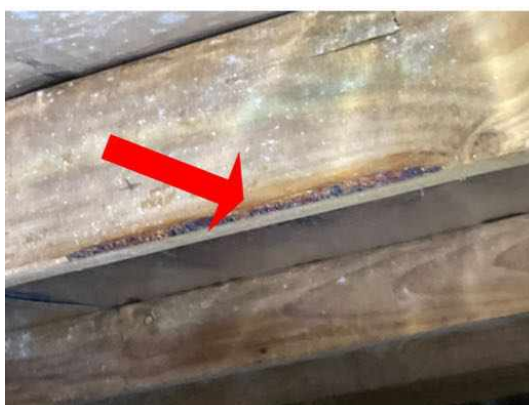
### Finding 3.11

Building:	Main Building
Location:	Subfloor / Roof void
Finding:	Chemical delignification identified
Information:	Chemical delignification also known as wood defibration refers to the chemical breakdown of timber building elements. This breakdown of the Lignin deteriorates the wood impacting on the structural integrity and tensile strength of the affected building element.

Chemical delignification is most common near marine environments due to the high levels of salt in the air however this deterioration may also occur in other areas where timber elements are frequently exposed to damaging gases chemicals etc.

Where timber building elements have deteriorated repair and / or replacement is required immediately to ensure the safety of the associated structures. The likely cause of the defibration should also be investigated and dealt with accordingly.

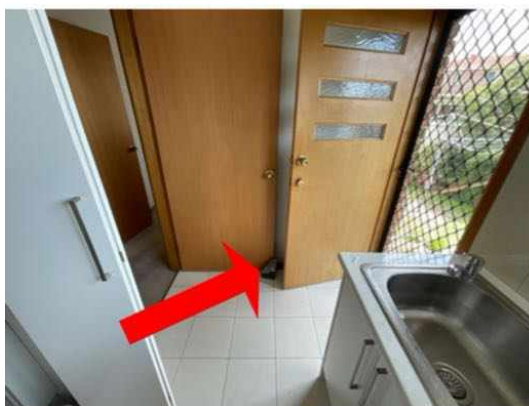
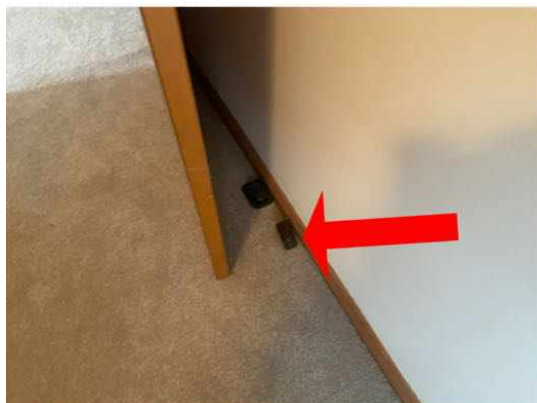
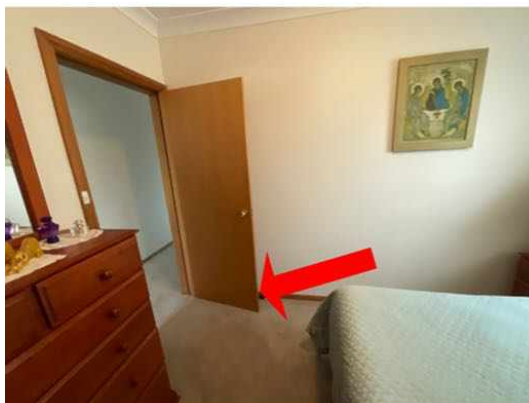
Building:	Main Building
Location:	All Internal Areas
Finding:	Door stop - Missing
Information:	The door stop is missing or is inadequate to stop the door handle from damaging the wall. Although some building elements may seem irrelevant or unnecessary, all building elements play a key role in the operation and function of the overall structure and its performance.

Re-installation or replacement of the door stop is advised as soon as possible to prevent any subsequent damage to the door or associated structures. A general handyman may be appointed to perform these works at client discretion.

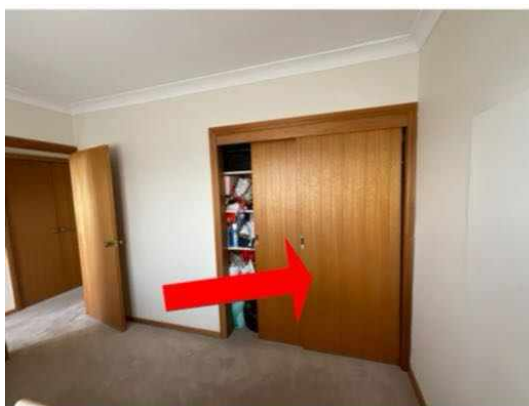
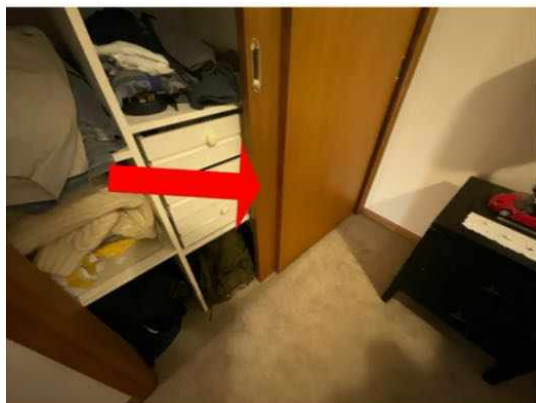
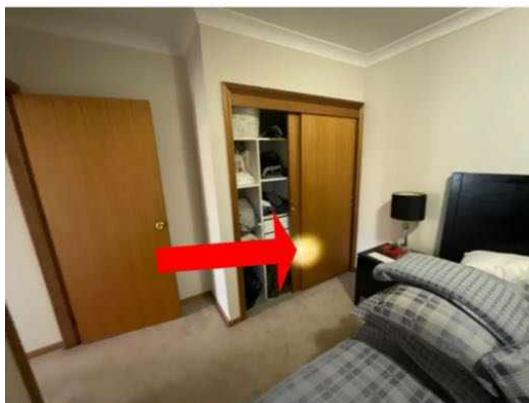
### Finding 3.13

Building:	Main Building
Location:	Bedrooms
Finding:	Sliding Door - Stiff to slide
Information:	The door in this area was jammed and difficult to slide along the associated tracks at the time of the inspection. Restricted function of the affected door may pose as a potential safety hazard if required for emergency egress from the building.

Generally, factors such as general age of the building element and a lack of maintenance are the usual causes for this type of defect.

Replacement of door hardware or tracks may be required, as well as minor repairs and cleaning. A registered builder or general handy person will be required to repair the affected doors.

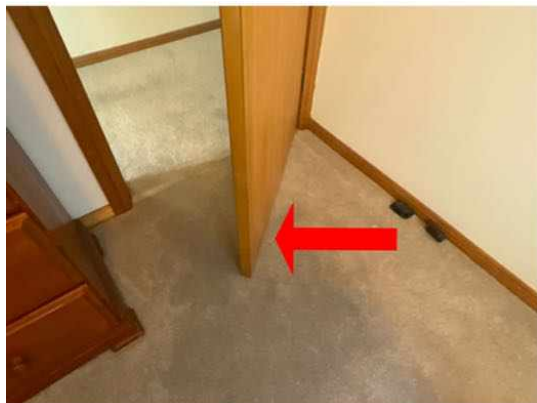
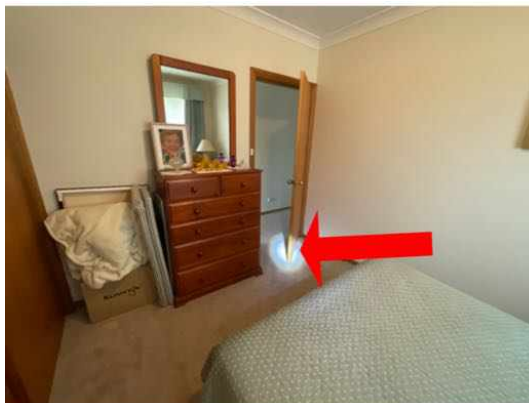
### Finding 3.14

Building:	Main Building
Location:	All Internal Areas
Finding:	Door - Binding/jamming
Information:	Binding and/or jamming of this door is evident during standard operation. This defect inhibits the functionality of the affected door as well as creating potential for secondary defects to associated building elements, such as damage to the floor covering.

A door that binds to flooring or to the associated door frame may have several causes, ranging from minor defects, such as poor installation of the door or deteriorated hinges, through to major structural issues, such as damage to subfloor structures.

Where door binding/jamming appears to indicate major structural issues, a registered builder specialising in re-stumping should be appointed to provide an estimate on the cost of rectification.

For minor causes, a qualified carpenter or general handyperson should be appointed to perform minor rectification works at client discretion.

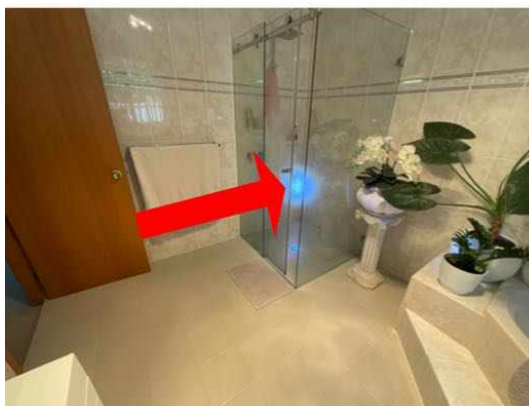
### Finding 3.15

Building:	Main Building
Location:	Bathroom
Finding:	Mould Growth to Sealant – Bathroom Area
Information:	Mould is visible to the silicone sealant at the junction between the basin / tiles and the wall tiles. Mould growth indicates excess moisture and inadequate maintenance, which may lead to deterioration of the sealant and potential water ingress into adjoining surfaces. Recommend removal and replacement of the affected sealant with a suitable mould-resistant silicone and ensuring proper cleaning and ventilation to prevent recurrence.

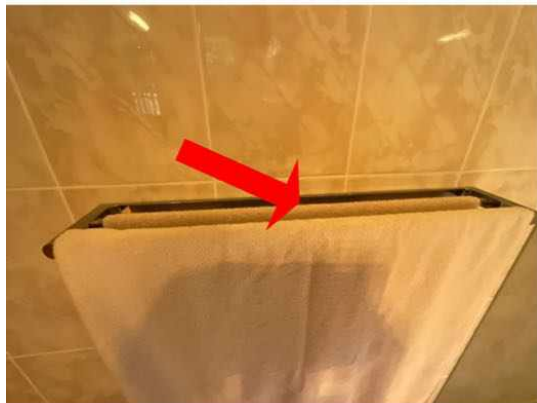
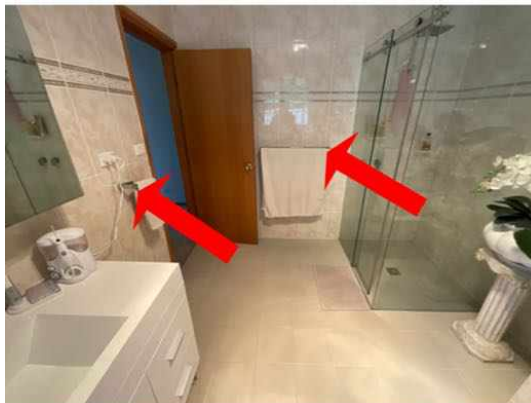
### Finding 3.16

Building:	Main Building
Location:	Bathroom
Finding:	Bathroom holders - Loose
Information:	The bathroom holder was found to be loose at the time of inspection. While not a major operational defect, function can deteriorate if the problem is left unmanaged.

It is advised that the homeowner performs remedial works to re-attach the bathroom holder to its original fixing. A general handyperson may be required to perform these works.

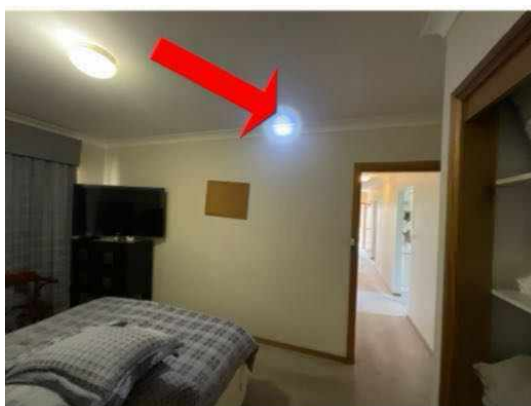
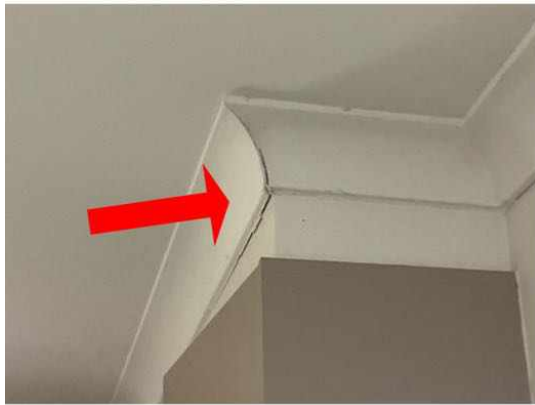
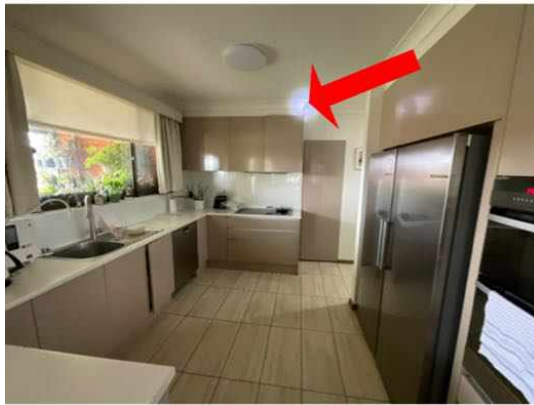
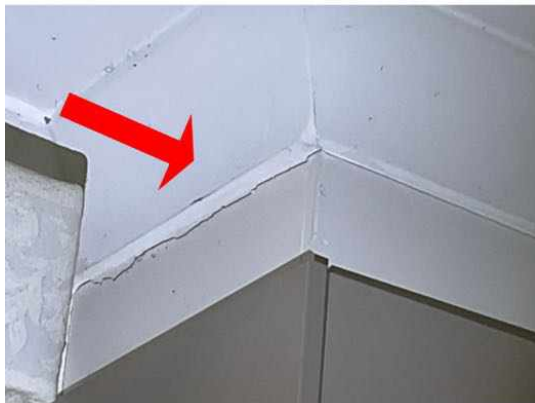
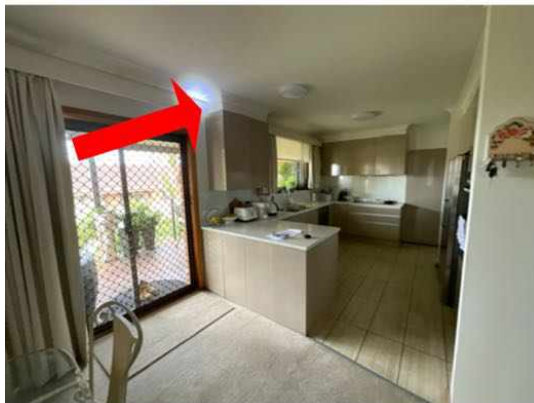
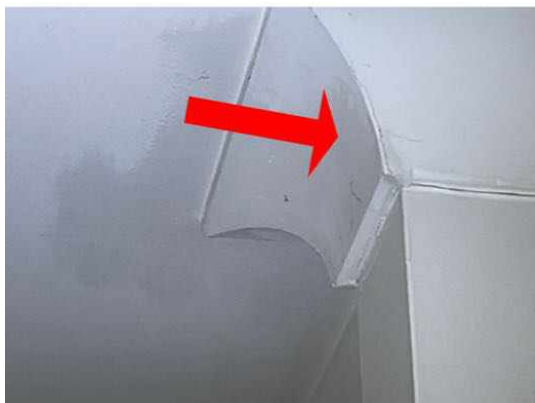
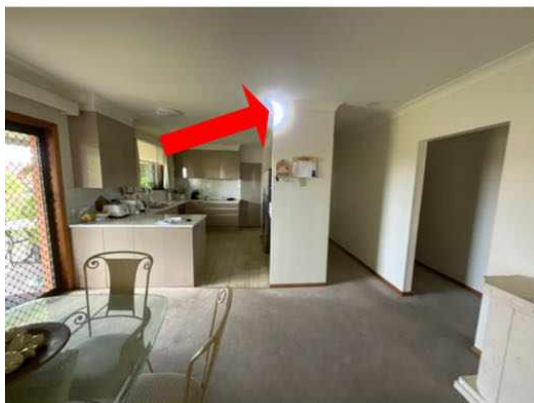
### Finding 3.17

Building:	Main Building
Location:	All Internal Areas
Finding:	Cornices - Sagging
Information:	Sagging and uneven cornices generally indicate that the building materials have swollen, due to contact with water, or the movement of the ceiling joints or that fixings (e.g. nails or glue) have become loose and require reattachment. In some cases, sagging and uneven surfaces may also indicate that there are structural issues causing surfaces to warp, twist, or sag.

Where sagging appears to be major, appointment of a structural engineer is advised to further inspect the property. Otherwise, minor works such as re-gluing of wall/ceiling sheets may be required and should be performed by an aptly qualified plasterer or carpenter.

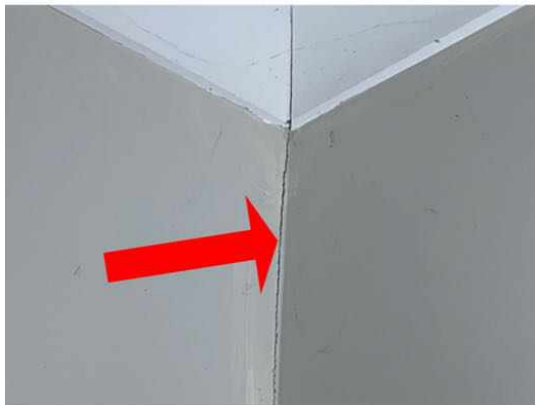
### Finding 3.18

Building:	Main Building
Location:	All Internal Areas
Finding:	Cracking - Damage Category 1 - Fine (up to 1mm)
Information:	Although fine cracks are quite noticeable, they are often only considered to be an appearance defect, and usually do not indicate any structural damage. Generally, the cause of a fine crack is indicative of a separation between building materials and finishes (e.g. paint, plaster, etc.) along joints.

Cracking of this nature can generally be repaired with minor sanding, filling and/or repainting. Such works should be performed by a qualified painter or a general handyman.

Monitoring of all cracking should be conducted frequently. Always contact a building inspector should cracks widen, lengthen, or become more numerous.

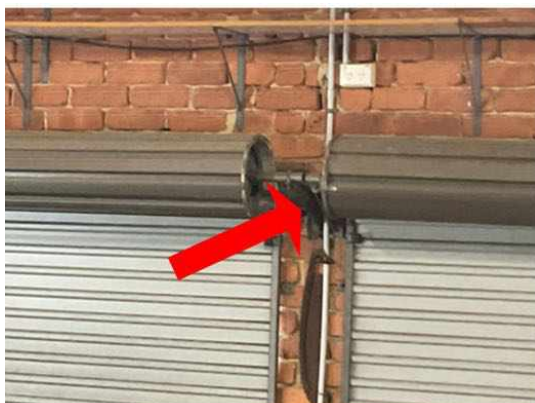
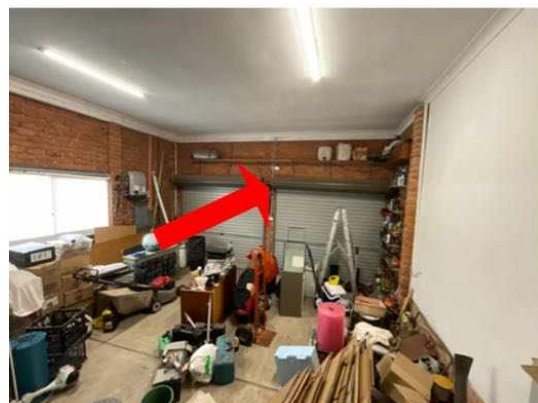
### Finding 3.19

Building: Main Building  
 Location: Garage  
 Finding: Garage door - motor is missing / not working  
 Information: The motor of garage roller door has been missing / not working as the time of inspection. Garage door is only working manually and it is inconvenient for using the garage space without garage door's motor

Repair and/or replacement of the garage door's motor would improve the condition of the garage but certainly not an urgent item

A qualified roller door installer or supplier should be engaged to check out the operation and overall condition of the doors to determine if repair is an option otherwise replacement may need to be considered.

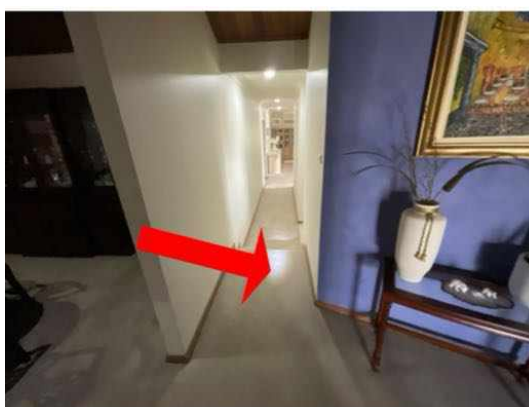
### Finding 3.20

Bouncy floors generally indicate that the floorboards or the subfloor structures are coming loose from the joists that they are installed on. Bouncy flooring may also be the result of gaps between flooring and stumps or joist structures, which require packing.

The client is advised to seek quotations for required repairs from a Registered Builder specialising in re-stumping. The potential resolution may range from packing gaps in subfloor structures through to replacement of subfloors stumps and refixing of flooring.

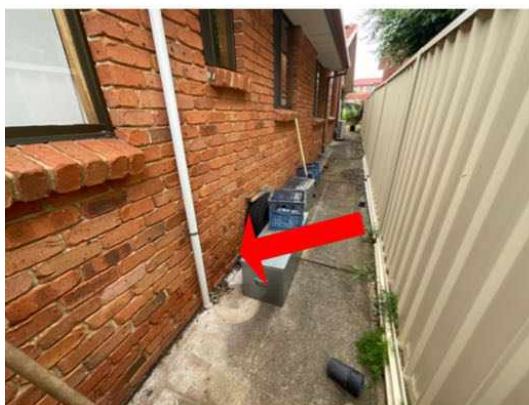
Weep holes in the exterior brickwork of the property are designed to allow condensation that may build up between the brickwork and subsequent timber framework to drain from within the wall hence preventing any deterioration of the timber building elements.

Additionally build-up of moisture is likely to occur if weep holes are covered further attracting termite activity to these areas.

It is highly recommended that weep holes are left exposed in all areas throughout the external property. Therefore if any termite activity leading into weep holes becomes easily detectable during frequent pest inspections.

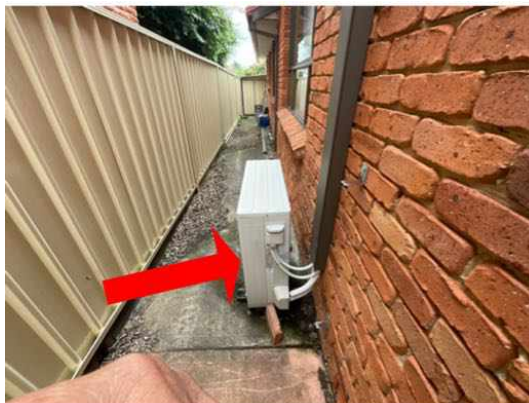
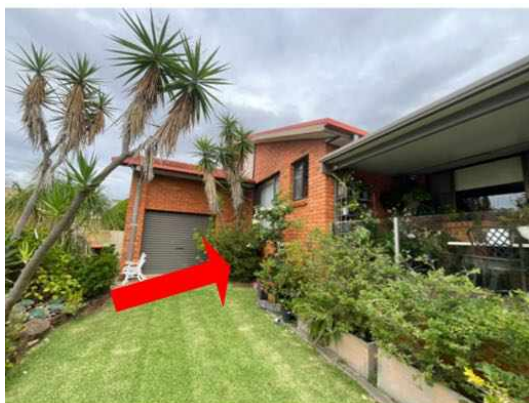
### Finding 6.02

Building:	Main Building
Location:	All Areas
Finding:	Bridging of termite barrier/inspection zones
Information:	Bridging is the spanning of a termite barrier or inspection zone so that subterranean termites are provided with passage over or around that barrier.

Where bridging has occurred, full inspection is prevented and termites may enter a property in a concealed or undetectable manner.

It is recommended that minimum 75mm clearance below the bottom of weep or ventilation holes be maintained where possible, otherwise annual inspections should be conducted by a licensed pest control company. Vegetation should also be kept clear of walls to allow regular inspection of all areas.

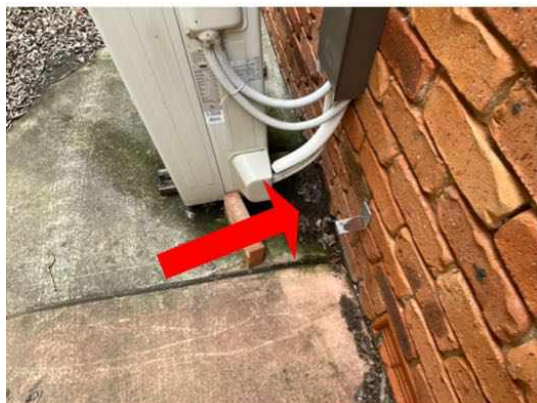
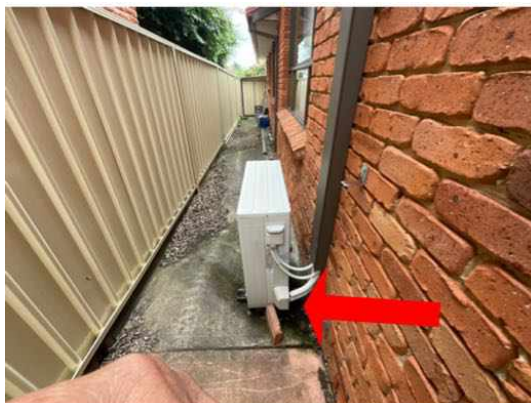
### Finding 6.03

Building:	Main Building
Location:	All Areas
Finding:	Air conditioner - Disconnected overflow
Information:	The Air Conditioner (A/C) overflow was found to be disconnected from storm water drainage and is creating excessive moisture in the surrounding area.

Such leaking creates an environment which is conducive to an array of defects, including water damage to associated building elements and the attraction of termite or timber pest infestation.

It is highly recommended that a licensed plumber be appointed to connect the A/C overflow in order to prevent such an environment from being created. These minor works should be carried out as soon as possible.

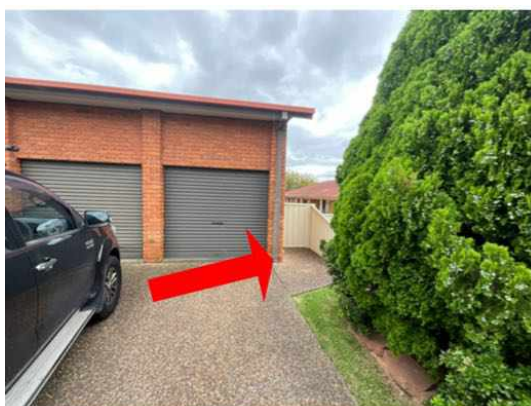
**Finding 6.04**

Building: Main Building  
 Location: All Areas  
 Finding: Overflow - Not plumbed for drainage  
 Information: The overflow is not plumbed or connected to suitable drainage, which has resulted in the surrounding area becoming excessively damp. These damp conditions can lead to secondary defects such as rot, rust or corrosion of associated building elements, the formation of fungal decay, or even the creation of potential slip hazards. When coupled with poor site drainage, pooling of water may also attract termite activity to this area. It is highly recommended that a qualified plumber be appointed to install adequate drainage to the overflow. These works will ensure that the area remains dry and free of any secondary defects.

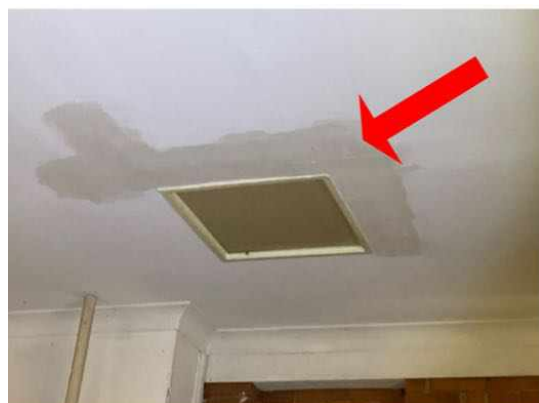
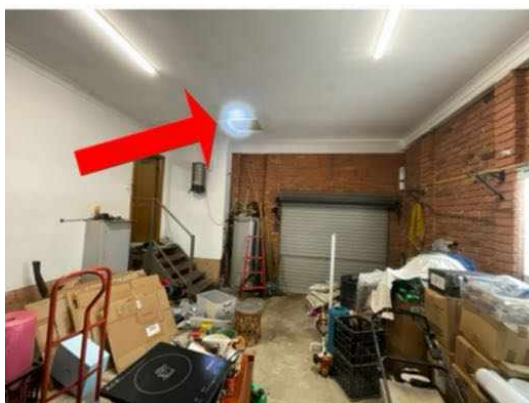
Building:	Main Building
Location:	Garage
Finding:	Ceiling – Suspected Water Damage (Further Investigation Required)
Information:	Suspected water damage was observed to the ceiling lining. This condition is generally indicative of excessive moisture within the roof void and may be associated with a leak from the roof covering, roof plumbing components, or mechanical services (such as air-conditioning units). At the time of inspection, the exact source and extent of the moisture ingress could not be confirmed.

This inspection is visual and non-invasive only. No invasive investigations were undertaken, and concealed areas were not accessible. Accordingly, this observation is noted as a suspected condition only and requires further investigation.

A suitably qualified roofing plumber should be engaged to carry out further investigations to identify the source of the moisture and undertake rectification works as necessary to prevent ongoing water ingress. Once the source of the leak has been rectified, consultation with relevant trades, including a plasterer and painter, is recommended to assess and repair the affected ceiling lining. Rectification may include replacement of damaged ceiling materials or repainting, depending on the extent of damage identified following investigation.

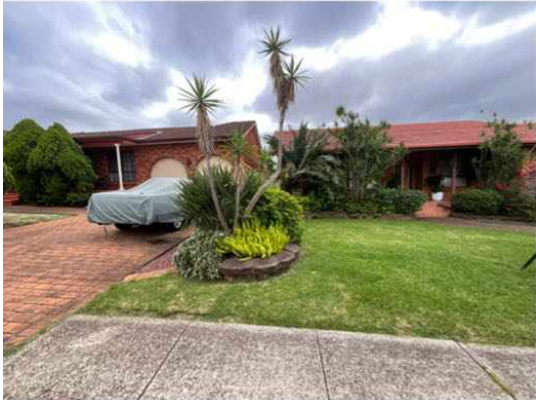
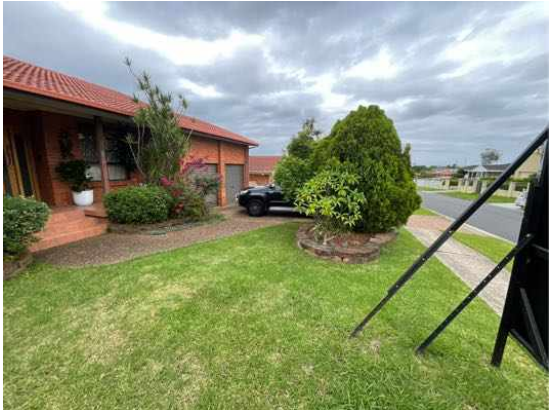
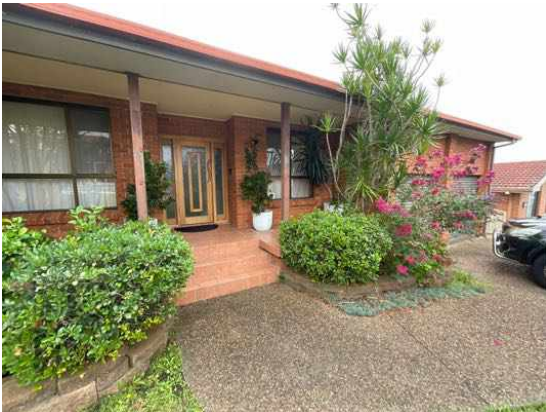
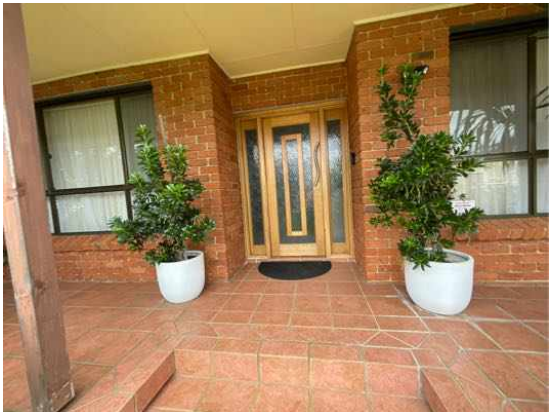
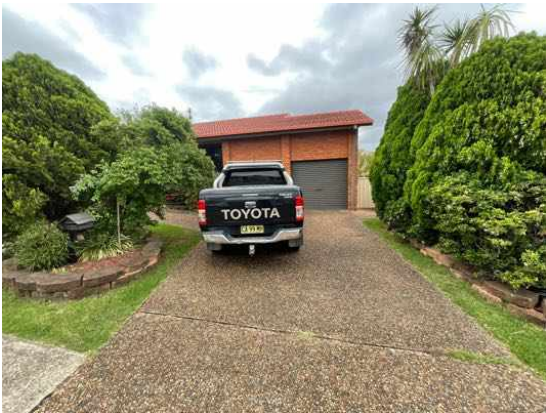
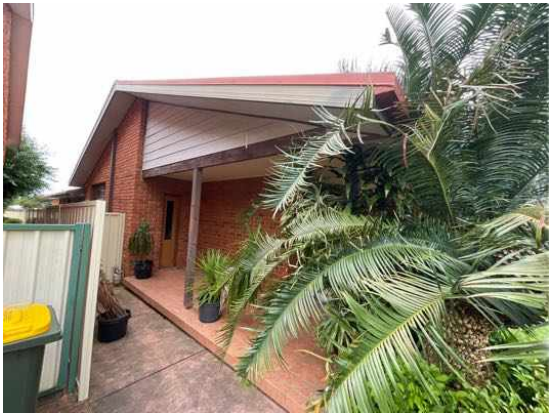
**Noted Item**

Building: Main Building  
Location: All Areas  
Finding: Additional Photos - Obstructions and Limitations  
Information: These photographs are an indication of the obstructions and limitations which impeded full inspection of the property at the time of inspection. These obstructions can hide an array of defects and should be removed to allow full inspection to be carried out. A re-inspection is recommended once the areas are made accessible.
