# Building and Timber Pest Inspection Report

Inspection Date: Fri, 13 Mar 2026

Property Address: 18 Narellan Cres, Bonnyrigg Heights NSW  
2177, Australia

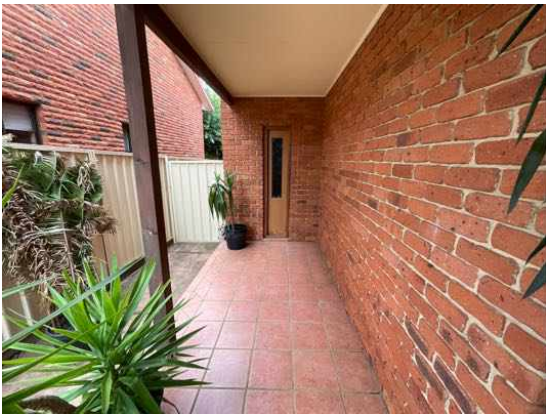
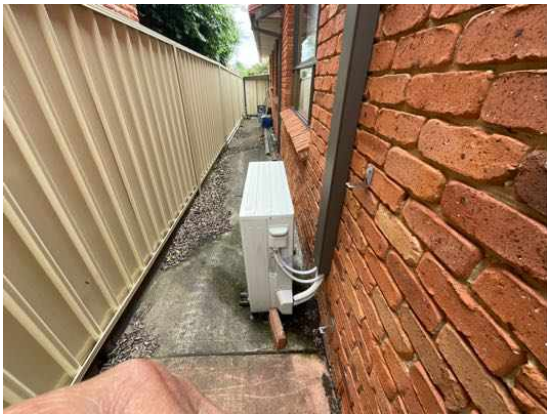
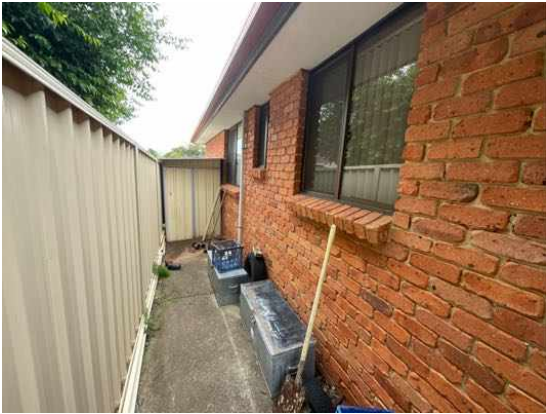
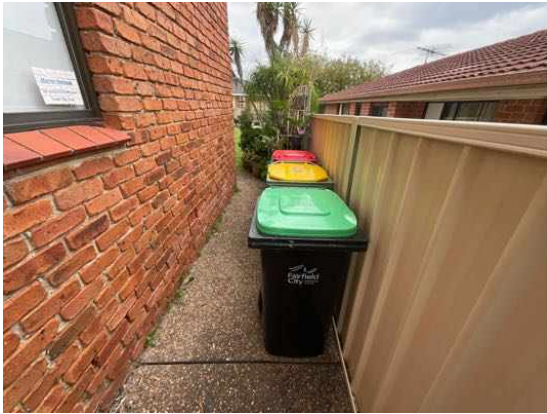
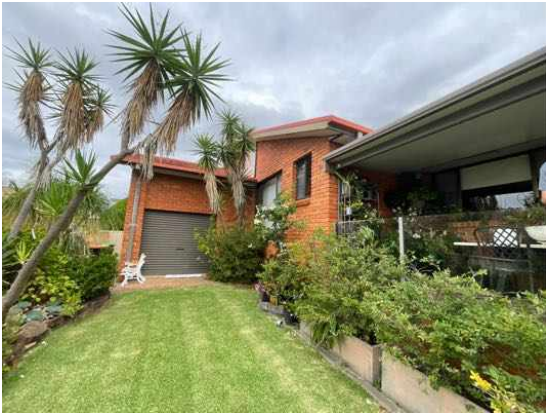
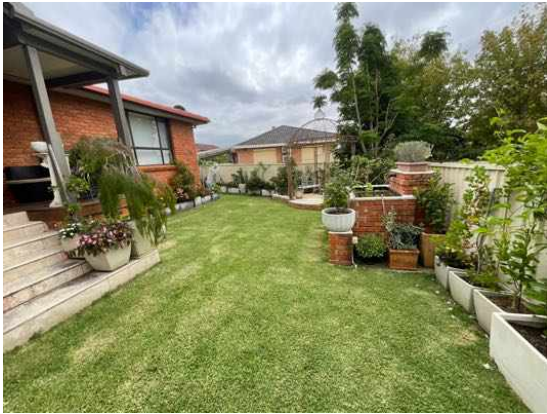
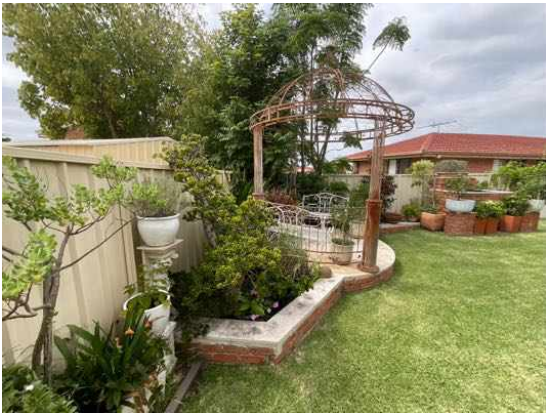
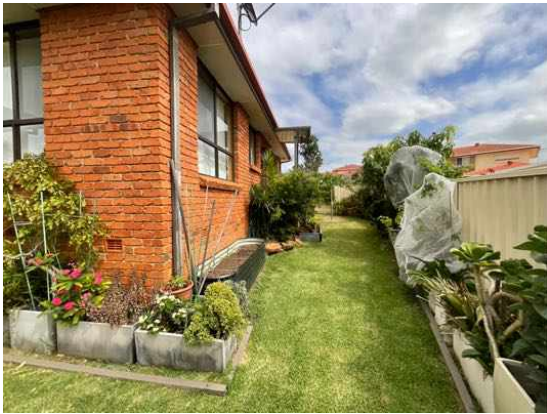
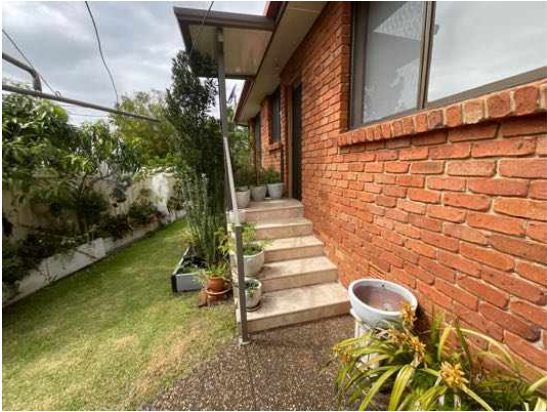
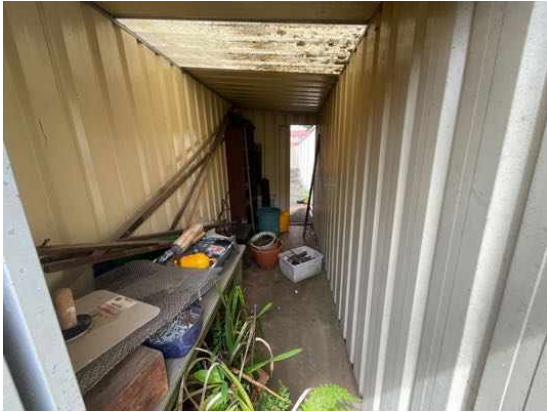
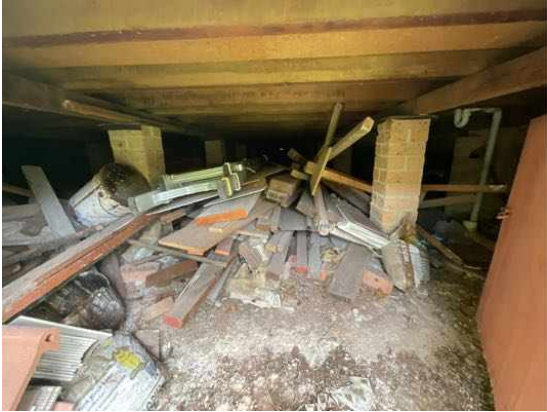
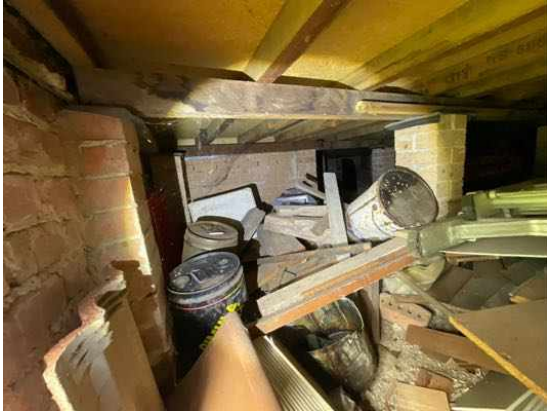
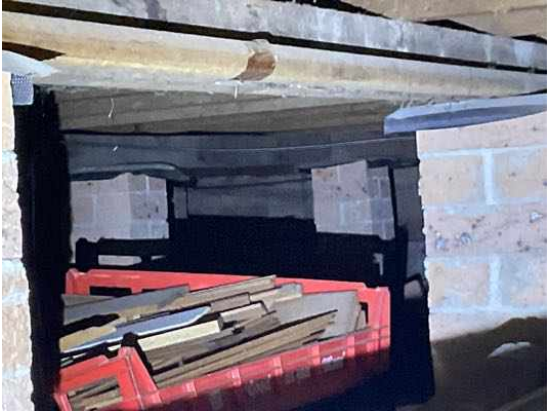
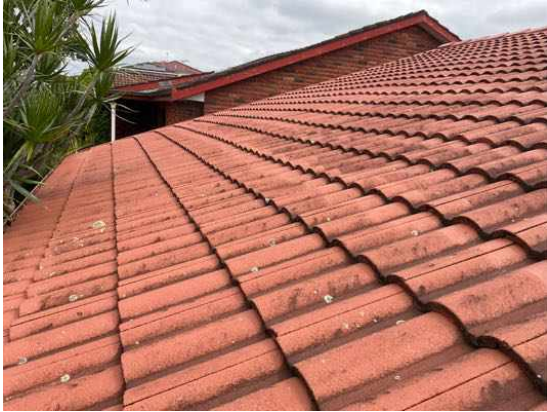
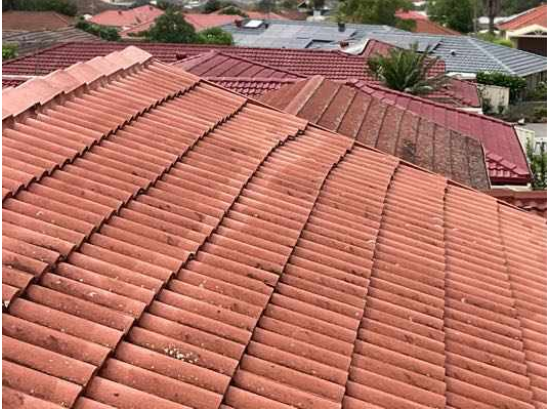
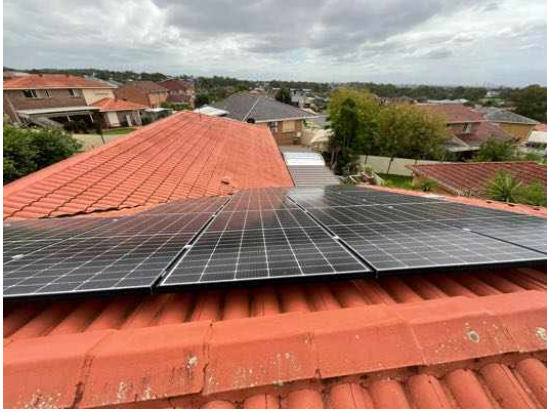
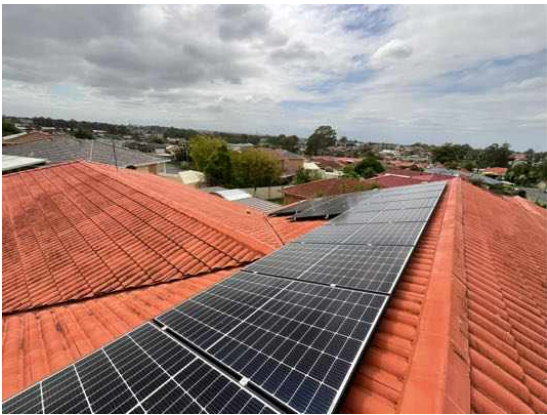
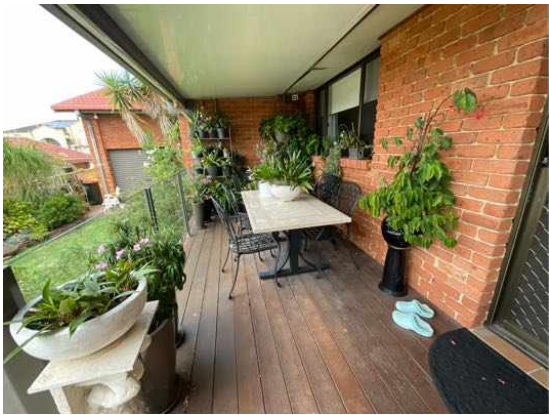
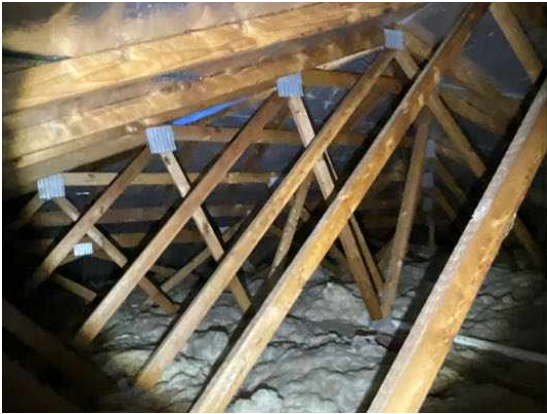
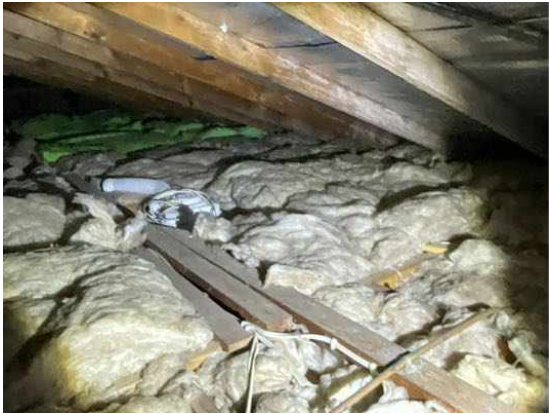
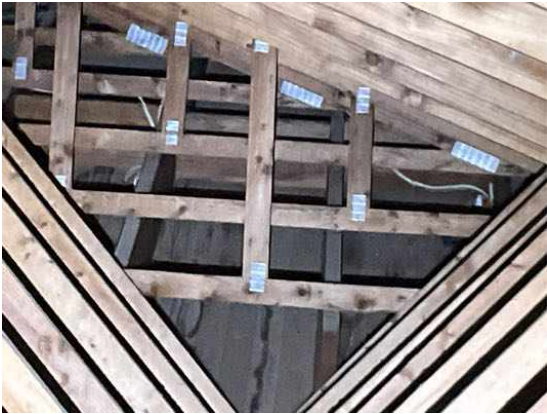
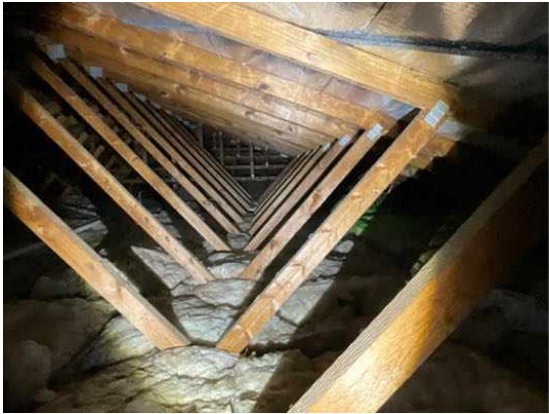
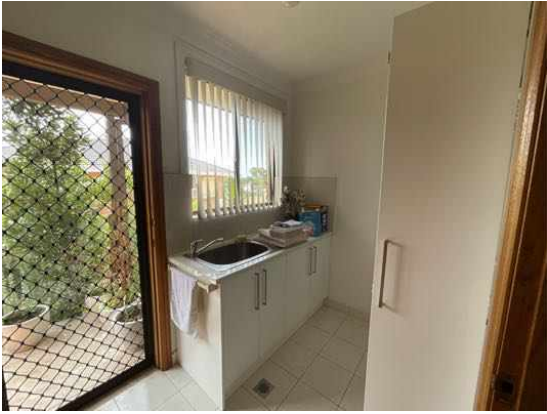
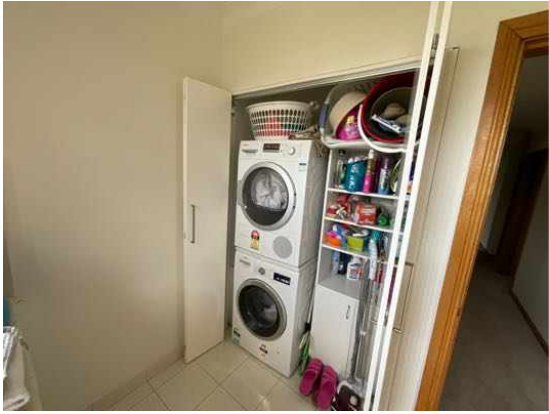
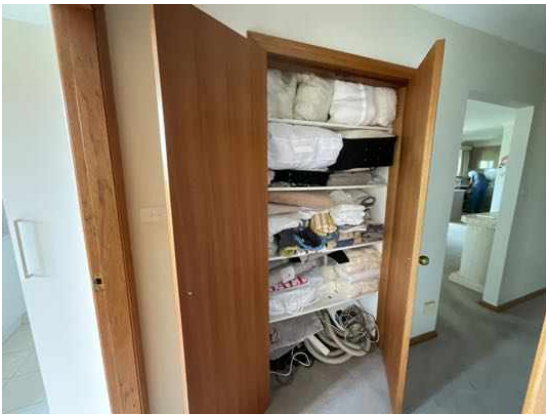
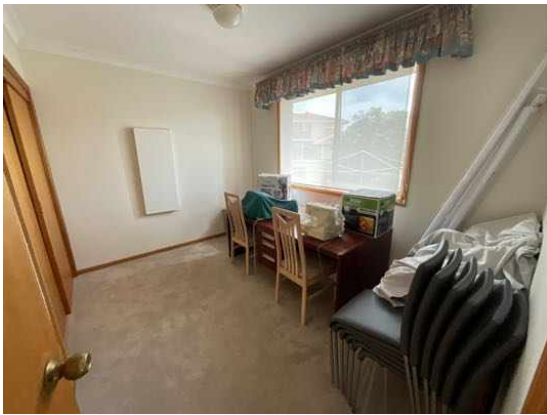
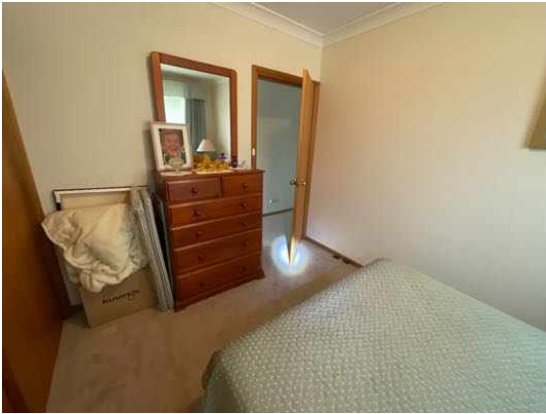
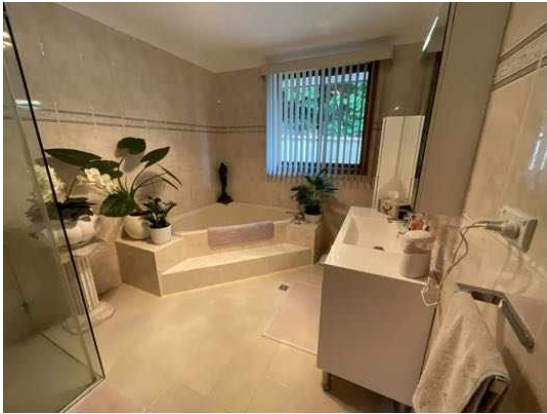
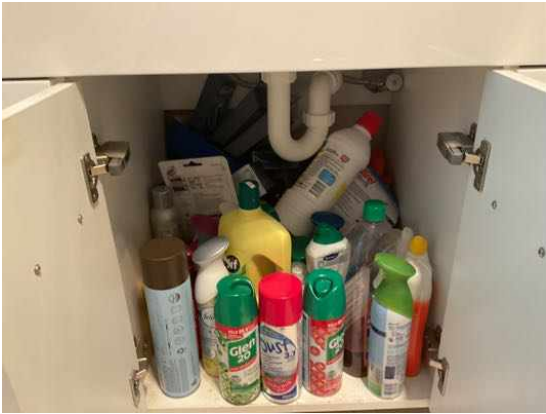
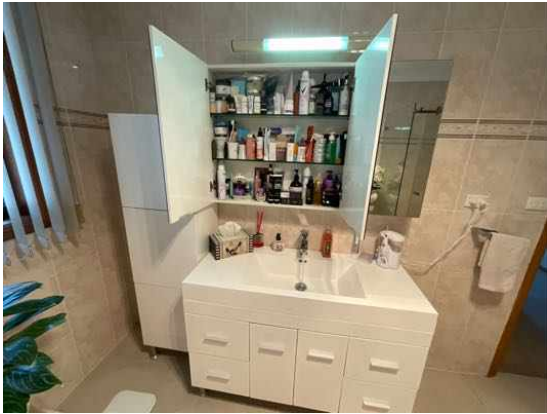
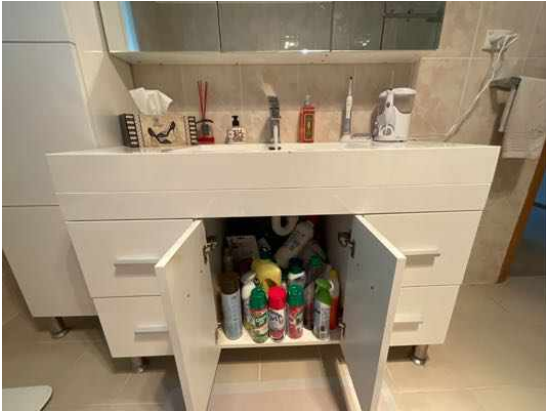
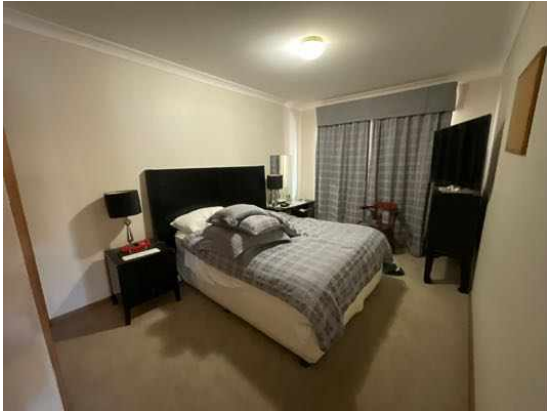
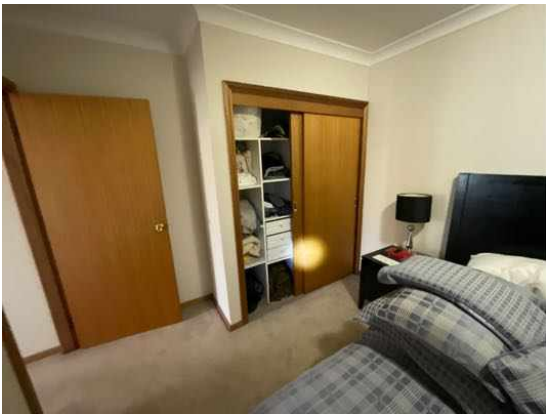
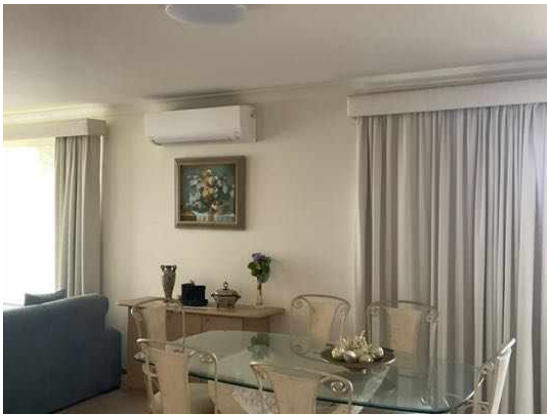
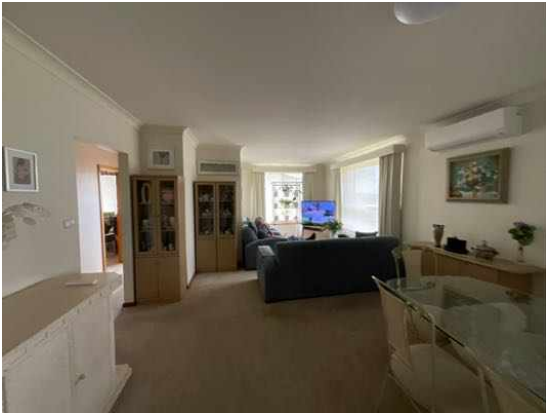
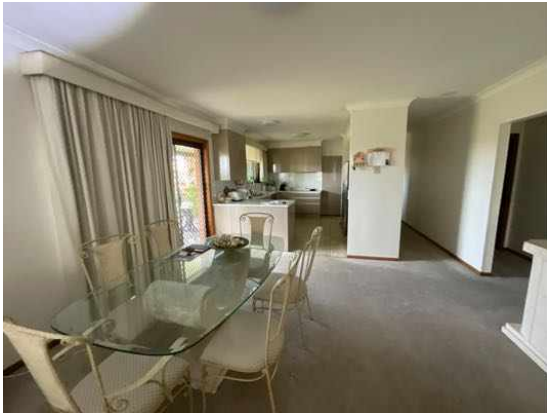
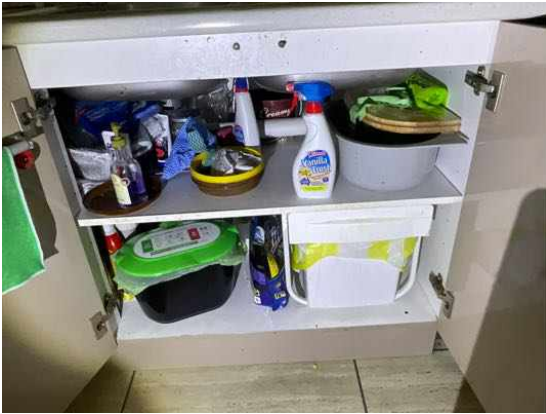
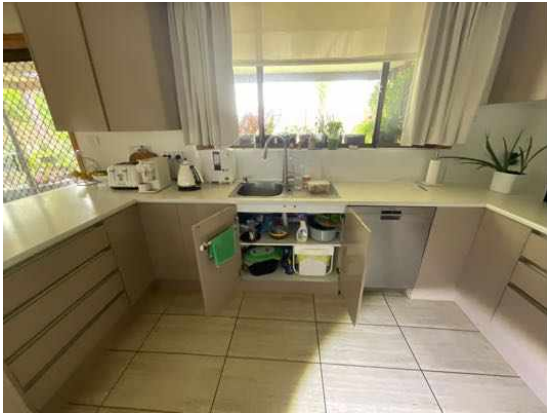
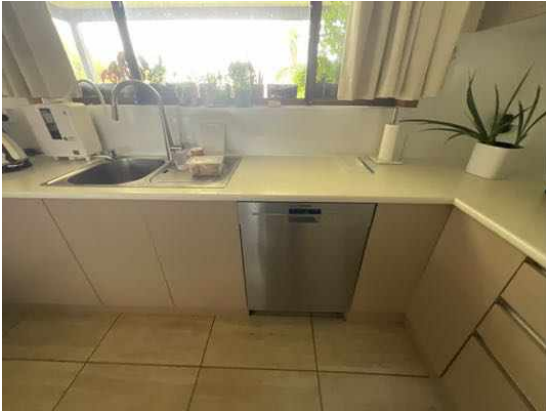
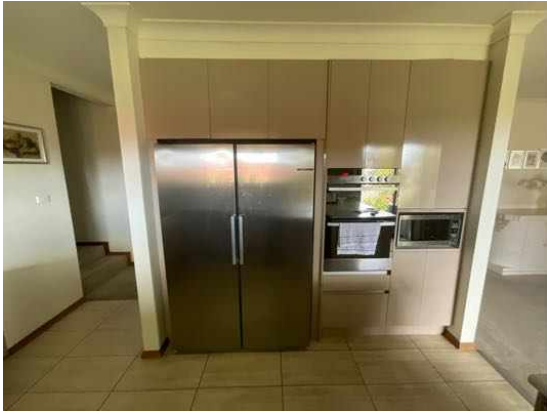
Building: Main Building  
Location: All Areas  
Finding: Additional Photos - Obstructions and Limitations  
Information: These photographs are an indication of the obstructions and limitations which impeded full inspection of the property at the time of inspection. These obstructions can hide an array of defects and should be removed to allow full inspection to be carried out. A re-inspection is recommended once the areas are made accessible.

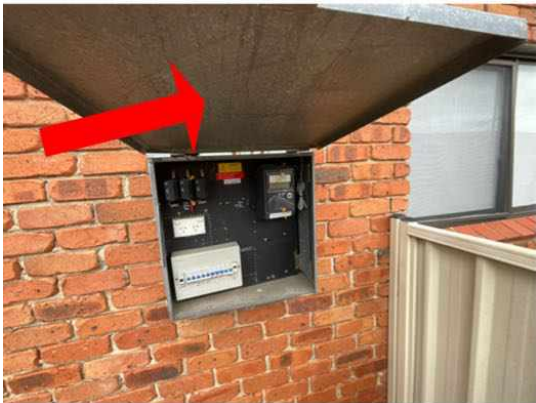
Building:	Main Building
Location:	All Areas
Finding:	Termite Management System - no evidence of a chemical installation
Information:	The application of a post-construction chemical termite barrier is highly recommended for all properties, particularly if live termite activity has been found on the site previously. Such barriers are highly effective in preventing termite attack on any timber building elements throughout the property.

A durable notice should be placed in the switchboard unit to indicate current termite barriers. At the time of inspection, it appeared as though no termite management system has been installed, with no evidence to suggest preventative works taking place.

The client may consider gaining further advice from a pest controller as to the costs and procedures involved with this application. It is recommended that obtaining such advice be a short-term priority.

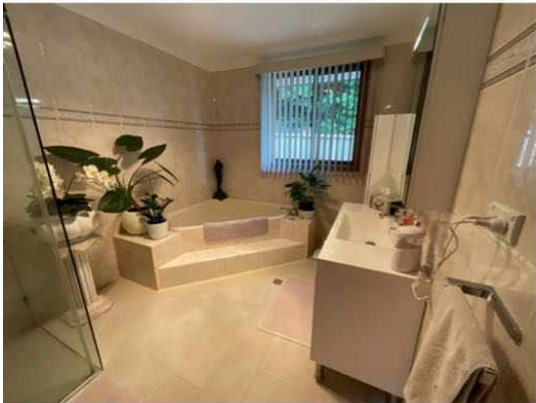
Building: Main Building  
Location: All Areas  
Finding: Water Proofing Membranes - Information Only  
Information: Internal Water Proofing Membranes, are crucial in preventing water ingress into the property is important to know that the Membrane System used is to Australian Standards and has been installed correctly. Please refer to the original Building Documents or Maintenance Schedule for the relevant information including; - Membrane used and Manufacturers Specifications. - The Installer and Installation Certification. Especially with older property's where this information is unavailable, all wet areas should be monitored. Generally new waterproofing with a certificate may only have a guarantee of 8yrs. If any leaks, water staining, peeling or bubbling of the paint become evident to any adjacent walls or ceilings below a licensed builder or waterproofing specialist is recommended to investigate further.
