Building and Timber Pest Inspection Report

Inspection Date: Fri, 27 Feb 2026

Property Address: 73 Willandra Cres, Windale NSW 2306,
Australia

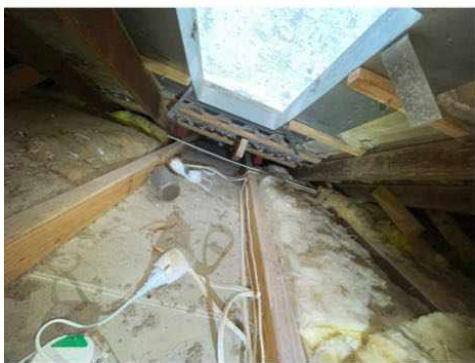
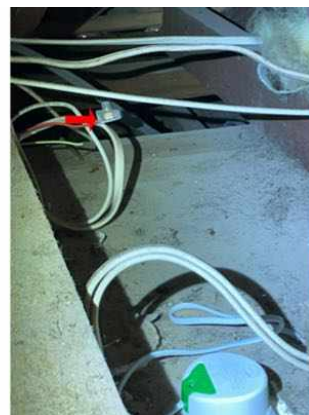
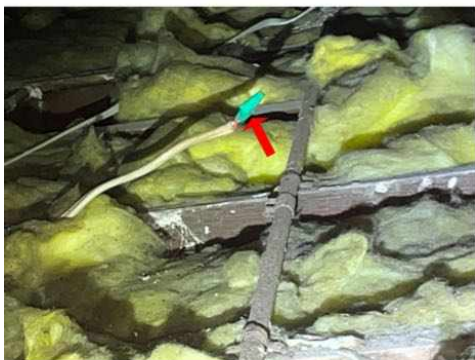
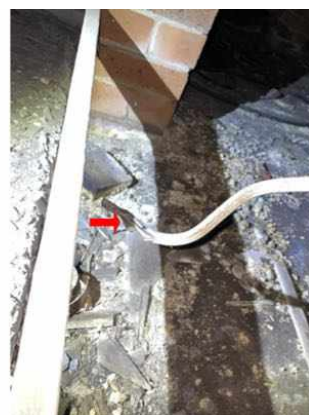
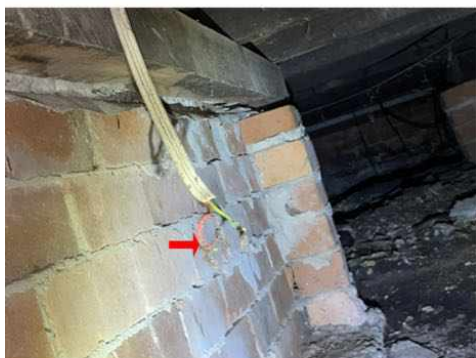
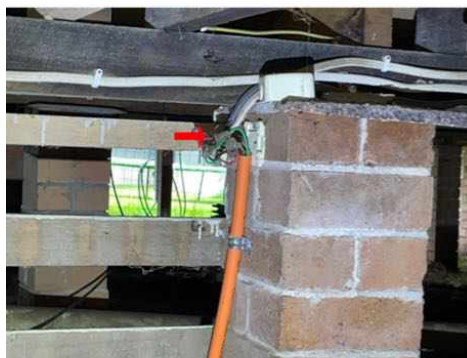
Building:	Main Building
Location:	Roof Void, Subfloor > All Areas
Finding:	Electrical junction box - Missing
Information:	Several wiring joins in the roof space and subfloor space are not adequately protected by a junction box. Junction boxes provide a second insulation barrier to adequately seal off and protect the wires, increasing the safety of the immediate environment and ensuring that the wiring is not damaged.

The absence of junction boxes in the roof space poses as an electrical safety hazard, providing risk of electrocution. It appears as though wiring in this area has been completed to a substandard level of workmanship, evidenced by the lack of adequate wiring protection.

Appointment of a licensed electrician is highly advised to provide additional information on the risks of unprotected wiring and to install junction boxes and any other elements as required. Such works should be carried out as a matter of urgency; until this time, any persons within the roof space should exercise a high level of caution.

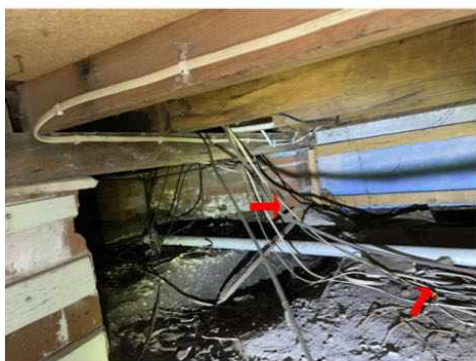
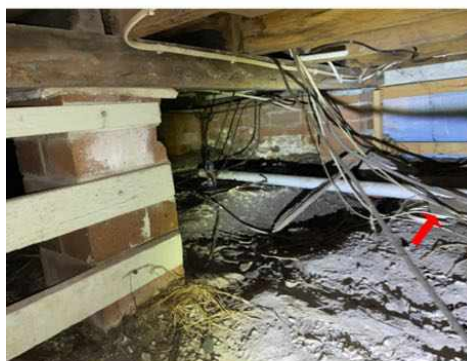
Finding 1.02

Building:	Main Building
Location:	Subfloor > Rear Left
Finding:	Electrical Cables - Not clipped off
Information:	Some of the electrical cabling in the subfloor area has not been correctly clipped off (secured) to the adjoining subfloor structure and are touching the ground. Where cables have not been clipped off, they are more susceptible to impact damage and moisture damage, particularly if they are in direct contact with the ground.

A qualified electrician should be appointed immediately to provide adequate clipping for the cables. Failure to do so may necessitate repair works or may become a safety hazard.

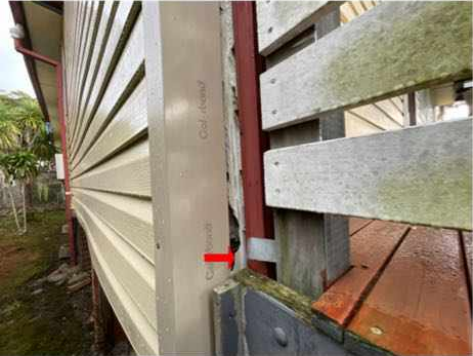
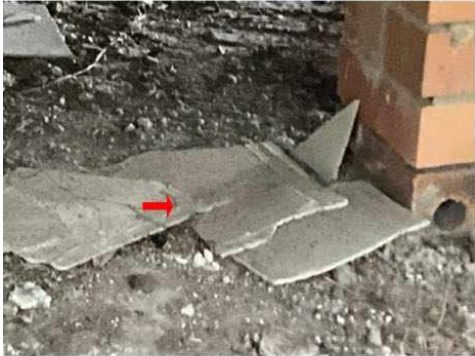
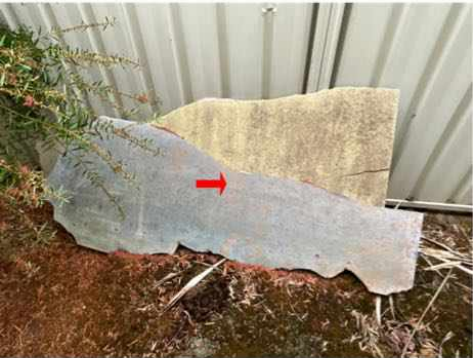
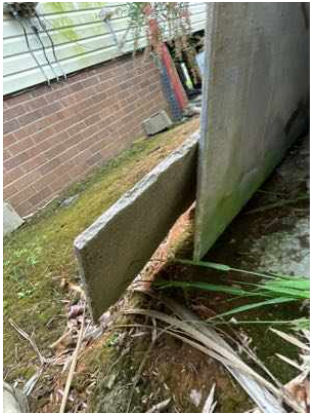
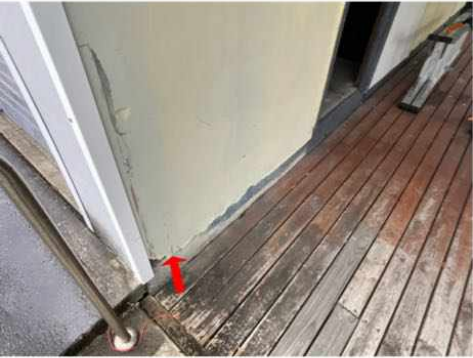
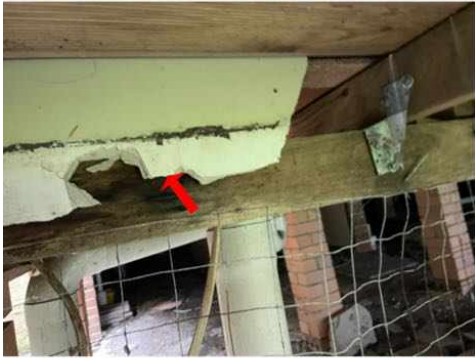
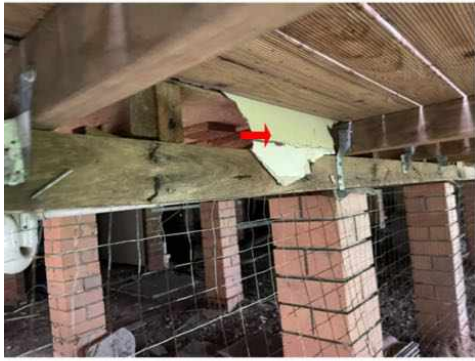
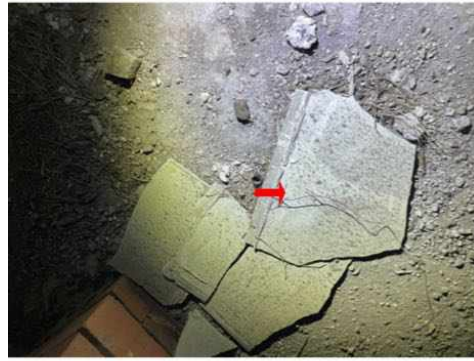
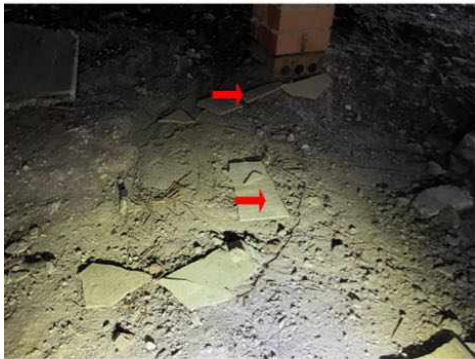
Finding 1.03

Building:	Main Building
Location:	Exterior walls > All Areas
Finding:	Asbestos - Suspected ACM Identified on Site
Information:	A number of areas appear to have damaged external cladding and broken boards that have been removed and left on site. Reporting on Asbestos is outside the Scope of this Report. This suspected defect is highlighted as a caution only. We suspect, based

As Asbestos Reporting is outside the scope of this report, we advise that you consider a separate Asbestos Inspection and Condition Audit, which can include the taking of samples for definitive confirmation of the presence of Asbestos.

In the interim, the client is advised to act with caution, especially when considering any damage to building materials general wear and tear renovations extensions demolition and general maintenance activities due to the suspected presence of Asbestos.

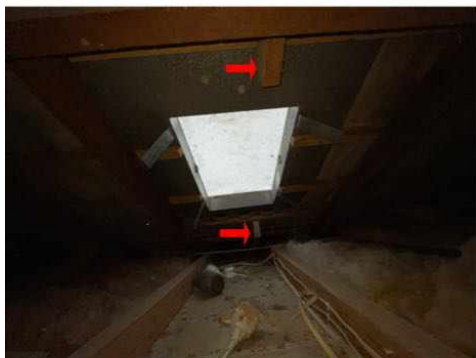
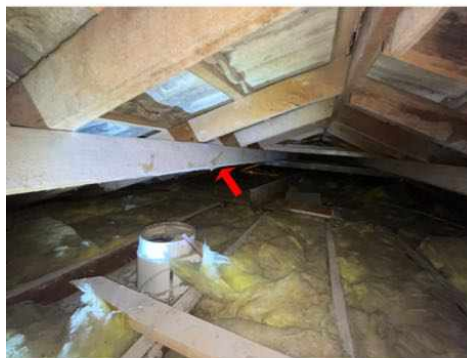
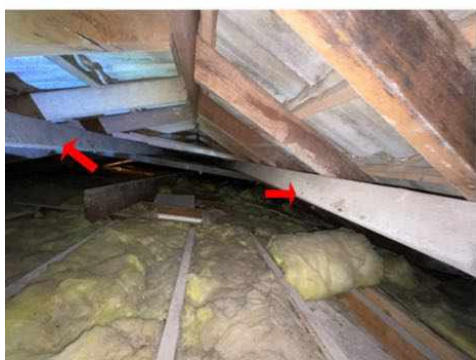
Finding 2.01

Building:	Main Building
Location:	Roof Void > Rear
Finding:	Roof Framing - Alterations
Information:	One of the roof rafters has been cut to accommodate the installation of a skylight. The purlins below the rafters were also noted to be without strut support. These conditions appear to have been present for some time.

Alterations to structural roof members and lack of support may affect load distribution within the roof structure over time.

It is recommended that a suitably qualified structural engineer or building contractor assess this area to confirm adequacy or advise if any remedial works are required.

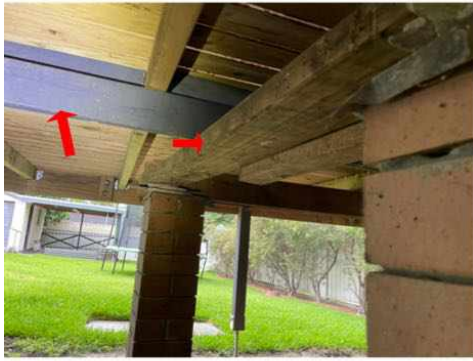
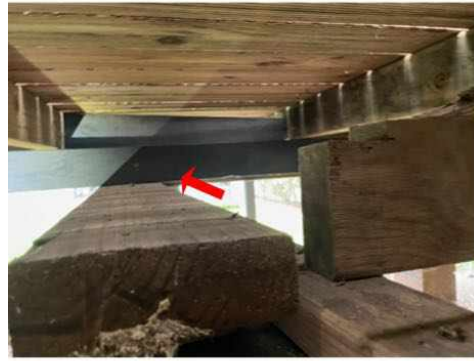
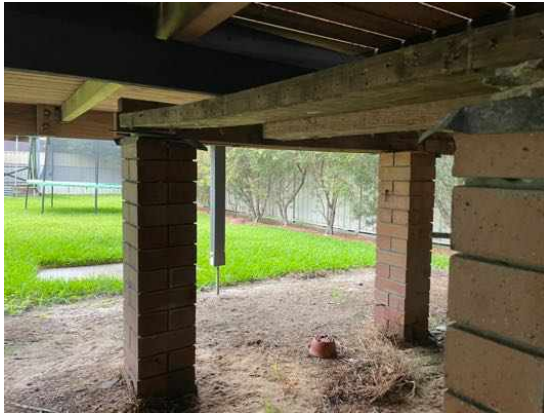
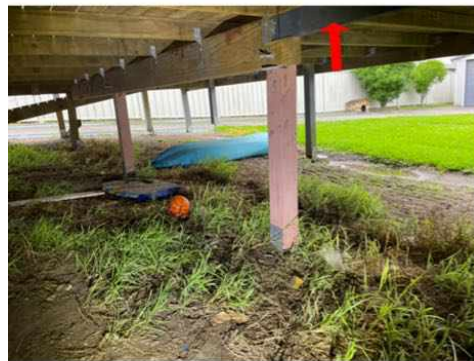
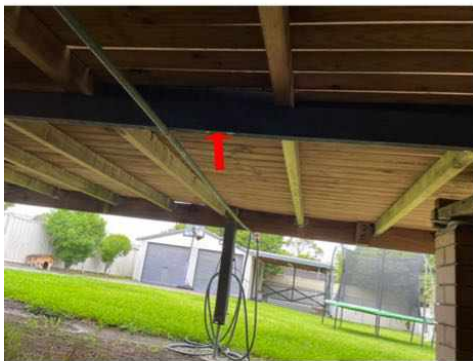
Finding 2.02

Building:	Main Building
Location:	Deck > Rear
Finding:	Rear Deck - Not adequately supported
Information:	The rear deck includes an area where the supporting structure does not appear to be adequately supported, with sections of framing showing limited bearing to the supporting piers.

Inadequate support may lead to excessive movement, sagging or structural deterioration over time if not addressed.

It is recommended that a suitably qualified builder or structural professional assess the deck support and undertake rectification as required to ensure the structure is adequately supported.

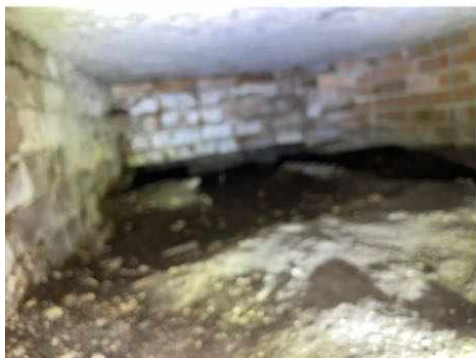
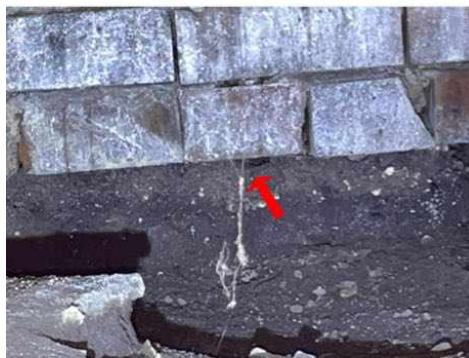
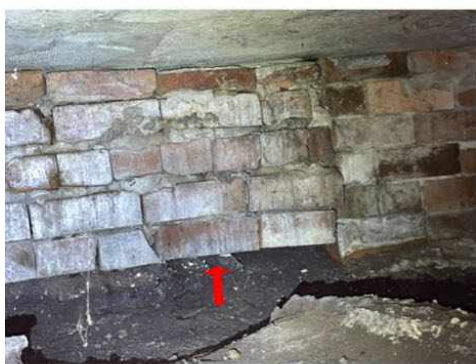
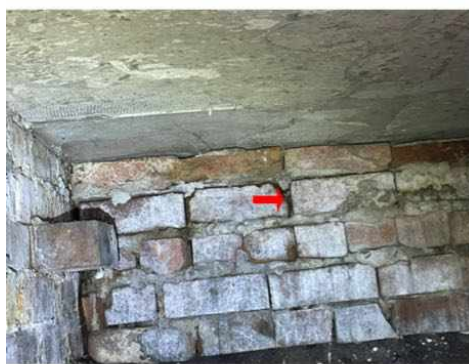
Finding 2.03

Building:	Main Building
Location:	Subfloor > Front
Finding:	Subfloor wall - Unstable
Information:	A subfloor masonry wall below the porch does not appear to be supported by an adequate footing.

Without adequate support, the wall may become unstable over time and there is a risk of localised movement or collapse. As the porch area includes a ramp and deck structure, any instability to the original porch supports may affect the stability of the overlying structures.

It is recommended that a suitably structural engineer assess the wall and supporting conditions to determine if remedial works or additional support are required.

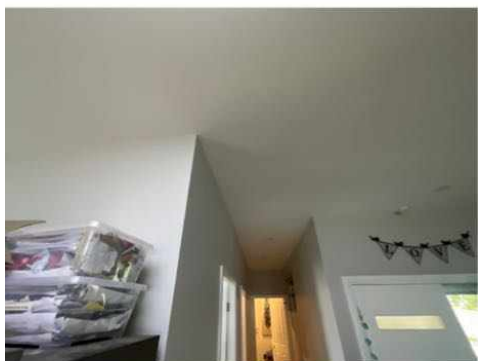
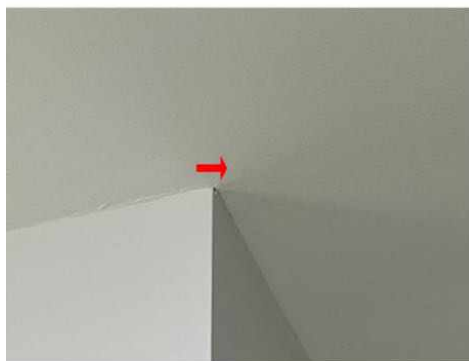
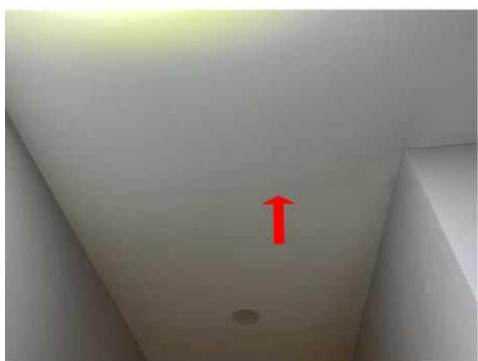
Finding 3.01

Building:	Main Building
Location:	All Internal Areas > All Areas
Finding:	Cracking - Damage Category 1 - Fine (up to 1mm)
Information:	Cracking was evident to the an area of plasterboard ceiling at the entry to the hallway. Although fine cracks are quite noticeable, they are often only considered to be an appearance defect, and usually do not indicate any structural damage. Generally, the cause of a fine crack is indicative of a separation between building materials and finishes (e.g. paint, plaster, etc.) along joints.

Cracking of this nature can generally be repaired with minor sanding, filling and/or repainting. Such works should be performed by a qualified painter or a general handyman.

Monitoring of all cracking should be conducted frequently. Always contact a building inspector should cracks widen, lengthen, or become more numerous.

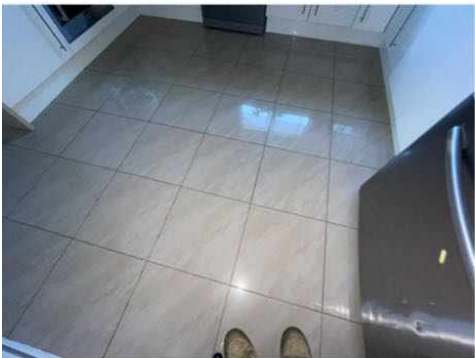
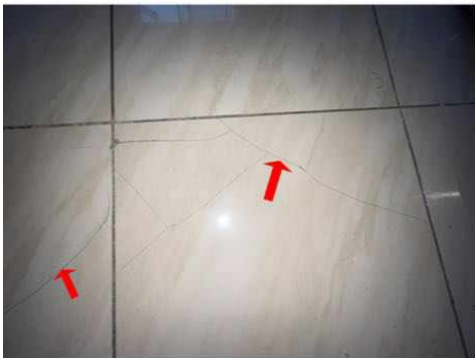
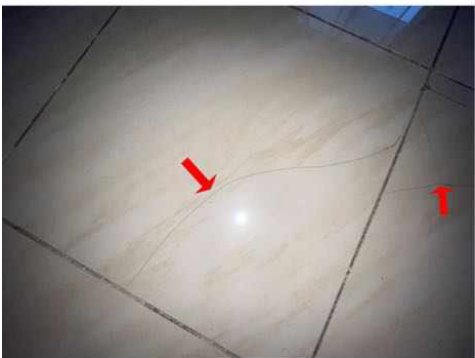
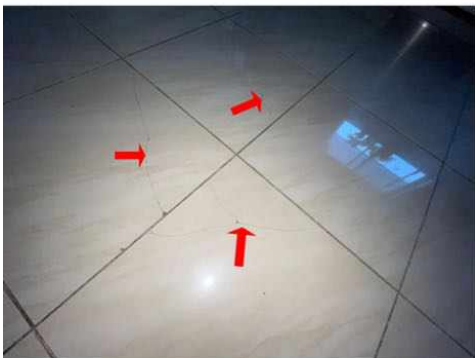
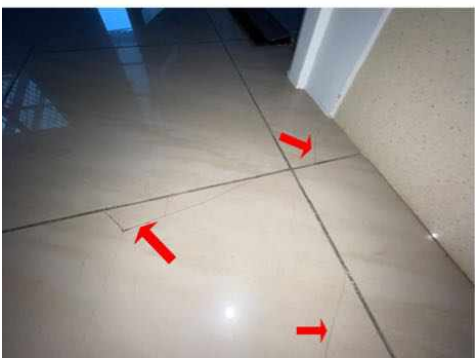
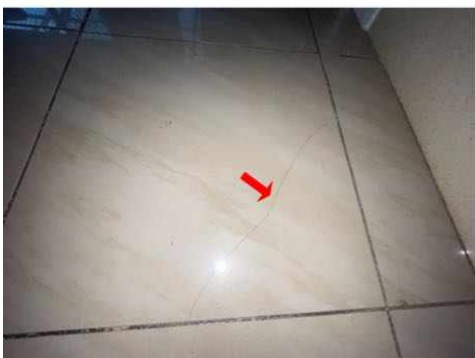
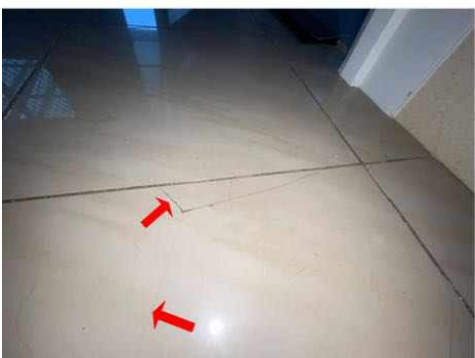
Building:	Main Building
Location:	Kitchen > Centre
Finding:	Cracked floor tiles
Information:	Cracking in the floor tiles was evident to the kitchen area at the time of inspection. It is suspected that this cracking has occurred as a result of minor settlement or shrinkage of the slab or impact damage.

Cracked tiles throughout the household detract from the overall appearance of the affected areas however it is unlikely to create or lead to any secondary defects.

While not considered a matter of urgency, replacement of cracked floor tiles is recommended at the clients discretion. A tiling contractor may be appointed to perform these works. Where cracks become more numerous, contact a licensed building inspector for further investigation.

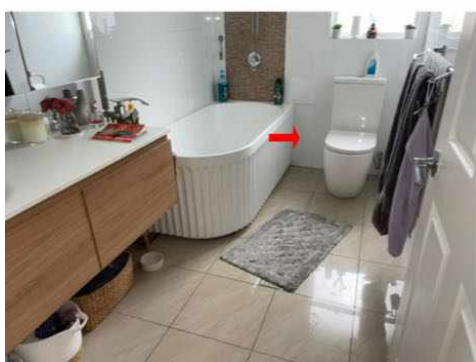
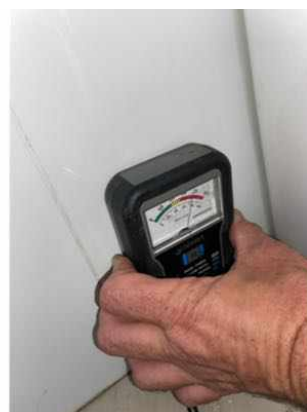
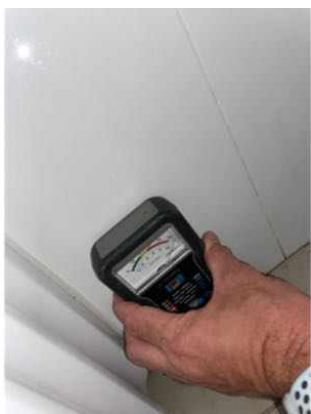
Finding 3.03

Building: Main Building
Location: Bathroom > Front Right
Finding: Moisture Located Externally to the shower screen
Information: Damp is evident to the tiling adjacent to the shower/bath on the exterior side. The moisture meter showed high levels of moisture. This defect is suspected to have been caused by moisture permeating through the tiling in this area or an inadequate or worn shower screen seal.

Damp (or structural damp) refers to the presence of unwanted moisture in the structure of a building, either as the result of intrusion from outside, or condensation from within the structure. In the shower area, internal water leaks or other sources of excessive moisture are generally the cause of damp.

Unmanaged damp in the shower recess is likely to facilitate the formation and development of mould and fungi growth, decaying associated building materials and compromising their structural integrity. It is important to address damp conditions, as the World Health Organisation notes that excess moisture leads - on almost all indoor materials - to growth of microbes such as moulds, fungi and bacteria, which subsequently emit spores and other matter into the indoor air. Exposure to these contaminants is associated with a wide range of respiratory and other health-related problems.

Consultation with a qualified plumber or bathroom specialist is advised to identify the cause of damp and to perform remedial works as required.

Always ensure that sealant and grout is in good condition to prevent any moisture

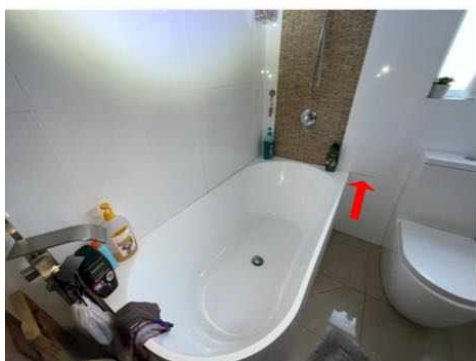
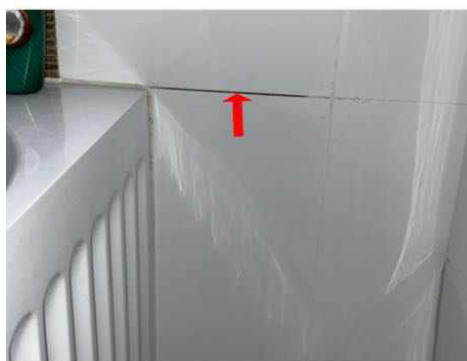
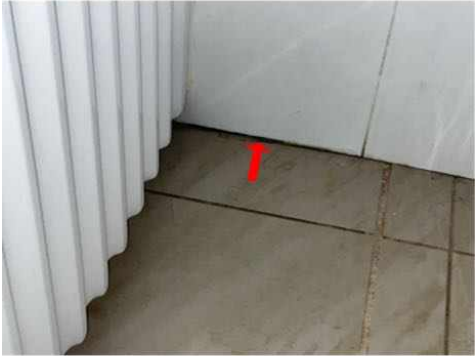
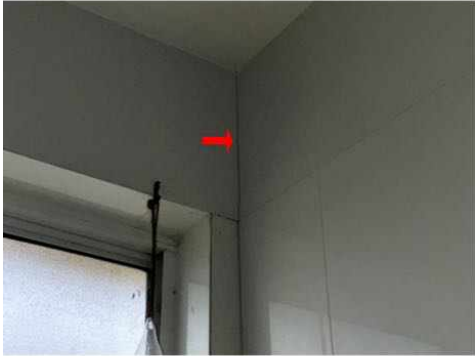
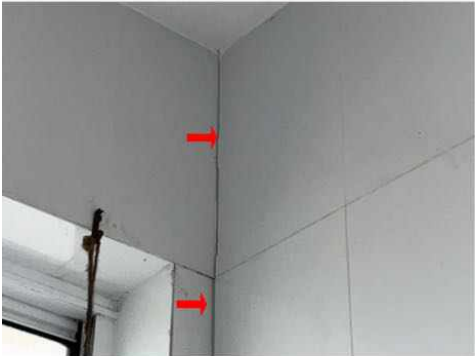
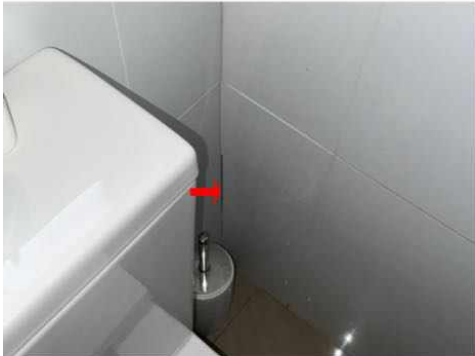
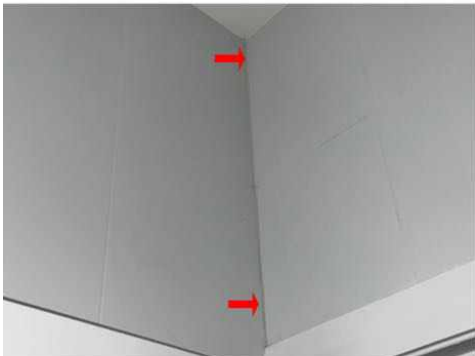
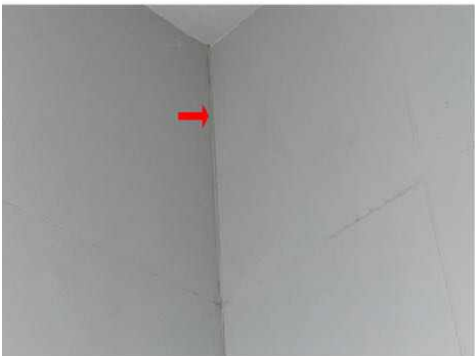
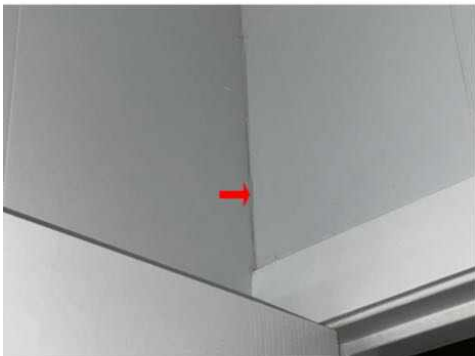
Finding 3.04

Building:	Main Building
Location:	Bathroom > Front Right
Finding:	Sealant and grouting - Missing or damaged
Information:	It was noted on inspection that sealant or grout is degraded to areas of the bathroom.

Different materials and floor areas move at different rates, generally causing cracking to grout or sealant at this point. A flexible sealant is required to allow for expected expansion and contraction, while keeping the joint water tight and protective of all associated building materials.

There appears to be excessive mould to the sealant and grout which will likely require scraping out and replacement.

Flexible and mould resistant materials should be applied to affected areas to prevent any subsequent water damage that is likely to occur. Regular maintenance and replacement of damage or missing or damaged sealant and grout is highly recommended to the wet areas, as this is a regular wear and tear defect. Sealant and grouting in areas that come into regular contact with water should be maintained for the long term care of your property.

A sealant specialist or tiling contractor should be appointed to complete these works as soon as possible

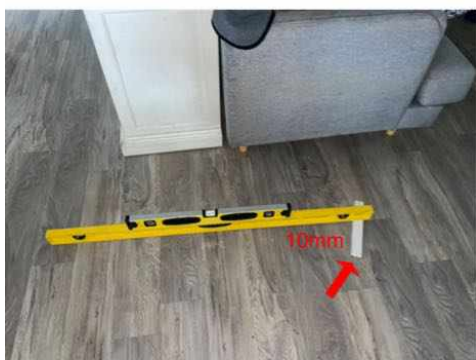
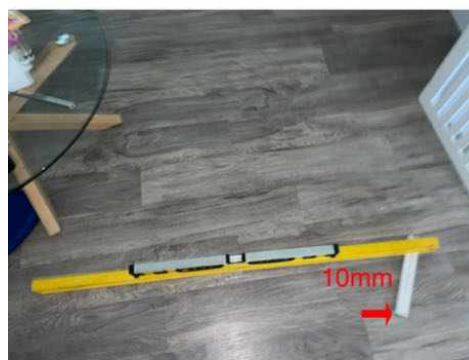
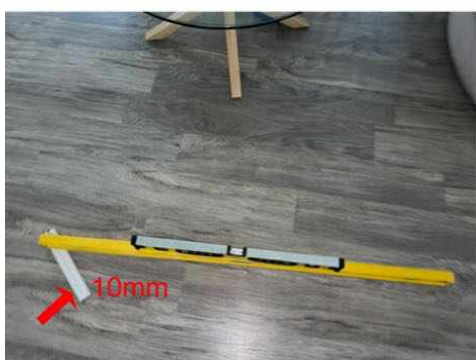
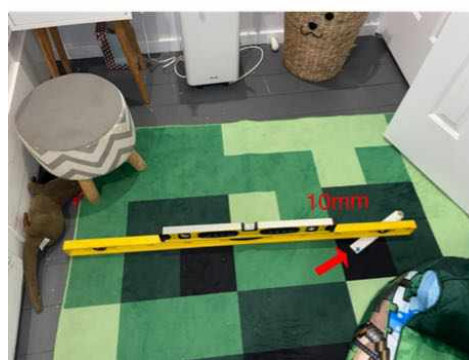
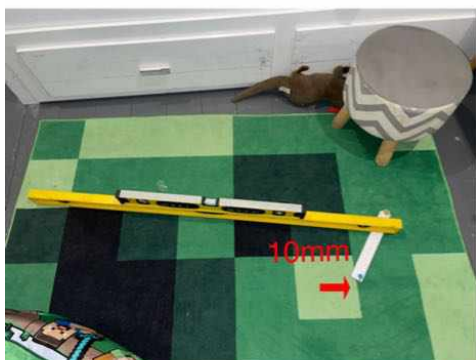
Finding 3.05

Building:	Main Building
Location:	All Internal Areas > All Areas
Finding:	Flooring - Uneven
Information:	The internal flooring in this area is out of level and uneven by approximately 10mm over a 1.2m length. Uneven flooring is likely to indicate minor defects such as expected movement of the foundations of the property, but may also indicate subsidence of the associated subfloor stumps.

It is advised that the flooring be closely monitored to identify any further movement. Where flooring remains relatively unchanged for an extended period of time (i.e. several months), it is likely that this defect has been caused by expected movement of the foundations of the property.

However, where flooring is uneven further, potentially invasive inspection of the subfloor structures and stumps in this area is required. In this case, works to repair are likely to be required, and would be carried out by a builder specialising in re-stumping.

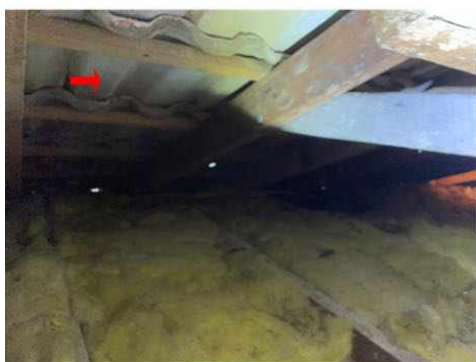
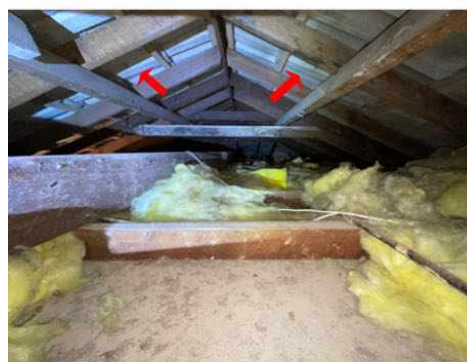
Finding 3.06

Building:	Main Building
Location:	Roof Void > All Areas
Finding:	Sarking - Missing
Information:	Sarking is missing under the roof sheeting. Sarking acts as an insulator that helps with noise reduction and protects against water penetration. Sarking plays a key role in the operation and function of the overall roofing structure and its performance.

Although not a requirement at the time of construction, replacement of any missing building element is advisable (although this can be quite expensive to do after the time of construction). Where sarking is missing, regular inspections of the roof tiles for cracking and potential moisture penetration is required.

Sarking may be retrospectively fitted by a builder at the discretion of the client.

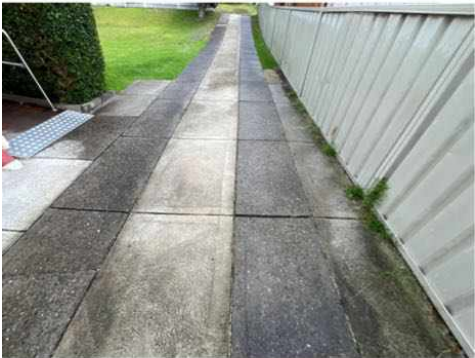
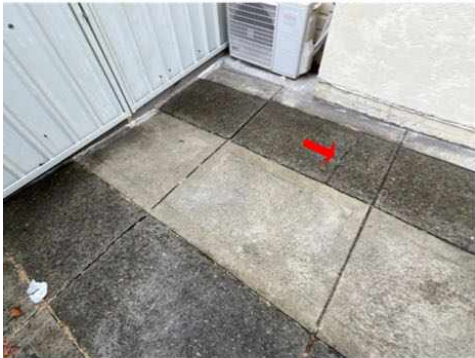
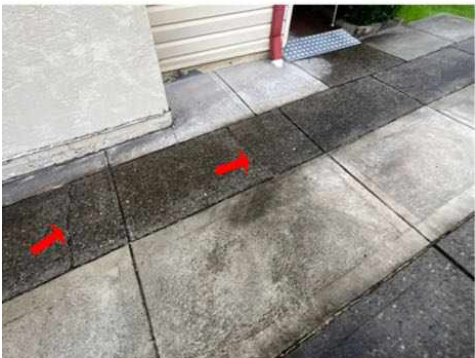
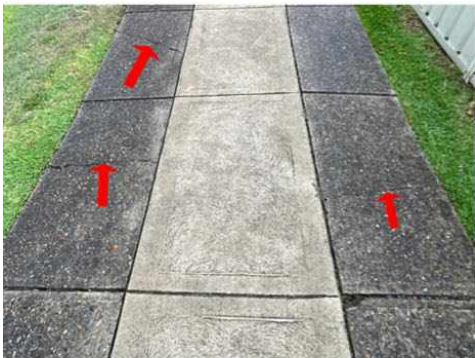
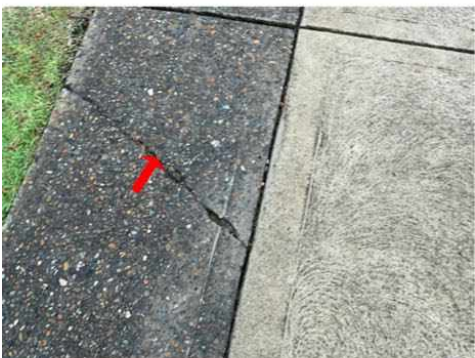
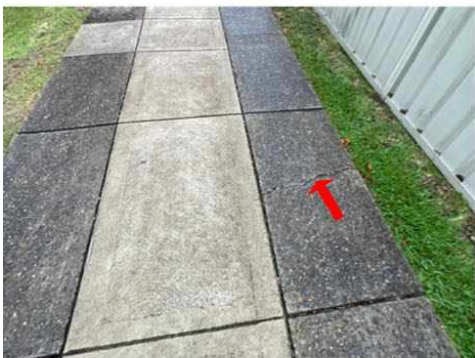
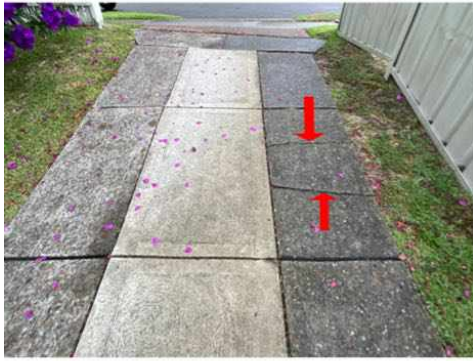
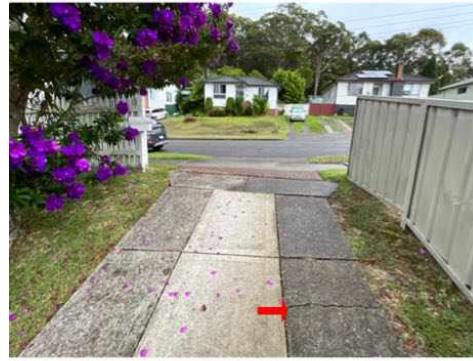
Finding 3.07

Building:	Main Building
Location:	Driveway > Front Left, Centre Left, Rear Left
Finding:	Crack in driveway slab - Category 1
Information:	Several cracks coded as Category 1 were identified in the driveway slab. A Category 1 crack is described as a fine but noticeable crack, with the slab at an otherwise

To be considered Category 1, the approximate width of the crack is less than 1.0mm, or a less than 10mm change in offset when a 3m straight edge is placed over the defect.

Category 1 cracks should be monitored for a period of 12 months. At the end of the monitoring period, identified cracks that are rated greater than Category 2 are considered defects, and require rectification.

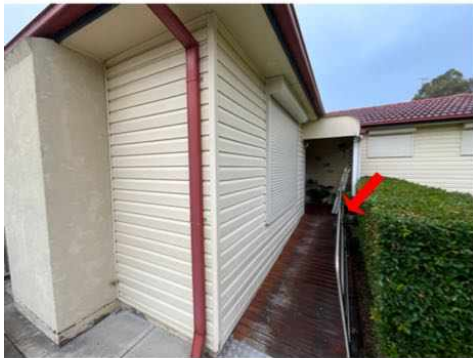
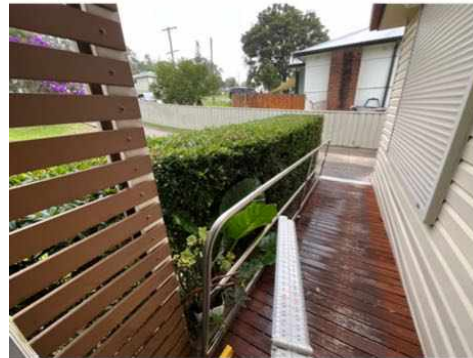
Finding 3.08

Building:	Main Building
Location:	Porch > Front
Finding:	Handrail - Loose
Information:	The handrail to the external ramp was noted to be loose and wobbly at the time of inspection.

A handrail that is not adequately fixed may reduce safety when in use and increase the risk of movement or failure under load.

It is recommended that a suitably qualified tradesperson secure the handrail to ensure it is stable and fit for purpose.

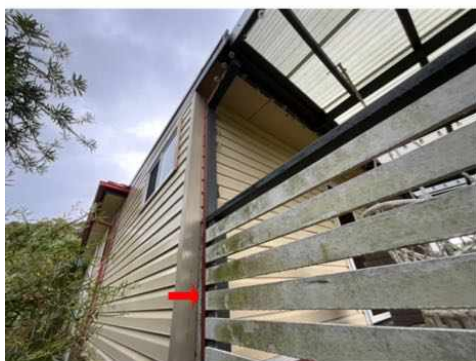
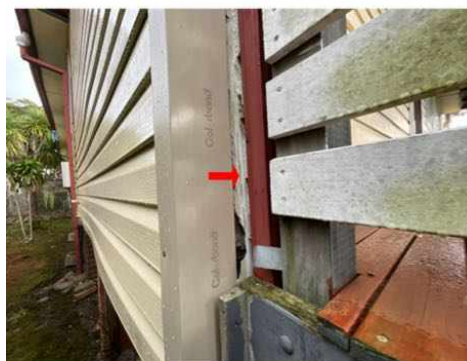
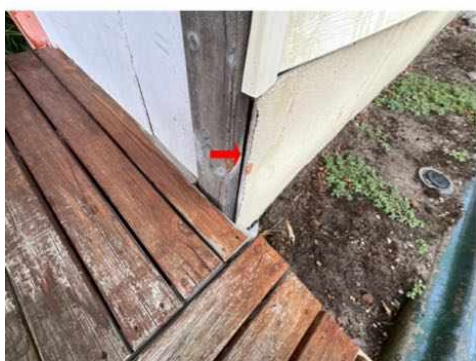
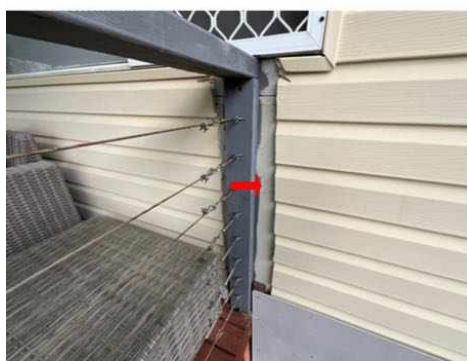
Finding 3.09

Building:	Main Building
Location:	Exterior walls > All Areas
Finding:	Asbestos - Suspected ACM Identified on Site
Information:	The original cladding below the 'Foreverboard' is most likely to be asbestos. Also the eave linings are also suspected be asbestos. Reporting on Asbestos is outside the Scope of this Report. This suspected defect is highlighted as a caution only. We suspect, based on our experience in the building industry, that there is a higher risk of

As Asbestos Reporting is outside the scope of this report, we advise that you consider a separate Asbestos Inspection and Condition Audit, which can include the taking of samples for definitive confirmation of the presence of Asbestos.

In the interim, the client is advised to act with caution, especially when considering any damage to building materials general wear and tear renovations extensions demolition and general maintenance activities due to the suspected presence of Asbestos.

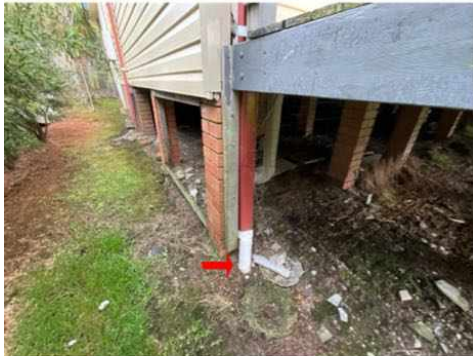
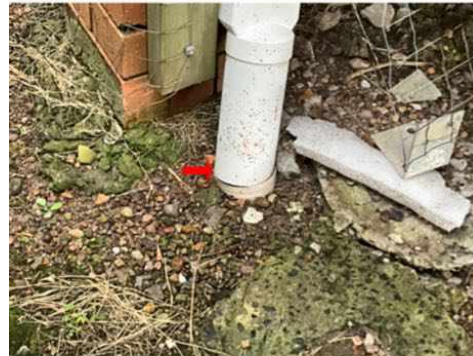
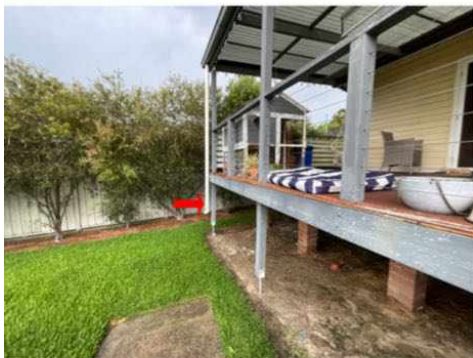
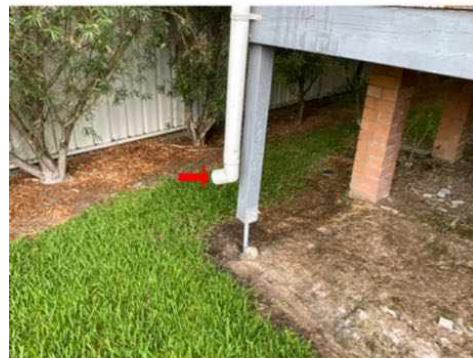
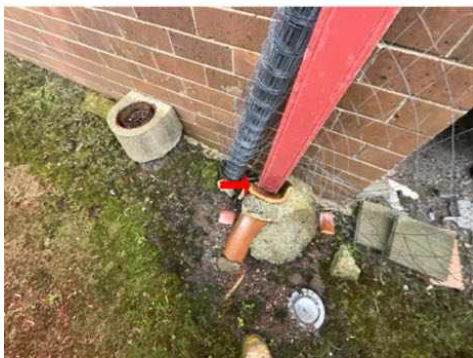
Building:	Main Building
Location:	Exterior walls > All Areas
Finding:	Downpipes not connected
Information:	Several downpipes were not connected or not adequately connected to the stormwater, which has resulted in the surrounding area becoming excessively damp. These damp conditions can lead to secondary defects such as rot, rust or corrosion of associated building elements, the formation of fungal decay, or even the creation of potential slip hazards.

When coupled with poor site drainage, pooling of water may also attract termite activity to this area.

It is highly recommended that a qualified plumber be appointed to install adequate drainage to the overflow. These works will ensure that the area remains dry and free of any secondary defects.

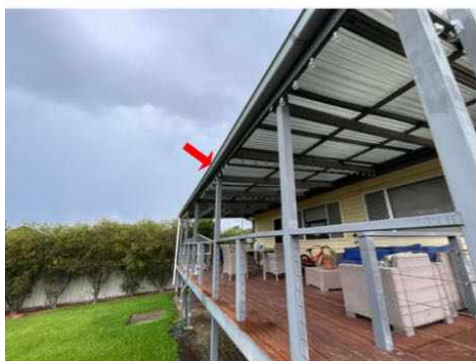
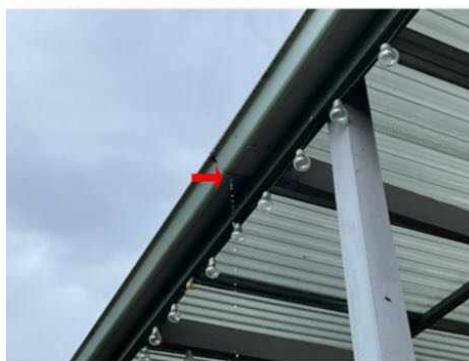
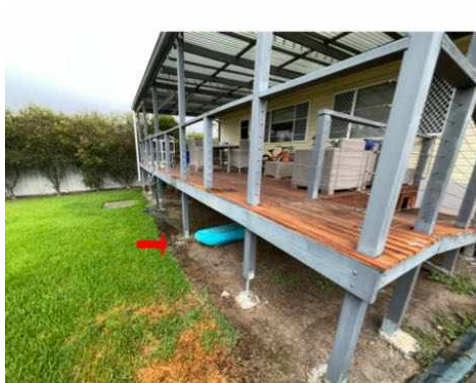
Finding 3.11

Building:	Main Building
Location:	Roof Exterior to deck > Rear
Finding:	Gutter - Leak
Information:	The gutter to the rear deck was observed to be leaking at a joint which does not appear to be adequately sealed and may represent a low point within the gutter line. Water pooling was also noted below this area.

Leaks and associated moisture may contribute to deterioration of surrounding materials over time and may also create conditions conducive to termite attraction.

It is recommended that a suitably qualified tradesperson assess the gutter fall and reseal or adjust the join as required to ensure effective drainage.

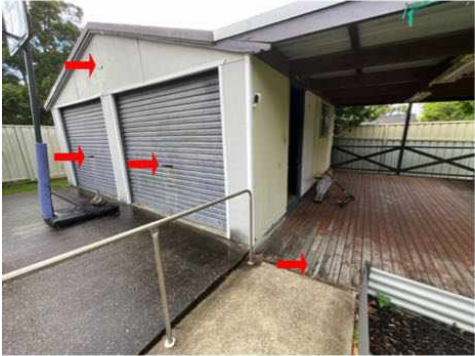
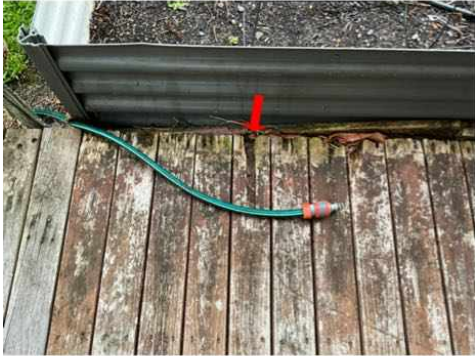
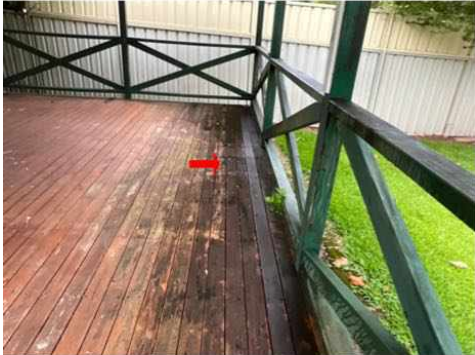
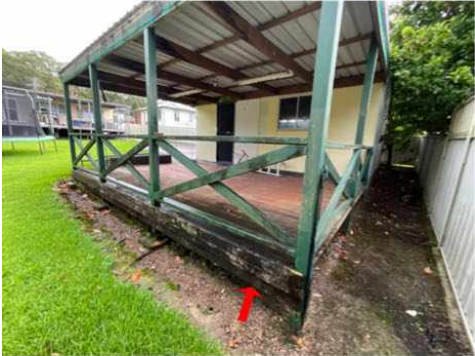
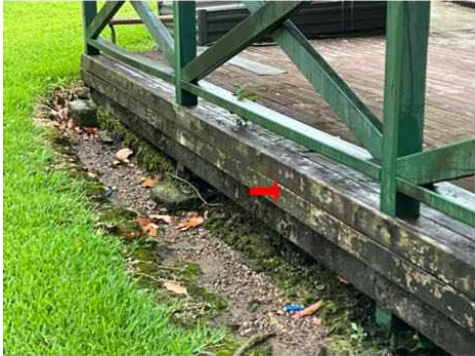
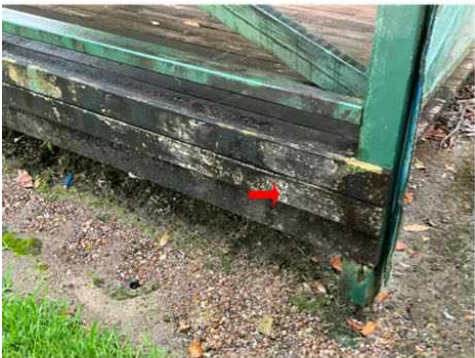
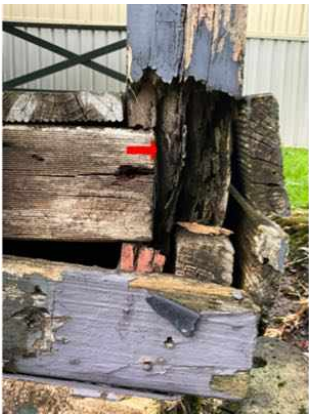
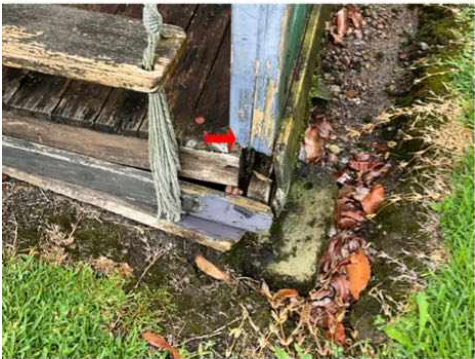
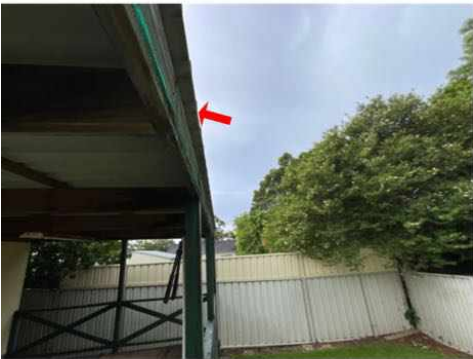
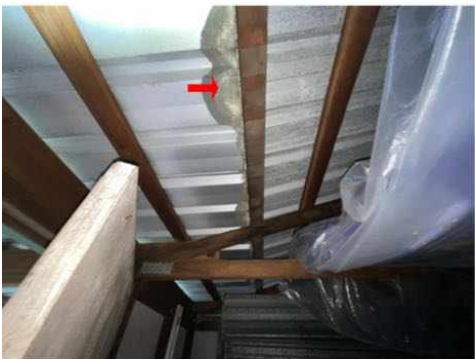
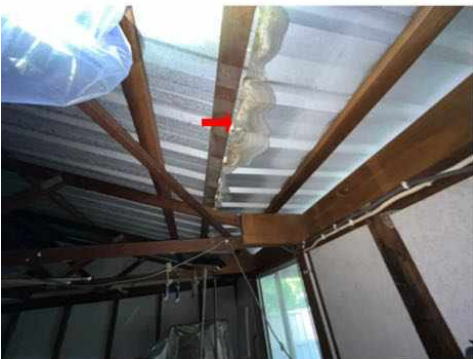
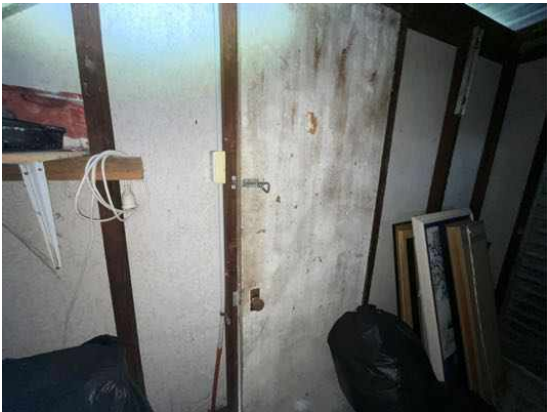
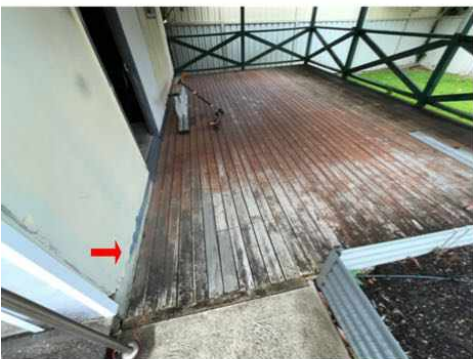
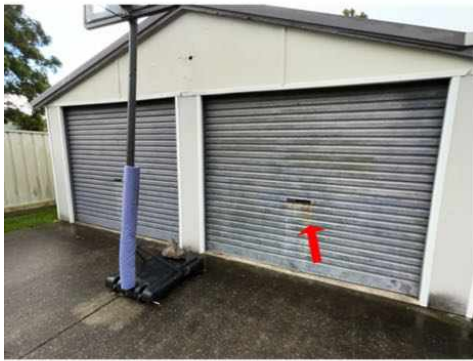
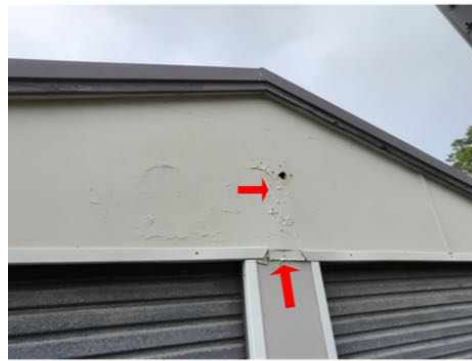
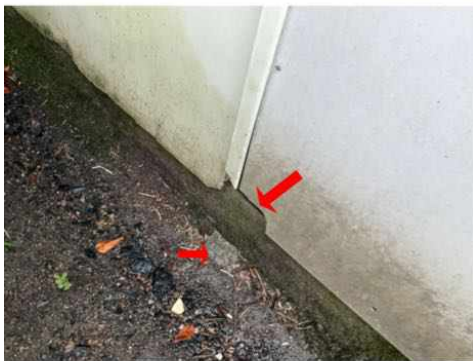
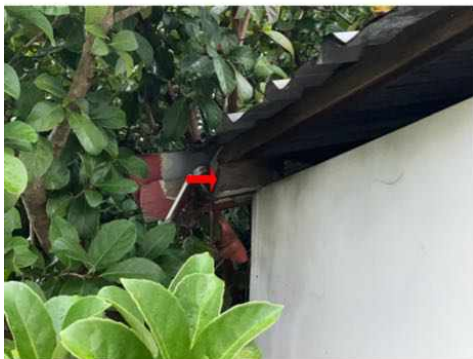
Finding 3.12

Building:	Main Building
Location:	Garage > Rear Left
Finding:	Garage - Defects
Information:	The rear garage and associated deck show a number of defects including wood rot to sections of the deck structure, the absence of a functional gutter due to damage, areas of bouncy decking, damaged fibro sheeting (potentially asbestos) to the lower sections, deteriorated deck staining, a weather-affected door, roof sheeting showing signs of corrosion, peeling paint, and wood rot to fascia and barge boards.

These defects indicate general deterioration and may allow further water ingress and material decay over time if not addressed.

It is recommended that a suitably qualified builder assess the structure and associated elements and undertake repairs or replacement as required. If the fibro sheeting is confirmed to contain asbestos, removal should be undertaken by a licensed asbestos

contractor.

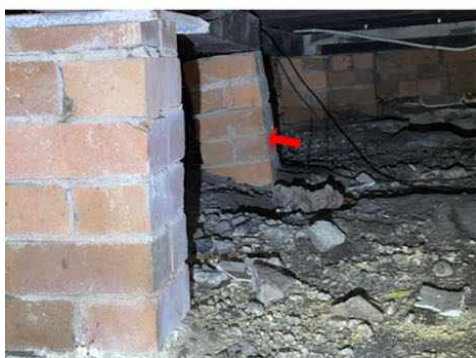
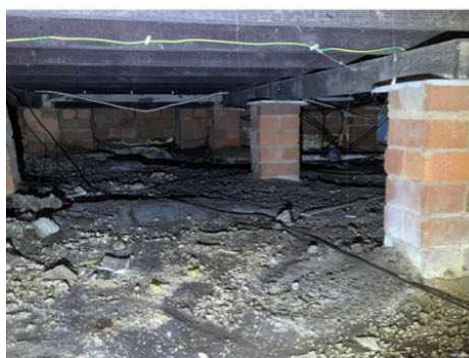
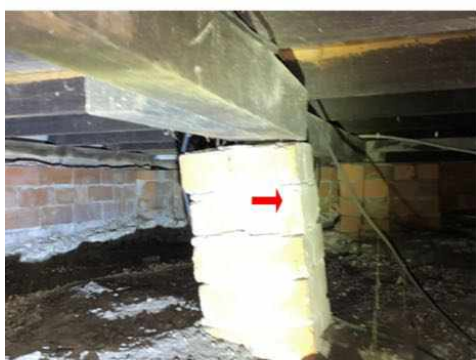
Finding 3.13

Building: Main Building
 Location: Subfloor > Rear
 Finding: Subfloor stump - Deviated
 Information: One of the subfloor support stumps was noted to be on a considerable angle. The subfloor space appeared damp at the time of inspection, which may have contributed to movement or subsidence. Mechanical ventilation has been installed within the subfloor.

A leaning stump may indicate localised movement or loss of bearing capacity and could affect the stability of the supported structure if movement continues.

It is recommended that a suitably qualified builder or structural professional assess the affected stump and subfloor conditions to determine if rectification or further stabilisation is required.

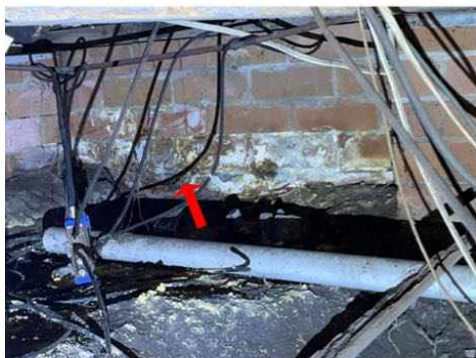
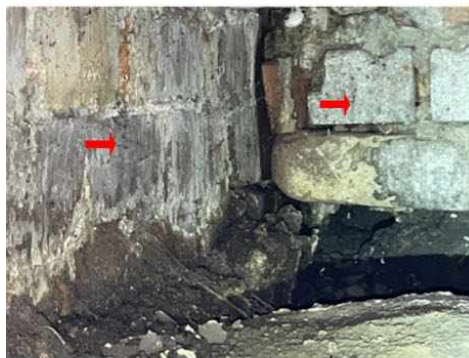
Finding 3.14

Building:	Main Building
Location:	Subfloor > Front,Front Right
Finding:	Brickwork - Efflorescence
Information:	Efflorescence appears to be affecting the brickwork, to areas of the subfloor. Efflorescence typically occurs when excess salts within the concrete or cement mortar is leached to the surface due to water transfer.

It is typically seen as white salt deposits on the surfaces of concrete pavement or mortar between bricks or tiles. While detracting from the overall appearance of the affected area, efflorescence is not likely to develop into secondary damage if left unmanaged.

Generally, soluble salt deposits can be removed by dry brushing with a stiff-bristled brush. Repeated dry brushing is an ideal treatment for eliminating this forming of efflorescence. A cleaning contractor or general handyperson may be appointed to perform these works at the discretion of the client.

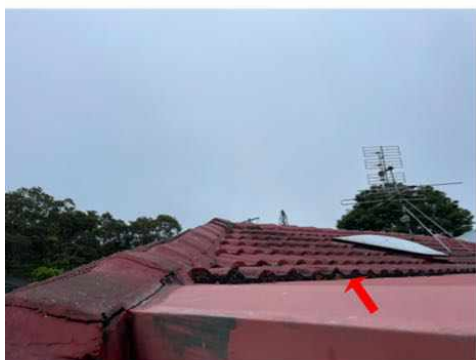
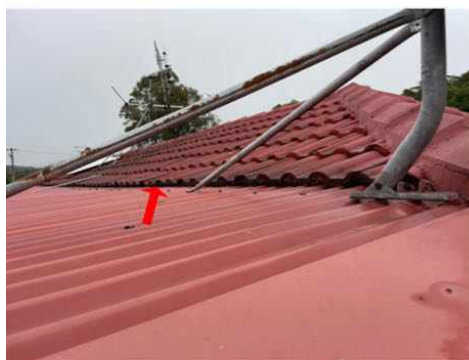
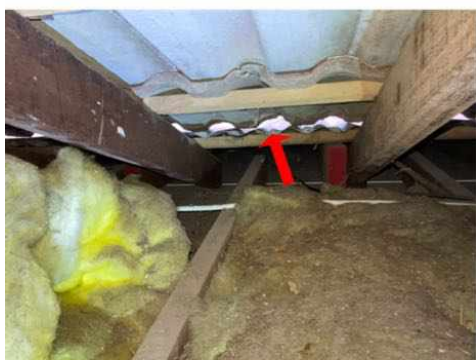
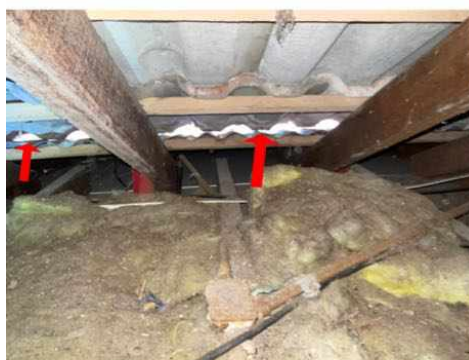
Finding 3.15

Building:	Main Building
Location:	Roof Exterior > All Areas
Finding:	Flashing between roof tiles and metal roof - Missing
Information:	No flashing was observed at the junction between the roof tiles and the Colorbond skillion roof to the rear extension, creating a potential pathway for water ingress during periods of heavy rain. No elevated moisture levels were detected at the time of inspection.

The absence of flashing at this junction may allow moisture to enter the building envelope over time, which can lead to concealed water damage, deterioration of building materials and possible mould growth if not addressed.

It is recommended that a suitably qualified roofer install appropriate flashing to this junction to ensure the area is adequately weatherproofed.
