Building and Timber Pest Inspection Report

Inspection Date: Fri, 27 Feb 2026

Property Address: 73 Willandra Cres, Windale NSW 2306,
Australia

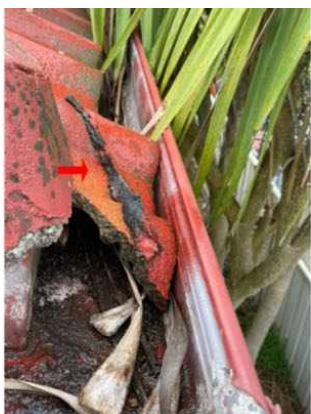
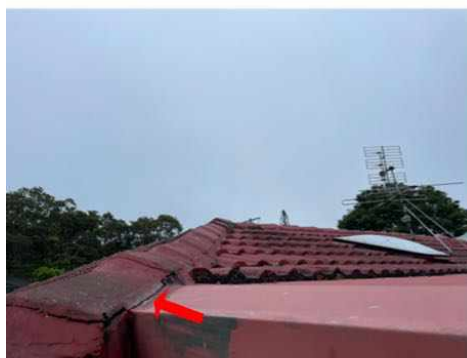
Finding 3.16

Building:	Main Building
Location:	Roof Exterior > All Areas
Finding:	Roof Tile - Dislodged
Information:	A roof tile at the gutter edge appears to have slipped out of position and is damaged, leaving part of the underlying area exposed. Minor cracking to the adjacent mortar was also noted.

Dislodged or broken tiles, along with deteriorated mortar, may allow water ingress into the roof space over time if not addressed and can contribute to localised moisture damage.

It is recommended that a suitably qualified roofer assess and reposition or replace the affected tile and repair the mortar as required.

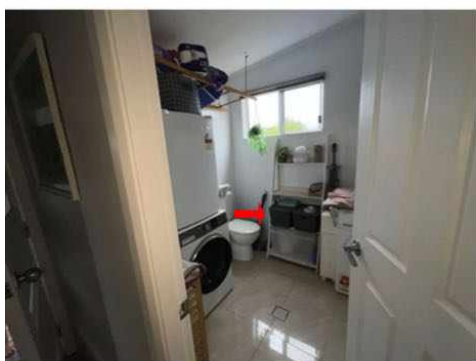
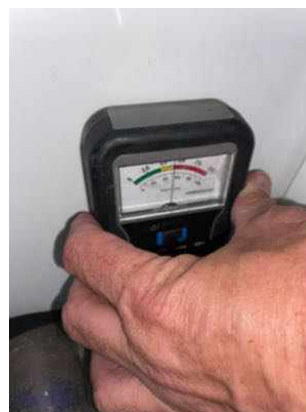
Finding 3.17

Building:	Main Building
Location:	Laundry > Rear Right
Finding:	Excessive moisture - identified
Information:	Elevated levels on the moisture meter was evident to the laundry wall at the time of the inspection. Excessive moisture can attract termites and produce conditions that promote fungal growth and wood decay.

Excessive moisture is generally caused by deteriorated, inadequate or missing roof drainage, leaking plumbing pipes or fixtures, poorly plumbed HWS overflows or condenser units and poor site drainage.

Prior to any remedial works being performed a qualified plumber should be appointed to further inspect the property and to identify the cause of the excessive moisture. Works to remove affected building elements may then be necessary and should be performed by an appropriate tradesperson.

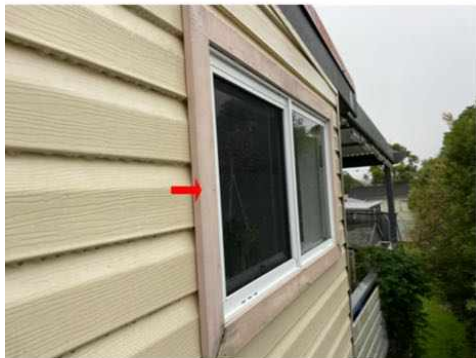
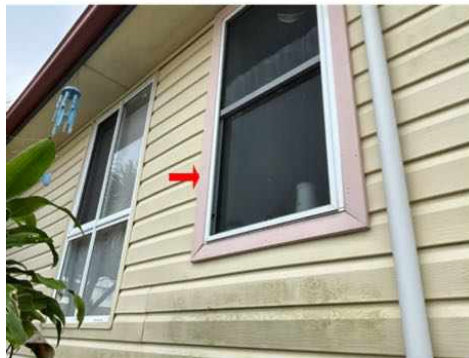
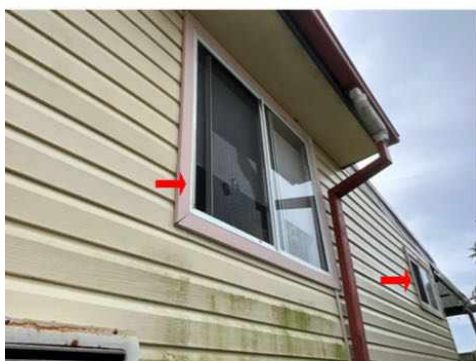
Information: The external architraves were observed to be incomplete and not painted.

Unfinished external timber elements may be more susceptible to weathering and deterioration over time if not sealed.

It is recommended that the architraves be completed and painted to provide appropriate protection.

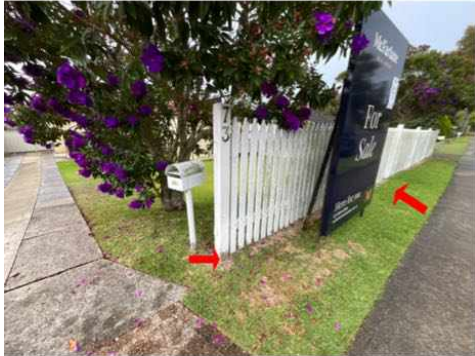
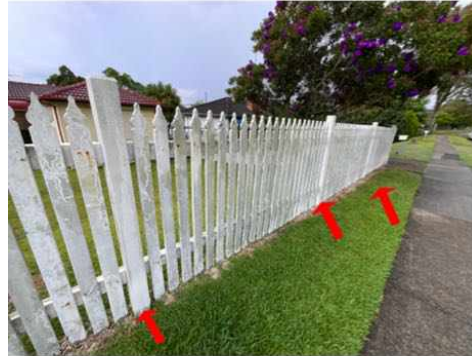
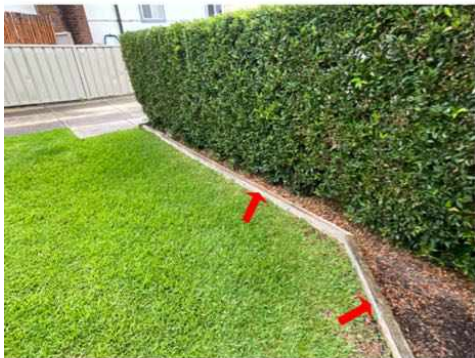
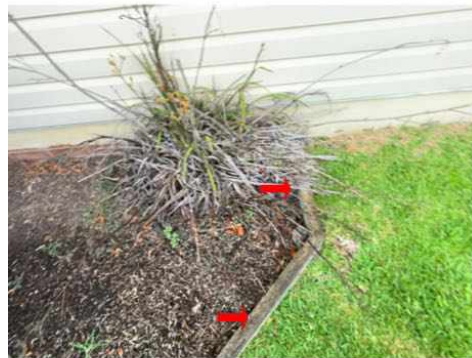
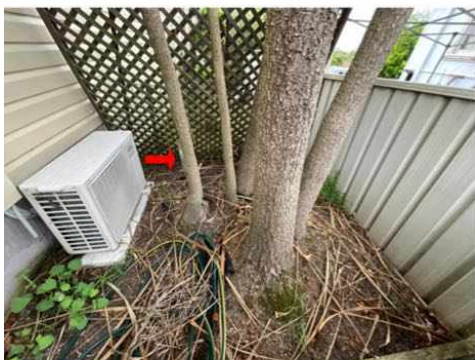
Finding 6.02

Building: Main Building
Location: All External Areas > All Areas
Finding: Timber in contact with ground
Information: At the time of inspection timber was in contact with the ground. Timbers that sit below ground level are likely to absorb moisture from the soil and deteriorate at an accelerated rate as they will be subject to wood rot and also increases the risk of termite activity being present.

If left unattended, replacement of these timbers is likely to be necessary in the short-term future. It is highly recommended that any timbers in contact with the ground be removed or altered to minimise the risk of wood rot and termite attack. Minimisation of risk / prevention of termite attack is far more adequate than dealing with the presence of termite activity. Contact a builder or carpenter to advise on course of action.

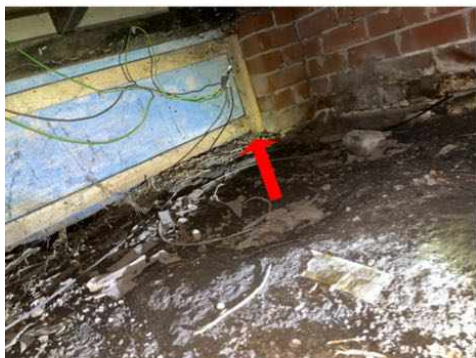
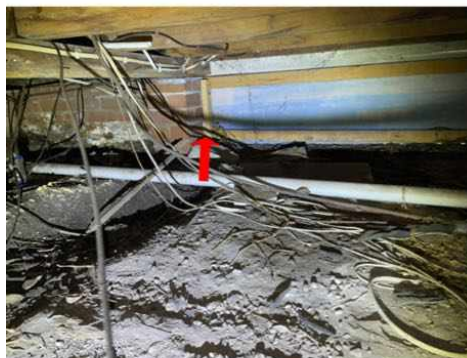
Finding 6.03

Building:	Main Building
Location:	Subfloor > All Areas
Finding:	Timber in contact with ground
Information:	At the time of inspection timber was in contact with the ground. Timbers that sit below

ground level are likely to absorb moisture from the soil and deteriorate at an accelerated rate as they will be subject to wood rot and also increases the risk of termite activity being present.

If left unattended, replacement of these timbers is likely to be necessary in the short-term future. It is highly recommended that any timbers in contact with the ground be removed or altered to minimise the risk of wood rot and termite attack. Minimisation of risk / prevention of termite attack is far more adequate than dealing with the presence of termite activity. Contact a builder or carpenter to advise on course of action.

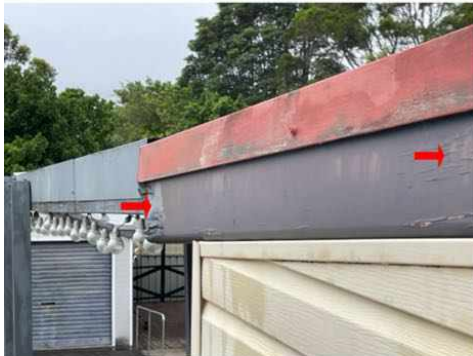
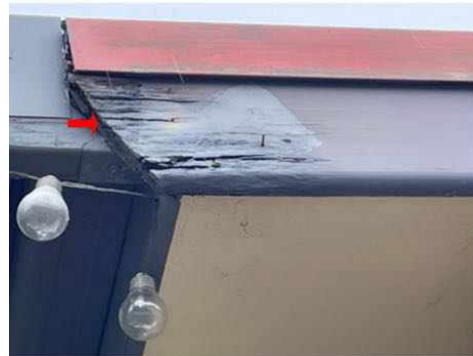
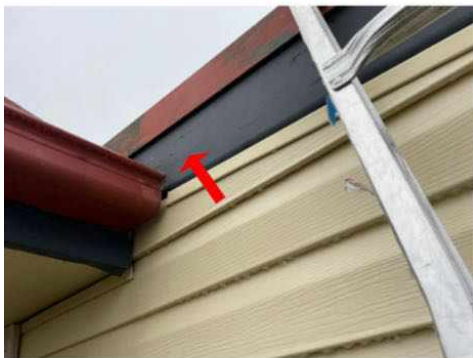
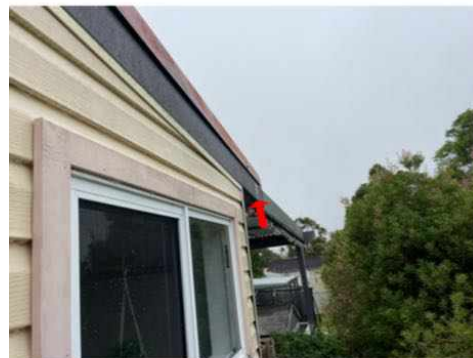
Finding 7.01

Building:	Main Building
Location:	All External Areas > All Areas
Finding:	Fascias - Wood rot
Information:	Wood rot was found to be affecting fascias and bargeboards in this area, evidenced by the presence of mould on the surface in some areas. Wood rot, also known as Fungal Decay, occurs when timbers and other cellulose building materials are exposed to damp conditions on an ongoing basis.

It is likely that this wood rot has developed as a result of faults in the roof plumbing, creating excessive moisture in this areas. Frequent exposure to rain and other weather conditions also make fascias and bargeboards susceptible to accelerated deterioration.

Early intervention and regular maintenance will prolong the useful life of these building elements. Prior to any works being performed, the cause of the moisture that has created the visible wood rot should be identified and addressed in a suitable manner.

It is advised that a roof plumber be appointed to inspect all roof plumbing and subsequently identify the cause of the wood rot. Replacement of affected fascias and bargeboards may then be a necessary step in protecting surrounding building elements from such deterioration.

A qualified plumber may be appointed to assess the cause of excessive moisture and to provide advice on any remedial works as required. A qualified carpenter or builder may also be required to replace affected building materials.

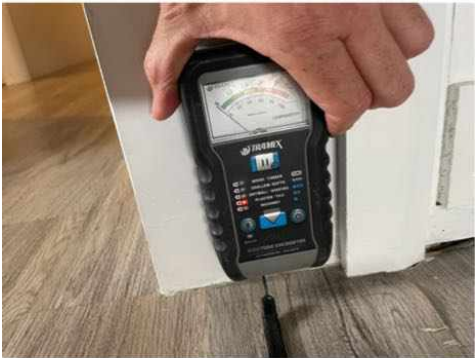
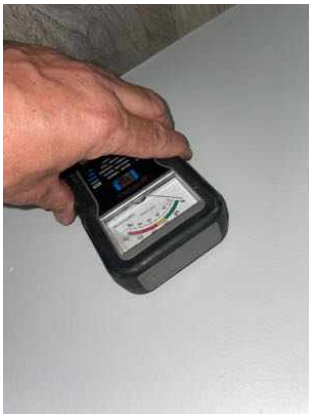
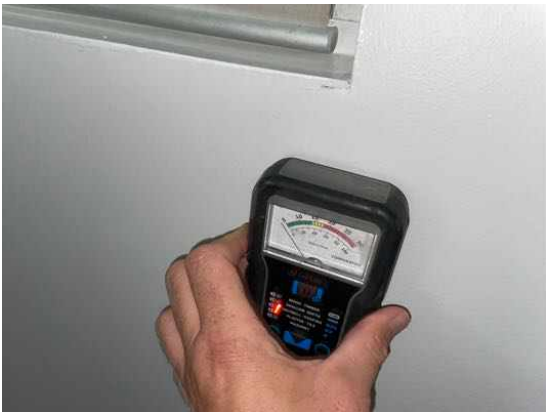
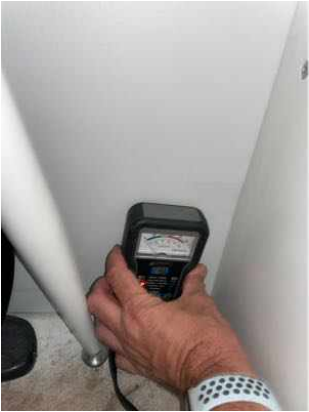
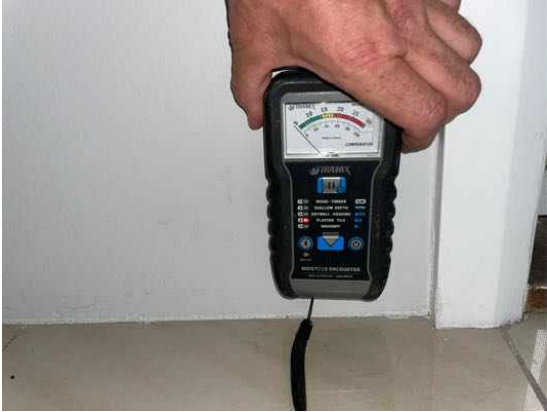
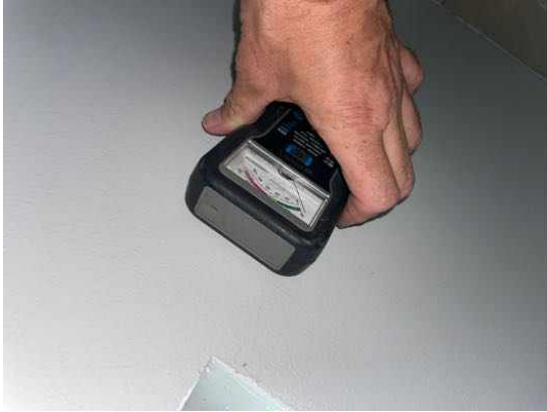
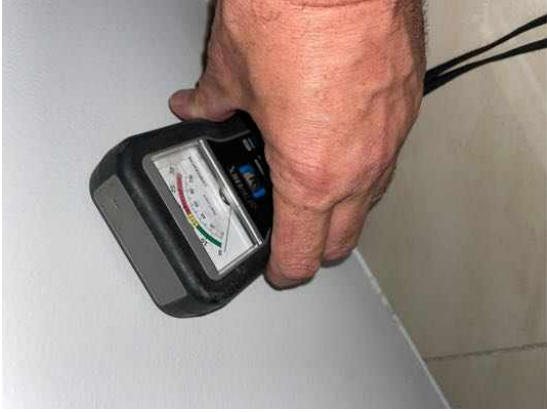
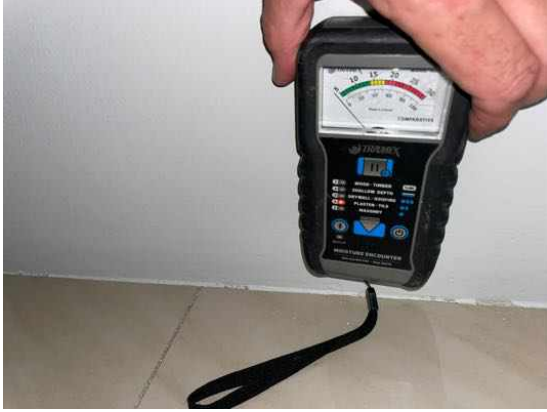
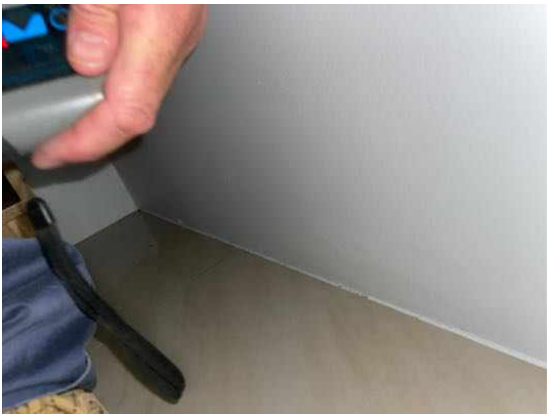
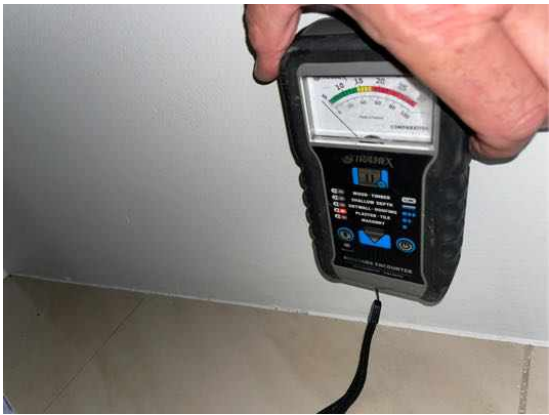
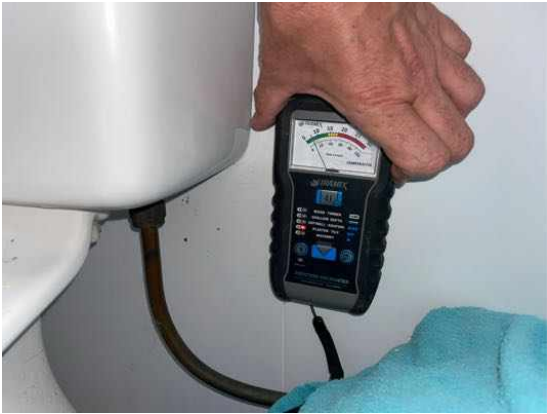
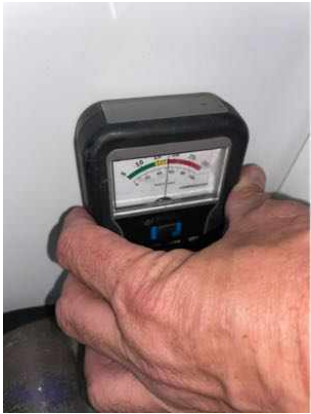
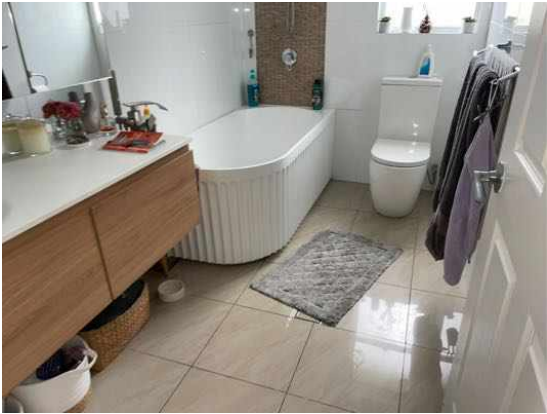
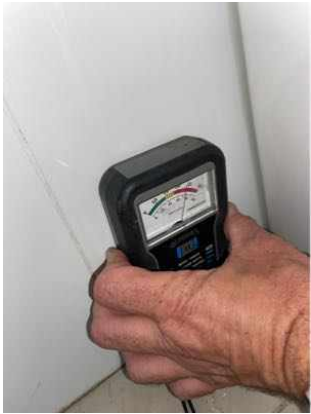
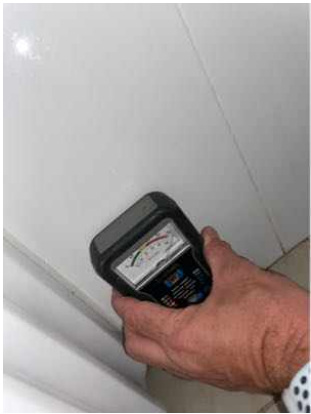
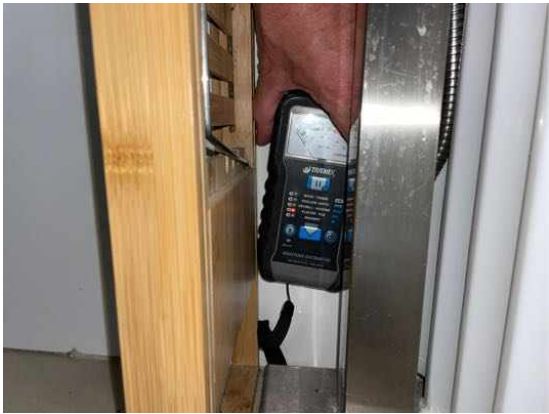
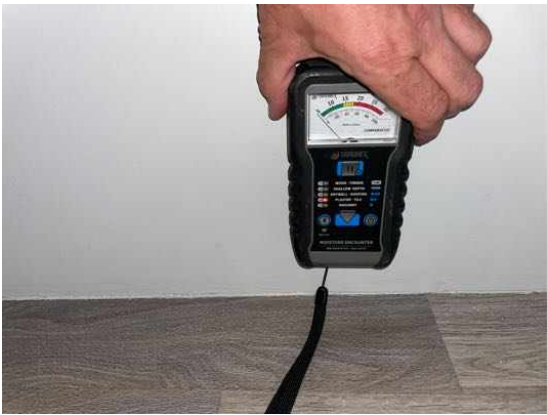
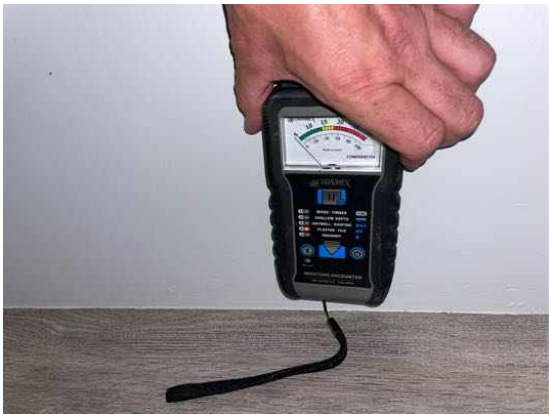
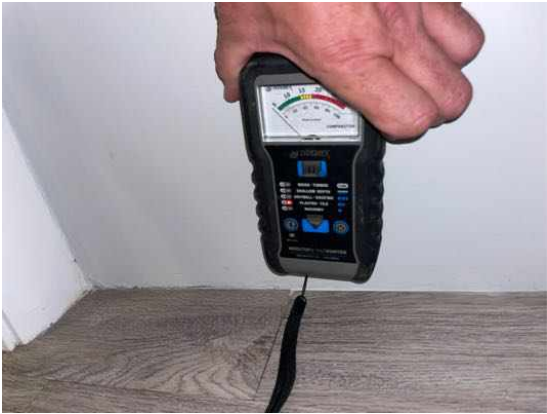
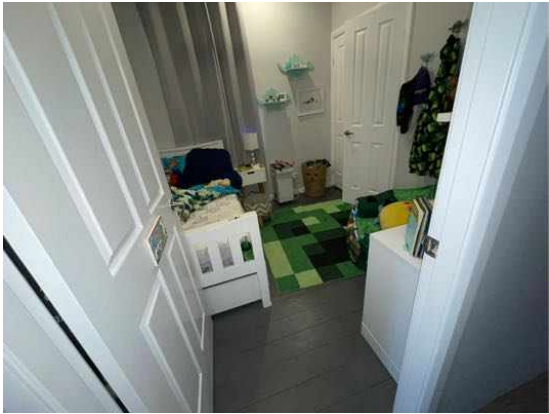
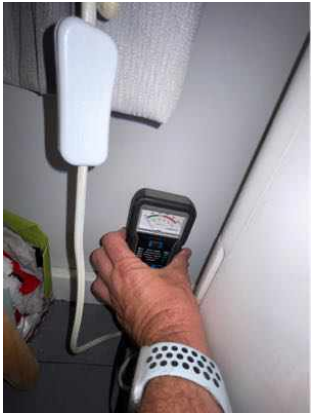
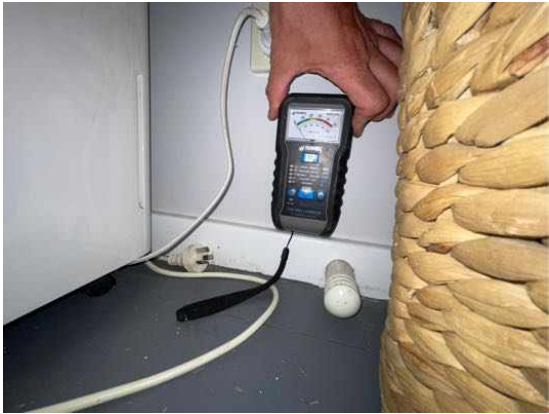
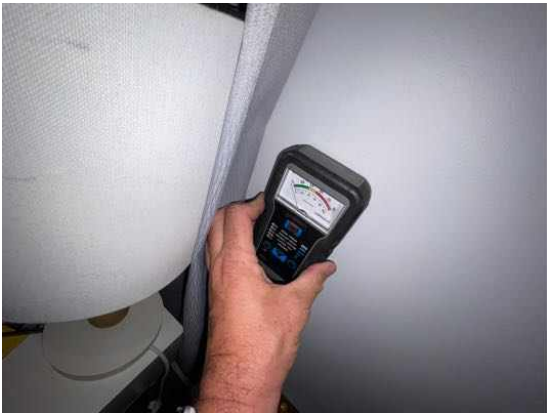
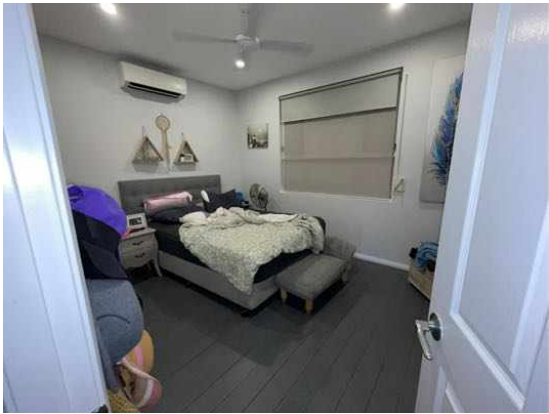
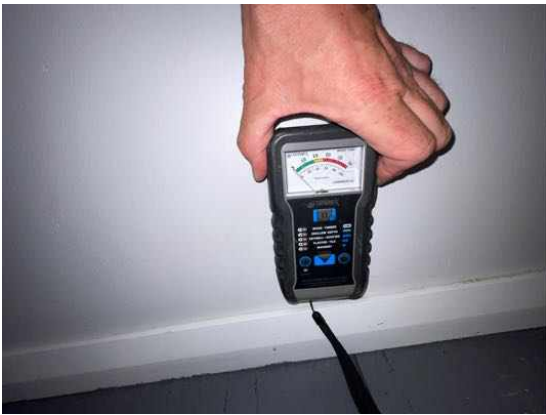
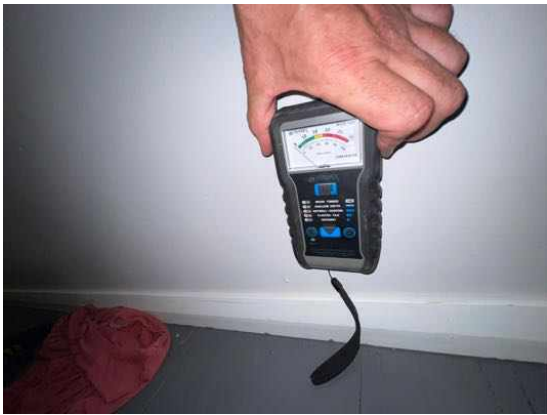
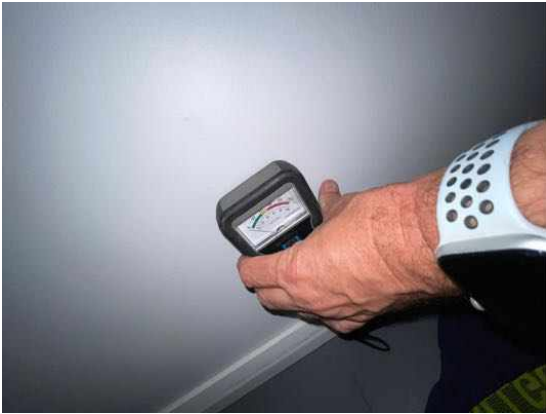
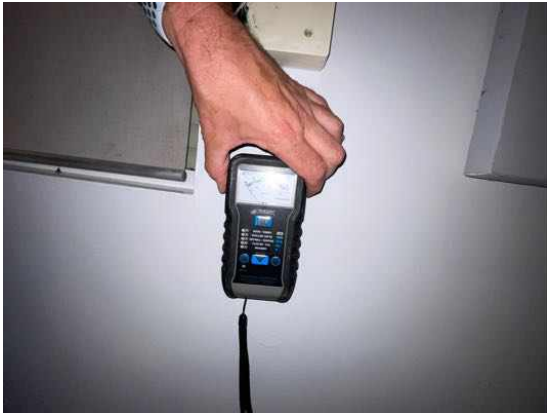
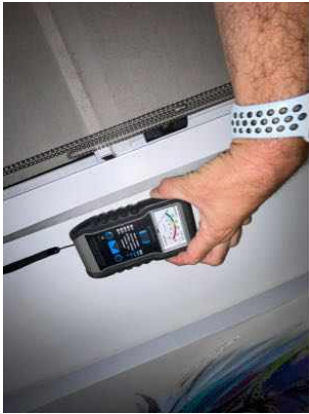
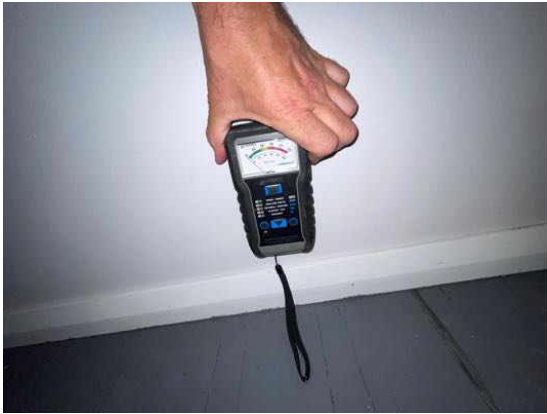
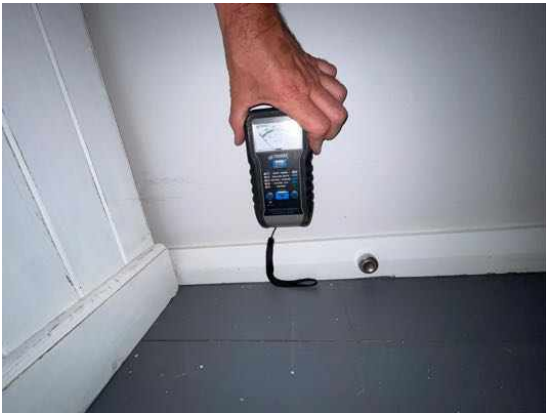
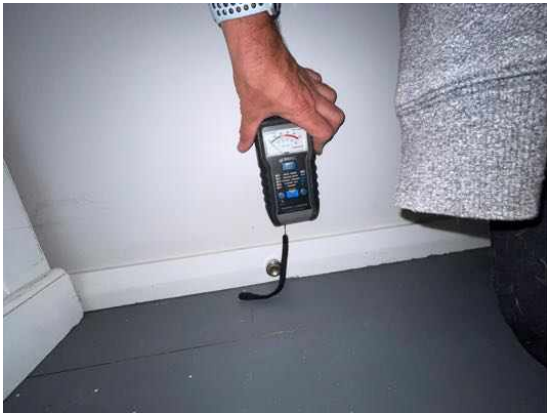
Building: Main Building
Location: All Internal Areas > All Areas
Finding: Moisture Readings
Information: Moisture readings were taken to the wet areas and below and beside windows.

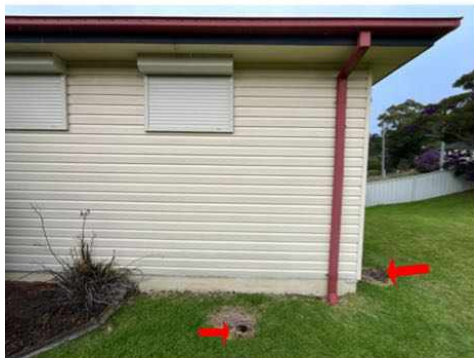
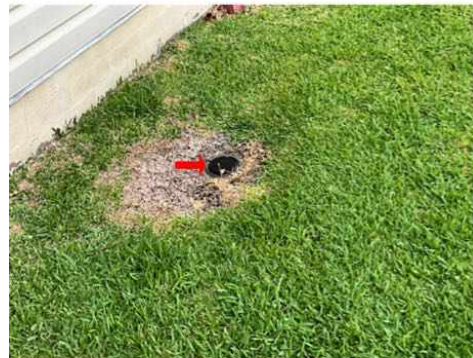
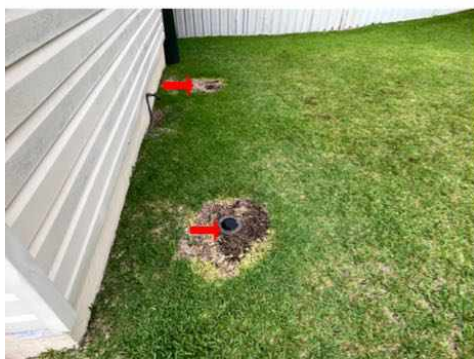
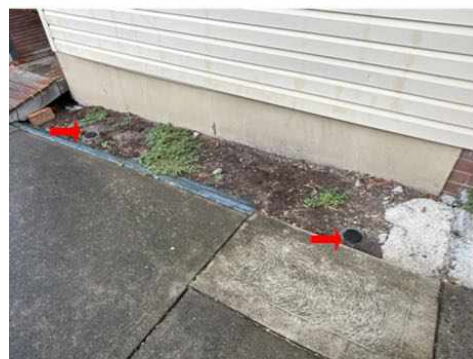
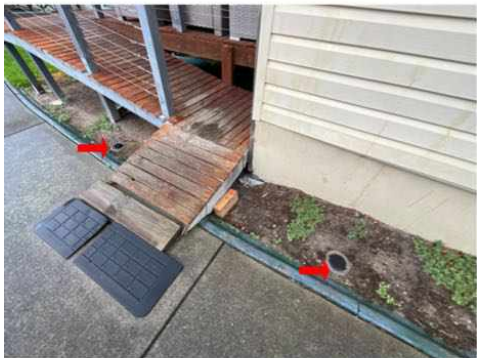
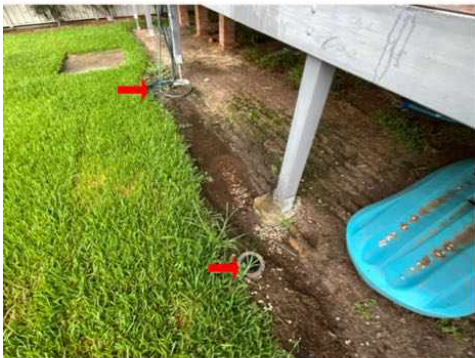
The following items were noted as - Evidence of a previous termite management program

Where a Termite Management System has been identified you should refer to the type of barrier date of installation warranty conditions and any documentation provided by a builder or past owner. Consult the company who installed the barrier to confirm whether the system is still under warranty.

It is recommended that the inspections by the existing pest controller be continued. Contact realestate for pest controllers details.
