Building and Timber Pest Inspection Report

Inspection Date: Wed, 3 Dec 2025

Property Address: 11a Figtree Ave, Randwick NSW 2031,
Australia

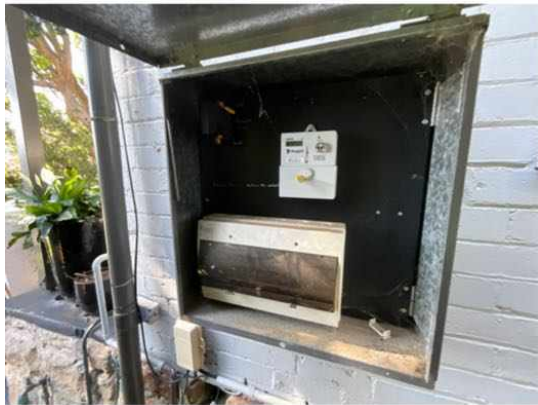
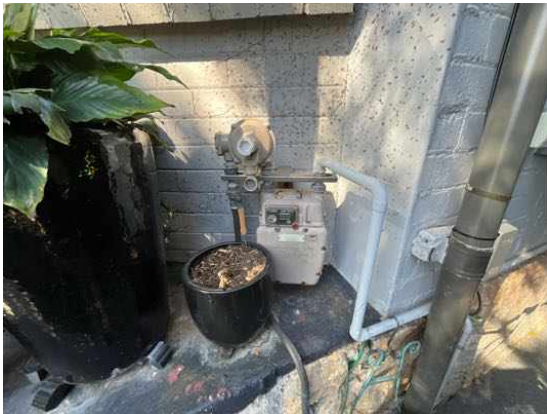
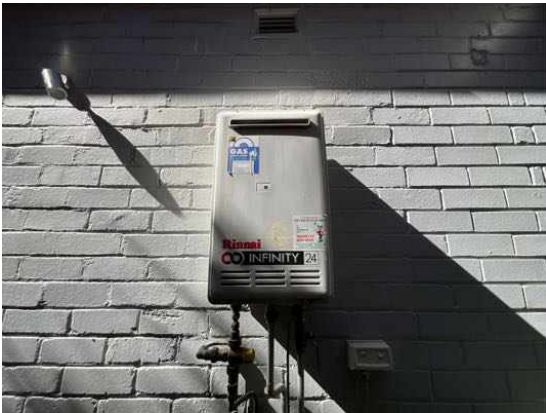
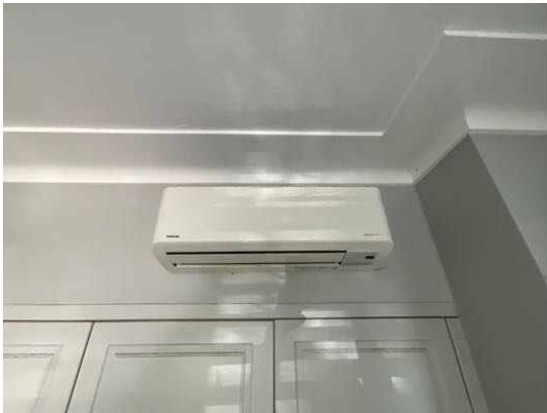
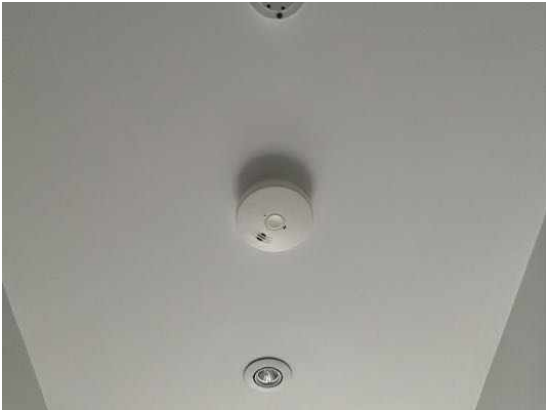
Building: Main Building
Location: All Areas
Finding: Photos Added
Information: Additional photos are provided for your general reference.

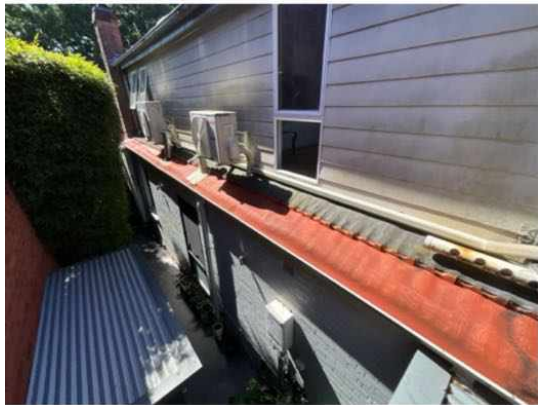
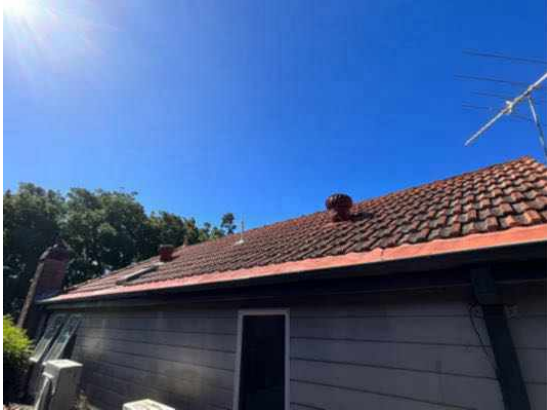
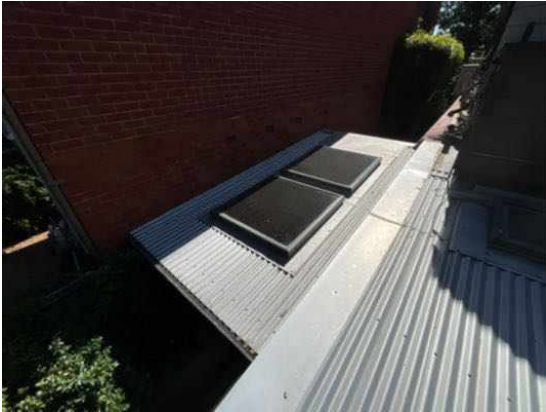
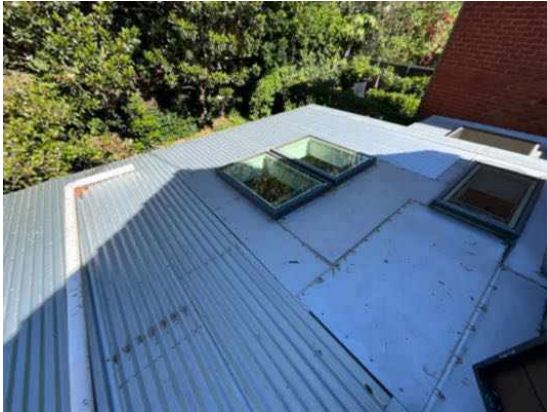
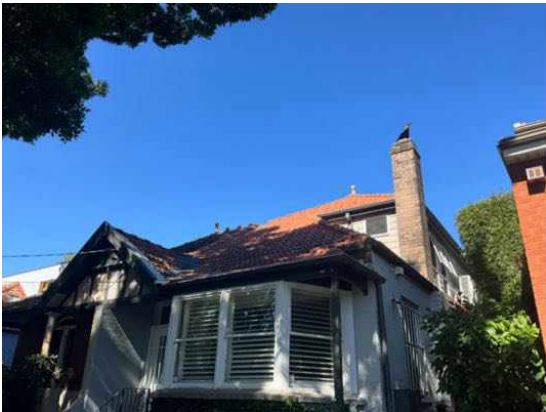
Building: Main Building
Location: Roof Exterior
Finding: Photos Added
Information: Additional photos are provided for your general reference.
