Building Inspection Report

Inspection Date: Tue, 17 Feb 2026

Property Address: 6 Milparinka Way, Berwick VIC 3806,
Australia

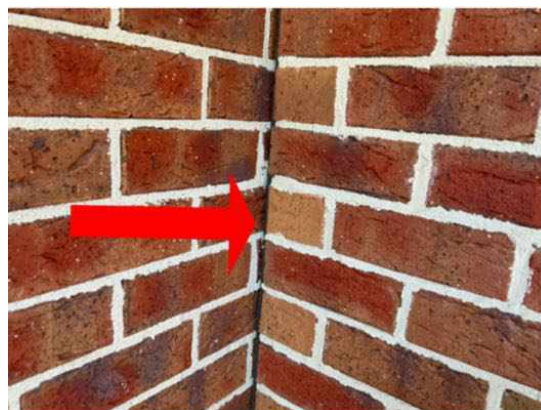
Defects 3.02

Finding: Brickwork expansion joint - Seal missing.

Information: During the inspection, it was noted that the seal for the brickwork expansion joint is missing on all exterior walls. Expansion joints in brickwork are critical as they accommodate the natural movement of building materials caused by thermal expansion, contraction, and other environmental factors. The absence of a proper seal in these joints can lead to several issues:

- Water Penetration: Without a seal, water can penetrate the expansion joint, potentially leading to water damage within the wall cavity and interior spaces. This can result in dampness, mold growth, and deterioration of building materials.

To address this issue, it is recommended that a qualified handyman, caulking specialist, or bricklayer be engaged to inspect and reseal the expansion joint. This will help maintain the integrity, durability, and appearance of the brickwork, as well as prevent potential water ingress and structural problems.

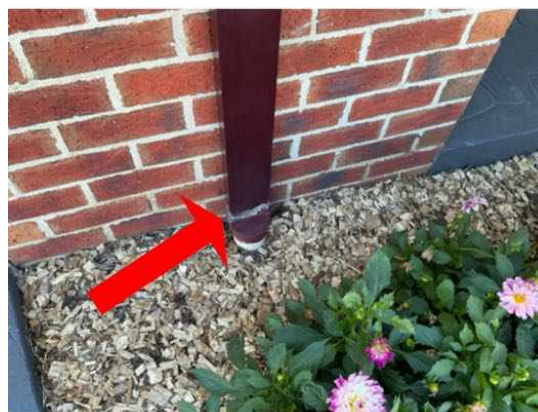
Defects 3.04

Building: Main Building
 Location: All External Areas
 Finding: Minor Leakage to Downpipes
 Information:

Several downpipes around the dwelling were observed to exhibit signs of minor leakage, with visible moisture staining and residue present to the pipe surfaces and adjacent areas.

Leaking downpipes may indicate loose joints, deteriorated seals, or minor connection defects. Ongoing leakage may result in localised moisture accumulation near wall bases and footings, which may contribute to surface deterioration and create conducive conditions for timber pest activity.

It is recommended that a licensed plumber inspect the affected downpipes, reseal or repair defective joints as required, and ensure that the stormwater drainage system is functioning effectively and discharging water correctly into the connected stormwater system.

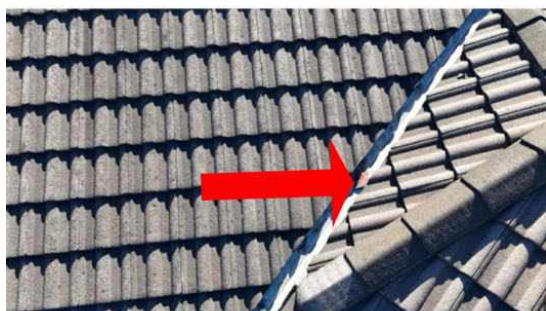
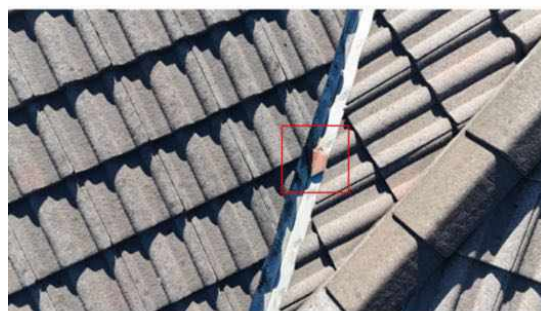
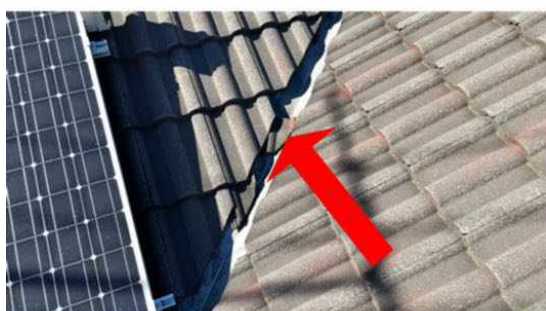
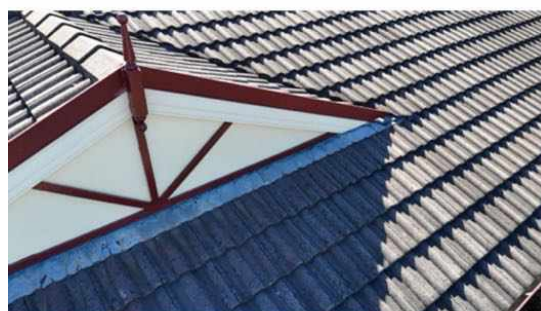
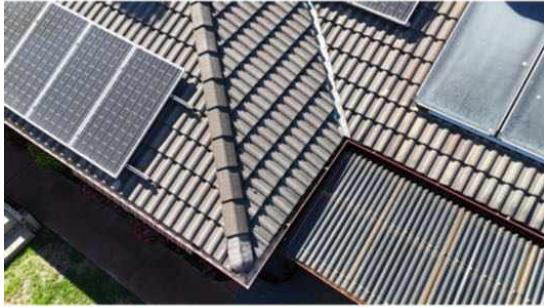
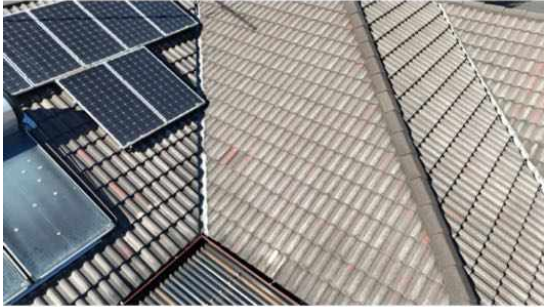
Defects 3.08

Information: Upon inspection of the exterior roofing, the majority of roof tiles were considered to be in a fair condition. While weathering of the tiles is consistent with the age of the property, maintenance works are required.

Isolated areas of mortar have come loose in the valleys and minor cracking is also present. Re-pointing and re-sealing the may be considered as an interim solution by the client to help preserve and extend the life span of the tiles.

Where left unmanaged, deteriorating roof tiles are likely to lead to a number of secondary defects, including minor water leaks and weather exposure to internal roofing structures.

Consultation with a roofing contractor is highly advised to gain advice on cost of remedial works that may be required in the short to medium term. Remedial works are likely to increase the longevity of the exterior roofing structure.

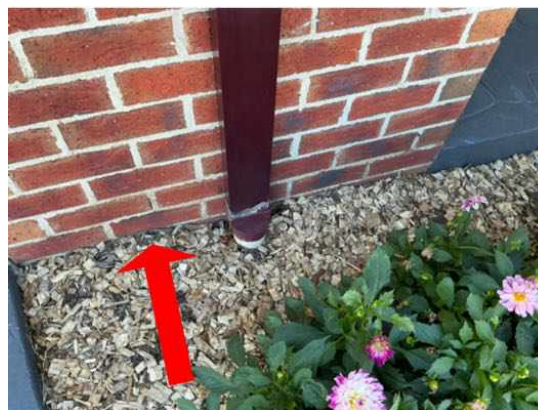
Defects 3.10

Building:	Main Building
Location:	All External areas
Finding:	Site drainage - Inadequate
Information:	The site drainage in sections of the yards was found to be inadequate at the time of

inspection, creating potential for subsequent water damage to associated building elements.

Where site drainage is inadequate, installation of an Agricultural (Aggie) Drain may be required. A qualified plumber should be appointed to further inspect the property and perform any remedial works as necessary. Water damage and secondary defects are likely to occur if left unmanaged.

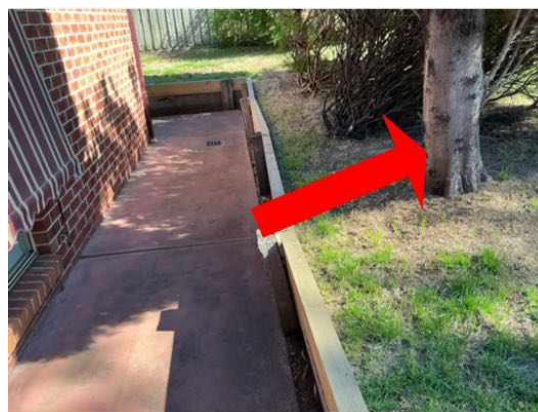
Defects 3.11

Building:	Main Building
Location:	Yard - Back
Finding:	Trees in close proximity to the building
Information:	Upon visual inspection, A tree was observed to be in close proximity to the perimeter of the house at the rear elevation. Trees situated close to the house can attract termites, which may lead to further issues with timber elements.

It is recommended that a an arborist assess the condition of the trees and their potential impact on the property. Regular monitoring of the trees, including their roots and potential for attracting pests, is advised to ensure they do not compromise the integrity of the house and surrounding features.

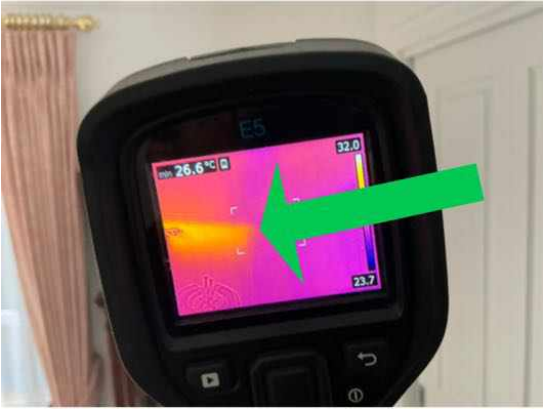
Defects 3.12

Building:	Main Building
Location:	All Internal Areas
Finding:	Inconsistent Thermal Performance to Ceiling Areas – Suspected Insulation Deficiencies
Information:	Thermal imaging conducted to internal ceiling areas at the time of inspection identified inconsistent heat patterns, which are indicative of variations in thermal performance across the roof space. These patterns are commonly associated with areas of

missing, displaced, or insufficient insulation above the ceiling linings.

Inadequate or uneven insulation coverage can reduce the energy efficiency of the dwelling, contribute to heat loss in cooler periods and heat gain in warmer conditions, and may result in reduced occupant comfort and increased heating and cooling costs. Due to the non-invasive nature of the inspection, the exact extent and condition of insulation could not be confirmed visually in all affected areas.

It is recommended that a qualified insulation contractor inspect the roof space, assess insulation coverage and condition, and top up or reinstate insulation where required to achieve consistent thermal performance throughout the property.

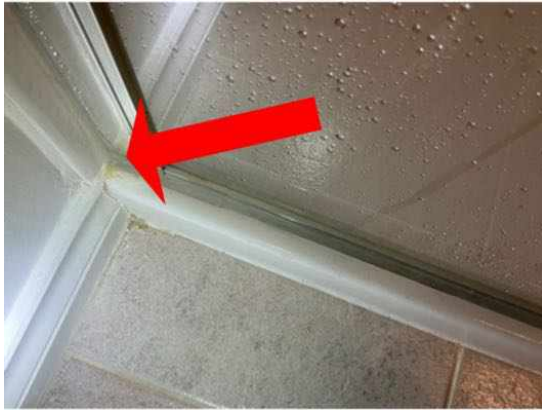
Defects 3.13

Building:	Main Building
Location:	Ensuite
Finding:	Shower screen - Leaking
Information:	Leaking was evident to the ensuite's shower screen at the time of inspection. It is suspected that the leaking has occurred as a result of deteriorated or missing caulking to the shower or general ageing of the building elements.

Leaking from the shower where left unattended, is likely to lead to water damage to adjoining flooring and walls. Such damage can lead to water damage and necessitate extensive remedial works being required. Active water leaks may also create an environment that is susceptible to the formation and development of mould.

Appointment of a caulking contractor is required to repair or replace the caulking to the shower area. Such works should be performed as soon as possible to ensure that no further damage occurs.

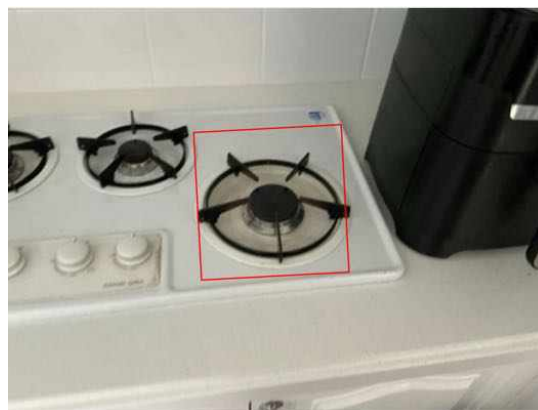
Defects 3.14

Building: Main Building
 Location: Kitchen
 Finding: Inoperative Ignition to Kitchen Burner
 Information:

The right-hand side kitchen cooktop burner was observed not to ignite using the automatic ignition function at the time of inspection. The burner was able to be manually ignited using an external lighter; however, the built-in ignition mechanism did not operate as intended.

A non-functioning ignition system may be due to a faulty igniter, wiring issue, moisture contamination, or internal component failure. Continued manual ignition is not ideal and may pose inconvenience or minor safety concerns if not properly managed.

It is recommended that a qualified gas appliance technician inspect the cooktop ignition system, diagnose the fault, and repair or replace defective components as required to restore proper automatic ignition functionality.

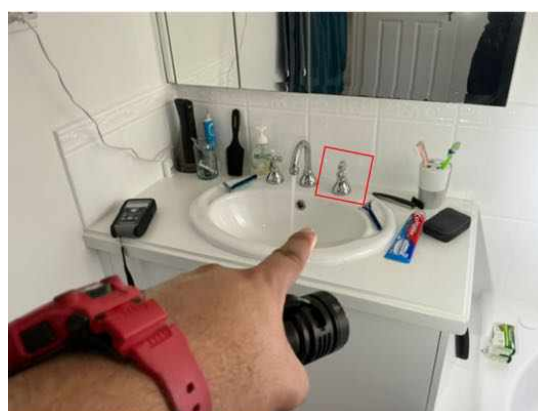
Defects 3.15

Information: The sink and shower taps show evidence of water hammer being present. Water hammer, a pressure surge resulting when a fluid is forced to suddenly change direction, is a common defect in plumbing fittings, particularly those that are aged and not frequently maintained. Water hammer is generally caused by factors that create high water pressure in the affected plumbing fixture, usually evidenced by a faint banging noise during operation of the affected tap.

Although water hammer is generally considered to be a minor defect, subsequent damage such as erosion of tap hardware and/or water damage to associated building elements is likely to occur if left unmanaged.

A licensed plumber should be appointed as soon as possible to replace any affected tap hardware and perform any remedial works as necessary. Please be advised that the appointment of a cabinet maker or qualified carpenter may be necessary if water damage to associated building elements has occurred.

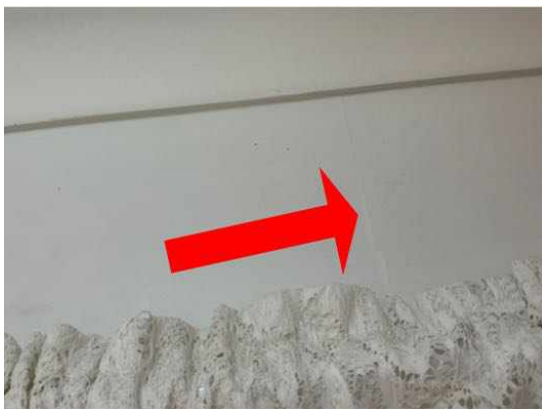
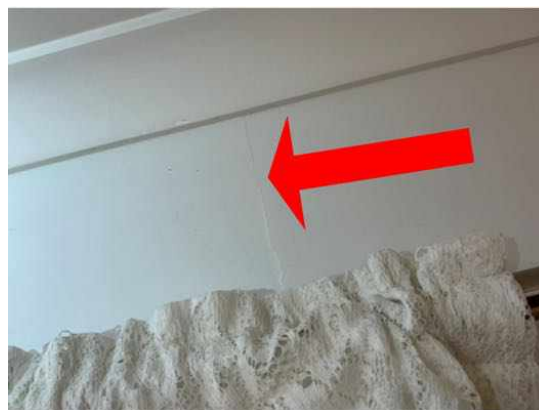
Defects 3.16

Building:	Main Building
Location:	Bedroom 2
Finding:	Cracking - Damage Category 1 - Fine (up to 1mm)
Information:	Although fine cracks are quite noticeable, they are often only considered to be an appearance defect, and usually do not indicate any structural damage. Generally, the cause of a fine crack is indicative of a separation between building materials and finishes (e.g. paint, plaster, etc.) along joins.

Cracking of this nature can generally be repaired with minor sanding, filling and/or repainting. Such works should be performed by a qualified painter or a general handyman.

Monitoring of all cracking should be conducted frequently. Always contact a building inspector should cracks widen, lengthen, or become more numerous.

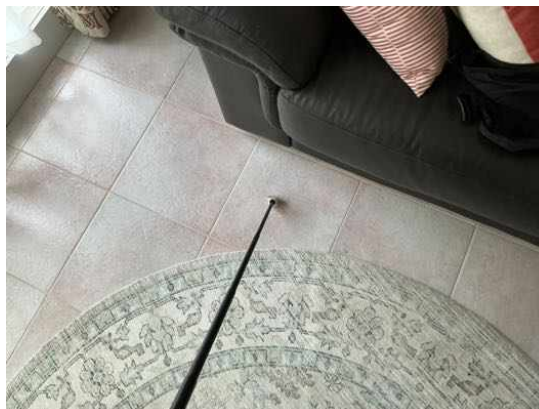
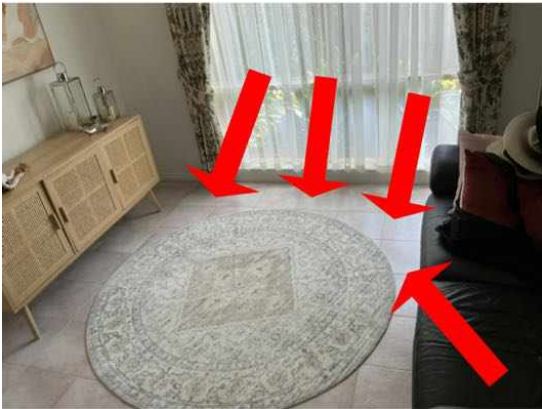
Defects 3.17

Tiled areas may swell and shrink with changes in air humidity if the area has sustained moisture damage. Any exposure to moisture is capable of causing tiled areas to become drummy and/or cracked over a prolonged period of time. Drummy tiled areas generally require removal and replacement of affected tiles, with adequate sealant and grouting.

Specialist trades are available for these types of services. A registered builder may be required to undertake works if damage is extensive or if secondary building defects have resulted. Otherwise, it is advised that a tiling contractor be appointed to perform works as necessary. Immediate action is recommended to ensure that no further damage is sustained in the affected area.

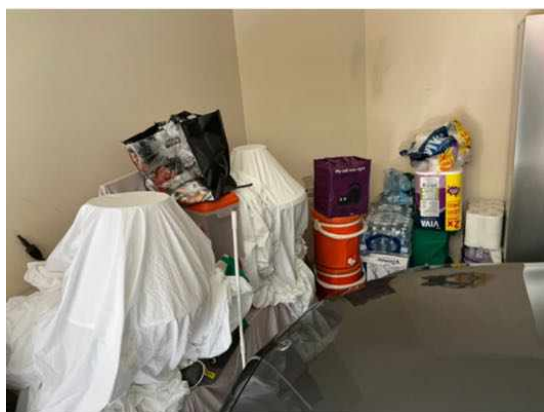
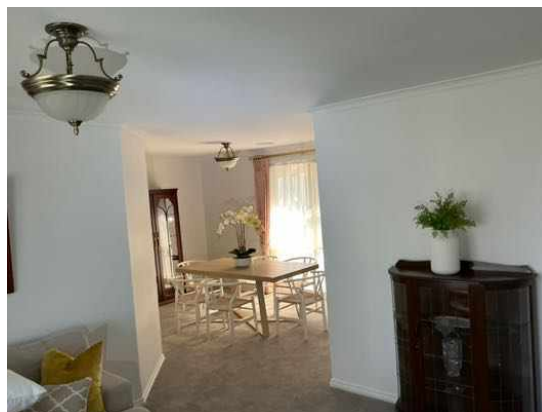
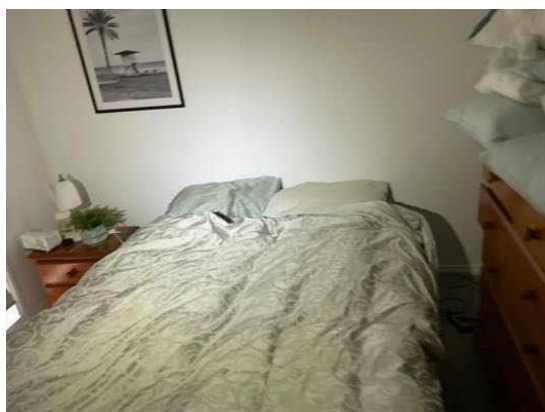
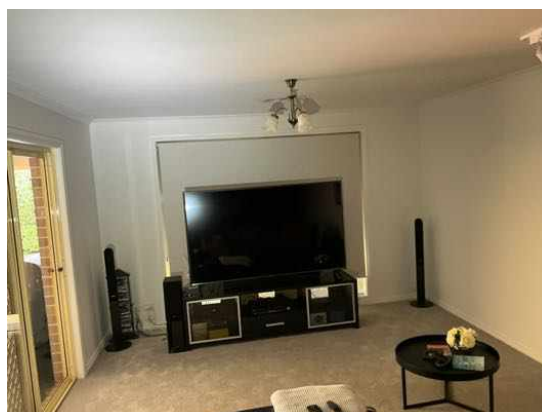
Noted Item

Building: Main Building
 Location: All Internal Areas
 Finding: Obstructions and Limitations - Interior
 Information: These photographs are an indication of the obstructions and limitations which impeded the inspection of the internal areas of the property at the time of inspection. These obstructions can hide an array of defects and should be removed to allow full inspection to be carried out. A re-inspection is recommended once the areas are made accessible.

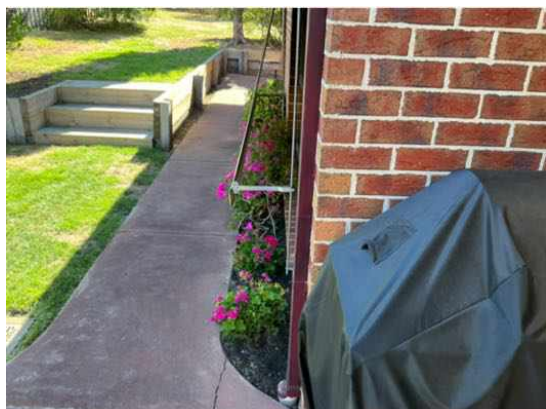
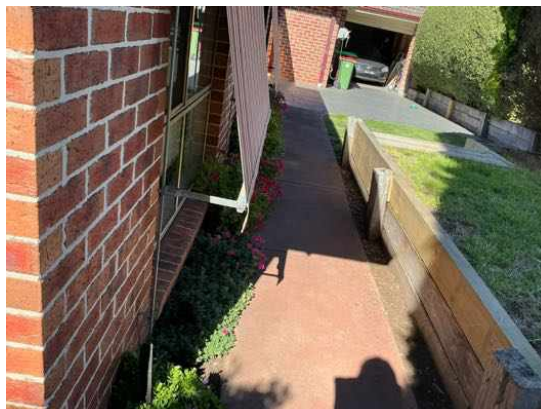
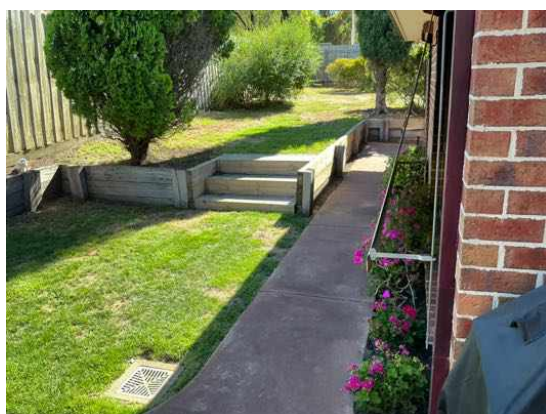
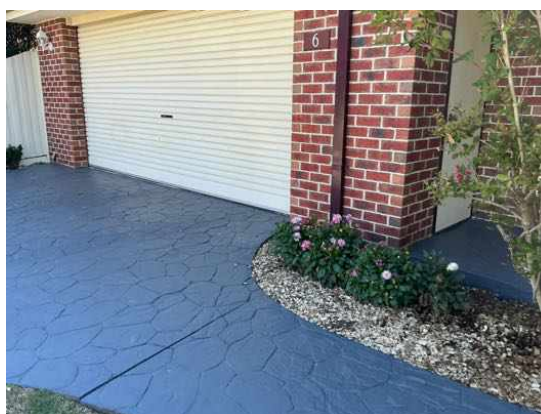
Noted Item

Building: Main Building
 Location: All External Areas
 Finding: Obstructions and Limitations - Exterior
 Information: These photographs are an indication of the obstructions and limitations which impeded the inspection of the external areas of the property at the time of inspection.

These obstructions can hide an array of defects and should be removed to allow full inspection to be carried out. A re-inspection is recommended once the areas are made accessible.

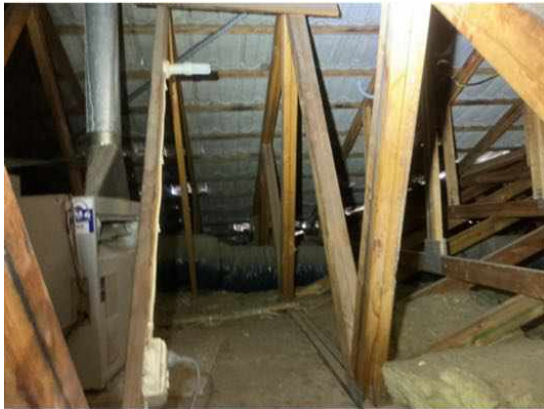
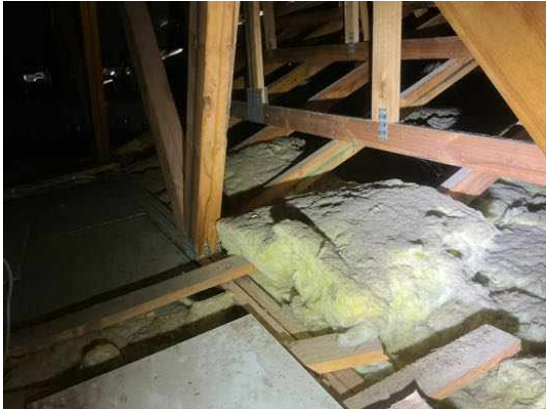
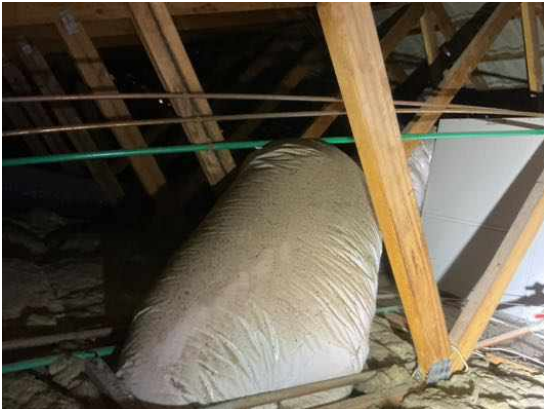
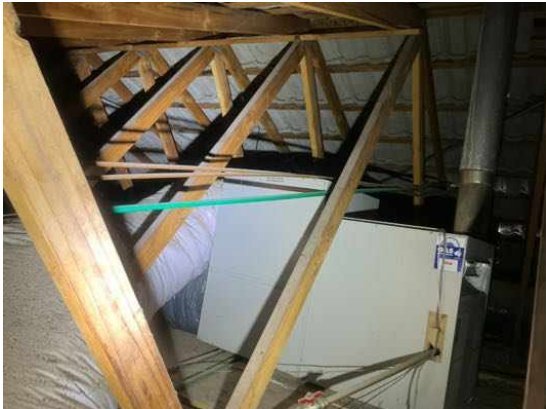
Building:	Main Building
Location:	Roof Void
Finding:	Obstructions and Limitations - roof cavity
Information:	photographs illustrate the obstructions and limitations that impeded the inspection of the roof cavity area of the property at the time of inspection. The access hole was particularly small, measuring approximately 35cm, which is below the minimum size required by Australian Standard AS4349.1. Such obstructions can conceal a range of defects and should be removed to allow a full inspection to be carried out. A re-inspection is recommended once the areas are made accessible.
