# Building Inspection Report

Inspection Date: Mon, 23 Feb 2026

Property Address: 12 Broomhill Ave, Blackburn VIC 3130,  
Australia

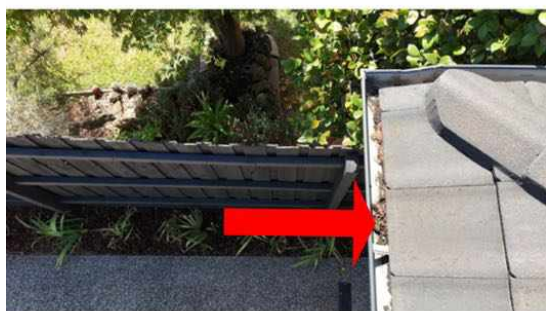
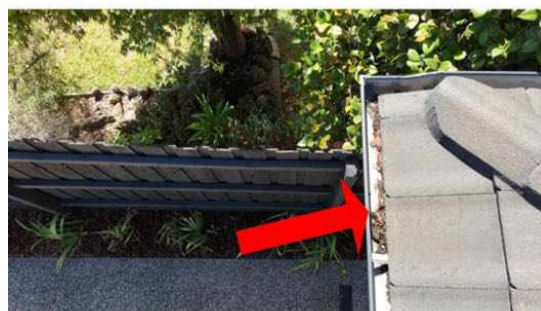
Blocked gutters are likely to lead to high levels of moisture in the affected areas. Such moisture will not only cause rust and decay of the associated building materials, but can also provide conditions that are conducive to termite and timber pest activity. Blockages in gutters should therefore be removed immediately to ensure dry conditions are maintained.

Consult a Licensed Plumber for further specific advice on remedial works that may be required. In the interim, it is highly advised that blocked gutters be removed by the homeowner or a general handyperson as a matter of urgency.

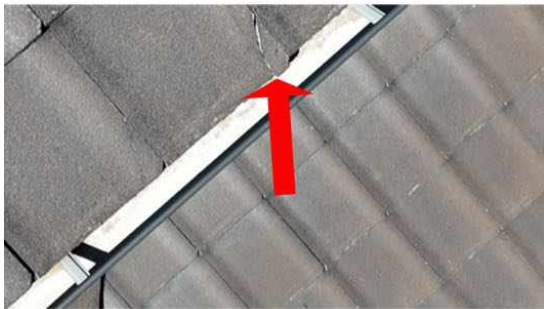
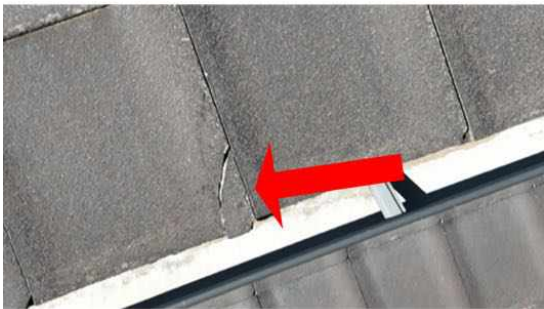
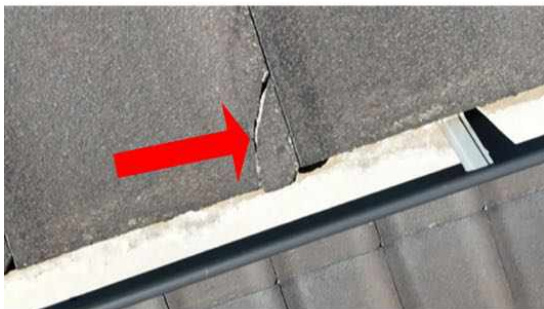
### Defects 3.17

Building:	Main Building
Location:	Roof Exterior
Finding:	Roof tiles - Broken
Information:	Upon inspection of the exterior roof covering, broken roofing tiles were identified. Broken and friable roof tiles are generally the result of ageing and weathering of what is essentially a porous material.

If left to further deteriorate, broken and brittle roof tiles are likely to lead to water penetration via the roof into the ceiling space, causing secondary damage to ceiling linings, insulation and roof structures. Broken roof tiles are also likely to detract from the effectiveness of the roof drainage system, creating potential for secondary damage to the exterior roof covering and roof plumbing.

Replacement of broken tiles is required and should be performed by a roofing contractor as soon as possible.
