Building and Timber Pest Inspection Report

Inspection Date: Mon, 9 Mar 2026

Property Address: 178 Camden St, Enmore NSW 2042,
Australia

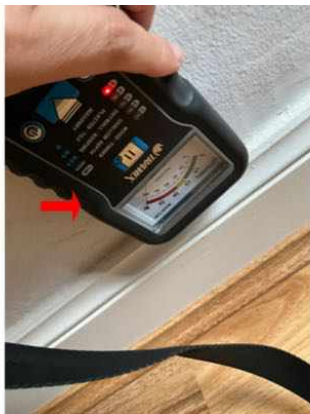
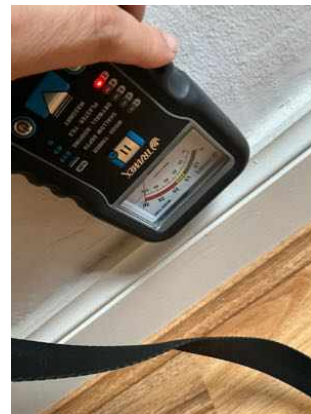
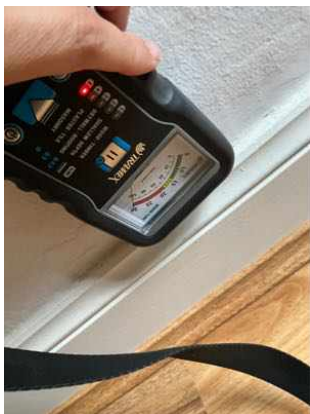
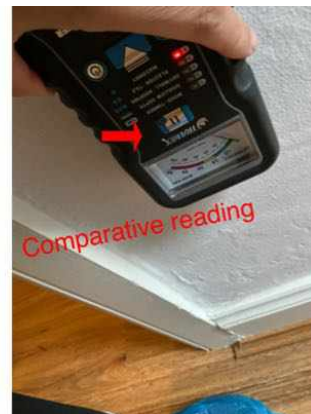
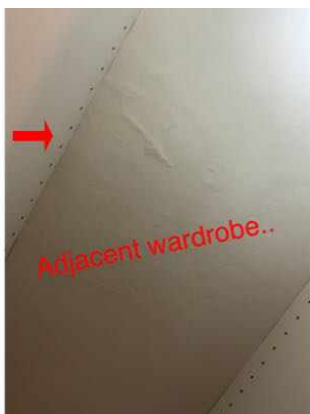
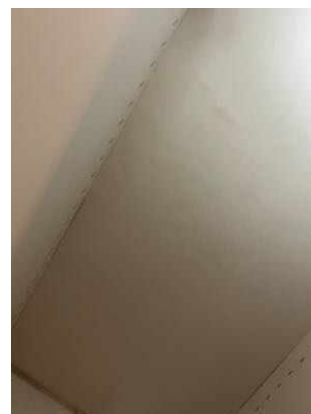
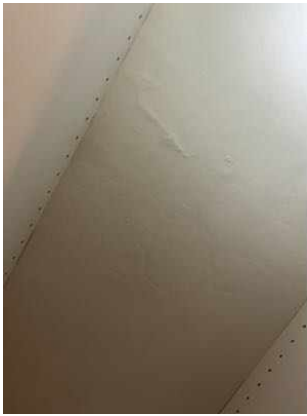
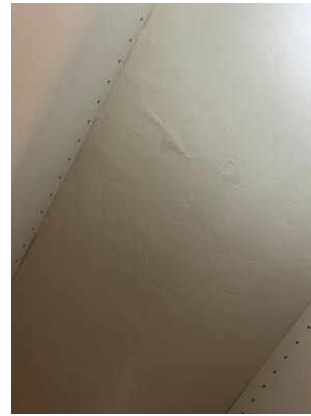
Finding 2.01

Finding: Evidence of excessive moisture - Drywall
Information: Excessive moisture is present at the time of , indicating a potential water leakage issue within the wall.

The prolonged presence of moisture can lead to mold growth, deteriorate the structure, and create an environment conducive to health hazards. Additionally, it may compromise the adhesive holding the tiles, leading to their detachment.

A licensed plumber or a qualified contractor specializing in water damage remediation should investigate the source of the moisture, fix any leaks, and address the damage. Additionally, replacing affected tiles and ensuring proper waterproofing are crucial to preventing future issues.

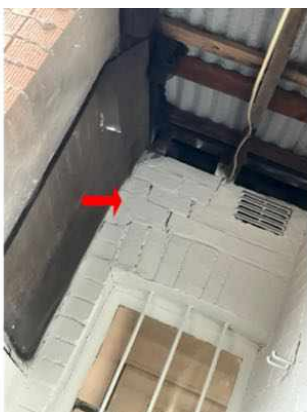
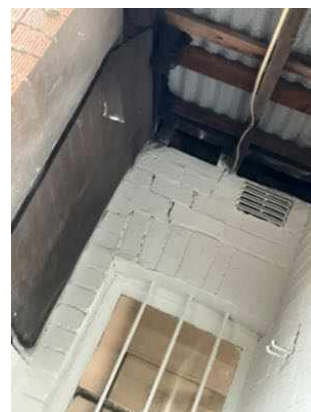
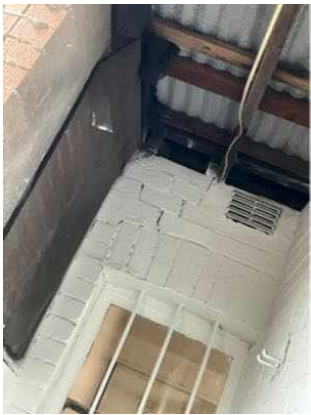
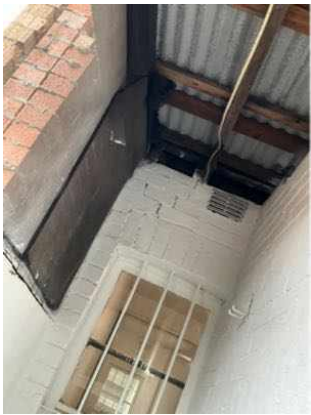
Finding 2.02

Finding: Brickwork - Cracking [Repair required]

Information: Major cracking was identified to the brickwork in this area. Cracks of this type are likely to have been caused by movement of building elements, but may also have a structural cause that is more significant.

A crack of this size may be repaired by extensive filling. Additionally, further remedial works to associated building elements, such as eave sheeting or external door frames, is likely to be required.

A qualified bricklayer should be contacted immediately to estimate and perform repair and restoration works. Consultation with a structural engineer may be required where structural instability is found to be the underlying cause of the cracking.

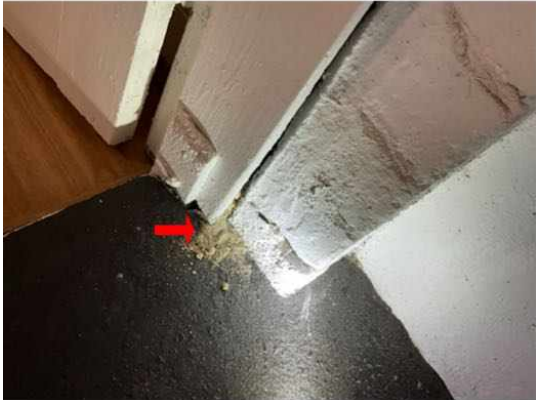
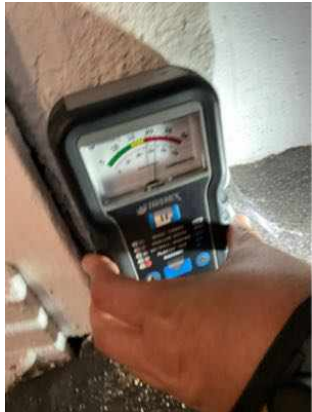
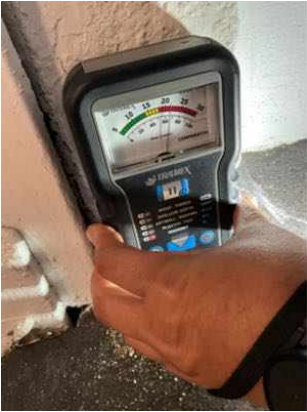
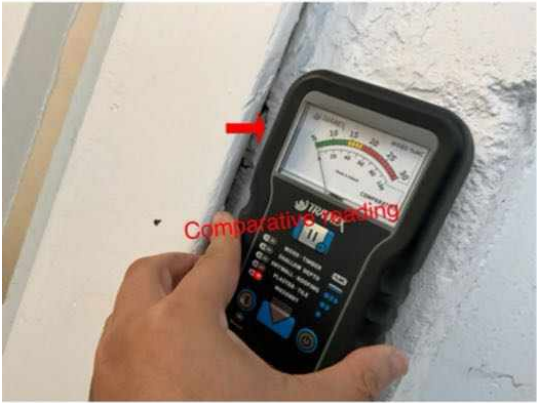
Finding 2.03

Building: Main Building
Location: Void
Finding: Evidence of excessive moisture - Drywall
Information: Excessive moisture is present at the time of , indicating a potential water leakage issue within the wall.

The prolonged presence of moisture can lead to mold growth, deteriorate the structure, and create an environment conducive to health hazards. Additionally, it may compromise the adhesive holding the tiles, leading to their detachment.

A licensed plumber or a qualified contractor specializing in water damage remediation should investigate the source of the moisture, fix any leaks, and address the damage. Additionally, replacing affected tiles and ensuring proper waterproofing are crucial to preventing future issues.

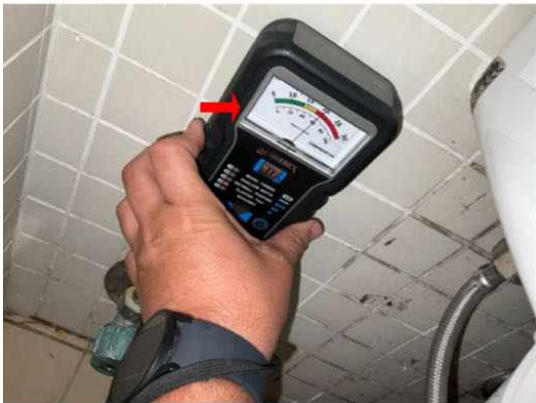
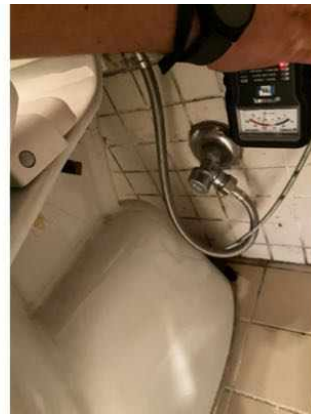
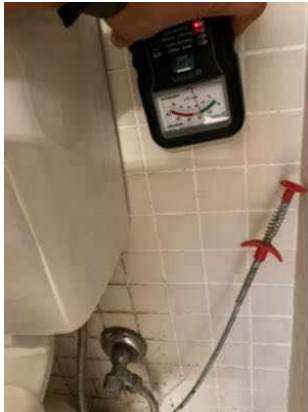
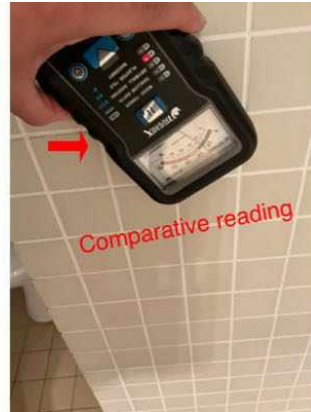
Finding 2.04

Building: Main Building
 Location: Bathroom
 Finding: Evidence of excessive moisture was present at the time of inspection
 Information: Excessive moisture is present behind the bathroom tiles, indicating a potential water leakage issue within the wall.

The prolonged presence of moisture can lead to mold growth, deteriorate the structure, and create an environment conducive to health hazards. Additionally, it may compromise the adhesive holding the tiles, leading to their detachment.

A licensed plumber or a qualified contractor specializing in water damage remediation should investigate the source of the moisture, fix any leaks, and address the damage. Additionally, replacing affected tiles and ensuring proper waterproofing are crucial to preventing future issues.

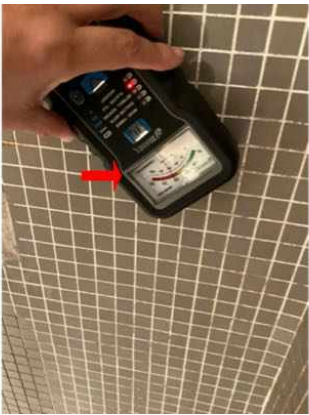
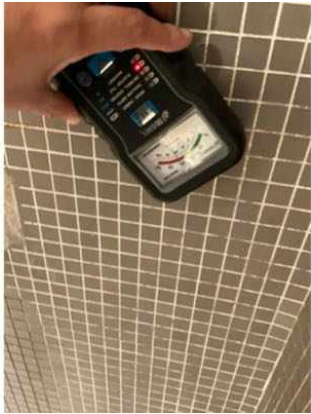
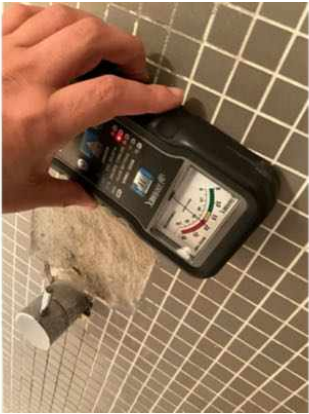
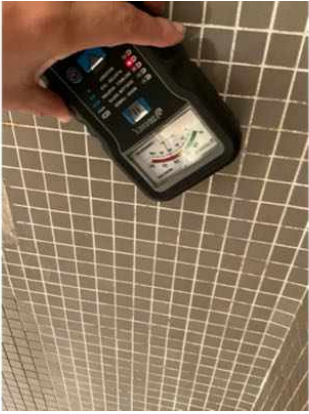
Finding 2.05

Building:	Main Building
Location:	Bathroom
Finding:	Evidence of excessive moisture was present at the time of inspection
Information:	Excessive moisture is present behind the bathroom tiles, indicating a potential water leakage issue within the wall.

The prolonged presence of moisture can lead to mold growth, deteriorate the structure, and create an environment conducive to health hazards. Additionally, it may compromise the adhesive holding the tiles, leading to their detachment.

A licensed plumber or a qualified contractor specializing in water damage remediation should investigate the source of the moisture, fix any leaks, and address the damage. Additionally, replacing affected tiles and ensuring proper waterproofing are crucial to preventing future issues.

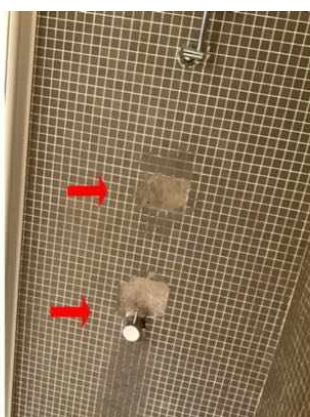
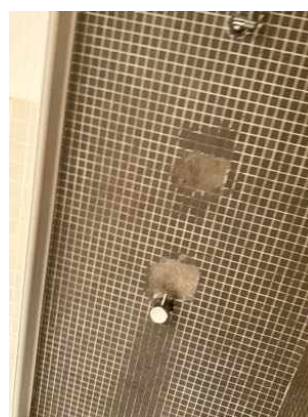
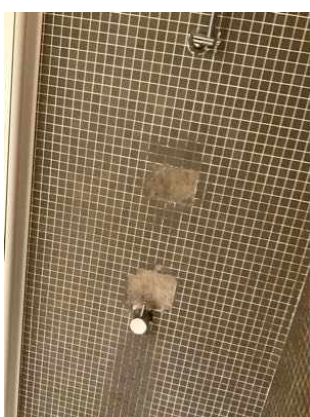
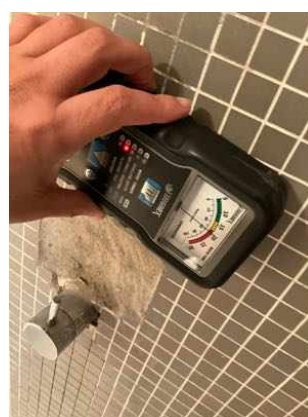
Finding 2.06

Building: Main Building
 Location: Bathroom
 Finding: Damaged Tile – Potential Waterproofing Risk
 Information: Damage was observed to a tile near the bath, likely caused by previous drilling or impact. The tile is chipped and cracked, exposing the substrate beneath. In wet areas, such damage may compromise the integrity of the waterproofing membrane underneath, which is essential for preventing water ingress.

Implication: Ongoing exposure to water in this area may result in membrane failure, water ingress, and deterioration of subfloor materials or adjoining finishes.

Recommendation: Engage a qualified tiler or waterproofing specialist to assess the extent of damage. An invasive inspection may be necessary to verify whether the waterproofing membrane has been breached and to undertake appropriate repairs to prevent future water damage.

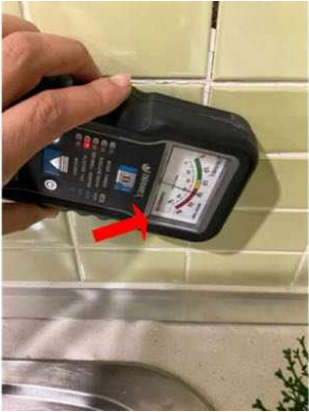
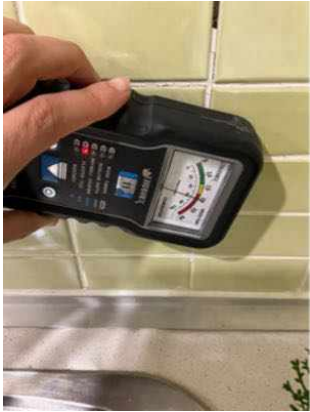
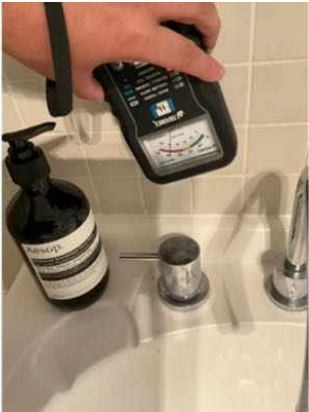
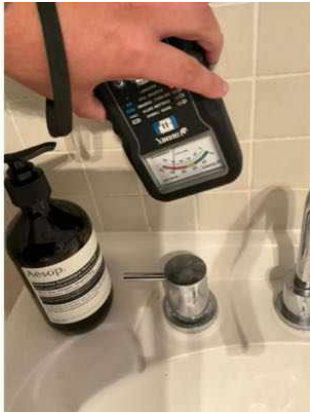
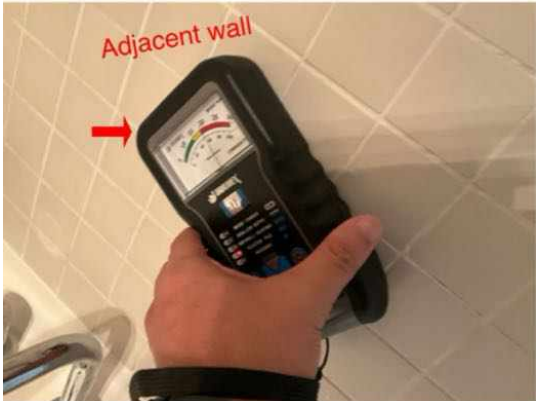
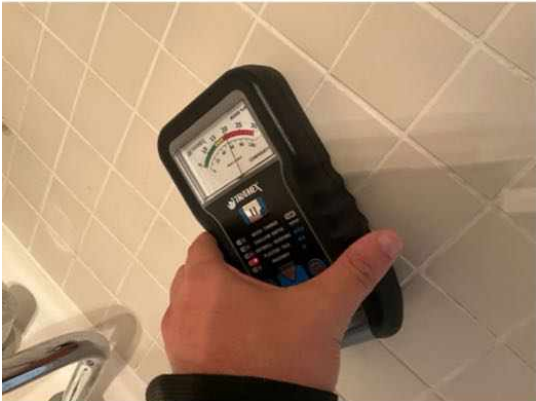
Finding 2.07

Building: Main Building
 Location: Kitchen
 Finding: Evidence of excessive moisture was present at the time of inspection
 Information: Excessive moisture is present behind the bathroom tiles, indicating a potential water leakage issue within the wall.

The prolonged presence of moisture can lead to mold growth, deteriorate the structure, and create an environment conducive to health hazards. Additionally, it may compromise the adhesive holding the tiles, leading to their detachment.

A licensed plumber or a qualified contractor specializing in water damage remediation should investigate the source of the moisture, fix any leaks, and address the damage. Additionally, replacing affected tiles and ensuring proper waterproofing are crucial to preventing future issues.

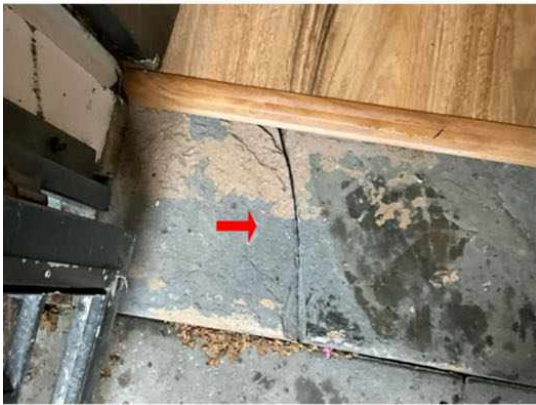
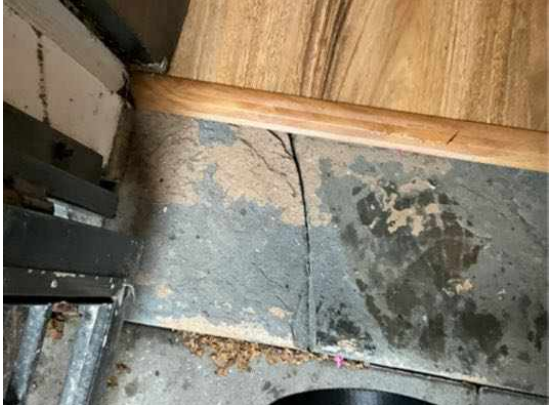
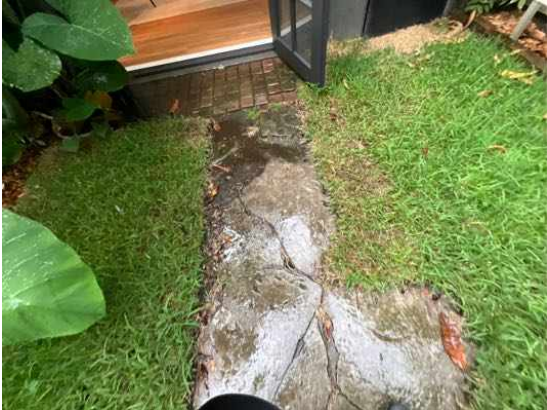
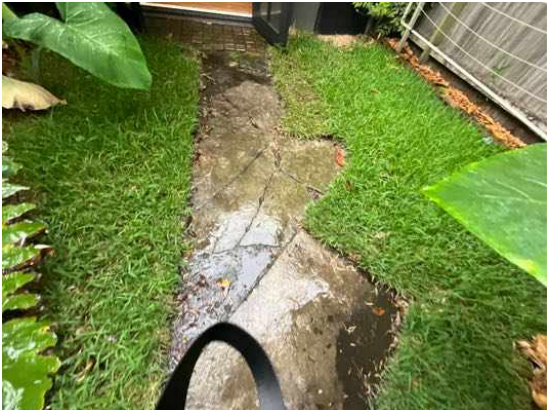
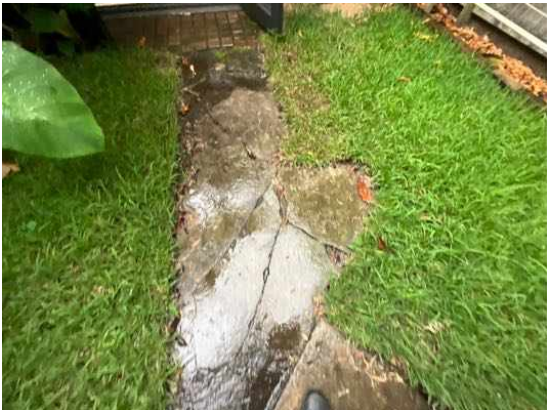
Building:	Main Building
Location:	All Areas
Finding:	Noticeable Cracking in Concrete Slab
Information:	Noticeable cracking has been observed in the concrete slab, failing to meet the required construction and quality standards.

- Cracks are visible on the surface and may extend through the depth of the slab.
- Evidence of improper curing or inadequate reinforcement leading to cracking.

- Compromised structural integrity of the slab, potentially leading to failure under load.
- Water ingress through cracks, causing corrosion of reinforcement and further weakening the structure.
- Potential trip hazards and aesthetic issues, reducing the overall value and safety of the property.
- Increased maintenance and repair costs due to ongoing deterioration.

- A structural engineer should be engaged to assess the extent of the cracking and recommend appropriate repair methods.
- A licensed contractor or concrete repair specialist should carry out the recommended repairs under the guidance of the structural engineer.

A detailed inspection should be conducted post-repair to confirm compliance with the required standards and to ensure that the structural integrity of the concrete slab has been restored.

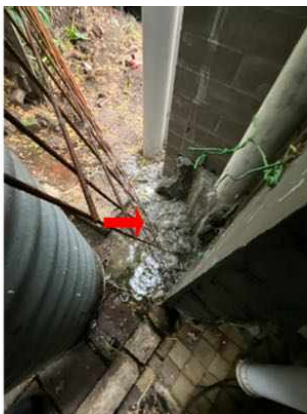
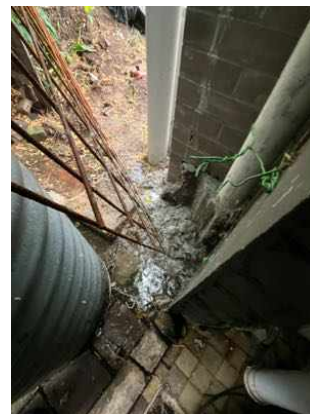
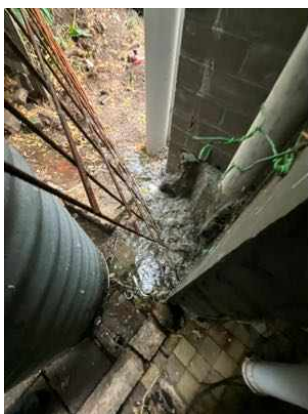
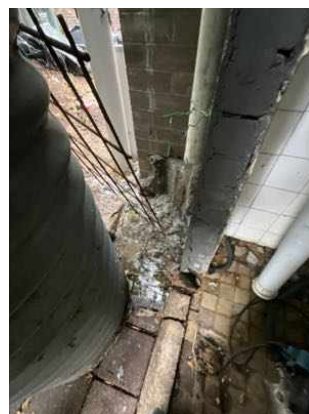
Finding 3.02

Building:	Main Building
Location:	Exterior walls - rear
Finding:	Disconnected downpipe
Information:	A notable defect with a disconnected downpipe, compromising the efficient drainage of rainwater from the roof. This disconnectivity poses an increased risk of water accumulation, potentially leading to foundation erosion, water damage to the property, and a conducive environment for mold growth.”

1. Foundation Erosion: Accumulated water around the foundation due to the disconnected downpipe can lead to soil erosion, jeopardizing the stability of the property's foundation.

2. Water Damage: Uncontrolled water runoff can result in water penetrating the building envelope, causing interior water damage to walls, ceilings, and other structural components.

3. Mold Growth: The presence of excess moisture provides an ideal environment for mold growth, posing health risks and necessitating costly remediation.

Engage a qualified and licensed roofing or gutter specialist to address the disconnected downpipe. This professional will reconnect the downpipe to ensure proper water drainage, mitigating the associated risks and preserving the integrity of the property.

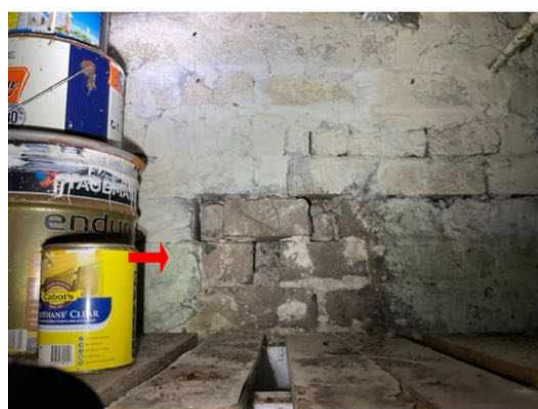
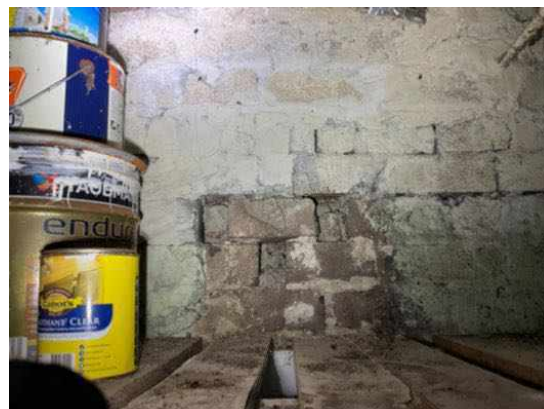
Finding 3.03

Building: Main Building
Location: Shed
Finding: Brickwork - Cracking [Repair required]
Information: cracking was identified to the brickwork in this area. Cracks of this type are likely to have been caused by minor expected movement of building elements, but may also have a structural cause that is more significant.

A crack of this size may be repaired by extensive filling. Additionally, further remedial works to associated building elements, such as eave sheeting or external door frames, is likely to be required.

A qualified bricklayer should be contacted immediately to estimate and perform repair and restoration works. Consultation with a structural engineer may be required where structural instability is found to be the underlying cause of the cracking.

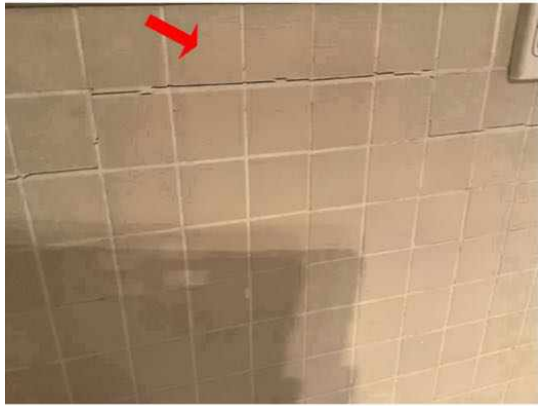
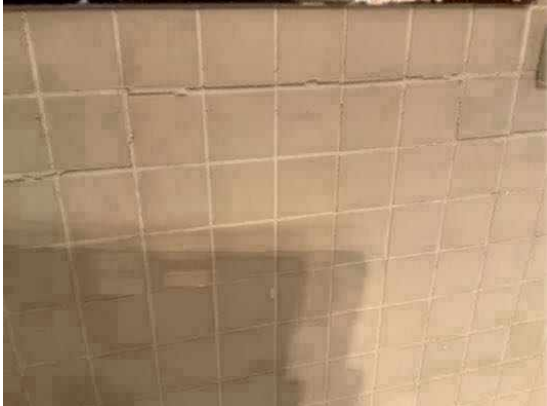
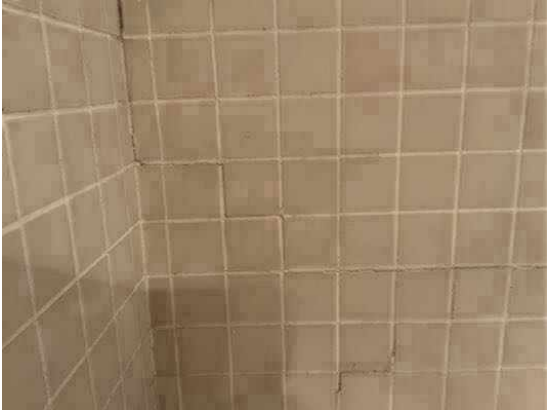
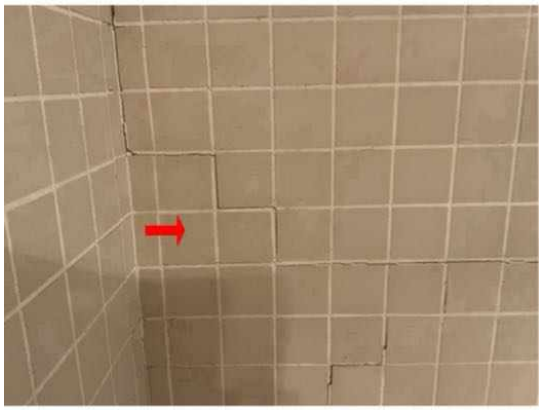
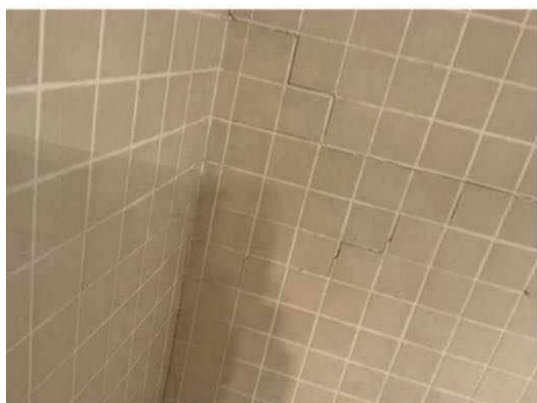
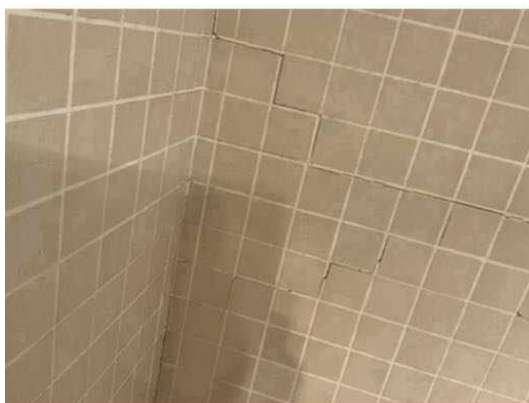
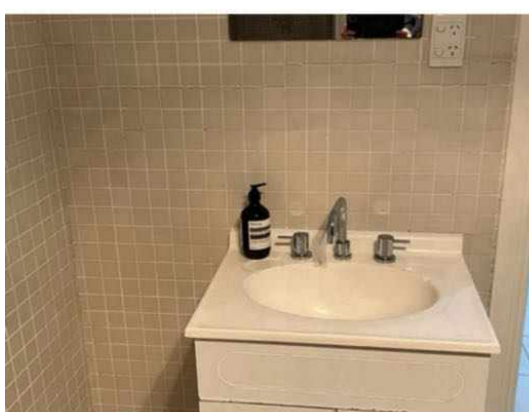
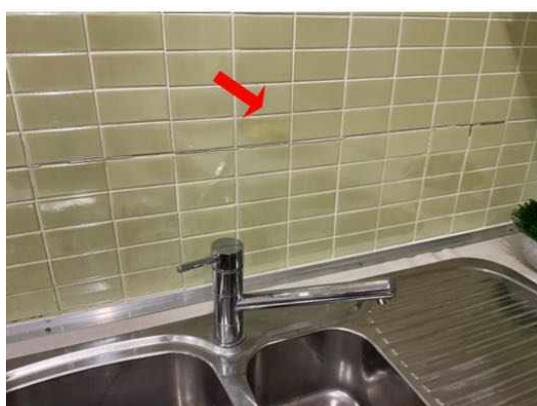
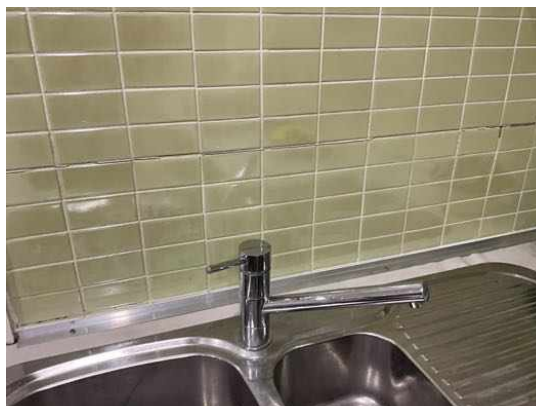
Finding 3.04

Building: Main Building
Location: Bathroom & Kitchen

Finding: Tiles - Cracked or damaged

Information: Cracking was evident to the tiling in this area at the time of inspection. This area is frequently exposed to water, allowing potential for water penetration into adjoining sections of walls or flooring.

If left unmanaged, water penetration to these areas may lead to subsequent water damage, which is likely necessitate repair work to affected building elements.

A tiling contractor should be appointed to ensure that no further water damage occurs. The re-application of silicone and grouting throughout remaining tile work is also advised, to further protect the area against water penetration.

Where water penetration has led to water damage, appointment of a relevant tradesperson may be required to repair damaged building elements.

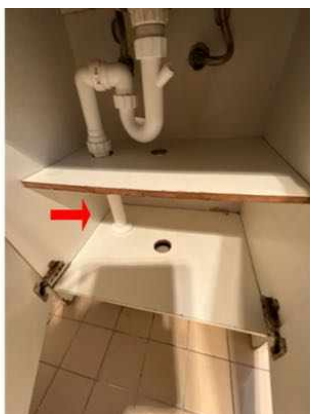
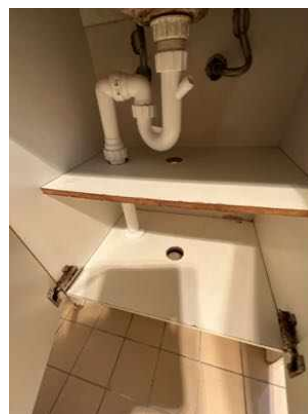
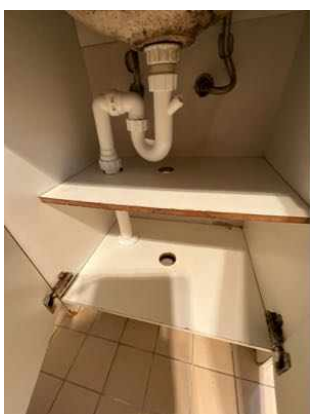
Finding 3.05

Building: Main Building
 Location: Bathroom
 Finding: Water damage / Vanity
 Information: "The vanity in the shower area has sustained water damage, resulting in swelling and discoloration of the wood, as well as potential structural issues. This damage compromises both the aesthetic and functional aspects of the vanity."

1. ****Carpenter or Woodworker:**** They can assess and repair the damage to the vanity, potentially replacing any irreparable parts.

2. **Plumber:** If the water damage is due to plumbing issues, a plumber can fix leaks and ensure there are no further water-related problems.

3. **General Contractor:** If the damage is extensive and affects the surrounding area, a general contractor can coordinate the repair work, including both the vanity and any related structural or cosmetic repairs.

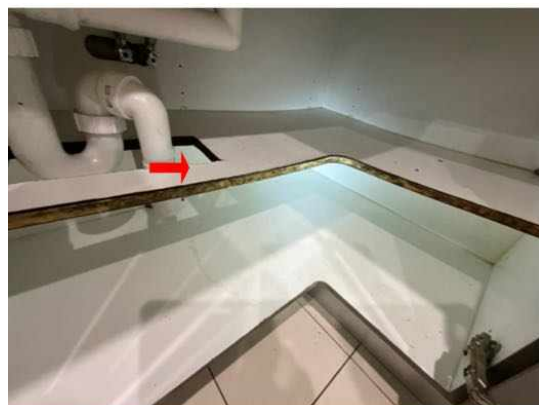
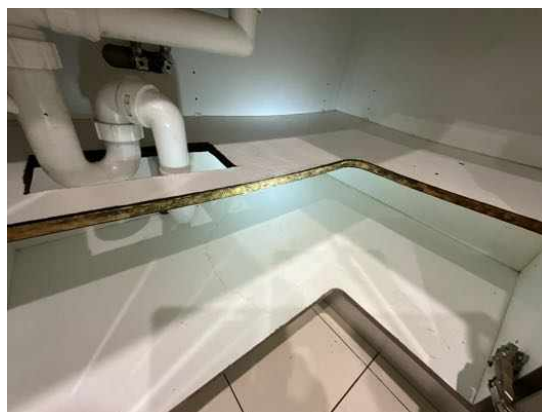
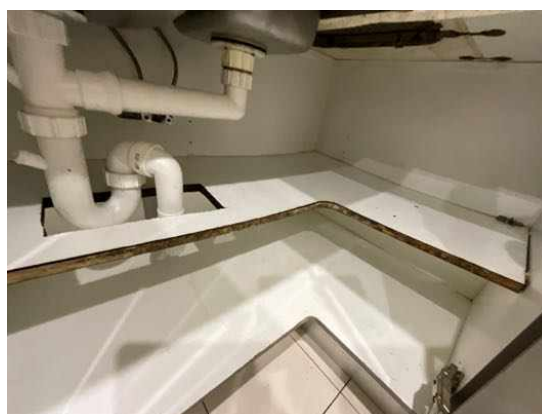
Finding 3.06

Building:	Main Building
Location:	Kitchen
Finding:	Water damage / Vanity
Information:	"The vanity in the shower area has sustained water damage, resulting in swelling and discoloration of the wood, as well as potential structural issues. This damage compromises both the aesthetic and functional aspects of the vanity."

1. **Carpenter or Woodworker:** They can assess and repair the damage to the vanity, potentially replacing any irreparable parts.

2. **Plumber:** If the water damage is due to plumbing issues, a plumber can fix leaks and ensure there are no further water-related problems.

3. **General Contractor:** If the damage is extensive and affects the surrounding area, a general contractor can coordinate the repair work, including both the vanity and any related structural or cosmetic repairs.

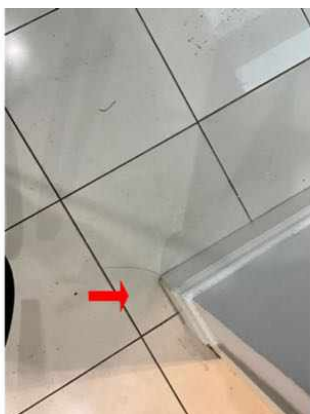
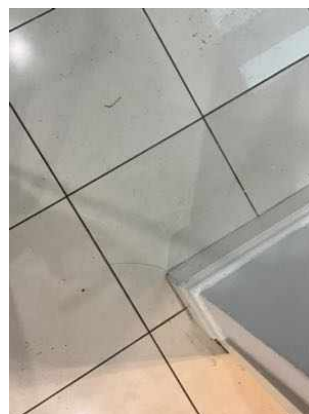
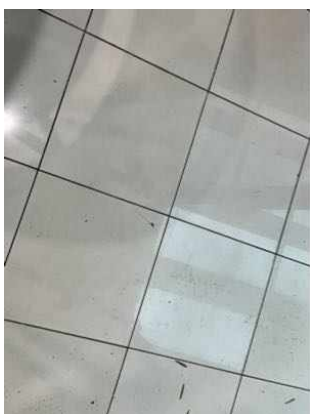
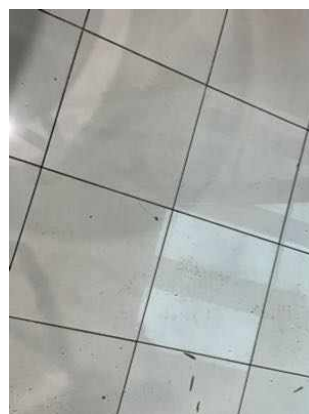
Finding 3.07

Building: Main Building
 Location: Kitchen
 Finding: Floor Tile crack
 Information: A floor tile has a visible crack on the surface.

The damaged tile presents a trip hazard, may lead to cuts if stepped on barefoot, and can allow moisture ingress into the substrate, which may cause further deterioration or loosening of adjacent tiles. It also affects the overall appearance of the floor.

A licensed tiler should be engaged to remove the damaged tile and install a matching replacement. If spare tiles are unavailable, additional remedial work may be required to blend the repair with surrounding finishes.

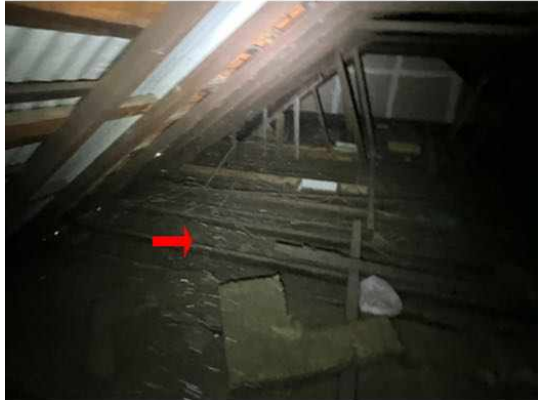
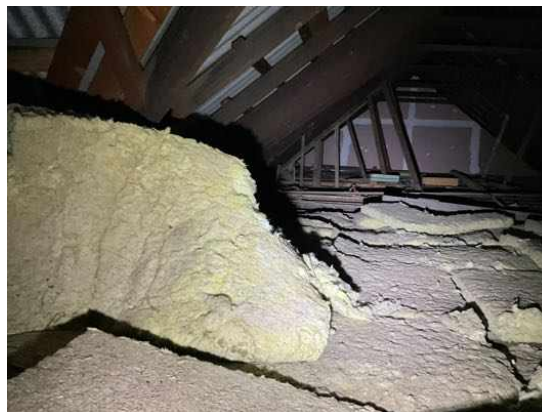
Finding 3.08

Building: Main Building
Location: Roof Void
Finding: Roof void - Brickwork incomplete
Information: Incomplete or missing brickwork was observed in the roof cavity. This section of the wall is not fully built up to meet the roof line, leaving gaps that compromise the integrity of the building envelope.

- Pest Entry: Open areas may allow vermin or insects to enter the roof space, leading to infestations and associated health hazards.
- Structural Integrity: Depending on the extent of the missing brickwork, there may be a reduction in the overall strength and stability of the wall, especially under wind load or other stresses.

- A licensed bricklayer or builder experienced in remedial work should be engaged to assess and complete the missing brickwork to ensure proper sealing and support.
- A structural engineer may be required to assess the impact of the missing brickwork on the structural integrity of the building and specify any necessary reinforcement.

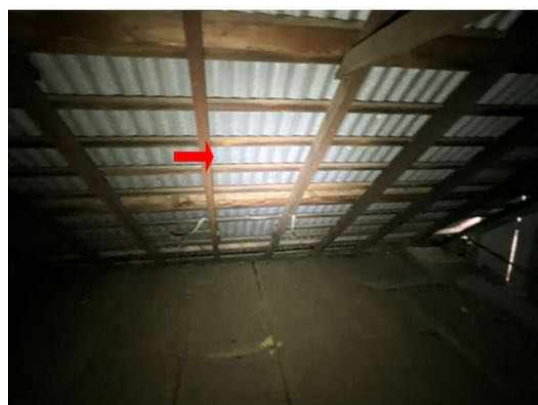
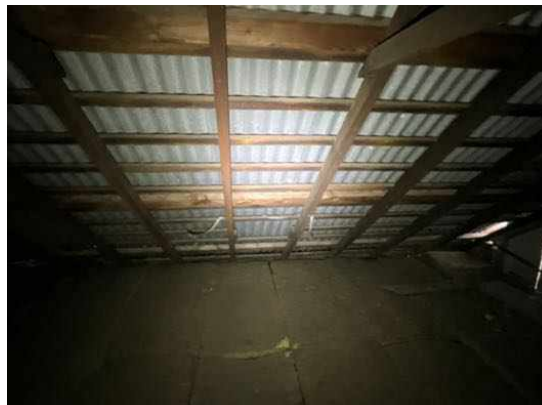
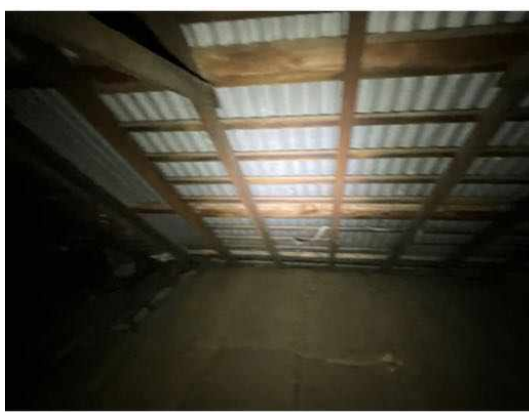
Finding 3.09

Building:	Main Building
Location:	Roof Void
Finding:	Sarking - Missing
Information:	Sarking is missing under the roof sheeting. Sarking acts as an insulator that helps with noise reduction and protects against water penetration. Sarking plays a key role in the operation and function of the overall roofing structure and its performance.

Although not a requirement at the time of construction, replacement of any missing building element is advisable (although this can be quite expensive to do after the time of construction). Where sarking is missing, regular inspections of the roof tiles for cracking and potential moisture penetration is required.

Sarking may be retrospectively fitted by a registered builder at the discretion of the client.

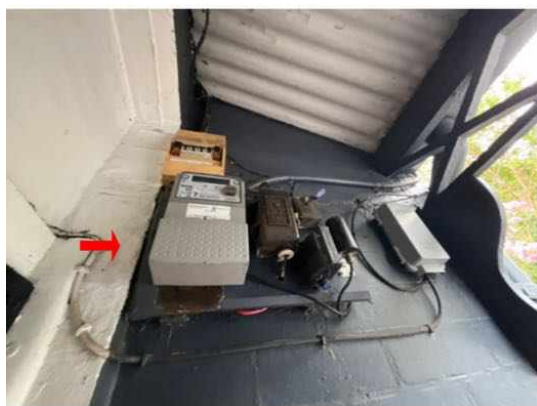
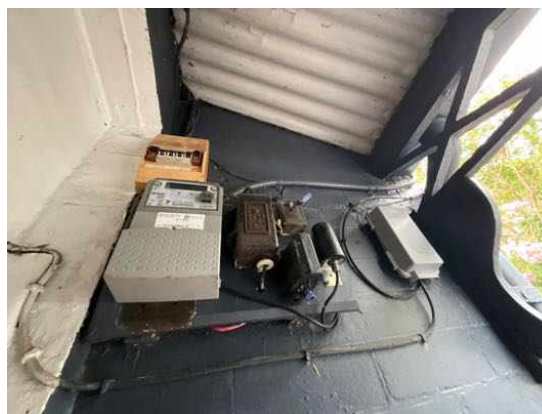
Building: Main Building
 Location: Front porch
 Finding: No Evidence of Termite Management System - Durable notice / Legible Sticker
 Information: The application of a pre & post-construction chemical termite barrier is highly recommended for all properties. Such barriers are highly effective in preventing termite attack on any timber building elements throughout the property.

A durable notice was not placed in the switchboard unit to indicate current termite barriers is legible at the time of inspection.

Client must seek further information from the vendor or real estate agent if the conditions of termite management systems were maintained.

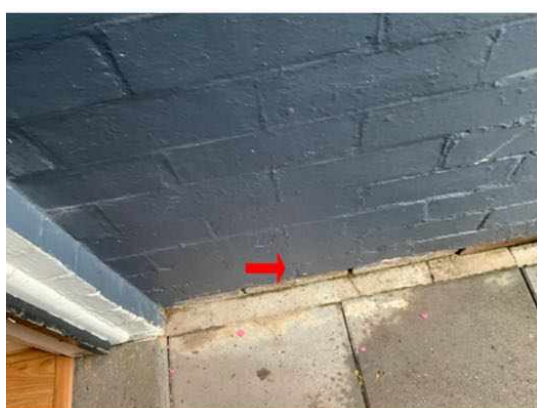
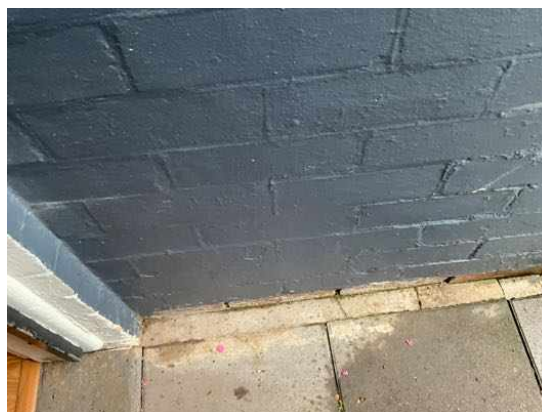
Finding 6.02

If the slab edge is not properly exposed there is a high risk of termite attack. Sometimes, in order to determine the type of slab, a suitably qualified person such as an architect or builder may be required to consult the construction plans.

Where the slab edge cannot be properly inspected, it is highly recommended that termite or timber pest inspections be carried out every 6-12 months to aid protection of the property against infestation.

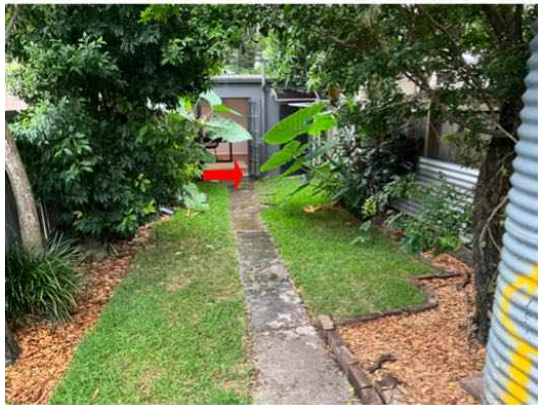
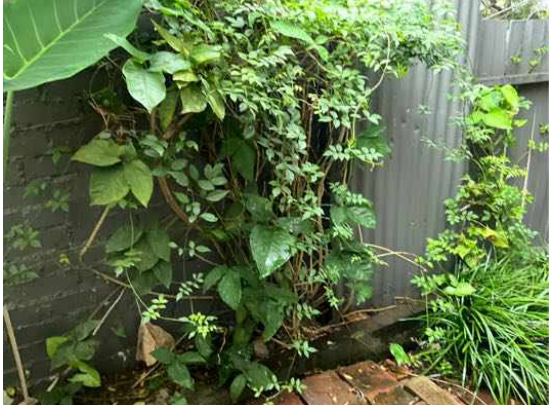
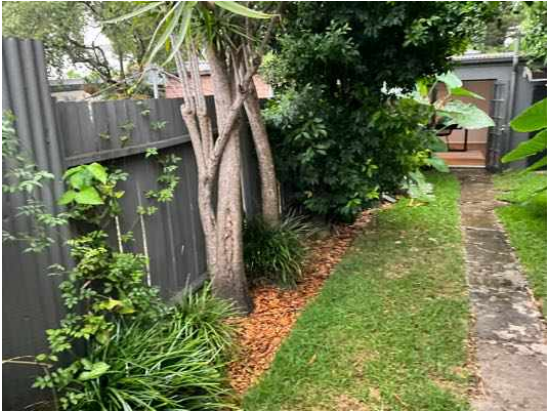
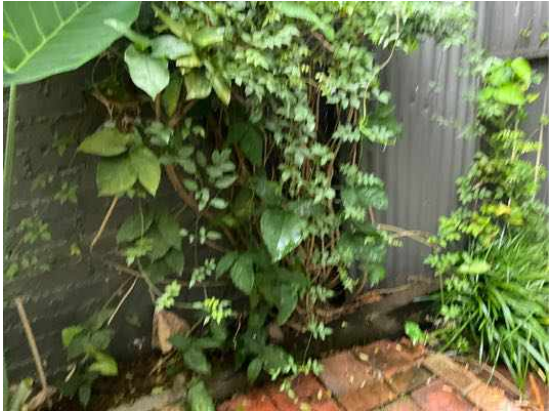
Finding 6.03

Building: Main Building
Location: All Areas
Finding: Dense vegetation around a property can increase the risk of termite infestation
Information: The presence of dense vegetation around a property can increase the risk of termite infestation, as it provides a conducive environment for them. To address this, consider maintaining a clear space between the vegetation and your home. If you suspect a termite issue, it's advisable to consult with a licensed pest control professional for inspection and treatment.

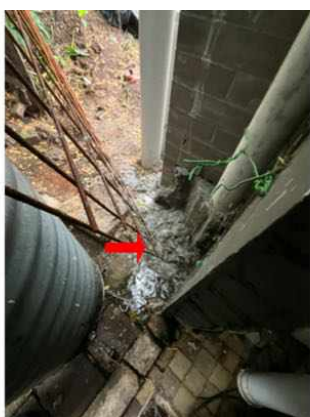
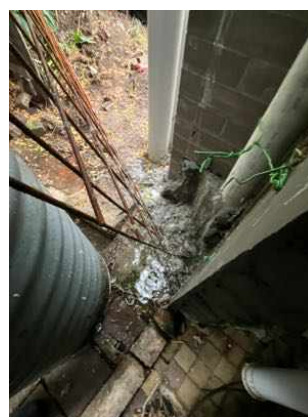
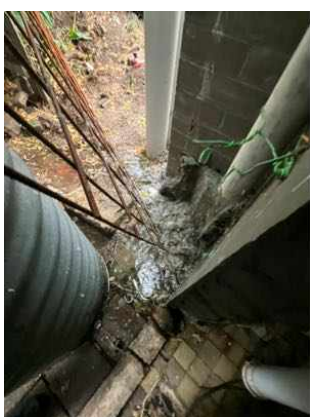
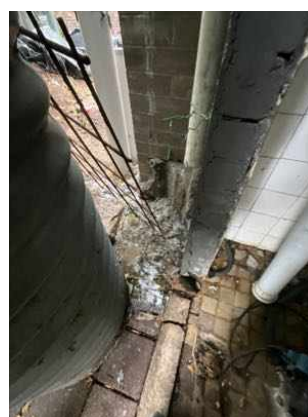
Finding 6.04

Building:	Main Building
Location:	Exterior walls - rear
Finding:	Downpipes not connected- Conducive conditions for timber pest
Information:	Unconnected downpipes can indeed pose a risk for attracting termites, as they provide a source of moisture near a building's foundation. Termites are attracted to moisture and wood, so it's important to address this issue to prevent potential infestations. Connecting downpipes to the stormwater system or ensuring proper drainage away from the building can help mitigate this a licensed plumber is the most qualified professional to handle plumbing-related tasks, including connecting downpipes to the stormwater system. They have the necessary expertise and tools to ensure proper installation.

Please remember that proper installation is essential to ensure effective drainage and prevent future issues, so it's often best to hire a qualified professional, especially for complex or extensive downpipe installations.

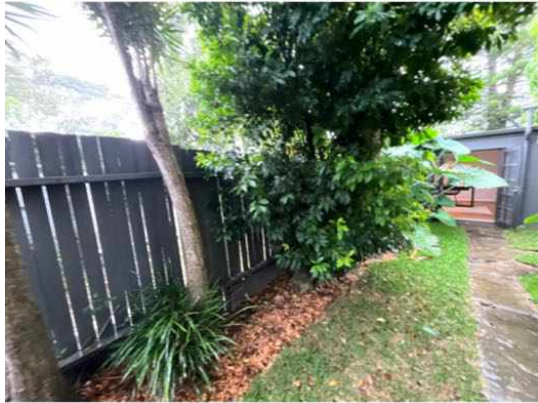
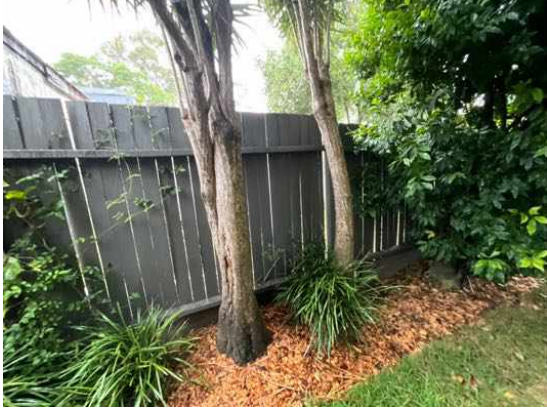
Finding 6.05

Building:	Main Building
Location:	All Areas
Finding:	Timber on ground / conducive conditions to termite damage
Information:	Timber on the ground is indeed conducive to termite damage. Termites are known to thrive in moist environments, and wood in contact with soil or moisture is more

susceptible to infestation.

To prevent this, it's important to keep timber elevated and away from direct ground contact. Regular inspections and proper termite control measures are also essential to protect your wooden structures from termite damage.

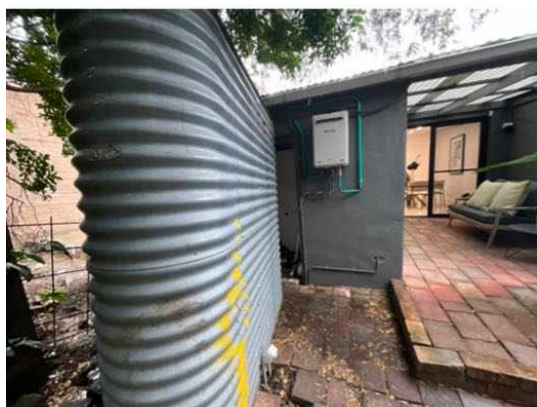
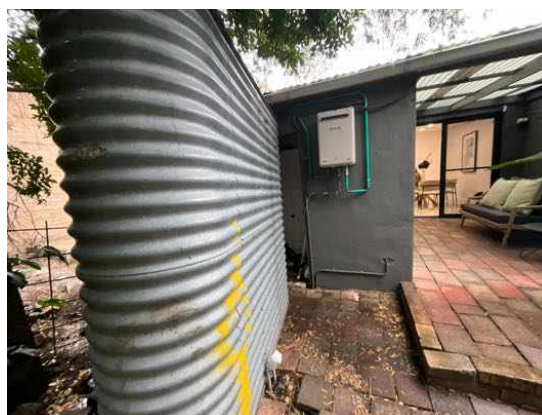
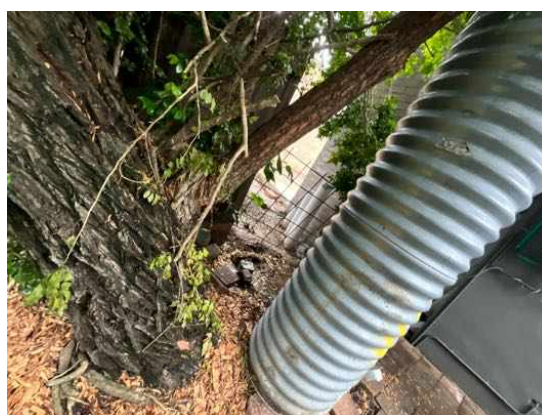
Finding 6.06

Building:	Main Building
Location:	All Areas
Finding:	Bridging or Obstruction Conducive environment for Termites
Information:	Bridging of termite barriers occurs when termites bridge (usually by building a mud

Where bridging has occurred full inspection is prevented and termites may enter a property in a concealed or undetected manner.

Recommended moving obstructions away from the external walls for further and future inspections.

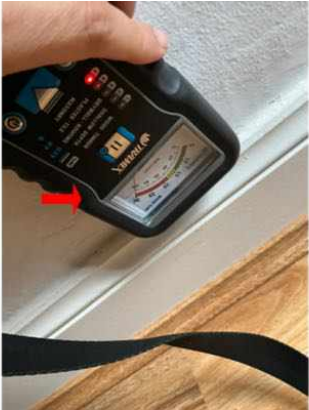
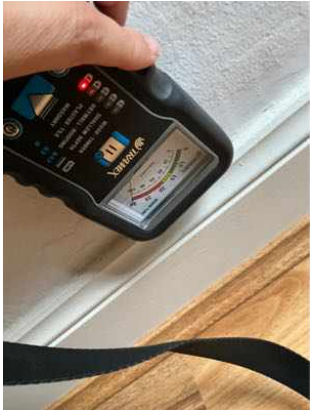
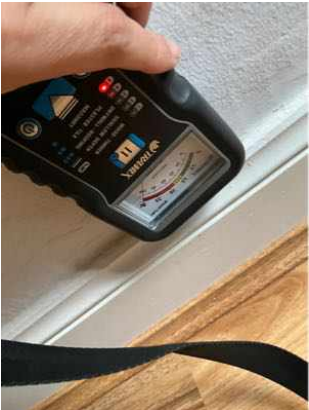
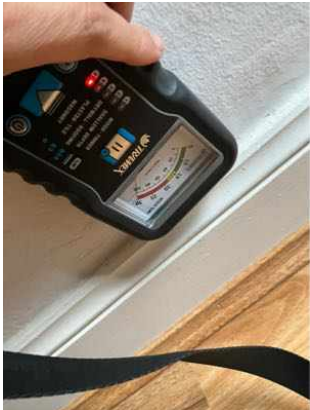
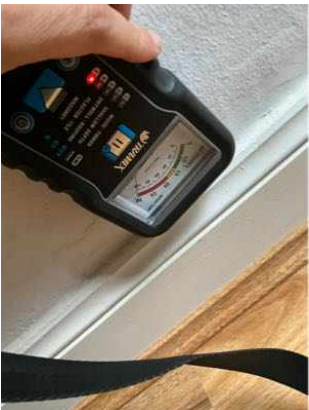
Finding 6.07

Building:	Main Building
Location:	Bedroom
Finding:	Excessive moisture - Conducive to Timber pest
Information:	Excessive moisture can attract termites and produce conditions that promote fungal growth and wood decay.

Excessive moisture is generally caused by deteriorated inadequate or missing roof drainage leaking plumbing pipes or fixtures poorly plumbed HWS overflows or condenser units and poor site drainage.

If mould growth has been found there may be environmental biological or health issues involved. In these cases an appropriately qualified inspector should also be contacted.

Prior to any remedial works being performed a qualified plumber should be appointed to further inspect the property and to identify the cause of the excessive moisture. Works to remove affected building elements may then be necessary and should be performed by an appropriate tradesperson.

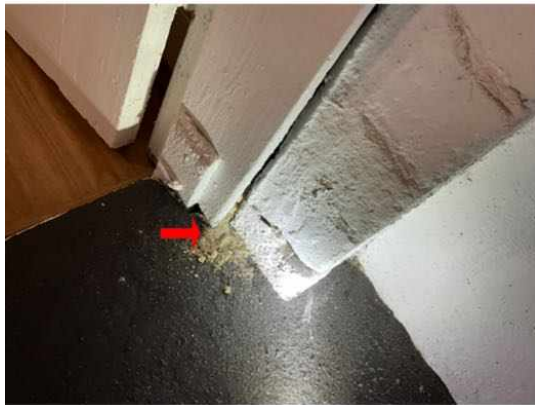
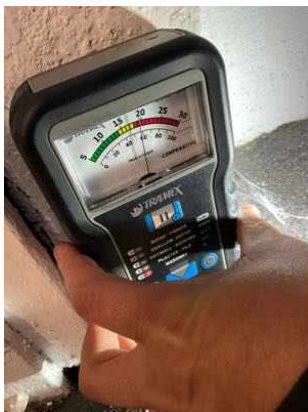
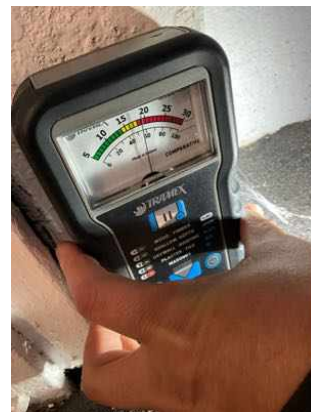
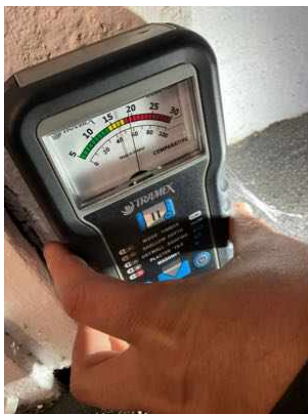
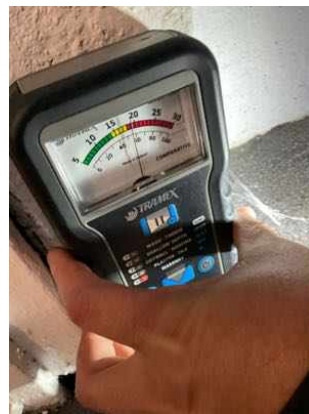
Finding 6.08

Building: Main Building

Location: Void
Finding: Excessive moisture - Conducive to Timber pest
Information: Excessive moisture can attract termites and produce conditions that promote fungal growth and wood decay.

Excessive moisture is generally caused by deteriorated inadequate or missing roof drainage leaking plumbing pipes or fixtures poorly plumbed HWS overflows or condenser units and poor site drainage.

If mould growth has been found there may be environmental biological or health issues involved. In these cases an appropriately qualified inspector should also be contacted.

Prior to any remedial works being performed a qualified plumber should be appointed to further inspect the property and to identify the cause of the excessive moisture. Works to remove affected building elements may then be necessary and should be performed by an appropriate tradesperson.

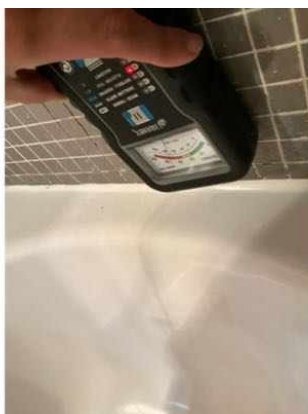
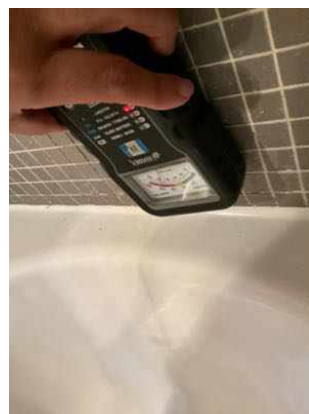
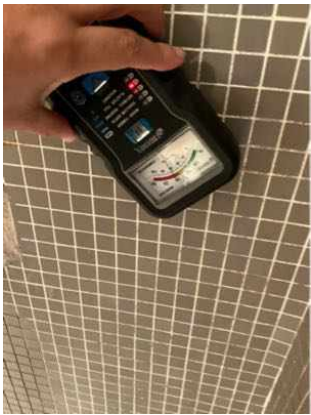
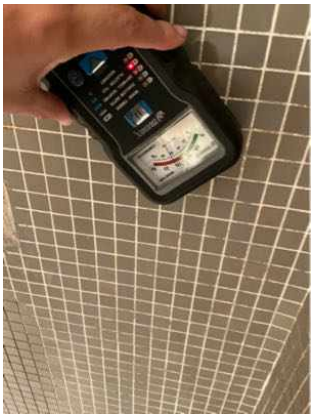
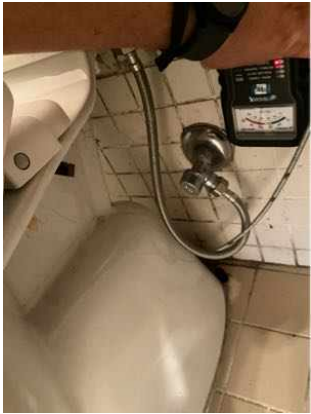
Finding 6.09

Building:	Main Building
Location:	Bathroom
Finding:	Excessive moisture - Conducive to Timber pest
Information:	Excessive moisture can attract termites and produce conditions that promote fungal growth and wood decay.

Excessive moisture is generally caused by deteriorated inadequate or missing roof drainage leaking plumbing pipes or fixtures poorly plumbed HWS overflows or condenser units and poor site drainage.

If mould growth has been found there may be environmental biological or health issues involved. In these cases an appropriately qualified inspector should also be contacted.

Prior to any remedial works being performed a qualified plumber should be appointed to further inspect the property and to identify the cause of the excessive moisture. Works to remove affected building elements may then be necessary and should be performed by an appropriate tradesperson.
