Building and Timber Pest Inspection Report

Inspection Date: Mon, 9 Mar 2026

Property Address: 178 Camden St, Enmore NSW 2042,
Australia

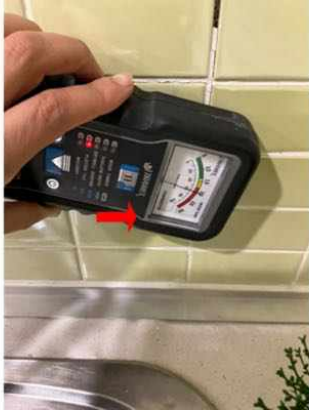
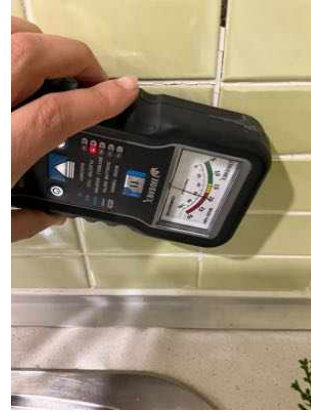
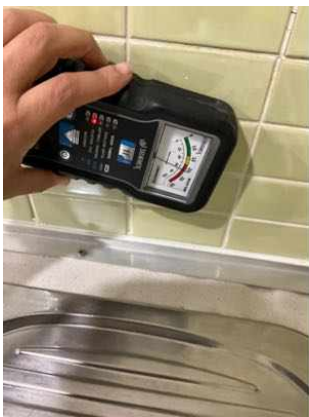
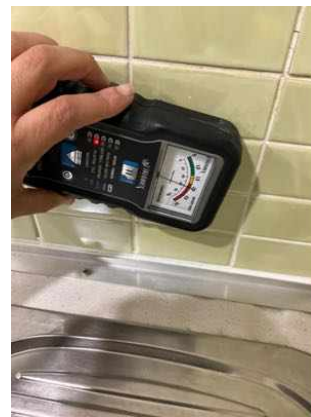
Finding 6.10

Building: Main Building
 Location: Kitchen
 Finding: Excessive moisture - Conducive to Timber pest
 Information: Excessive moisture can attract termites and produce conditions that promote fungal growth and wood decay.

Excessive moisture is generally caused by deteriorated inadequate or missing roof drainage leaking plumbing pipes or fixtures poorly plumbed HWS overflows or condenser units and poor site drainage.

If mould growth has been found there may be environmental biological or health

issues involved. In these cases an appropriately qualified inspector should also be contacted.

Prior to any remedial works being performed a qualified plumber should be appointed to further inspect the property and to identify the cause of the excessive moisture. Works to remove affected building elements may then be necessary and should be performed by an appropriate tradesperson.

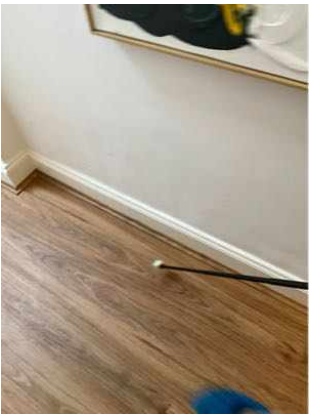
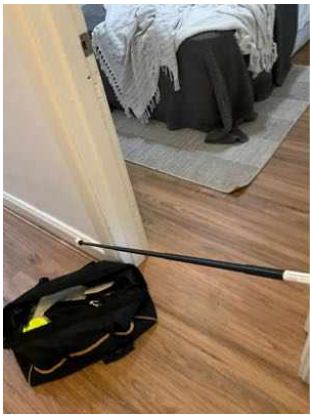
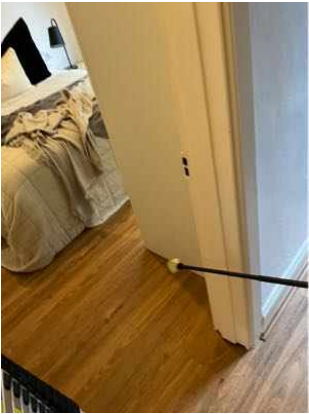
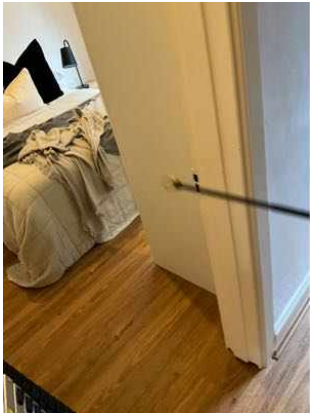
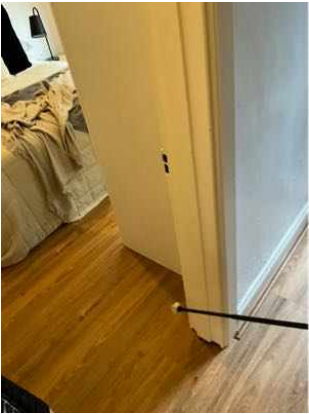
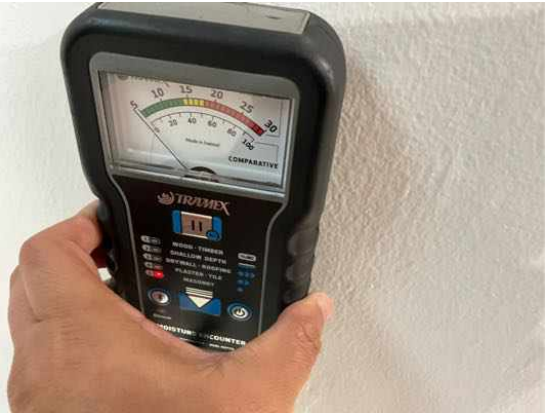
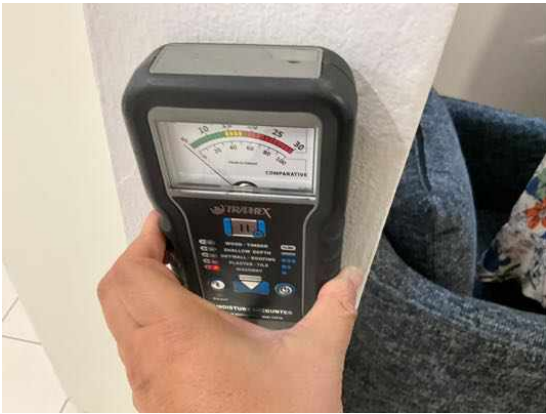
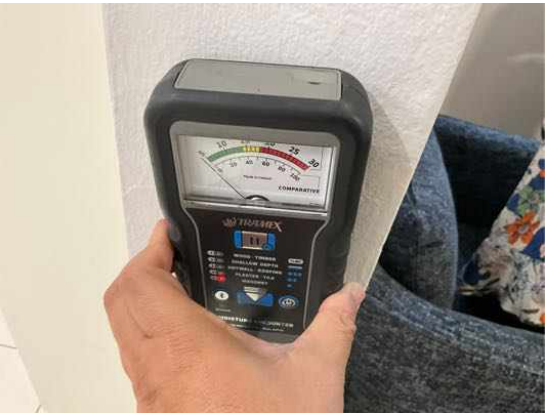
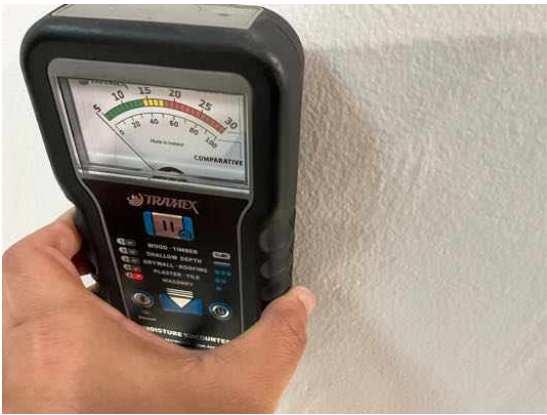
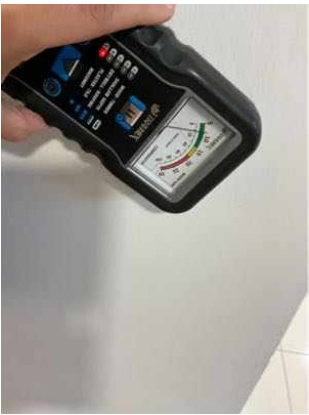
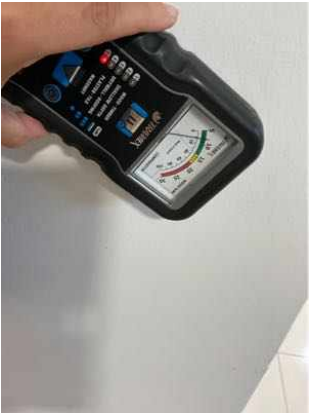
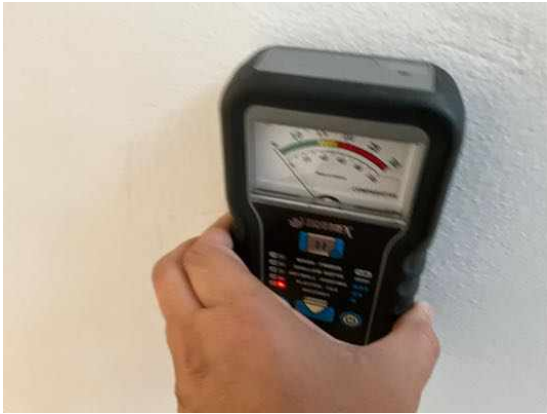
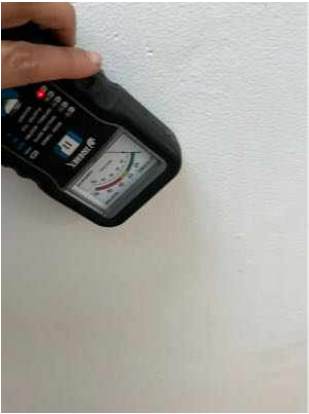
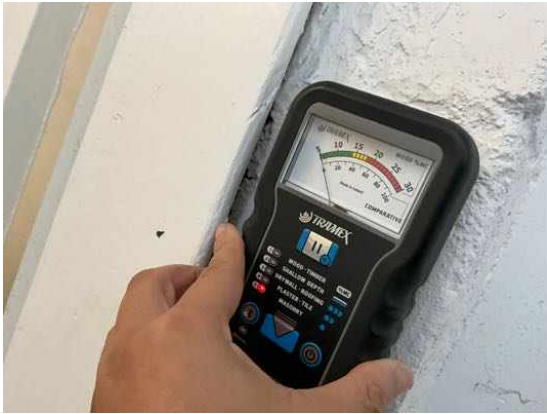
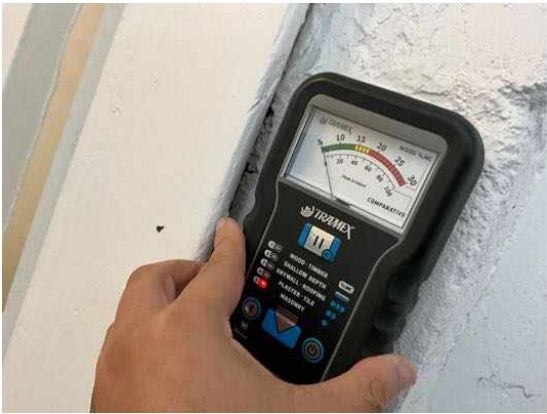
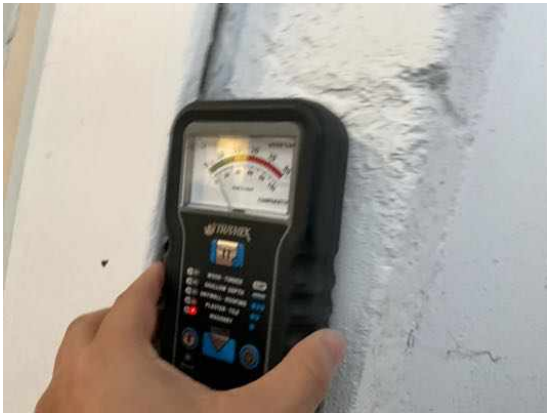
Building: Main Building
Location: All Areas
Finding: Additional Photos
Information: Additional photos are provided for your general reference

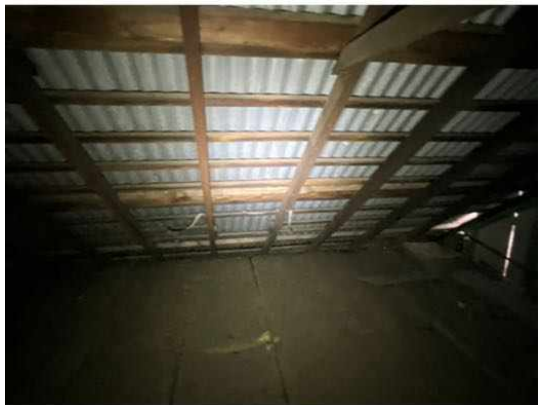
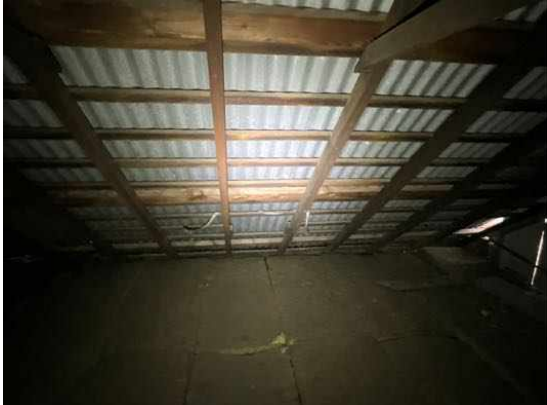
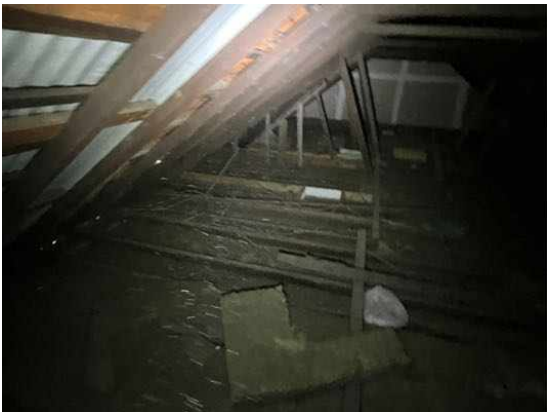
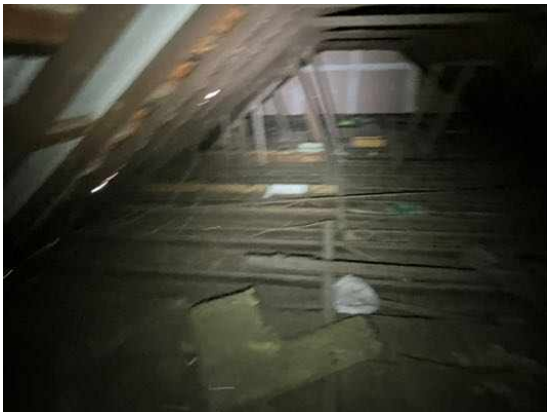
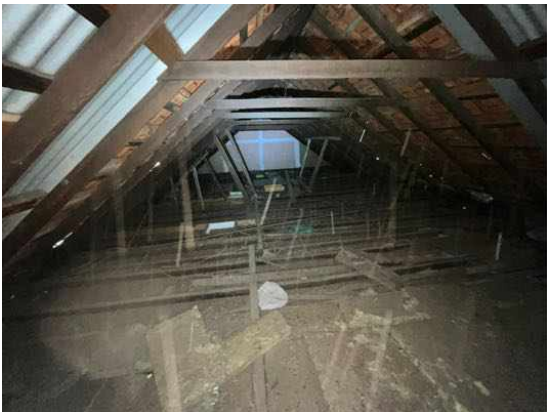
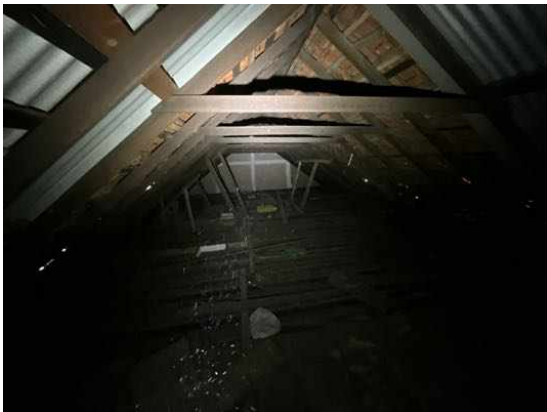
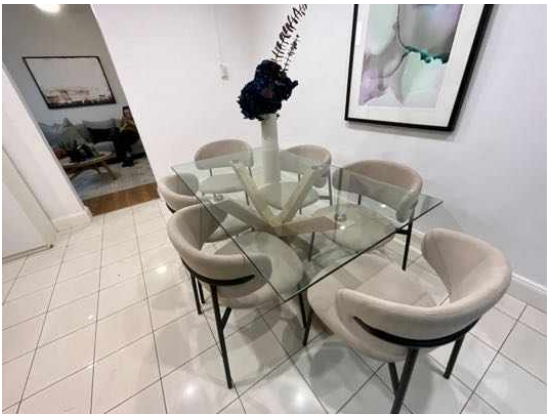
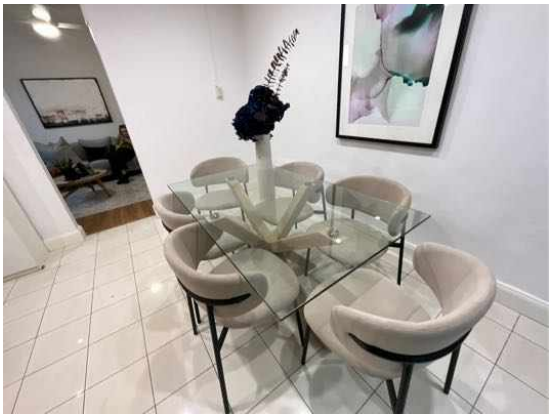
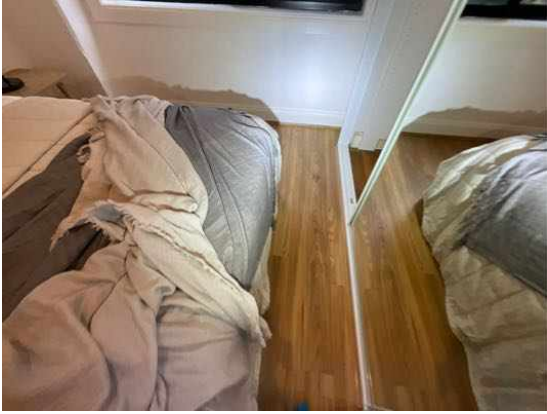
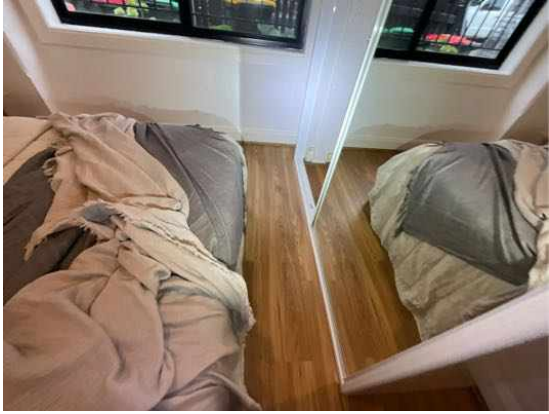
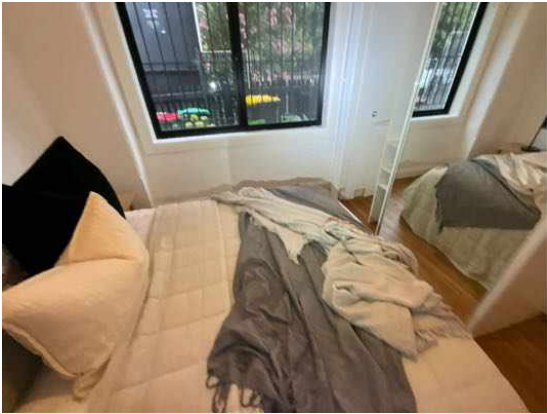
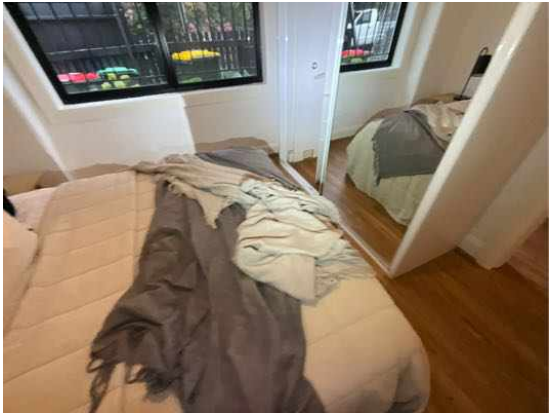
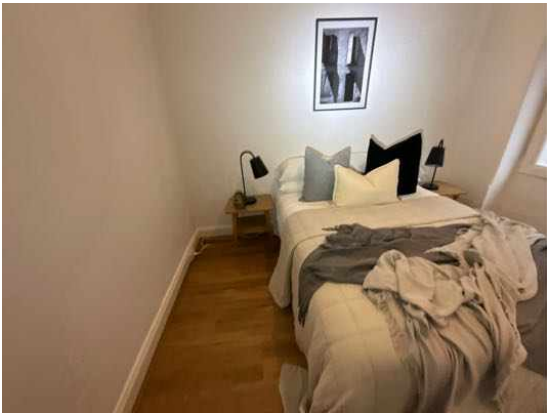
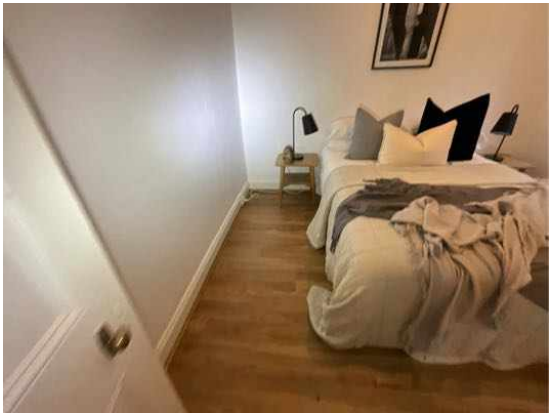
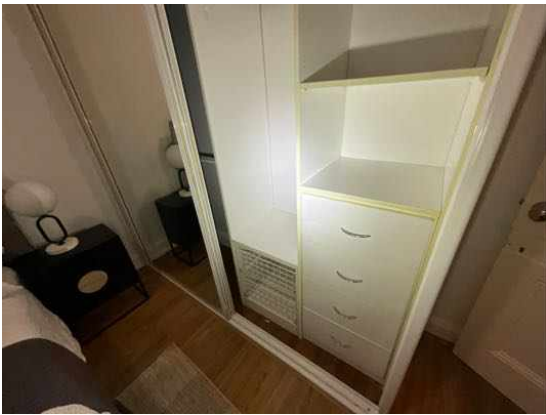
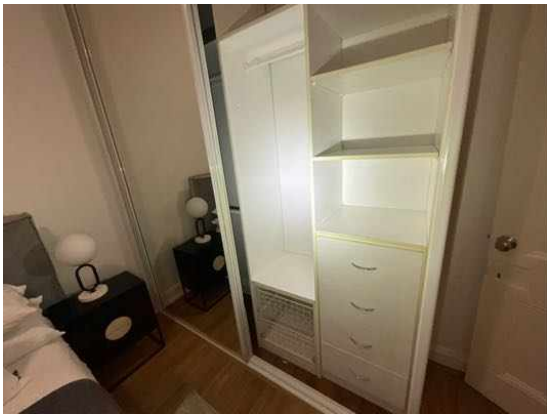
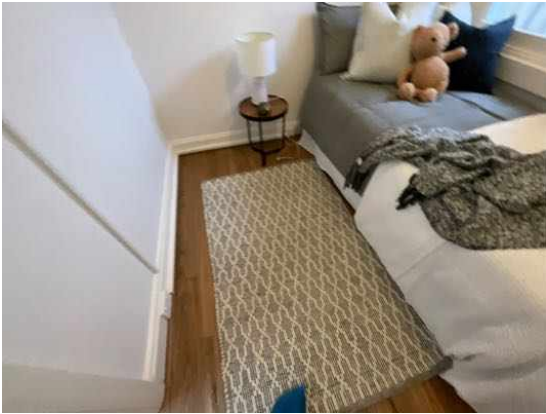
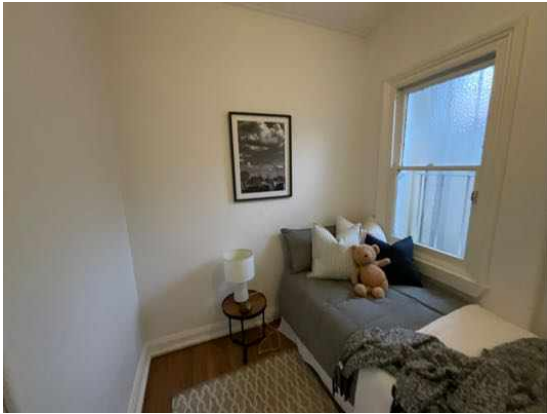
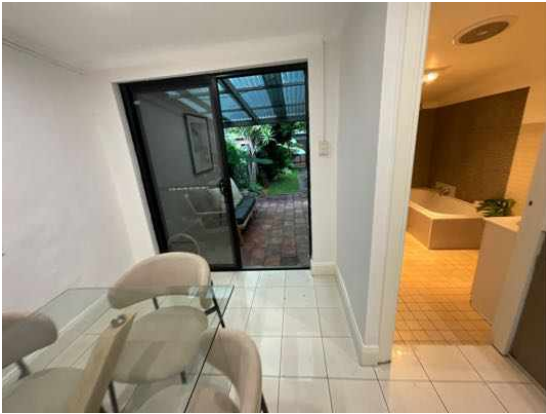
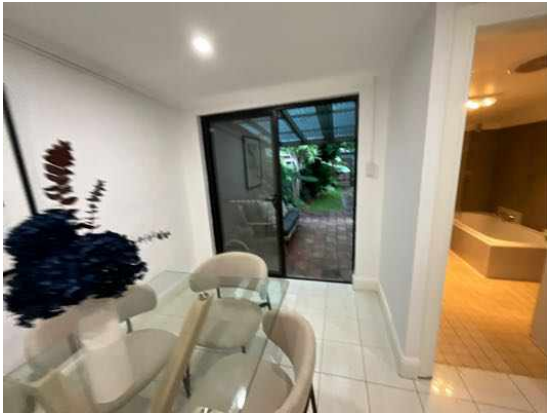
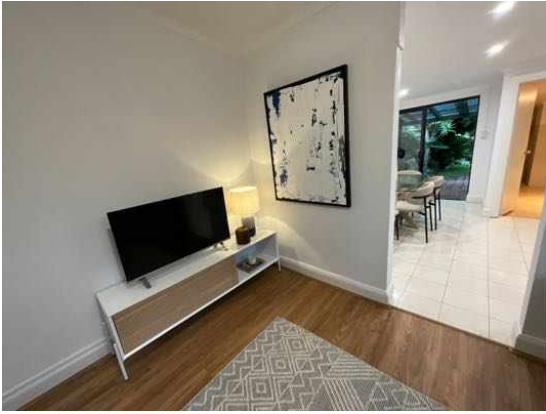
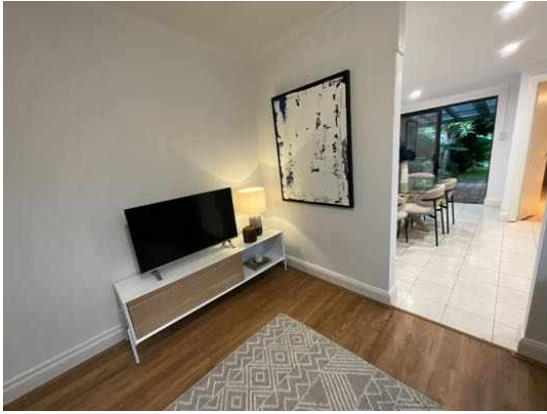
Building: Main Building
Location: All Areas
Finding: Additional Photos - Obstructions and Limitations
Information: These photographs are an indication of the obstructions and limitations which impeded full inspection of the property at the time of inspection. These obstructions can hide an array of defects and should be removed to allow full inspection to be carried out. A re-inspection is recommended once the areas are made accessible.
