Building and Timber Pest Inspection Report

Inspection Date: Tue, 20 Jan 2026

Property Address: 44 Glenora Dr, Ingle Farm SA 5098,
Australia

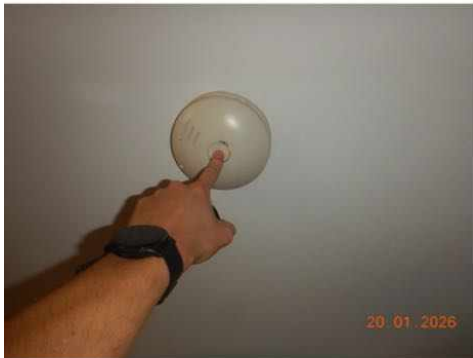
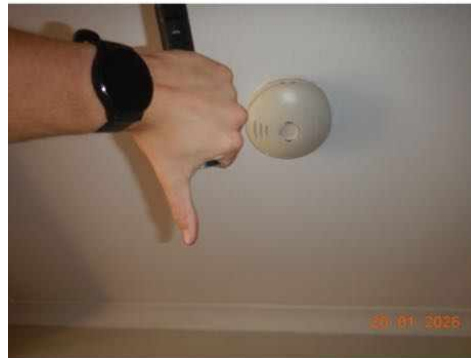
Please note that this defect is highlighted as a caution only. We suspect, based on our experience in the building industry, that the absence of smoke detectors, or their poor condition, should be addressed as a matter of urgency to improve occupant safety.

Always ensure sufficient working and suitable smoke detectors are installed prior to occupying any building. Additionally, it is advised that all smoke detectors be tested by the homeowner on a monthly basis.

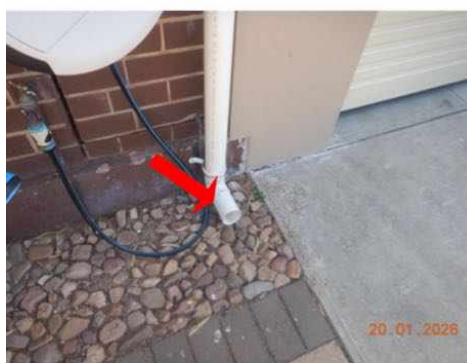
Finding 2.01

Building:	Building 1
Location:	Front Elevation
Finding:	Stormwater drain - Not connected or leaking

Information: The roof plumbing is not adequately connected to stormwater drainage or is leaking in several areas on the site. This issue negatively impacts the functional capacity of the roof plumbing. It appears that the rear stormwater drainage is contained and run out to the road however the front pipes appear to spill directly adjacent the dwelling.

Where roof plumbing doesn't drain adequately, the area at the base perimeter can become excessively damp, potentially creating an environment that is susceptible to rust and corrosion of surrounding building elements, as well as attracting termites and other pests.

It is highly recommended that a plumber be appointed to further inspect the area and to install or repair drainage equipment where necessary.

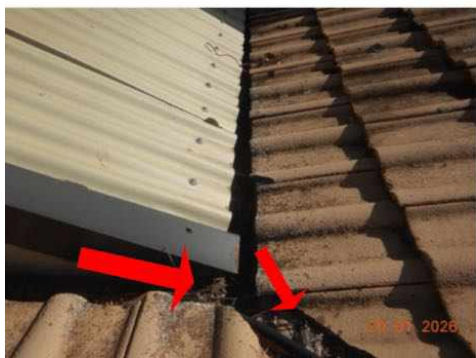
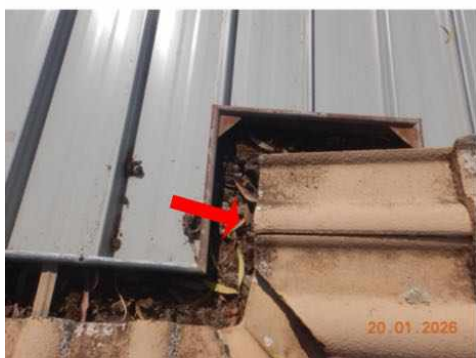
Finding 2.02

Building: Building 1
 Location: Roof Exterior
 Finding: Gutters - Blocked
 Information: Roof plumbing structures, such as guttering and downpipes, should be free of all debris to prevent blockages. Blockages of the guttering and downpipes will lead to pooling and accumulated water overflows, which is likely to subsequently flood eaves and exterior walls.

Blocked gutters are likely to lead to high levels of moisture in the affected areas. Such moisture will not only cause rust and decay of the associated building materials, but can also provide conditions that are conducive to termite and timber pest activity. Blockages in gutters should therefore be removed immediately to ensure dry conditions are maintained.

Consult a Licensed Plumber for further specific advice on remedial works that may be required. In the interim, it is highly advised that blocked gutters be removed by the homeowner or a general handyperson as a matter of urgency.

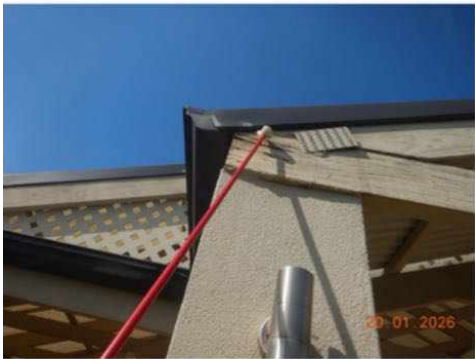
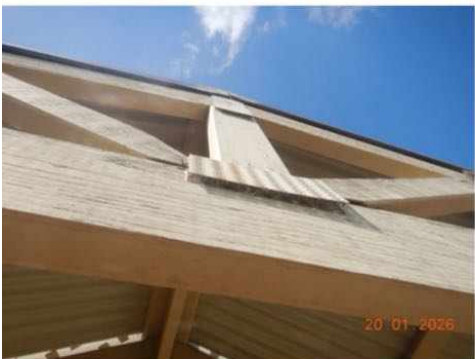
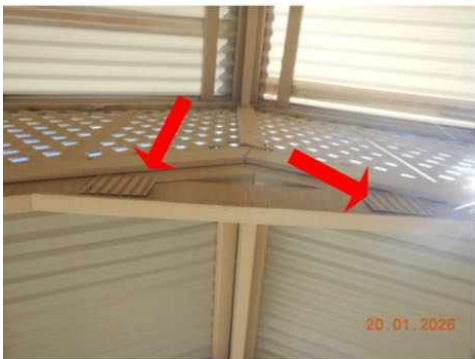
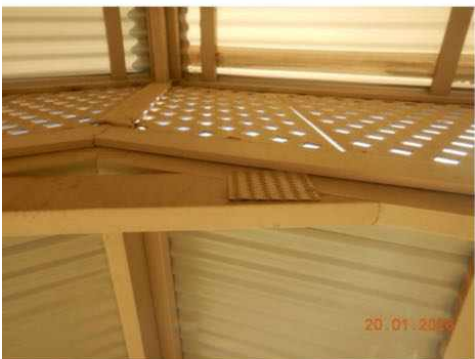
Finding 2.03

Building: Building 1
 Location: Pergola
 Finding: Trusses - Nail plate back out
 Information: There were several nail plates evident to the pergola roof trusses at the time of inspection that are backing out of their original positions.

This could be due to one or more of several reasons including faulty, nail plates, varying moisture levels, and exposure to the elements. Secondary defects can be created, worth of which being to structural failure and collapse.

The issue appears to be effecting relatively few truss plates (estimated 10%) and as such repair is likely possible. There is however rot evident to several trusses which will repair repair or replacement.

A structural engineer would be required to provide recommendations to be carried out by a licensed builder ASAP to prevent any further deterioration and to prevent a hazard being created.

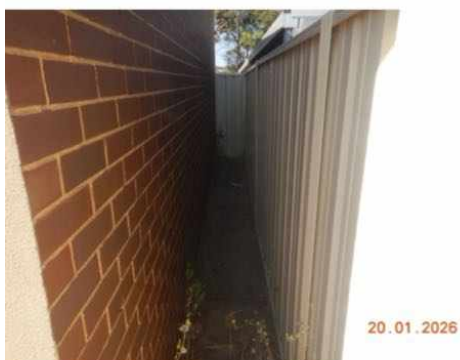
Building:	Building 1
Location:	Exterior walls
Finding:	Brickwork - Cracking [Fine]
Information:	There were fine cracks evident to the external brickwork at the time of inspection.

Although fine cracks are quite noticeable, they are often only considered to be an appearance defect and usually do not indicate any structural damage. Generally, the cause of a fine crack is indicative of a separation between brickwork and mortar throughout the structure, but single bricks may also show cracks of this nature.

Cracking of this nature can generally be repaired with minor filling and should be conducted by a qualified bricklayer.

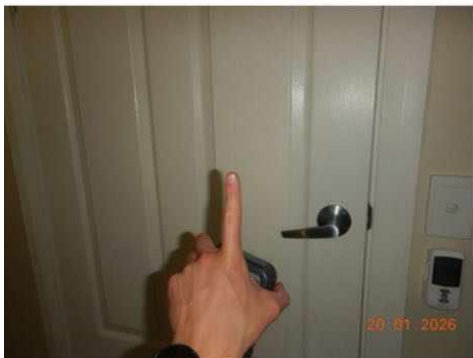
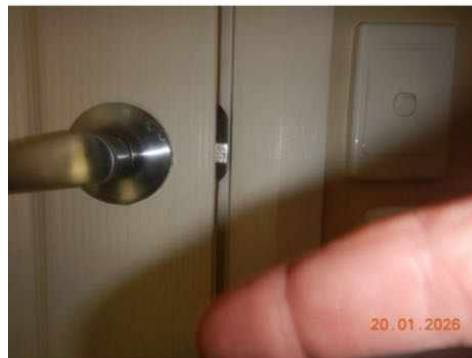
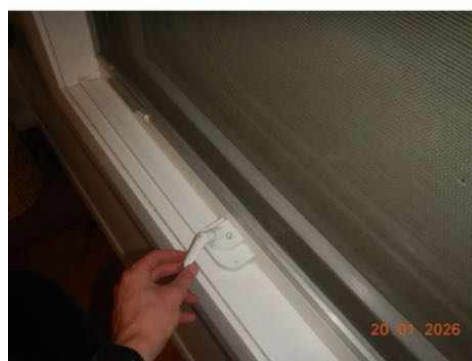
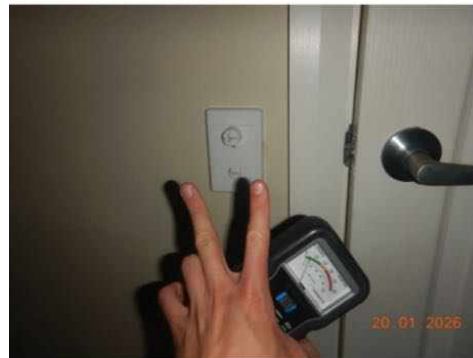
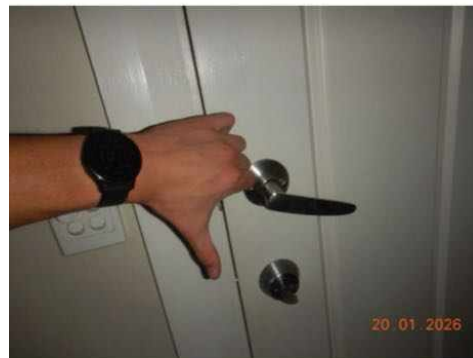
Finding 3.07

Building: Building 1
 Location: All Areas
 Finding: Minor defects present
 Information: There were several age and maintenance related defects evident to the dwelling at the time of inspection. These defects include but are not limited to

- Sill bricks damaged
- Rust to lintels
- Loose tiles to front porch
- Minor cracking/ damage to rear boxed eave linings
- We could not get the kitchen down lights working at the time of inspection.

Appropriate licensed trades people could be appointed to make repairs at the discretion of the client.

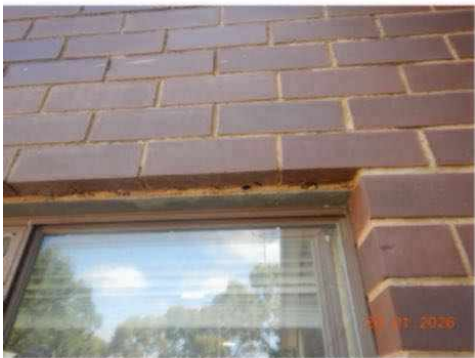
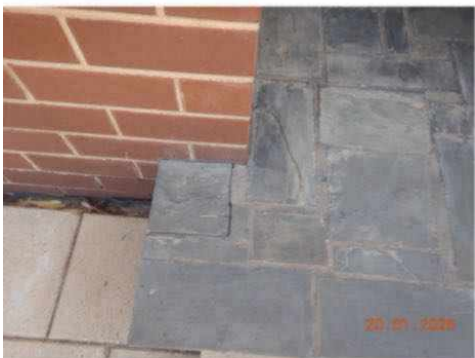
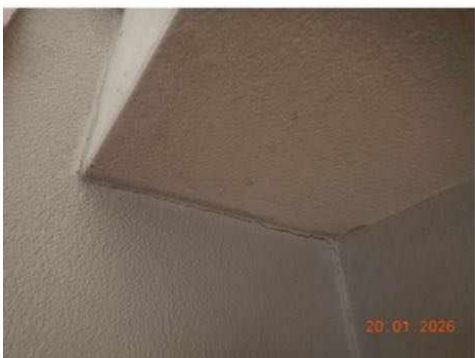
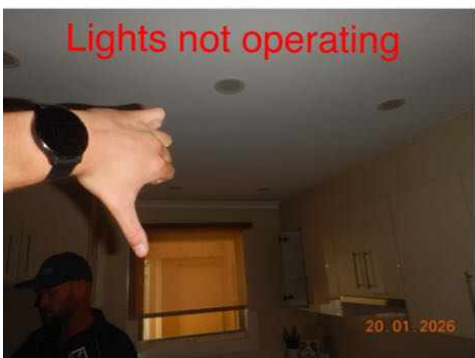
Building:	Building 1
Location:	All External Areas
Finding:	Untreated or non-durable timbers in a hazardous environment
Information:	To reduce the risk of timber pest attack it is essential that timber used in a hazardous environment (e.g. in direct contact with the ground or frequently exposed to damp conditions) is of sufficient durability and/or is adequately preservative treated. Additionally any timber lying around or timber stumps should be removed.

Untreated timbers in direct contact with the ground are likely to develop severe wood rot and/or fungal decay if left unattended creating attraction for subterranean termites to infest the timbers from surrounding areas.

If untreated or non-durable timbers are found to be in a hazardous environment it is highly advised that replacement of these building elements be performed as soon as possible to aid the protection of the property against termite / timber pest attack. Failing this close monitoring is recommended in an attempt to identify termite infestation at an early stage.

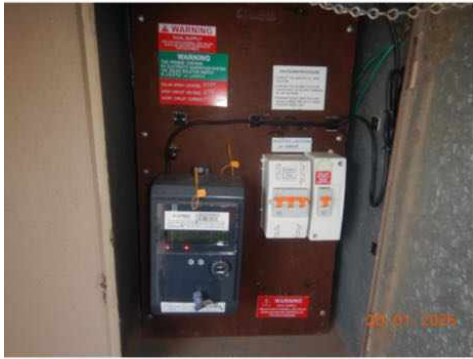
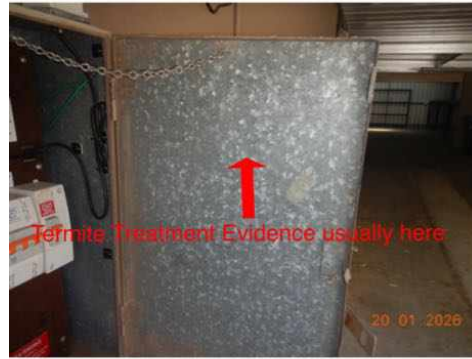
Finding 6.02

Building:	Building 1
Location:	All Areas
Finding:	Termite Management System - no evidence of a chemical installation
Information:	The application of a post-construction chemical termite barrier is highly recommended for all properties, particularly if live termite activity has been found on the site previously. Such barriers are highly effective in preventing termite attack on any timber building elements throughout the property.

At the time of inspection, it appeared as though no termite management system has been installed, with no evidence to suggest preventative works taking place.

The client may consider gaining further advice from a pest controller as to the costs and procedures involved with this application. It is recommended that obtaining such advice be a short-term priority.

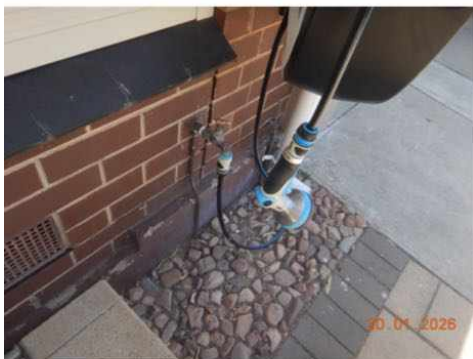
Finding 6.03

Building:	Building 1
Location:	All External Areas
Finding:	Air conditioner and or external tap - No drainage
Information:	Moisture around the perimeter of the building should be minimised to ensure that the area is kept dry and stable which in turn reduces the risk of water damage and termite infestation.

There appears to be no drainage points set up to the air conditioning unit, and or the external tap. While this is not a legal requirement it is recommended to reduce the risk of moisture related issues and the creation of an environment conducive to termite activity.

It is recommended that a licensed plumber be appointed to set up drainage in order to prevent such an environment from being created.

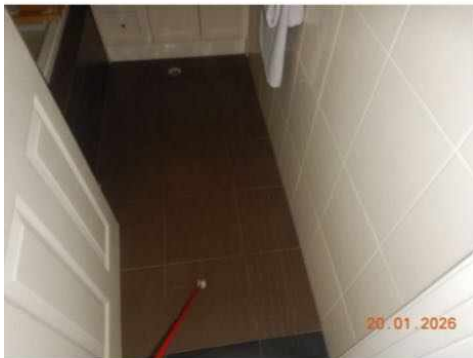
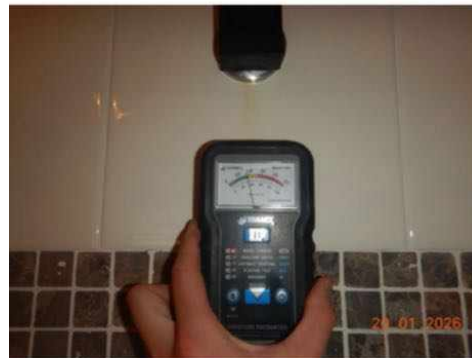
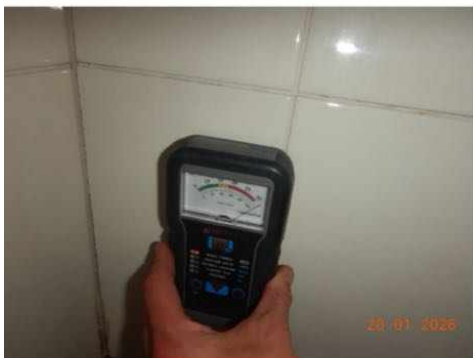
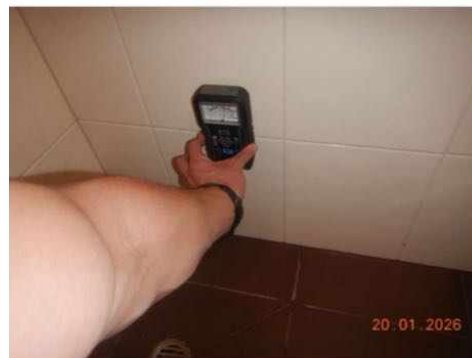
Finding 6.04

Building:	Building 1
Location:	Bathroom
Finding:	Shower damp - Sealant and grout
Information:	Damp is evident to sections of the lower wall to the shower alcove.

This defect is quite common, and is suspected to have been caused by moisture permeating or leaching through the tiling, grouting and sealant in this area, which shows evidence of deterioration.

There were no high moisture readings around the taps.

Unmanaged damp in the shower recess is likely to facilitate the formation and development of mould and fungi growth, decaying associated building materials and compromising their structural integrity of associated elements.

Damp conditions also create a conducive environment for termite infestation.

Consultation with a bathroom sealant specialist is advised immediately to make repairs to the shower alcove.

Always ensure that sealant and grout is in good condition to prevent any moisture issues occurring in the future.

Repair sealant and grout to bathroom

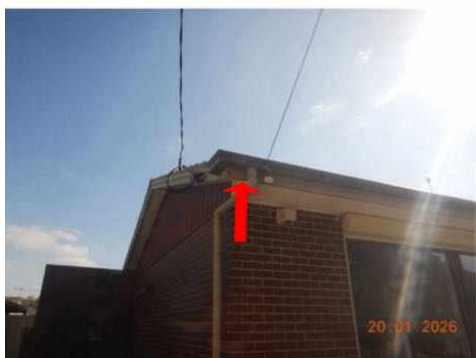
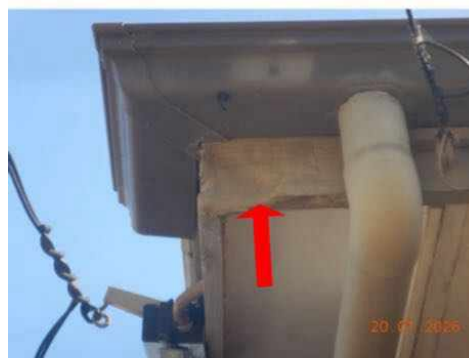
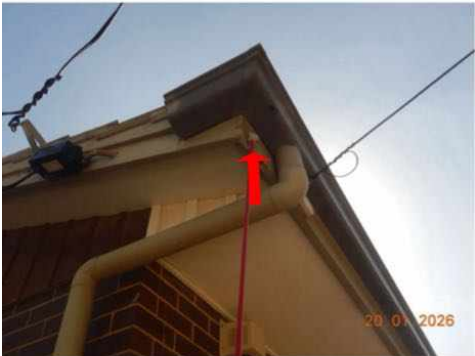
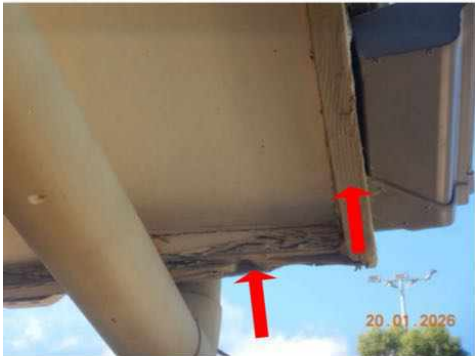
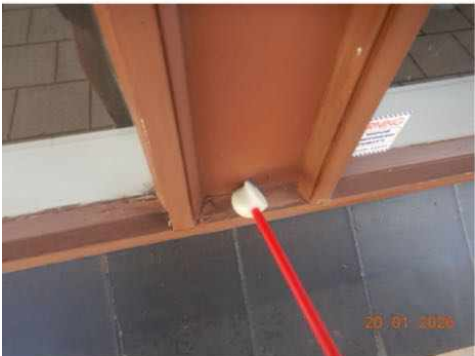
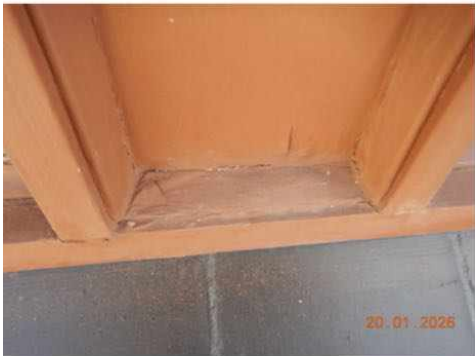
Building: Building 1
Location: All External Areas
Finding: Several elements - Wood rot
Information: Wood rot was found to be affecting several elements including sections of the external fascias, external pergola truss and a small section of the front window at the time of inspection.

Wood rot, also known as Fungal Decay, occurs when timbers and other cellulose building materials are exposed to damp conditions on an ongoing basis.

It is likely that this wood rot has developed as a result of frequent exposure to rain and other weather conditions however deteriorated guttering or building elements can be a contributing factor also.

It is also suspected that failure to maintain these elements over a prolonged period has resulted in them deteriorating at an accelerated rate, increasing their susceptibility to the development of wood rot.

Repair and/or replacement of affected areas may be a necessary step in protecting surrounding building elements from such deterioration. Remedial works should be performed by a registered builder at the clients disgression to prevent any further damage.

Replace damaged pergola trusses

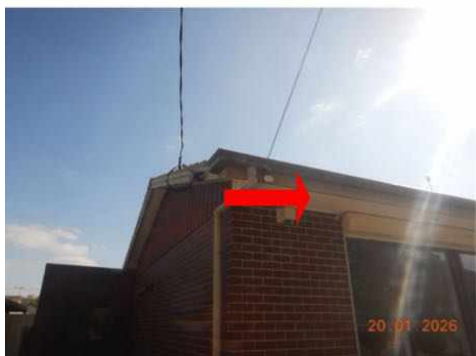
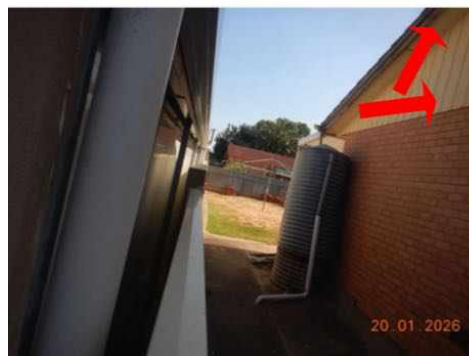
Building: Building 1
Location: All External Areas
Finding: Asbestos - Suspected ACM Identified on Site
Information: Reporting on Asbestos is outside the Scope of this Report. This suspected defect is highlighted as a caution only. We suspect, based on our experience in the building industry, that there is a higher risk of several building element containing asbestos as documented in photos. This is not necessarily the full extent.

As Asbestos Reporting is outside the scope of this report, we advise that you consider a separate Asbestos Inspection and Condition Audit, which can include the taking of samples for definitive confirmation of the presence of Asbestos.

In the interim, the client is advised to act with caution, especially when considering any damage to building materials general wear and tear renovations extensions demolition and general maintenance activities due to the suspected presence of Asbestos.

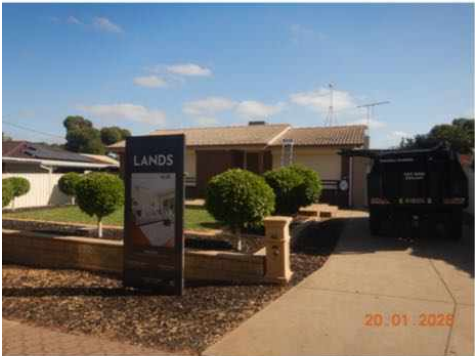
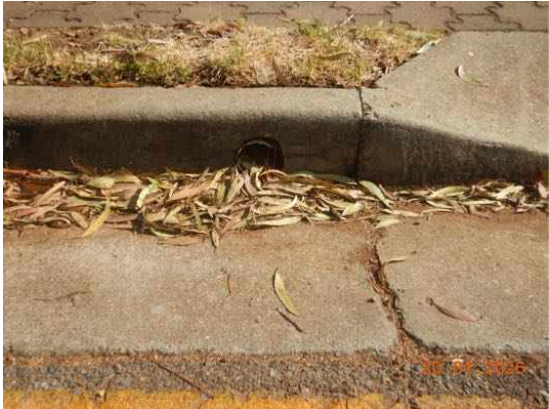
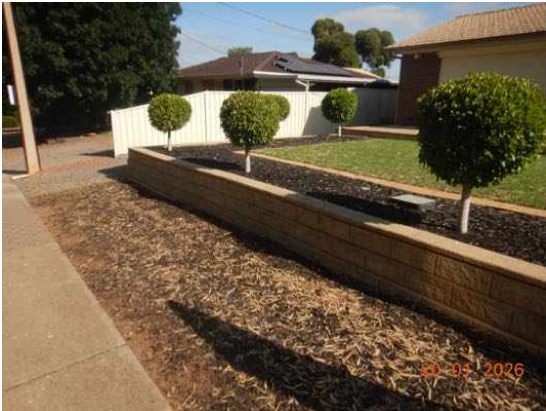
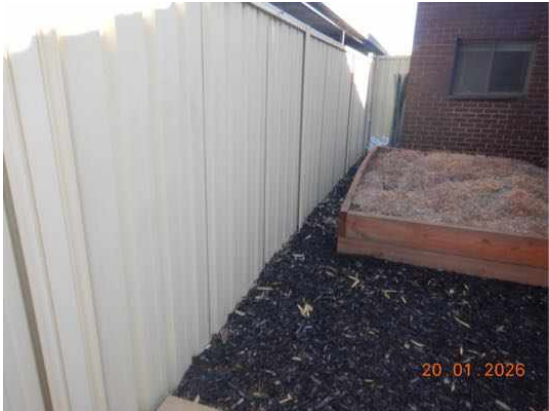
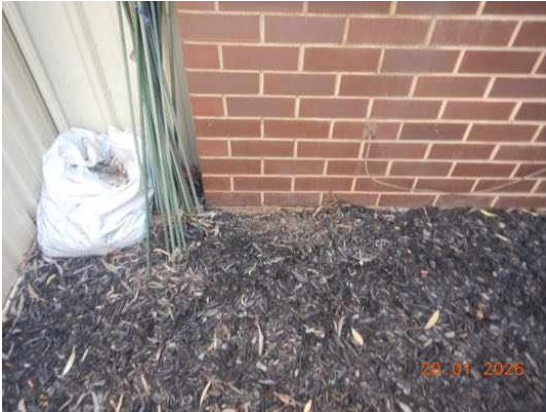
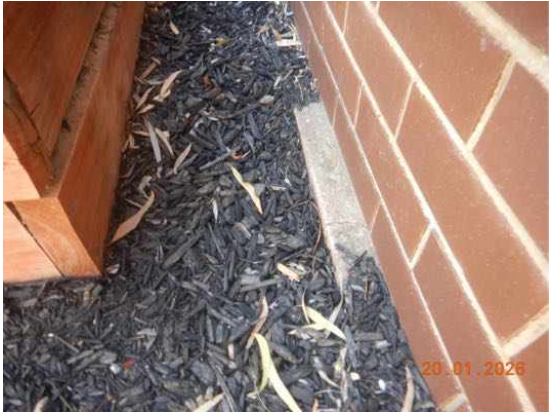
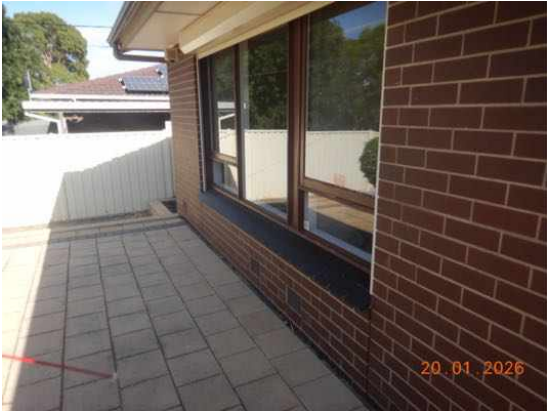
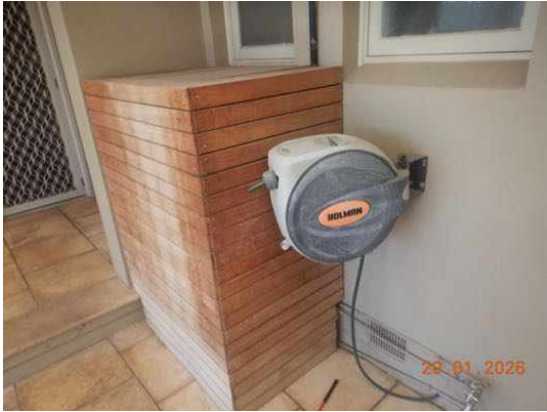
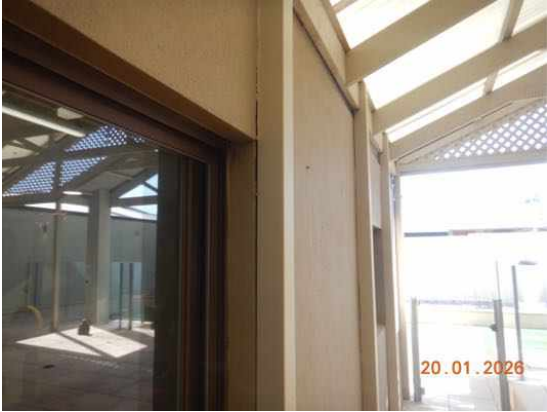
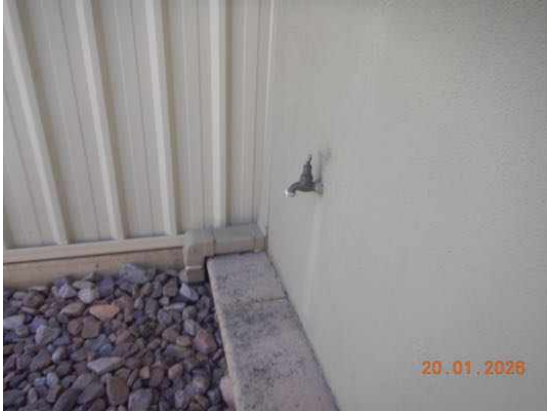
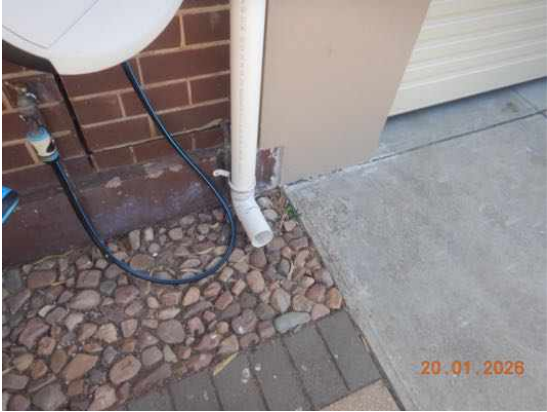
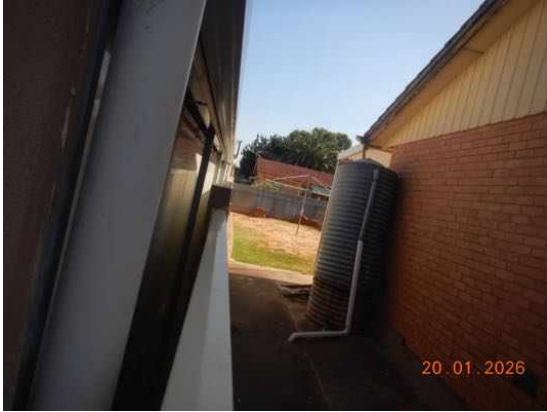
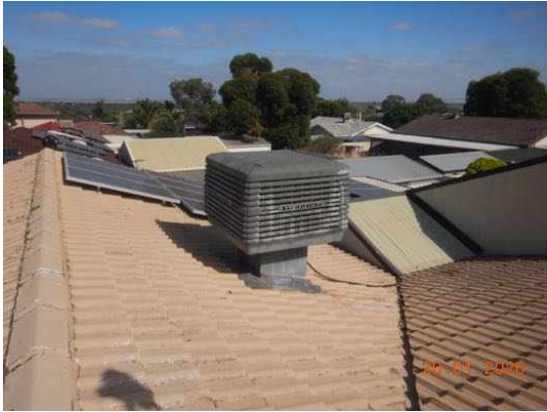
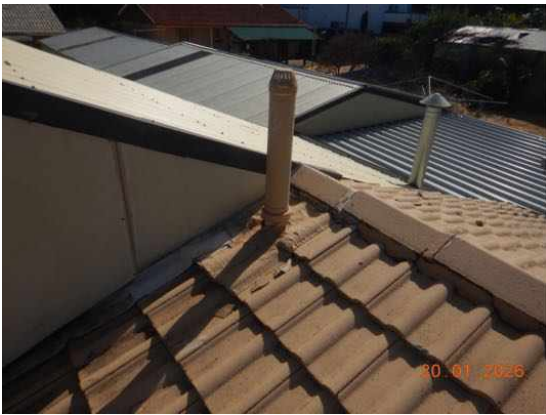
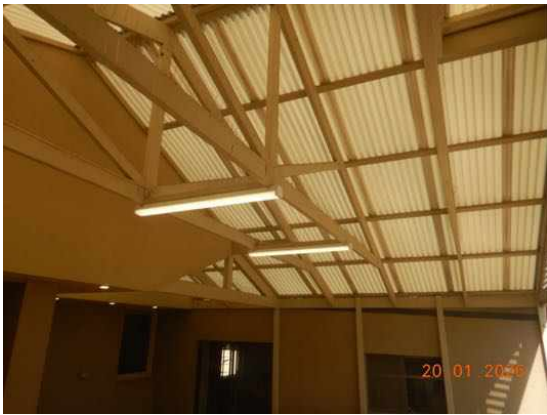
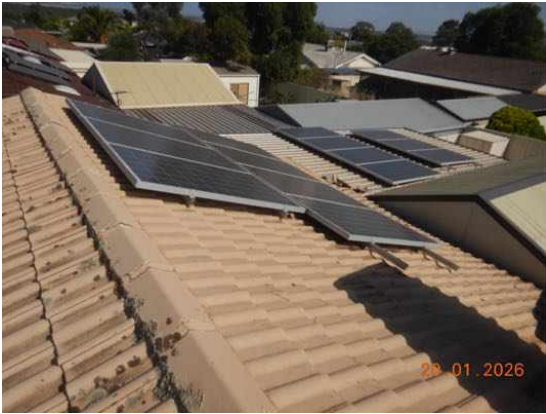
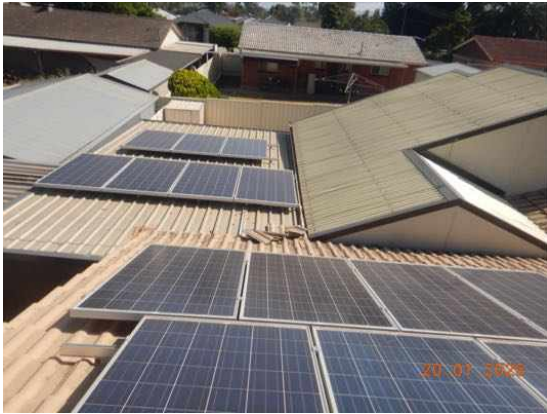
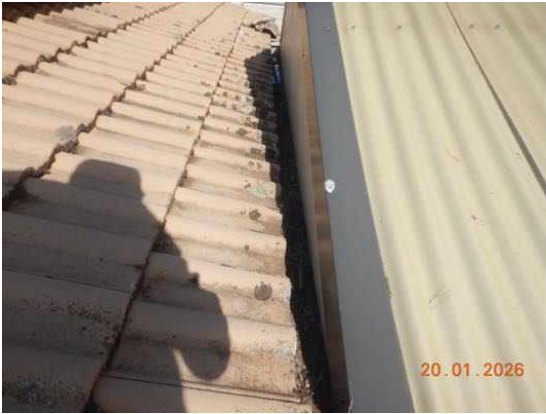
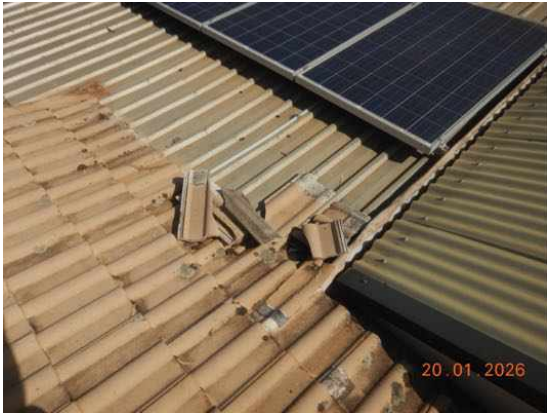
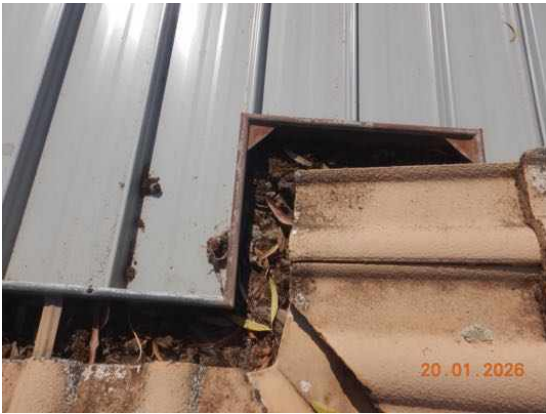
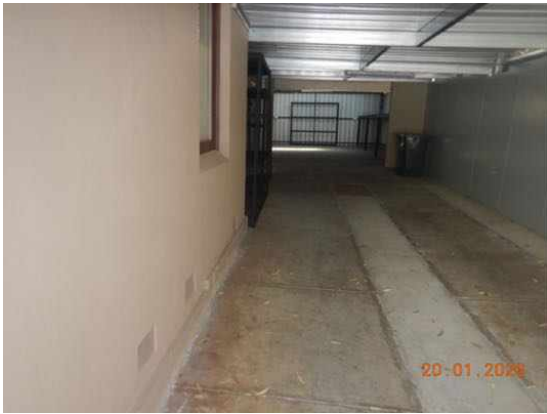
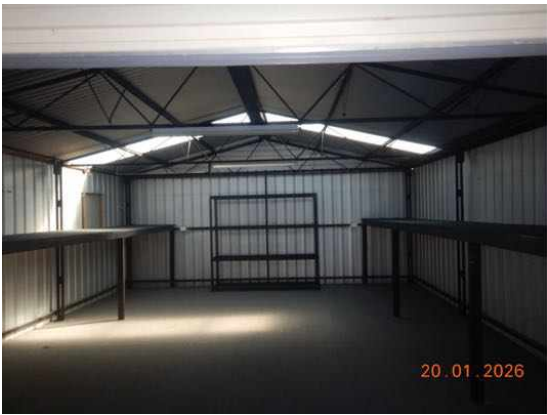
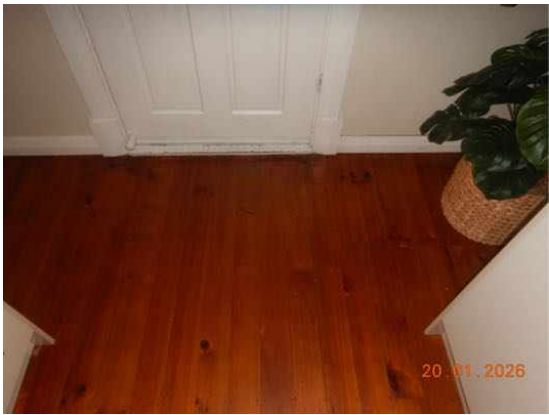
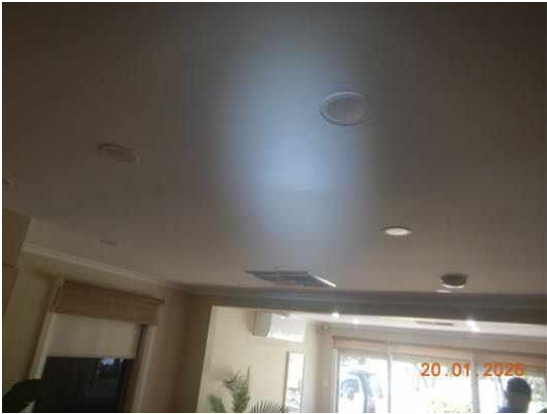
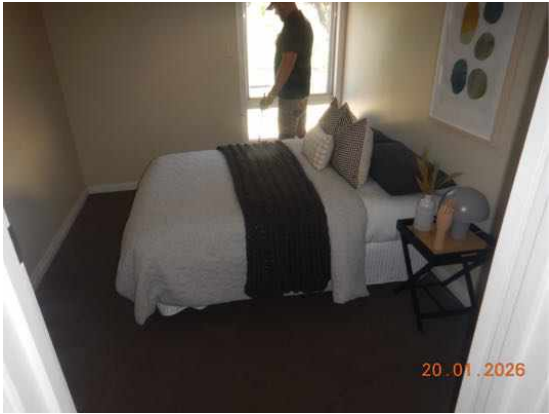
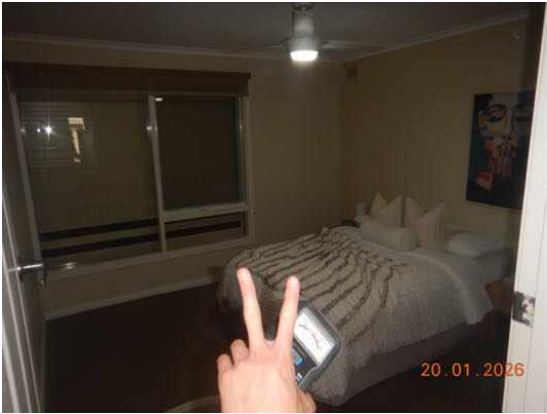
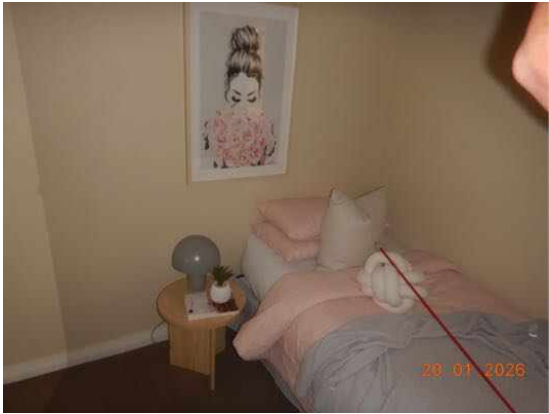
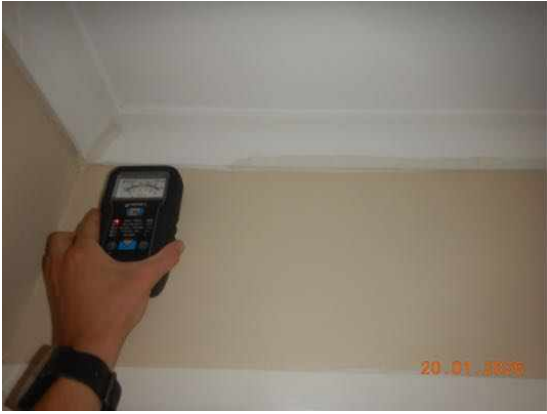
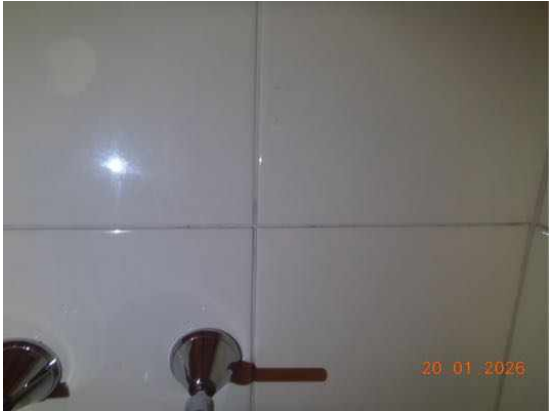
Building: Building 1
Location: All Areas
Finding: Additional Photos - Obstructions and Limitations
Information: These photographs are an indication of the obstructions and limitations which impeded full inspection of the property at the time of inspection.

These obstructions can hide an array of defects and should be removed to allow full inspection to be carried out.

A re-inspection is recommended once the areas are made accessible.
