Building and Timber Pest Inspection Report

Inspection Date: Wed, 25 Feb 2026

Property Address: 8 King Rock Road, Austral, NSW 2179

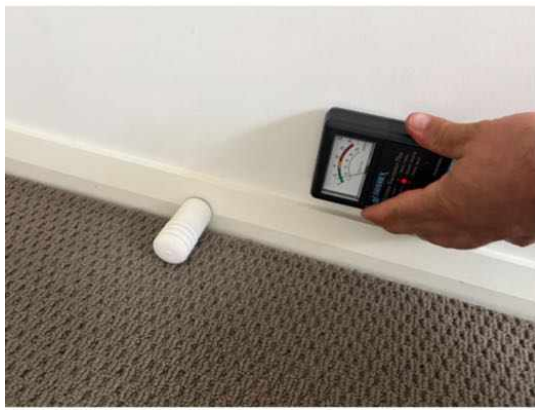
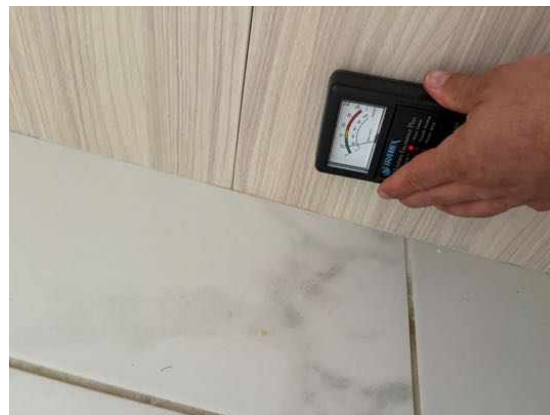
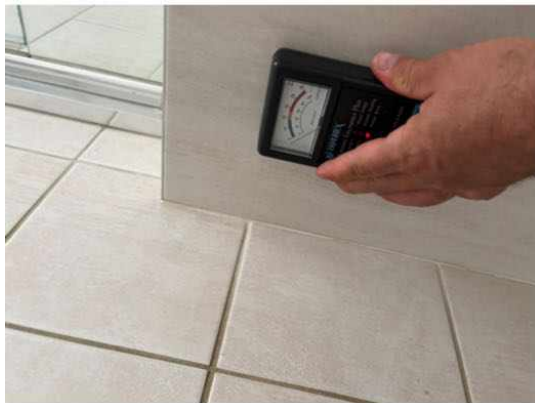
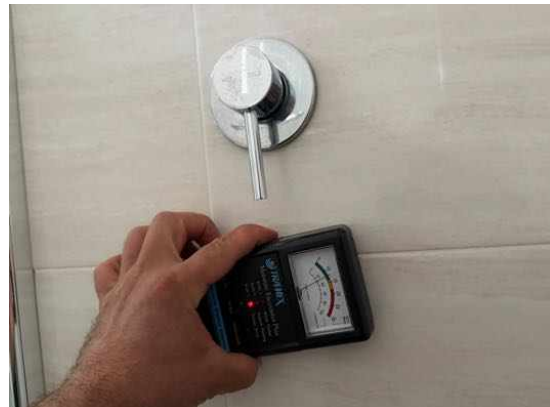
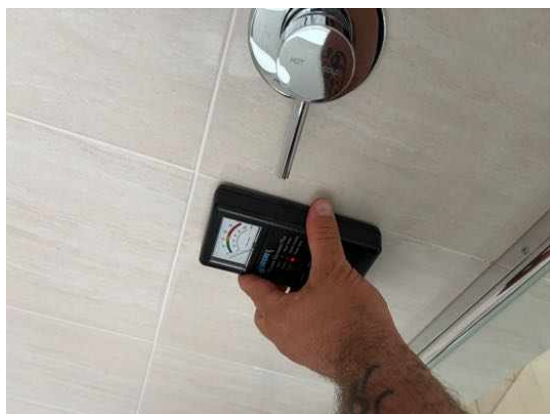
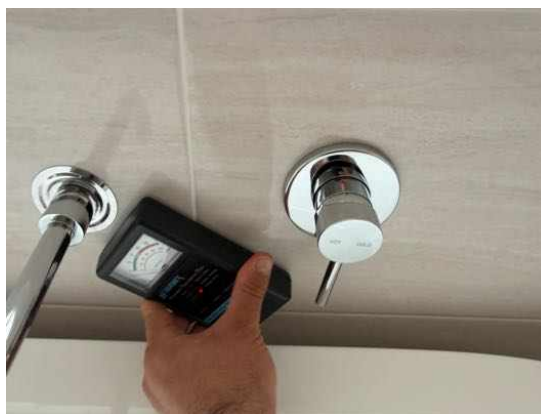
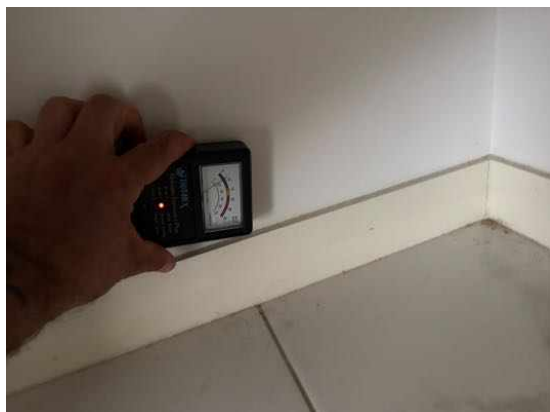
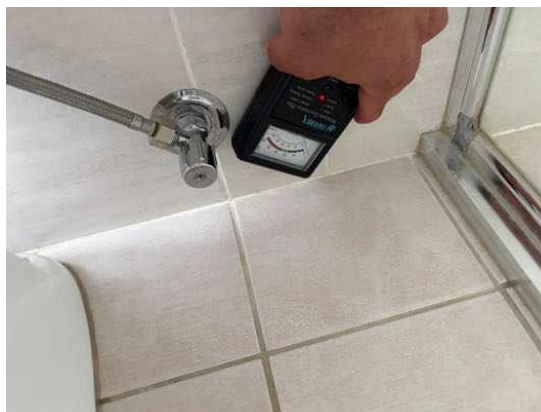
Building: Main Building
Location: All Areas
Finding: Moisture metre
Information: During the inspection the property was checked for moisture using a moisture metre.

This is for information only.

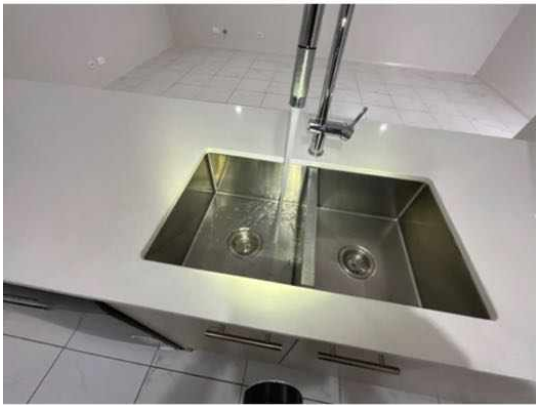
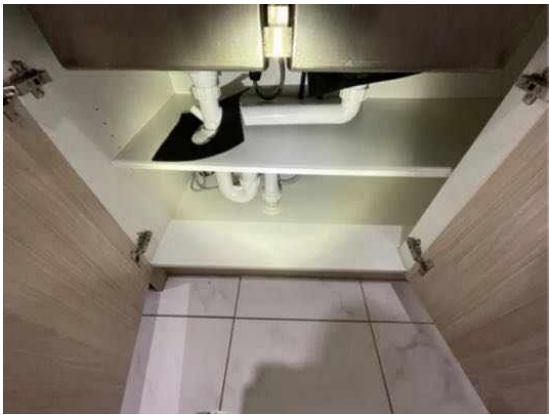
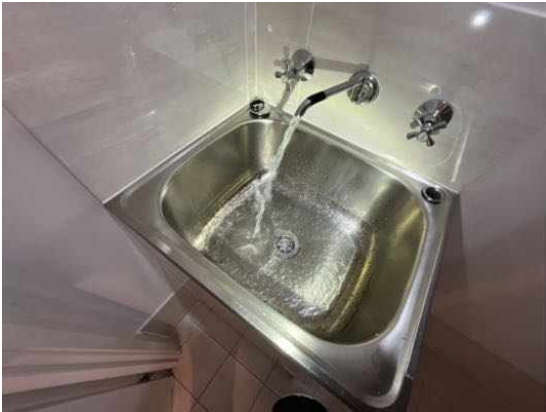
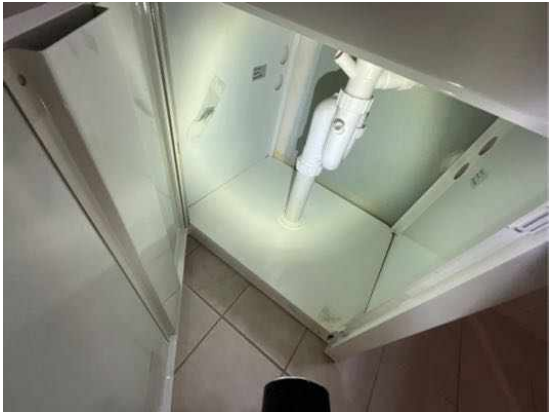
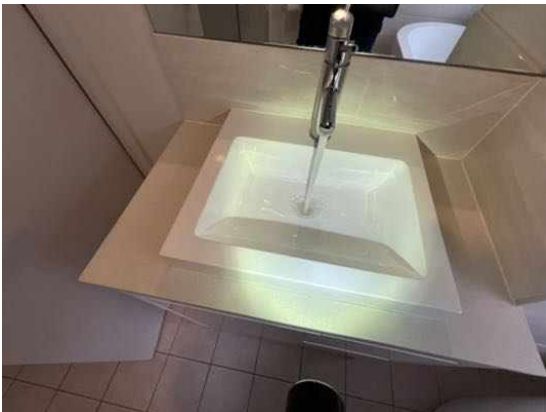
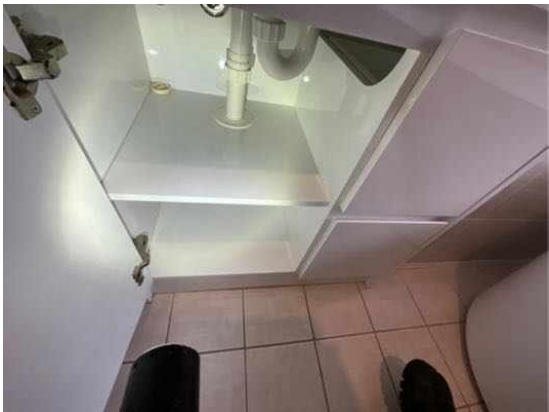
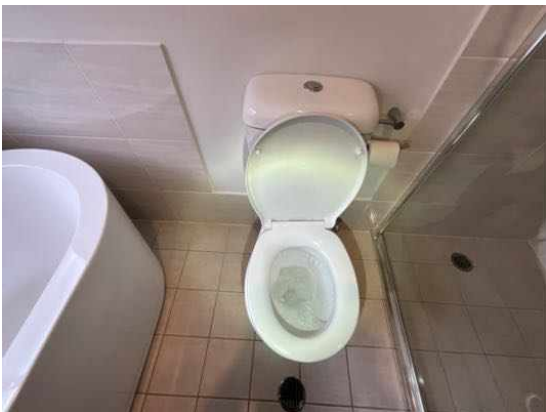
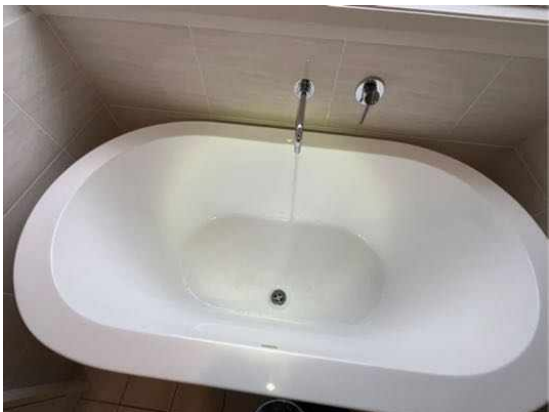
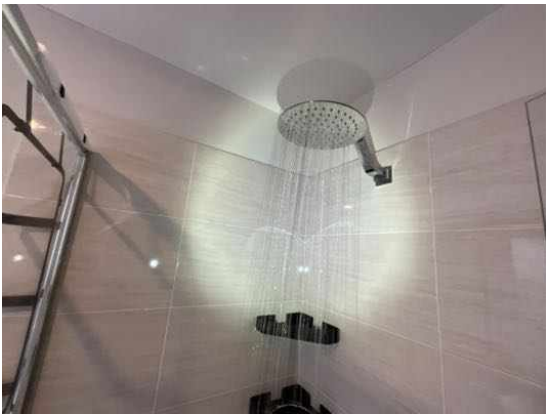
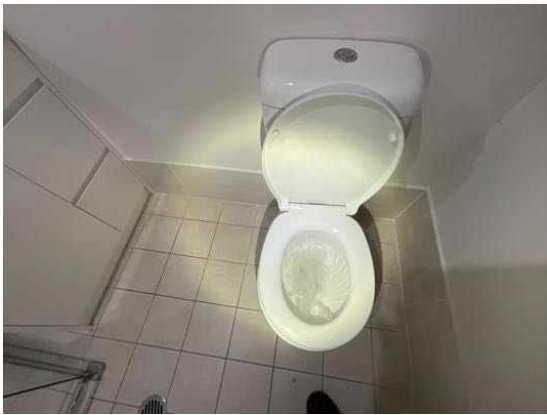
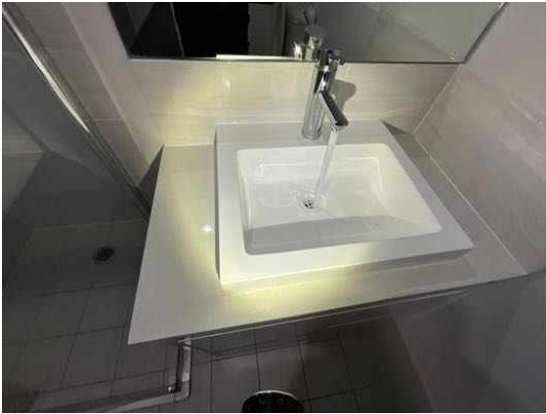
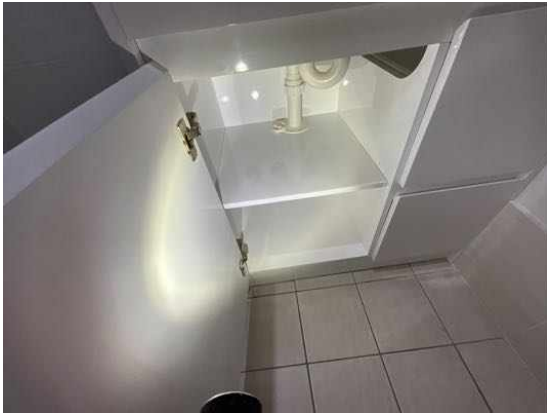
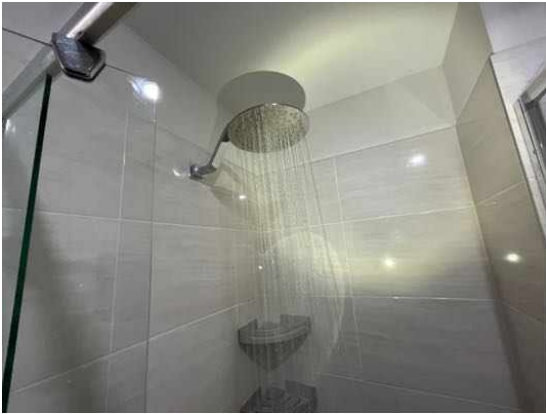
Building: Main Building
 Location: All Wet Areas
 Finding: Waterproofing
 Information:

All taps, mixers and toilets were tested for operation, except for those obstructed. The waterproofing to the shower recess was assessed by checking the walls in and around the shower recess for varying moisture content. There were no significant variations across the tested areas. No sign of recent water damage was evident upon a visual inspection of the surrounding walls, where the visual nature of the inspection was possible.

Consequently, there is no conclusive evidence of any current shower recess leakage other than those which may have already been mentioned earlier in this report. It is reasonable to assume the shower waterproofing is sound. Note that if the shower is not used, or has not been used for some time, moisture readings would not vary significantly and this can lead to erroneous results. It is not possible under the visual inspection criteria (under which a prepurchase inspection is carried out) to categorically determine if there are leaks. If a more accurate assessment is required, a special purpose inspection should be requested. Alternatively, the assumption should be made that the shower may leak.

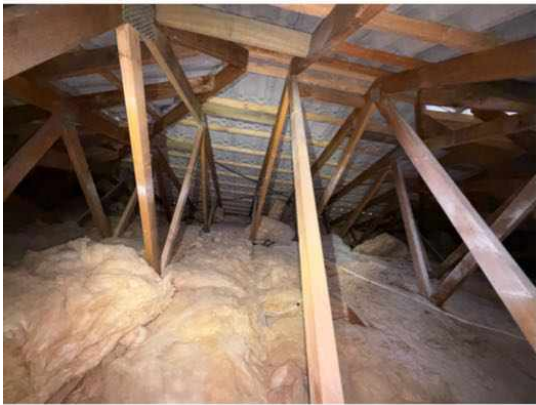
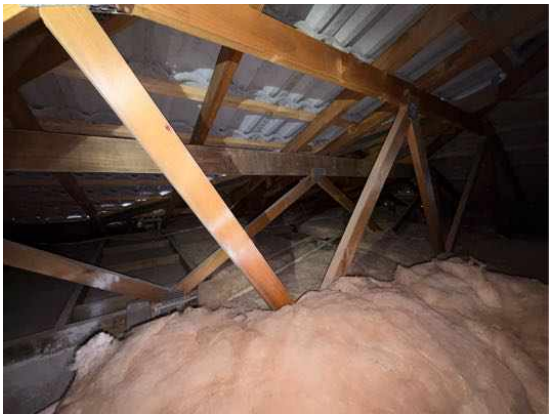
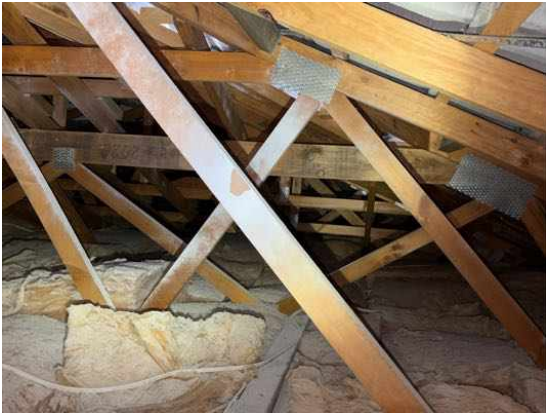
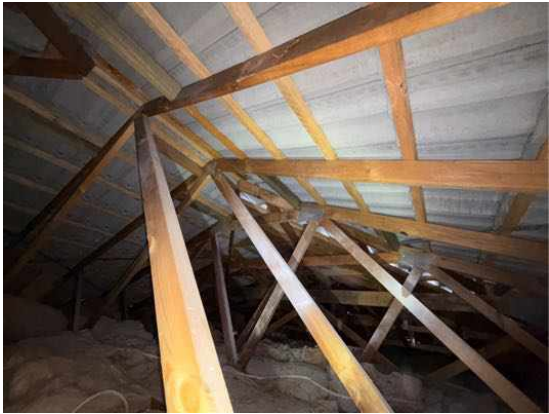
Building: Main Building
Location: Roof Void
Finding: Additional Photos
Information:

Additional photos are provided for your general reference.

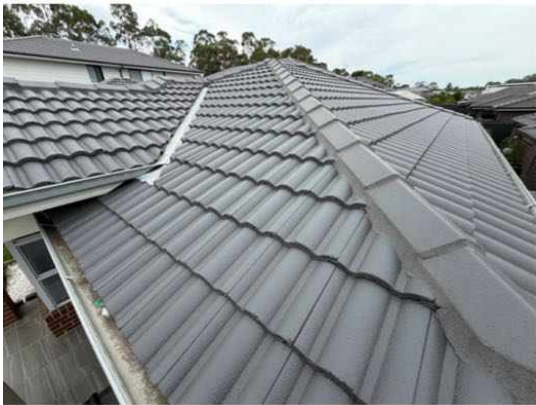
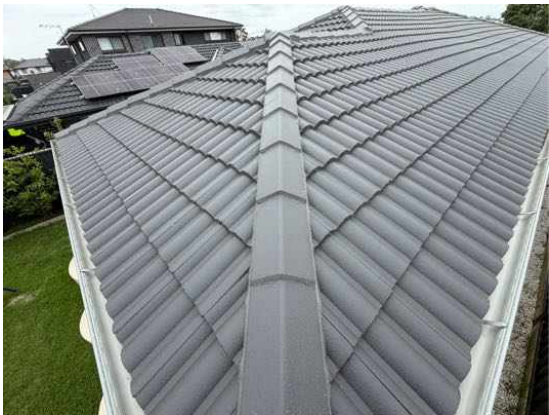
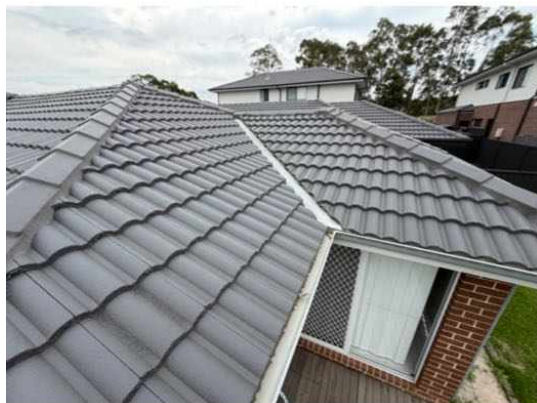
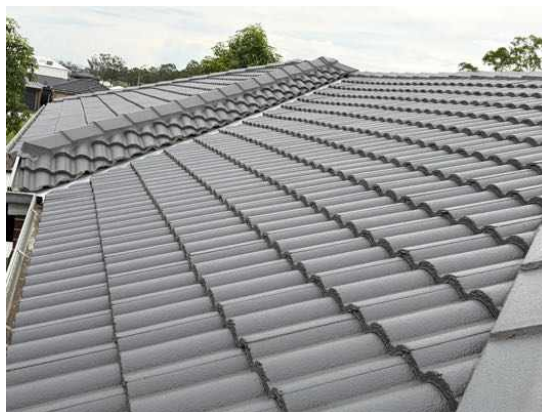
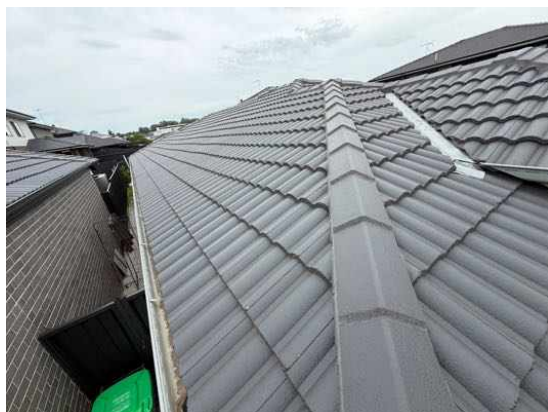
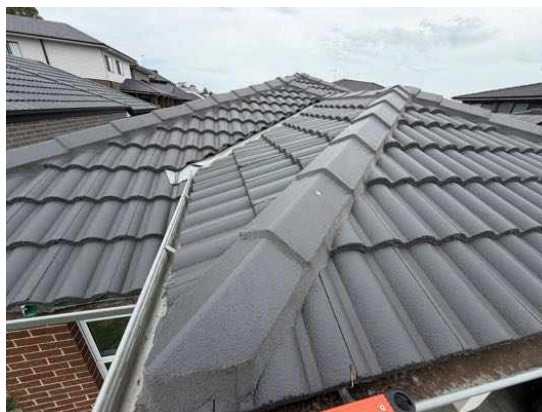
Building: Main Building
Location: Roof Exterior
Finding: Additional Photos
Information:

Additional photos are provided for your general reference.

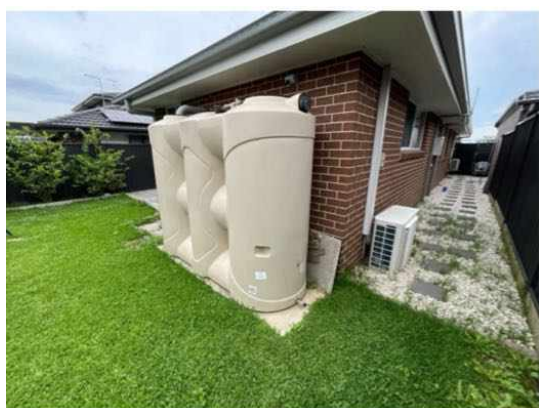
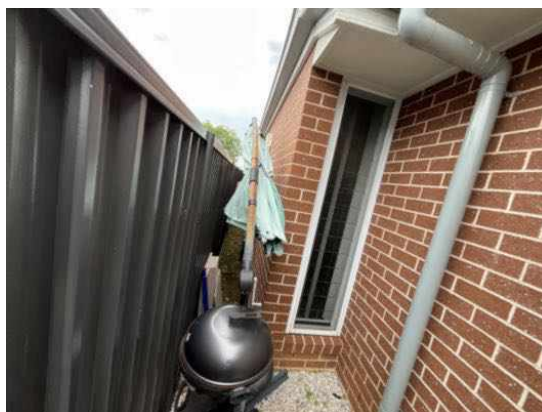
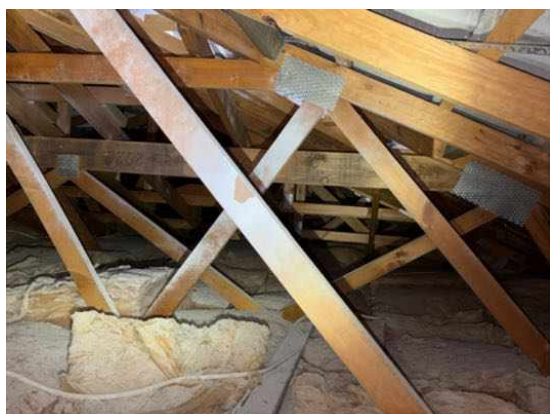
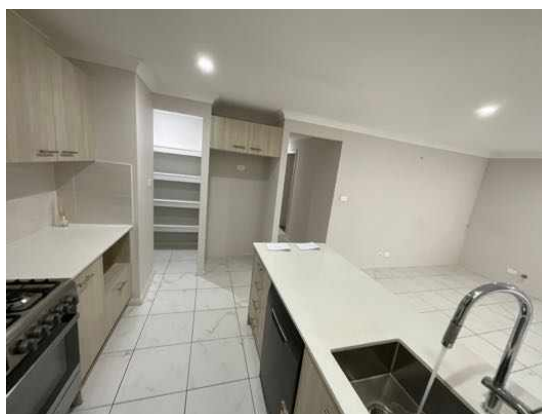
Building: Main Building
 Location: All Areas
 Finding: Additional Photos - Obstructions and Limitations
 Information:

These photographs are an indication of the obstructions and limitations which impeded full inspection of the property at the time of inspection. These obstructions can hide an array of defects and should be removed to allow full inspection to be carried out. A re-inspection is recommended once the areas are made accessible.

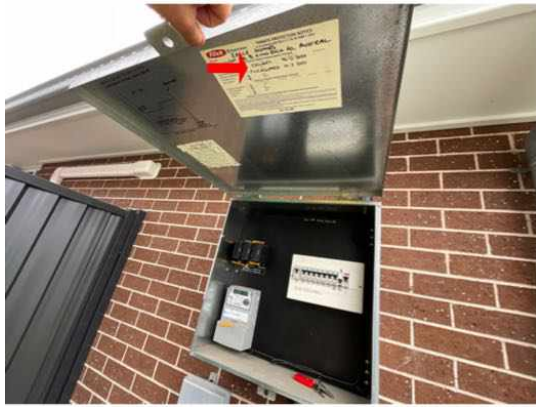
The following items were noted as - Evidence of a previous termite management program

Where a Termite Management System has been identified you should refer to the type of barrier date of installation warranty conditions and any documentation provided by a builder or past owner. Consult the company who installed the barrier to confirm whether the system is still under warranty.

Most chemical termite management systems expire and require replenishment and all physical systems are primarily designed to prevent concealed entry.
