Building and Timber Pest Inspection Report

Inspection Date: Fri, 6 Mar 2026

Property Address: 52 Old Punt Rd, Seelands NSW 2460,
Australia

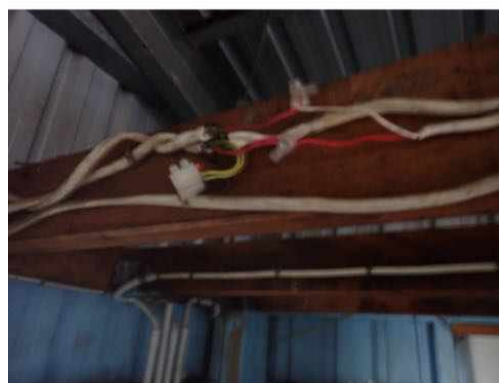
Finding 1.01

Building:	Shed
Location:	Shed
Finding:	Exposed Electrical Wiring to Shed
Information:	Exposed electrical wiring was identified to the shed at the time of inspection. Exposed wiring can present a safety hazard and may be susceptible to damage from weather, impact, or pests if not properly protected. This condition may be due to previous alterations, deterioration, or incomplete installation. It is recommended that a qualified electrician assess the wiring and carry out repairs or install appropriate protection and securing as required to ensure the electrical installation is safe and compliant. Repairs should be carried out as deemed necessary.

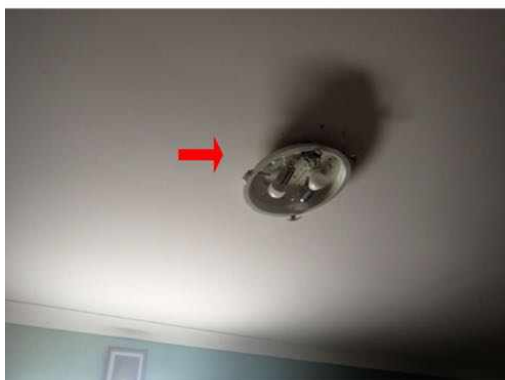
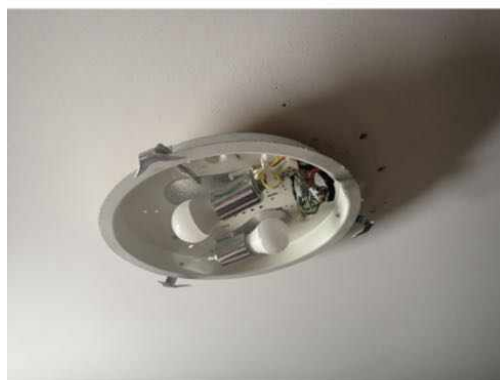
Finding 1.02

Building:	Main Building
Location:	Kitchen
Finding:	Loose Kitchen Light Fitting with Missing Cover
Information:	A light fitting in the kitchen was found to be loose and missing its protective cover at the time of inspection. Loose or incomplete light fittings may present a safety hazard and can allow exposure to electrical components. This condition may be due to previous damage, deterioration, or incomplete installation. It is recommended that a qualified electrician inspect the fitting and carry out repairs or replacement as required to ensure the light fitting is secure and safe to operate. Repairs should be carried out as deemed necessary.

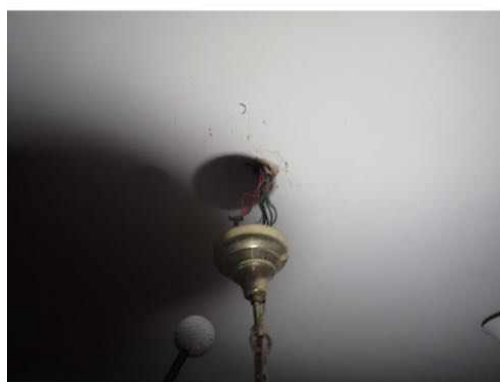
Finding 1.03

Finding: Loose Light Fitting in Bedroom

Information: A light fitting in the bedroom was found to be loose at the time of inspection. Loose light fittings may present a safety hazard and can lead to damage to the fitting or associated wiring if not secured. This condition may be due to deterioration of fixings, previous alterations, or incomplete installation. It is recommended that a qualified electrician inspect the fitting and secure or repair it as required to ensure it is safe and properly installed. Repairs should be carried out as deemed necessary.

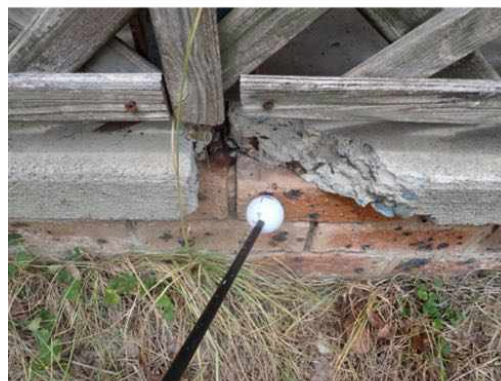
Finding 2.01

Finding: Damage to Edge of Concrete Slab at Left-Hand Side of Patio Area

Information: Damage was identified to the edge of the concrete slab on the left-hand side of the patio area at the time of inspection. Edge damage to concrete can occur due to impact, ground movement, or general wear over time and may worsen if left

unaddressed. It is recommended that a qualified concreter assess the affected area and carry out repairs as required to prevent further deterioration and maintain the integrity of the concrete. Repairs should be carried out as deemed necessary.

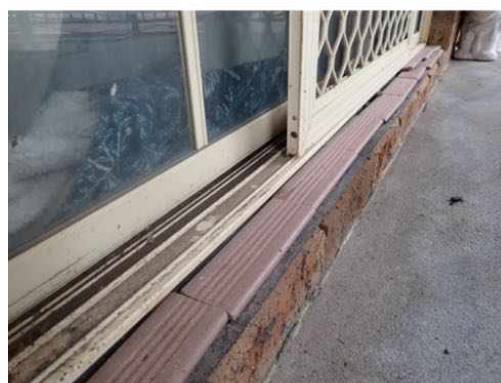
Finding 2.02

Building:	Main Building
Location:	Patio area
Finding:	Loose and Poorly Laid Sill Tiles to Bedroom Sliding Door Threshold
Information:	Loose and poorly laid sill tiles were identified to the bedroom sliding door threshold at the time of inspection. Movement of tiles in this location may allow water penetration and can lead to further deterioration of the tiles and surrounding materials if not addressed. This condition may be due to poor installation, inadequate adhesive, or general wear over time. It is recommended that a qualified tiler assess the affected area and re-fix or replace the tiles as required to ensure they are properly secured and sealed. Repairs should be carried out as deemed necessary.

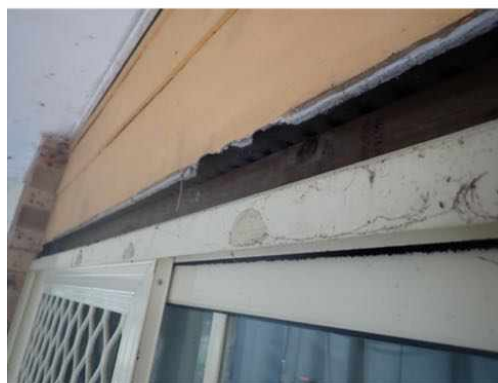
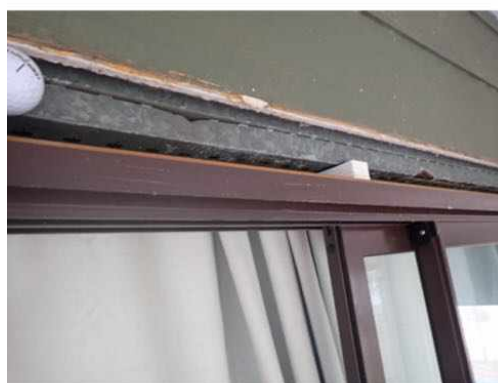
Finding 2.03

Building:	Main Building
Location:	Patio area
Finding:	Missing Sliding Door Architraves Below External Cladding
Information:	Architraves were missing below the sliding door where it meets the external cladding

at the time of inspection. Missing trim elements may allow moisture, pests, and debris to enter gaps around the door frame and may contribute to deterioration of surrounding building materials if left unaddressed. This condition may be due to previous alterations, incomplete installation, or removal of the trim. It is recommended that a qualified carpenter install appropriate architraves or trim to the affected area to provide proper finishing and protection to the door opening. Repairs should be carried out as deemed necessary.

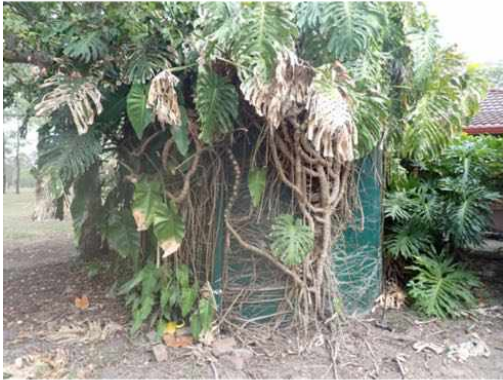
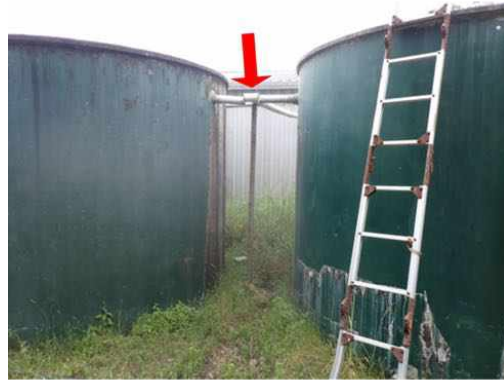
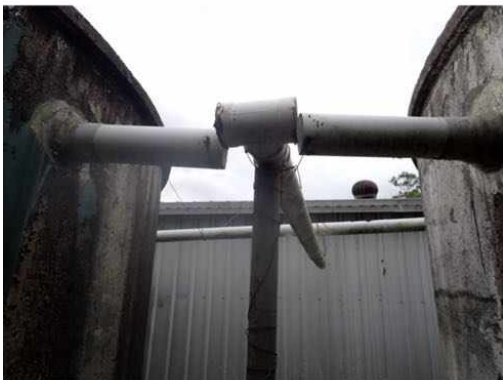
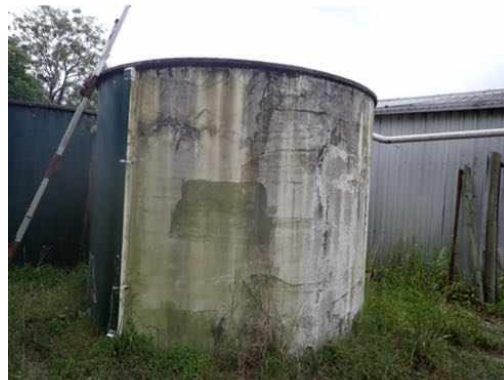
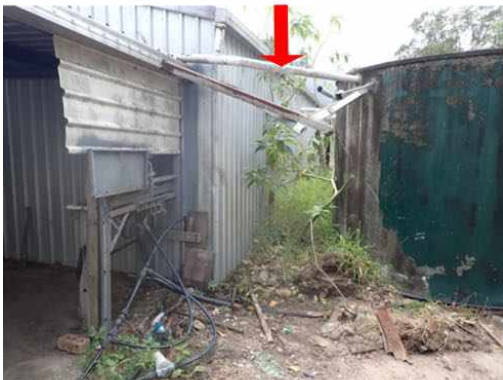
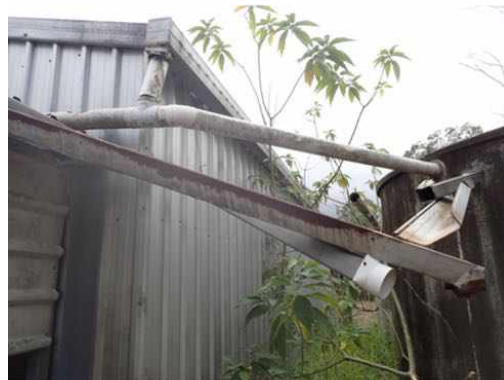
Finding 2.04

Building:	Yard
Location:	Water tanks
Finding:	Water Tanks in Average Condition – Plumbing Connections and Vegetation Require Attention
Information:	The water tanks on the property were generally found to be in average condition at the time of inspection, with the exception of the tank located near the green shed which appeared to be relatively new. The plumbing connections to the tanks were observed to be in poor condition and require attention. In addition, vegetation overgrowth was noted around the tanks on the right-hand side of the building, which may restrict access for maintenance and contribute to deterioration of the tanks and associated plumbing. It is recommended that a qualified plumber repair or replace the plumbing connections as required, and that vegetation around the tanks be cleared to allow proper access and maintenance. Repairs and maintenance should be carried

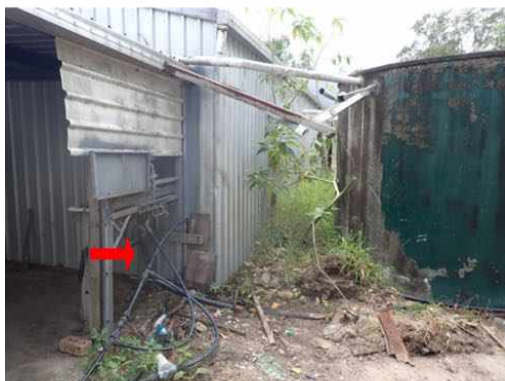
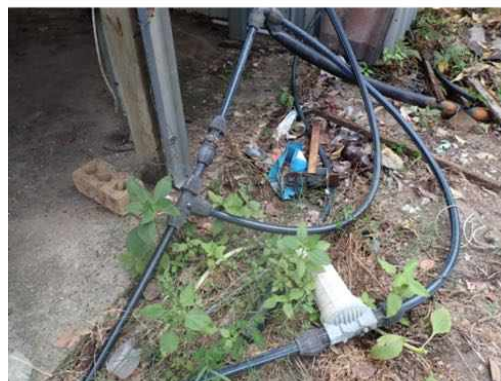
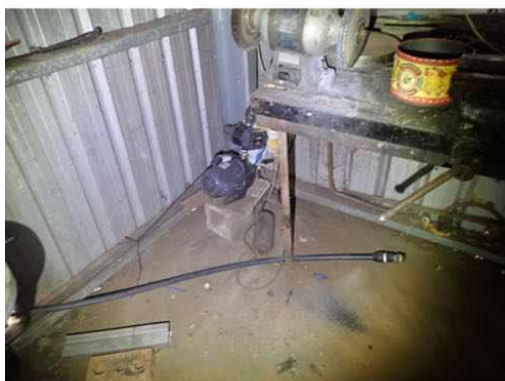
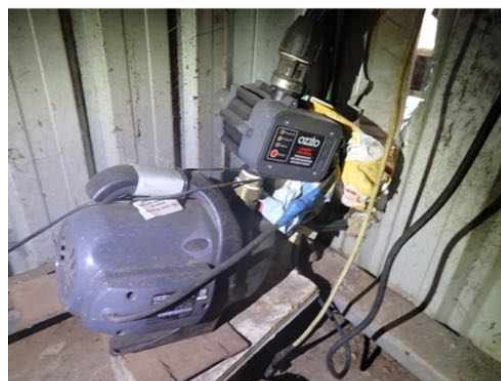
Finding 2.05

Building:	Yard
Location:	Shed
Finding:	Poorly Installed General Water Supply Plumbing Including Water Pump
Information:	The general water supply plumbing on the property, including the water pump installation, appeared to be poorly installed at the time of inspection. Poorly installed plumbing can lead to leaks, reduced performance, and premature failure of plumbing components if not rectified. This condition may be due to previous unprofessional installation or alterations to the plumbing system. It is recommended that a qualified

plumber assess the installation and carry out repairs or reinstallation as required to ensure the system is properly fitted and functioning as intended. Repairs should be carried out as deemed necessary.

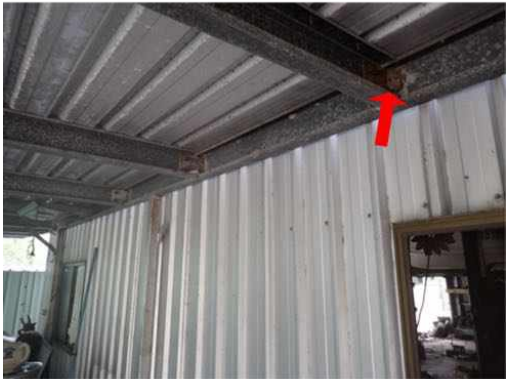
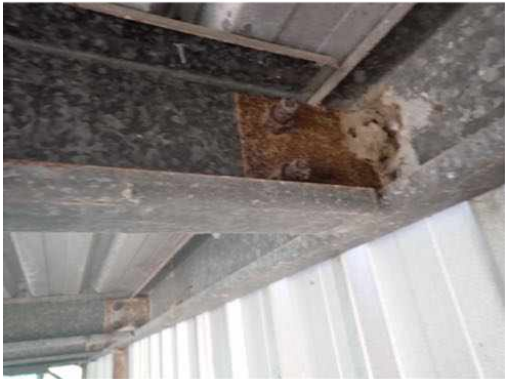
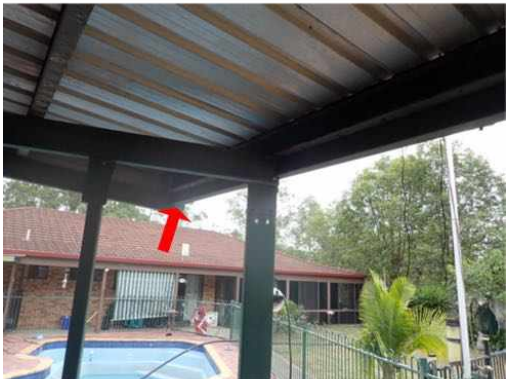
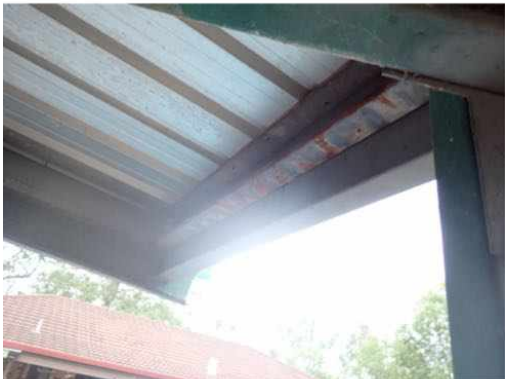
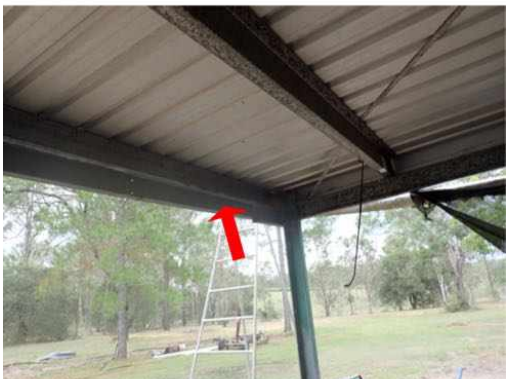
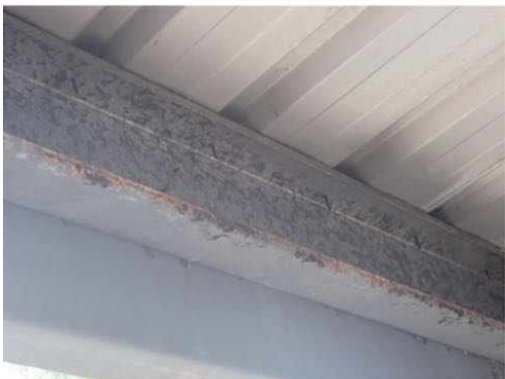
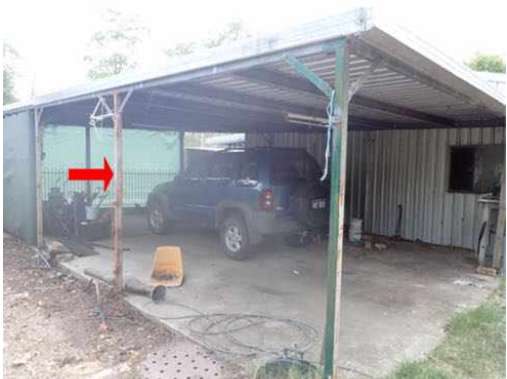
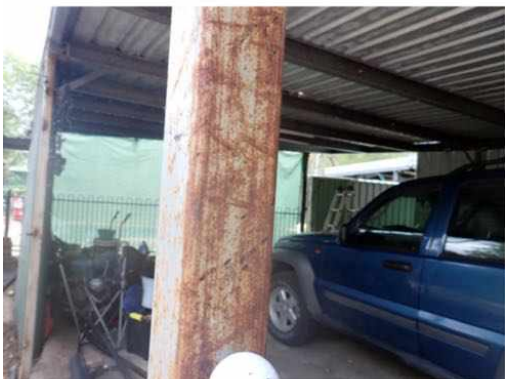
Finding 2.06

Building:	Carport
Location:	Carports
Finding:	Surface Rust to Carport Structure at Multiple Locations
Information:	Surface rust was identified to the carport structure at multiple locations at the time of inspection. Surface corrosion to steel elements can occur over time due to exposure to weather and moisture and may worsen if not addressed. It is recommended that a qualified painter or metal contractor clean, treat, and apply appropriate protective coatings to the affected areas to help prevent further corrosion and deterioration. Maintenance and repairs should be carried out as deemed necessary.

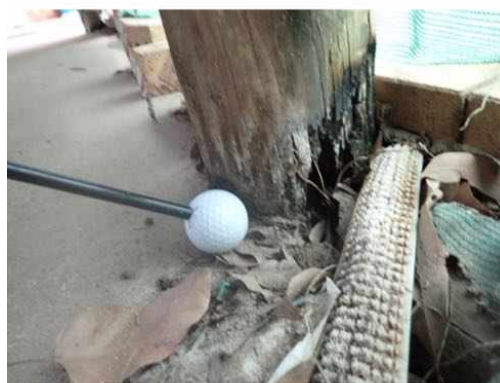
Finding 2.07

Building:	Carport
Location:	Carports
Finding:	Wood Rot to Bottom of Timber Carport Posts
Information:	Wood rot was identified to the bottoms of the timber posts supporting the carport at the time of inspection. Deterioration to structural timber elements can reduce the strength and durability of the posts and may worsen if left unaddressed. This condition is commonly caused by prolonged moisture exposure and timber being in close proximity to ground level. It is recommended that a qualified carpenter or builder assess the affected posts and carry out repairs or replacement as required. Repairs should be carried out as deemed necessary.

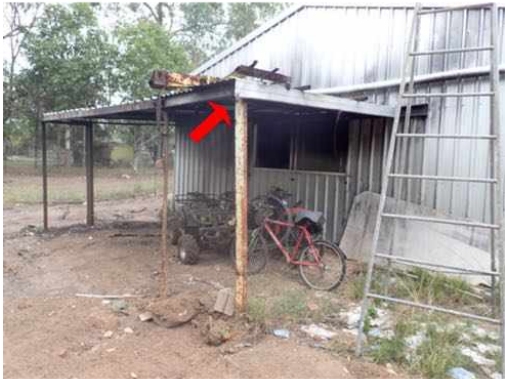
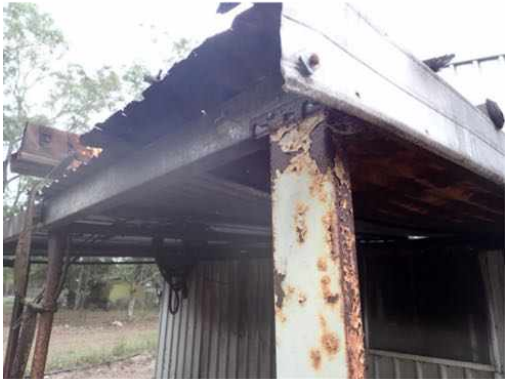
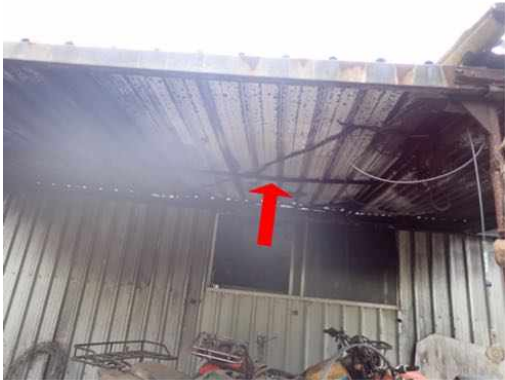
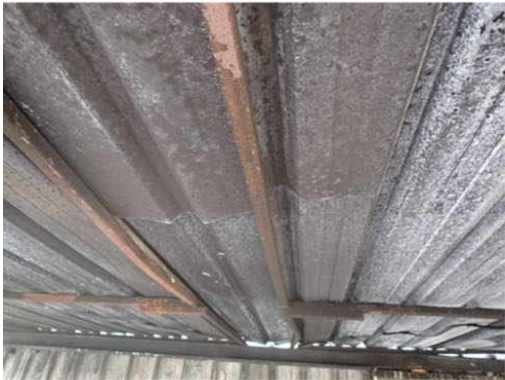
Finding 2.08

Building:	Shed
Location:	Lean to roof on the left hand side of main shed
Finding:	Possible Fire Damage to Lean-to Roof on Left-Hand Side of Main Shed
Information:	What appeared to be fire damage was identified to the lean-to roof on the left-hand side of the main shed at the time of inspection. Damage of this nature may affect the integrity and durability of the roofing materials and supporting structure. The extent of the damage could not be fully determined during the visual inspection. It is recommended that a qualified builder assess the affected roof structure and carry out repairs or replacement of any damaged materials as required to ensure the roof structure remains safe and serviceable. Repairs should be carried out as deemed necessary.

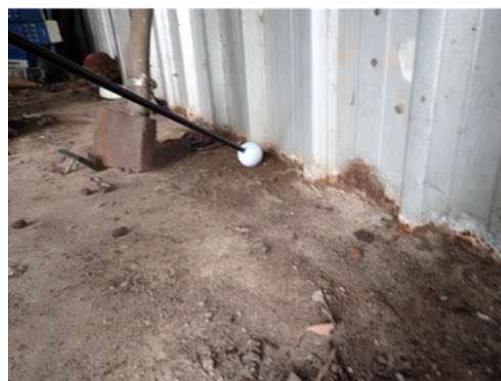
Finding 2.09

Building: Shed
Location: Shed
Finding: Rust to Bottom of Shed Wall Cladding
Information: Rust was identified to the bottom of the shed wall cladding at the time of inspection. Corrosion to metal cladding commonly occurs in lower sections where moisture, debris, or ground contact may be present and may worsen over time if not addressed. Continued deterioration can lead to weakening of the cladding and potential openings that allow moisture ingress. It is recommended that a qualified builder or metal contractor assess the affected areas and carry out repairs or replacement of the rusted sections as required. Repairs should be carried out as

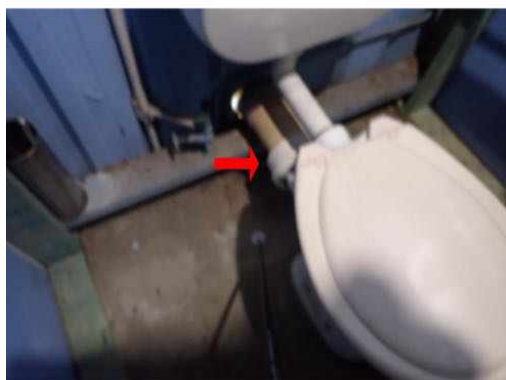
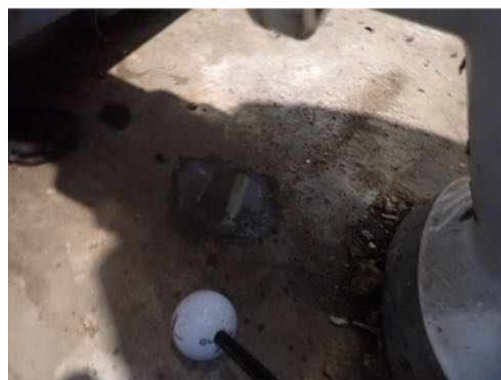
Finding 2.10

Building:	Shed
Location:	Shed
Finding:	Leaking Toilet in Shed When Flushed
Information:	The toilet located in the shed was observed to leak when flushed at the time of inspection. Plumbing leaks can lead to water wastage, moisture-related damage, and potential deterioration of surrounding building materials if not addressed. The leak may be due to worn seals, faulty fittings, or deterioration of internal cistern components. It is recommended that a qualified plumber inspect the toilet and carry out repairs or replacement of defective components as required to ensure the fixture is functioning correctly. Repairs should be carried out as deemed necessary.

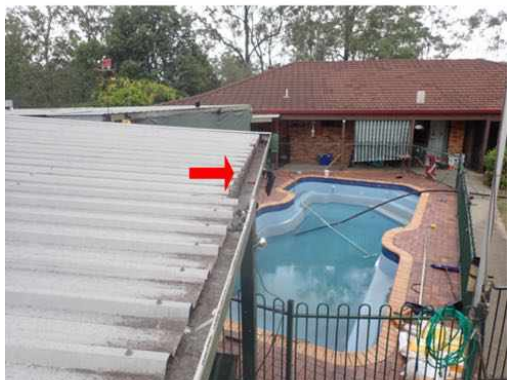
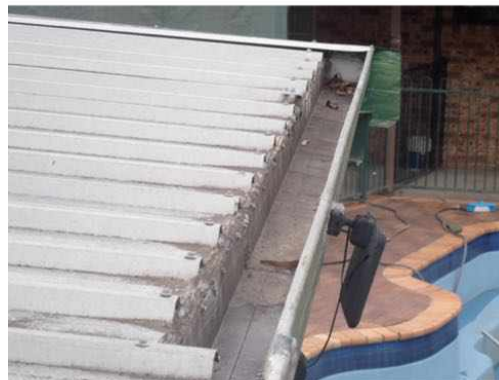
Finding 2.11

Building:	Carport
Location:	Carport
Finding:	Carport Roof Cladding Cut Short of Gutter
Information:	A section of the carport roof cladding was observed to be cut short of the gutter at the time of inspection. Roof cladding should generally discharge directly into the gutter to ensure rainwater is effectively captured and directed to the stormwater system. Where

the cladding terminates short of the gutter, water may overshoot the gutter and discharge onto surrounding building elements, which may lead to moisture-related deterioration over time. This condition may be due to poor installation or previous alterations. It is recommended that a qualified roofer or builder assess the affected area and carry out rectification works as required to ensure the roof cladding correctly directs water into the gutter. Repairs should be carried out as deemed necessary.

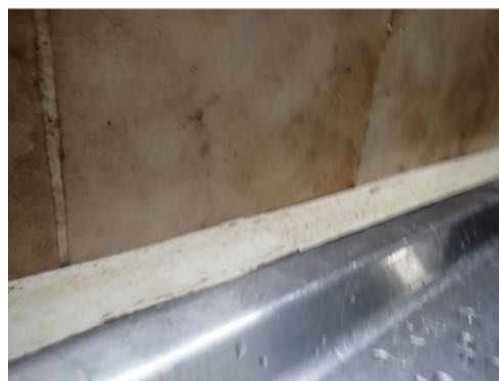
Finding 2.12

Finding: Kitchen in Average Condition with Multiple Defects Identified

Information: The kitchen was found to be in average condition at the time of inspection. Defects observed included missing kick boards, a swollen bench top around the sink area, missing tiles behind the oven, a swollen cupboard carcass below the sink, and duct tape wrapped around the sink waste plumbing which may indicate a previous or ongoing leak. Deterioration to cabinetry and benchtops is commonly associated with prolonged moisture exposure, particularly around sink areas. It is recommended that a qualified carpenter or kitchen installer assess the cabinetry and benchtop and carry out repairs or replacement as required, and that a qualified plumber inspect the sink waste plumbing to identify and rectify any leaks to prevent further damage. Repairs and maintenance should be carried out as deemed necessary.

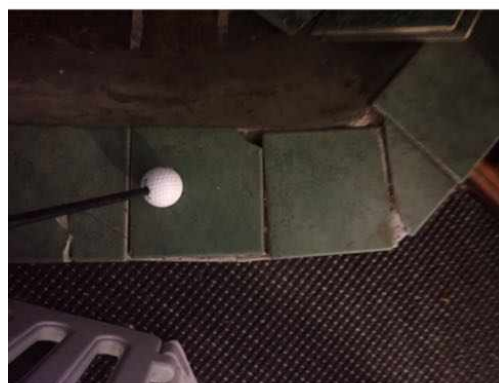
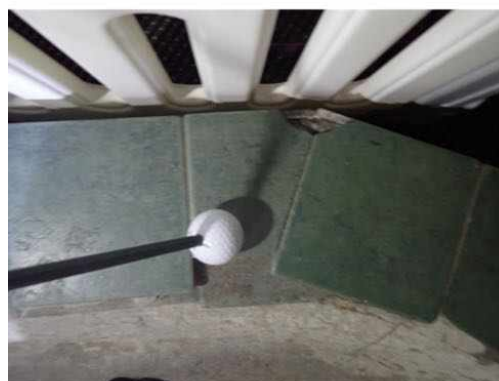
Finding 2.13

Building:	Main Building
Location:	Living Room
Finding:	Poorly Laid and Damaged Tiles Around Fireplace
Information:	Tiles around the fireplace were observed to be poorly laid and damaged at the time of inspection. Poor installation and damaged tiles may allow movement of the tiles and can lead to further deterioration of the tiled surface if not addressed. This condition may be due to poor workmanship, inadequate adhesive, or general wear over time. It is recommended that a qualified tiler assess the affected area and carry out repairs or replacement of the damaged tiles as required to prevent further deterioration. Repairs should be carried out as deemed necessary.

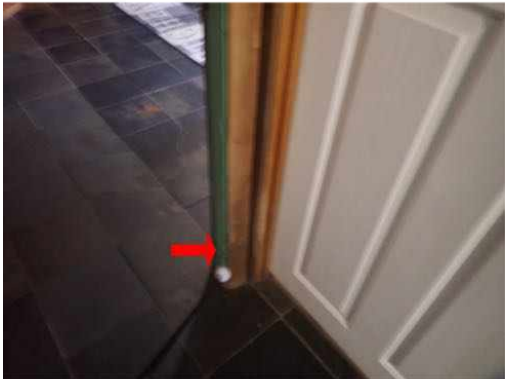
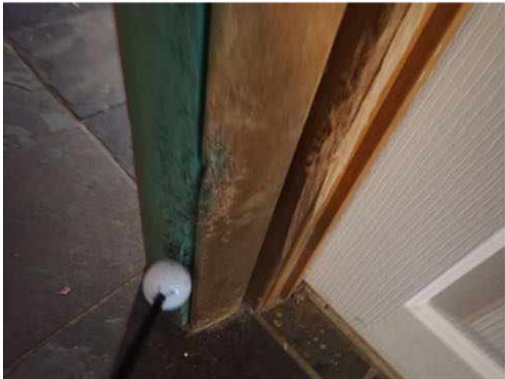
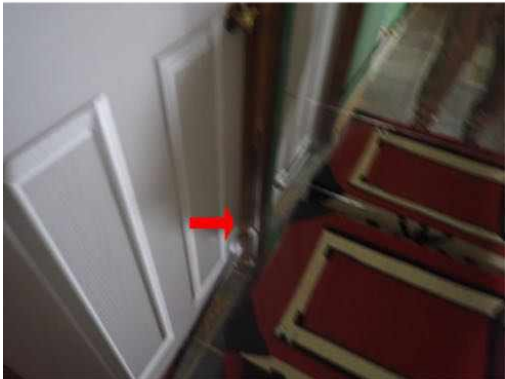
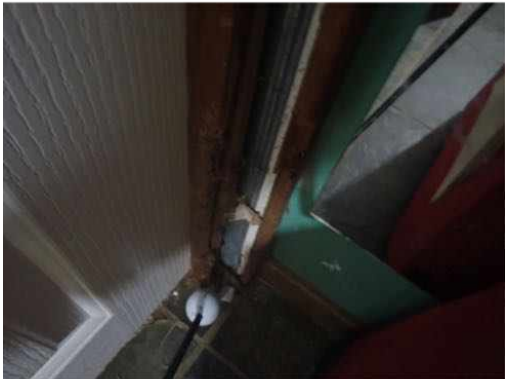
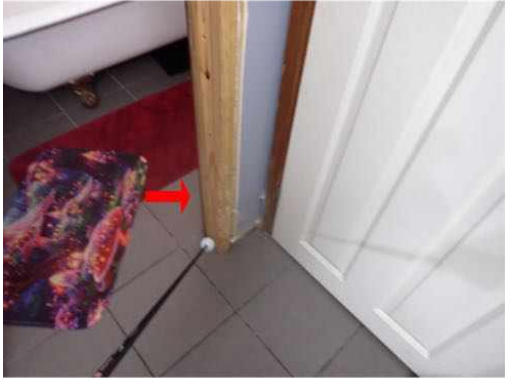
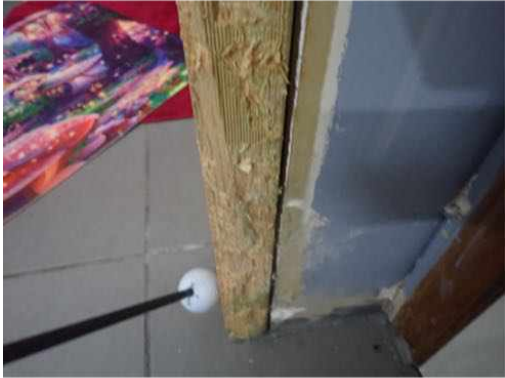
Finding 2.14

Building:	Main Building
Location:	All Areas
Finding:	Damaged or Missing Door Architraves and Jambs at Several Locations
Information:	Damaged or missing door architraves and jambs were identified at several locations throughout the building at the time of inspection. The damage appeared consistent with pet-related wear, likely caused by a dog. Damage to these elements can affect the finish and protection of door openings and may worsen if not repaired. It is recommended that a qualified carpenter assess the affected areas and carry out repairs or replacement of the damaged architraves and jambs as required. Repairs should be carried out as deemed necessary.

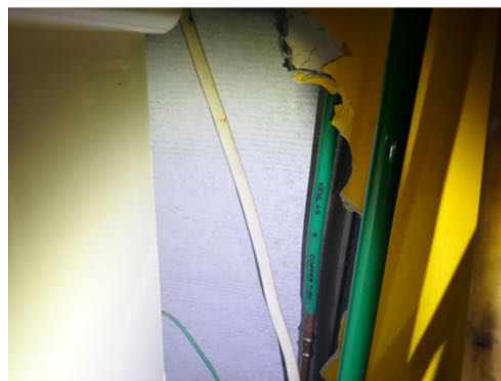
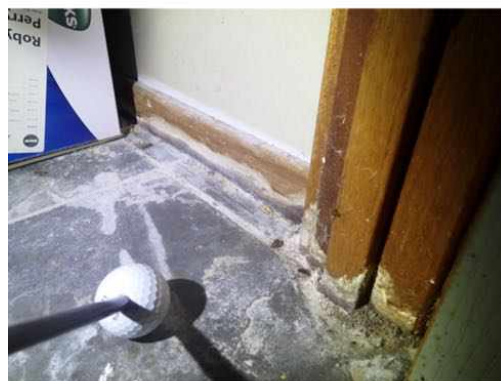
Finding 2.15

Building: Main Building
Location: Laundry and linen cupboard
Finding: Removed Laundry Wall Cladding and Water Damage Adjacent to Shower
Information: Wall cladding had been removed in the laundry to the wall that backs onto the shower, and water damage was identified in the linen cupboard which also backs onto the shower at the time of inspection. These conditions may indicate possible water ingress from the renovated bathroom or associated plumbing and waterproofing. The extent of any concealed damage could not be determined during the visual inspection. It is recommended that a qualified plumber investigate the shower plumbing and that a

qualified builder assess the affected wall areas and carry out repairs as required to prevent further deterioration. Further investigation and rectification works should be carried out as deemed necessary.

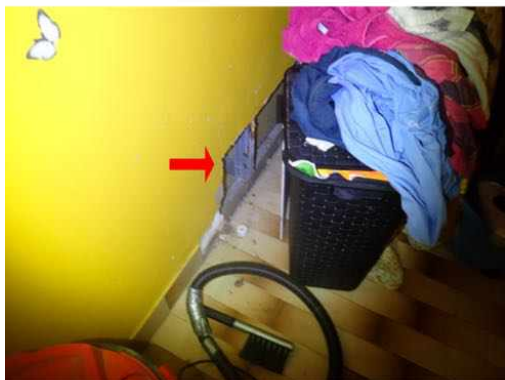
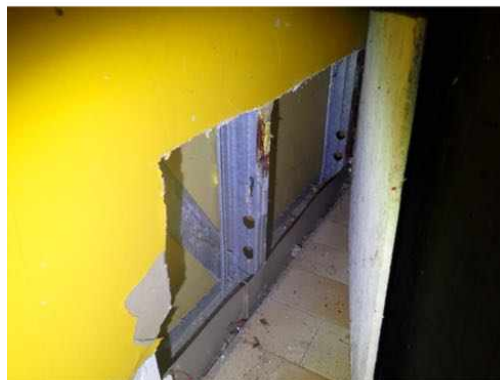
Finding 2.16

Building:	Main Building
Location:	Laundry
Finding:	Plasterboard Cut Out in Laundry Wall
Information:	A section of plasterboard had been cut out from the laundry wall at the time of inspection. Openings in wall linings may expose internal wall components and can allow moisture, pests, or debris to enter the wall cavity if left unrepaired. The cut-out may be related to previous plumbing works, repairs, or investigation of moisture issues. It is recommended that a qualified plasterer or handyman repair and reinstate the plasterboard lining once any underlying issues have been addressed. Repairs should be carried out as deemed necessary.

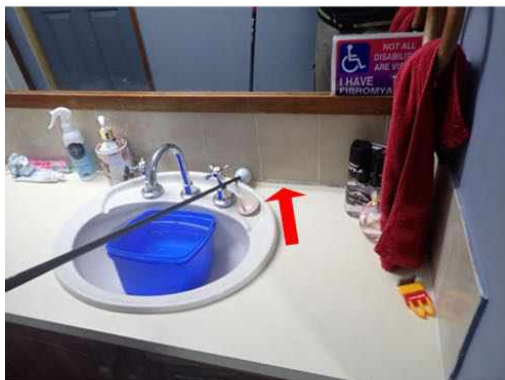
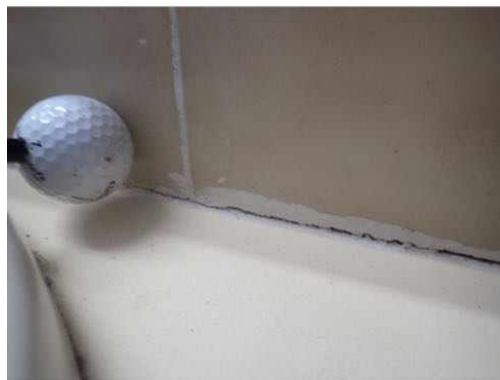
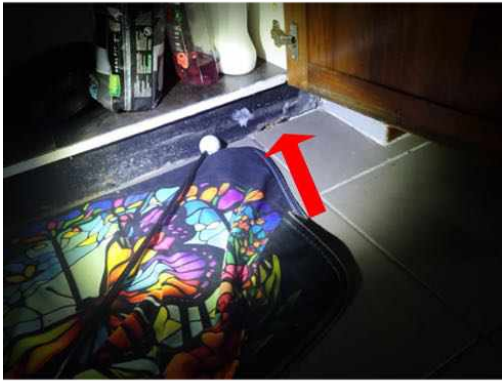
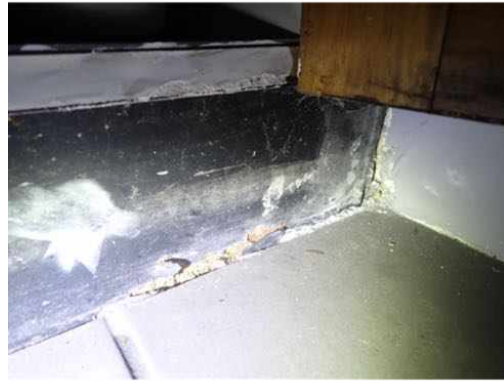
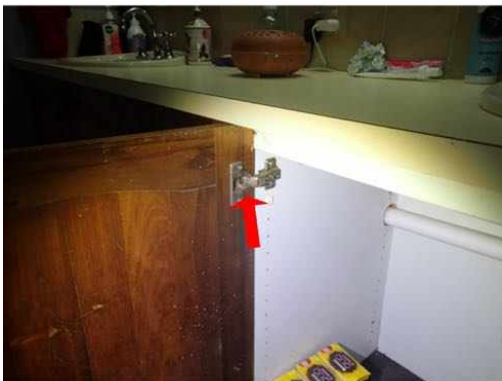
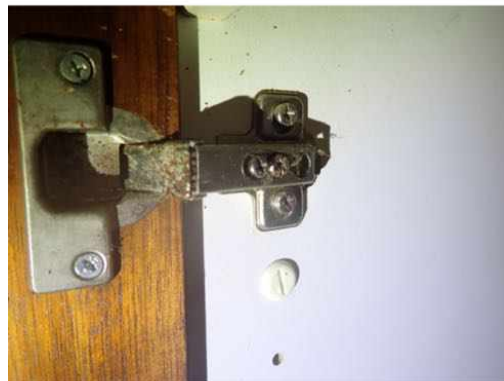
Finding 2.17

Finding: Bathroom Vanity Cupboard in Average Condition with Deterioration

Information: The bathroom vanity cupboard was found to be in average condition at the time of inspection. Defects observed included deteriorated kick boards, deteriorated silicone to the bench top and tile junction, and surface rust to the cupboard hinges. Deterioration in vanity units is commonly associated with moisture exposure in wet areas and may worsen if not maintained. It is recommended that a qualified carpenter repair or replace the deteriorated components as required and that the silicone to the bench top and tile junction be renewed to help prevent moisture ingress. Repairs and maintenance should be carried out as deemed necessary.

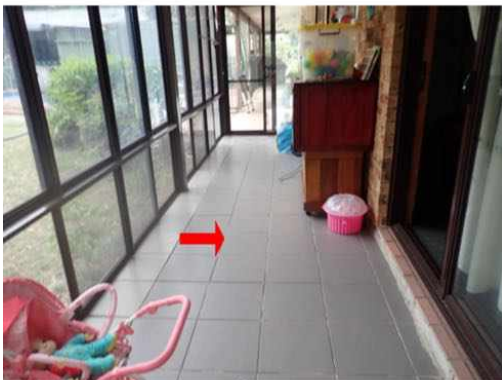
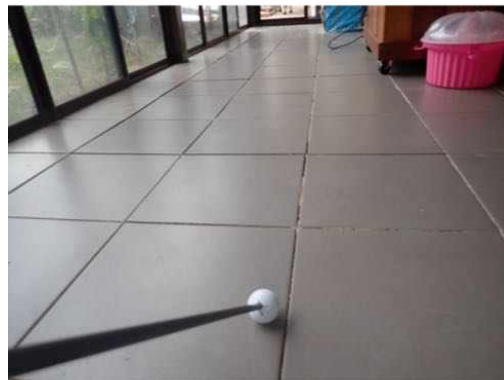
Finding 2.18

Building:	Main Building
Location:	Enclosed side veranda area
Finding:	Poorly Laid Floor Tiles to Enclosed Veranda Area
Information:	The floor tiles to the enclosed veranda area were found to be poorly laid at the time of inspection. Poor installation of tiles may lead to movement, cracking, or loosening of the tiles over time if not addressed. This condition may be due to inadequate surface preparation, insufficient adhesive, or poor workmanship during installation. It is recommended that a qualified tiler assess the tiled area and carry out repairs or reinstallation as required to ensure the tiles are properly secured and finished. Repairs should be carried out as deemed necessary.

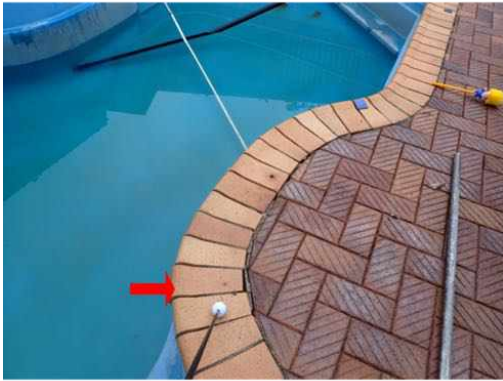
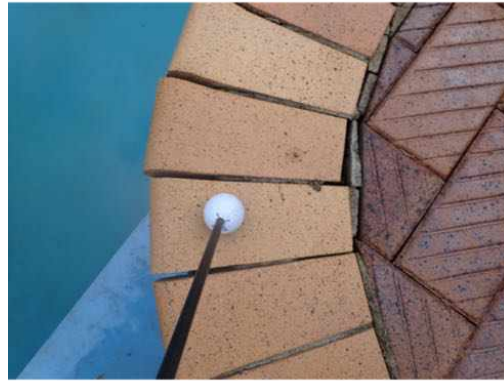
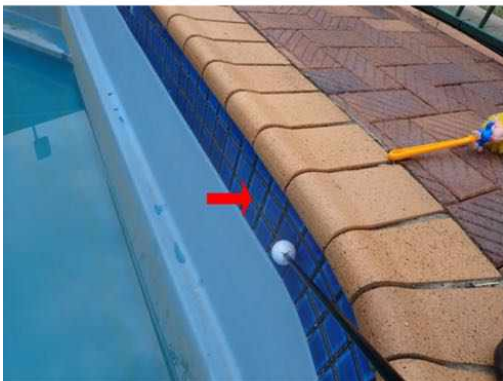
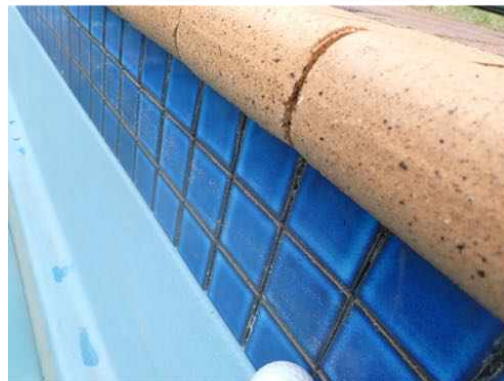
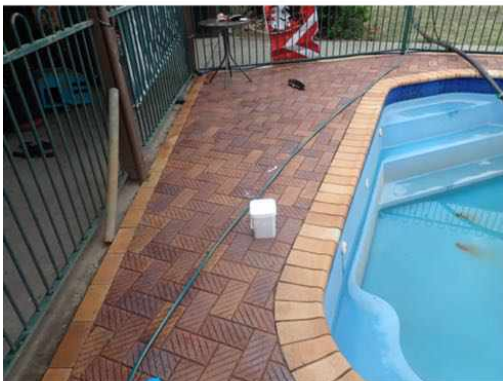
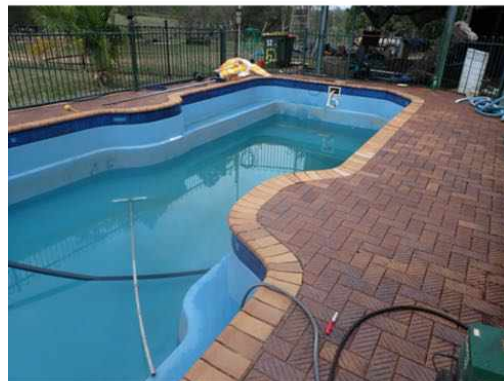
Finding 2.20

Building:	Yard
Location:	Pool
Finding:	Loose Pool Coping and Deteriorated Grout Around Pool
Information:	The paving around the pool was found to be in good condition at the time of inspection. However, sections of the pool coping were loose and the grout to the pool coping and tile band was deteriorated. Loose coping and deteriorated grout can allow movement of the coping and may permit water penetration which can lead to further deterioration if not addressed. It is recommended that a qualified tiler or pool contractor assess the affected areas and carry out re-fixing of the coping and re-grouting as required to prevent further deterioration. Repairs should be carried out as deemed necessary.

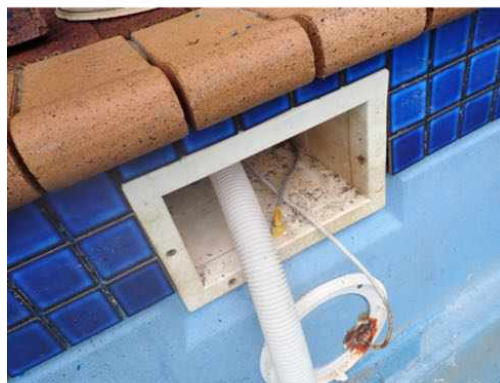
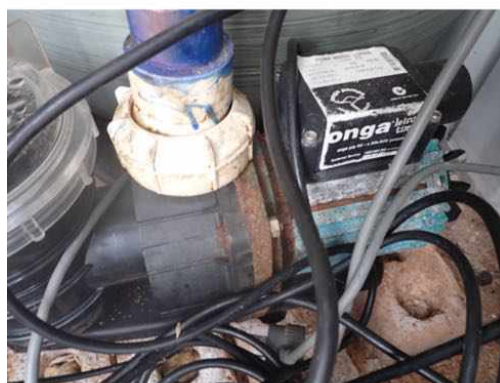
Finding 2.21

Building:	Yard
Location:	Pool
Finding:	Pool Pump Not Operating at Time of Inspection – Equipment in Average Condition
Information:	The pool pump and associated plumbing were found to be in average condition at the time of inspection; however, the pump was not operating at the time of inspection. The reason for the pump not functioning could not be determined during the visual inspection. It is recommended that a qualified pool technician or electrician inspect the pump and associated equipment to determine the cause of the issue and carry out repairs as required to ensure the system is functioning correctly. Repairs should be carried out as deemed necessary.

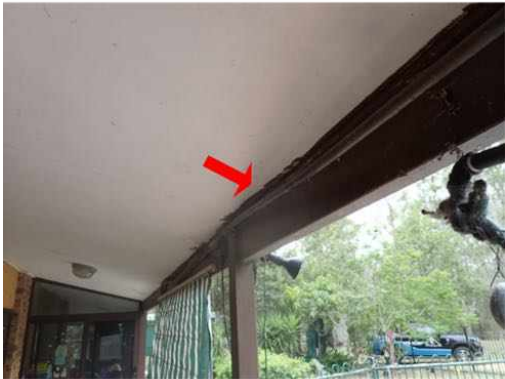
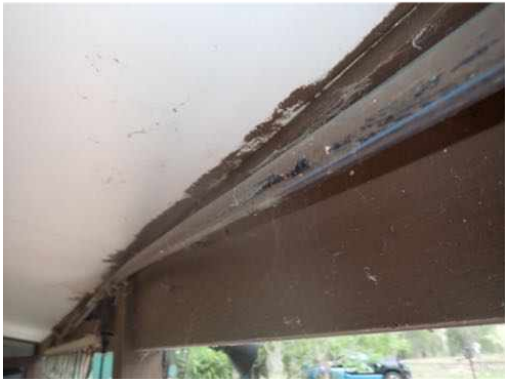
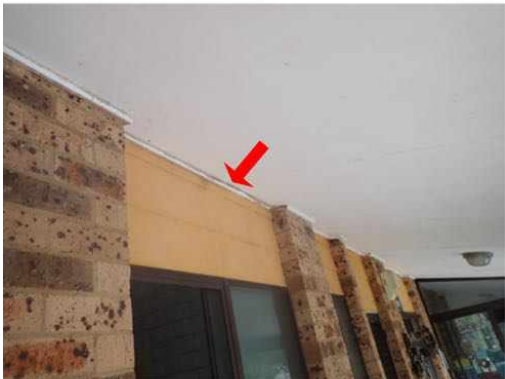
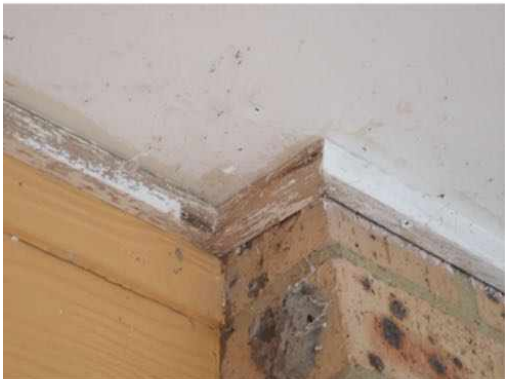
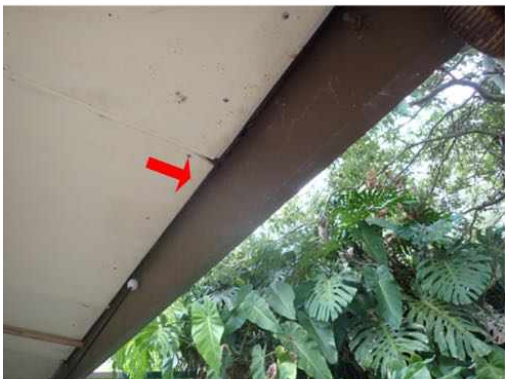
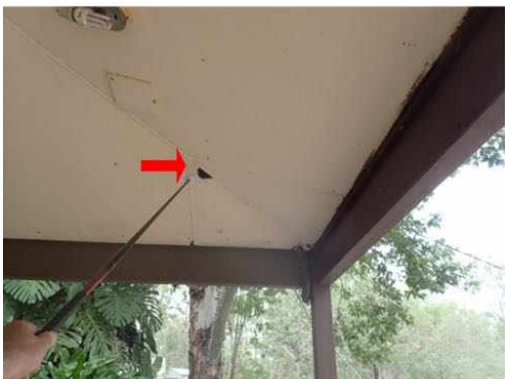
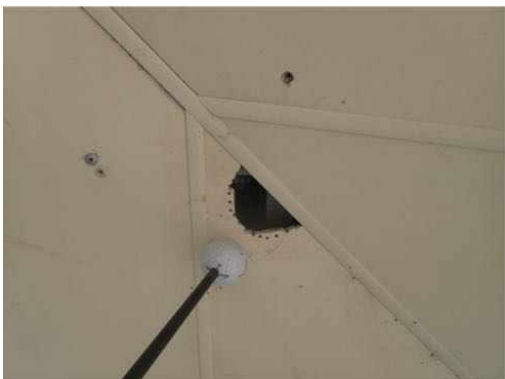
Finding 3.01

Building:	Main Building
Location:	Ceiling around patio area
Finding:	Patio Ceiling Cladding Damage, Poor Paint Finish and Missing Timber Trim
Information:	The ceiling around the patio area was found to be in poor condition at the time of inspection. Defects observed included a hole in the ceiling cladding, a poor-quality paint finish, and missing timber trim to the right-hand side of the patio ceiling. These issues may allow deterioration to progress and reduce the overall durability and appearance of the area. This condition may be due to ageing materials or previous poor-quality repairs or installation. It is recommended that a qualified carpenter and/or painter carry out repairs to the ceiling cladding, replace missing trims, and rectify the paint finish to prevent further deterioration. Regular maintenance of external ceiling areas will assist in preventing similar issues in the future. Repair or replacement should be carried out as deemed necessary.

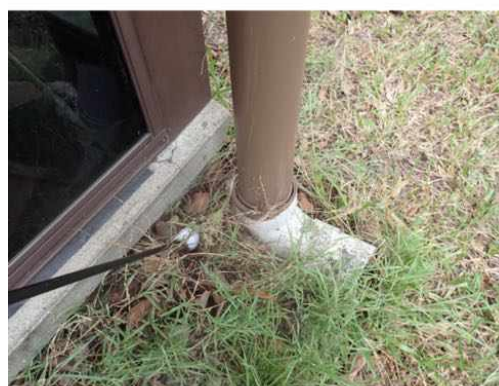
Finding 3.02

Building:	Main Building
Location:	Rear left hand corner of building
Finding:	Downpipe Not Secured to Wall at Rear Left Corner of Building
Information:	A downpipe at the rear left-hand corner of the building was observed to be connected to the gutter but not properly secured along the wall at the time of inspection. Downpipes should be adequately fixed to the wall to provide support and prevent movement or damage during normal use and weather events. This condition may be due to missing or loose brackets or previous repairs. It is recommended that a qualified plumber or handyman secure the downpipe to the wall with appropriate brackets to ensure it is adequately supported and functioning as intended. Repairs should be carried out as deemed necessary.

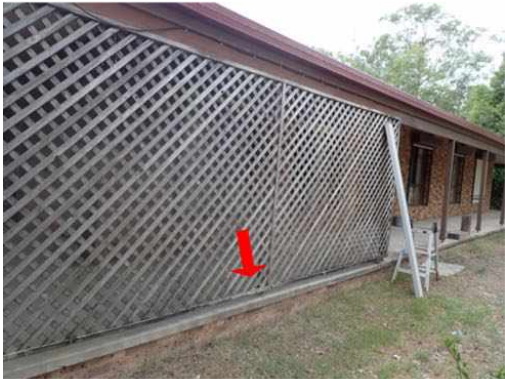
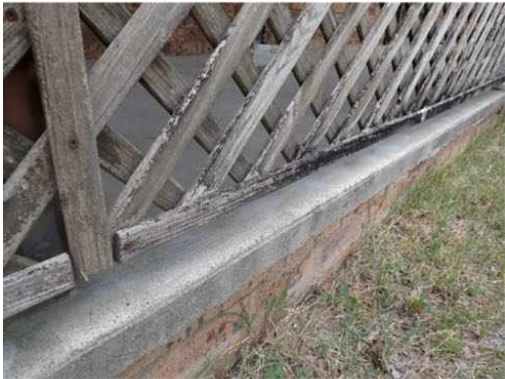
Finding 3.03

Building:	Main Building
Location:	Patio area
Finding:	Timber Trellis to Patio in Average Condition
Information:	The timber trellis on the right-hand and front sections of the patio were found to be in average condition at the time of inspection. Deterioration and weathering to timber trellis elements are common with this type of building material due to ongoing exposure to the elements and ageing of the timber. It is recommended that a qualified carpenter carry out maintenance, repairs, or replacement of deteriorated sections as required. Regular sealing, painting, or treatment of the timber will assist in extending the service life of the trellis. Repairs or replacement should be carried out as deemed necessary.

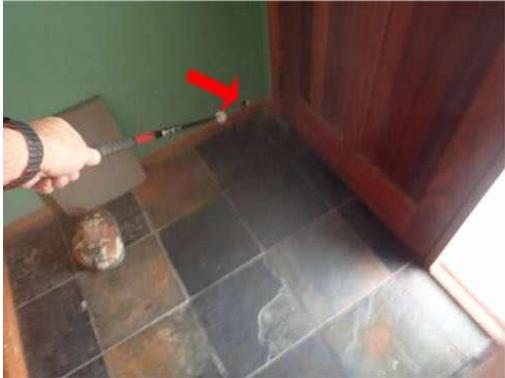
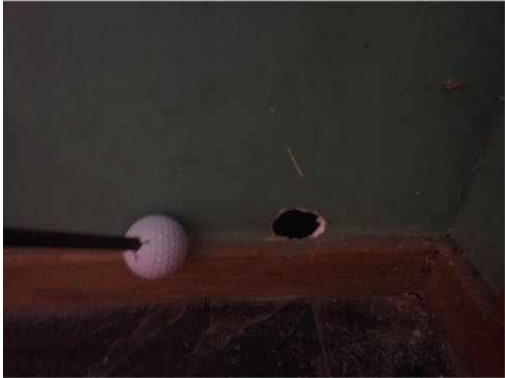
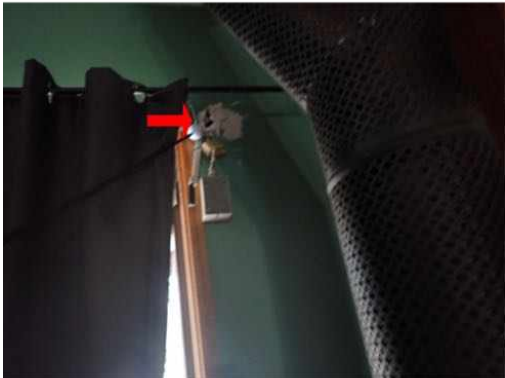
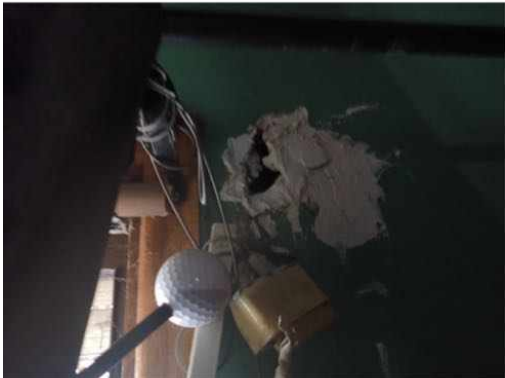
Finding 3.04

Building: Main Building
Location: Living room
Finding: Small Holes in Plasterboard Cladding
Information: A small hole was identified in the plasterboard wall cladding behind the front entry door and living room wall at the time of inspection. Damage to internal cladding can occur due to impact, general wear, or previous alterations and may allow further deterioration if not repaired. It is recommended that a qualified plasterer or handyman repair the affected section of plasterboard and refinish the surface as required to restore the wall finish. Repairs should be carried out as deemed necessary.

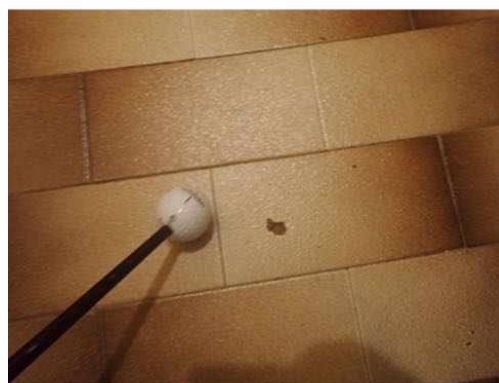
Finding 3.05

Building:	Main Building
Location:	Laundry
Finding:	Chipped Floor Tiles to Laundry
Information:	Chipped floor tiles were identified in the laundry at the time of inspection. Damage to floor tiles can occur due to impact, general wear, or movement and may worsen over time if not repaired. It is recommended that a qualified tiler assess the affected tiles and carry out repairs or replacement as required to maintain the condition of the floor surface. Repairs should be carried out as deemed necessary.

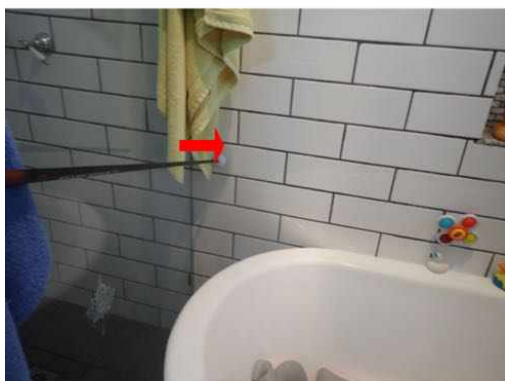
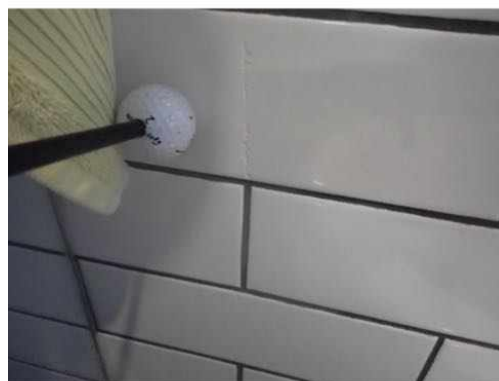
Finding 3.06

Building:	Main Building
Location:	Bathroom
Finding:	Small Cracks in Bathroom Wall Tiles
Information:	Small cracks were identified in the bathroom wall tiles at the time of inspection. Cracking to wall tiles can occur due to minor movement in the wall structure, impact damage, or deterioration of the tile adhesive over time. Damaged tiles may allow moisture to penetrate behind the tiled surface if not maintained. It is recommended that a qualified tiler assess the affected tiles and carry out repairs or replacement as required to maintain the integrity of the tiled surface. Repairs should be carried out as

deemed necessary.

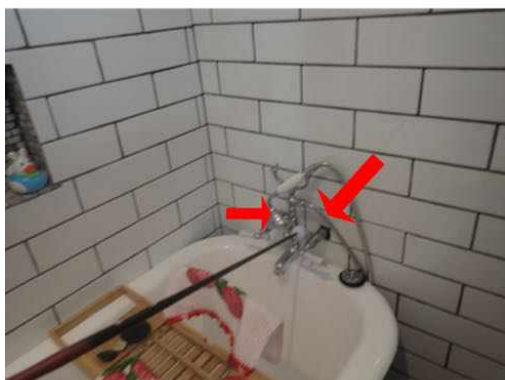
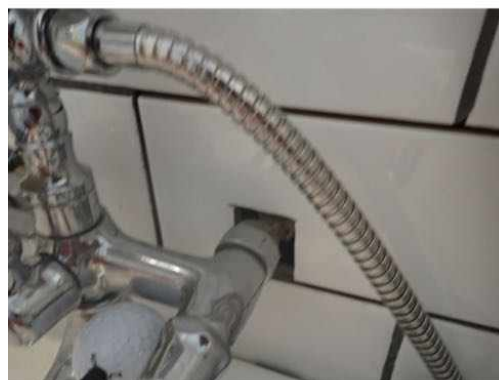
Finding 3.07

Finding: Bath Tub Tap Wall Penetrations Not Sealed

Information: The wall penetrations around the bath tub taps were not sealed at the time of inspection. Unsealed penetrations in wet areas may allow water to enter the wall cavity which can lead to moisture damage and deterioration of surrounding building materials over time. This condition may be due to poor installation or deterioration of previous sealant. It is recommended that a qualified plumber or tiler seal the penetrations with an appropriate waterproof sealant to help prevent moisture ingress. Repairs should be carried out as deemed necessary.
